APPENDIX 6 2023 ANNUAL GEOTECHNICAL INSPECTION REPORT

2023 Annual Geotechnical Inspection Meliadine Gold Mine, Nunavut, Canada

PRESENTED TO
Agnico Eagle Mines Limited

JANUARY 31, 2024
ISSUED FOR USE
FILE: 704-ENG.EARC03140-33
AGNICO EAGLE DOCUMENT NUMBER: 65-600-230-TCR-001

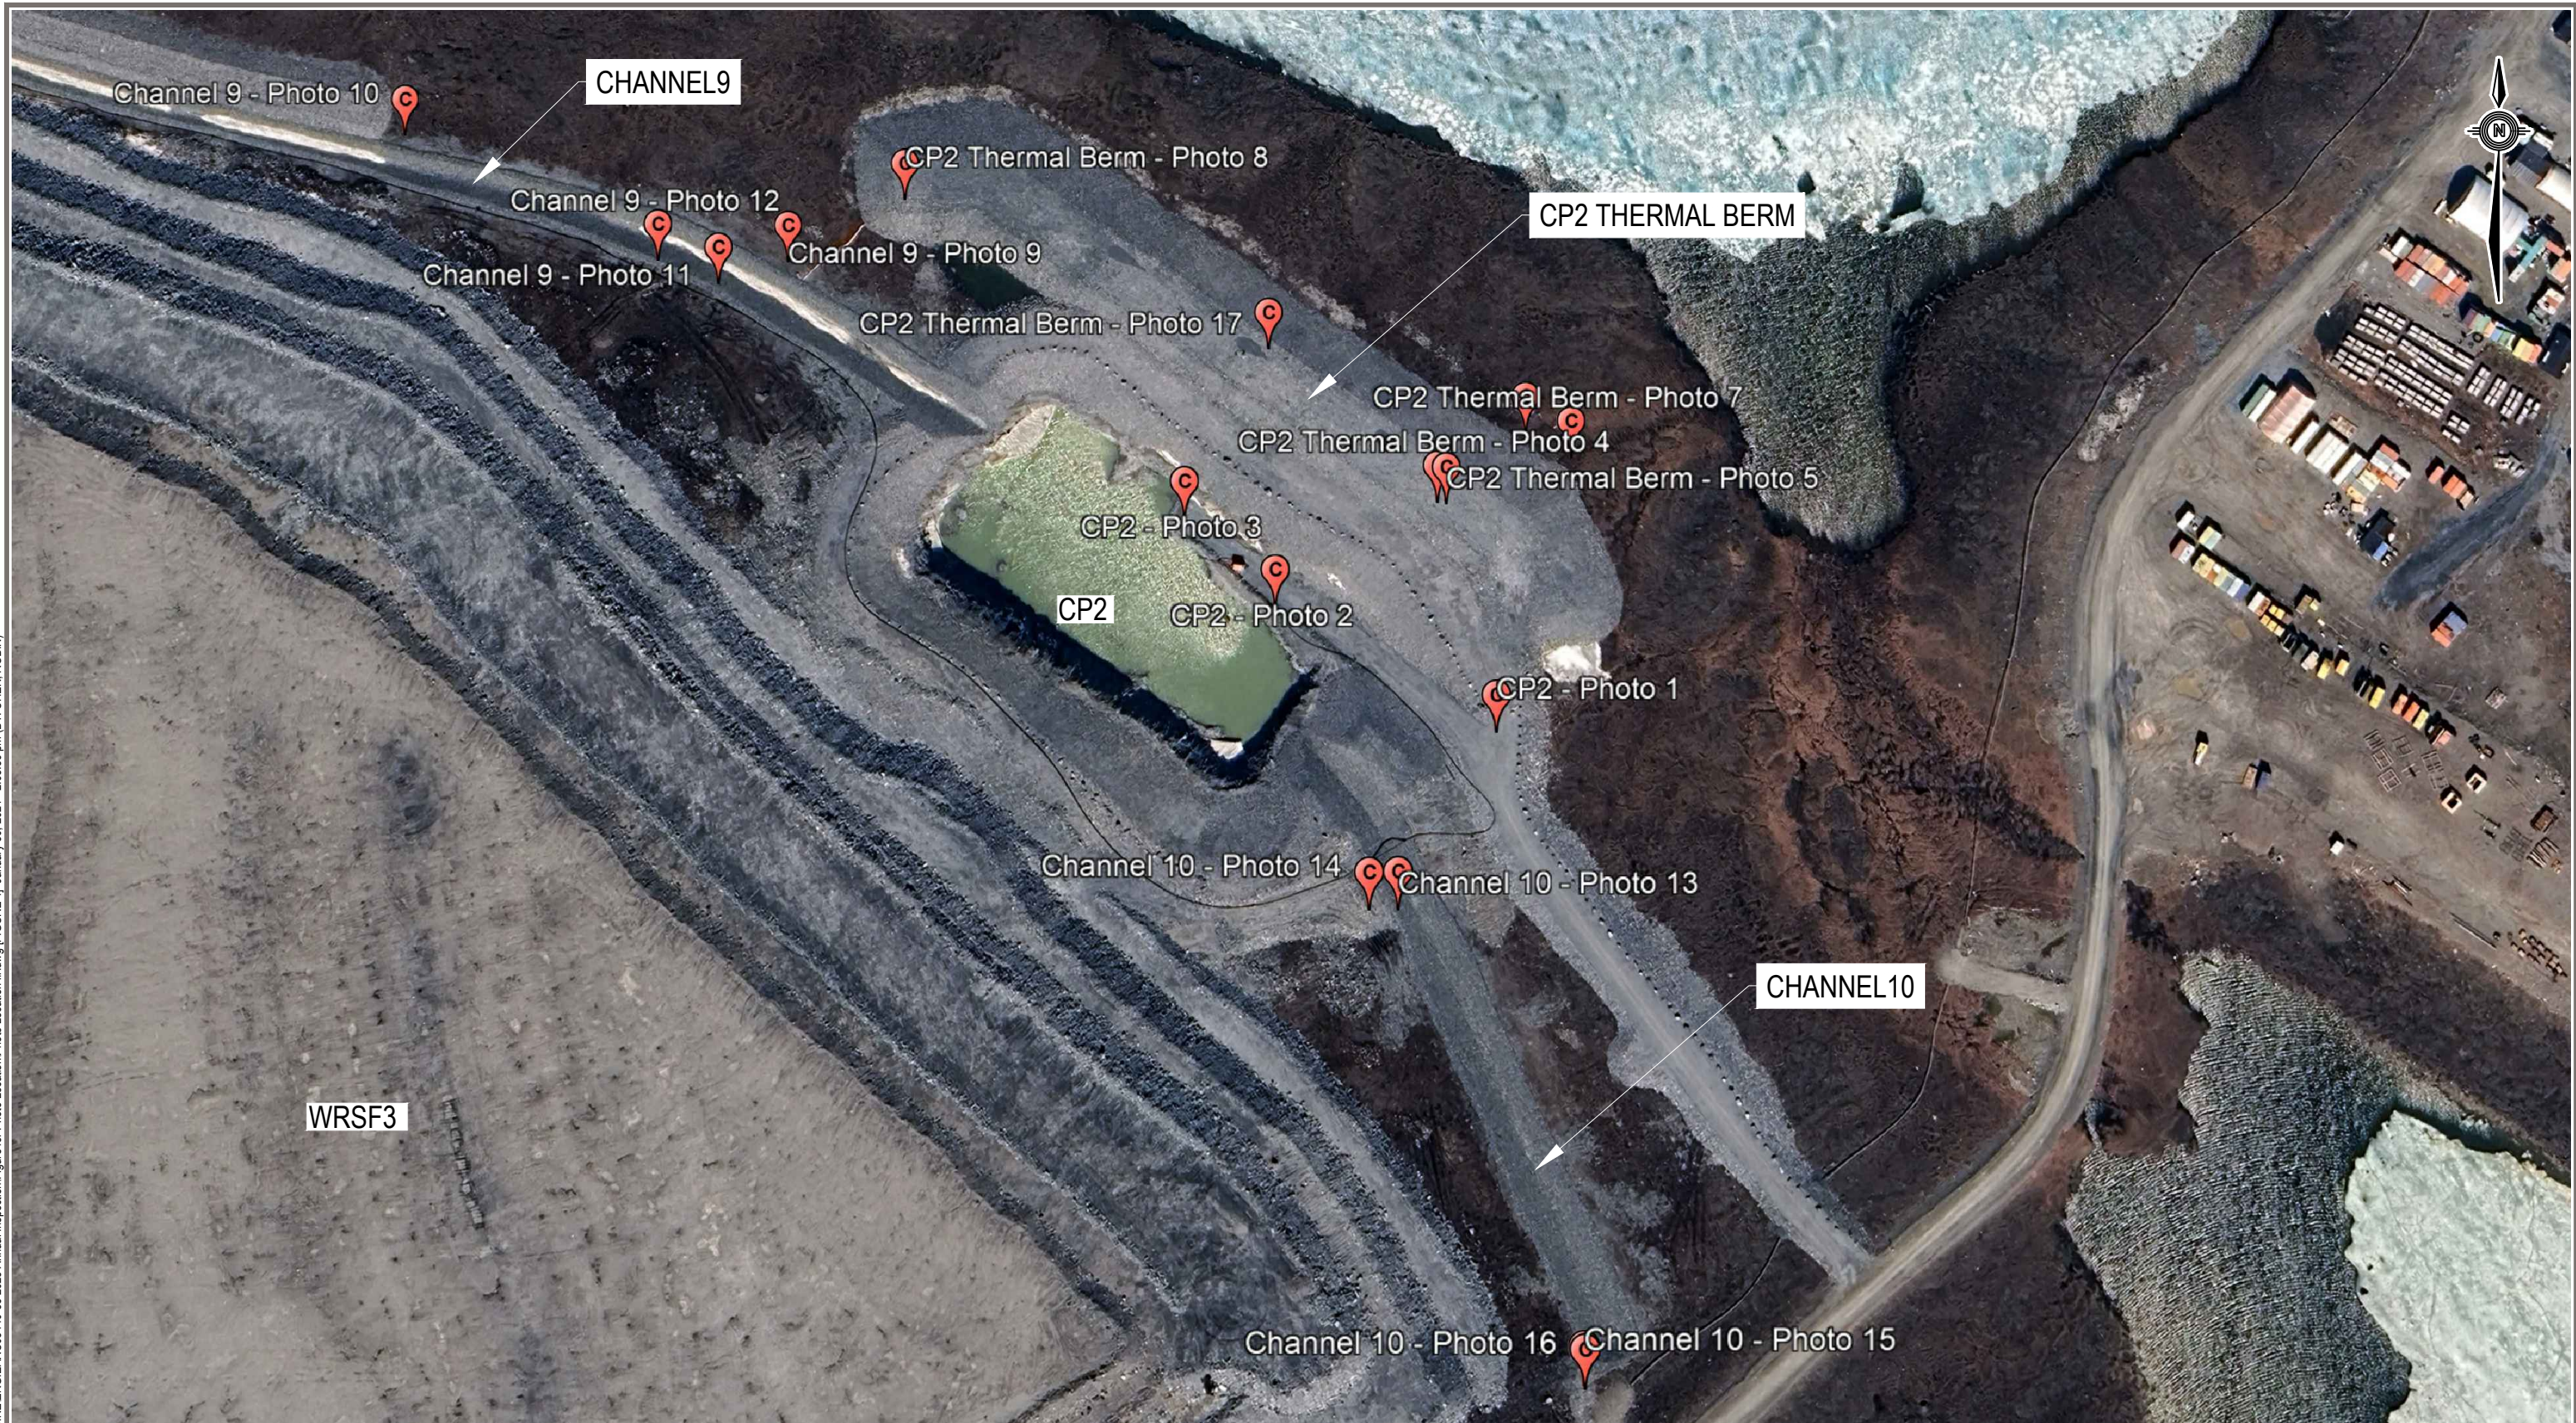
PROJECT NO. ENG. EARC03140-33	DWN RC	CKD HX	REV 0	FIGURE 4
OFFICE EDM	DATE January 05, 2024

Surface ponding was observed against the upstream toe of CP2 Thermal Berm where the protective layer of rockfill was not placed as shown in Photo 8 in Appendix C. Tetra Tech did not observe noticeable sign of permafrost degradation around CP2 Thermal Berm.
