ALL-WEATHER ACCESS ROAD (AWAR)

APPENDIX S

ITIVIA FUEL STORAGE AND BYPASS ROAD

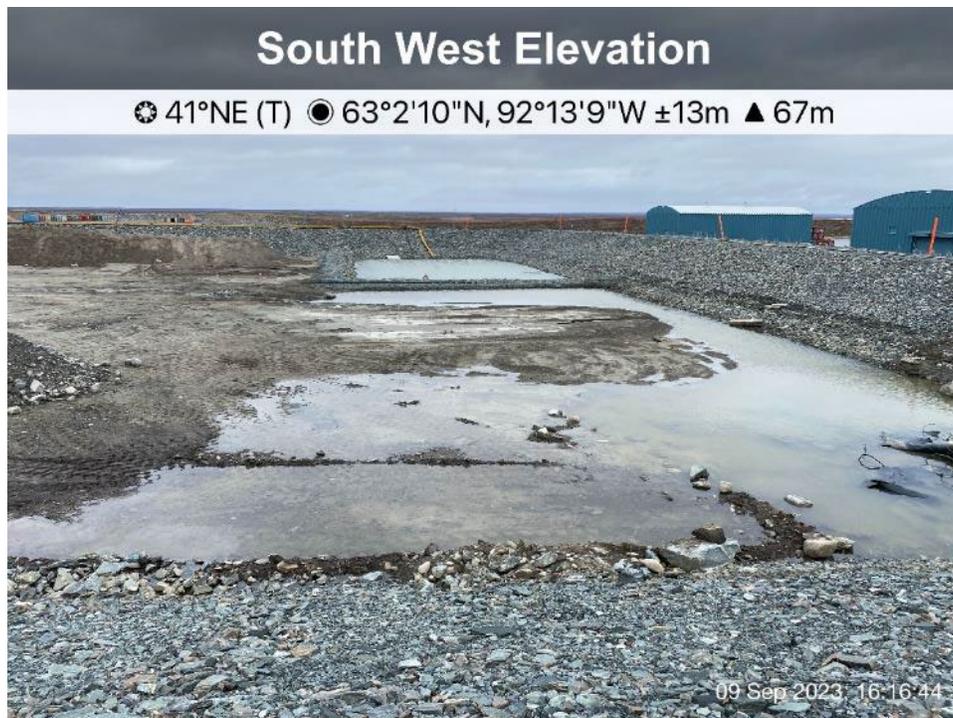
Landfarm - Photo 21: Landfarm - Contaminated soil -2

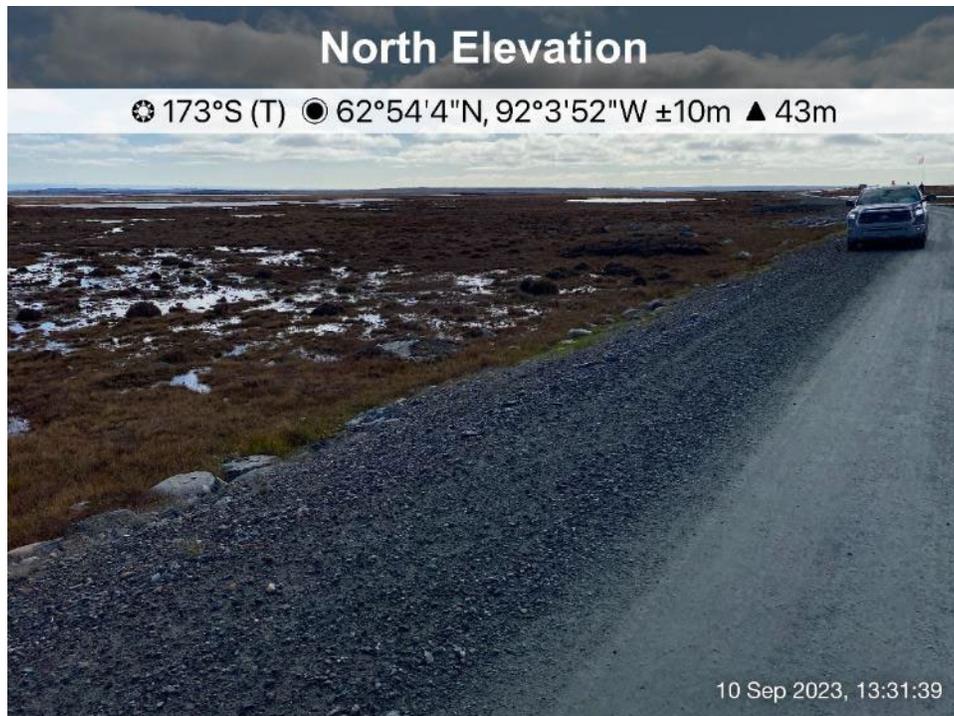
AWAR Road/Culvert - Photo 33: KM 12.6 - No culvert installed, poor drainage condition, no sign of water flow.

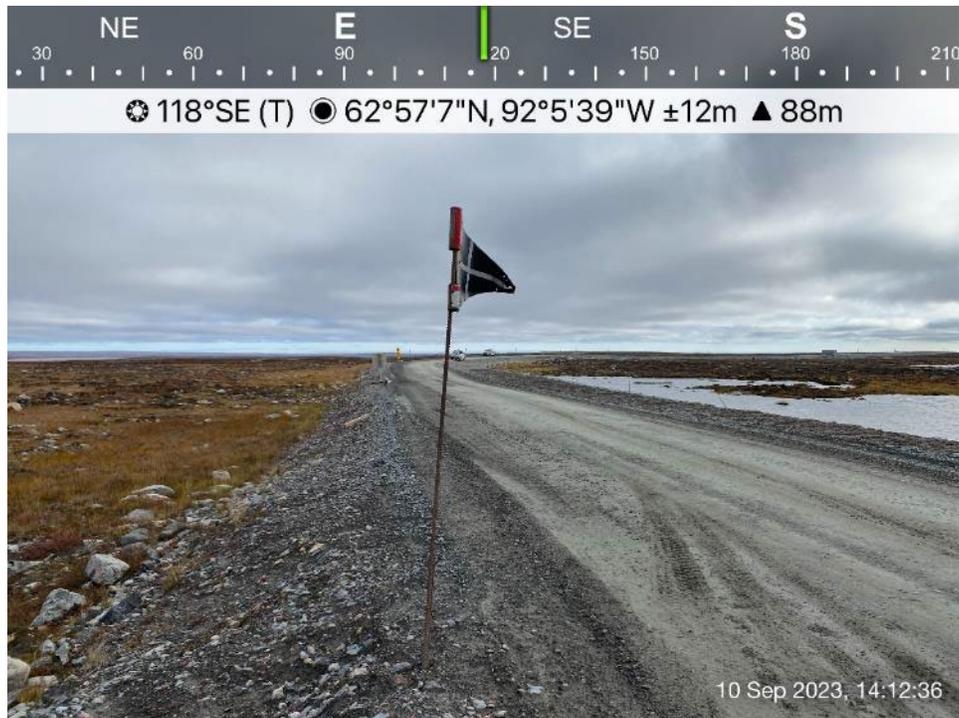
AWAR Road/Culvert - Photo 48: KM 19 - No culvert installed, ponded water upstream, no sign of overflow.

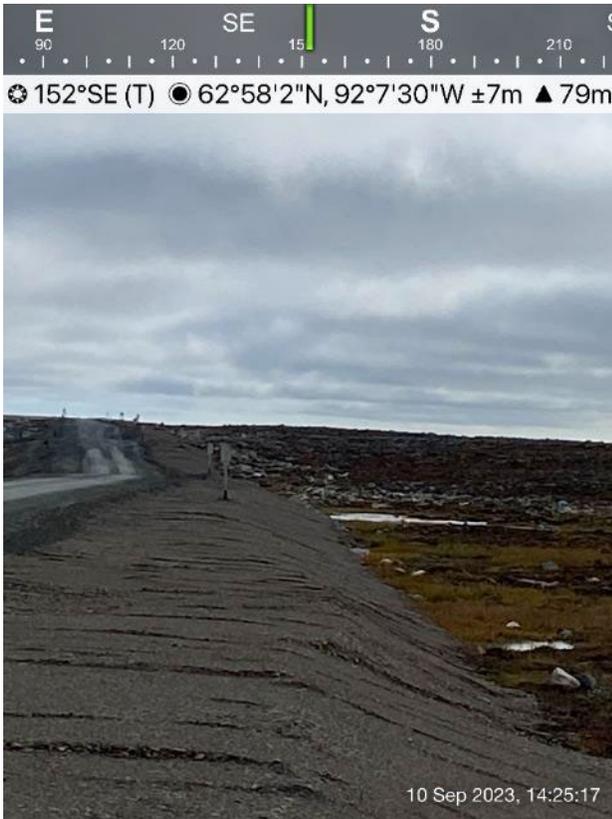
AWAR Road/Culvert
- Photo 51:

KM 21.7 - Culverts were buried during the waterline construction, ponded water observed, poor drainage

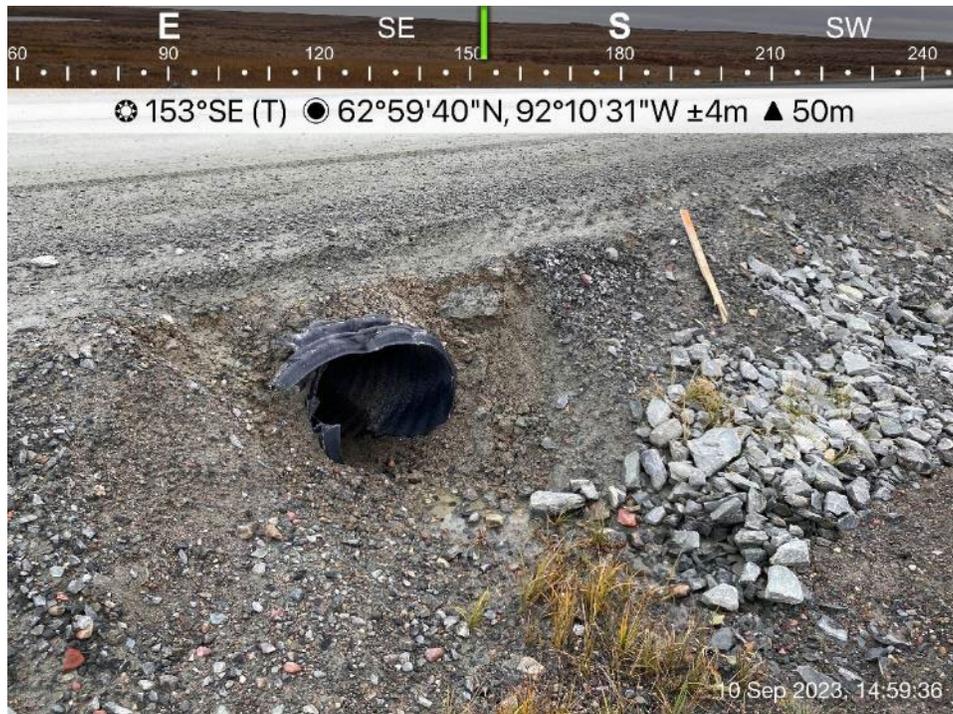
AWAR Road/Culvert - Photo 57: Culvert KM 25.8 - HDPE corrugated culvert - sign of deformation observed.

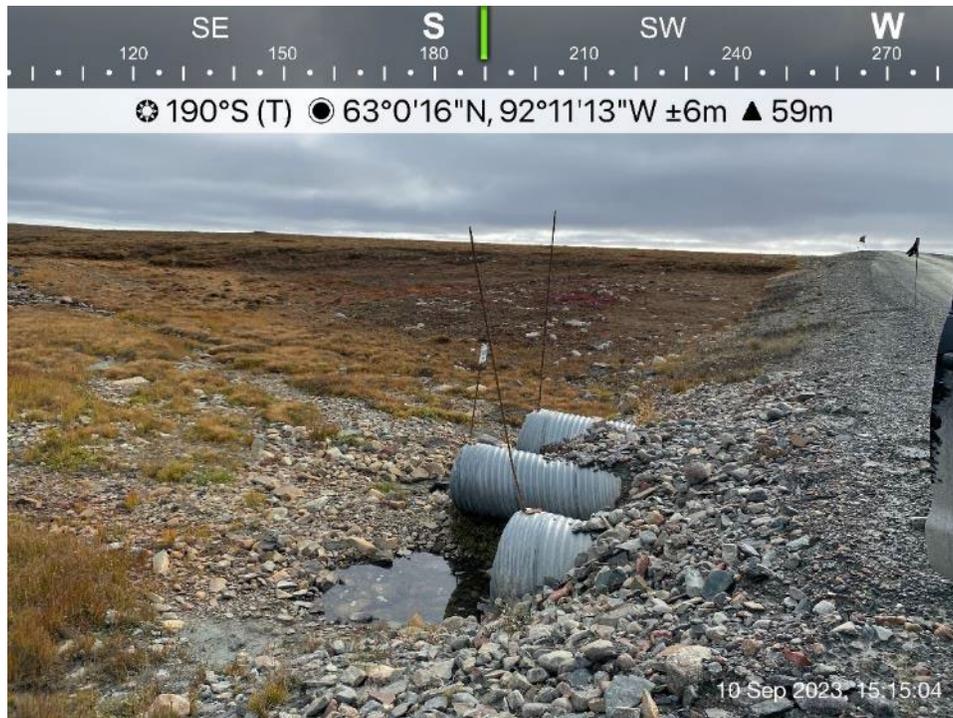
AWAR Road/Culvert - Photo 64: Culvert KM 26.8 - steel pipe as culvert, outlet was buried during the waterline project construction.
