Project Certificate Inspection Report

Authorization	Representative
Agnico Eagle Mines Ltd.	Kyle Conway
Authorization No. / Expiry	Representative's Title
Project Certificate No.:006	Environment General Supervisor
Inspection Date	Inspector
March 4, 2024	RMO Kyle Amsel
Other Authorization/s	
KVCA07Q08, KVCA11Q01, KVPL11D01, 2AM-MEL1631	
Activities Inspected	
<input checked="" type="checkbox"/> Camp, Commercial <input type="checkbox"/> Drilling <input checked="" type="checkbox"/> Mining <input checked="" type="checkbox"/> Construction <input type="checkbox"/> Reclamation <input checked="" type="checkbox"/> Fuel Storage <input checked="" type="checkbox"/> Roads/Hauling <input type="checkbox"/> Winter Hauling <input type="checkbox"/> Camp, Private <input type="checkbox"/> Other Click or tap here to enter text.

On March 4, 2024 Resource Management Officer Kyle Amsel (Inspector) for Crown-Indigenous Relations and Northern Affairs Canada conducted an Inspection of Project Certificate No.:006 (PC) issued to Agnico Eagle Mines Ltd. (Proponent) for the operation of the Meliadine Gold Project.

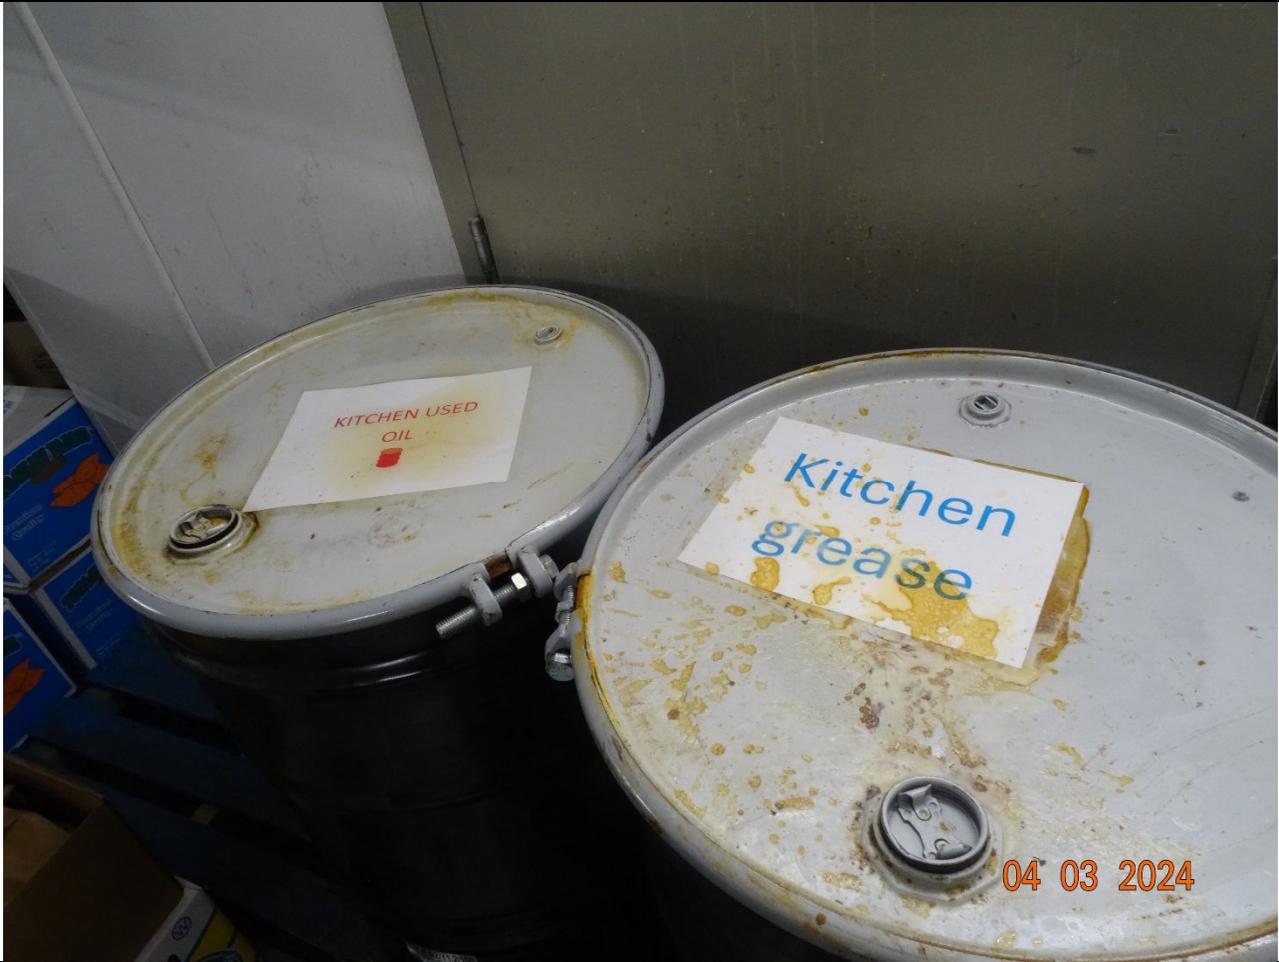
Photo No.	Lat/Long (DD.MM.SS.SS, NAD83)
Photo 2	NA

- 1) Management of attractants, 3.1.6 of TEMMP
 - a) Food wastes on site are not left outside to prevent wildlife from getting into them. Kitchen waste is kept in a designated area within the kitchen complex and removed by a designated crew who sort the removed waste and transport to the designated areas (Photo 1 & 2). Oils and grease are placed into drums and stored in closed sea cans prior to shipping south to disposal facilities, food wastes are taken to the incinerator building and stored inside prior to incineration (Photo 3), cardboard is taken to the burn pad (Photo 4) to be burned with other clean material and cans are placed in closed sea cans to be shipped South.

Description:
Grease and oil storage inside drums within the kitchen complex.

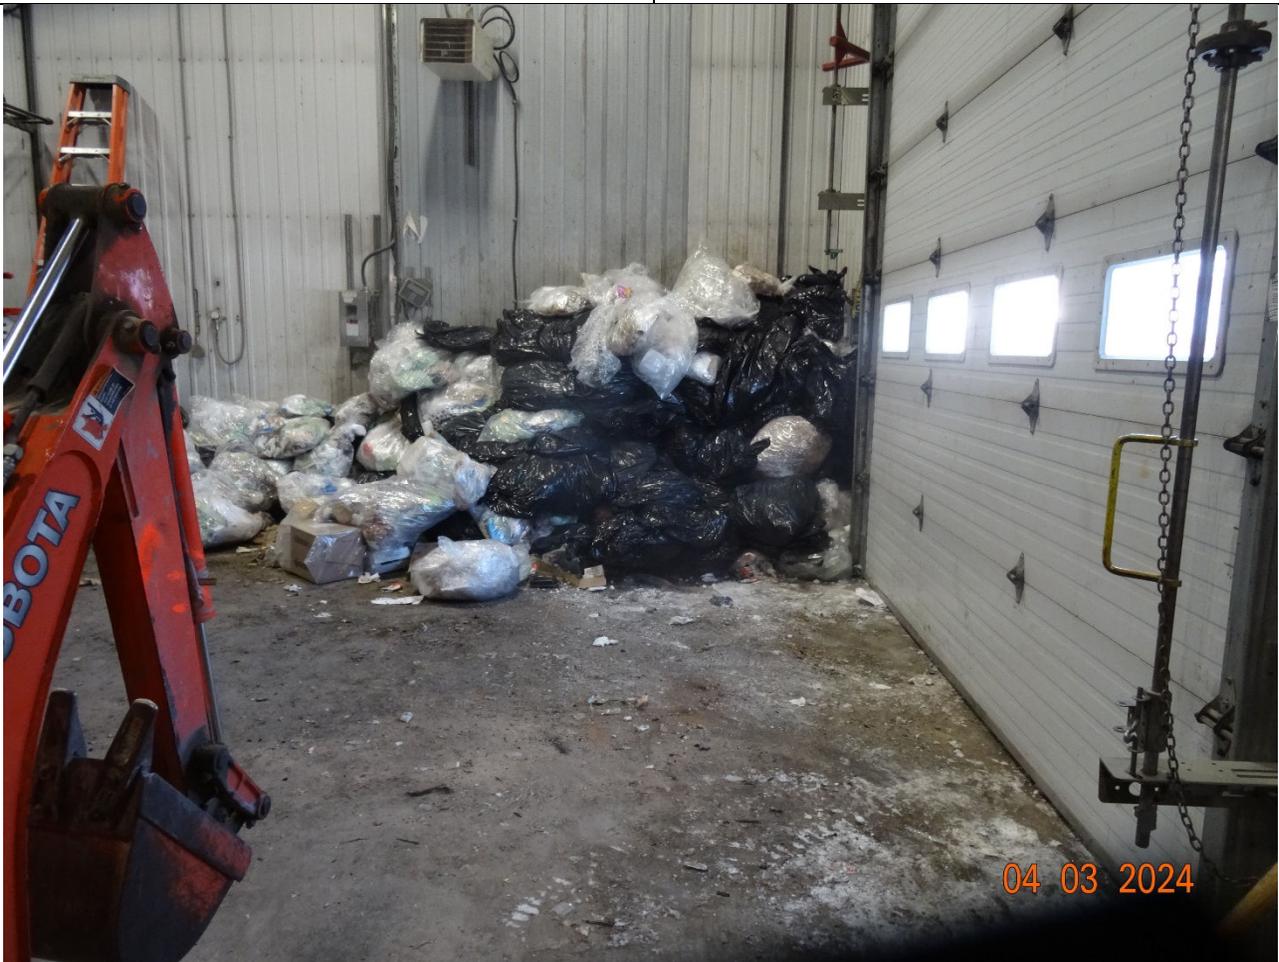
Photo No.	Lat/Long (DD.MM.SS.SS, NAD83)
Photo 3	NA

Description:
Waste stored inside incinerator building prior to being burned.

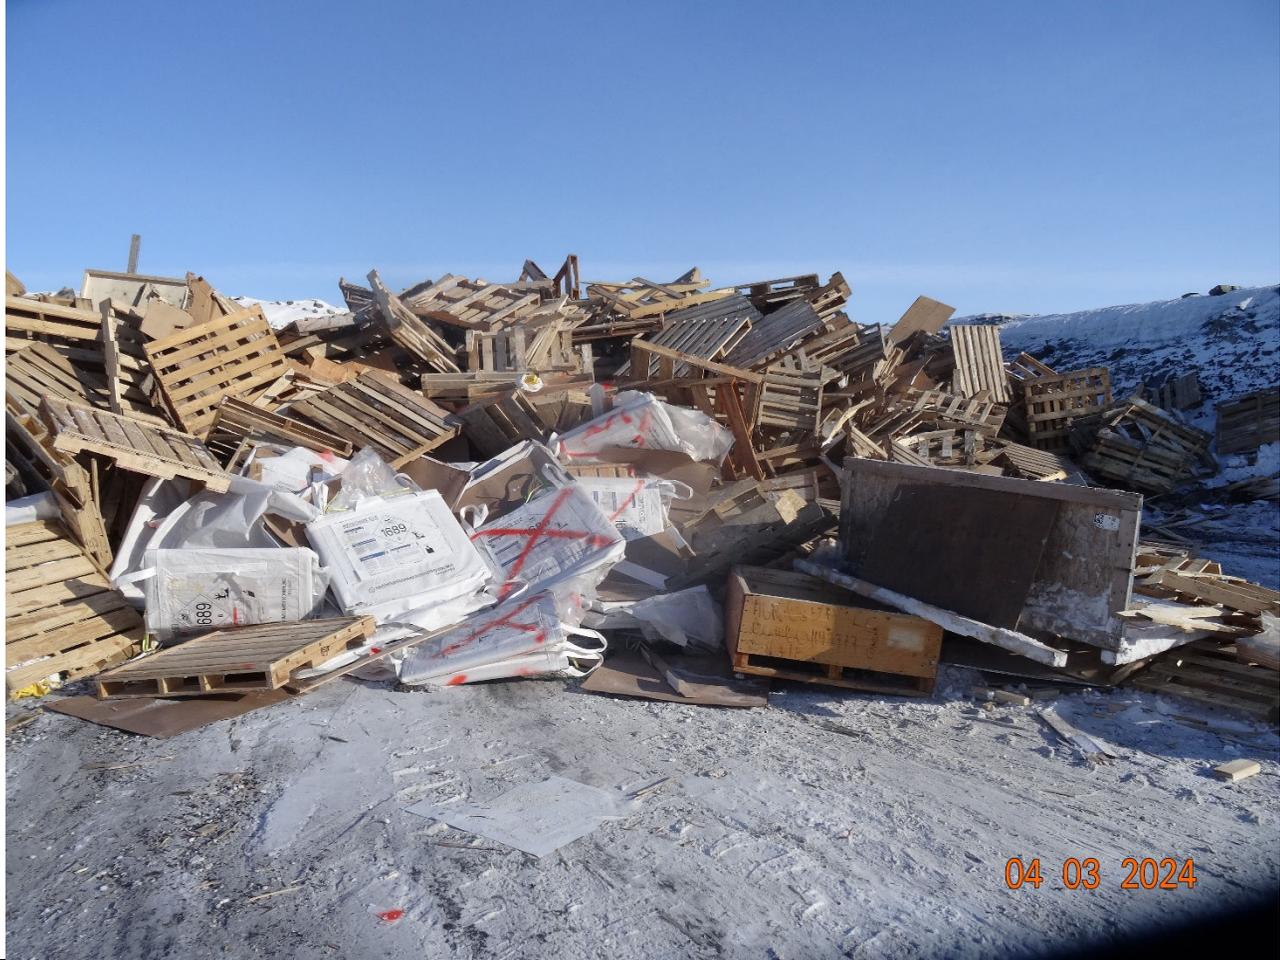
Photo 4

Burn Pad. Note only clean material is to be burned here. Plastic bags are cyanide bags and are burned in this way as per International Cyanide Code.

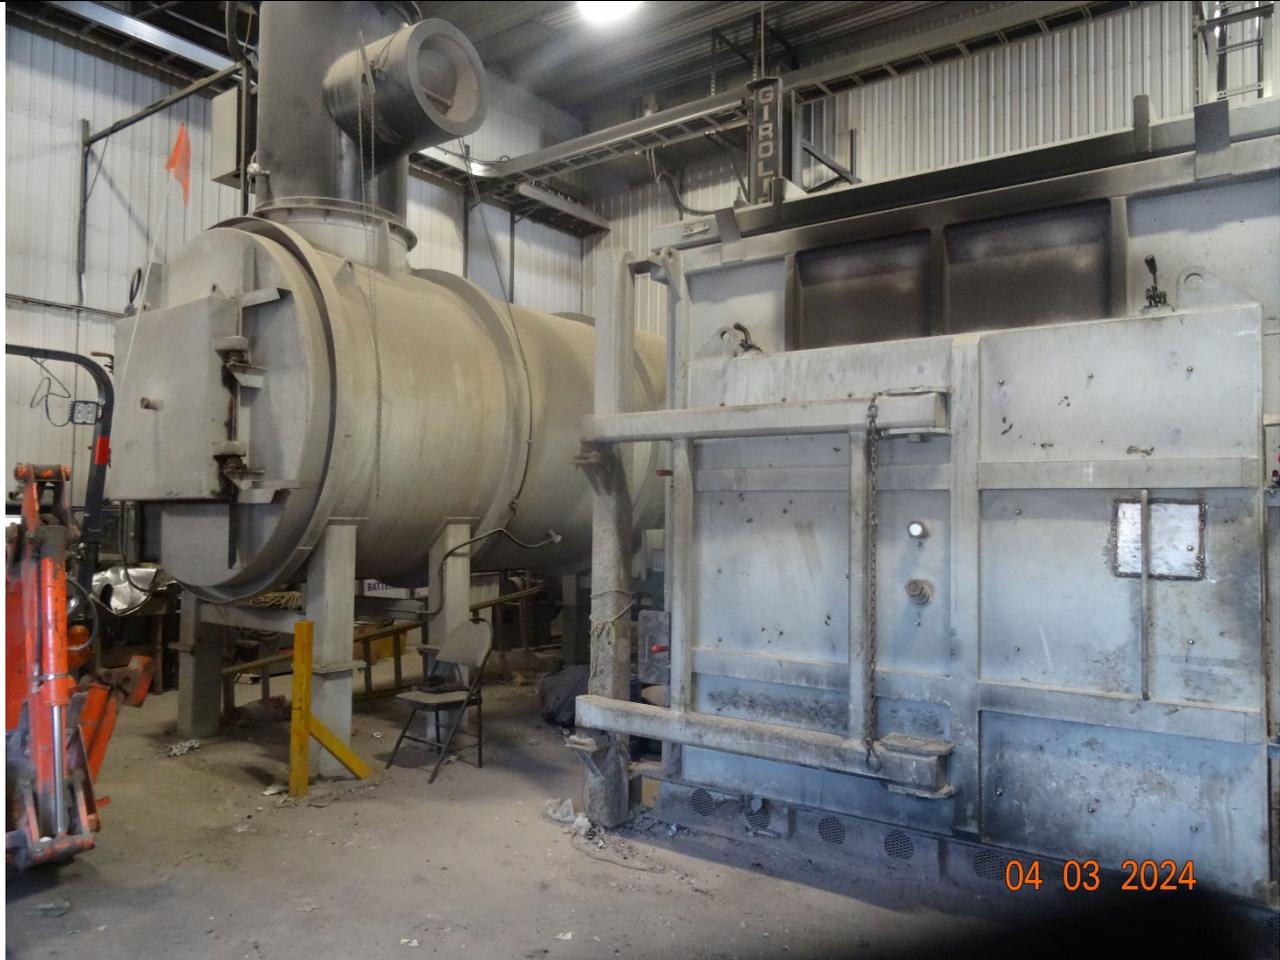
Photo 5

- b) Representatives state that staff working outdoors are provided indoor areas to have lunch.
 - c) One incinerator is inside a building (Photo 5) and the backup incinerator is currently outside. Representative states that a building is currently under construction which will house the incinerator soon.

Incinerator.

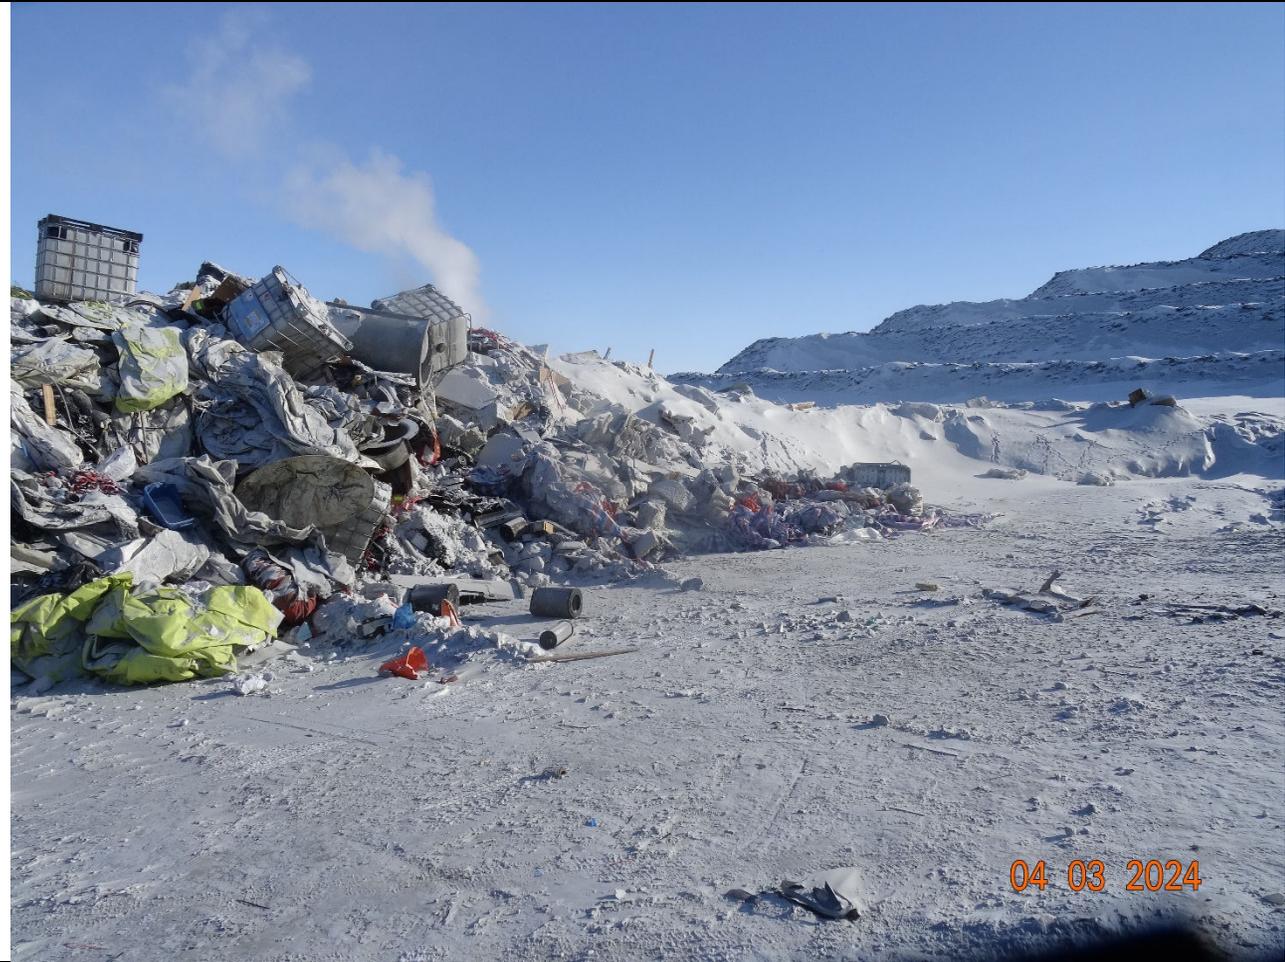
Photo No.	Lat/Long (DD.MM.SS.SS, NAD83)
Photo 6	N63° 1' 56" W92° 13' 41"

- d) As part of the waste management system the garbage truck operator upon taking a load to the landfill personally inspects the dumped wastes to ensure no attractants contained therein. Upon inspection of the landfill and burn area no attractants were observed. (Photo 6)

Description:
Landfill. Note lack of animal tracks on right indicating minimal attractants if any, located within the landfill. No other concerning items were observed in the landfill.

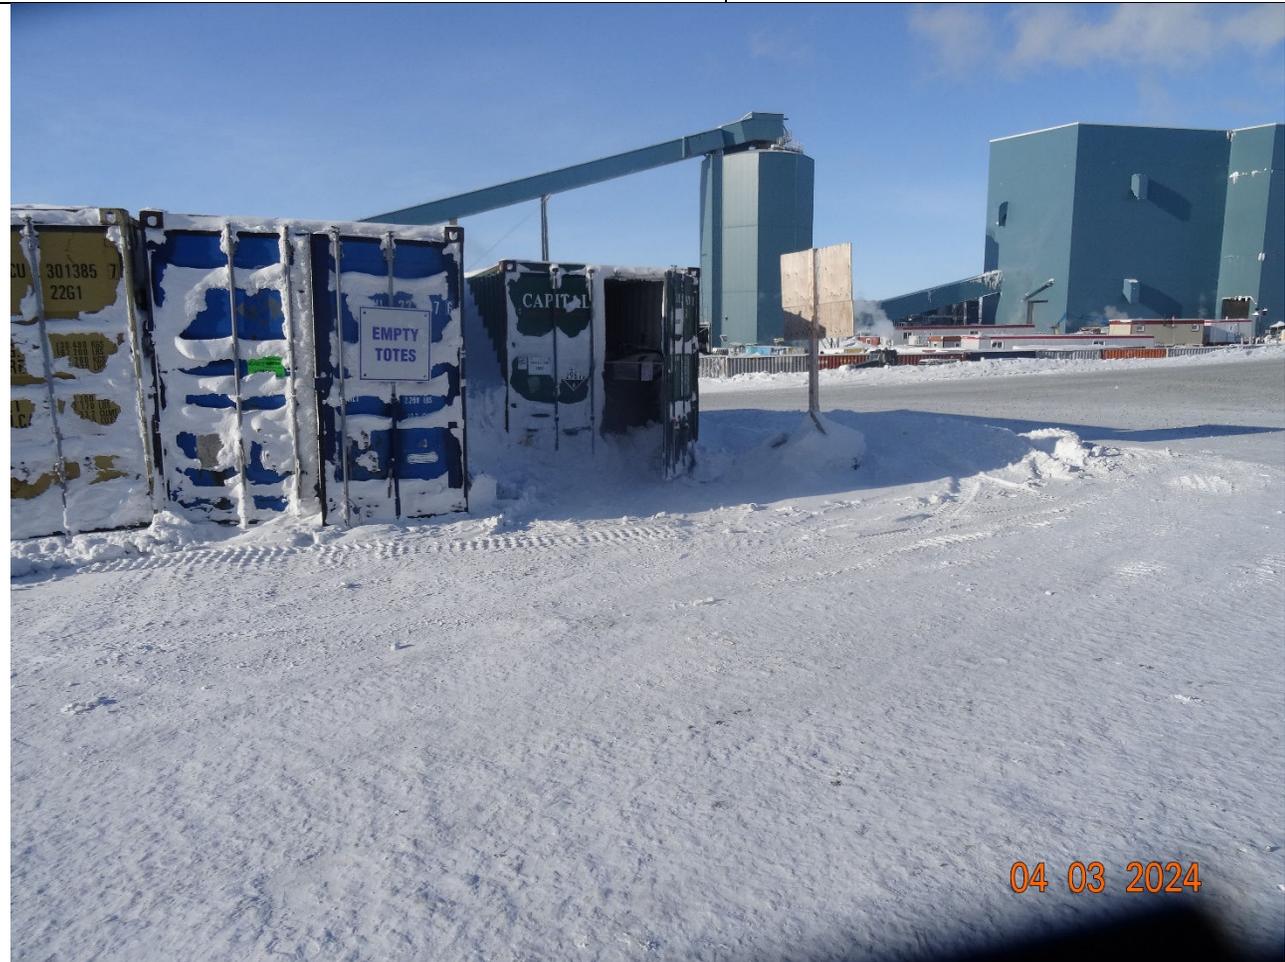
Photo No.	Lat/Long (DD.MM.SS.SS, NAD83)
Photo 7	N63° 1' 56" W92° 13' 41"

- e) In review of the new hire training and E-learning prior to attending site new staff are indoctrinated to sort their waste appropriately.
 - f) Sea cans on site are generally appropriately closed. Approximately 10 sea cans were observed which had open doors and un-disturbed snow at the entrance suggesting they were open for longer periods without use (Photo 7). The Inspector is not concerned with the efforts by the Proponent in this matter, but encourages them to continue best efforts to ensure doors are closed.

Description:
Seacan with door open.

Section 2 Non-Compliance with Project Certificate
No items of non-compliance identified
Section 3 Action Required
The proponent will increase efforts to ensure sea can doors are closed when not in use.
Section 4 Other
