Submission of Annual Geotechnical Inspection – 2024, Mary River Project – Nunavut, Project # CA0039374.4332

The 2024 geotechnical inspection was conducted by Laszlo Bodi, M.Sc., P.Eng., Senior Principal Civil/Geotechnical Engineer with WSP Canada Inc. The inspection focused on waste and water retention infrastructure located at the Mary River Project as required by Type "A" Water Licence No: 2AM-MRY1325 – Amendment No.1 Part I, Item 12. In addition to Part I, Item 12 requirements, Baffinland elected to voluntarily inspect water and waste conveyance structures as well as select bridge and culvert infrastructure.

September 27, 2024

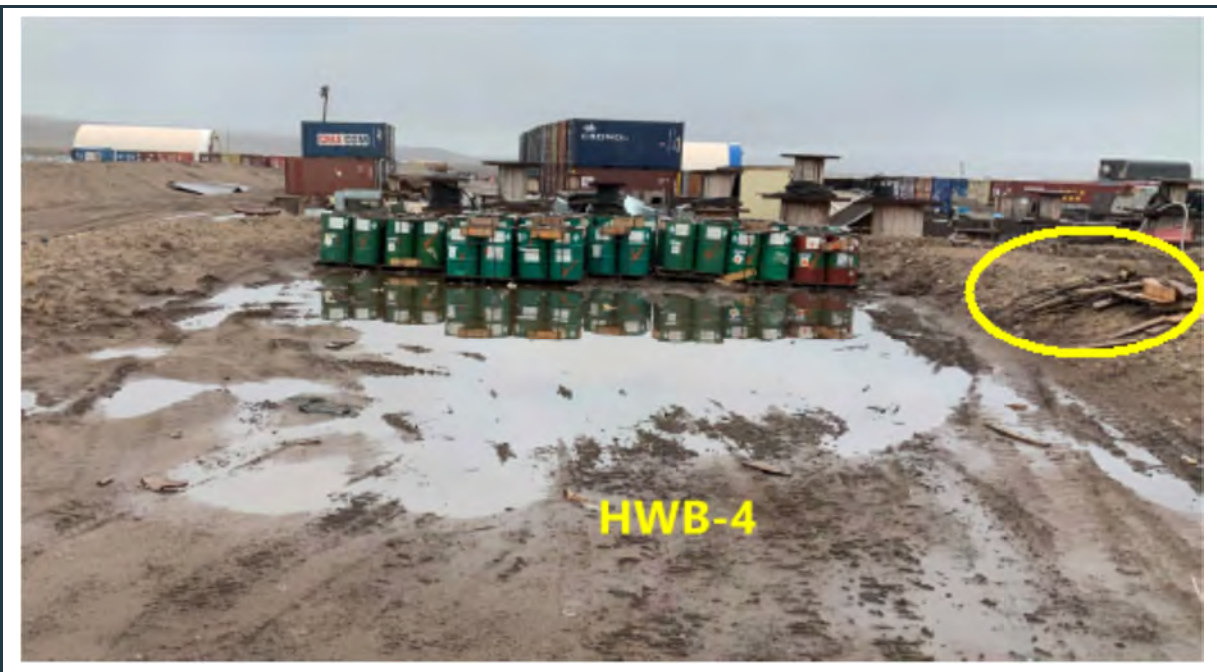
Figure 20: View of stable perimeter berm around the HWB-4 cell, with fuel barrels on wooden pallets stored in the cell. The presence of water in the cell indicates good liner performance. The debris, visible on the right berm, should be removed and disposed (yellow circle).

Recommendation: The debris, visible on the central berm between the two cells should be removed and disposed.

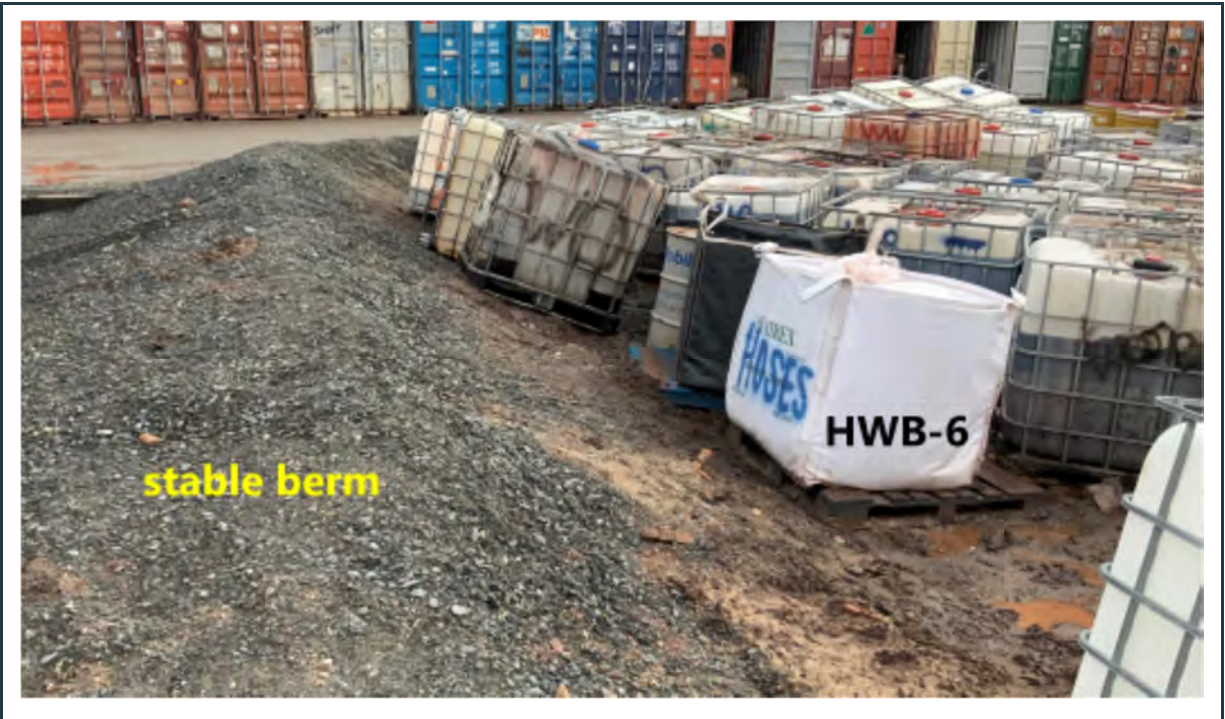
Figure 22: View of the recently regraded stable berm at the HWB-6 cell. The presence of ponding water in the cell indicates good liner performance. This cell is almost always filled to its capacity.

Recommendation: No material should be stored on the slopes or crest of the berms, therefore some of the stored materials in this cell should be rearranged.

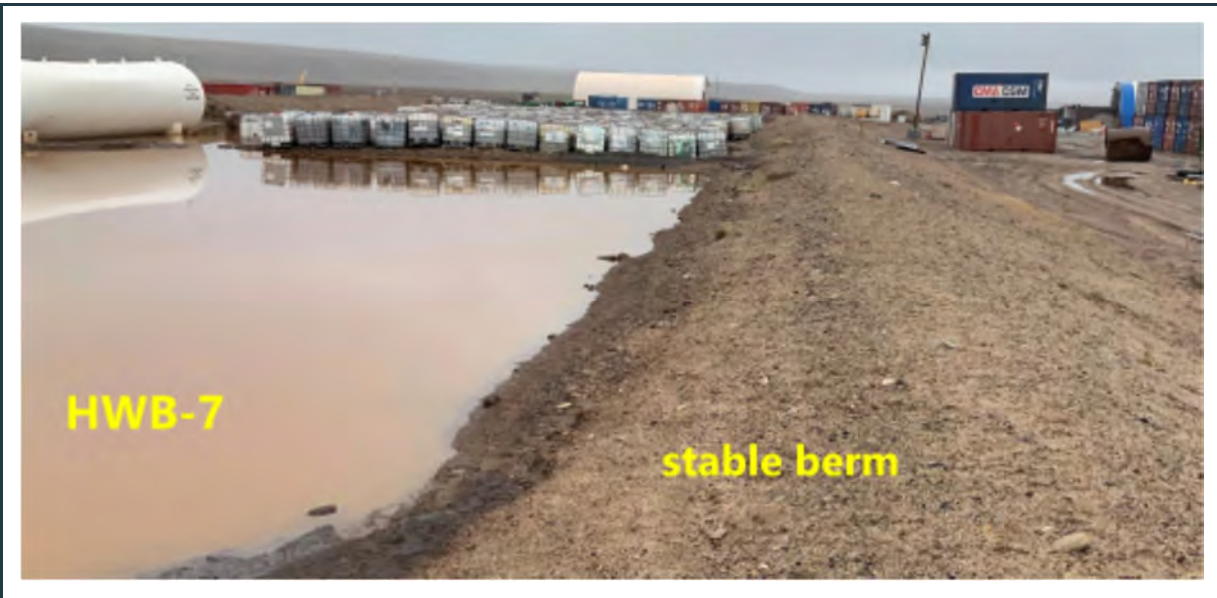
Figure 23: View of the stable berm around the HWB-7 cell, with an old fuel tank and oil filled plastic containers stored in the cell. The ponding water indicates good liner performance.

Recommendation: The level of ponding water in this cell should be monitored closely, and some of the water should be removed if required, to prevent the uncontrolled release of water.

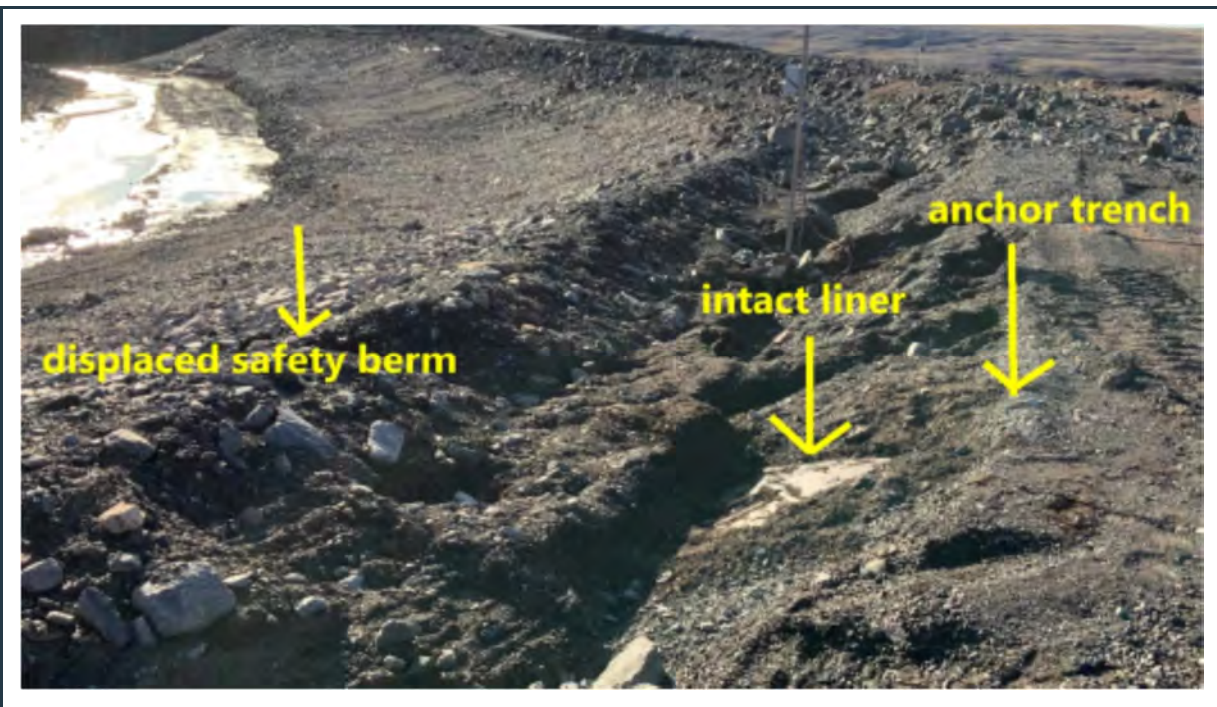
Figure 36: View of the displaced safety berm and the intact liner at the south pond (image was taken on August 26, 2024).

Recommendation: It is likely that the rehabilitation of the slope will include the placement of sand cover and riprap in the upper (displaced) part of the cover layers, and the reconstruction of the safety berm at its original location adjacent to the anchor trench. It is also likely that placement of additional riprap along the toe of the south slope will be necessary (like a wide and heavy toe-berm) to provide additional support at the toe to prevent similar sliding of the cover layers in the future.

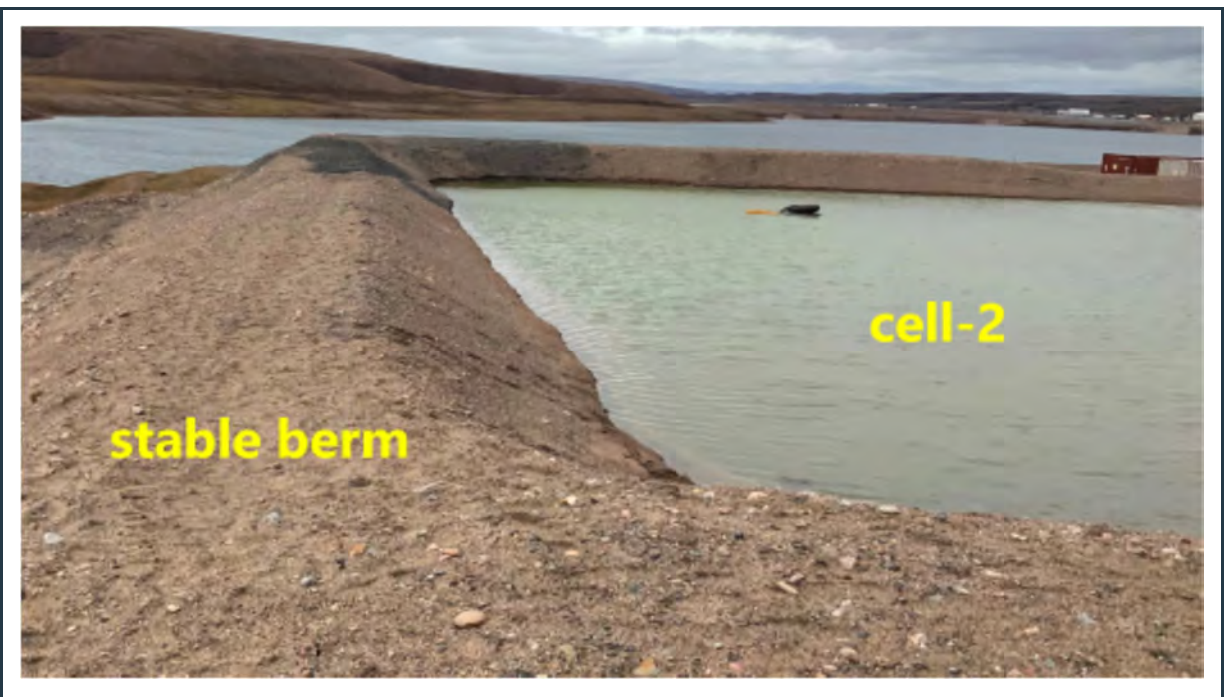
Figure 44: View of the stable berm around the currently empty cell-2 of the new landfarm. The ponding water indicates good liner performance. Note that the water should be removed prior to storing any material in this cell.

Recommendation: The ponded water within cell#2 of the landfarm should be removed and properly disposed, prior to storing any material within the cell.

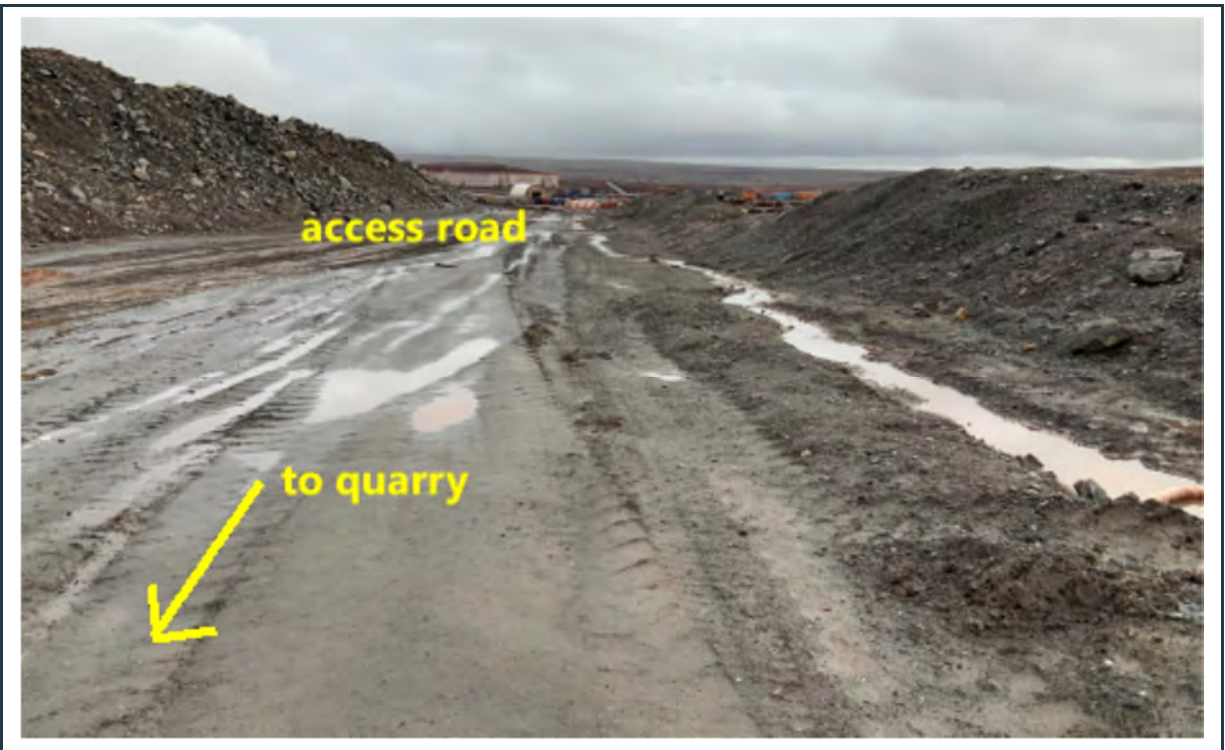
Figure 48: Drainage problems still exist at the first quarry level. Surface drainage shall be rectified.

Baffinland Action: Baffinland is assessing and has previously identified the above noted issue. Drainage improvements of the lower level of QMR2 quarry is being developed. A plan based on the above recommendation will be implemented in 2025.

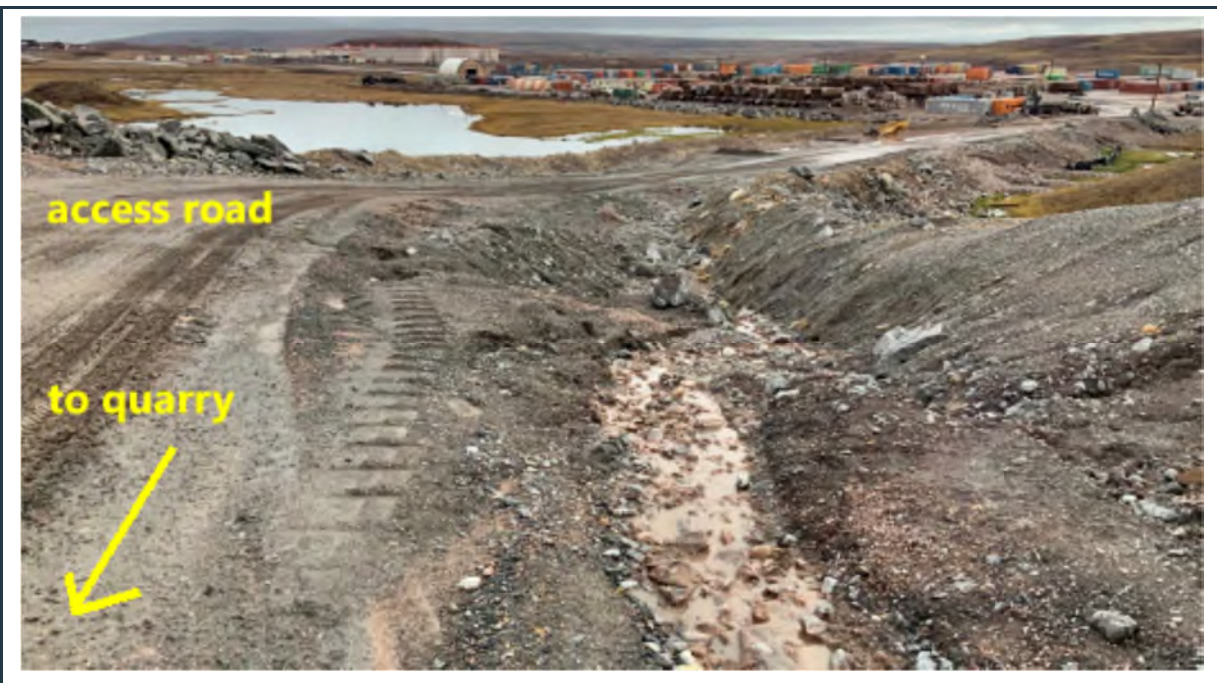
Figure 49: Serious erosion problem still exists along the edge of the access road to the quarry.

Recommendation: It is suggested that consideration be given to the installation of slope-drain pipes, chutes, or flume drains from the sumps, as erosion protection measures on the side-slope, instead of letting the water to flow uncontrolled along the edge of the access road and down on the side-slopes.

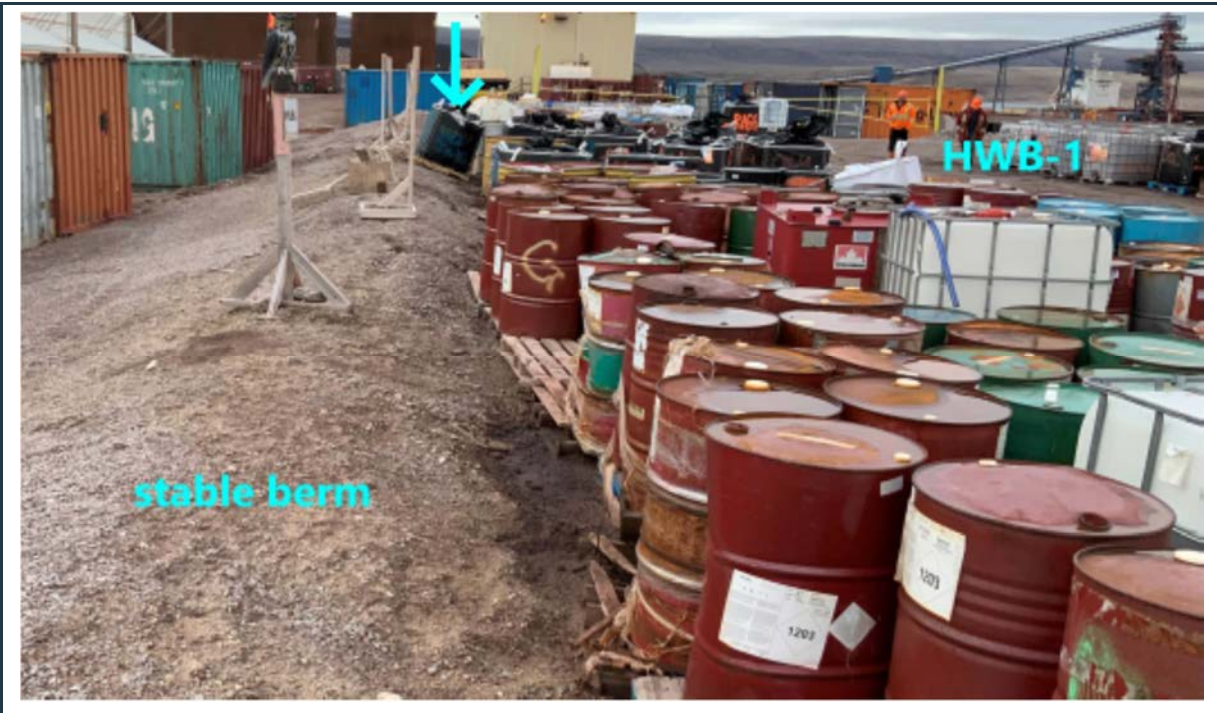
Figure 53: View of the stable perimeter berm around the lined HWB-1 cell with various materials and two shipping containers stored within the cell. Materials on pallets should be stored within the cell, not on the berms (note the container marked by the blue arrow).

Recommendation: Materials on pallets should be stored within the cell, not on the berms.
