# Baffinland Iron Mines Corporation

September 27, 2024  
Project #: CA0039374.4332

Annual Geotechnical Inspection – 2024  
APPENDIX "C" – Tote/Haul Road - Photographs  
Figures 89 to 118

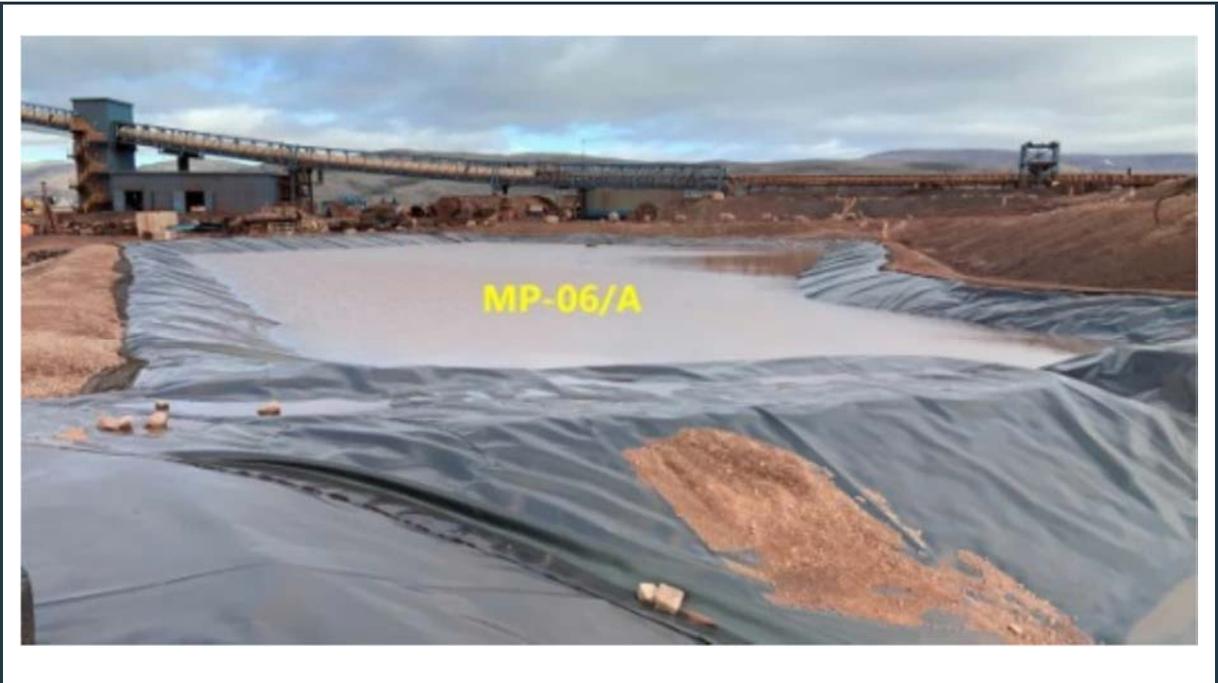
Figure 65: View of the lined MP-06A overflow pond with robust stable berms.

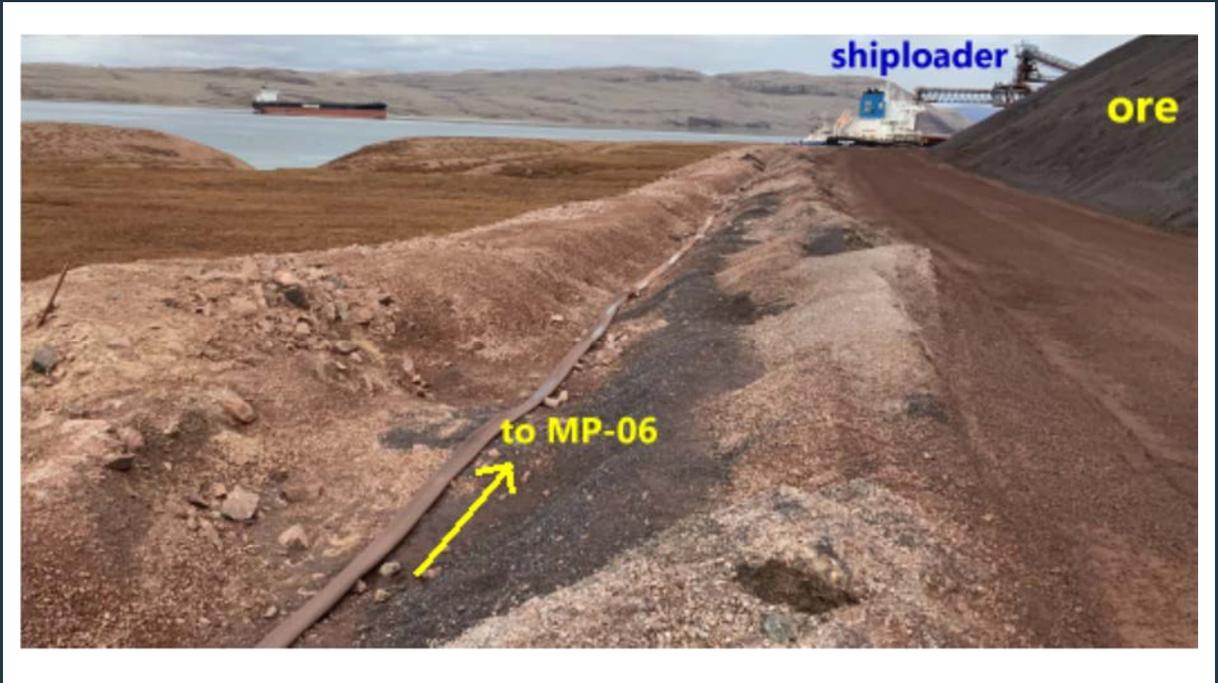
Figure 66: View of the 2023 condition of the “west” surface water collection ditch adjacent to the ore storage area, draining water from pond #3 to the MP-06 pond. This photograph was taken in 2023. Note the changes in ditch condition in Figure 67, which was taken in August 2024.

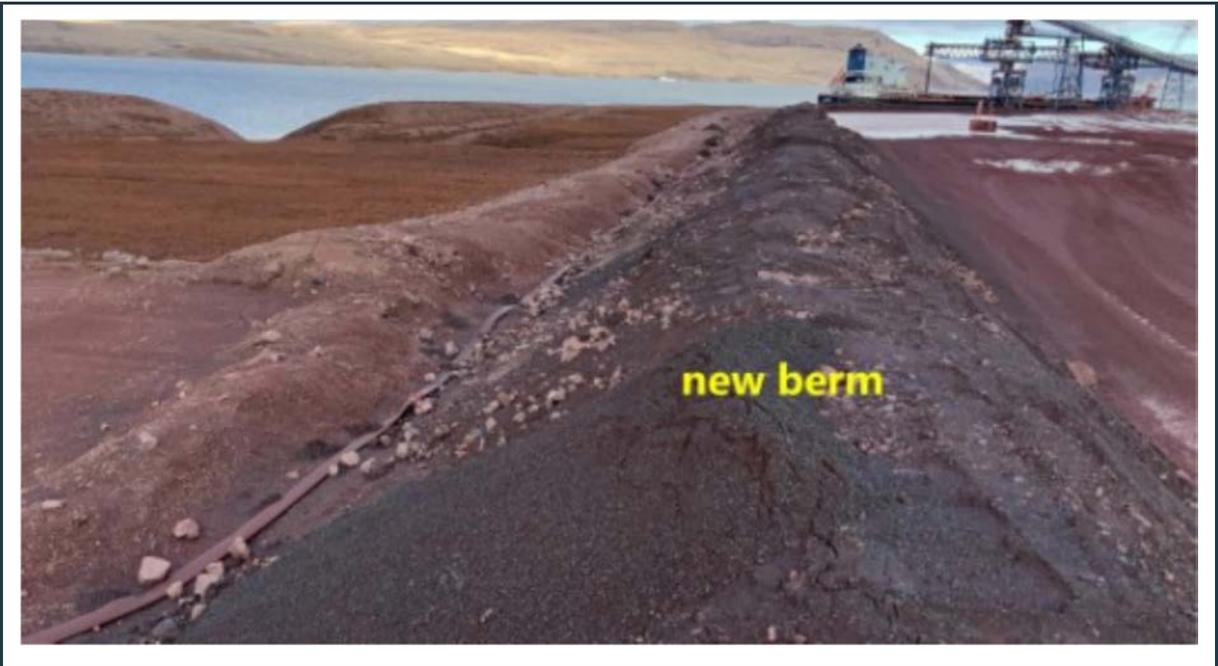
Figure 67: View of the 2024 condition of the “west” surface water collection ditch adjacent to the ore storage area. Note the new, widened berm along the ditch, partly constructed within the ditch.

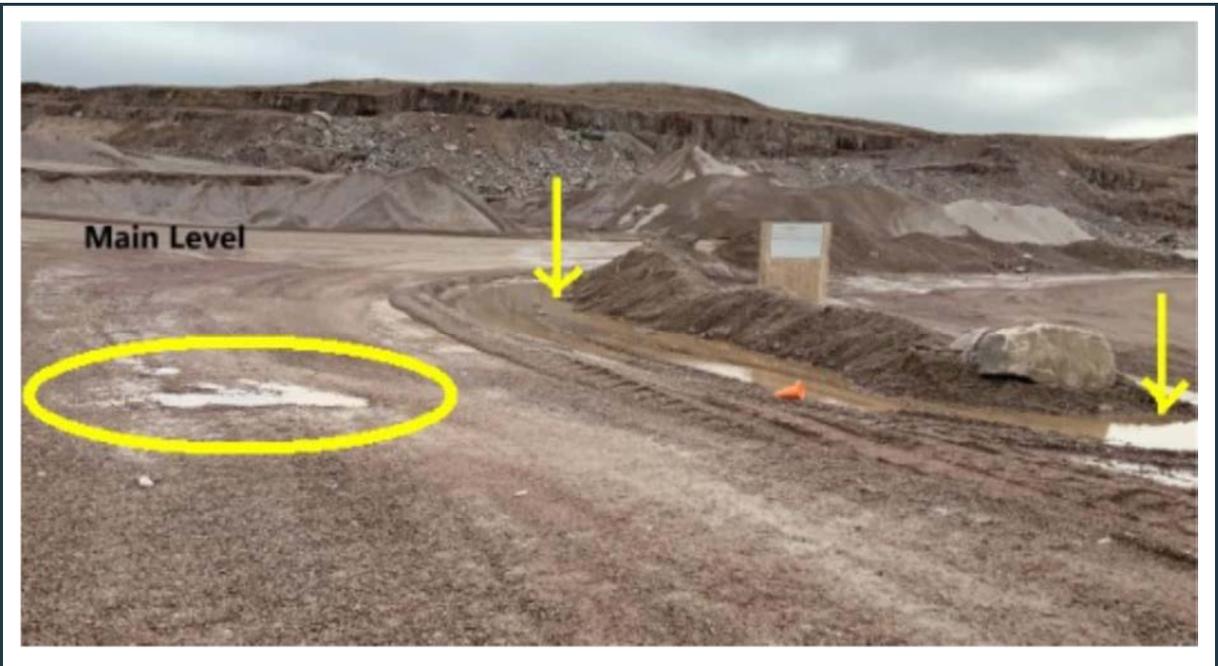
Figure 68: View of ponding and flowing water at many areas of the lower (main) level of the Q01 rock quarry. The drainage problem should be rectified prior to restarting the operation in the quarry.

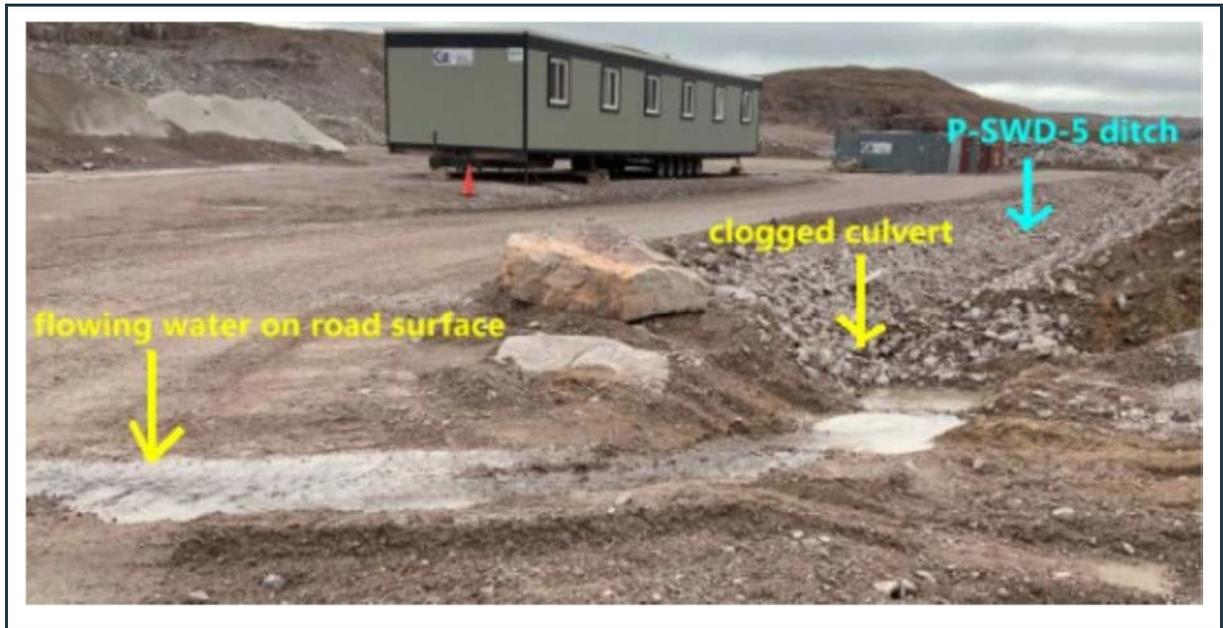
Figure 69: Poor surface water control in many areas of the lower (main) level of the Q01 rock quarry.

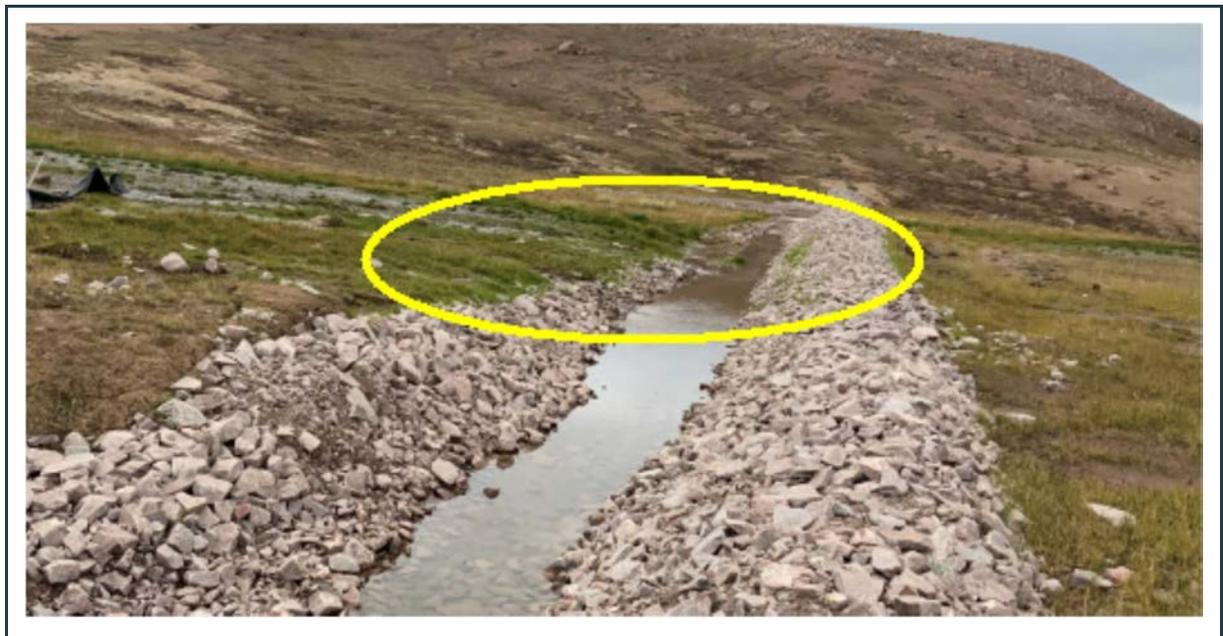
Figure 70: View of the southern section of the P-SWD-3 surface water collection ditch with failed slope sections and ponding water due to inadequate longitudinal channel slope.

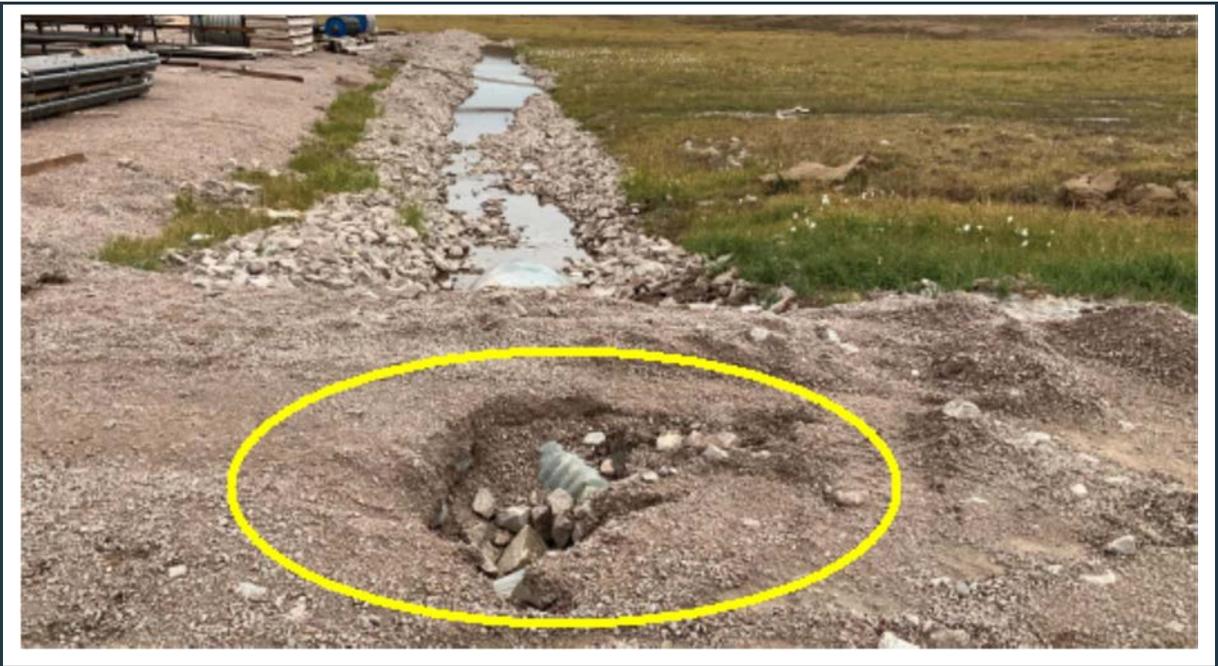
Figure 71: View of the damaged culvert (yellow circle) and the northern section of the P-SWD-3 surface water collection ditch with failed slopes and ponding water.

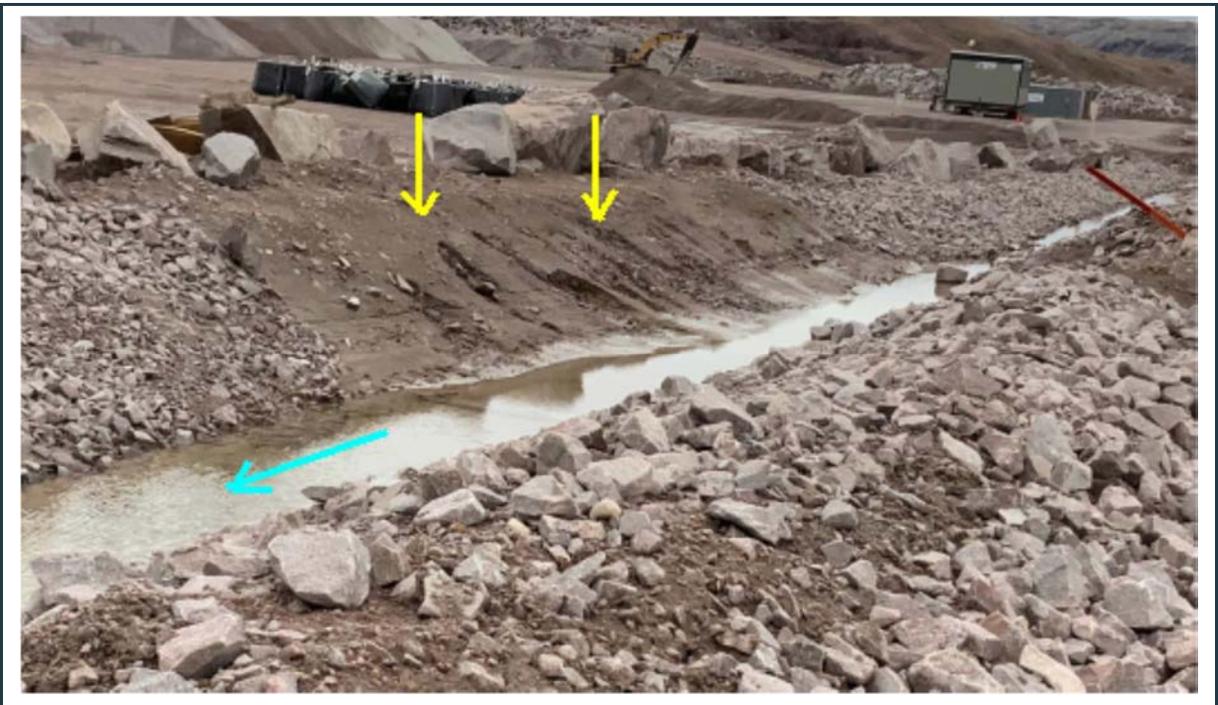
Figure 72: P-SWD-5 – “Q01-North” surface water collection ditch with missing riprap at one section of the ditch. Note the continuous seepage from the granular fill pad of the quarry’s lower level.

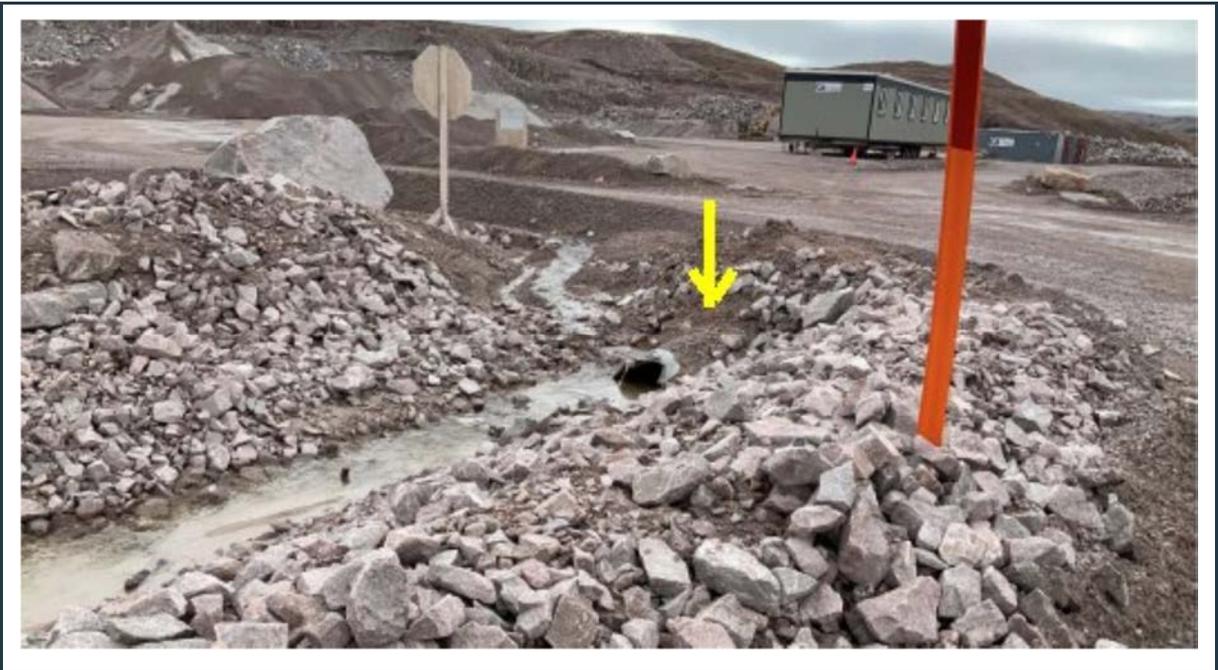
Figure 73: View of the clogged, undersized culvert beneath the access road to the Q01 rock quarry. This culvert should be removed and replaced with a larger diameter pipe.

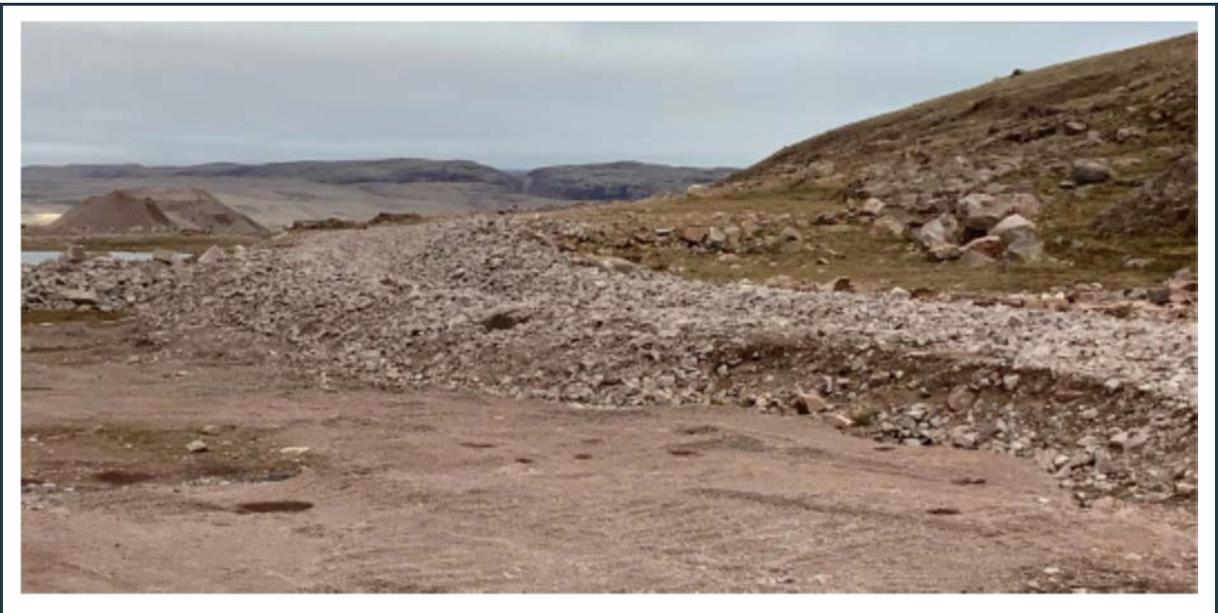
Figure 74: View of the P-SWD-6 surface water collection ditch. As opposed to the original design intent, no water is drained from the quarry in this ditch with its invert level constructed above the current (lower) level of the quarry (see Figure 75 as well).

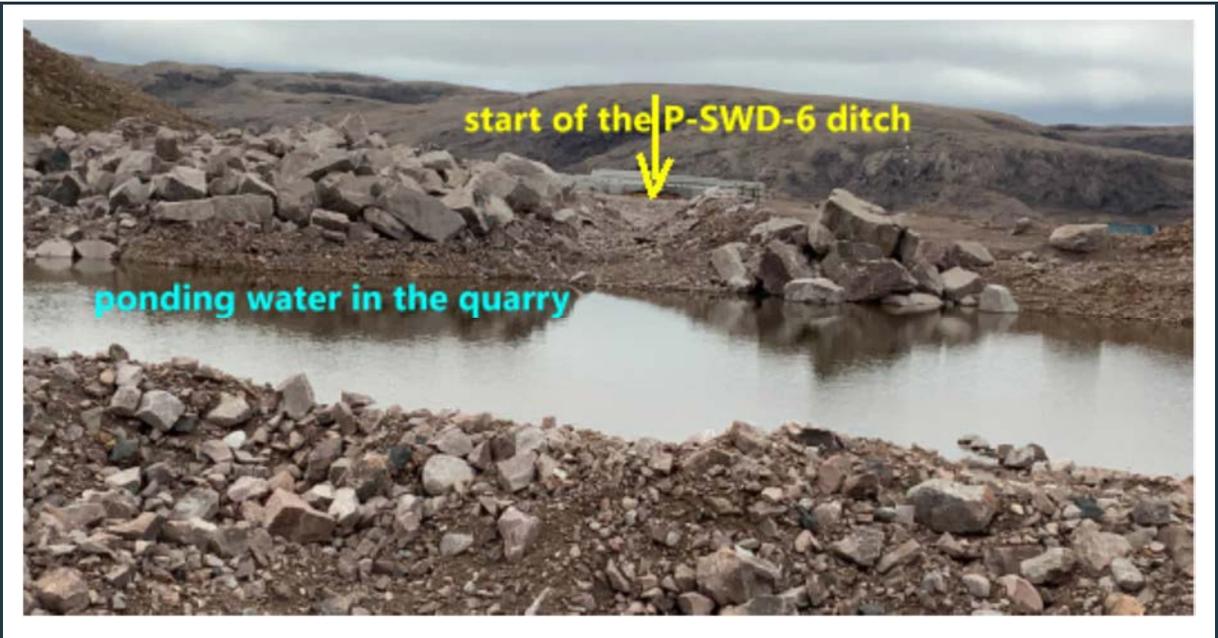
Figure 75: View of the over-excavated southern area of the Q01 quarry with ponding water (see Figure 11 for location). Note the start of the P-SWD-6 ditch in the image, with its invert level well above the new ground level in the area (bottom of the pond).

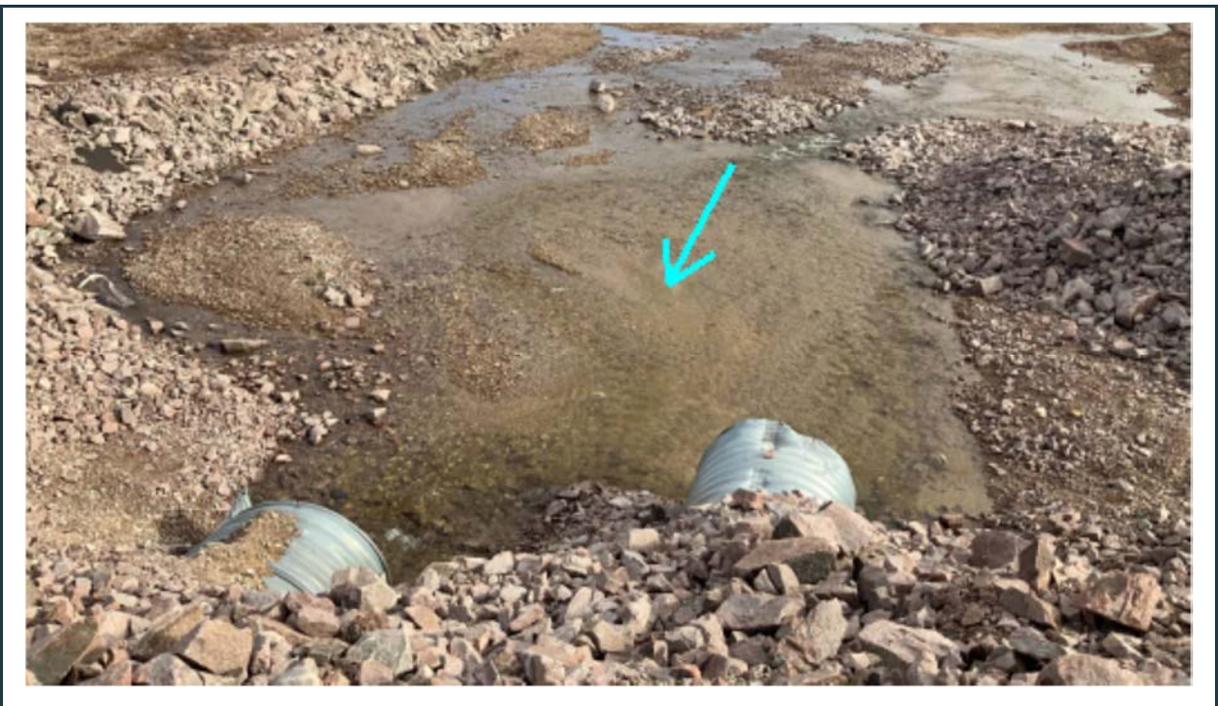
Figure 76: View of the P-SWD-7 surface water collection ditch and culverts (inlet).

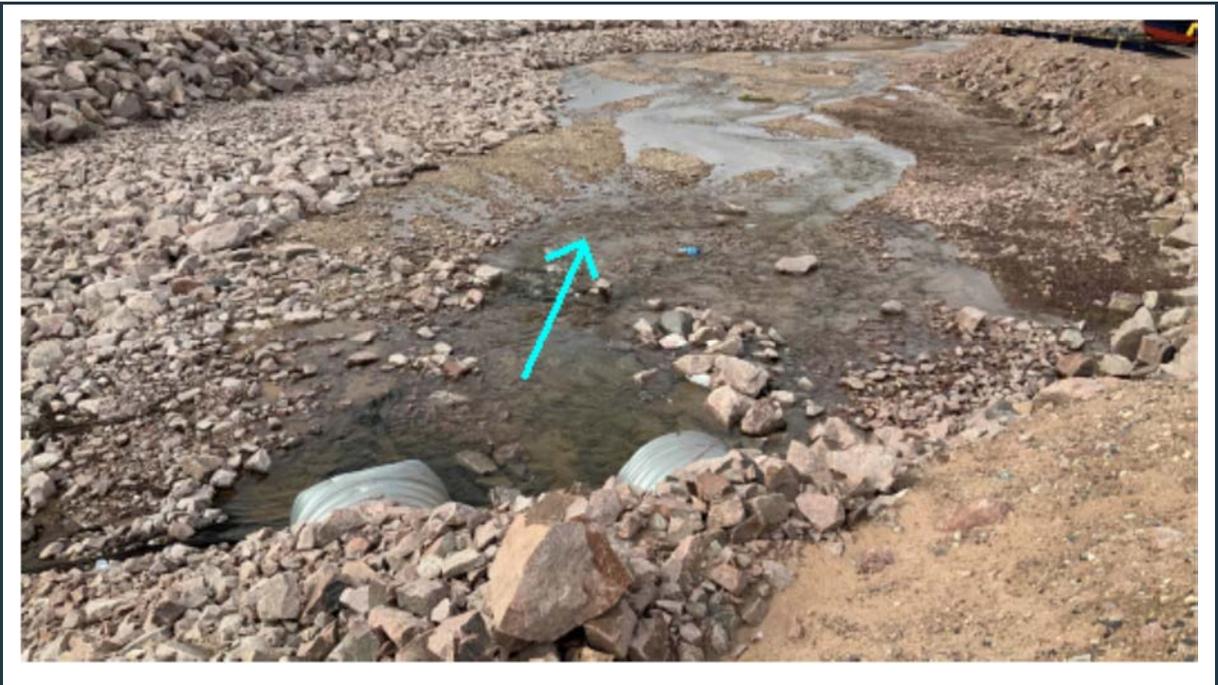
Figure 77: View of the well-maintained P-SWD-7 surface water collection ditch and culverts (outlet).

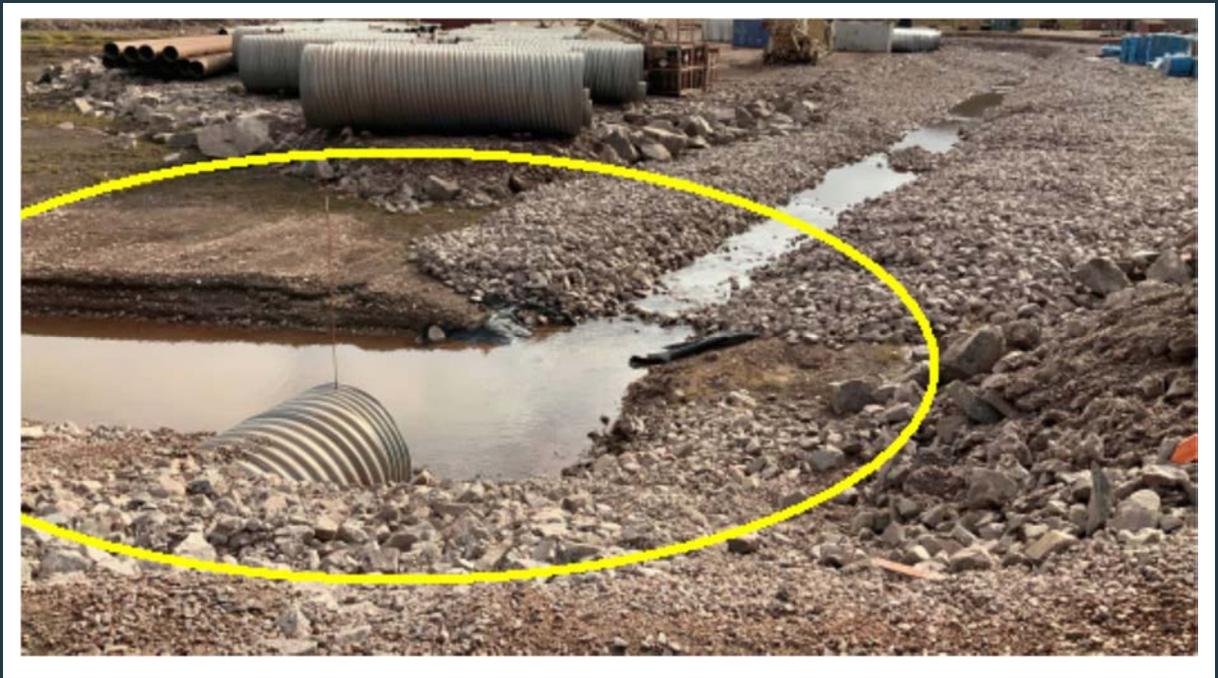
Figure 78: View of the partly completed W3/W14 surface water collection ditch with crushed rock riprap slope protection. The area around the culvert's inlet and the side-ditch from the left still require the placement of geotextile and riprap for erosion protection.

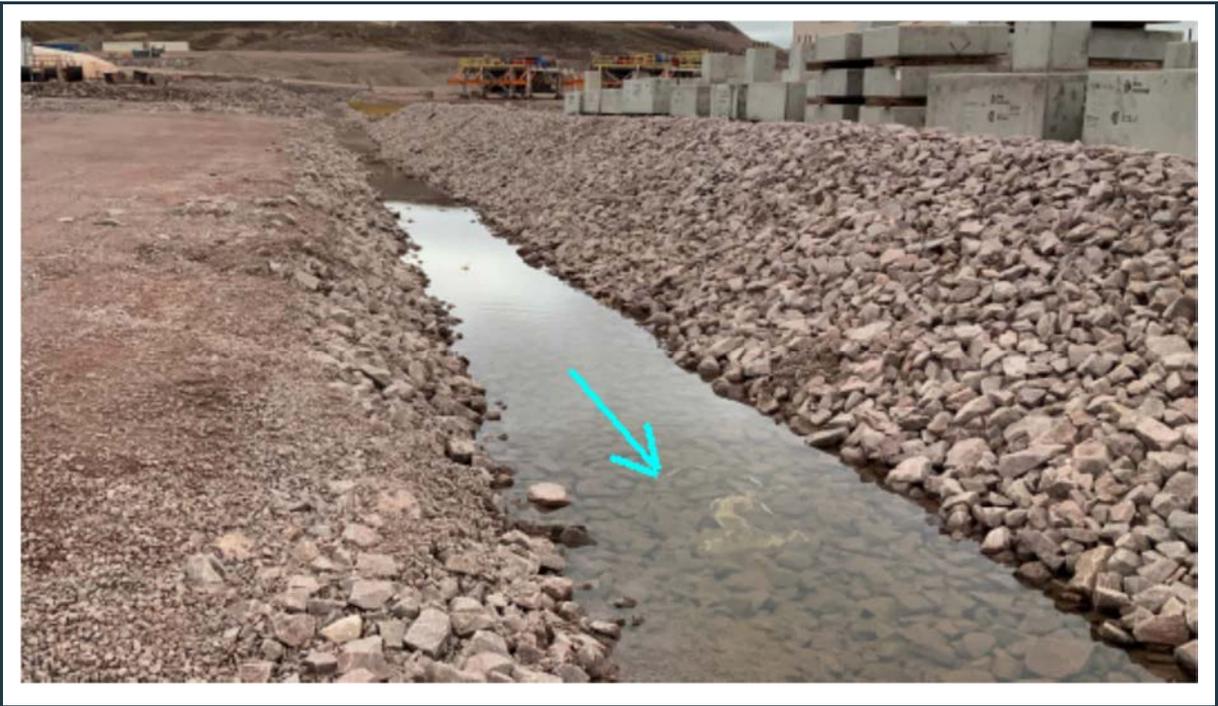
Figure 79: View of the well-maintained south section of the 380-Person Camp surface water collection ditch.

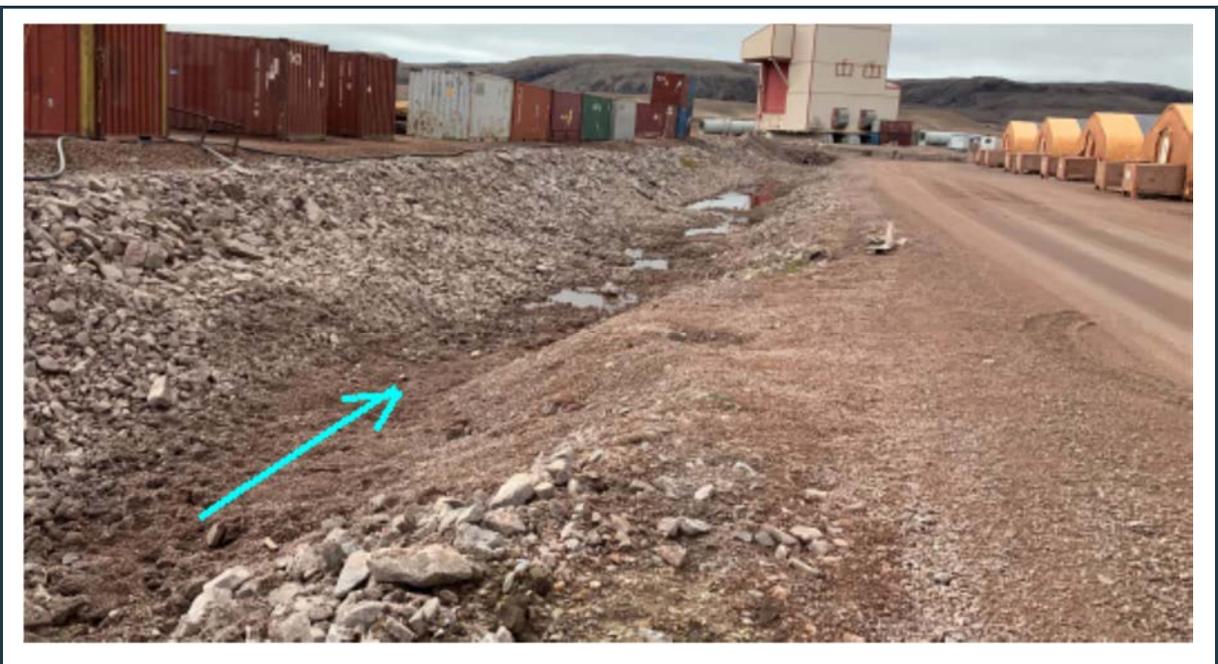
Figure 80: View of the east section of the 380-Person Camp surface water collection ditch in good condition.

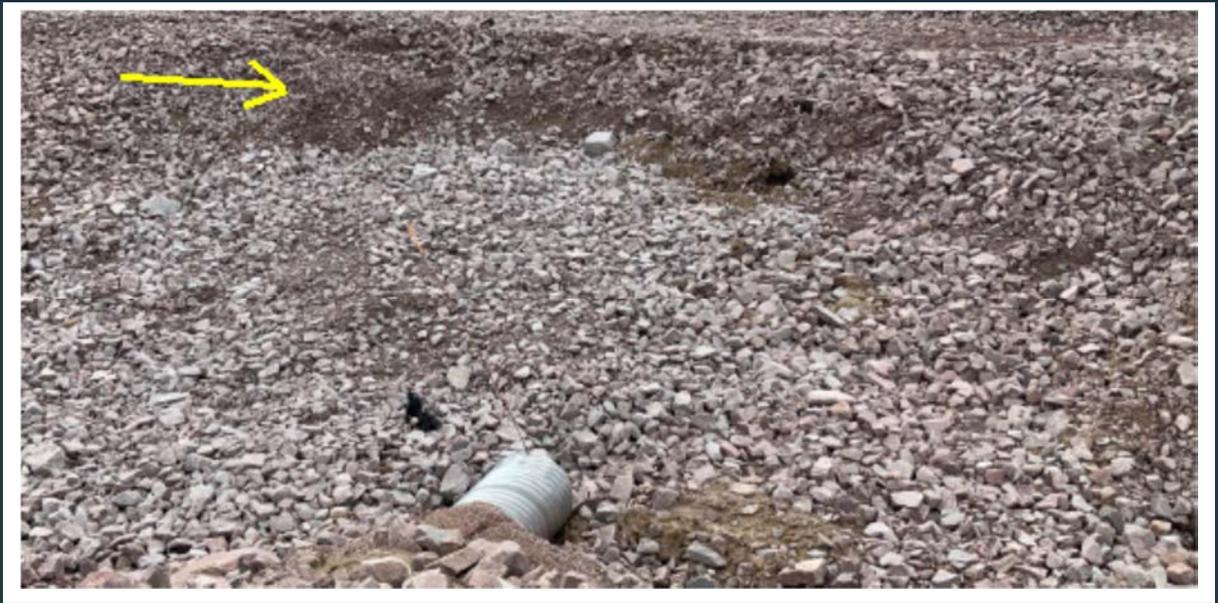
Figure 81: View of the “west end” of the PSC surface water collection ditch (red circle in Figure 8). Note the localized slope degradation due to frequent water seepage from the granular fill of the LP-2 laydown pad (yellow arrow). The culvert shown in the image can be removed.

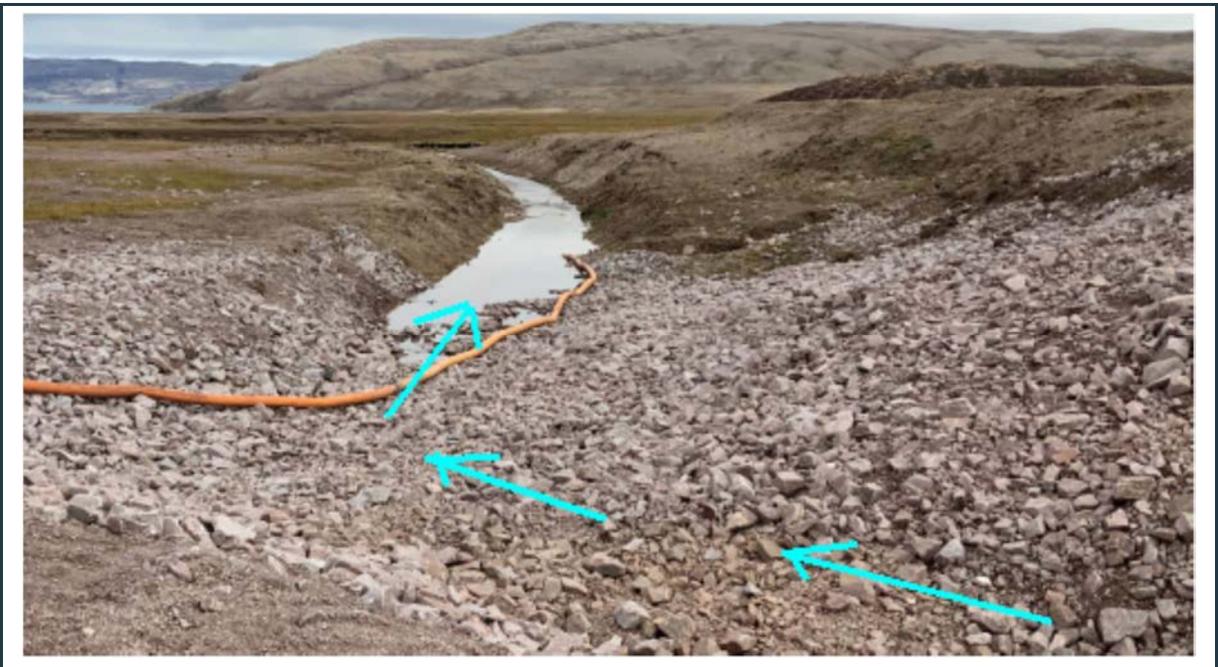
Figure 82: View of the “east end” of the PSC surface water collection ditch (also shown by green circle B in Figure 8). Additional riprap and a check dam should be installed along this section of the ditch.

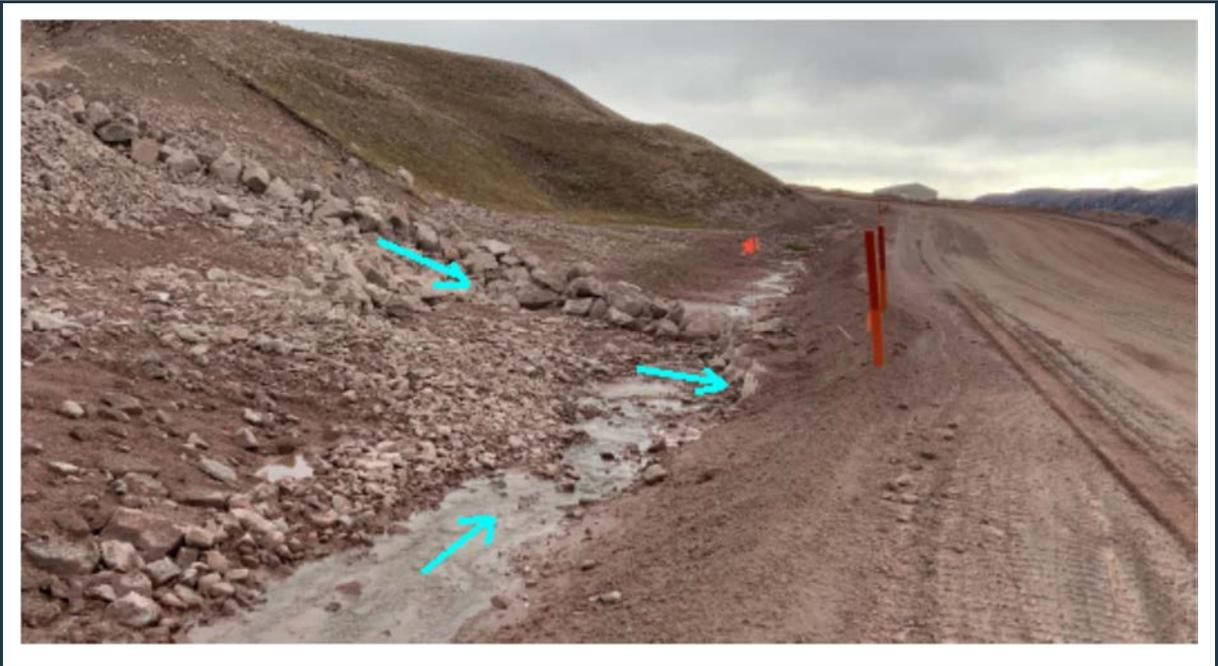
Figure 83: View the inlet of twin culverts draining surface water from the P-SWD-6 ditch and from the road's side-ditch, under the tote road.

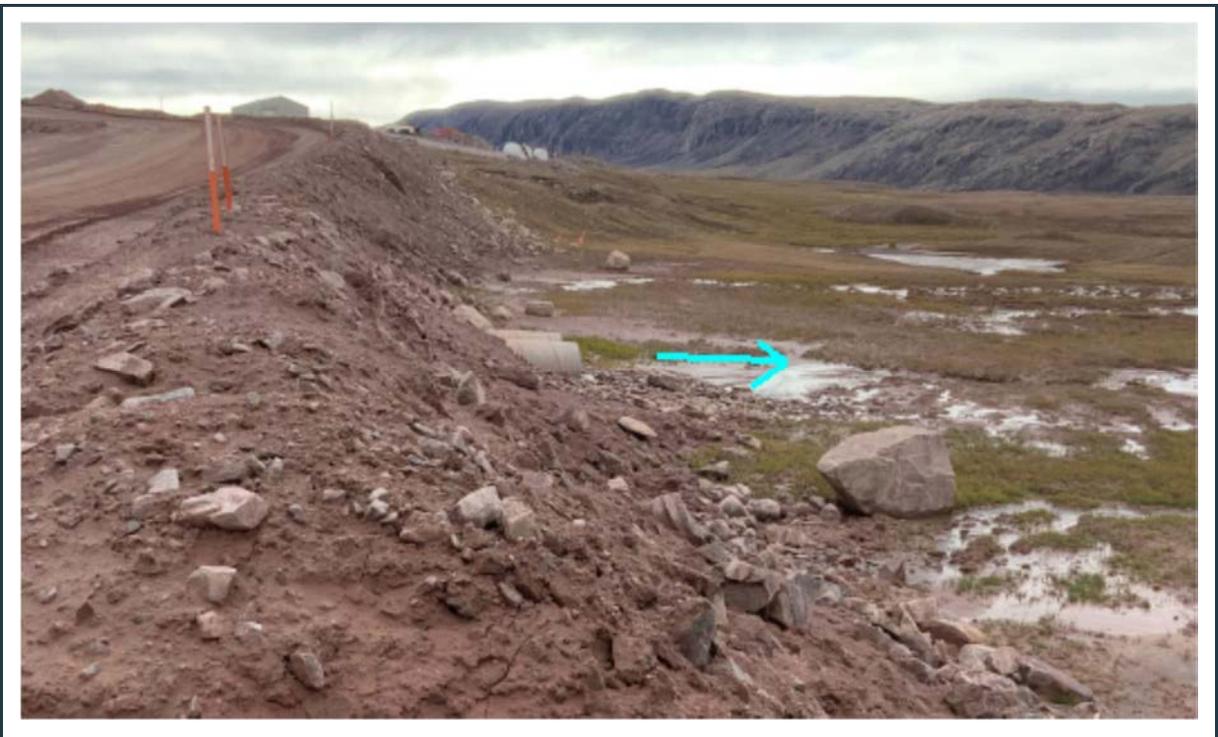
Figure 84: View of the outlet of the twin culverts, installed within the road embankment.

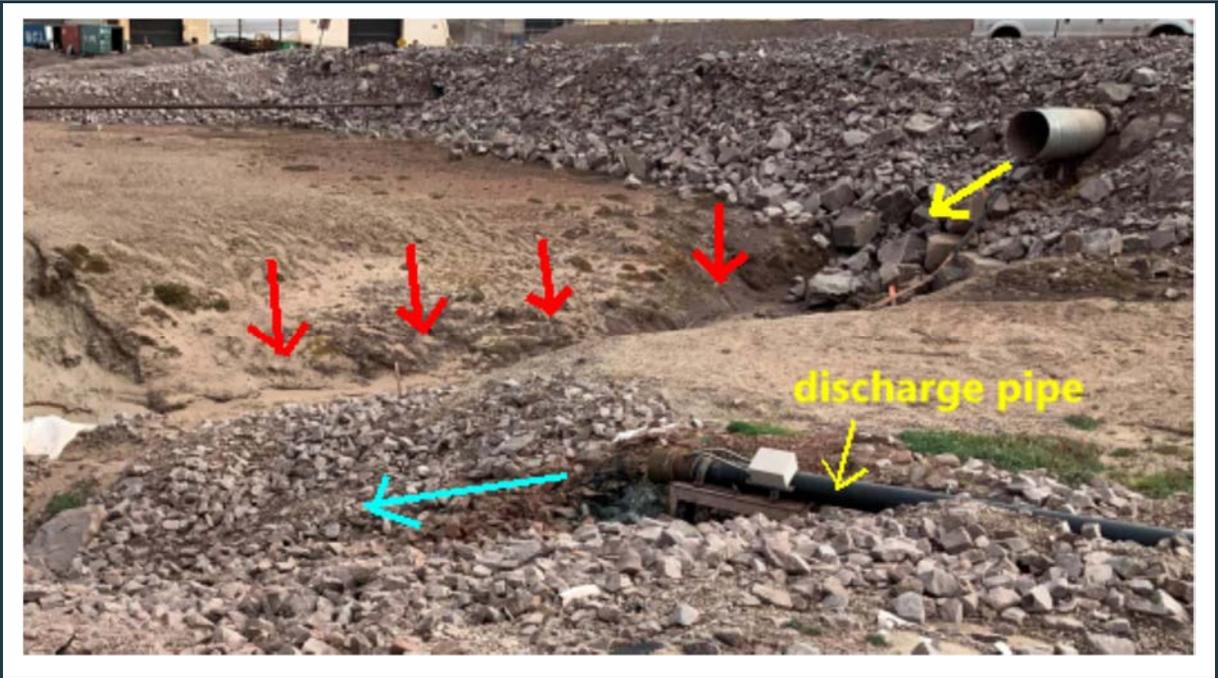
Figure 85: View of the end of the water discharge pipe (blue arrow) and a nearby culvert (yellow arrow) draining water to the same valley. More ripraps should be placed into the upper section of the valley, marked by red arrows, to prevent erosion of the valley floor and side-slopes.

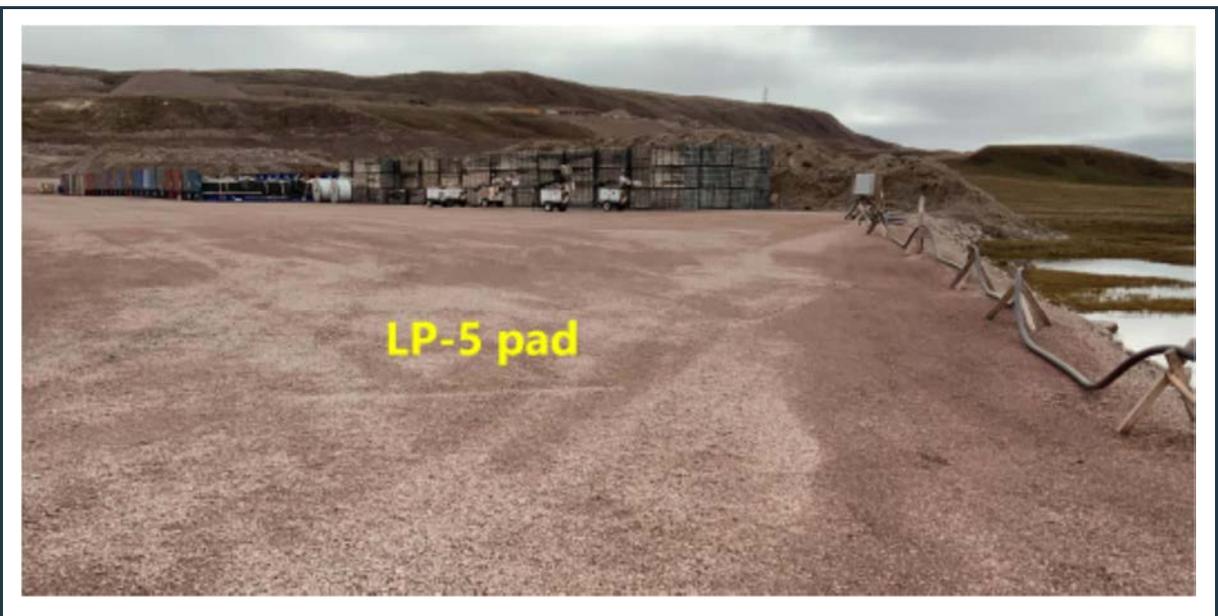
Figure 86: View of the recently regraded LP-5 storage area.

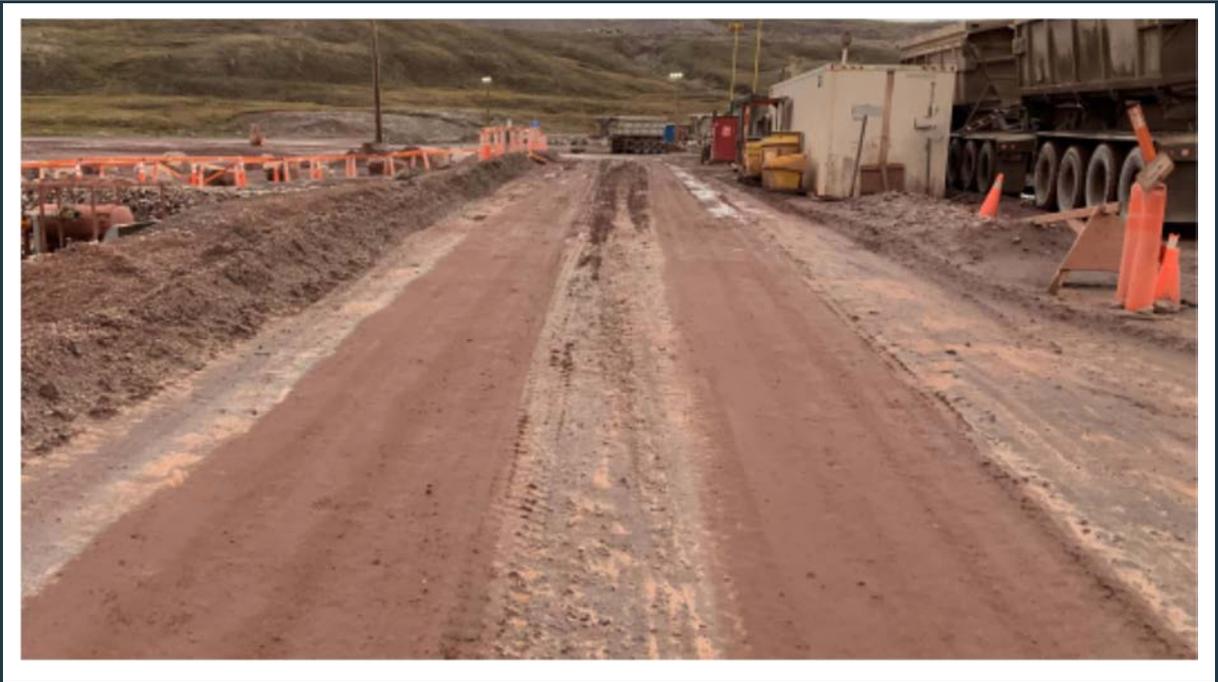
Figure 87: View of the Western Globe Fuel Module (WGFM) north of the 380 Camp. No humps are visible at the entrance and exit points of the refueling station.

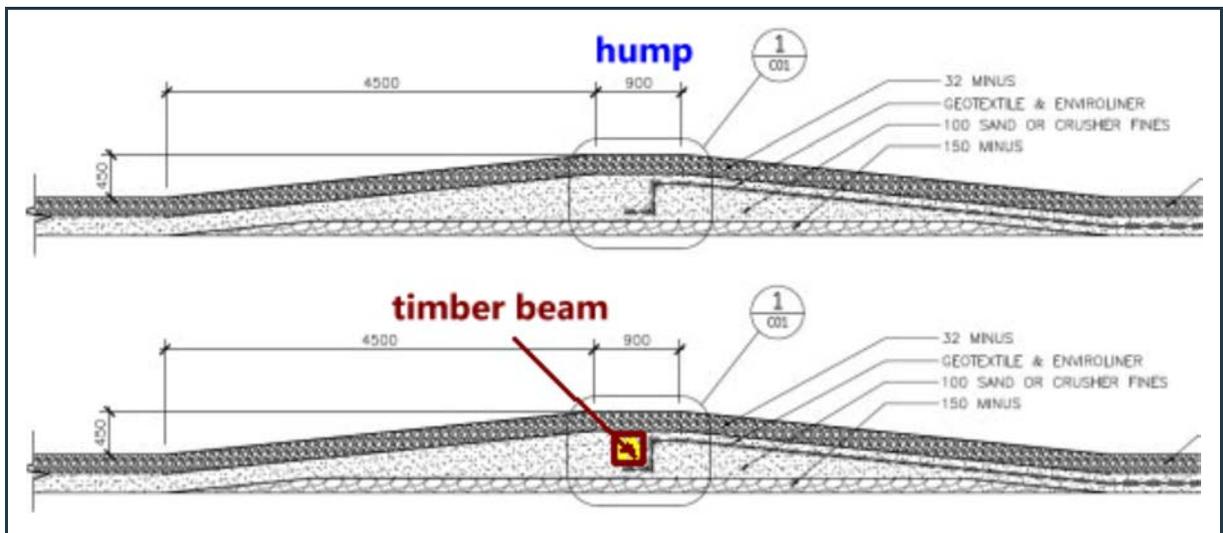
Figure 88: Top image: Section of 900 mm wide (at its crest) drainage control hump with 10H:1V slopes for the Western Globe Fuel Module (WGFM), specified by B.H. Martin Consulting Engineer and Architect, in June 2016. Lower image: A 10" by 10" timber beam should be installed within the humps to prevent the flattening of the granular fill by the heavy trucks. The humps should prevent potential oily surface water escaping the refueling area toward the ends of the WGFM.

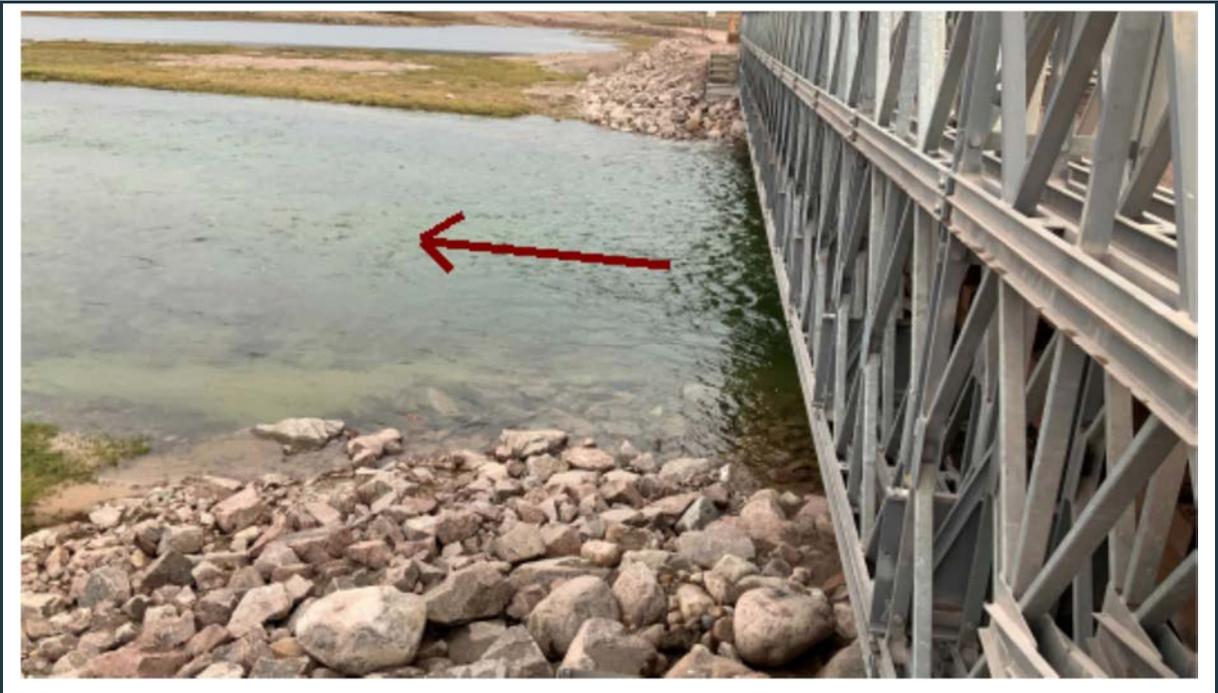
Figure 89: View of the stable abutments with riprap erosion protection at the north side of bridge KM17.

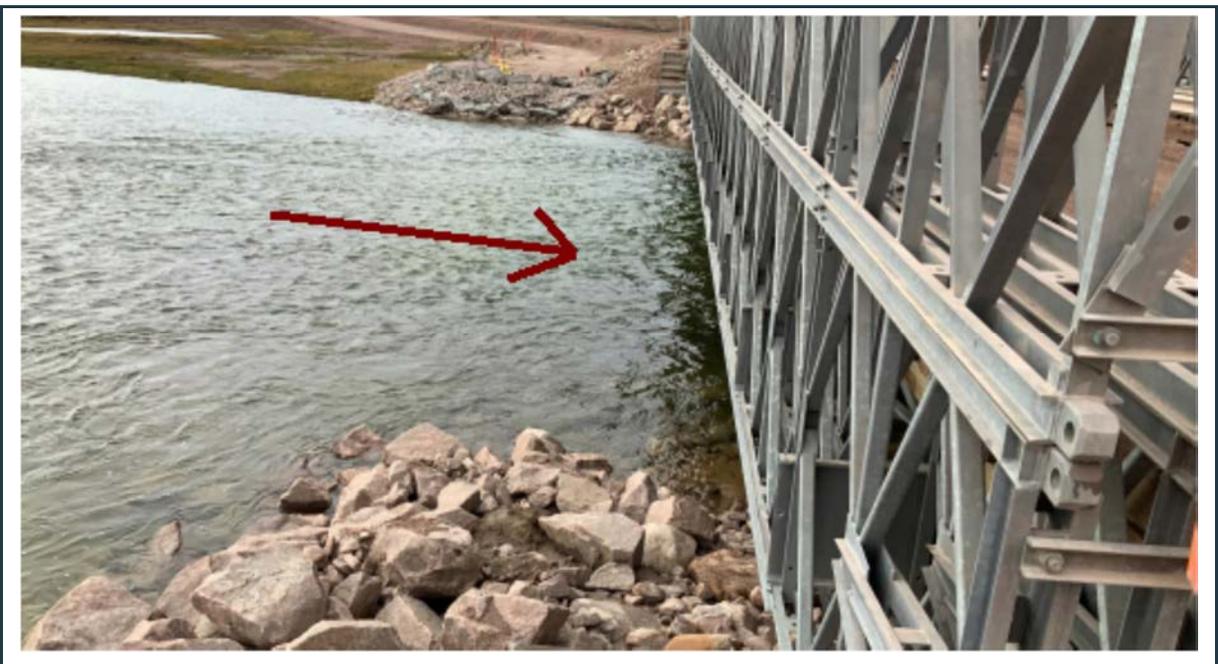
Figure 90: View of the stable abutments with riprap scour protection at the south side of bridge KM-17.
