# Baffinland Iron Mines Corporation

September 27, 2024  
Project #: CA0039374.4332

Annual Geotechnical Inspection – 2024  
APPENDIX "C" – Tote/Haul Road - Photographs  
Figures 89 to 118

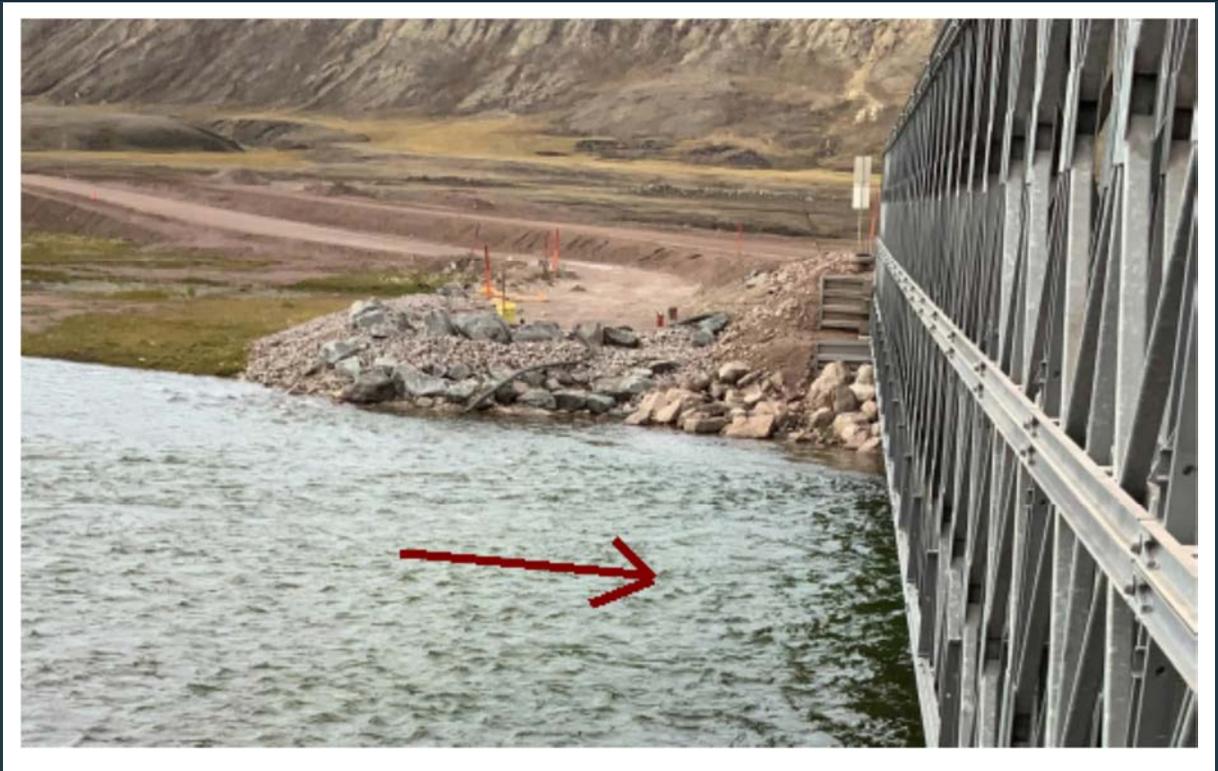
Figure 91: View of the west abutment, where the old metal crib has been removed and replaced with new riprap erosion protection at the south side of bridge KM17.

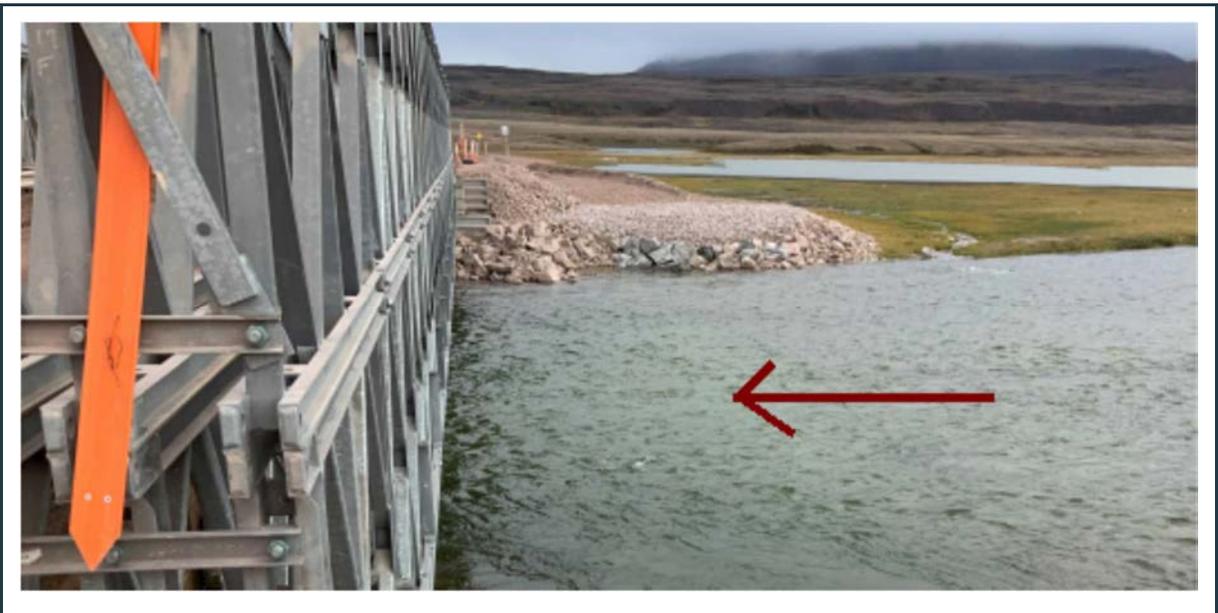
Figure 92: View of the east abutment, where the old metal crib has been removed and replaced with new riprap erosion protection at the south side of bridge KM17.

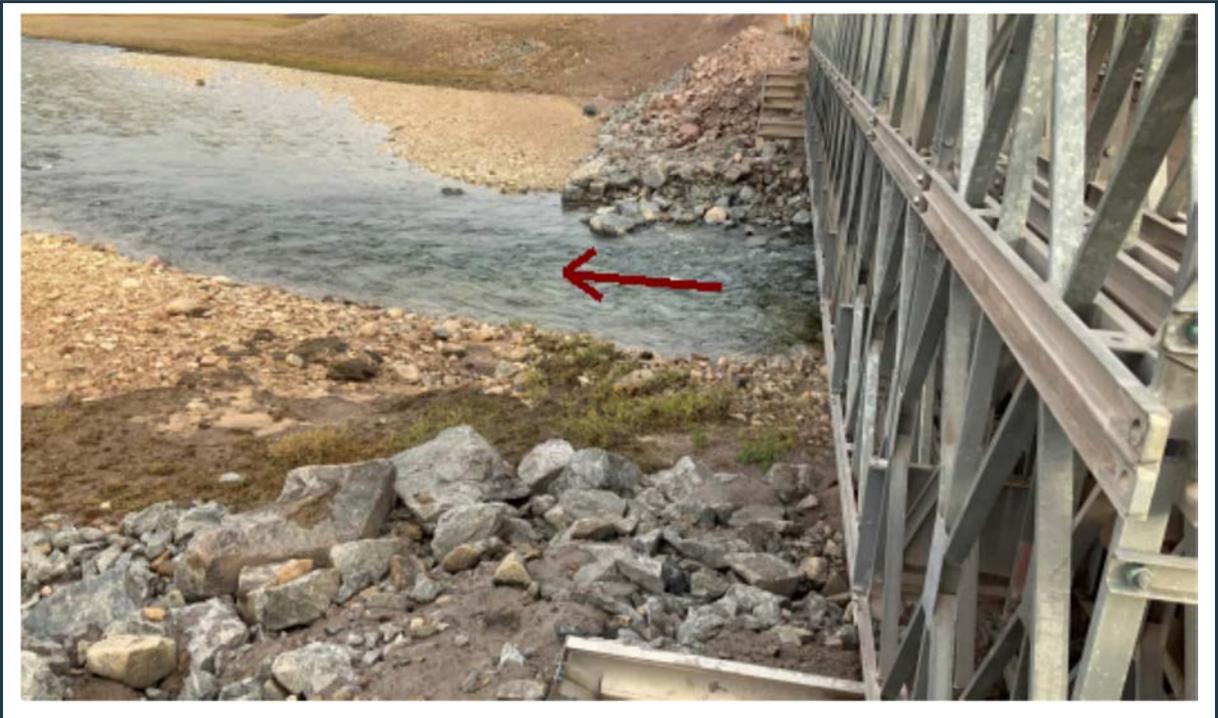
Figure 93: View of the west side of bridge 63, with stable abutments and riprap scour protection.

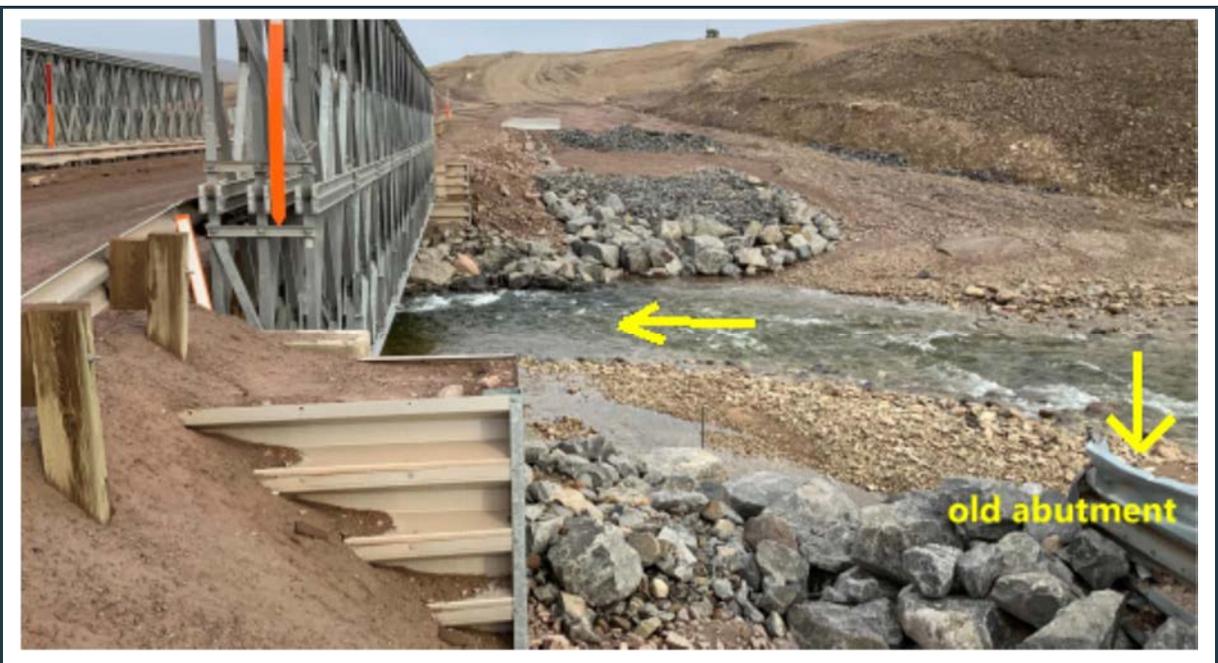
Figure 94: View of the stable abutments at the east side of bridge 63. Also note that one (south) of the two “old” crib abutments is still in place, while the north one has been removed and replaced with rock fill (cobble and boulders).

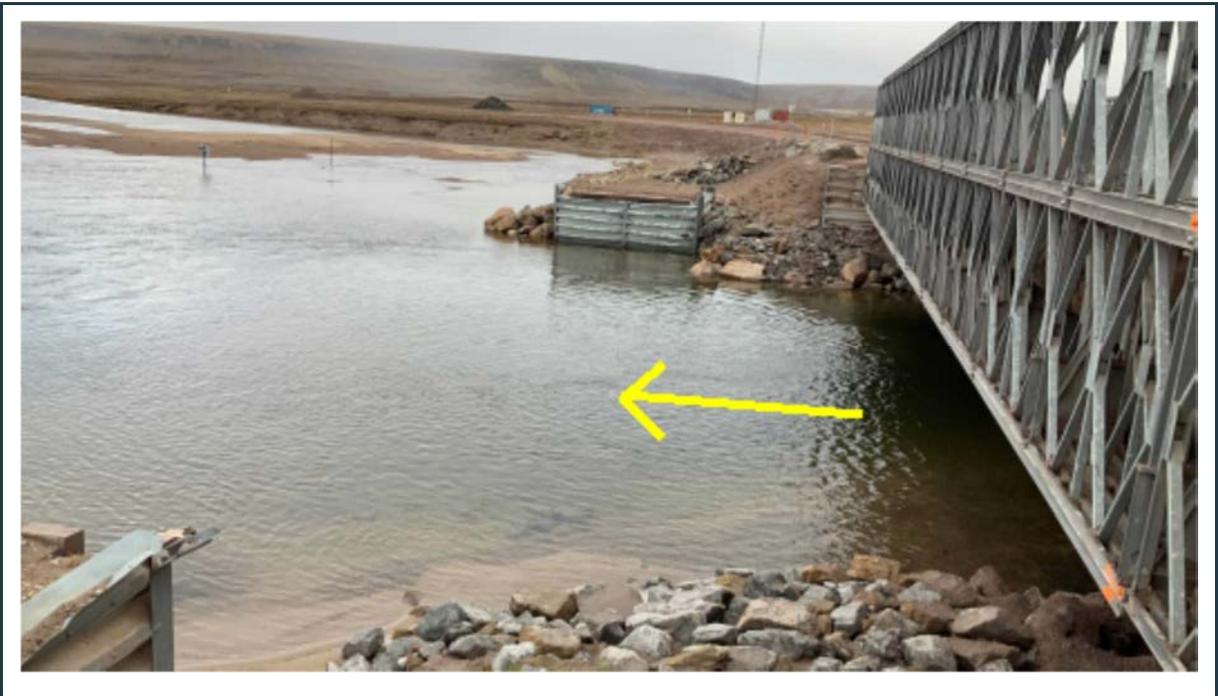
Figure 95: View of the west side of bridge 80, with riprap scour protection around the abutments.

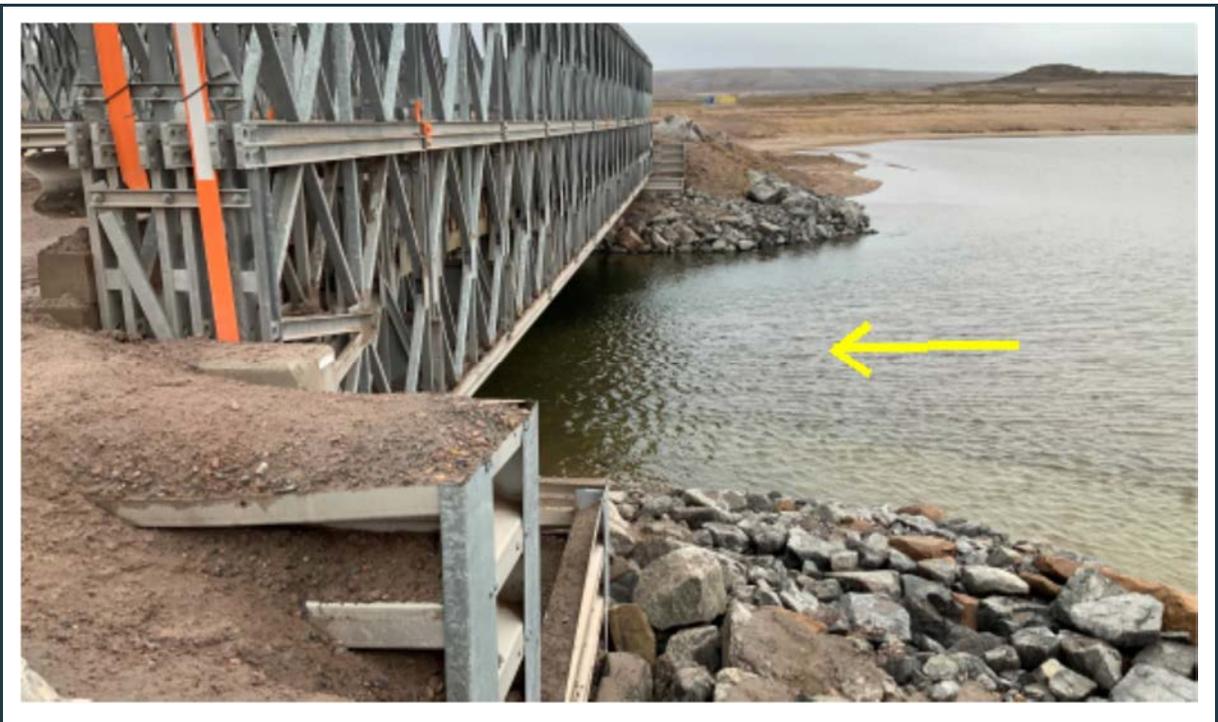
Figure 96: View of the abutments with riprap scour protection at the east side of bridge 80.

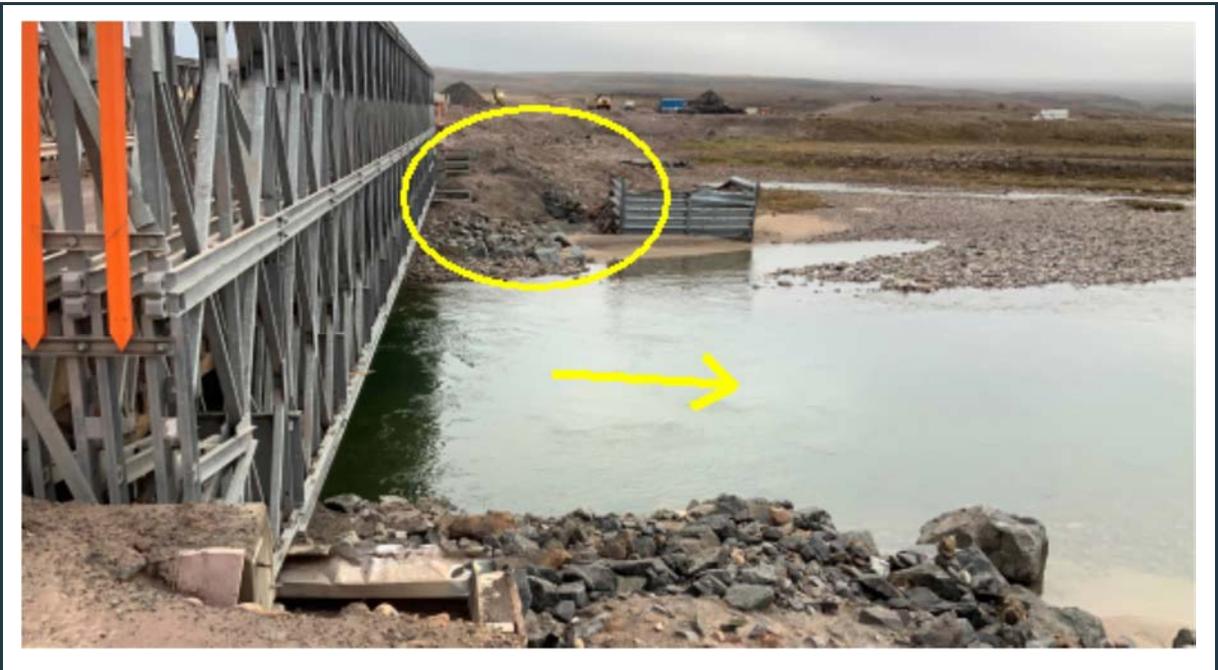
Figure 97: View of the stable abutments at the west side of bridge KM 97. As shown, there is only one remaining old crib abutment present at this bridge. Note the area between the old and new abutments (yellow circle) where additional rock fill should be placed for erosion protection.

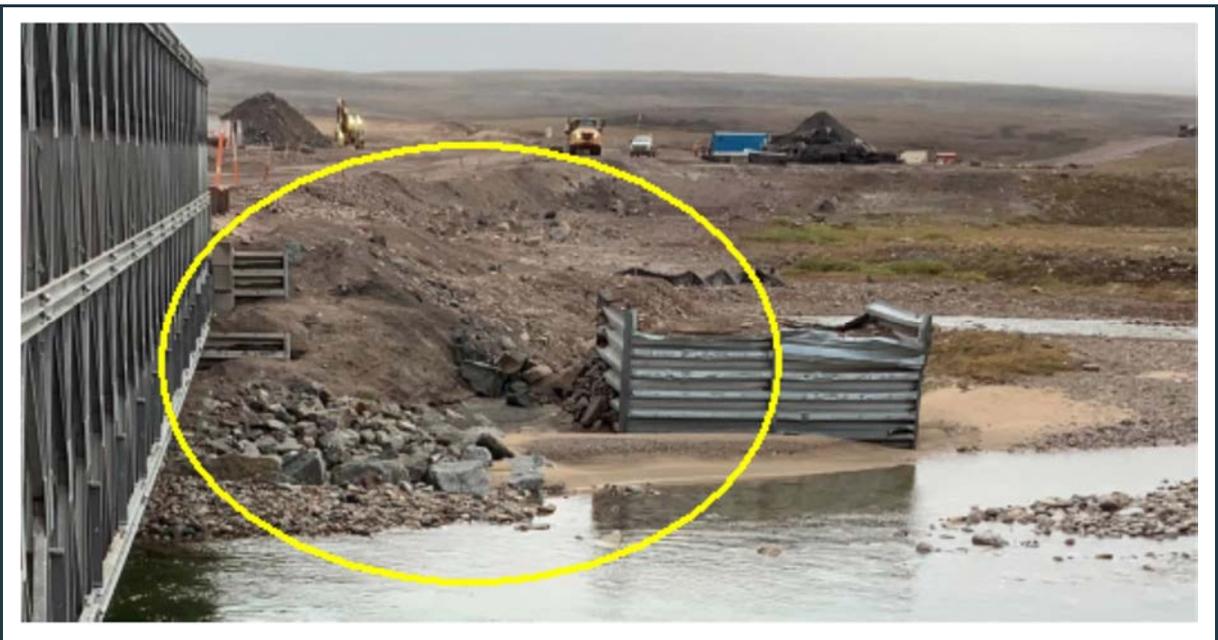
Figure 98: View the enlarged image of the area between the old and new abutments (yellow circle) where additional rock fill should be placed for erosion protection.

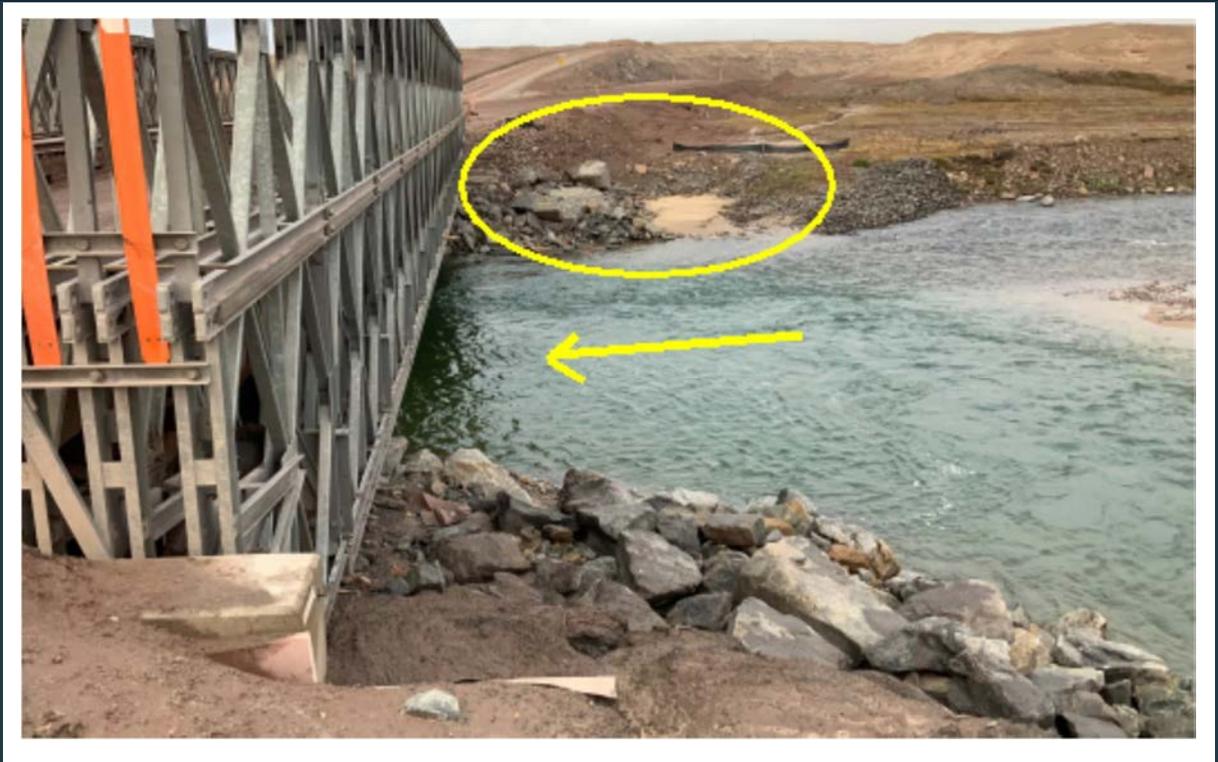
Figure 99: View of the stable abutments at the east side of bridge KM97. Note the area marked by the yellow circle where additional rock fill should be placed at the shore of the river and adjacent to the approach embankment to the bridge abutment, for erosion protection.

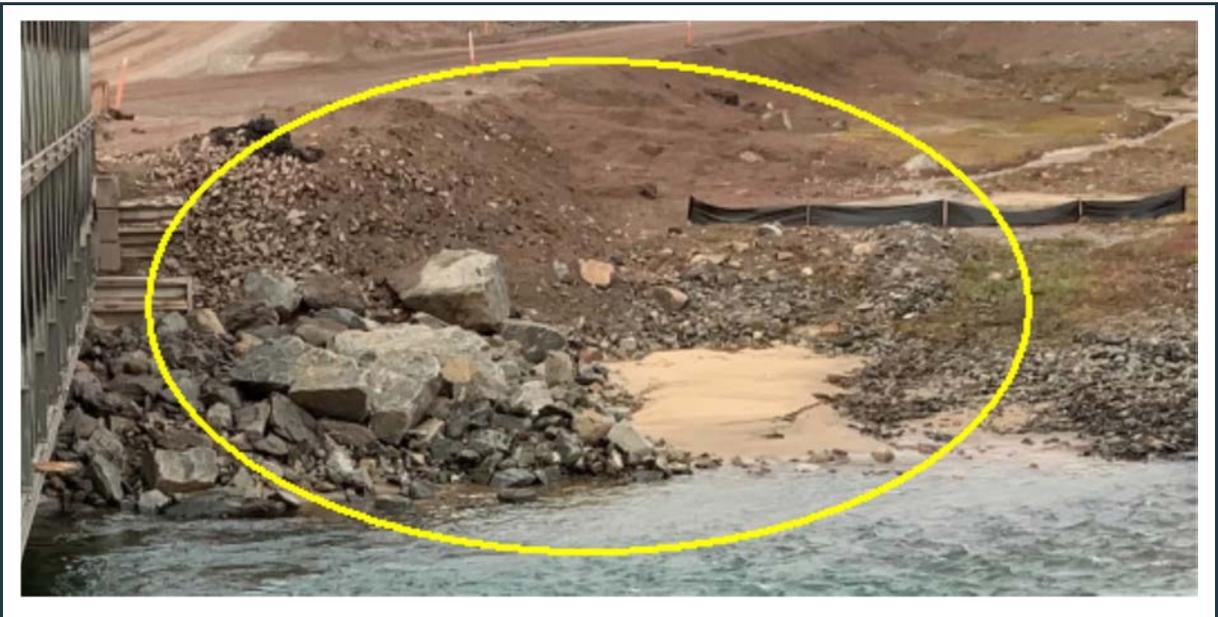
Figure 100: View of the enlarged image of the area marked by the yellow circle in Figure 99, where additional rock fill should be placed for erosion protection.

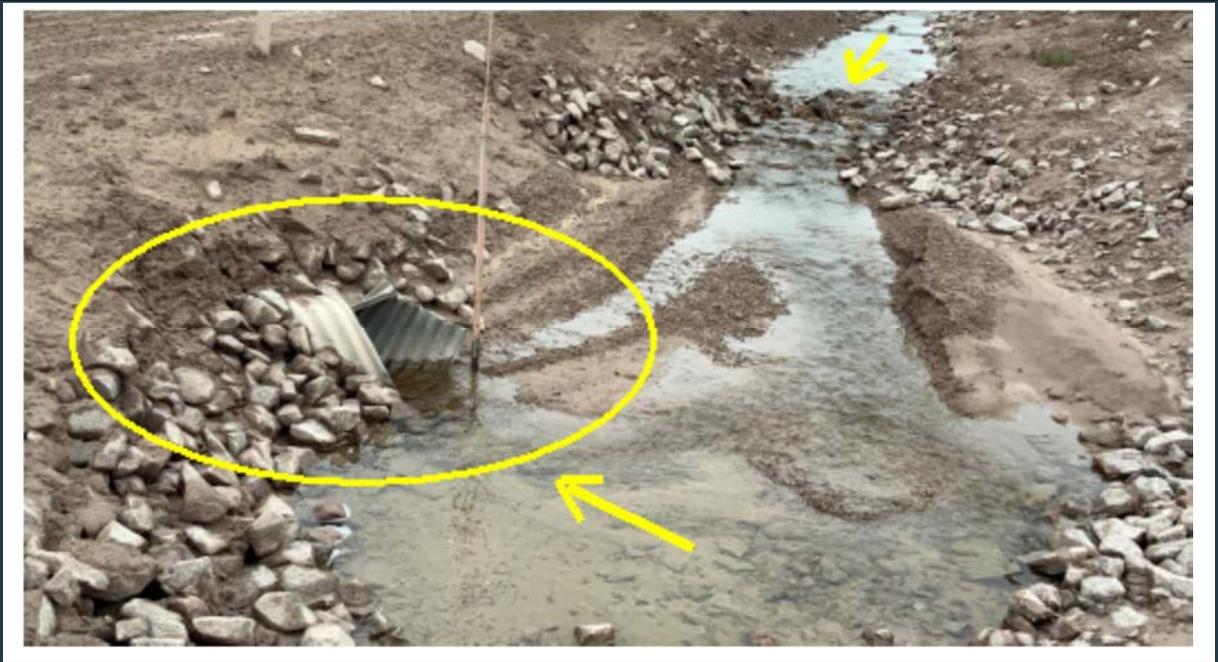
Figure 101: View of the damaged culvert at its inlet at KM 32+900. The culvert should be replaced as soon as practically possible. More rockfill should also be placed around the culvert's inlet.

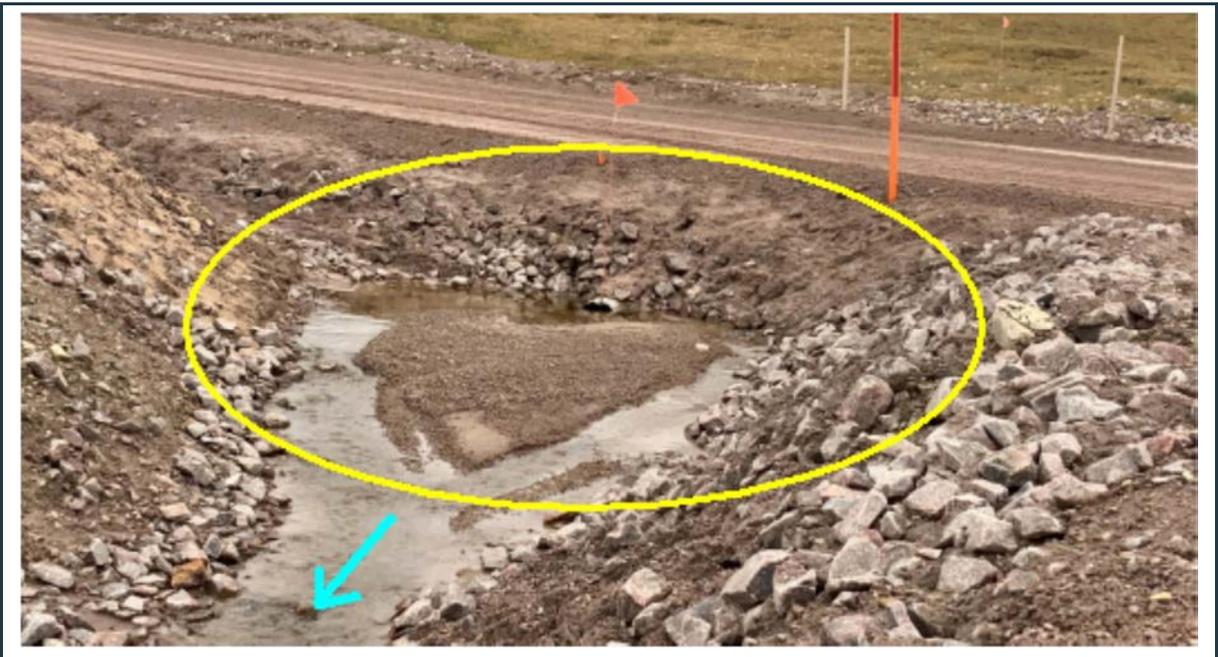
Figure 102: View of the outlet of the culvert at KM 32+900. The ditch at the front of the culvert should be cleaned from the sediment during culvert replacement, and more ripraps should be placed.

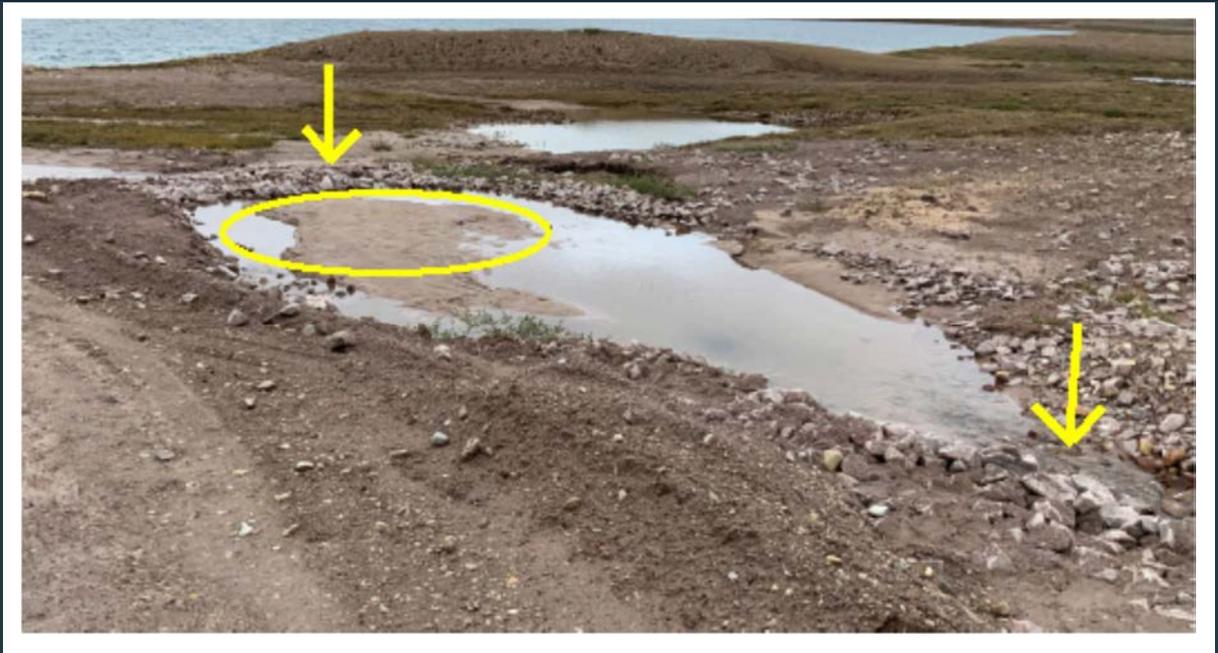
Figure 103: View of the ditch and check dams at KM 32+900. The ditch should be cleaned (yellow circle) and the crest of the check dams repaired/raised (yellow arrows) during maintenance work.

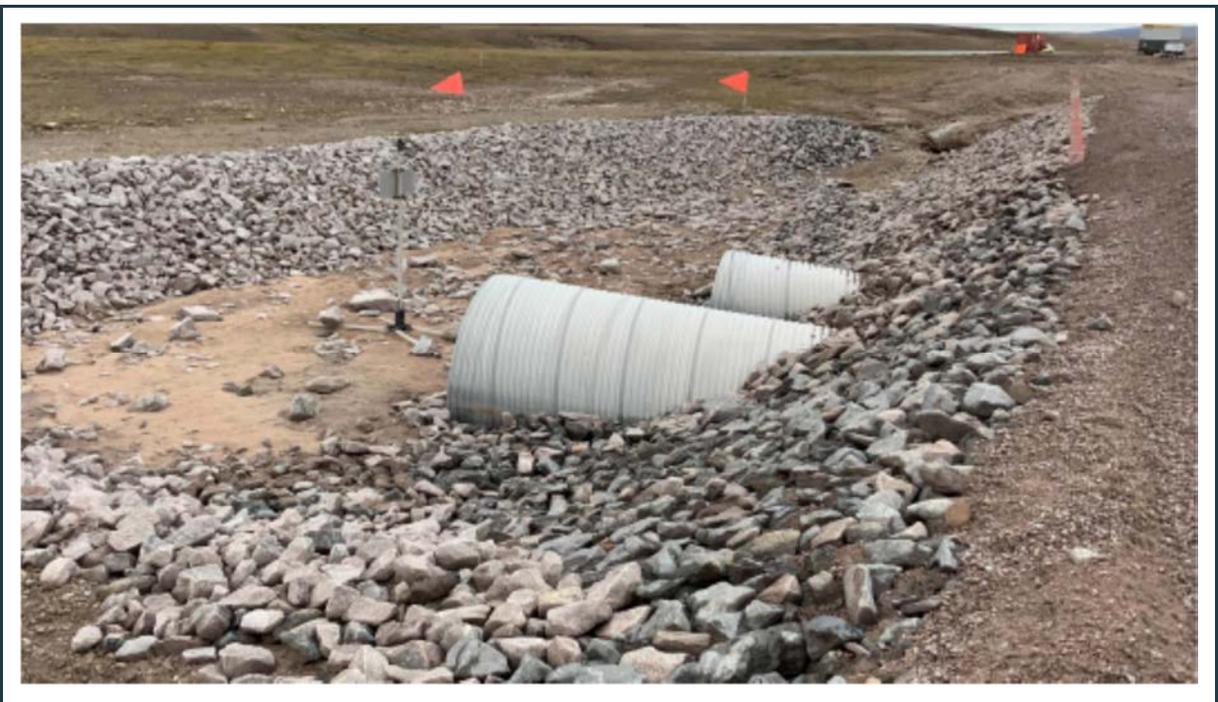
Figure 104: View of the inlet of the twin culverts at KM 33+100. No water was flowing through the culverts that show some sagging in their centre, under the weight of the road embankment.

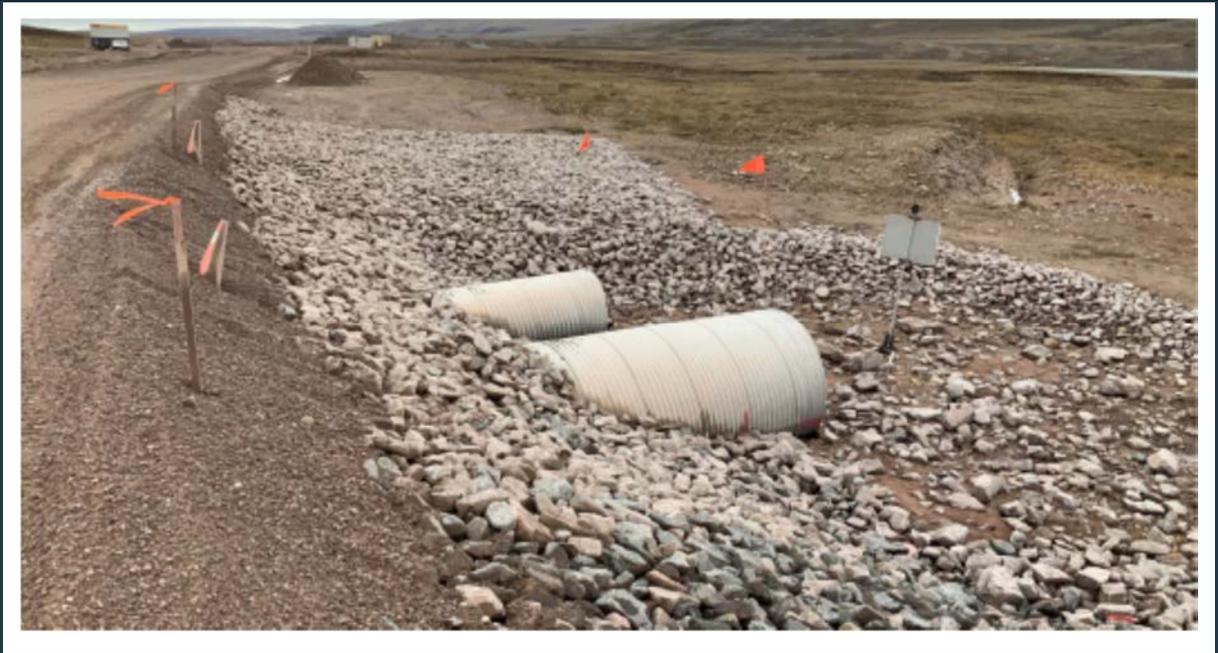
Figure 105: View of the outlet of the twin culverts at KM 33+100. No water was flowing through the culverts that show some sagging in their centre, under the weight of the road embankment.

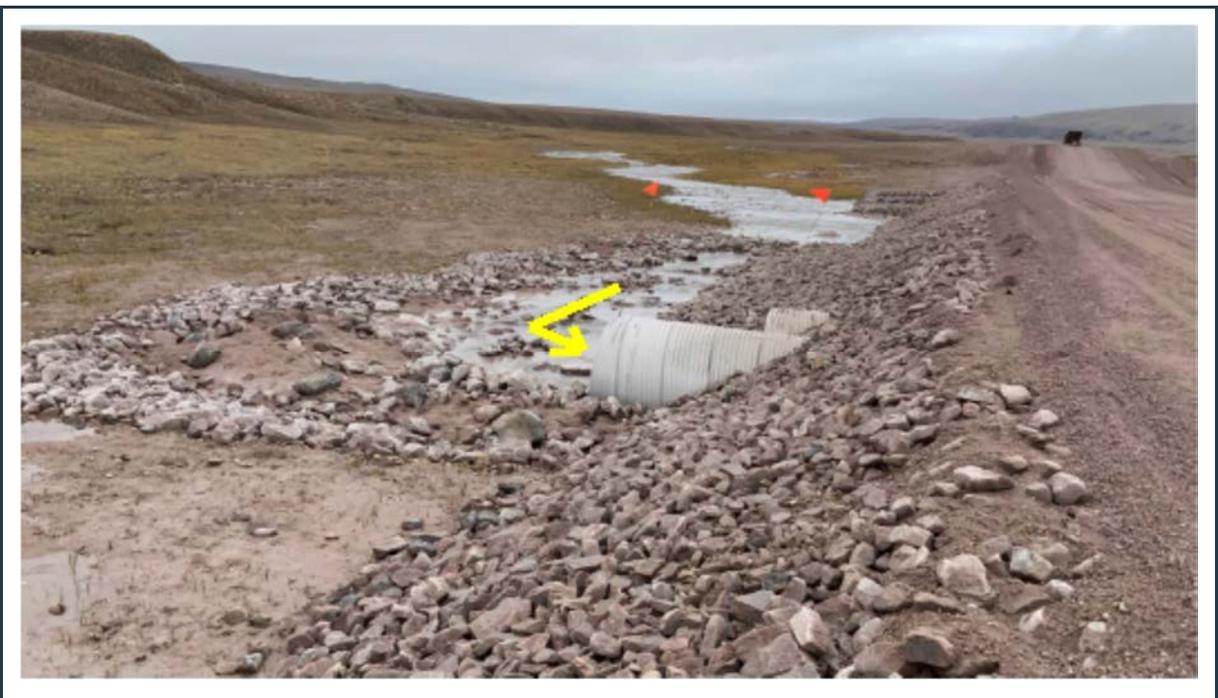
Figure 106: View of the inlet of the twin culverts at KM 36+000, in good condition.

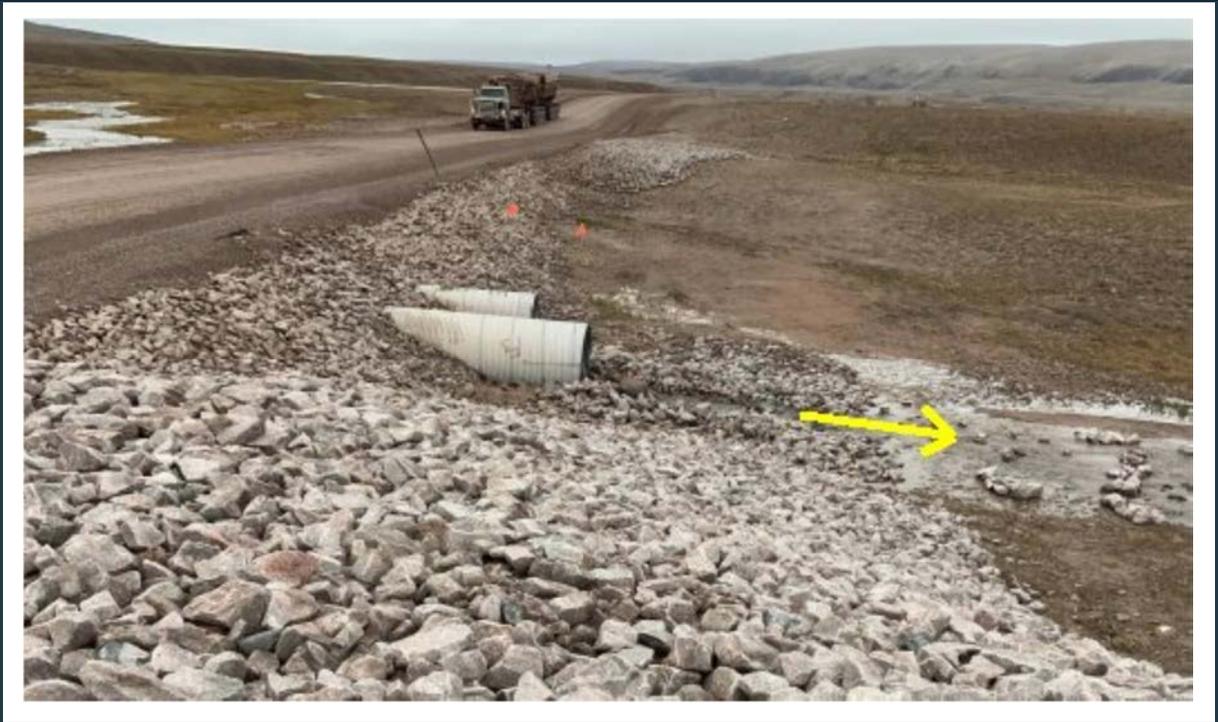
Figure 107: View of the outlet of the twin culverts at KM 36+000, in good condition.

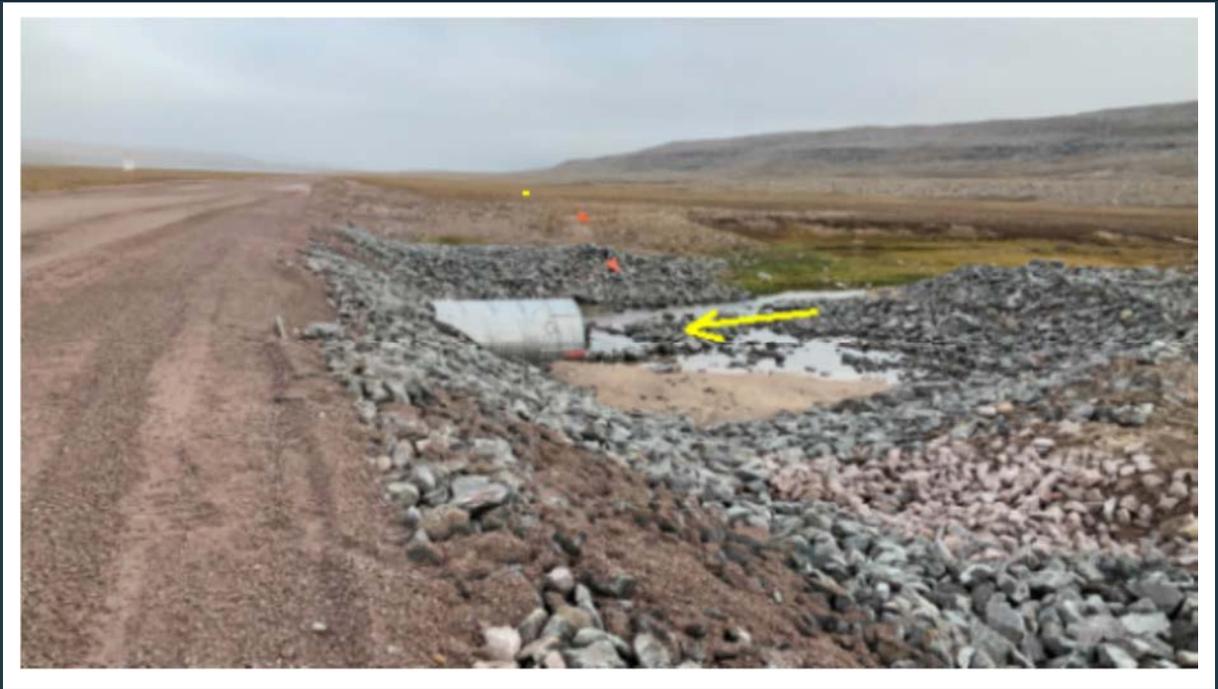
Figure 108: View of the inlet of the twin culverts at KM 59+800, in good condition.

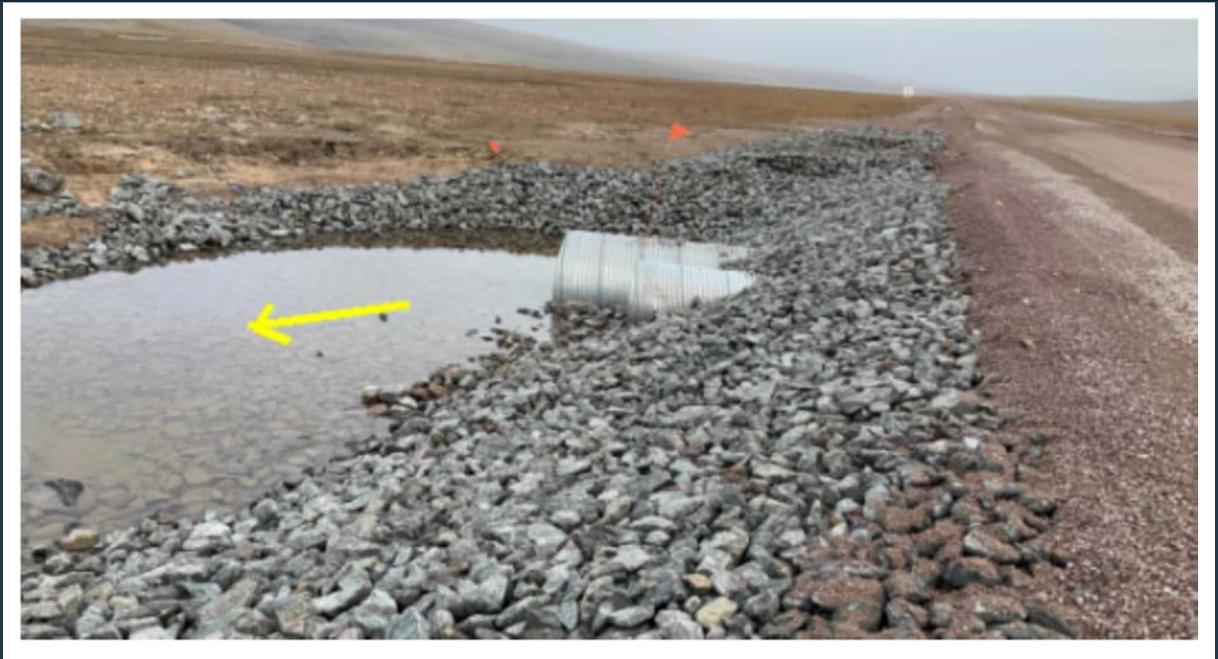
Figure 109: View of the outlet of the twin culverts at KM 59+800, in good condition.

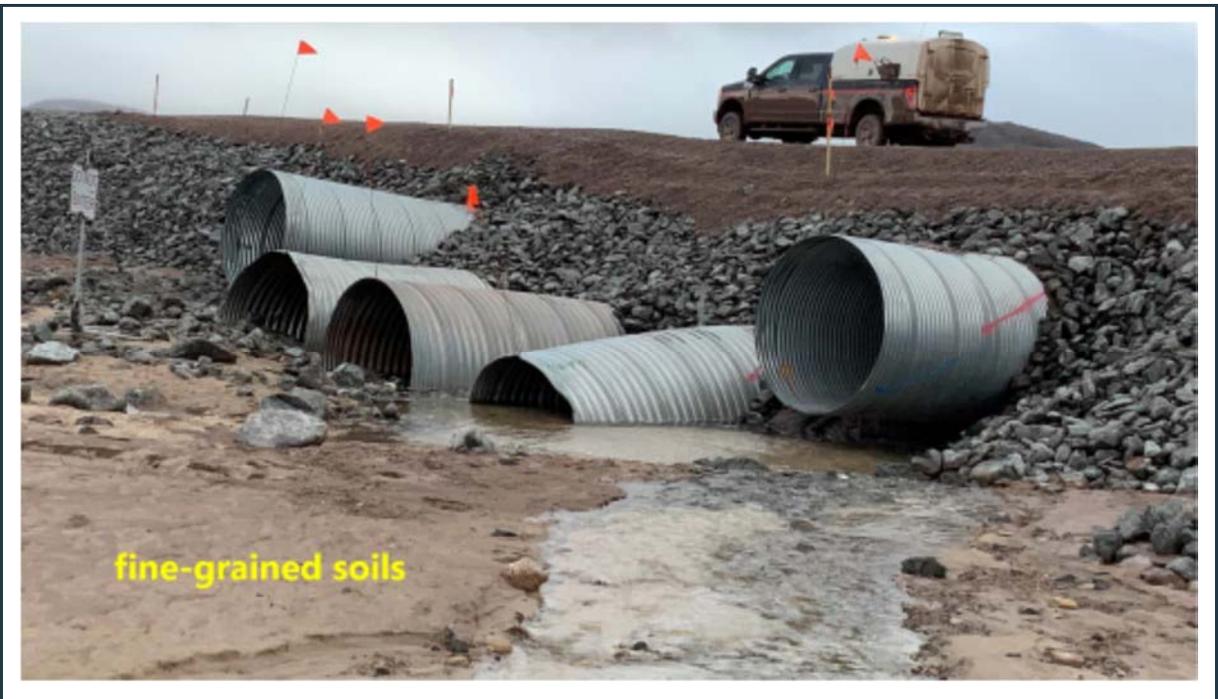
Figure 110: View of the inlet of five culverts at KM 80+500. All five culverts suffered serious differential settlements (sagging) and all of them will need to be replaced as soon as practically possible.

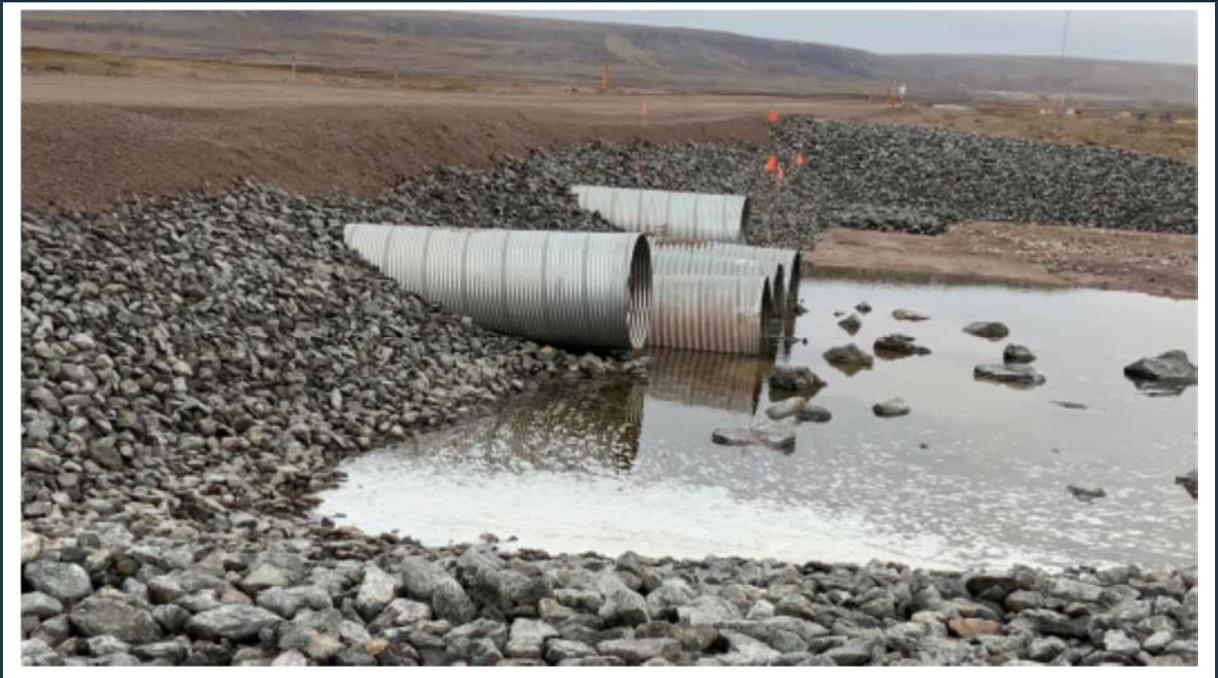
Figure 111: View of the outlet of five culverts at KM 80+500. All five culverts suffered serious differential settlements (sagging) and all of them will need to be replaced as soon as practically possible.

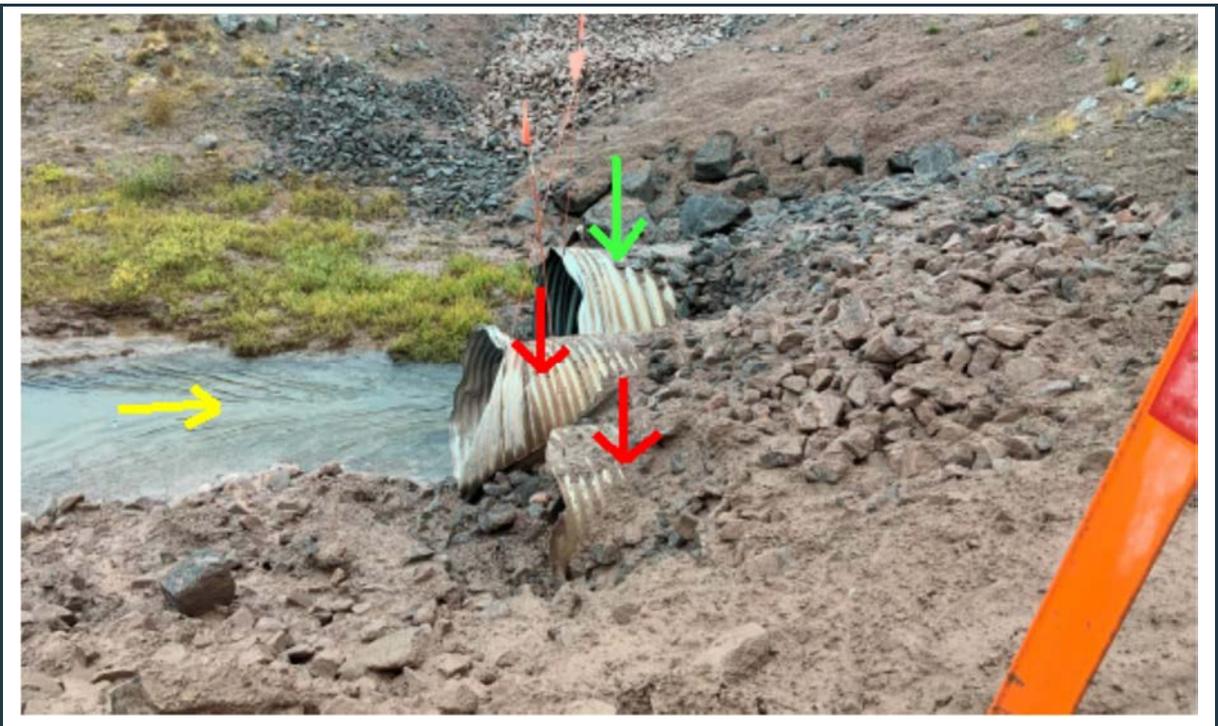
Figure 112: View of the inlet of three culverts at KM 90+100. Only one (green arrow) is operational.

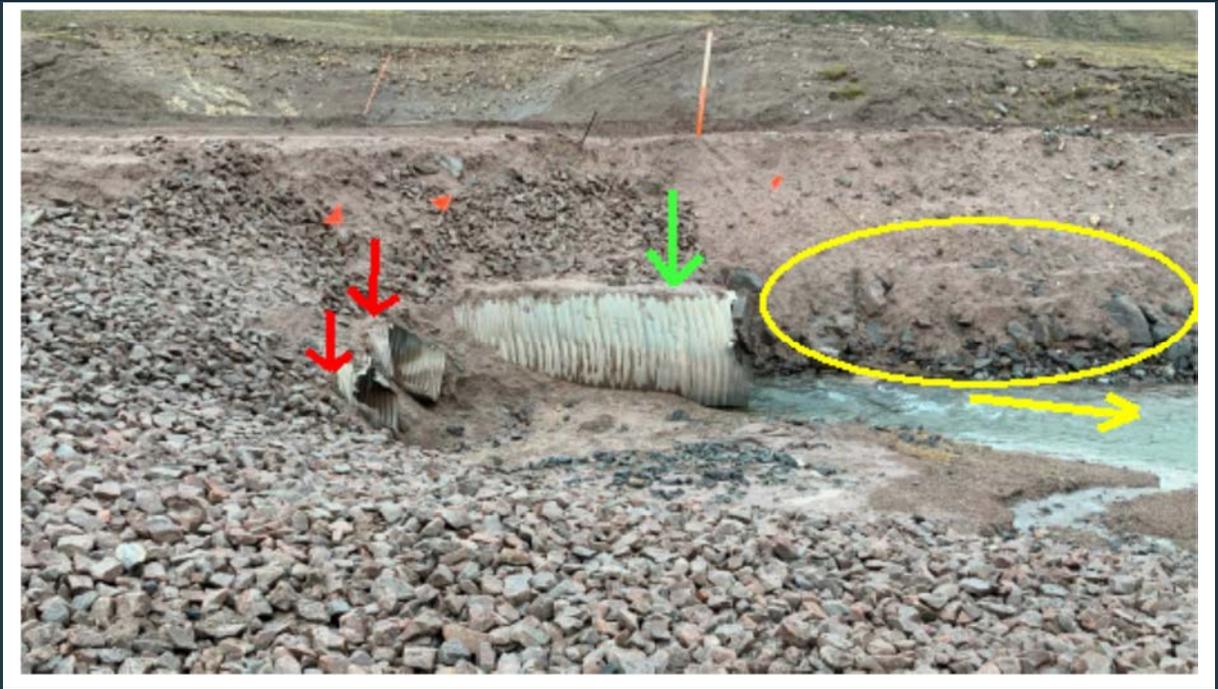
Figure 113: View of the outlet of three culverts at KM 90+100. Only one (green arrow) is operational.

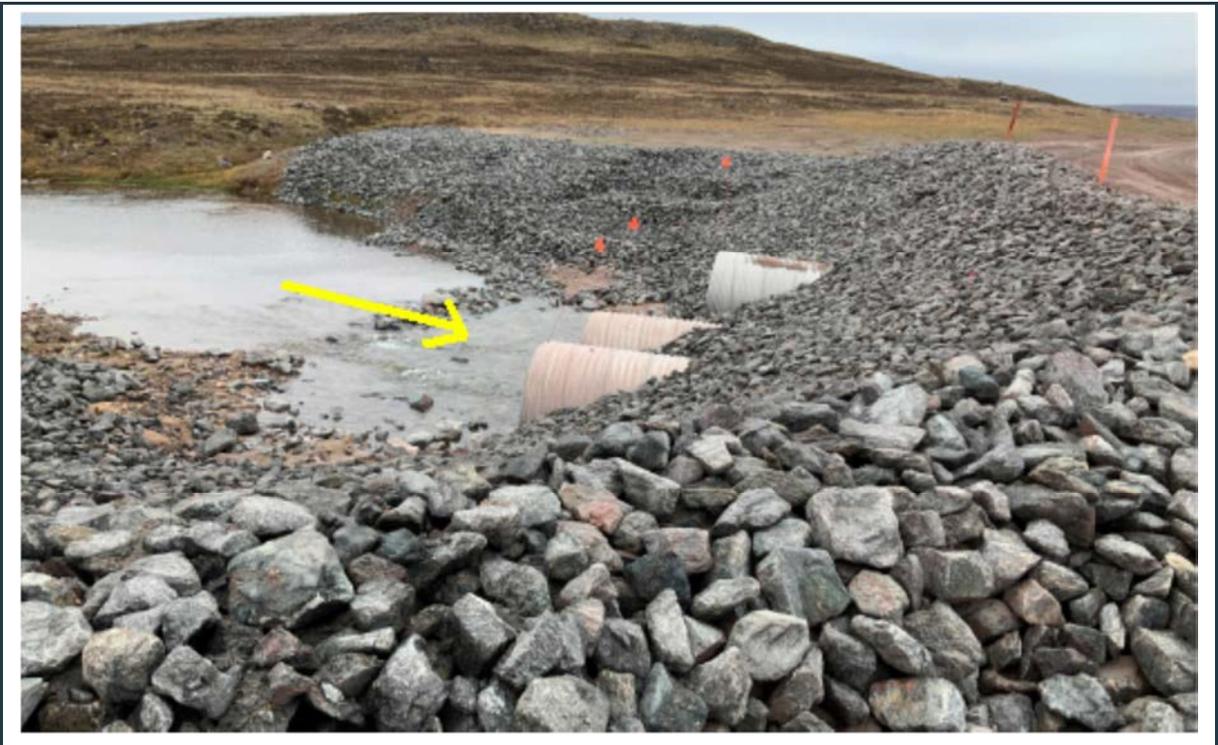
Figure 114: View of the inlet of three culverts at KM 94+060, in good condition.
