4.3 Roads on Permafrost

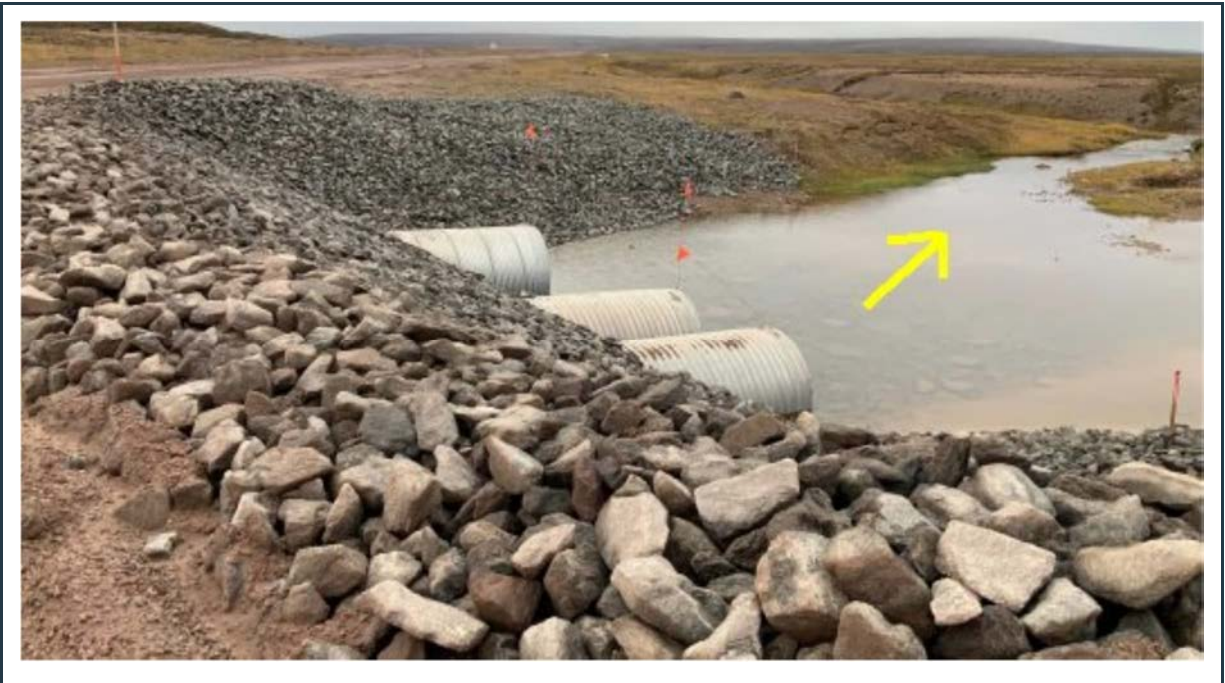
Figure 115: View of the outlet of three culverts at KM 94+060, in good condition.

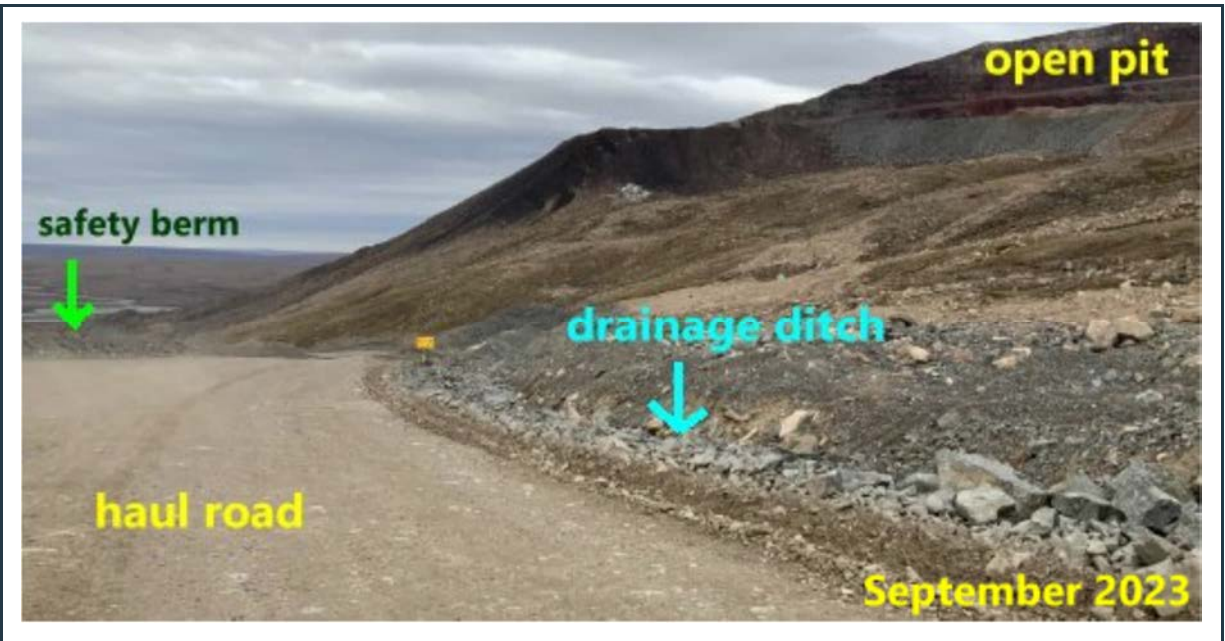
Figure 116: View of a 2023 image of the well-maintained haul road between the crusher pad and the open pit around KM-107. Note the safety berm along the downslope side and the upgraded, erosion-controlled drainage ditch along the upslope side of the road with additional rock fill in critical areas.

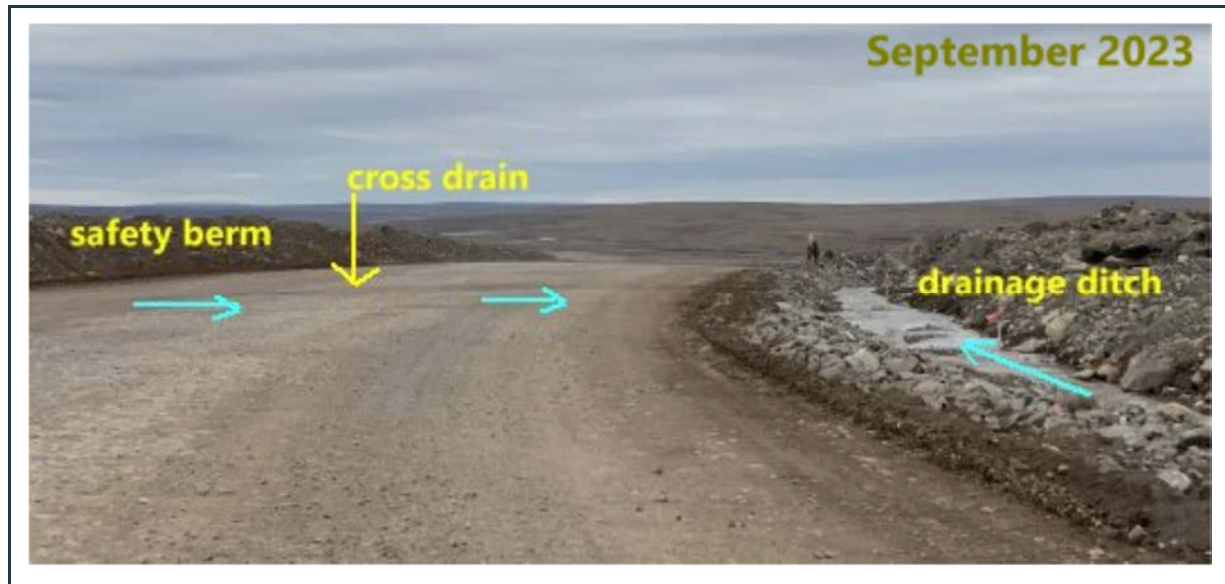
Figure 117: View of a 2023 image of a cross drain (combination of a whoa-boy and shallow ditch) intercepting run-off flowing down the haul road and direct the collected water to the side-ditch. The excellent condition of the haul road is an indication of effectiveness of such drains.

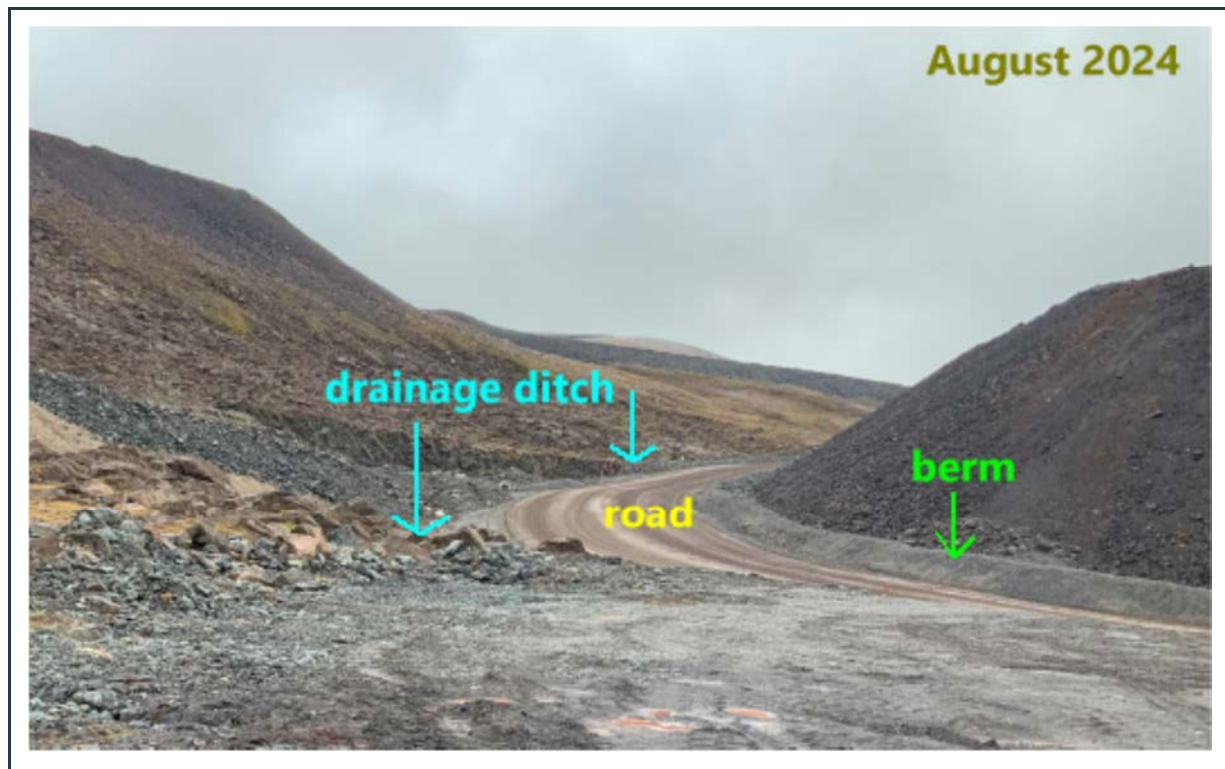
Figure 118: View of the well-maintained haul road at KM106, in August 2024.
