TECHNICAL MEMORANDUM

Reference No.
CA0036314.1956_1000_TM_01_Dec2024_Rev0

AUGUST 2024 ANNUAL GEOMECHANICAL AND GEOTECHNICAL INSPECTION, BAFFINLAND IRON MINES, PIT 1 – NULUUJAAK OPEN PIT AND WASTE ROCK STORAGE FACILITIES

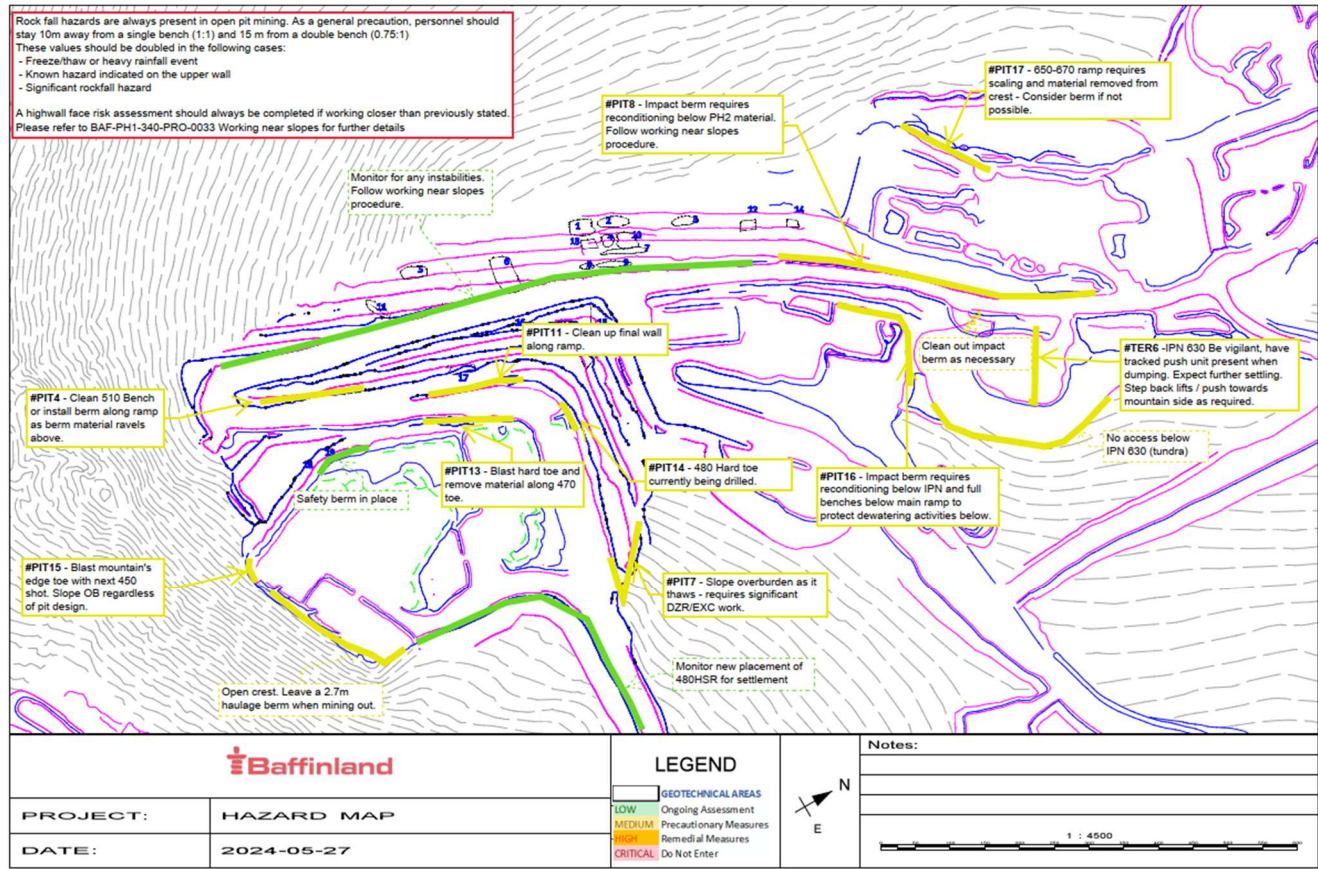
Below is an example Hazard Map.

WSP note that this hazard map not only presents the hazards but also repeats general geotechnical best practices such as safe offset distance from a single and double bench (10m and 15m) respectively and “Slope OB regardless of pit design.” Per the Baffinland Ground Control Hazard Management Plan, the geotechnical hazard maps are to be updated every three weeks.

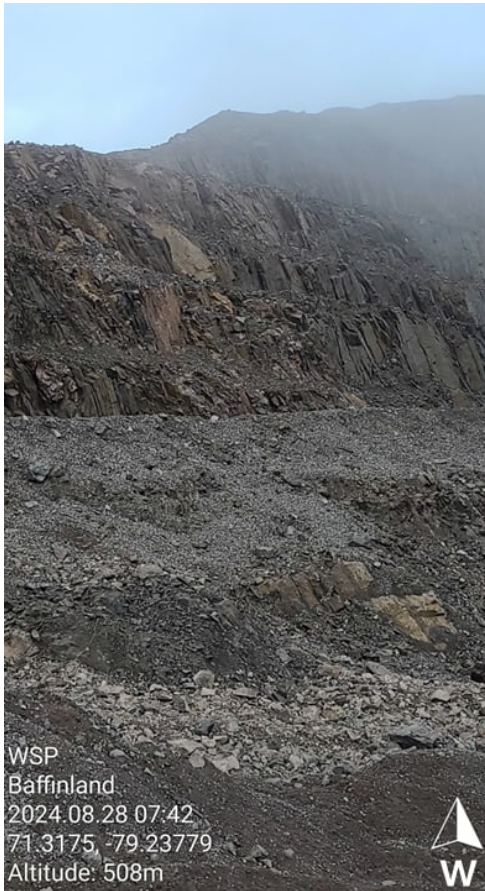
Photo 5

Blasting notes:

No pre-shearing.

Trim / cushion blasting.

No stab-holes, though Jordon has requested them on occasion, specific wall control blasts.

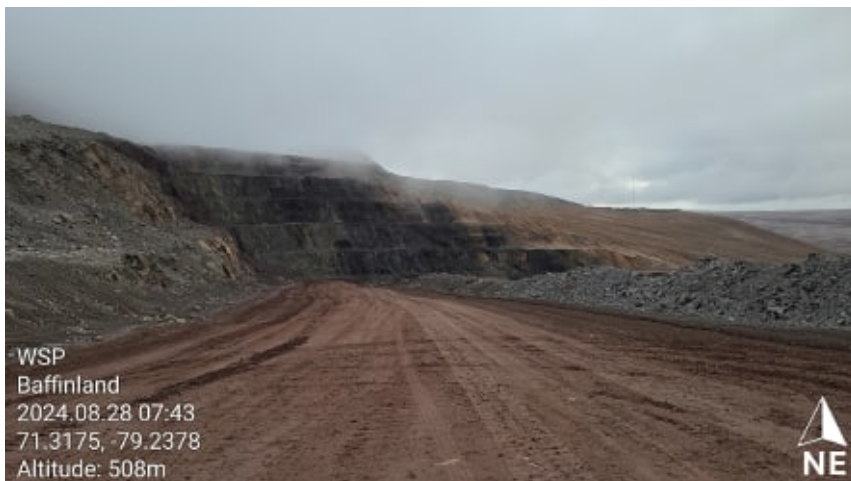
Monitoring:
Visual.

Instrumentation:
- no prisms
- no radar
- no inclinometers.

Does Deposit 1 need prisms as a second source of information on long-term deformation?

Marc to follow-up on this. Is InSar the right option in this context? Is Baffinland already collecting InSar data incidentally?

Of what value are prisms in the short or long term, this open pit geotechnical setting?

We might want inclinometers in the planned OB ramp.

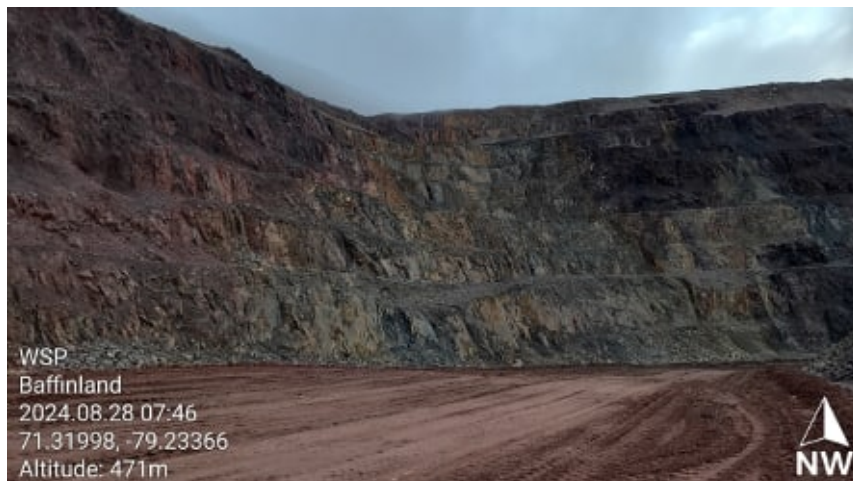
Photo 12

View of ore and waste rock, Phase 1.
Footwall

Ore is darker.

One wet zone, along sub-vertical bedding, in the waste rock.

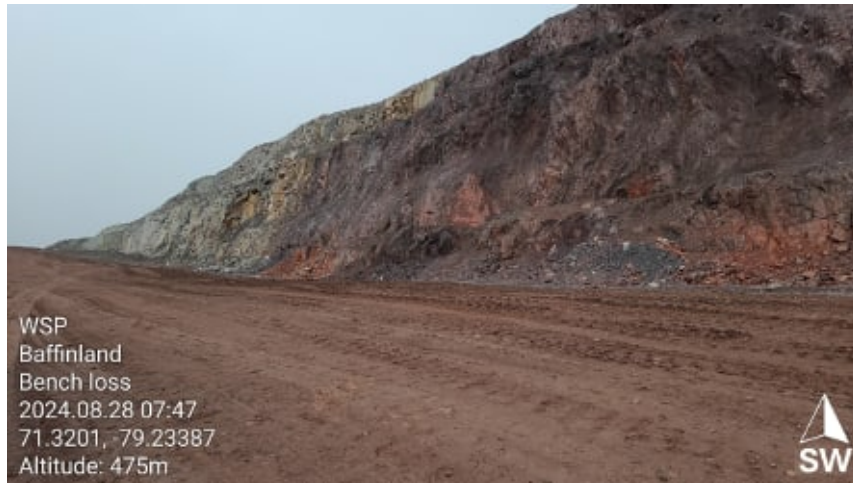
Photo 17

Notes: Bench loss

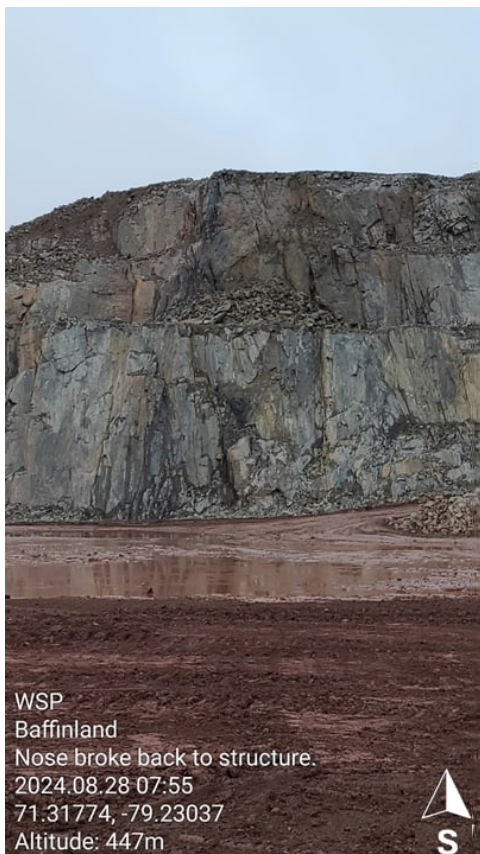
Photo 20

Notes: Nose broke back to structure.

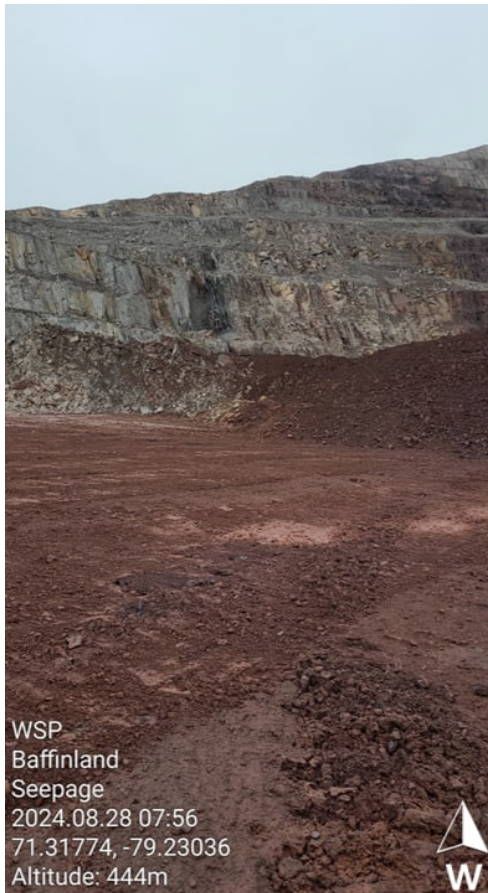
Photo 23

Notes: Seepage

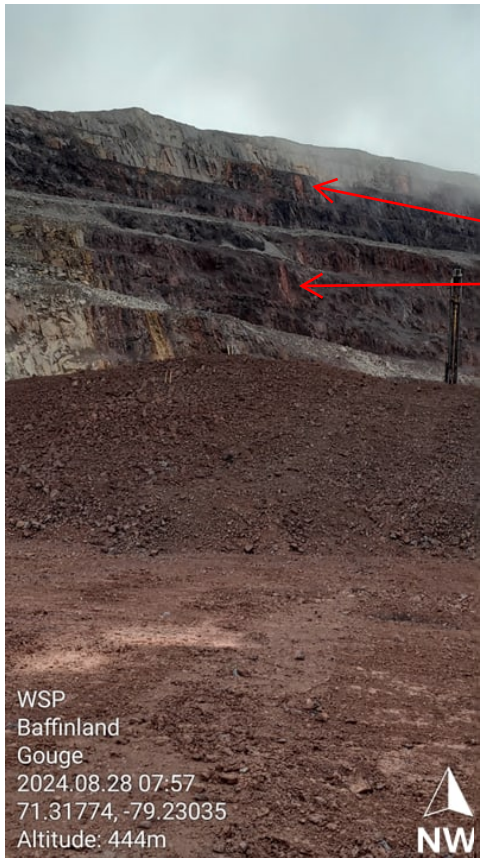
Photo 25

Notes: Gouge

Gouge. Along a consistent trend.

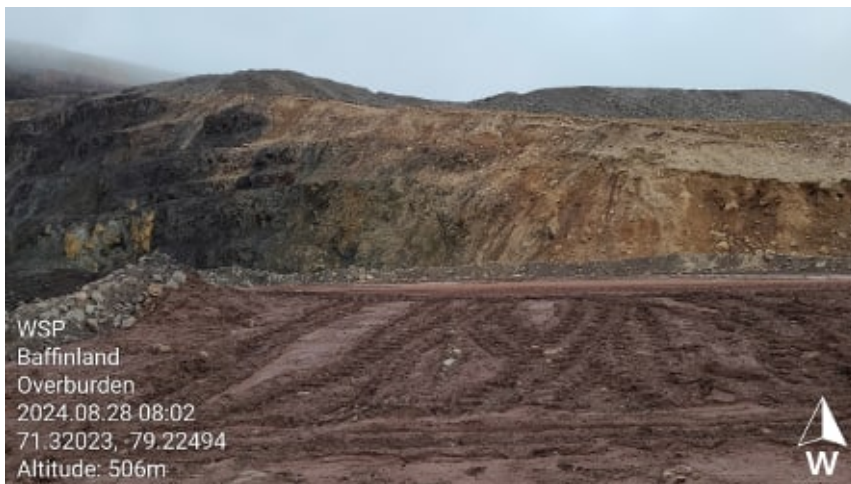
Photo 26

Future Ramp in Overburden	During the site visit we discussed that a future permanent ramp may be developed through thick overburden here. See Photos 26 and 27. The concern is that in the long term mine plan, the planned ramp geometry appears to be too steep for overburden. The proposed design appears to assume the ramp will be excavated in rock.	Recommendation Low priority given the lead time:’ <ul style="list-style-type: none"> Redesign the ramp, where it will be through overburden with overburden slope angles. Assume an angle of repose of the overburden of is 32 ° to 36 °. Document the existing overburden exposure and behaviour.

A future permanent ramp will be developed through this overburden.

Jordon notes that the overburden is deep here according to the geological model. He also noted that the ramp slopes appear to assume the ramp will be excavated rock.

Performance issues for ramp assumed to be in rock:

- erosion and slumping
- loss of travel width

Action: Redesign the ramp with side slopes appropriate to overburden.

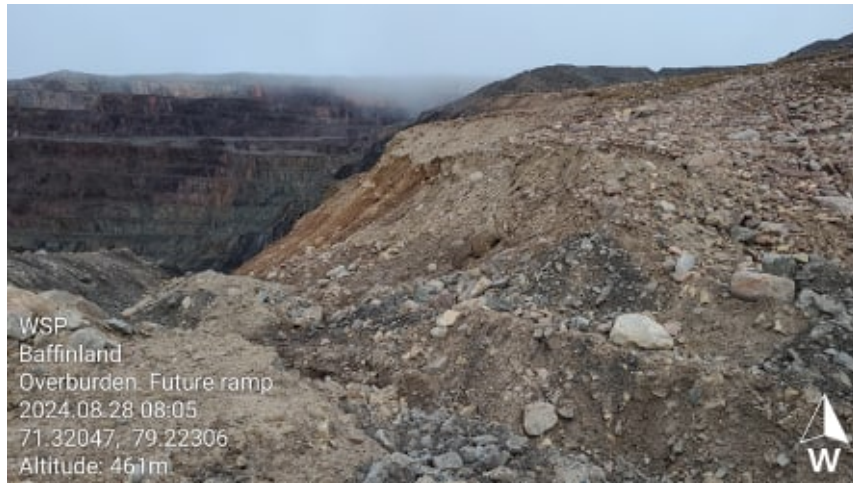
Photo 27

Notes: Overburden. Future ramp

Apparent dip of the overburden slope is approximately 36 degrees.

This seems steep. I was expecting 30 degrees.

I grabbed hand samples. This is well graded till, full of angular cobbles, sub-rounded to angular. The matrix is medium to fine sand.

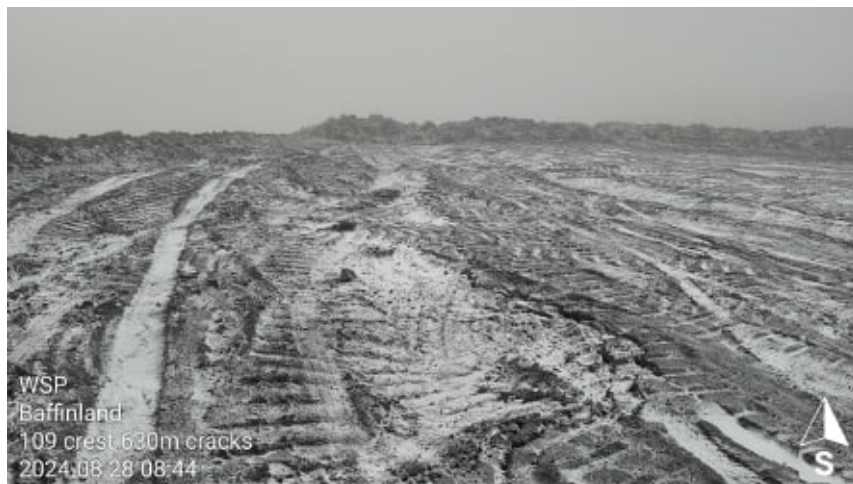
Photo 28

Notes: 109 crest 630m cracks

No one is concerned with these minor settlement cracks.

I wonder how they relate to the underlying topography. Is the differential settlement partly due to underlying lifts?

Mine Area	Observations	Recommendations
Waste Rock Dump	No geotechnical concerns based on visual inspection during site visit or shared. Apparent angle of repose of lifts is 32 °. See Photos 39-45.	Continue with current visual monitoring practices. No modifications to daily and weekly procedures.
109 km Stockpile (IPN Stockpile)	No geotechnical concerns. Modest lift height. No signs of deformation on slopes (bulging, heave). Minor cracking on the top surface of 109 (elevation 630m). The stockpile is inactive. WSP believe these cracks are of no concern because they are due to minor differential settlement typical in dumps. The cracking and minor settlement would not be noticed in an active dump due to heavy traffic and regular regrading. See Photos 28-31.	Recommendation: (Low Priority) Best practice is to regrade / fill such crack, to prevent water ingress as a pro-active maintenance measure. However, given the low height of 109, not doing so will likely only produce additional settlement that can be filled and regraded if and when the dump become active. Alternatively Continue monitoring. If conditions worsen, backfill the cracks. It is common for minor cracks to develop on inactive dumps.

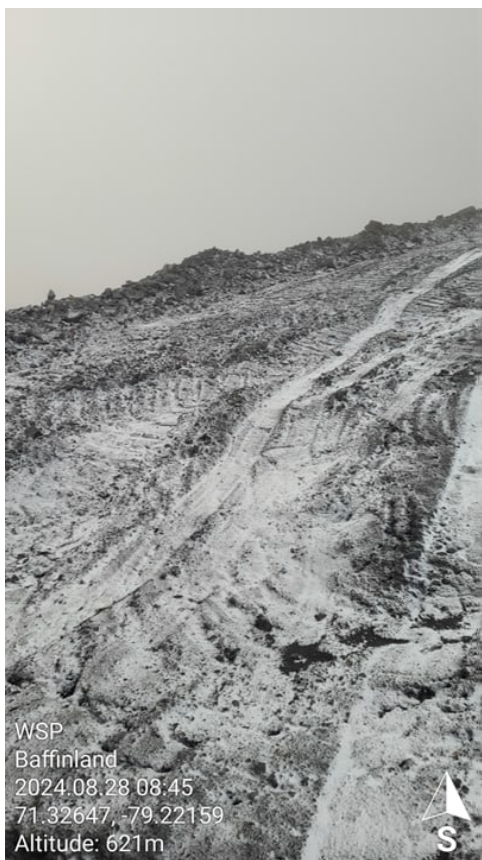
Photo 29

The minor cracking is difficult to see in the photos.

The stockpile is inactive.

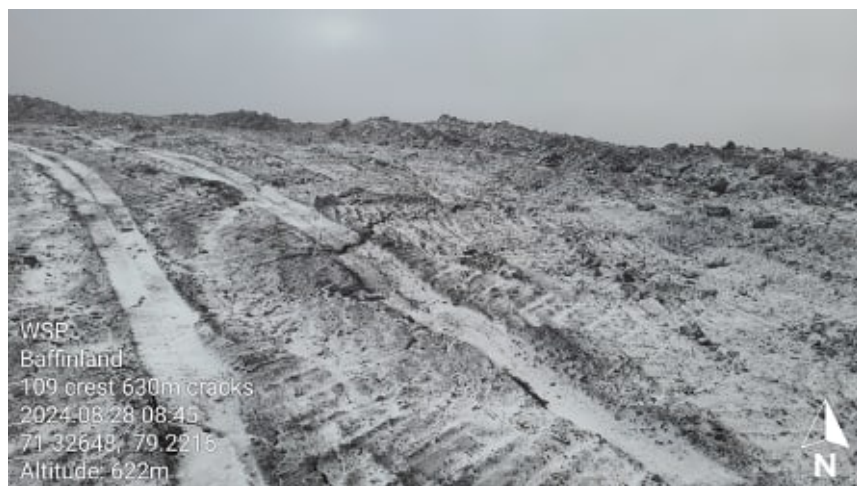
Photo 30

Cracks

109 Stockpile

Inactive

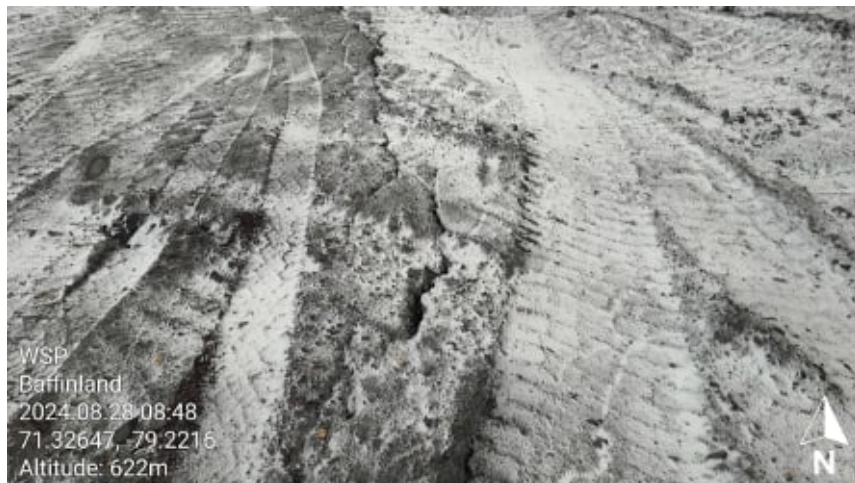
Photo 31

Minor cracks

Parallel to advancing front

109 stockpile

inactive

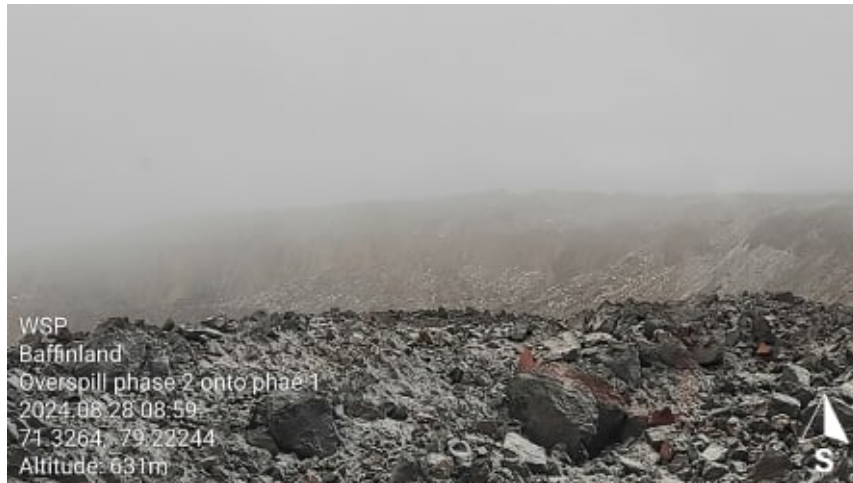
Photo 35

Notes: Overspill phase 2 onto phase 1

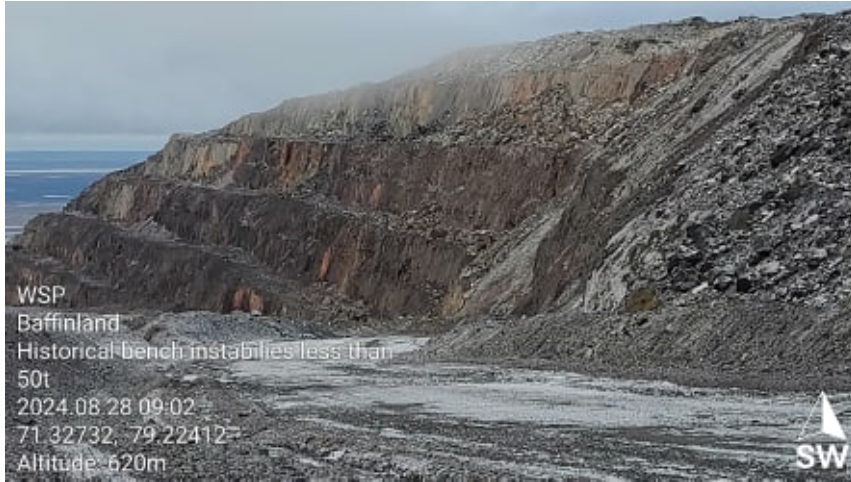
Photo 37

Notes: Historical bench instabilities less than 50t

Falls of ground greater than 50t must be reported.

Jordan explained that most of the FOG shown were less than 50t (and not reported).

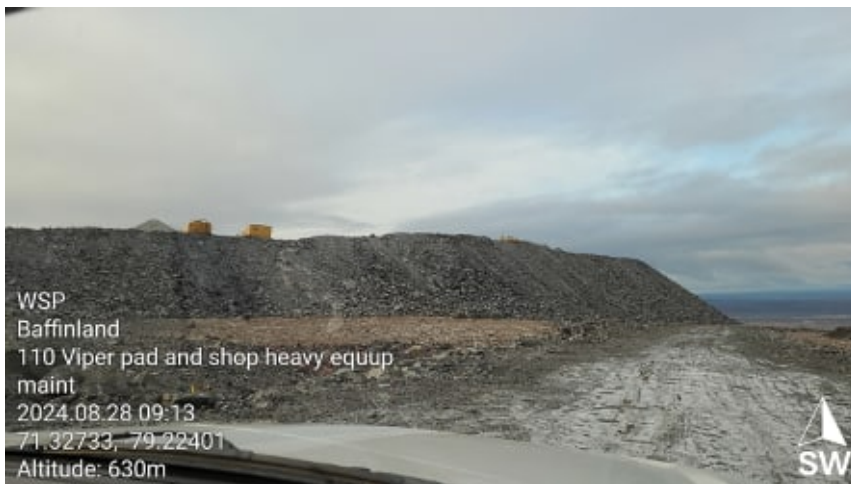
Photo 38

This is the km 110 stockpile.

The apparent slope of the dump face on the right hand side of the photo is 32 degrees.

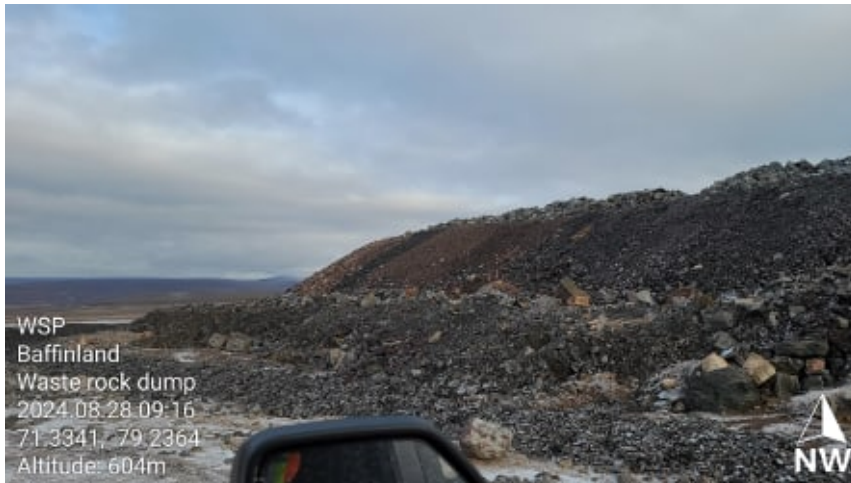
Photo 39

Waste rock dump and perimeter ditch.

Ditch is rip rapped.

Apparent dip of the waste rock slope is 32 degrees.

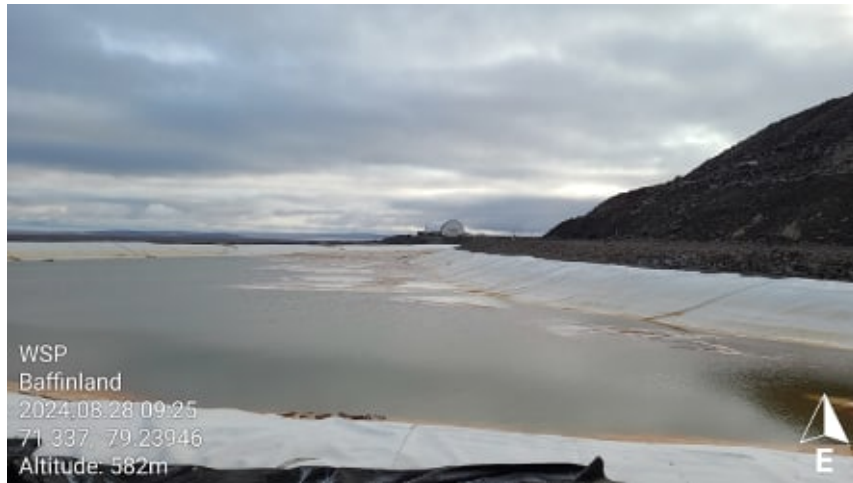
Photo 41

This liner is "new" to me (MR).

When I was last year, 8 years-ish ago, there was a different liner, black, that leaked.

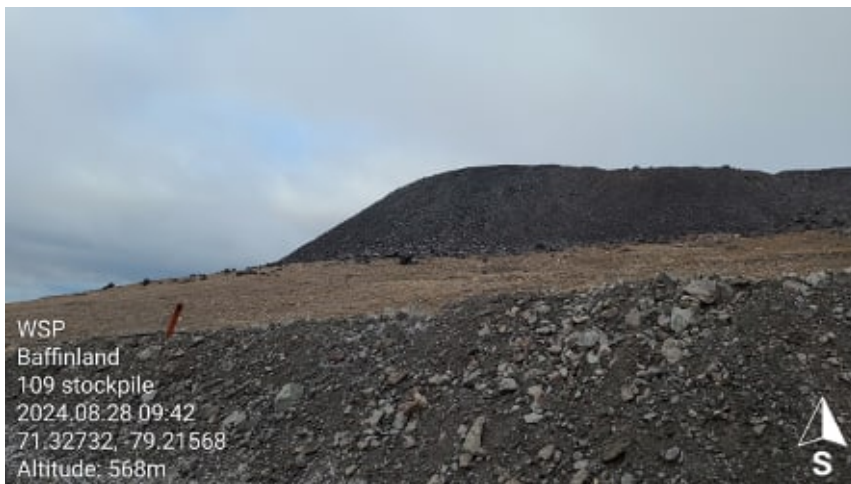
Photo 46

Apparent dip of the stockpile lift is 30 degrees.

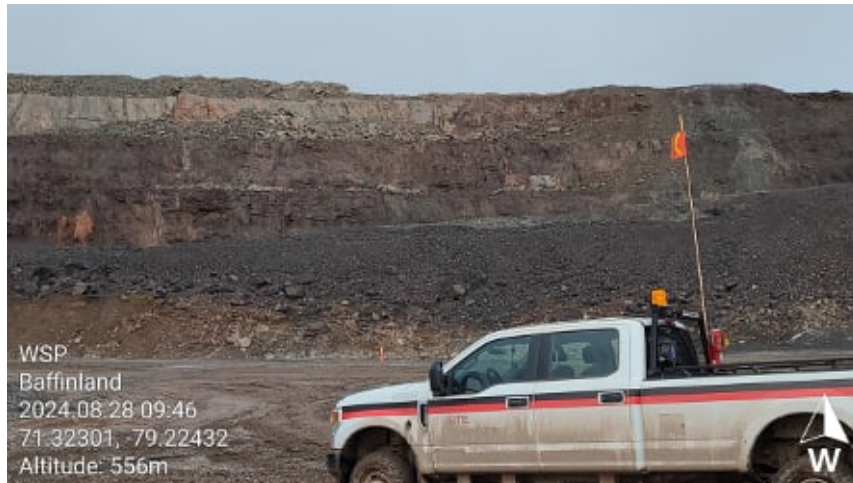
View of overspill onto bench.

- combination of overspill from ploughing and Phase 1 development above.
