TOTE ROAD CV-225

BAFFINLAND IRON MINES
MARY RIVER PROJECT

APPENDIX C

Erosion and Sediment Controls implemented in 2024

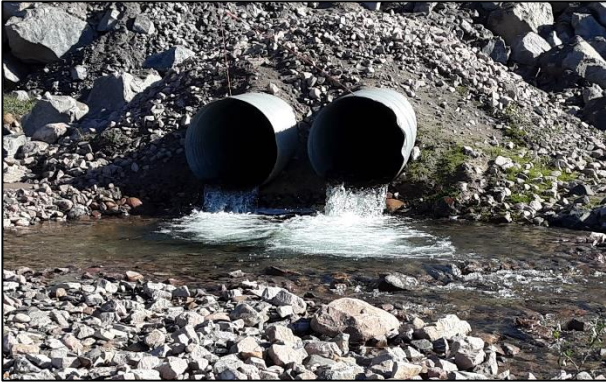
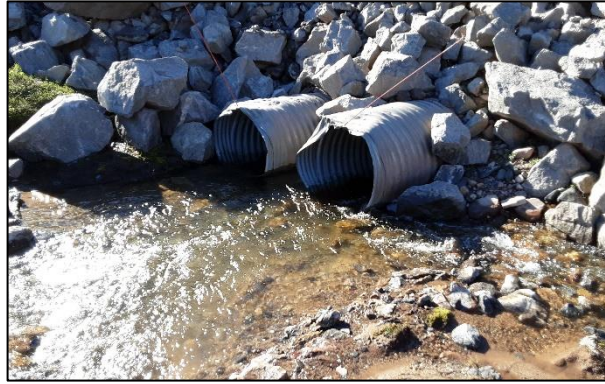
Downstream catch rates (5.48 fish/minute) of juvenile Arctic Char were approximately twice as high as upstream (2.60 fish/minute) in spring 2024. Additionally, no fish smaller than 119 mm were captured upstream of the crossing. Both fish passage culverts are perched and the relatively high in-culvert velocities (>1.00 m/s in spring 2024) likely restrict upstream access to only larger juveniles. Char use habitat in the stream for rearing and there is potential for adult use in the deeper pools near Camp Lake. There is no char spawning or overwintering habitat in the stream.

Photos 1-2. Photos taken of the culvert in spring 2024: (A) downstream end; and (B) upstream end.

The Tote Road crosses an unnamed stream at site CV-225 that flows south into Camp Lake 250 m downstream of the crossing. Camp Lake has been extensively surveyed and is known to support both overwintering and char spawning. This crossing has been identified for remediation.

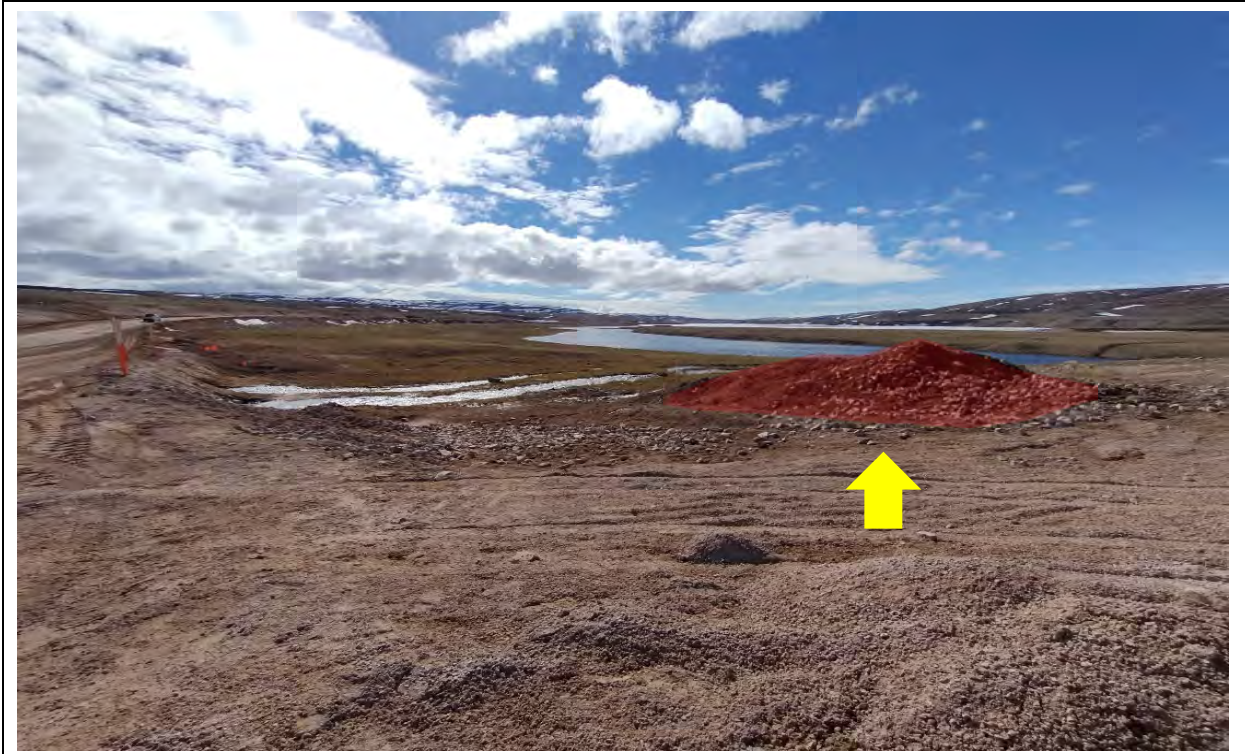
Photo 1. CV-112 downstream (east side), north bank. Pile of snow and aggregate identified adjacent to watercourse.

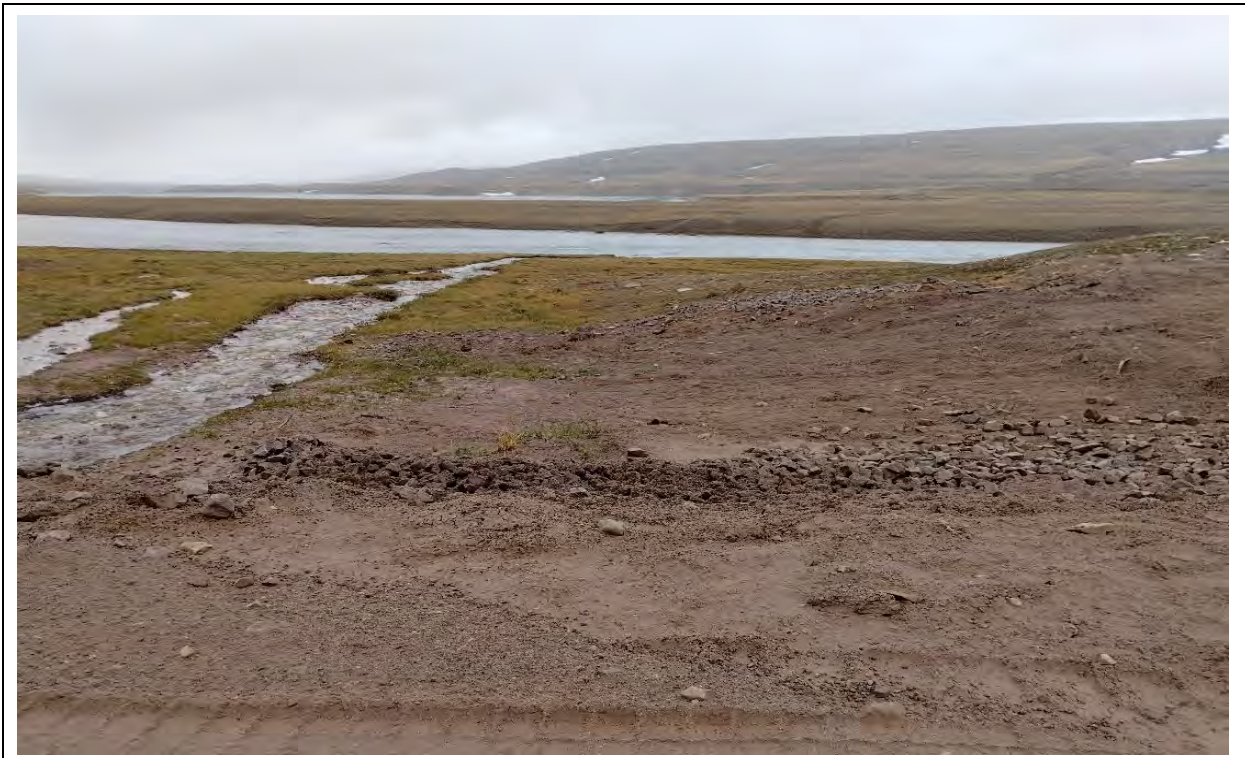
Photo 2. CV-112 downstream (east side), north bank. Pile of mixed snow and aggregate has been removed.

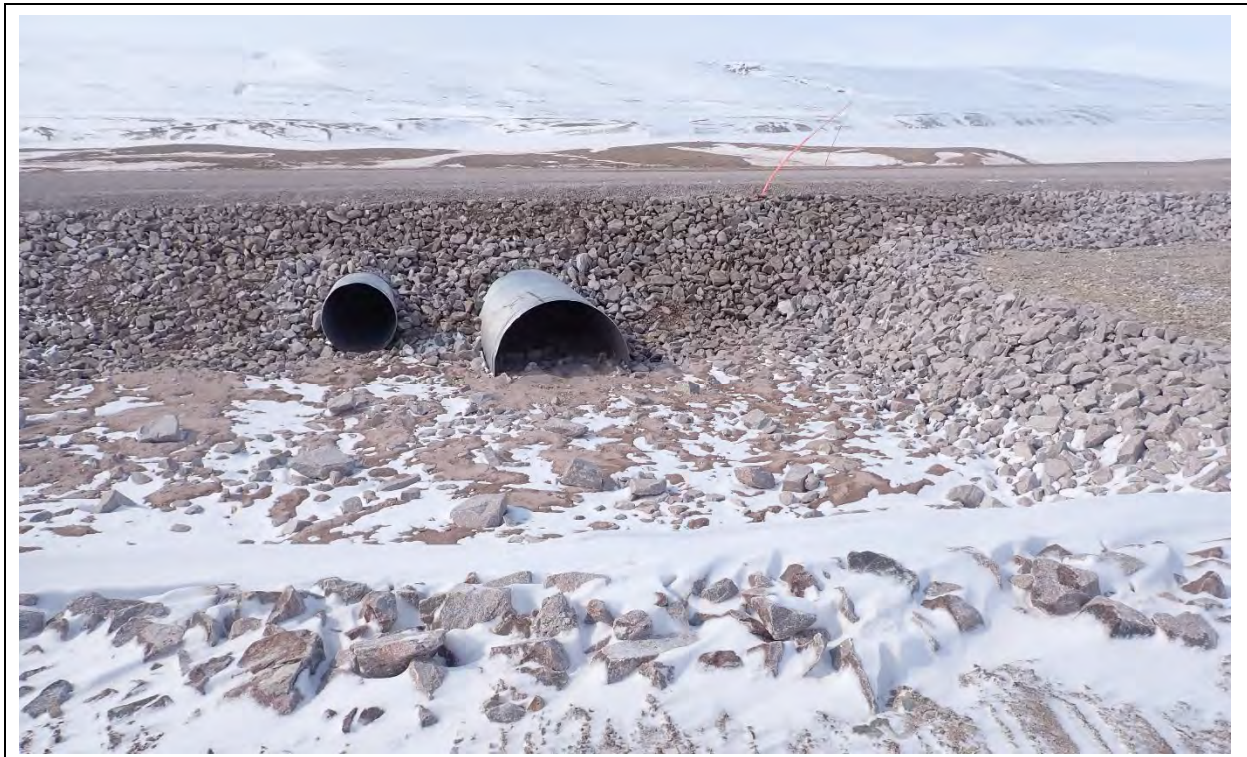
Photo 3. CV-106 upstream, culvert inlet after remedial construction.

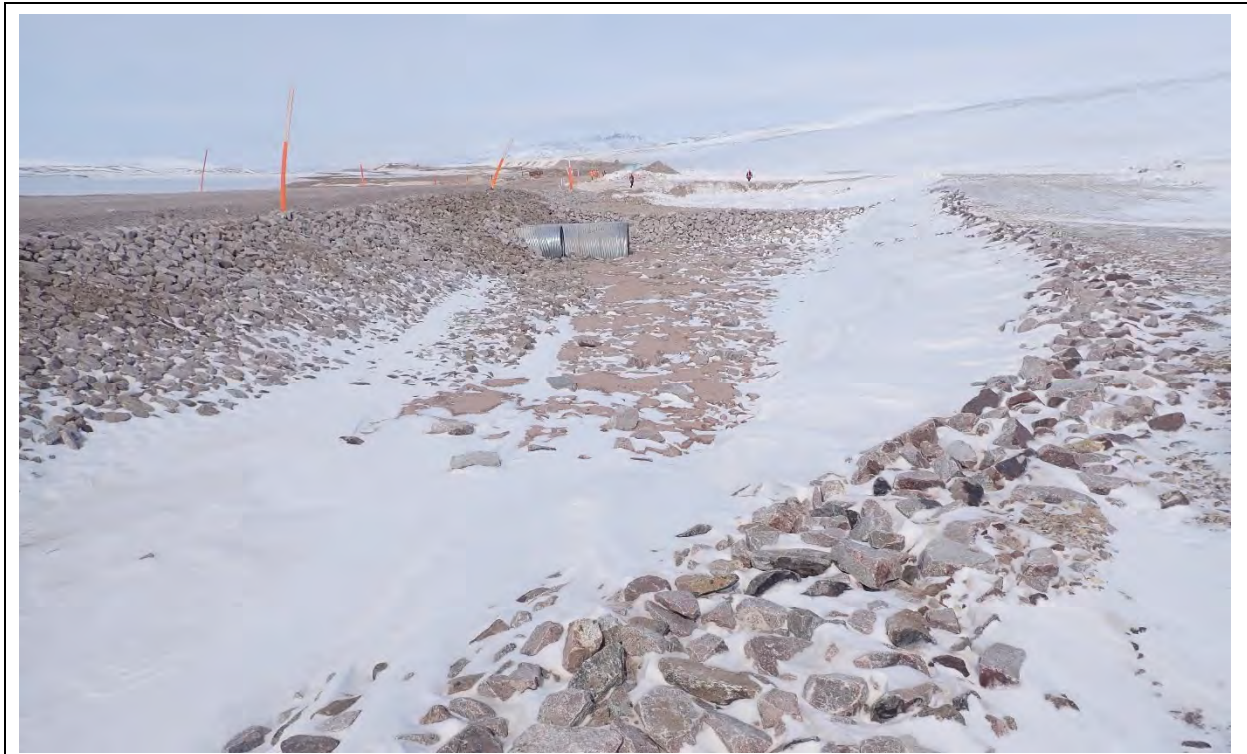
Photo 4. CV-106 upstream, culvert inlet apron after remedial construction.

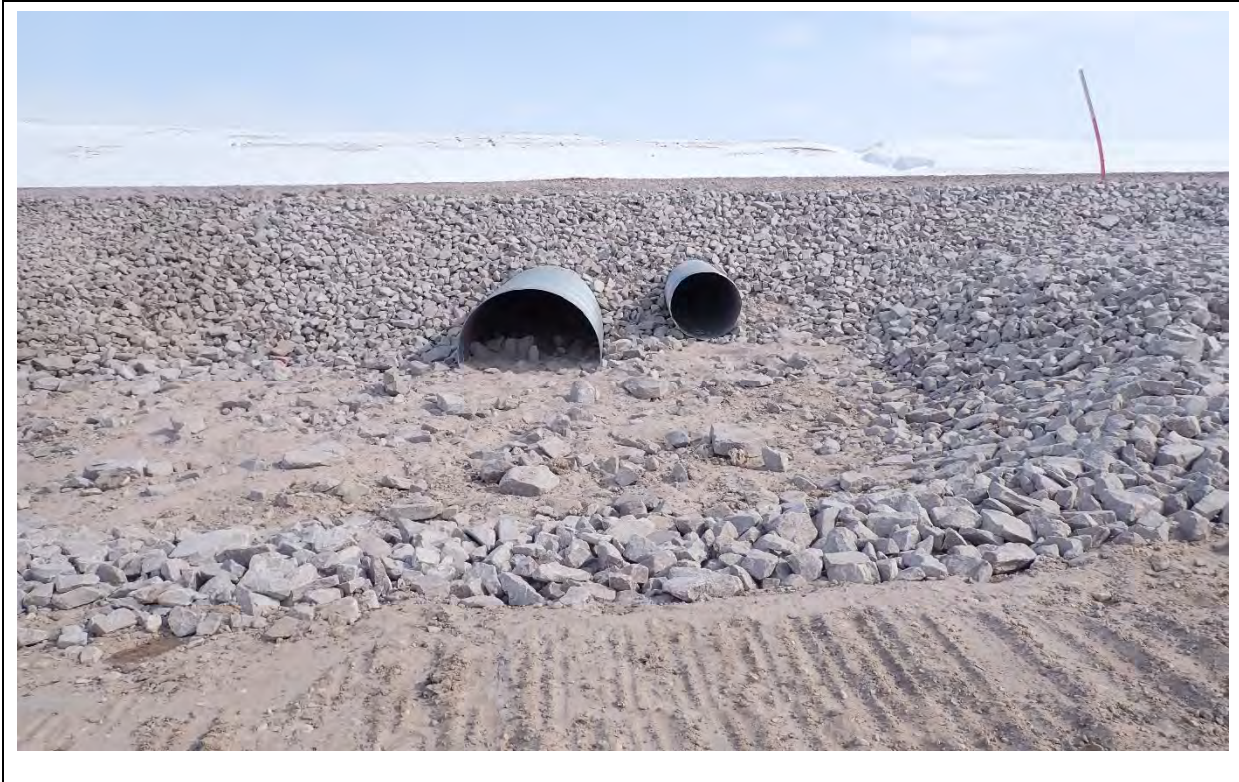
Photo 5. CV-106 downstream, culvert outlet after remedial construction.

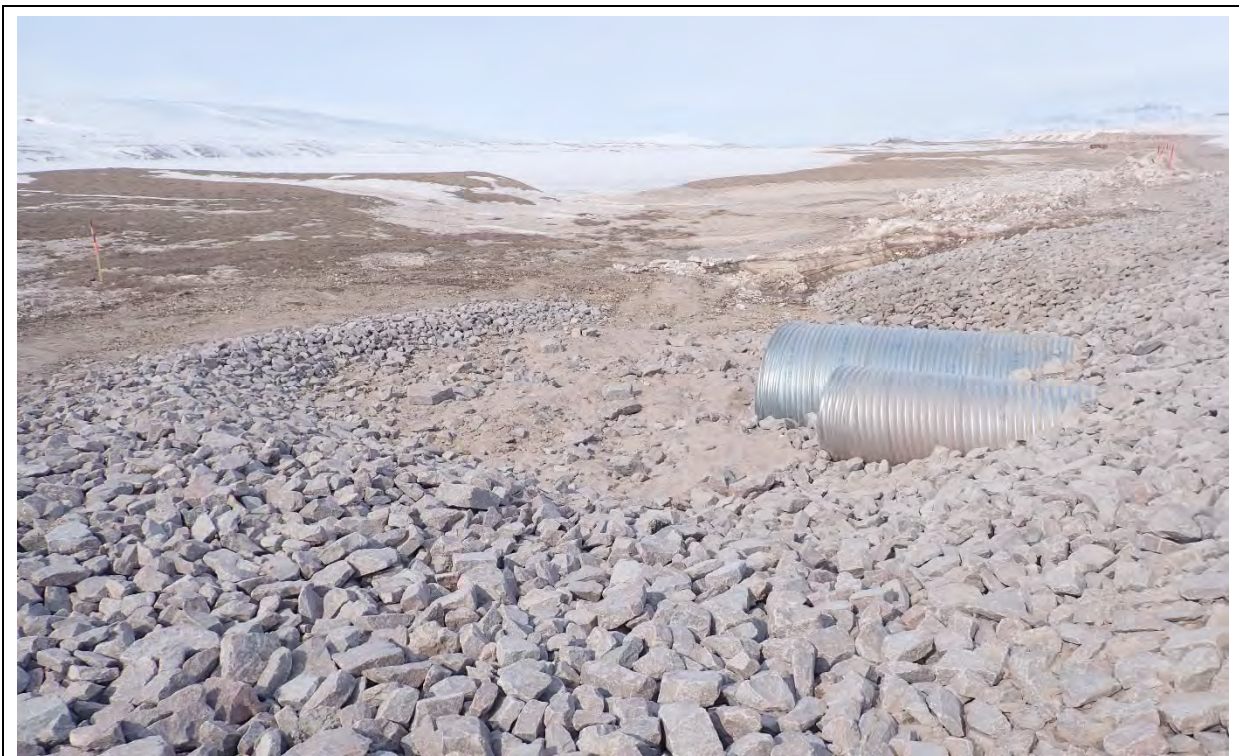
Photo 6. CV-106 downstream, culvert outlet apron after remedial construction.

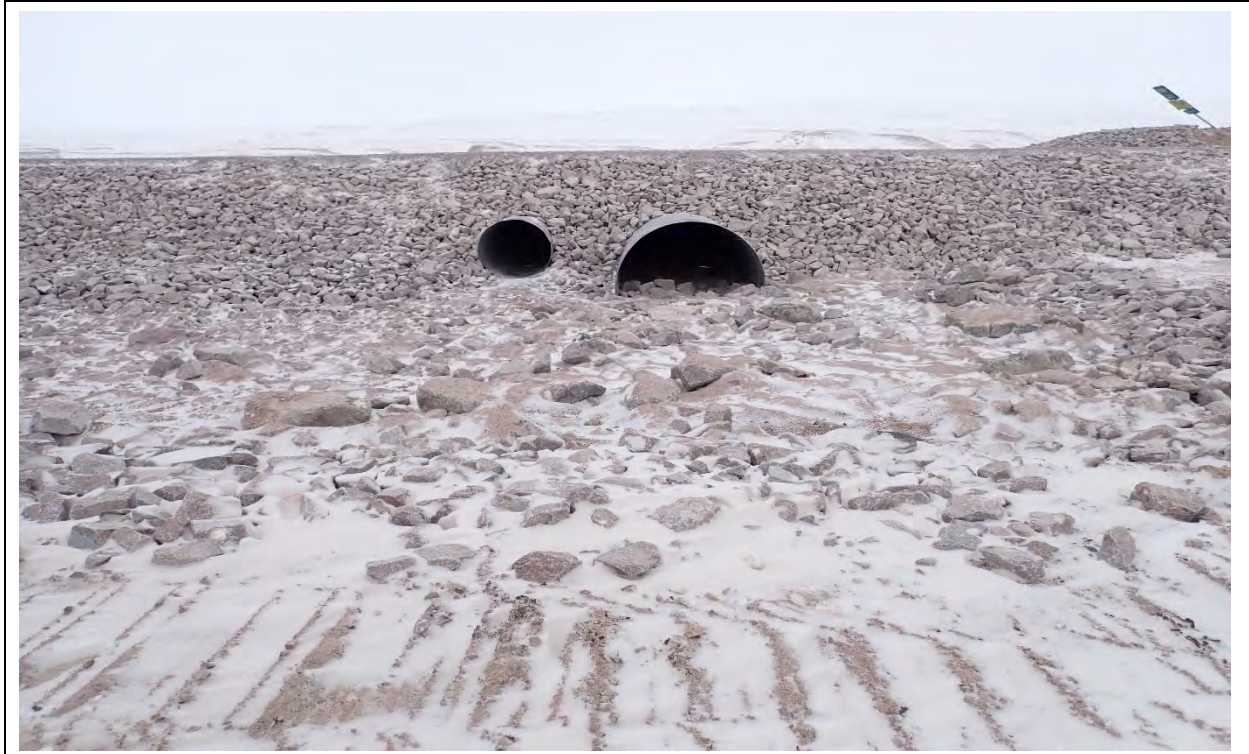
Photo 7. CV-102 upstream, culvert inlet after remedial construction.

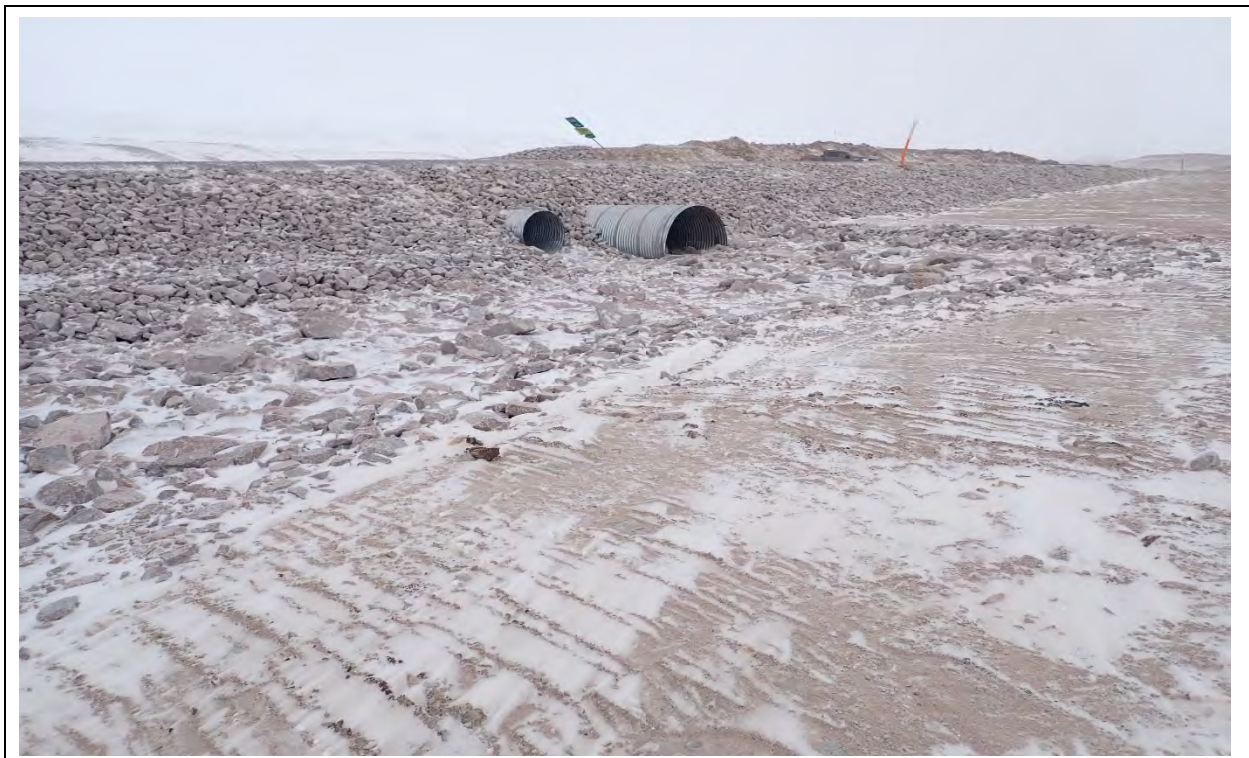
Photo 8. CV-102 upstream, culvert inlet apron after remedial construction.

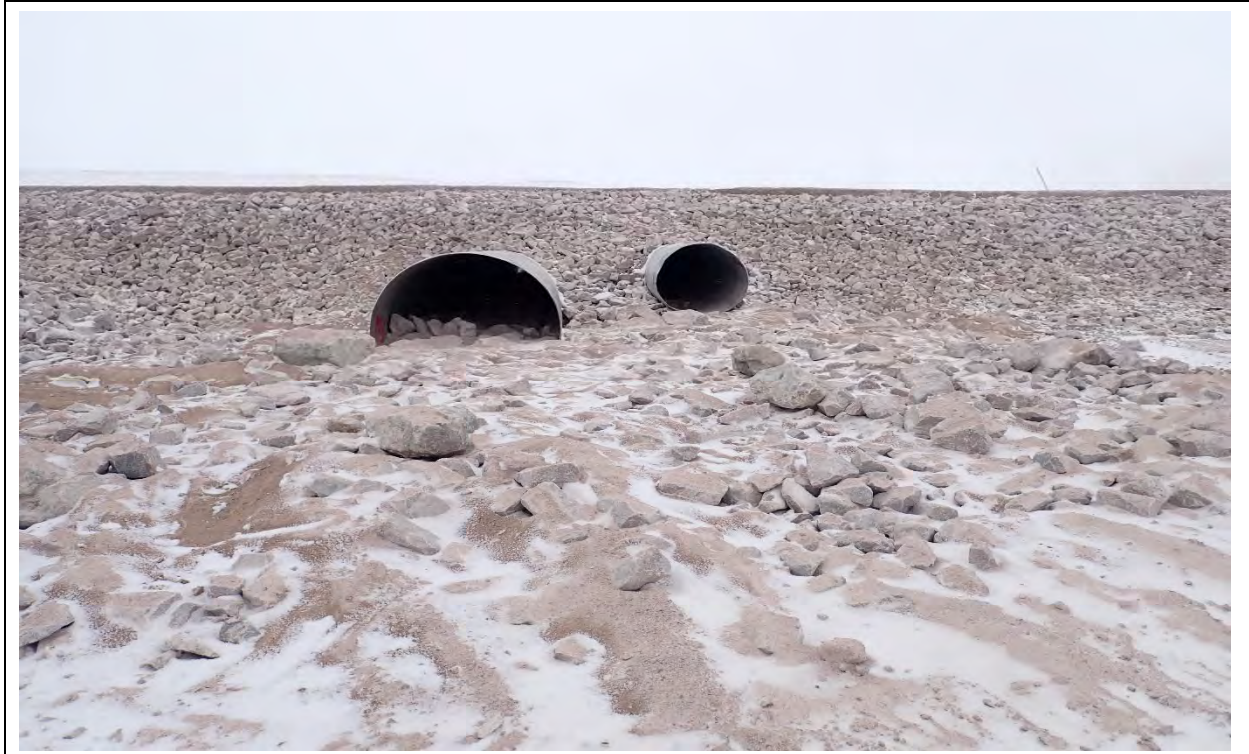
Photo 9. CV-102 downstream, culvert outlet after remedial construction.

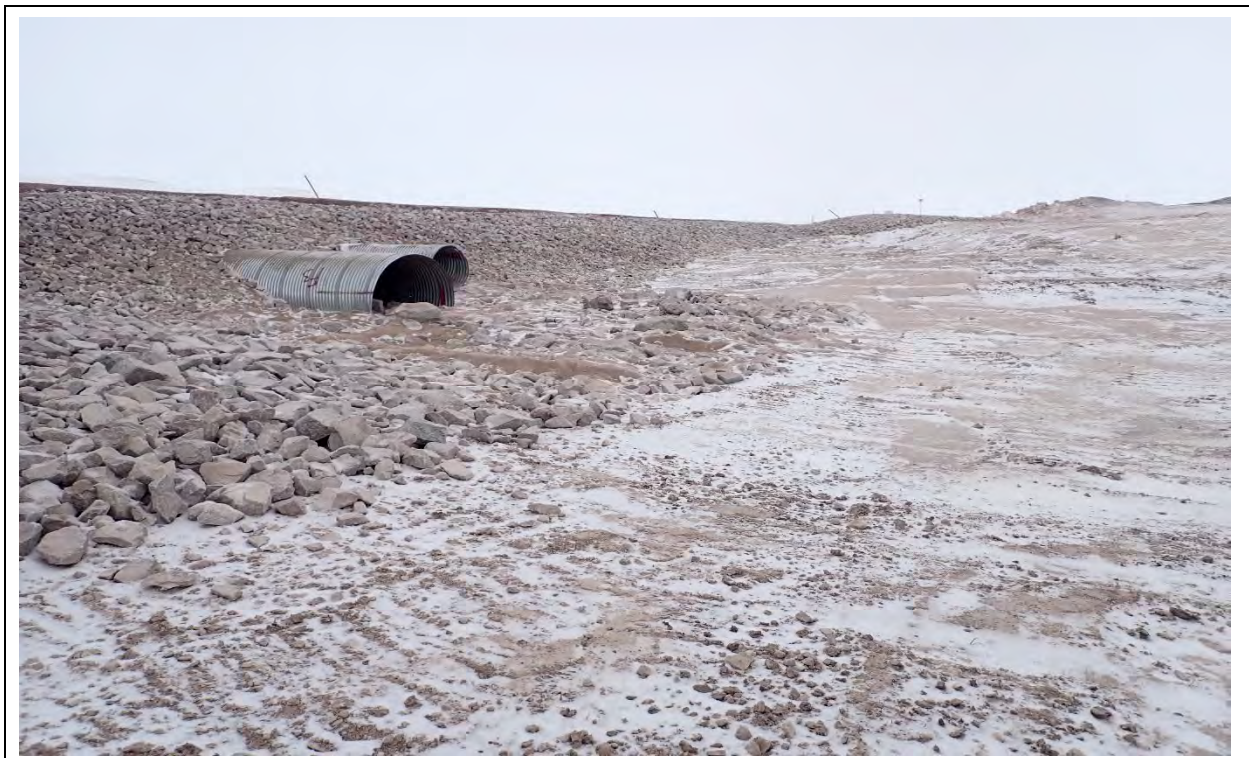
Photo 10. CV-102 downstream, culvert outlet apron after remedial construction.

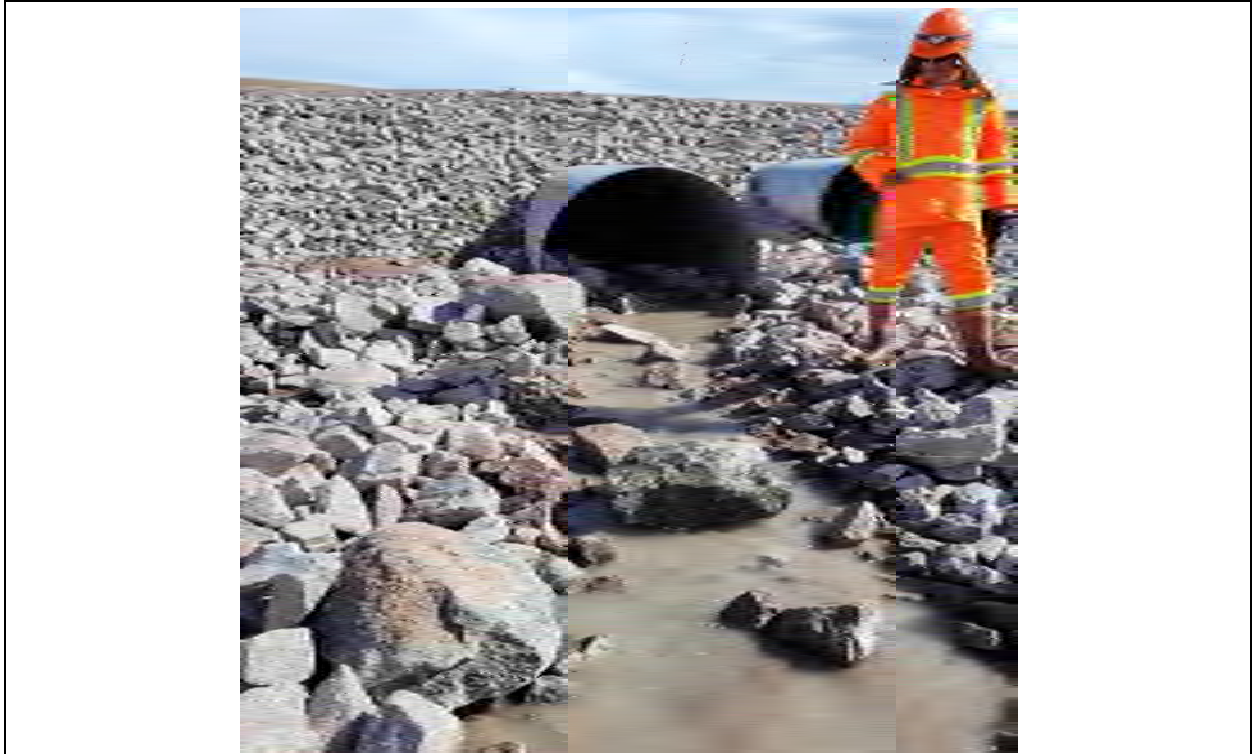
Photo 11. CV-102 downstream, culvert outlet apron rip rap thinned out to improve fish passage.

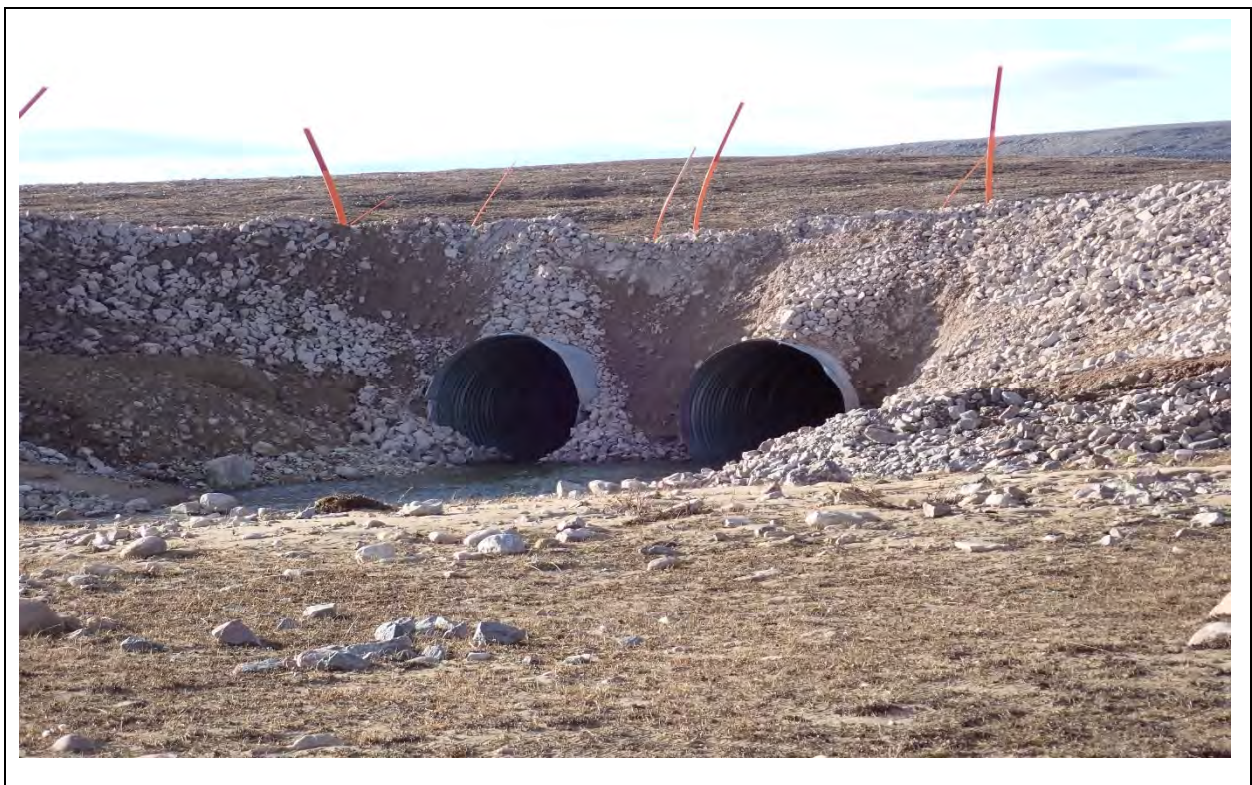
Photo 12. CV-078 upstream, culvert inlets detached and road embankment eroded during September rain event, repaired yet to be completed.

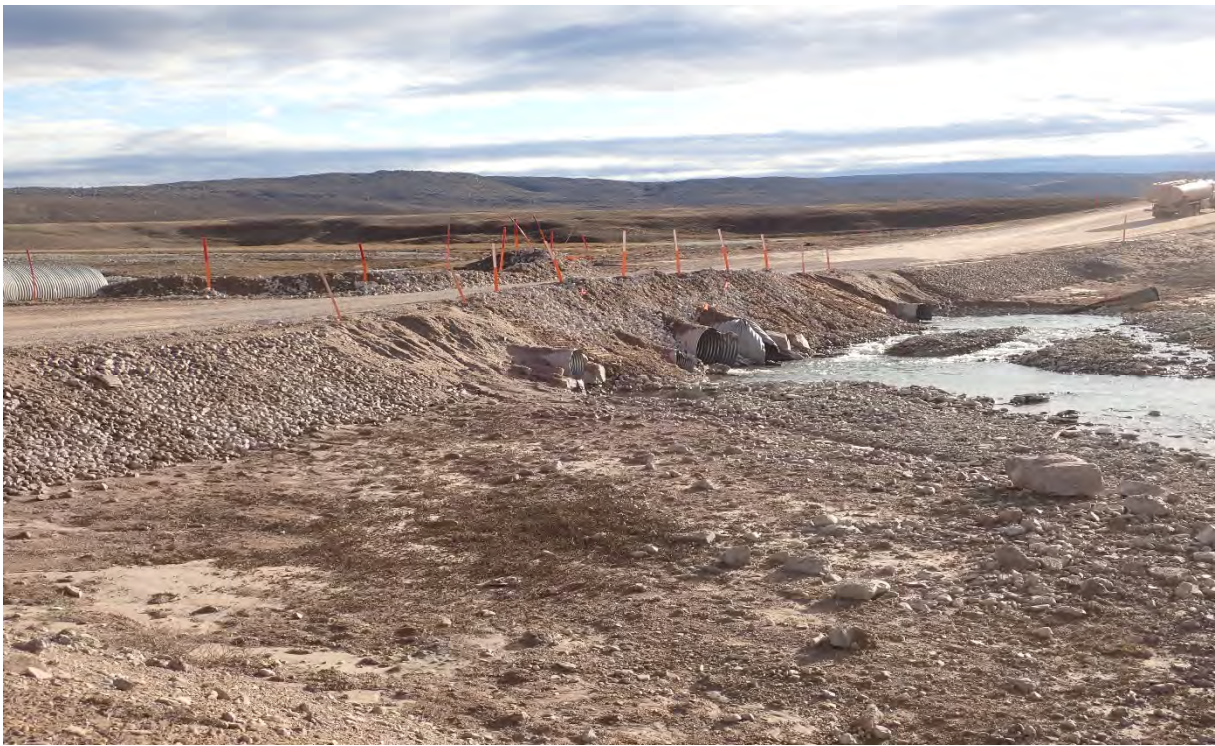
Photo 13. CV-078 downstream, re-established safe travel on the downstream lane of the road and re-armoured the embankment.

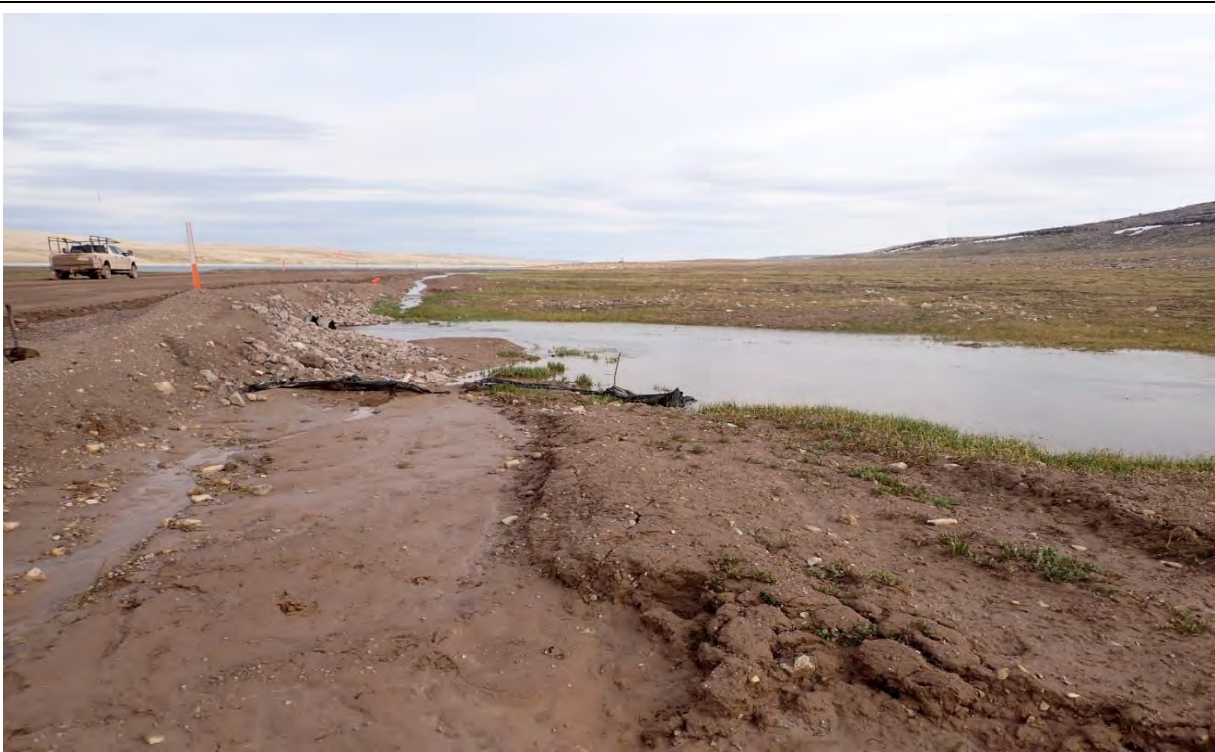
Photo 14. CV-060 downstream, silt fence in disrepair.

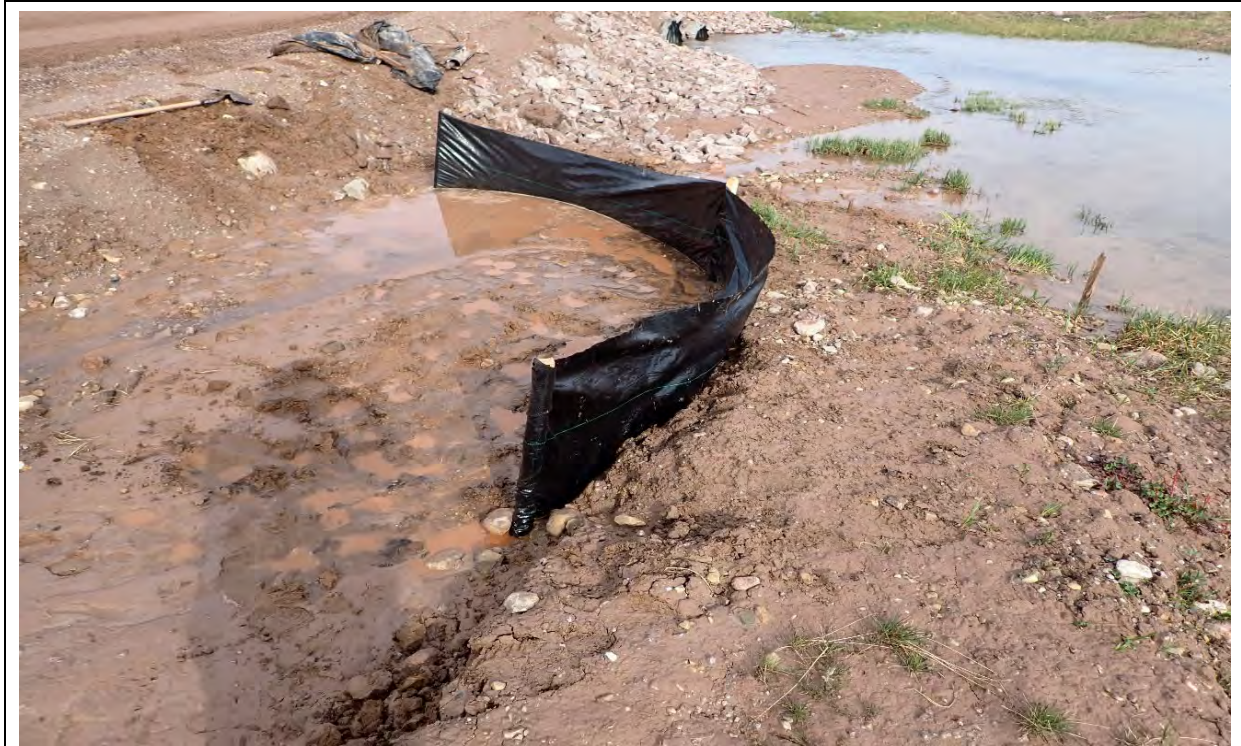
Photo 15. CV-060 downstream, silt fence replaced.

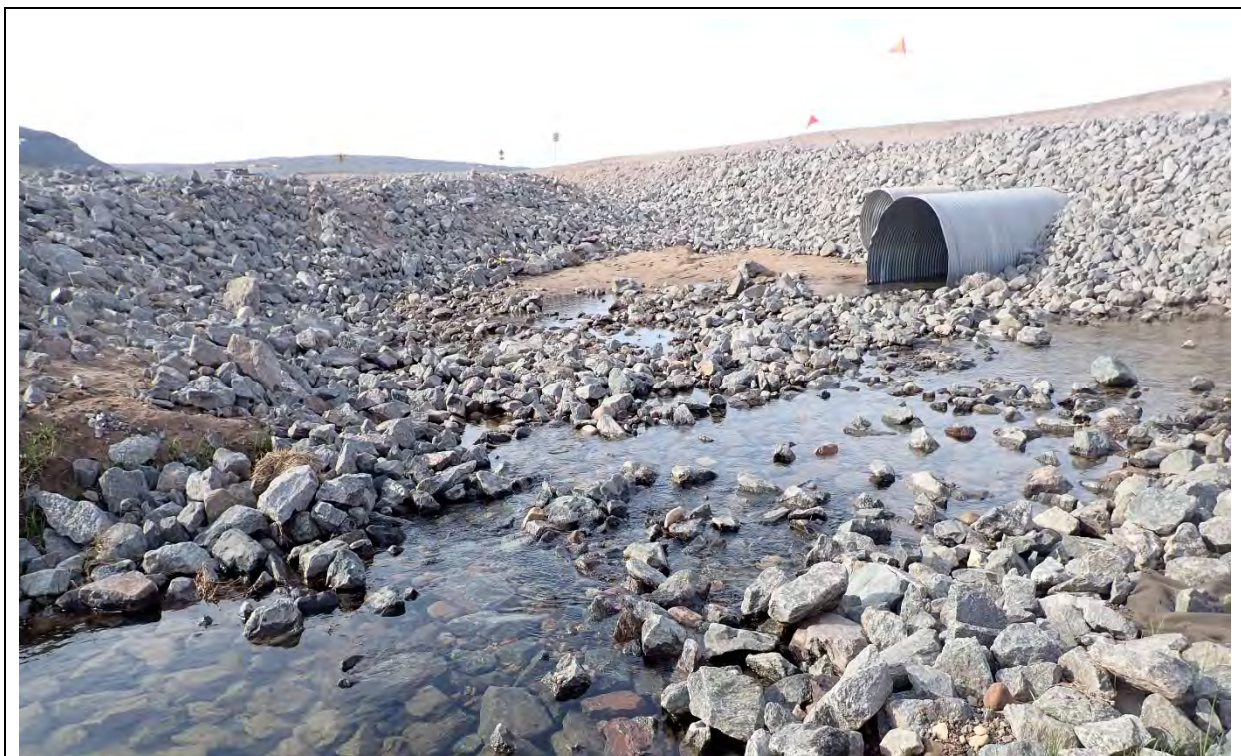
Photo 16. CV-059 upstream culvert inlet after remedial construction.

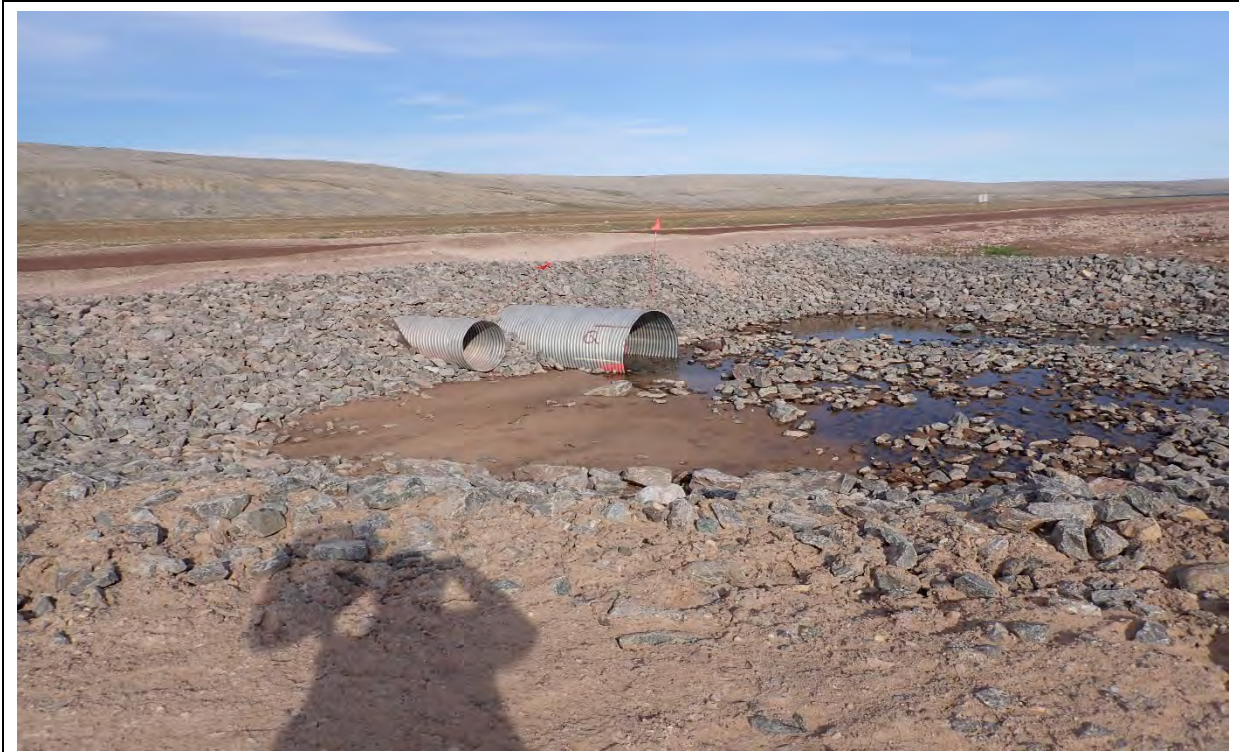
Photo 17. CV-059 upstream, culvert inlet apron after remedial construction.

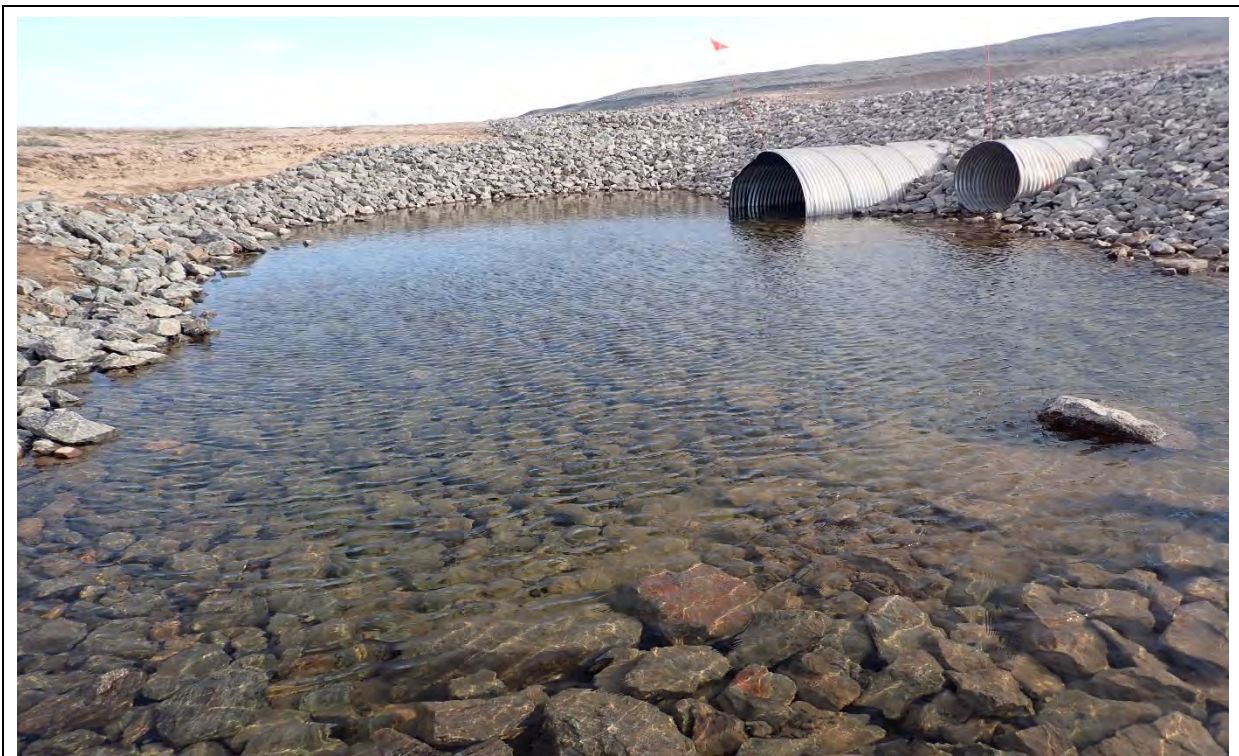
Photo 18. CV-059 downstream culvert outlet apron after remedial construction.

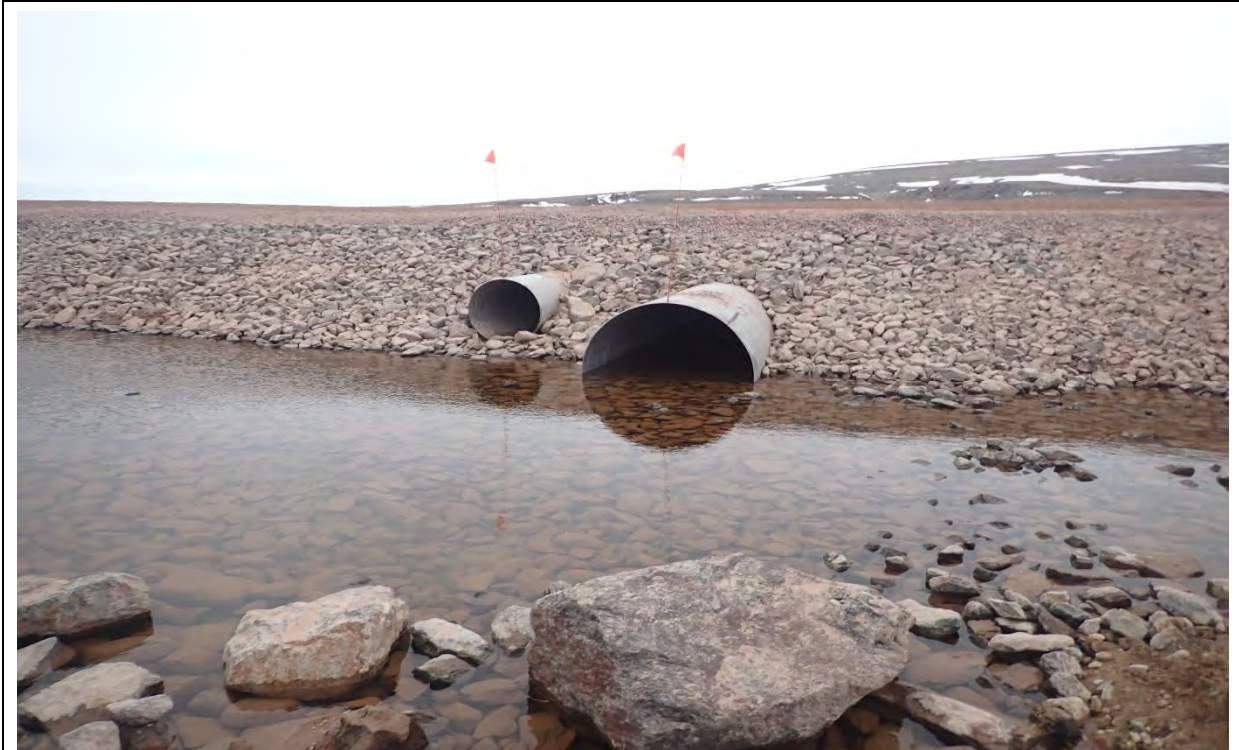
Photo 19. CV-057 upstream culvert inlet after remedial construction.

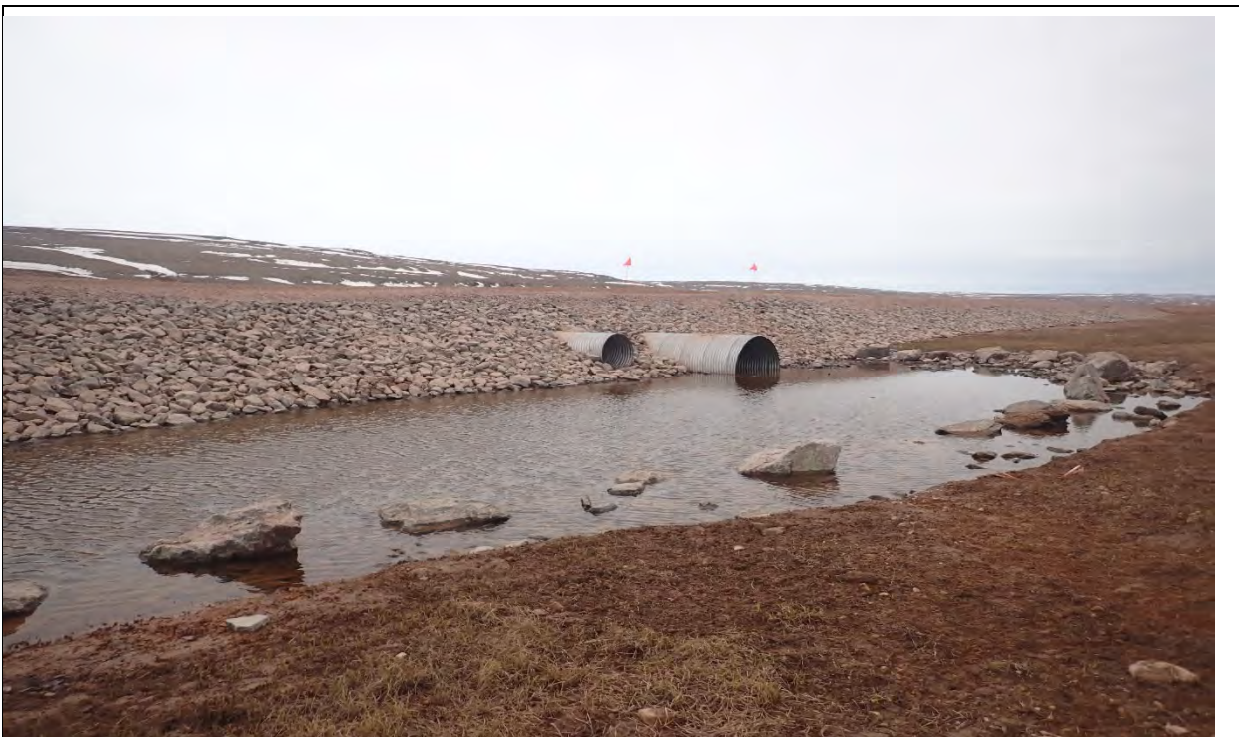
Photo 20. CV-057 upstream culvert inlet apron after remedial construction.

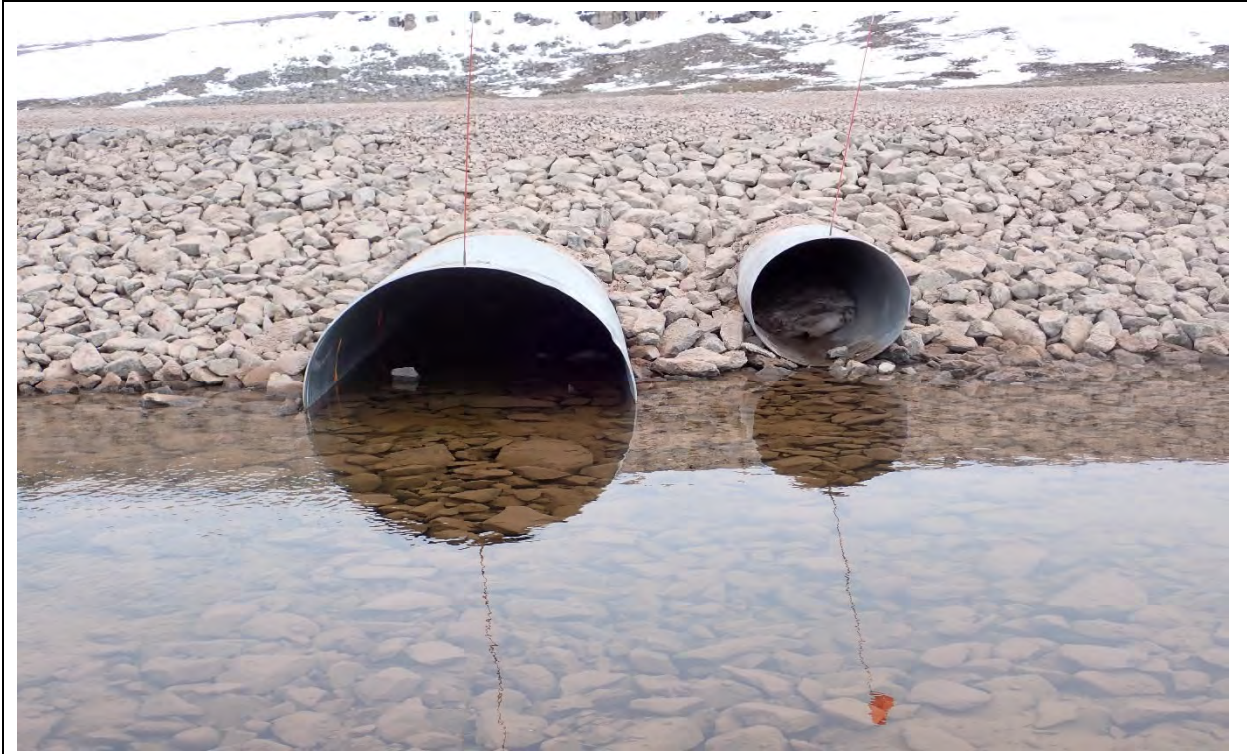
Photo 21. CV-057 downstream culvert outlet after remedial construction.

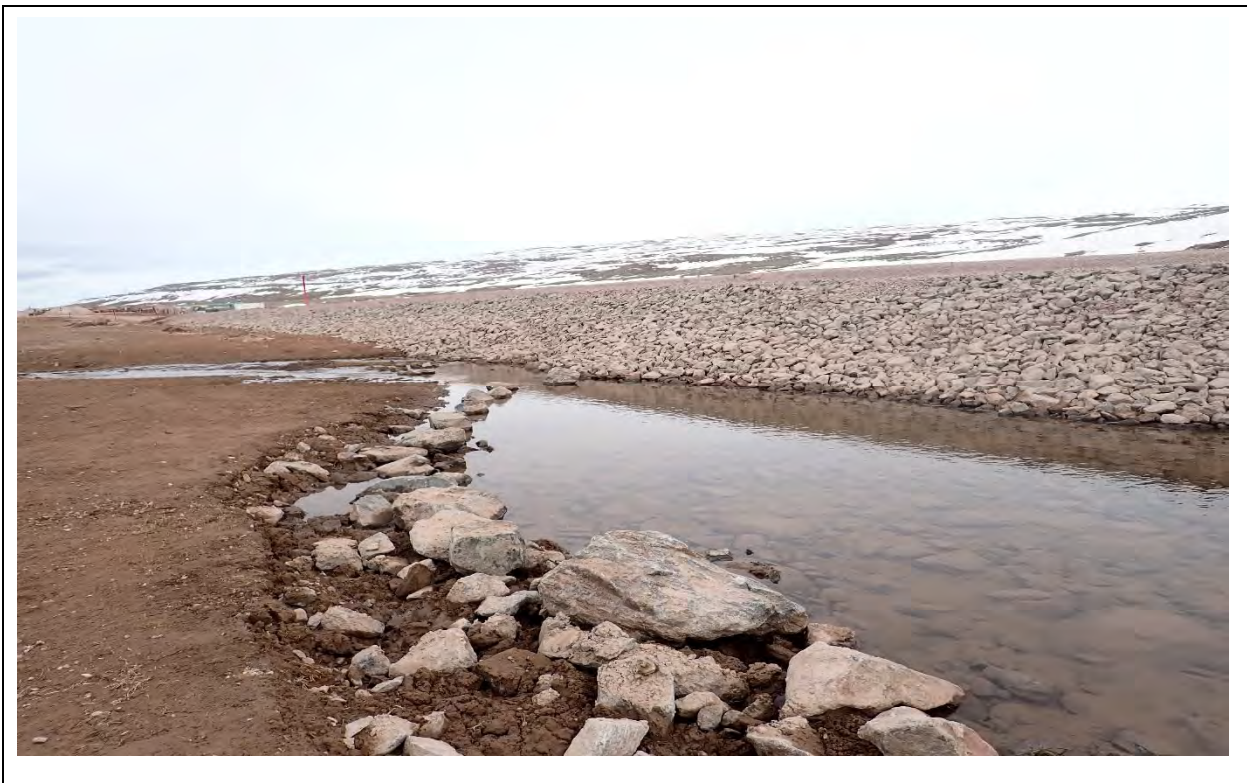
Photo 22. CV-057 downstream culvert outlet apron after remedial construction.

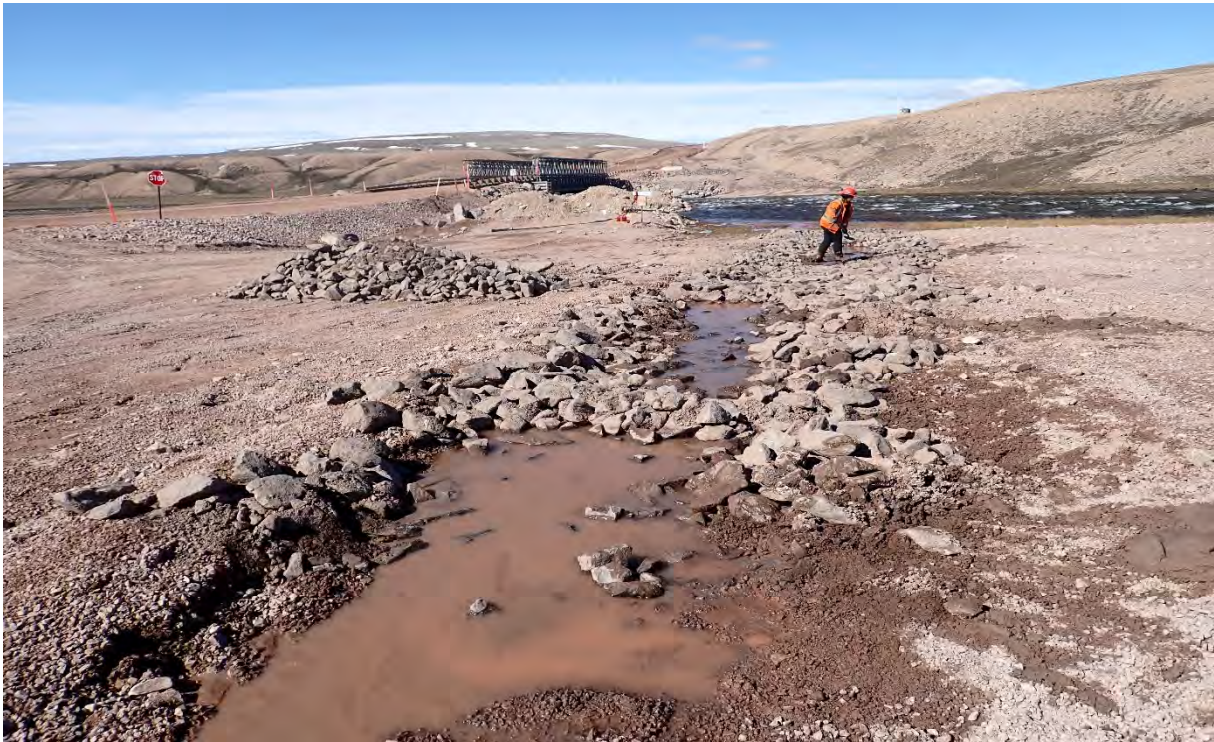
Photo 23. BG-50 sediment removal from snow stockpile check dams.
