TOTE ROAD CV-225

BAFFINLAND IRON MINES
MARY RIVER PROJECT

APPENDIX C

Erosion and Sediment Controls implemented in 2024

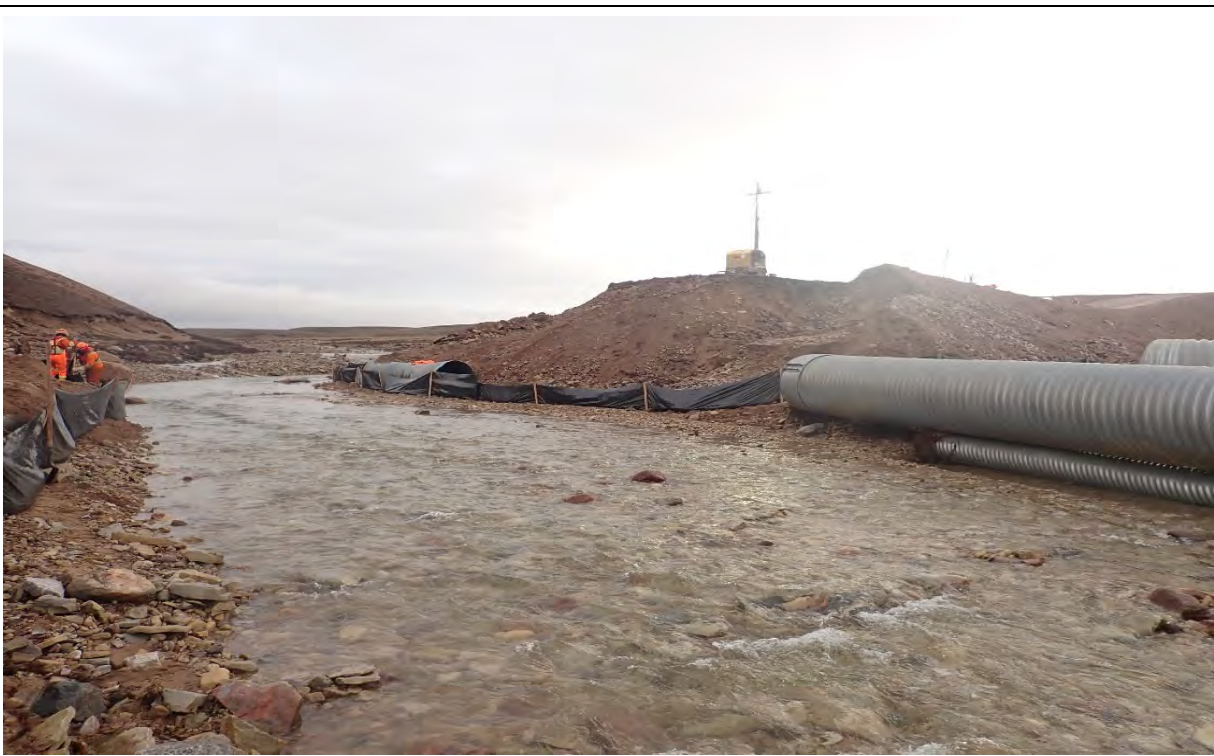
Photo 24. CV-049 looking upstream, silte fence installed to prevent sediment deposition into watercourse during to re-construction of the washed out crossing.

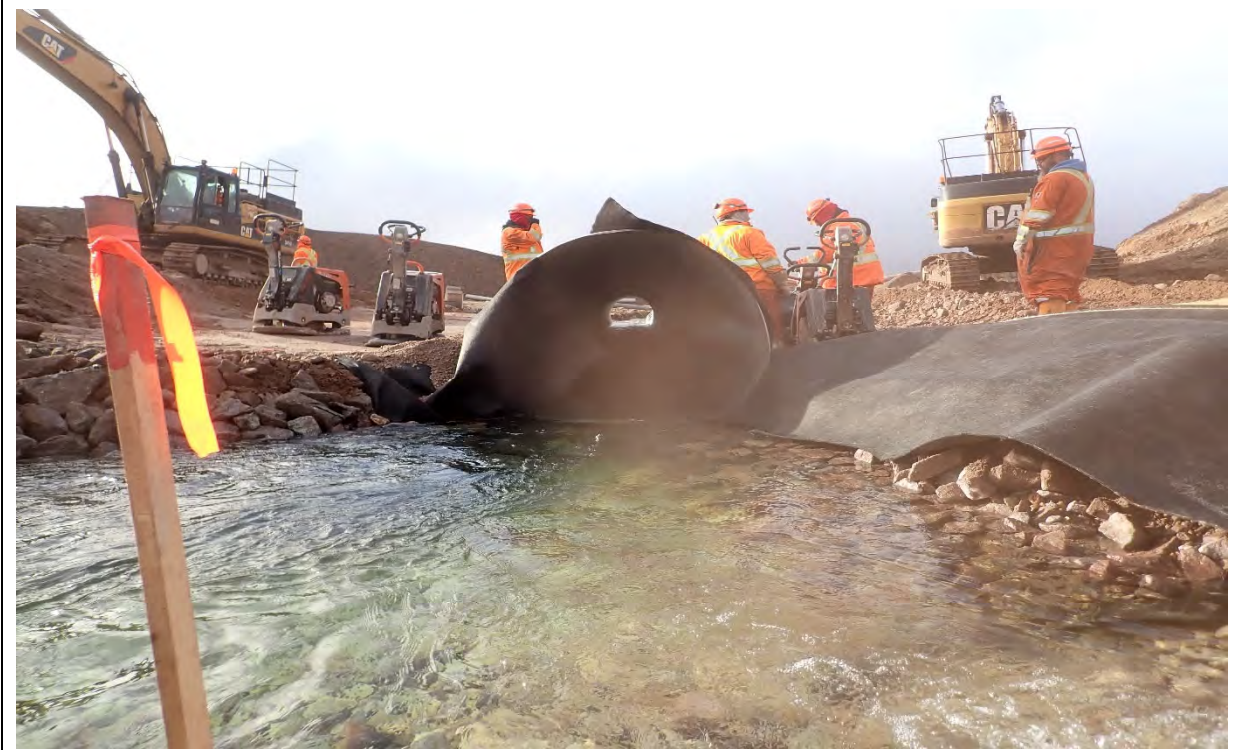
Photo 25. CV-049 upstream, geotextile placed behind rock armouring to prevent culvert bedding material from entering watercourse during re-construction

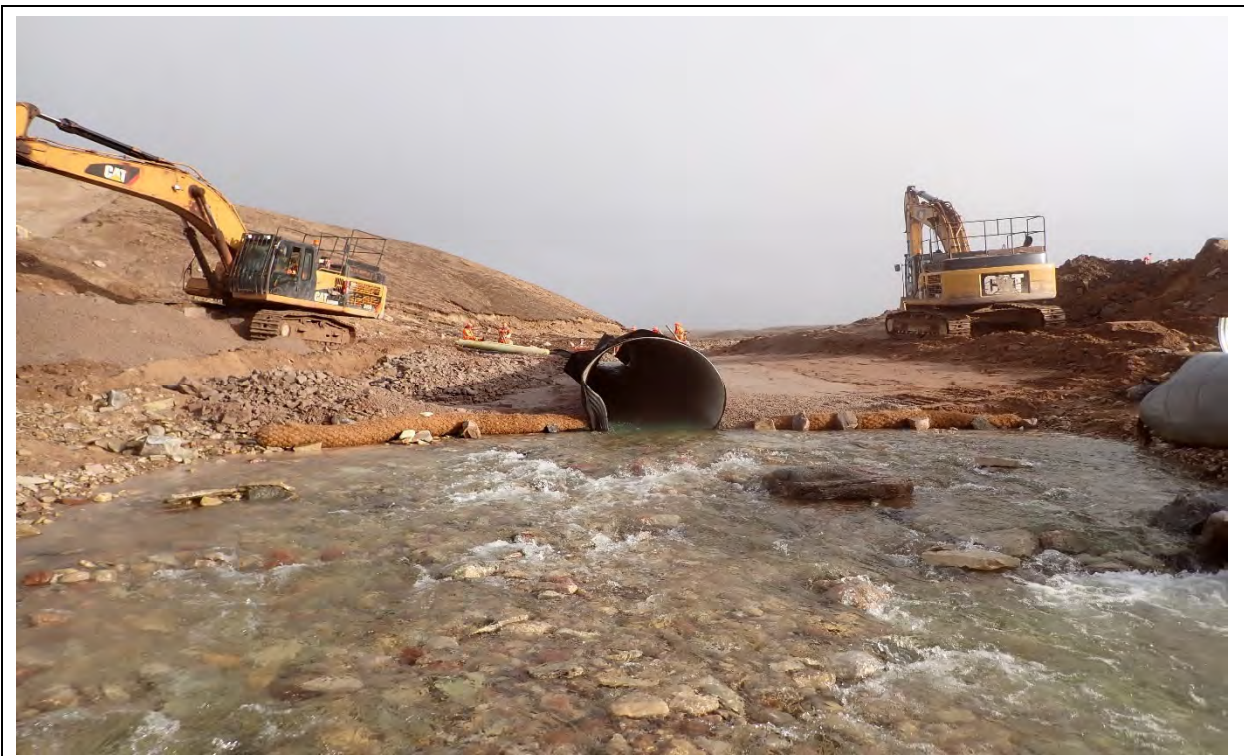
Photo 26. CV-049 downstream, coir logs placed during to protect culvert bedding material from erosion due to back eddy flow at culvert outlet.

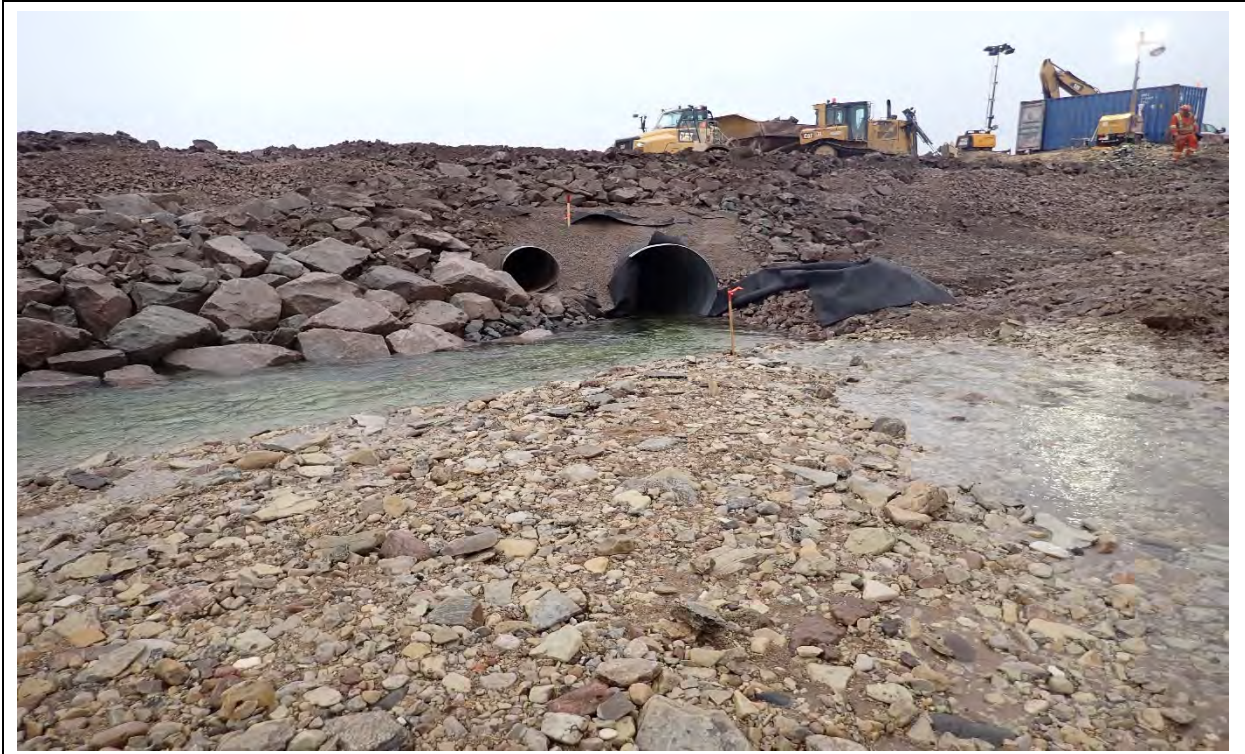
Photo 27. CV-049 upstream, culvert inlet completed with rock armouring of embankment

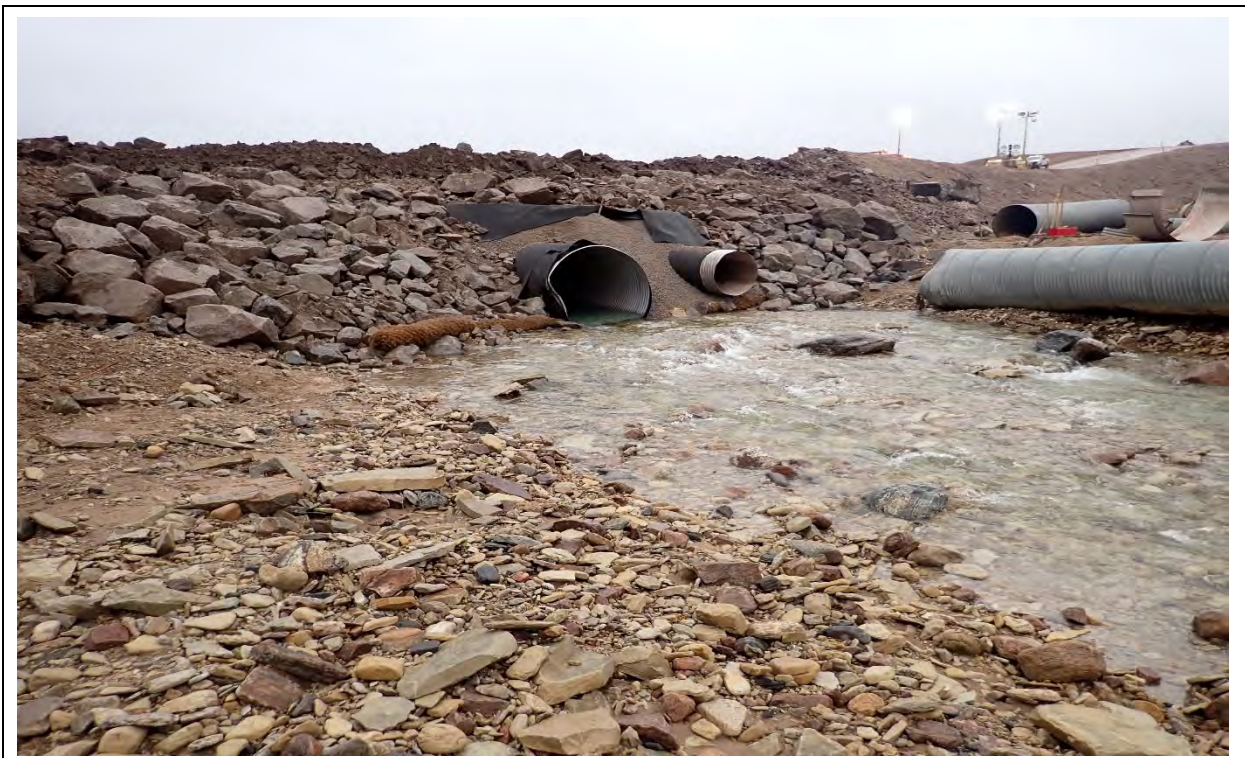
Photo 28. CV-049 downstream, culvert outlet completed with rock armouring of embankment

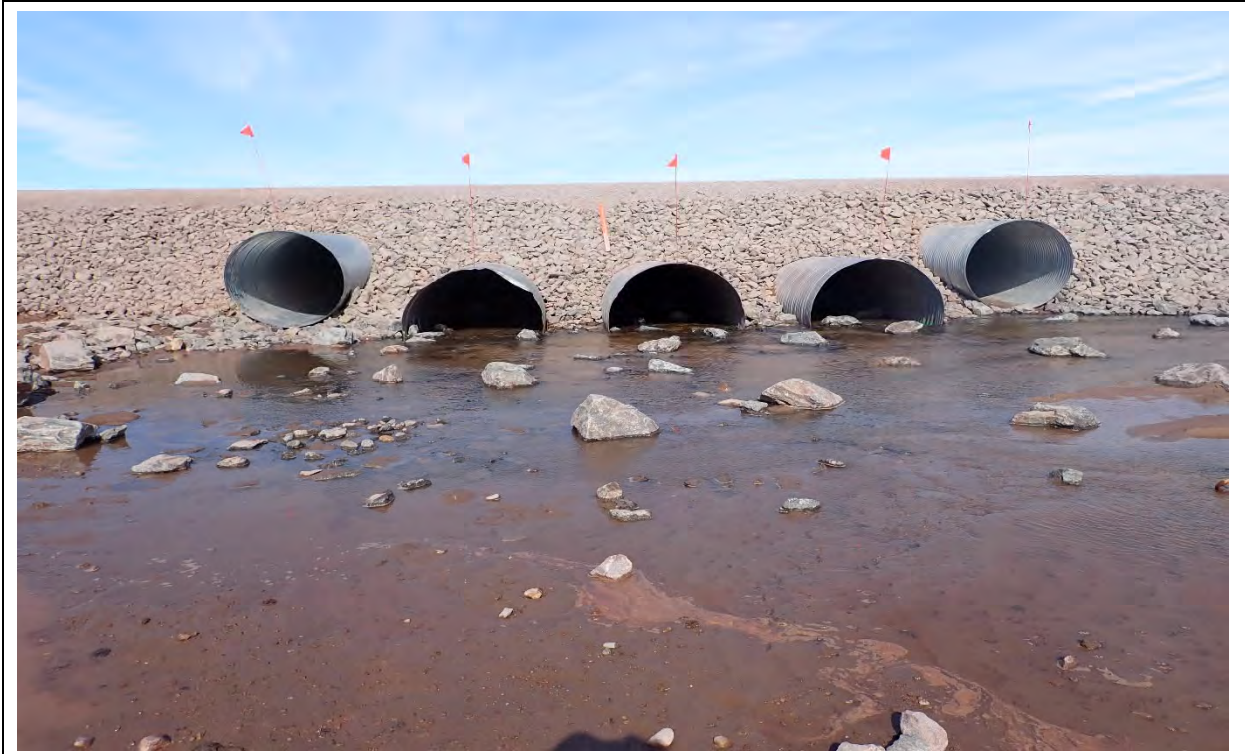
Photo 29. CV-216 upstream, culvert inlets after remedial construction.

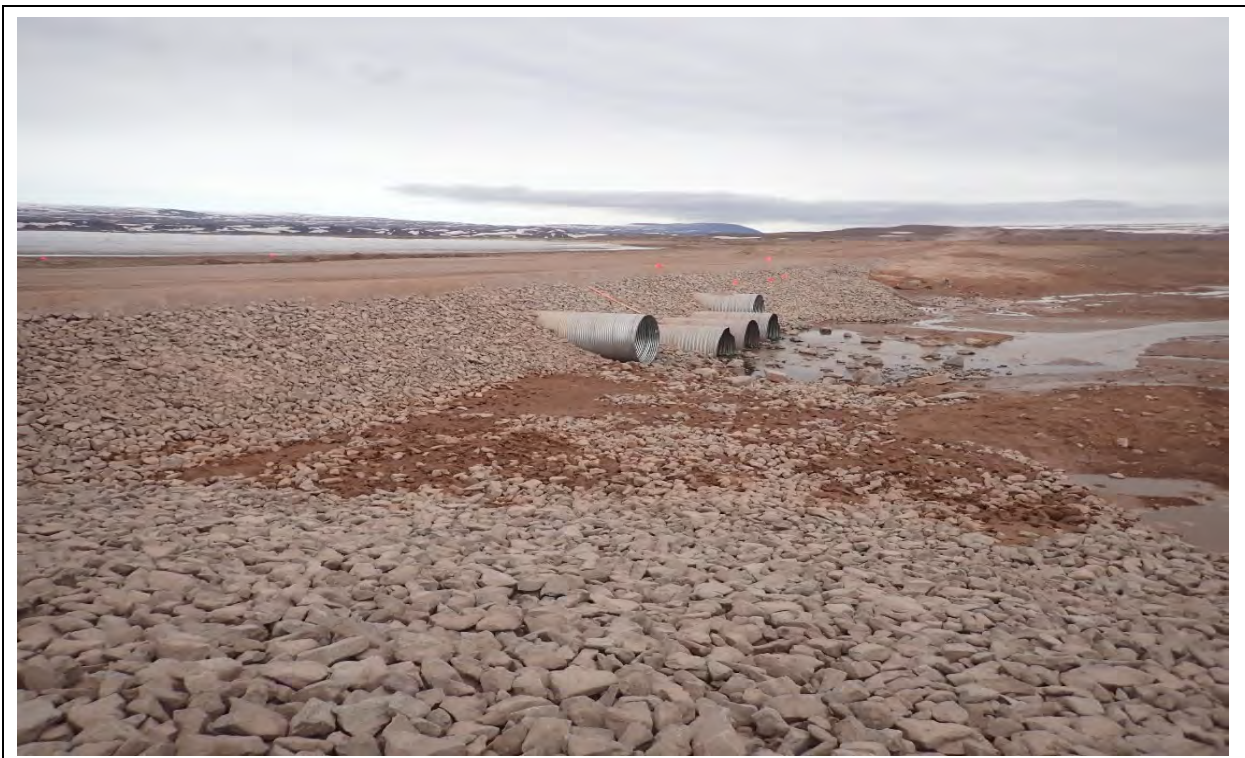
Photo 30. CV-216 upstream, culvert inlet apron after remedial construction.

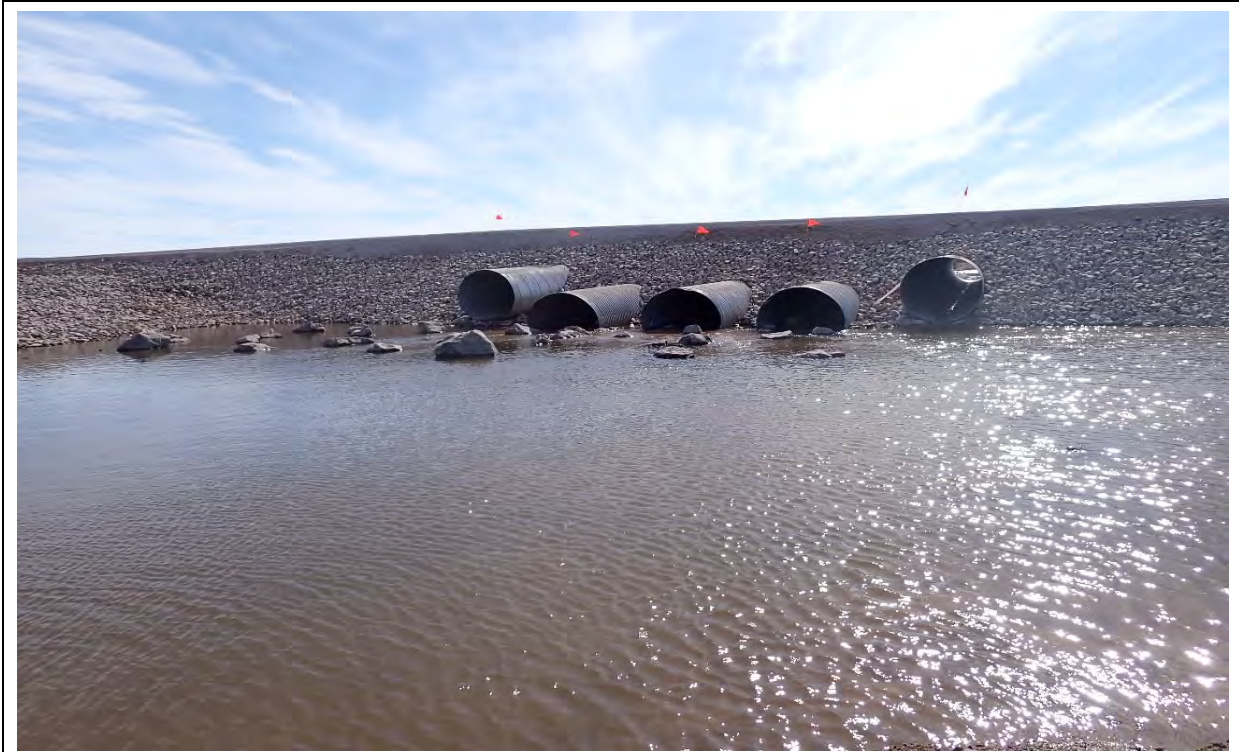
Photo 31. CV-216 downstream, culvert outletapron after remedial construction.

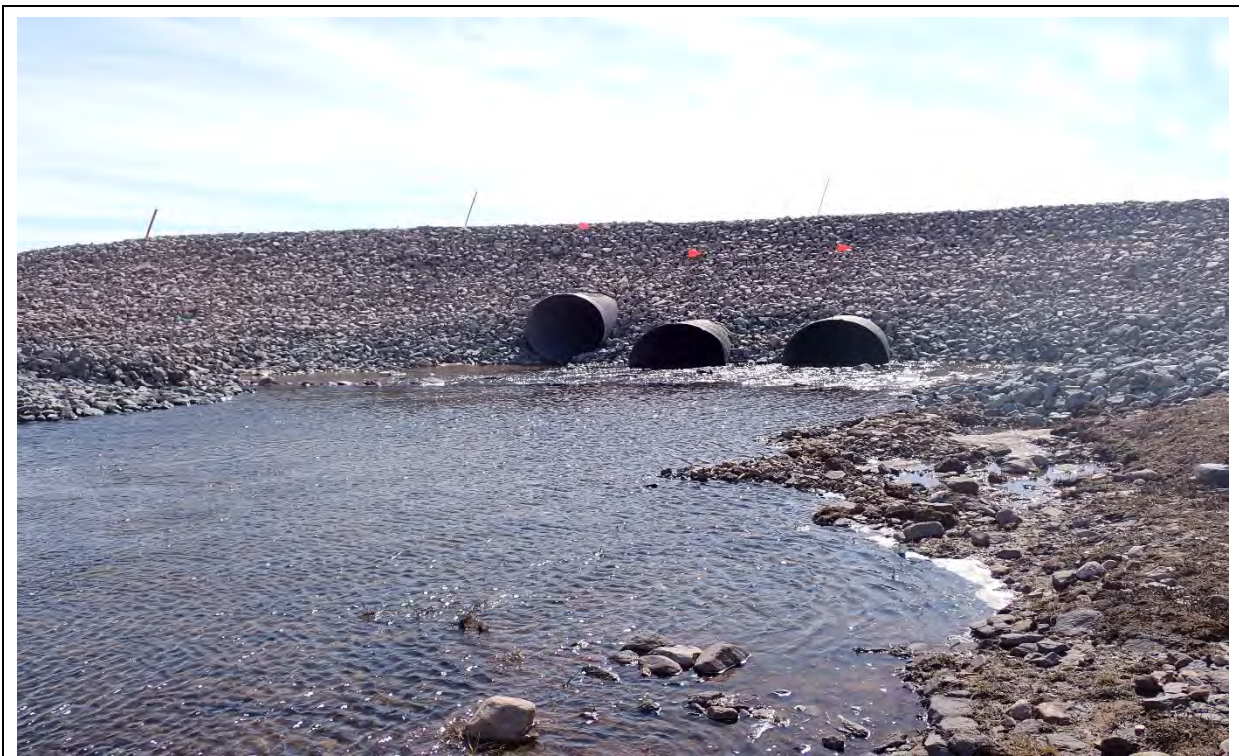
Photo 32. BG-04 upstream, culvert inlets after remedial construction.

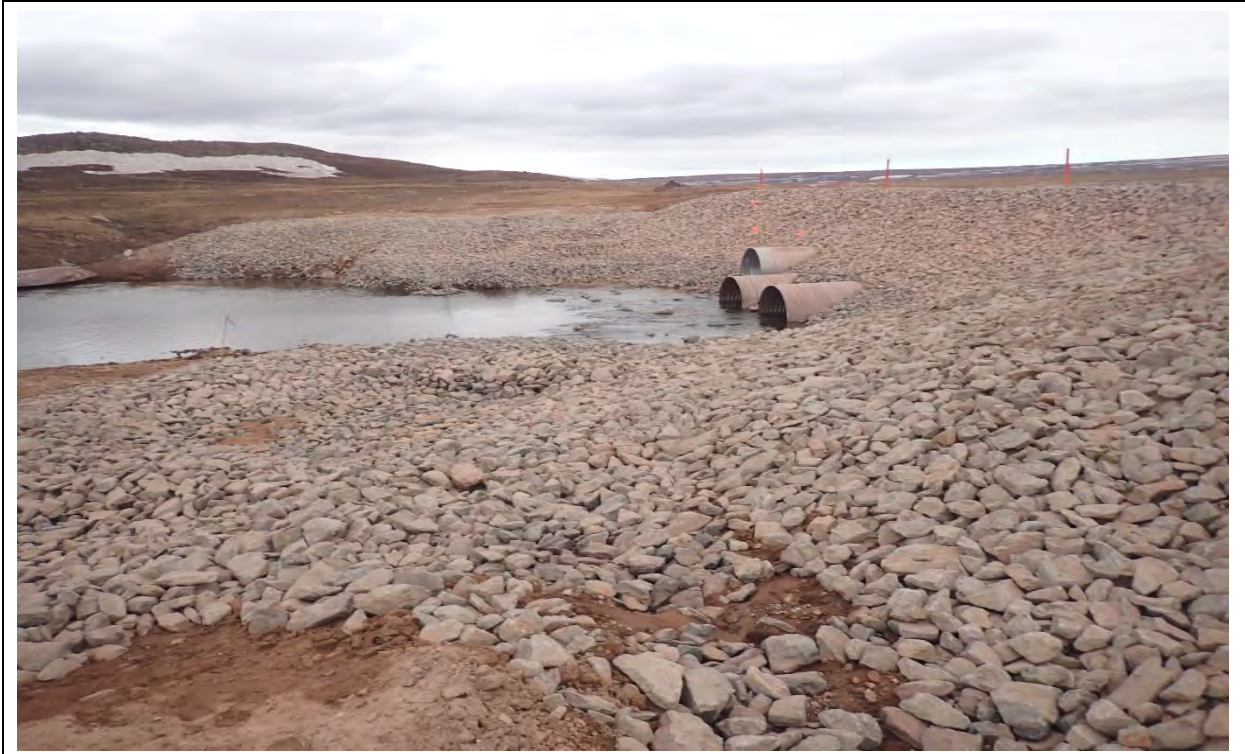
Photo 33. BG-04 upstream, culvert inlet and apron after remedial construction.

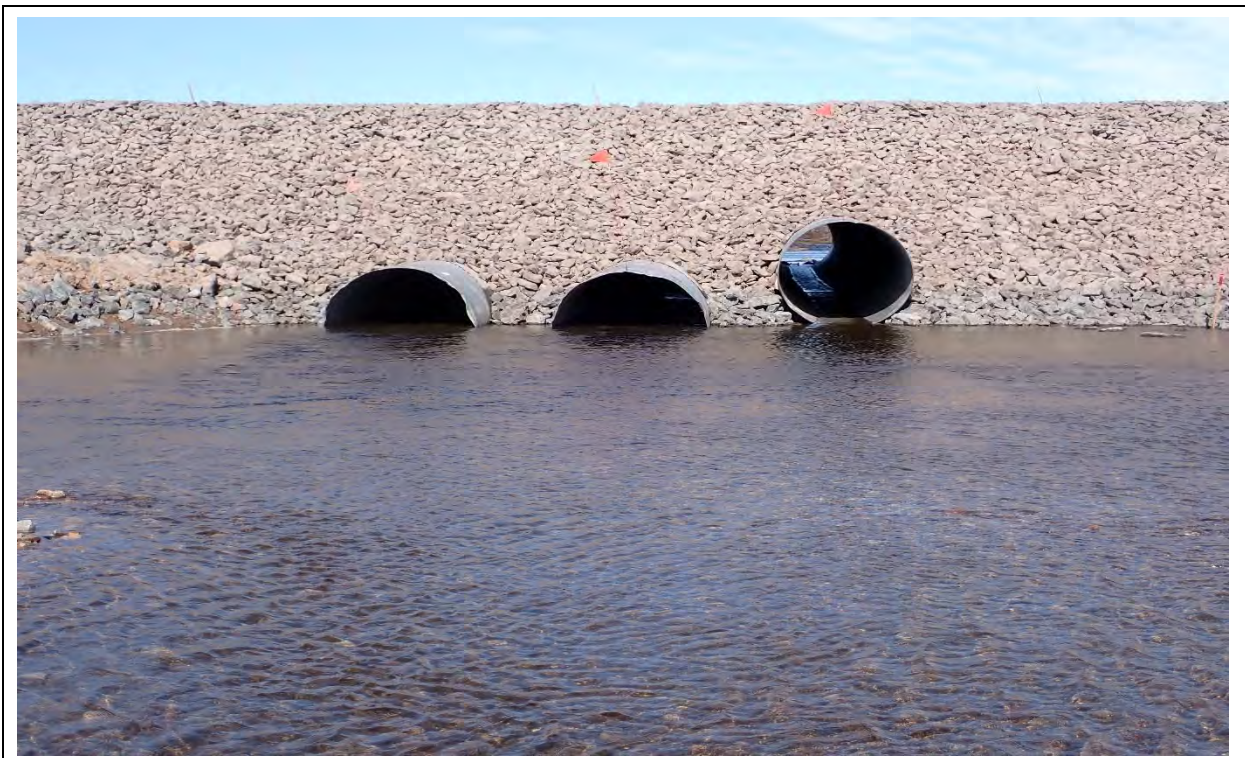
Photo 34. BG-04 downstream, culvert outlet after remedial construction.

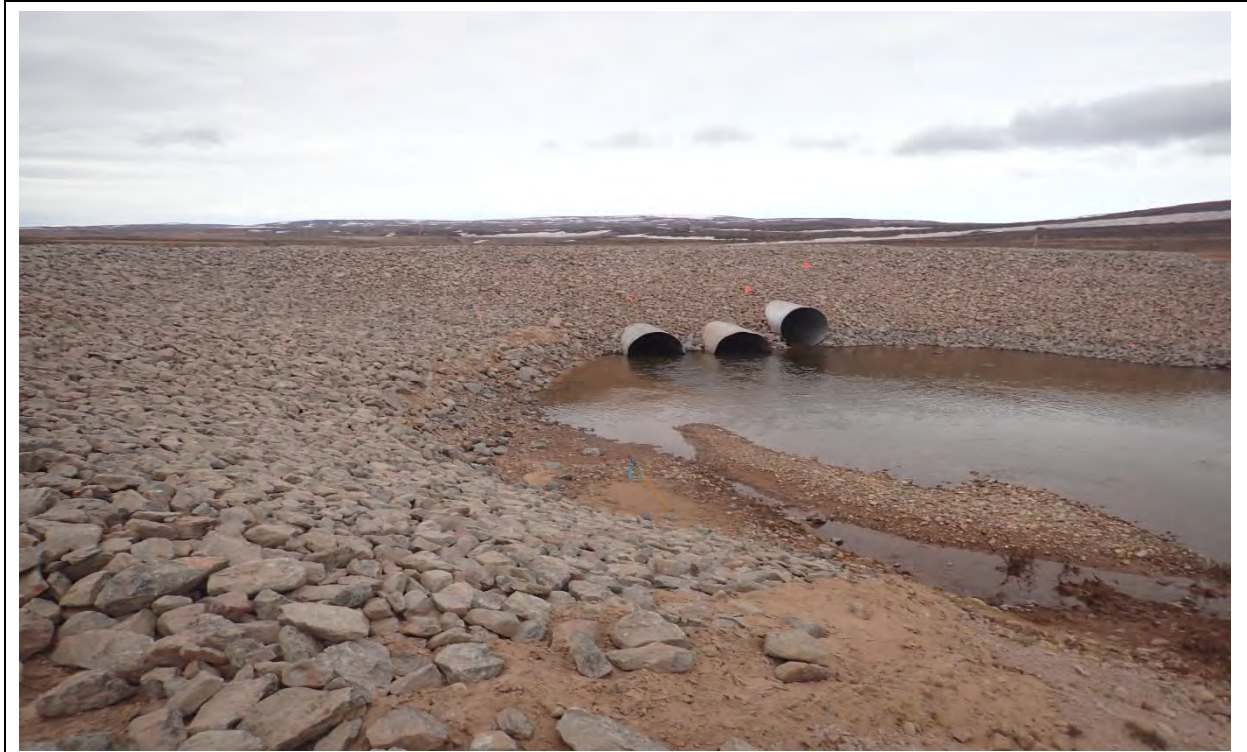
Photo 35. BG-04 downstream, culvert outlet apron after remedial construction.

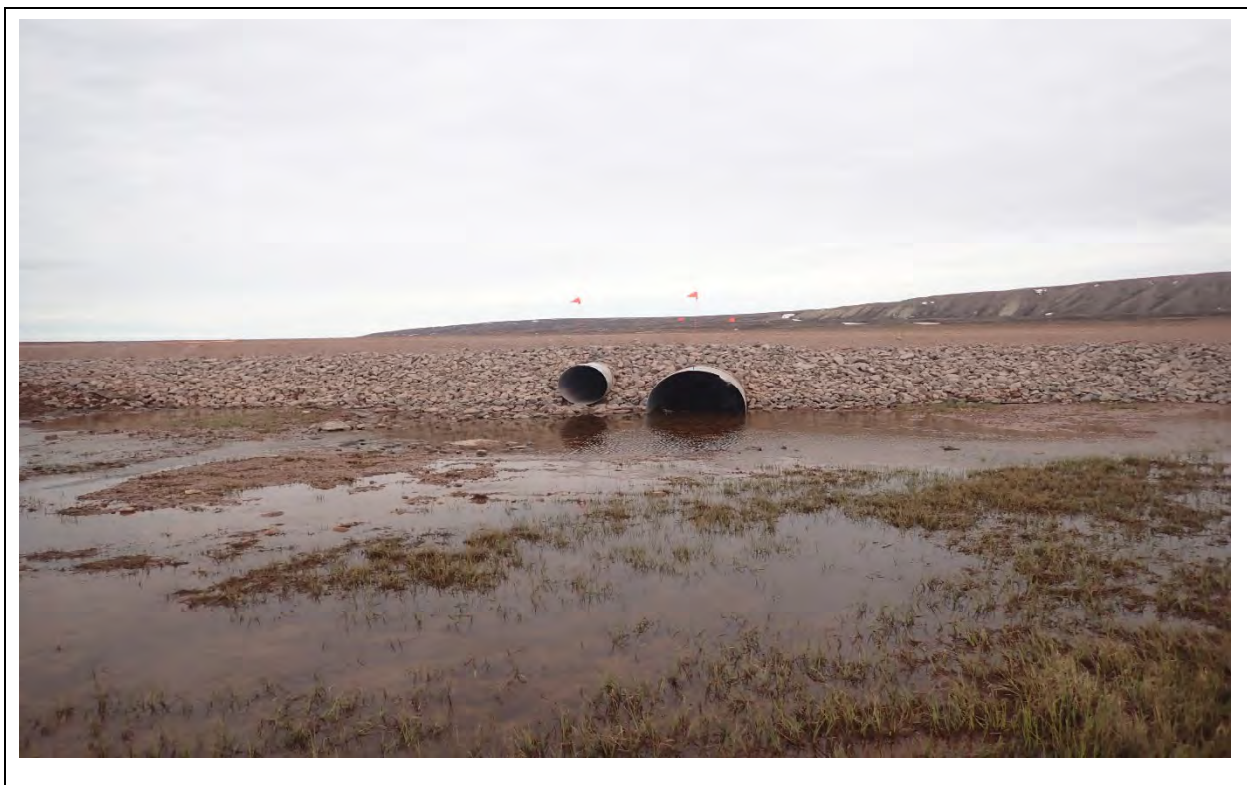
Photo 36. CV-001 upstream, culvert inlet after remedial construction.

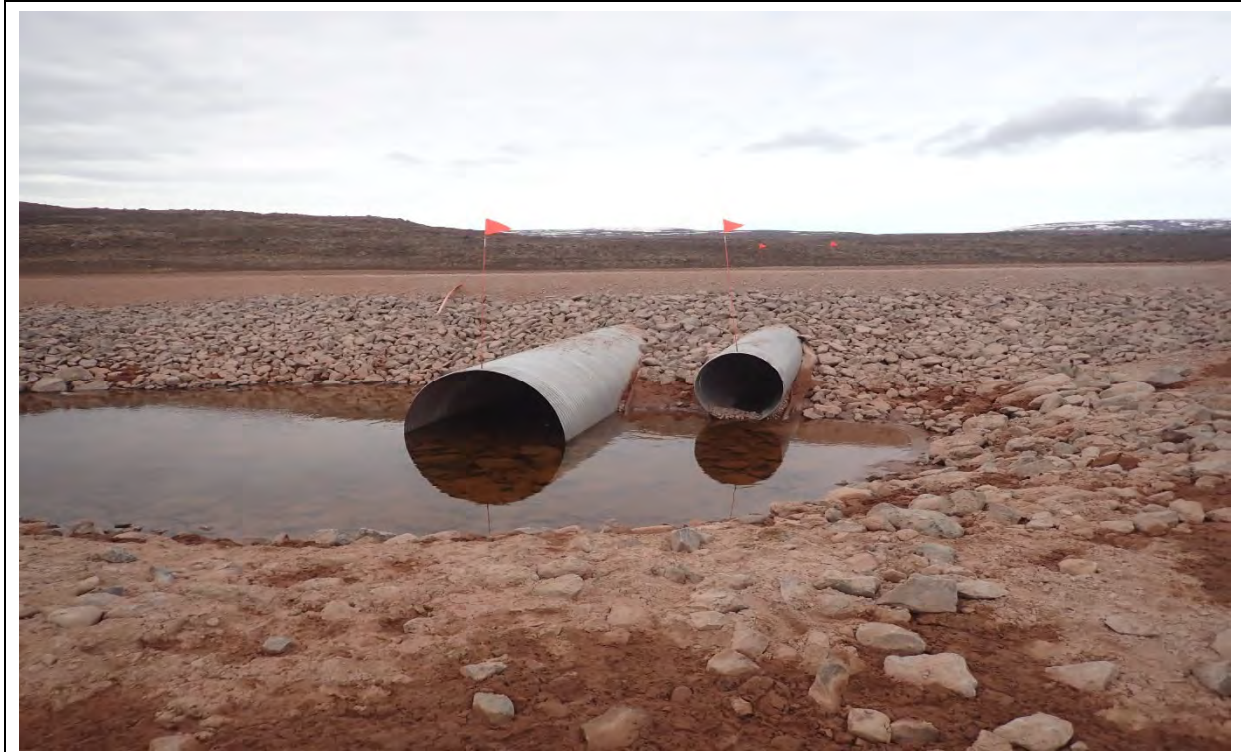
Photo 37. CV-001 downstream, culvert outlet after remedial construction.

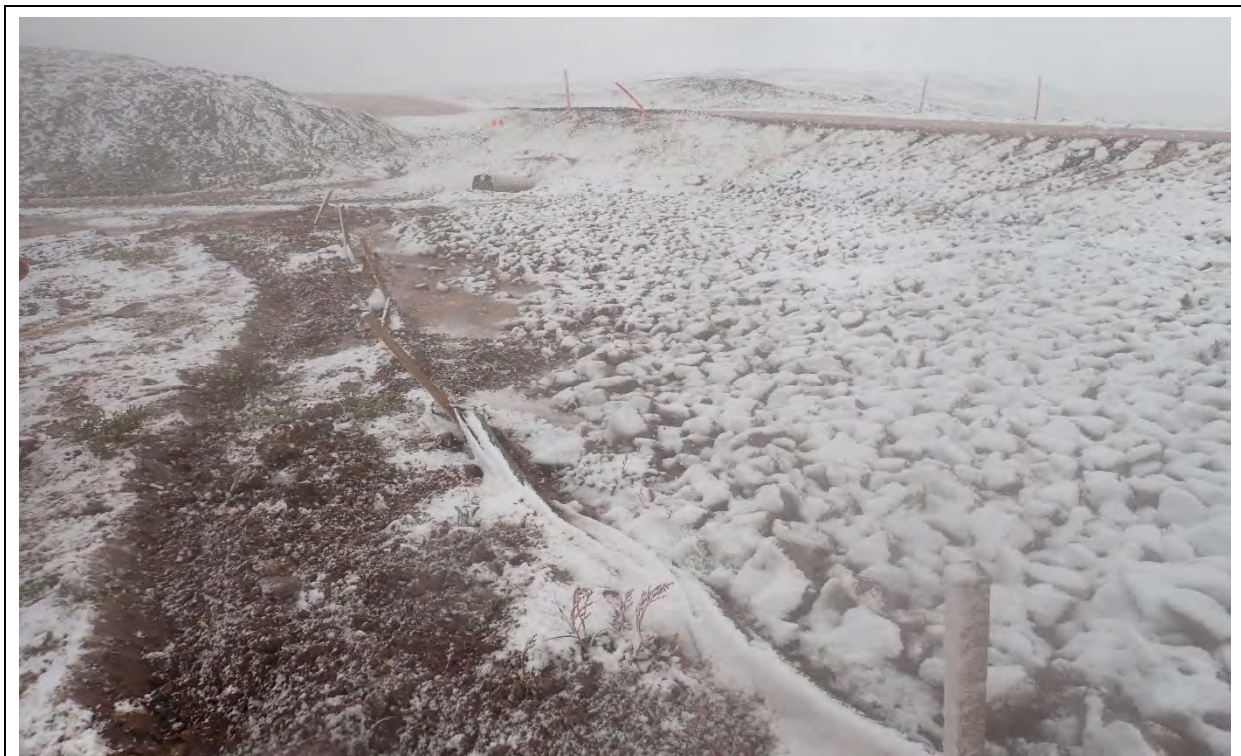
Photo 38. CV-224 downstream, silt fence in disrepair.
