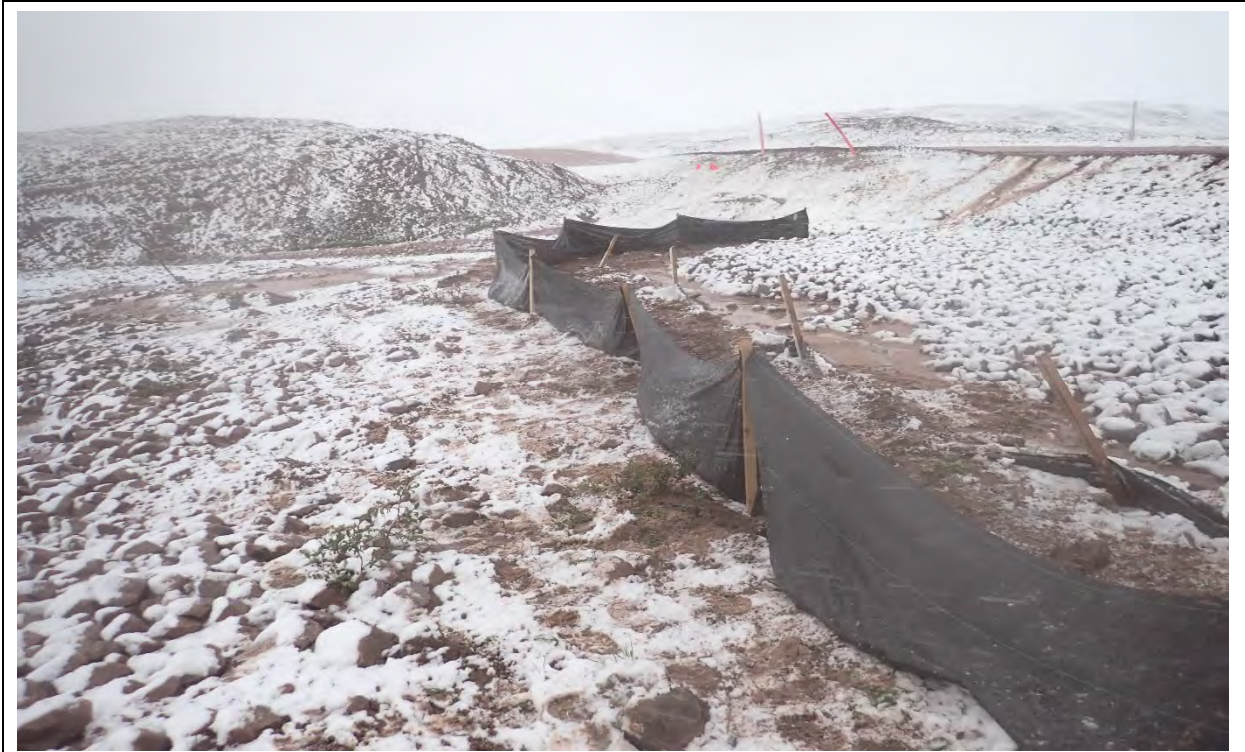
Photo 39. CV-224 downstream, silt fence replaced.

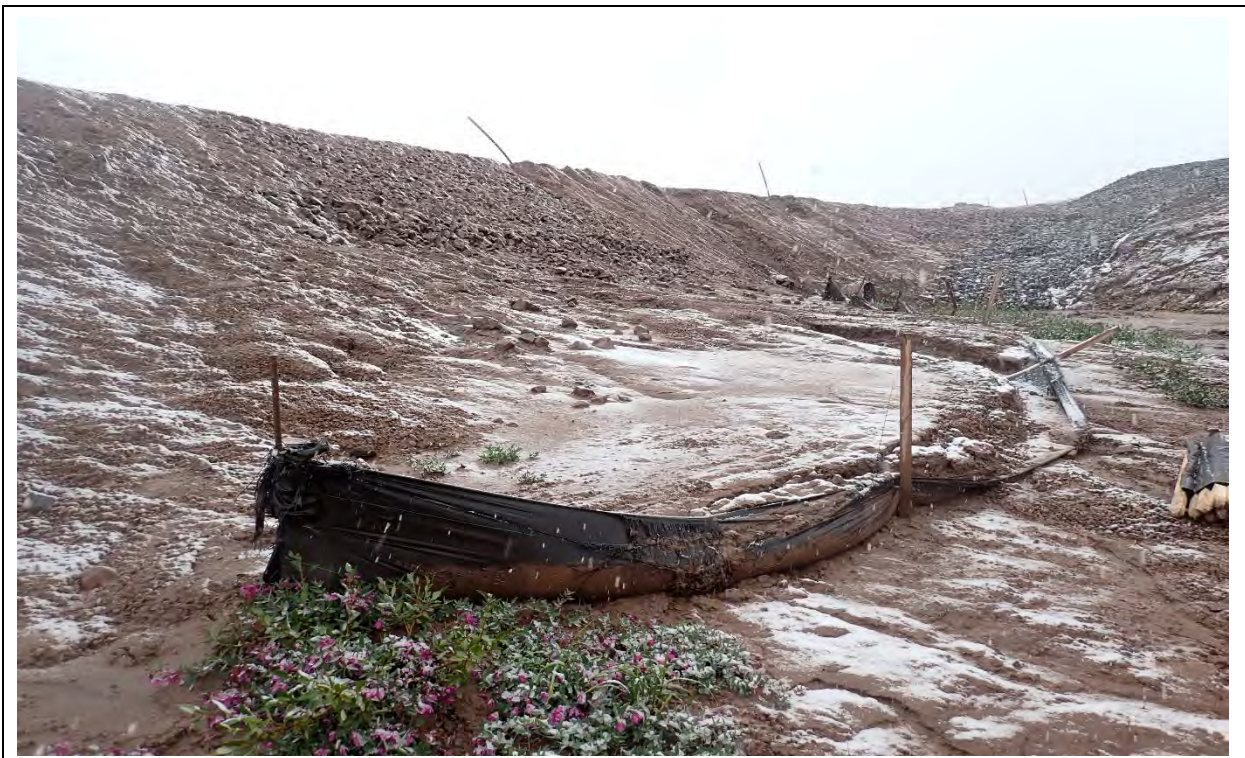
Photo 40. BG-01 upstream, silt fence in disrepair.

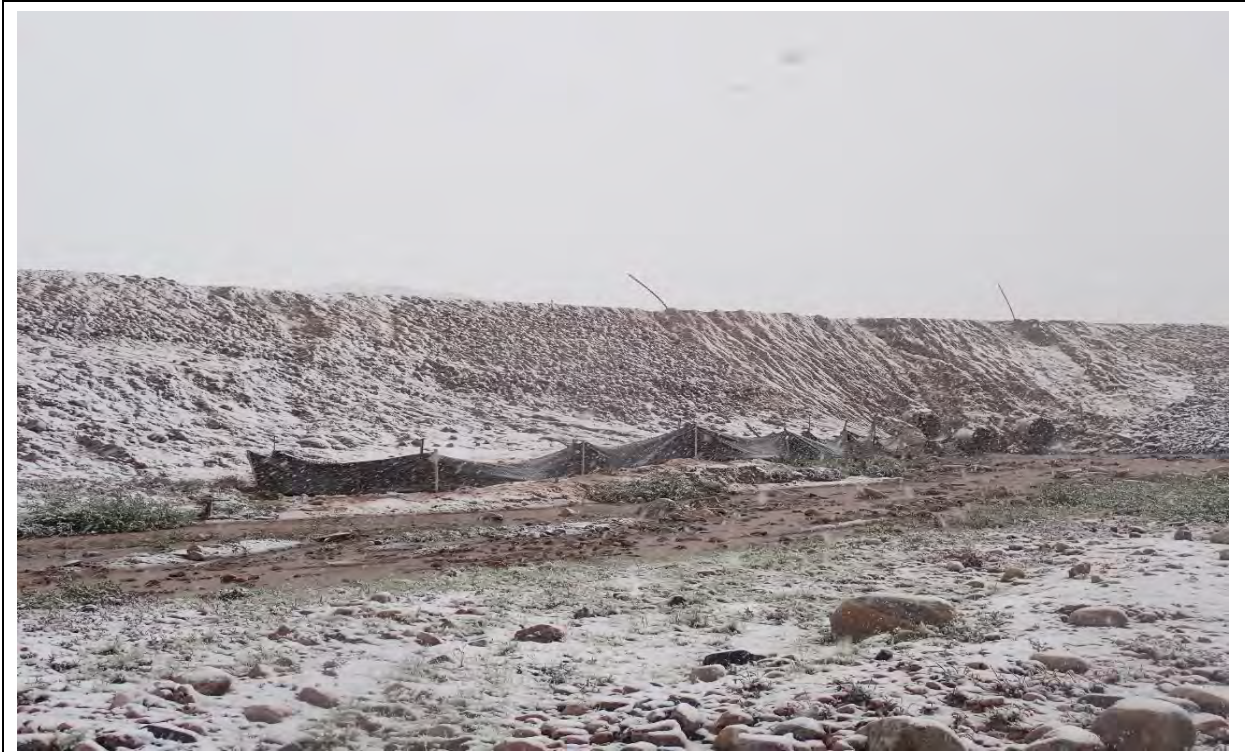
Photo 41. BG-01 upstream, silt fence replaced.

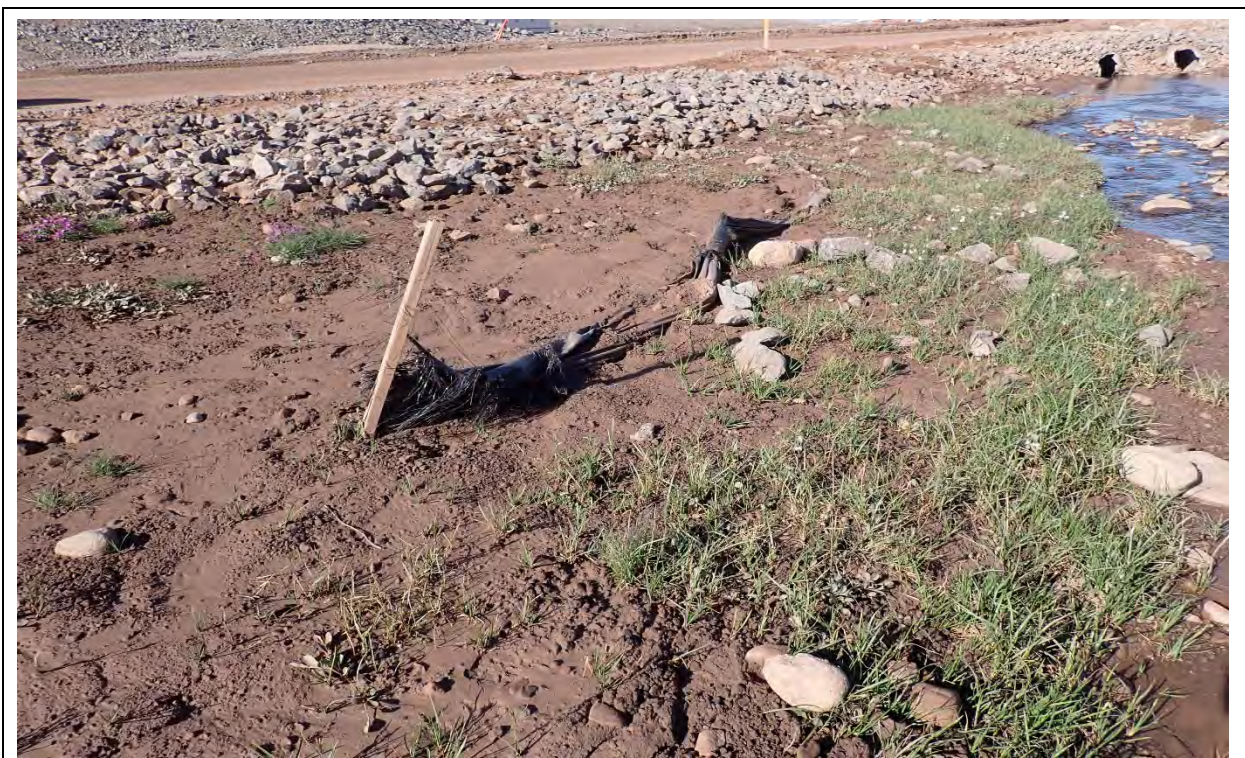
Photo 42. CV-186 upstream, silt fence along south bank in disrepair.

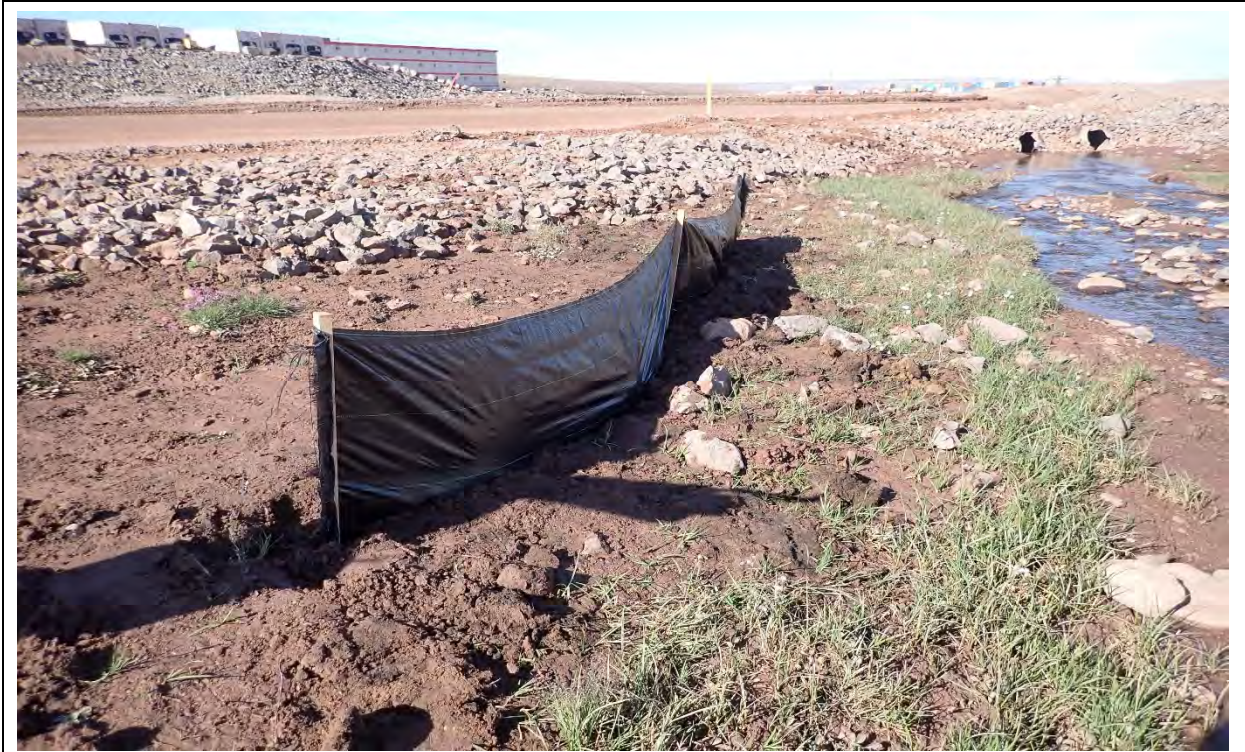
**Photo 43.** CV-186 upstream, silt fence along south bank replaced.

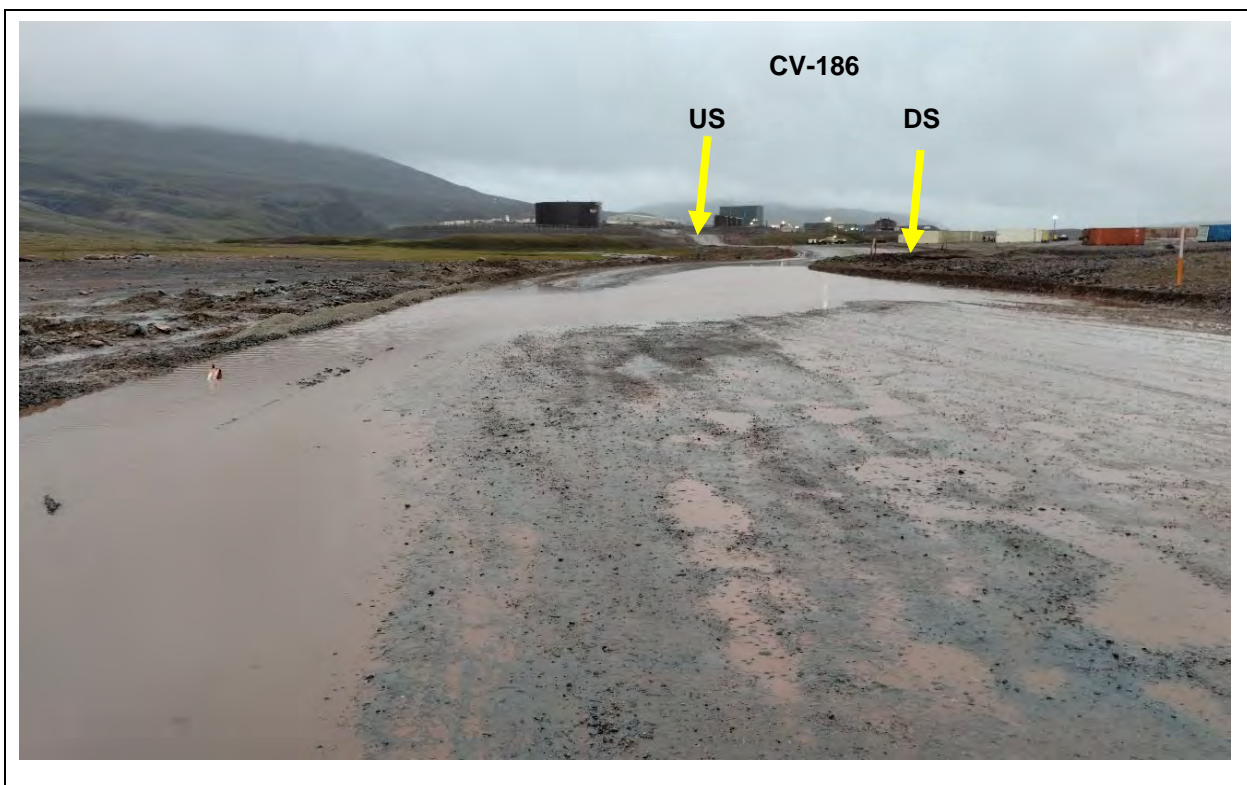
**Photo 44.** CV-186 water pooling on roadway near culvert crossing.

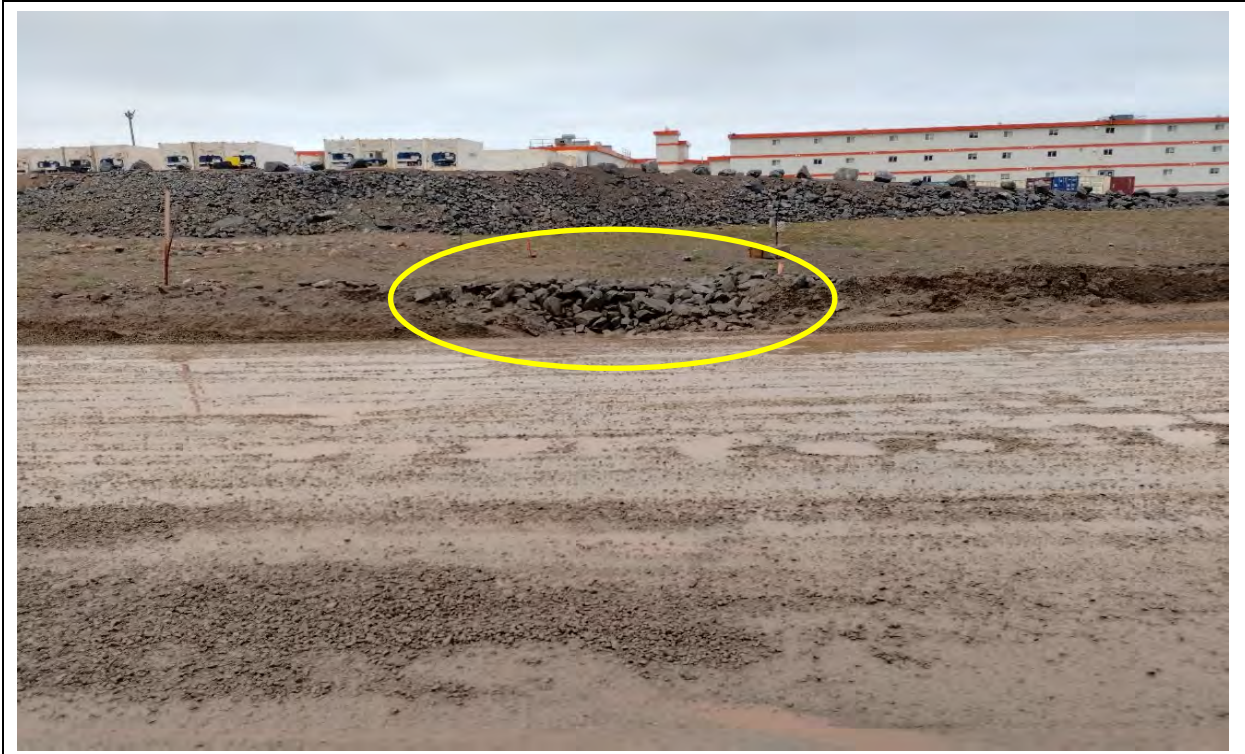
**Photo 45.** CV-186 downstream, rock armouring of roadside berm.

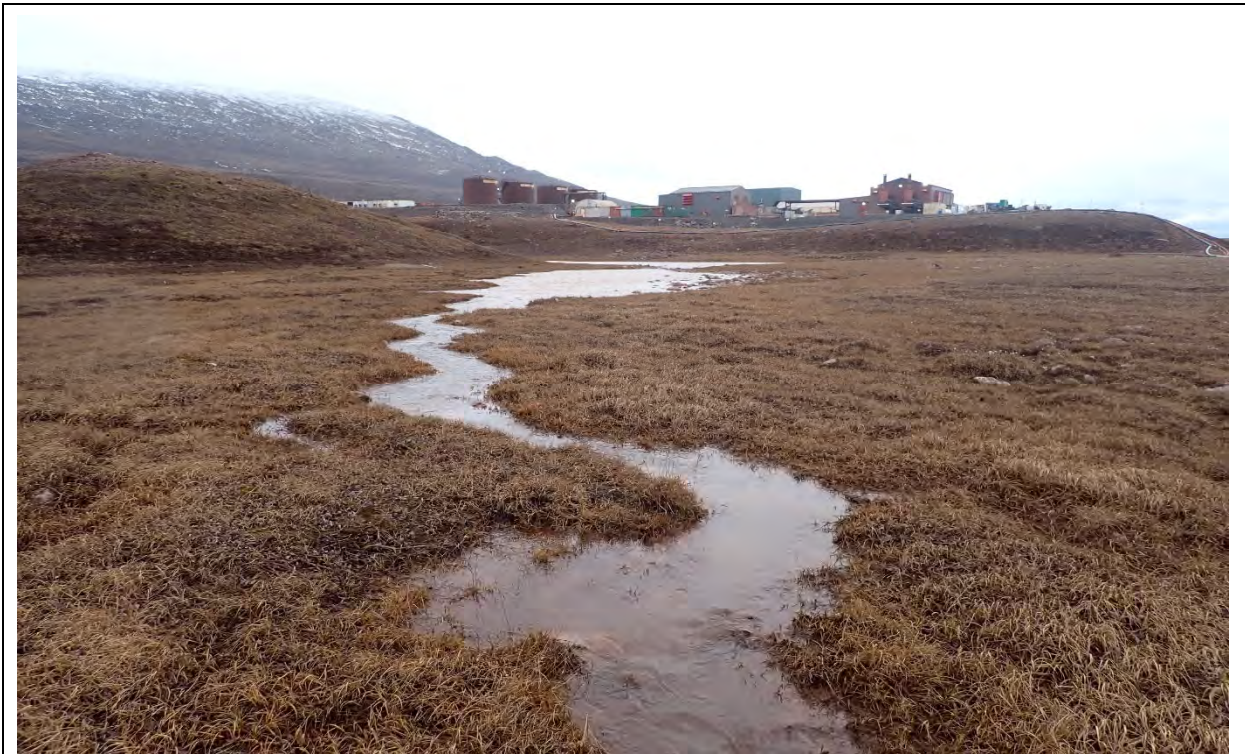
**Photo 46.** CV-187 upstream, turbid water approximately 140 m upstream of CV-187 due to rain event.

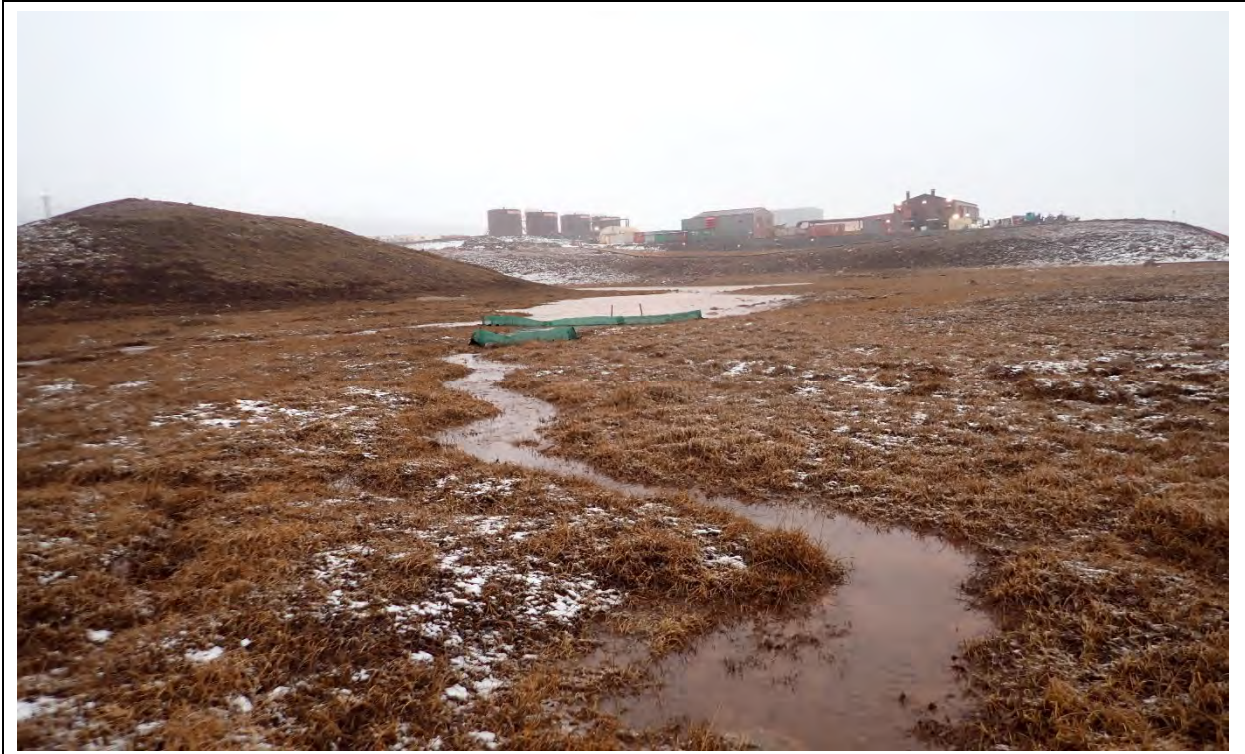
**Photo 47.** CV-187 upstream, spring berms installed approximately 140 m upstream of CV-187 due to rain event.
