N2021C0004
2023 CIRNAC LAND USE ANNUAL REPORT

FOR THE ASTON BAY PROPERTY
(ALSO KNOWN AS THE STORM PROPERTY)
NUNAVUT, CANADA

Prepared by: APEX Geoscience Ltd.
410-800 West Pender Street
Vancouver BC V6C 2V6
Canada

March 2024

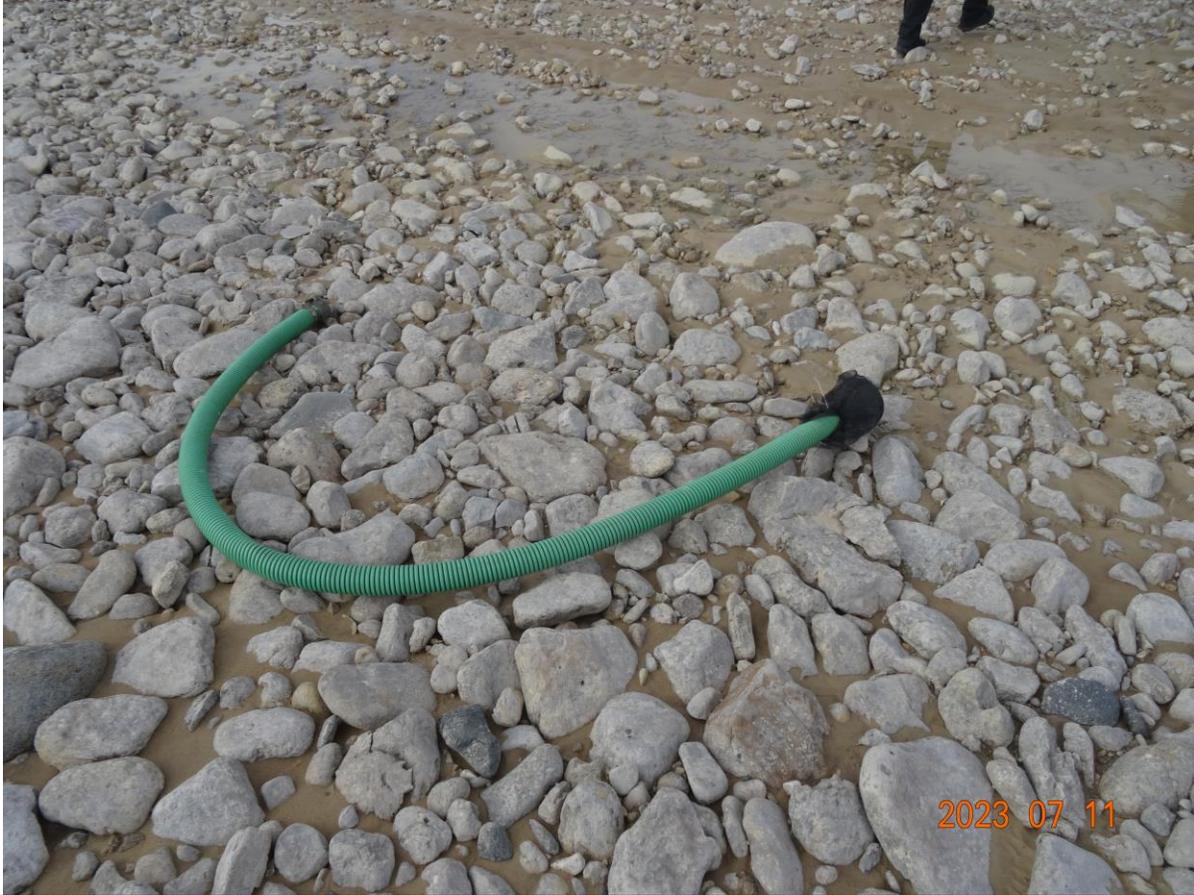
Photo No.	Lat/Long (DD.MM.SS.SS, NAD83)
Photo 1	Click or tap here to enter text.

Description:
 This end of the hose is used to collect water form the Aston River. The hose has a mesh screen to ensure no fish or sediment enter the system.

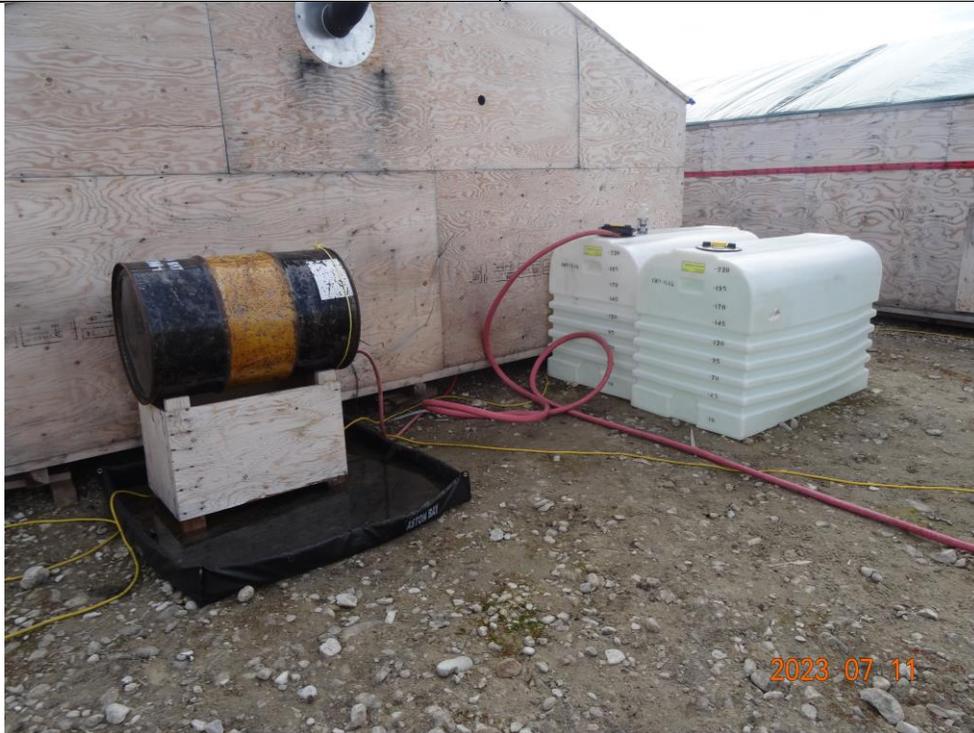
3. Raw water is stored outside in two 225 gallon storage tanks outside of the main facilities (Photo 2).
4. Along with the tanks outside, there are 2 different water storage tanks inside of 2 different cabins. "Tank 2" is 350 gallons and is located in the cabin that also has the UV filter system and the Micron filter system (Photo 3). Inspector Bolt has also taken a photo of the water use logs located inside the filtration cabin (Photo 4).
5. "Tank 1" is in the cabin next to the filtration cabin and is a smaller 250 gallon tank (Photo 5).
6. Inspectors observed 2 hot water heaters on site (Photo #3, #5).
7. 3 washing machines, 3 sinks and 6 showers were observed on site (Photo 7 and Photo 8).

In this image you can see 2 water storage tanks. Both are 225 Gallons. 1 is full and the other one has approximately 120 Gallons. Also, you can see a fuel drum used for the heaters stored in secondary containment.

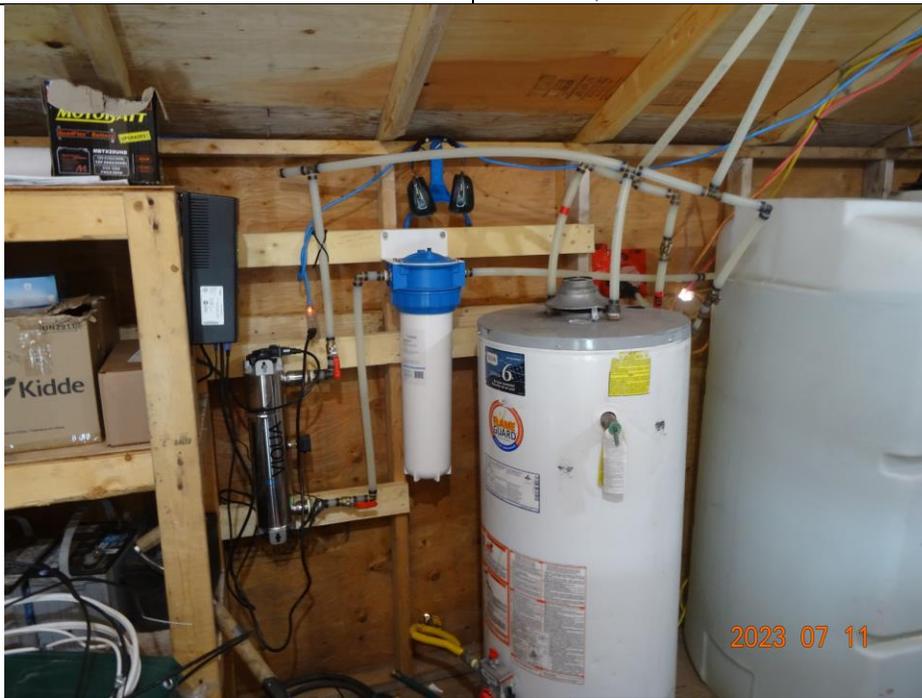
A micron filter and a UV system work to treat the raw water. Also in the photo, a hot water heater and a 350 Gallon water tank that is nearly full.

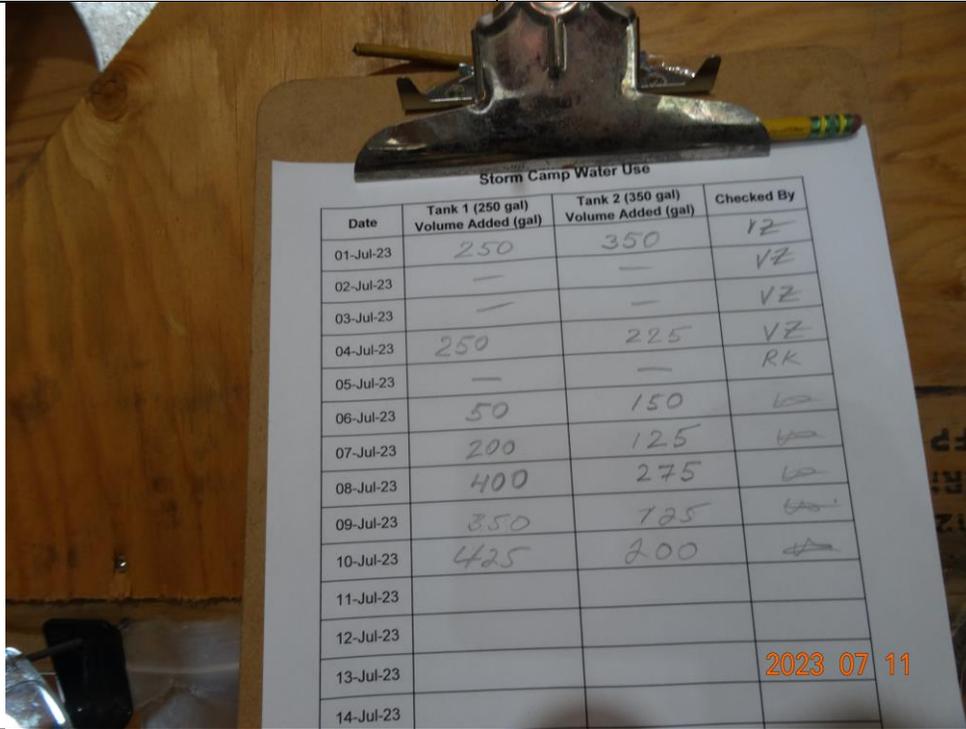
Photo 4

Daily Water Use logs for Storm Camp. Measured in Gallons.

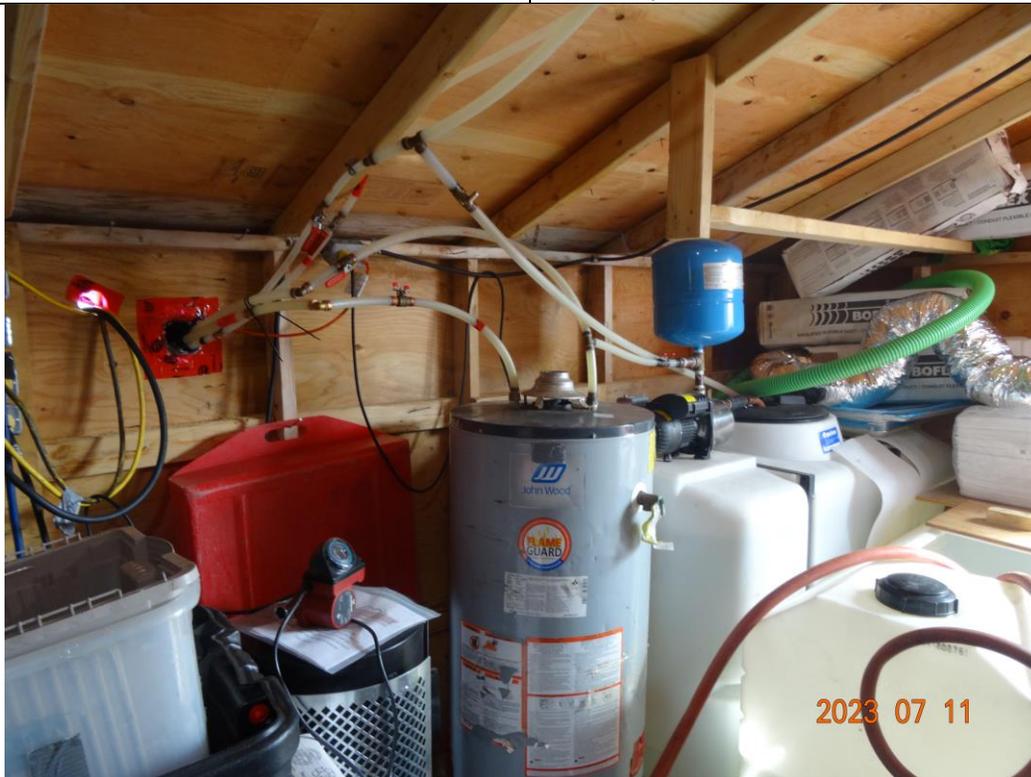
Photo 5

In a separate cabin, there was another hot water heater and a smaller water storage tank which was ¾ full.

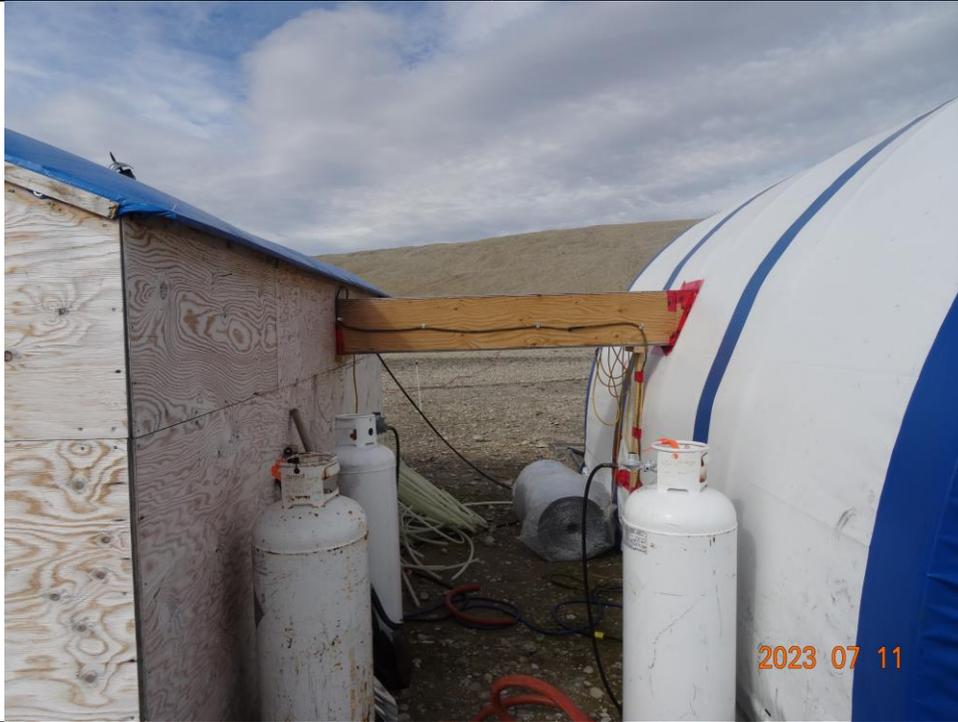
Photo 6

This image shows an example of how the water and wires travel through camp. Hoses are inside the box connecting cabin to tent.

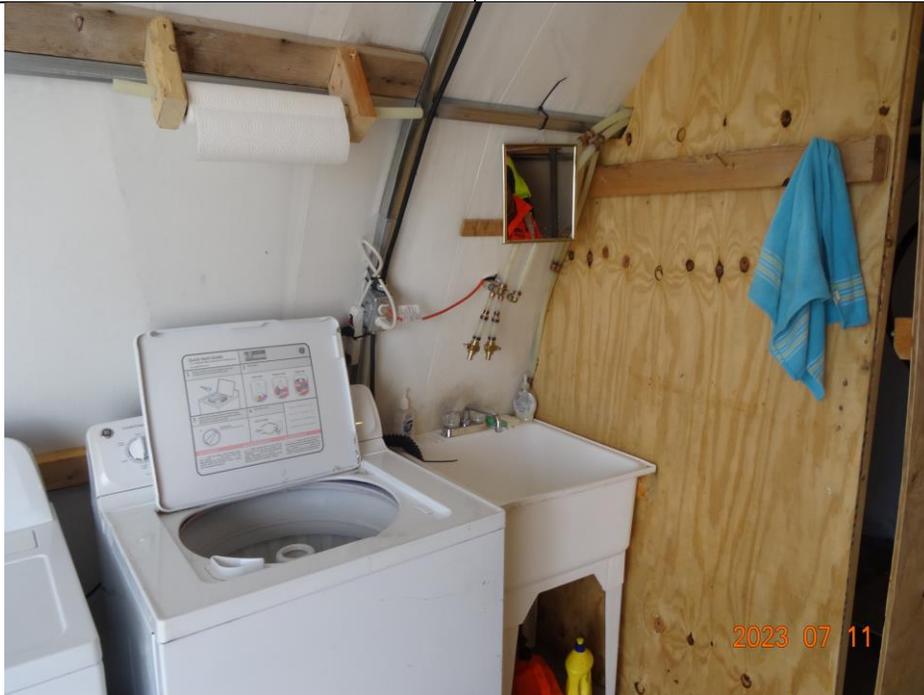
Photo 7

Inside this tent is 2 showers, a washer and a sink.

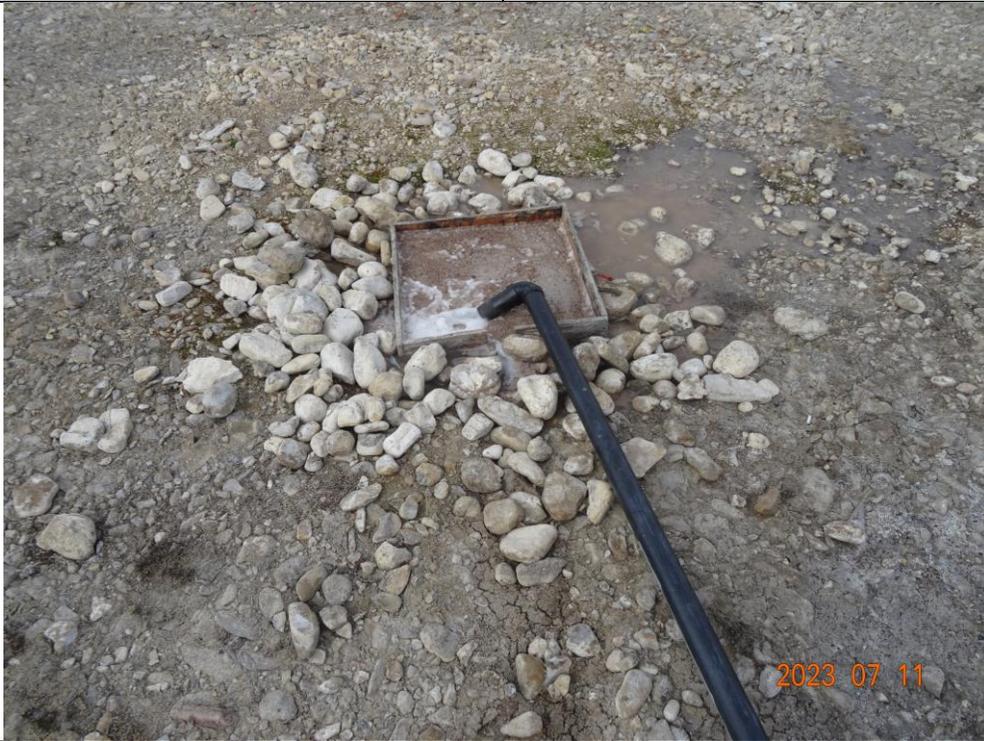
An example of an active grey water pipe.

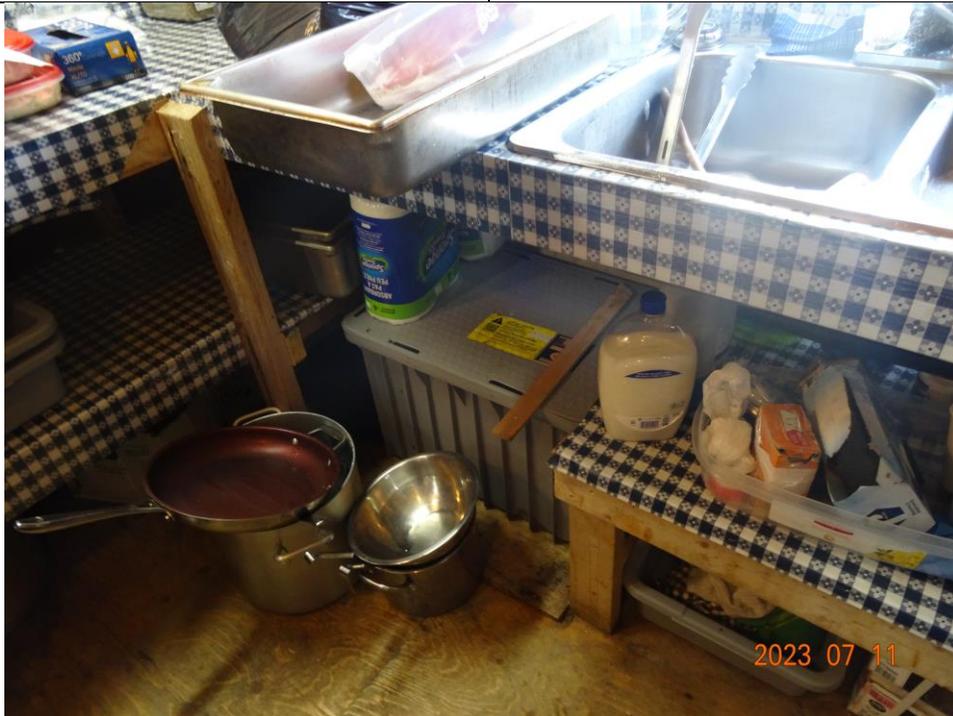
The grease trap/sump is in the kitchen.

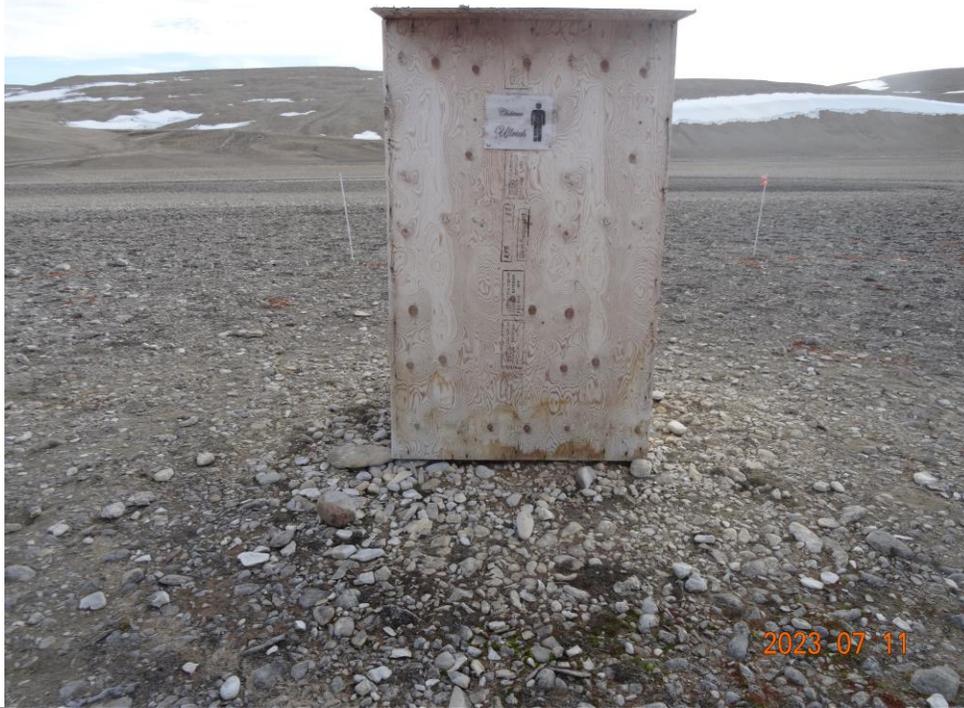
Standing Unirnal Latrene.

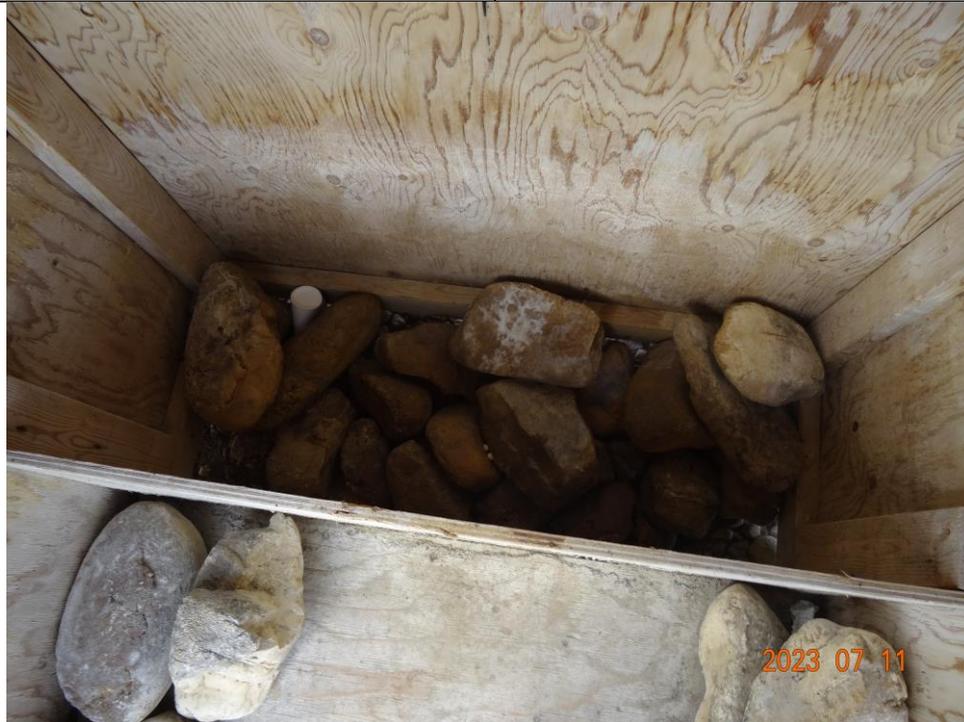
Inside the latrene where people pee. Large rocks supposed to act as sediment erosion control or splash break.

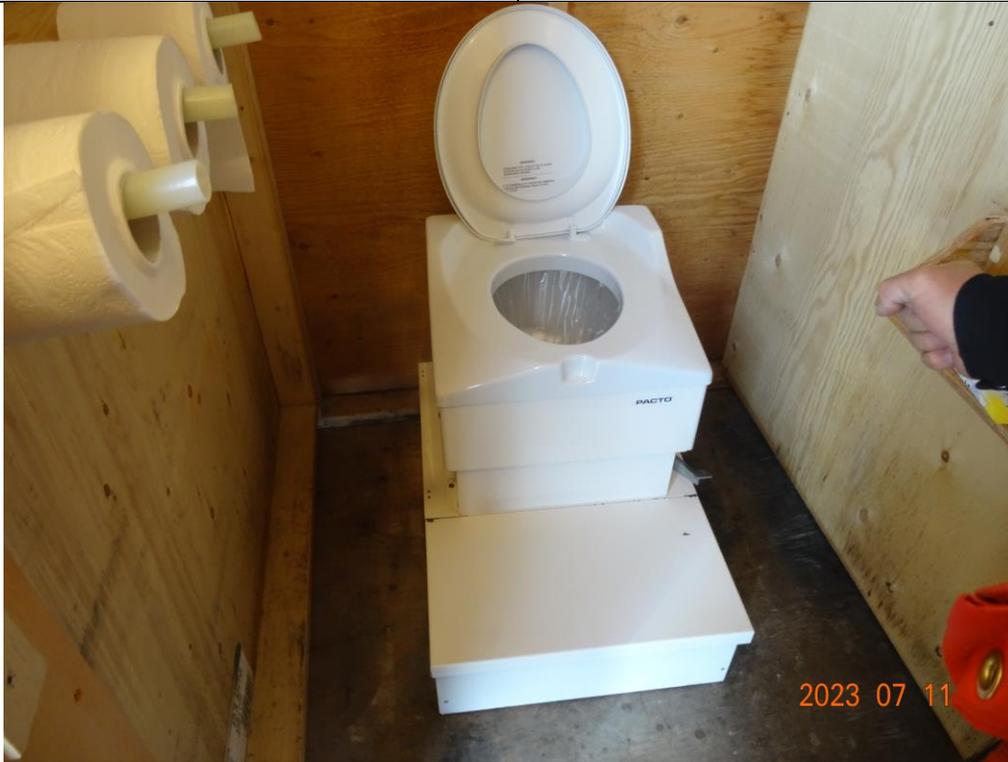
Photo No.
Photo 14

Pacto Toilets are used on site. The plastic bag lines the toilet and when done you tie the bag and dispose of it. Bags can then be burned in the incinerator or flown off site.

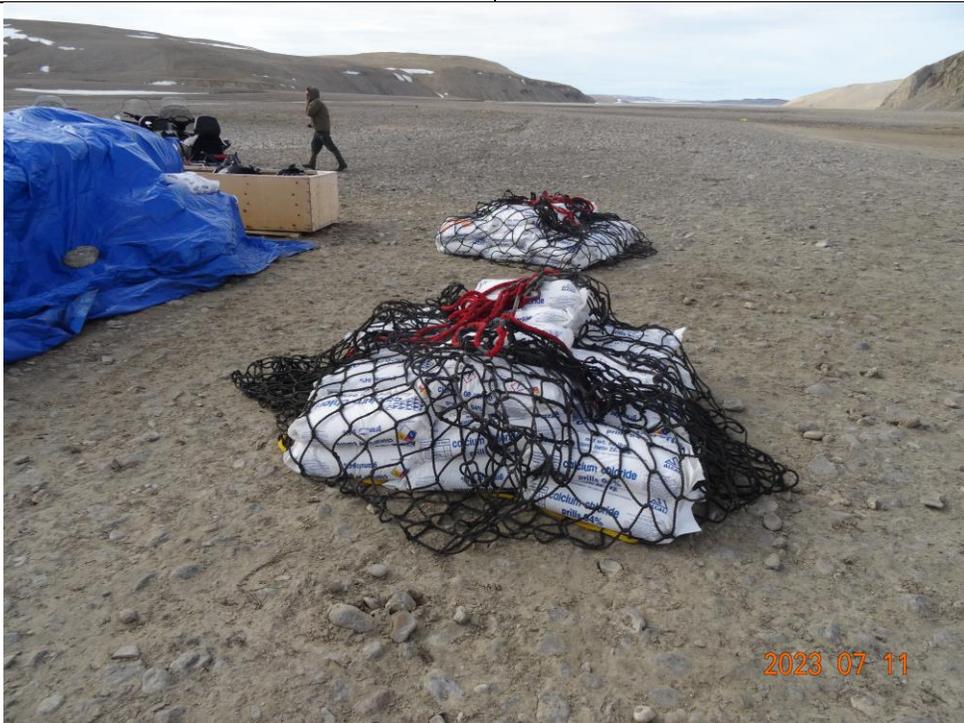
Photo No.
Photo 15

This pile of calcium chloride is resting on the ground awaiting transport to the drill site. There are more bags under the blue tarp.

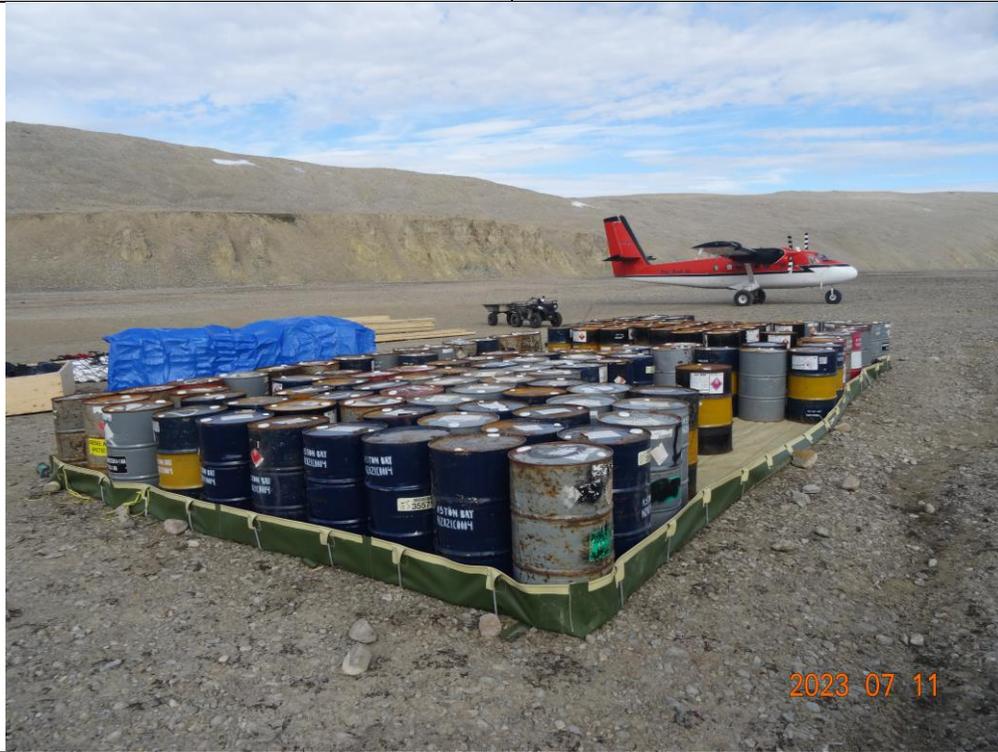
Photo No.
Photo 16

Description:
A fuel berm located close to the air strip.

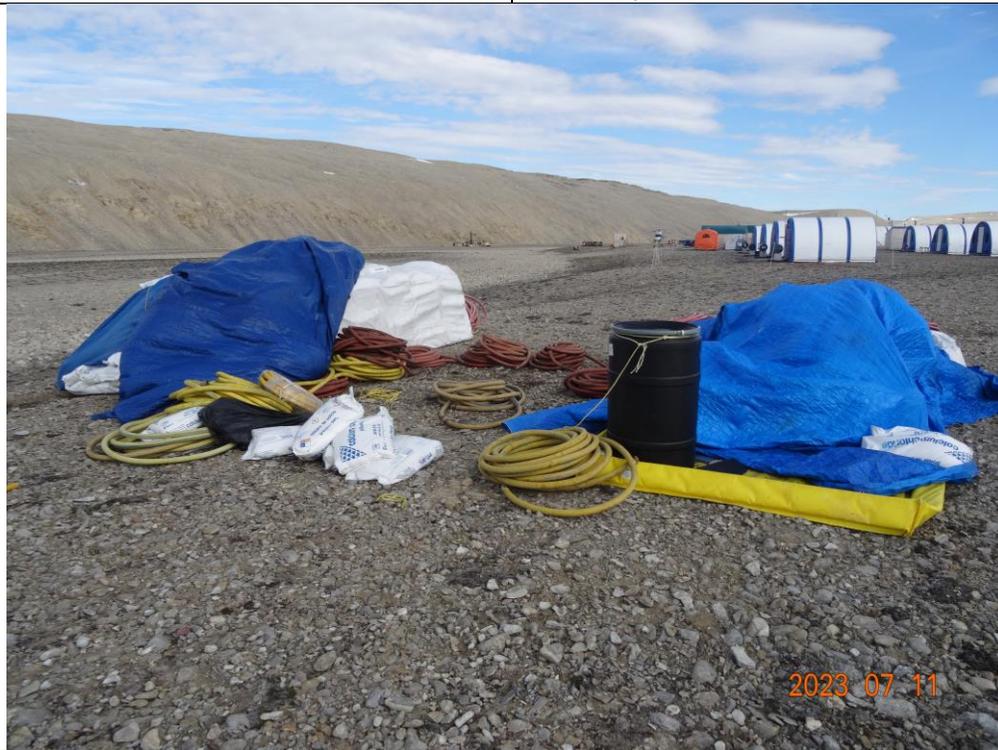
Photo No.
Photo 17

Description:
1 pile of Calcium Chloride stored in secondary containment on the right, the pile on the left isn't in secondary containment.

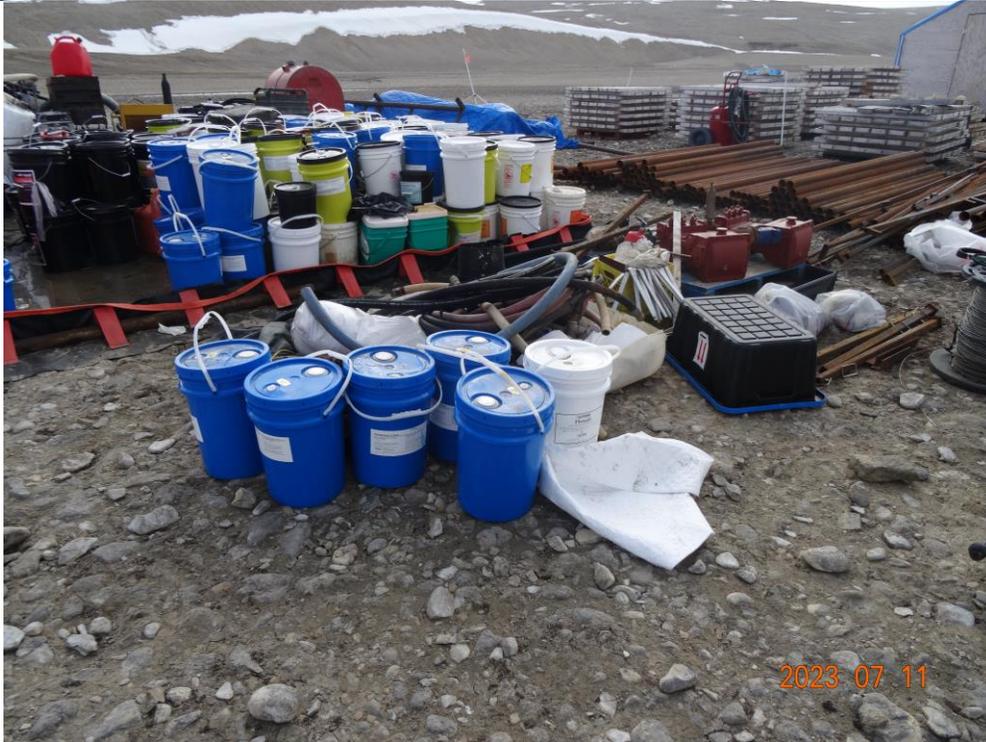
Image shows hazardous waste storage near the camp, buckets of blue dye are stored on the ground.

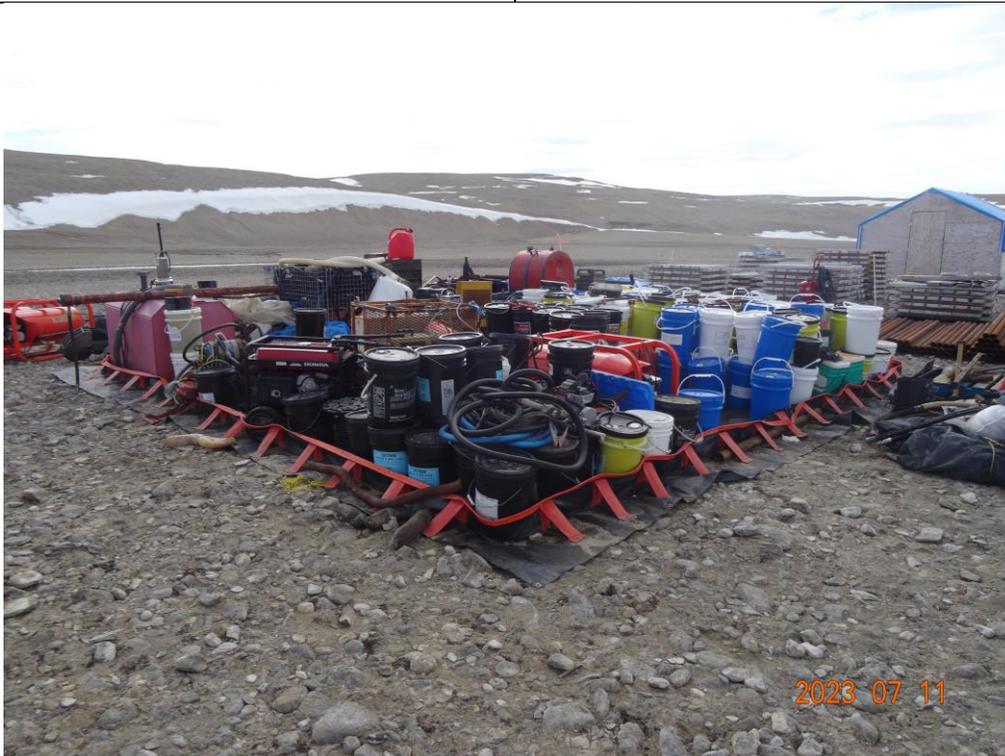
20. The hazardous waste berm has standing water inside of it. This water should be considered waste (Photo 20).
21. More storage space is required for the hazardous waste berm as there is no more space for more items. Buckets are beginning to pile up outside the berm (Photo 18).
22. The walls of the berm appear to be deteriorating.
23. Items inside the hazardous waste berm have been placed on the walls and cause the walls to fold over and reduce the ability to hold contaminated water and product. This berm should be replaced (Photo 19).
24. A second hazardous waste berm may be required.

Another view of the hazardous waste storage. The left side of the bem wall is compromised, this is due to the fuel drum hand pump.

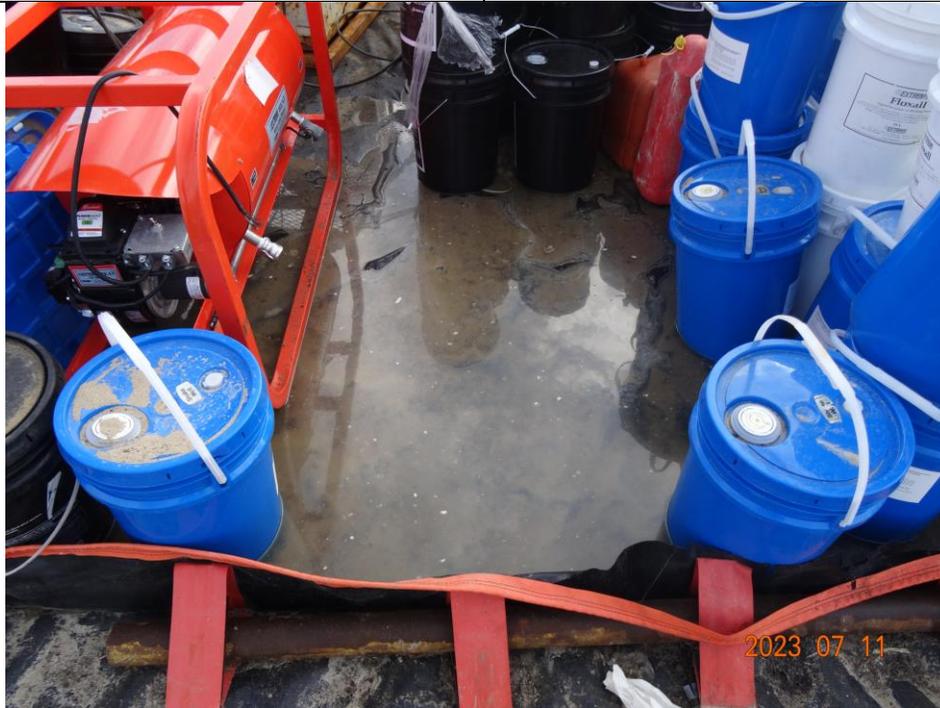
Photo No.
Photo 20

Description:
Water is pooling inside the hazardous waste berm.

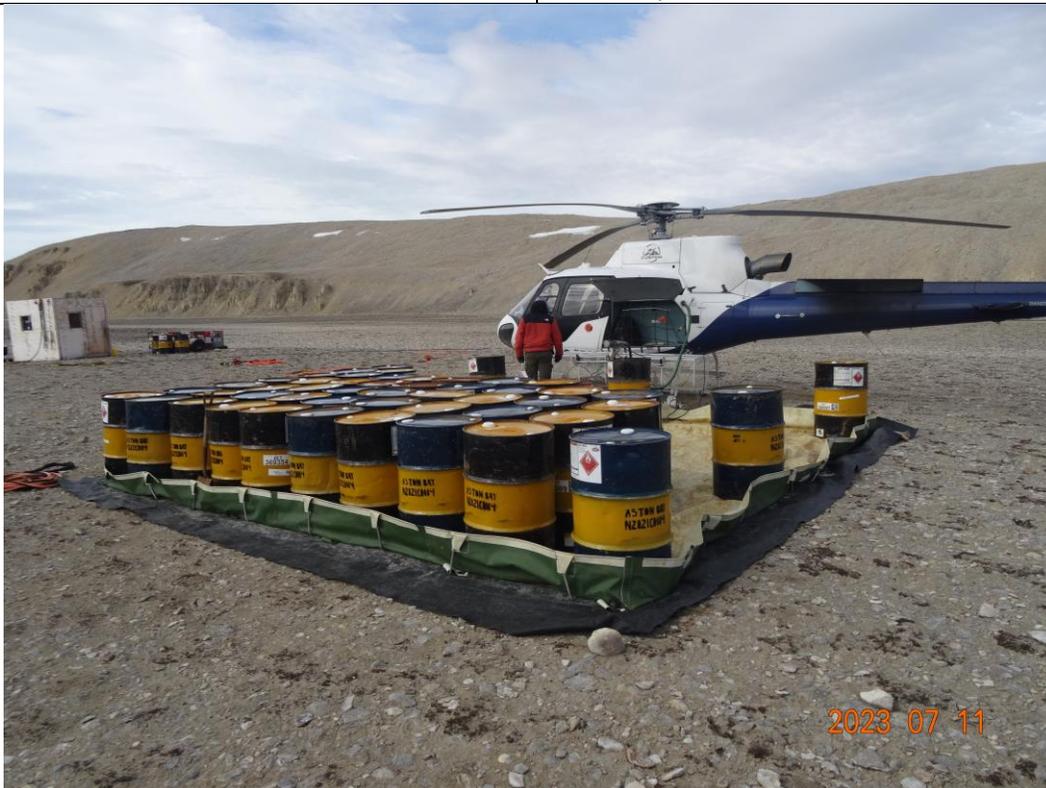
Photo No.
Photo 21

Description:
Helicopter fuel storage berm

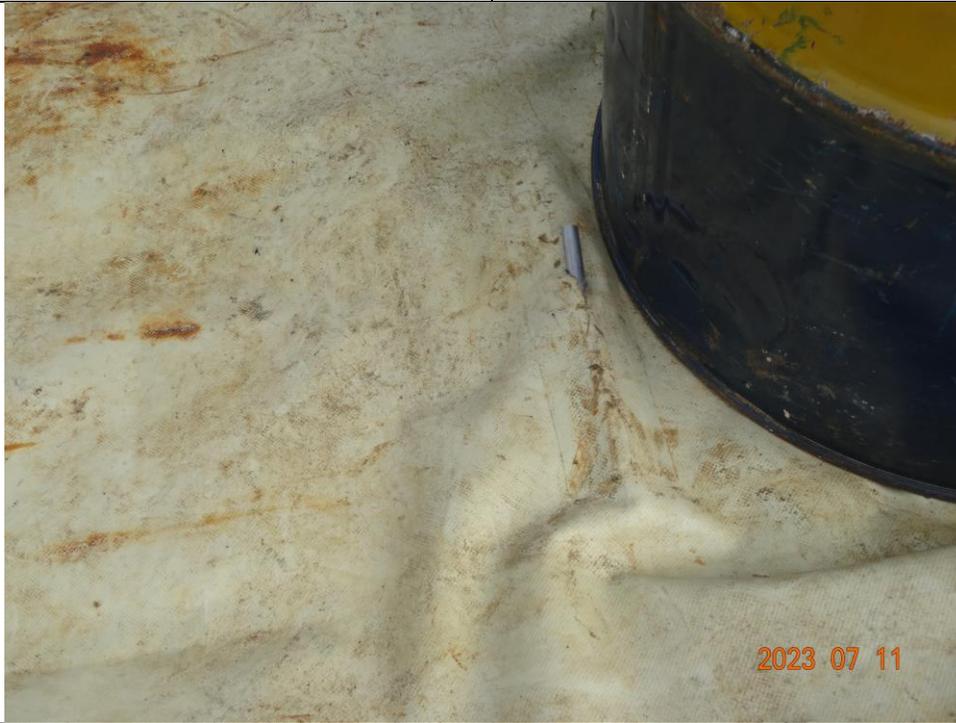
Photo No.
Photo 22

The helicopter fuel storage berm has a hole from the barrels and aluminum braces coming in contact. This is on the floor

- 1. All fuel caches should be inspected. Helicopter Pad fuel storage berm and the 2 fuel berms inside the bear fence should be changed.
- 2. Drilling site water pump and fuel drums in secondary containment should be moved at least 31m away from the high water mark. (Photo #32)
- 3. The hazardous waste berm needs to be replaced.
- 4. Only acceptable waste should be incinerated. Unacceptable waste should be removed from the incinerator and disposed of accordingly.
- 5. Any Ash from incineration found on the ground should be cleaned up and placed into ash barrels and sent off site.

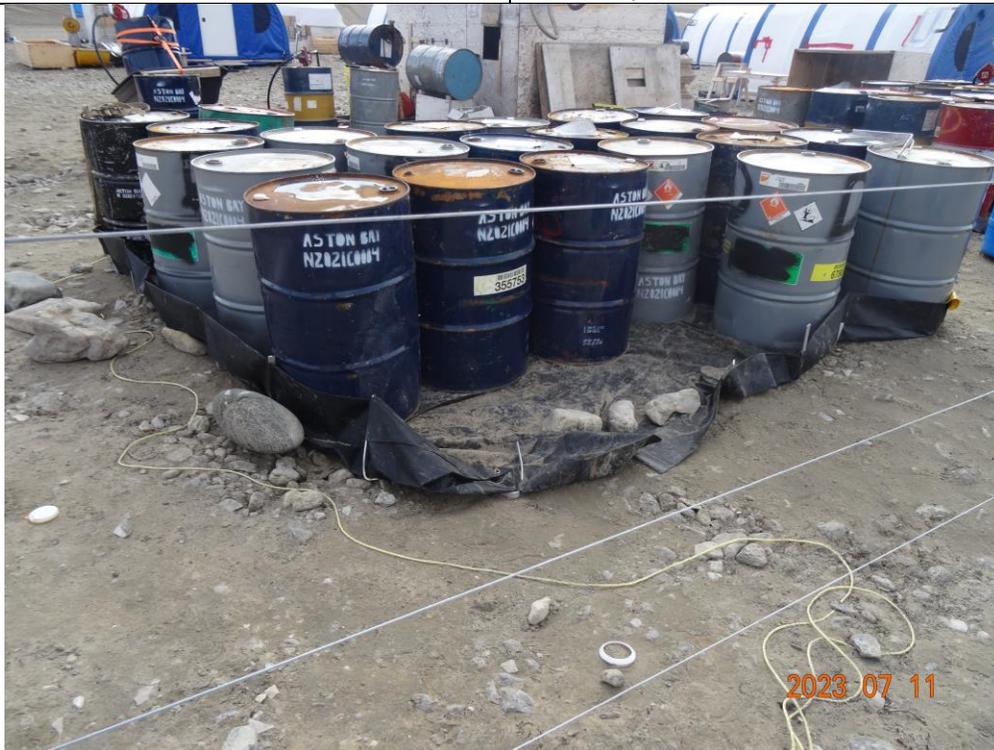
Photo No.
Photo 23

15. Two fuel storage berms are located inside the bear fence close to the cabins. Both berms need to be replaced as they are both compromised. (photo 23 and 24) Photo 25 shows the hole in one of the containment berms.

Fuel berm 1 of 2 inside the bear fence. The walls have fallen and would not hold product and or contaminated water.

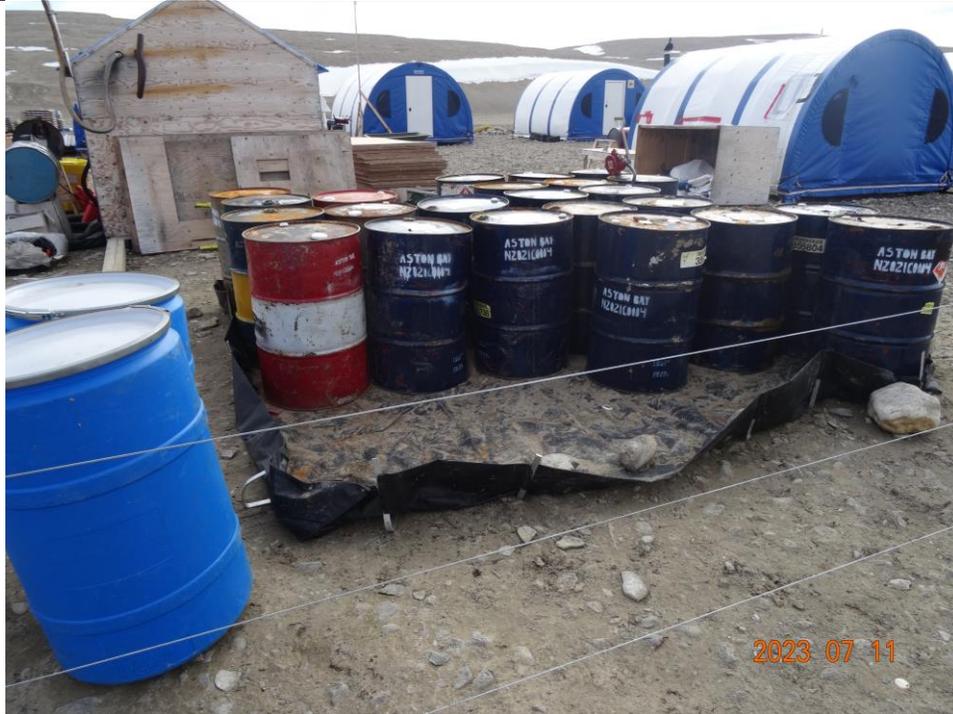
Photo No.
Photo 24

Berm 2 of 2 inside the bear fence. This berm's walls are falling over and Inspector Bolt found a hole in the bottom.

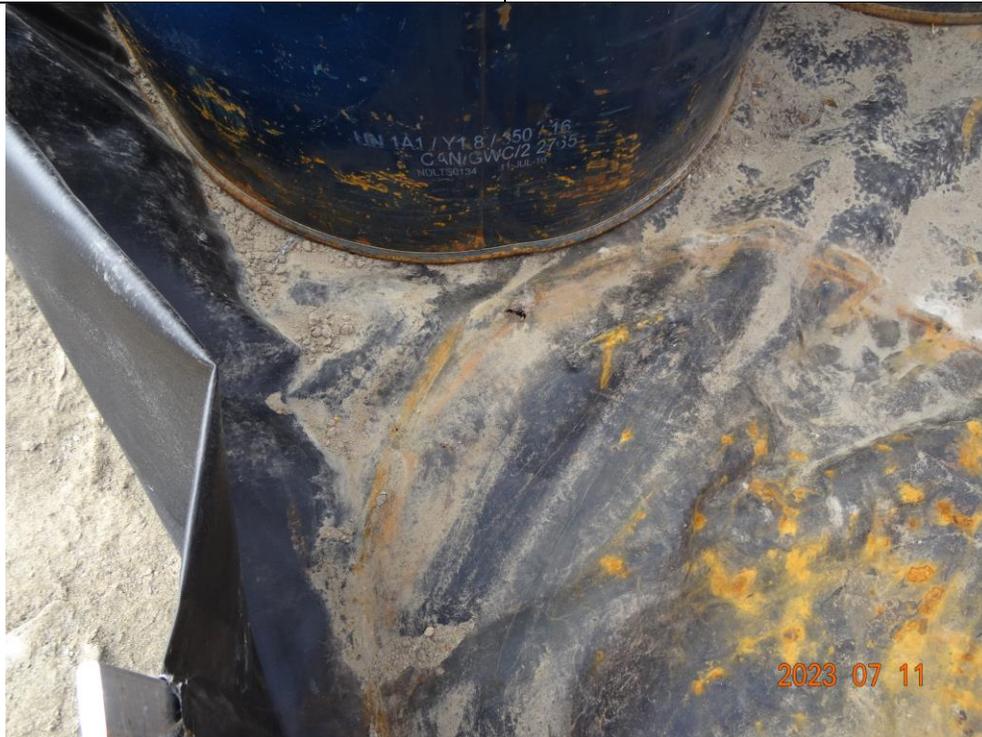
Photo No.
Photo 25

This photo is of the same fuel berm as the photo above. You can see the hole just below the bottom of the barrel.

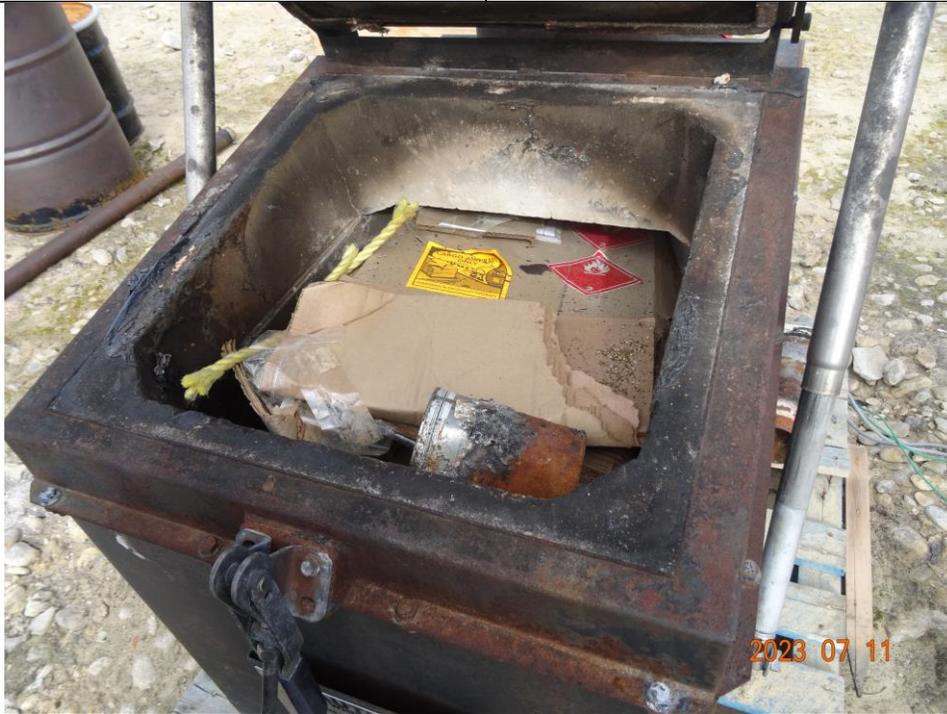
Photo No.
Photo 28

17. Aston Bay project is not authorized to practice on-site landfilling. All domestic waste is hauled off site.
18. An incinerator was observed on site at the time of inspection. The incinerator had plastic rope, and a can found inside at the time of inspection. The can had been burned previously. Part D, Item 5 of the issued water license reads –*"The Licensee shall not open burn plastics, wood treated with preservatives, electric wire, Styrofoam, asbestos or painted wood to prevent the deposition of waste materials of incomplete combustion and/or leachate from contaminated ash residual, from impacting any surrounding waters, unless otherwise approved by the Board in writing."*
19. Inspectors observed 3 piles of ash on the ground near the incinerator (Photo 27). The ash from incineration should be placed into ash bins and disposed of off site.

Description:
The incinerator had cardboard, some rope, and a burnt can.

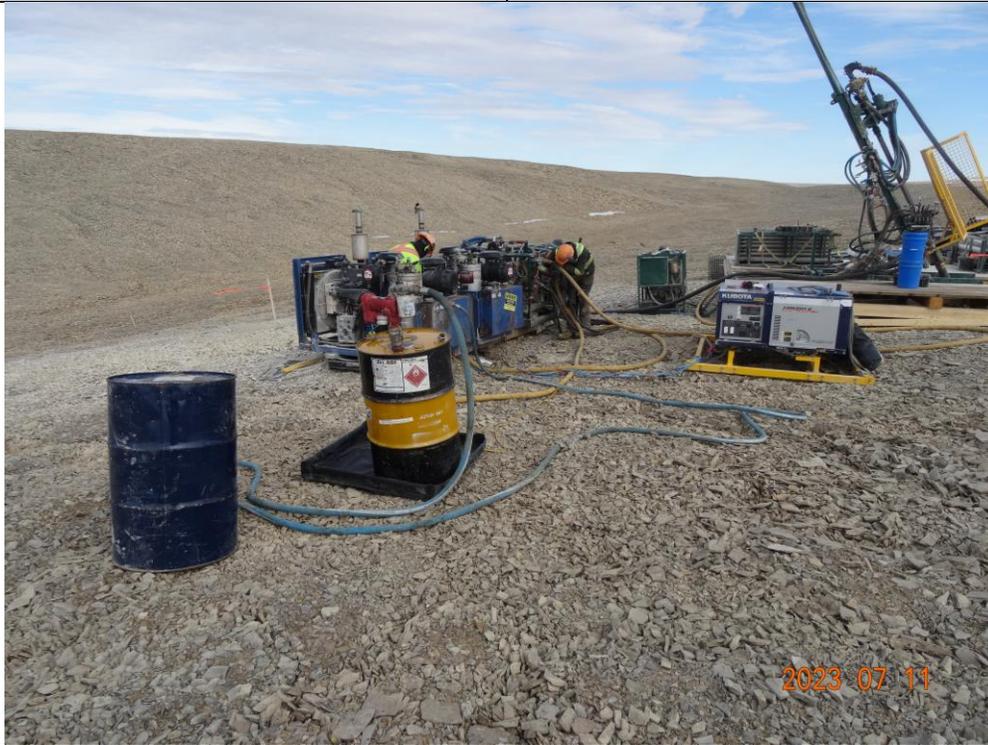
Photo No.
Photo 29

Description:
Dry drilling site, no water is used, fuel is on site and stored in secondary containment.

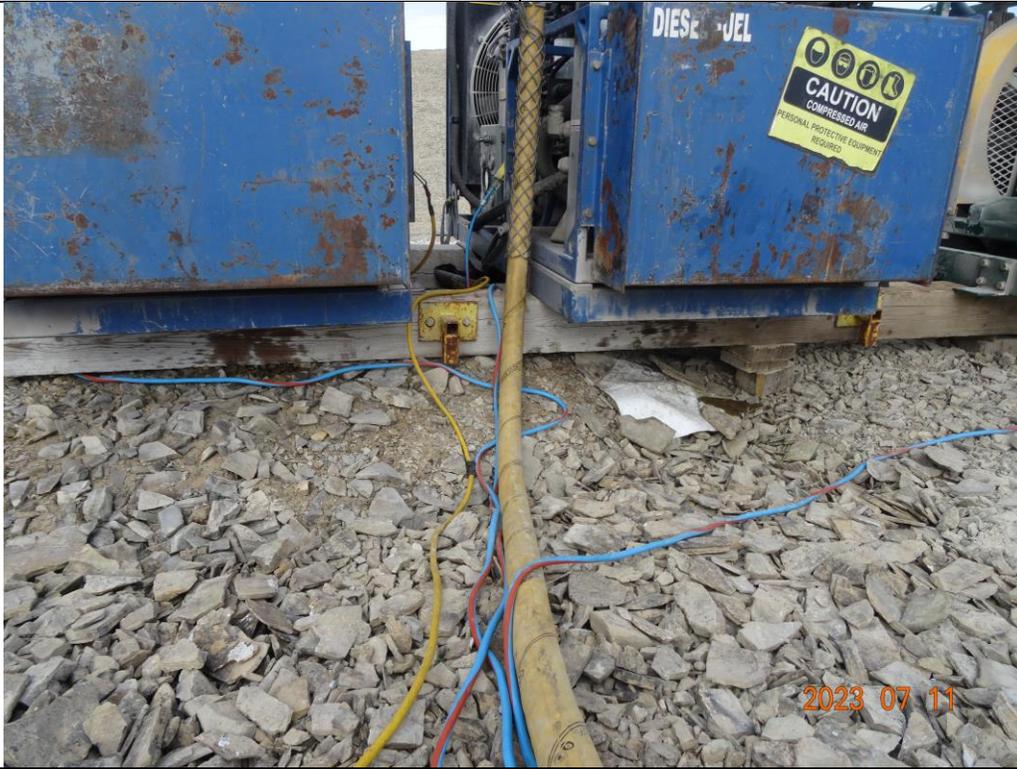
Photo No.
Photo 30

- 25. Inspectors visited 1 drill site with boots on the ground and 2 other sites were inspected by aerial view and photos.
- 26. Inspectors Bolt and Monteith got boots on the ground at one of the projects “dry drilling” sites. This drill does not use water. Inspectors did observe a small leak at the site, but a spill pad and spill tray were being used. No concerns (photo 30).

The compressors at the dry drilling site did have leaks. Spill pads and a spill trays have been placed on the ground.

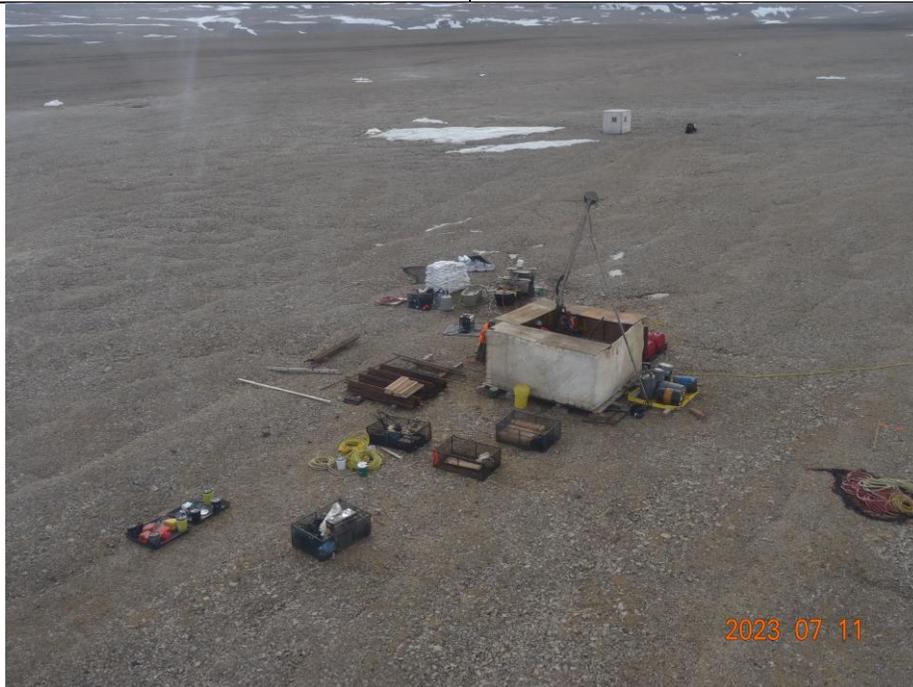
Photo No.
Photo 31

This is another drill site, but this drill uses water, we did not land at this site as we took arial photos and notes. Everything was in secondary containment.

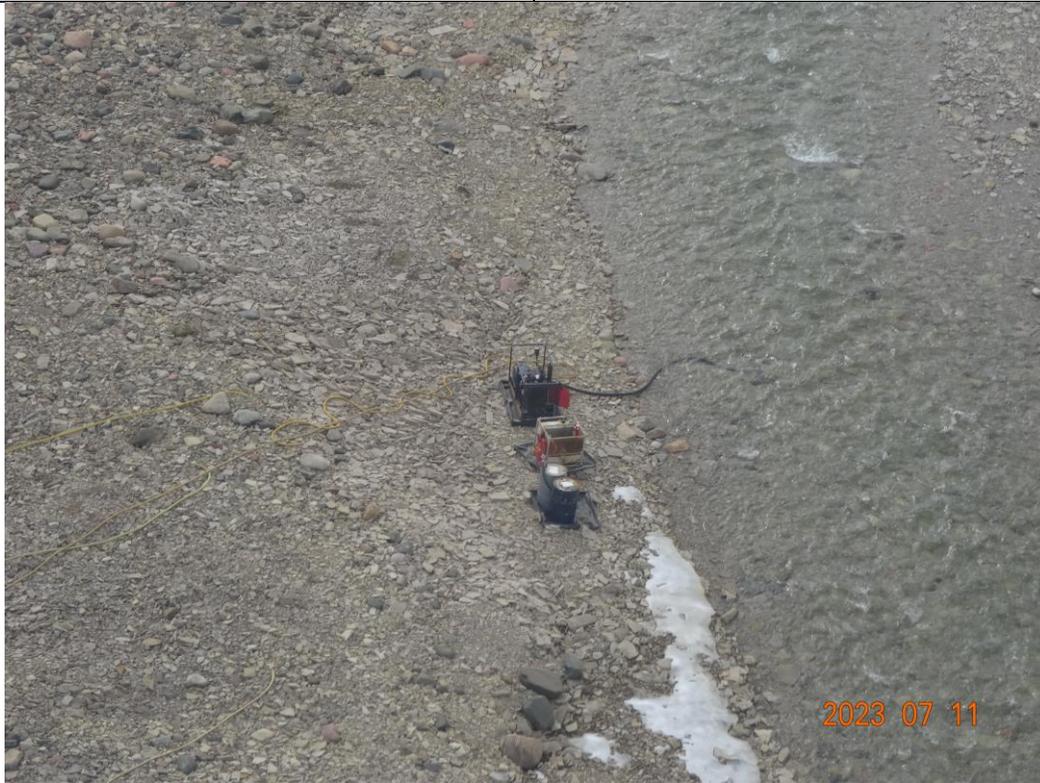
- 27. All fuel and hazardous waste seems to be in secondary containment at the time of inspection.
- 28. A water pump and a fuel berm with 2 barrels were observed to be within 4 metres of a river (photo 32).
Part H, Item 2 of the Issued water license states: “The Licensee shall prevent any chemicals, petroleum products or Wastes associated with the project from entering Water. All sumps and fuel caches shall be located at a distance of at least thirty one (31) metres from the ordinary High Water Mark of any adjacent Water body and inspected on a regular basis.”

Description:
2km away from the water drill. The pump used to draw water for drilling activities, and the small fuel berm with 2 barrels.
