N2021C0004
2023 CIRNAC LAND USE ANNUAL REPORT

FOR THE ASTON BAY PROPERTY
(ALSO KNOWN AS THE STORM PROPERTY)
NUNAVUT, CANADA

Prepared by: APEX Geoscience Ltd.
410-800 West Pender Street
Vancouver BC V6C 2V6
Canada

March 2024

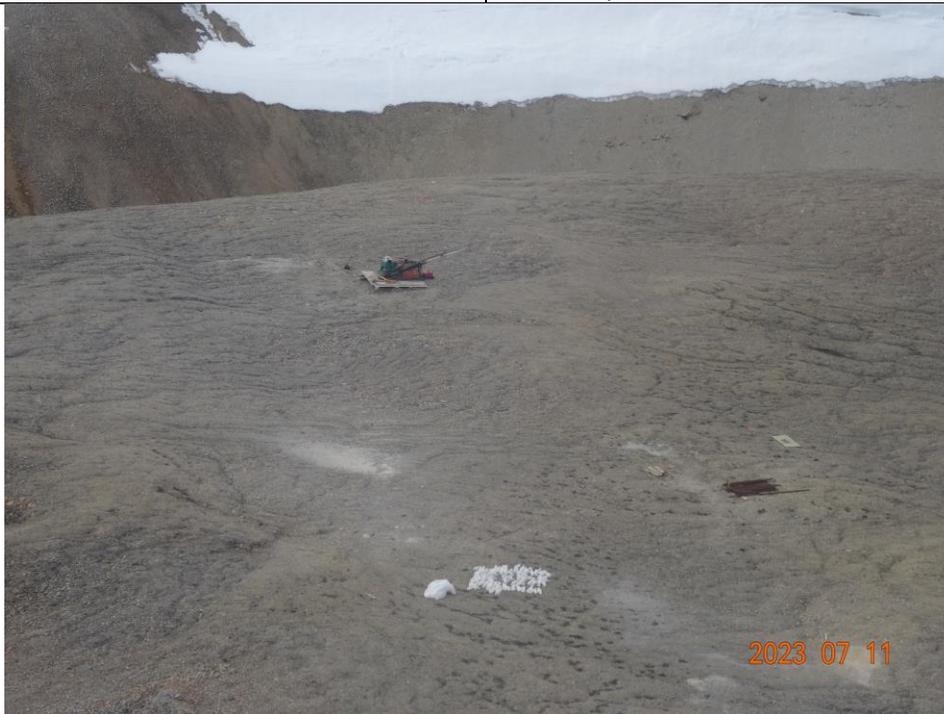
Description:
This image is of another drill site that was left since the previous year. Sample bags, the drill and platform and drill rods are in the photo.
