**RE: Mary River Project – Qikiqtani Inuit Association June 2025, 1st Annual Environmental Inspection Findings and Recommendations**

RE: Water License 2AM-MRY1325 – Mary River Project Follow up Report to June 2025  
Environmental Inspection

# Baffinland Mine Site June 2025 Environmental Investigation

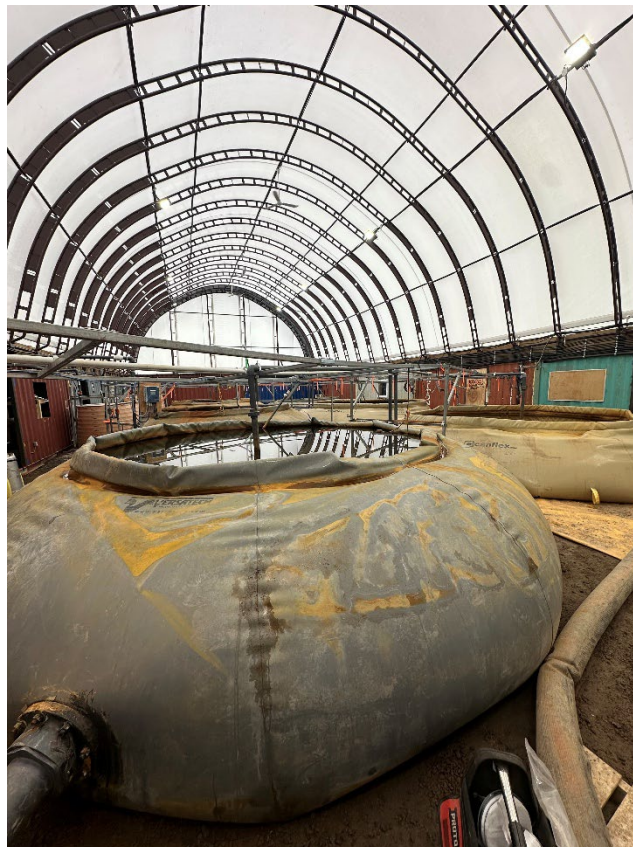
Photo 2 – Waste Rock Facility preparations (June 18<sup>th</sup>, 2025).

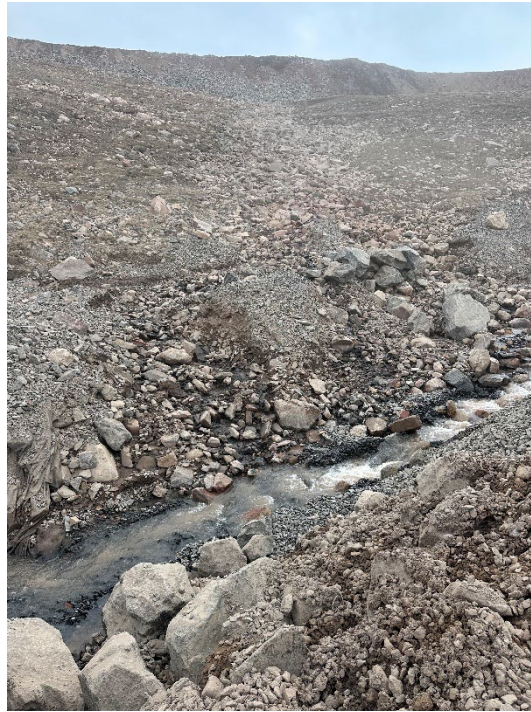
During the September 2024 inspection, the environmental inspectors noticed sediment-laden runoff originating from up-slope on the mountain and running into the north ditch of the haul road at KM106.5. The sediment laden water was visibly turbid. A noticeable increase in turbidity was observed when sediment laden water mixed with the relatively clear runoff from the haul road ditch. Baffinland followed up with a report that included drone imagery of where the sediment-laden runoff was originating. During the June 2025 inspection, the Inspectors stopped at the same location but did not observe sediment-laden runoff. The water flowing through the mine haul road ditches was clear with no signs of elevated concentrations of TSS. The Inspectors stopped at two locations in this region to confirm concentrations of TSS were not elevated.

Photo 3 – KM106.5, where inspectors previously saw turbid water (June 18<sup>th</sup>, 2025).

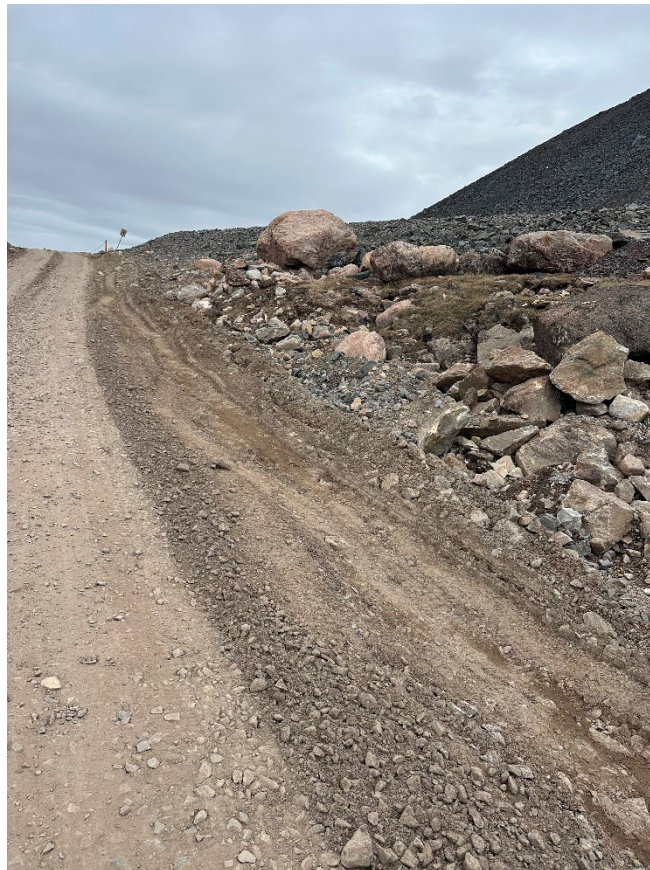
- On June 6<sup>th</sup>, 2025, at approximately 12:45pm, personnel observed contact water from the Km 106 Ore Stockpile bypassing the diversion berm and being released to the tundra. The water is now being redirected to a containment sump and is being transferred to the facilities containment area. Remedial actions to address the source are underway. The release did not migrate from the immediate vicinity downstream of the diversion berm and has not entered the receiving environment. Initial field readings of the release indicate elevated levels of TSS in exceedance of the applicable water license and MDMER criteria. Water quality monitoring and corrective actions will be presented in the follow-up report. The incident occurred on IOL located approximately 300 meters from Mary River, the nearest fish bearing waters. This spill is being reported as required by the conditions of water license no. 2AM-MRY1325, Part H, item 9(b) and section 31 of the Metal and Diamond Mining Effluent Regulations under the Fisheries Act.

Photo 4 – KM106 stockpile, where a spill was reported (June 18<sup>th</sup>, 2025).

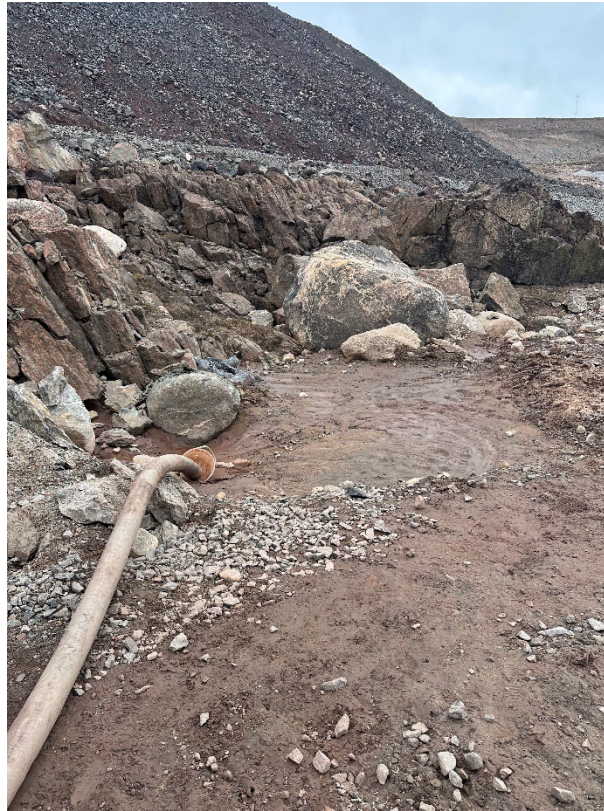
Photo 5 – Pooling location caused by the KM106 spill (June 18<sup>th</sup>, 2025).

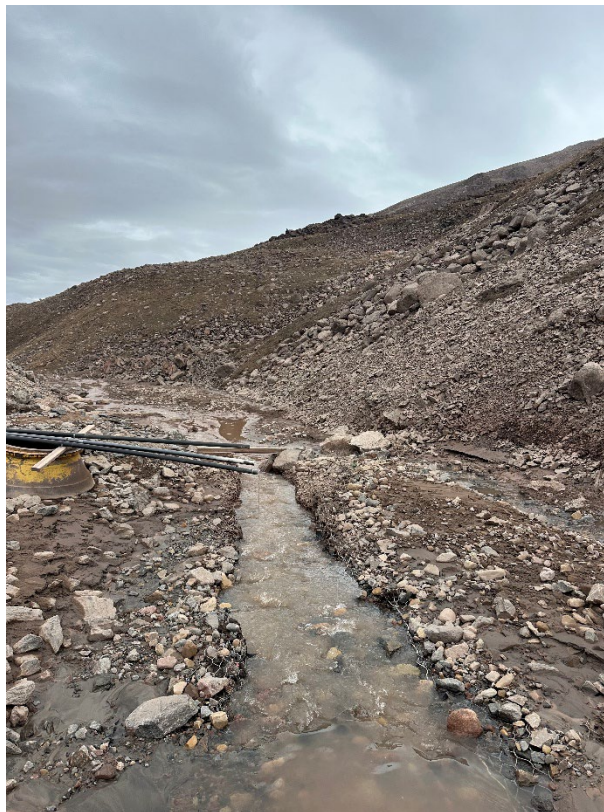
Photo 6 – Dosing facility upstream of the KM105 infrastructure. Note the secondary flow path (June 10, 2024).

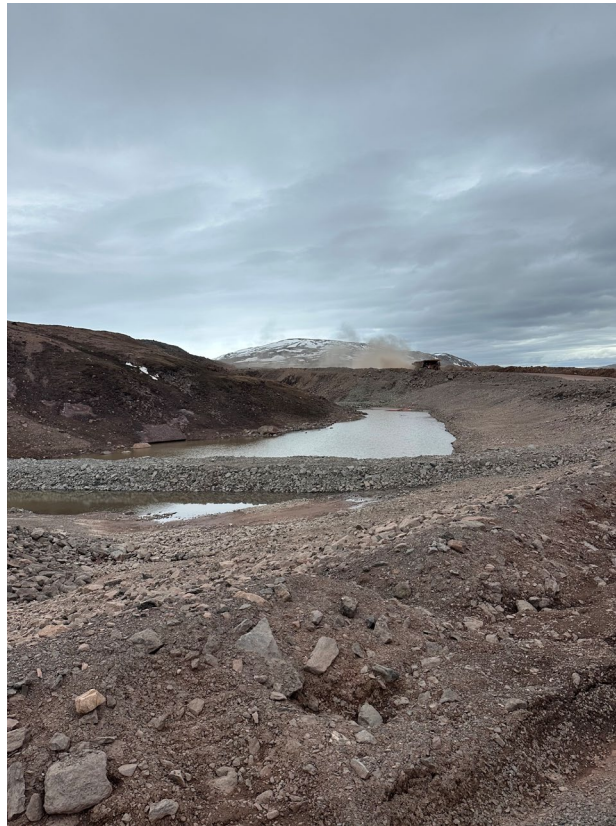
Photo 7 – New filter berm upstream of KM105 (June 18<sup>th</sup>, 2025).

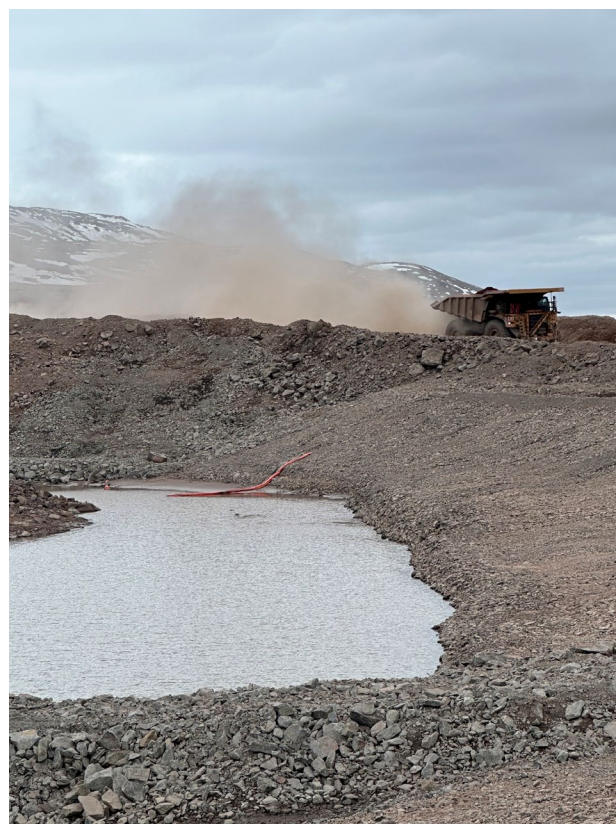
Photo 8 – Dust behind a large truck by KM105 on the mine haul road (June 18<sup>th</sup>, 2025).

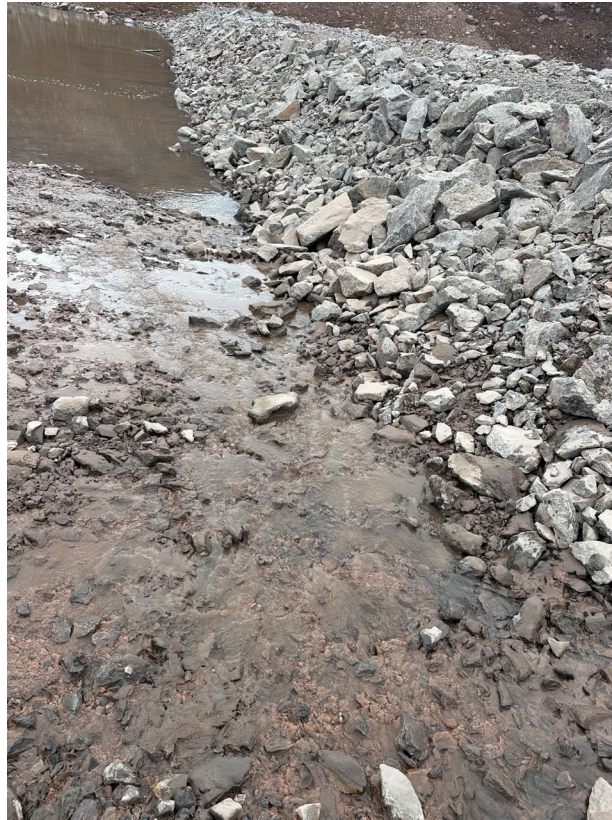
Photo 9 – Horizontal view of the new filter berm (June 18<sup>th</sup>, 2025).

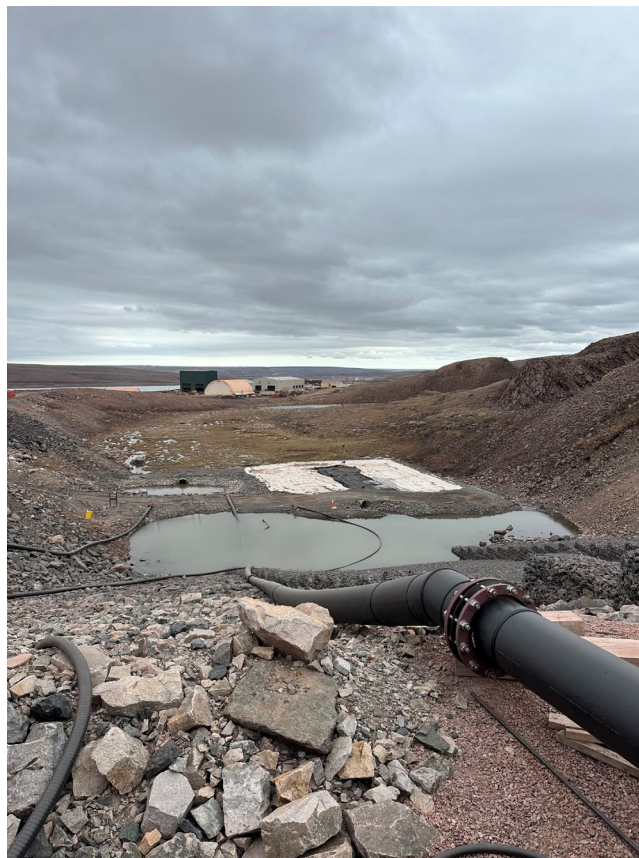
| Item No. | Project Location | Description of Concern | QIA Requested Action | Has the Concern Been Addressed Based on Previous Recommendations (Bold terms are updates from June 2025) |
|---|---|---|---|---|
| 9 | Immediately downstream of pond KM 105 | Fine sediments (silt/clay) were observed in the areas downstream of the KM 105 dam. These sediments are believed to be a result of the dam bypass and from high sediment load events. The sediments appear to be fine silts/clays. These introduced fine sediments have the potential to change the shallow soil characteristics (nutrient balance, pH, and other edaphic | <ul style="list-style-type: none"> <li>Remediation of the KM 105 pond dam and upstream channel will minimize the amounts of fine sediments able to travel downstream.</li> <li>Continue to monitor turbidity, water levels and chemical parameters in pond KM 105.</li> <li>Increased ESC controls should be employed to minimize entrained sediments and encourage</li> </ul> | <p>Yes, but attempts to repair KM 105 pond have been unsuccessful.</p> <p><b>KM105 is no longer part of the surface water management strategy.</b></p> |

Photo 10 – Tundra below KM105 Dam (June 18<sup>th</sup>, 2025).

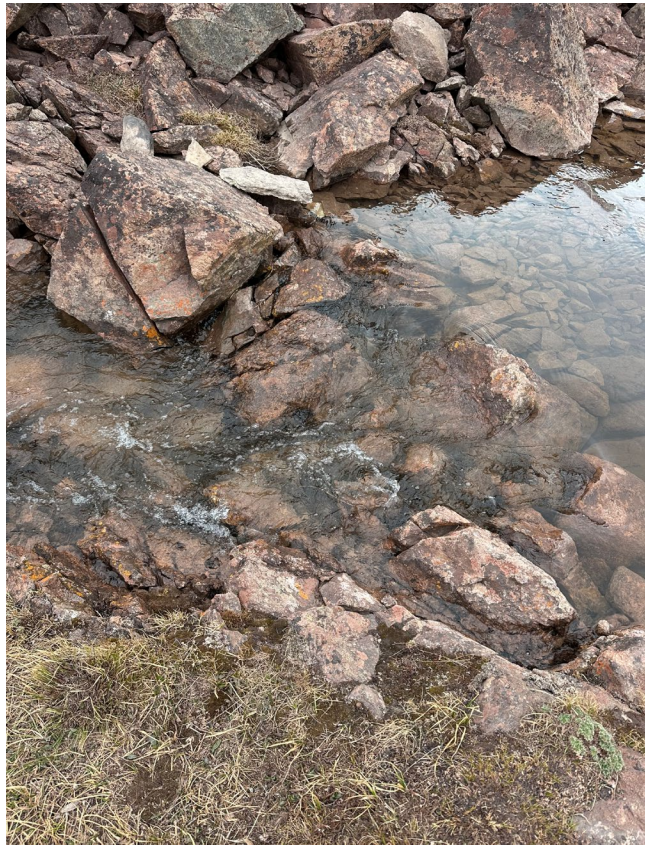
this location, which was rationalized by lessons learned from the KM105 dam and pond system. However, Baffinland will be monitoring the water quality rigorously at this flow through location. The engineered structure at the final discharge point will be installed as soon as possible, but as discussed on site Baffinland cannot expose the permafrost on the slopes. Exposure of permafrost will lead to the same problems as at KM105. Thus, a weir may not be possible because they cannot excavate the area. Discussions are ongoing internally at Baffinland to develop the best possible solution based on knowledge gained from KM105.

Photo 11 – Endpoint of treatment system where an engineered structure will be installed. (June 18<sup>th</sup>, 2025).

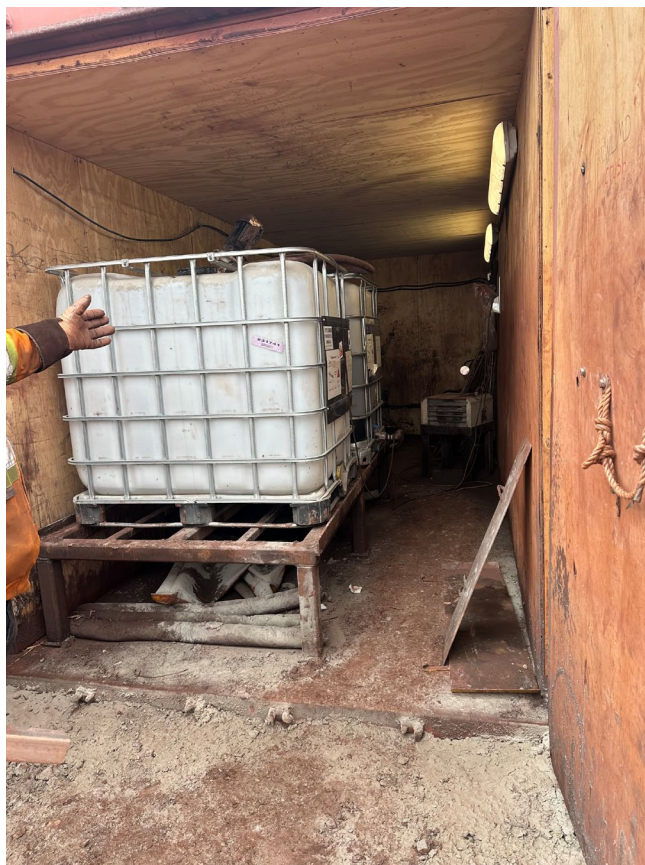
Photo 12 – Crusher Pond Totes for dust suppression (June 18<sup>th</sup>, 2025).

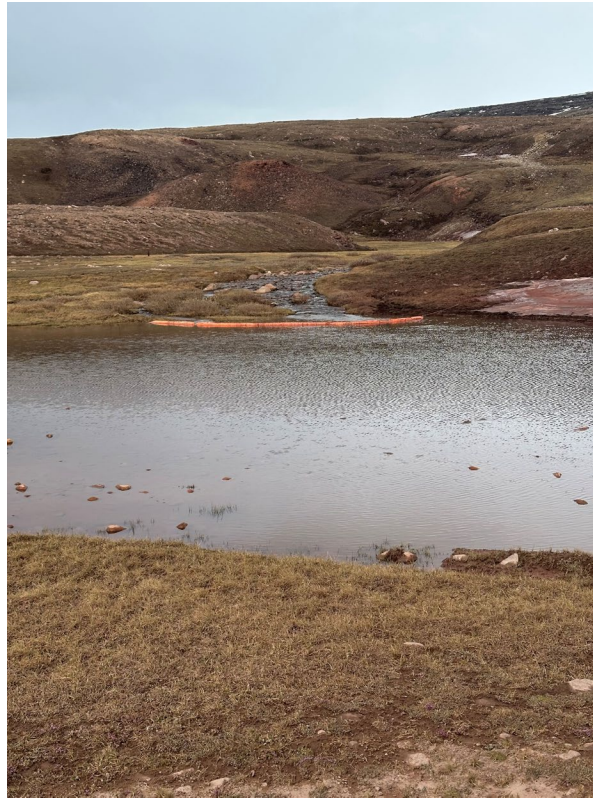
Generally, the water quality behind Sailiivik Camp at Sheardown Tributary was the clearest (low turbidity) Dr. Kay has observed visually during any inspection. There were likely a couple reasons for the improved water quality. First, Baffinland has reduced the use of silt fences through this region and increased the amount of coir logs as requested by Dr. Kay during the October unscheduled inspection and LGL inspectors during previous inspections. Secondly, the improvements made during the 2025 spring freshet at the KM105 infrastructure. Thirdly, Baffinland modified their snow management plan to ensure snow was not being pushed into the tributary, which was demonstrated to negatively influence water quality (see LGL June 2024 Report). The largest modification to the snow management plan was to excavate the snow from this region instead of plowing or clearing. The Inspectors discussed with Bill the S-bend behind Sailiivik Camp being at a lower elevation than the surrounding area, which results in erosion of sediment into Sheardown Tributary. A strategy discussed was to potentially setup a pump system to pump the water out of this region to Camp Lake Tributary. Further water treatment facilities would be installed but this may alleviate some of the erosion through this depression on the landscape. Additionally, Baffinland will be testing geo cells behind Sailiivik Camp. The geo cells are a woven structure composed of rubber tires inserted directly into the road and hopefully will further reduce erosion.

Photo 13 – Sheardown Tributary behind Sailiivik Camp (June 18<sup>th</sup>, 2025).

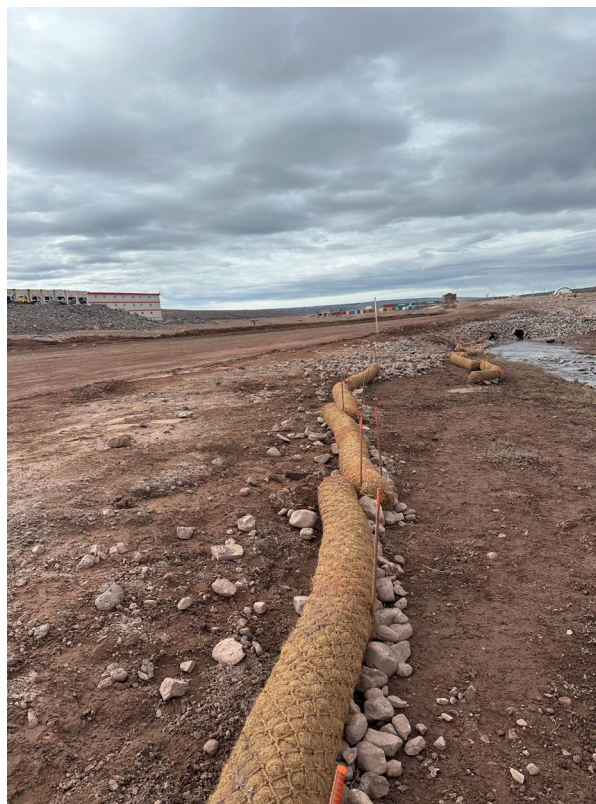
Photo 14 – Coir logs behind Sailiivik Camp (June 18<sup>th</sup>, 2025)

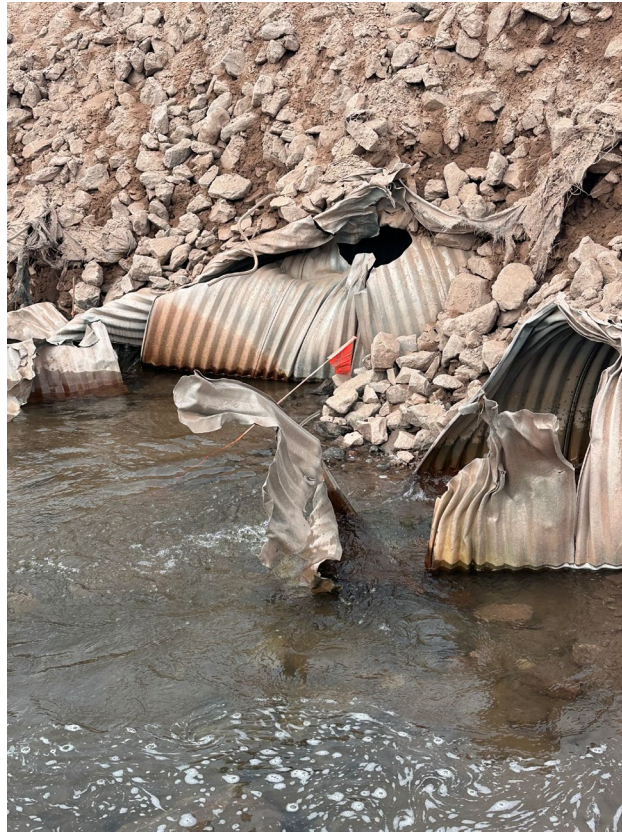
Culvert 88, located behind Sailiivik Camp, was collapsed internally but still allowed some water to flow. There were no plans to replace this specific culvert. Further downstream near the confluence of Sheardown Tributary and Sheardown Lake there were no signs of erosion on the banks following the spring freshet. The lack of erosion at this key confluence likely supports Baffinland's hypothesis of a pretty slow melt compared to previous years. There was still ice of lake, but there was water flowing into the lake and the edge of the lake was clear. The silt curtain was functional but does need to be reset at the mouth of the tributary and likely could use some quick repairs to ensure structural integrity.

Photo 15 – Damaged culverts behind Sailiivik Camp (June 18<sup>th</sup>, 2025).

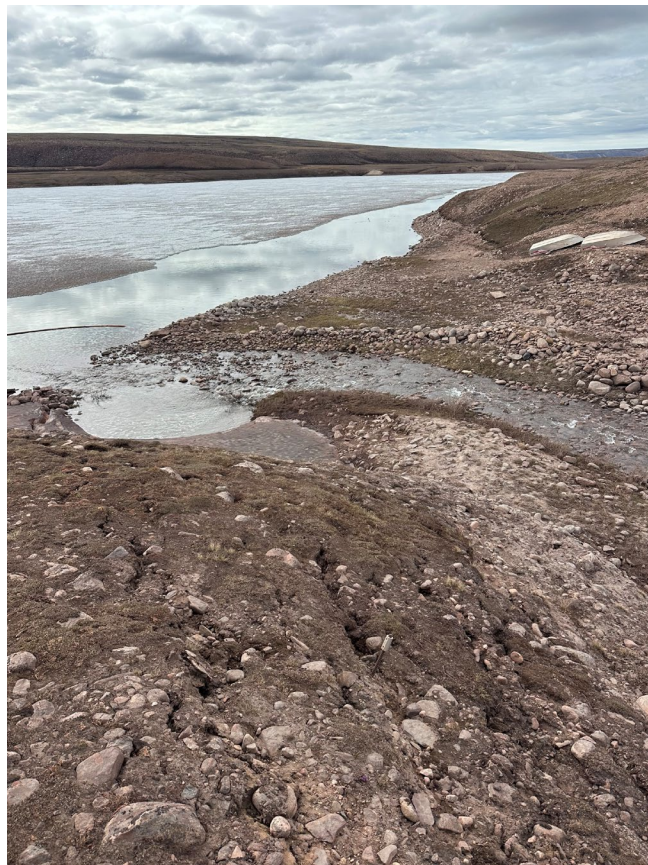
Photo 16 – Sheardown Tributary entering Sheardown Lake (June 18<sup>th</sup>, 2025)

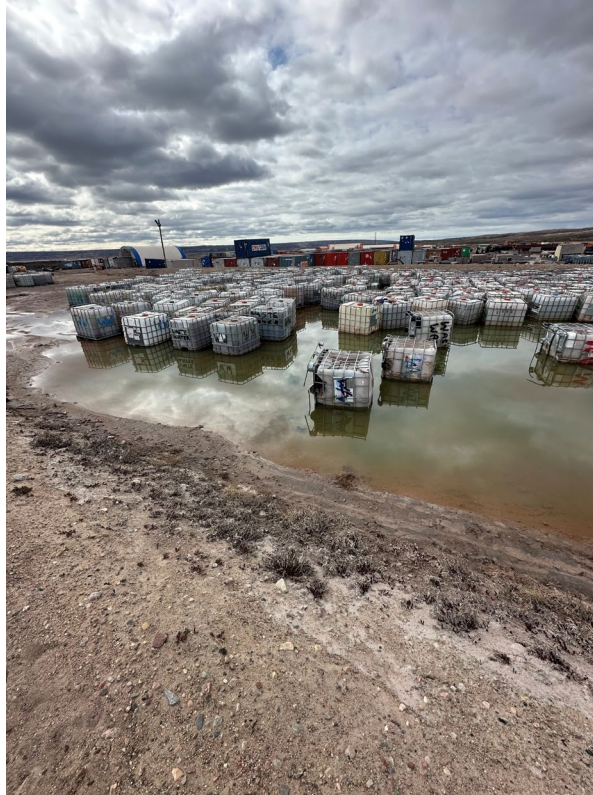
The Inspectors (Assol) identified and reported to Baffinland numerous locations where totes or containers full of liquid were not labelled properly. The two examples provided in the report were at the crusher pad and water/oil separator fuel berm. Some of the totes were sitting in an unknown liquid. We recommended Baffinland ensures all

Photo 17 – Totes sitting in standing water at the fuel berm (June 19<sup>th</sup>, 2025).

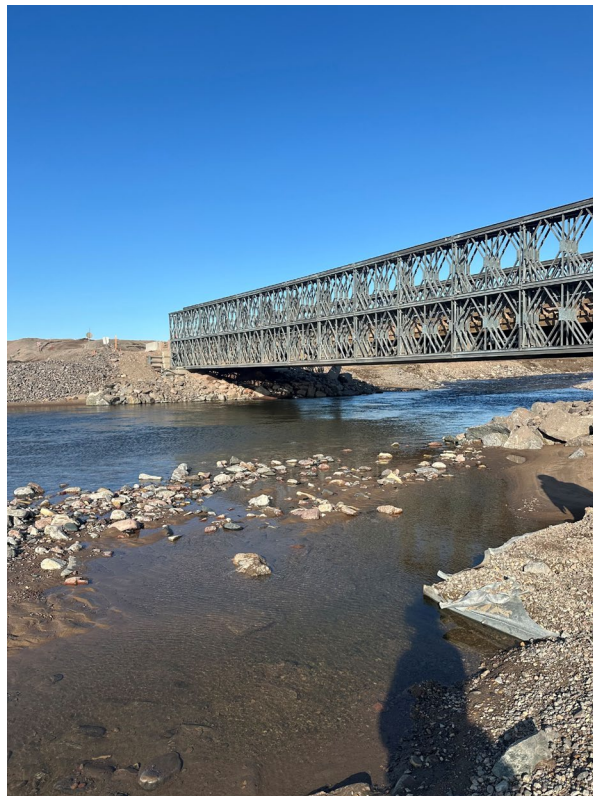
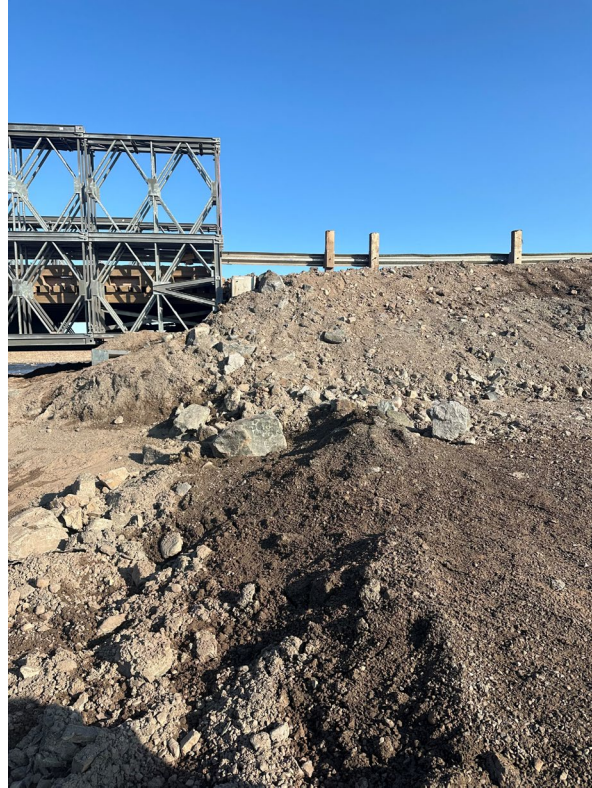
The first water crossing on the Tote Road the Inspectors stopped at was the KM97 Bridge. There was an ice road constructed here during the winter season. The bridge was reinforced by burying sea cans at the approach of both sides, which will hopefully help improve the stability of the bridge and Tote Road. The speed limit was reduced greatly to 15 km/hr for bridge crossings. The culverts and bridge abutments both looked good at this crossing, and no ecological or structural issues were noted here.

Photo 18 – KM97 Bridge crossing (June 19<sup>th</sup>, 2025).

Photo 19 – KM97 Bridge crossing reinforced during winter 2025 (June 19<sup>th</sup>, 2025).

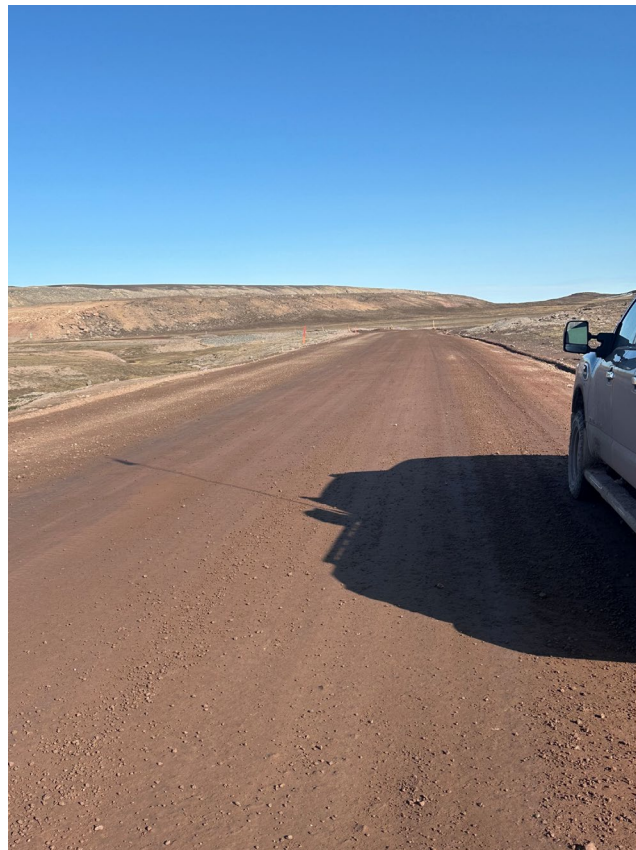
Photo 20 – Tote Road after application of calcium chloride and water (June 19<sup>th</sup>, 2025).

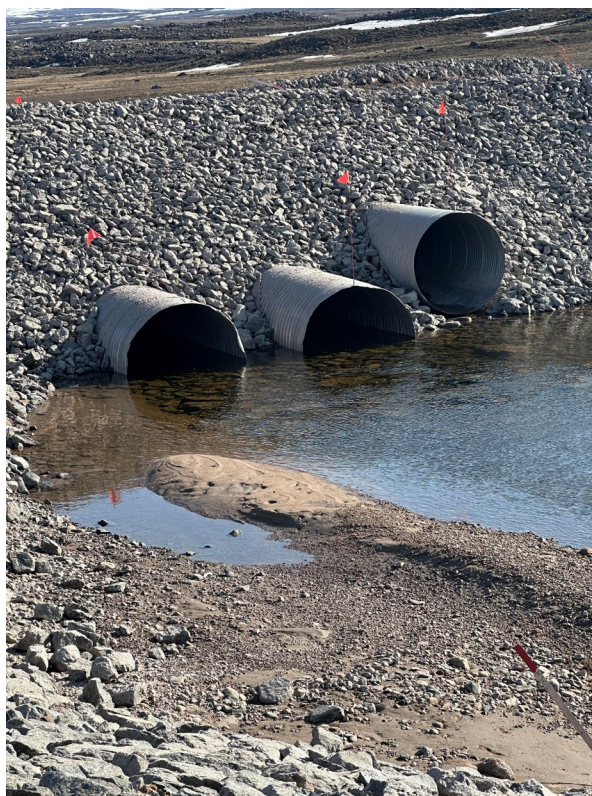
Photo 21 – Culvert replacement on the Tote Road (June 19<sup>th</sup>, 2025).

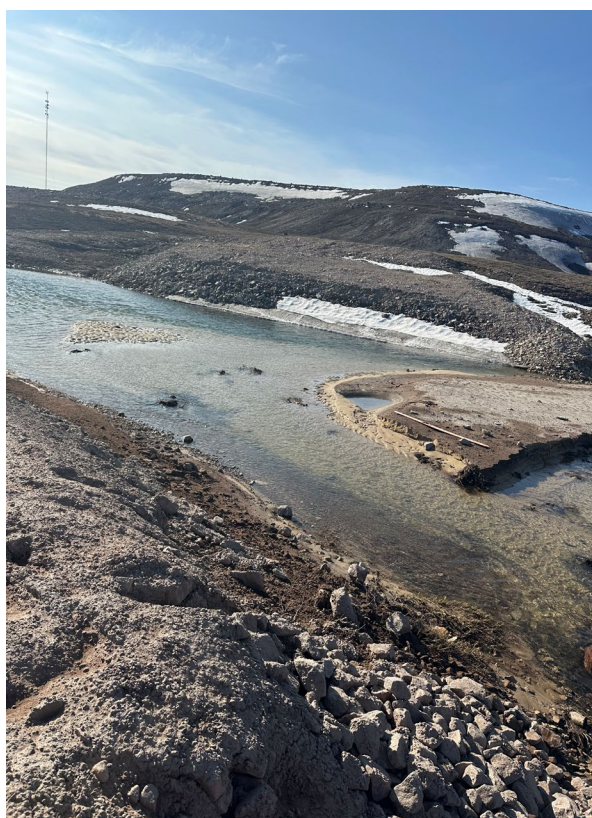
This washout was a focal point of the unscheduled inspection during October 2024. The road was repaired and most of the sand was removed from the road. The culvert here had no structural issues. The Inspectors identified on the upstream side of the culvert there was potential for fish to be stranded in the pool located on the left side. This is due to a new flow path following the unprecedented rain event, which developed an isolated pool under low flow conditions. The Inspectors recommended Baffinland watch the water balance of this stream and pool to ensure the pool is not isolated during low flow. If the pool is isolated, Baffinland should alter the flow paths at this location.

Photo 22 – Potentially isolated pool at KM87.5 (June 19<sup>th</sup>, 2025).

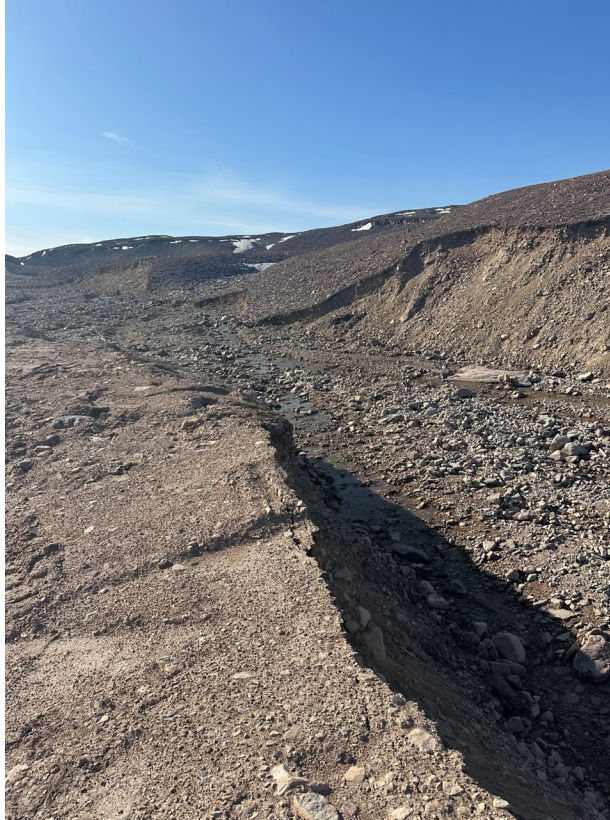
Photo 23 – KM63.5 washout (June 19<sup>th</sup>, 2025).

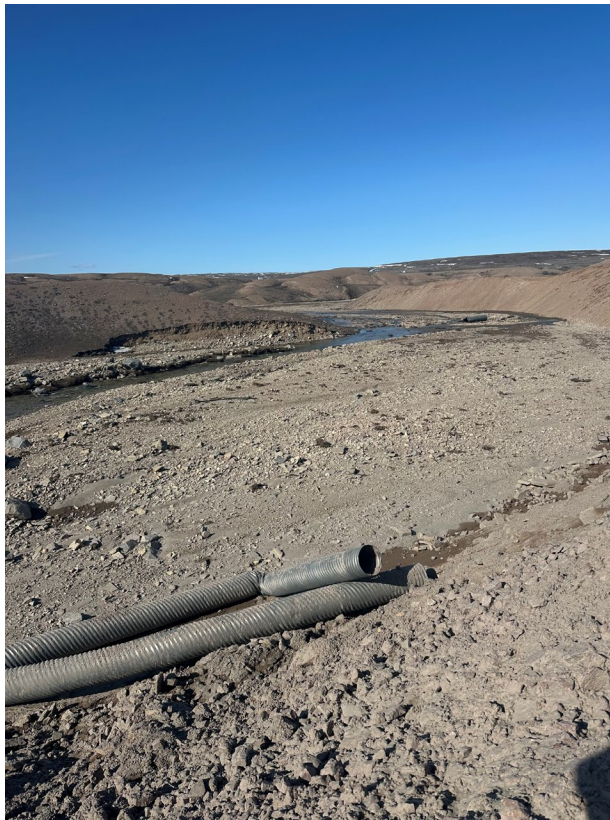
Photo 24 – Culverts still scattered at KM63.5 (June 19<sup>th</sup>, 2025).

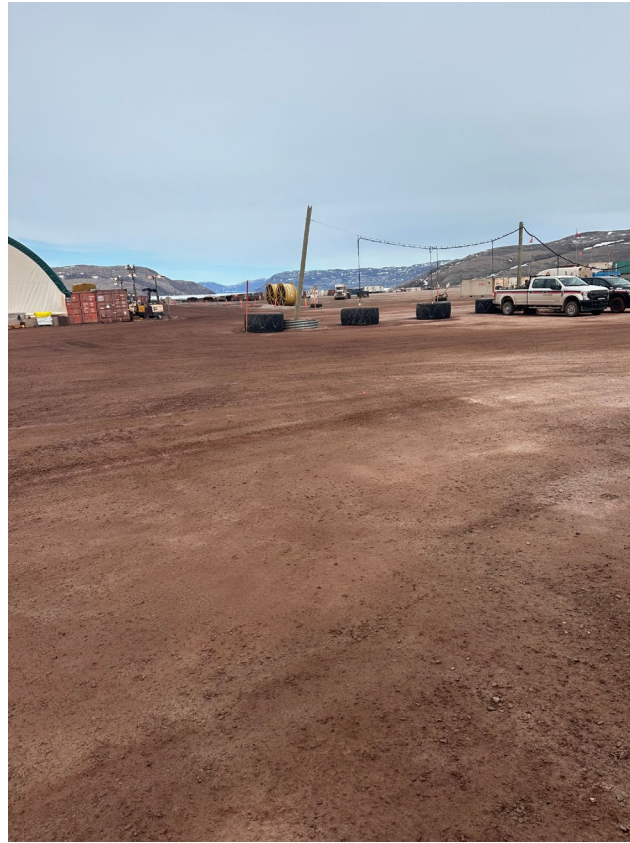
The fuel spill described in the 'Fuel and Lubrication Truck West; Follow-Up to Spill #2025-202' report was fully cleaned up even though Baffinland reported this would be a phased approach in the report. There were no lingering concerns from the Inspectors about the spill and there was no evidence of the spill exceeding the reported area. The drive back from port was dustier than the drive to port, which was noted with Baffinland during the drive.

Photo 25 – Location of spill reported at Milne Port. (June 19<sup>th</sup>, 2025).

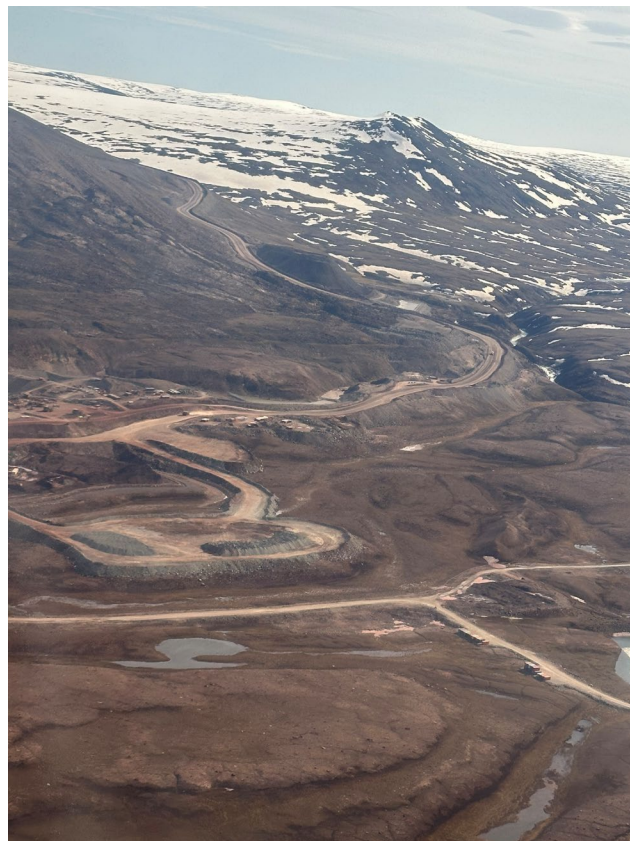
Photo 26 – View of new aggregate pad and tote road from plane. (June 20<sup>th</sup>, 2025)
