**RE: Mary River Project – Qikiqtani Inuit Association September 2025, 2nd Annual Environmental Inspection Findings and Recommendations**

Date: 5 November 2025

**Baffinland Mine Site September 2025 Environmental  
Investigation  
APPENDIX A - PHOTOGRAPHS**

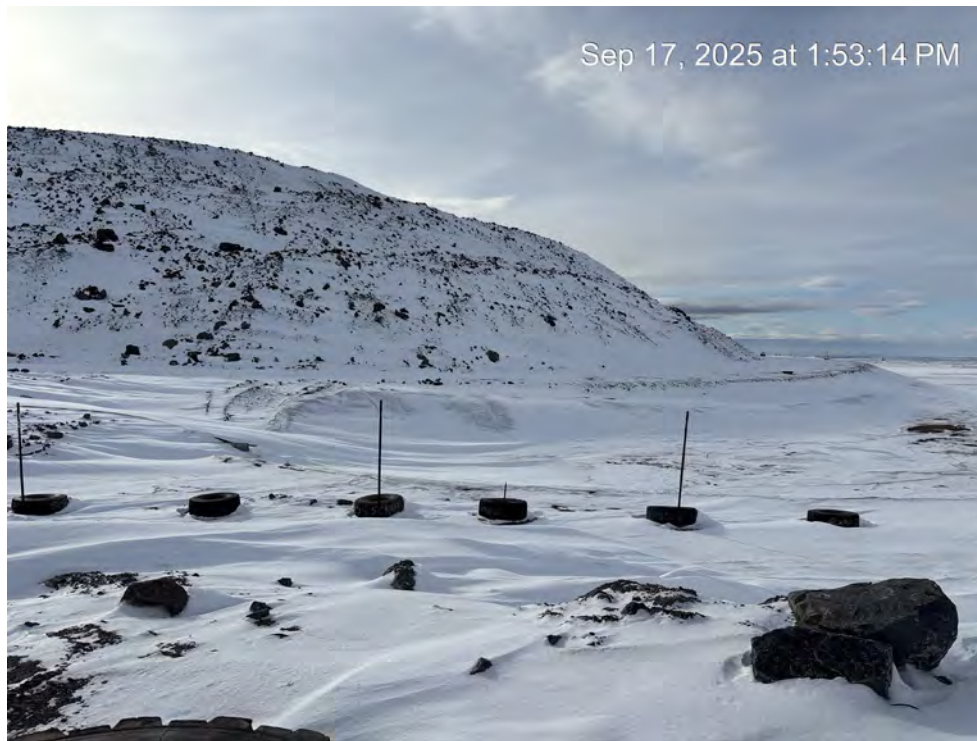
On the morning of September 17<sup>th</sup>, the Inspectors travelled with Bill and Jacob Prince via light duty truck from Sailiivik Camp to the waste rock facility at the top of the mountain. Snow cover from a precipitation event the previous week hampered visibility of the pond, treatment facility and surrounding tundra. The waste rock treatment facility was not online during the inspection. While inspecting the waste rock stockpile and pond, Bill noted that potentially acid generating (PAG) rock has been capped with non-acid generating (NAG) rock. This capping, in addition to silt curtains within the pond, has reduced the frequency of treatment required. Water has only been treated once in 2025 during the spring season. Water levels in the pond were low and mostly frozen at the time of

Photo 1 –Waste Rock Facility Pond still frozen and covered in snow (September 17, 2025).

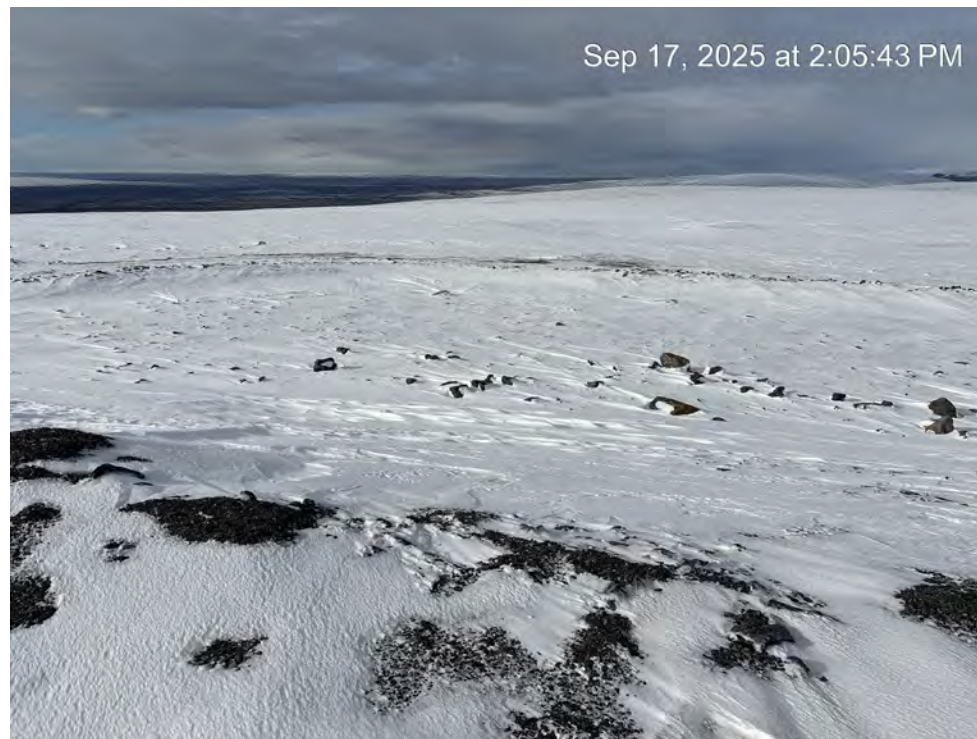
inspection. The Inspectors also visited the area where snowmelt seepage from the west perimeter ditch of the stockpile was recorded on June 20, 2025. Bill explained that snow had filled the ditch resulting in a diversion of flows and the release of snowmelt water into the surrounding tundra. The release was estimated to have occurred for 6 hours. Bill indicated that the water did not reach any watercourse as confirmed with ariel surveys. While snow cover reduced visibility in the area, no concerns related to the event were noted.

Photo 2 – Area of snowmelt seepage southwest of Waste Rock Stockpile(September 17, 2025).

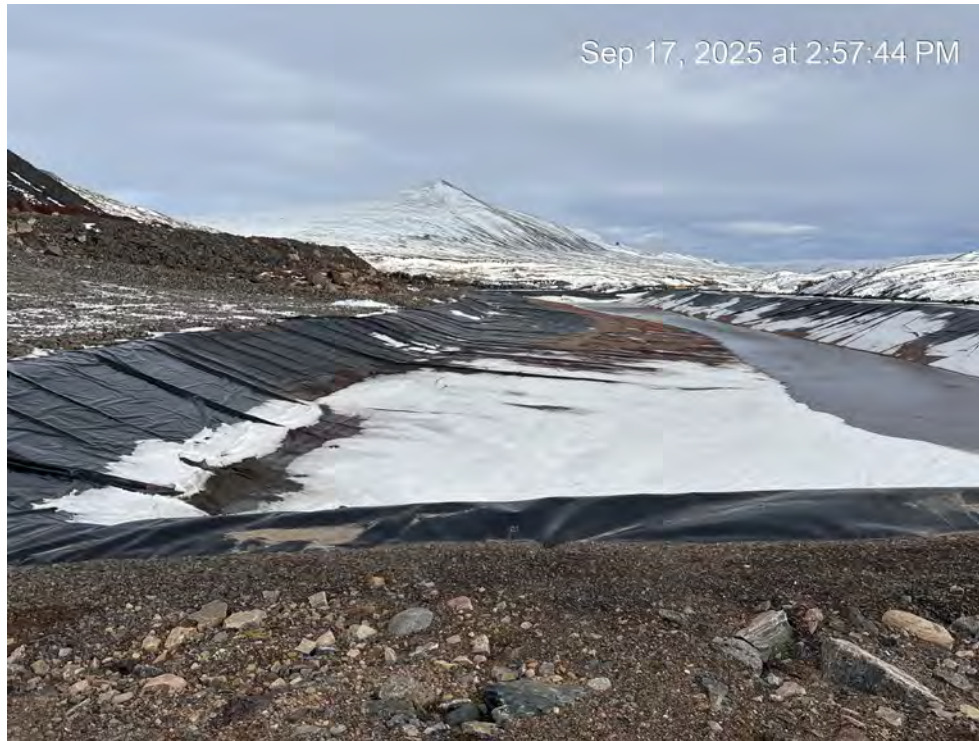
The water level in the KM106 pond was low and no concerns were noted related to the pond or liner. Bill informed the inspectors that the area to the north of the pond, where sediment has been observed during previous inspections served as a former drainage gully prior to the construction of the KM106 pond. This feature is no longer in use, but this information allowed the Inspectors to confirm that previously noted sedimentation was not the result of an accidental release.

Photo 3 – Low water levels in KM 106 pond (September 17, 2025).

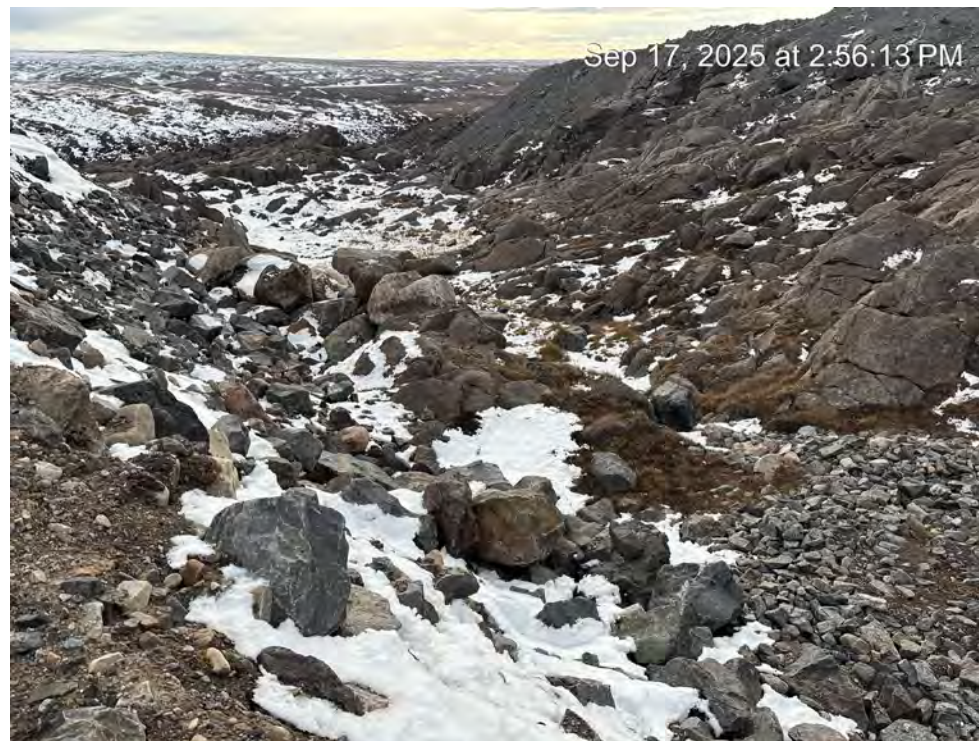
Photo 4 – Former drainage gully north of the KM106 pond (September 17, 2025).

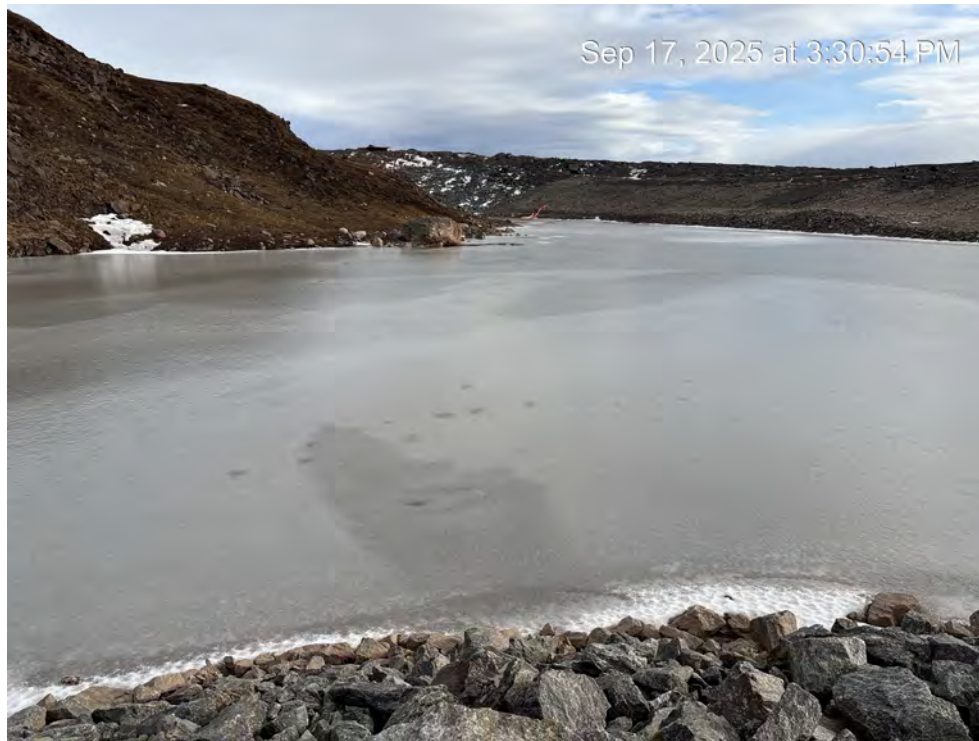
Photo 5 –Partially frozen conditions at KM105 pond (September 17, 2025).

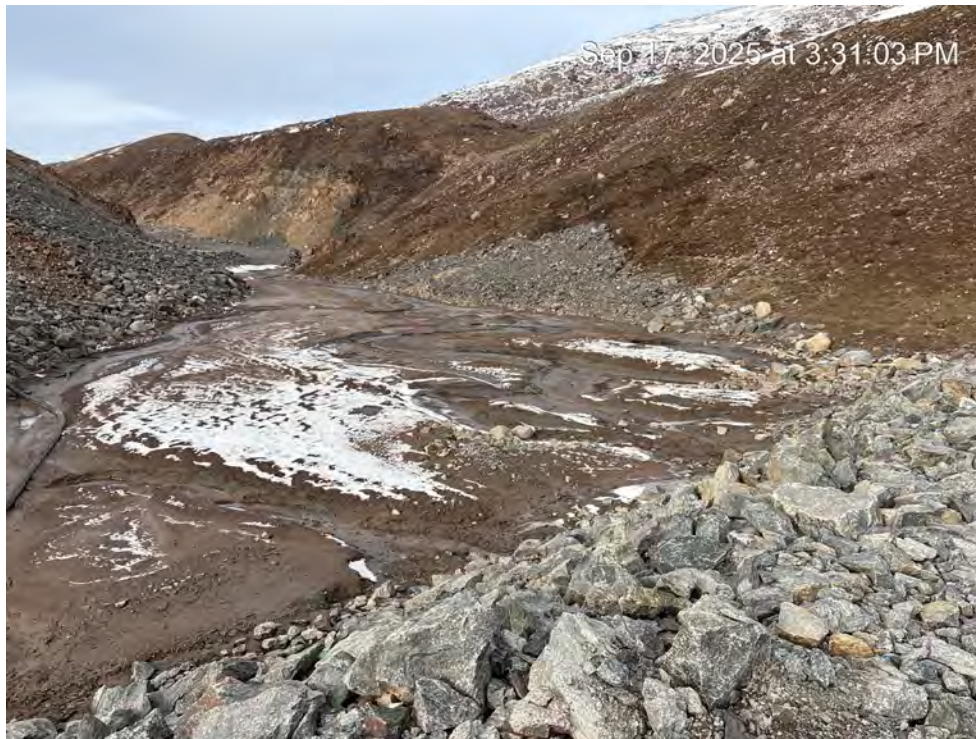
The Inspectors proceeded to the newly constructed filter berms downstream of the chemical dosing station and upstream of the KM105 dam. Bill informed the Inspectors that the filter berms were not engineered, but Baffinland will design properly engineered structures if the filter berms become ineffective. The two filter berms appeared to be functioning well; however, it has been noted that relatively moderate flows were experienced during the 2025 spring freshet. Inspectors noticed that a large amount of fine sediment has collected downstream of the second filter berm. Inspectors estimate that the sediment in this area is likely greater than 1 m in depth (based on observations since 2022). The accumulation of this sediment poses a risk for mobilization during future high-flow events. It was discussed with Bill, that this sediment should be removed from the area to prevent migration further downstream during higher flow conditions.

Photo 6 – Accumulation of sediment downstream of second filter berm at KM105 pond (September 17, 2025).

Recommended actions resulting from the inspection were discussed at the close out meeting between Joe Cavallo, Chloe Robinson, Andrew Jarowenko, and Bill Bowden. Current recommendations are provided in Table 1 attached to this report. A main recommendation made during the inspection is that accumulating sediment be removed from areas of accumulation. This is critical to prevent the migration of sediment further downstream during high

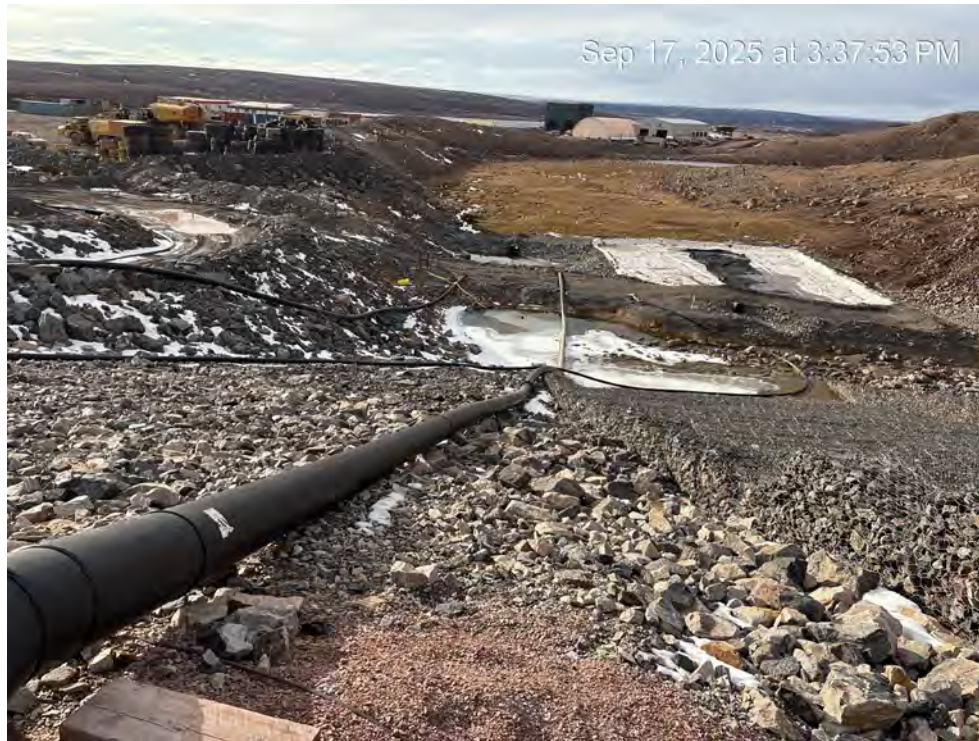
The KM105 dam is now functioning as a large filter berm due to the permeability of the structure. Water flowing through the structure was clear. No turbidity or fine sediments were noted in the tundra downstream of the KM105 dam. The Inspectors noted an upwelling to the southwest of the dam which may be where water is flowing under the structure. The filter bag/geotube system was still in place but is no longer being used. Inspectors noted that controls and materials, including the geotube system, that are no longer in use should be removed from the site.

Photo 7 –Geotube infrastructure in place but not in use downstream of KM105 dam (September 17, 2025).

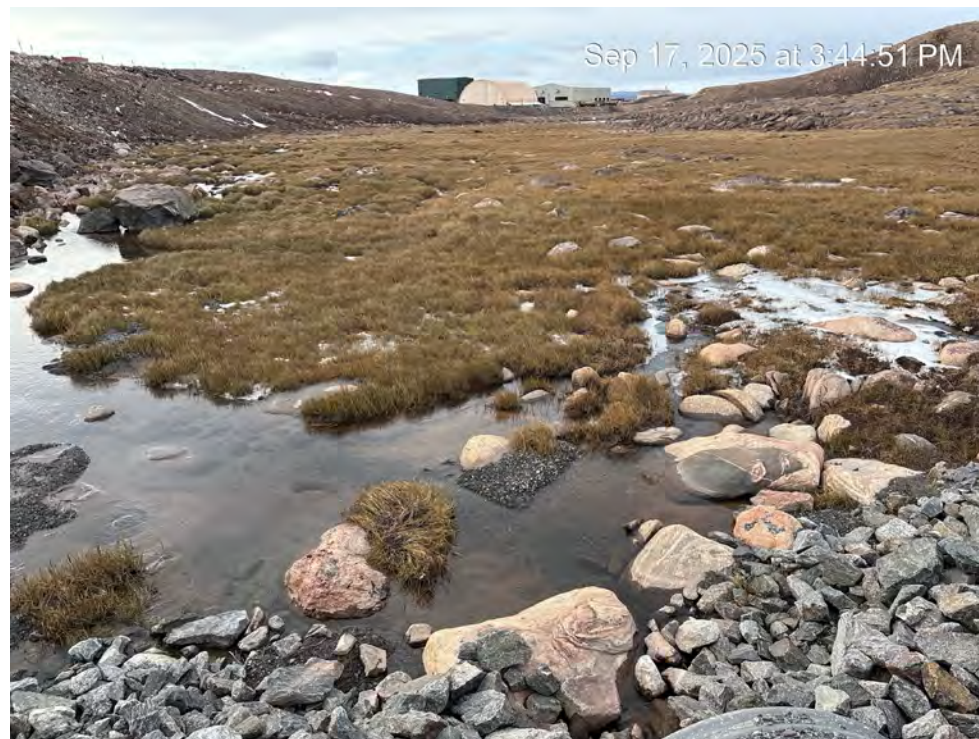
Photo 8 – Clear water downstream of KM105 dam. Area of upwelling present in the left corner of photo (September 17, 2025).

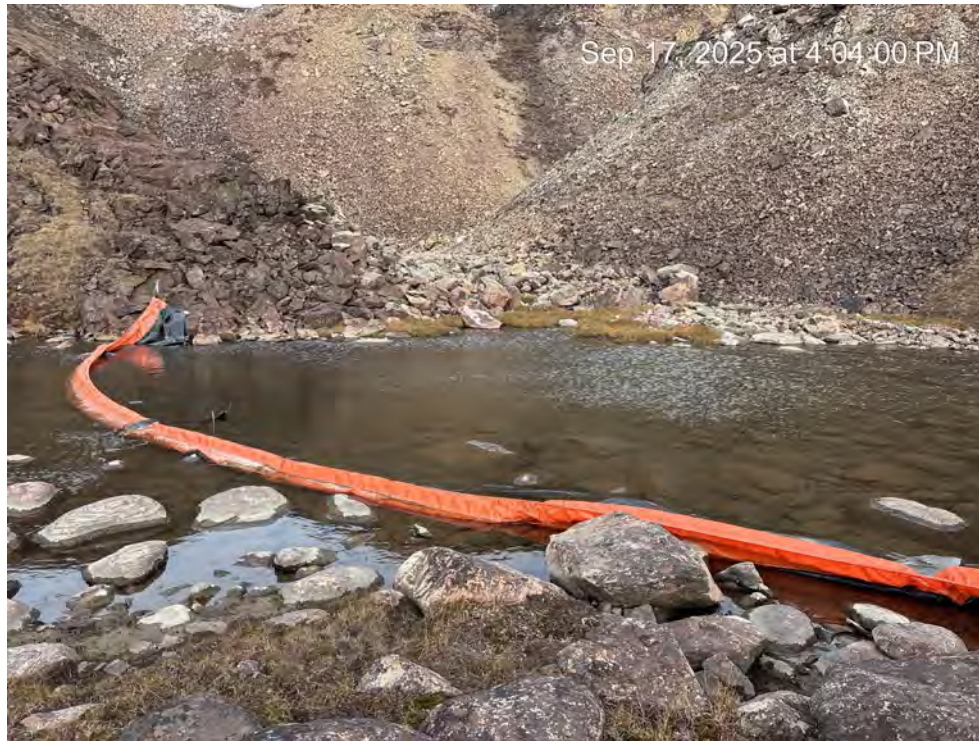
At the polishing pond, two silt curtains were in place. One curtain was installed in the middle of the pond and another just upstream of the proposed final discharge location (MS-11). As observed throughout the treatment

Photo 9 –Silt curtain in place at polishing pond downstream of KM105 dam (September 17, 2025).

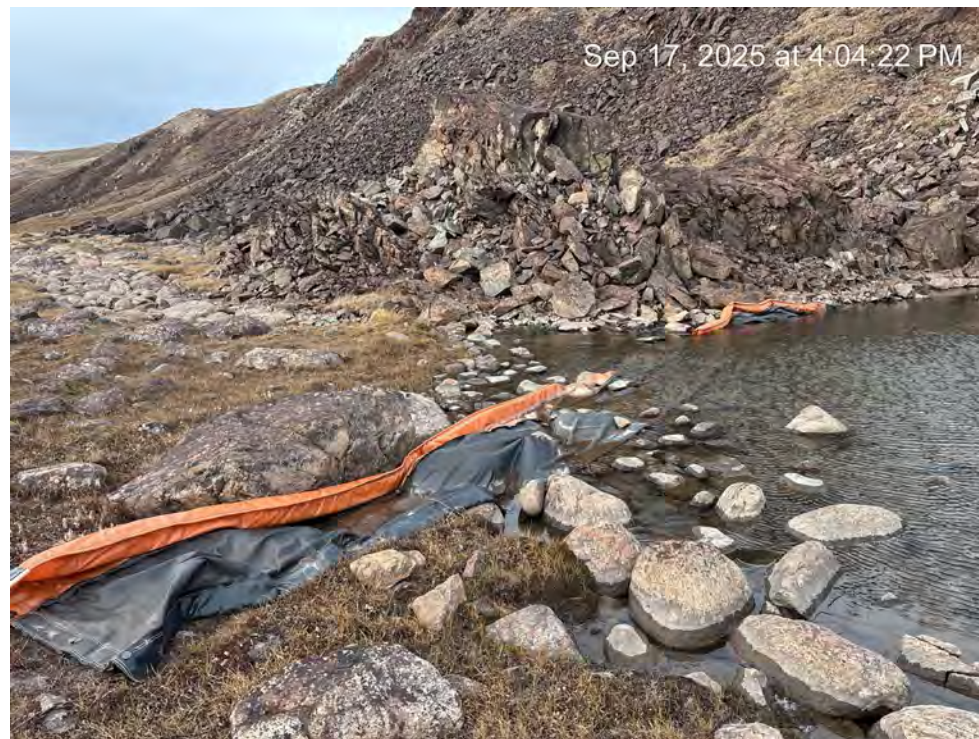
Photo 10 – Final discharge point and location of proposed weir structure downstream of KM105 (September 17, 2025).

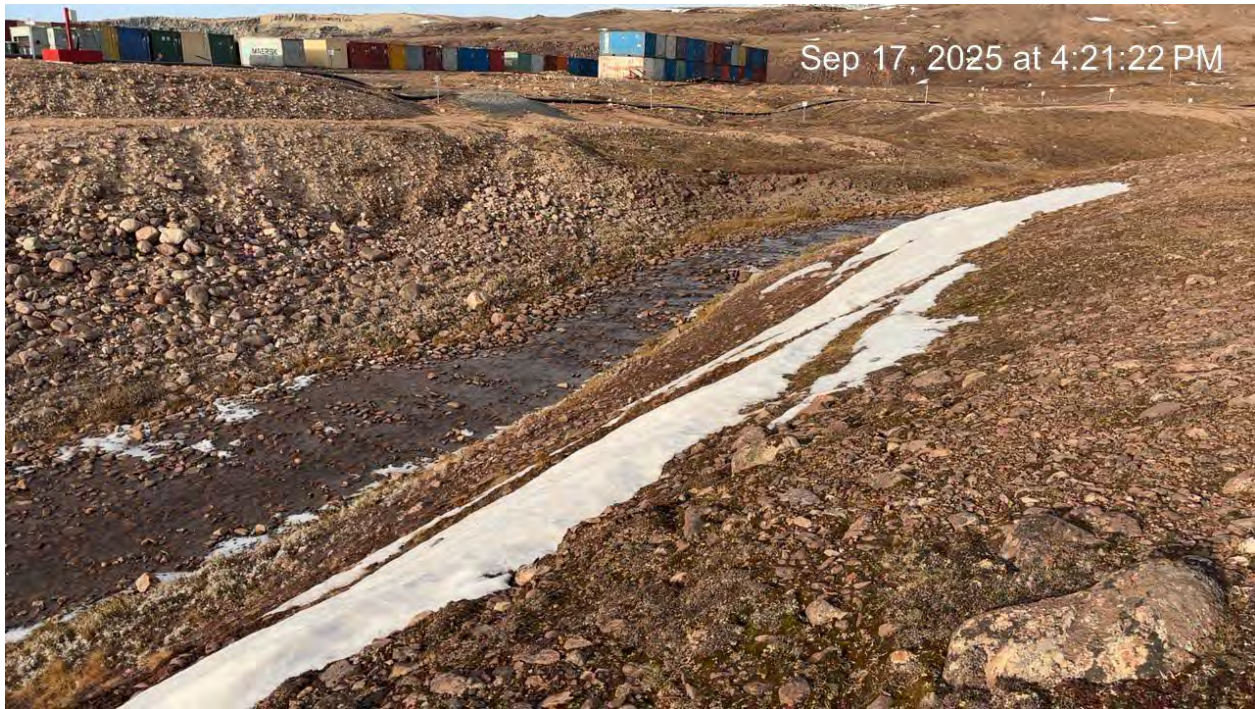
Photo 11 – Clear water in Sheardown Tributary (September 17, 2025).

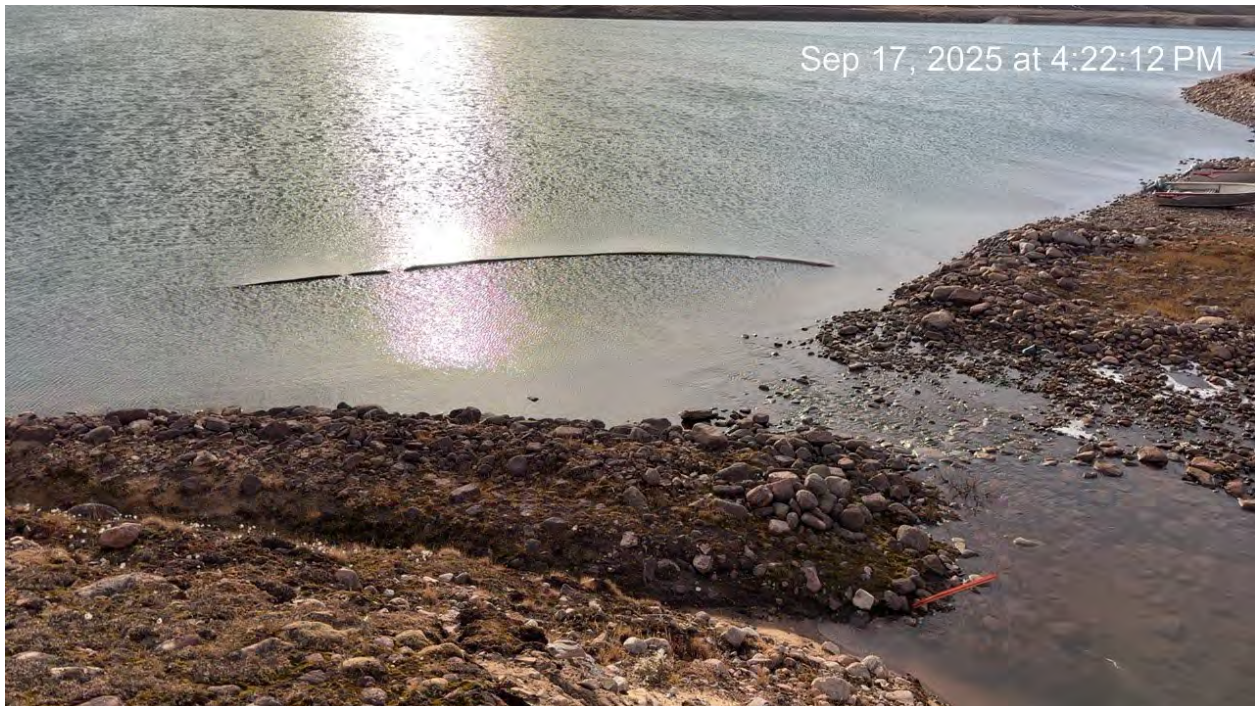
The Inspectors travelled downstream to the confluence of Sheardown Tributary and Sheardown Lake. The water was very clear, with the lowest turbidity observed during recent inspections. This observation is consistent with that observed by Dr. Kay in June of 2025. This observation is likely the result of improvements throughout the upstream treatment train and generally low flows at the time of inspection.

Photo 12 – Clear water at the convergence of Sheardown Tributary and Sheardown Lake (September 17, 2025).

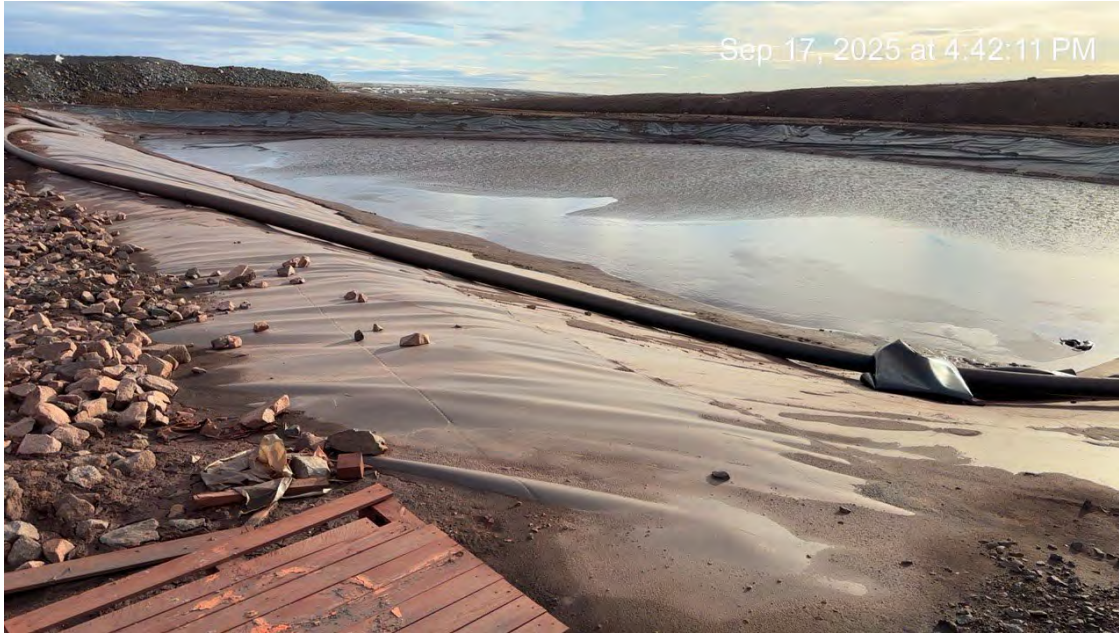
The Inspectors and Bill toured the crusher pad under the direction of Spencer Stinson (Baffinland). Water levels were low in the crusher pond at the time of the inspection. Baffinland informed the Inspectors that the main parameter of concern in the pond is TSS, and that metal concentrations are always below targets. The Inspectors walked the entire berm around the pond. Some areas of sediment deposition and scouring were noted in the berm. Spencer indicated that the structure is maintained regularly throughout the year, a process that has been made easier with aggregate now accessible from an adjacent production site. Spencer also informed the Inspectors that dedicated lines and pumps now exist to better handle pumping to and discharging from the pond. A bermed containment area has been constructed east of the pond where runoff was found to be collecting. This water is now contained in this location and pumped into the pond as required.

Photo 13 – Low water levels in the Crusher Pond (September 17, 2025).

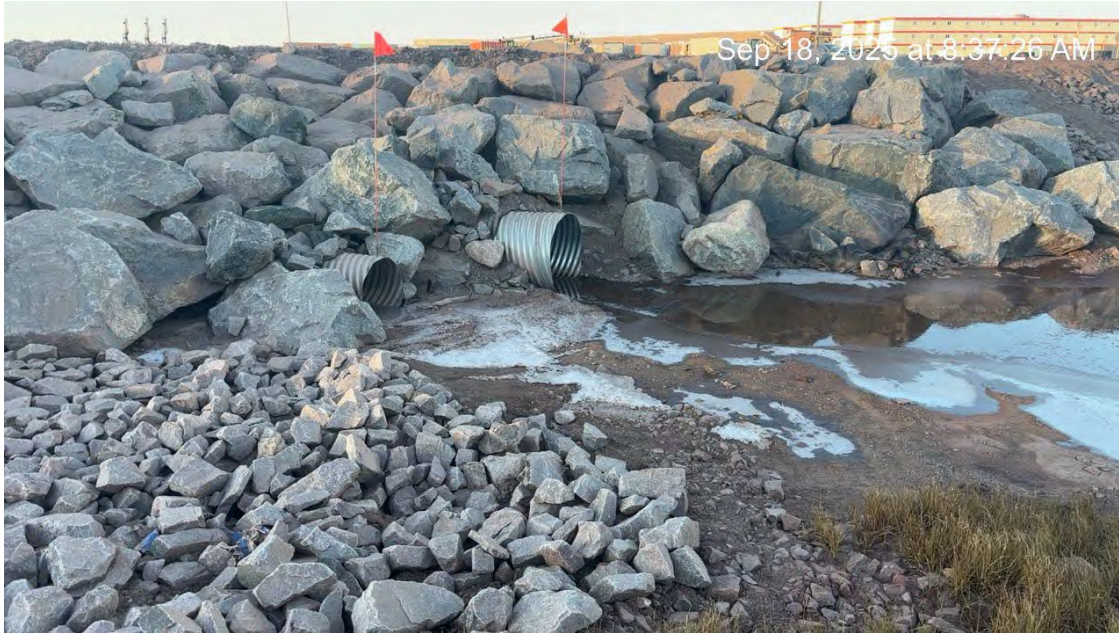
The two culverts at this crossing next to Sailiivik Camp were completely blocked during the June 2025 inspection. At the time, Baffinland had resorted to pumping water across the road. These culverts were replaced only days after the June inspection and were in good repair at the time of the September 2025 visit. In addition to culvert replacement, the embankment had been stabilized with armored stone. Some minor concerns related to exposed fines on the north side of the crossing were noted by the Inspectors. Overall, there has been vast improvement at this crossing. Bill explained that the area to the southeast of the crossing is expected to be developed as a loading site for the Steensby Rail. Plans to build an additional water management structure at this location have been put on hold indefinitely.

Photo 19 – CV187 replaced in June 2025 (September 18, 2025).

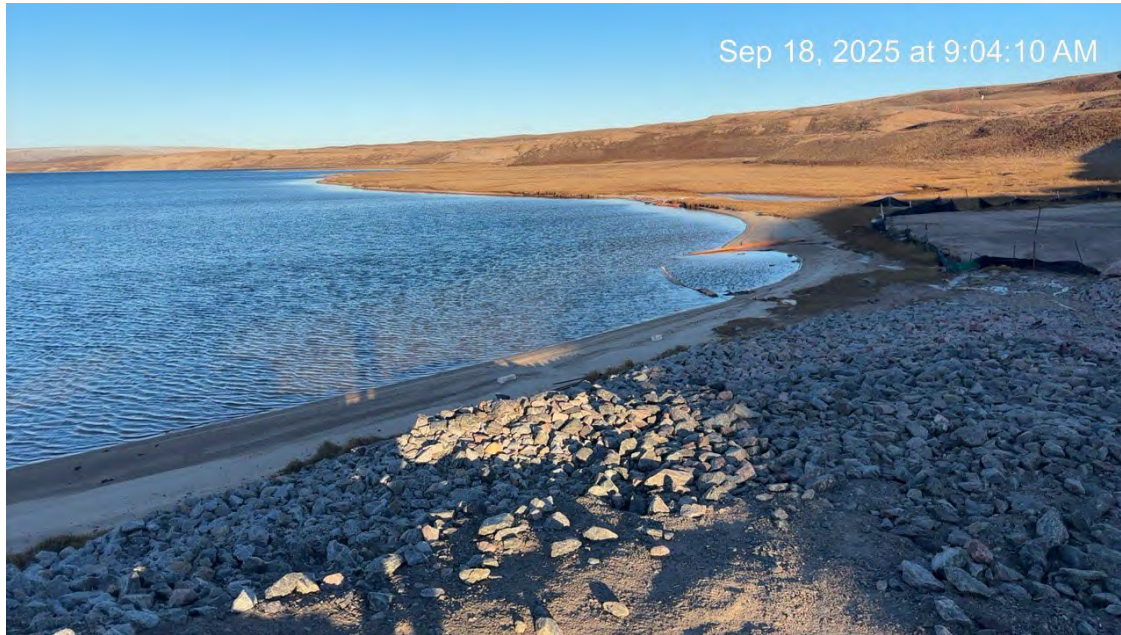
No concerns related to water quality were noted at Camp Lake or Camp Lake Tributary. As observed across the mine site, turbidity was very low, and erosion and sediment controls were working as intended. The armoring along the slope adjacent to Camp Lake was in good condition. Debris including old silt curtains and Styrofoam floats was present along the beach at Camp Lake. This debris should be cleaned up to prevent it from breaking apart and dispersing into the lake and surrounding habitat. This issue has been documented previously and reinforces the

Photo 21 – Debris on beach at Camp Lake (September 18, 2025).

The other reoccurring recommendation was related to the clean-up of debris across the project site. Project debris was noted on the beach at Camp Lake, at KM 64 and on the shoreline northwest of Milne Port. Addressing this deficiency is important to ensure that debris does not migrate into surrounding habitats, where it could negatively affect wildlife and water quality.

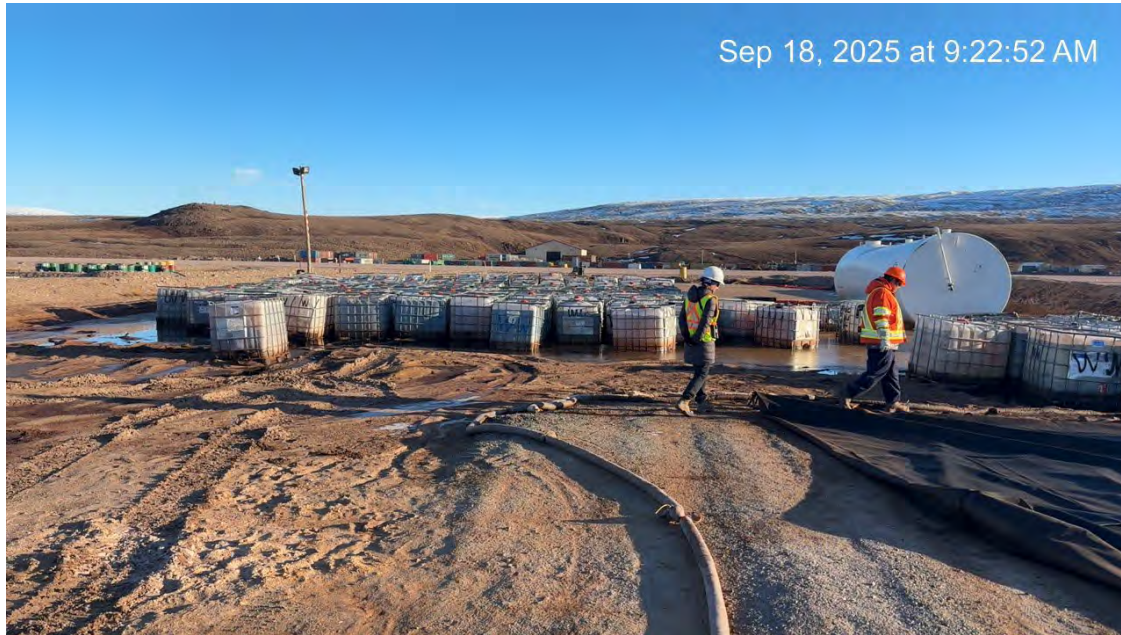
The Inspectors visited the oil/water separator located adjacent to the airstrip (south side) where minor concerns were noted during the June 2025 inspection. Specifically, during the previous inspection unlabelled totes were observed in standing water. At the time of the current inspection, these totes were labelled as 'wastewater'. It was also explained that the standing water previously noted is the wastewater being treated in the first step of the oil/water separation process. The oil/water separator appeared to be working as intended. There was very little wastewater within the bermed containment area, and the Inspectors understand that very little water is discharged to the tundra at the end of the separation process.

Photo 25 – Labelled totes at Oil Water Separator (September 18, 2025).

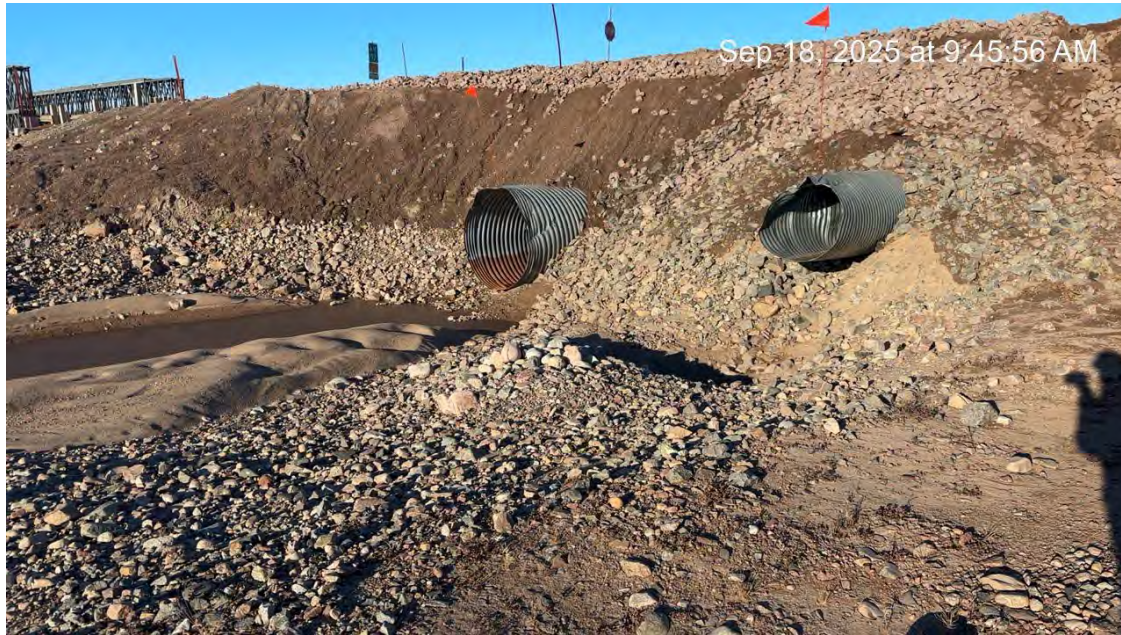
The first stop during the inspection of the Tote Road was the KM97 Bridge. Bill explained that the bridge had been reinforced with a buried sea can at each approach. This reinforcement appears to have been successful, and the Inspectors did not note any concerns related to the bridge. Two CSP culverts just east of the bridge were inspected and Inspectors noted that the culverts were perched. However, as the main flow of the watercourse is directed under the bridge, it was determined that these culverts do not impede fish passage at this crossing.

Photo 27 – Perched culverts at KM97 (September 18, 2025).

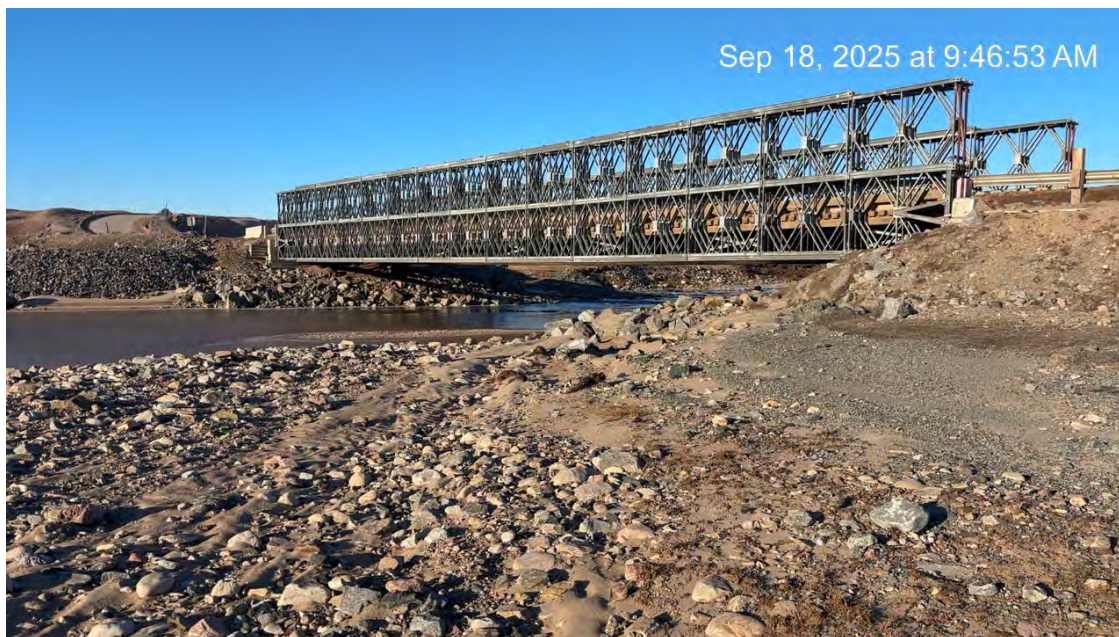
Photo 28 – Reinforced bridge at KM97 (September 18, 2025).

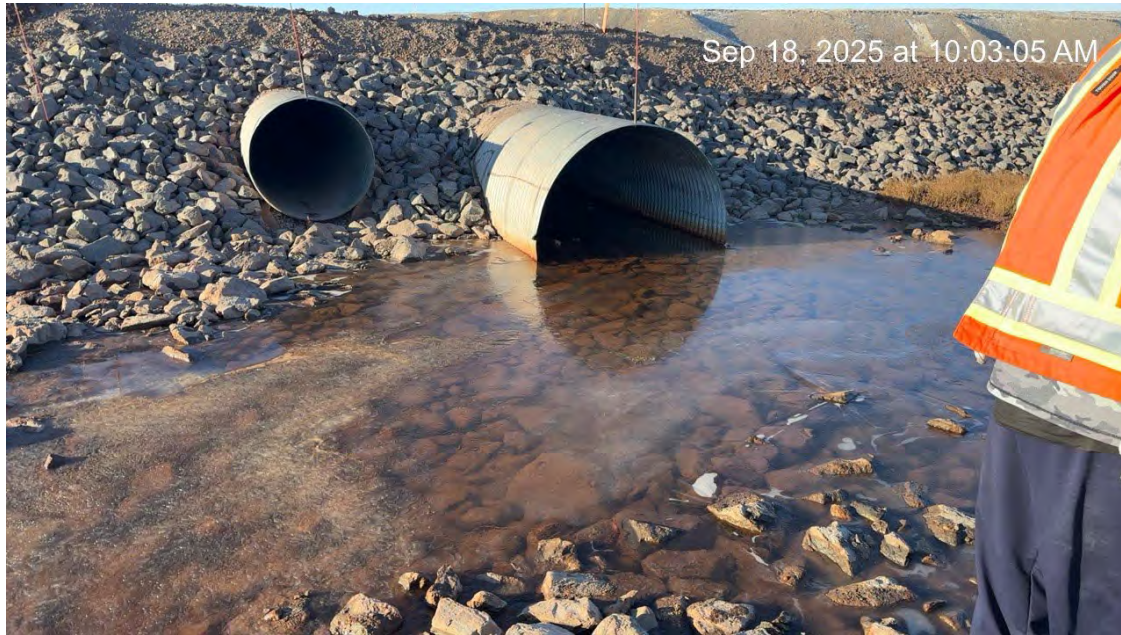
Bill explained that the two CSP culverts at this location provided a strong example of the success of culverts designed with consideration of site-specific conditions. The culvert replacement at KM95 occurred during the 2024-2025 winter season. The main culvert is embedded and is functioning well. At this crossing Bill also showed inspectors an example of the new fish crossing signs. These signs have been installed at all fish bearing crossings along the Tote Road. These signs will assist in implementing the snow management plan by indicating areas where snow piling is prohibited.

Photo 29 – CV001 at KM95 (September 18, 2025).

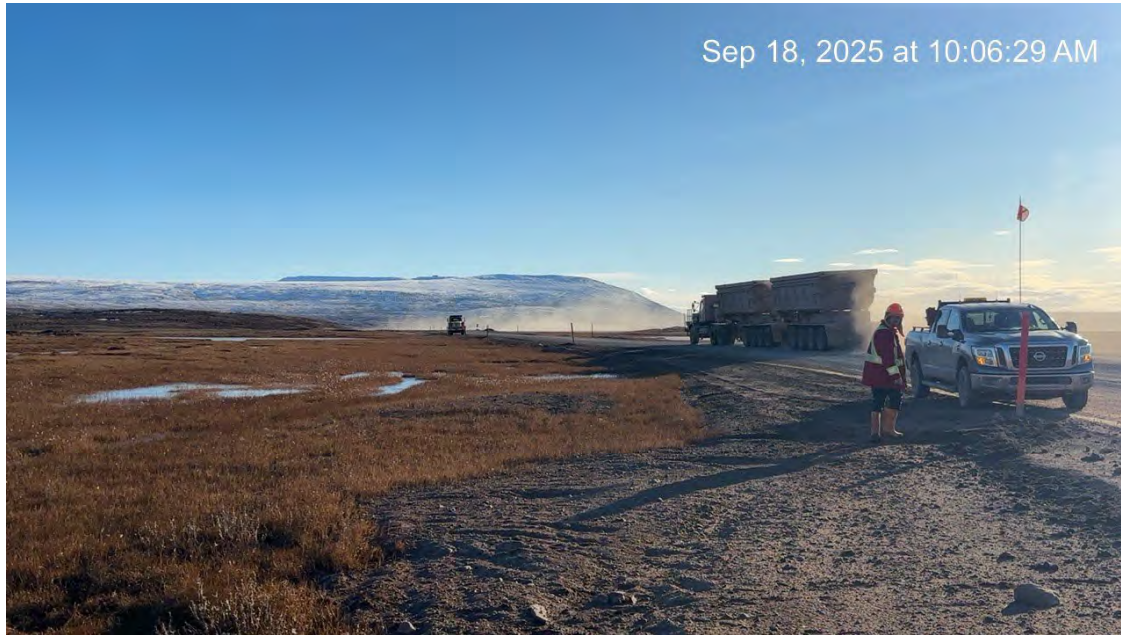
Throughout the inspection, the ongoing issue of dust generation was noted along the Tote Road. Bill informed the inspectors that calcium chloride and water continue to be applied to the road as a method of dust suppression. It was noted that there were areas of notable dry conditions along the road generating large amounts of dust, while other areas were moist, generating little to no dust. It was unclear if the areas not generating dust were treated, or simply areas that retained more moisture.

Photo 31 – Example of dust created by truck traffic along the Tote Road (September 18, 2025).

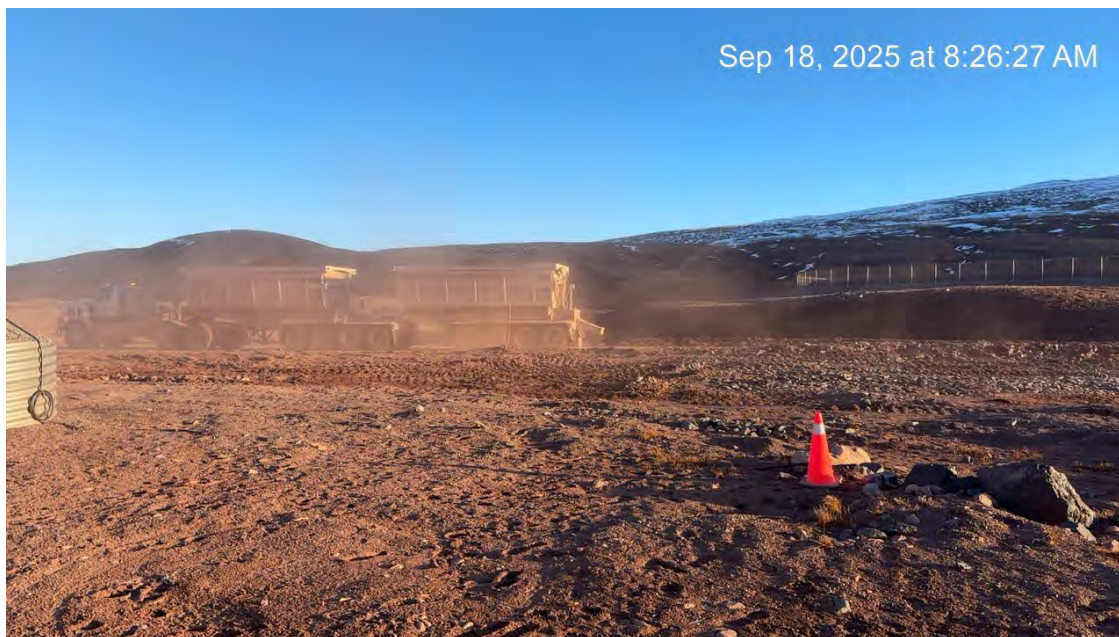
Photo 32 – Dust at the Mine Site (September 18, 2025).

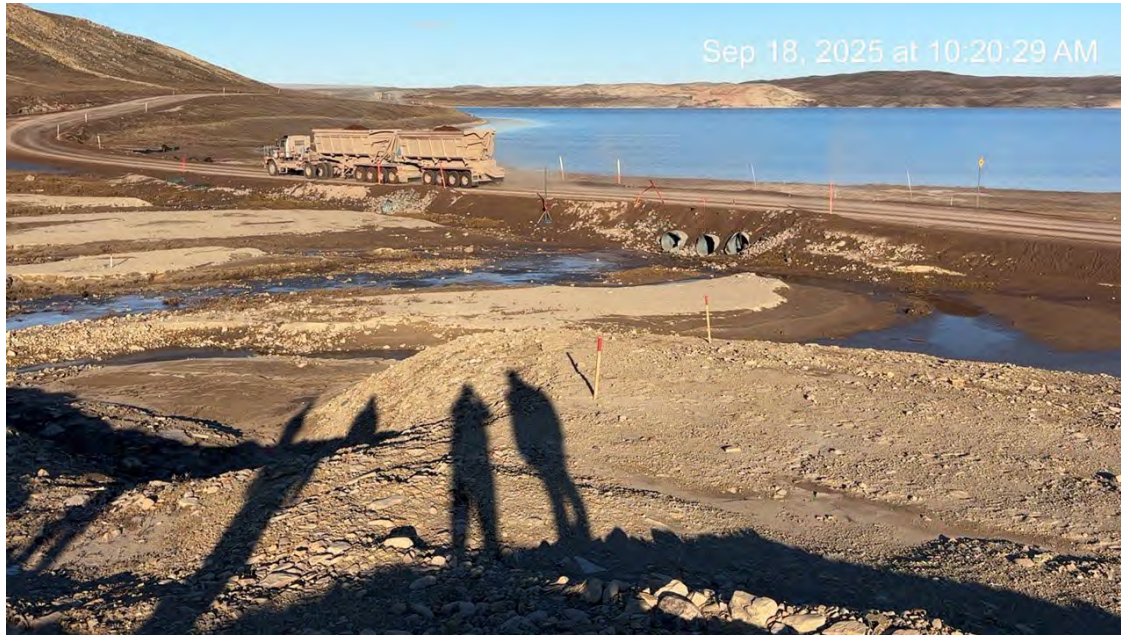
This site, next to Davids's Lake, experienced significant erosion during the September 2024 unprecedented rain event. During the June 2025 inspection it was noted that washout in the area may have resulted in a pool where fish could potentially be isolated. During the current inspection, the Inspectors did not notice any isolated pools and had no concerns about fish movement south of the Tote Road, upstream of David's Lake. The three culverts here were perched with significant erosion having occurred on the embankment. Bill and the Inspectors agreed these culverts presented a barrier to fish passage. Bill informed the Inspectors that a fish salvage had been

Photo 33 – Area of erosion (KM87.5) adjacent to David's Lake (September 18, 2025).

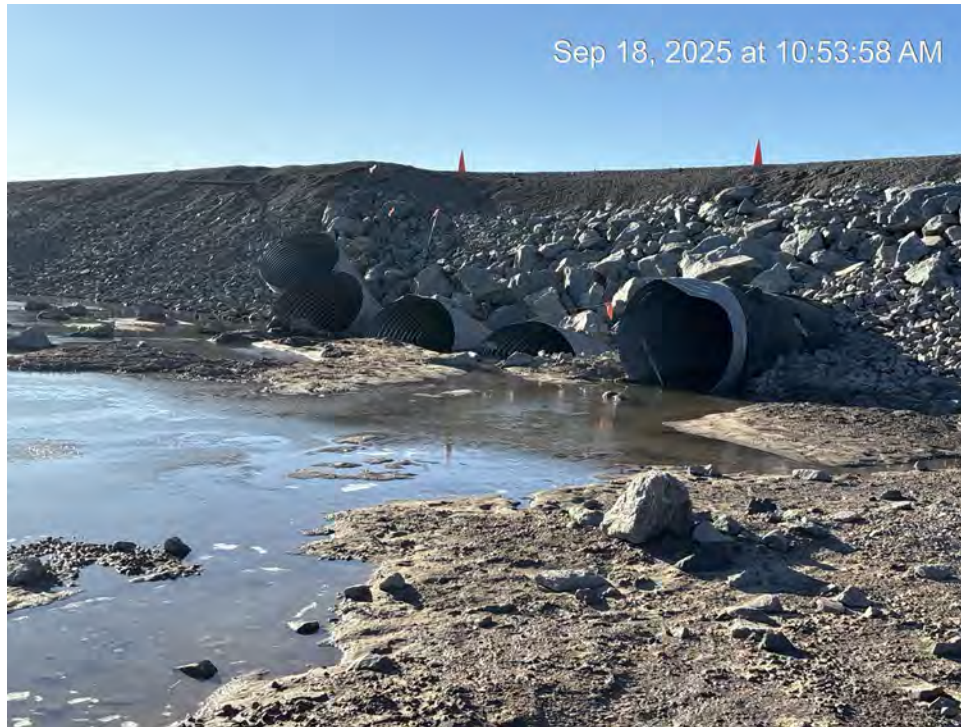
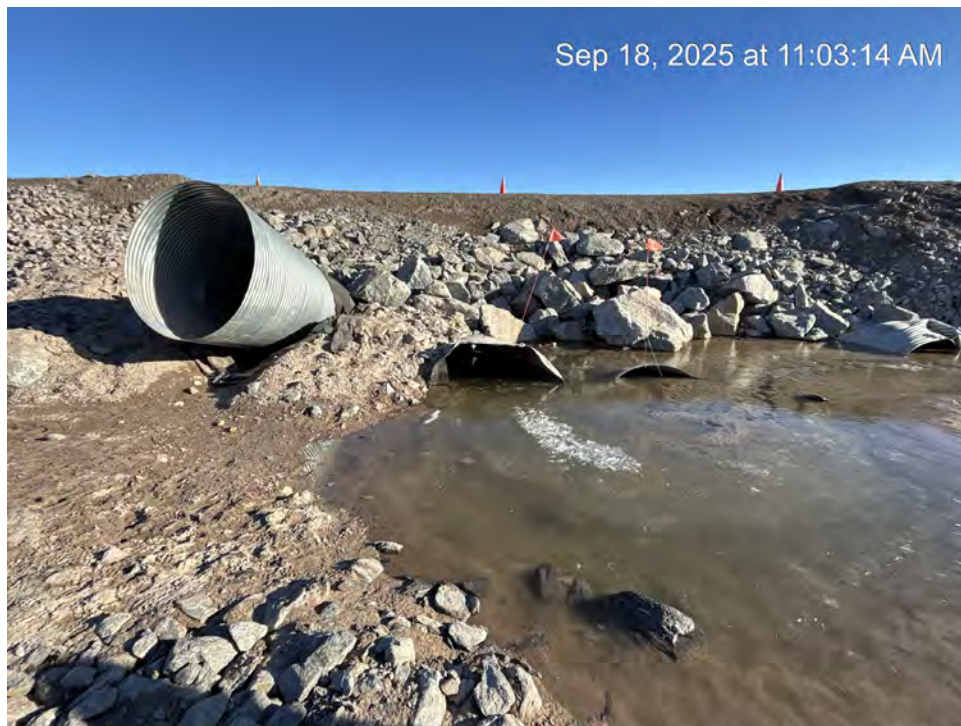
Photo 37 – Compressed culverts at KM216 (September 18, 2025).

Photo 38 – Compressed culverts at KM216 (September 18, 2025).

Multiple upgrades to crossings along the Tote Road are expected to occur in the coming months. This includes emergency works on CV216 and upgrades to the crossing at KM 87.5. It is recommended that Baffinland provides an update to QIA related to these works as they occur. As requested during the June 2025 inspection, it is also recommended that Baffinland provides QIA with a schedule of culvert replacements.

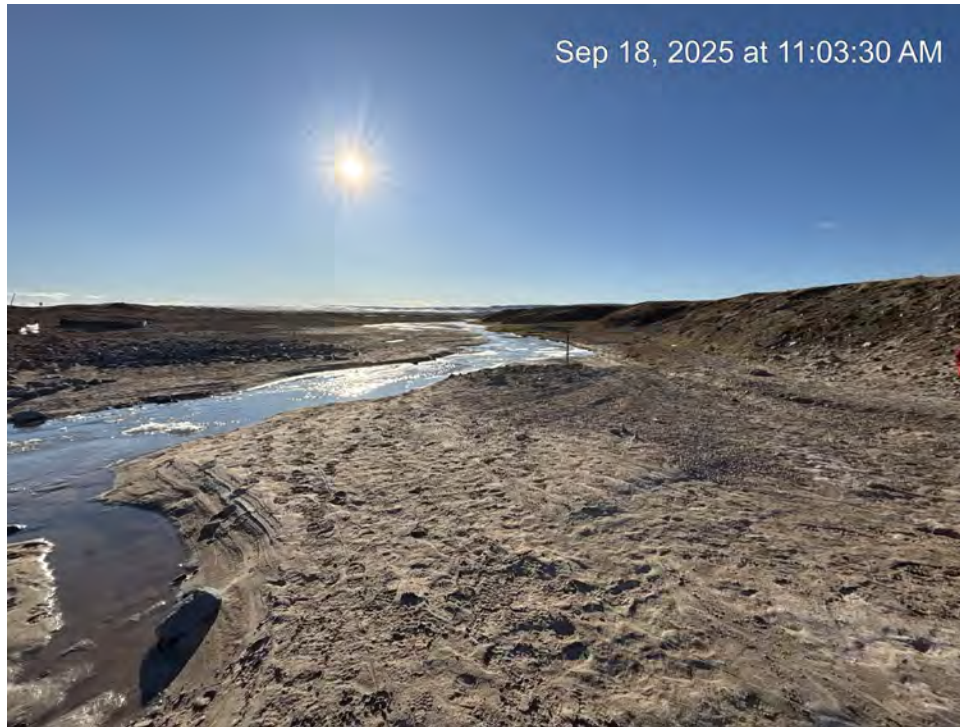
This site was a focal location of the September 2025 inspection. These 5 culverts were replaced in 2024 after structural problems were identified with the former culverts. Due to complication that likely involve an ice lens in the location, the culverts experienced significant vertical and horizontal compression, and all 5 culverts are completely blocked. Emergency work is scheduled to occur on the crossing within 2 weeks of the inspection (week of September 25<sup>th</sup>), with the plan to move the Tote Road 30 m upstream (south). Once the new road and crossing is constructed, the existing crossing will be removed entirely. At the time of inspection, plans were in review with DFO. The Inspectors had concerns that the same issues associated with the ice lens would occur at this new crossing. We asked that Bill/BIM provide an update to QIA once the repairs were completed at this location.

Photo 39 – Location of Tote Road relocation 30 m south of existing culverts at KM81 (September 18, 2025).

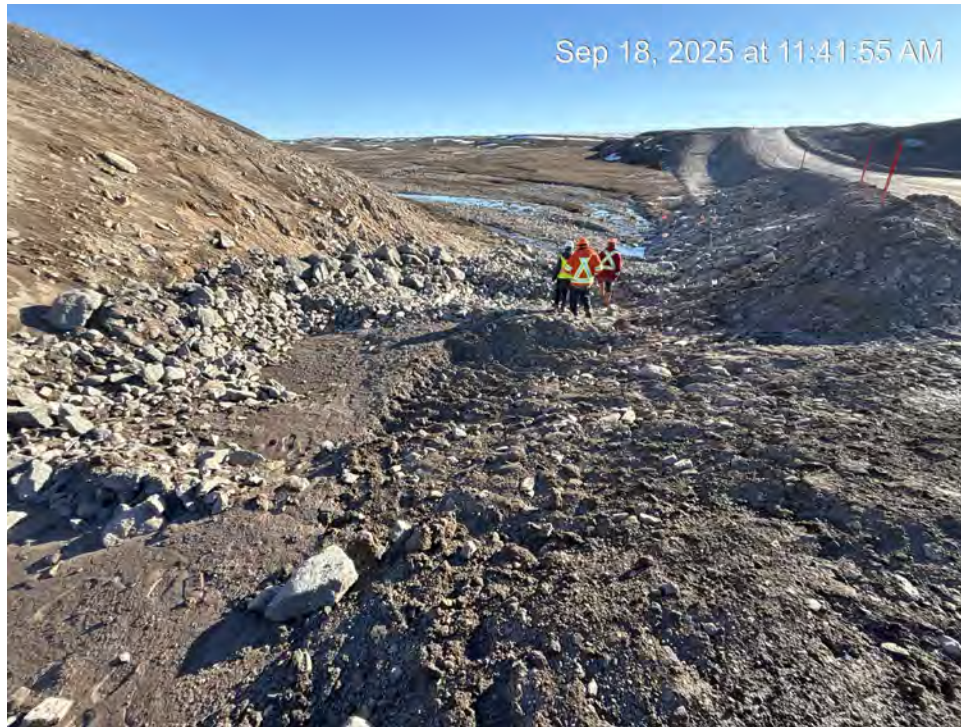
flow conditions. Accumulating sediment was noted at multiple locations during the inspection including upstream of the KM105 dam and at the KM64 crossing.

Photo 41 –Accumulation of sediment in check dams at KM64 (September 18, 2025).
