**RE: Mary River Project – Qikiqtani Inuit Association September 2025, 2nd Annual Environmental Inspection Findings and Recommendations**

Date: 5 November 2025

**Baffinland Mine Site September 2025 Environmental  
Investigation  
APPENDIX A - PHOTOGRAPHS**

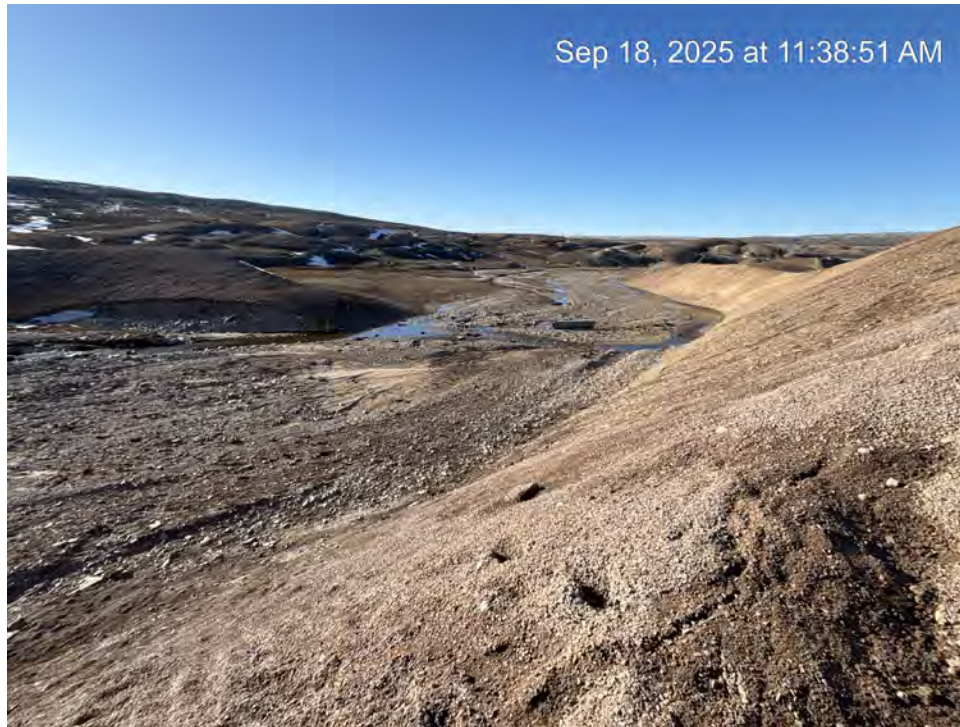
Photo 43 – Location of washed-out culverts at KM64 that need to be removed (September 18, 2025).

The other reoccurring recommendation was related to the clean-up of debris across the project site. Project debris was noted on the beach at Camp Lake, at KM 64 and on the shoreline northwest of Milne Port. Addressing this deficiency is important to ensure that debris does not migrate into surrounding habitats, where it could negatively affect wildlife and water quality.

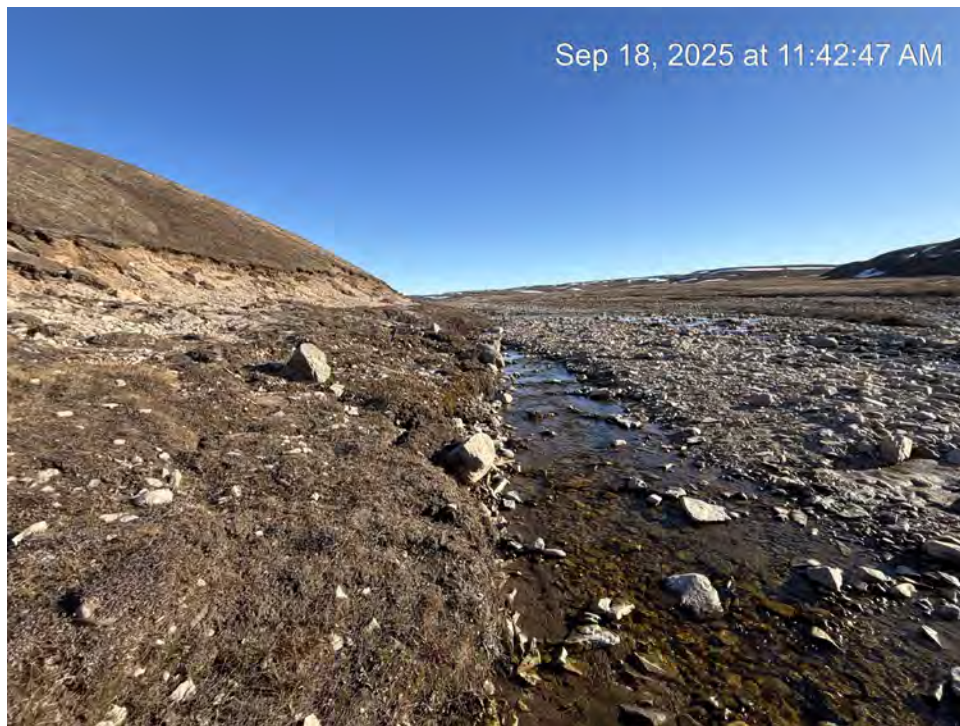
This location experienced heavy rainfall and extremely high flows during the unprecedented rain event in September 2024. Since the event, significant upgrades have occurred at this crossing including armouring of the embankment along the Tote Road, the replacement of 2 culverts, and the installation of check dams. The Inspectors noted that fine sediment had collected in the check dams east of the Tote Road and should be cleaned out to prevent sediment from being flushed downstream during high flows. While the culverts were in good condition at the time of inspection the Inspectors did note that the size of culverts seemed small considering the high flows experienced in this area during rain events.

Photo 44 – Erosion on hill at KM64 showing high flow levels during September 2025 rain event (September 18, 2025).

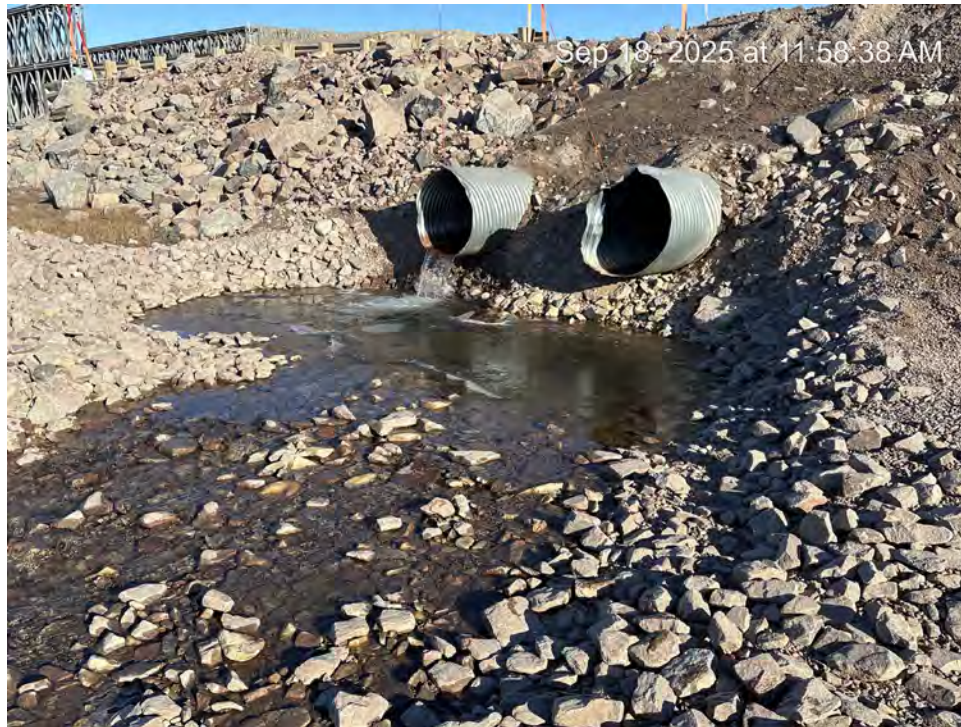
As with the previously mentioned bridges, the KM63 bridge was reinforced with sea cans to improve the stability of the bridge and Tote Road. No structural integrity concerns, or concerns related to erosion were noted at the KM63 bridge. The two culverts immediately south of the bridge were perched on the west side. However, as the main flow is directed under the bridge, it was determined that this would not affect fish passage. Bill informed the Inspectors that DFO had recently inspected the culverts and agreed that the perching of the culverts was not of concern. Downstream of the culverts minor erosion was observed on the north side of the channel. Remedial rock work was evident immediately downstream of the culvert but did not extend to the area where erosion was noted. During the time of inspection flows were low and no concerns with turbidity were noted in the area.

Photo 45 – Perched culverts at KM63 bridge (September 18, 2025).

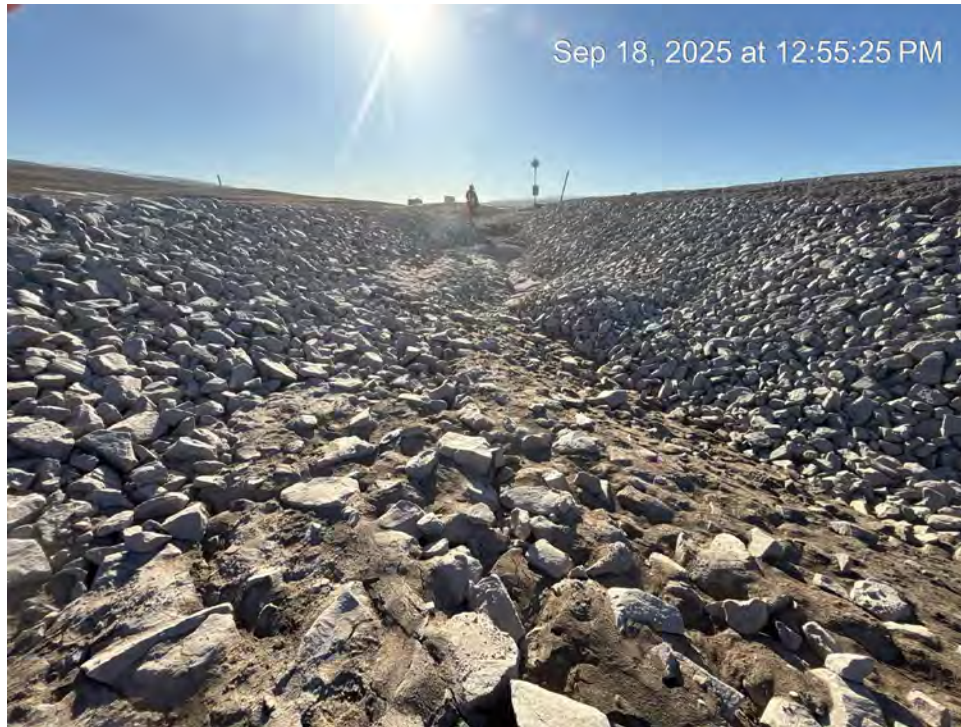
There was currently no flow through the two culverts at KM33. Bill informed the Inspectors that these culverts have likely also been damaged due to an ice lens in this location. The culverts were installed perpendicular to the Tote Road, which does not follow the natural path of flow. This has resulted in flows through the road and around the

Photo 47 – Sediment accumulation but no flow in ditch upstream of culverts at KM33 (September 18, 2025).

We recommend that culvert CV106 @ KM33 be replaced due to the issues noted related to the maintenance of flows and fish passage. The new design should incorporate site specific information/conditions including geotechnical data to inform whether underlying ice lens conditions might compromise future function. As noted, this culvert supports fish-bearing habitat and as such, should be made a priority.

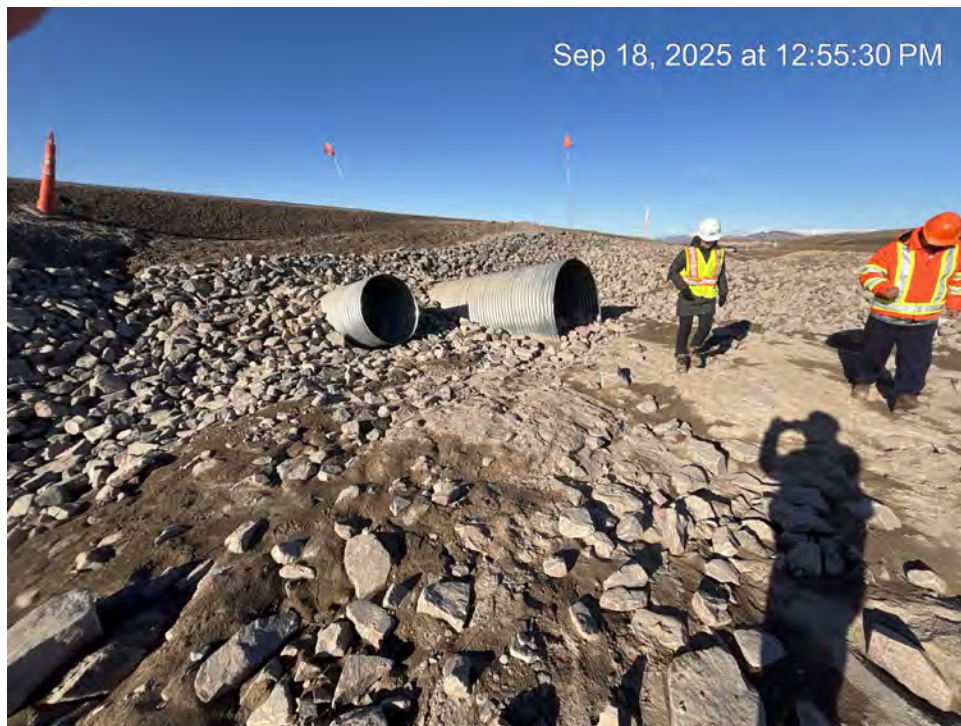
culverts which has melted the ice lens and led to damage of the culverts. Bill told the Inspectors that CV106 is not on the list of culverts to be immediately replaced. He suggested that fish passage does not occur at the crossing and so the replacement has not been deemed an emergency. However, following the inspection, Inspectors were informed by Conor Goodard that Arctic Char have previously been observed stranded at this crossing. As a result, the Inspectors feel that the replacement of this culvert should be made a priority.

Photo 48 – Blocked culverts at KM33 (September 18, 2025).

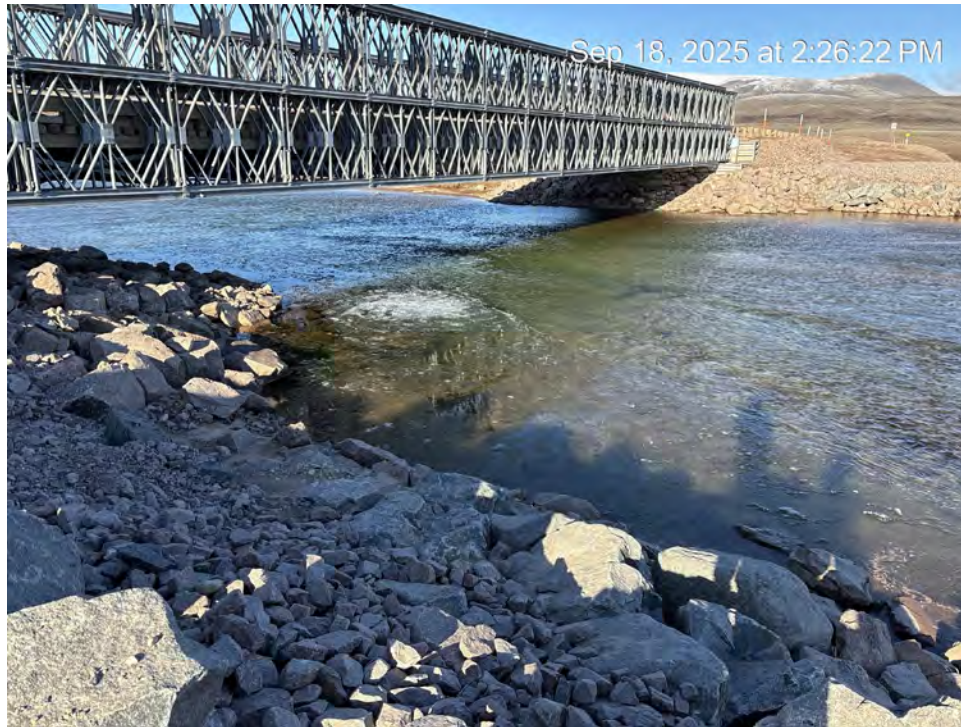
The KM17 bridge was reinforced by burying sea cans at the approach of both side, which will hopefully help improve the stability of the bridge and Tote Road. No concerns were noted at this location.

Photo 49 – Clear flows under KM17 bridge (September 18, 2025).

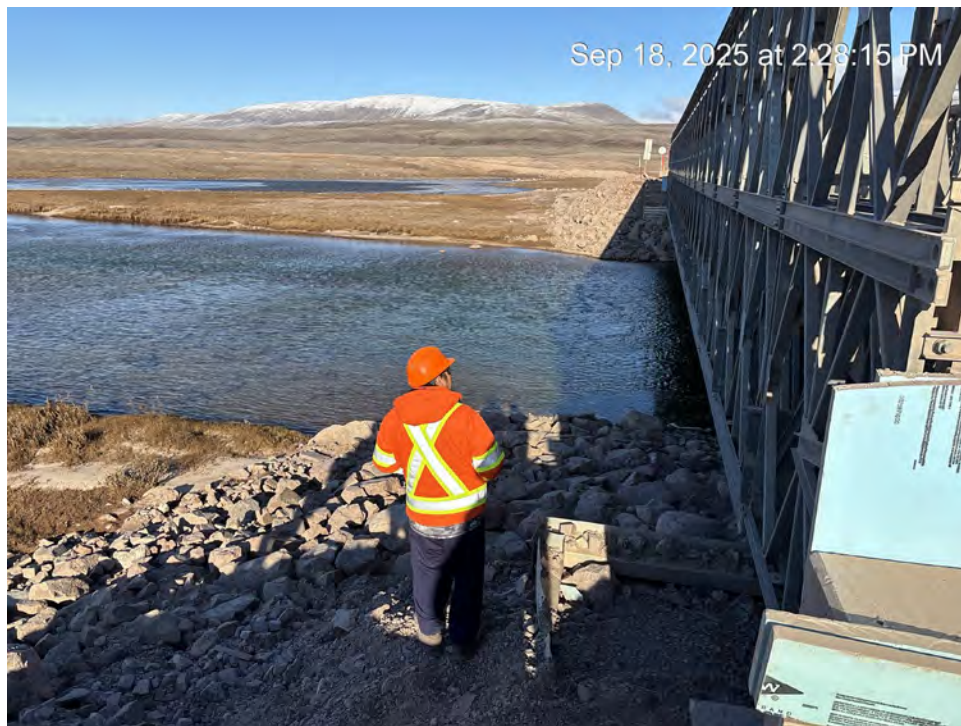
Photo 50 – Corner of buried sea can used to reinforce KM17 bridge (September 18, 2025).
