On July 24-25, 2026, NIRB staff conducted a site visit to Agnico Eagle's Meadowbank Complex projects, accompanied by Agnico Eagle environmental staff. The visit focused on observing site activities, environmental management practices, and implementation of Project Certificate requirements. During the visit, NIRB staff observed ongoing operational activities and held discussions with the Proponent regarding environmental monitoring, mitigation measures, and adherence to Project Certificate requirements (Table 3-1 and Table 3-2).

### 3.1. Meadowbank

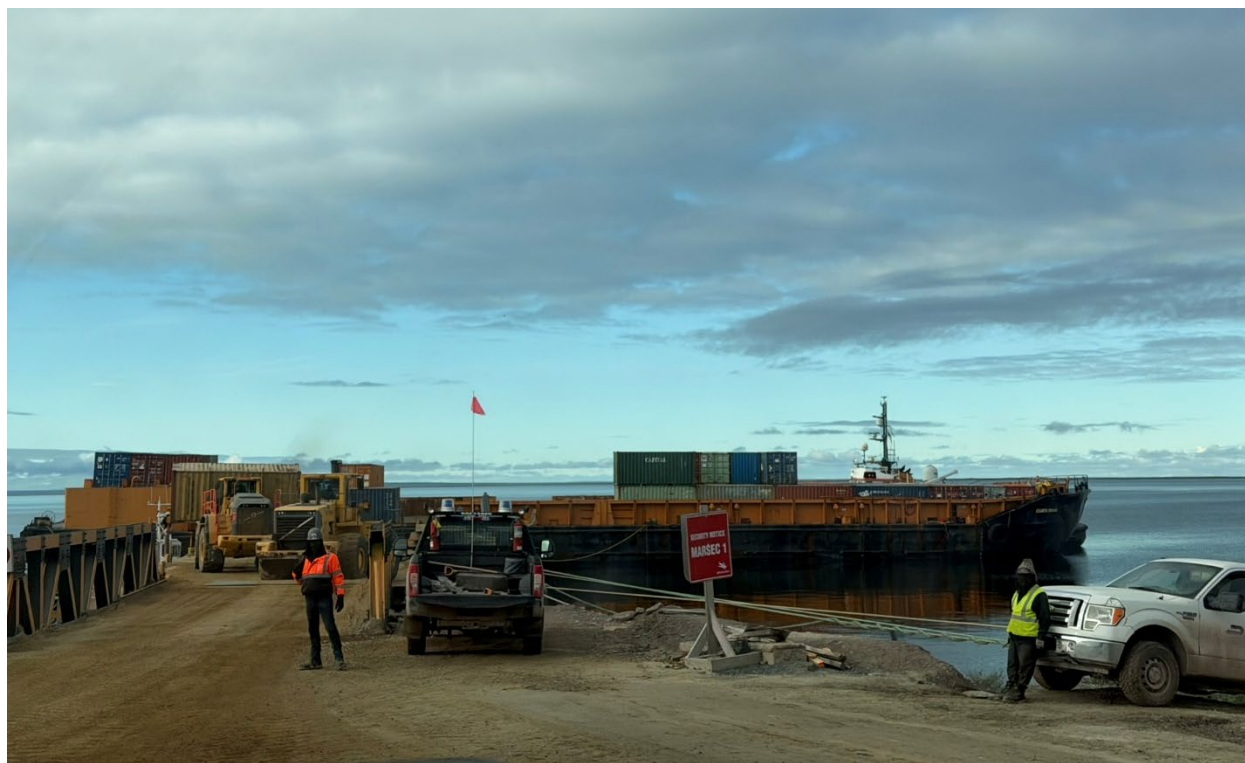
| 82 | Monitor the ingress/egress of ship cargo at Baker Lake and report any accidents or spills immediately | Sealift operations were underway at the time of the visit. Observed the dock and barge landing area (Photo 1), a loader handling seacans during barge unloading (Photo 2), and seacans being loaded and dispatched to site from the laydown area (Photo 6). |

**Photo 1: Dock and barge landing area**

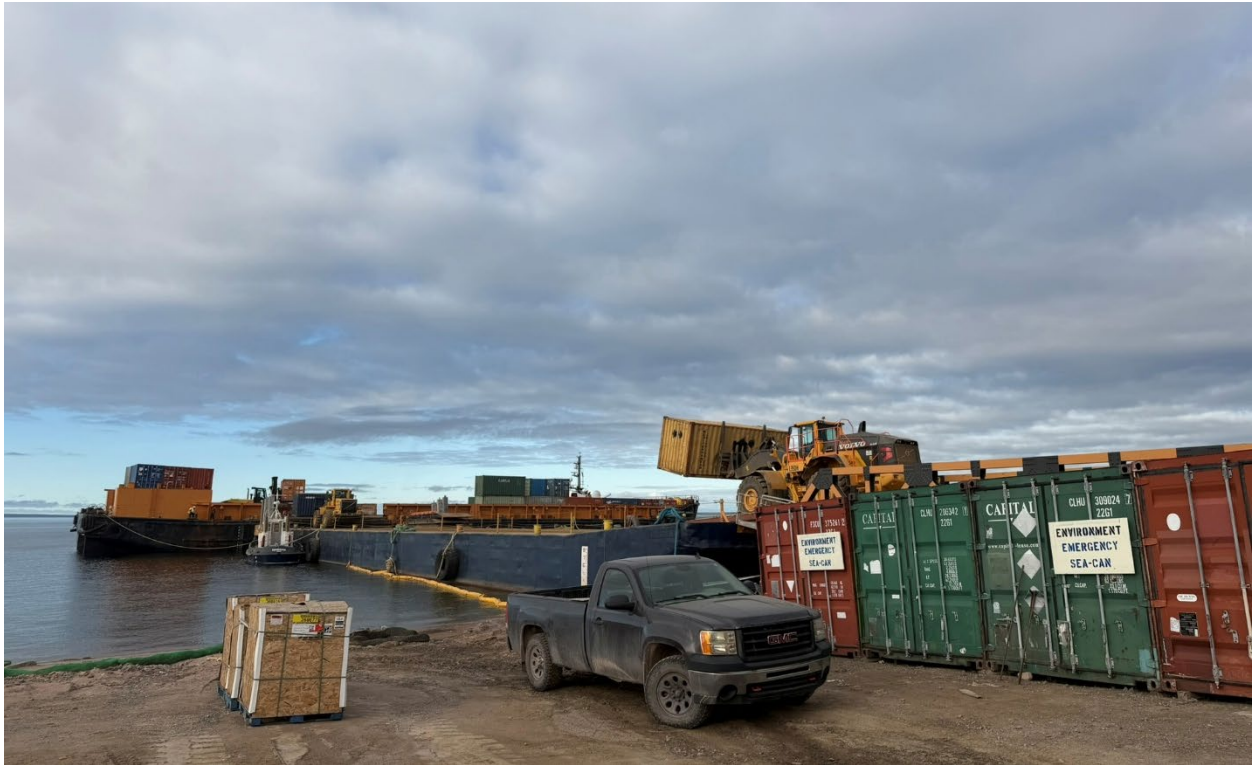
**Photo 2: Loader handling seacan during barge unloading operations, with dedicated spill response seacans available for environmental protection and emergency response**

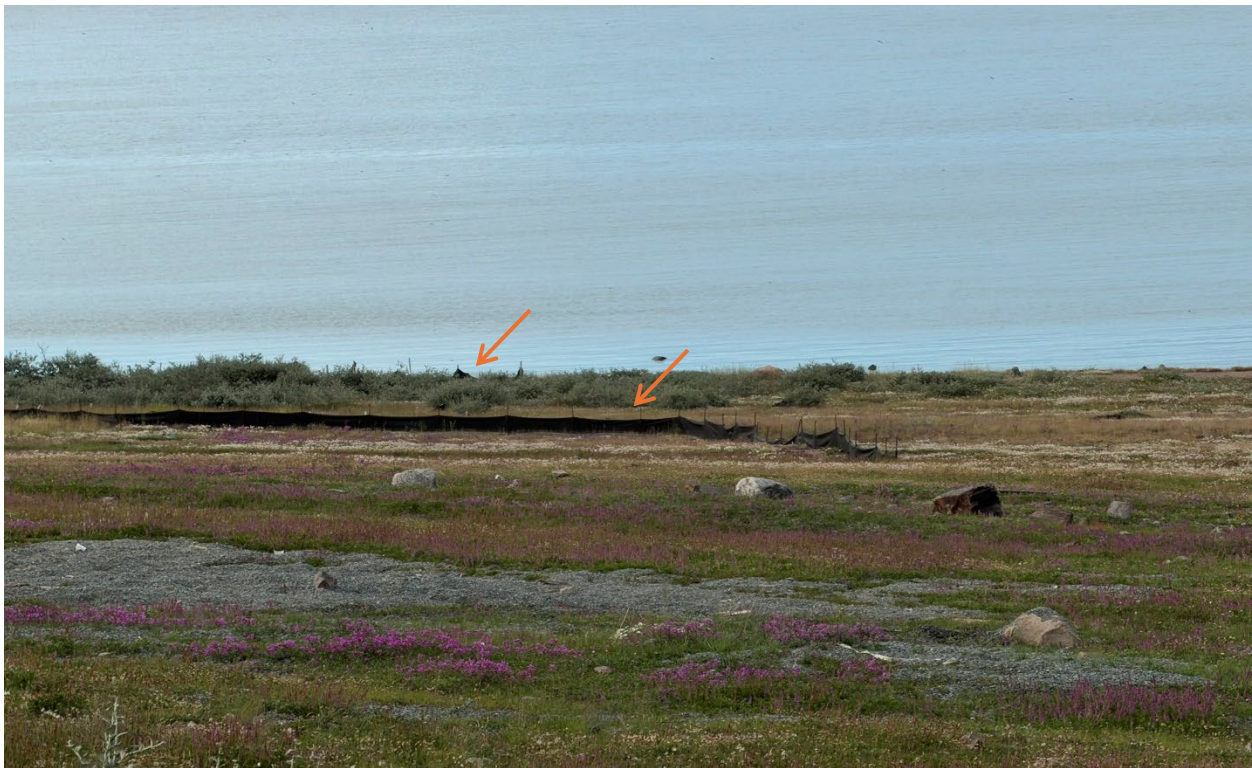
**Photo 5: Close-up view of silt fences**

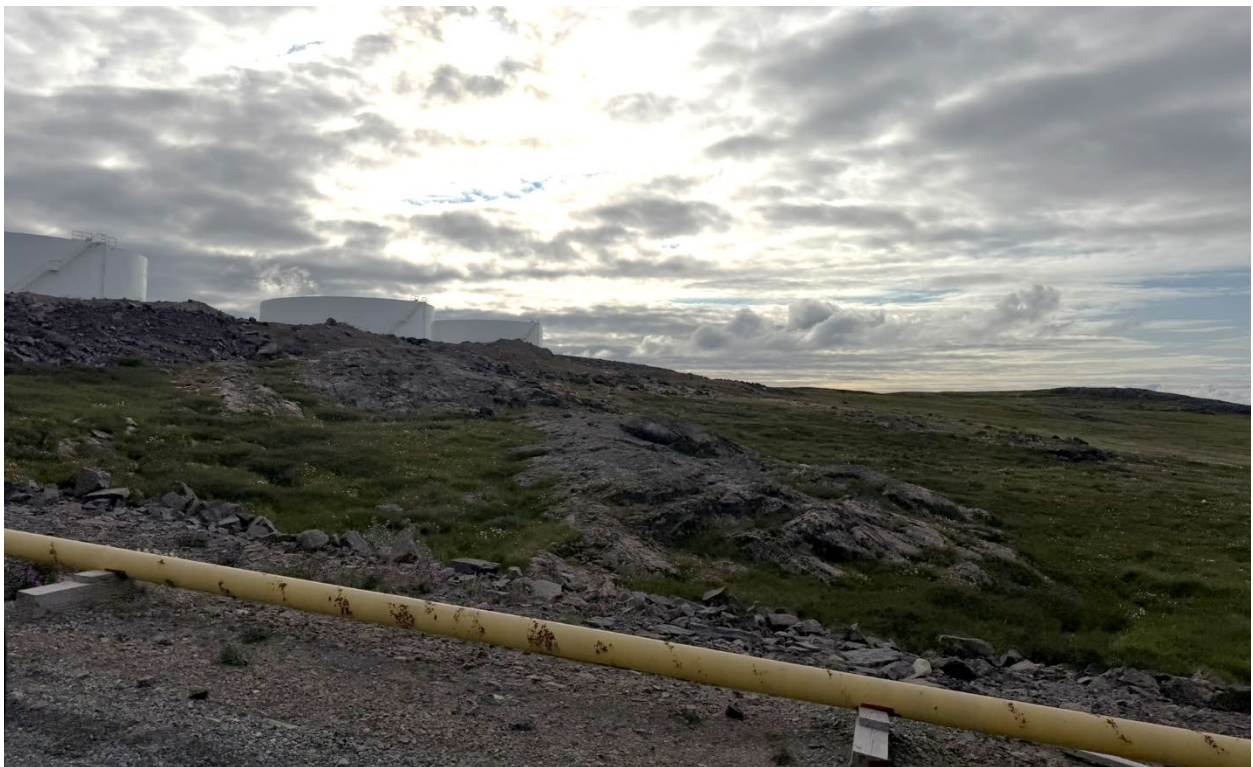
**Photo 7: The rigid fuel transfer line running from shore to fuel storage tanks for sealift fuel transfer operations**

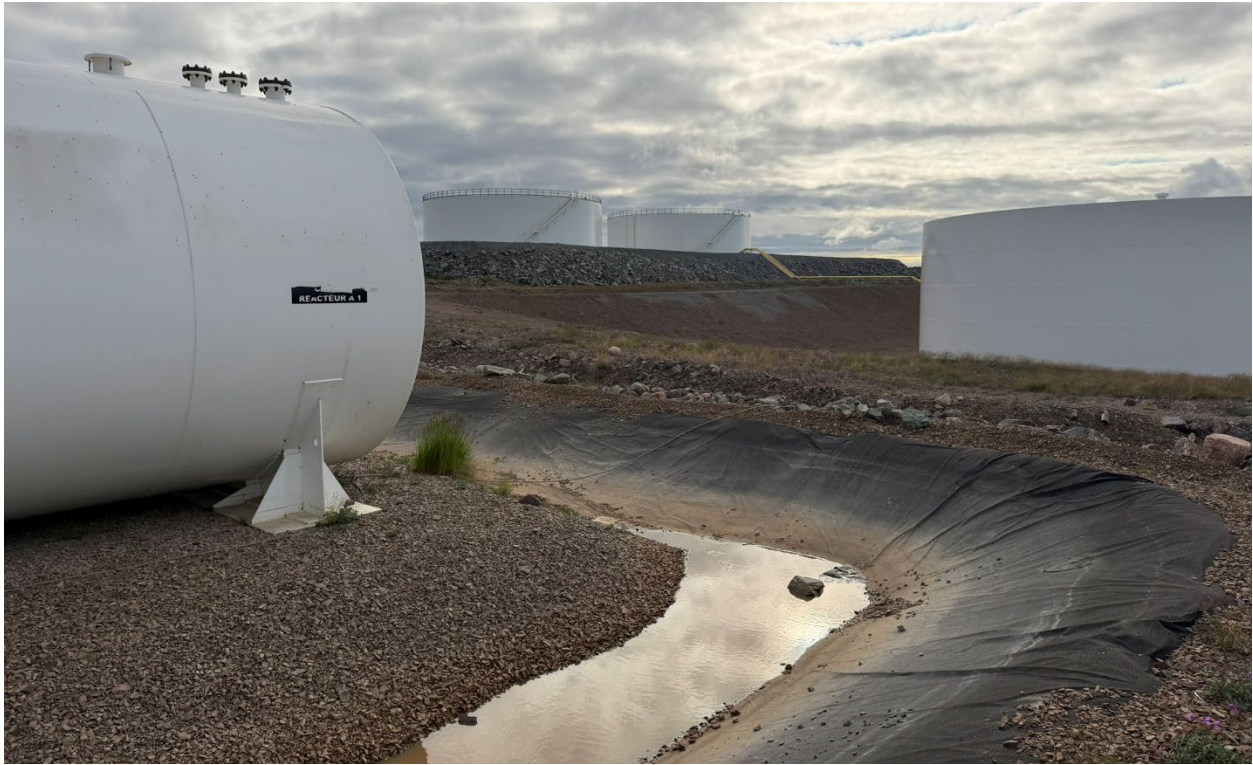
At the fuel tank farm, sections of the geomembrane liner were observed exposed, with water pooled within the lined containment and drainage areas and vegetation established along the liner edges (Photo 9, Photo 10, and Photo 11). Exposed liner and water accumulation have been recurring observations at this facility from 2022 through 2026, and Environment and Climate Change Canada's (ECCC) review of the 2025 Annual Report identified holes and tears in the liner, water accumulation, and evidence of elevated water levels.

Photo 10: Exposed liner, vegetation growth, and standing water adjacent to horizontal fuel tanks

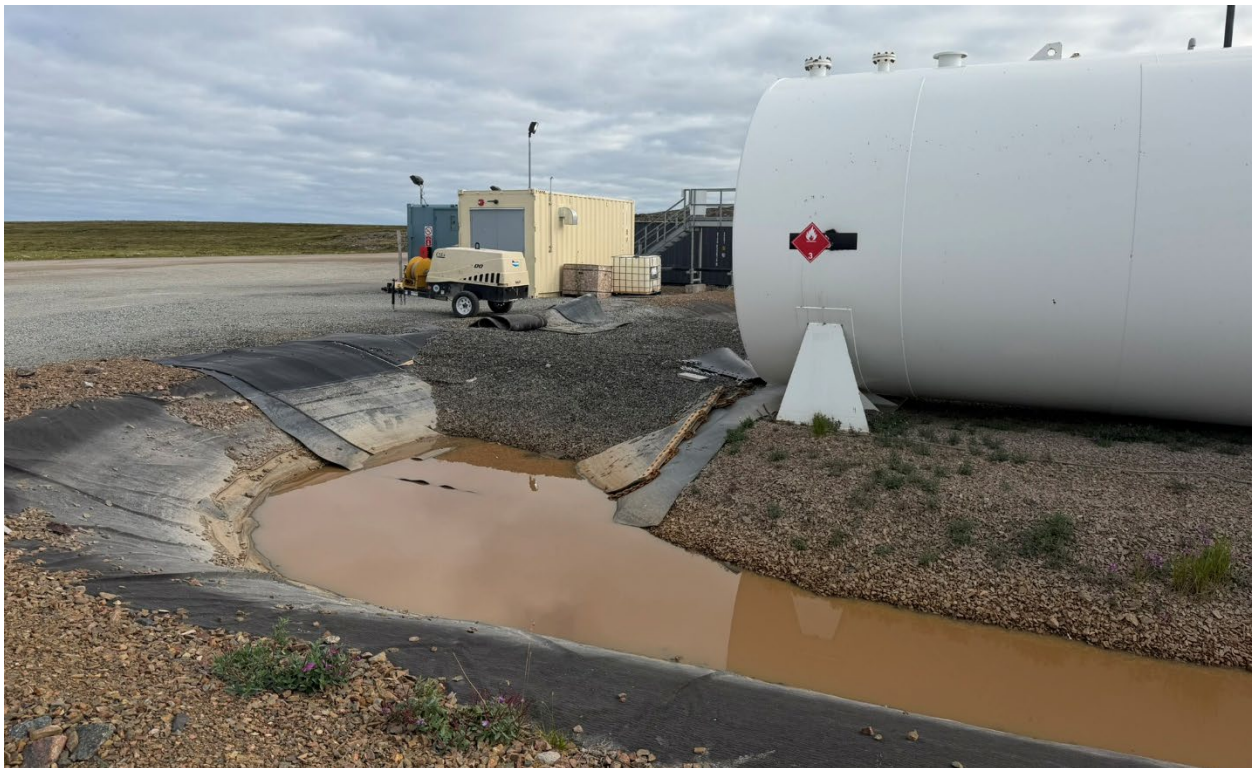
Photo 11: Exposed liner, vegetation growth, and standing water adjacent to horizontal fuel tanks

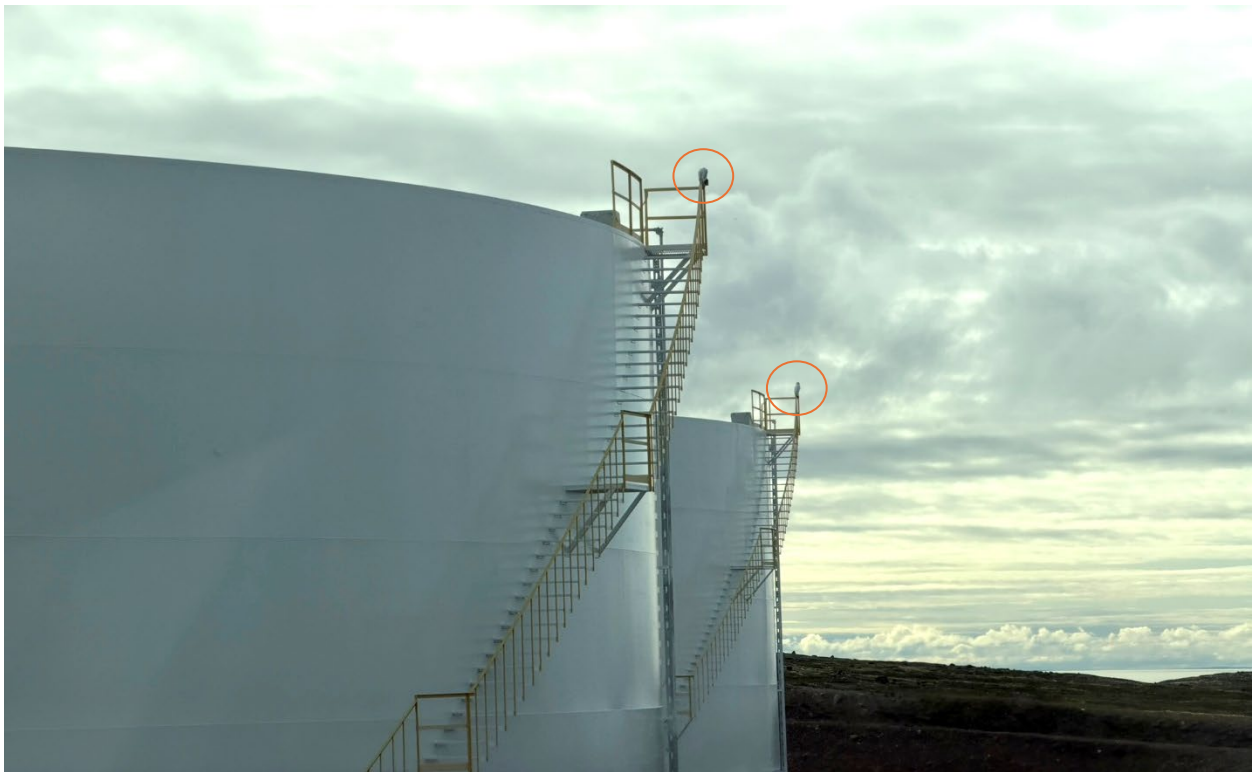
**Photo 13: Bird/raptor deterrent on fuel tanks**

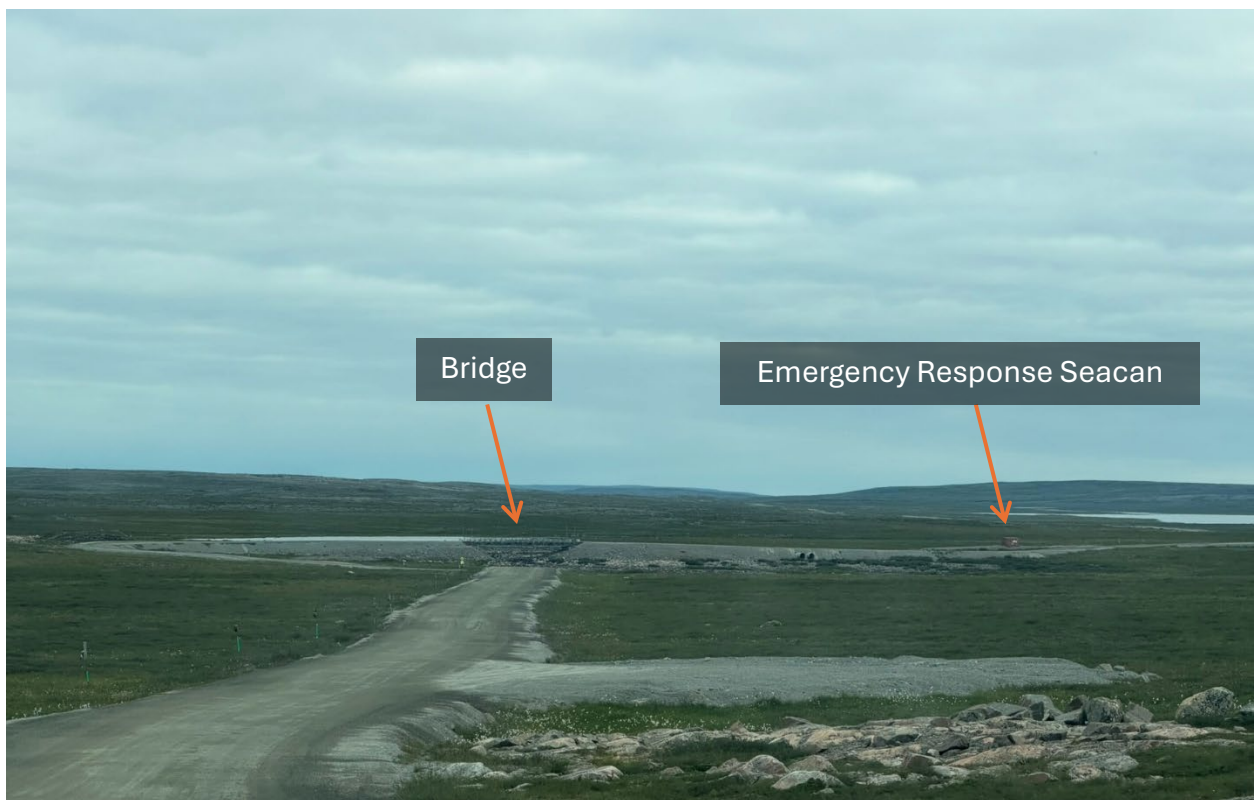
Bridges and watercourse crossings were observed to be in good repair. Metal plates have been installed to close the gaps along the sides of the bridge decks, preventing road material and debris from falling into the watercourses below. Emergency response seacans were observed at each bridge crossing.

**Photo 15: Distant view of the KM 8 bridge and nearby emergency response seacan**

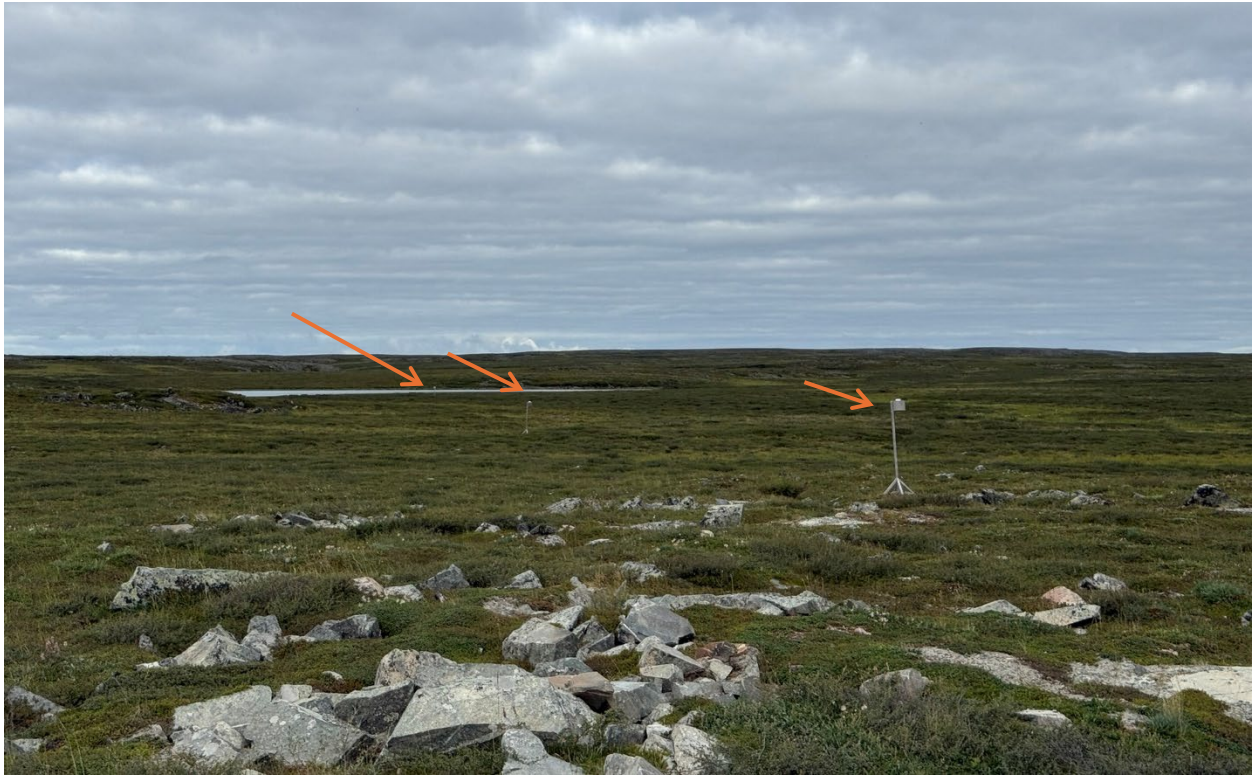
**Photo 18: Dust monitoring transects at KM 18, with canisters positioned at set distances**

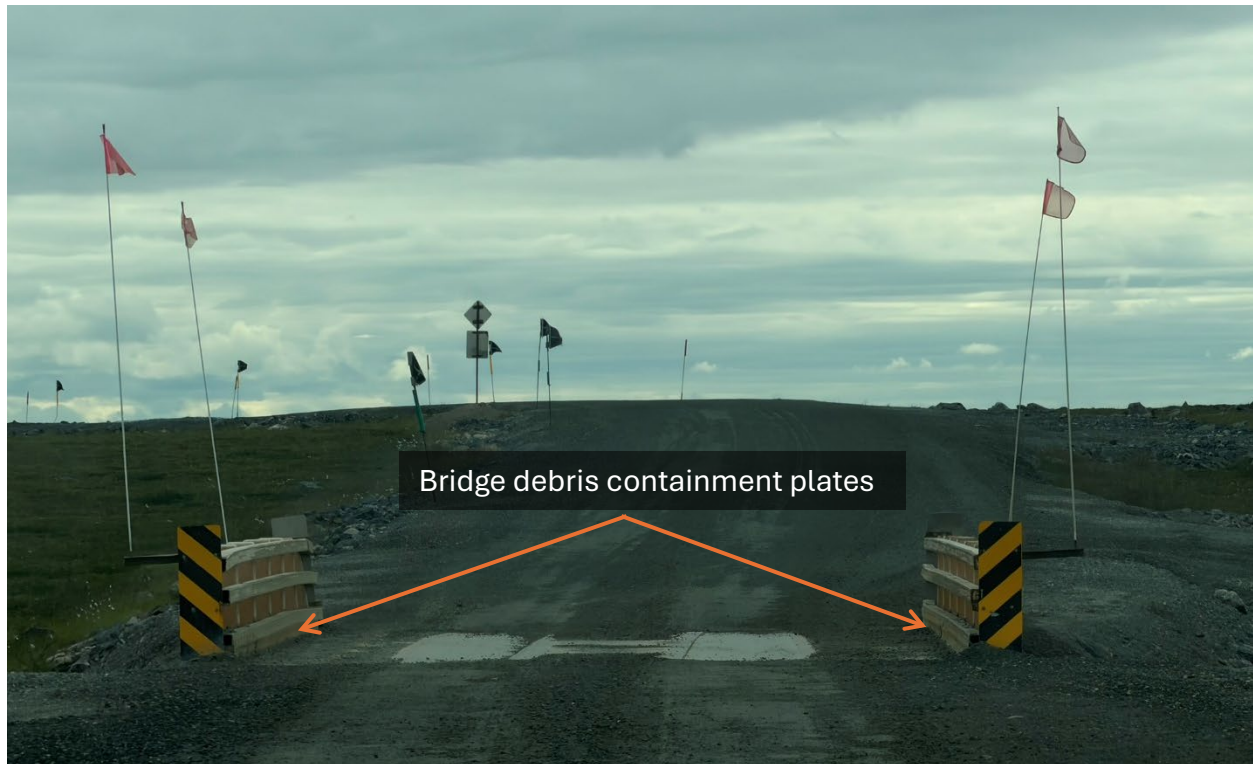
Photo 22: KM 80 bridge

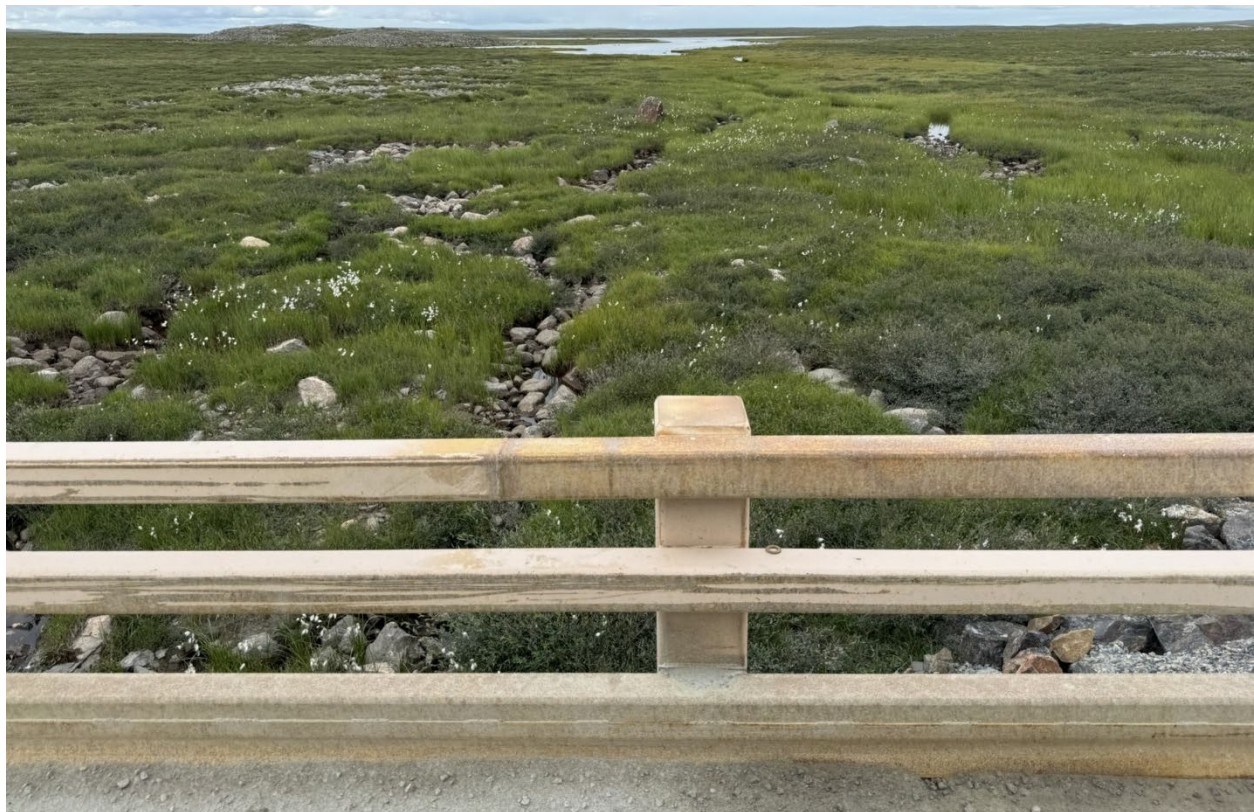
Photo 23: Close-up view of containment plates

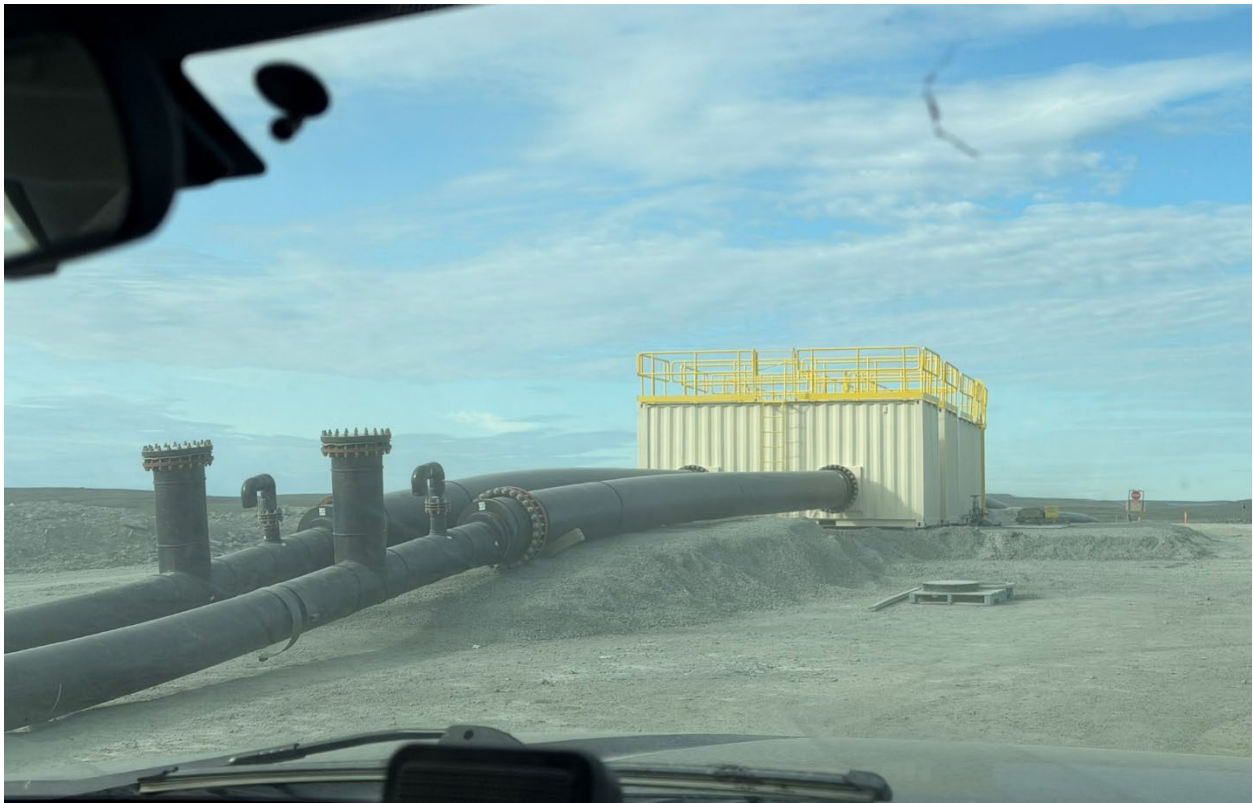
**Photo 35: Vault waterline, with pressure relief housing at a high point on the line**

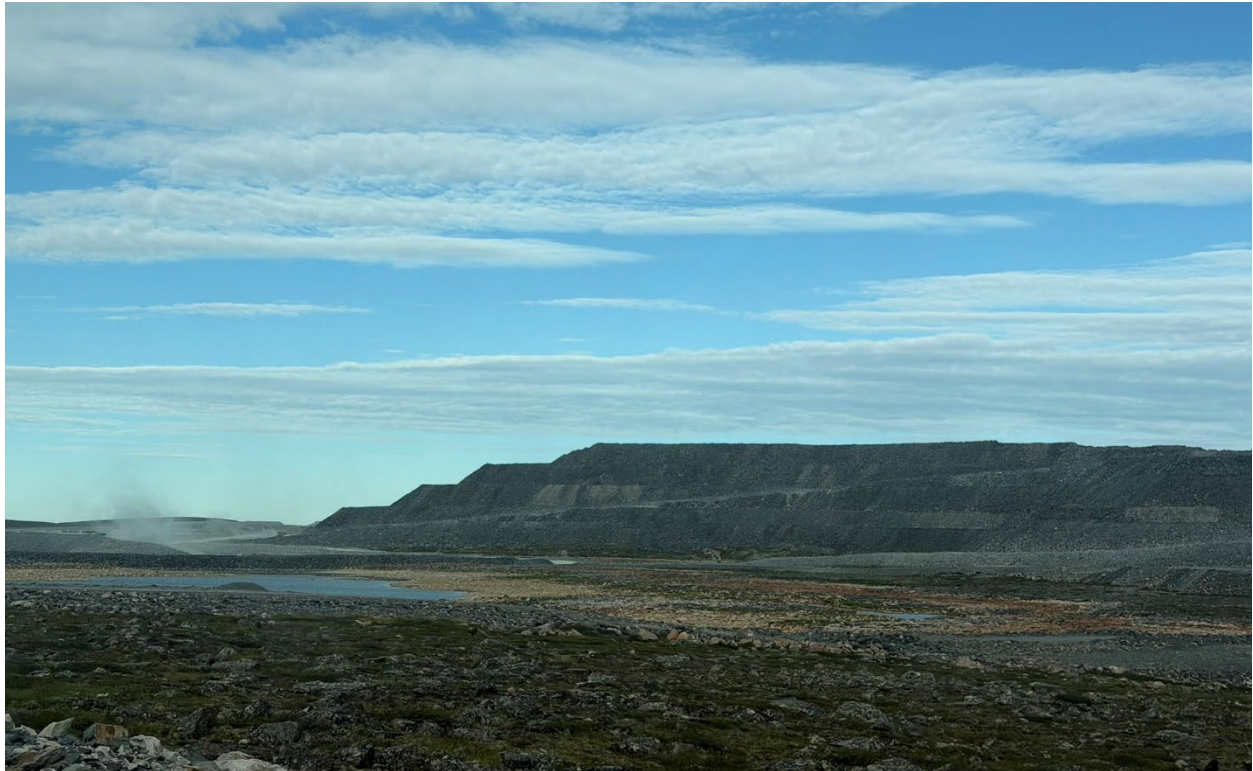
**Photo 36: Vault Waste Rock Storage Facility (Vault WRSF)<sup>2</sup>**

<sup>2</sup> Non-acid generating (NAG) waste rock is being crushed at the Vault Waste Rock Storage Facility for use as construction material and aggregate. Very dusty conditions were observed in this area at the time of the visit, and dust was observed blowing from the crushing area toward the adjacent attenuation ponds and pit lakes.

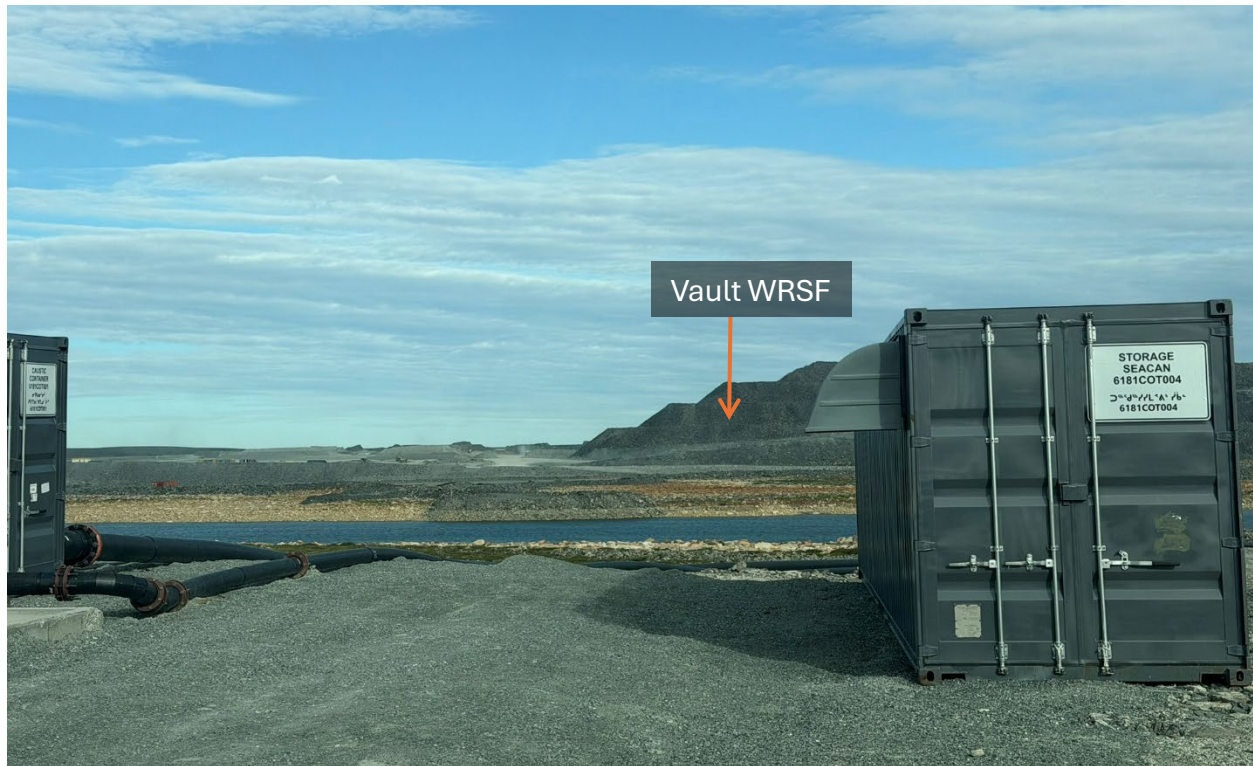
**Photo 38: Vault Attenuation Pond<sup>3</sup>**

<sup>3</sup> The Vault attenuation pond discharges to Wally Lake, and Agnico Eagle has identified this discharge as the Meadowbank site's final discharge point with the greatest potential to adversely affect the receiving environment. Deposition of fugitive dust from the crushing operation into the attenuation pond therefore has the potential to affect water quality at the point of discharge.

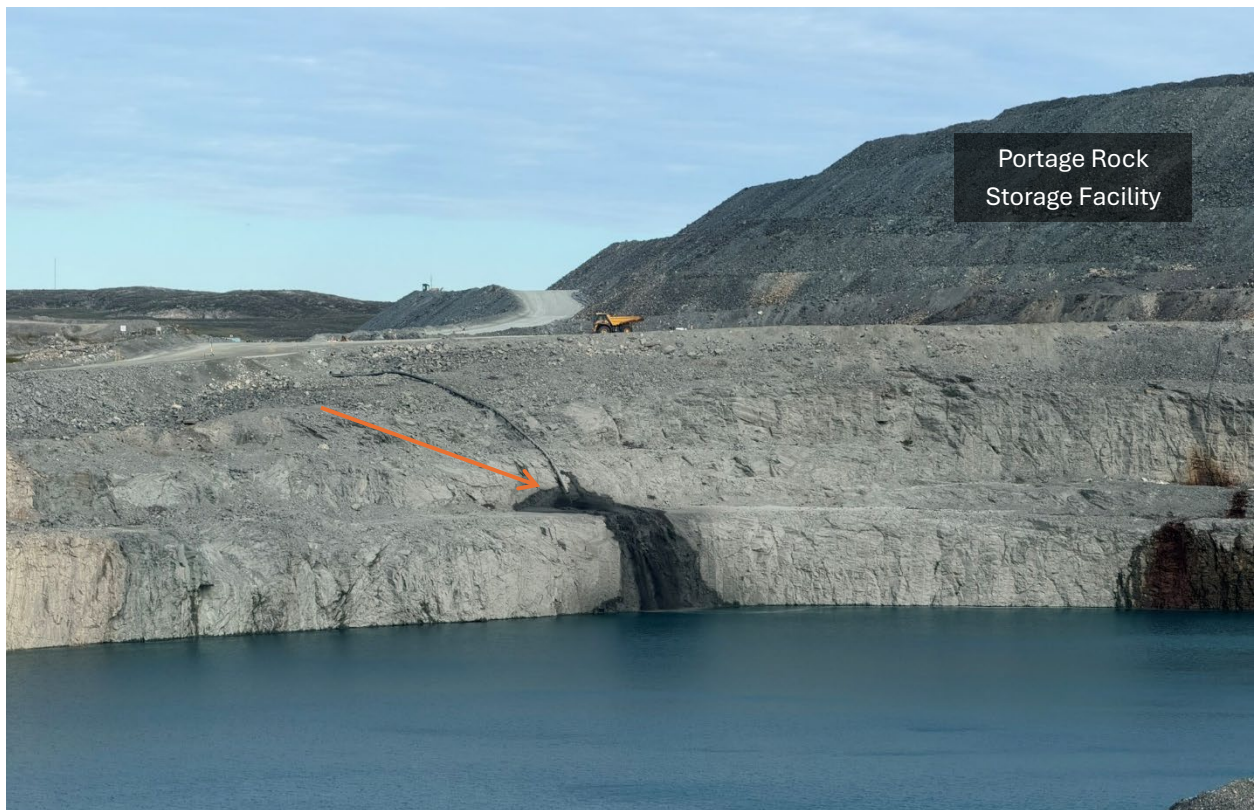
**Photo 43: Active in-pit tailings deposition at Portage Pit A**

<sup>5</sup> Portage Pit A is a mined-out open pit at the Meadowbank site used for in-pit tailings deposition. Deposition commenced in December 2024 and continued through 2025. Under the current deposition plan, Pit A is to receive tailings through to June 2027.

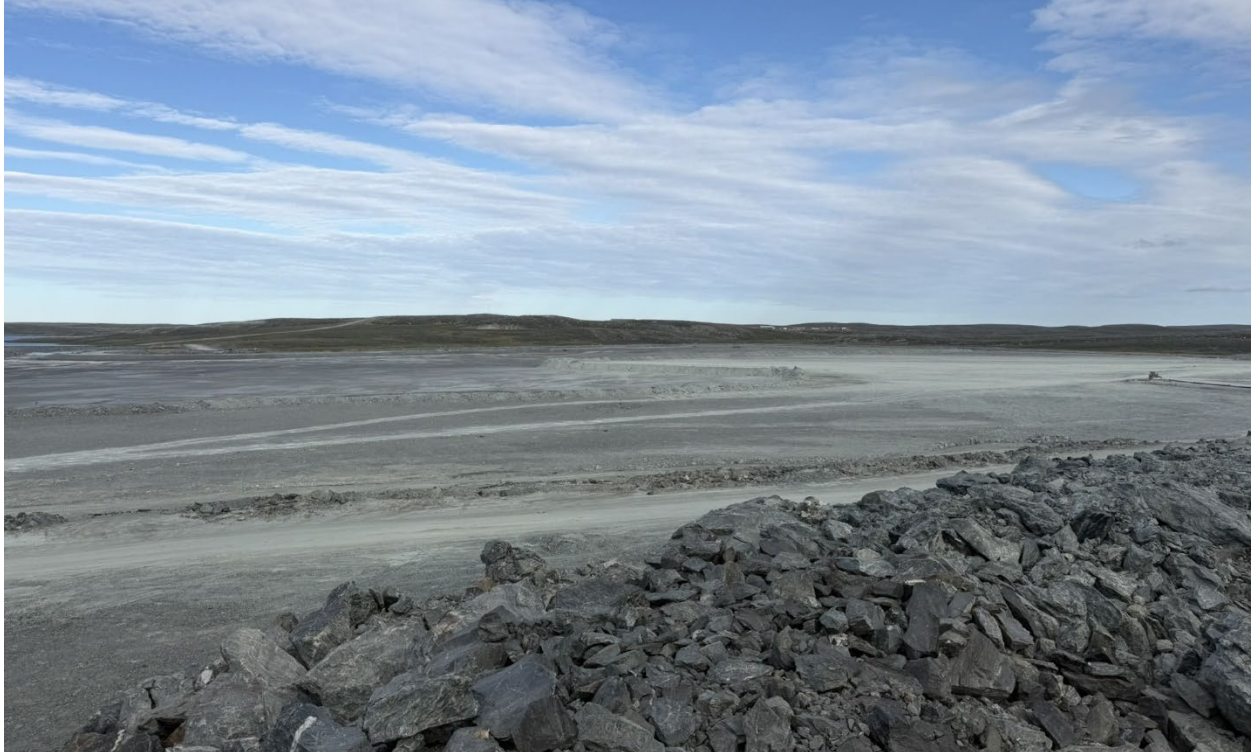
**Photo 50: Tailings Storage Facility – North Cell, with active NAG capping underway as part of progressive reclamation activities**

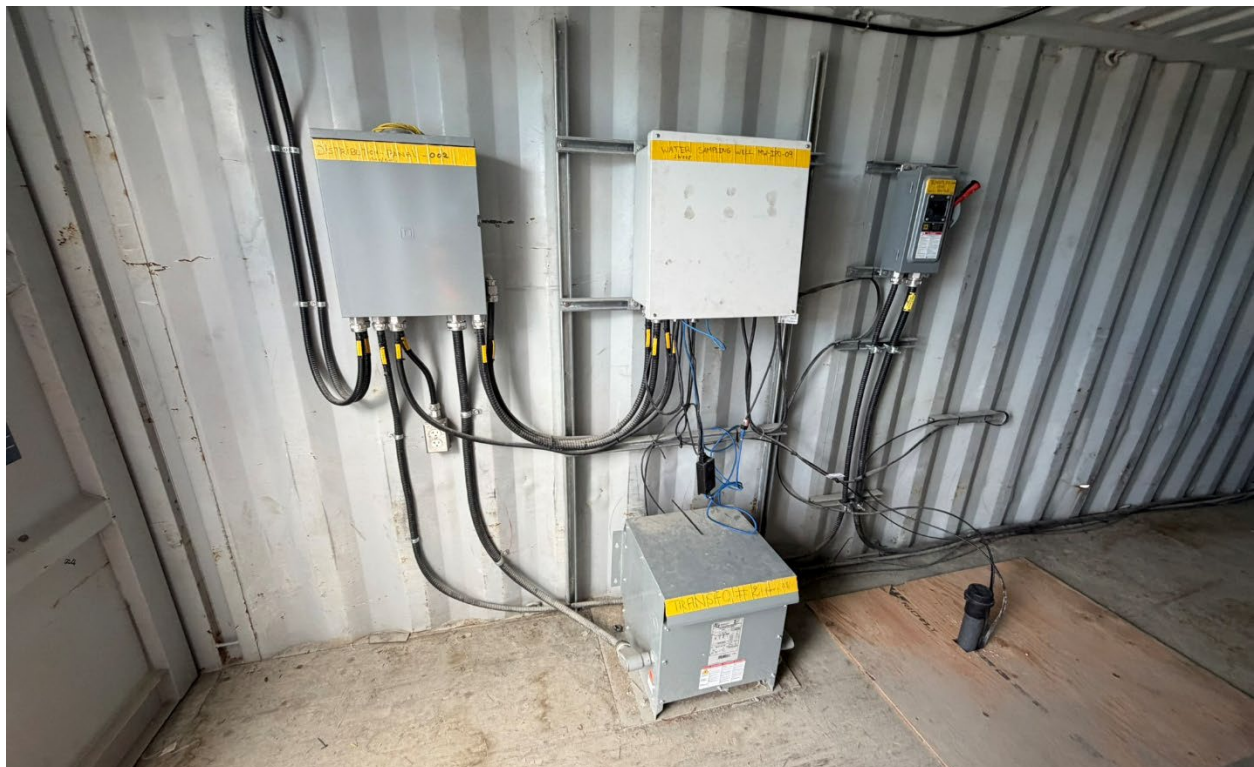
| T&C No. | Topic / summary | Site Observation |
|---|---|---|
| 8, 20 | Conduct groundwater monitoring and report results; identify mitigation for contamination from tailings and assess/monitor fault permeability to groundwater movement | Observed one of the five groundwater monitoring wells operating at the site (Photo 55). Agnico Eagle advised that seepage at the Assay Lab Road continues to be monitored and managed through the contact water management system. |

**Photo 55: One (1) of Five (5) groundwater monitoring wells at the site**

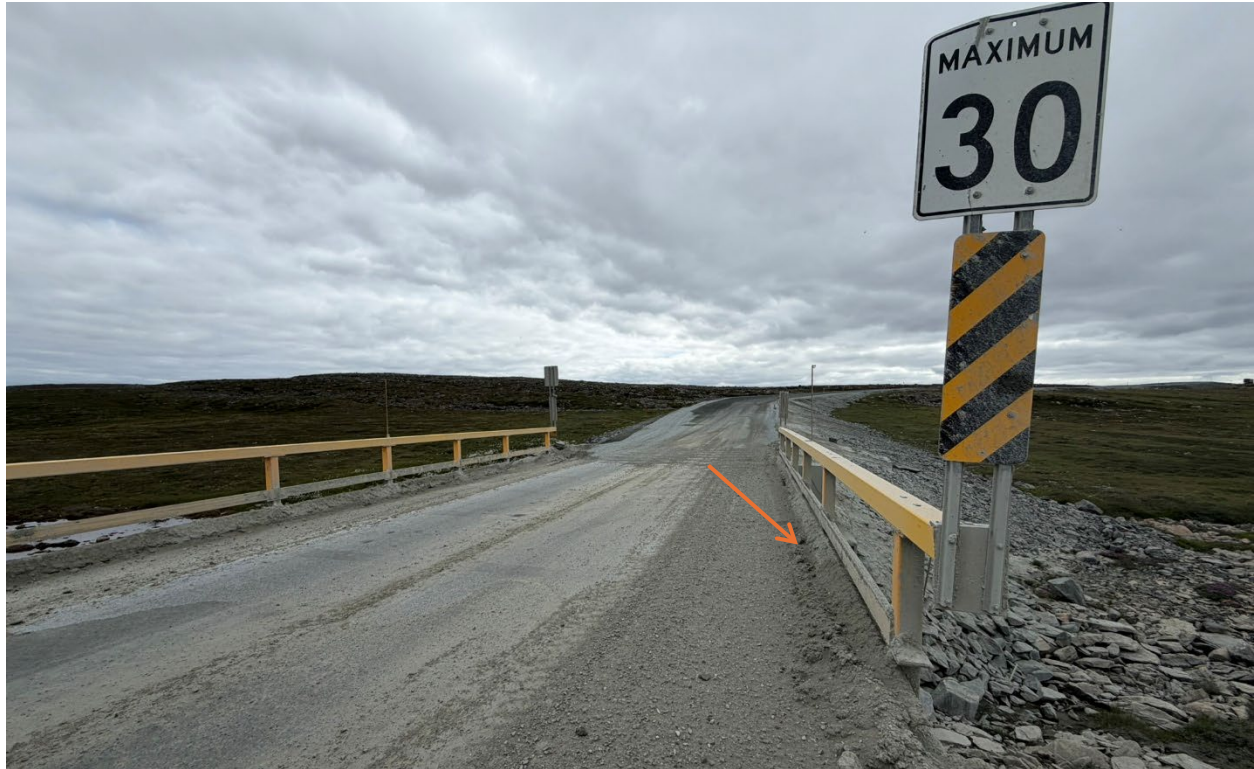
**Photo 63: Bridge crossing at WTHR KM 102 with speed limit signage; note fine road material along the road edge and shoulder**

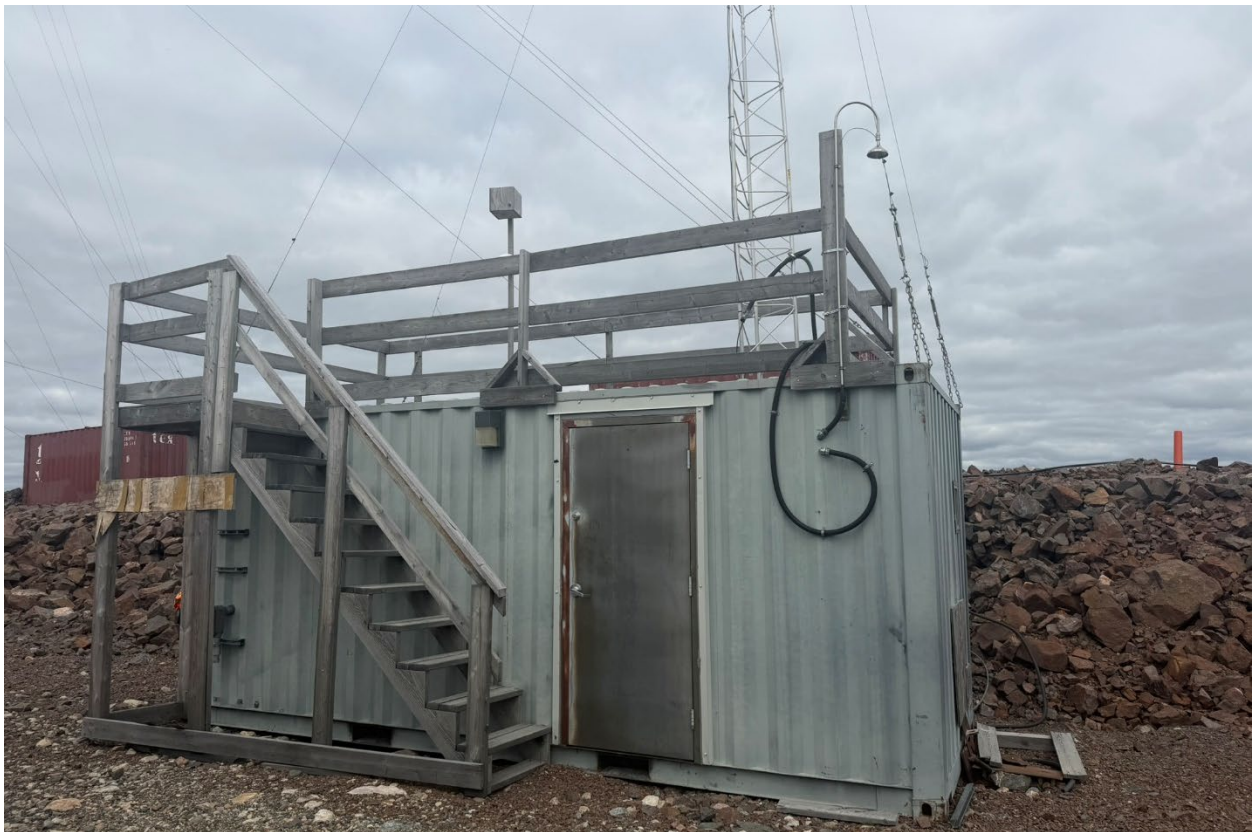
| T&C No. | Topic / summary | Site Observation |
|---|---|---|
| 1 | Air Quality Monitoring and Management Plan with adaptive management thresholds; continuous NO <sub>2</sub> monitoring downwind of mining activities | Observed the air quality monitoring station on the Whale Tail Haul Road, equipped with both active and passive NO <sub>2</sub> monitors (Photo 68). |

**Photo 68: NO<sub>2</sub> monitoring station, with both active and passive NO<sub>2</sub> monitors**

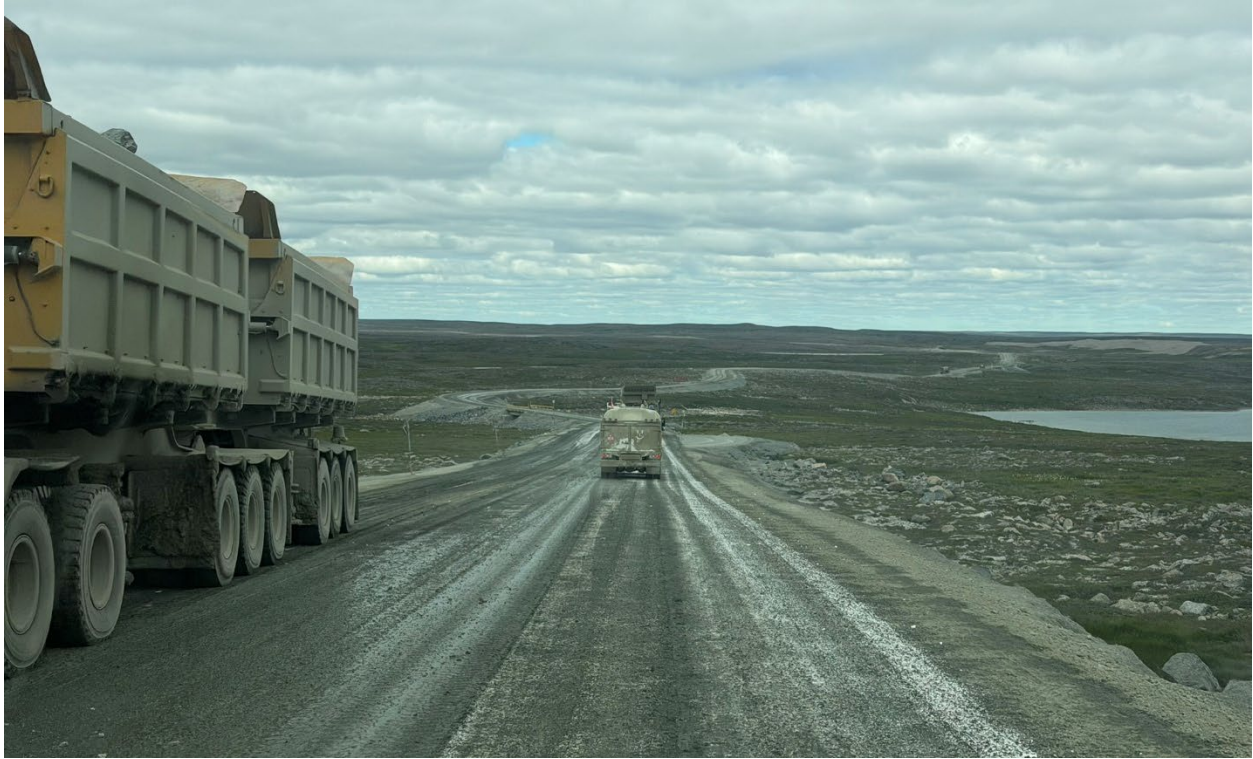
| T&C No. | Topic / summary | Site Observation |
|---|---|---|
| 2 | Mitigate dust impacts on project roads, including dust suppression on all project roads | Calcium chloride dust suppressant was being actively applied along the Whale Tail Haul Road at the time of the visit (Photo 75). Application was ongoing and had not been completed along the full length of the road; dusty conditions were observed in untreated sections and near the IVR Rock Storage Facility (Photo 76), and in areas where road maintenance was underway (Photo 69). Dustfall monitoring transects were observed along the road, with collection canisters positioned at set distances from the road edge (Photo 70). |

**Photo 75: Active application of calcium chloride dust suppressant along the WTHR**

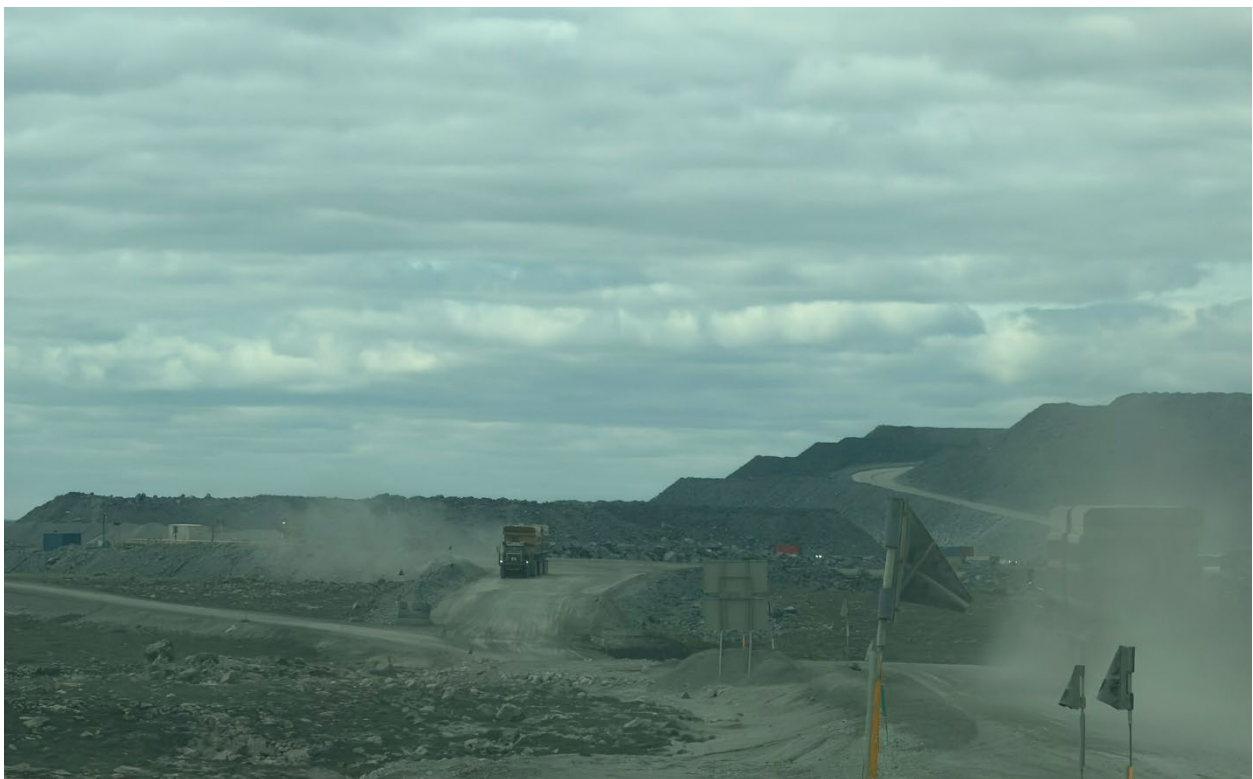
**Photo 76: Dusty conditions on WTHR near IVR Rock Storage Facility**
