On July 24-25, 2026, NIRB staff conducted a site visit to Agnico Eagle's Meadowbank Complex projects, accompanied by Agnico Eagle environmental staff. The visit focused on observing site activities, environmental management practices, and implementation of Project Certificate requirements. During the visit, NIRB staff observed ongoing operational activities and held discussions with the Proponent regarding environmental monitoring, mitigation measures, and adherence to Project Certificate requirements (Table 3-1 and Table 3-2).

### 3.1. Meadowbank

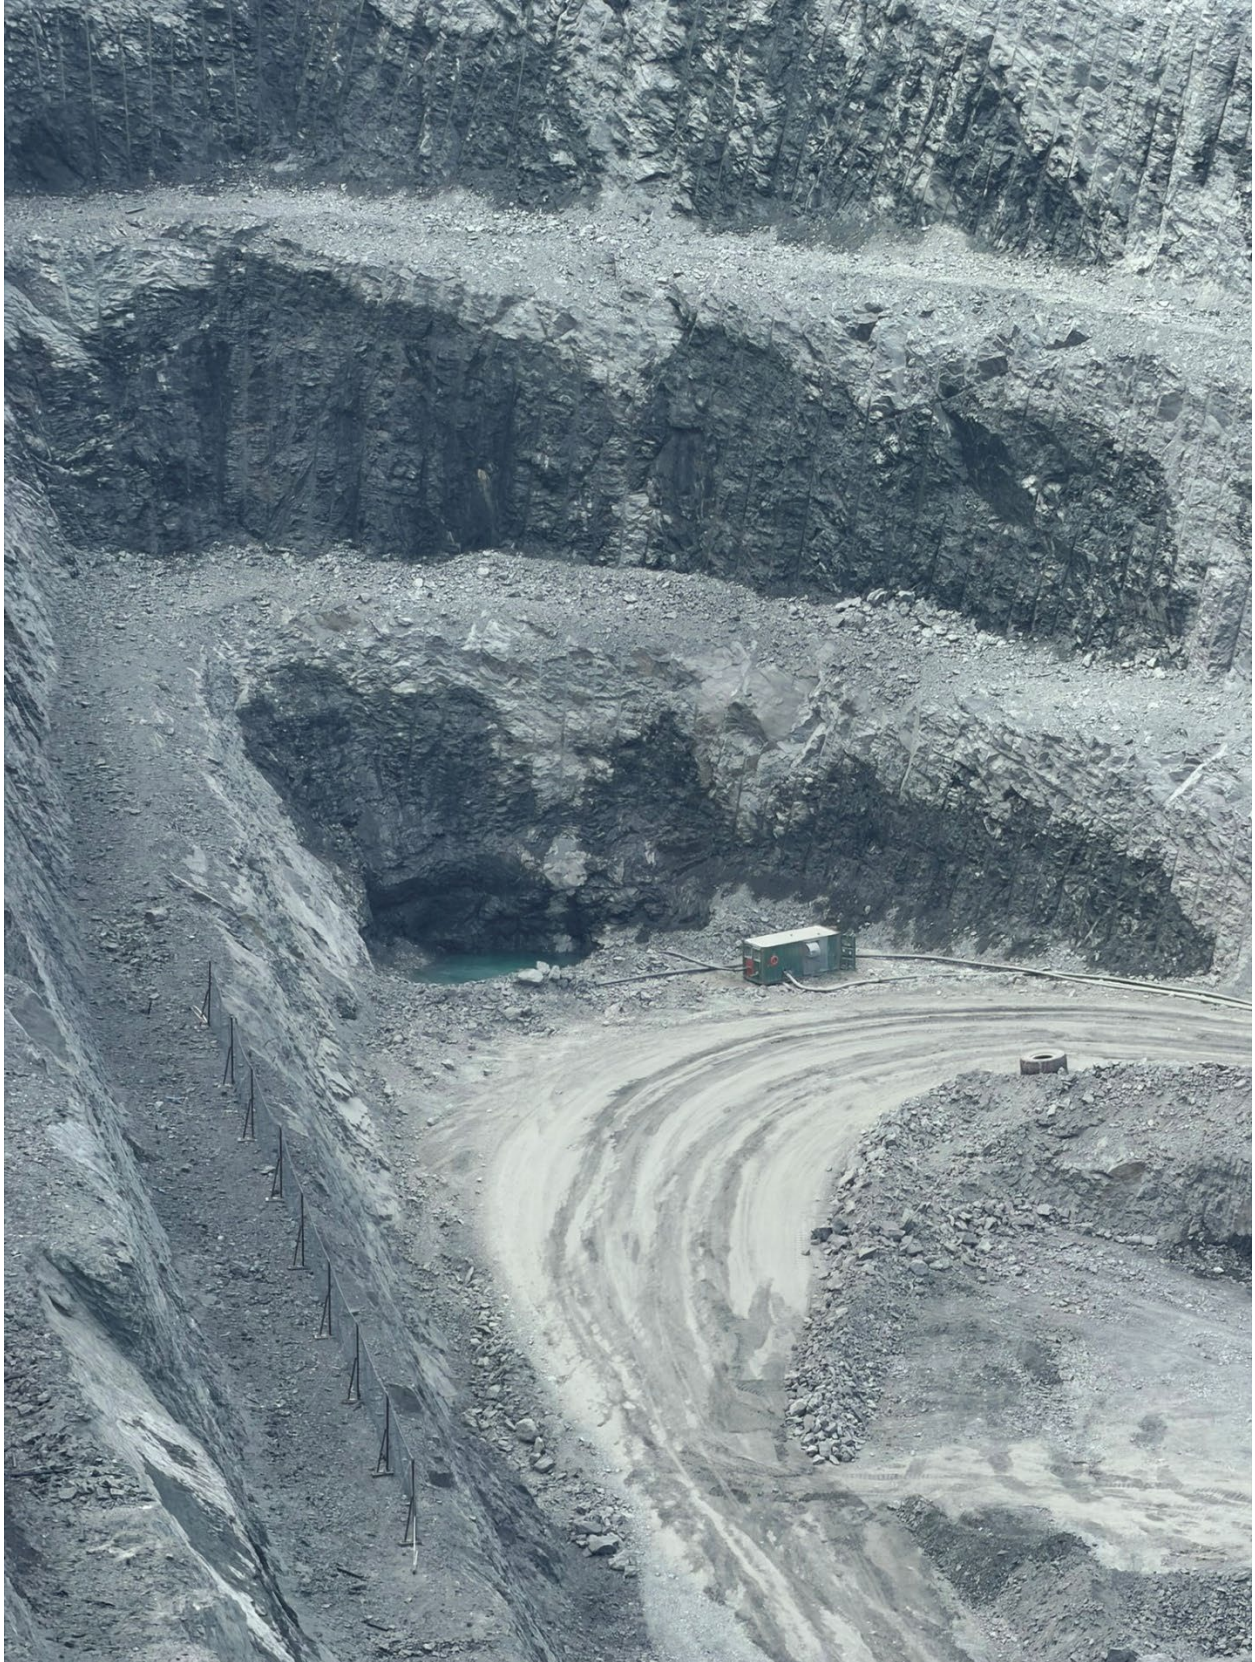
**Photo 83: Pool of water at the base of the WT Pit**

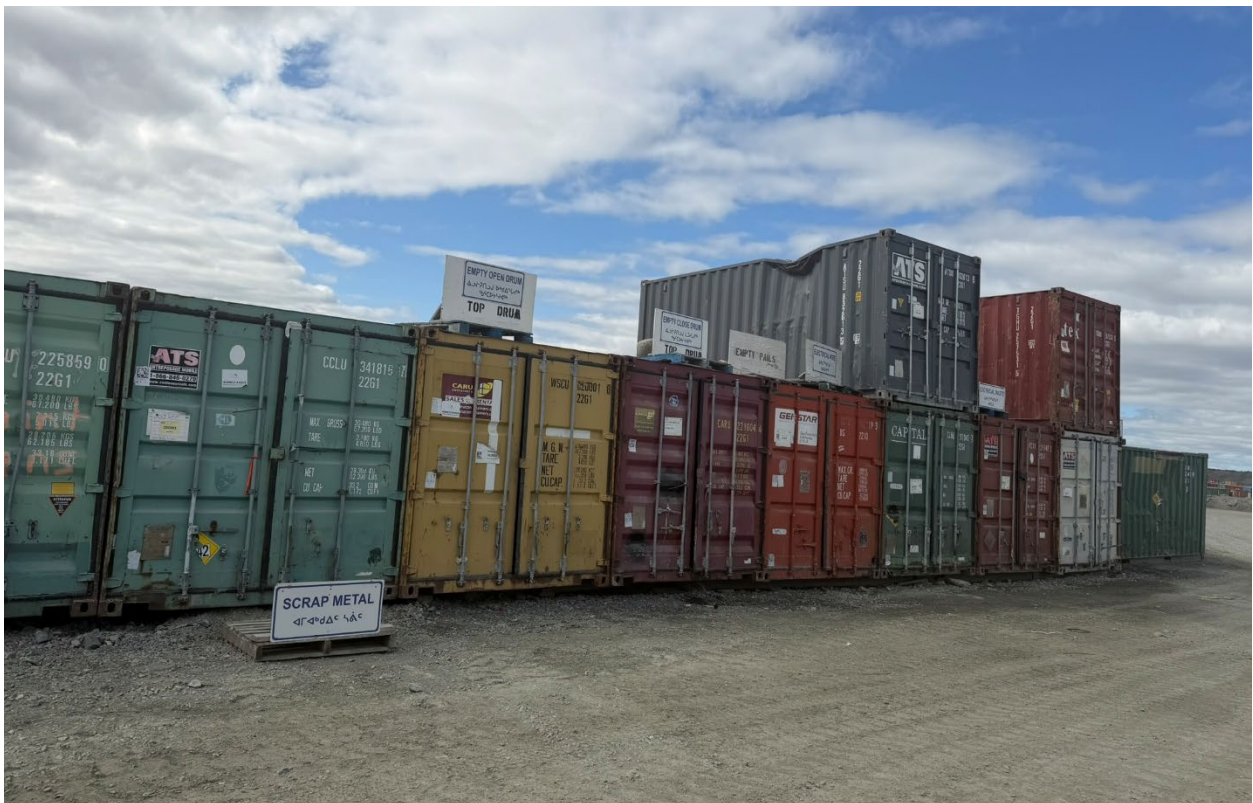
Photo 101: HAZMAT storage seacans adjacent to Composter Building, appeared well organized
