## 2026 Site Visit Report

# MELIADINE GOLD MINE PROJECT

Site visit report of the Meliadine Gold Mine Project for the 2025-2026 reporting year

**Site Visit Date:** July 20, 2026

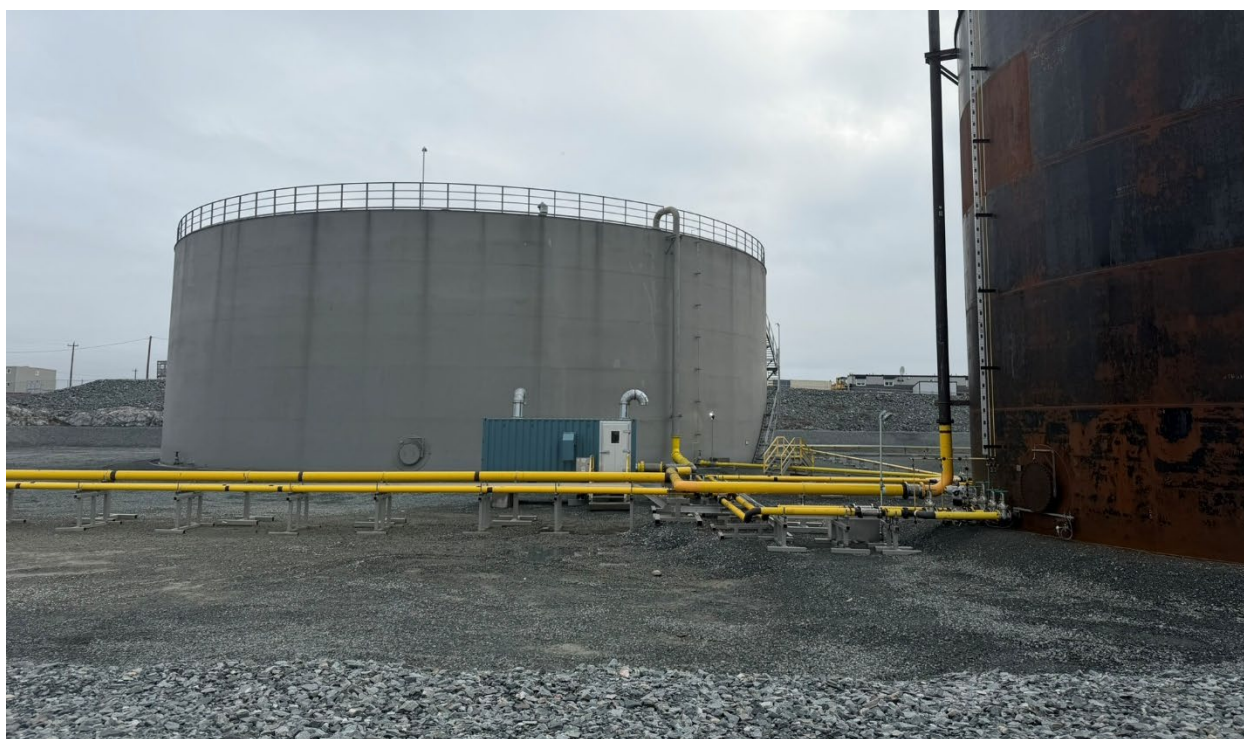
**Photo 4: Fuel Tank Farm in secondary containment at Itivia<sup>1</sup>**

<sup>1</sup>The four (4) fuel storage tanks at the Itivia Fuel Tank Farm were observed within secondary containment, with no standing water present during the site visit.

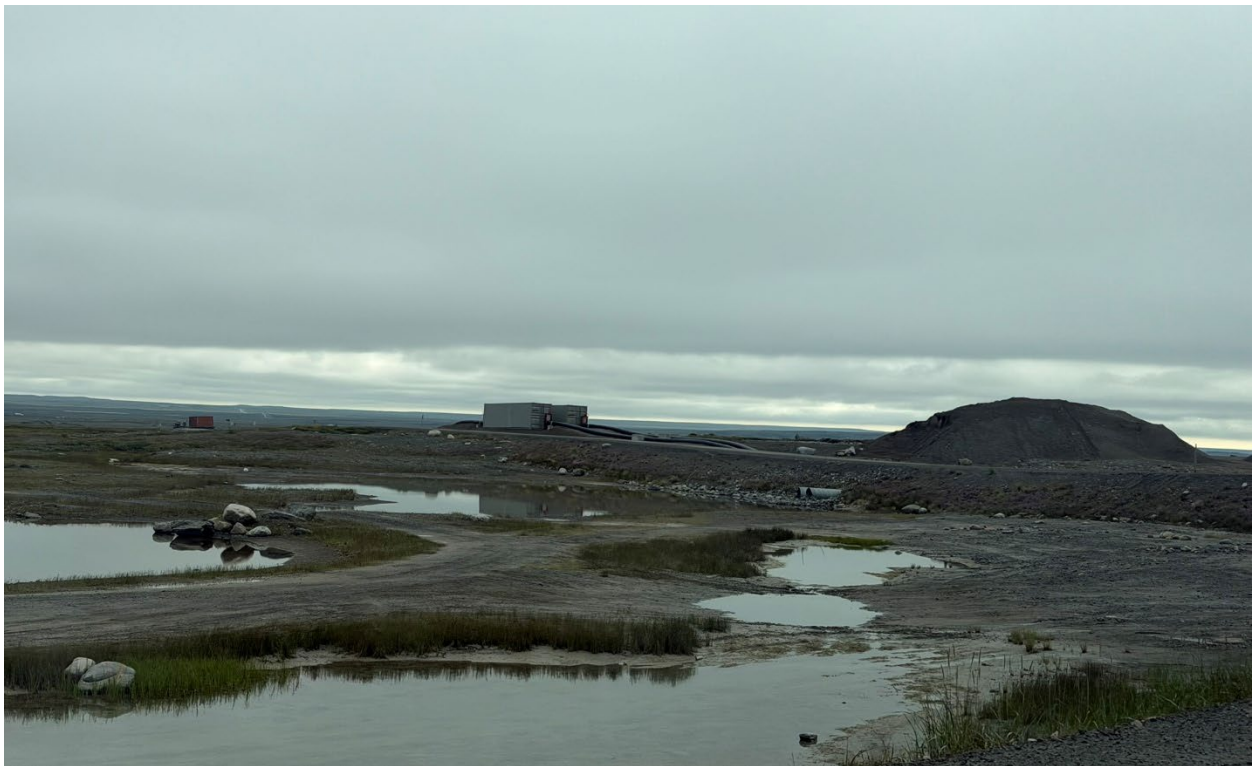
**Photo 17: Distant view of air pressure relief sea cans and exposed waterlines at KM 4**

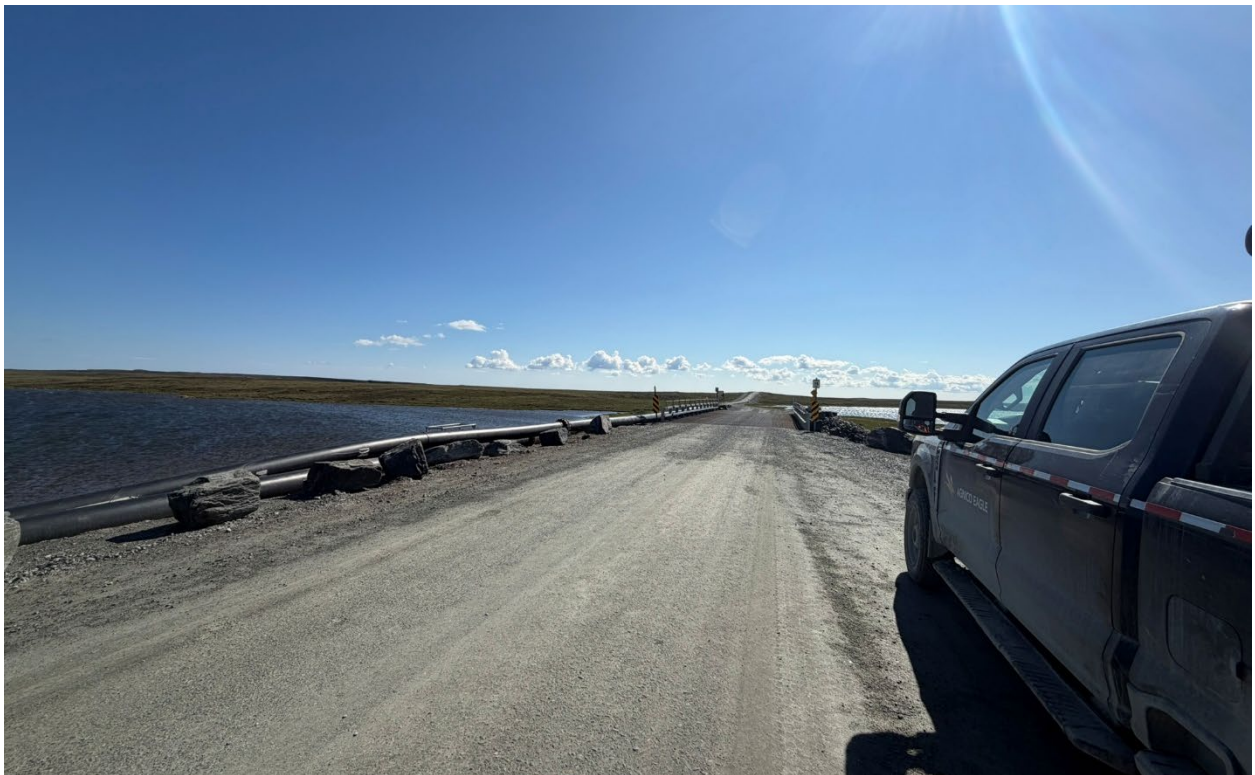
**Photo 25: Bridge crossing and exposed waterlines at KM 11**

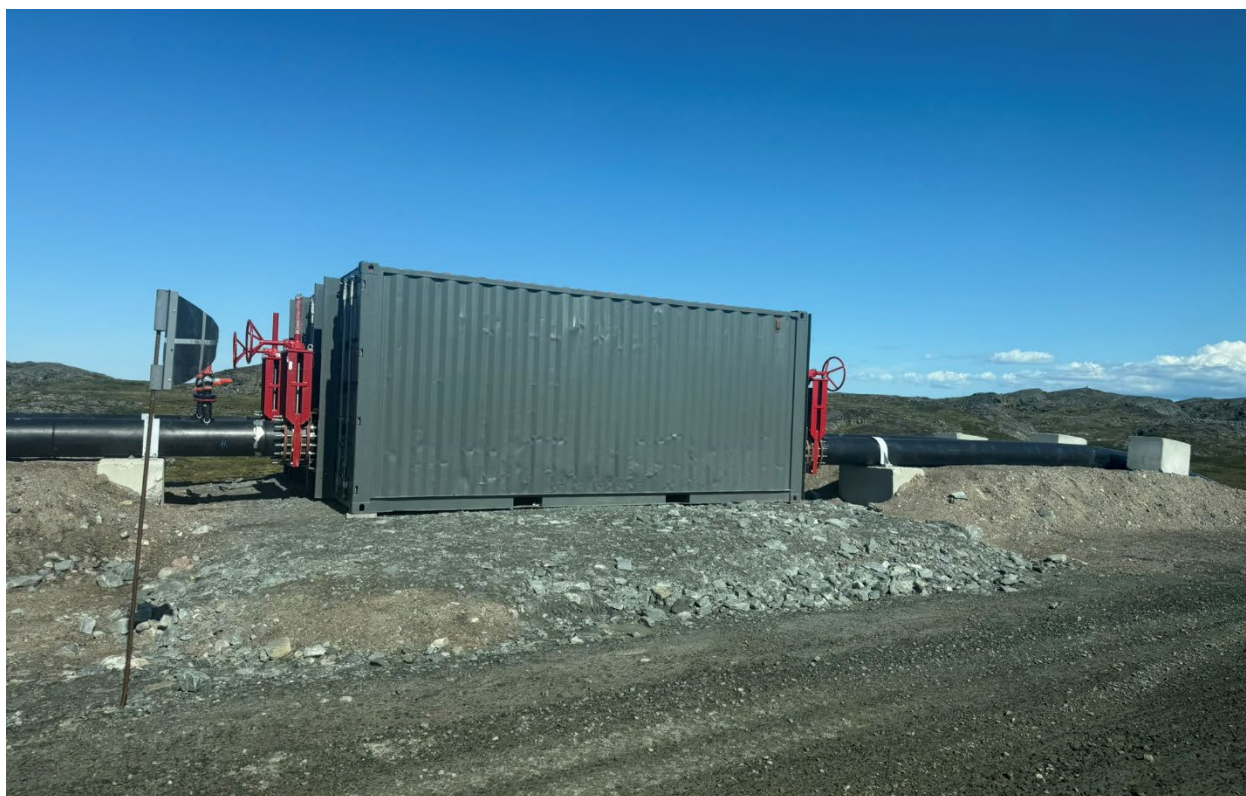
**Photo 27: One of multiple seacans containing pressure relief valves and exposed waterlines along the corridor**

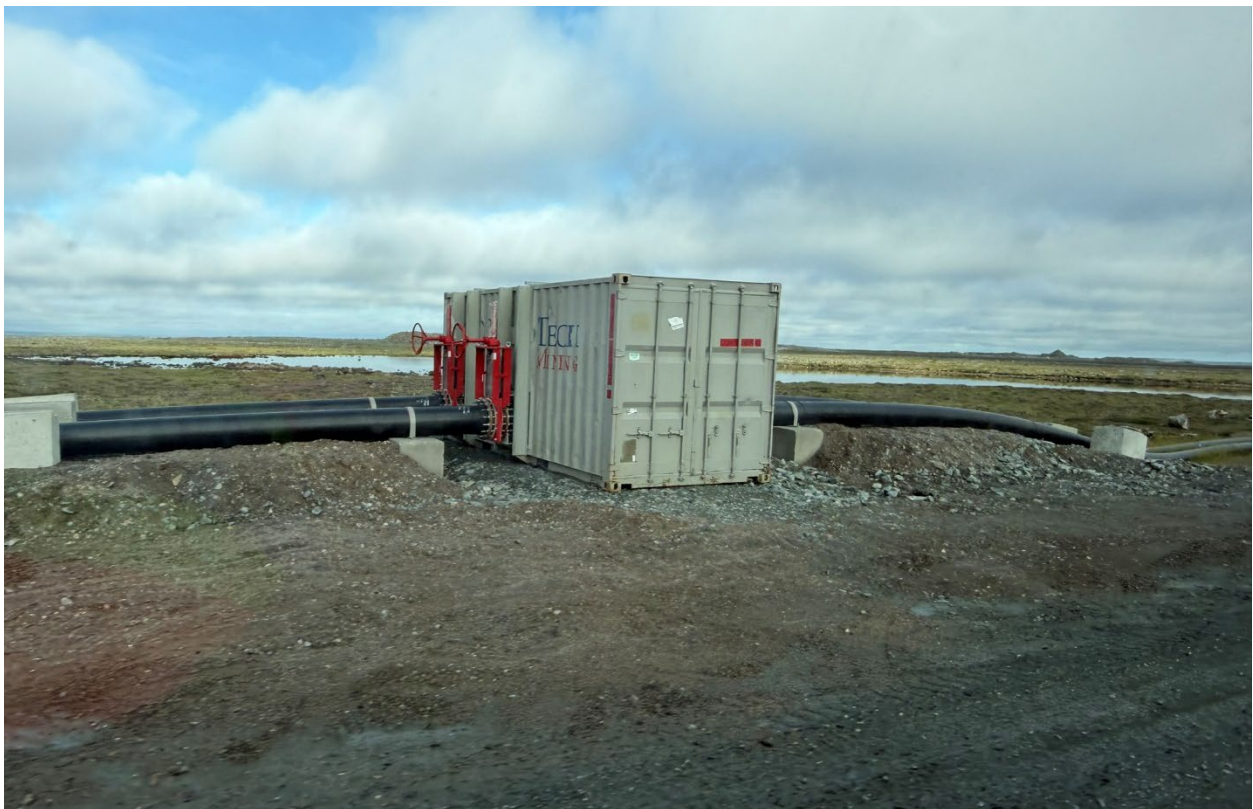
**Photo 29: Seacan containing pressure relief valves, and exposed waterline at KM 18**

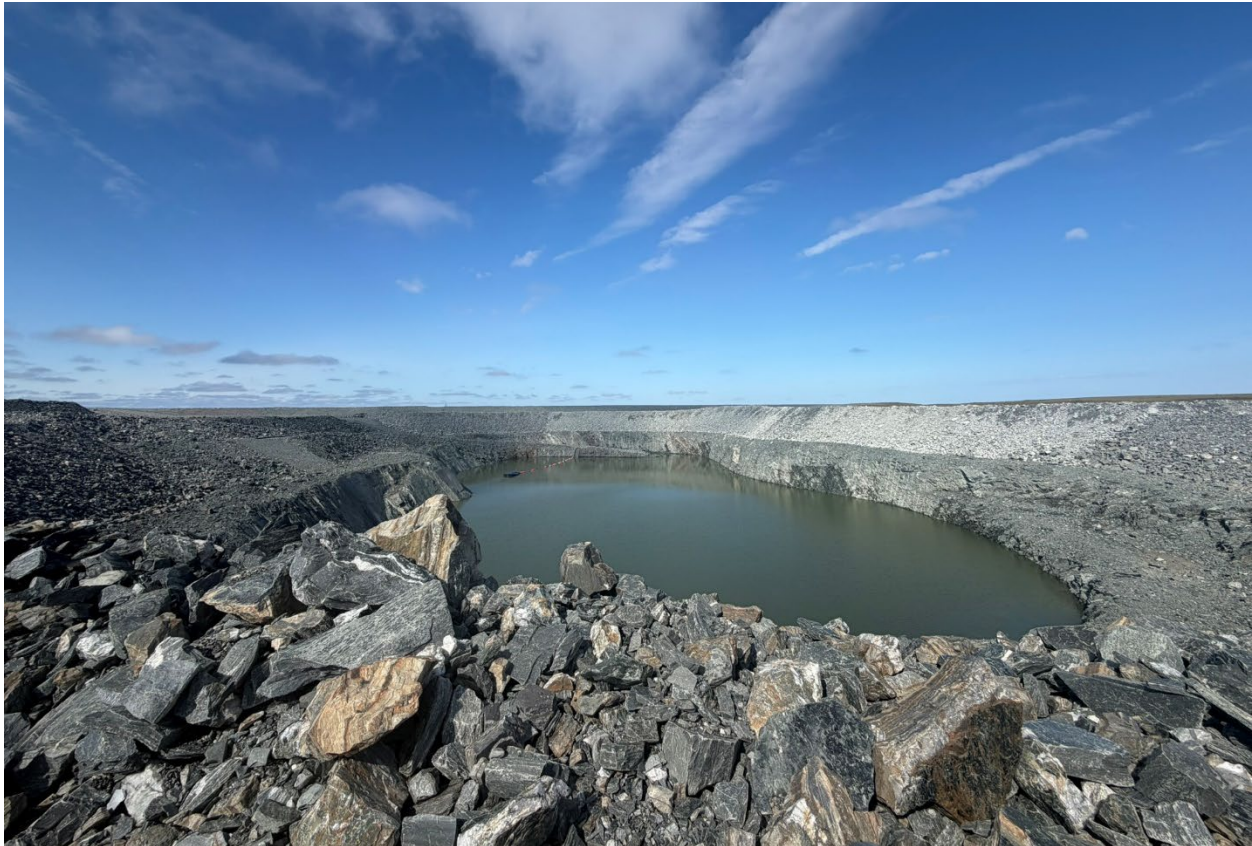
**Photo 36: Open pit Pump 01 / CP 9<sup>2</sup>**

<sup>2</sup> PUMP01 has been mined out, and the pit is now used as collection pond CP9. Agnico Eagle advised that surface contact water from WRSF6 and the wider Pump area is collected in CP9.

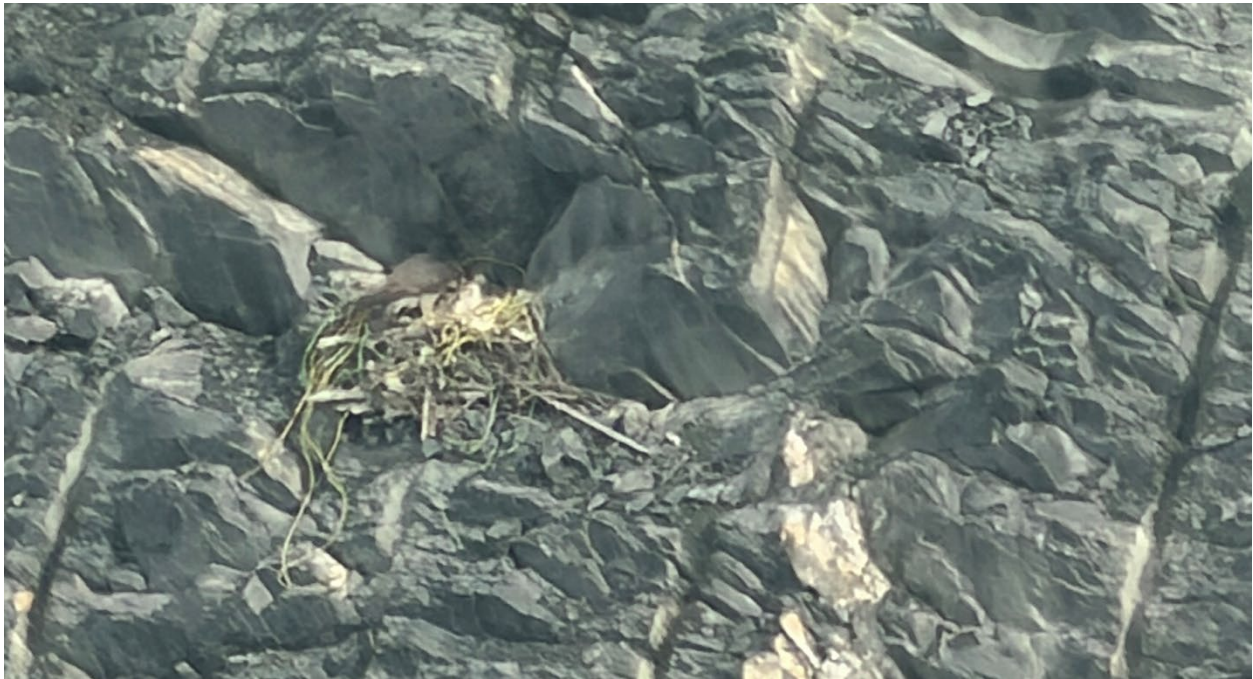
**Photo 48: Close up view of falcon nest observed on a bench on the northeast side of TIRI01<sup>3</sup>**

<sup>3</sup> A falcon nest was observed on a bench on the northeast side of TIRI01, which had hatched at the time of the visit. Agnico Eagle staff identified the nest as a falcon nest and advised that it was being actively monitored and that work in the immediate area was being avoided.

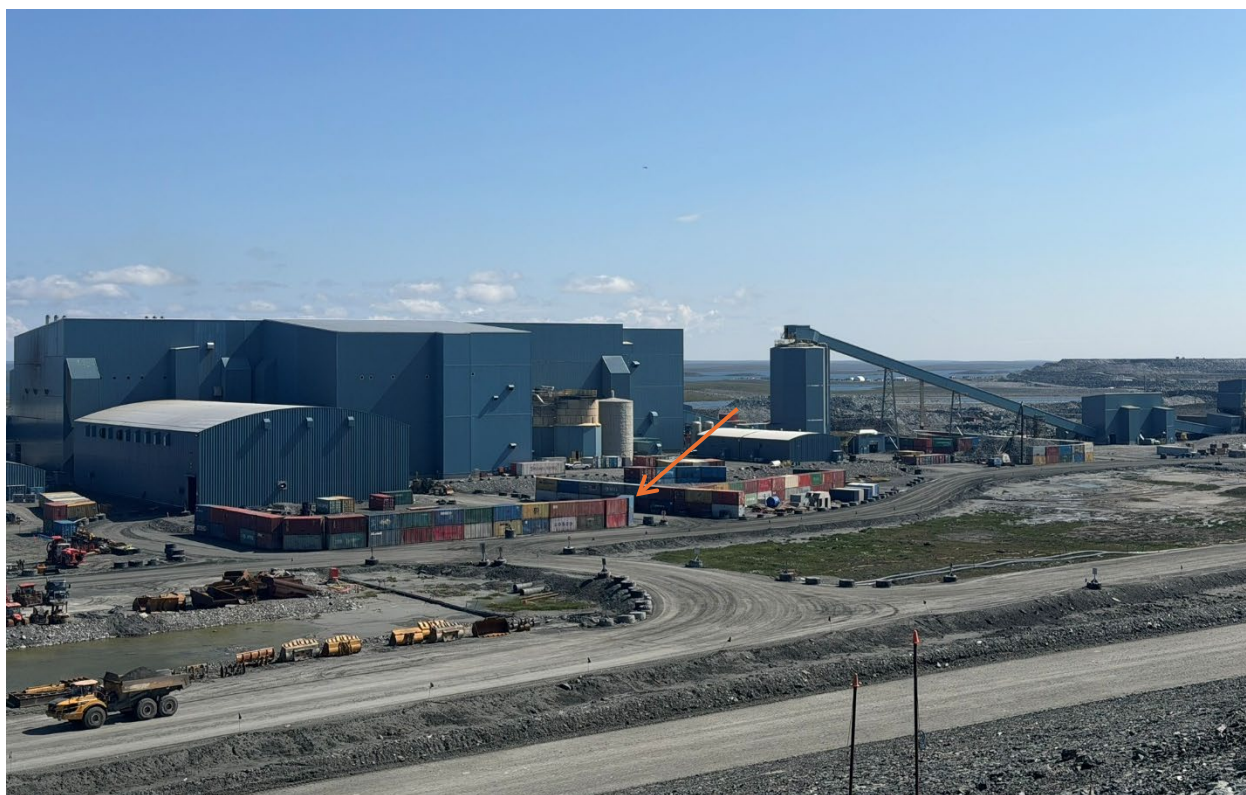
**Photo 57: Processing Plant, with seacans stacked two high to form a screening wall<sup>4</sup>**

<sup>4</sup> Agnico Eagle advised that seacans have been stacked two high around the Processing Plant to form a wall screening the facility, reducing visual disturbance to caribou moving through the area.

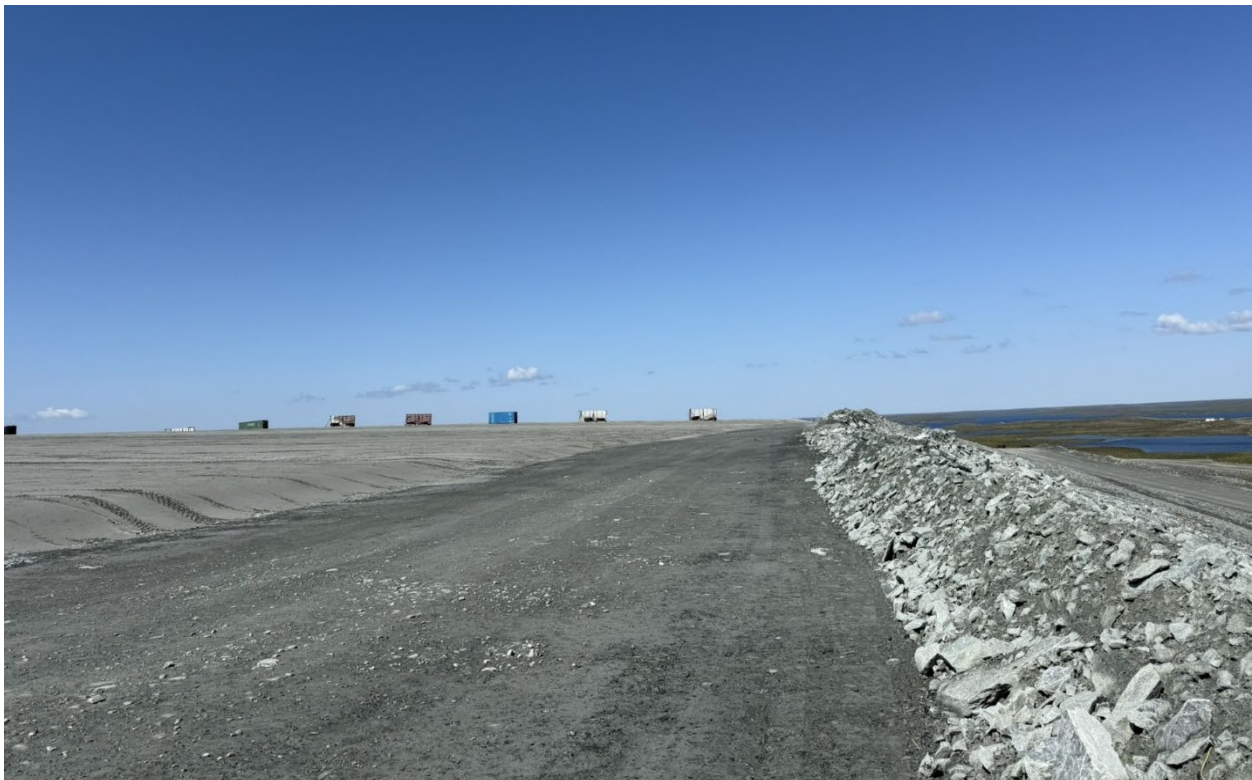
**Photo 67: Seacans stacked on top of the Tailings Storage Facility to act as wind fences<sup>6</sup>**

<sup>6</sup> Seacans have been stacked on the surface of the facility to act as wind fences, reducing fugitive dust and limiting deposition to nearby waterbodies. Runoff and seepage from the facility are collected in the site collection pond system for treatment before discharge.

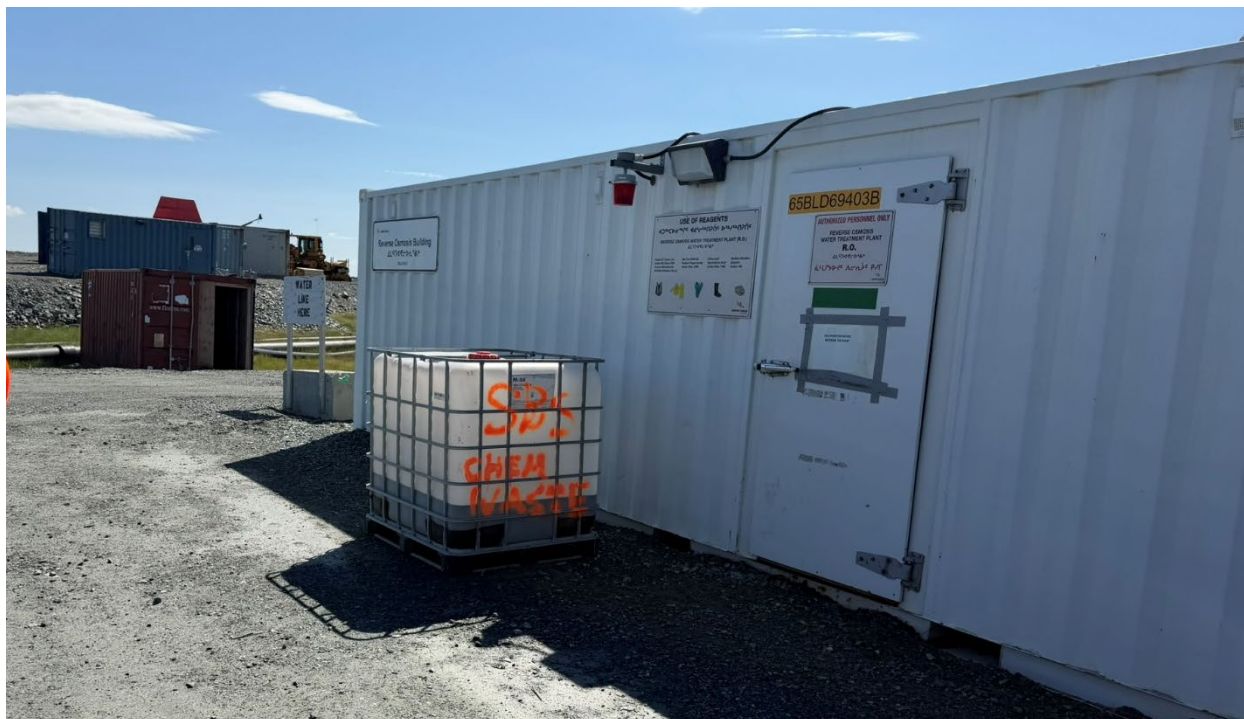
**Photo 74: Reverse Osmosis (RO) Plant<sup>9</sup>, with chemical waste tote noted stored outside of secondary containment**

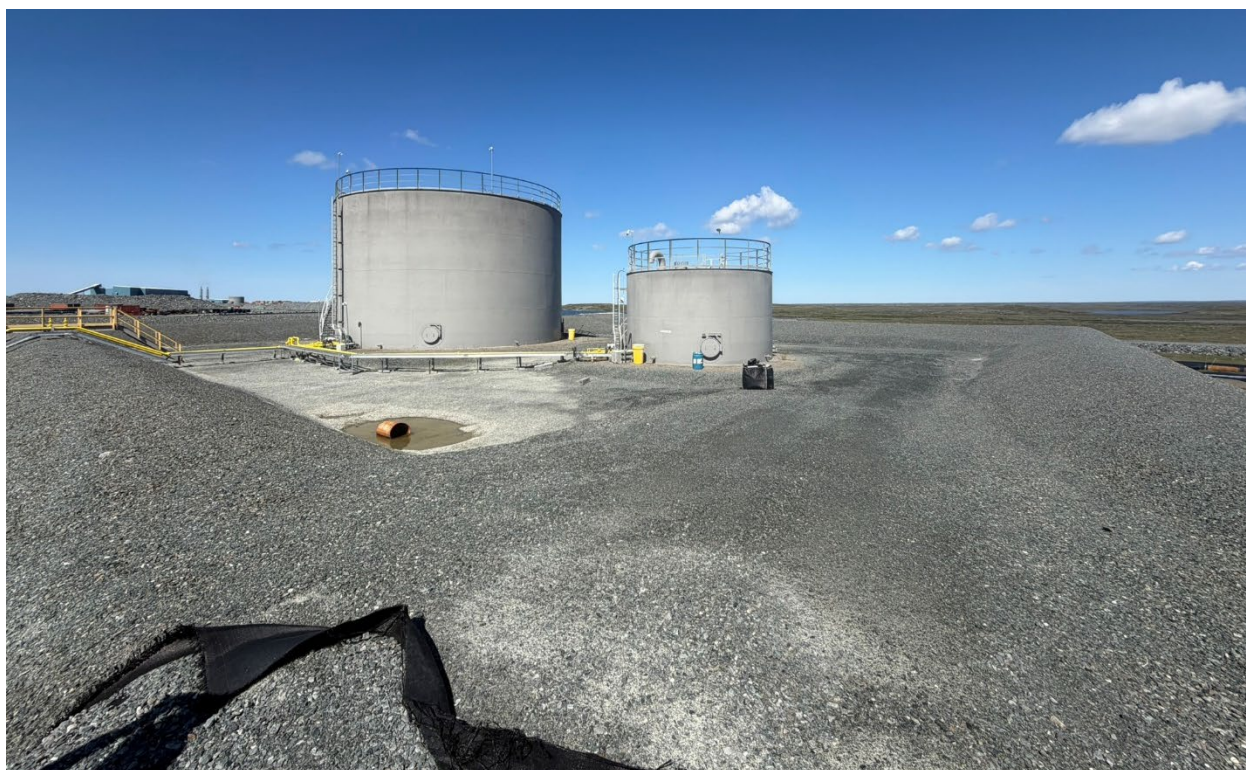
**Photo 85: Fuel tanks at onsite 3M Fuel Tank Farm in secondary containment; noted exposed liner**

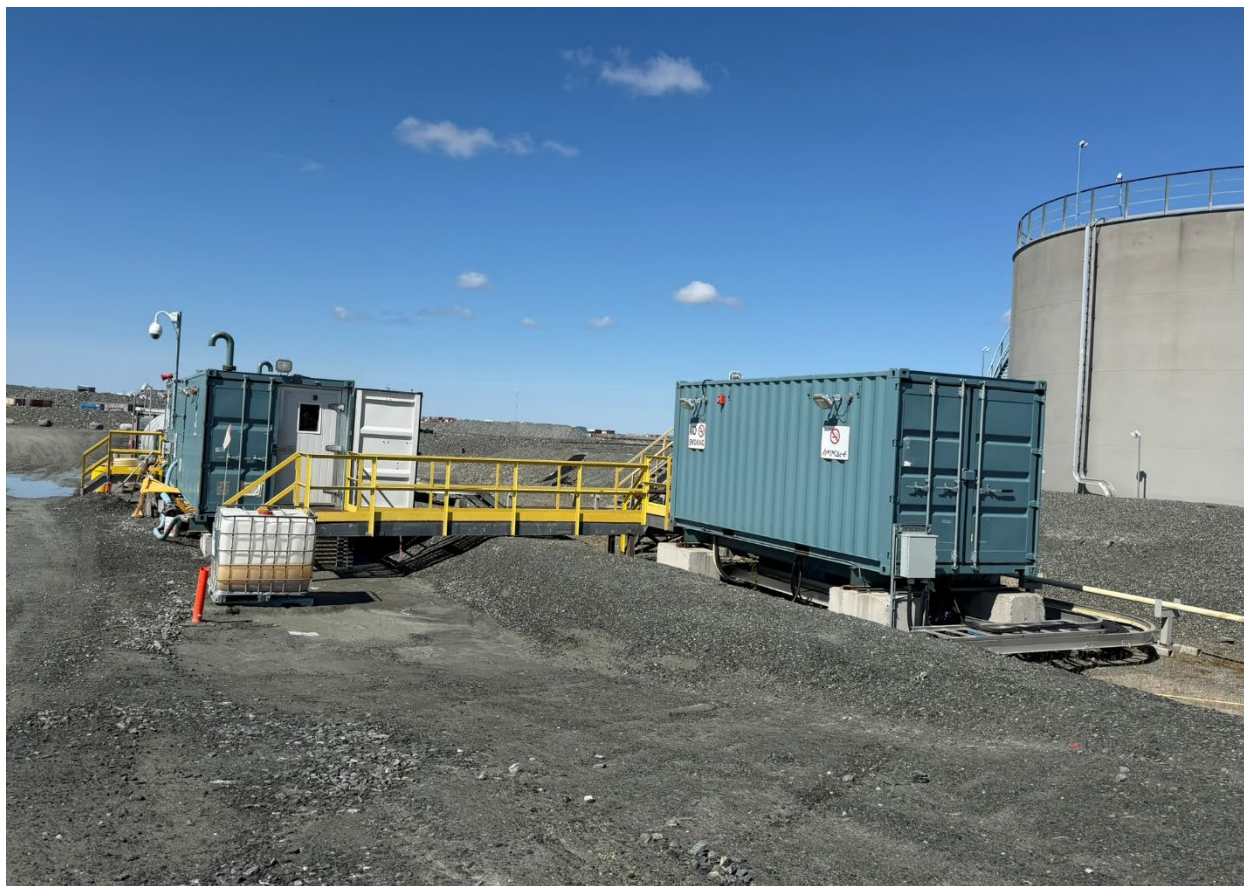
**Photo 86: 3M Pumping Station, with the DEF storage tank located outside secondary containment**

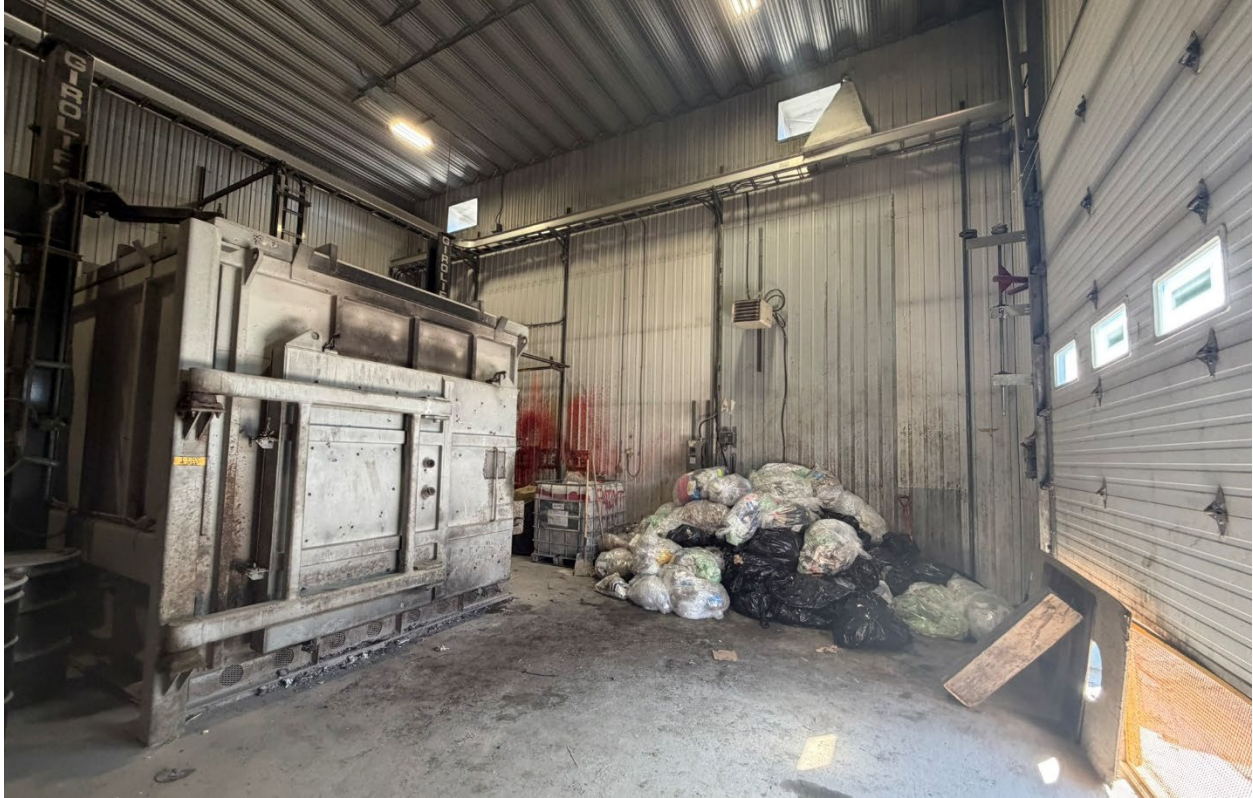
**Photo 90: Bagged waste accumulated within the incinerator building**

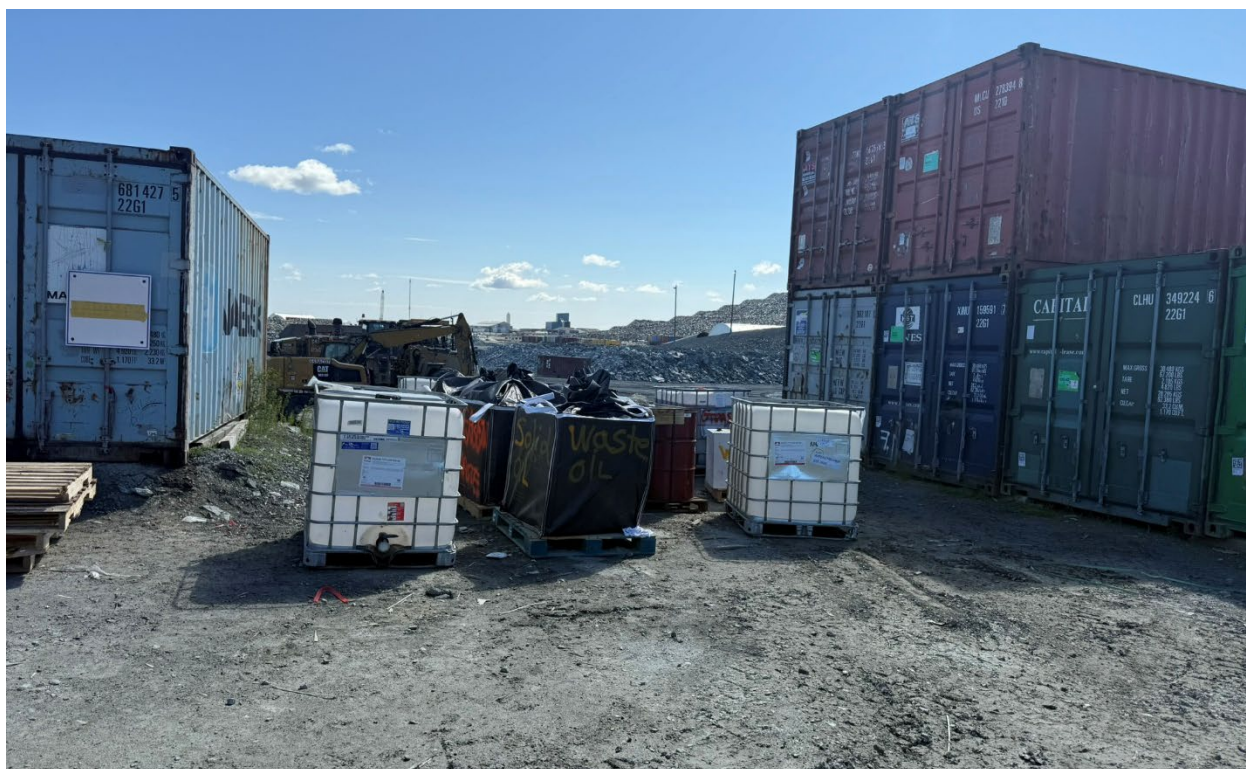
**Photo 93: Hazardous material totes and bulk bags staged outside of the seacans without secondary containment**

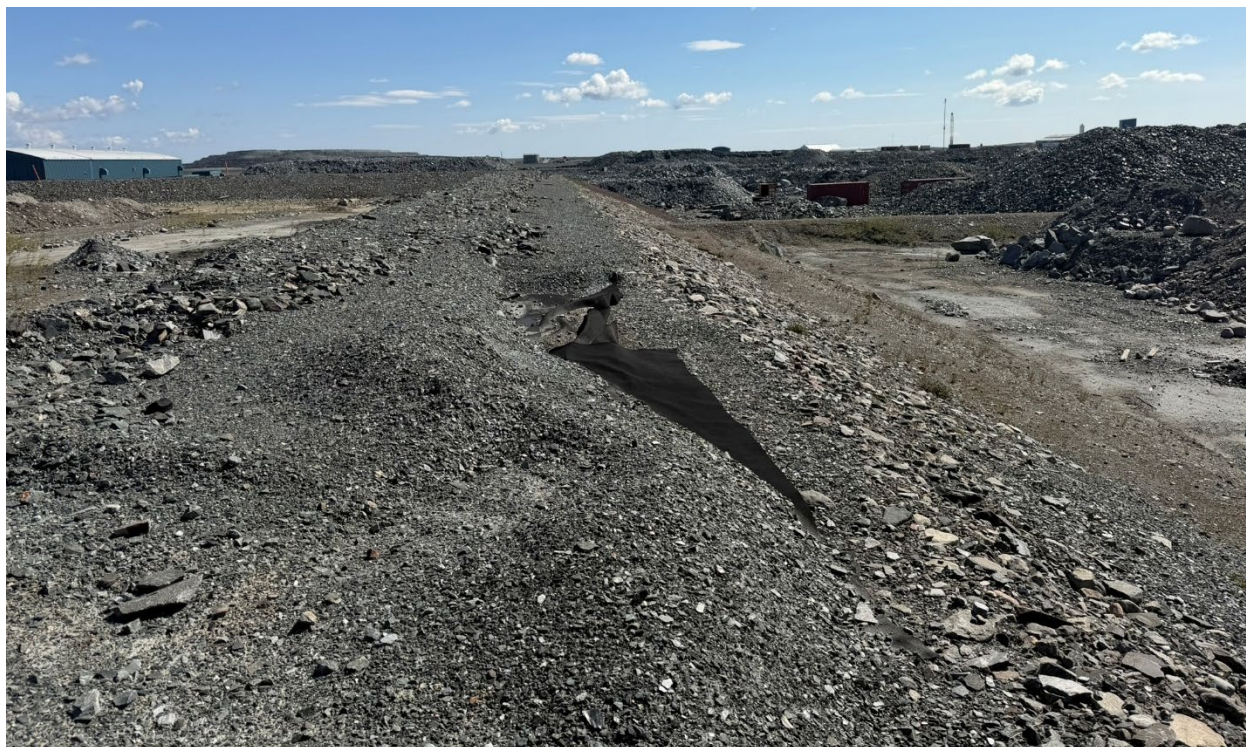
**Photo 94: Landfarm cells used for contaminated soil treatment; noted exposed liner**

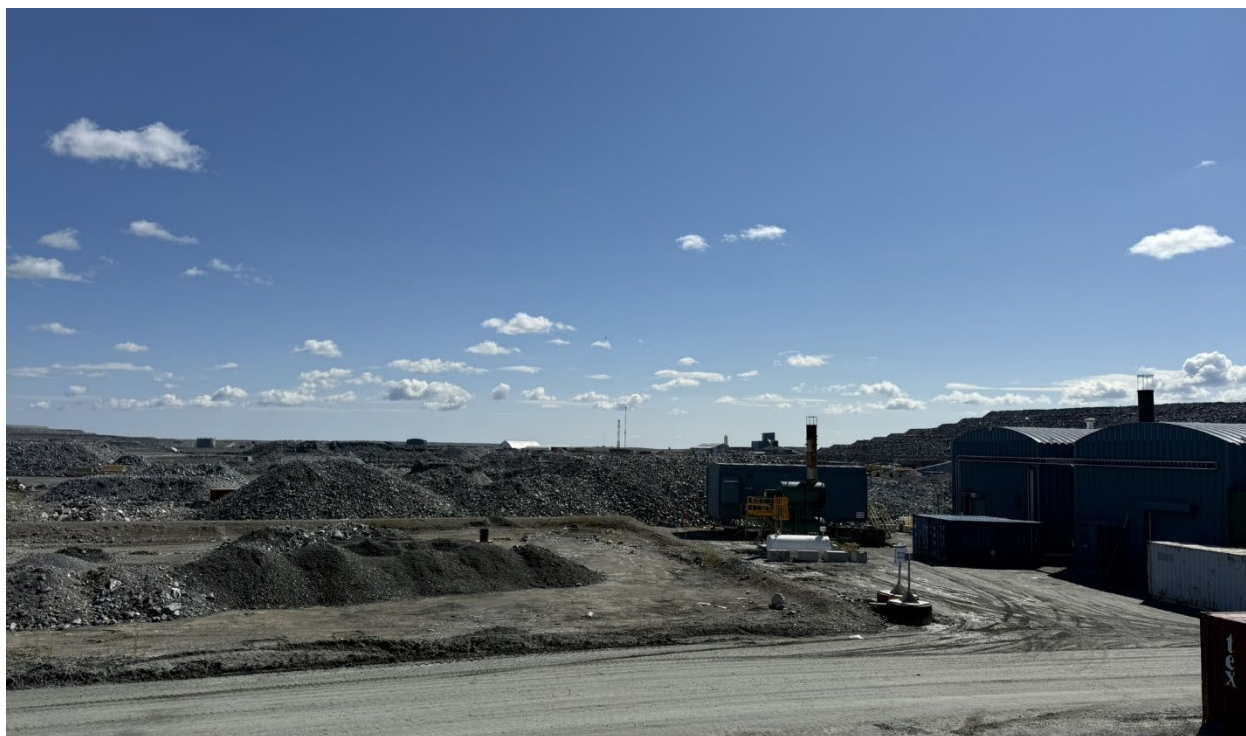
**Photo 95: Landfarm cells to treat contaminated soil<sup>12</sup>**

<sup>12</sup> At the landfarm, the perimeter berm appeared to consist of stacked soil rather than an engineered structure.

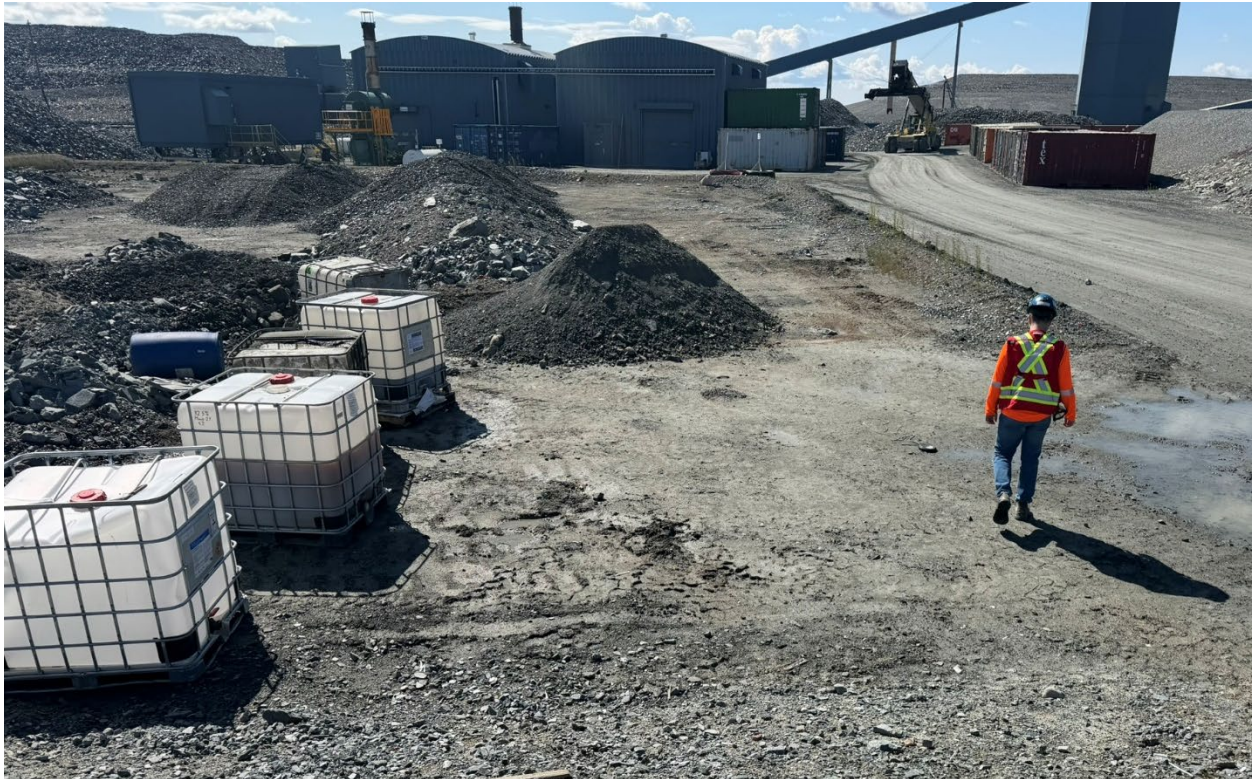
**Photo 96: Totes containing hazardous materials staged at landfarm cells**
