## 2026 Site Visit Report

# DORIS NORTH GOLD MINE & PHASE 2 HOPE BAY BELT (HOPE BAY PROJECTS)

File Nos. 05MN047 & 12MN001  
Project Certificates 003 & 009

Site visit report of the Hope Bay Projects for the 2025-2026 reporting year

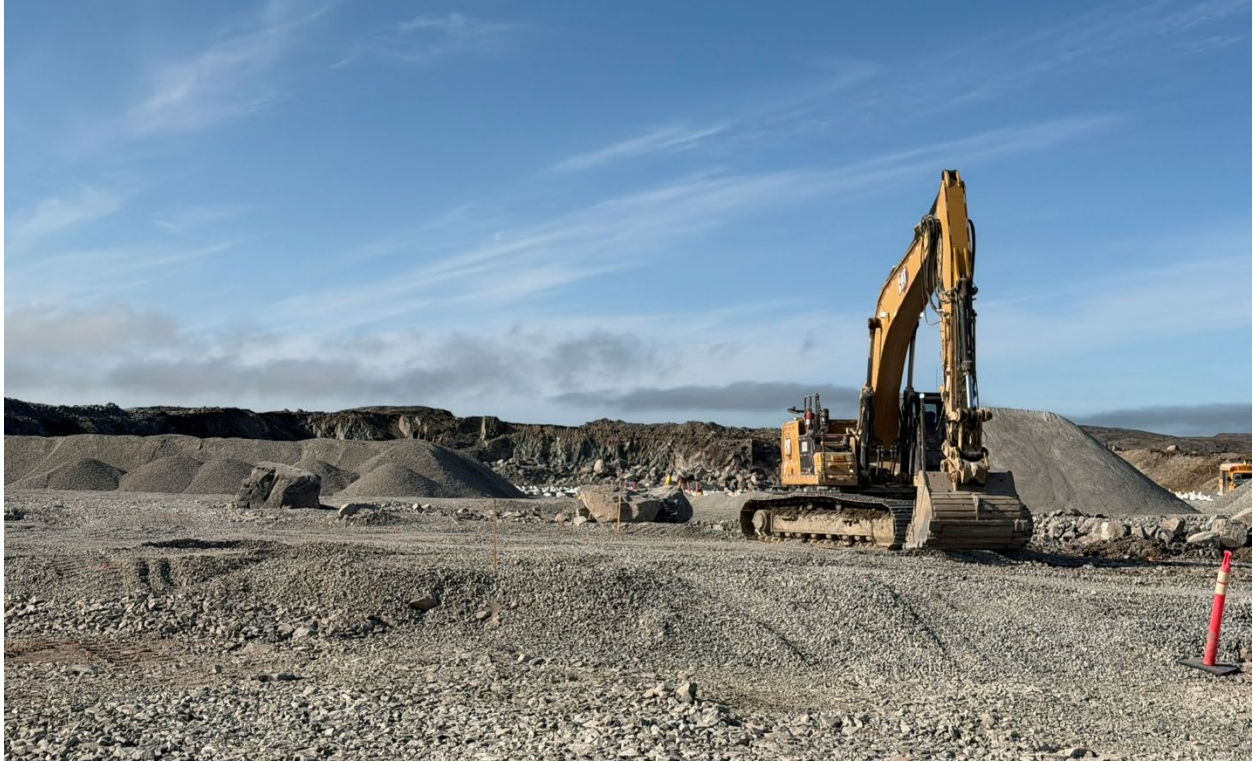
**Photo 13: Ongoing earthworks for future tank farm at Quarry AF**

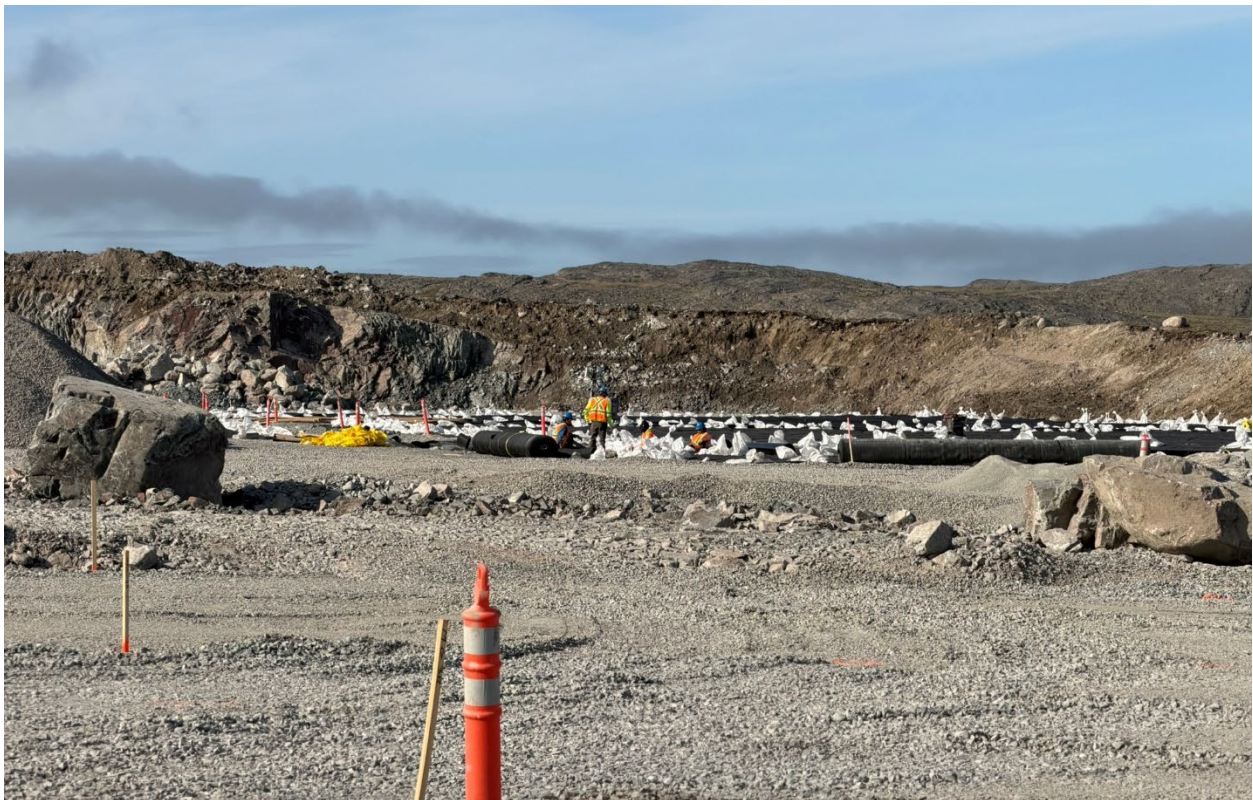
**Photo 14: Liner installation at Quarry AF**

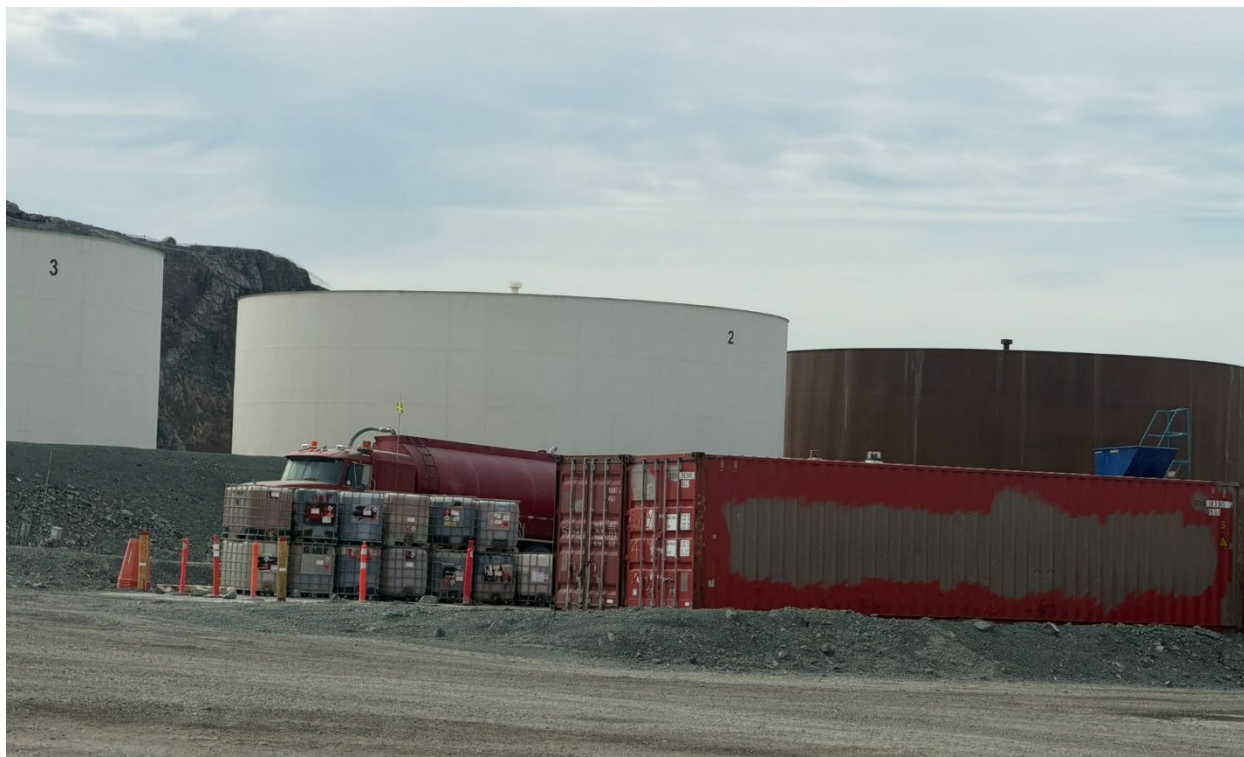
| <b>52</b> | Ensure that areas used to store fuel or hazardous materials include sufficient secondary containment and that all oil handling facilities have the required Oil Pollution Emergency Plan (OPEP) in place. | At the Roberts Bay tank farm, hazardous-material totes were observed stored on without proper secondary containment (Photo 17). |

**Photo 17: Hazardous-material totes stored adjacent to the Roberts Bay Tank Farm, without proper secondary containment**

Hazardous-material totes were observed stored adjacent to the Roberts Bay tank farm, without proper secondary containment (Photo 17). NIRB staff encourage Agnico Eagle to ensure all fuel and hazardous materials are stored within adequate secondary containment.

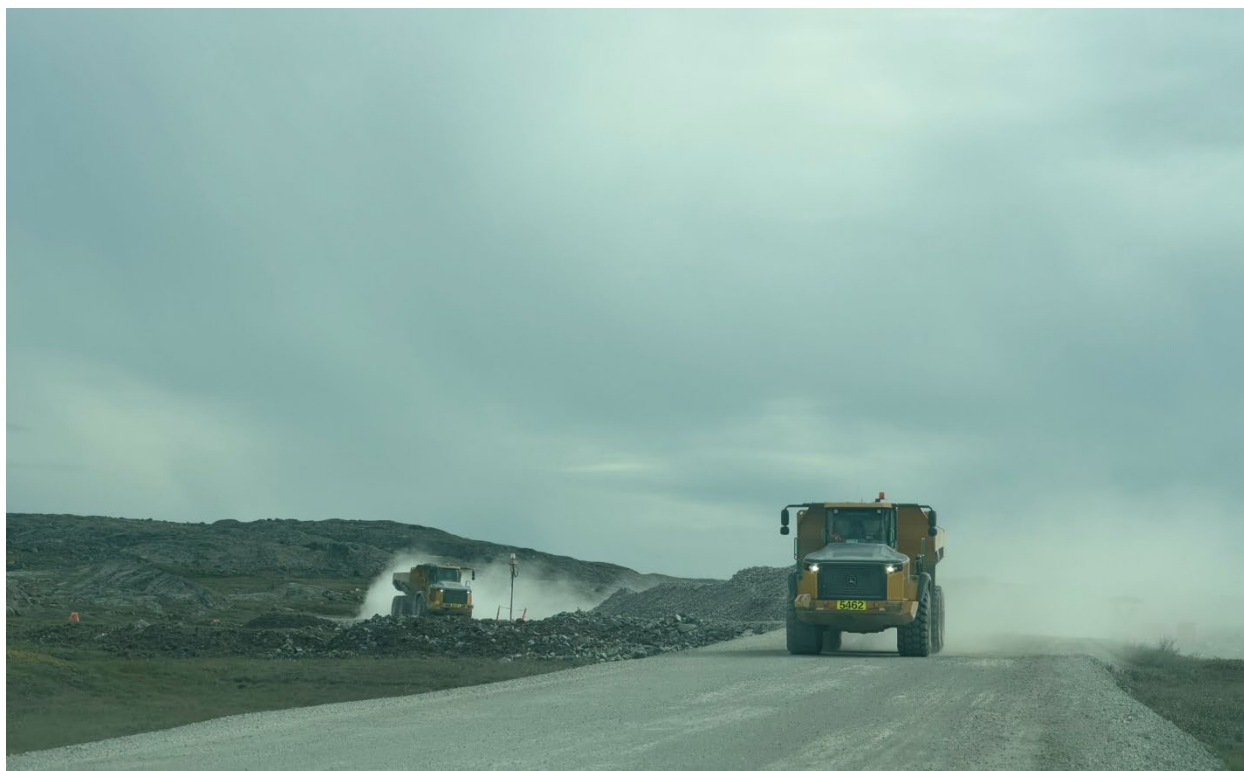
**Photo 22: Visible dust clouds on the Primary Road caused by ongoing haul truck operations**

Dust clouds were observed following haul-truck traffic along the Primary Road and at the airstrip extension, though dust suppressant was being applied to these high-traffic areas (Photo 22). NIRB staff encourage Agnico Eagle to continue monitoring dust and apply additional controls where localized dust persists.

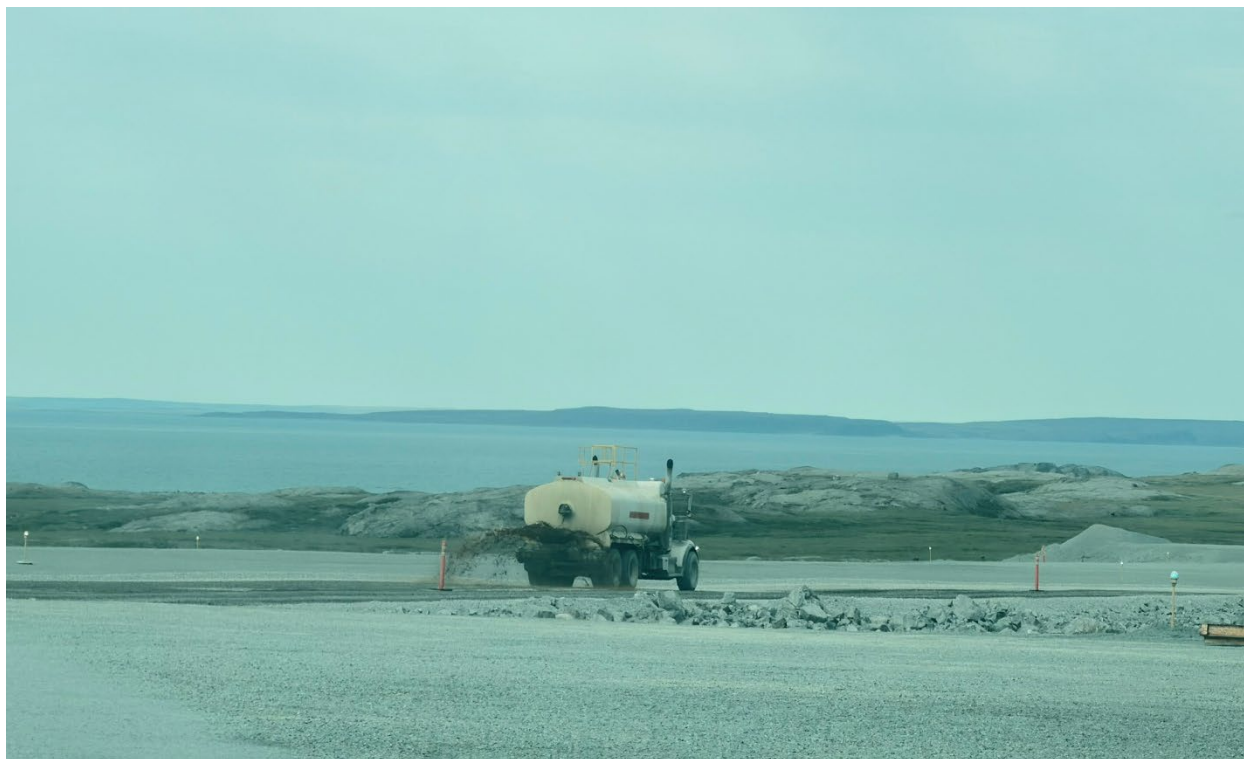
**Photo 23: Active dust suppressant being applied on the Primary Road and airstrip**

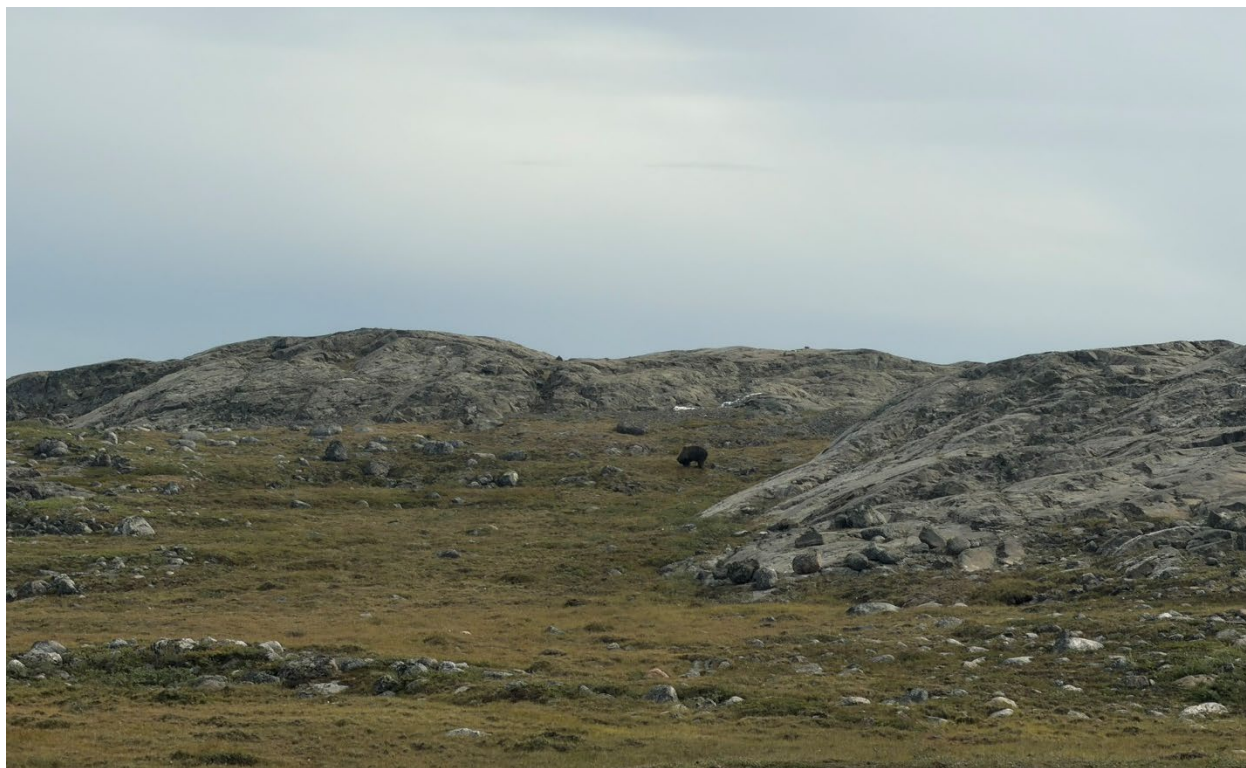
**Photo 27: Grizzly bear moving east away from the operational area following deployment of bear bangers**

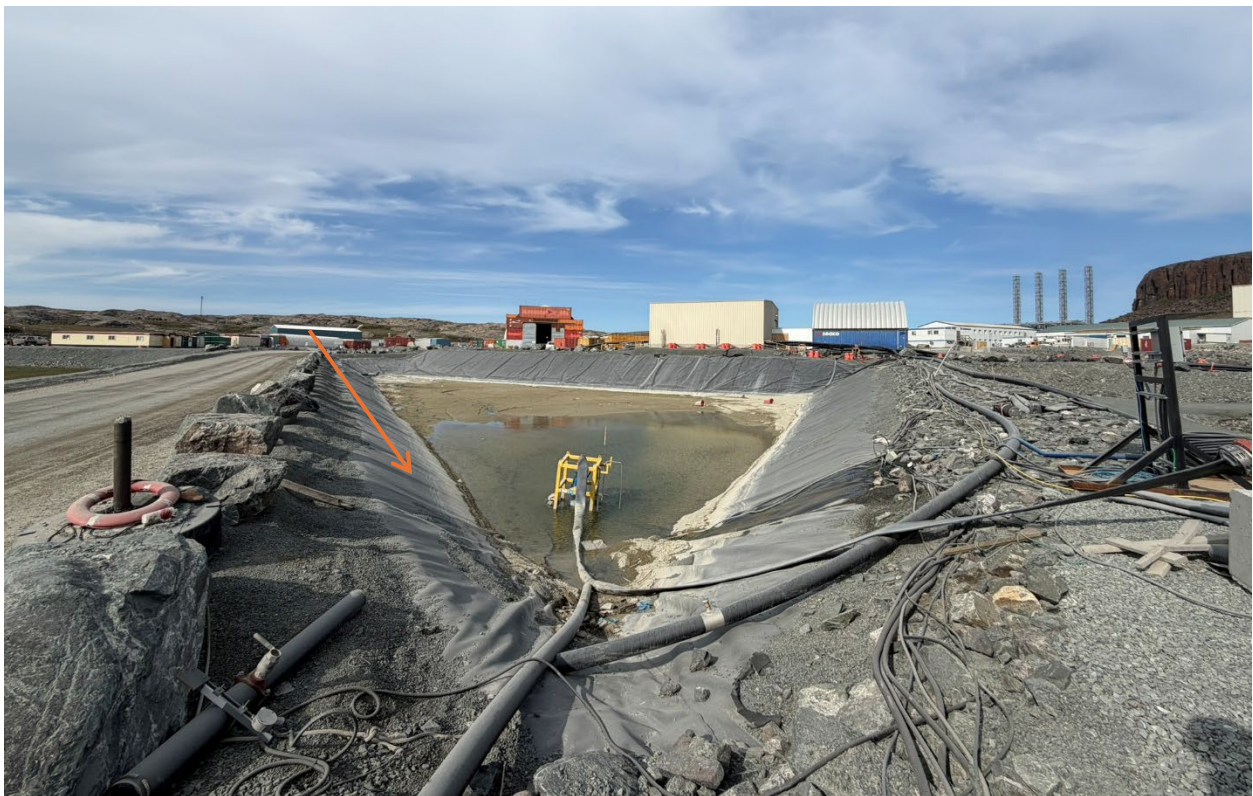
**Photo 36: Sedimentation Pond, exposed liner noted**

Exposed liner was observed at the Doris sedimentation pond, consistent with the 2025 observation (Photo 36). NIRB staff encourage Agnico Eagle to confirm if the inspection and repair measures are in place.

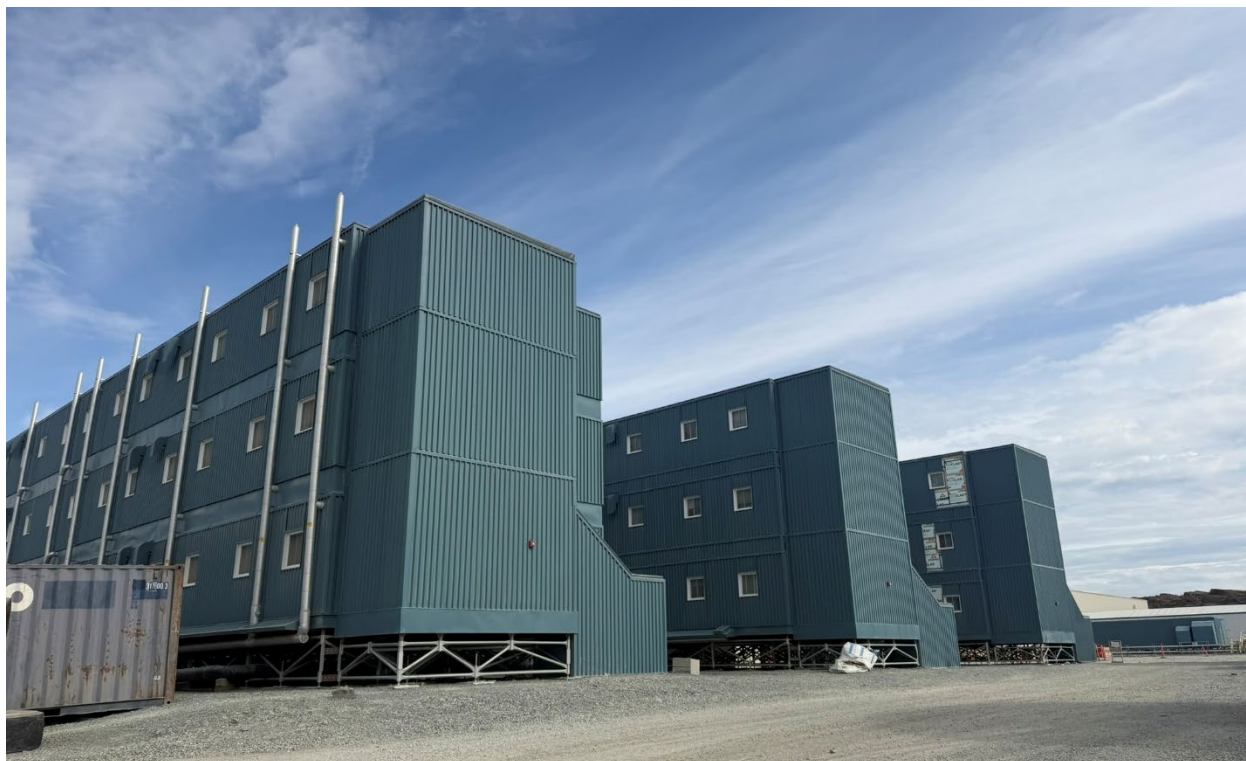
| <b>34</b> | Give notice of any significant planned changes to the mine facility. | Continued dismantling of the Doris Mill was observed, along with the Power Plant, MSB Building and Process Plant construction areas. The Doris camp expansion was observed (Photo 39 and Photo 41). |

**Photo 39: Newly built three-wing, three-storey accommodation complex at Doris Camp, future expansion planned**

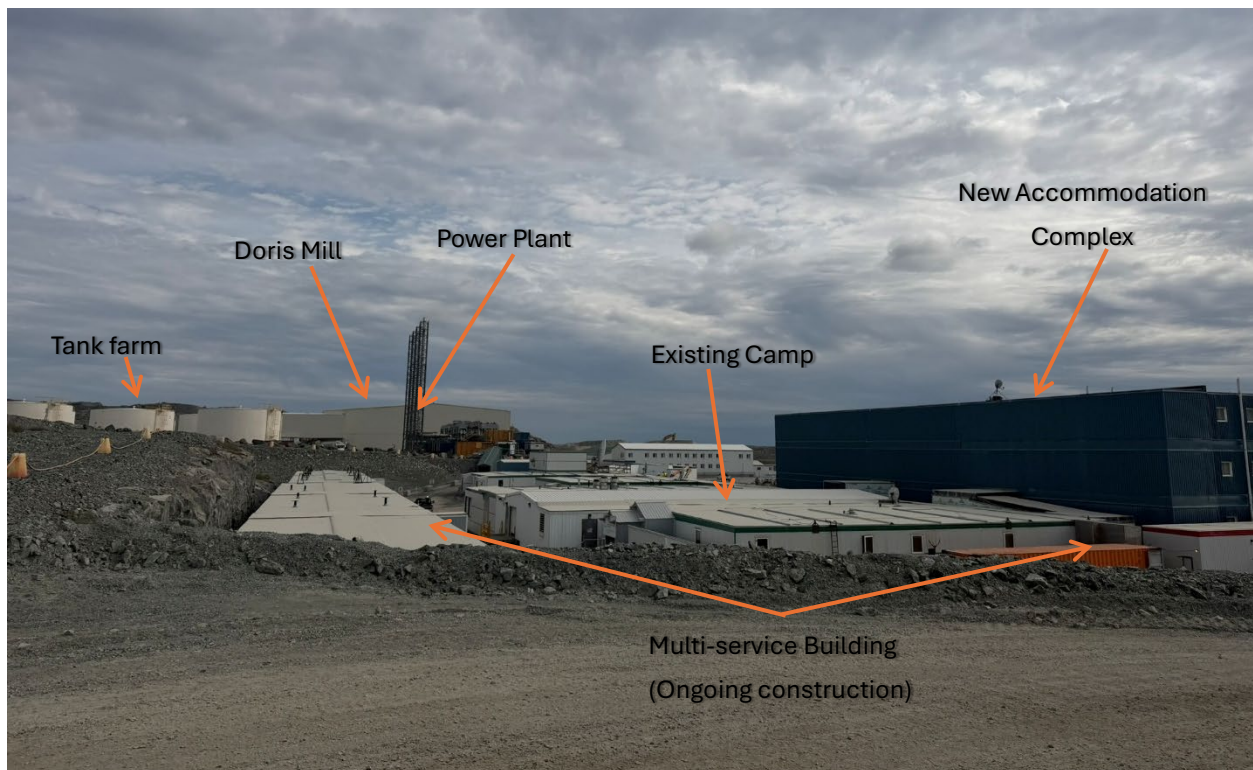
**Photo 41: Doris Camp, facing east (2026)**

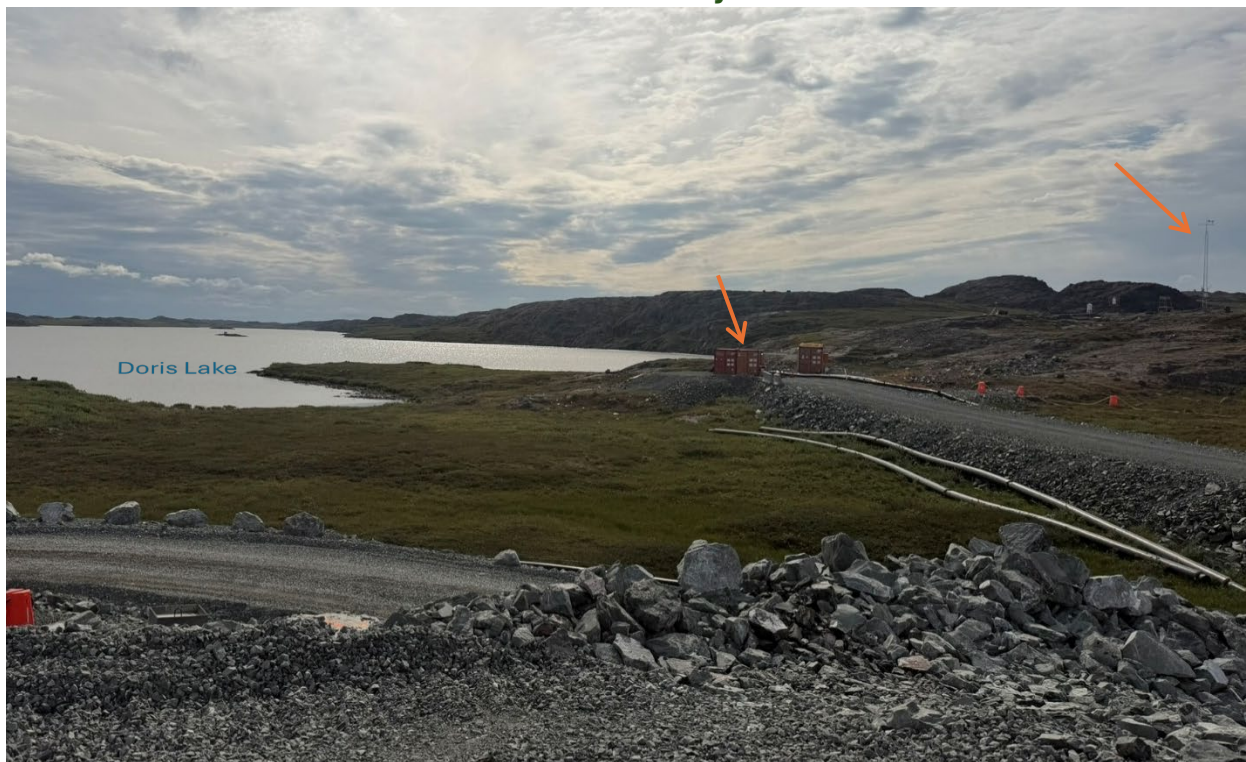
| T&C No. | Topic / summary | Site Observation |
|---|---|---|
| 8 | Collect atmospheric data and install a Weather Station. | The Doris meteorological station and atmospheric monitoring station were observed (Photo 51), along with dust monitoring stations across the site. |

**Photo 51: Doris connector vent raise and weather station**

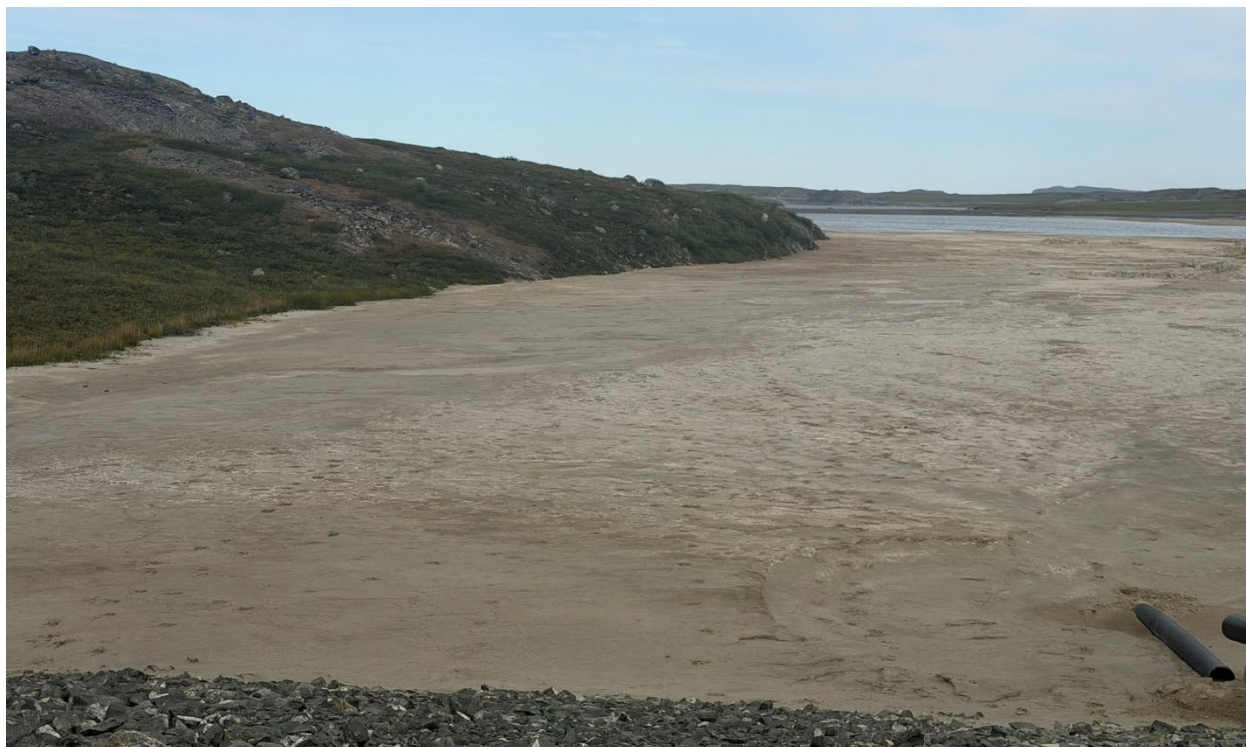
**Photo 62: Wildlife tracks observed on the tailings beach at the TIA South Dam, no wildlife deterrents were observed**

Wildlife tracks were observed on the tailings beach at the TIA South Dam (Photo 62), with no deterrents in that area. Agnico Eagle advised that wildlife pass through the area and do not linger at the TIA. NIRB staff encourage Agnico Eagle to confirm that wildlife monitoring measures at the TIA are effective in discouraging wildlife use.

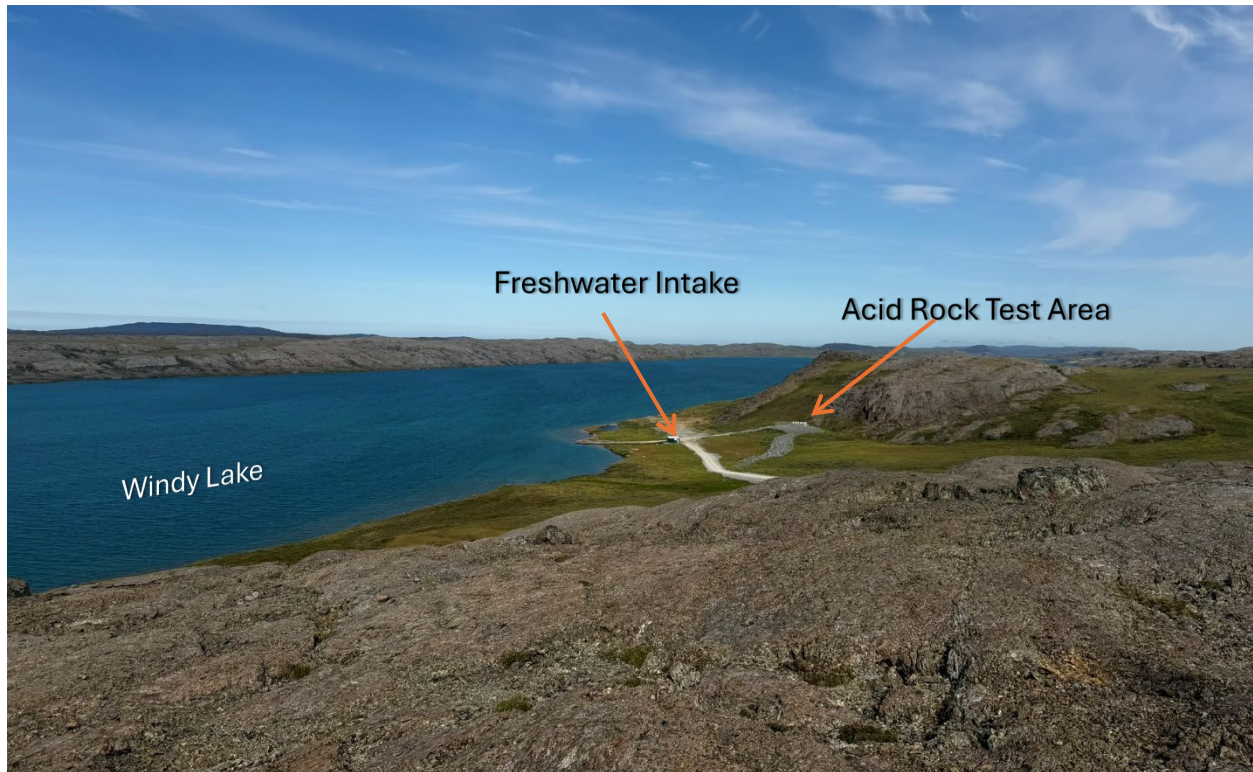
| <b>T&amp;C No.</b> | <b>Topic / summary</b> | <b>Site Observation</b> |
|---|---|---|
| <b>5</b> | Maintain a stand-alone Acid Rock Drainage and Metal Leaching Management Plan. | The acid rock testing area near Windy Lake was observed (Photo 68). |

**Photo 68: Windy Lake and Freshwater Intake**
