Canadian Coast Guard, tower removal, Mulroak Island, NU. 2019

MULROAK ISLAND TOWER DECOMMISSIONING PLAN, 2018.

PERMIT APPLICATION

MULROAK ISLAND DAY BEACON

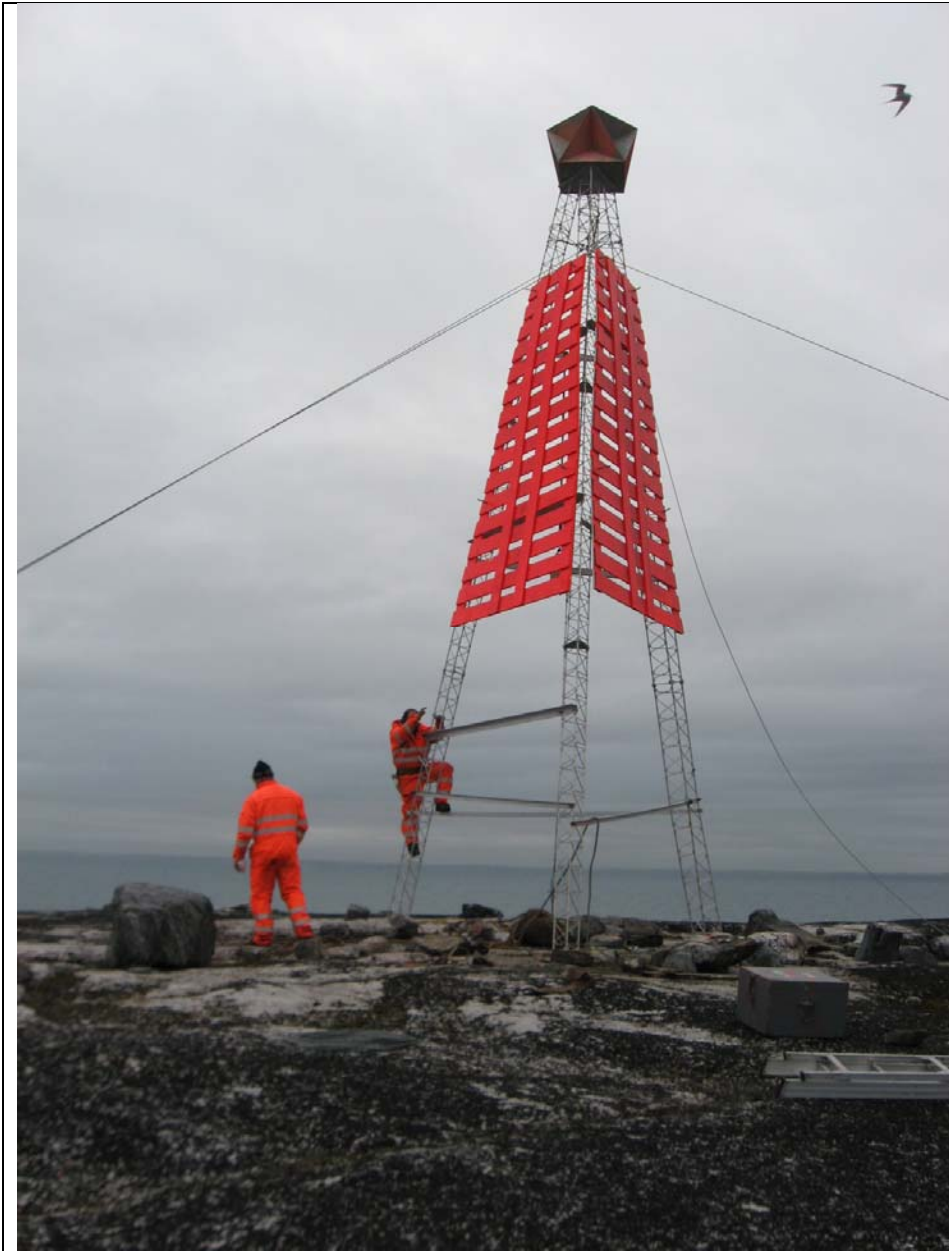
SITE VISIT AUGUST 2007

Site visited by:	SWL		
Date:	August 14, 2007 Not visited 2008		
Chart #: 7783	L.L. #: 4530	SWL #: 7090	WAC #:
Tower Size/Type:	30' Tripod.		
Tower:	Radar reflector to be re-positioned prior to F/A installation. Replace 1 – 13" lower leg section.		
Turnbuckles (3):	Eye to Eye type – New 2007		
Anchors (3):	Require 3 – Closed-eye Pins		
Day Mark:	2 new 2007		
Guy Wires 3 – 3/8"x 70' attached to top of tower – New 2007	Crosby Clips: 6 – 3/8"/Stay. (New 2007)		
	Radar Reflector	Top	Big
Site Condition:			
Site Pictures:	2007		
Site Access by:	Helicopter.		
<u>Fall Protection:</u>	Required with F/A Cautionary Sign.		
Safety:	Fall protection gear/equipment to be worn to climb tower.		
Environmental:	Lumber and braces removed 2007		
2007 Comments:	Leg levelling rods were functional in 2007 Replaced 9" lower leg, Installed 2 new Daymarks, Replaced 3 stays with 70' Installed closed eye turnbuckles and bulldogs Old braces and lumber removed from site. Pictures taken Nesting Arctic Terns on Island

2009 Requirements:	Change anchor pins with close eye with wedges Change 1 – 13" lower leg section		
MIMS TOWER #: AS333644		MIMS WORK PLAN #: W470239	
Helicopter Time (Est.):		Total Man Hours (Avg.):
