KM18
Layout of Preliminary Reclamation Trial

3.2 FOLLOW-UP MONITORING

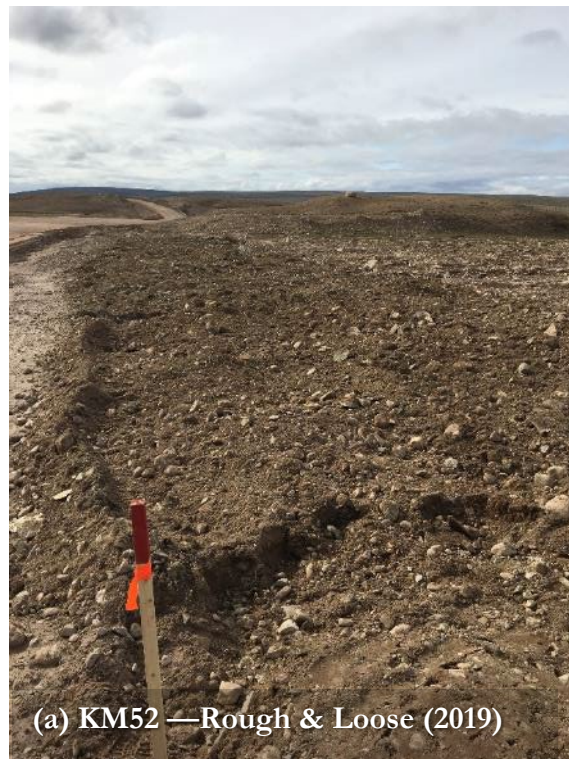
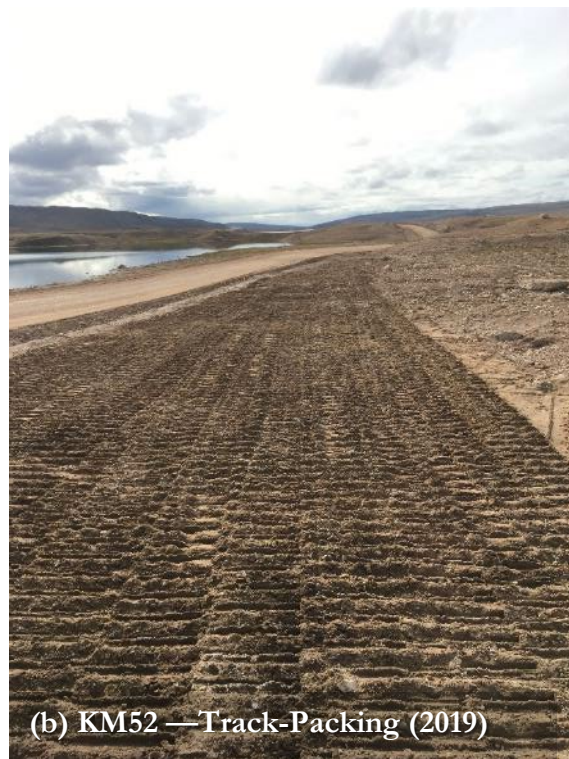
Photo 10. KM52 — Rough-and-loose (a) and track-packing (b).

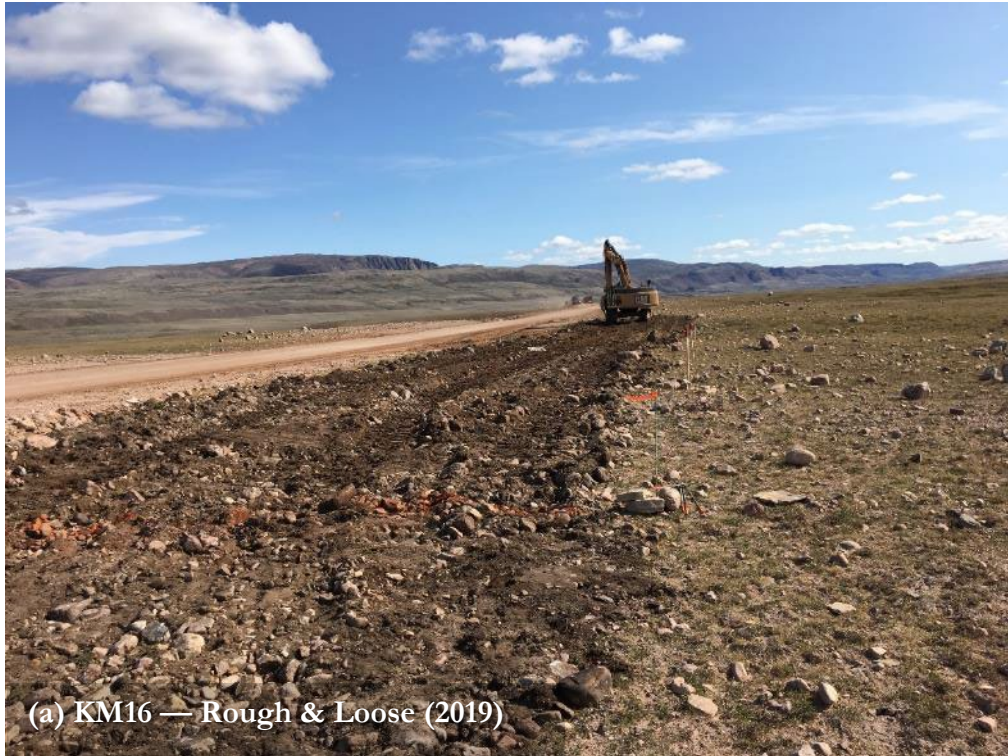
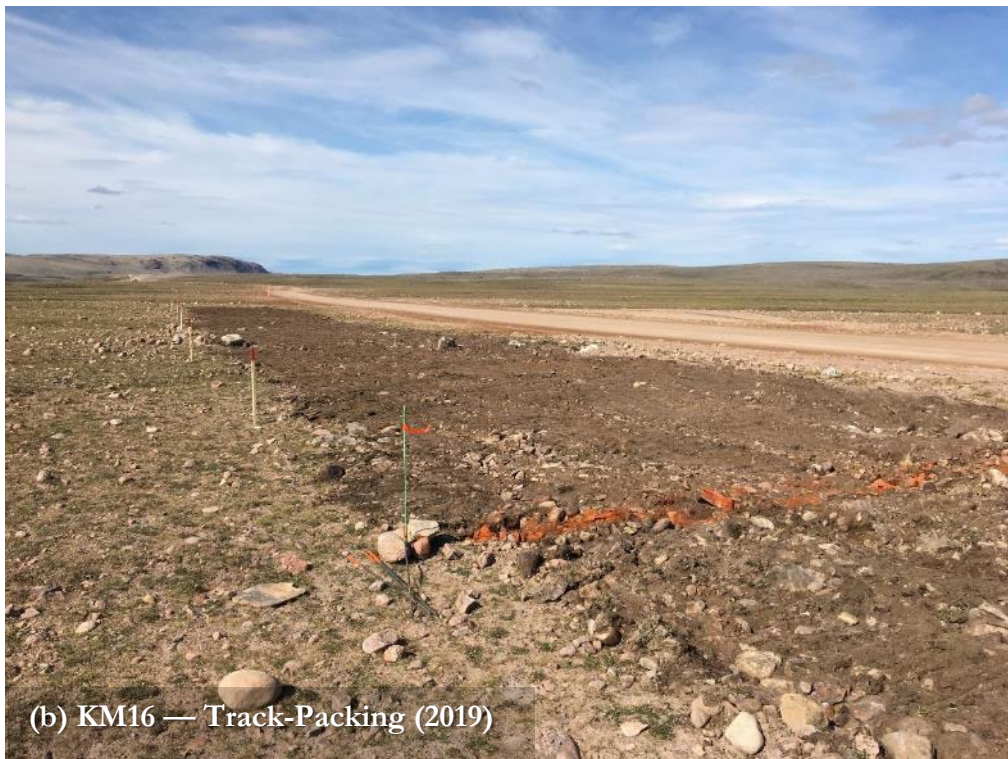
Photo 11. KM16 — Rough-and-loose (a) and Track-Packing (b).

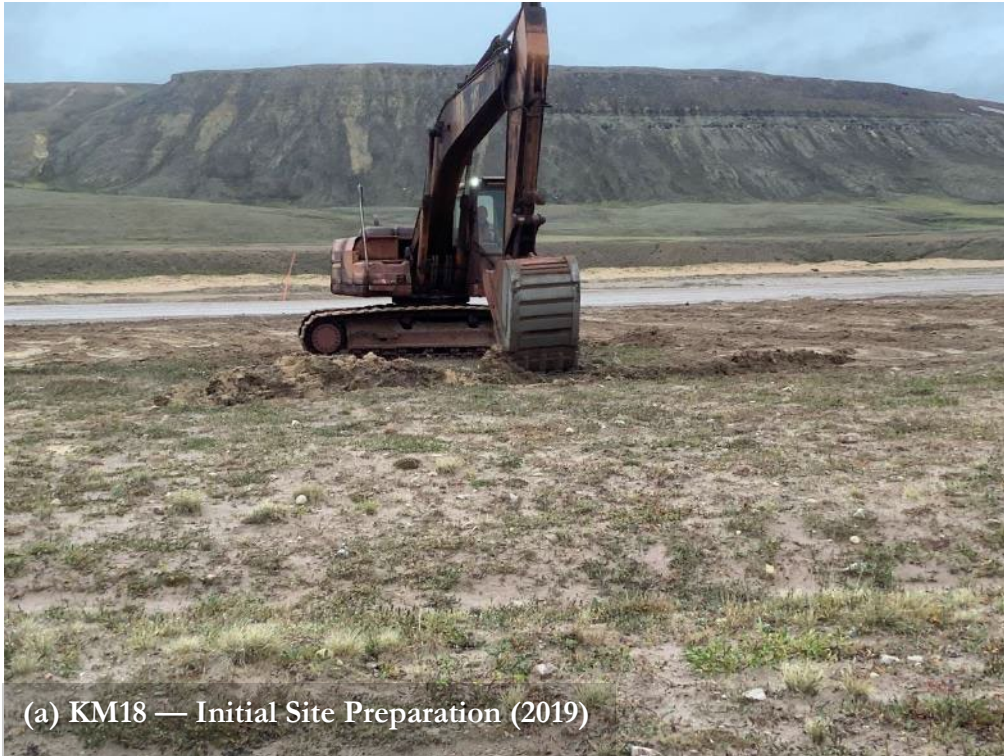
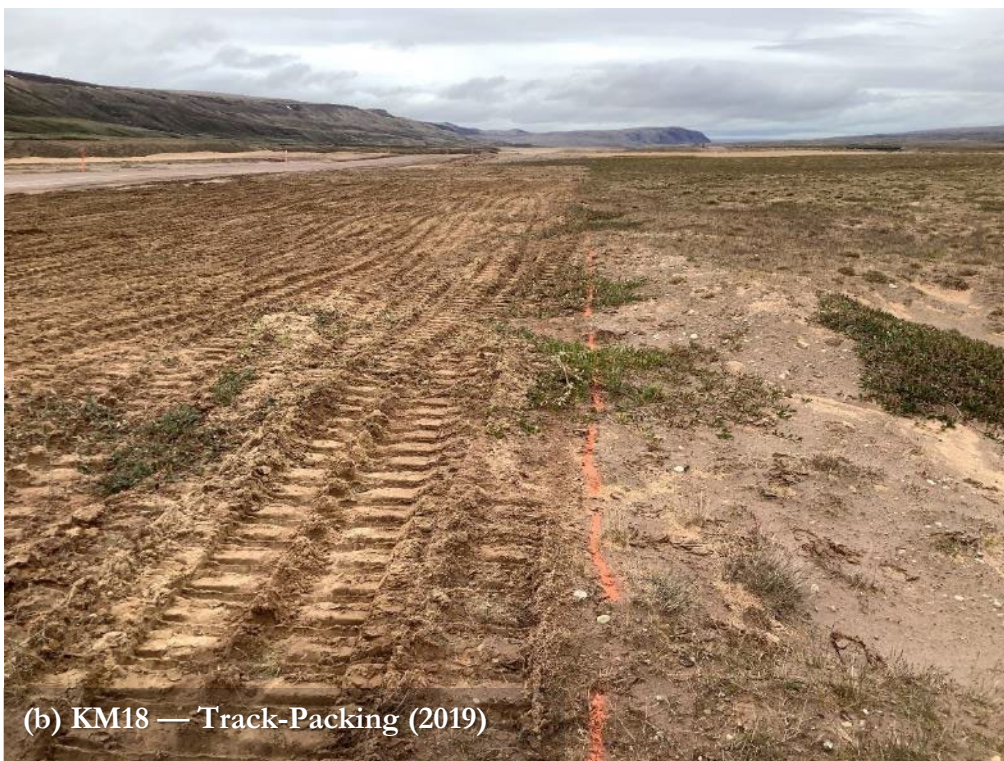
Photo 12. KM18 — Initial site preparation (a) and surface track-packing (b).

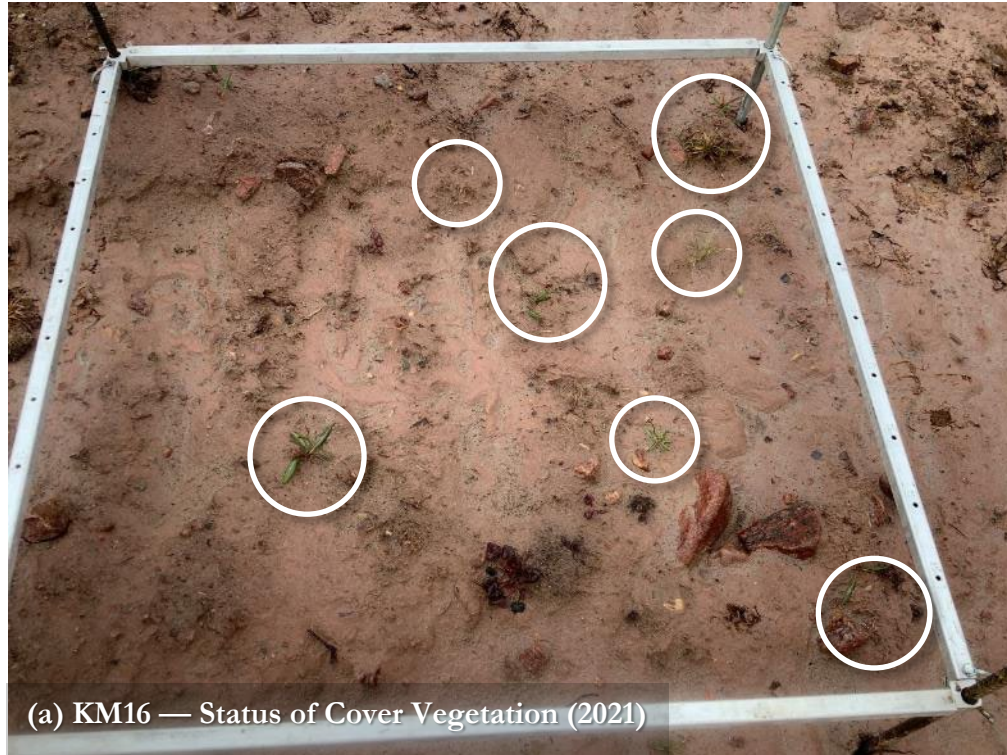
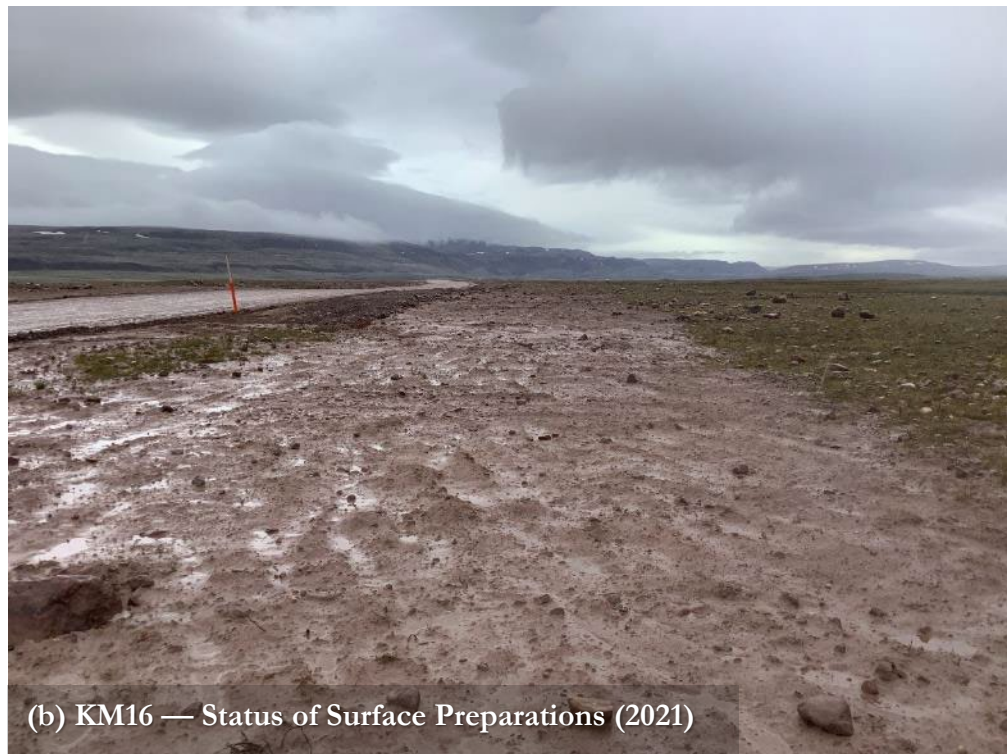
The KM52 and KM16 trial sites were revisited as part of a qualitative walk-over assessment in 2020 and a quantitative assessment in 2021 using the same methods described in Section 2.2. No measurable changes in revegetation at either site (both at transect and vegetation quadrat scales) were noted, but a few small volunteer forbs and graminoids were found to have colonized the area (Photo 13a and Photo 14a; refer to highlighted plants). A key observation was that the surface preparations (i.e., rough-and-loose and track-packing) had been ‘washed out’ due to weathering and were no longer apparent at both trial sites (Photo 13b and Photo 14b). The surface preparations are intended to create surface heterogeneity and micro-site conditions favourable to seed establishment and germination while reducing erosion potential and enhancing surface stability. Both sites were stable and deemed to have a low erosion potential. However, due to the nature of the growth substrate and surficial geology (i.e., predominantly sand and sandy loam), surface texturing and micro-topographical variations had been ‘washed out’ progressively in 2020 and 2021 as a result of snowfall/snowmelt, rainfall, wind and weathering.

(a) KM16 — Status of Cover Vegetation (2021)

(b) KM16 — Status of Surface Preparations (2021)

Photo 13. KM16 — 2021 Status of Cover Vegetation (a) and Surface Preparations (b).

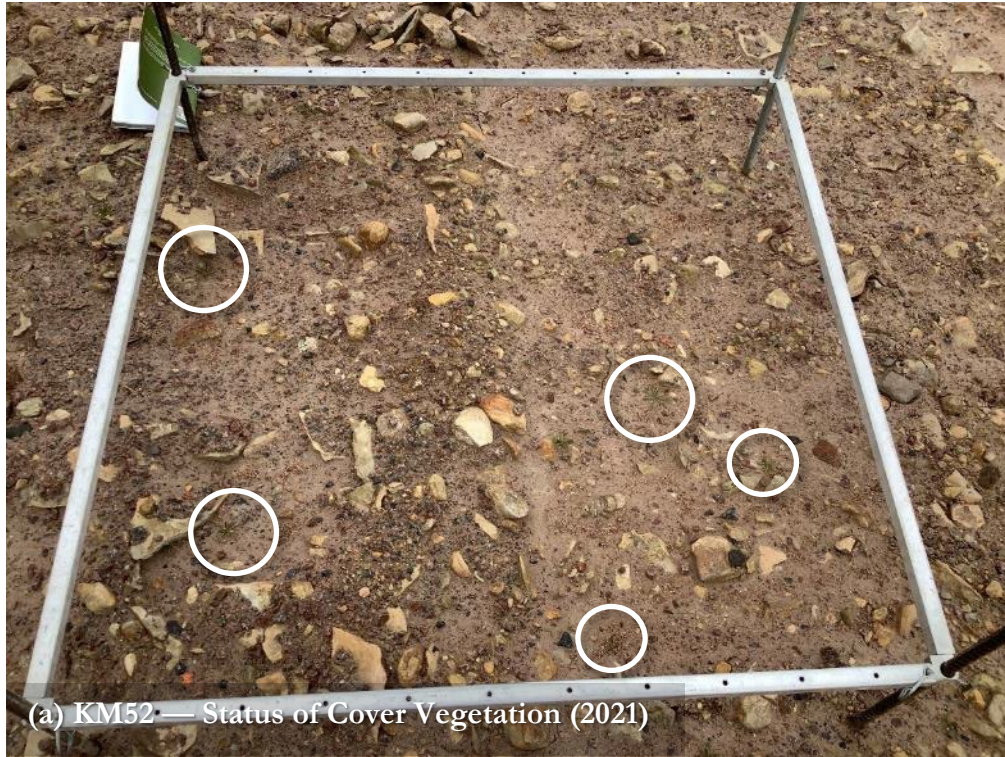
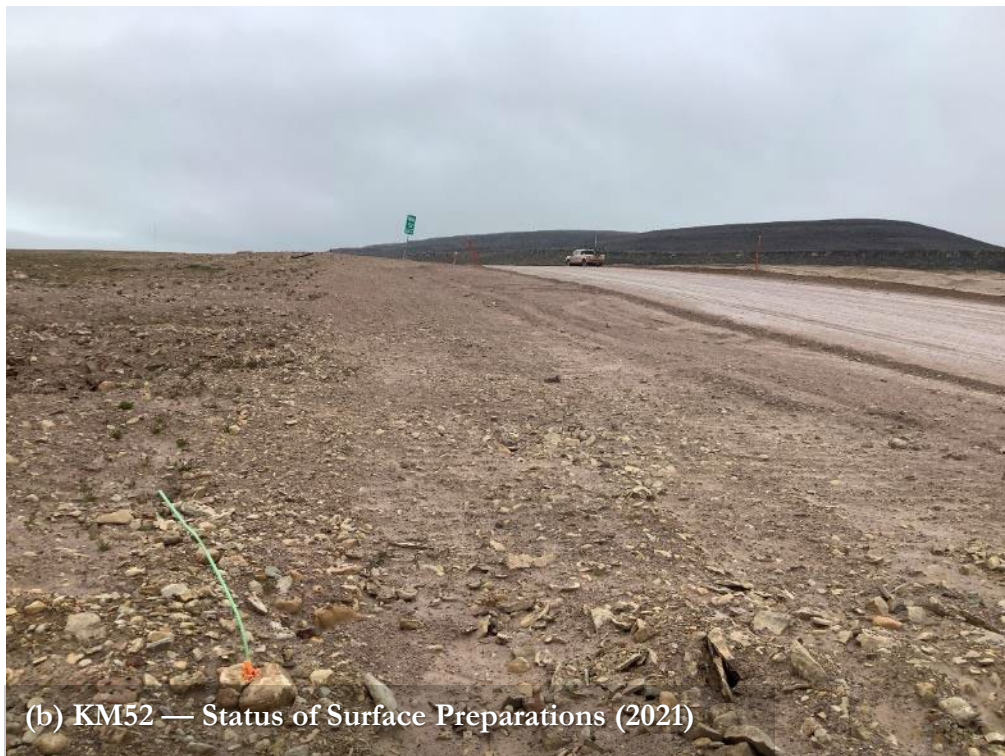
Photo 14. KM52 — 2021 Status of Cover Vegetation (a) and Surface Preparations (b).

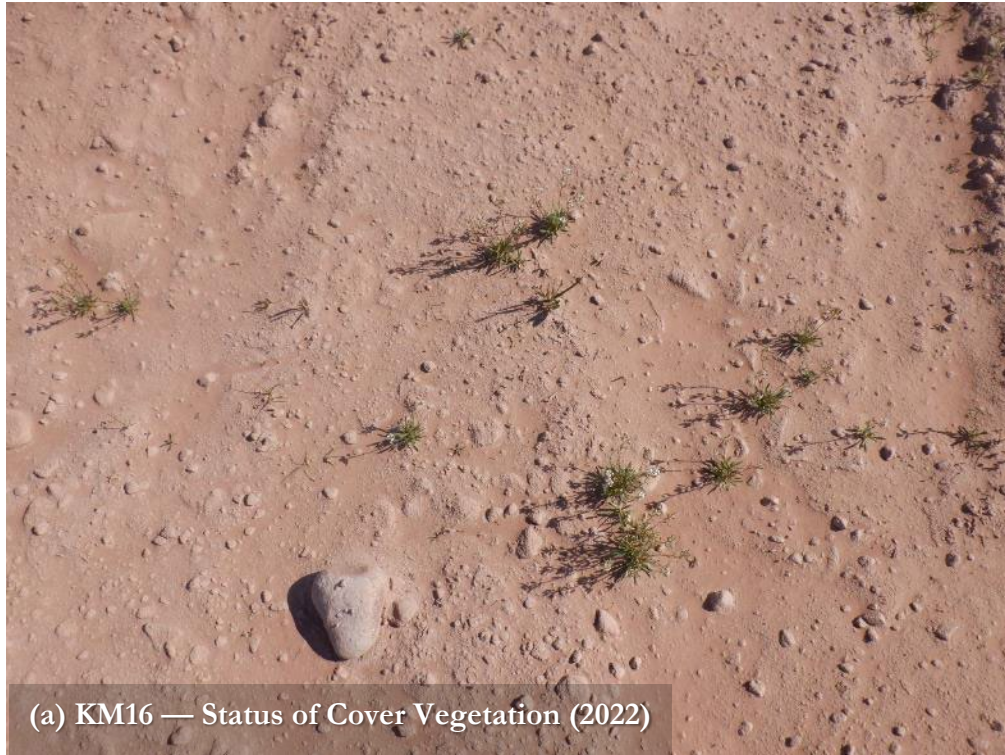
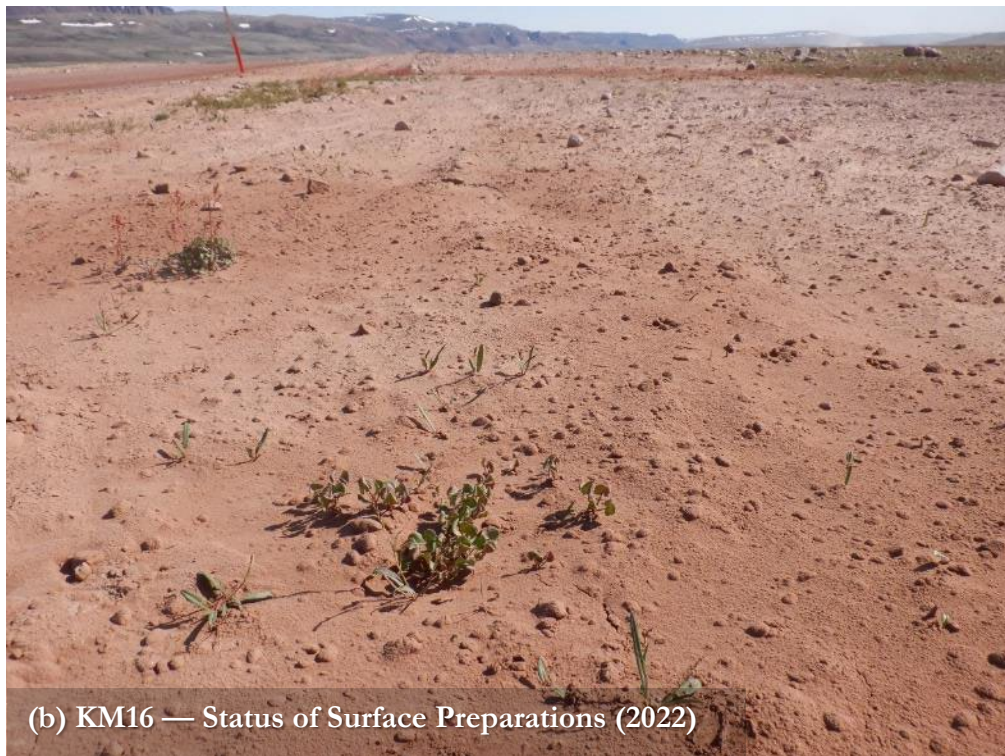
An increasing number of small volunteer forbs and graminoids were found to have colonized all sites (KM16, Photo 15a-b; KM18, PPhoto 16a-b; KM52, Photo 17a-b). The highest levels of revegetation (i.e., based on visual assessment) were observed at KM18 and KM16 (both characterized as subxeric), whereas KM52 (characterized as xeric) had the lowest levels of revegetation. Notably, the status of volunteer colonization and revegetation by Arctic willow (*Salix arctophila*) — a common low-lying, creeping shrub known to hold multiple ethnobiological usages, including fire fuel (*personal communications*) — at KM18 was at a more advanced level than expected, given only 1-year post-disturbance. In this case, adjacent land vegetation cover remained intact and viable. Following 2021 surface preparations, this species is suspected of having quickly adapted to site conditions leading to its predominance within the disturbed landscape. A similar observation regarding the proximity and viability of adjacent vegetation cover was made with respect to the vegetation cover conditions at KM16 during the 2019 assessment (refer to Section 2.5).

Photo 15. KM16 — 2022 Status of Cover Vegetation (a) and Surface Preparations (b).

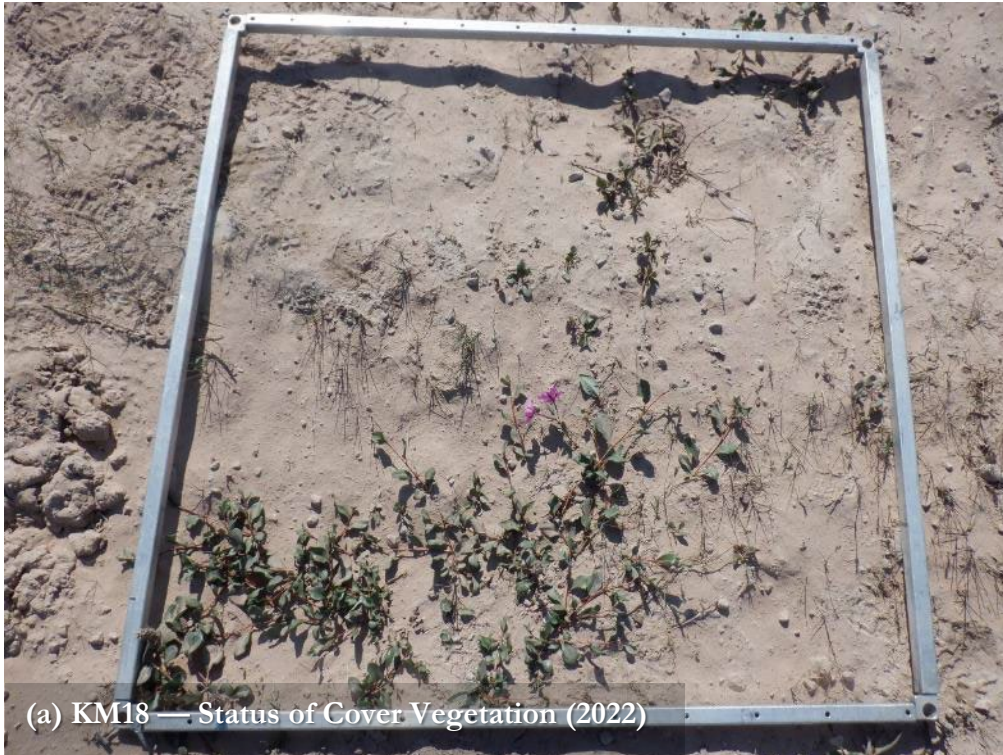
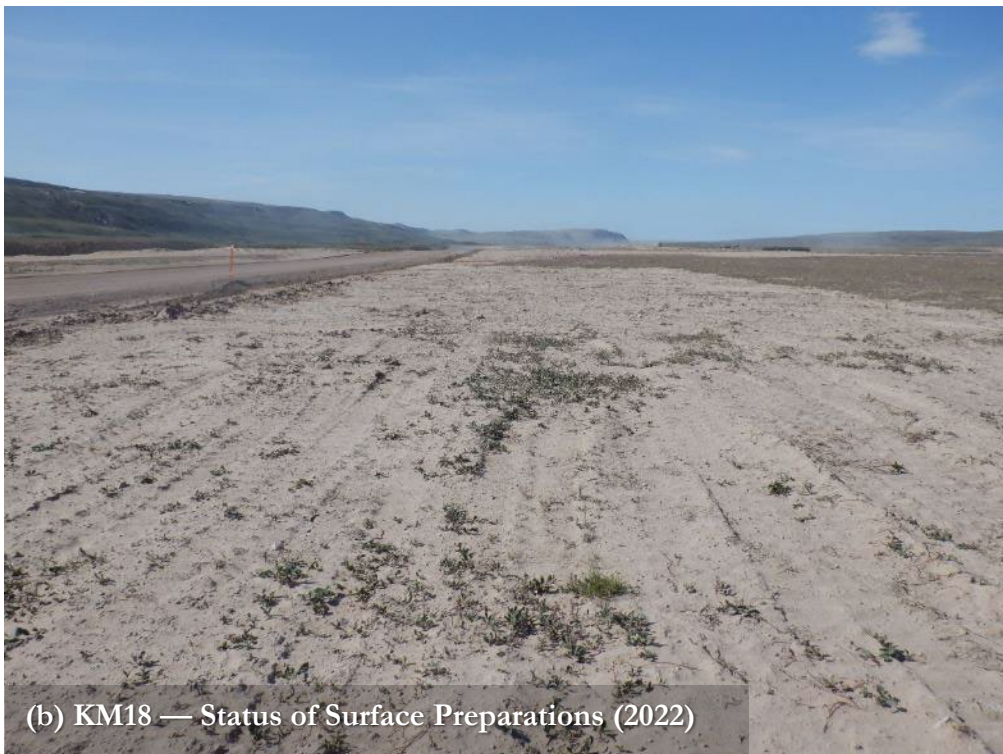
Photo 16. KM18 — 2022 Status of Cover Vegetation (a) and Surface Preparations (b).

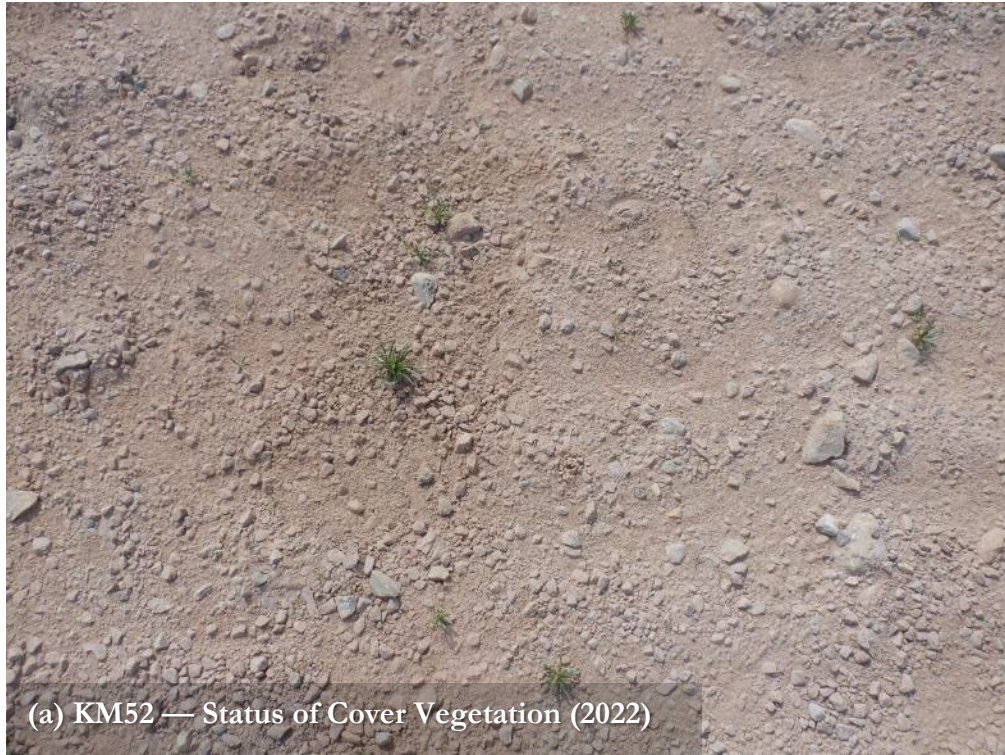
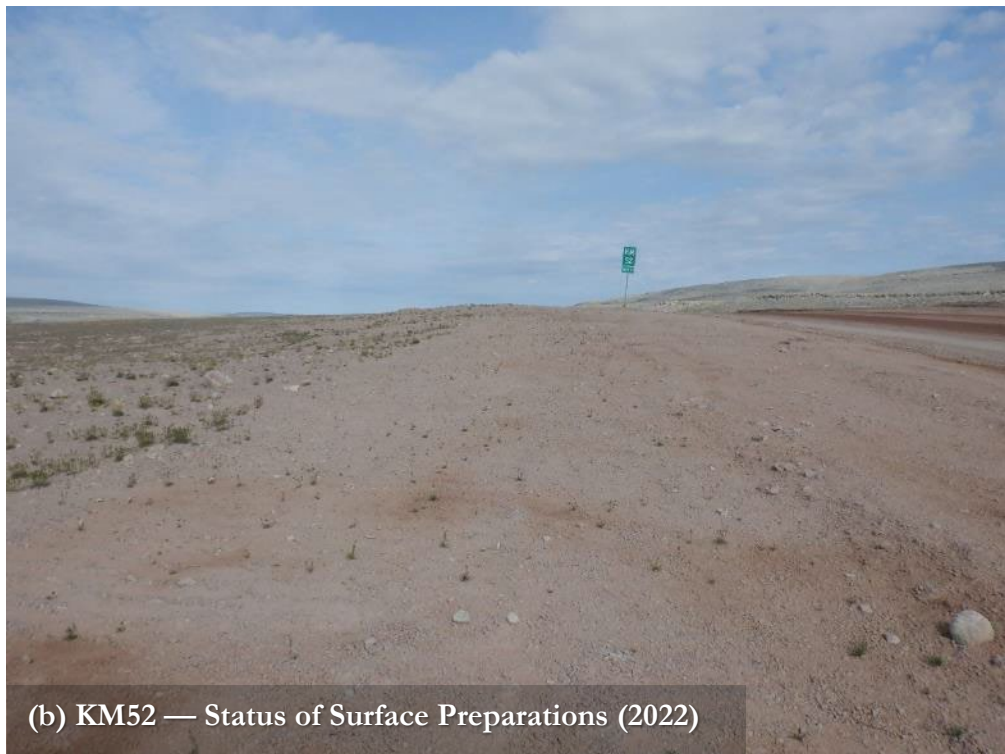
Photo 17. KM52 — 2022 Status of Cover Vegetation (a) and Surface Preparations (b).

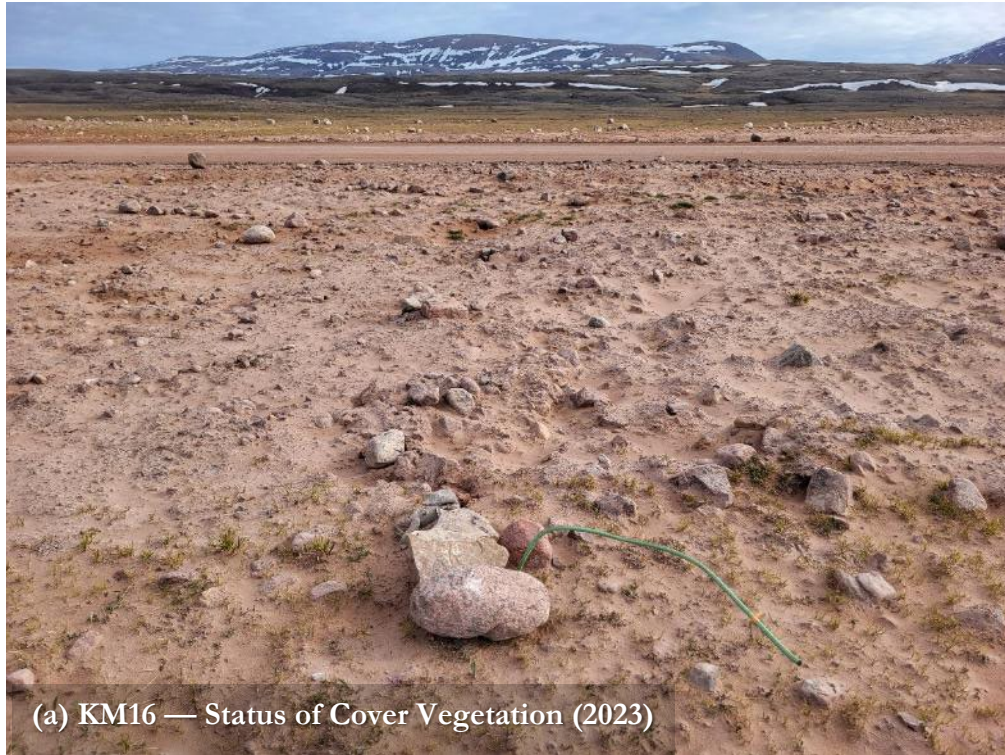
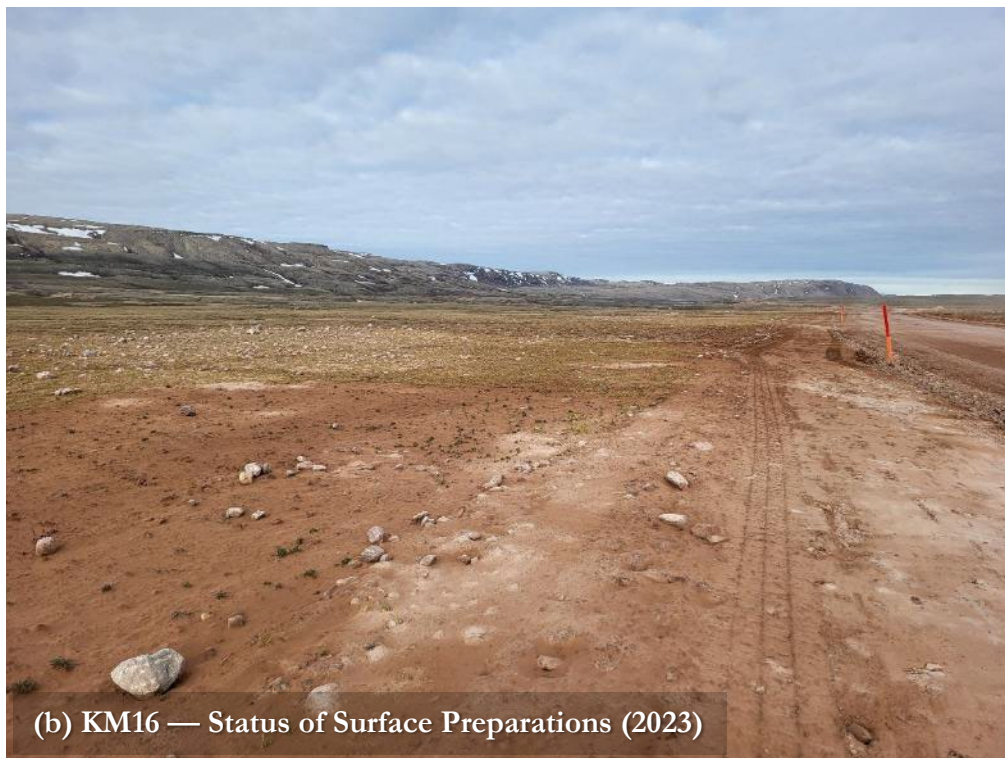
The KM52, KM18 and KM16 trial sites were revisited as part of a qualitative walk-over assessment in July 2023, again comprising visual evaluation and documentation. Consistent with 2022 observations, an increasing number of small volunteer forbs and graminoids were found to have colonized all sites (KM16, Photo 18a-b; KM18, Photo 19a-b; KM52, Photo 20a-b). Indicators of early vegetation re-establishment were most apparent at KM18 and KM16 (both characterized as subxeric), whereas KM52 (characterized as xeric) was still mostly comprised of bare soil.

Photo 18. KM16 — 2023 Status of Cover Vegetation (a) and Surface Preparations (b).

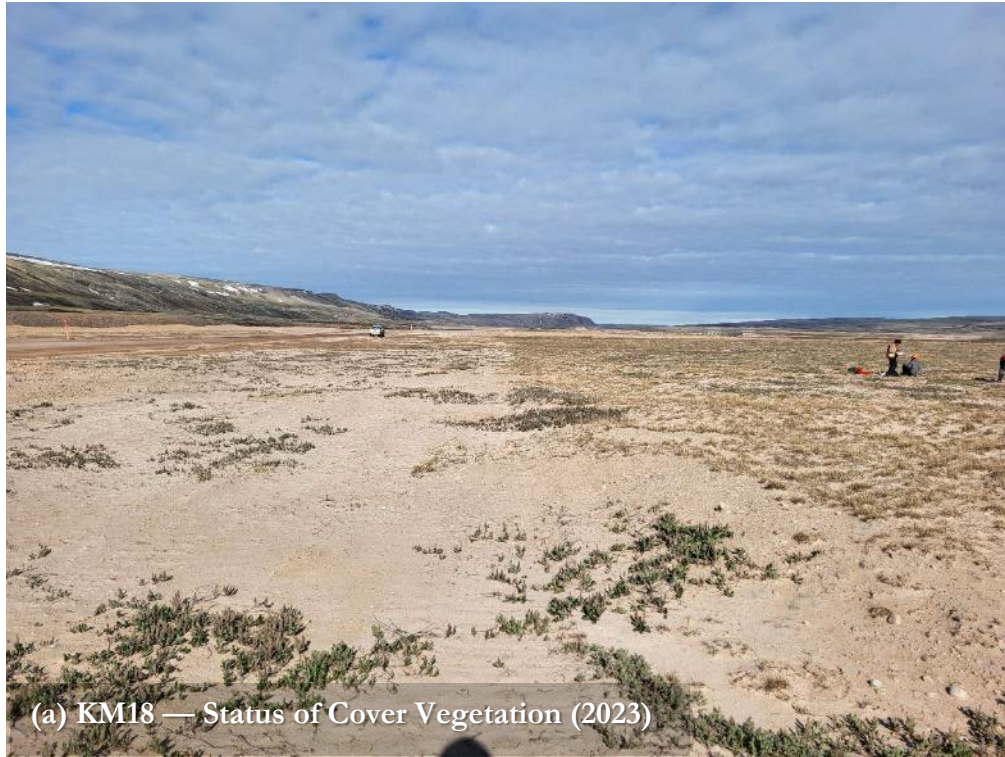
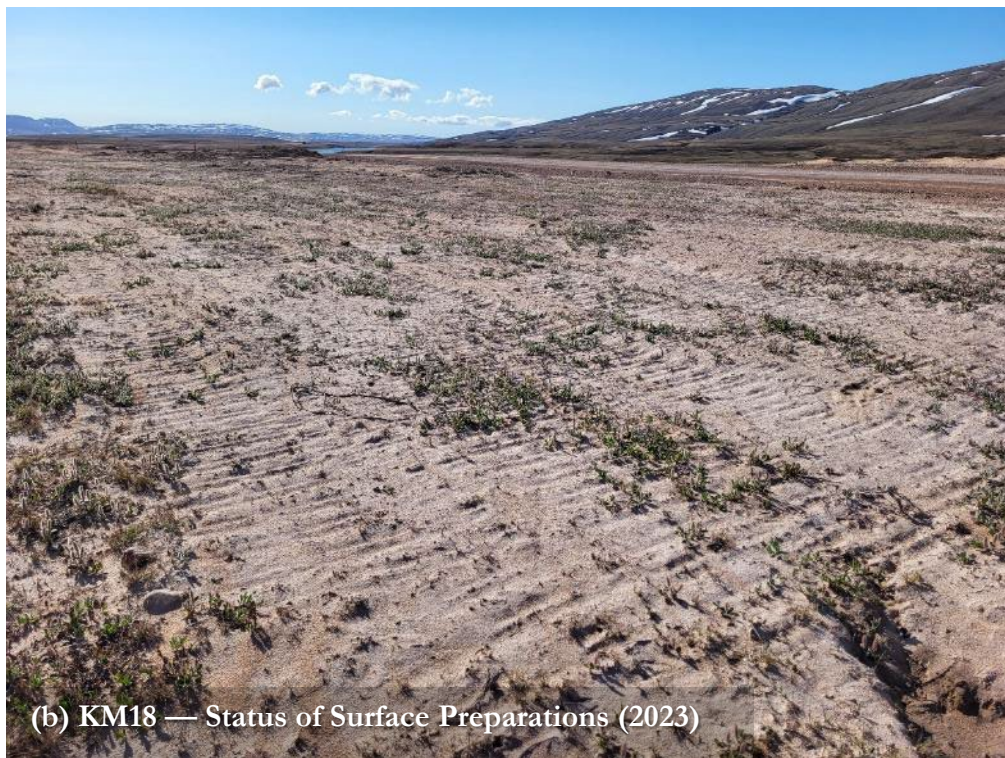
Photo 19. KM18 — 2023 Status of Cover Vegetation (a) and Surface Preparations (b).

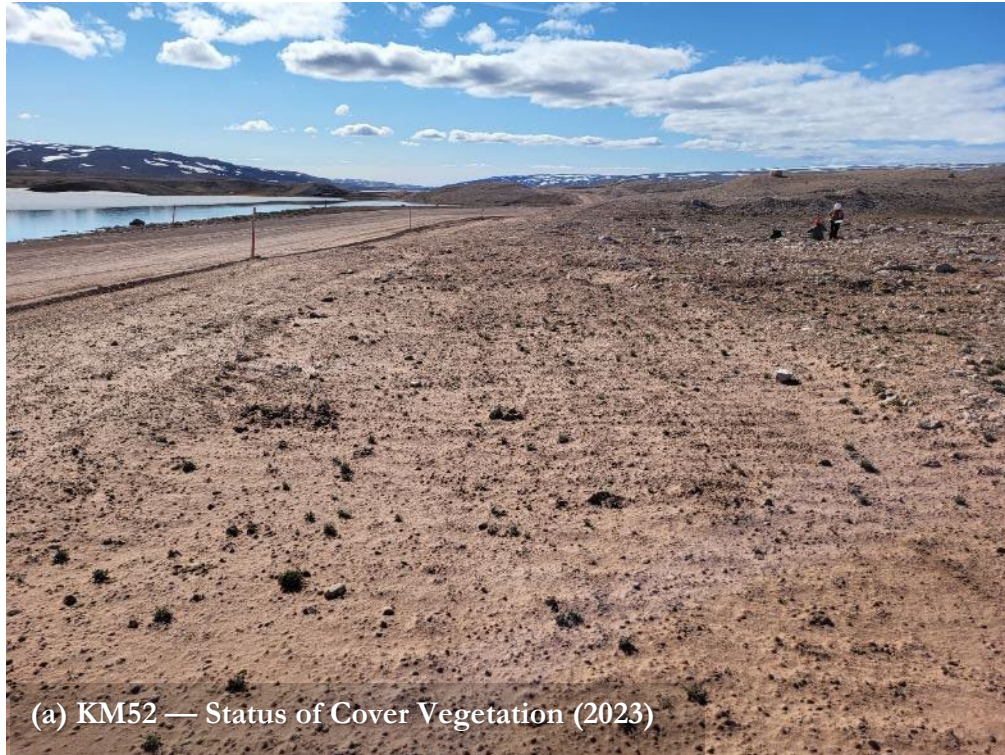
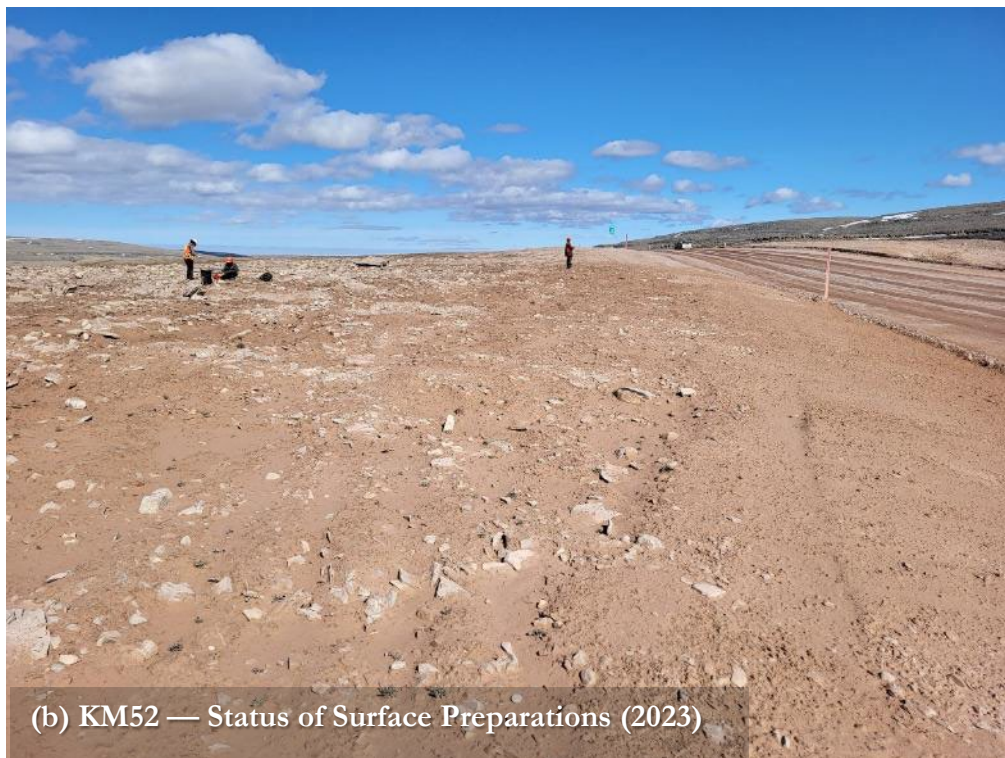
Photo 20. KM52 — 2023 Status of Cover Vegetation (a) and Surface Preparations (b).

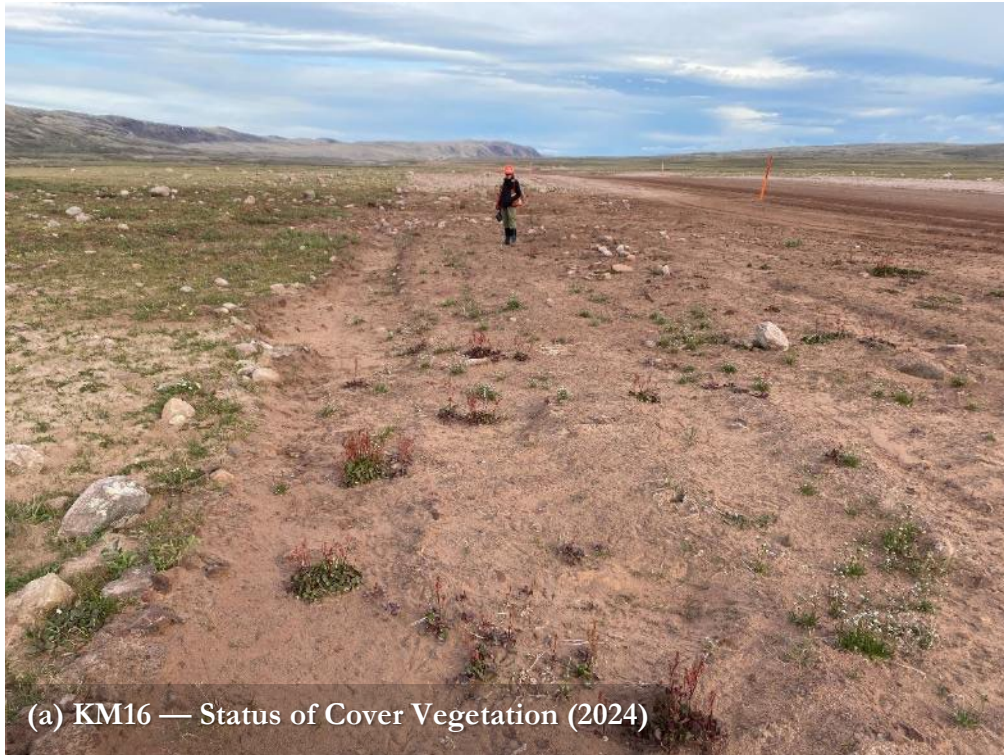
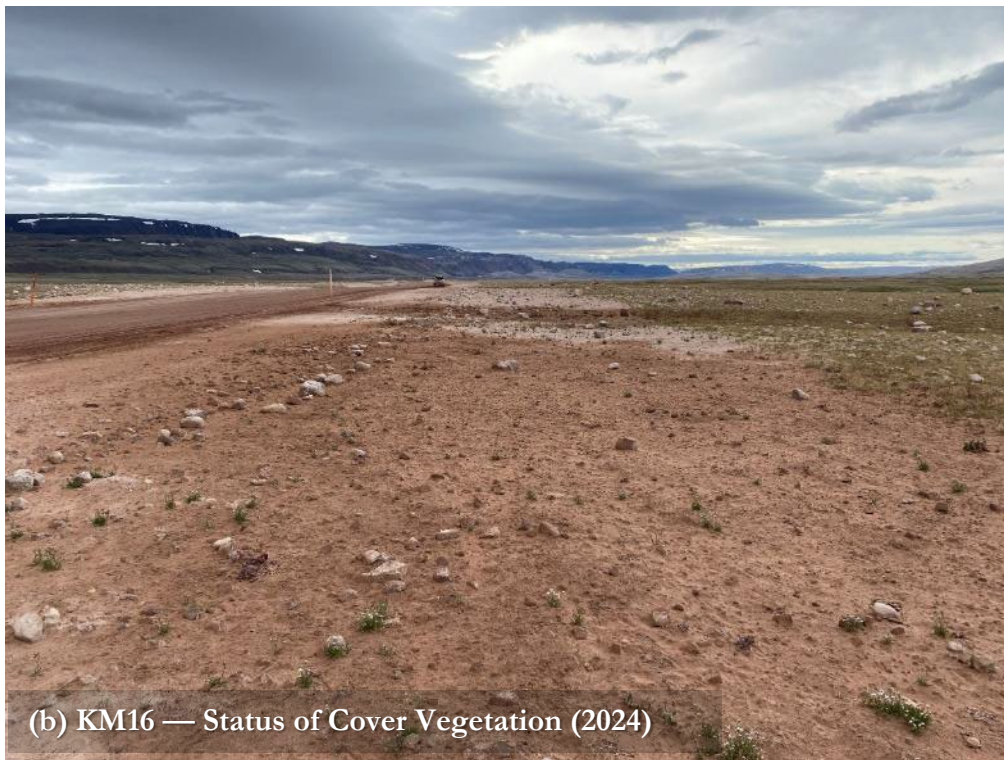
Consistent with 2022 and 2023 observational trends, an increasing number of small volunteer forbs and graminoids were found to have colonized all sites (KM16, Photo 21a-b; KM18, Photo 22a-b; KM52, Photo 23a-b). The proportion of unvegetated bare soil/rock at the trial sites is still high (ranging from ~90-95% depending on location), but vegetation cover re-establishment and accumulated litter has increased (ranging from ~5-10%). Each site had different vegetation species composition that comprised similar species to the adjacent (control) biodiversity. Arctic mountain avens (*Dryas* sp.) were commonly observed at each trial site; Arctic willow had established as the predominant species at the KM18 trial site.

(a) KM16 — Status of Cover Vegetation (2024)

(b) KM16 — Status of Cover Vegetation (2024)

Photo 21. KM16 — 2024 Status of Cover Vegetation (a-b).

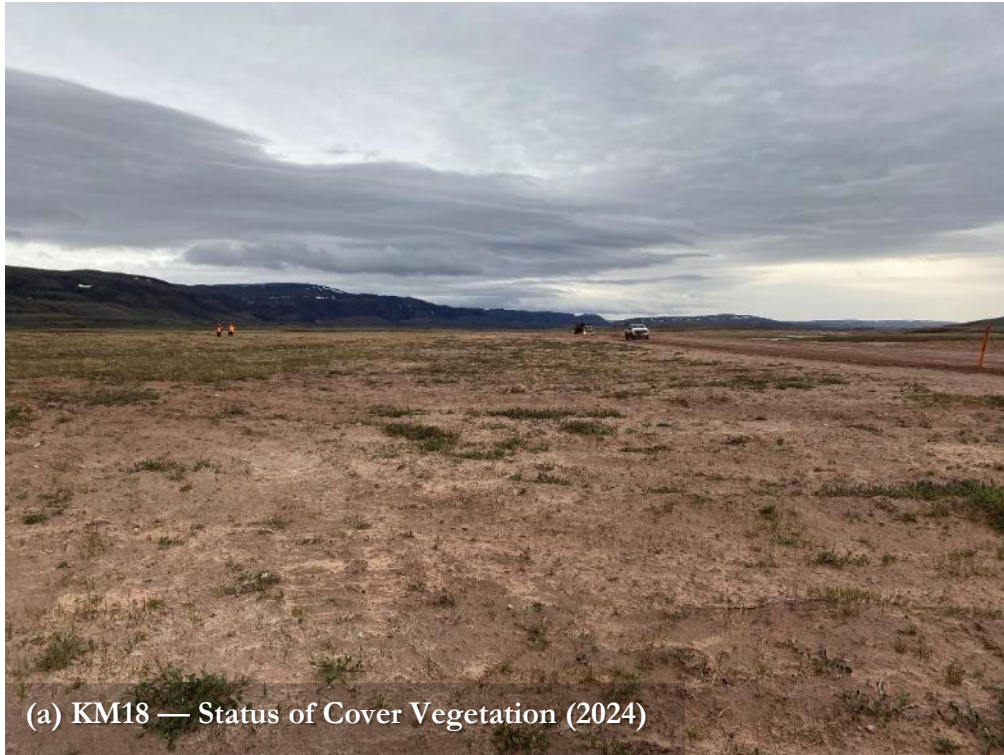
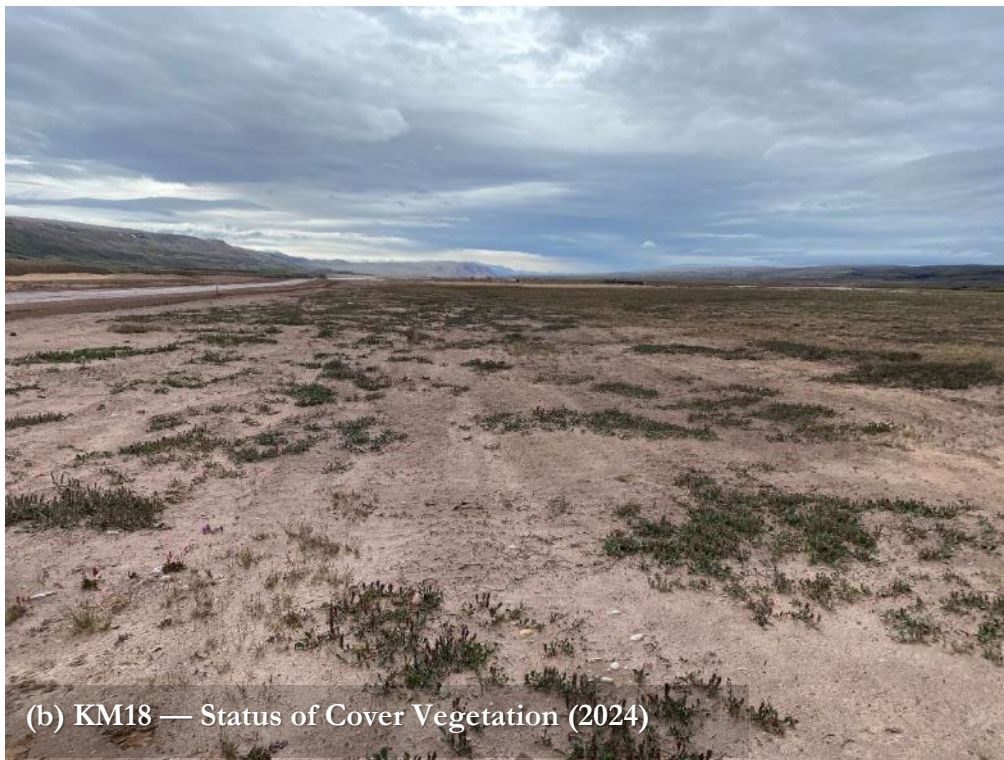
(a) KM18 — Status of Cover Vegetation (2024)

(b) KM18 — Status of Cover Vegetation (2024)

Photo 22. KM18 — 2024 Status of Cover Vegetation (a-b).

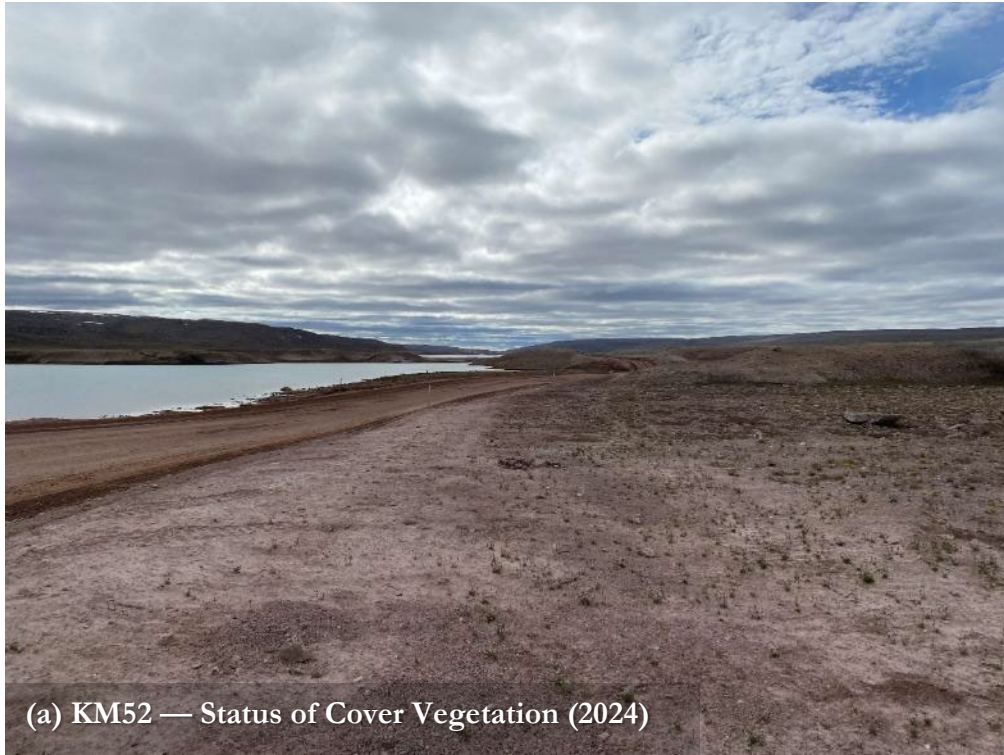
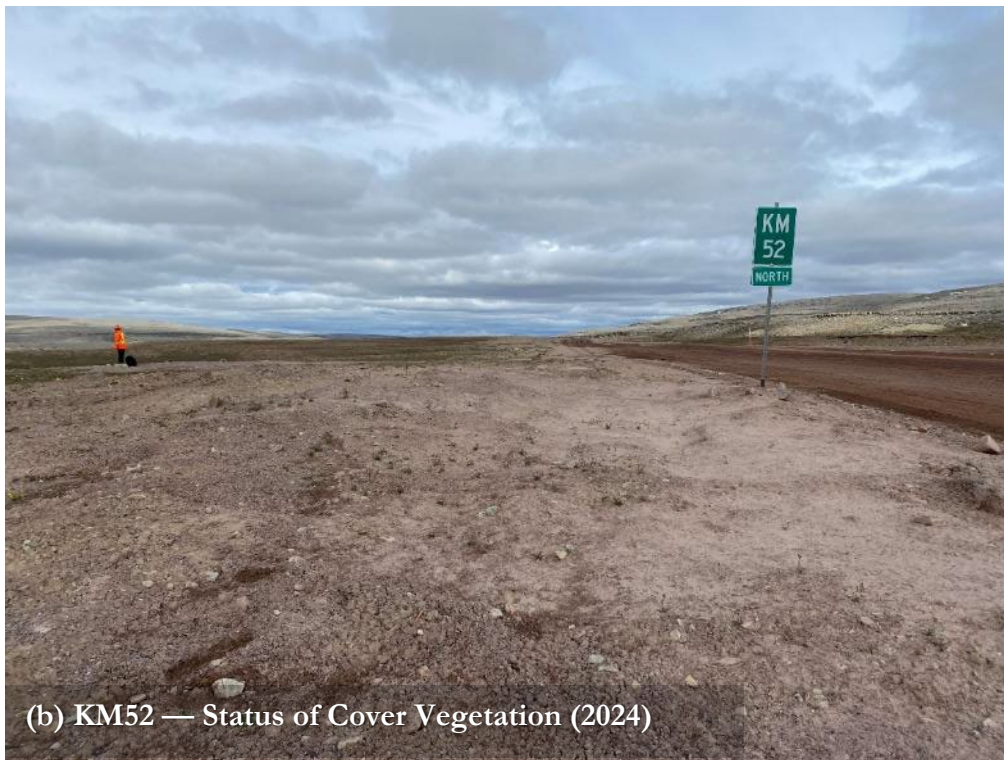
(a) KM52 — Status of Cover Vegetation (2024)

(b) KM52 — Status of Cover Vegetation (2024)

Photo 23. KM52 — 2024 Status of Cover Vegetation (a-b).
