KM18
Layout of Preliminary Reclamation Trial

3.2 FOLLOW-UP MONITORING

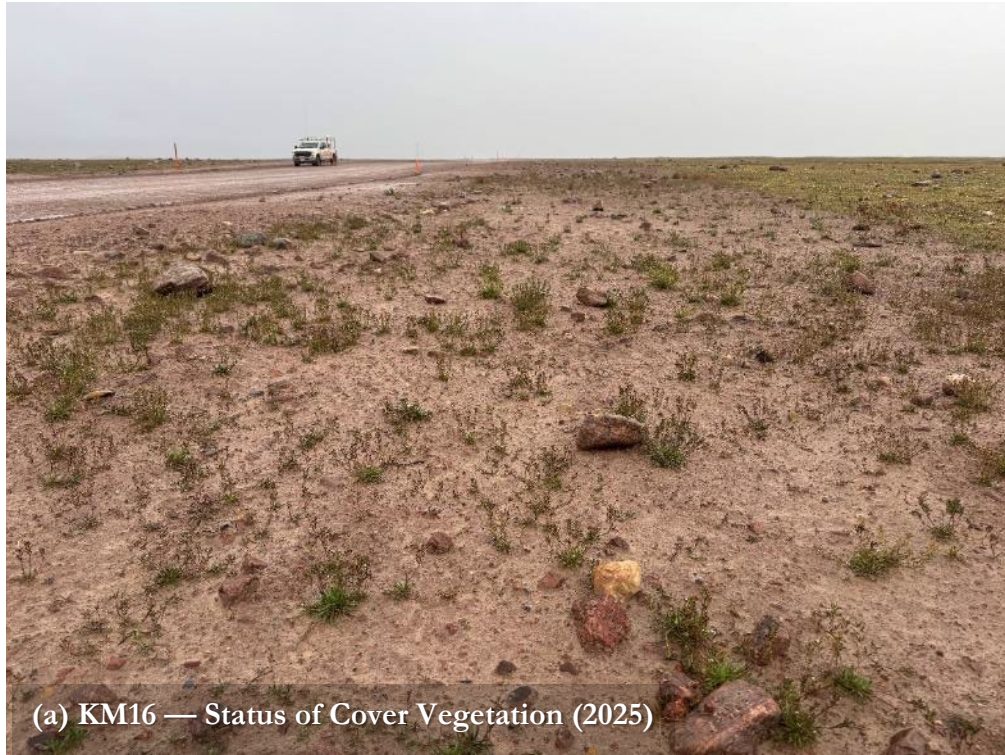
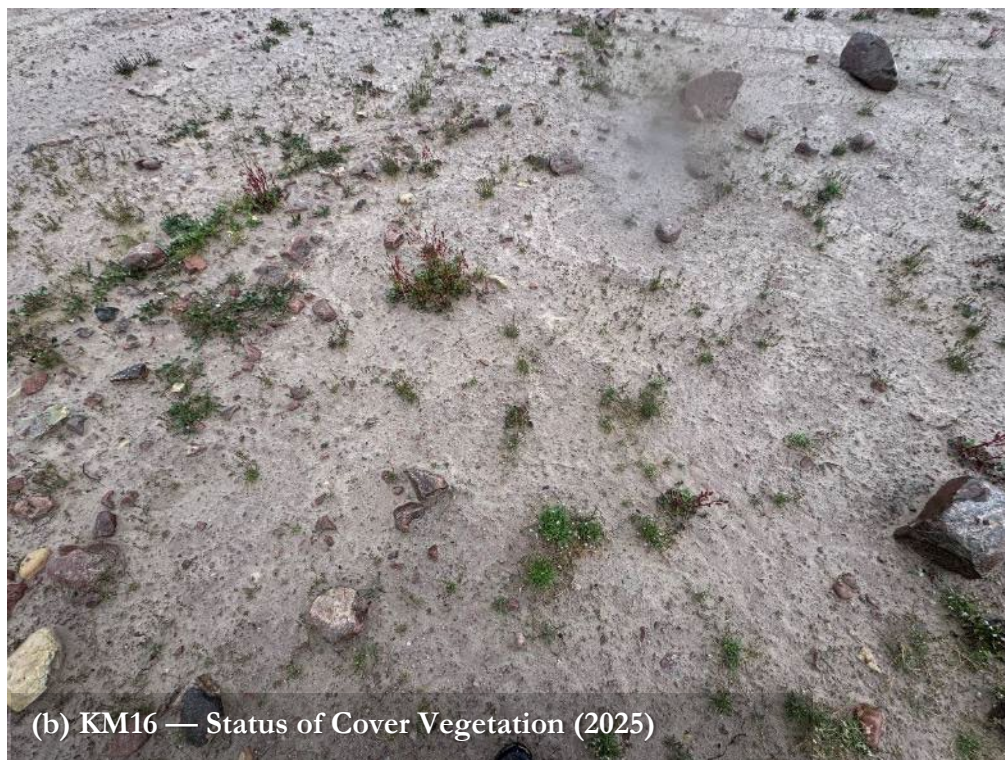
The KM52, KM18 and KM16 trial sites were revisited as part of a qualitative walk-over assessment in July 2025, comprising visual evaluation and photo-documentation. Consistent with 2024 observations, an increasing number of small volunteer forbs and graminoids were found to have colonized all sites (KM16, Photo 24a-b; KM18, Photo 25a-b; KM52, Photo 26a-b). As previously observed, indicators of early revegetation establishment continue to be most apparent at KM18 and KM16 (both characterized as subxeric), whereas KM52 (characterized as xeric) was still mostly comprised of bare soil. Notably, Arctic Willow at the KM18 trial site has become the predominant cover species. The health and vigour of cover vegetation at all sites was deemed to be good and continues to improve (e.g., at some location vegetation were flowering). Established vegetation appeared to have benefited from recent rain resulting in good growth, vibrant tissues, and deep rooting.

Photo 24. KM16 — 2025 Status of Cover Vegetation (a-b).
