## Appendix C - Material (Granular) Assessments

**Re: OTT-000254843-A0      Review of Existing Aggregate Resources  
Hamlet of Taloyoak, Nunavut - SOA 2018-77**

*Government of Nunavut  
Review of Existing Aggregate Resources  
Taloyoak Sewage Lagoon, Hamlet of Taloyoak, Nunavut  
Project: OTT-00254843-A0  
December 7, 2020*

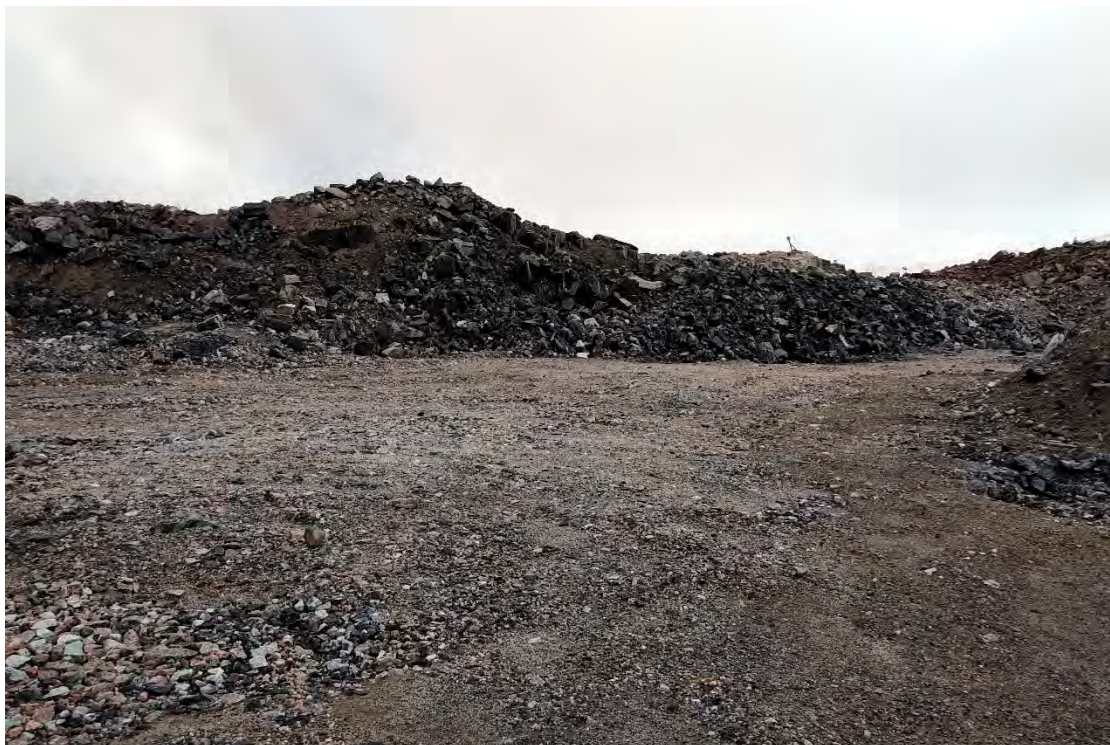
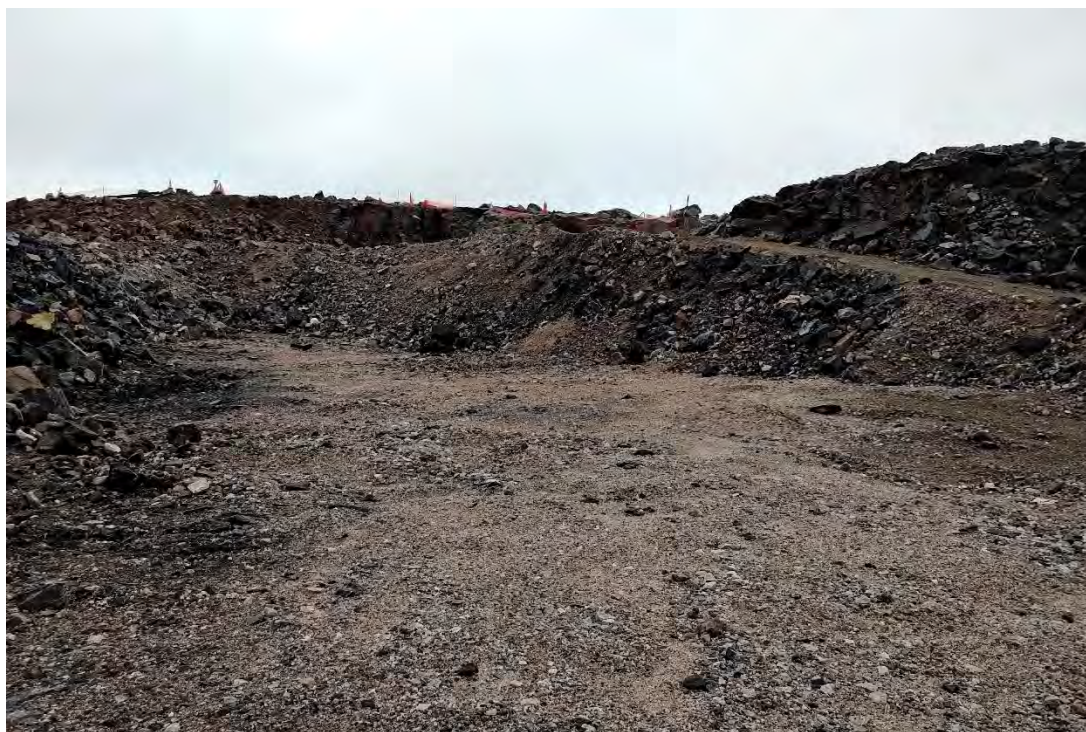
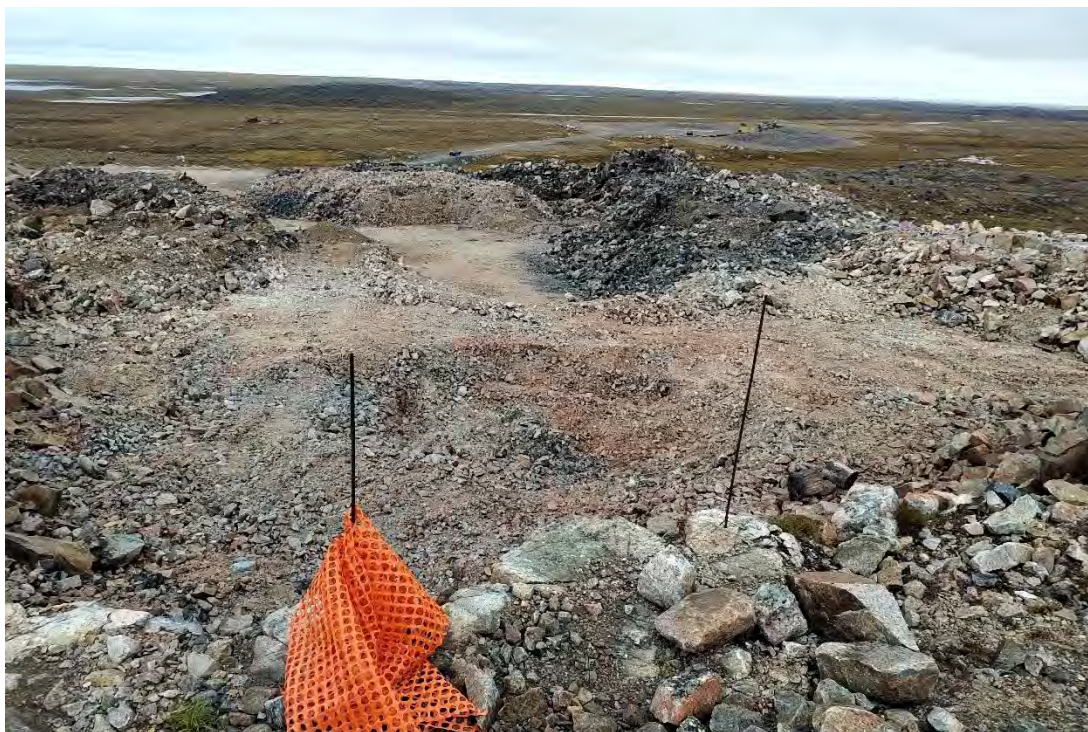
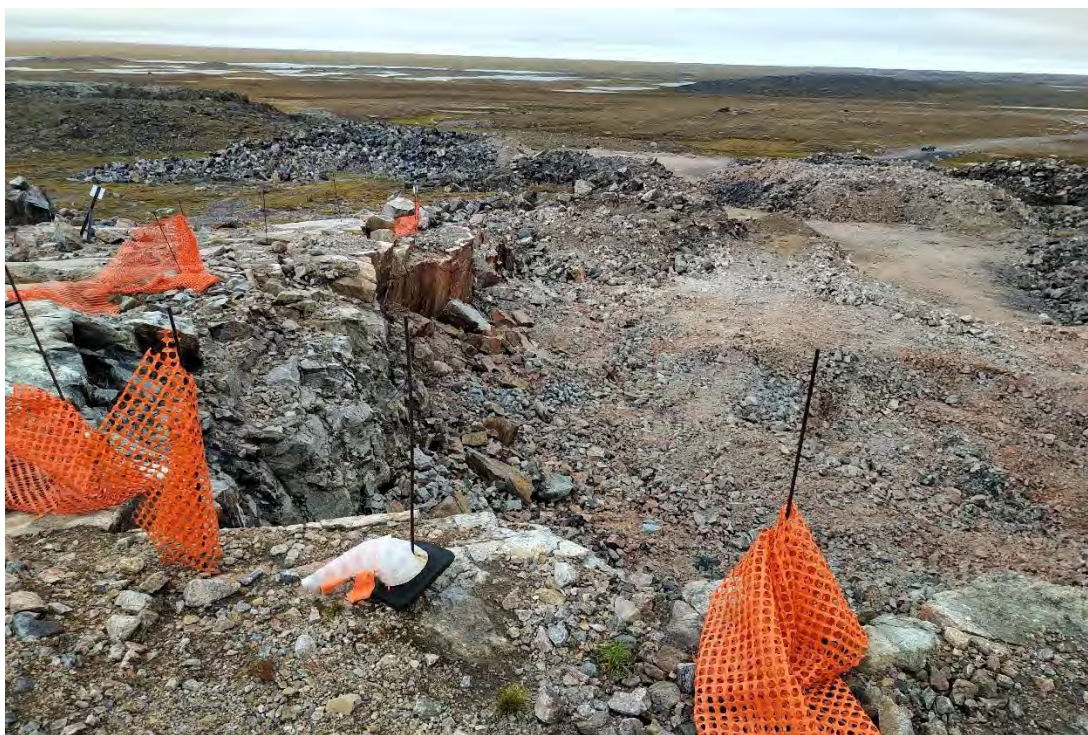
- The existing quarry measures approximately 300 m by 300 m in size and has a rock face with a height of +/- 6 m. There are good access roadways to the quarry and a water source near the quarry;

- Rock has been blasted already between UTM 15W0478590 and 15W478684 and 7716738 and 7716514;
- There was a small stockpile of 19 mm sized stone on-site (20 m in diameter, 4 m in height) along with a small stockpile of medium sized blasted bedrock (20 m in diameter and 4 m in height);

- There is an existing crusher on-site which was last used 3 years ago. The crusher appears to be in good condition. The trucks and loaders owned by Kudlik and previously used at this quarry are stored at the airport. The stockpiles and crusher coordinates are at UTM 047868 and 7716834;

- This existing rock quarry is of unlimited quantity and the rock appears to be of good quality. This quarry can be expanded in the north-south as well as in the east-west directions; and

**Photo 1: Site 1- Kudlik Quarry - Blasted rock stockpiled Ready for Crushing**

**Photo 2: Site 1- Kudlik Quarry – Additional Blasted Rock Stockpiles for Crushing**

**Photo 3: Site 1- Kudlik Quarry - View of quarry from top of Rock outcrop looking from East limit westward**

**Photo 4: Site 1- Kudlik Quarry – East Limit view Looking West**

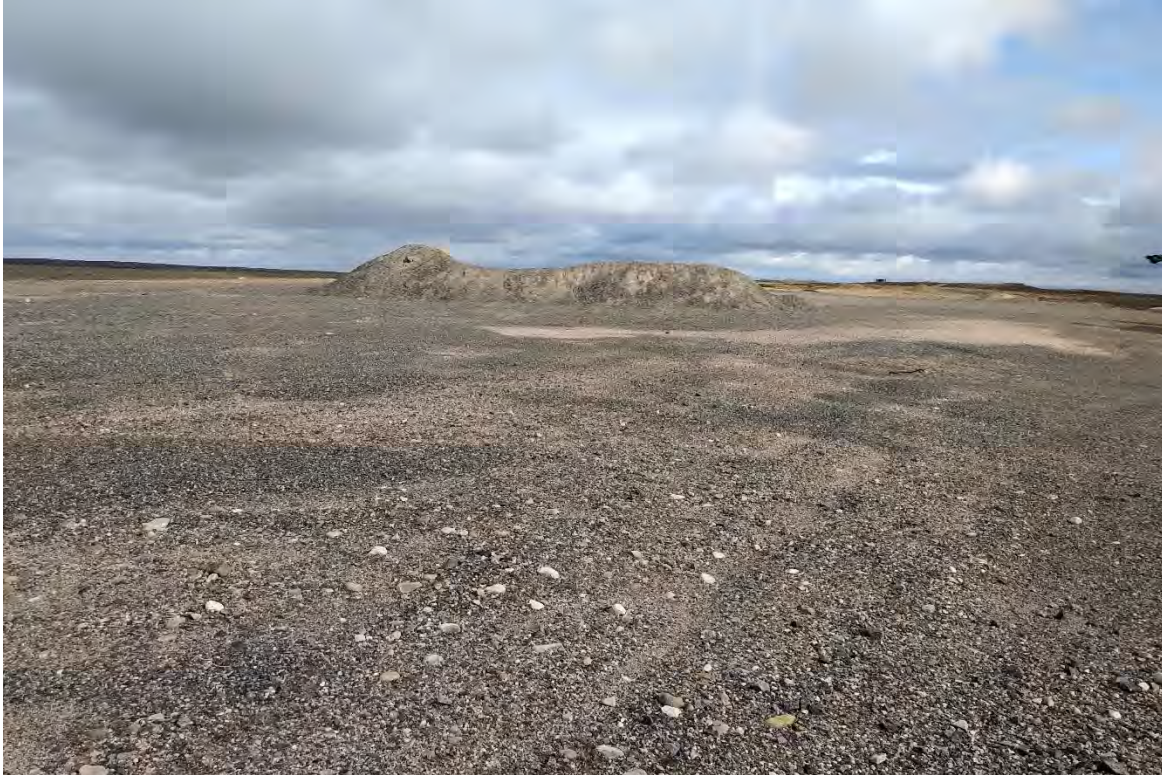
- This stockpile is 30 m by 30 m in size by 3 m in height and consists of 19 mm sized crushed granular located on the east side of the runway at UTM 15W0477645 AND 7715347. This stockpile is not to be used by the hamlet and is for airport use only; and
- The site is located 2.6 kilometres approximately east from the existing lagoon.

**Photo 5: Site 2- Airport Stockpile (30m by 30m y 2m high). For Airport use only**

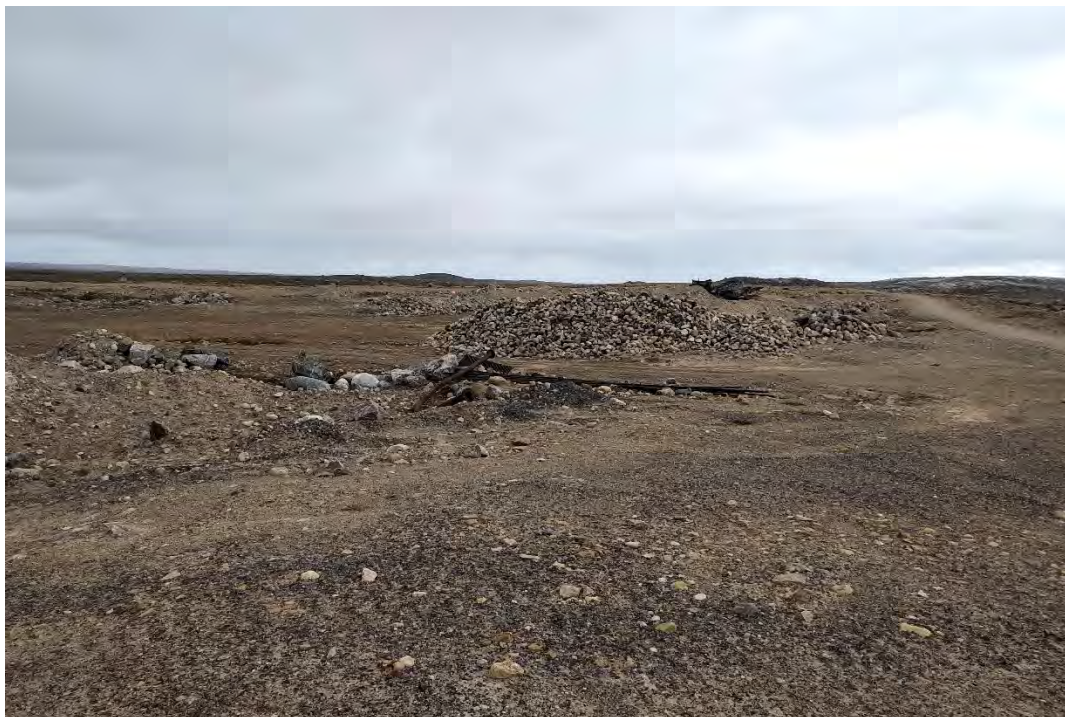
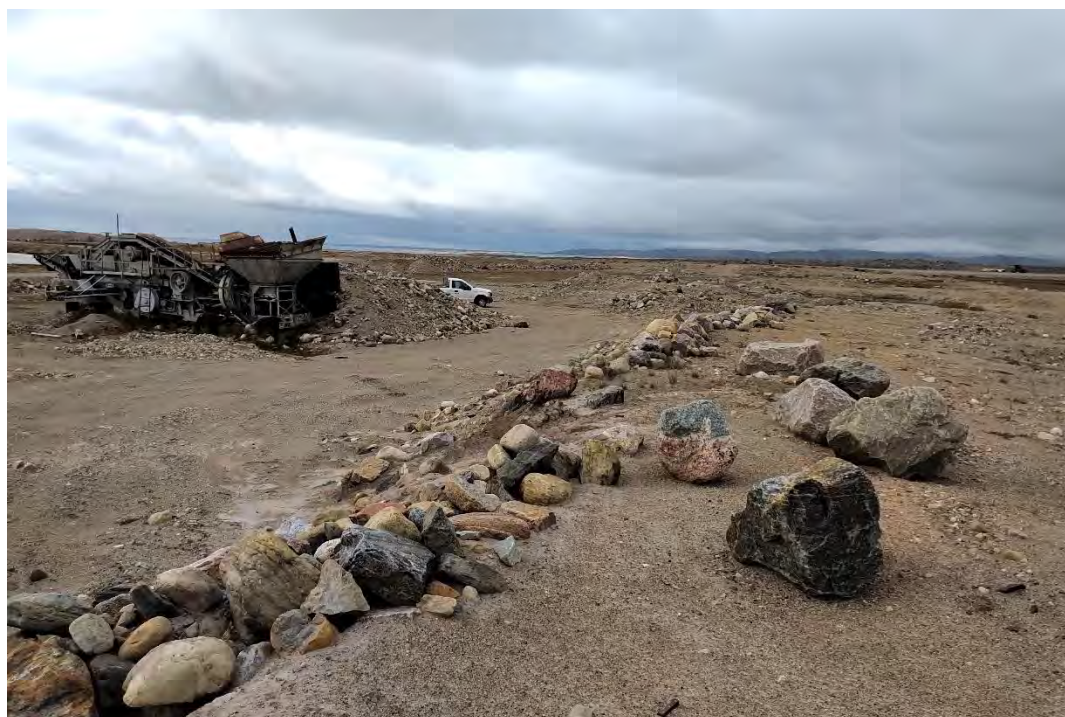
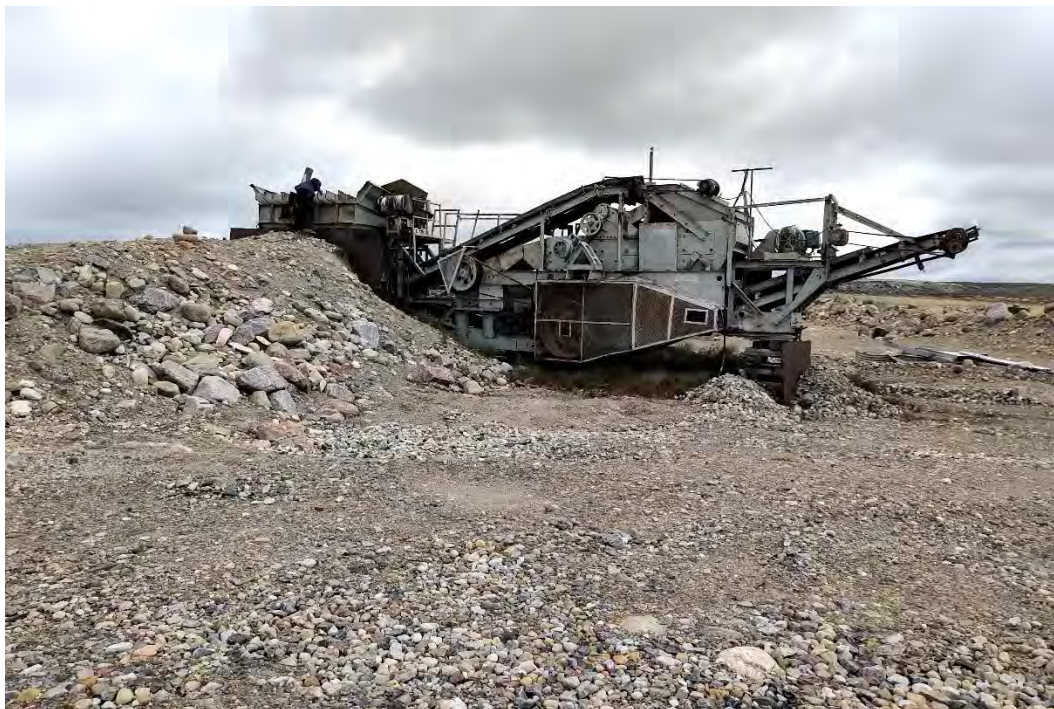
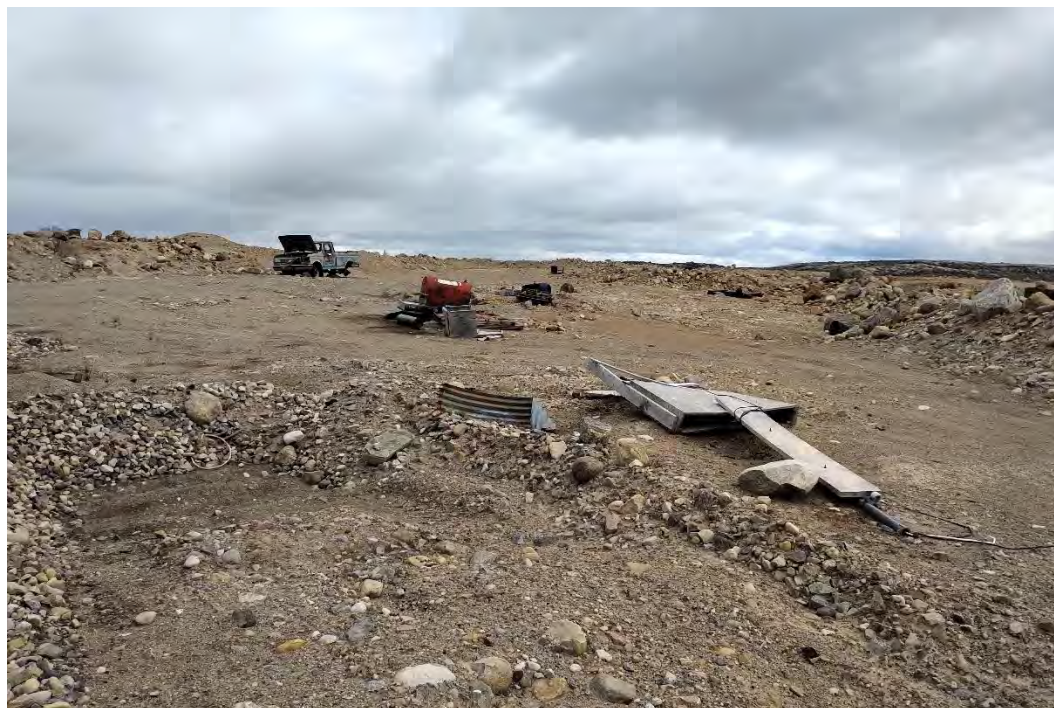
- This pit has been abandoned for almost 20 years; UTM location between 15W0477790 and 15W0477589 and 7715847 and 7715603;
- Approximately a 100 m to 150 m in wide and 1.0 kilometre (1,000 m) long area have been scraped to remove sand and gravel for screening and crushing purposes;
- Old crushing plant and screens are on-site and appeared to be in a non-working condition;
- Crushable sand and gravel remain available on-site for one (1) season of screening and crushing;
- There are many small 1 m to 3 m high stockpiles of sand and gravel over the site that can be screened and crushed, if needed; and
- The site is located 3.0 kilometres east approximately from the existing lagoon.

In summary, this is an abandoned pit with a possible one (1) season of sand and gravel that may be scraped, crushed and screened.

**Photo 6: Site 3 – Old Abandoned Pit -Middle Lake Road**

**Photo 7: Site 3- Abandoned Pit -Middle Lake Road- Old and Abandoned Crusher**

**Photo 8: Site 3- Abandoned Pit -Middle Lake Road- Close View of Abandoned Crusher**

**Photo 9: Site 3- Abandoned Pit -Middle Lake Road- Old Vehicles and Metal Debris Throughout**

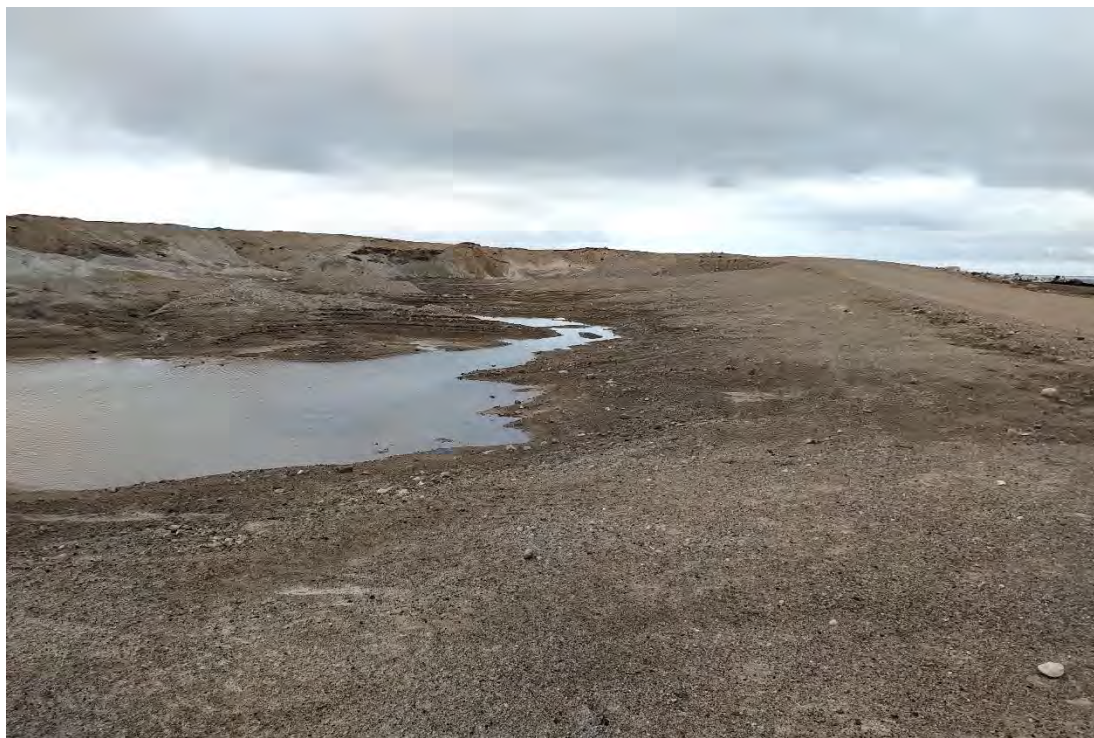
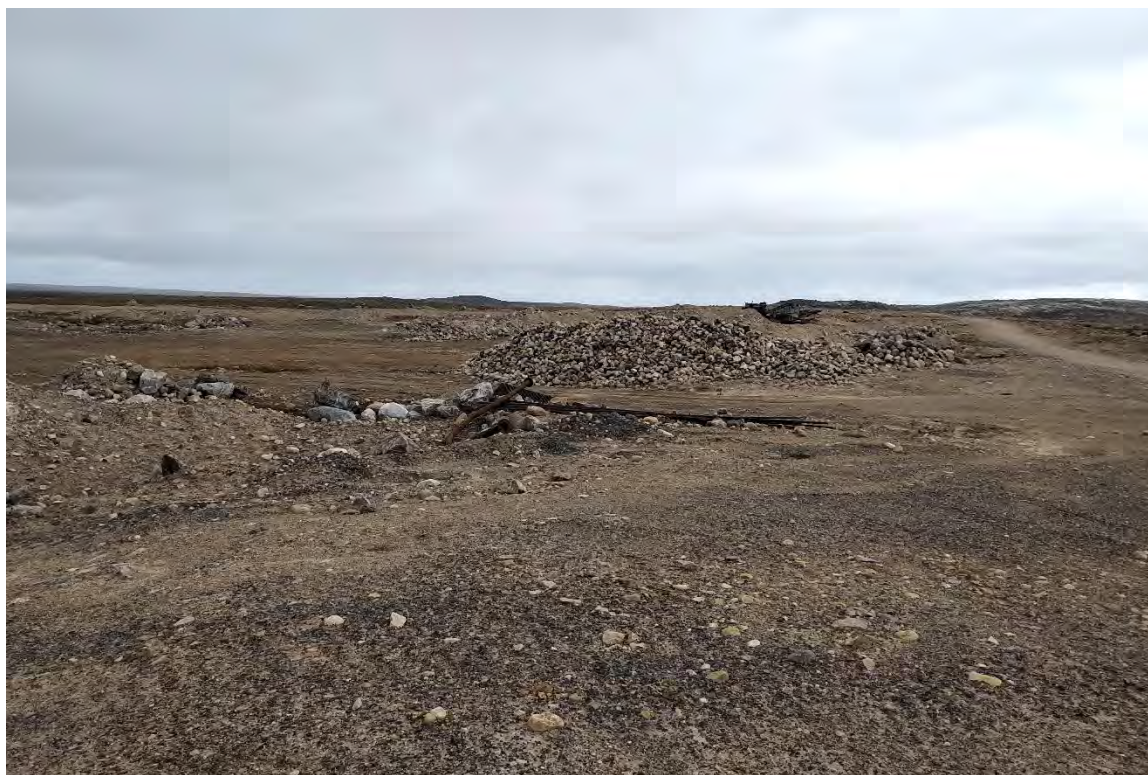
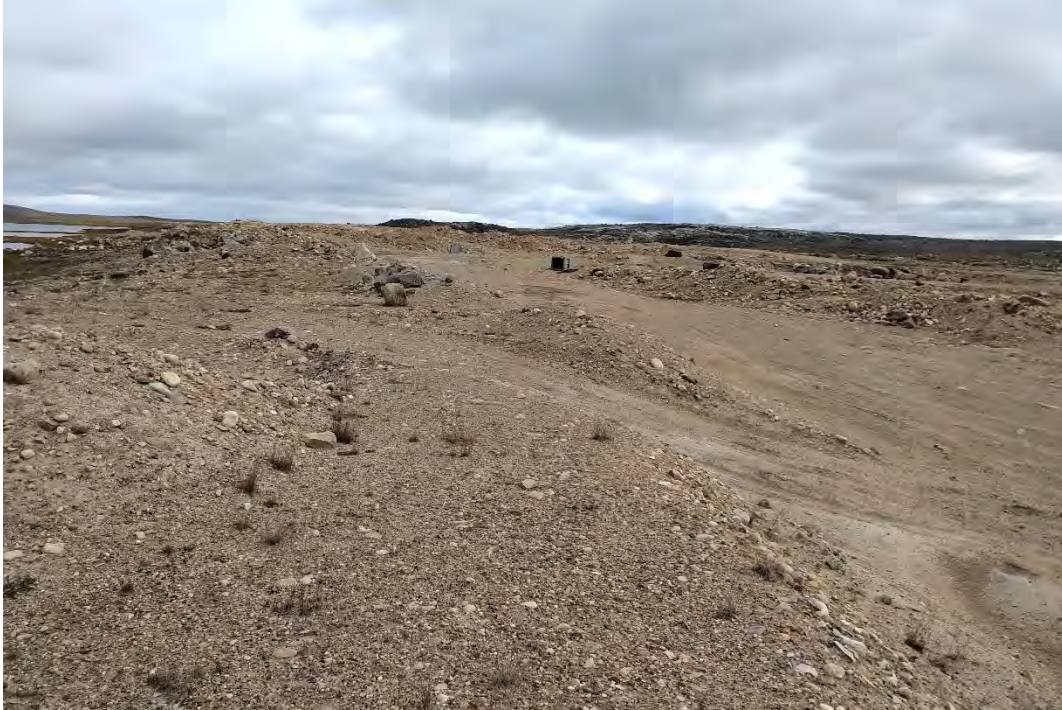
- This pit is approximately 100 m by 400 m in size and at UTM 15W0477589 and 15W477220 and 7715606 and 7715337;
- This pit is mainly sand with gravel and has been used occasionally by the hamlet for screening of sand product;
- Some pit material may still be available from this source to scrape and screen; potential of half ( $\frac{1}{2}$ ) season of use; and
- The site is located 550 m east approximately from the existing lagoon.

**Photo 10: Site 4- Lagoon Road Sand Pit- Looking North along West side of Lagoon Road**

**Photo 11: Site 4- Lagoon Road Sand Pit- Looking South on West side of Lagoon Road**

**Photo 12: Site 4- Lagoon Road Sand Pit- Looking East from West side of Lagoon Road**

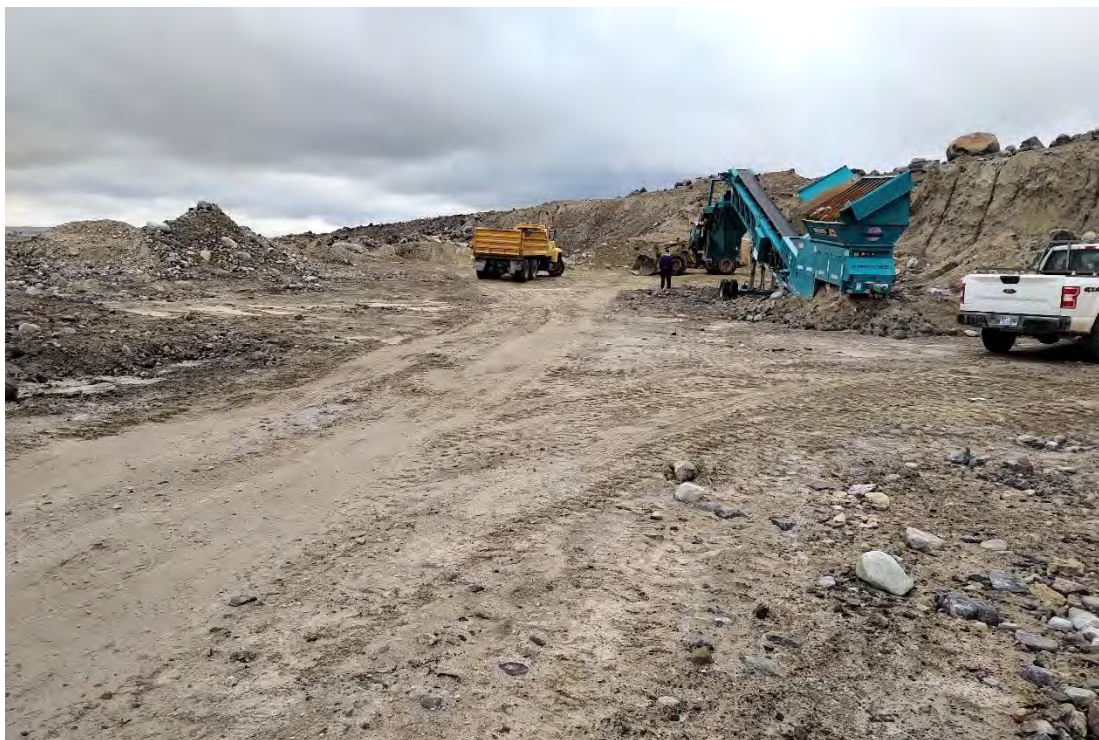
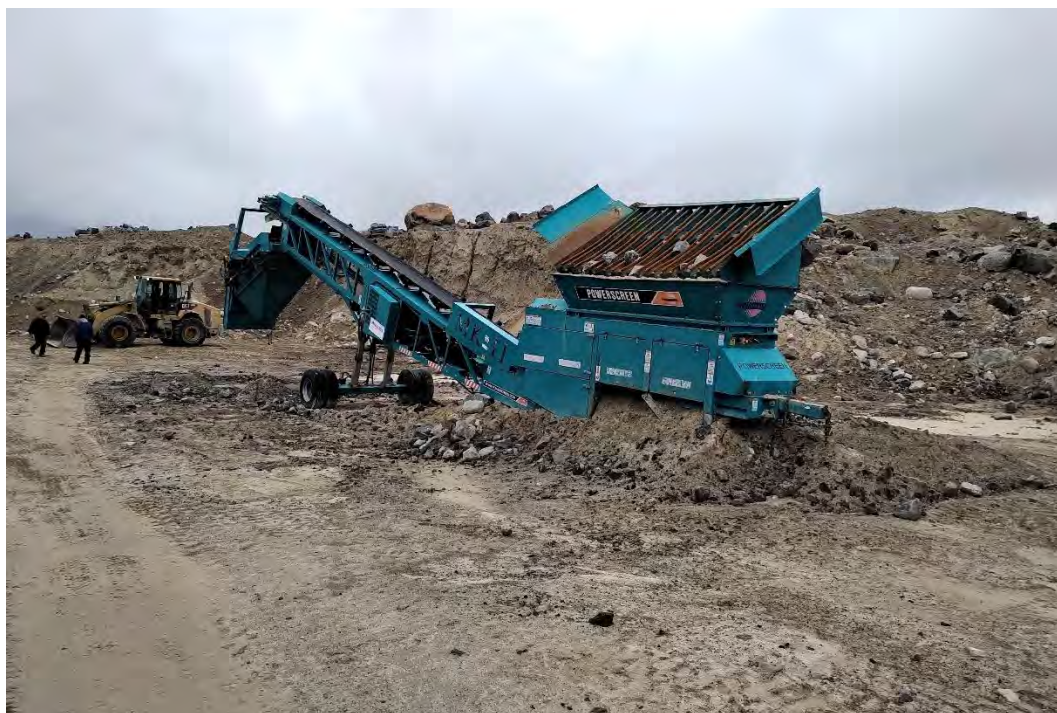
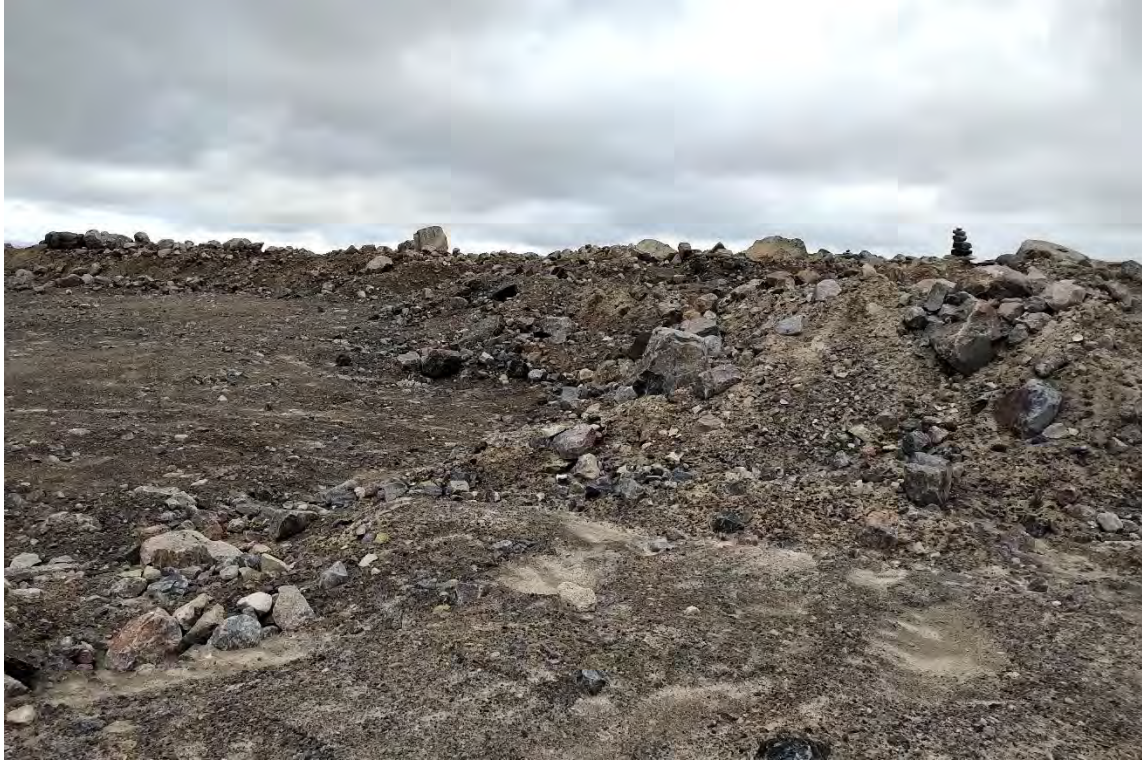
- This pit has been in use since the 1980s mainly for the production of granular required for construction of housing pads and roadway subgrades;
- This pit has 8 m to 10 m high vertical banks which are being cut and loaded on trucks directly for use around the hamlet. Boulders are present and have been stockpiled on-site. The native source consists mostly of silty sand till with some gravel and boulders and trace of clay;
- There is a screener on site which appears to be in use by the hamlet;
- Another 20 year plus can be available for use in the eastern direction within the pit;
- The area is dry and has stable banks to allow for easy access and removal; and
- The site is located 3.1 kilometres east approximately from the existing lagoon.

In summary, this pit has potential for additional granular material that can be screened and used around the hamlet.

**Photo 13: Site 5 Hamlet Borrow Pit- Water Plant Road**  
Screening plant only with loader and truck- 6m Banks- in operation

**Photo 14: Site 5 Hamlet Borrow Pit- Water Plant Road -Screening Plant and Loader**

**Photo 15: Site 5 Hamlet Borrow Pit – Water Plant Road- Rock and Boulder Stockpiles**

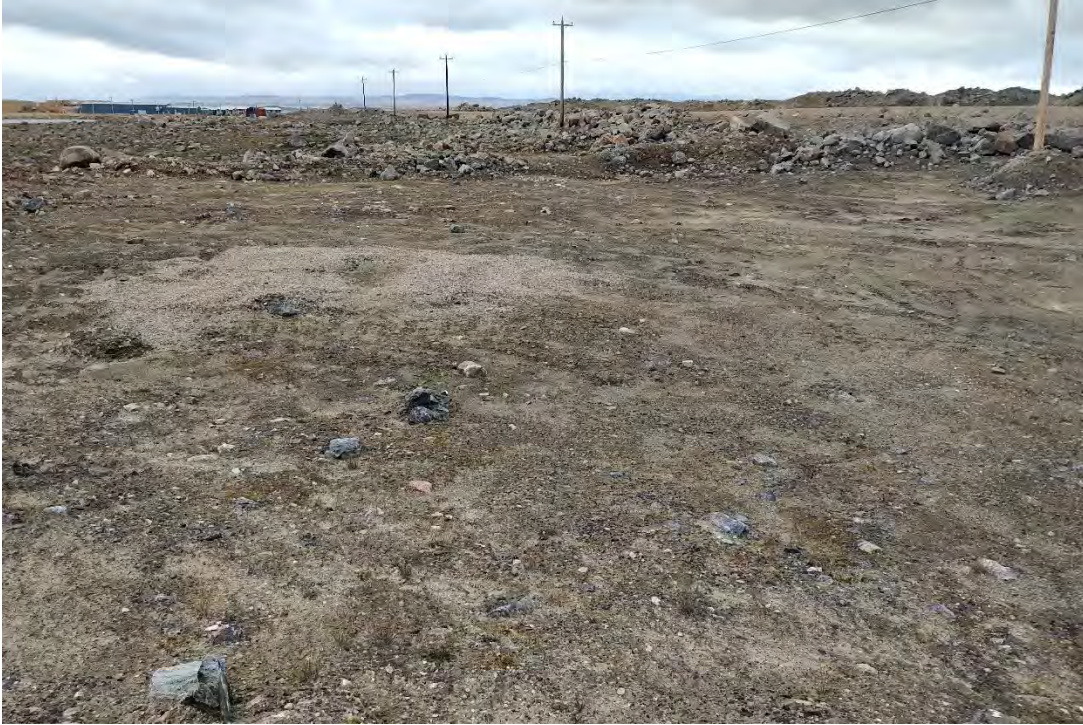
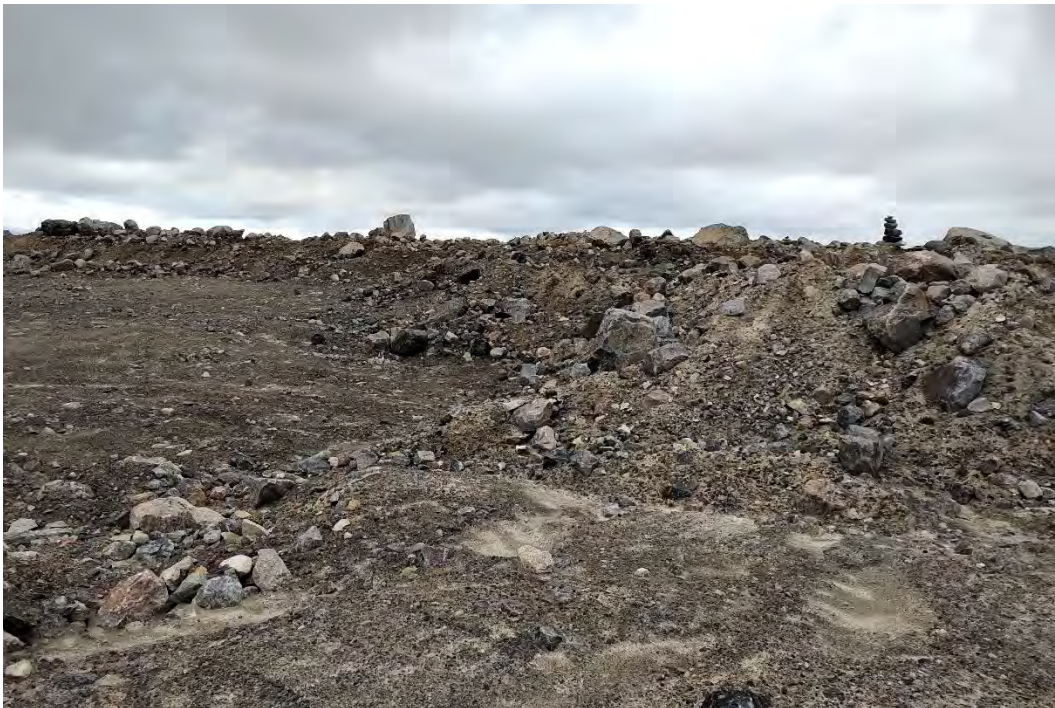
- This pit is located east of the hamlet borrow pit on Water Plant Road, on top of the bank of the borrow pit at UTM 15W0479080 and 7715000;
- This pit is about 20 m by 100 m in size and has been in use for many years. Presently, large boulders have been scraped back to 20 m from the edge of the borrow pit to approximately 2 m below grade. Each year, clay is stripped and used from this source, as needed; and
- The site is located 3.0 kilometres east approximately from the existing lagoon.

**Photo 16: Site 6 Clay Pit – East of Hamlet Borrow Pit – Just Before the Pump Station stripped to Surface of Clay**

**Photo 17: Site 6 Clay Pit – East of Hamlet Borrow Pit – Area on top of Borrow Pit Stripped to Surface of Clay**

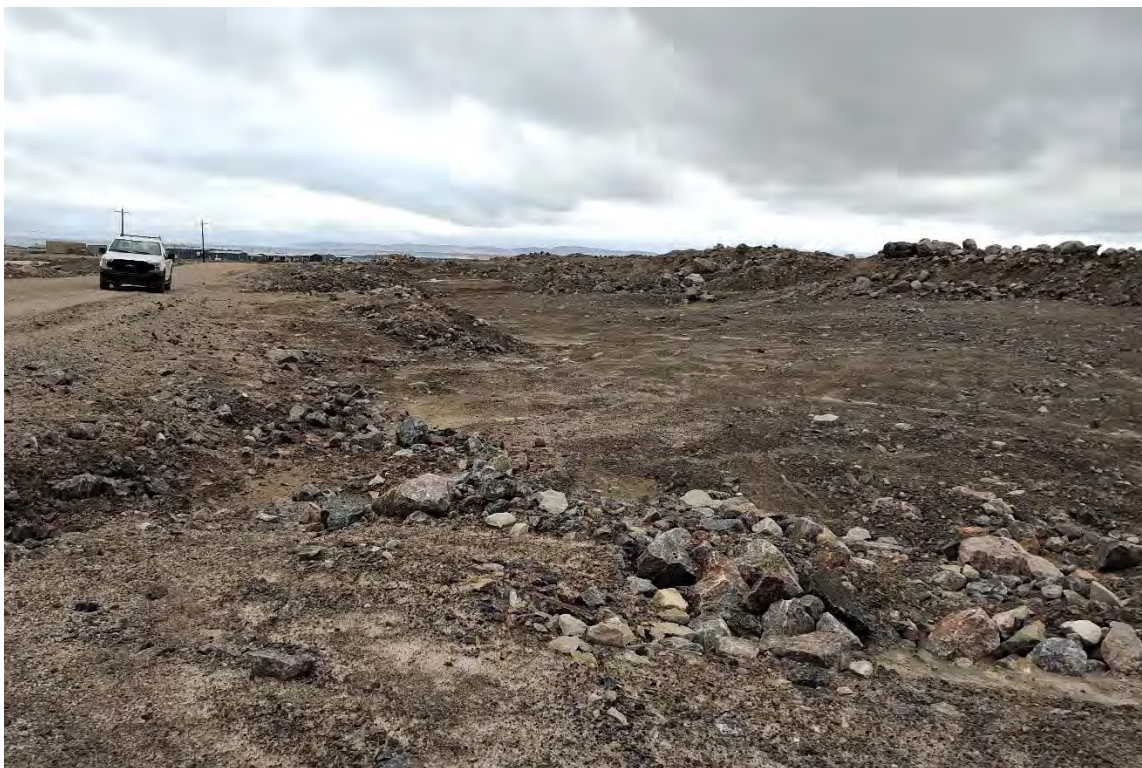
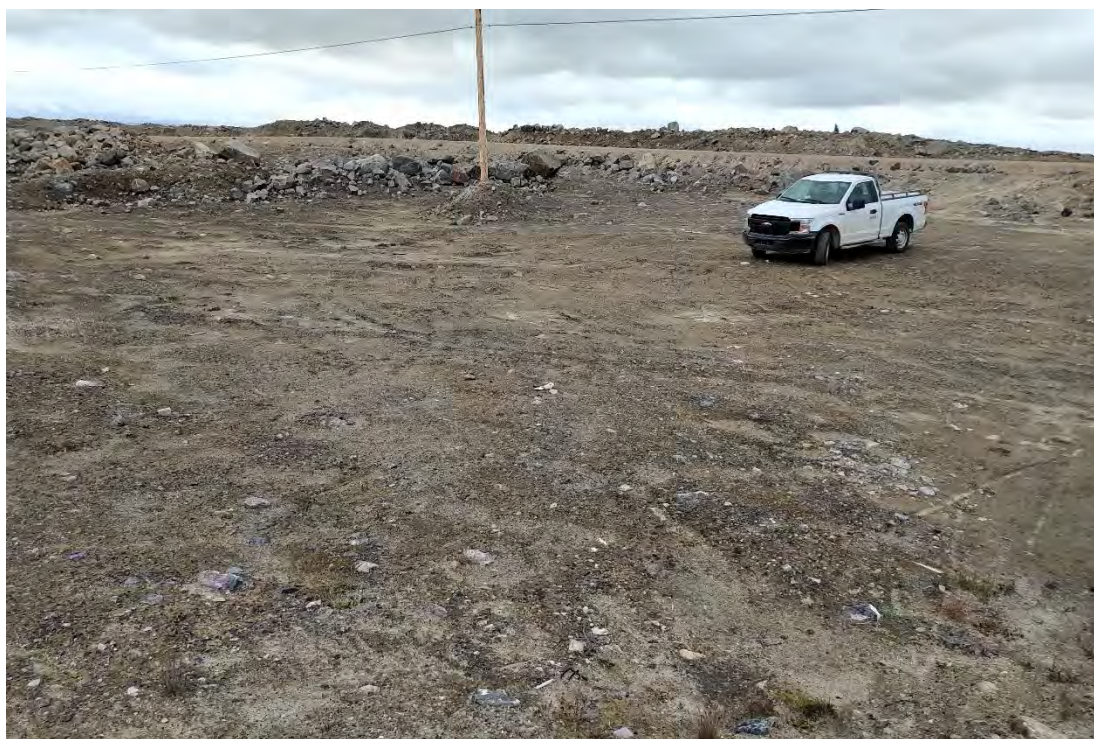
This pit is located on the south side of the roadway before Plant Road and is approximately 50 square metre in area and has been used for years. The pit is located at UTM 15W04479360 and 7715133. This pit has very limited resources left; and

**Photo 18: Site 7 , Clay Source North side of Water Plant Road**

**Photo 19: Site 7 – Clay Source - South side Waterfront Road**
