Full Report Title: *2024 Site Visit Report for the Nunavut Impact Review Board's Monitoring of the Back River Gold Mine Project (NIRB File No. 12MN036)*

Project: Back River Gold Mine Project
Project Location: Kitikmeot Region, Nunavut

NIRB File No.: 12MN036
Back River Gold Mine Project Certificate No. 007

Site visit date: August 5-6, 2024

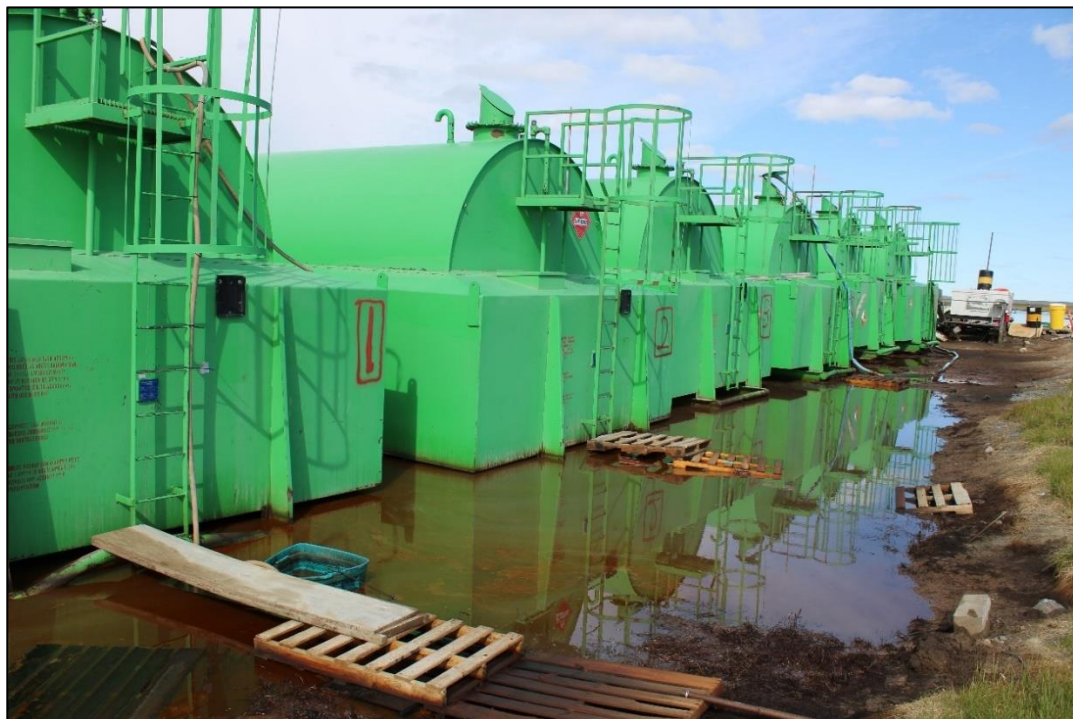
Photo 11: Contaminated Water Storage Inside the lined Bulk Fuel Storage Area

The exploration laydown area is located south of the exploration camp and is composed of maintenance shops, storage buildings, incinerator facilities, drill core storage, the core shack and bulk fuel storage. NIRB staff noted some concerns with contaminated water storage inside the lined fuel storage facility. B2Gold Nunavut indicated that this water has been tested and they are currently waiting for an oily water separator to arrive for proper treatment. At the close out meeting, it was discussed that this water shouldn't be stored in open containment, even if temporarily and that B2Gold Nuanvut should prioritize resolving this matter and storing the contaminated water in a covered container in the interim.

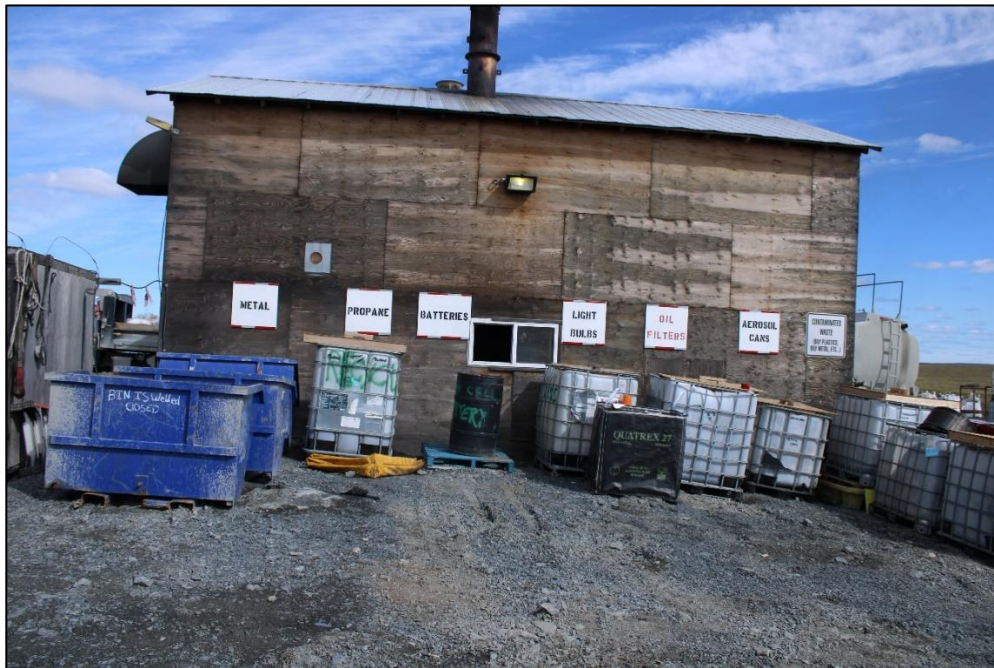
Photo 12: Waste Segregation at Goose Camp

Within the camp, waste is segregated as shown below with combustible and non-hazardous waste sent to the incinerator, and clean wood and cardboard to the open burn box both at Goose Lake and the MLA. These open burn pits are burnt on an as-needed basis and planned burns are targeted around rain events to reduce potential fire risks. Outside the incinerator, other waste segregation containers were placed for non-combustible waste and later removal from site.

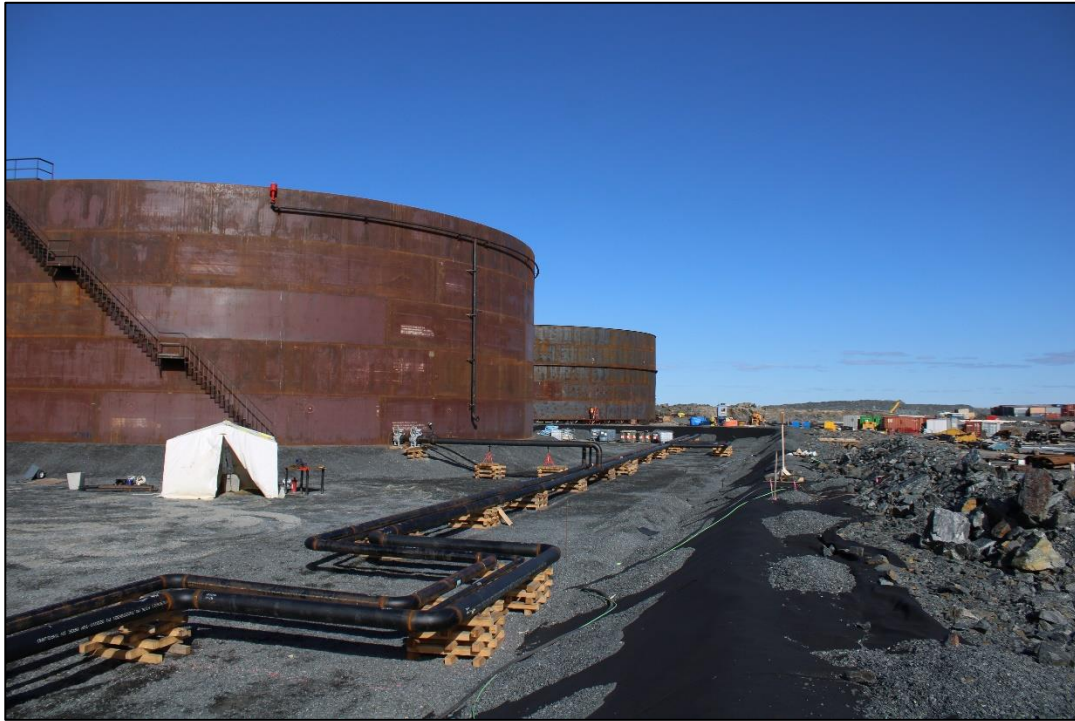
Photo 14: Tank Farm and Berm

Overall, the bulk diesel fuel and hazardous materials were well managed at Goose Camp. Bulk diesel fuel was contained in double walled tanks within a containment. There were some occurrences of fuel barrels being stored outside of secondary containment which was discussed at the close out meeting. B2 Gold Staff committed to correcting this immediately.

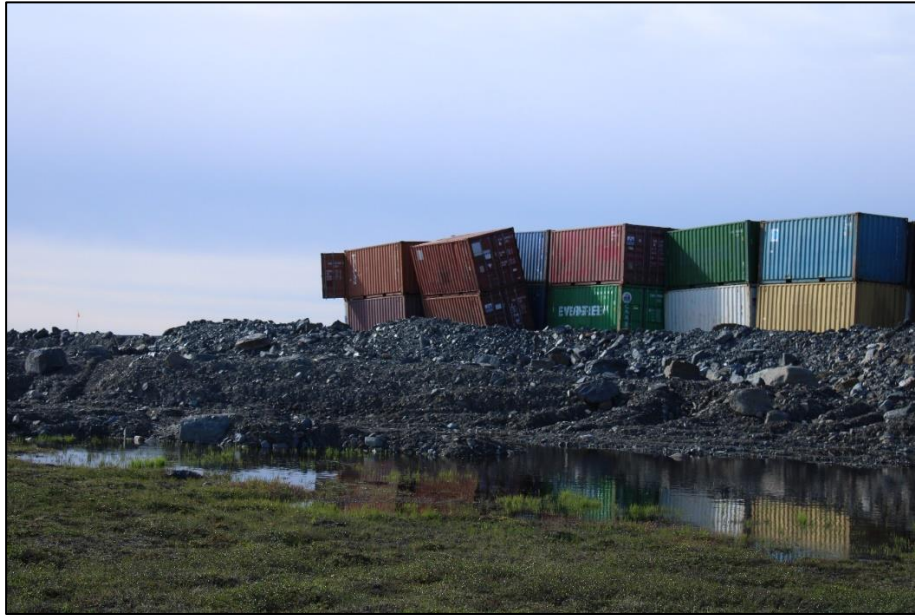
Photo 17: Seacan tipping over

laydown areas, B2Gold Nunavut noted that this was an ongoing challenge with the mix of staff and contractors on site but that they would continue to work on the practice. NIRB staff also noted a seacan that appeared nearly tipped over onto the tundra at a Goose Lake Laydown area and B2Gold Nunavut staff agreed to correct this immediately.

- Limited translation of signage around site and in the accommodations facility;
- Site was overall well organized and clean; however, several laydown areas contained small plastic and wood debris that posed a hazard and needed to be cleaned up;
- Some barrels and totes were stored outside of secondary containment;
- Secondary Containment of the diesel tank farm at the Exploration Camp contained diesel from a spill. B2Gold Nunavut noted that they were in contact with a contractor and working on testing this water and getting an oily water separated to properly dispose of it. NIRB staff recommended prioritizing this to ensure that it has minimal impact on the environment; and
- A seacan at one of the Goose Lake laydowns was stored unsafely and at risk of falling over.

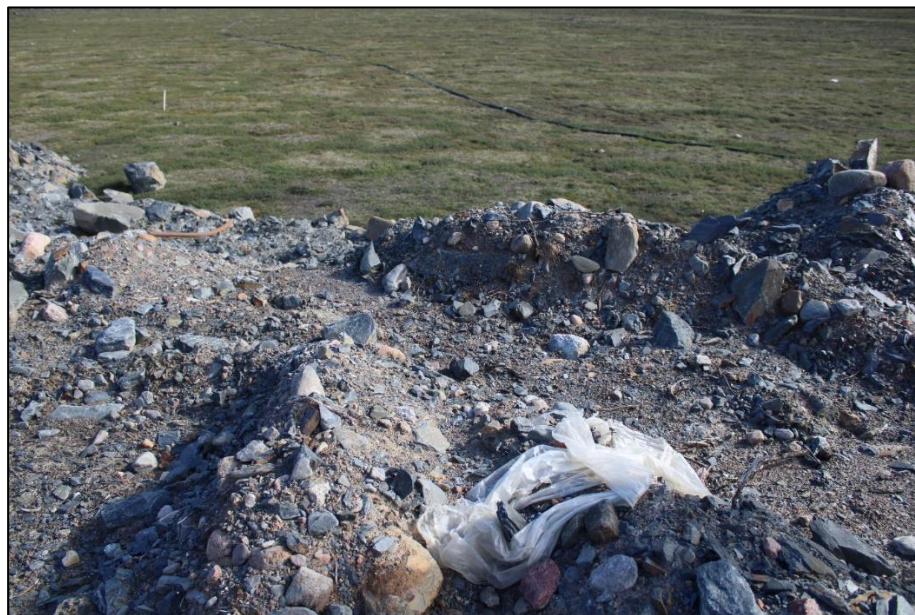
Photo 18: Plastic Debris on the ground in laydown Area

Laydown and storage areas at the Goose Lake Camp were generally tidy; however, there was some minor debris (plastic, wood, metal) on the ground in some laydown areas. This was noted at several different

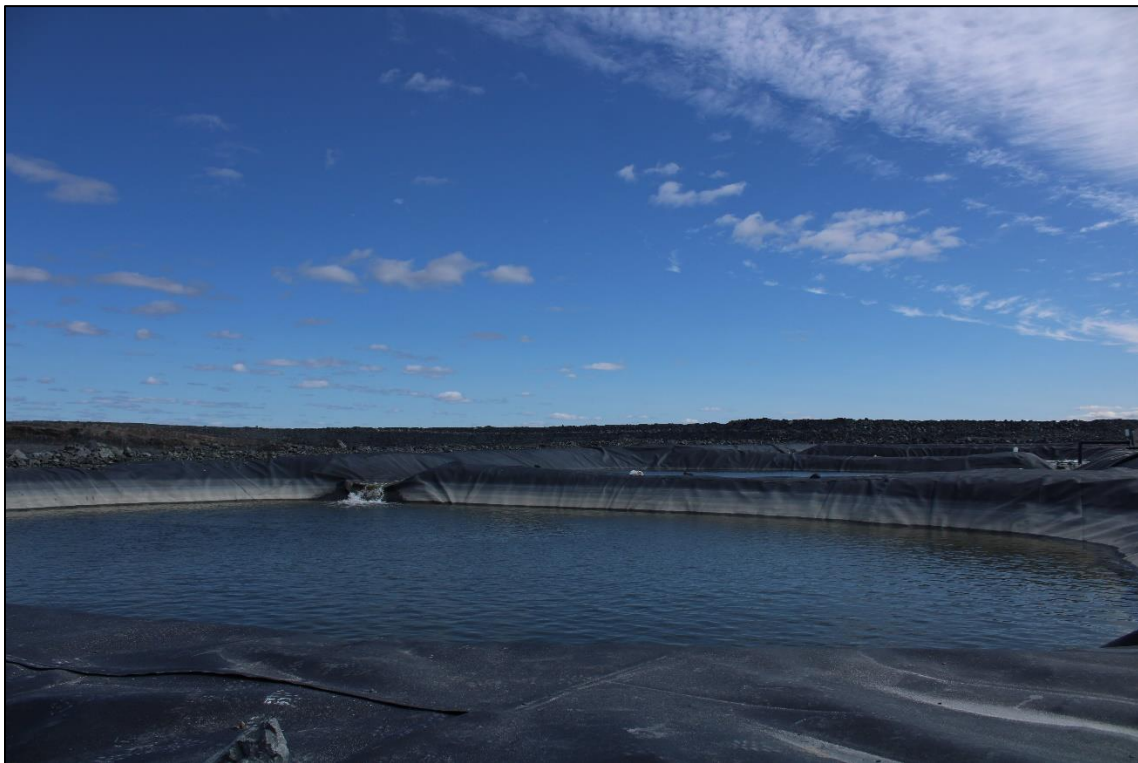
Photo 20: Sedimentation and Treatment Ponds

B2Gold has constructed storage ponds where water from the pits is stored and treated until effluent discharge criteria can be met. There has also been the installation of two culverts near rascal stream to maintain water flow during freshet as well as allow for fish migration.

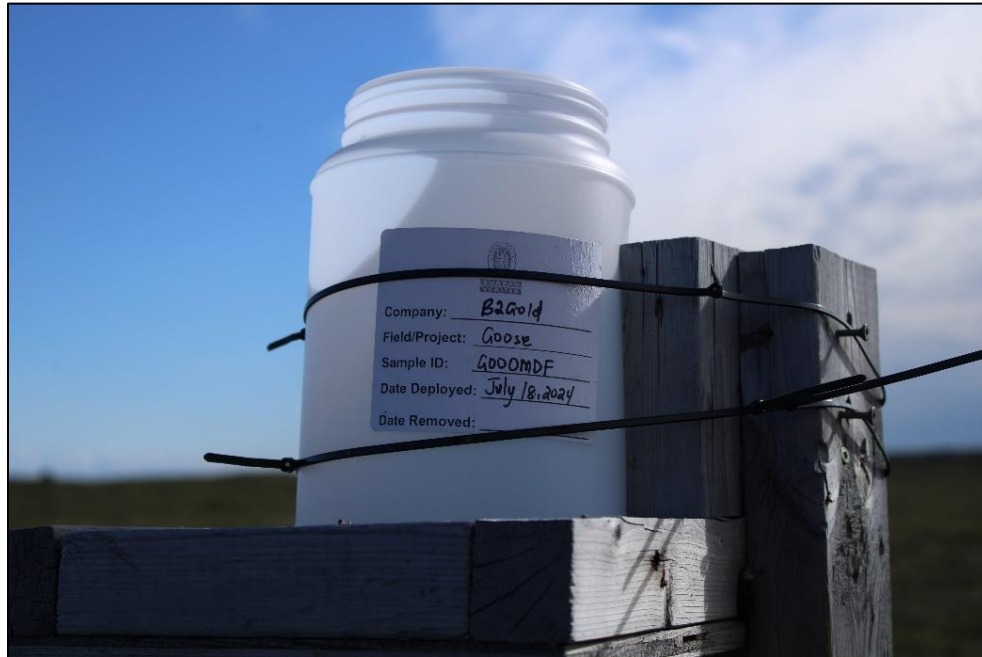
Photo 29: Dust Fall Monitoring Station at Goose Lake

On site, the Monitoring Officers had the opportunity to observe different environmental monitoring activities including dust fall monitoring, active air quality sampling and tag monitoring of Grayling in Rascal creek.

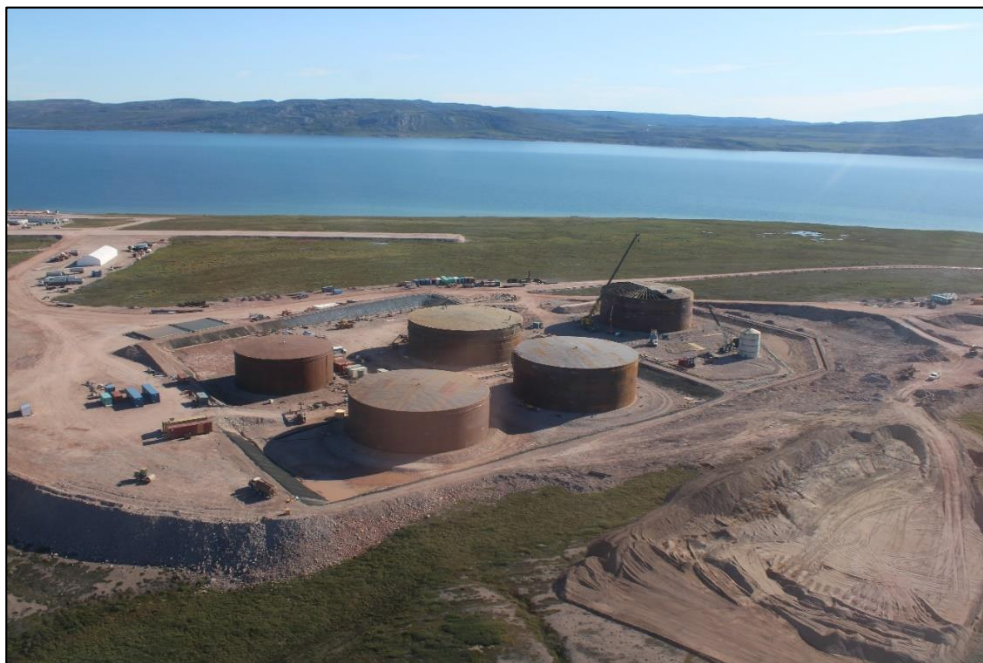
Photo 35: New Fuel Tank Farm Aerial View

B2Gold Nunavut is in the process of constructing a Bulk Fuel Tank Facility at the MLA where larger quantities of fuel can be stored after sealift and before the Winter Ice Road is operational. The tank farm was under construction but appeared to be well maintained and a clean worksite with adequate secondary containment.
