# Back River Mine

## 2024 Wildlife Mitigation and Monitoring Program Report

DATE  
March 2025

REFERENCE  
0704187

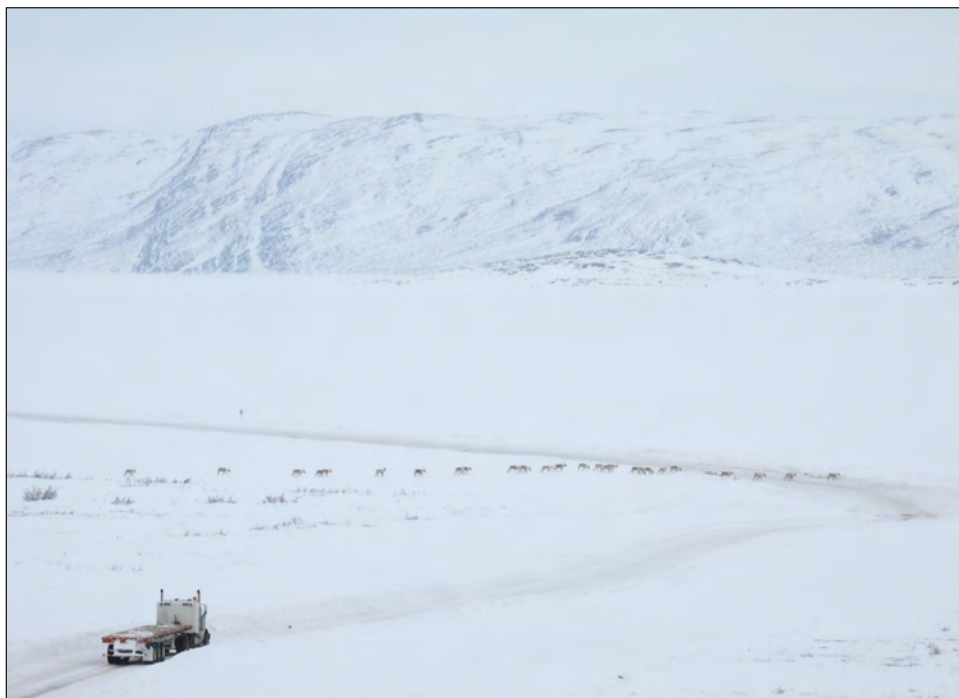
Photo 2.3-1 Vehicle stopped on the Winter Ice Road, April 22, 2024.

A traffic rate of 20 vehicles/h has been shown to likely cause a low crossing rate for large caribou groups trying to cross a pipeline road in Alaska (Smith and Cameron 1985). More recent studies suggest that the relative probability of crossing the road declines at a lower traffic rate of approximately 12.5 vehicles/h (Smith and Johnson 2023). The WIR was generally operational for 24 hours per day, apart from days where weather restricted traffic resulting in reduced traffic or temporary road closures. In 2024, an average of 34 heavy vehicles per day used the WIR. Therefore, the WIR had a traffic rate of approximately 1.4 vehicles per hour, remaining below the threshold of disturbance. In addition, B2Gold Nunavut safety rules required trucks to travel in convoys of at least three trucks at a time, further reducing the frequency of individual vehicles per hour (Photo 2.3-1).

Mitigation and monitoring in place by B2Gold Nunavut for the WIR was effective at reducing traffic levels along the WIR. Traffic rates along the WIR remained below levels that may disrupt caribou movement (12.5 to 20 vehicles/h; Smith and Johnson 2023; Smith and Cameron 1985). Although traffic levels were above the estimated 1,900 one-way trips per year, there was no evidence of disturbance to caribou (Section 3.3) and no additional mitigation was required in 2024. If traffic levels are higher than estimated in the FEIS for 3 consecutive years and if deemed required by the NIRB, then B2Gold Nunavut will conduct an assessment of road effects on caribou at that time (Section 7.3.1.8 of the WMMP Plan).
