# **Cambridge Bay, NU**

## **Geotechnical Site Investigation - Potential Borrow Sources**

307034-00016-00-SS-REP-0001

15 November 2012

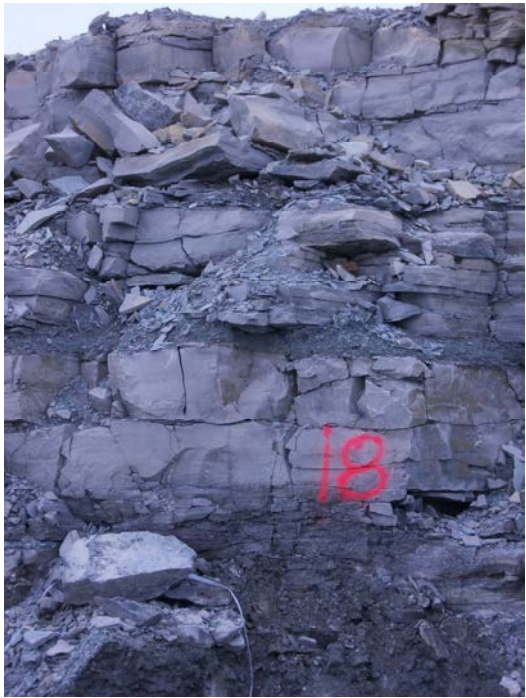
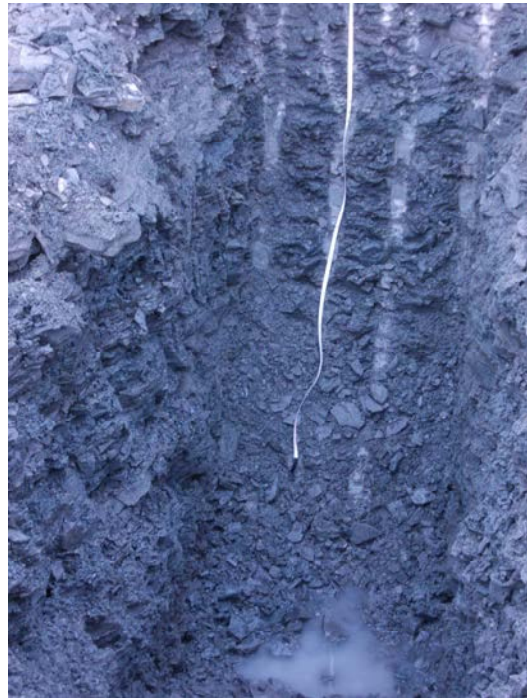
TP-18

Two test pits (TP-18 and TP-19) were excavated within Quarry Pit No. 3, in the active quarry zone. The excavated face adjacent to each test pit was approximately 2.5 m from the existing ground surface and comprised of grey, gently dipping, massively interbedded sandstone and siltstone. Both test pits were excavated to 2.5 m below existing grade (approximately 5.0 m below ground surface) and encountered a grey to dark grey, thinly bedded, highly fractured, very weak to weak siltstone / claystone. The lateral and vertical extent of this siltstone / claystone unit (historically this material has been referred to as clay) is currently unknown. Based on a preliminary airphoto review, in conjunction with the 2.5 m thickness identified in our test pits, we estimate that at least 7,000 cubic metres of claystone is available from this source.
