Tote Road Site CV-049

**Baffinland Iron Mines
Mary River Project**

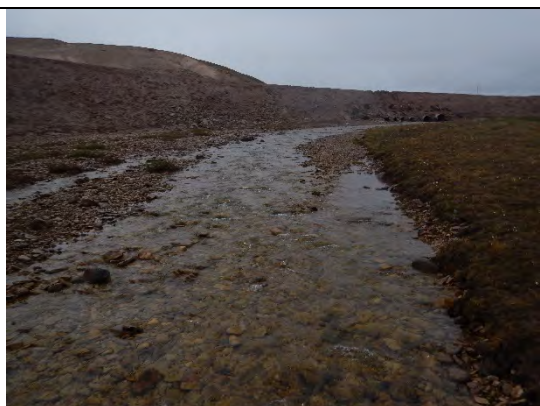
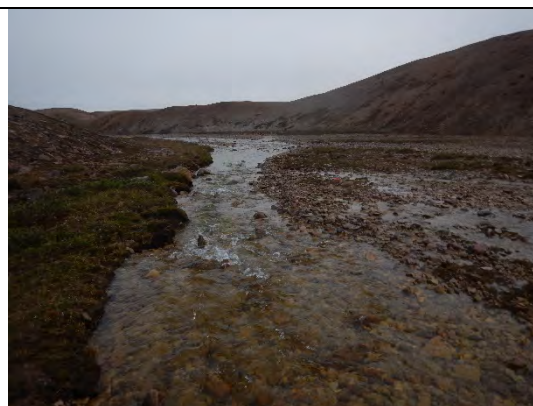
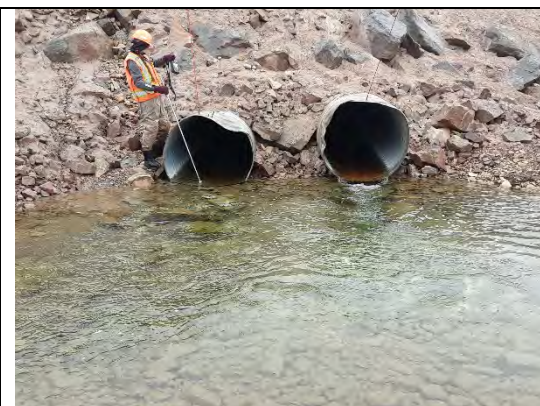
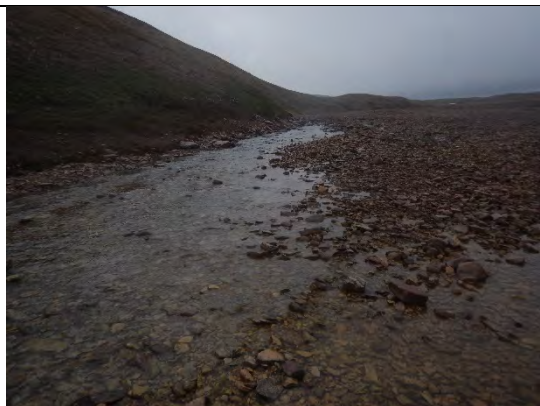
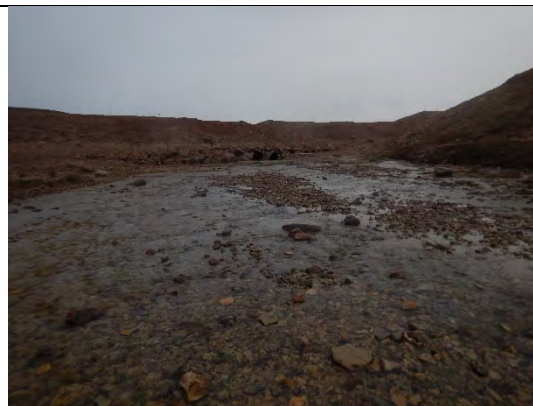
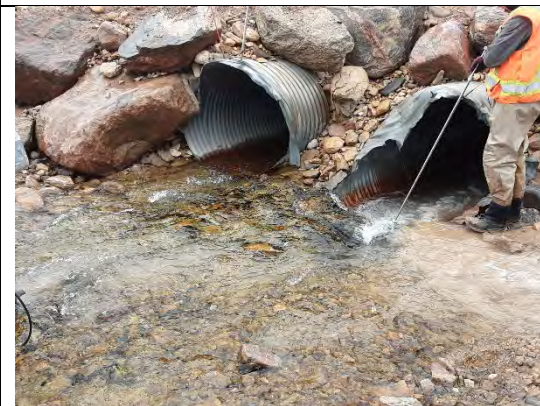
Summary: Site provides abundant summer rearing habitat for juvenile Arctic Char. There were no fish passage issues in 2021.

Photos 1. Photographs downstream (top) and upstream (bottom) of the Tote Road crossing CV-049: (A,D) looking upstream during spring; (B,E) looking downstream during spring; and (C,F) looking at culverts during fall.

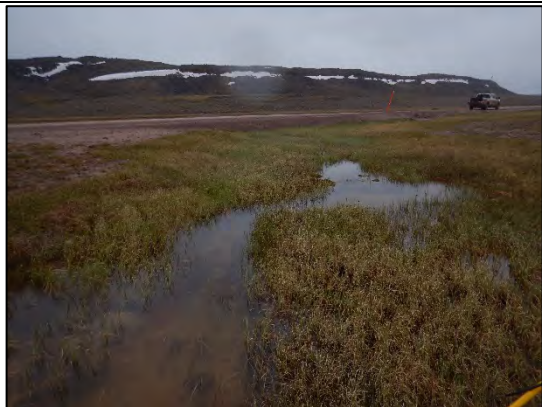
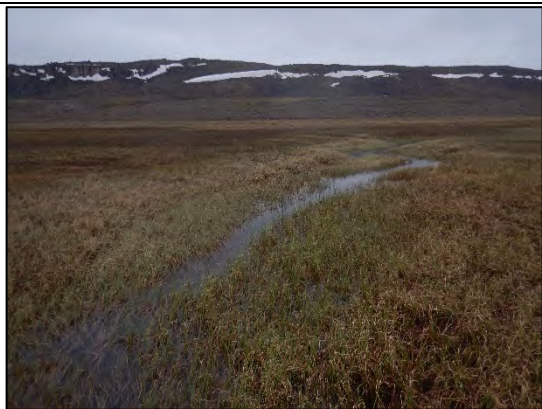
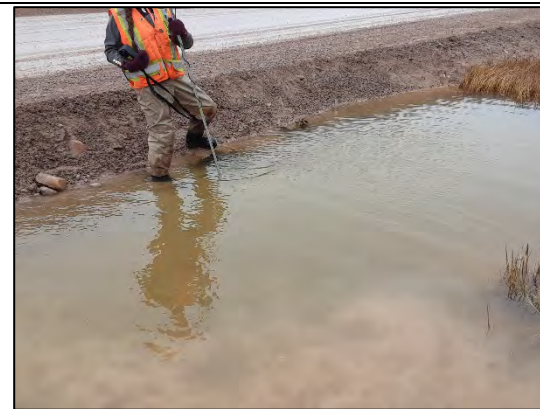
Photos 1. Photographs downstream (top) and upstream (bottom) of the Tote Road crossing CV-057: (A,D) looking upstream during spring; (B,E) looking downstream during spring; and (C,F) looking at culverts during fall.

Summary: Site provides some summer rearing habitat for juvenile Arctic Char. There were no fish passage issues in 2021; however, culverts are becoming increasingly full of sediment and may soon create a blockage to fish movements if not remediated. Remediation recommended for winter months.

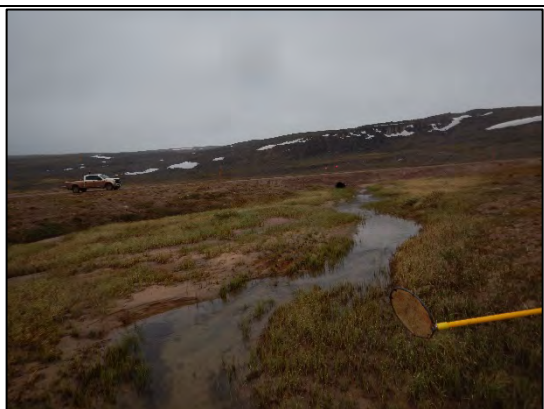
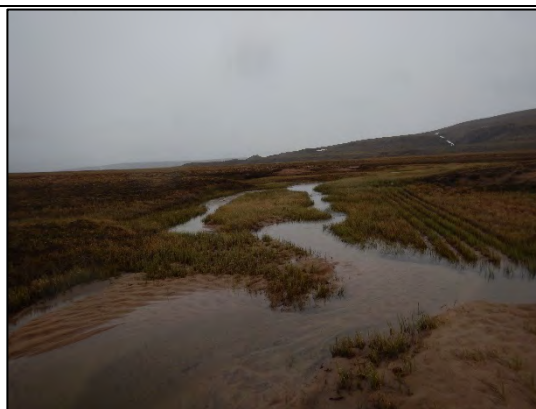
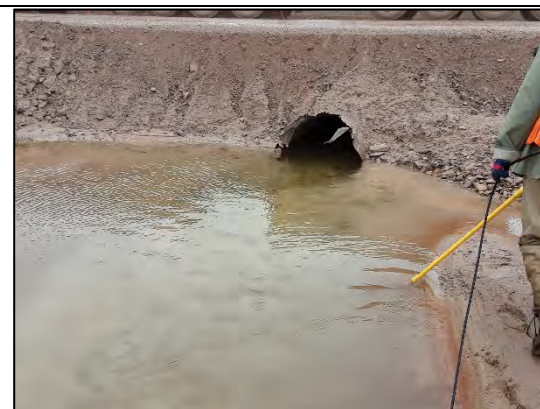
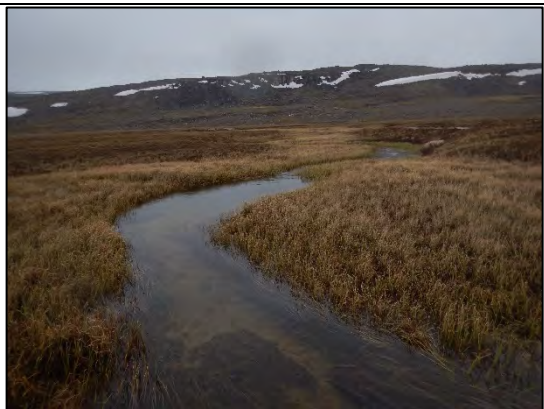
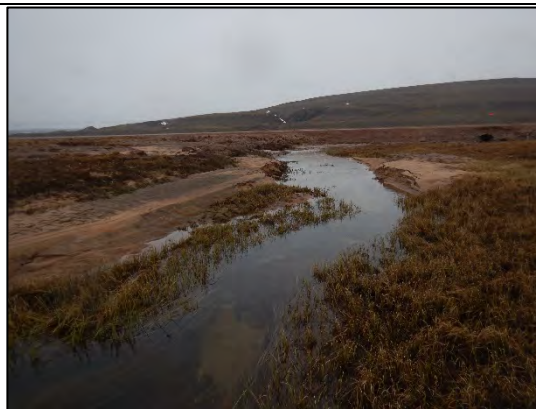
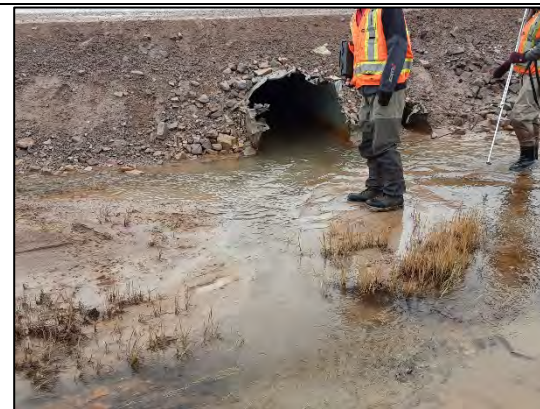
Summary: Site provides abundant summer rearing habitat for juvenile Arctic Char. There were no fish passage issues in 2021.

Photos 1. Photographs downstream (top) and upstream (bottom) of the Tote Road crossing CV-058: (A,D) looking upstream during spring; (B,E) looking downstream during spring; and (C,F) looking at culverts during fall.

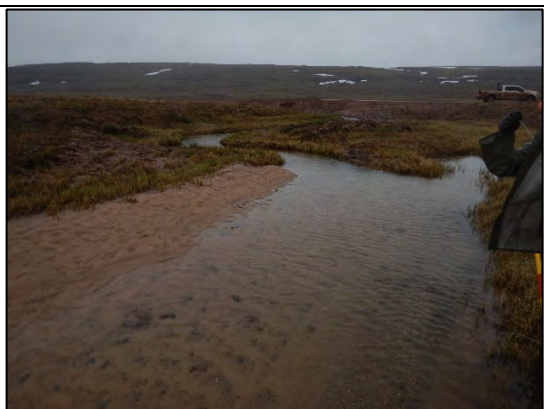
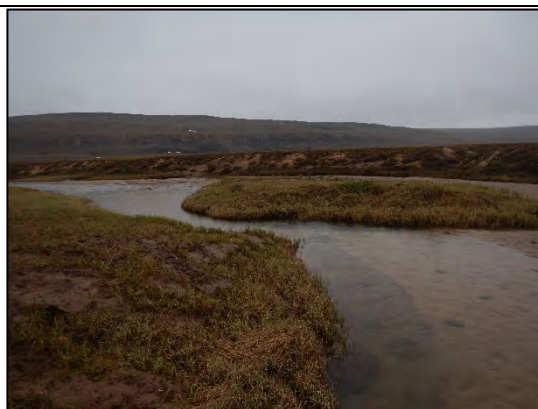
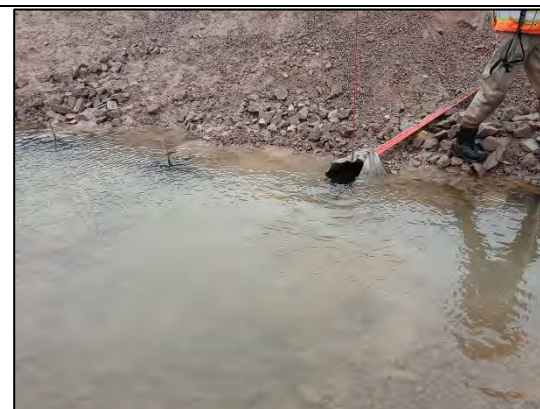
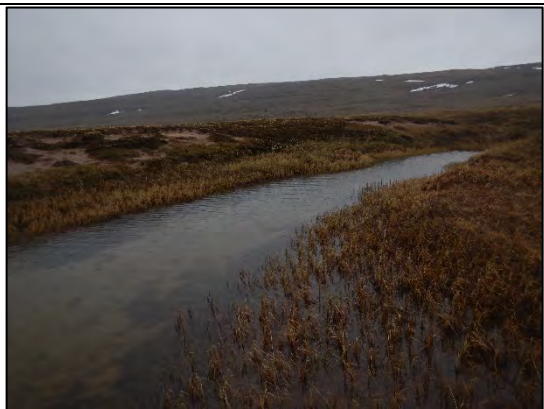
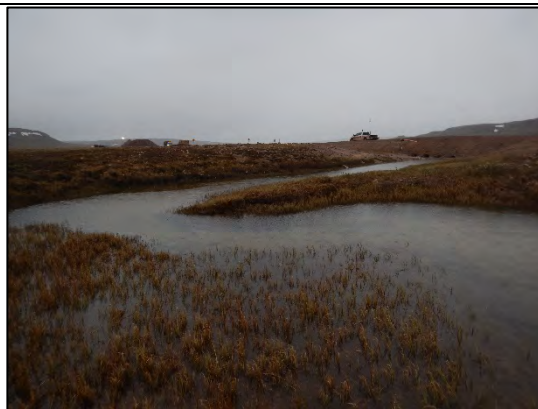
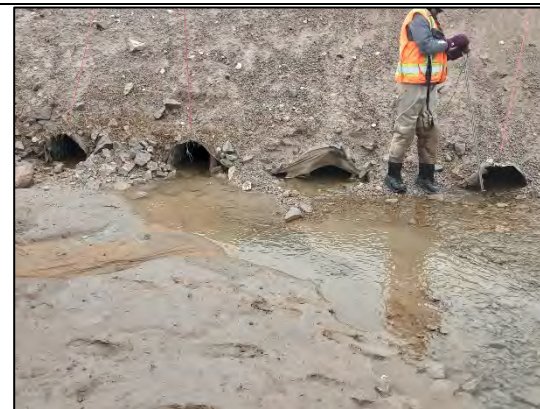
Summary: Site provides abundant summer rearing habitat for juvenile Arctic Char. There were no fish passage issues in 2021.

Photos 1. Photographs downstream (top) and upstream (bottom) of the Tote Road crossing CV-059: (A,D) looking upstream during spring; (B,E) looking downstream during spring; and (C,F) looking at culverts during fall.

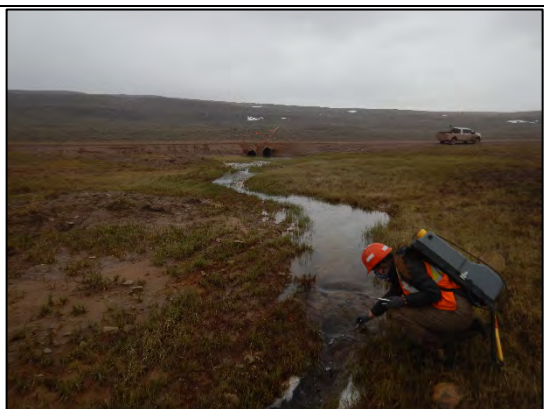
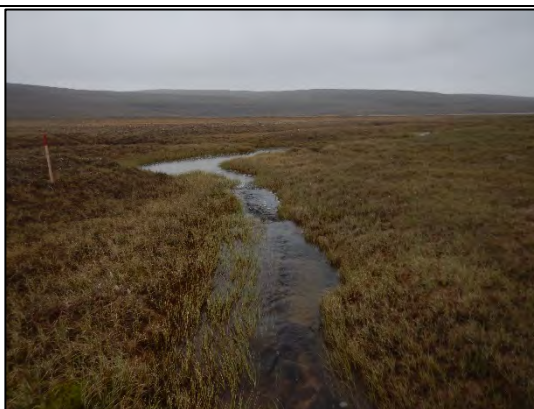
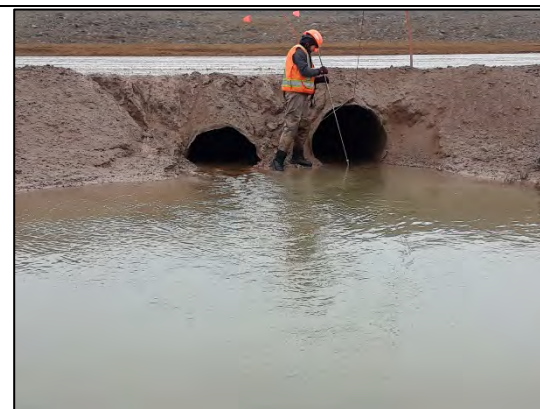
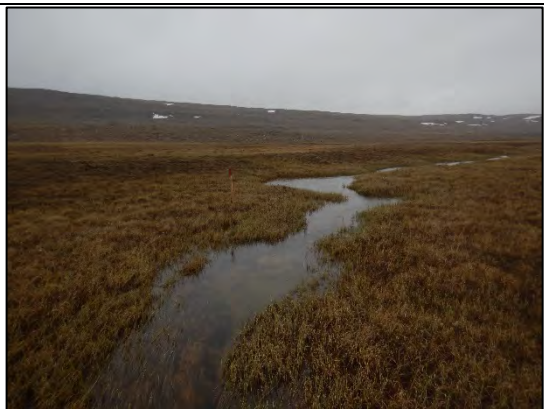
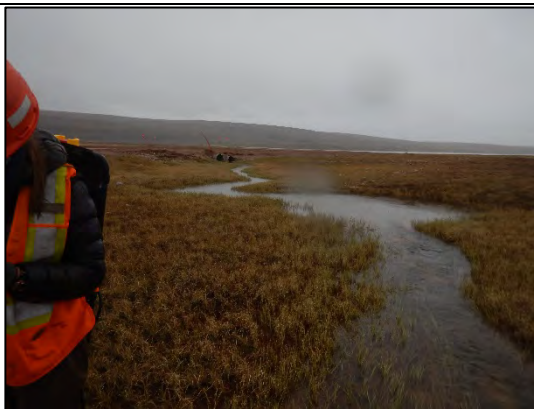
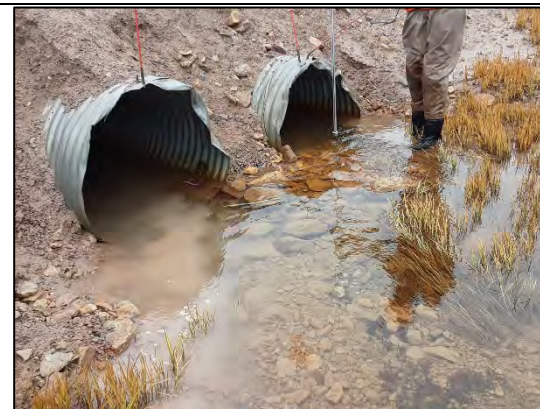
Summary: Site provides abundant summer rearing habitat for juvenile Arctic Char. There were no fish passage issues in 2021.

Photos 1. Photographs downstream (top) and upstream (bottom) of the Tote Road crossing CV-060: (A,D) looking upstream during spring; (B,E) looking downstream during spring; and (C,F) looking at culverts during fall.

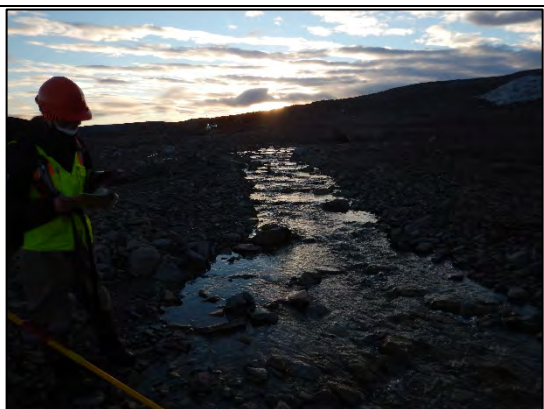
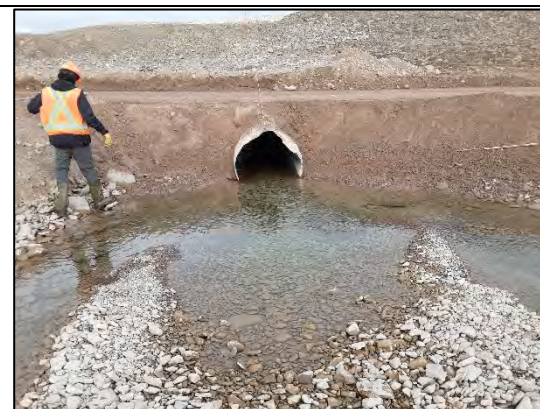
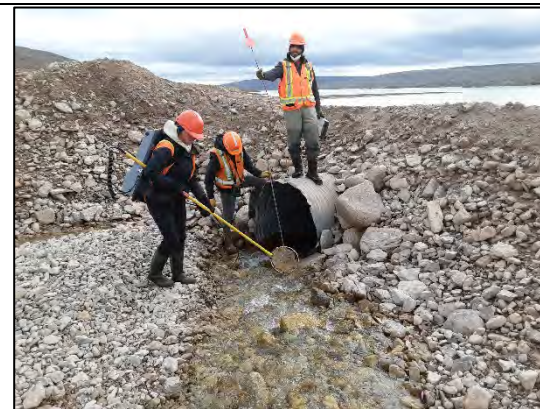
Summary: Site provides abundant summer rearing habitat for juvenile Arctic Char. There were no fish passage issues in 2021.

Photos 1. Photographs downstream (top) and upstream (bottom) of the Tote Road crossing CV-072: (A,D) looking upstream during spring; (B,E) looking downstream during spring; and (C,F) looking at culverts during fall.

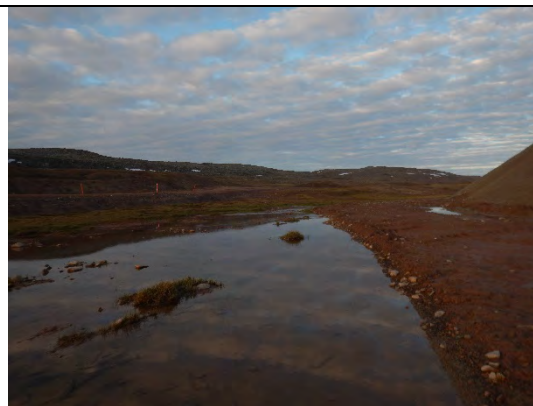
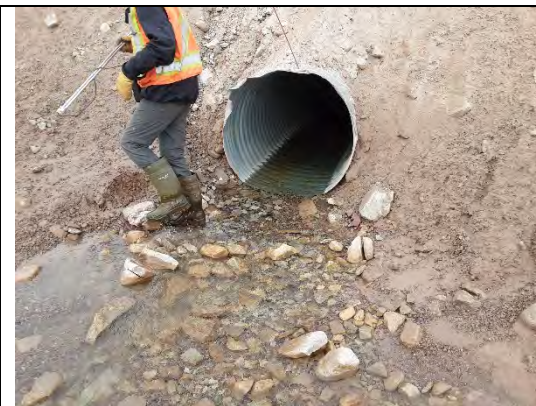
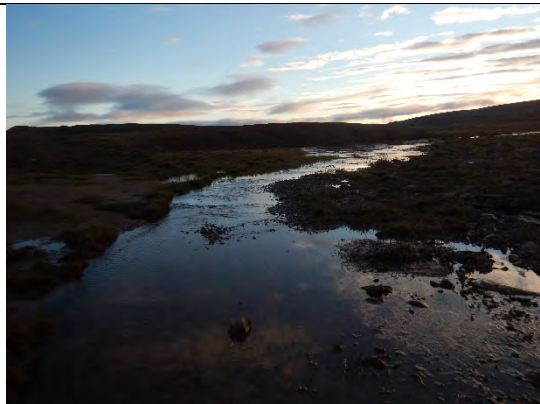
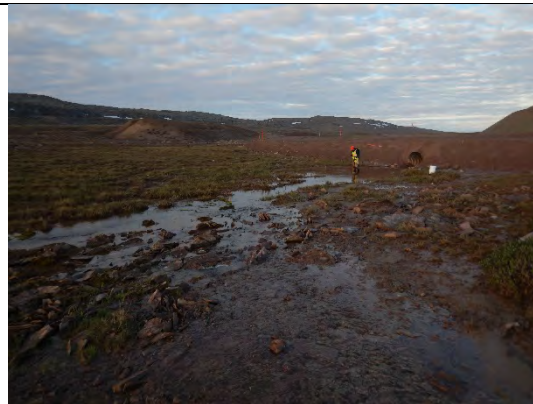
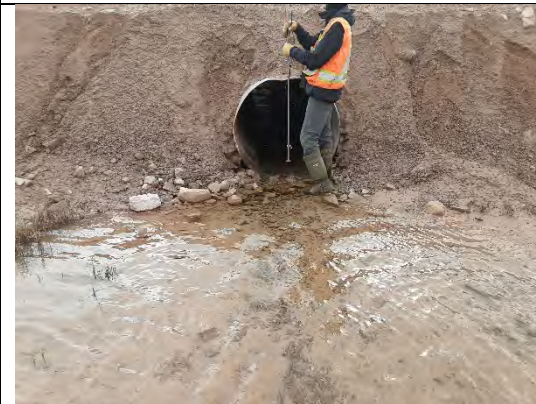
Summary: Small stream providing summer rearing habitat for juvenile Arctic Char. There were no issues affecting fish passage in 2021.

Photos 1. Photographs downstream (top) and upstream (bottom) of the Tote Road crossing CV-076: (A,D) looking upstream during spring; (B,E) looking downstream during spring; and (C,F) looking at culverts during fall.

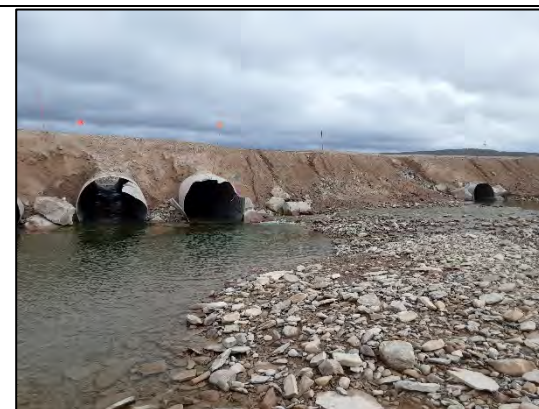
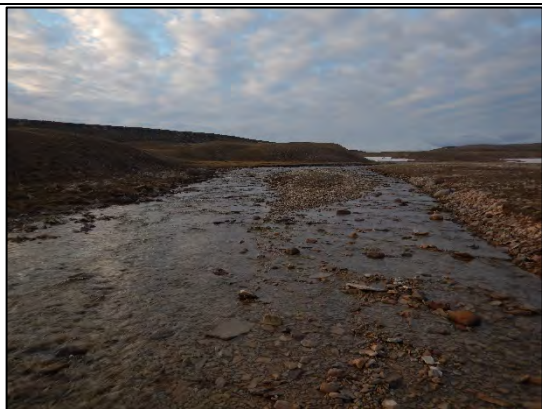
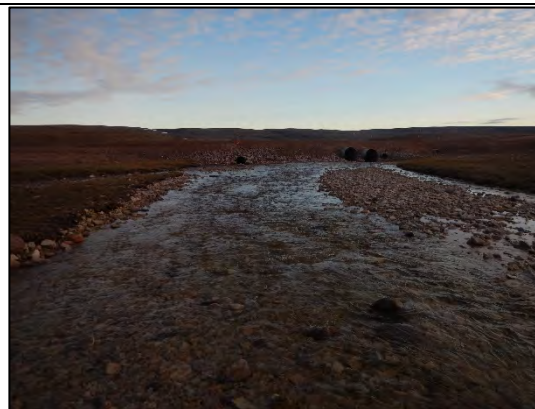
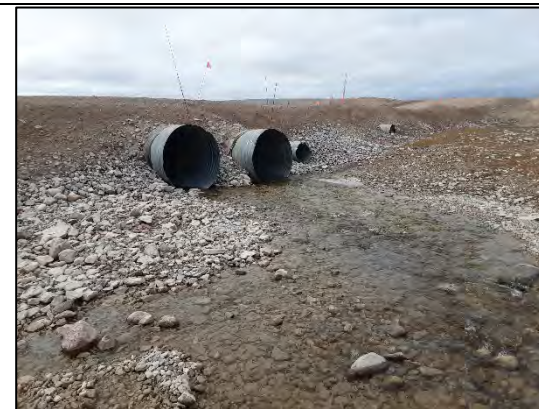
Summary: Site provides abundant summer rearing habitat for juvenile Arctic Char. There were no fish passage issues in 2021.

Photos 1. Photographs downstream (top) and upstream (bottom) of the Tote Road crossing CV-078: (A,D) looking upstream during spring; (B,E) looking downstream during spring; and (C,F) looking at culverts during fall.

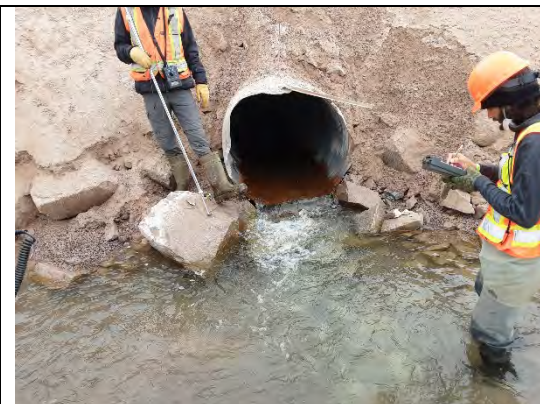
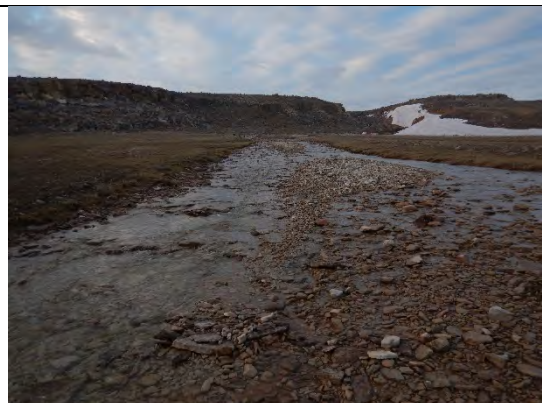
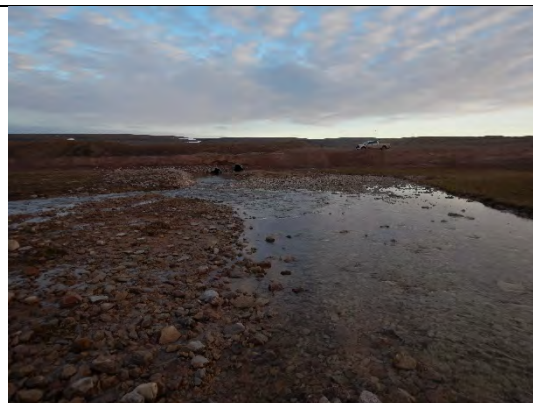
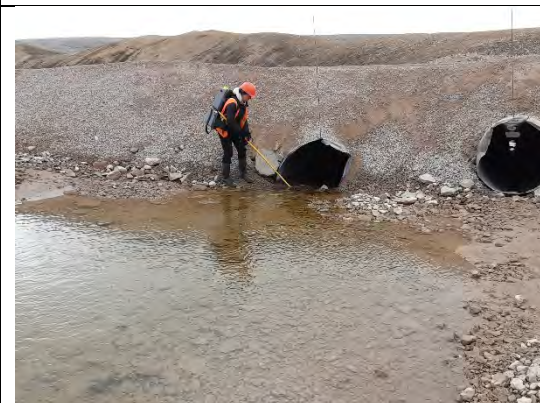
Photos 1. Photographs downstream (top) and upstream (bottom) of the Tote Road crossing CV-079: (A,D) looking upstream during spring; (B,E) looking downstream during spring; and (C,F) looking at culverts during fall.

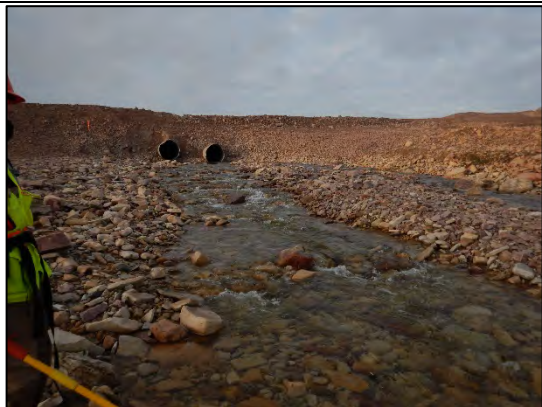
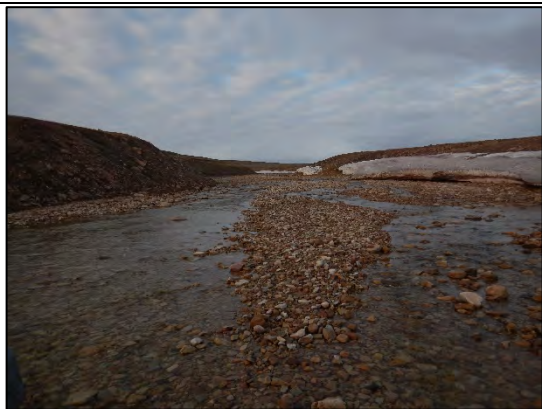
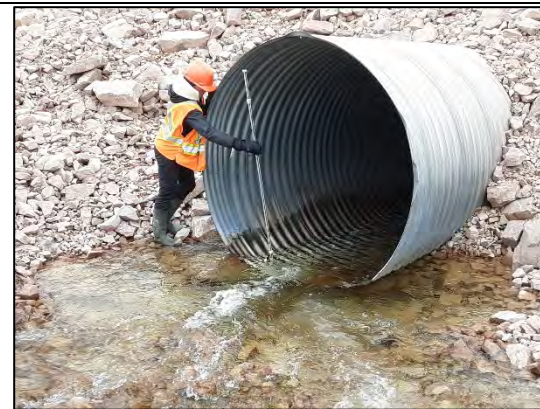
Photos 1. Photographs downstream (top) and upstream (bottom) of the Tote Road crossing CV-099: (A,D) looking upstream during spring; (B,E) looking downstream during spring; and (C,F) looking at culverts during fall.

Summary: A large stream with abundant fish habitat. Water velocities in the culverts can be high enough to restrict upstream access to larger juveniles during periods of very high flows. There were no fish passage issues in 2021.

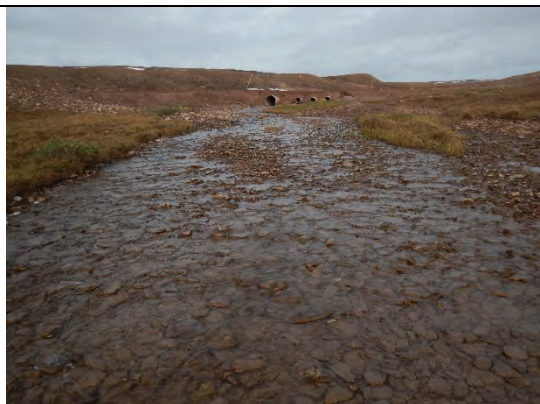
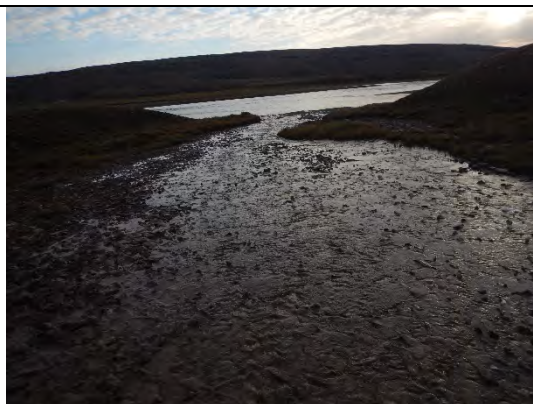
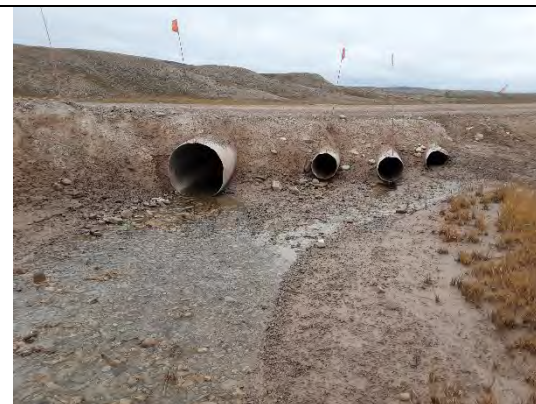
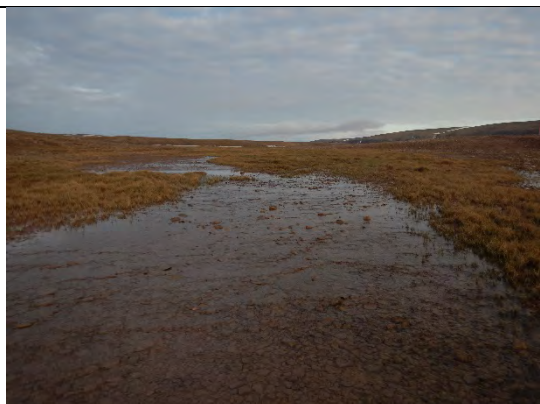
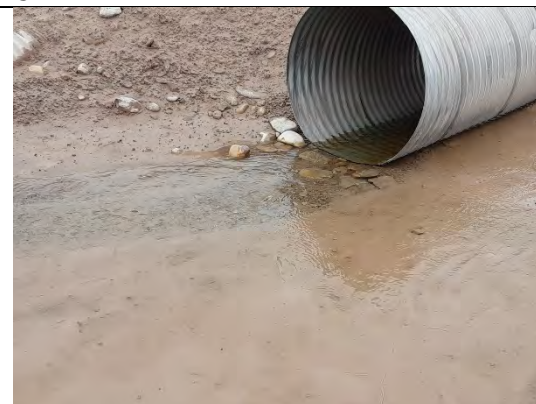
Summary: This stream typically provides summer rearing habitat for juvenile Arctic Char. There were no fish passage issues in 2021.

Photos 1. Photographs downstream (top) and upstream (bottom) of the Tote Road crossing CV-102: (A,D) looking upstream during spring; (B,E) looking downstream during spring; and (C,F) looking at culverts during fall.

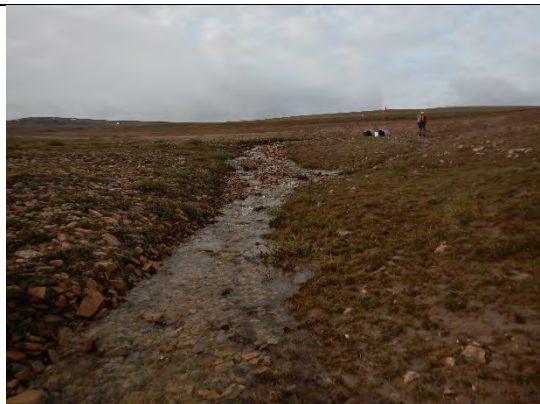
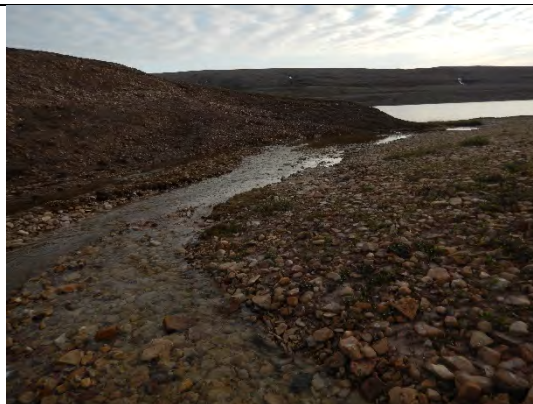
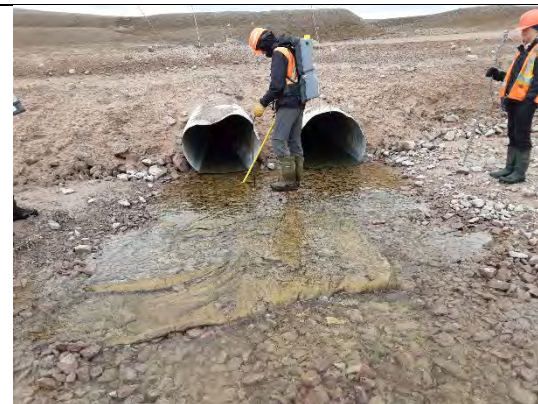
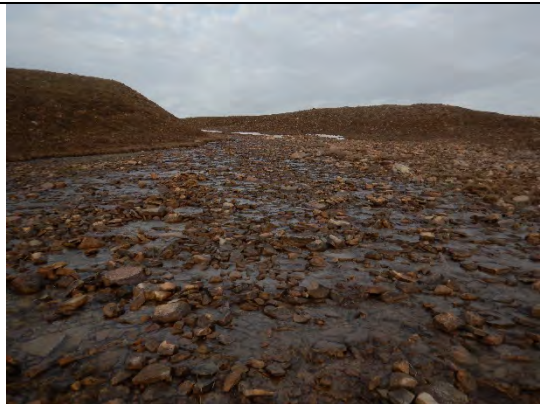
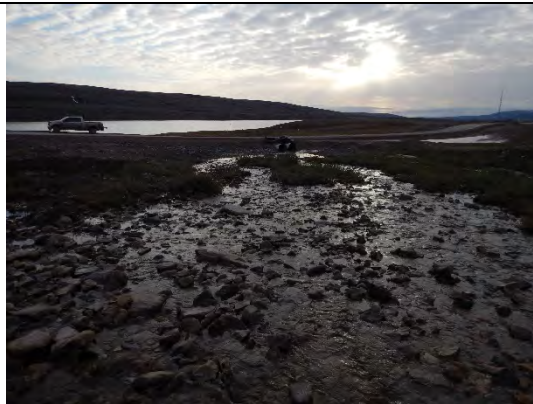
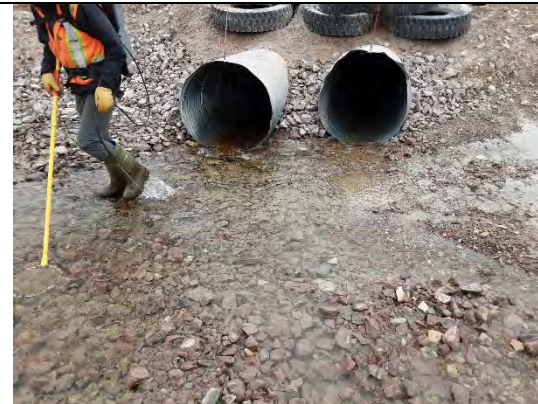
Summary: Though water levels are occasionally low (e.g., 2019), this stream typically provides summer rearing habitat for juvenile Arctic Char. There were no passage issues in 2021.

Photos 1. Photographs downstream (top) and upstream (bottom) of the Tote Road crossing CV-104: (A,D) looking upstream during spring; (B,E) looking downstream during spring; and (C,F) looking at culverts during fall.

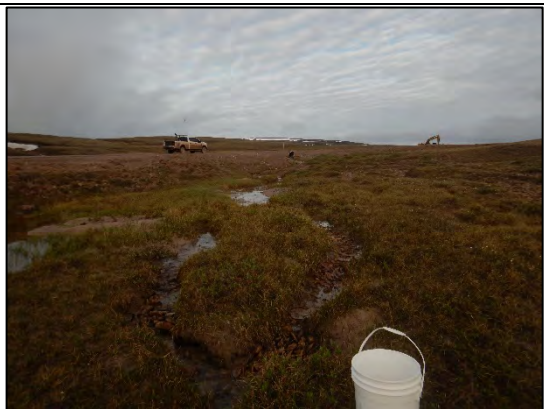
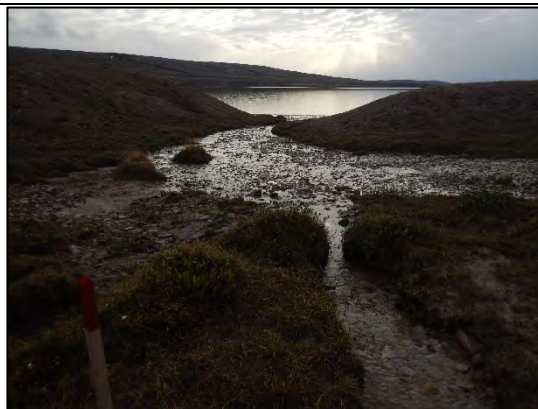
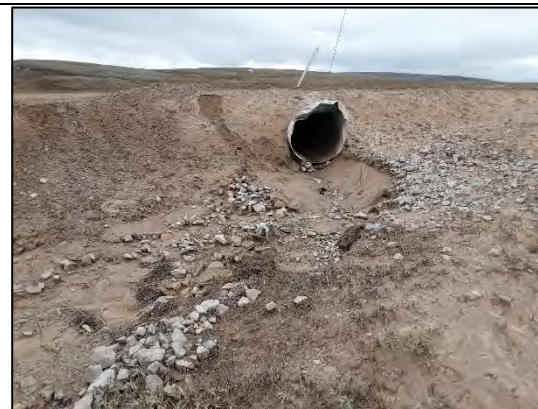
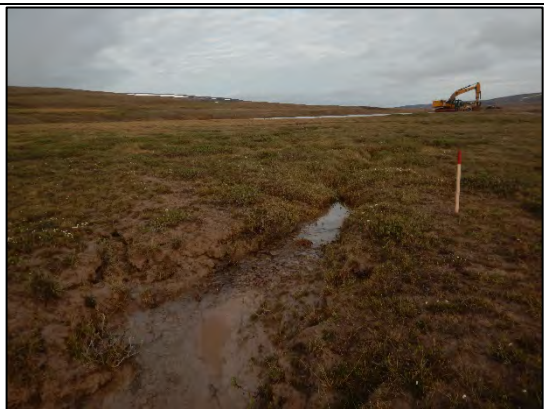
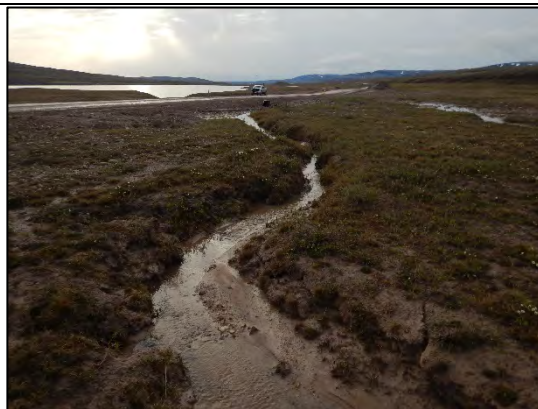
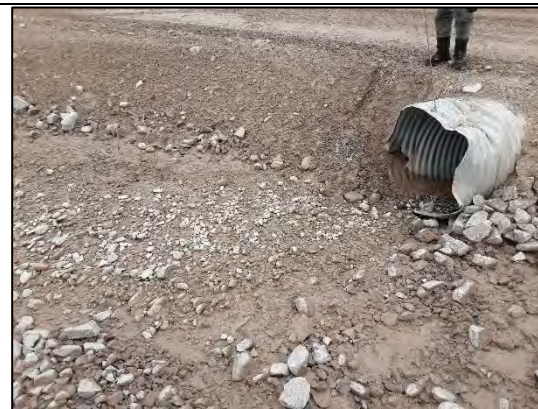
Photos 1. Photographs downstream (top) and upstream (bottom) of the Tote Road crossing CV-106: (A,D) looking upstream during spring; (B,E) looking downstream during spring; and (C,F) looking at culverts during fall.

Summary: Stream provides summer rearing habitat for juvenile Arctic Char, though it frequently becomes dry following freshet without additional inputs of precipitation. An existing ramp (installed in 2018) designed to improve access received additional modifications in 2019 and 2020. Similar issues existed in 2021. Additional remediation may be required to improve the effectiveness of the ramp at providing fish passage during the periods of low water often experienced by this stream.

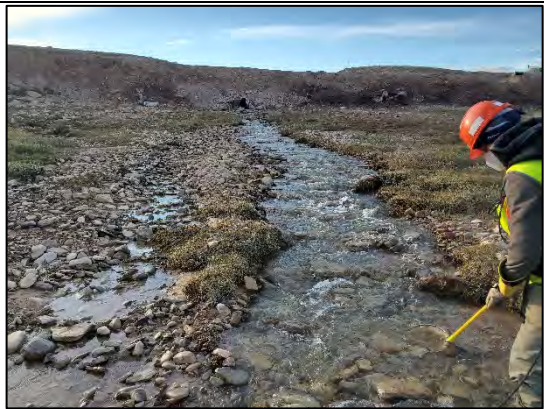
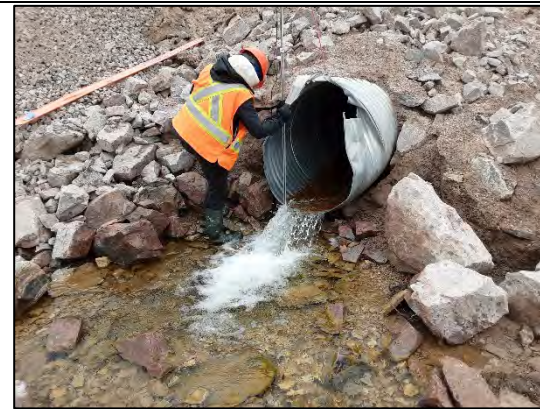
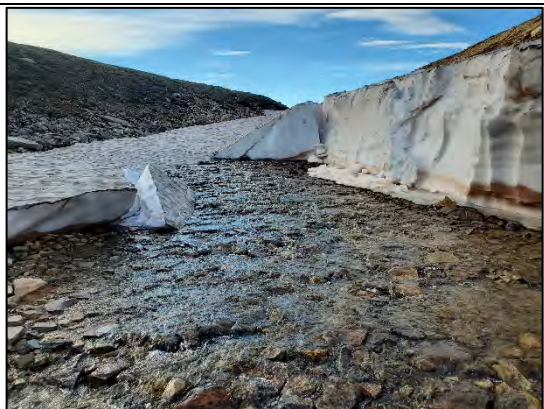
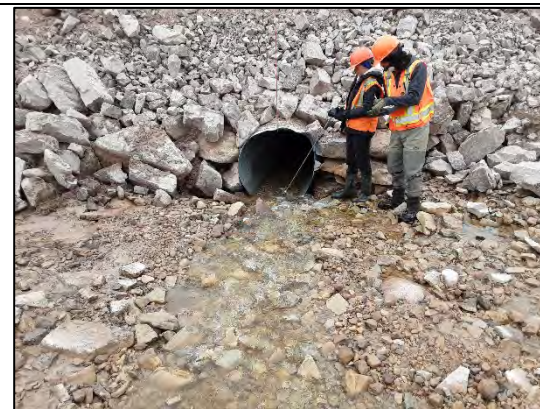
Photos 1. Photographs downstream (top) and upstream (bottom) of the Tote Road crossing CV-111: (A,D) looking upstream during spring; (B,E) looking downstream during spring; and (C,F) looking at culverts during fall.

Summary: This stream provides summer rearing habitat for juvenile Arctic Char. Culvert was reinstalled during the winter of 2018/2019 with a high perch. Remediation measures in fall 2019 were insufficient to improve fish access and issues remained in 2021. Additional remediation required. See remediation Appendix for details.

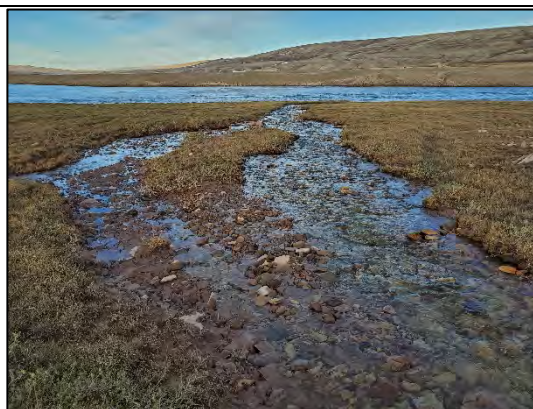
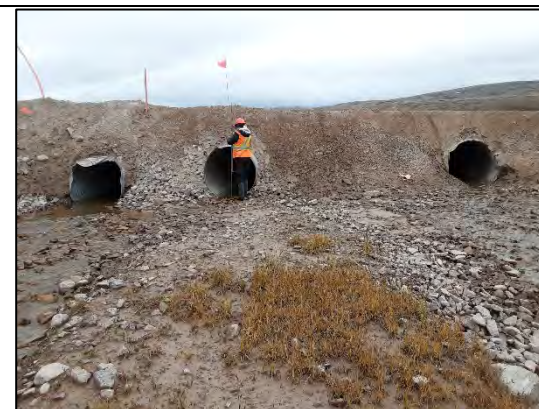
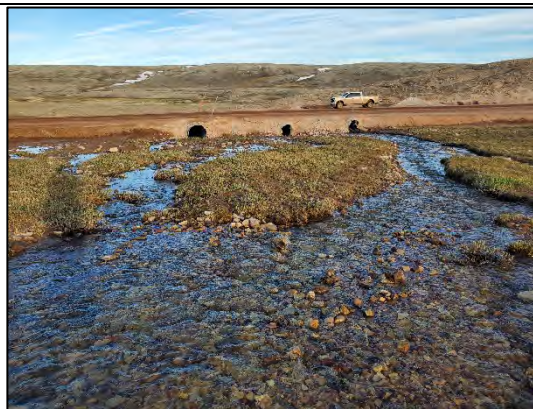
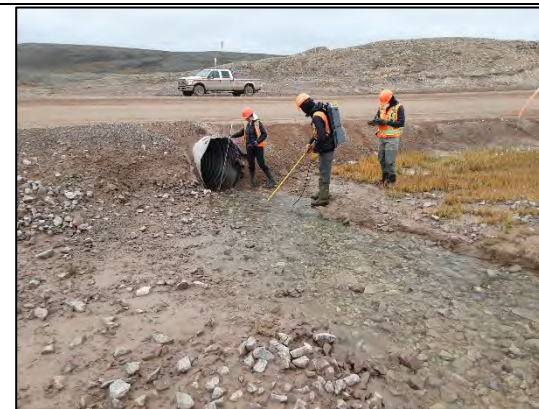
Summary: This stream provides summer rearing habitat for juvenile Arctic Char. There were no fish passage issues in 2021.

Photos 1. Photographs downstream (top) and upstream (bottom) of the Tote Road crossing CV-112: (A,D) looking upstream during spring; (B,E) looking downstream during spring; and (C,F) looking at culverts during fall (upstream photo includes only the left culvert).

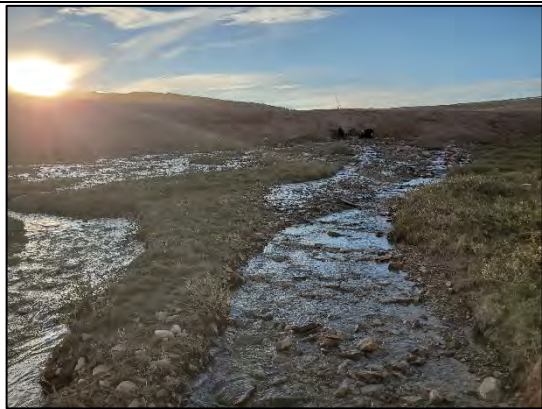
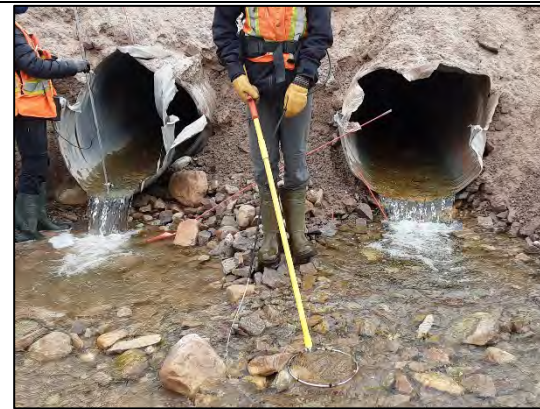
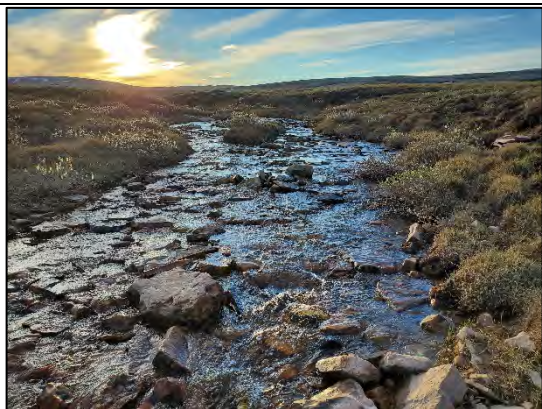
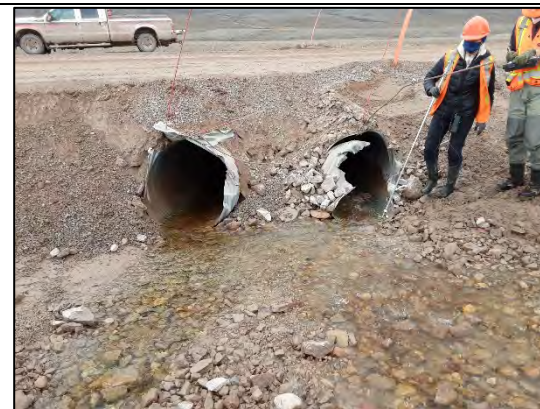
Photos 1. Photographs downstream (top) and upstream (bottom) of the Tote Road crossing CV-114: (A,D) looking upstream during spring; (B,E) looking downstream during spring; and (C,F) looking at culverts during fall.

Summary: This stream provides habitat for juvenile Arctic Char. Perched culverts that may affect upstream access were remediated in fall 2019 and minor repairs to the works were completed in fall 2020. The remediation structure was destroyed during freshet and/or during snow clearing activities in 2021. New remediation measures will be required.

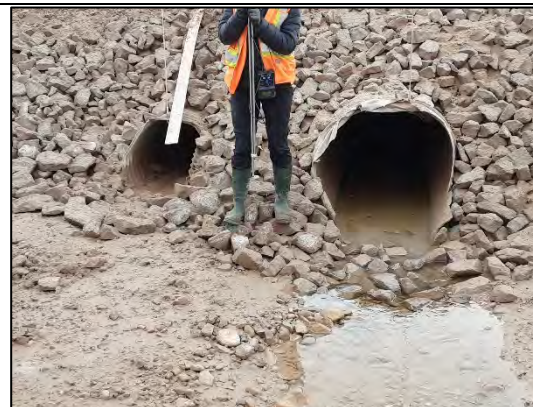
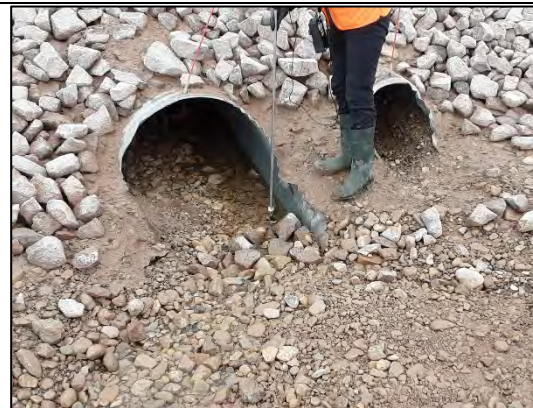
Photos 1. Photographs downstream (top) and upstream (bottom) of the Tote Road crossing CV-115: (A,C) looking upstream during spring; and (B,D) looking at the culvert during fall.

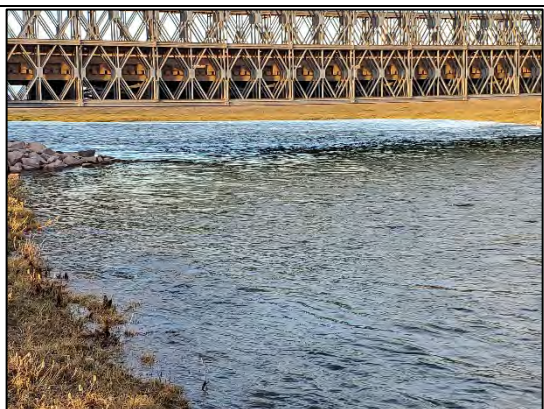
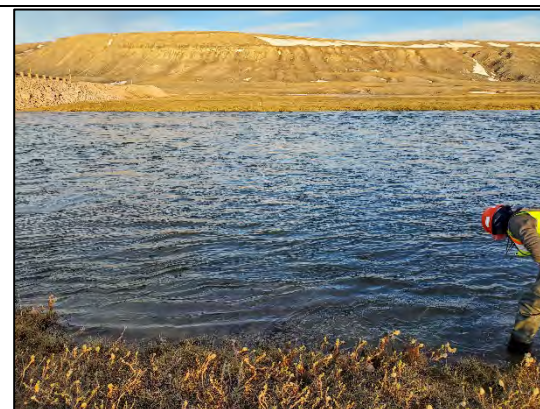
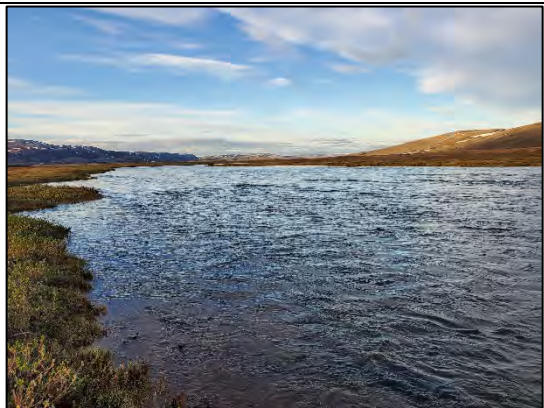
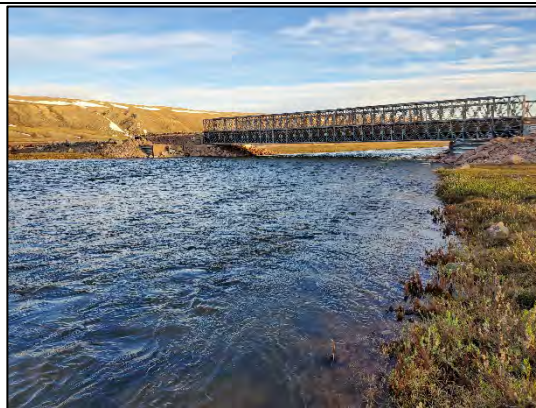
Summary: A bridge crossing of a major river that has consistently provided abundant fish habitat with no passage issues in 2021.

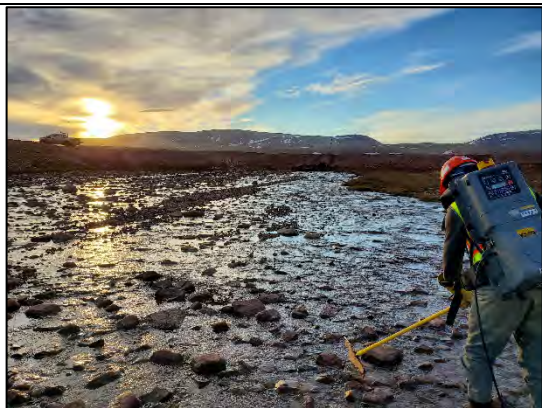
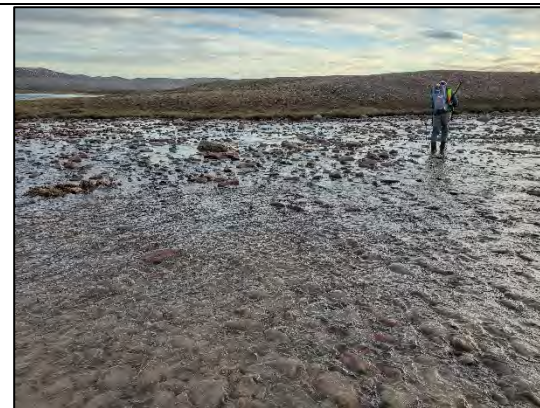
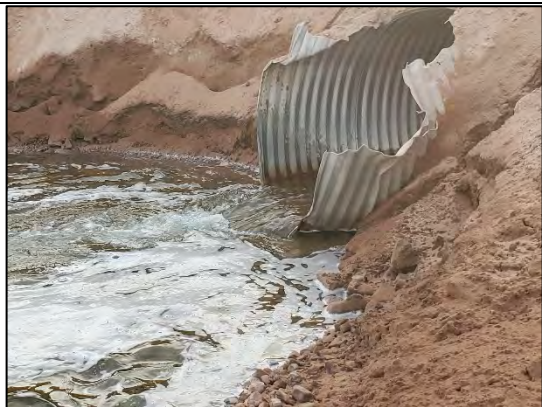
Photos 1. Photographs at the Tote Road crossing CV-129: from downstream of the road looking upstream (A), downstream (B), and across (C) during spring; looking at the downstream end of the culvert during spring (D) and fall (E); and looking at the upstream end of the culvert during fall (F).

Summary: This site has consistently provided good quality summer rearing habitat for juvenile Arctic Char and is the first large tributary upstream of the impassable falls on Phillips Creek (i.e., fish use is restricted to land-locked Arctic Char). Small culvert perch was remediated in fall 2019 and minor repairs to the remediation works were conducted in fall 2020. The structure was damaged, and the perch reoccurred in 2021. Alternate remediation measures may be required. Upstream overwintering lake provides additional habitat.

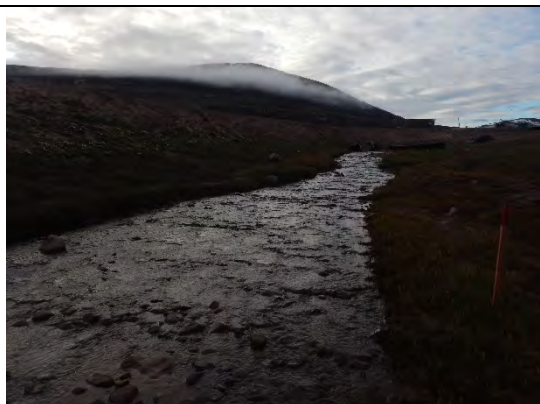
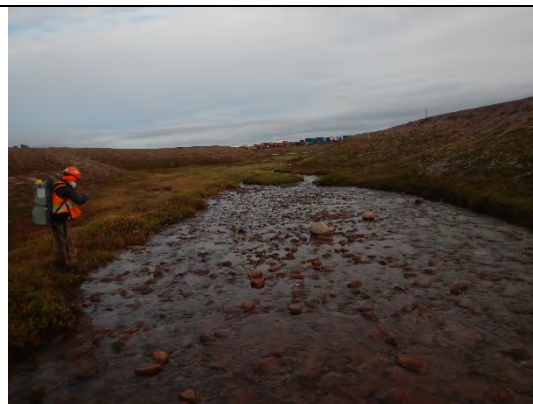
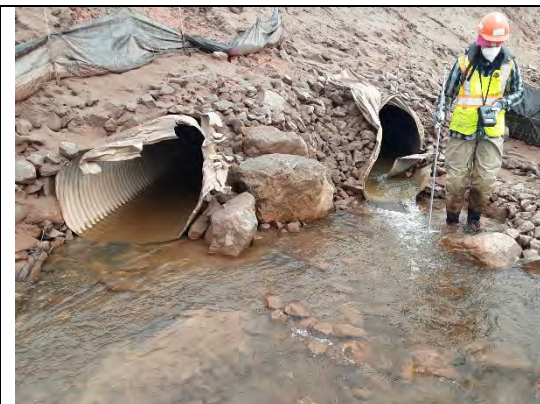
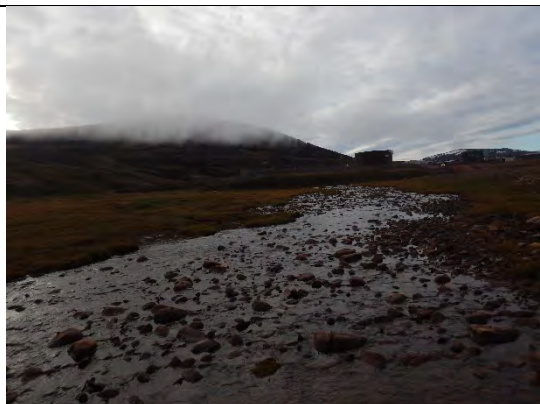
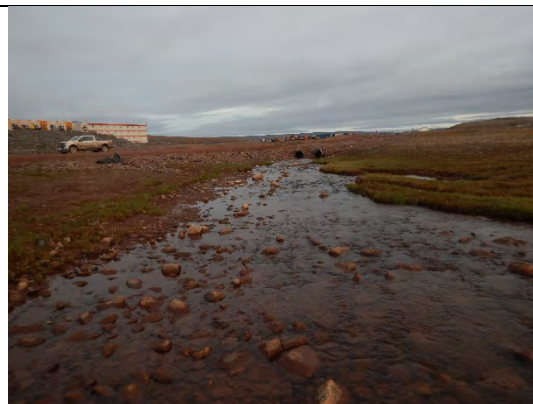
Summary: Site provides summer rearing habitat for both species. No fish passage issues in 2021.

Photos 1. Photographs downstream (top) and upstream (bottom) of the Tote Road crossing CV-186: (A,D) looking upstream during spring; (B,E) looking downstream during spring; and (C) looking at culverts during fall.

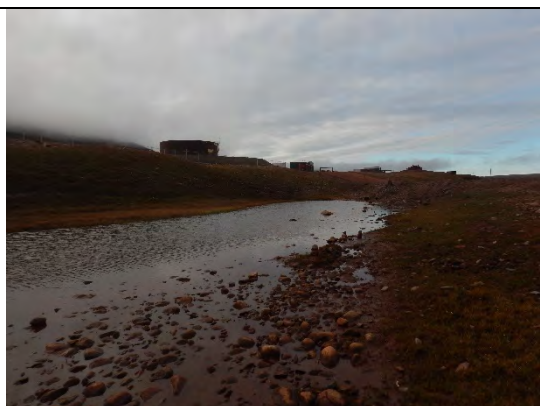
Summary: Site provides summer rearing habitat for both species, though upstream reaches become dry as water levels decrease. No fish passage issues in 2021.

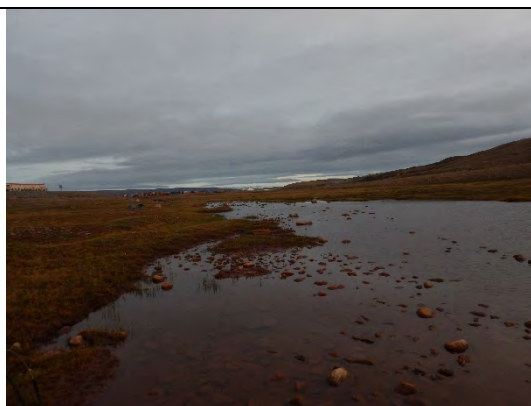
B

Photos 1. Photographs downstream (top) and upstream (bottom) of the Tote Road crossing CV-187: (A,D) looking upstream during spring; (B,E) looking downstream during spring; and (C) looking at culverts during fall.
