Tote Road Site CV-049

**Baffinland Iron Mines
Mary River Project**

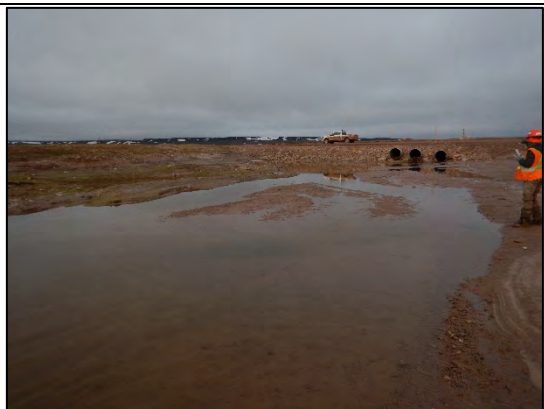
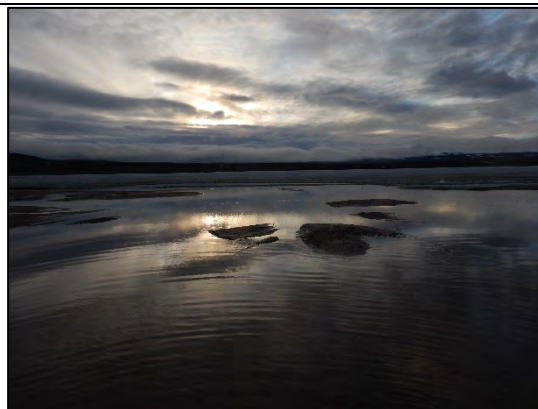
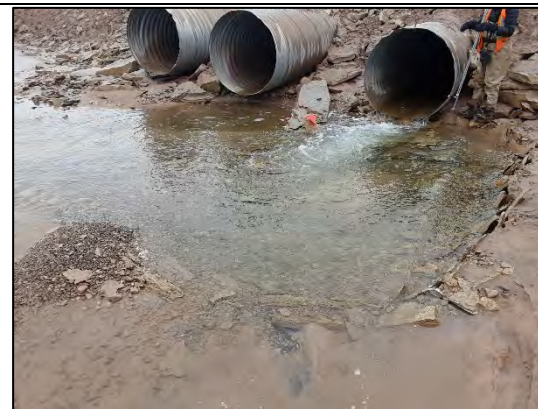
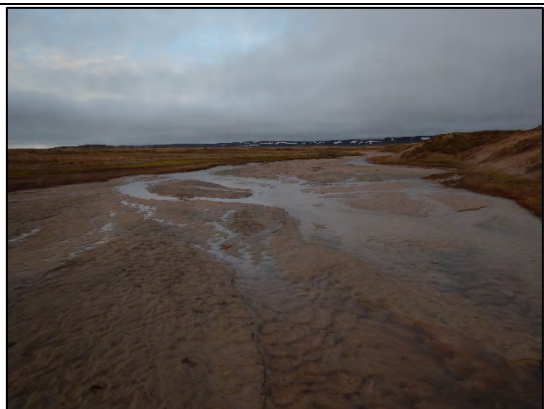
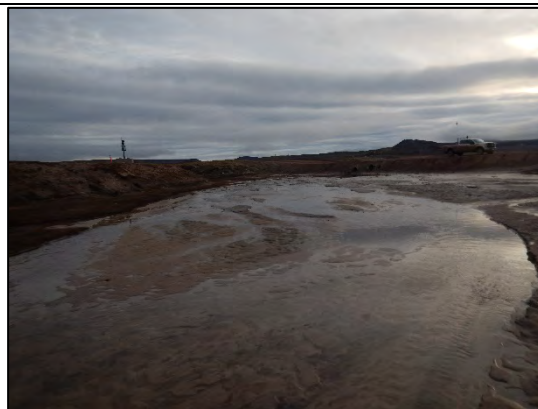
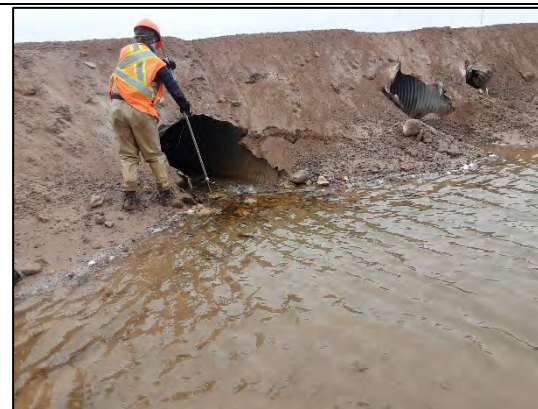
Photos 1. Photographs downstream (top) and upstream (bottom) of the Tote Road crossing CV-186: (A,D) looking upstream during spring; (B,E) looking downstream during spring; and (C,F) looking at culverts during fall.

Summary: A small stream that provides habitat for Ninespine Stickleback and small juvenile Arctic Char (especially young-of-the-year from Muriel Lake). A slight perch was remediated in 2019 and small repairs to the structure were completed in fall 2020. The structure was damaged during freshet or snow clearing activities in early 2021. Alternative remediation may be required.

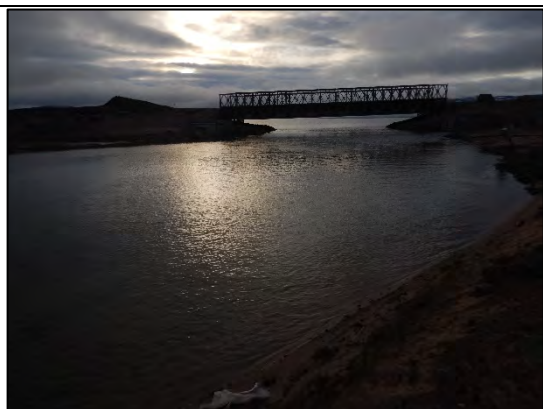
Summary: A bridge/culvert crossing with abundant habitat for both species and no passage issues in 2021.

Photos 1. Photograph downstream of the Tote Road crossing CV-217: (A) looking upstream; (B) looking downstream; and (C) looking across.

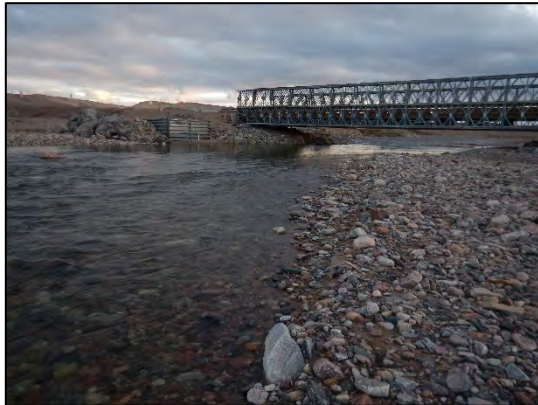
A

Summary: This large river (Tom River) includes both bridge and culvert crossings. All channels provide abundant summer rearing habitat for Arctic Char. No fish passage issues in 2021.

Photos 1. Photographs downstream (A) and upstream (B) of the Tote Road crossing CV-223.

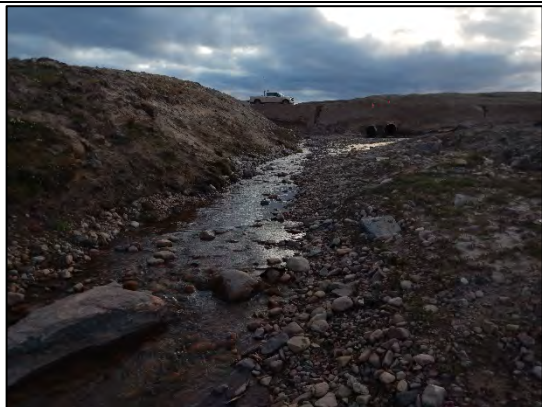
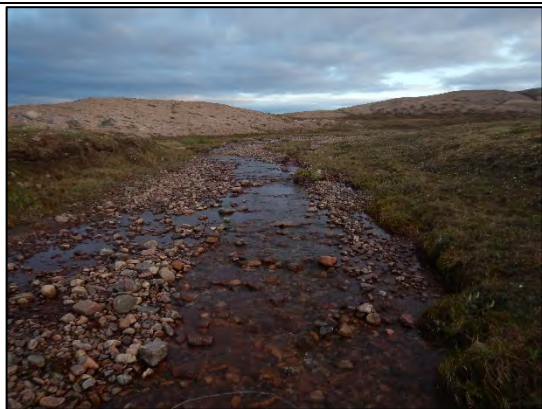
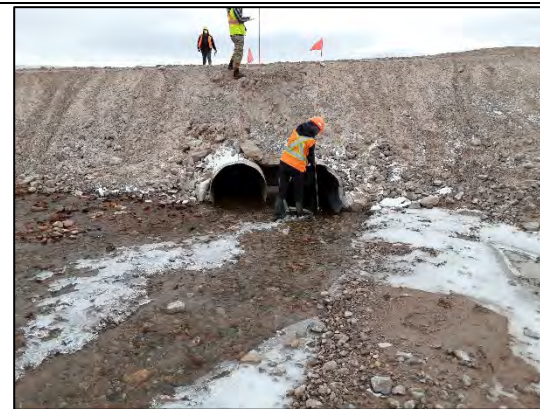
Photos 1. Photographs downstream (top) and upstream (bottom) of the Tote Road crossing CV-224: (A,D) looking upstream during spring; (B,E) looking downstream during spring; and (C,F) looking at culverts during fall.

Summary: The site provides summer rearing habitat for both species. The fish passage culvert was still frozen after peak freshet at the time of the spring 2021 survey. No other fish passage issues were observed in 2021. Crossing should be monitored every spring for recurrence of ice damming.

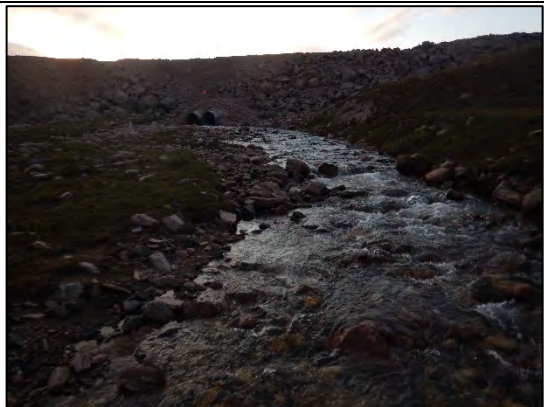
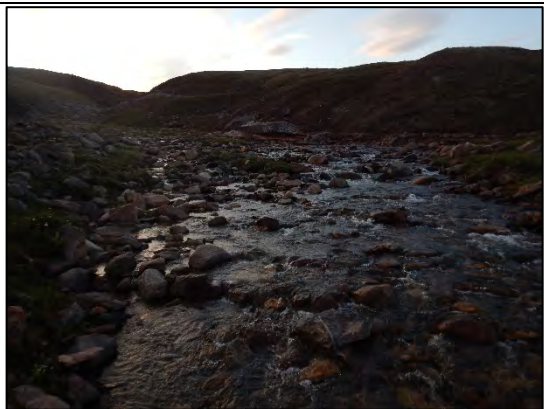
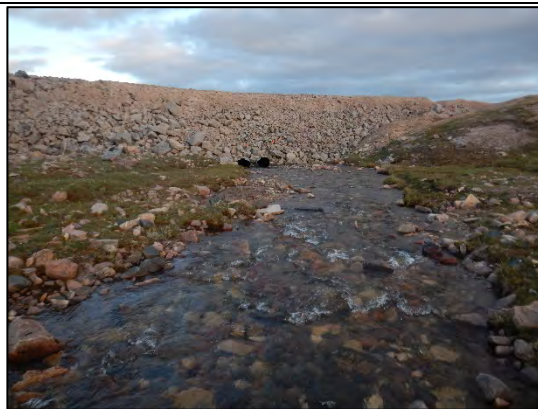
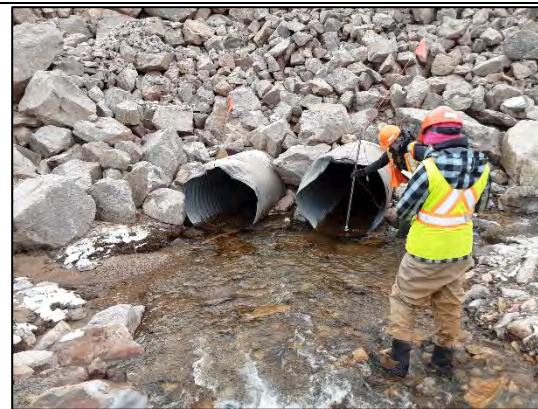
Photos 1. Photographs downstream (top) and upstream (bottom) of the Tote Road crossing CV-225: (A,D) looking upstream during spring; (B,E) looking downstream during spring; and (C,F) looking at culverts during fall.

Summary: Site provides summer rearing habitat for both species. Remediation completed in early spring 2020 successfully reduced perching. However high culvert velocities remain a potential issue and spring ice damming inside the culverts is common. Continue monitoring of road and culverts going forward.
