REPORT

Chapter 9.0 Tide Gauge Results

2021 Marine Environmental Effects Monitoring Program (MEEMP) and Non-Indigenous Species / Aquatic Invasive Species (AIS) Monitoring Program

MILNE PORT TIDE GAUGE INSTALLATION AND RECOVERY INSTRUCTIONS

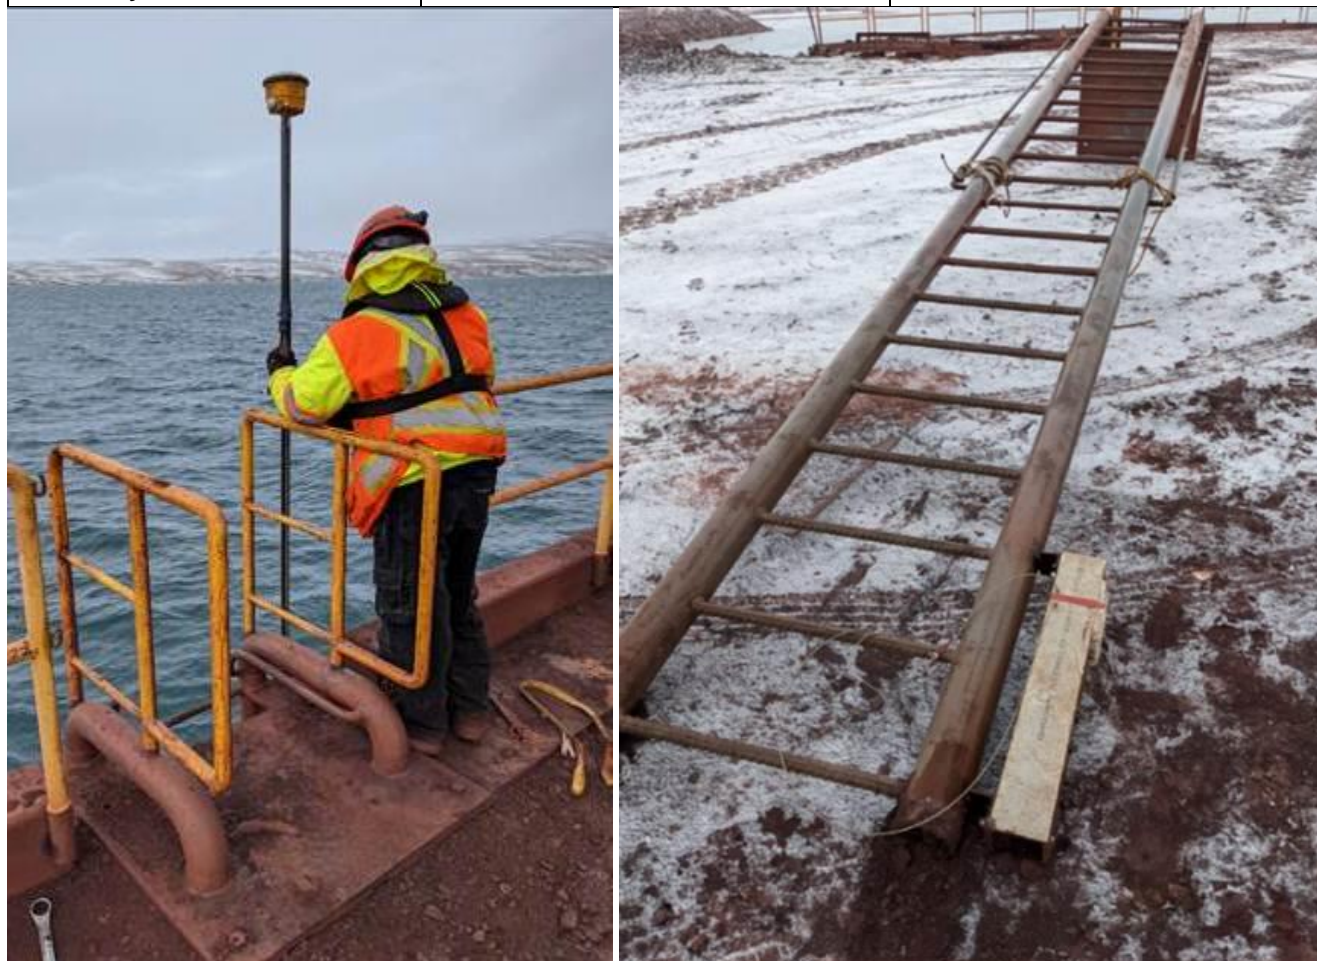
Figure 1: Left: RTK Survey of the ore dock ladder top plate. Right: Ore dock ladder following removal, with the tide gauge housing shown on the bottom right of the ladder. (Ritgen, 2020)

Table 3 shows the elevation of the ladder top plate and tide gauge measured in the Milne Port tide gauge programs from 2017 to 2021. It is noted that both the ladder top plate and the tide gauge have been deployed in the same location and configuration each year, however, the results of the RTK GPS survey show the elevation of the ladder top plate and tide gauge increasing year-on-year, with a total elevation difference of 0.24 m (standard deviation of 0.0943m and trend of 0.0569 m/year).

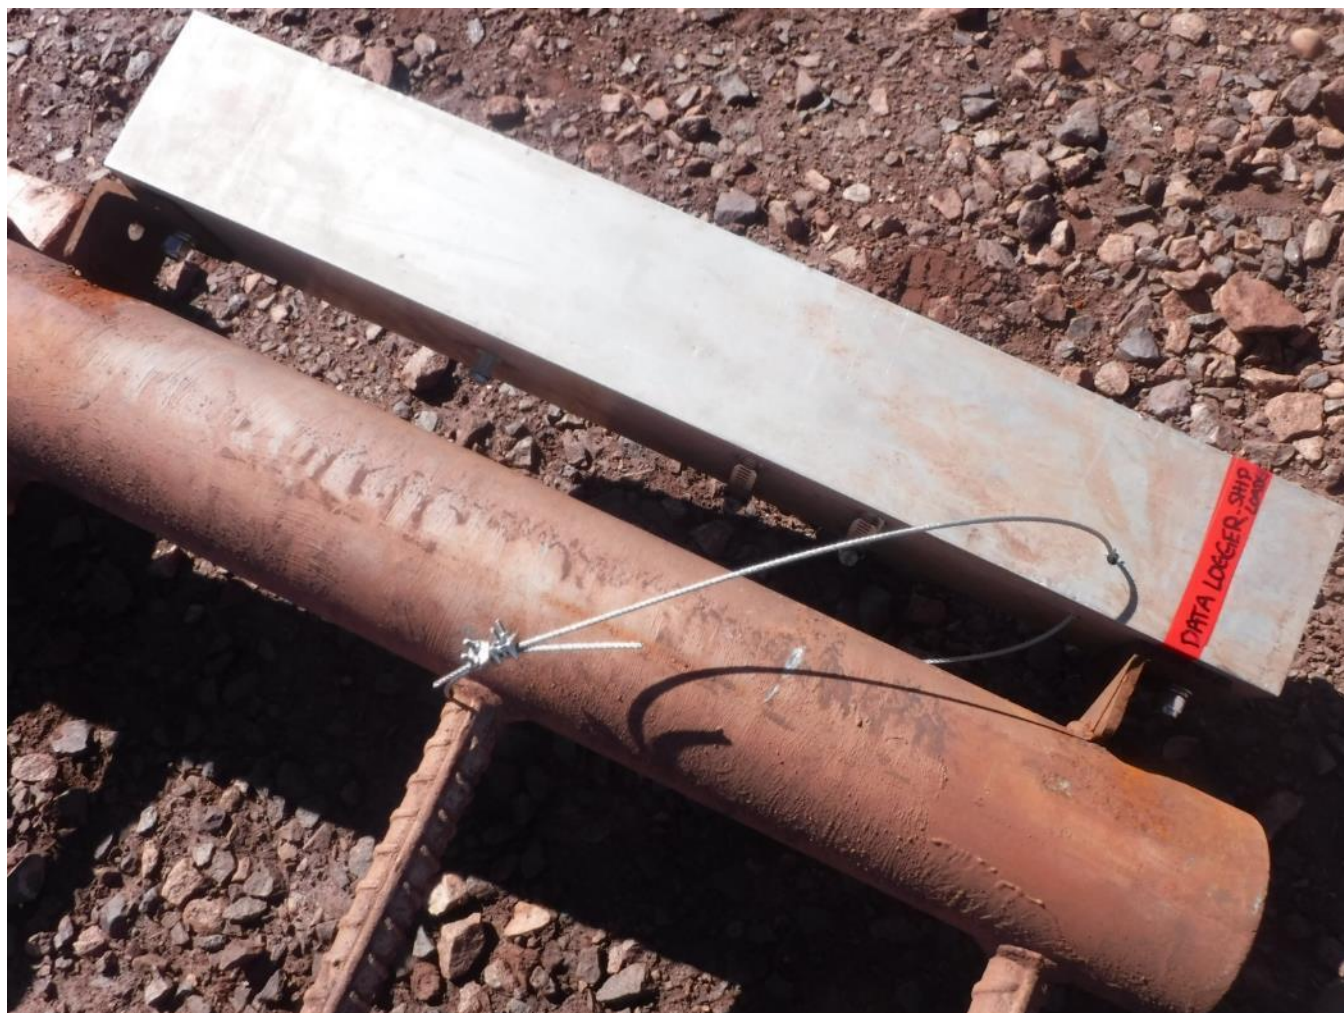
Figure 2: Hardware attaching aluminum tube to steel L brackets and wire rope for redundancy of the L bracket attachments.

Step 1) Two 1/4" diameter holes need to be drilled in the aluminum tube. These holes will be used to add a length of 3mm 316 stainless steel wire rope as redundant security against a hardware failure (Figure 2). On the outside of the aluminum tube two zinc anodes should be replaced with new anodes and secured with one stainless steel bolt (316 stainless 1/2" x 1") per anode (Figure 5).

Step 5) Add a length of 3 mm 316 stainless steel wire rope passed through the two holes on the square tube, and around the bottom ladder rung, and join wire rope together with 2 wire rope clips (1/8" stainless steel). This is to provide a redundant mounting system (Figure 2).

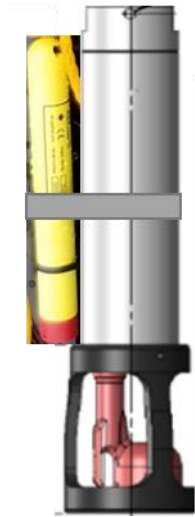
Figure 3: Configuration of an RBRsolo hose clamped to an RBRconcerto.

Step 2) The redundant tide gauge (RBRsolo – small yellow cylinder) should be hose clamped to the primary tide gauge (RBRconcerto – white cylinder). The sensor on the RBRsolo (red end) should be facing the same direction as the sensor end of the RBRconcerto (red/black end). This configuration is shown in Figure 3. Measure and record the distance between the sensor on the primary tide gauge and the sensor on the redundant tide gauge.

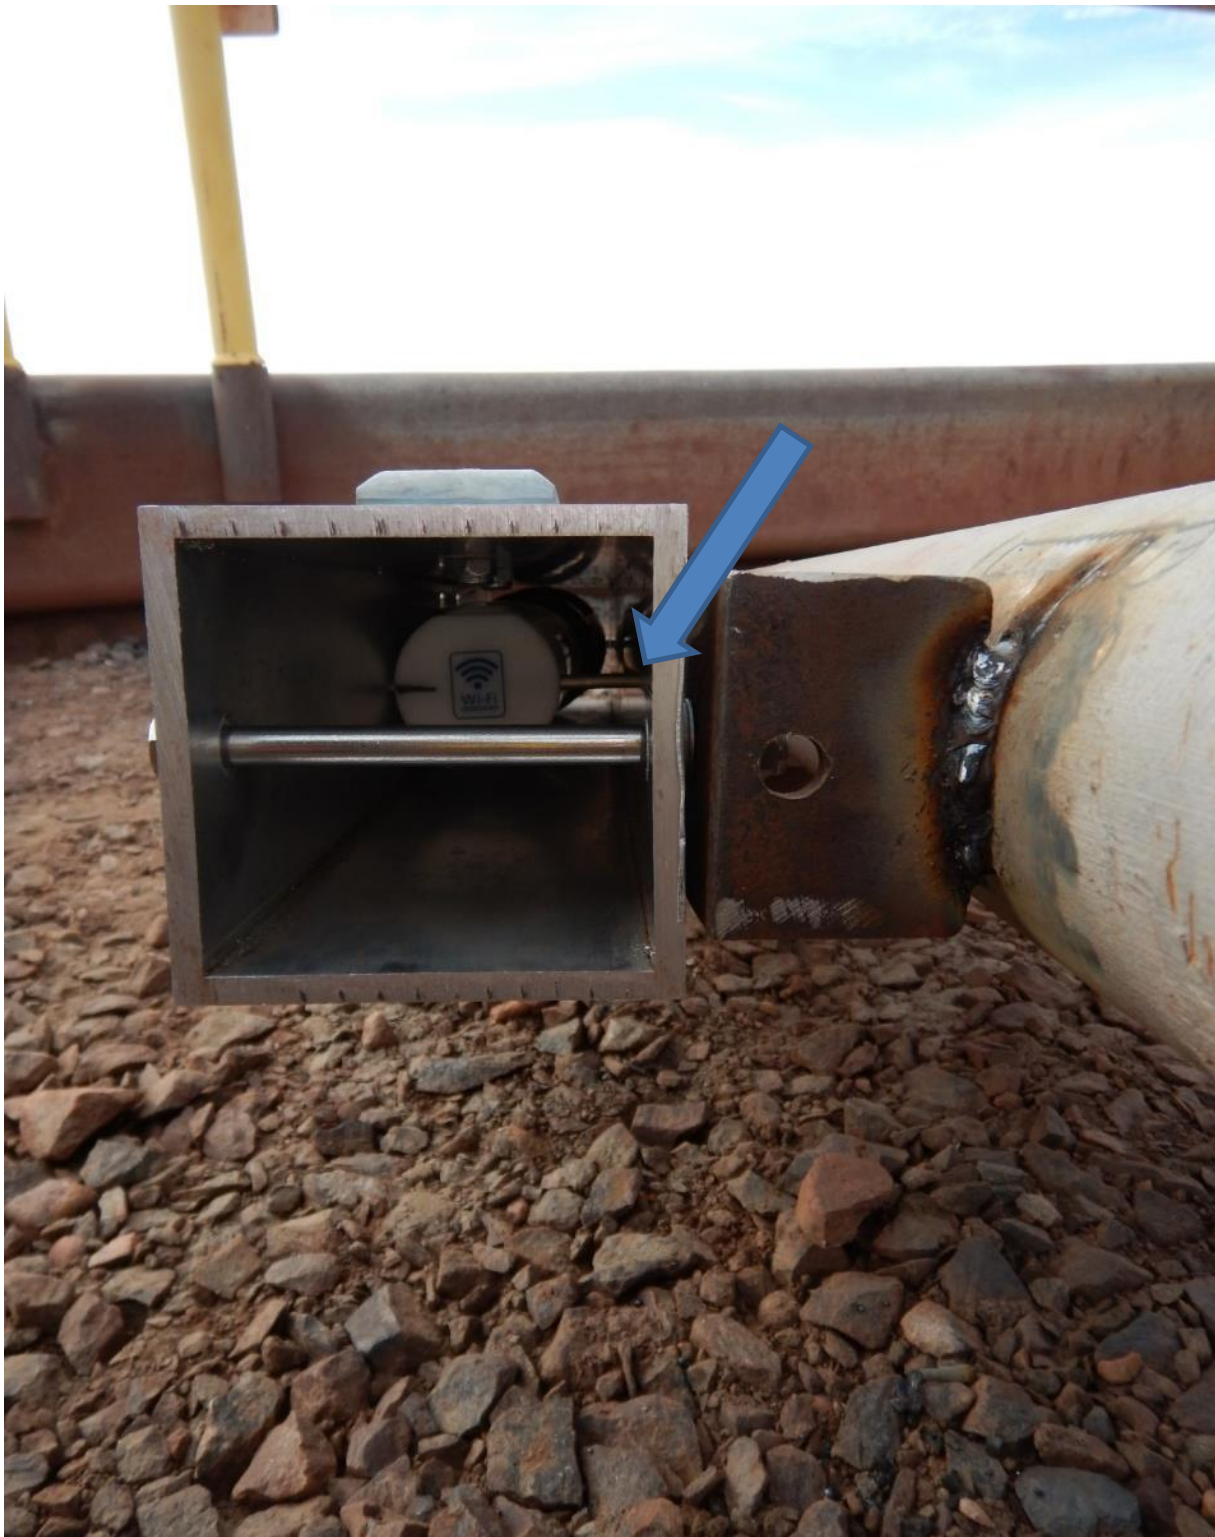
Figure 4: Hardware attaching aluminum tube to L brackets and view of the primary tide gauge mounted in the tube. Arrow shows location of the 1/4" bolt that should pass through the end cap of the primary tide gauge. Note that the redundant tide gauge is not shown in this photo, but would be sitting to the right of the primary tide gauge in this photo.

Step 3) The primary tide gauge (RBRconcerto – white Delrin cylinder) should be mounted inside the aluminum square tube with one stainless steel bolt (316 stainless 1/4" x 4 1/2"), washer, nylon shoulder washer, lock nut (Figure 4) and two stainless steel hose clamps wrapping around the body of both RBR loggers, using caution to not overtighten against the plastic housing. The bolt should be passed through the hole on the end cap of the primary tide gauge, making sure not to twist the end cap in the process, and secured to the square tube with nylon shoulder washers inserted in the drilled holes on the aluminium square tube (Figure 5). The white RBRconcerto (not the yellow RBRsolo) should rest against the aluminum tube.

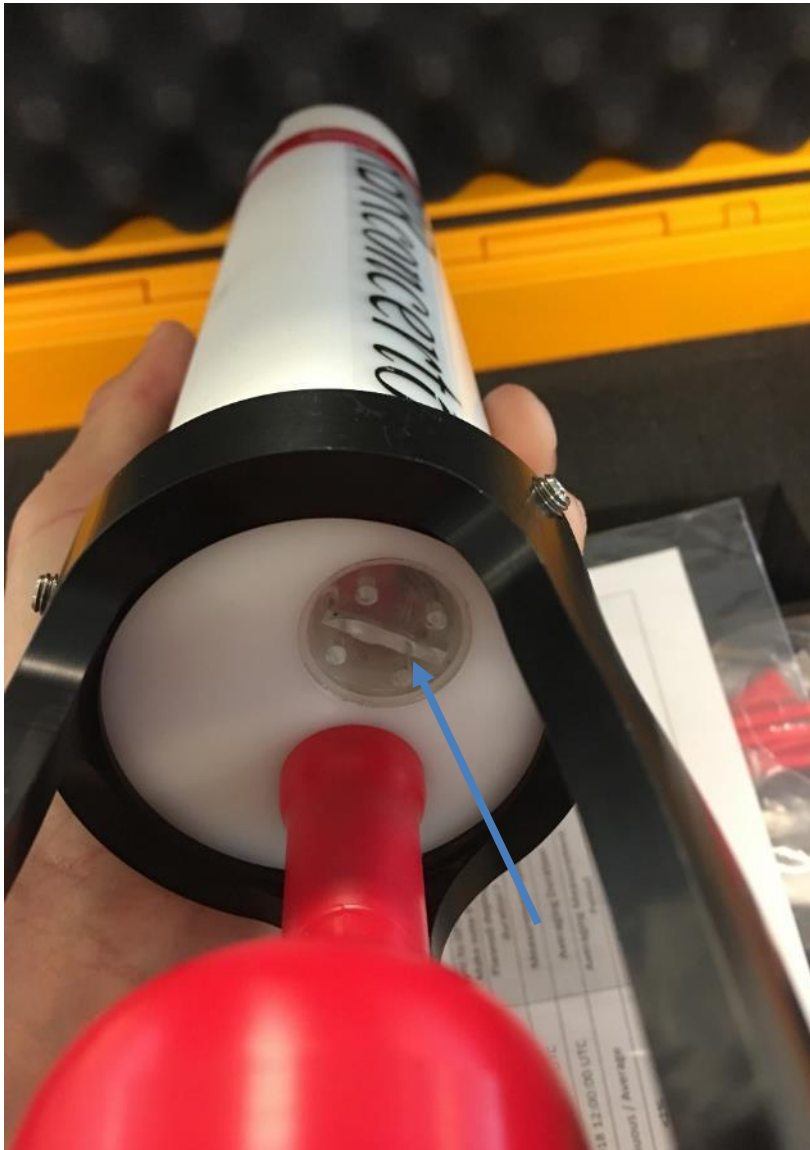
Figure 7: Pressure sensor location, shown by the arrow, on the downward facing end of the primary tide gauge

Step 1) The distance from the primary tide gauge pressure sensor (Figure 7) and the bottom of the aluminum tube to the steel ladder top plate (Figure 8) should be recorded and accompanied by a photo of the measurements (i.e. a photo of the tape measure). The distance from the secondary tide gauge sensor to the primary tide gauge sensor should also be recorded.

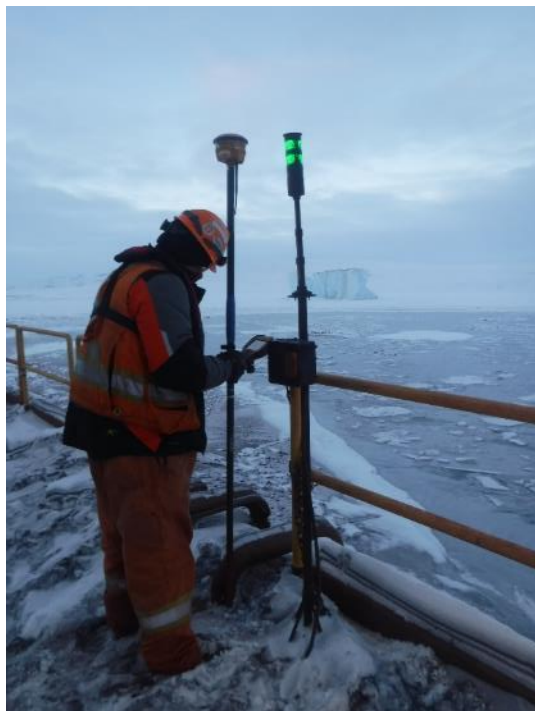
Figure 8: RTK GPS survey conducted in 2018

Step 7) In 2018 the elevation and position of the ladder was surveyed using five survey points measured from an RTK GPS system. The following table provides the survey position and elevation of the primary tide gauge pressure sensor in 2018. The pressure sensor is located behind the plastic sensor cover on the downward facing end of the primary tide gauge (Figure 7). The distance from the bottom of the aluminum tube to a point at the top plate of the ladder and from the pressure sensor to a point at the top plate of the ladder was measured as 6.57 m and 6.42 m in 2018, respectively.
