MELIADINE GOLD PROJECT

Screening Decision Report 16QN071

APRIL 2019

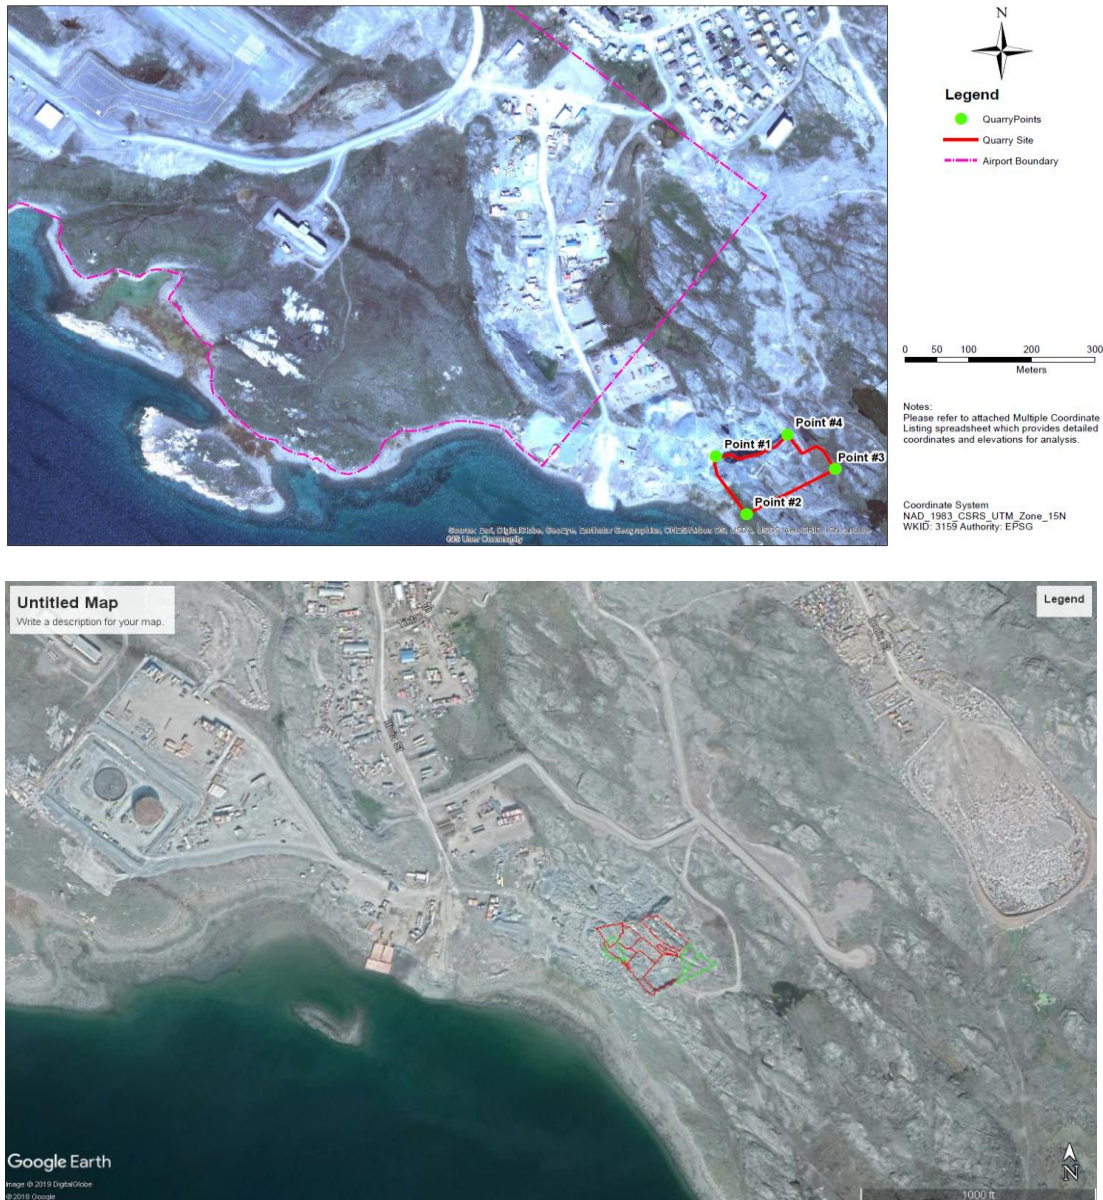
Figure 1 and 2 Itivia Quarry Boundary and Blast Location

During 2018, material was extracted from Itivia Quarry for the construction of the Bypass Road and associated laydown areas. The location of the quarry is shown in Figure 1. Approximately 8,800 m³ of material was blasted using four production blasts. Approximately 21,800m³ of material was extracted, including approximately 13,000 m³ blasted in 2017. A diagram showing the locations of the blasts is provided in Appendix A.
