Iqaluit Marine Infrastructure Project

Nunavut Impact Review Board – Deep Sea Port End of Construction Report

REP-GN-02-Deep Sea Port End of Construction-0001-23.R1

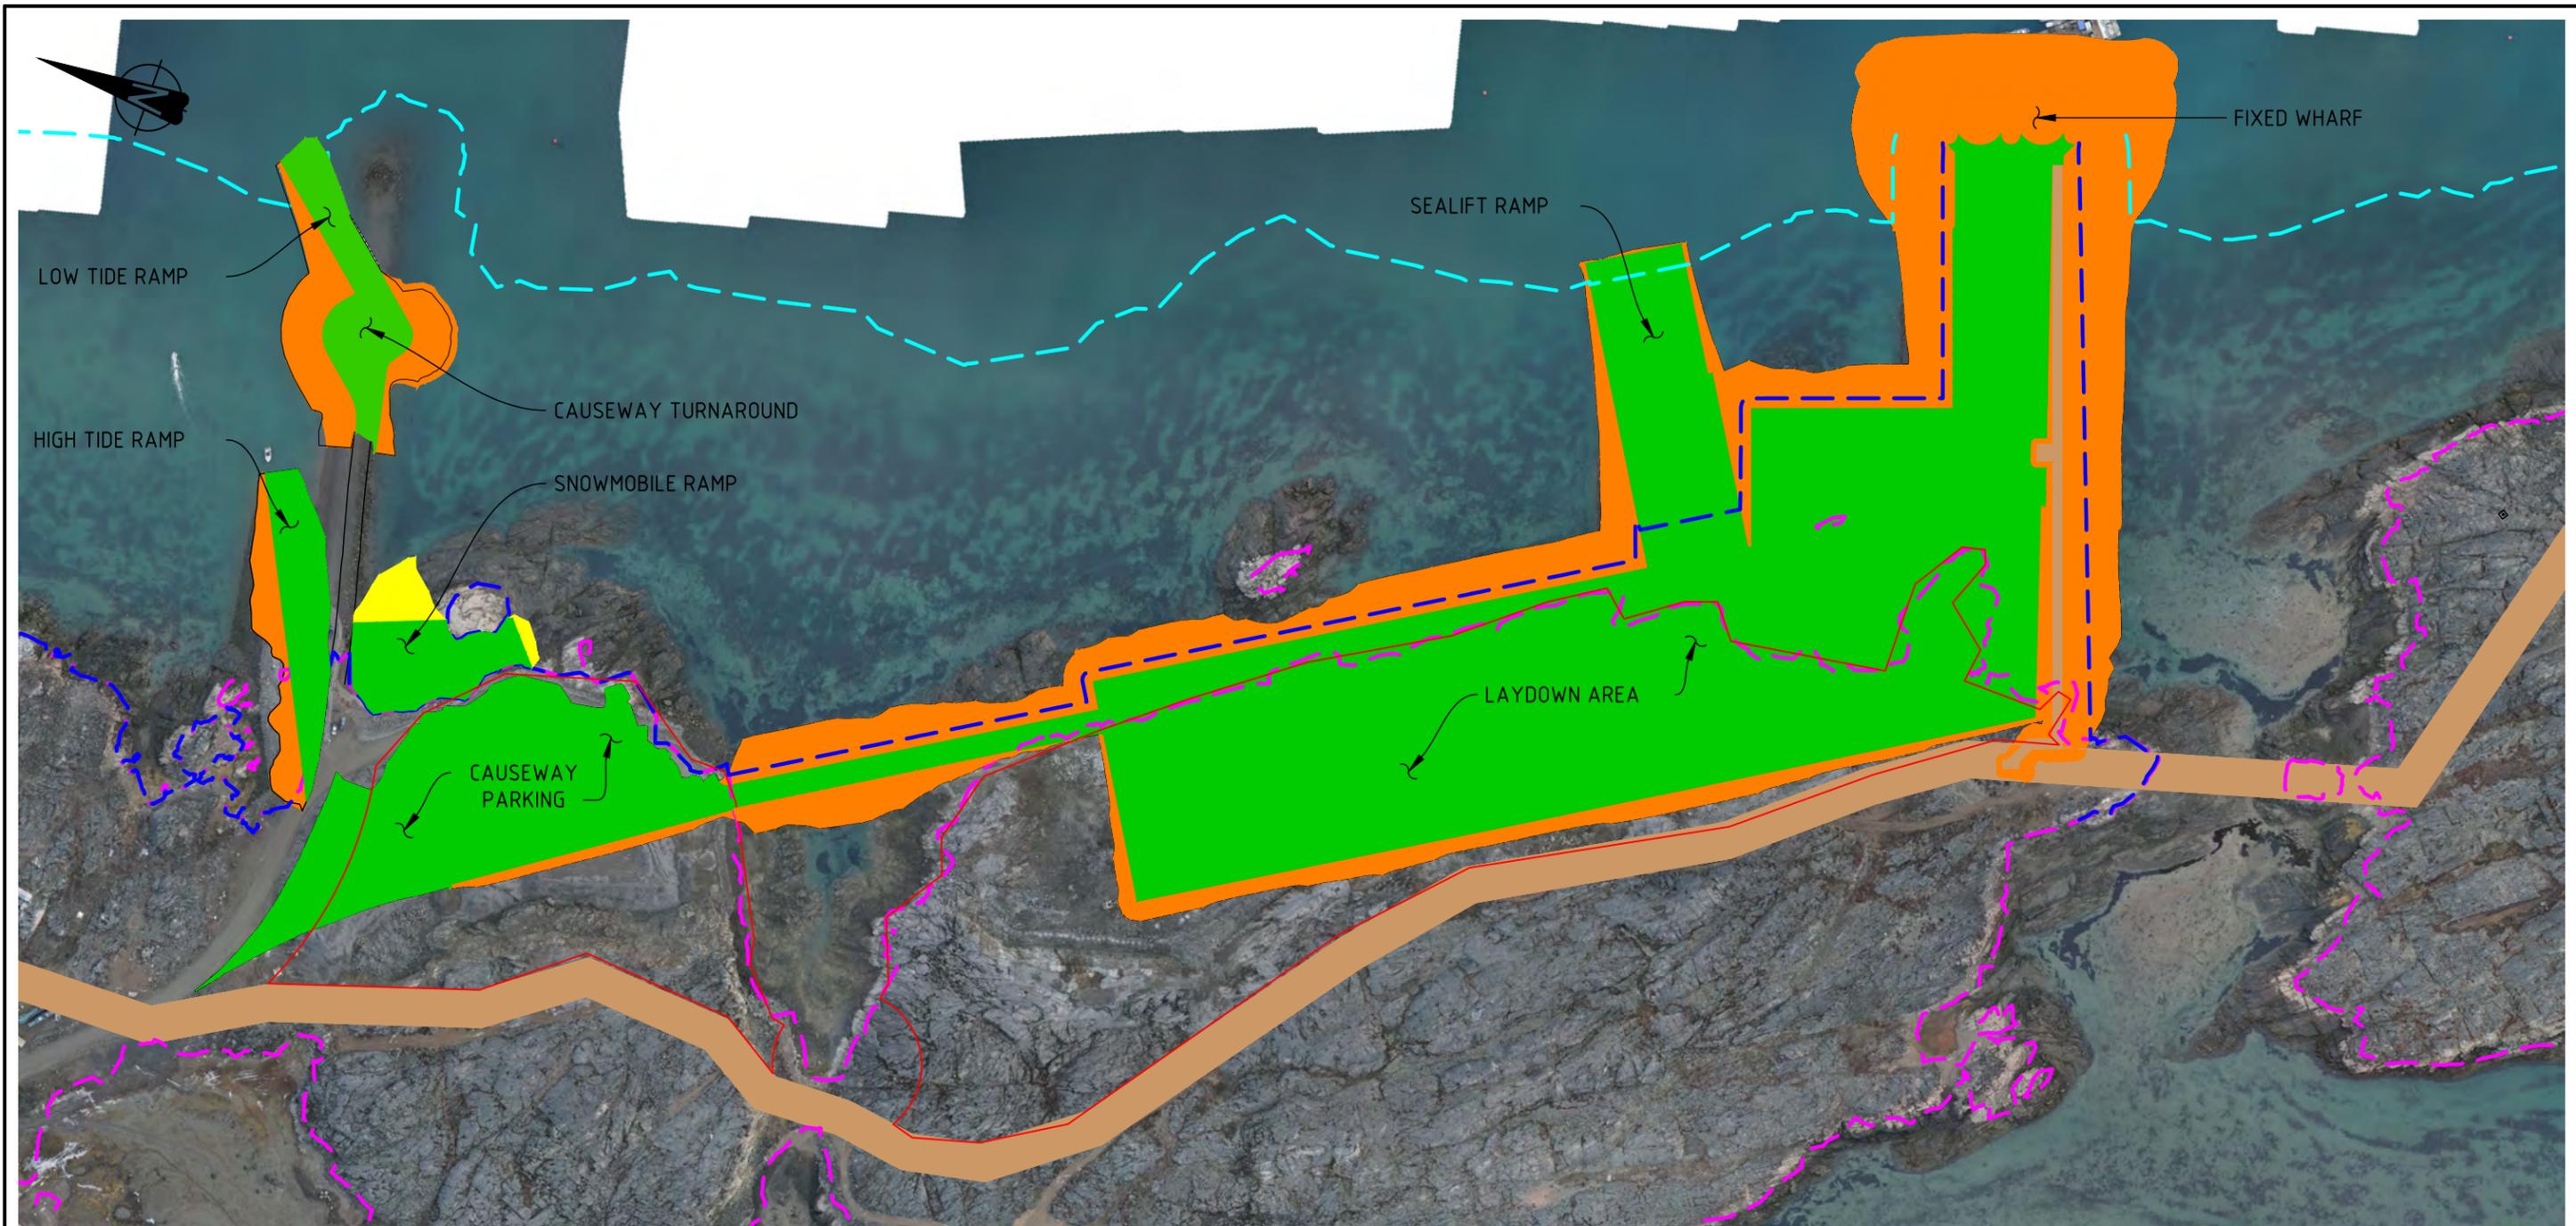
GOVERNMENT OF NUNAVUT DEEP SEA PORT AND CAUSEWAY				
GENERAL ARRANGEMENT (REVISED)				
	Date: 09-MAR-21	Drawn by: JLC	Edited by: JLC	App'd by: VBC
				Worley Project No. 307071-01148
	FIG No. 1-1		REV A

The DSP Project components are described in Table 1-1 and depicted in Figure 1-1. The DSP Project consisted of the construction of the DSP and upgrades to the existing causeway.

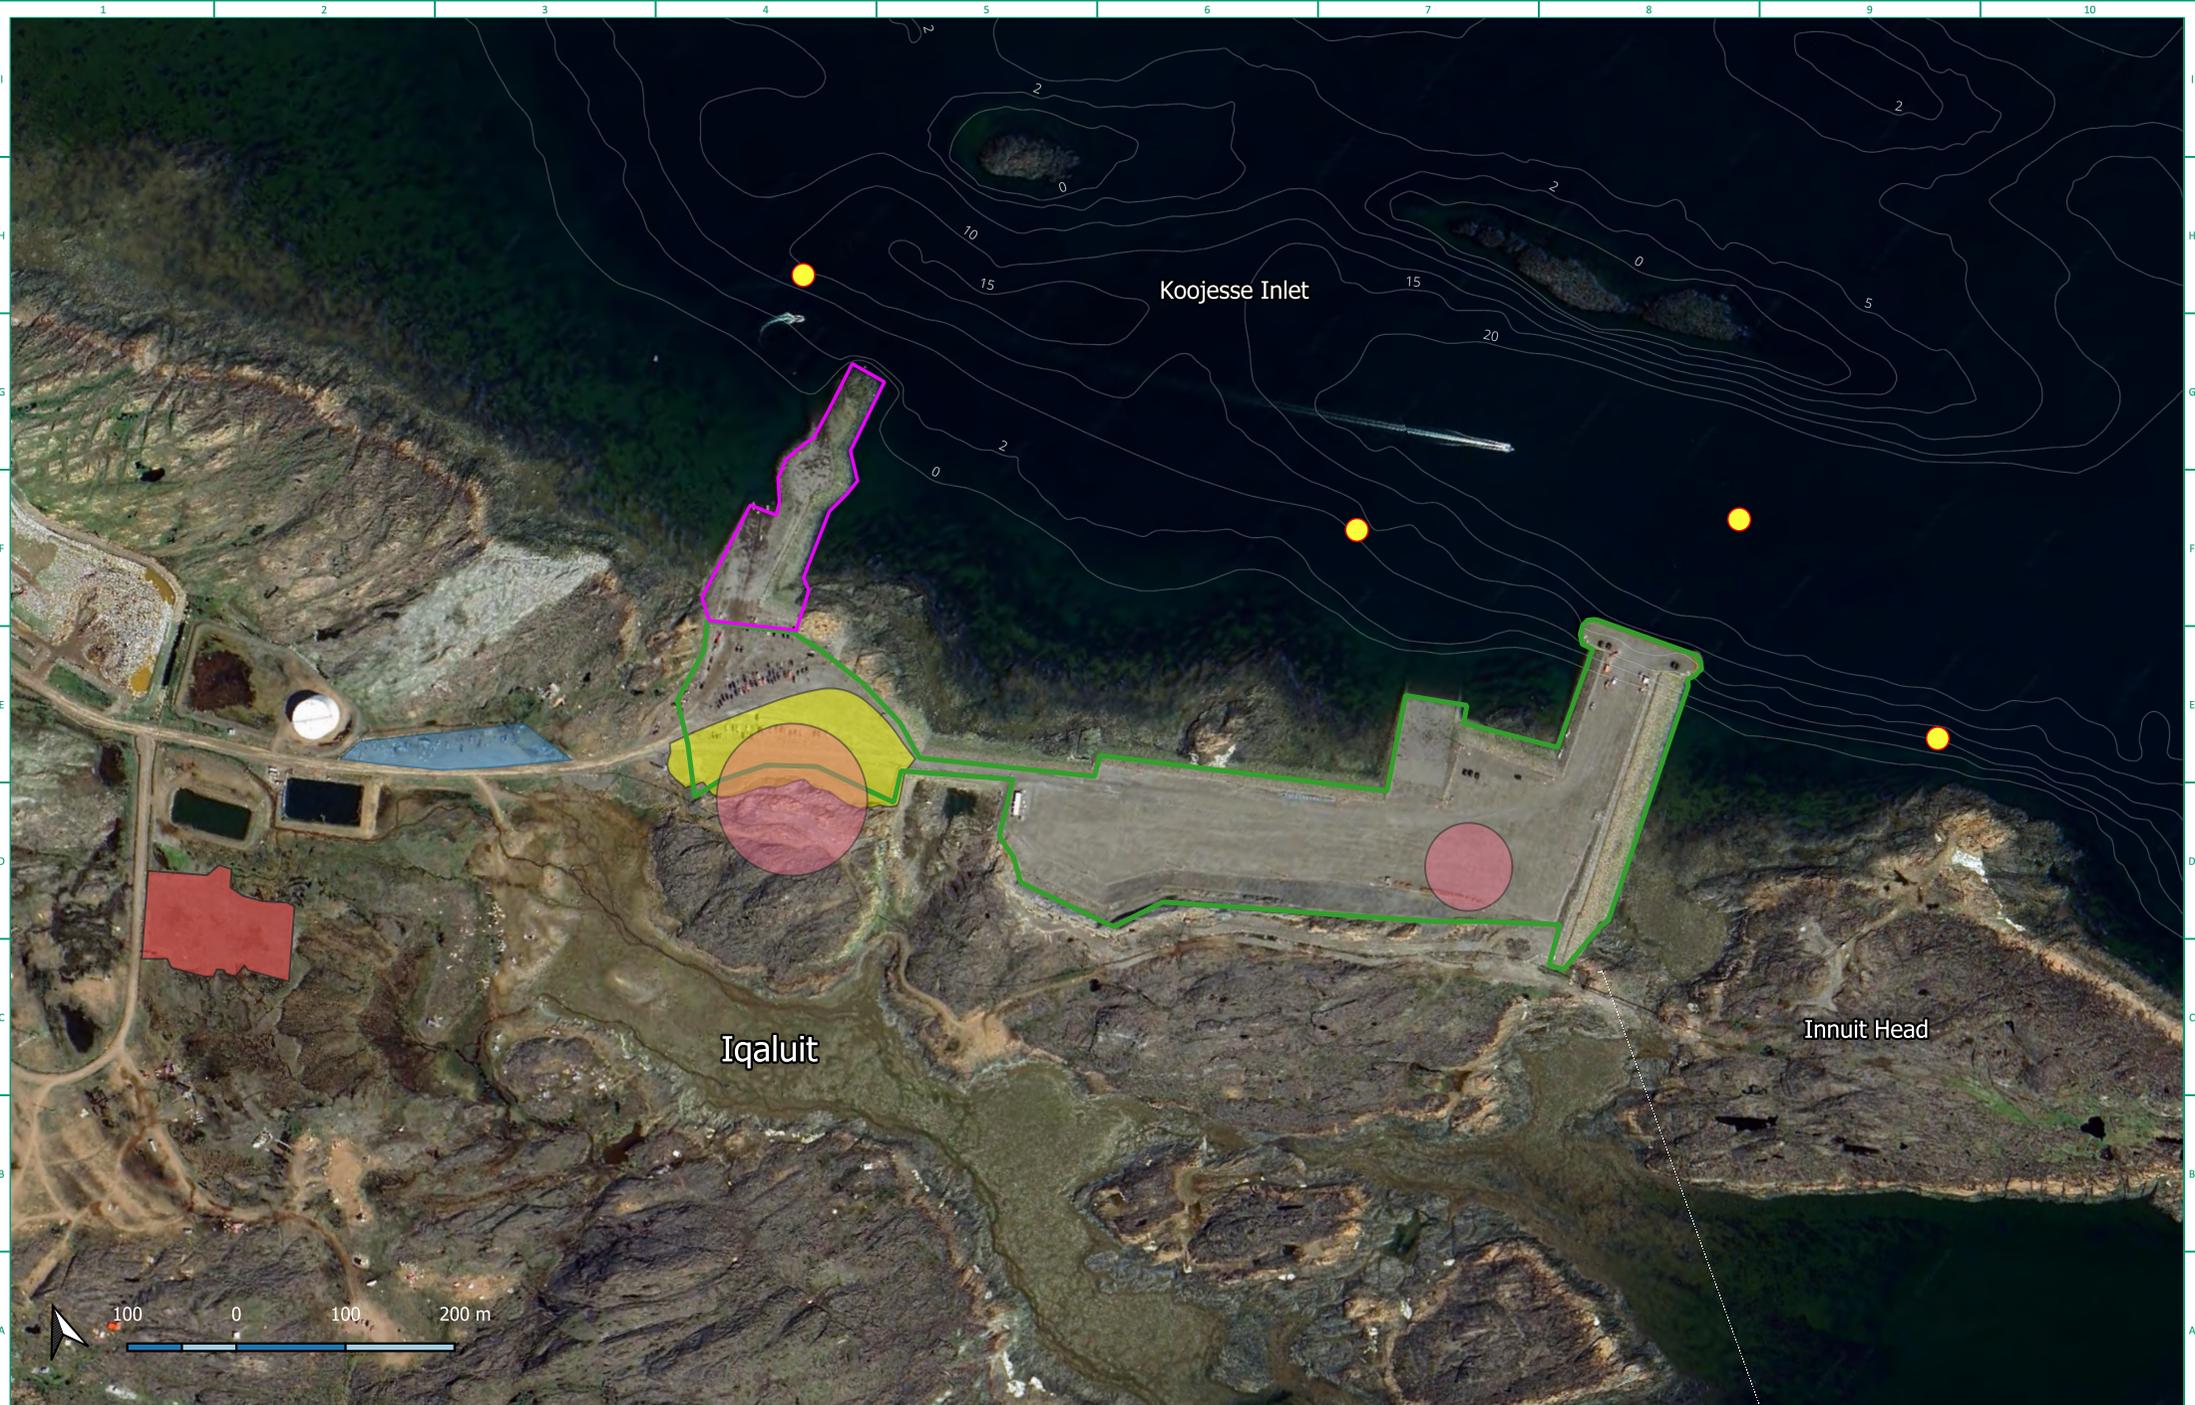
To support DSP Project construction, Tower required laydown areas outside of the DSP Project footprint. This included a laydown area A and B for equipment, chemicals and hazardous materials storage, and an explosives storage area (see Figure 1-2, Figure 1-3).

where access was being restricted (Figure 3-2). Temporary parking was made available to the community during periods of restricted access (Figure 1-2).

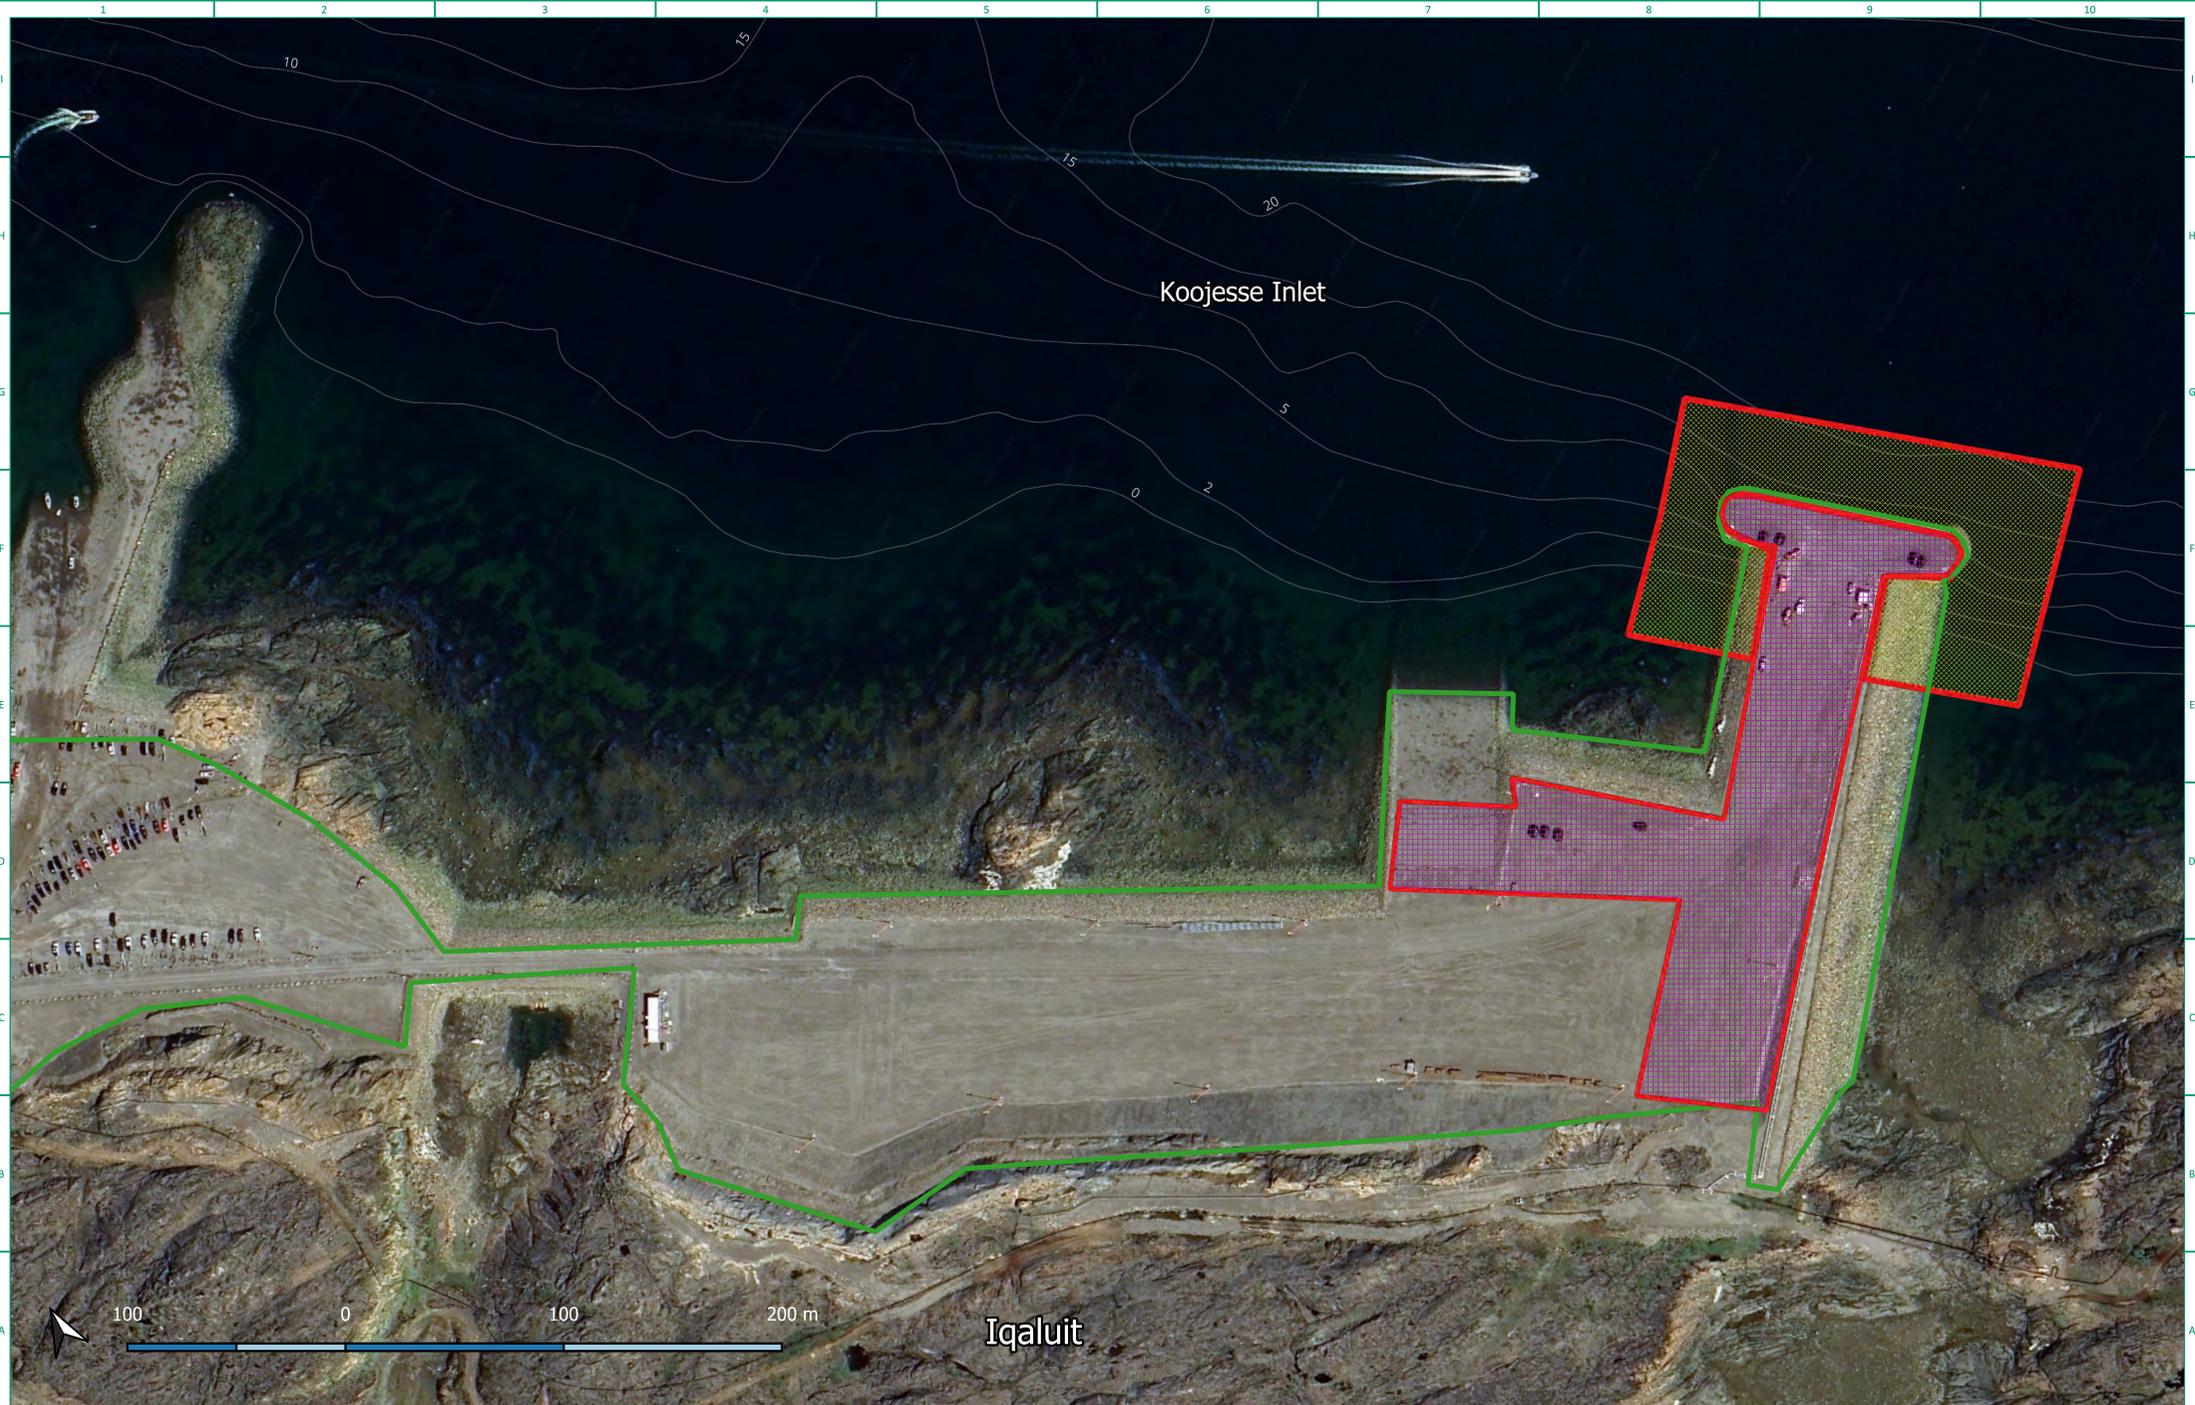
Near-water and marine fuelling locations for the DSP Project are depicted in Figure 3-1.

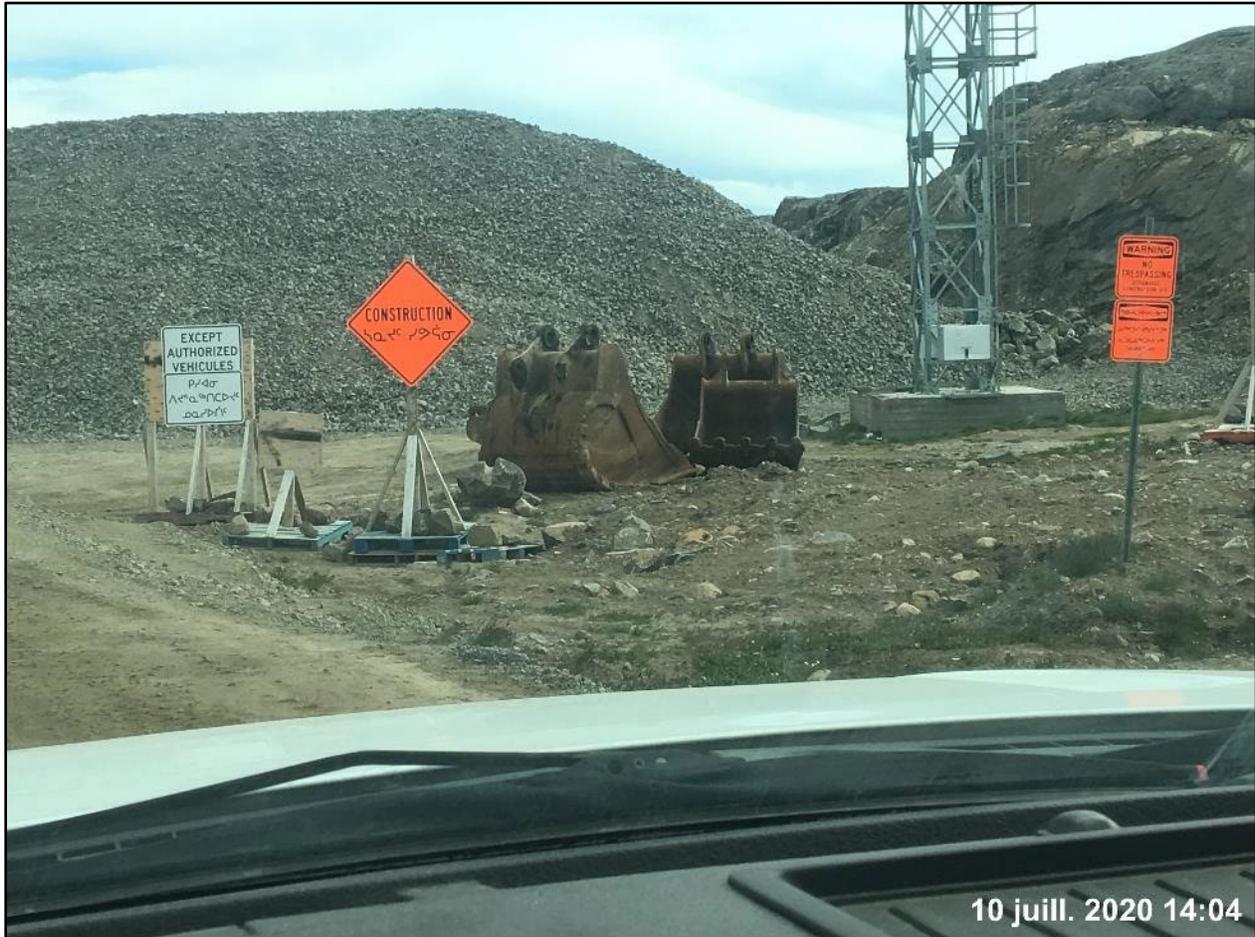
Photo 3-2: Demonstrative Community Notice Sign

English and Inuktitut signs were posted at access points to the DSP to warn of potential hazards (e.g. blasting), and/or to notify of changes to marine access (Photo 3-2). Notifications of these potential hazards/access changes were also posted to the Iqaluit community Facebook page.

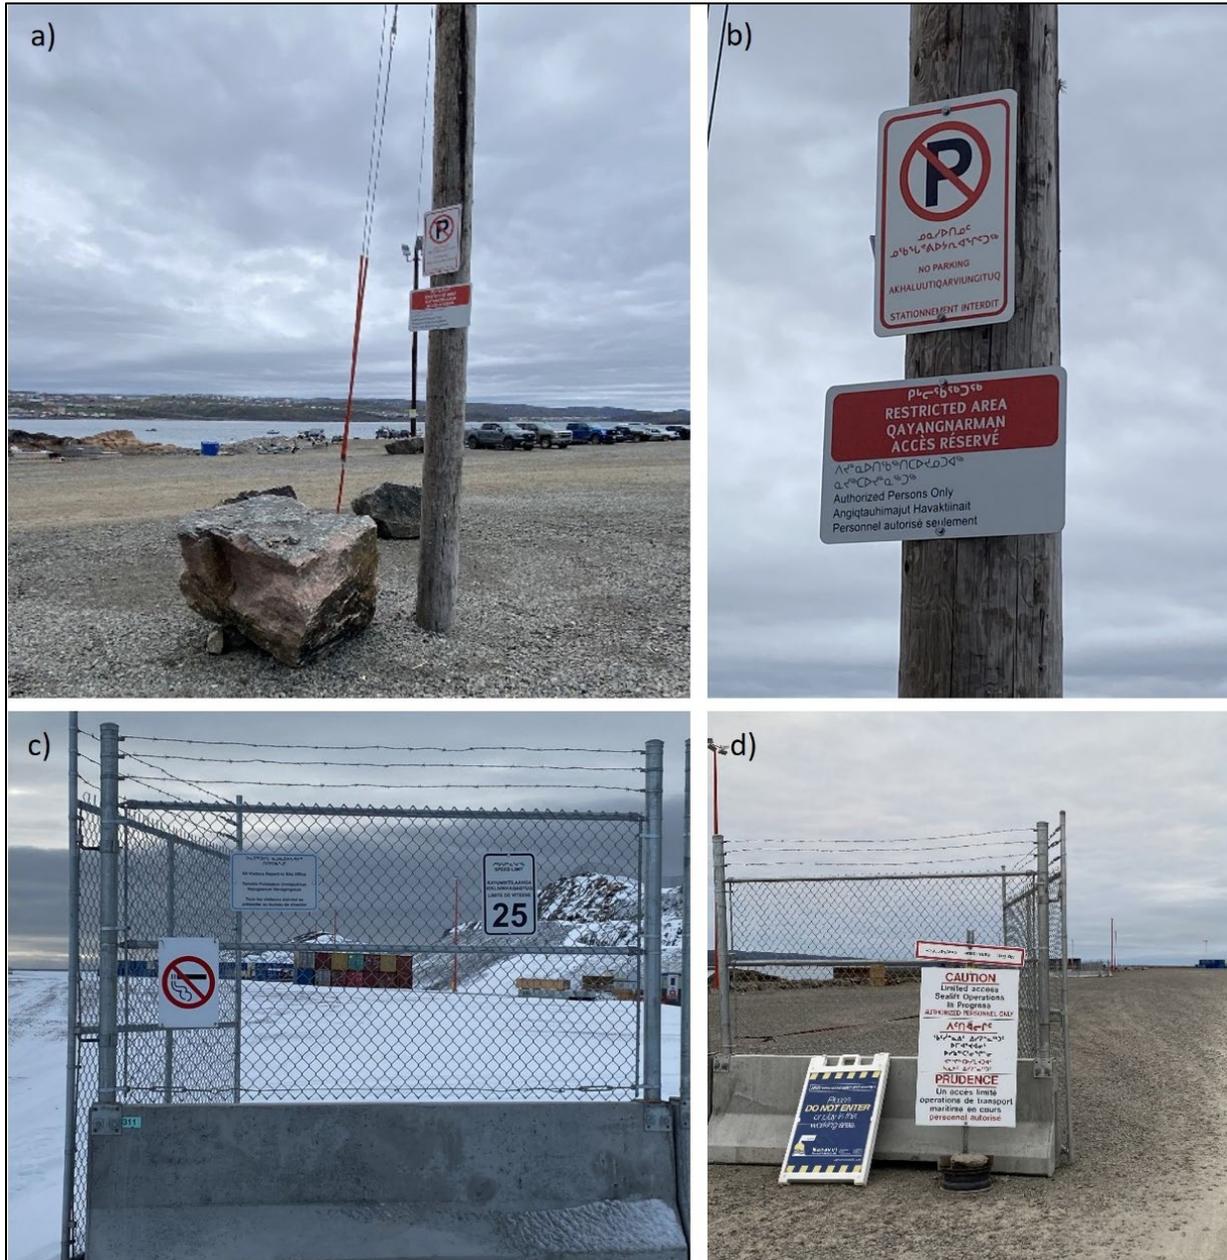
Photo 4-1: a), b) Signage at the Entrance Roadway to the Cargo Terminal Indicating No Parking and Restricted Areas; c), d) Signage at the Industrial Entrance to Cargo Terminal, Adjacent to the Security Office Indicating Restricted Access During Site Sealift Operations, Speed Limit and Directing Visitors to the Site Offices

The DSP is not accessible to the public and during the sealift season, the gate and security building are manned by the GN-EDT staff during the day and a security firm during night shifts. Photo 4-1 (Panel a and b) show some of the signage that has been used for the 2023 season.
