WTD-TH 0+665

Whale Tail Dike

AGNICO EAGLE  
AMARUQ

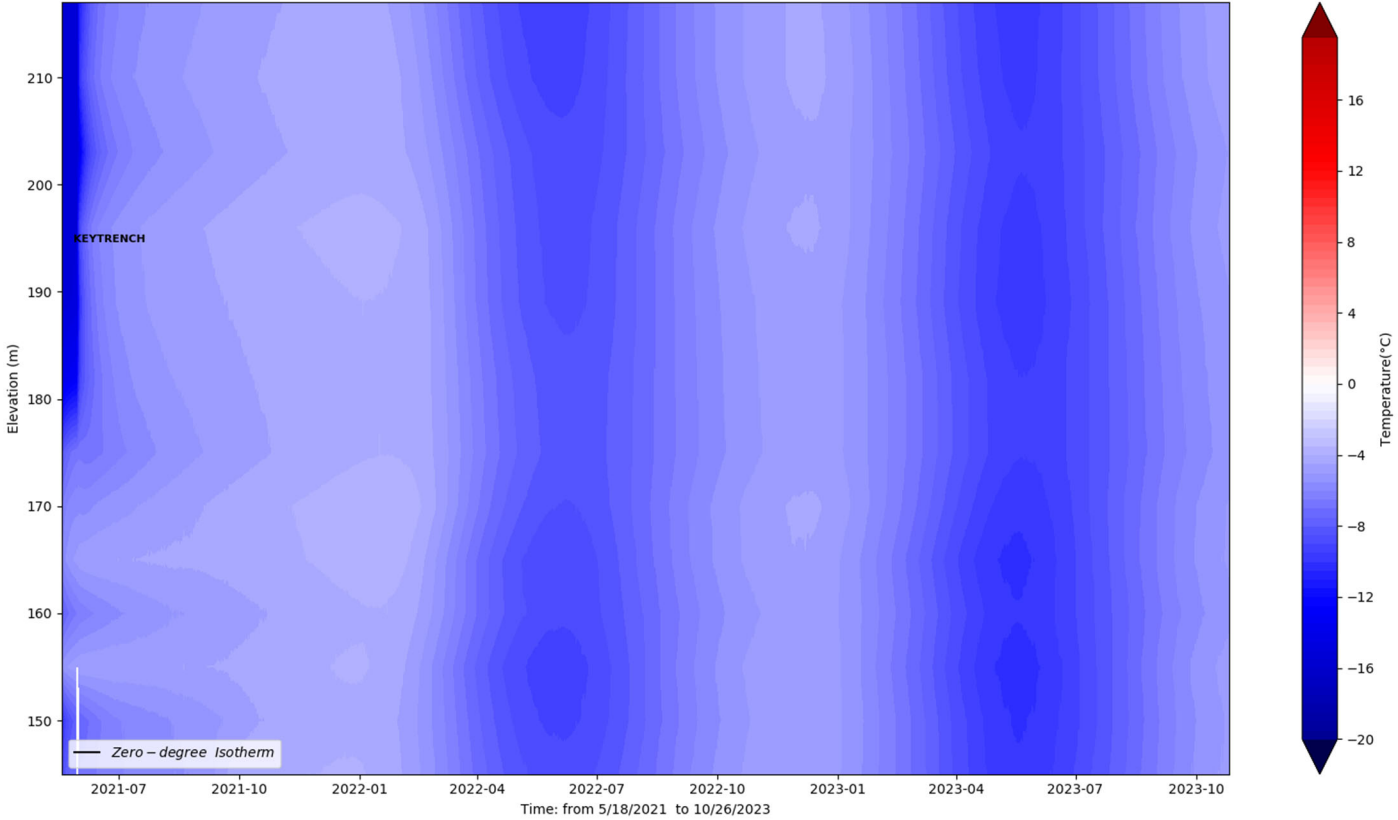
IVR-D1-TH5

NOTE: This TH is horizontal and in Keytrench and must be reflected this way when reading the thermal graph

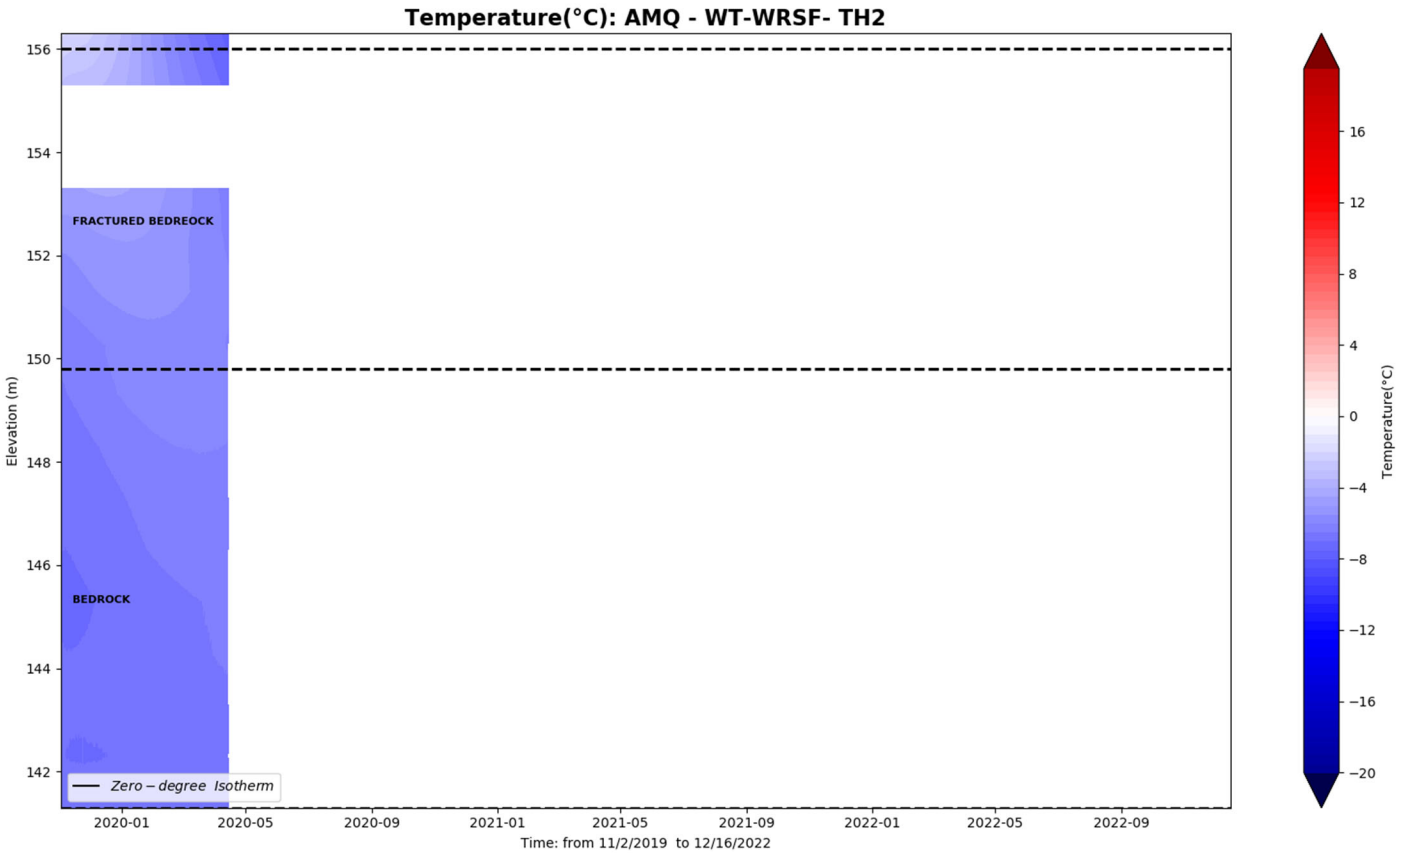
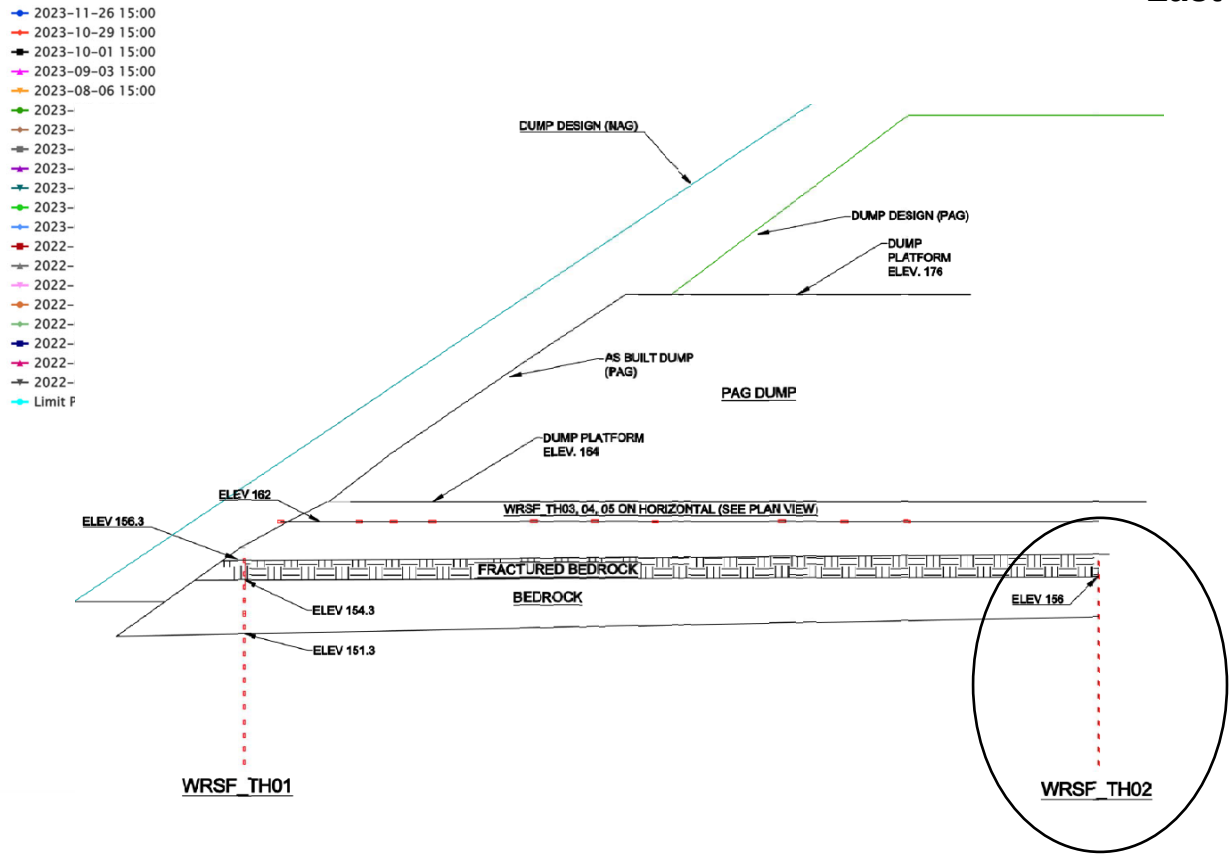
WT WRSF TH2

Last data May 2020

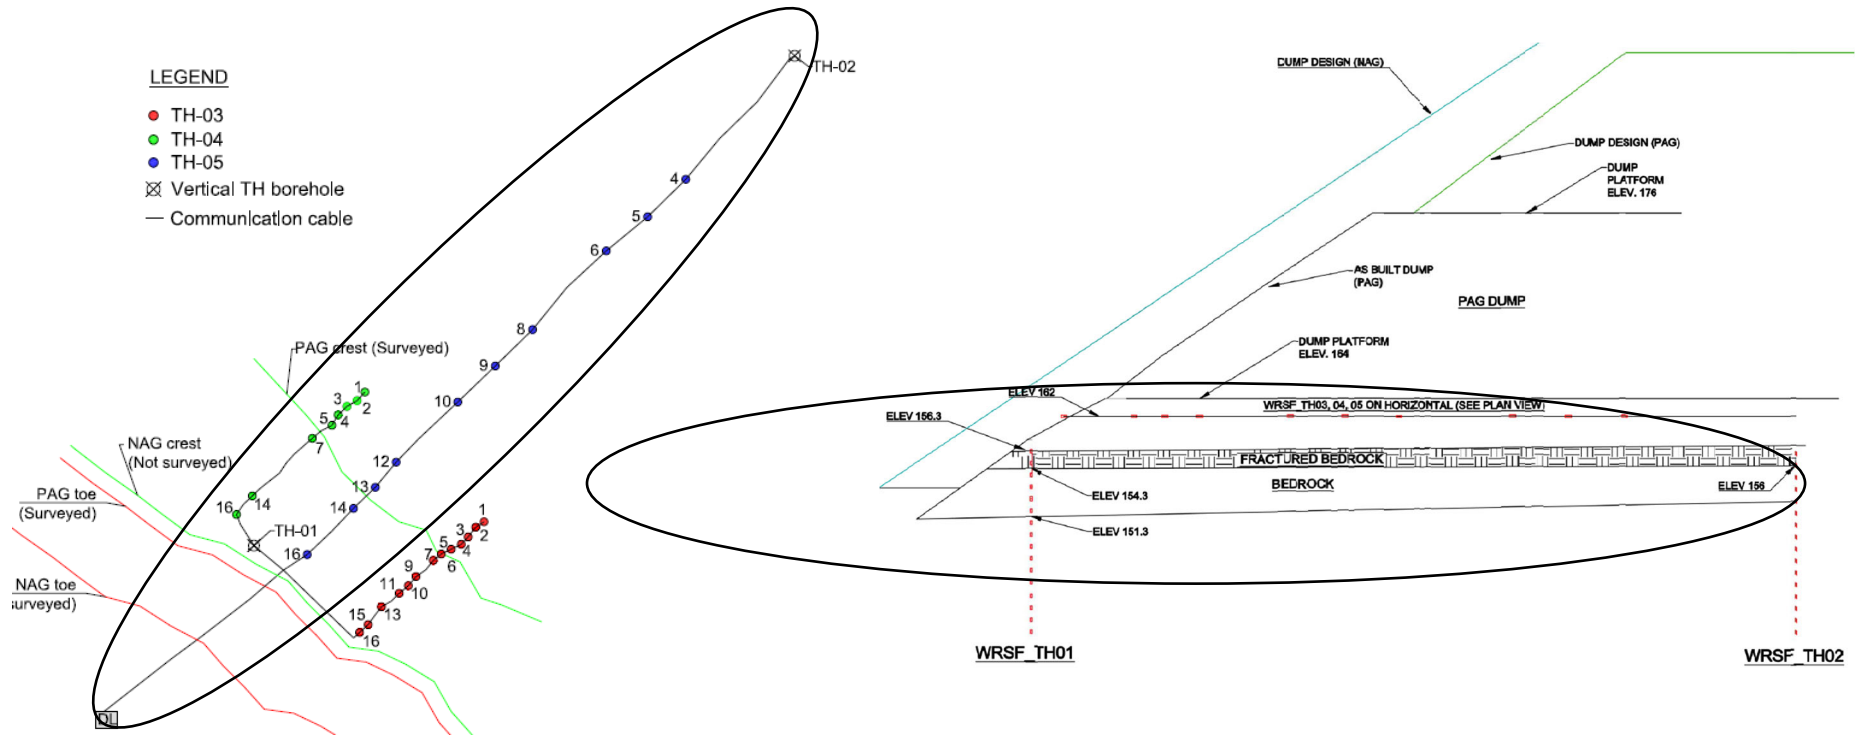
WT WRSF TH5

This instrument is installed horizontally and chart needs to be read accordingly

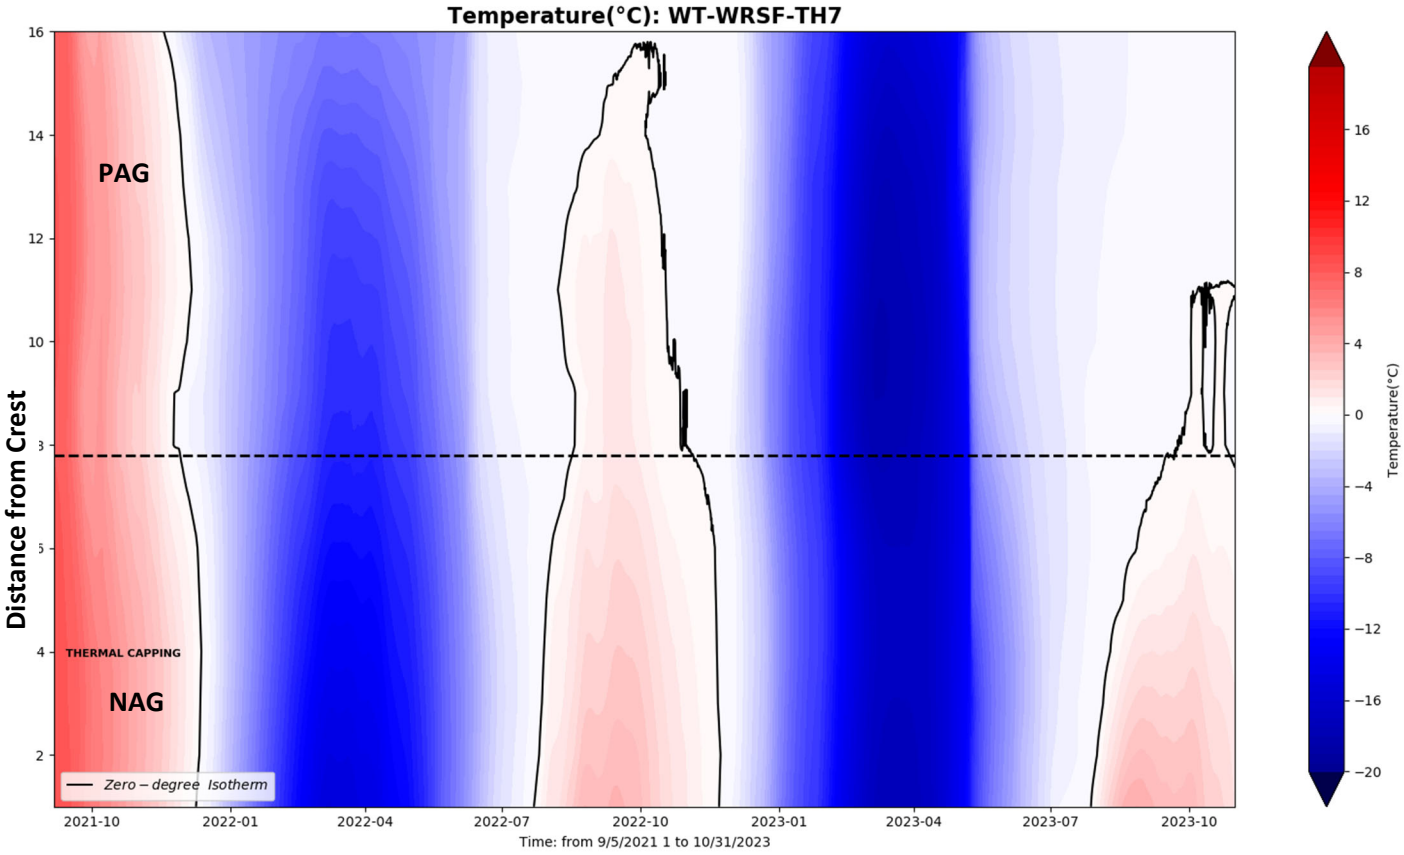
WT WRSF TH07

There was no data from Dec 20 to Feb 2 due to loss of battery power in the instrument.

This instrument is installed horizontally and chart needs to be read accordingly

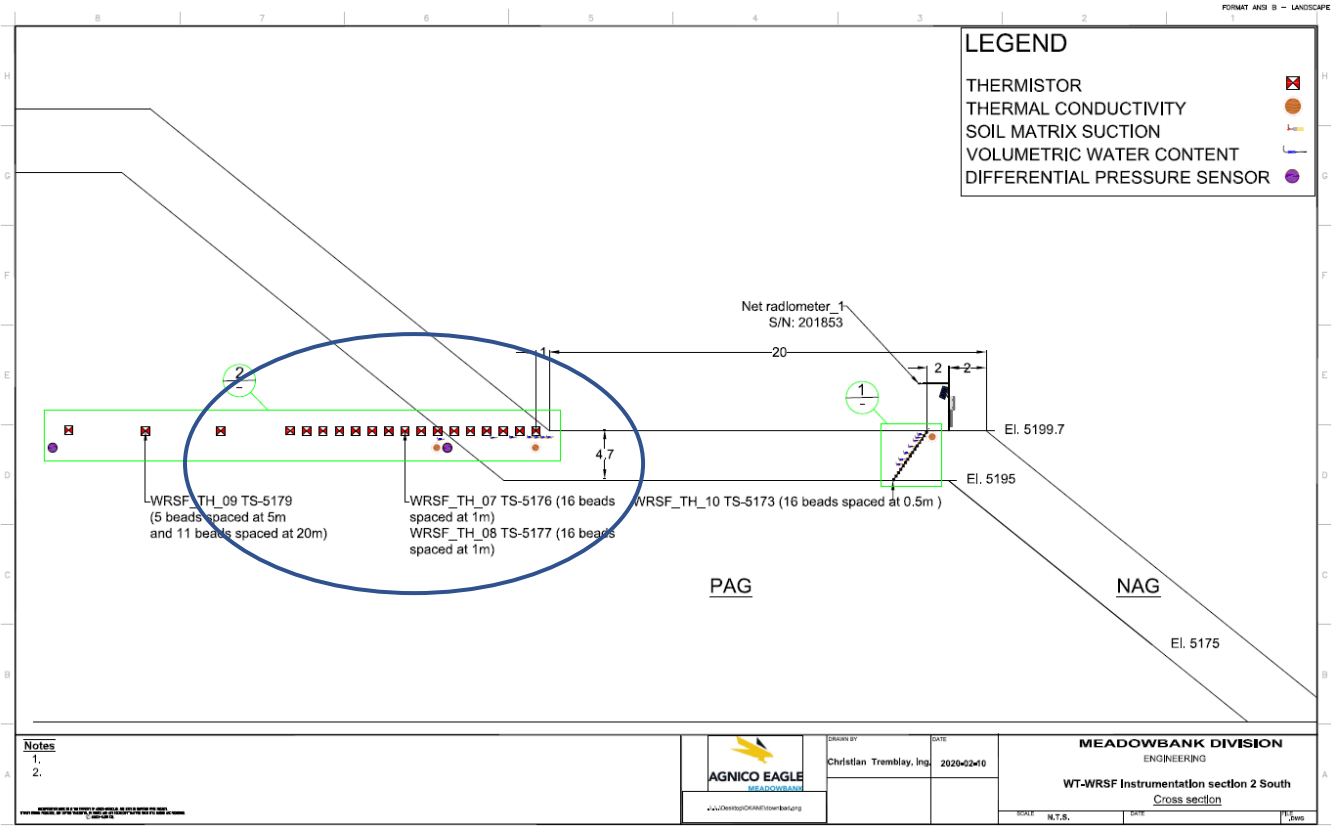
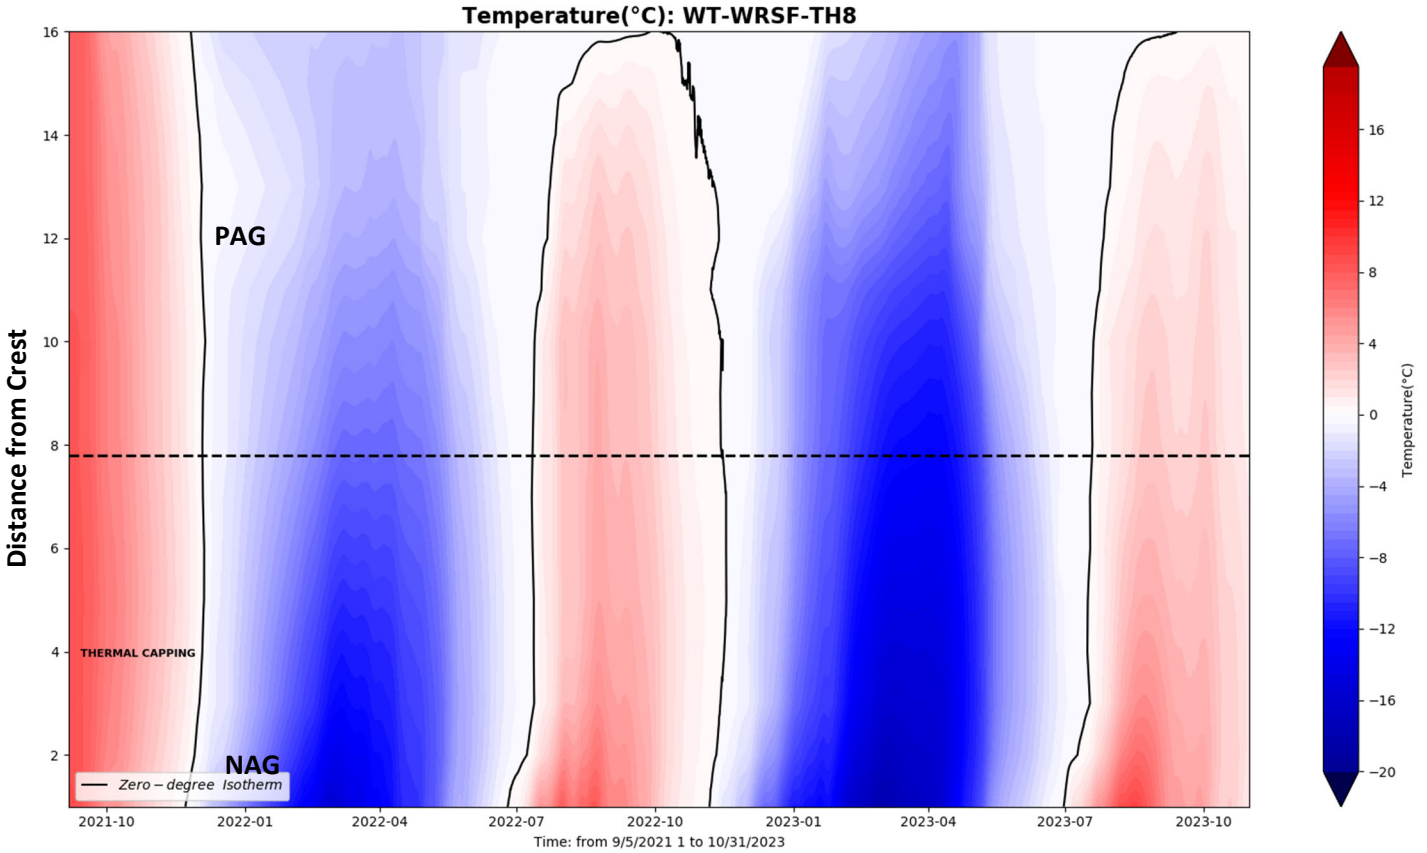
WT WRSF TH08

This instrument is installed horizontally and chart needs to be read accordingly

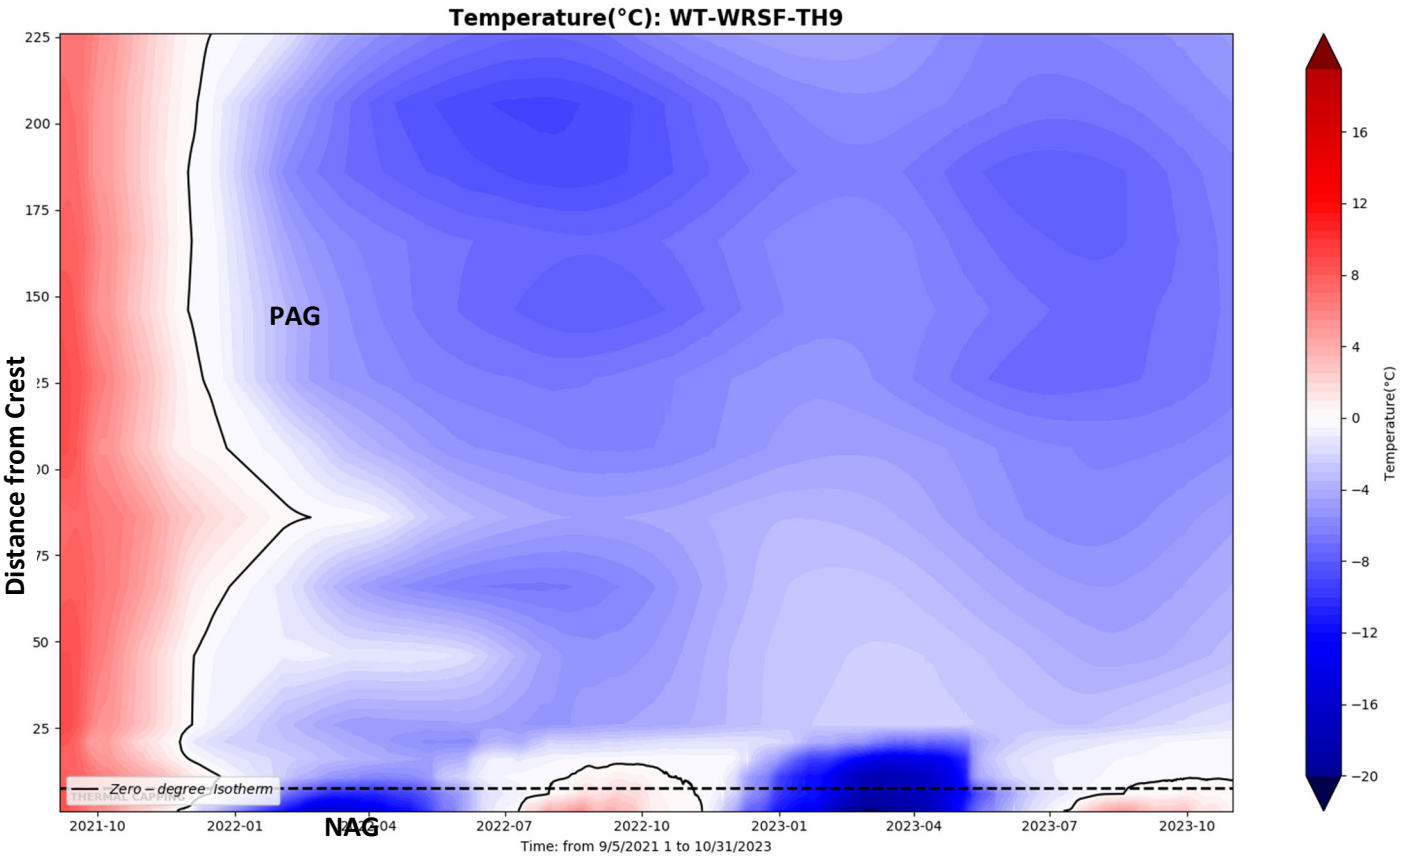
WT WRSF TH09

This instrument is installed horizontally and chart needs to be read accordingly

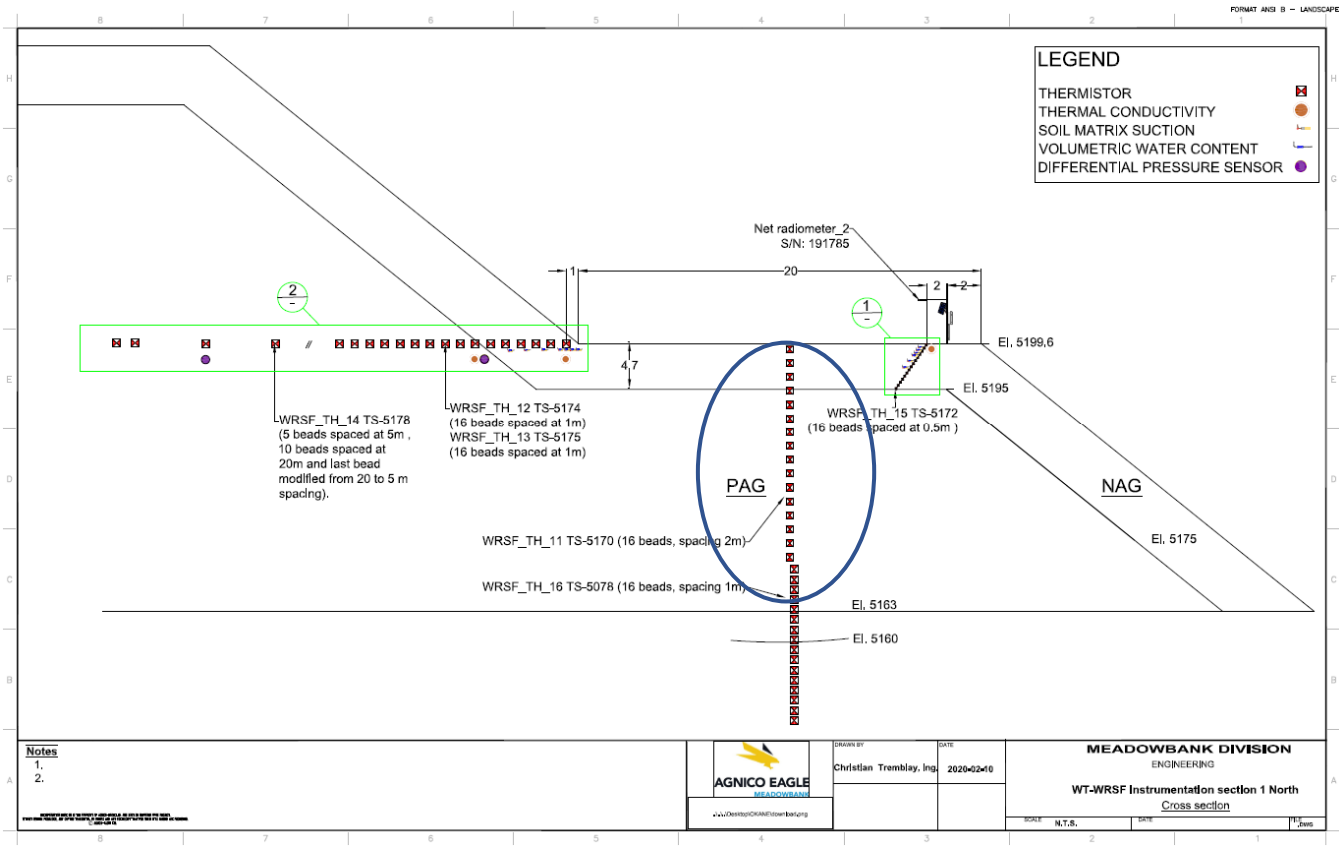
WT WRSF TH11

TH-11 & TH-16	
String # :	RST 5170 & 5078
Drill Hole Coordinates	
Northing	8479.2480
Easting	14259.1830
Elevation	5199.637

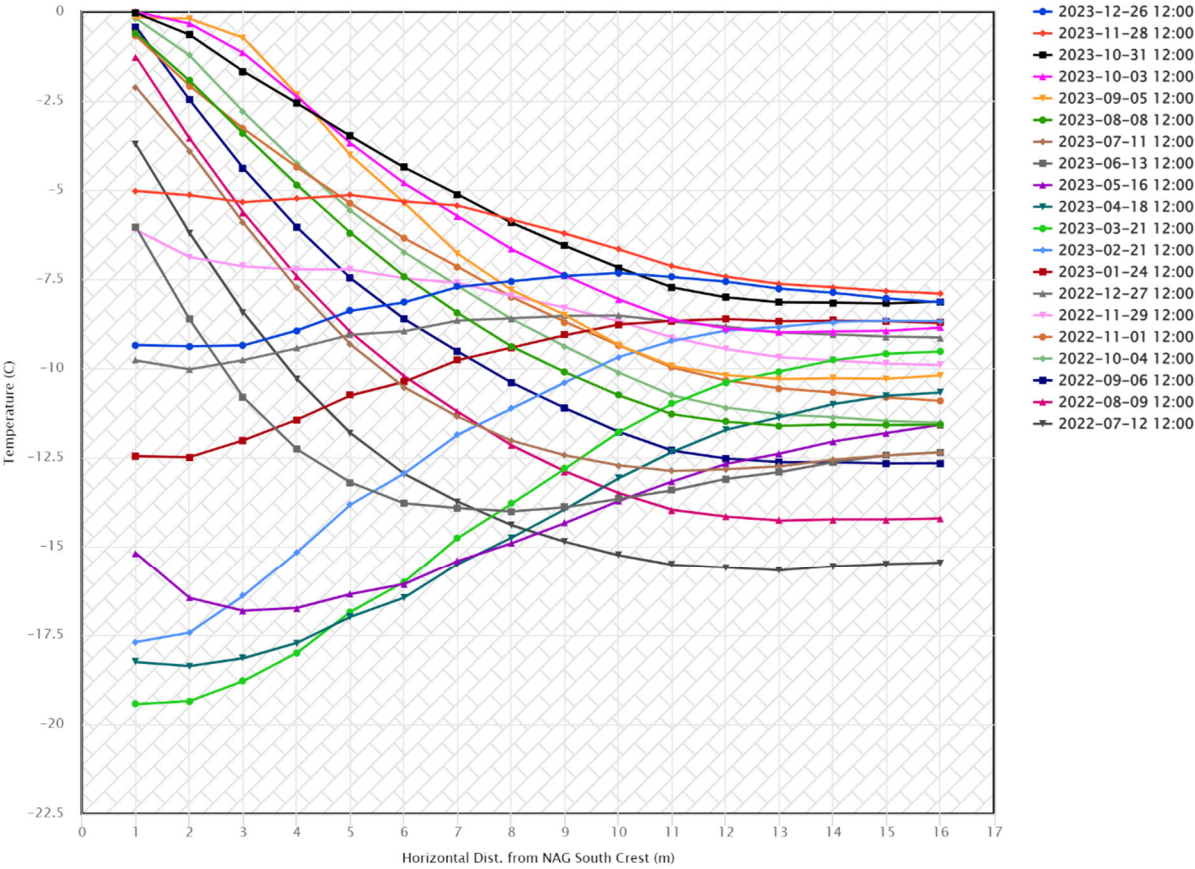
WT WRSF TH12

This instrument is installed horizontally and chart needs to be read accordingly

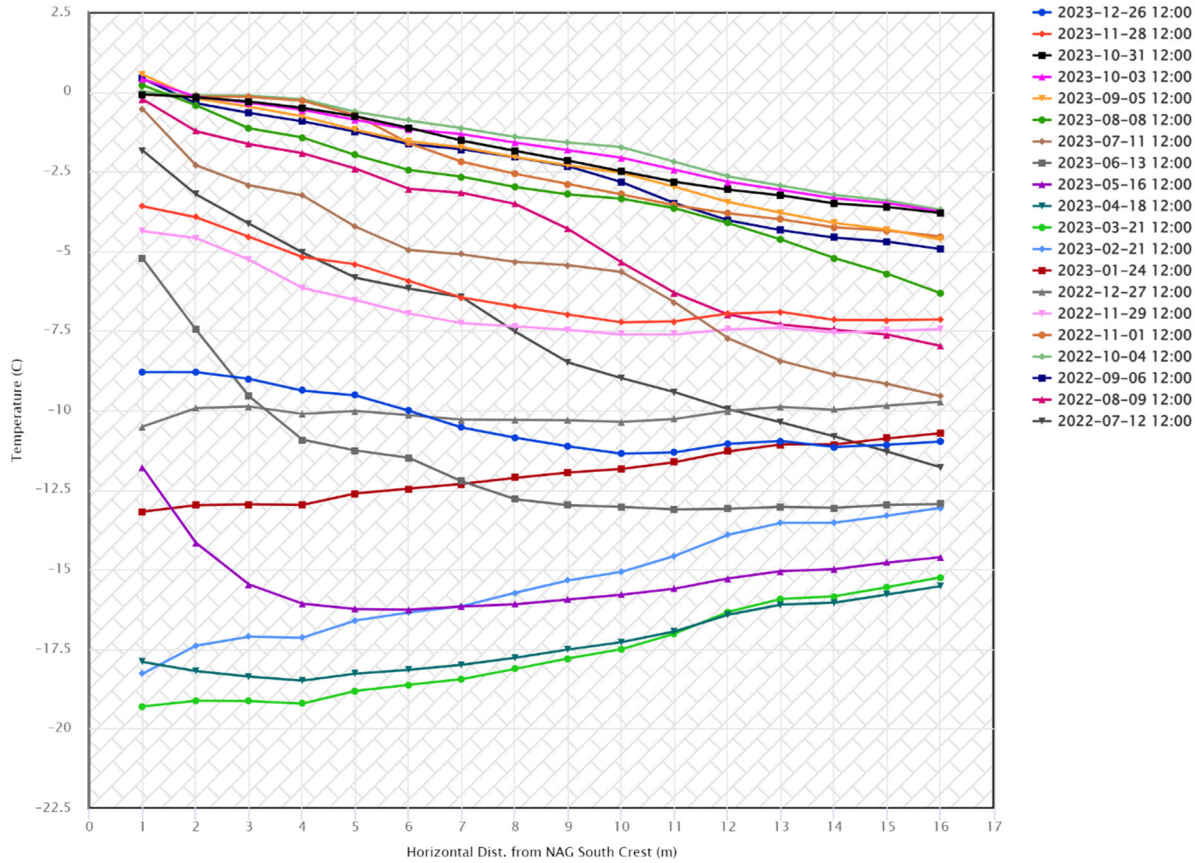
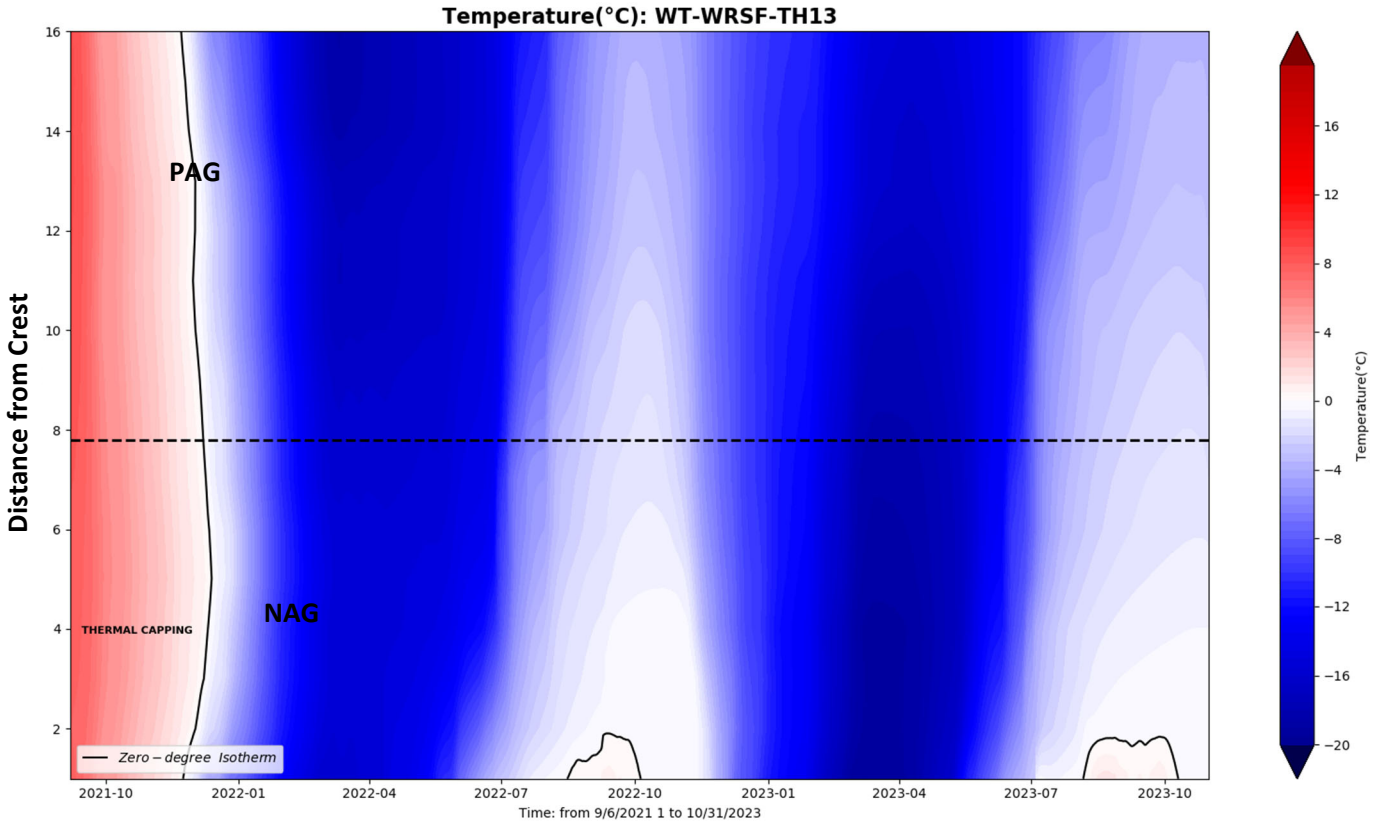
WT WRSF TH13

This instrument is installed horizontally and chart needs to be read accordingly

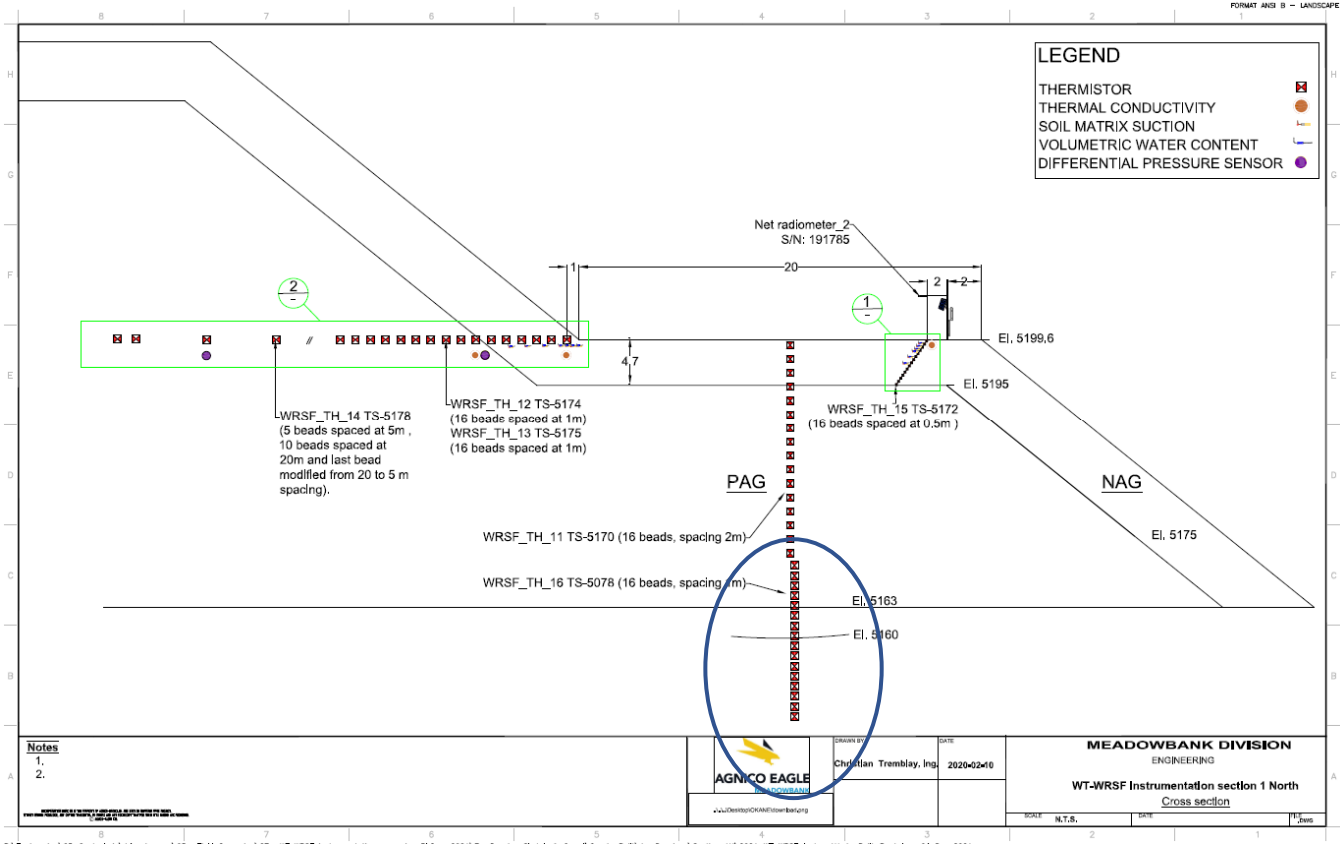
WT WRSF TH16

There was no data from Dec 20 to Feb 2 due to loss of battery power in the instrument.

TH-11 & TH-16

String #: RST 5170 & 5078

Drill Hole Coordinates

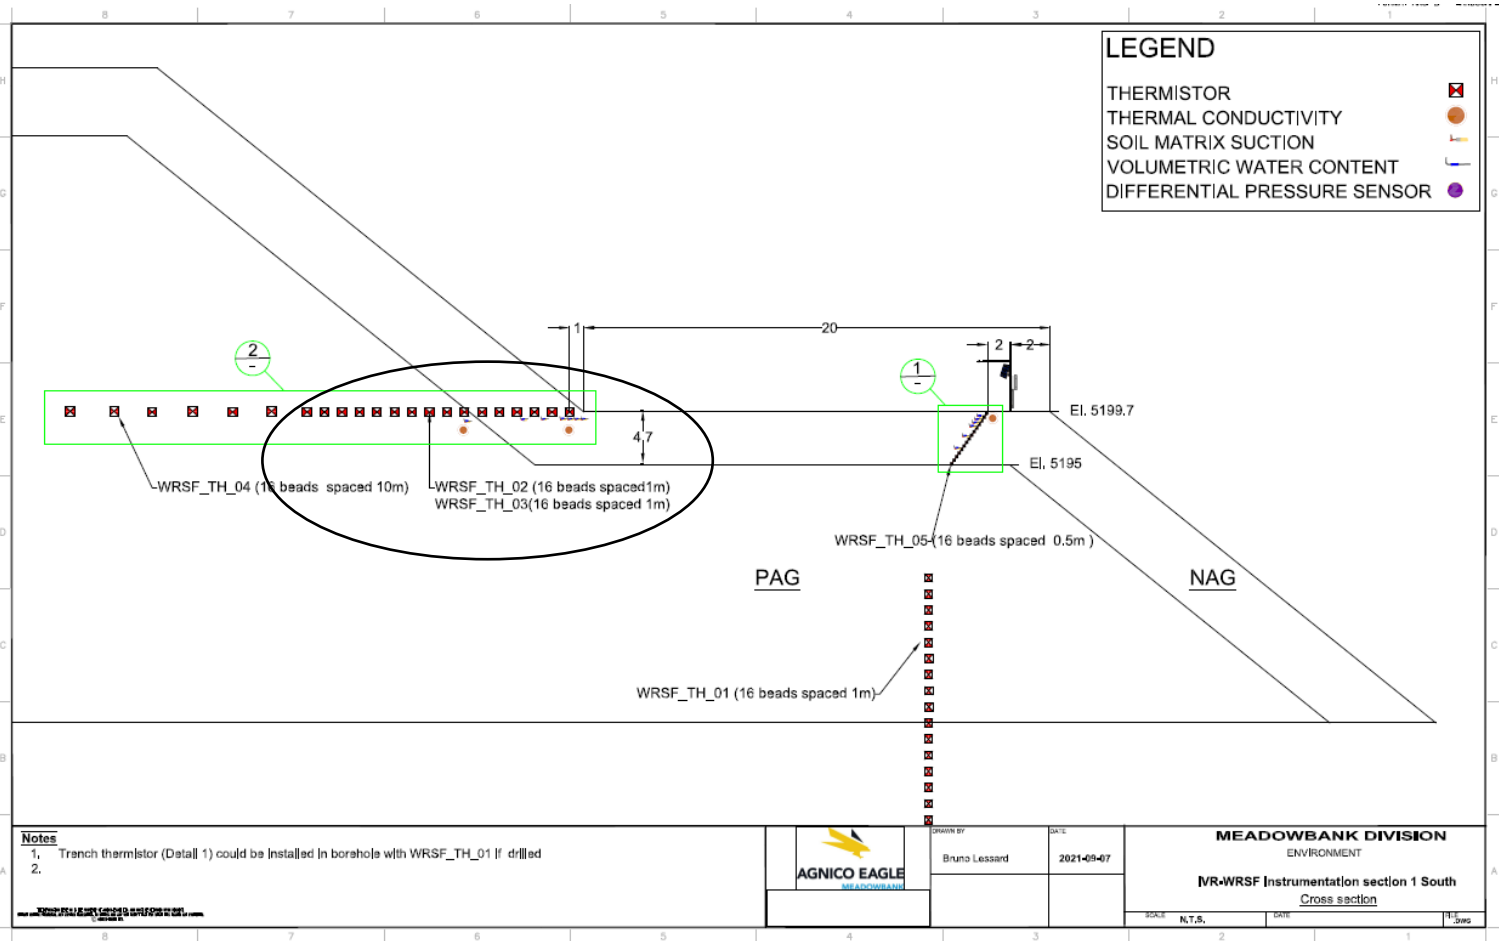
IVR WRSF TH02

AMQ – WRSF – IVR\_TH\_02  
Horizontal thermistor South

This instrument is installed horizontally and chart needs to be read accordingly

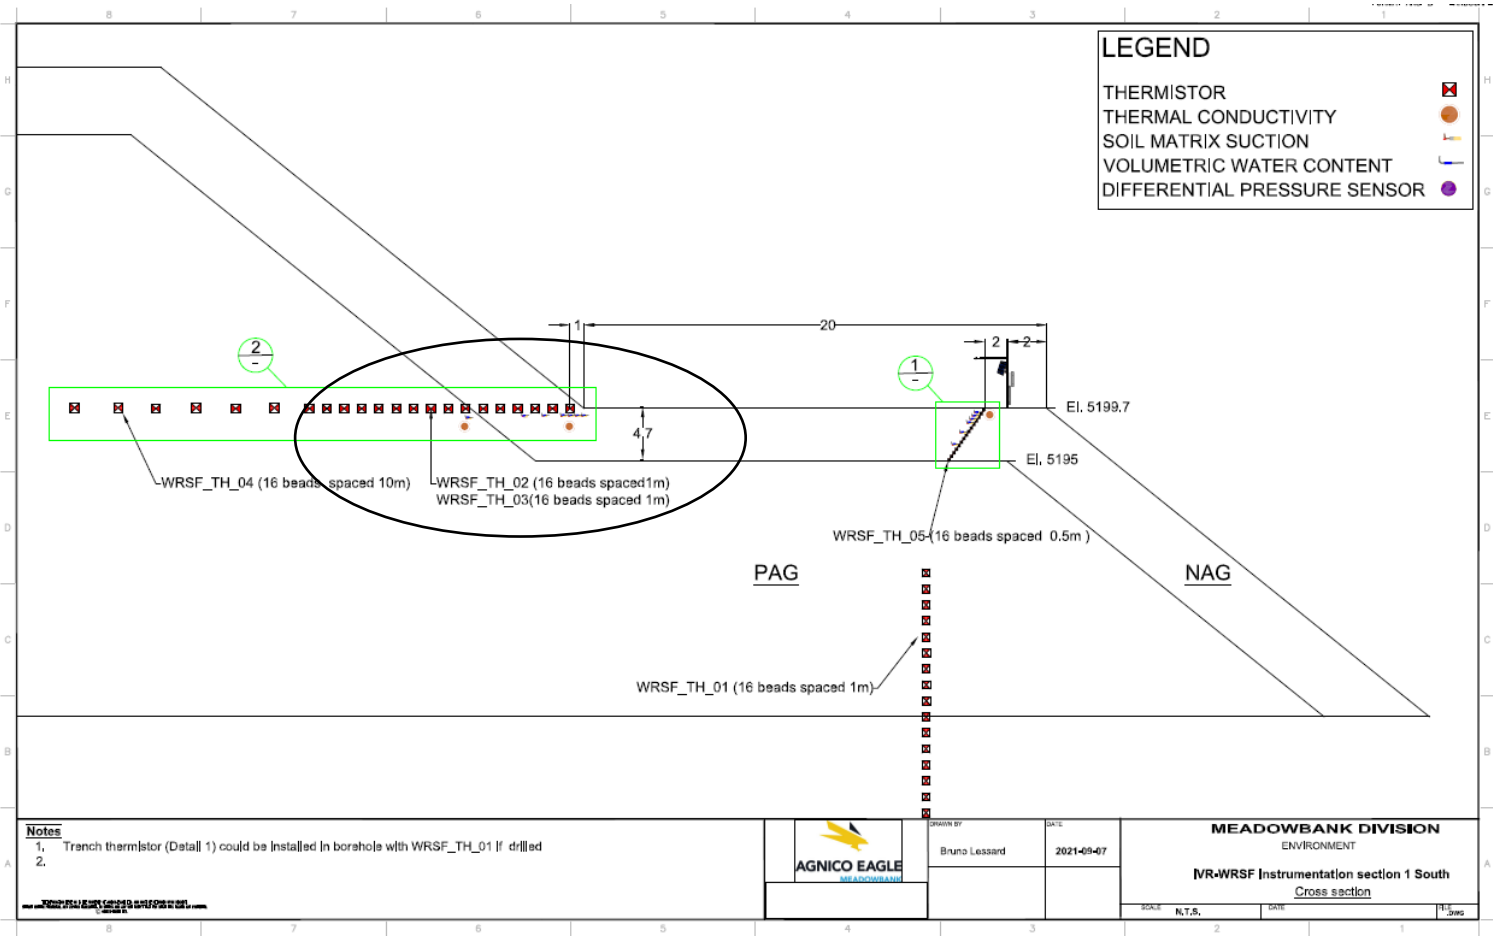
IVR WRSF TH03

This instrument is installed horizontally and chart needs to be read accordingly

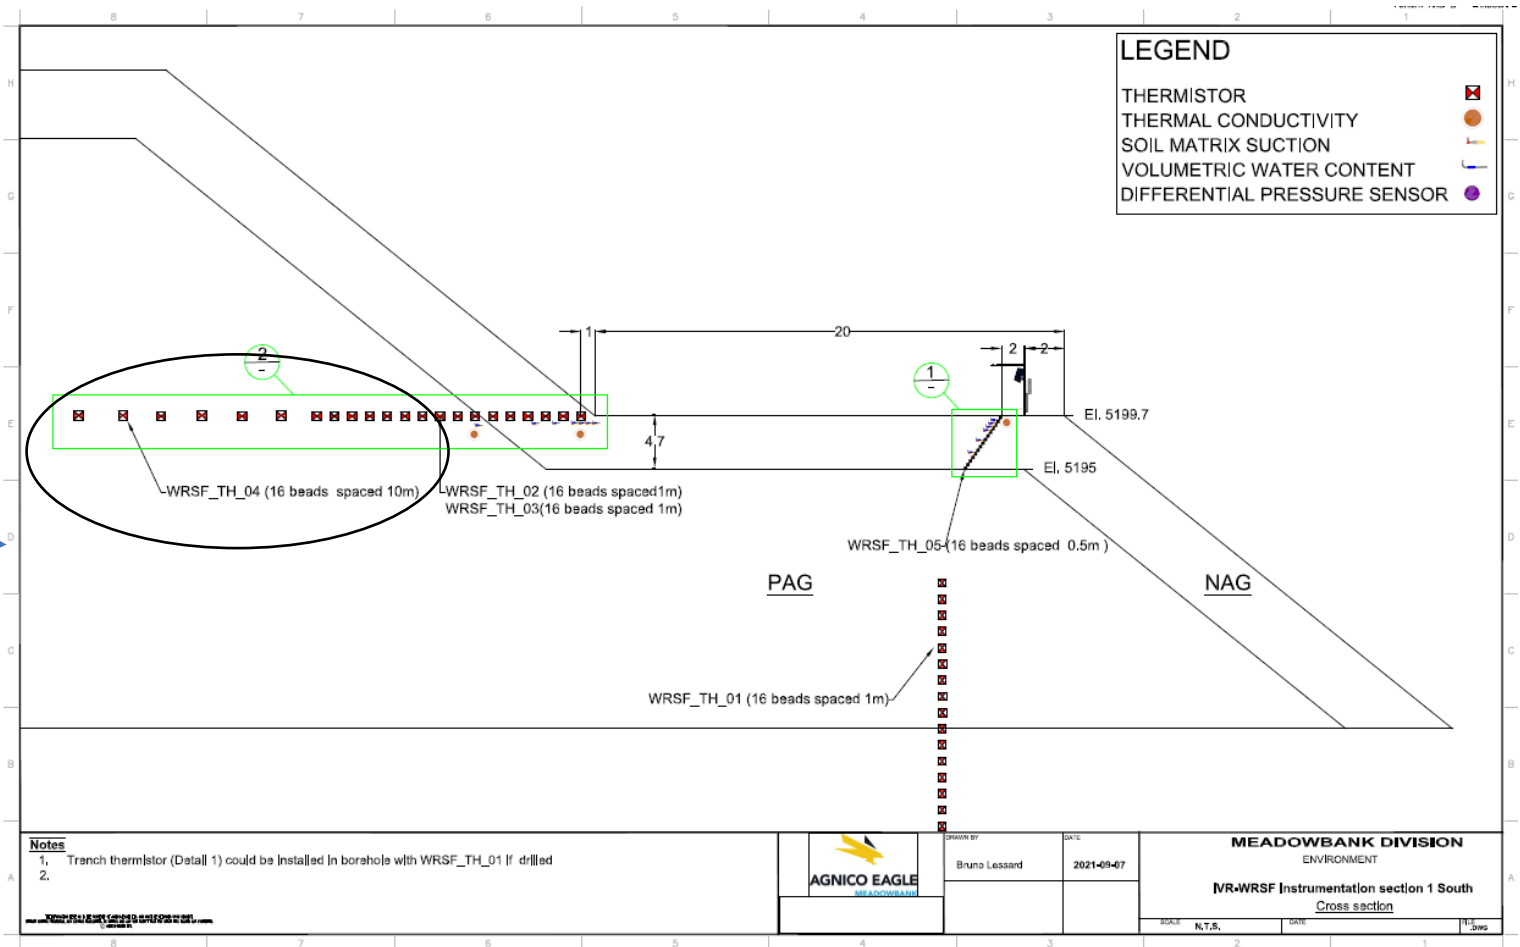
IVR WRSF TH04

AMQ – WRSF – IVR\_TH\_04  
Horizontal Thermistor South

This instrument is installed horizontally and chart needs to be read accordingly

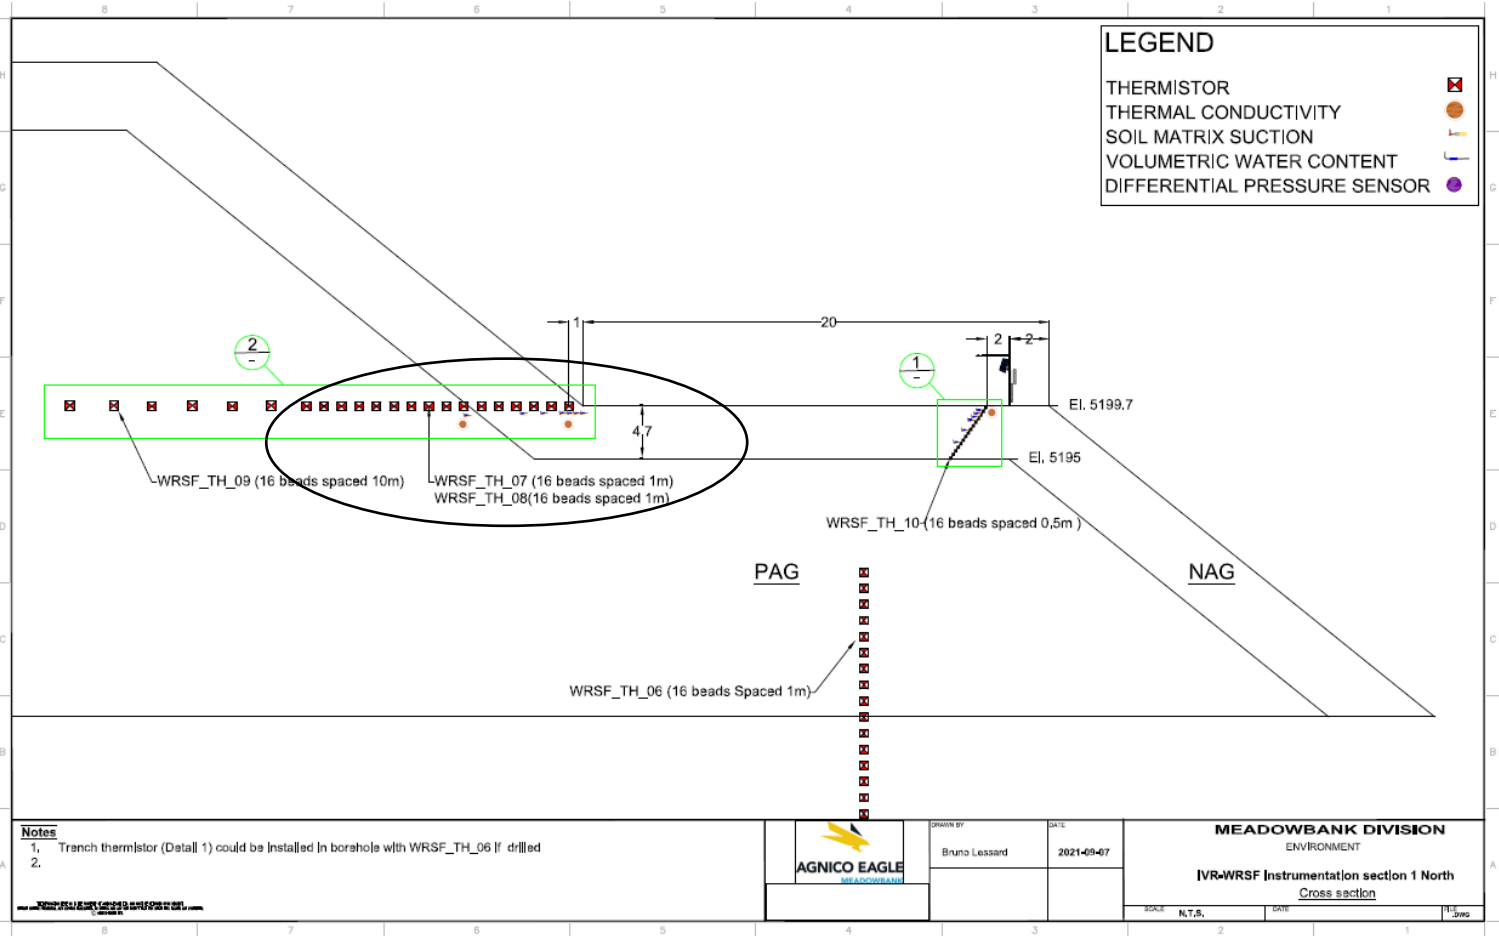
IVR WRSF TH07

This instrument is installed horizontally and chart needs to be read accordingly

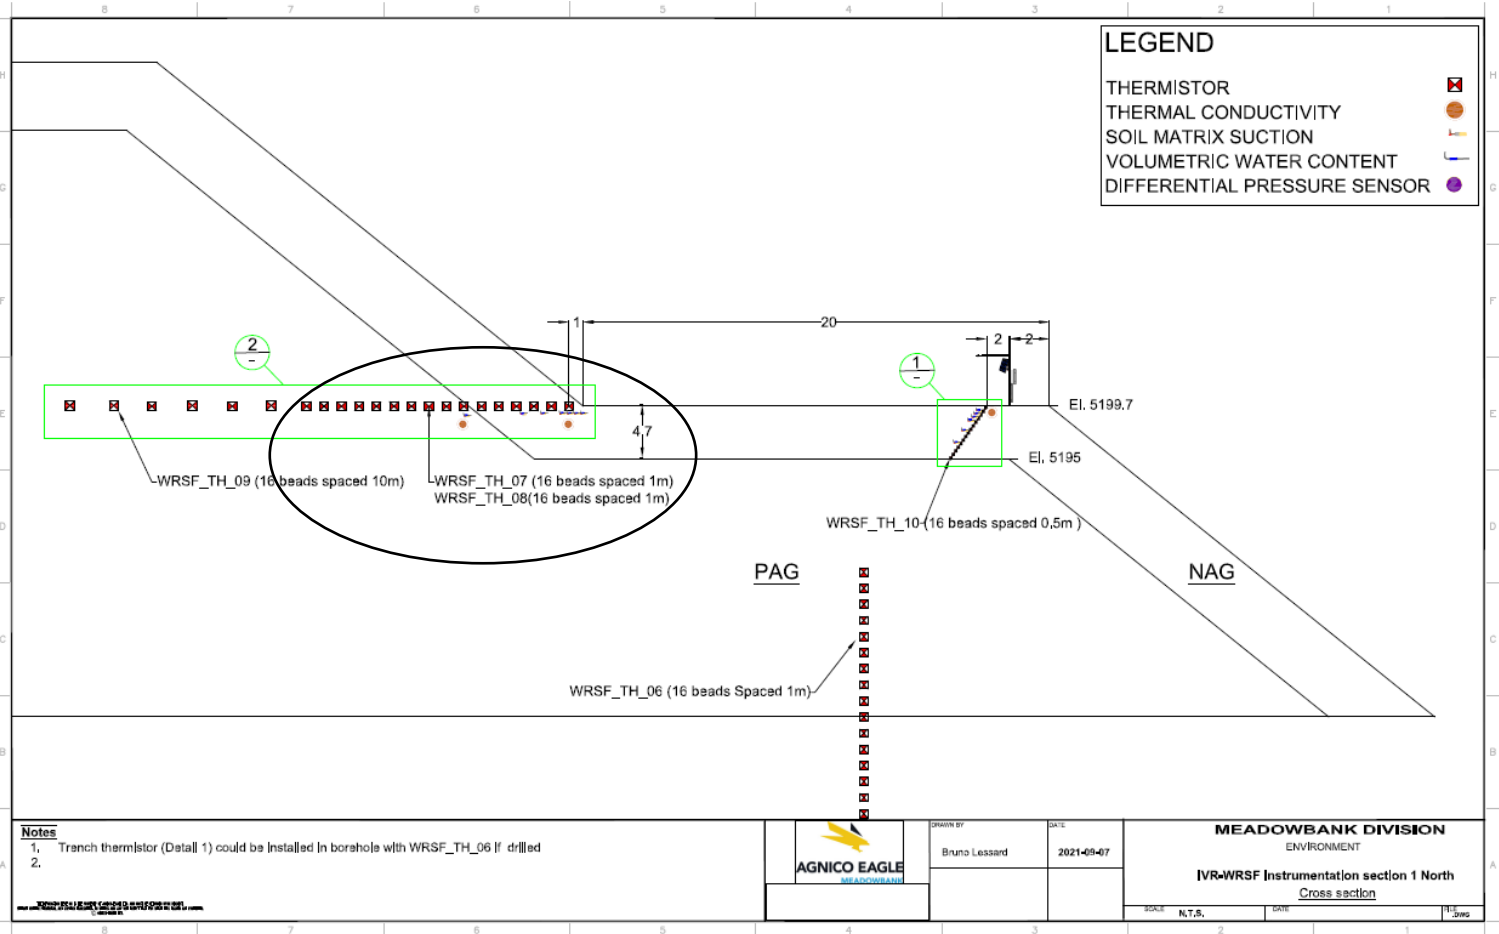
IVR WRSF TH08

This instrument is installed horizontally and chart needs to be read accordingly
