WTD-TH 0+665

Whale Tail Dike

AGNICO EAGLE  
AMARUQ

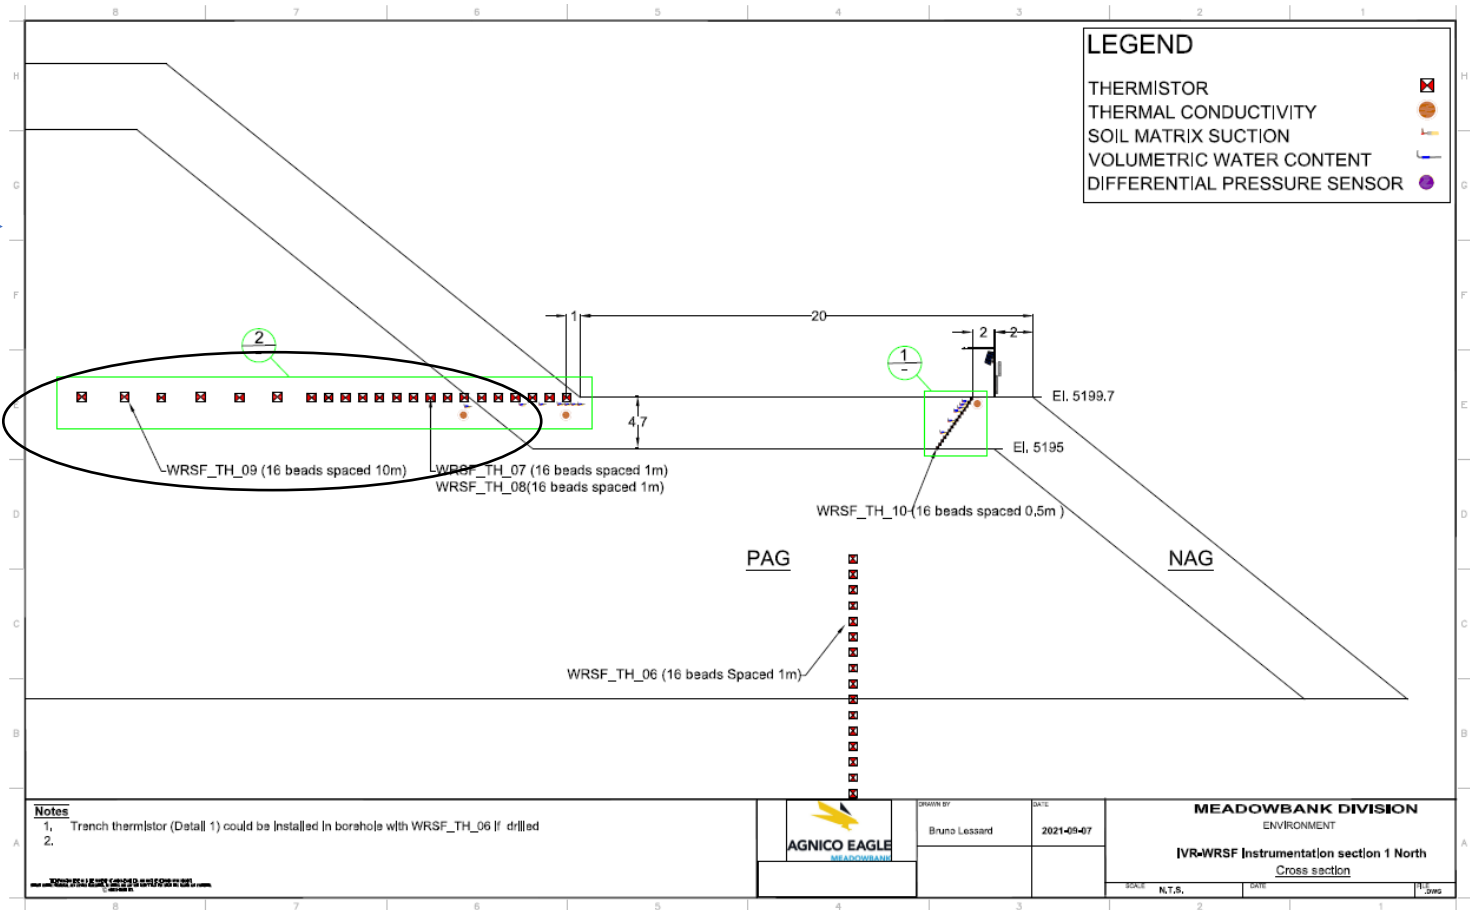
IVR WRSF TH09

This instrument is installed horizontally and chart needs to be read accordingly
