2023 Monitoring of Metal Leaching and Acid Rock Drainage Potential at the Ulu Camp, Ulu Gold Project, Nunavut

Blue Star Gold Corp

SRK Consulting (Canada) Inc.
CAPR002649
March 2024

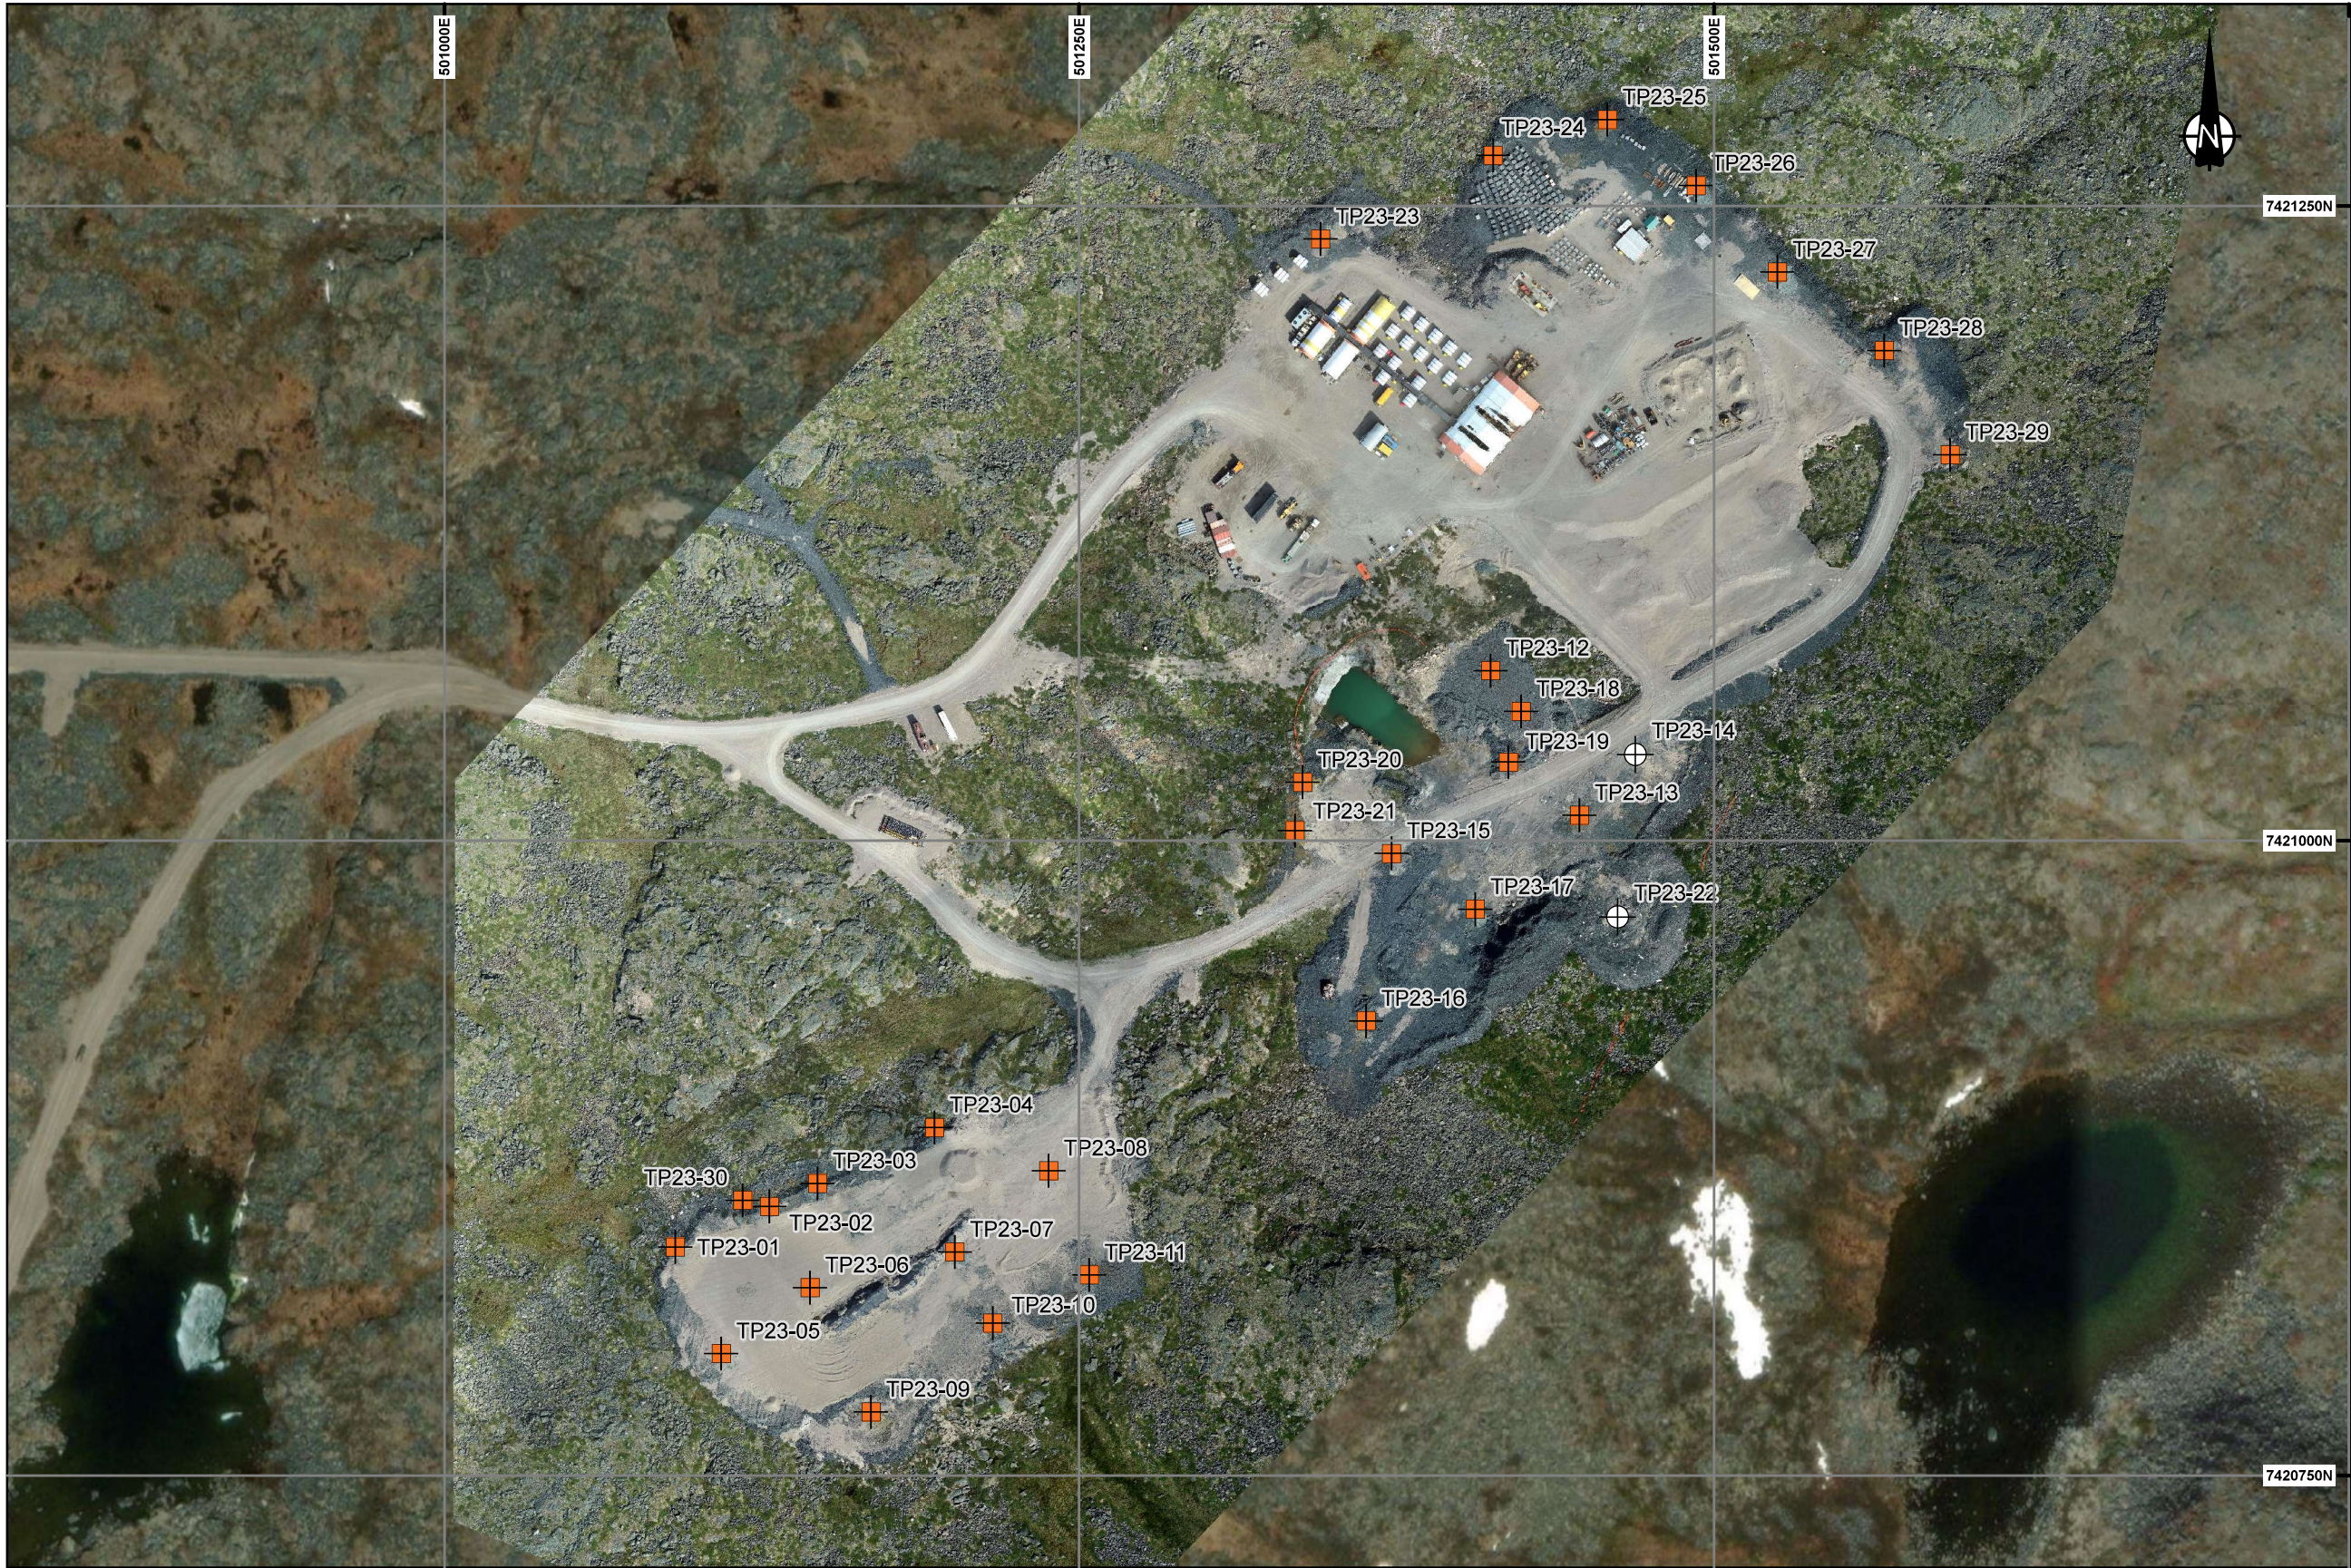
Sample depths are provided with the results. Rinse testing included measurement of rinse pH and rinse conductivity. Results are provided in Section 5.1.

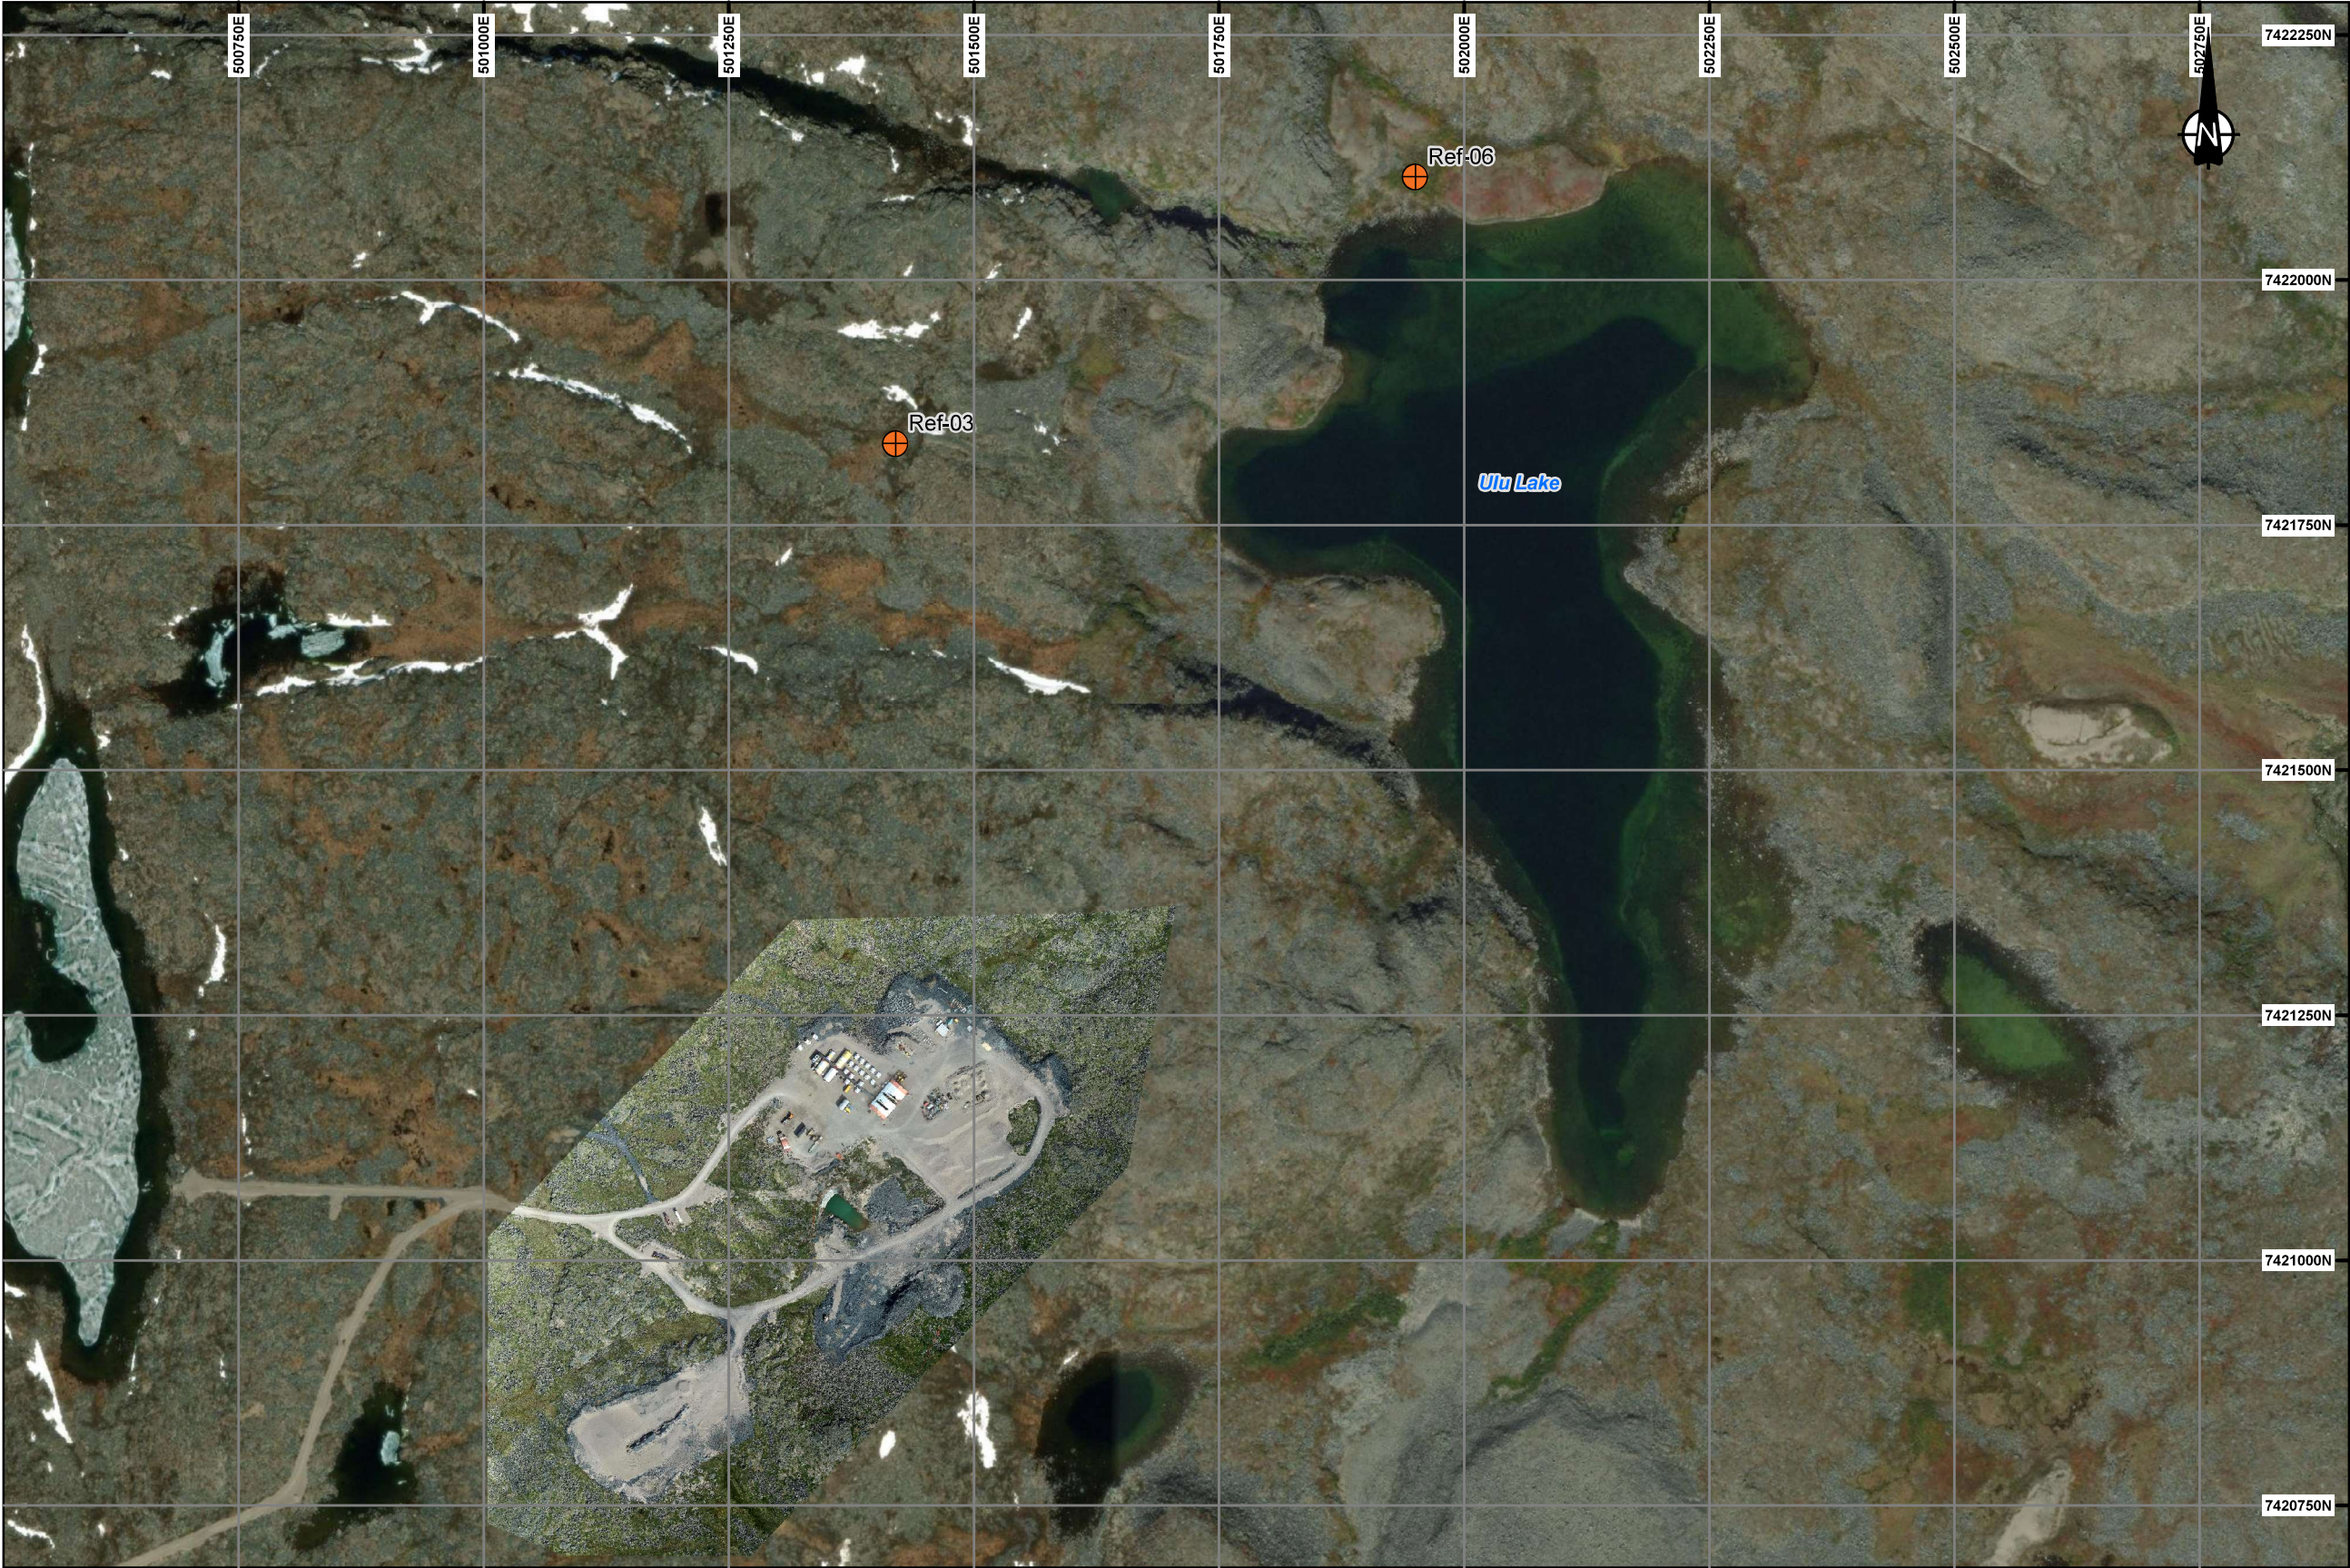
Figure: 3.4

In addition to the seepage samples, the two reference stations (Ref-03 and Ref-06) were sampled on June 13 and July 3. These were dry when checked on July 29. Their locations are shown on Figure 3.4.
