Appendix A – Test Pit Photo Logs

Ulu ML/ARD Monitoring	Test Pits (July 2023) Photo Log	
		Test Pit TP23-01	
AppA_Ulu Test_Pit_Photo_Log_CAPR002649_Rev00.pptx		Date: March 2023	Appendix A

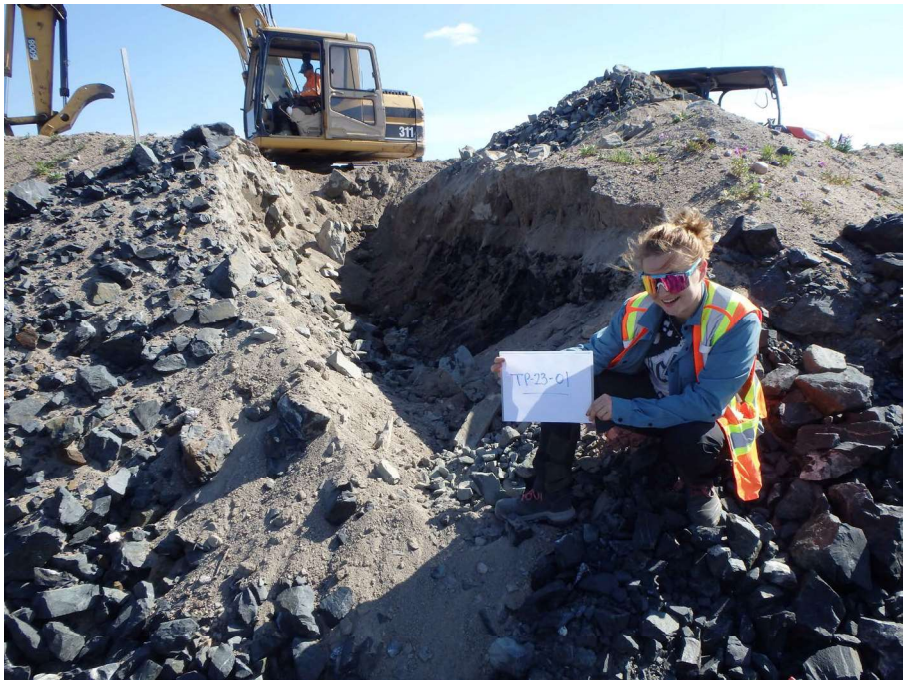
Photo 1: TP23-01

Location	Ore pad
Samples Collected	Depth (m)
TP23-01	0.88

Interval/sample	From (m)	To (m)	Description
	0	0.58	Sand
TP23-01	0.58	0.88+	Grey metabasalt

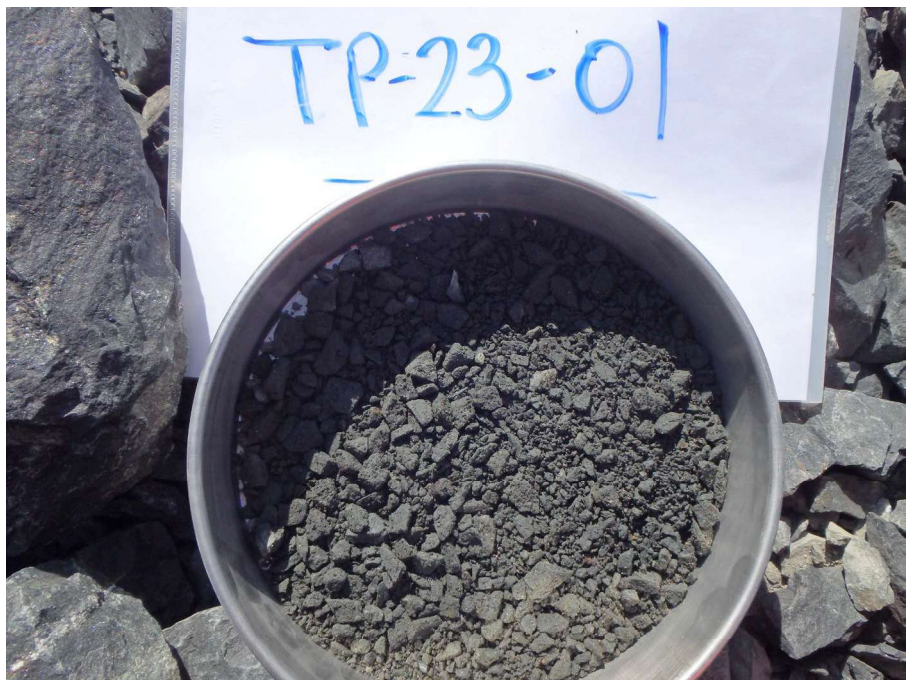
Photo 2: Sample before 2mm sieving

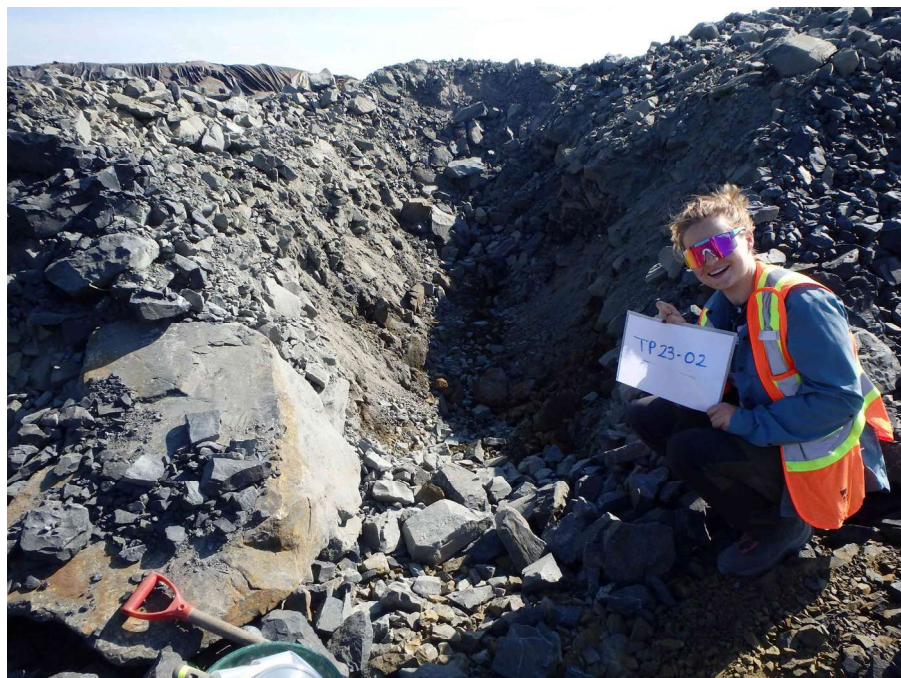
Photo 1: TP23-02

Location	Ore pad
Samples Collected	Depth (m)
TP23-02A	1.30
TP23-02B	1.15

Interval/sample	From (m)	To (m)	Description
TP23-02A	0	1.15	Grey metabasalt
TP23-02B	1.15	1.90	Orange rock
	1.9+		Outcrop or large glacial boulder

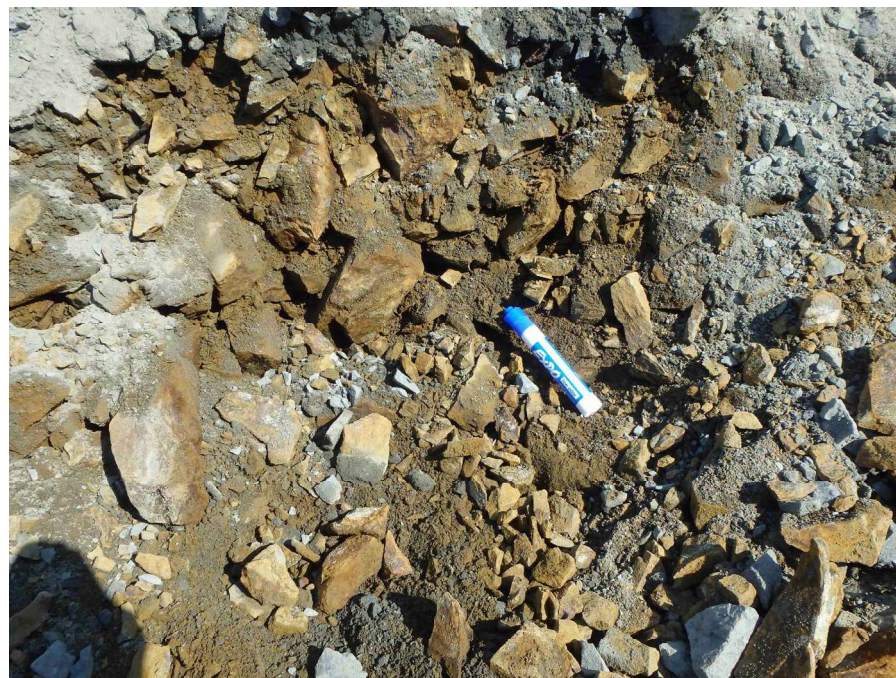
Photo 2: Orange strongly oxidized rock

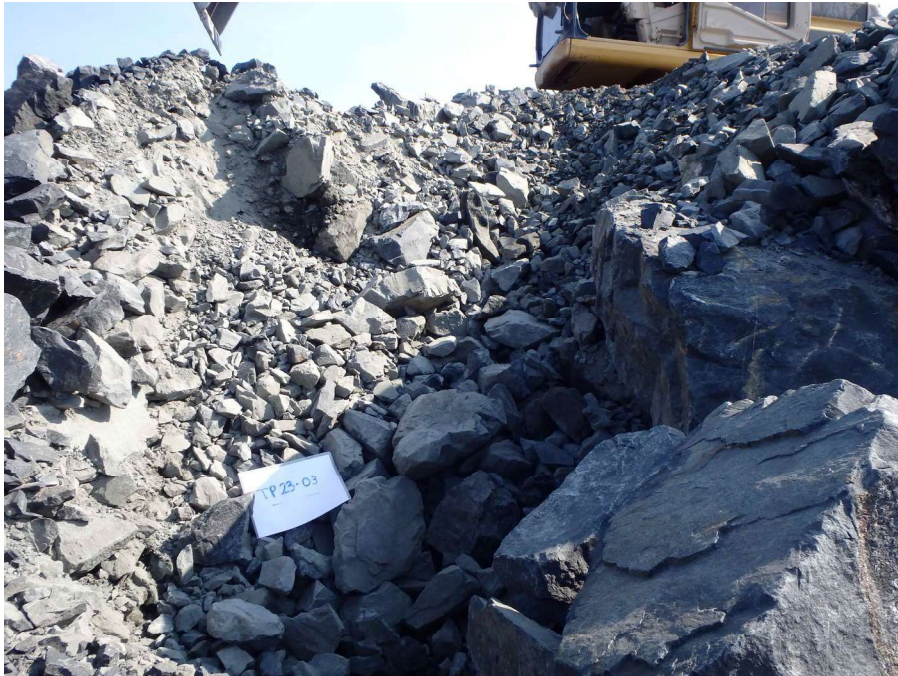
Photo 1: TP23-03

Location	Ore pad		Interval/sample	From (m)	To (m)	Description
Samples Collected	Depth (m)		TP23-03	0	1.90	Grey metabasalt
TP23-03	1.35			1.9+		Tundra soil

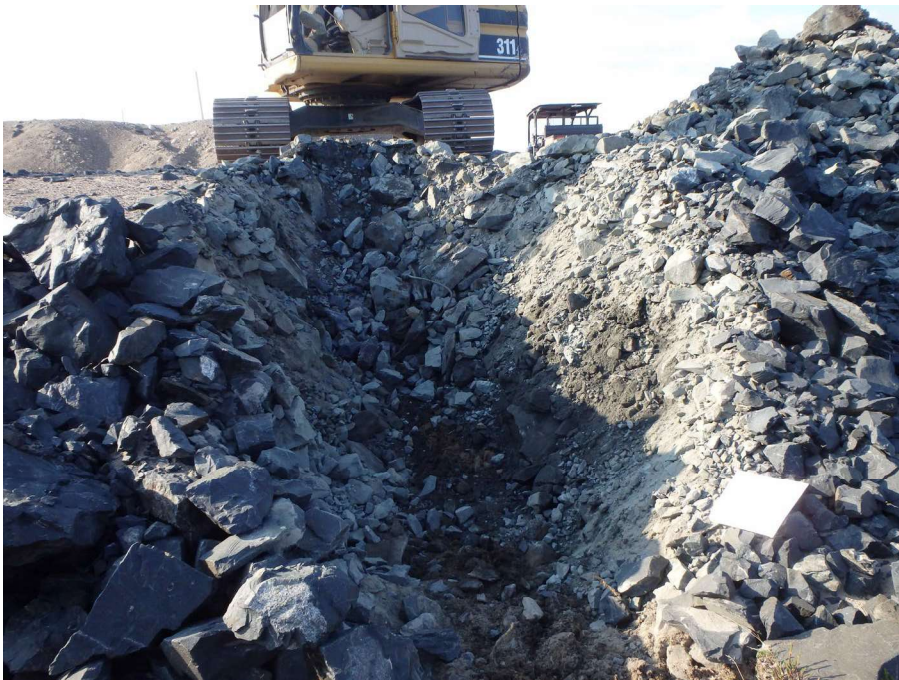
Photo 1: TP23-04

Location	Ore pad
Samples Collected	Depth (m)
TP23-04	0.90

Interval/sample	From (m)	To (m)	Description
TP23-04	0	1.5	Grey metabasalt
	1.5+		Tundra soil

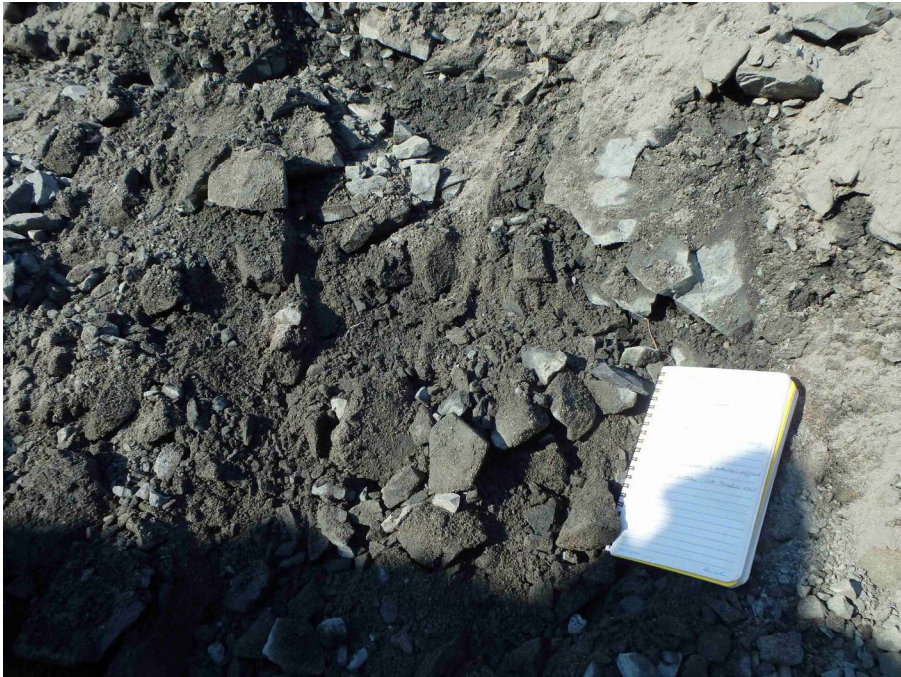
Photo 2: Grey metabasalt

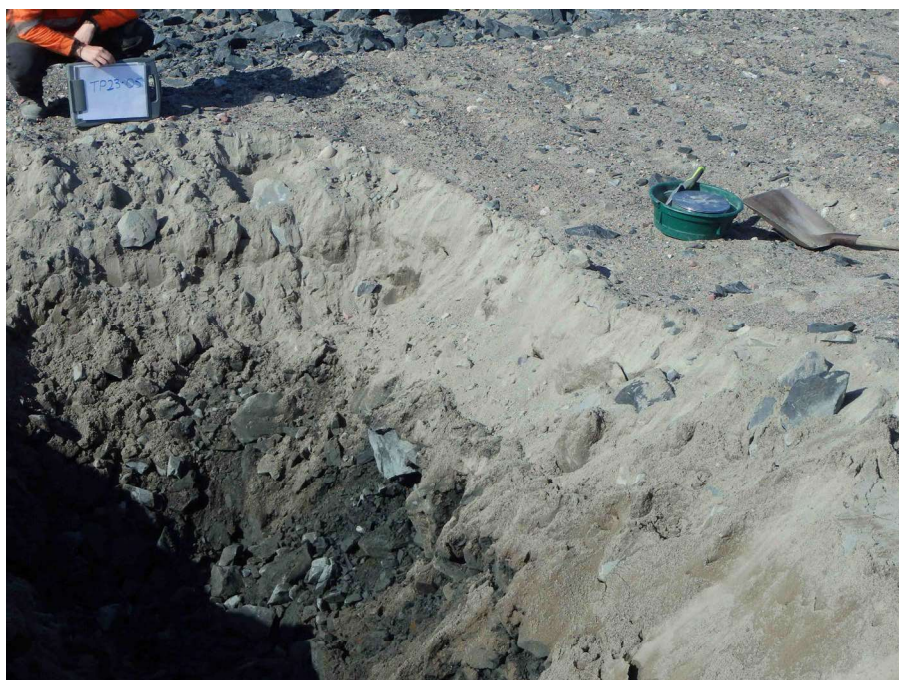
Photo 1: TP23-05

Location	Ore pad
Samples Collected	Depth (m)
TP23-05	0.85

Interval/sample	From (m)	To (m)	Description
	0	0.45	Sand
TP23-05	0.45	1.4	Grey metabasalt

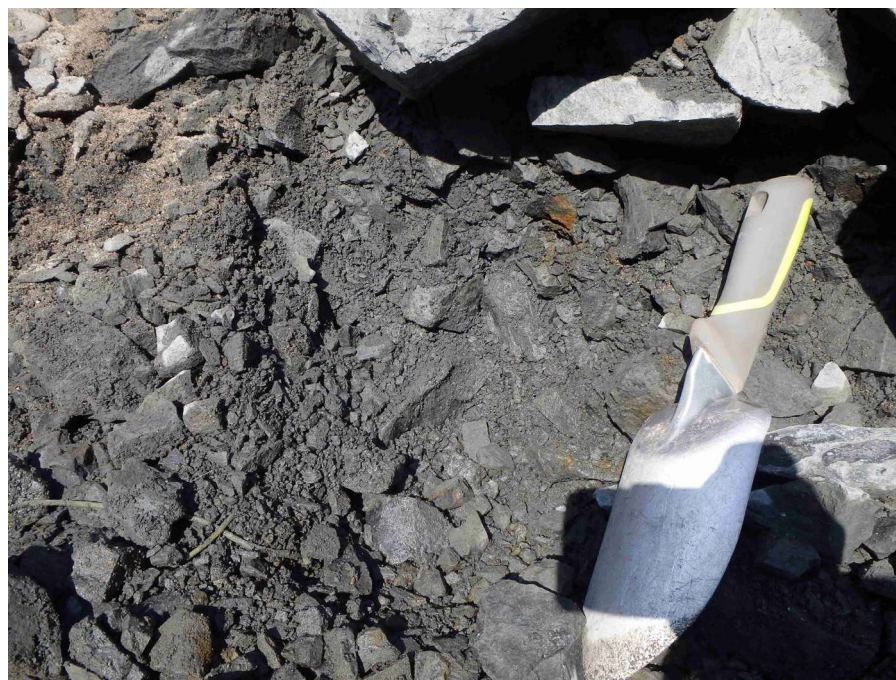
Photo 2: Grey metabasalt

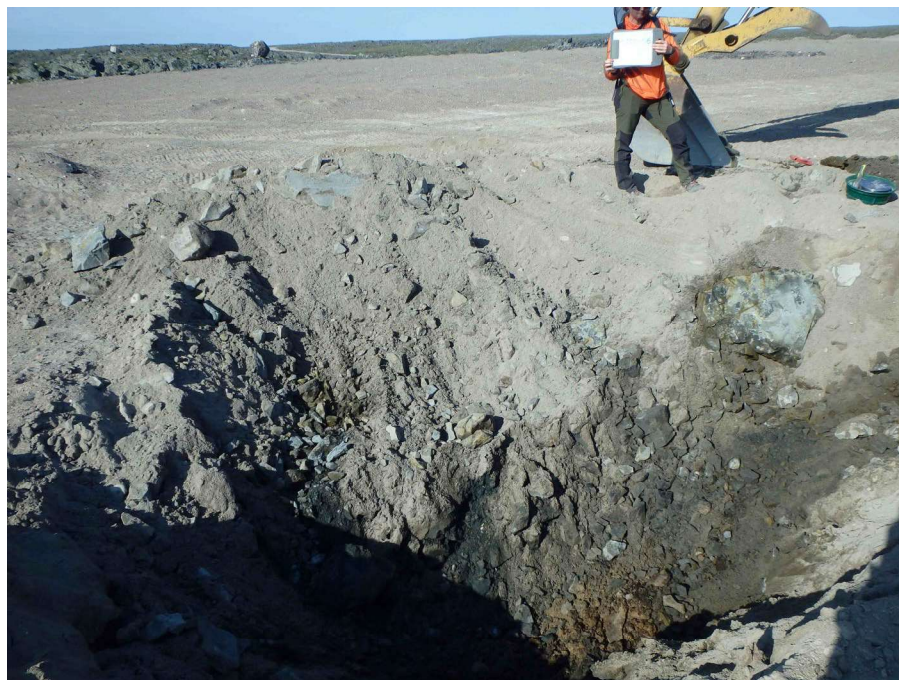
Photo 1: TP23-06

Location	Ore pad
Samples Collected	Depth (m)
TP23-06A	0.75
TP23-06B	1.20

Interval/sample	From (m)	To (m)	Description
	0	0.42	Sand
TP23-06A	0.42	0.75	Orange rock
TP23-06B	0.75	1.45	Grey metabasalt

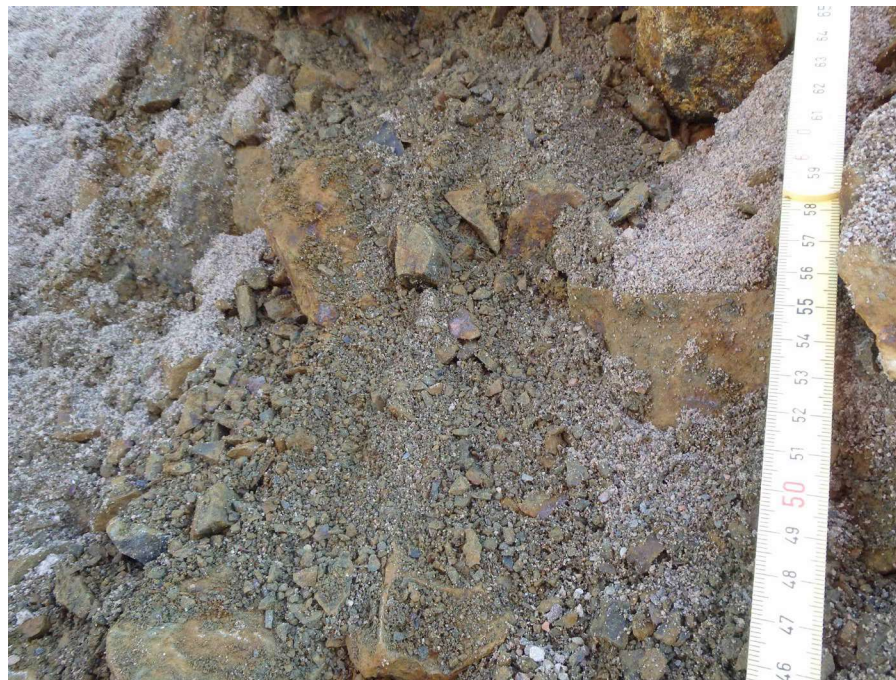
Photo 2: Orange strongly oxidized rock (some sand also present)

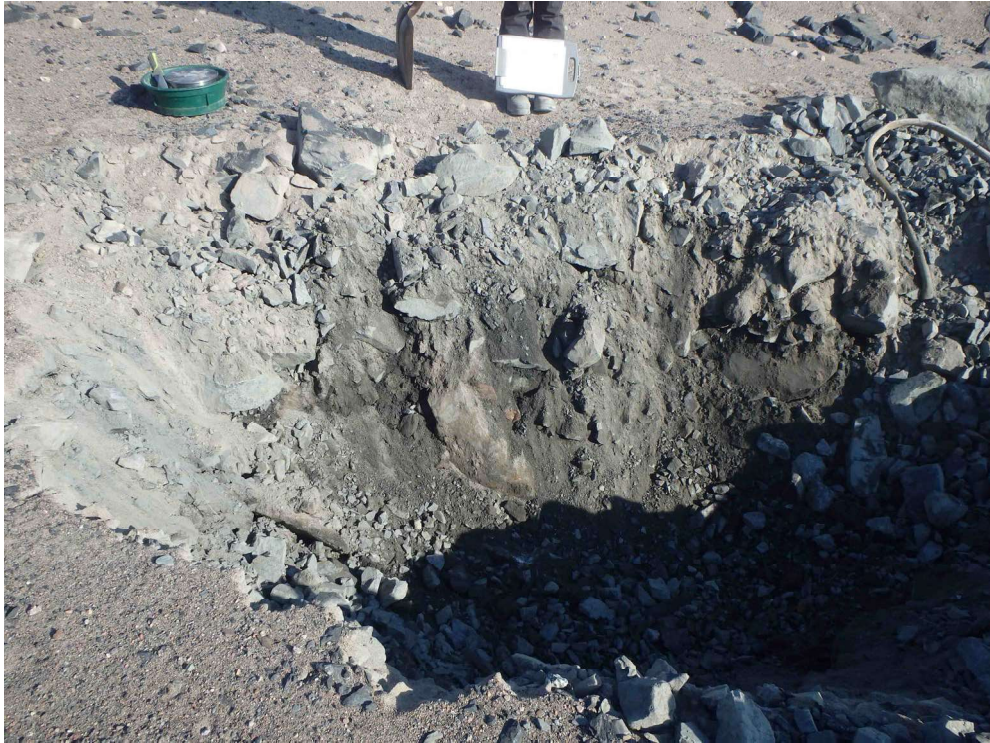
Photo 1: TP23-07

Location	Ore pad
Samples Collected	Depth (m)
TP23-07	0.60

Interval/sample	From (m)	To (m)	Description
	0	0.02	Sand
TP23-07	0.02	1.25	Grey metabasalt

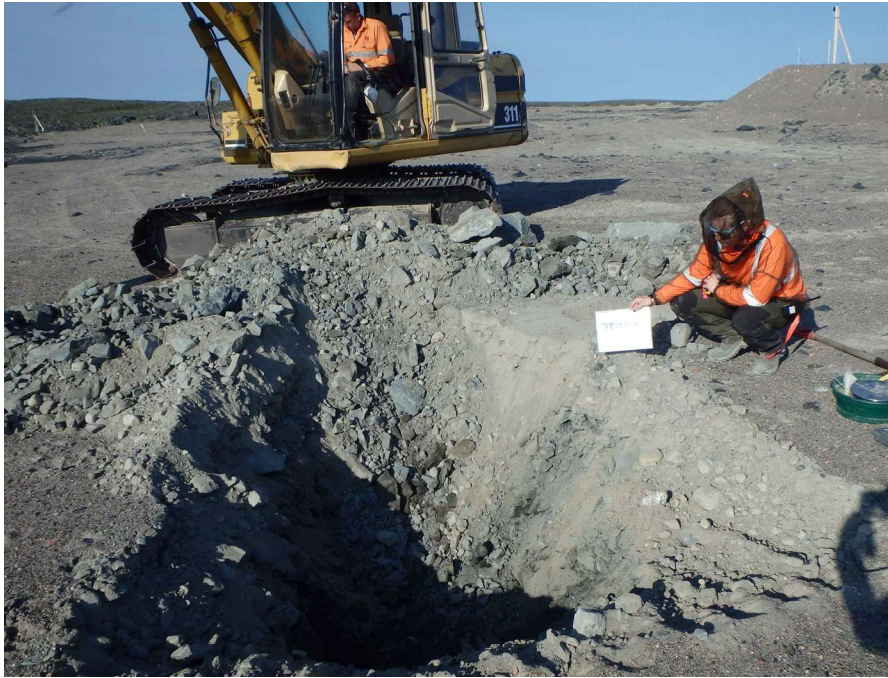
Photo 1: TP23-08

Location	Ore pad
Samples Collected	Depth (m)
TP23-08	0.60

Interval/sample	From (m)	To (m)	Description
	0	0.20	Sand
TP23-08	0.2	0.60+	Grey metabasalt

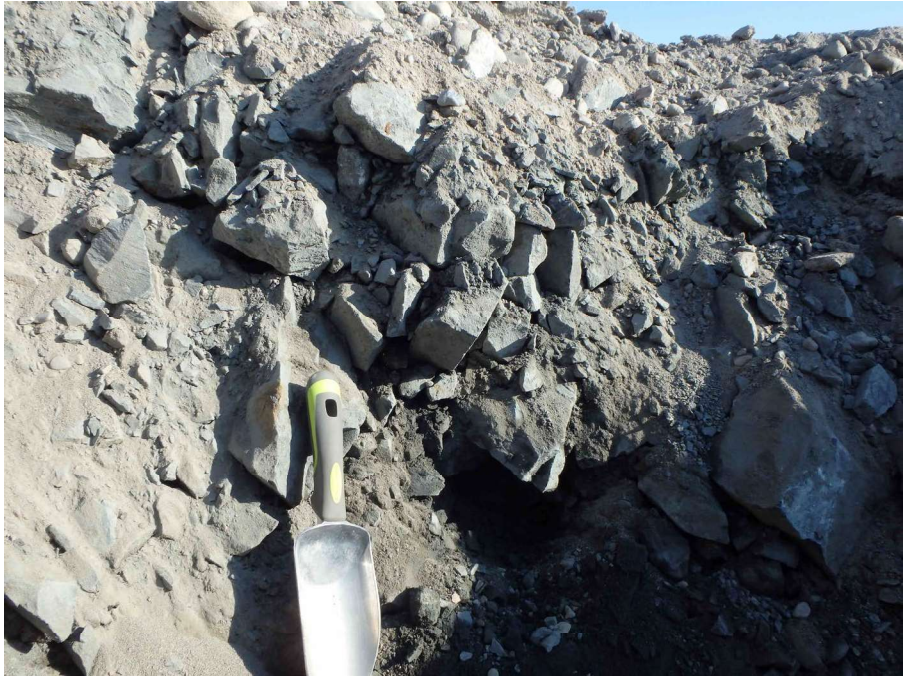
Photo 2: Grey metabasalt (some sand present)

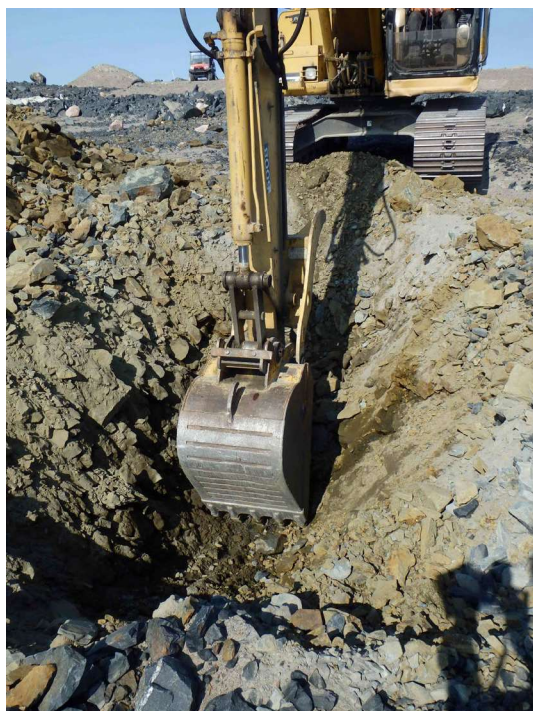
Photo 1: TP23-09

Location	Ore pad
Samples Collected	Depth (m)
TP23-09	1.80

Interval/sample	From (m)	To (m)	Description
TP23-09	0	2.0	Orange rock
	2+		Frozen ground

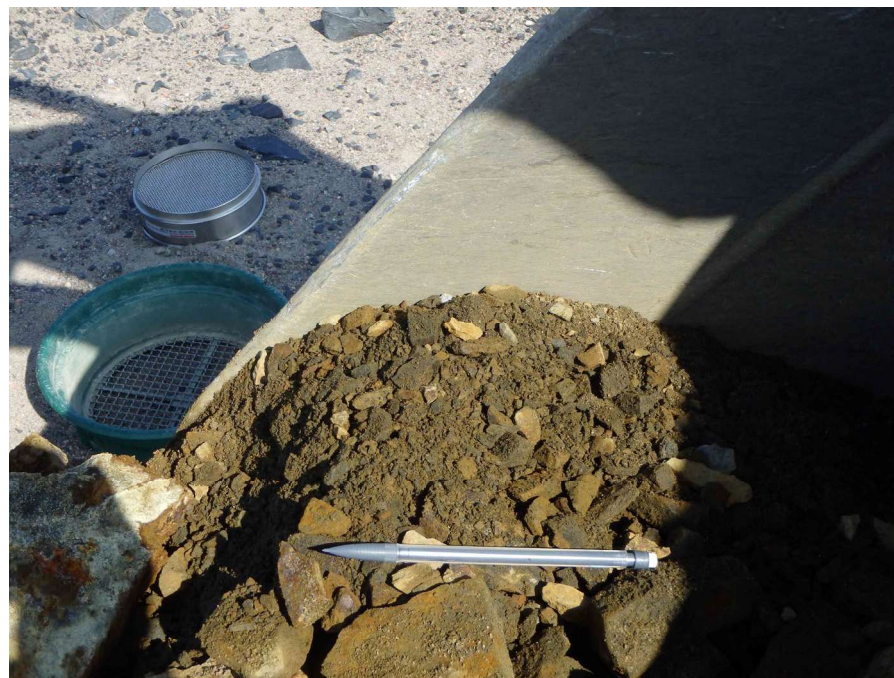
Photo 2: Orange strongly oxidized rock sampled with excavator bucket

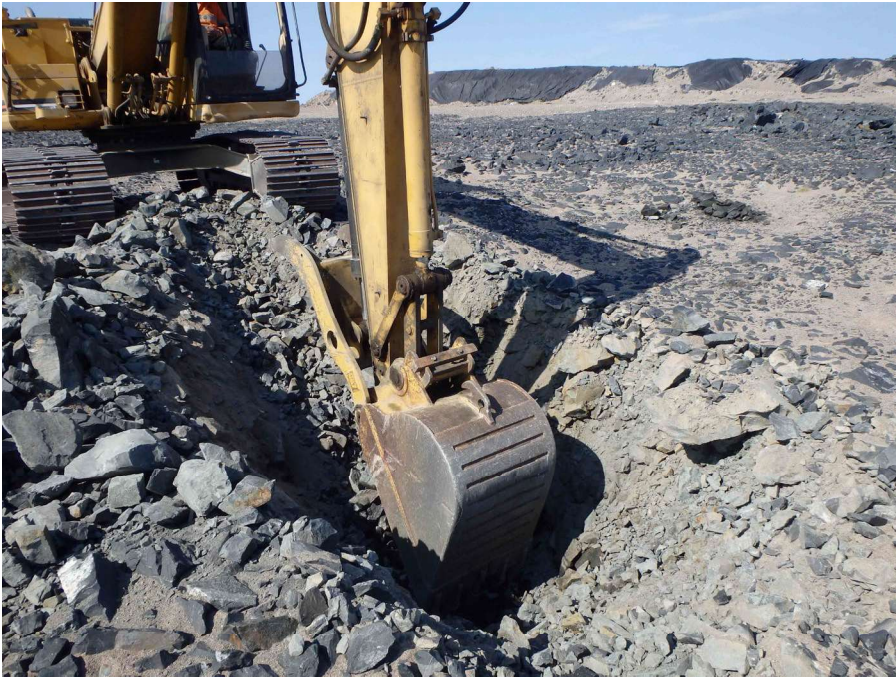
Photo 1: TP23-10

Location	Ore pad
Samples Collected	Depth (m)
TP23-10	1.20

Interval/sample	From (m)	To (m)	Description
TP23-10	0	1.35	Grey metabasalt

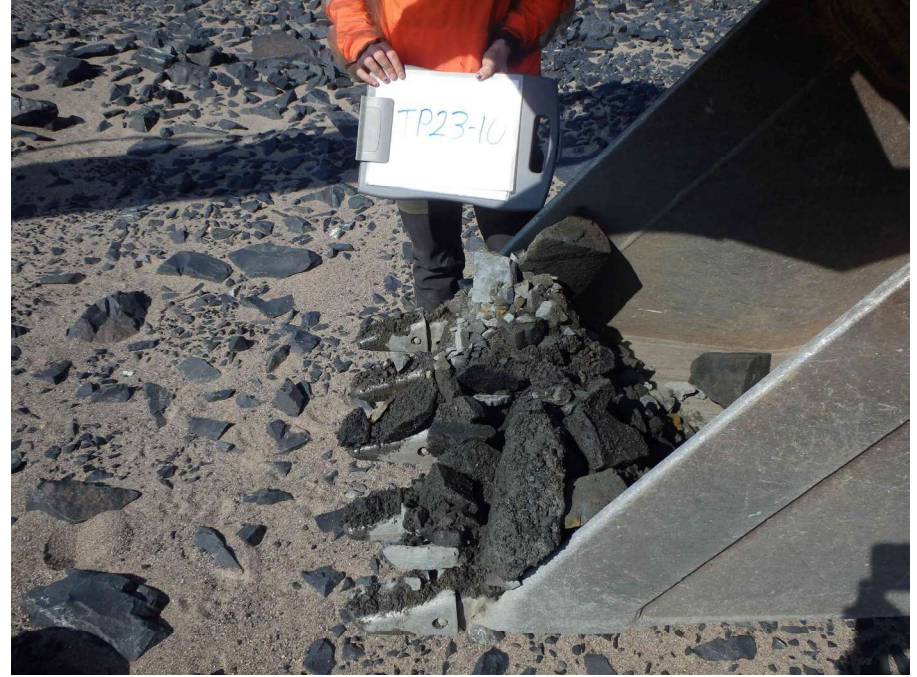
Photo 2: Grey metabasalt sampled with excavator bucket

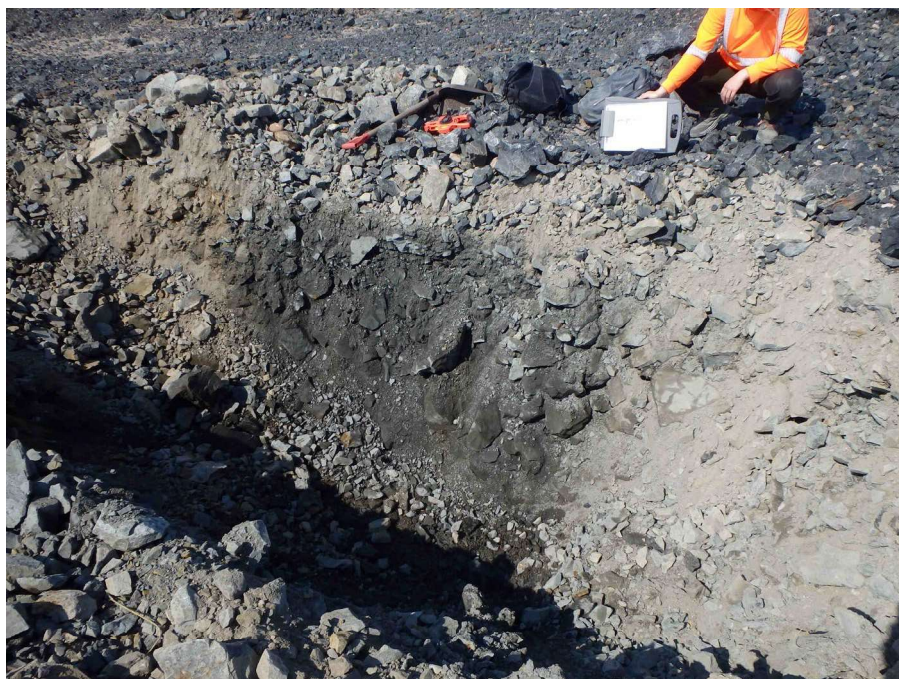
Photo 1: TP23-11

Location	Ore pad
Samples Collected	Depth (m)
TP23-11	0.70

Interval/sample	From (m)	To (m)	Description
	0	0.3	Sand and rock mixture
TP23-11	0.3	1.2	Grey metabasalt
	1.2+		Frozen ground

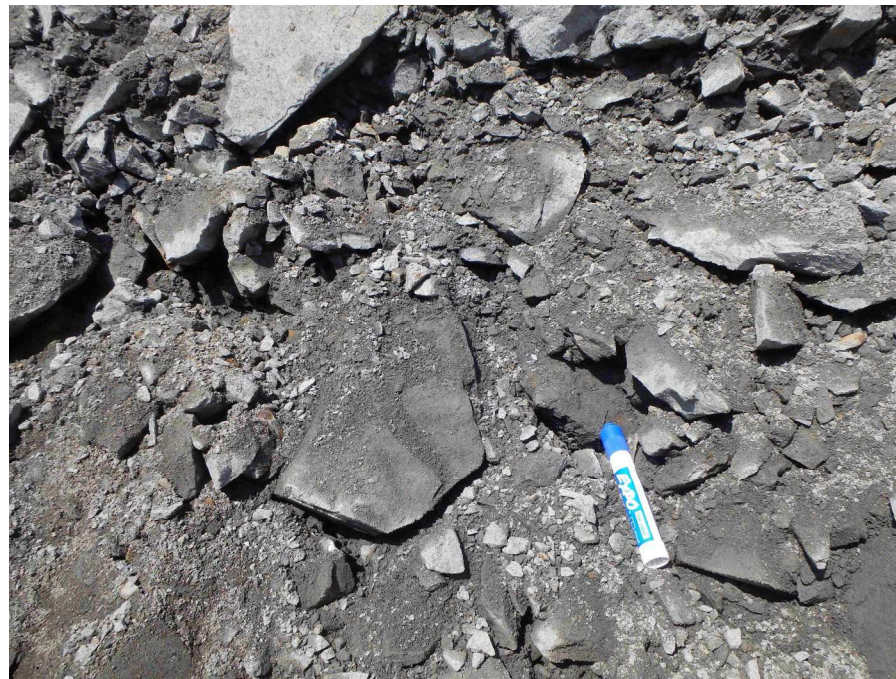
Photo 2: Grey metabasalt

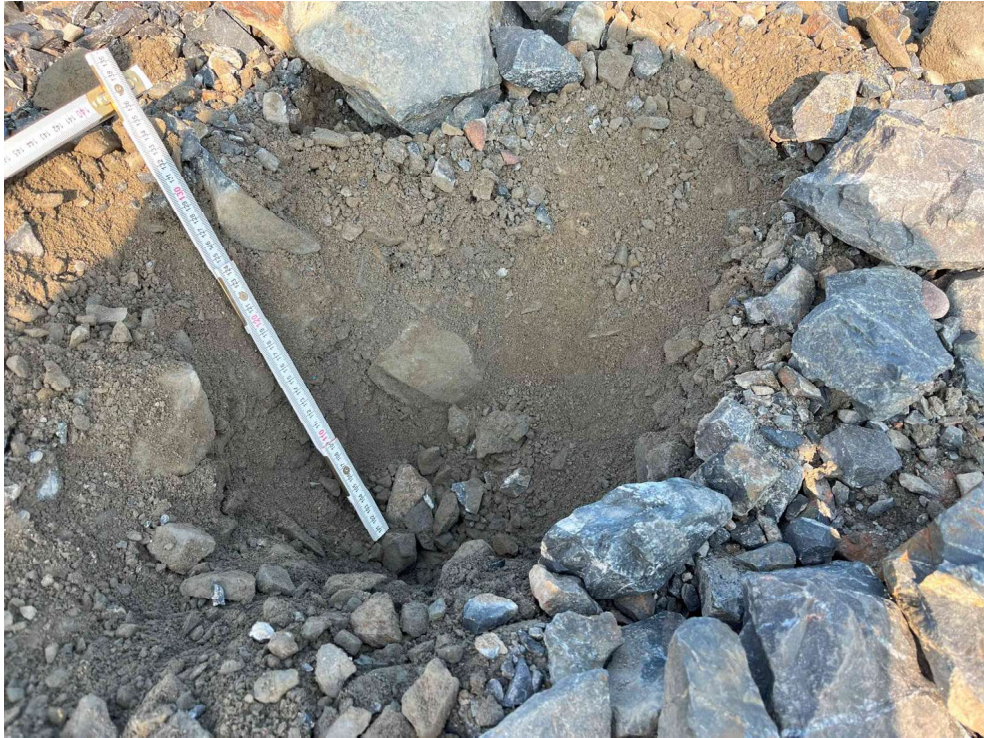
Photo 1: TP23-12

Location	Portal area (relocated ore)
Samples Collected	Depth (m)
TP23-12	0.15

Interval/sample	From (m)	To (m)	Description
TP23-12	0	0.2	Ore with grey-brown fines

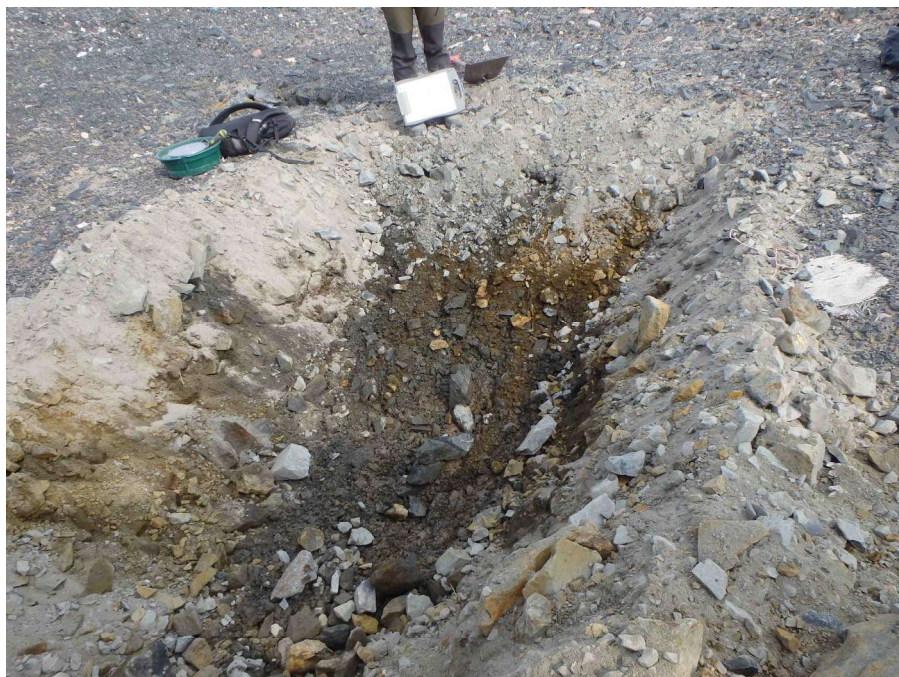
Photo 1: TP23-13

Location	Waste rock pad
Samples Collected	Depth (m)
TP23-13A	0.50
TP23-13B	0.70

Interval/sample	From (m)	To (m)	Description
	0	0.35	Mixed sand and grey rock
TP23-13A	0.35	0.55	Orange rock
TP23-13B	0.55	0.8	Grey rock
	0.8+		Glacial till

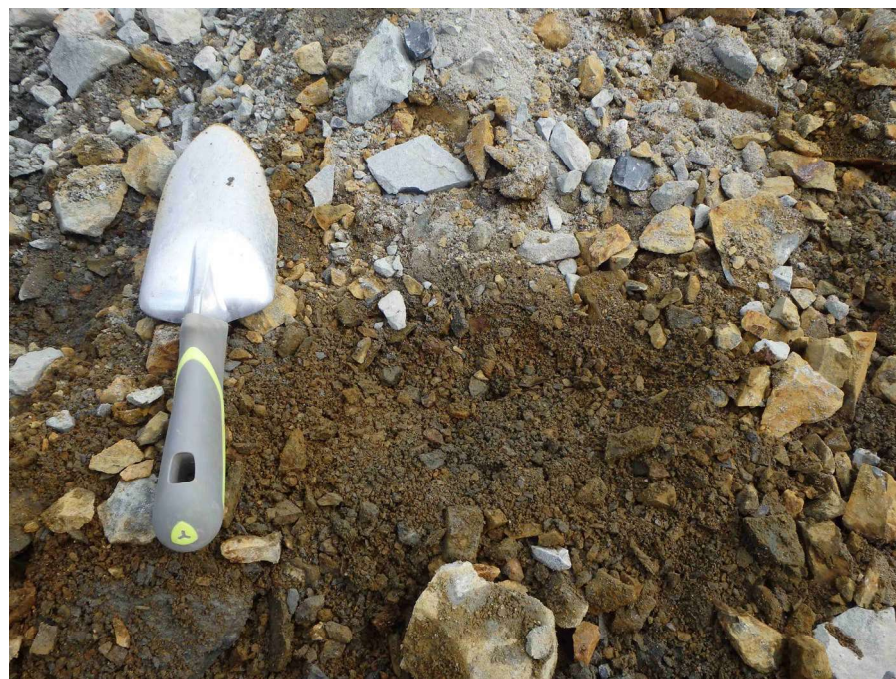
Photo 2: Strongly oxidized orange rock

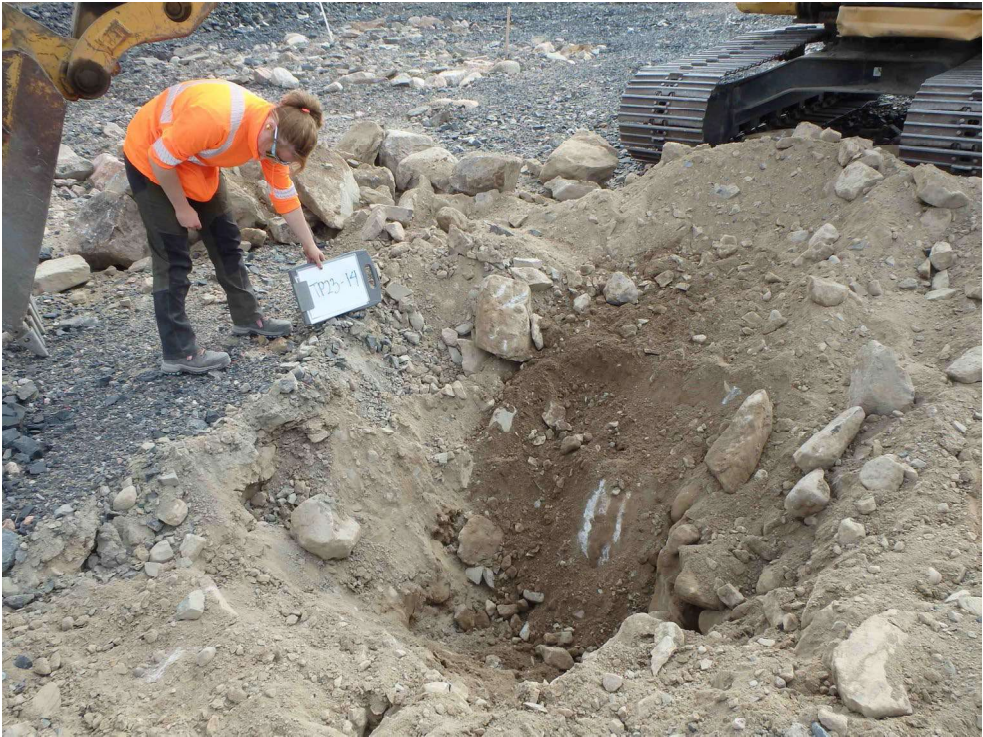
Photo 1: TP23-14

Location	Waste rock pad	Interval/sample	From (m)	To (m)	Description
Samples Collected	Depth (m)	TP23-14	0	0.96	Sand and glacial boulders
TP23-14	Not sampled
