Ulu ML/ARD Monitoring	Test Pits (July 2023) Photo Log	
		Test Pit TP23-15	
AppA_Ulu Test_Pit_Photo_Log_CAPR002649_Rev00.pptx		Date: March 2023	Appendix A

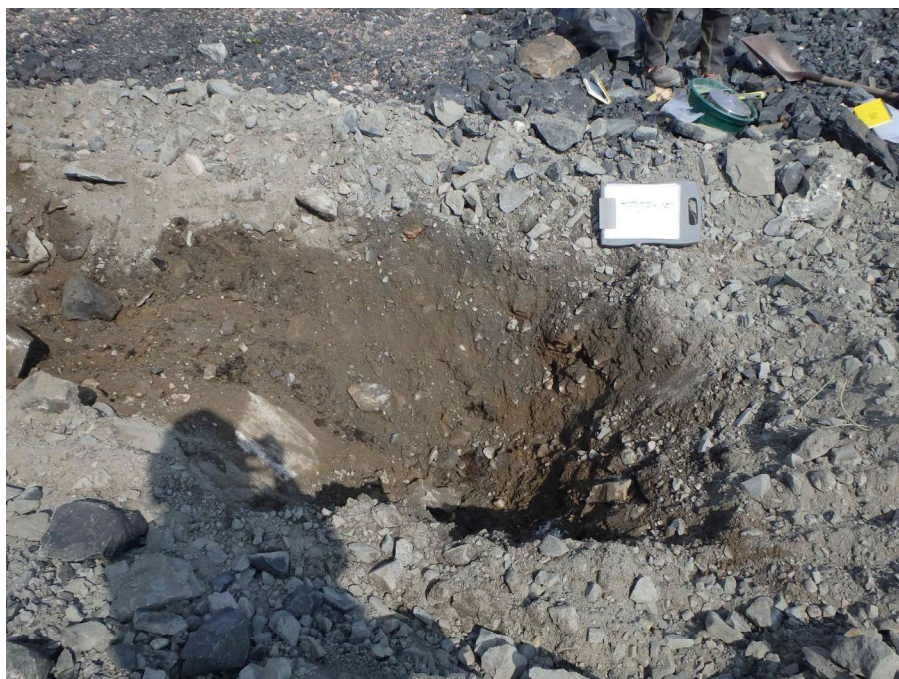
Photo 1: TP23-15

Location	Waste rock pad
Samples Collected	Depth (m)
TP23-15	0.50

Interval/sample	From (m)	To (m)	Description
TP23-15	0	0.8	Brown-grey rock
	0.8+		Tundra soil

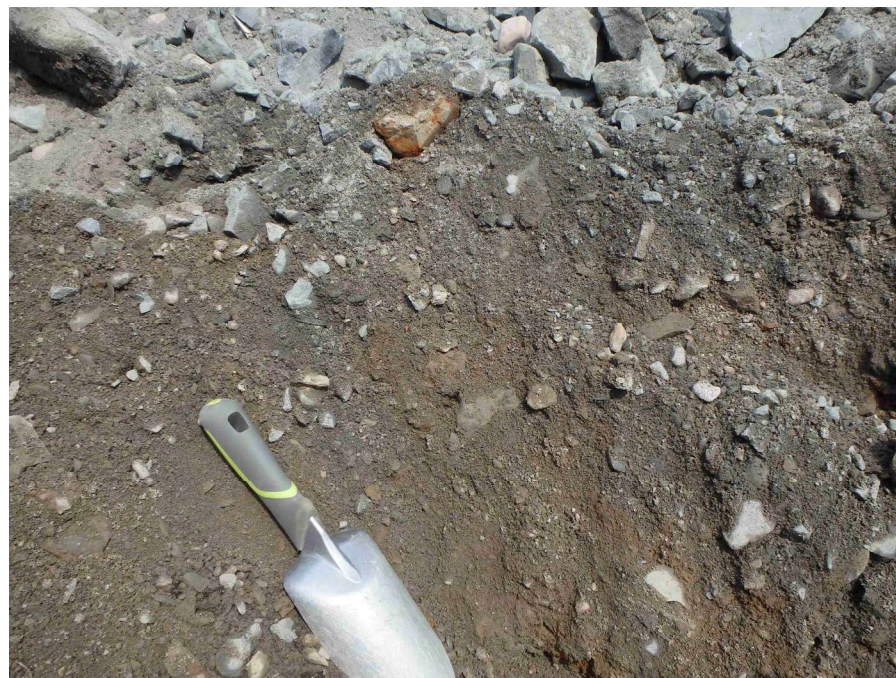
Photo 2: Brown-grey rock

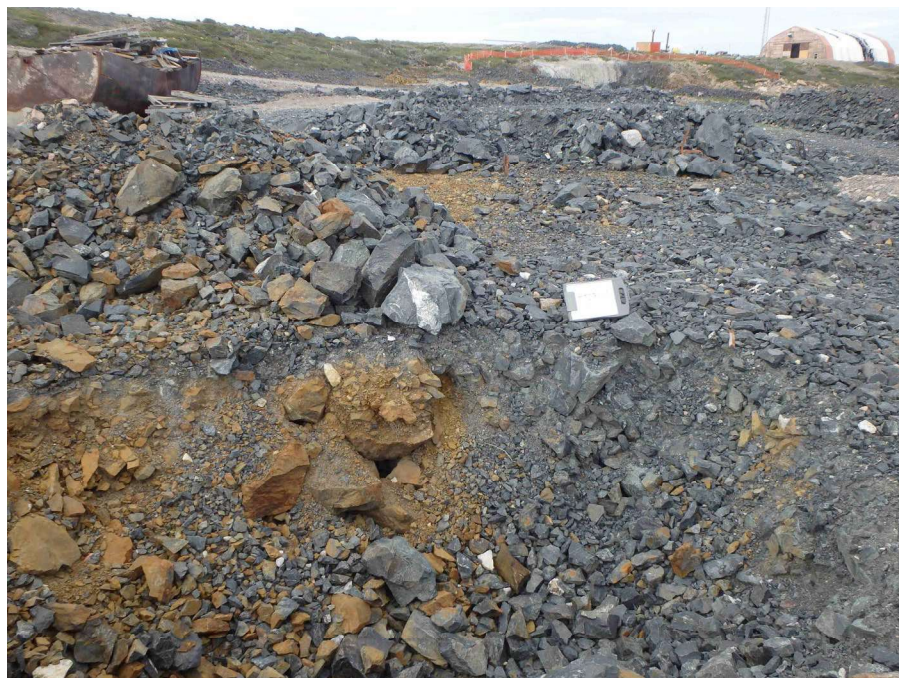
Photo 1: TP23-16

Location	Waste rock pad
Samples Collected	Depth (m)
TP23-16A	0.50
TP23-16B	0.45

Interval/sample	From (m)	To (m)	Description
TP23-16A	0	1.4	Grey metabasalt
TP23-16B	0	1.4	Orange rock
	1.4+		Tundra soil

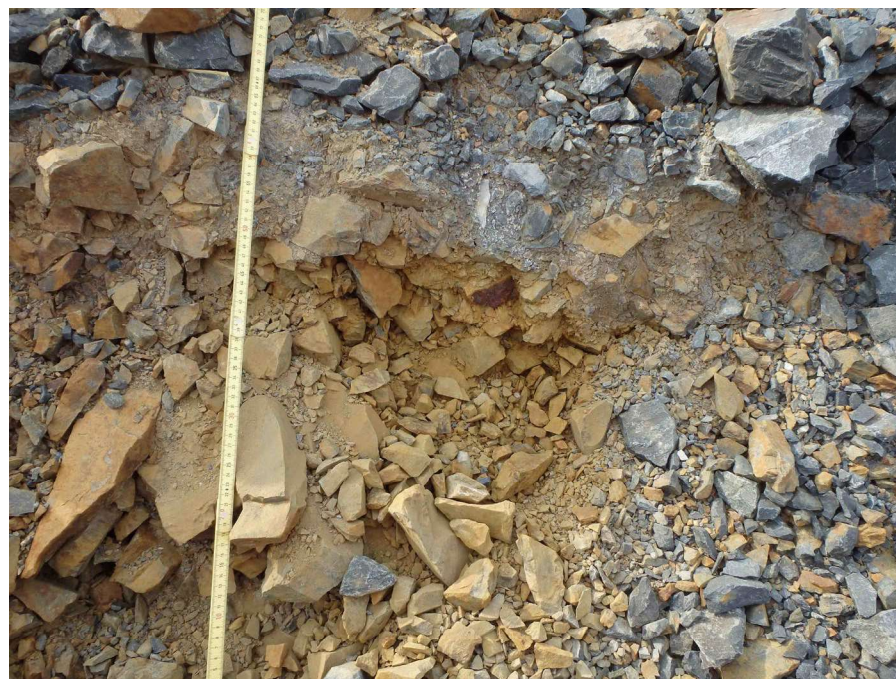
Photo 2: Strongly oxidized orange rock

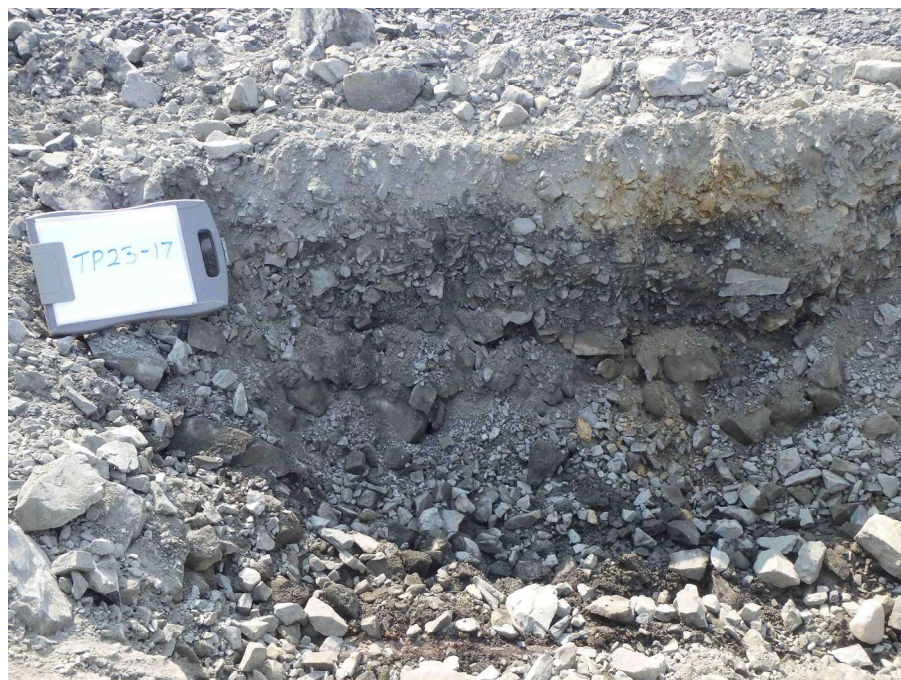
Photo 1: TP23-17

Location	Waste rock pad
Samples Collected	Depth (m)
TP23-17	0.10
TP23-17	0.50

Interval/sample	From (m)	To (m)	Description
TP23-17	0	0.05	Mixed grey rock and sand
	0.05	0.2	Orange rock
	0.2	0.75	Grey metabasalt
	0.75+		Tundra soil

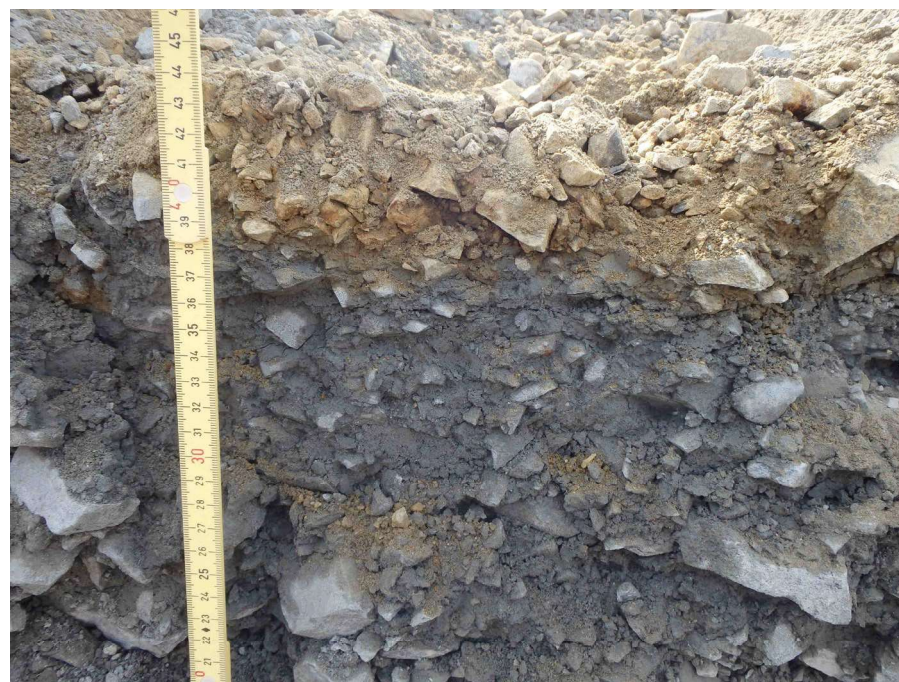
Photo 2: Strongly oxidized orange rock overlying grey metabasalt

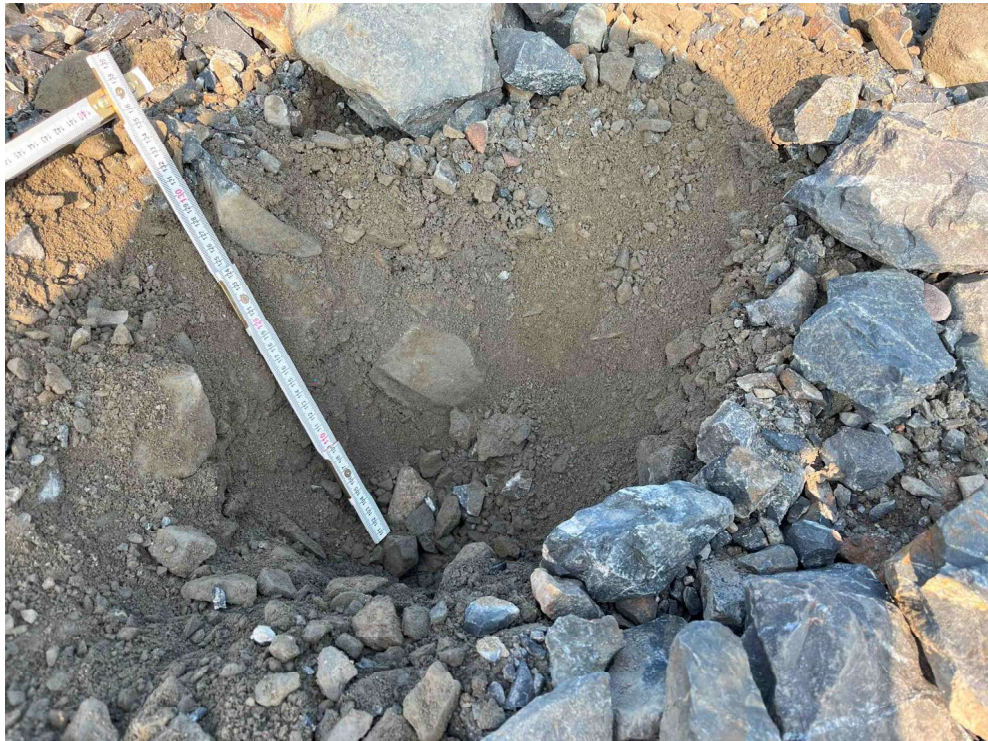
Photo 1: TP23-18

Location	Portal area (relocated ore)
Samples Collected	Depth (m)
TP23-18	0.20

Interval/sample	From (m)	To (m)	Description
TP23-18	0	0.2	Ore with grey-brown fines

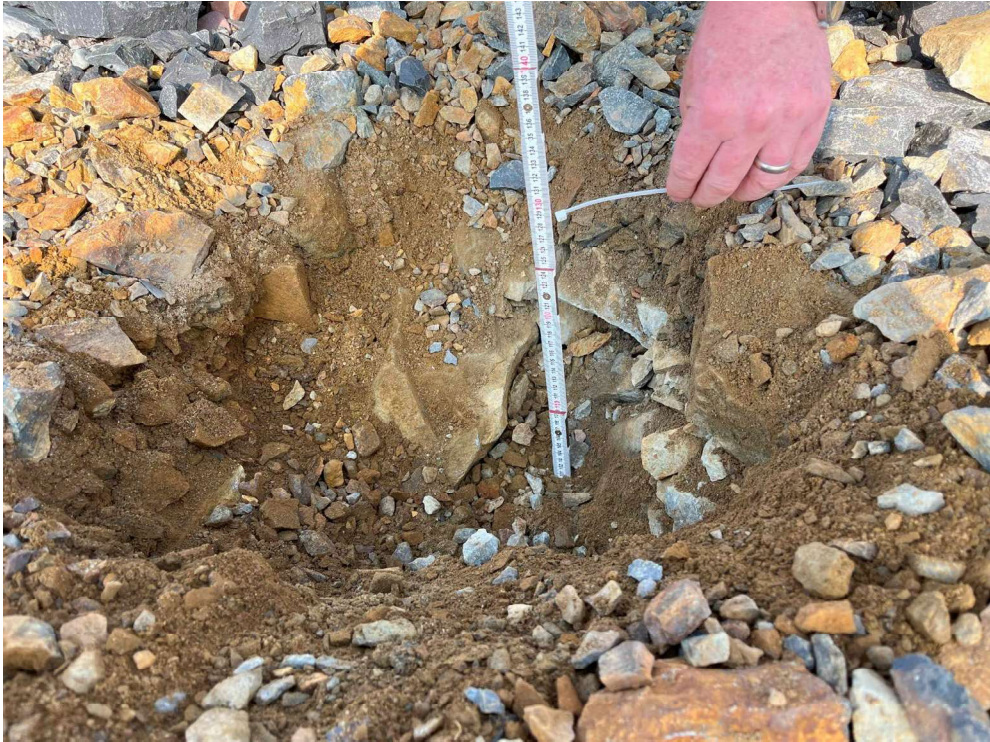
Photo 1: TP23-19

Location	Portal area (berm)	Interval/sample	From (m)	To (m)	Description
Samples Collected	Depth (m)				
TP23-19	0.20

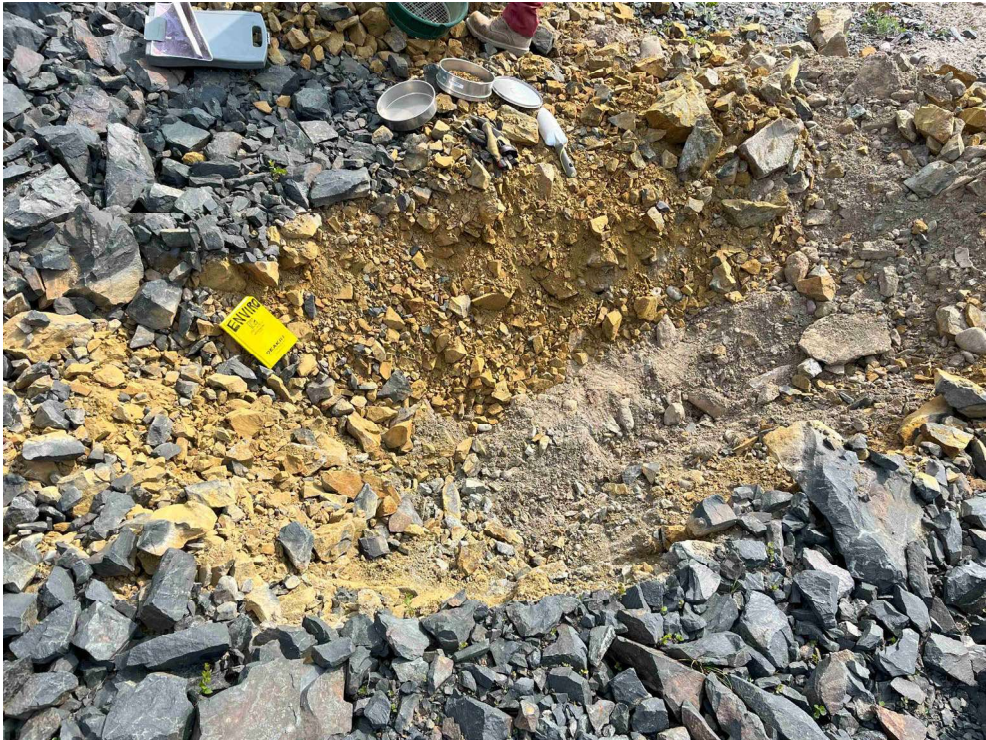
Photo 1: TP23-20

Location	Portal area (SW of pond)
Samples Collected	Depth (m)
TP23-20	0.50

Interval/sample	From (m)	To (m)	Description
TP23-20	0	0.7	Strongly oxidized orange rock
	0.7+		Sand

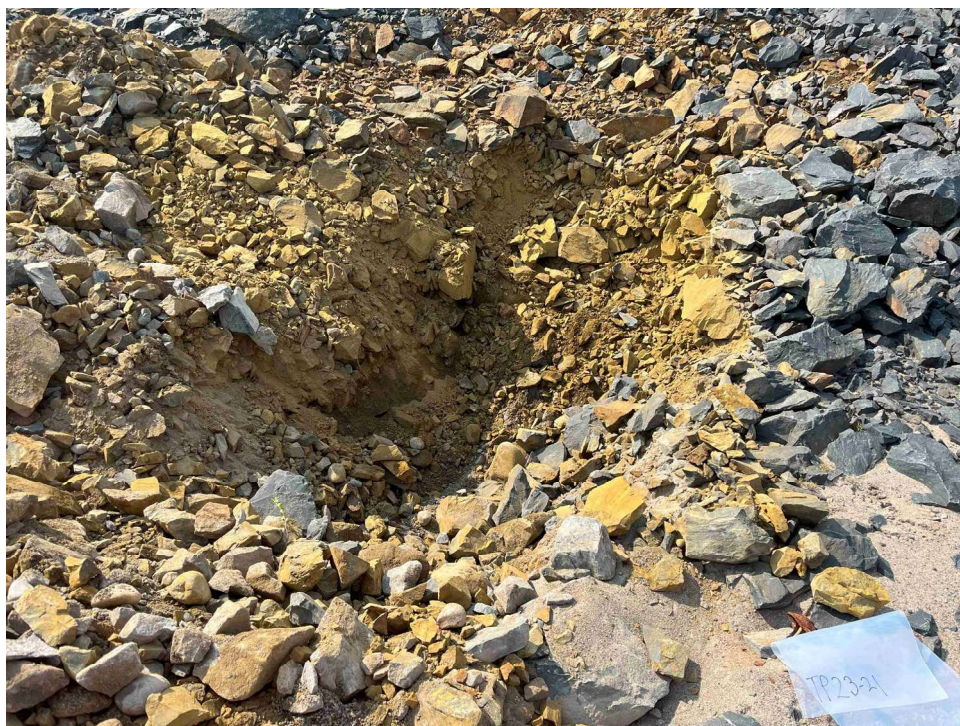
Photo 1: TP23-21

Location	Portal area (SW of pond)		Interval/sample	From (m)	To (m)	Description
Samples Collected	Depth (m)		TP23-21	0	0.7	Strongly oxidized orange rock
TP23-21	0.50			0.7+		Tundra soil/sand

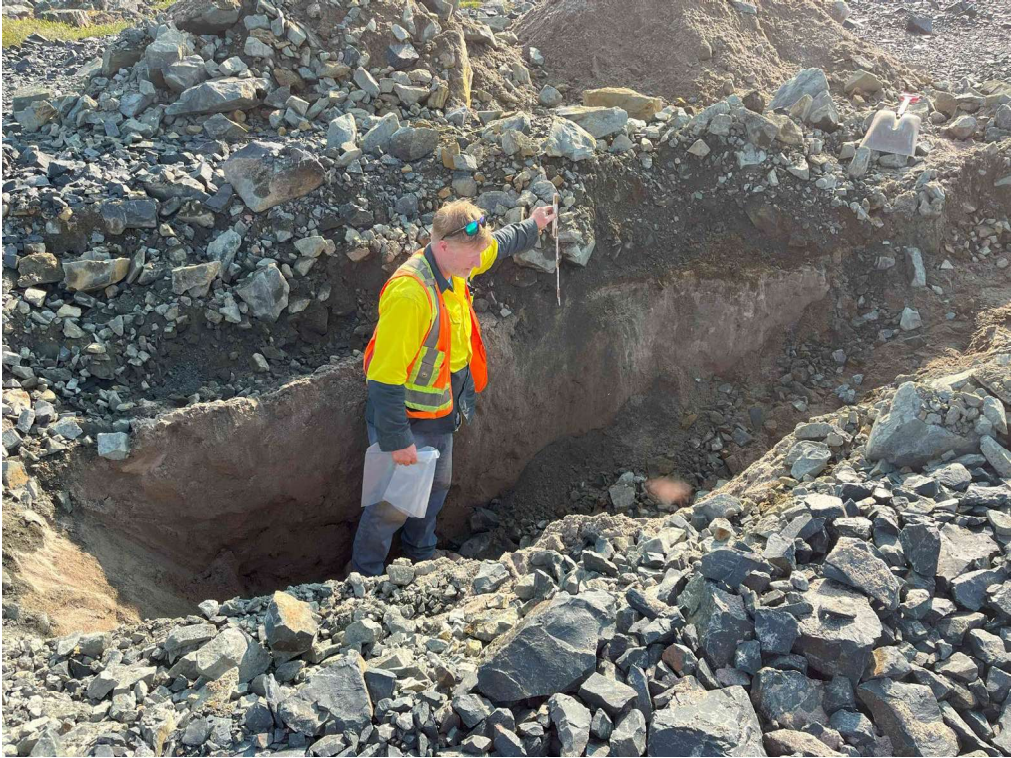
Photo 1: TP23-23

Location	Camp pad
Samples Collected	Depth (m)
TP23-23A	0.30 (from orange layer)
TP23-23B	0.45 (grey rock)

Interval/sample	From (m)	To (m)	Description
TP23-23A	0	0.35-0.7	Mostly grey rock with intermittent 10-20 cm thick orange layer
	0.7	1.5	Sand

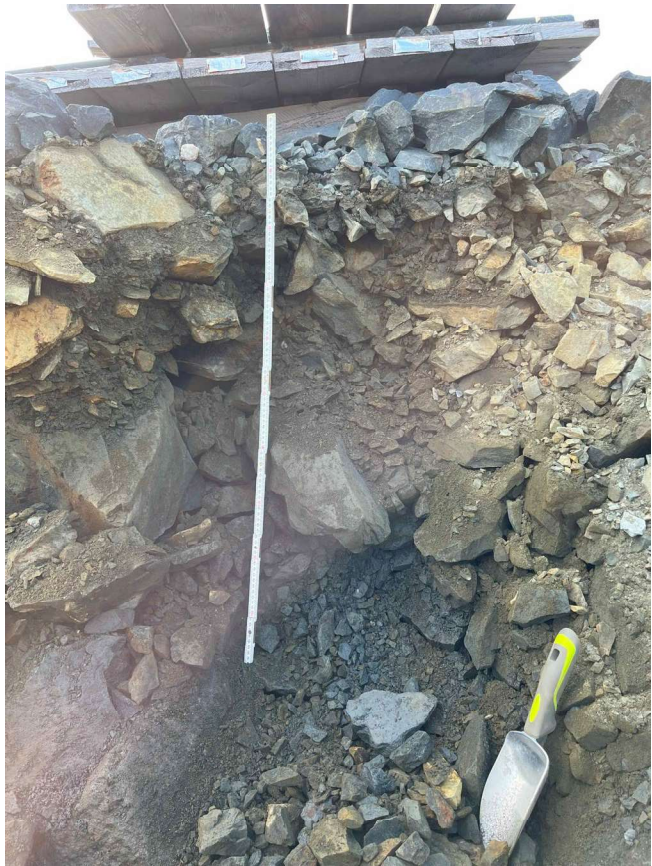
Photo 1: TP23-24

Location	Camp pad (drill core storage area)
Samples Collected	Depth (m)
TP23-24A	<0.60
TP23-24B	1.0

Interval/sample	From (m)	To (m)	Description
TP23-24A	0	0.6	Brown oxidized rock
TP23-24B	0.6	1.58	Grey rock

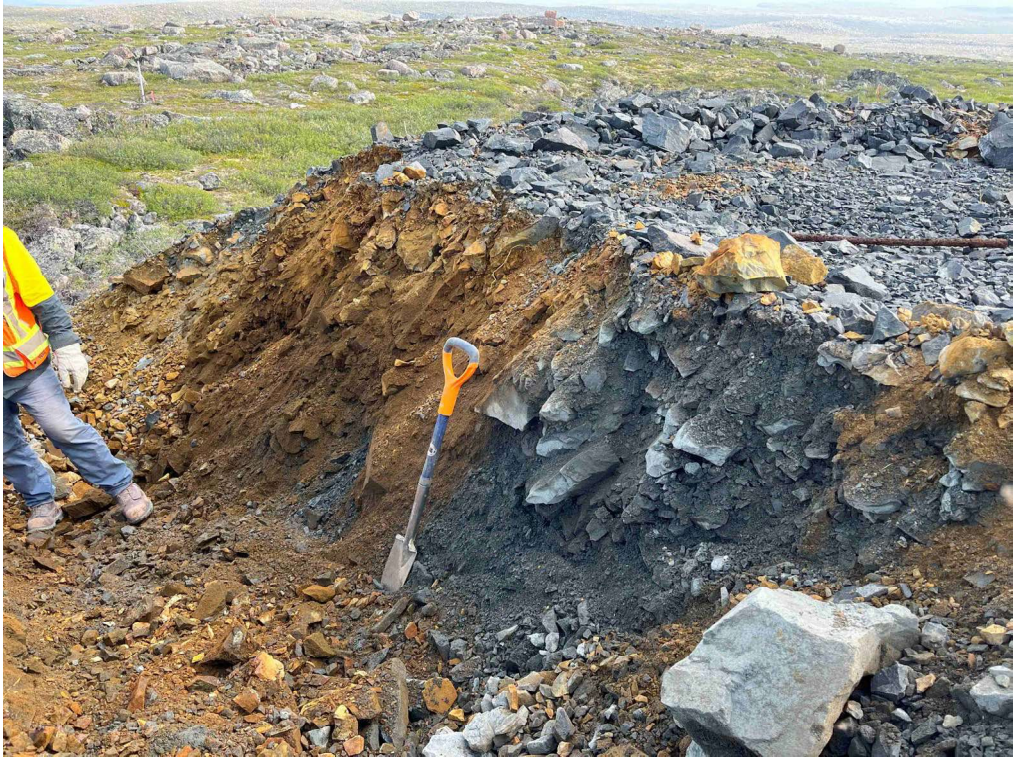
Photo 1: TP23-25

Location	Camp pad (drill core storage area)	Interval/sample	From (m)	To (m)	Description
Samples Collected	Depth (m)	TP23-25A	0	2	Strongly oxidized orange rock
TP23-25A	1.0	TP23-25C	2+		Grey rock
TP23-25B	0.50	TP23-25B	0	2	Grey rock
TP23-25C	2.0

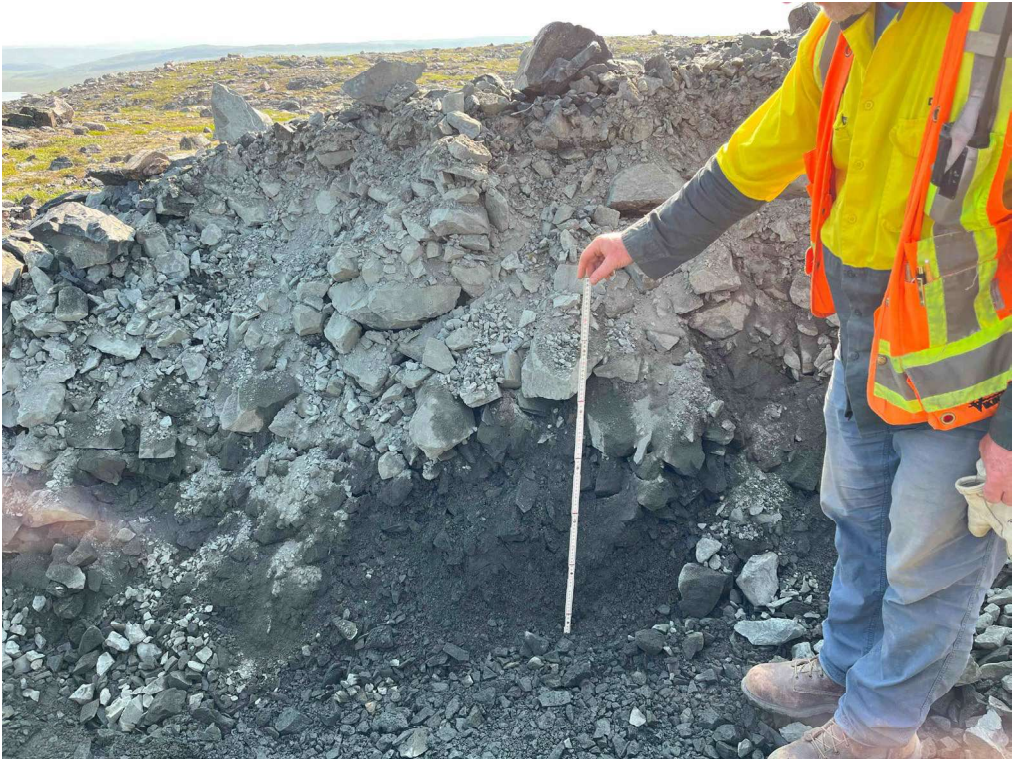
Photo 1: TP23-26

Location	Camp pad		Interval/sample	From (m)	To (m)	Description
Samples Collected	Depth (m)		TP23-26	0	1.5	Grey rock
TP23-26	1.0

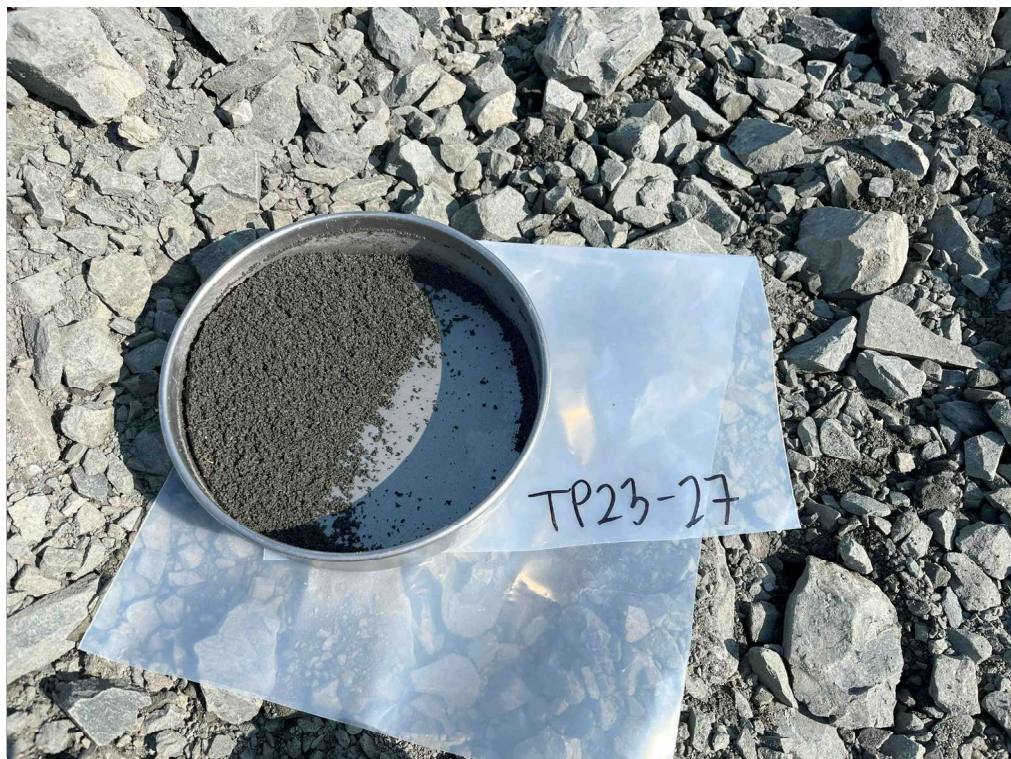
Location	Camp pad
Samples Collected	Depth (m)
TP23-27	1.0

Interval/sample	From (m)	To (m)	Description
	0	0.35	Sand mixed in with grey rock
TP23-27	0.35	1.75	Grey rock

**Photo 1: TP23-27 grey rock sampled
(no photo of test pit)**

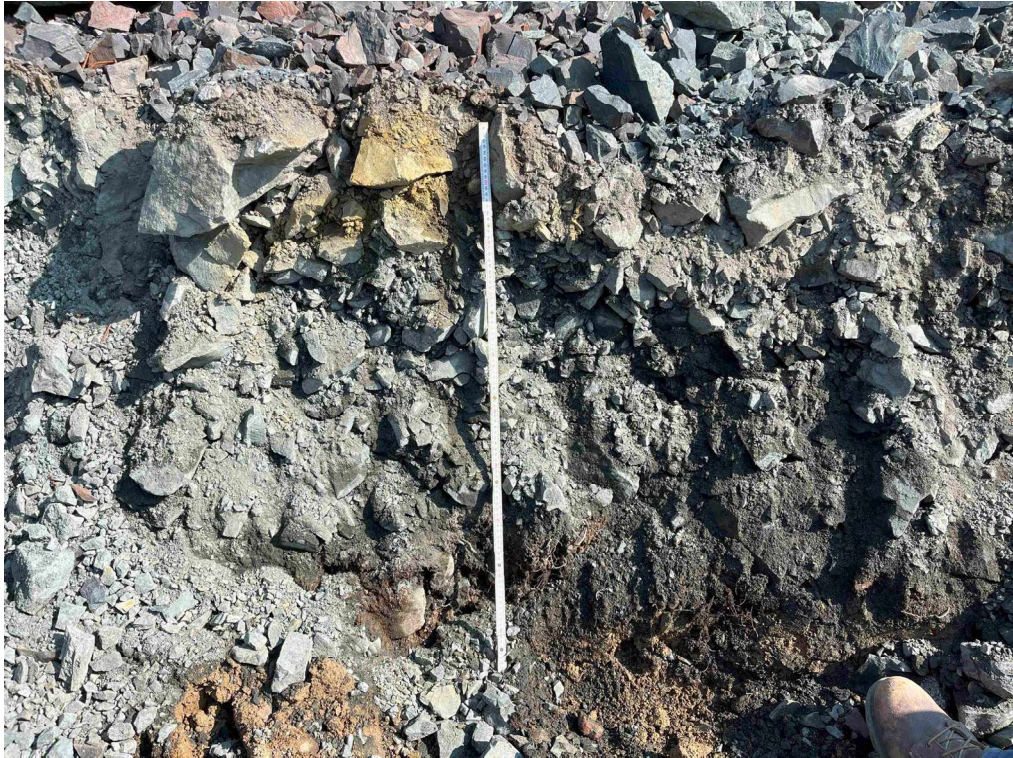
Photo 1: TP23-28

Location	Camp pad
Samples Collected	Depth (m)
TP23-28	0.60

Interval/sample	From (m)	To (m)	Description
	0	0.25	Coarse rock and sand
TP23-28	0.25	0.8	Grey rock
	0.8+		Tundra soil

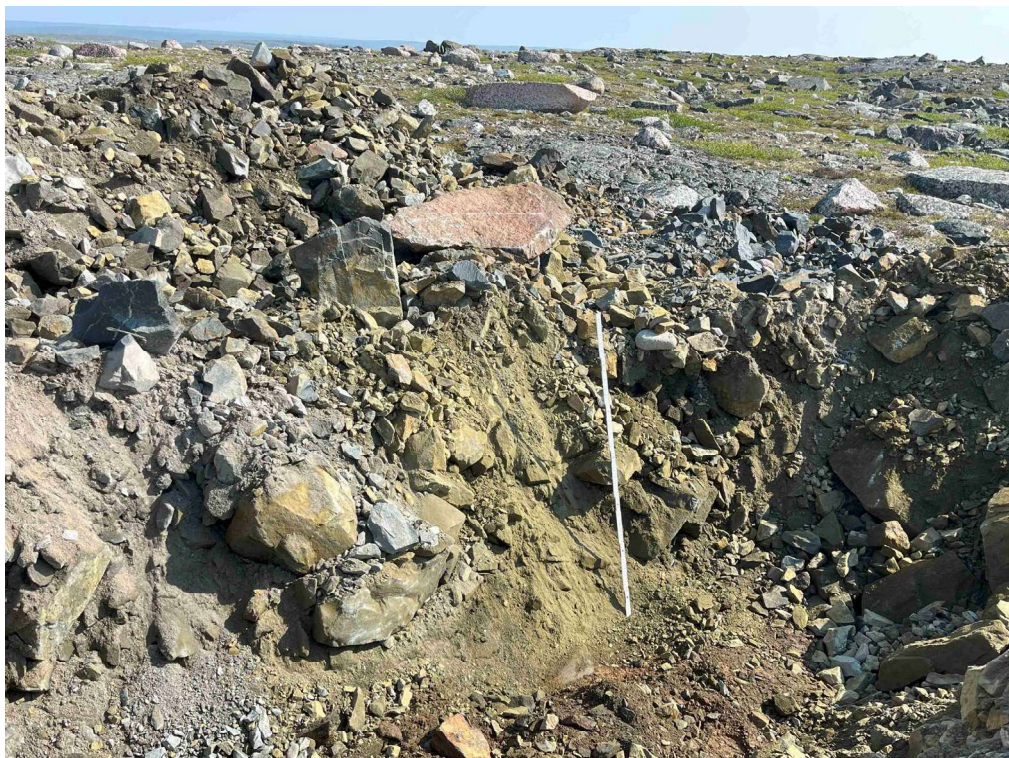
Photo 1: TP23-29

Location	Camp pad
Samples Collected	Depth (m)
TP23-29	<1.08

Interval/sample	From (m)	To (m)	Description
TP23-29	0	1.08	Brown oxidized rock
	1.08+		Soil and bedrock

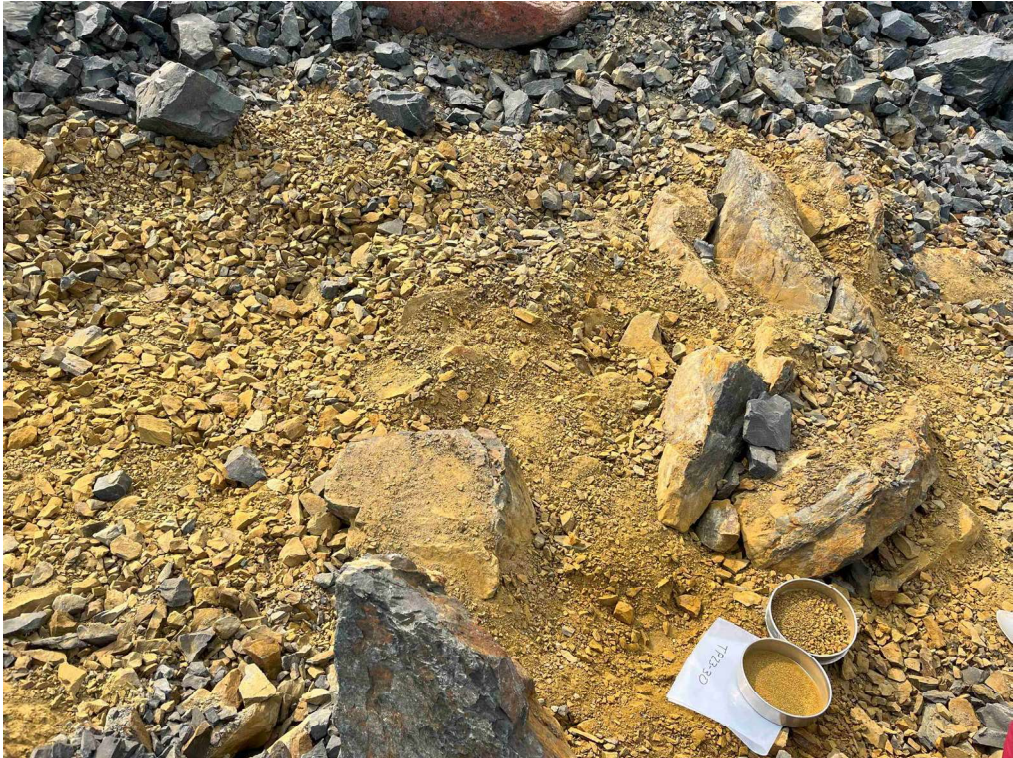
Photo 1: TP23-30

Location	Ore pad (just off north edge)		Interval/sample	From (m)	To (m)	Description
Samples Collected	Depth (m)		TP23-30	0	0.2	Strongly oxidized orange rock
TP23-30	0.20
