2024 ANNUAL REPORT:
Ulu Gold Project
Exploration and Progressive Reclamation
20EN001
2BM-ULU2030

Kitikmeot Region, Nunavut

March 2025

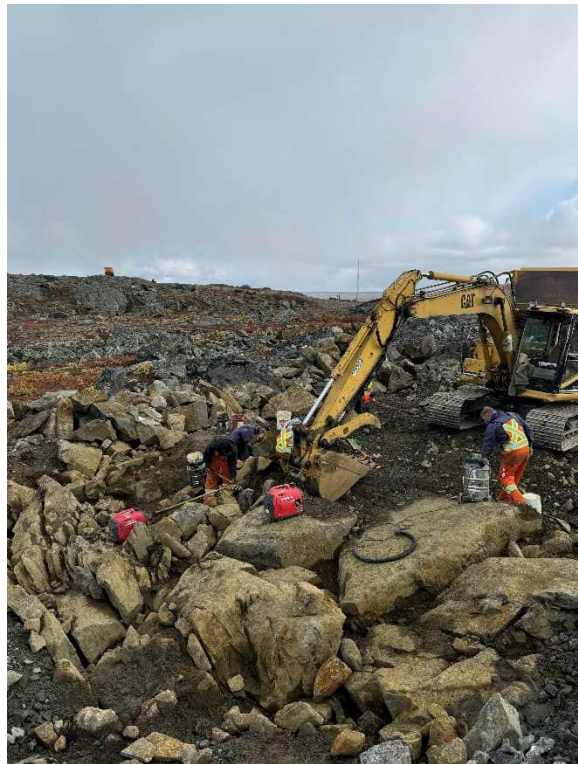
Plate 3. Ore pad - manual removal of fines 2024
