# 2024 Monitoring of Metal Leaching and Acid Rock Drainage Potential at the Ulu Camp

Ulu Gold Project, Nunavut, Canada  
Blue Star Gold Corp

This report summarizes the methods used, results, interpretations, and findings from the 2024 program and is the deliverable for Task 400 of SRK's scope of work dated April 9, 2024. It is intended for use by Blue Star to inform reclamation activities and support reporting on ML/ARD conditions to regulators.

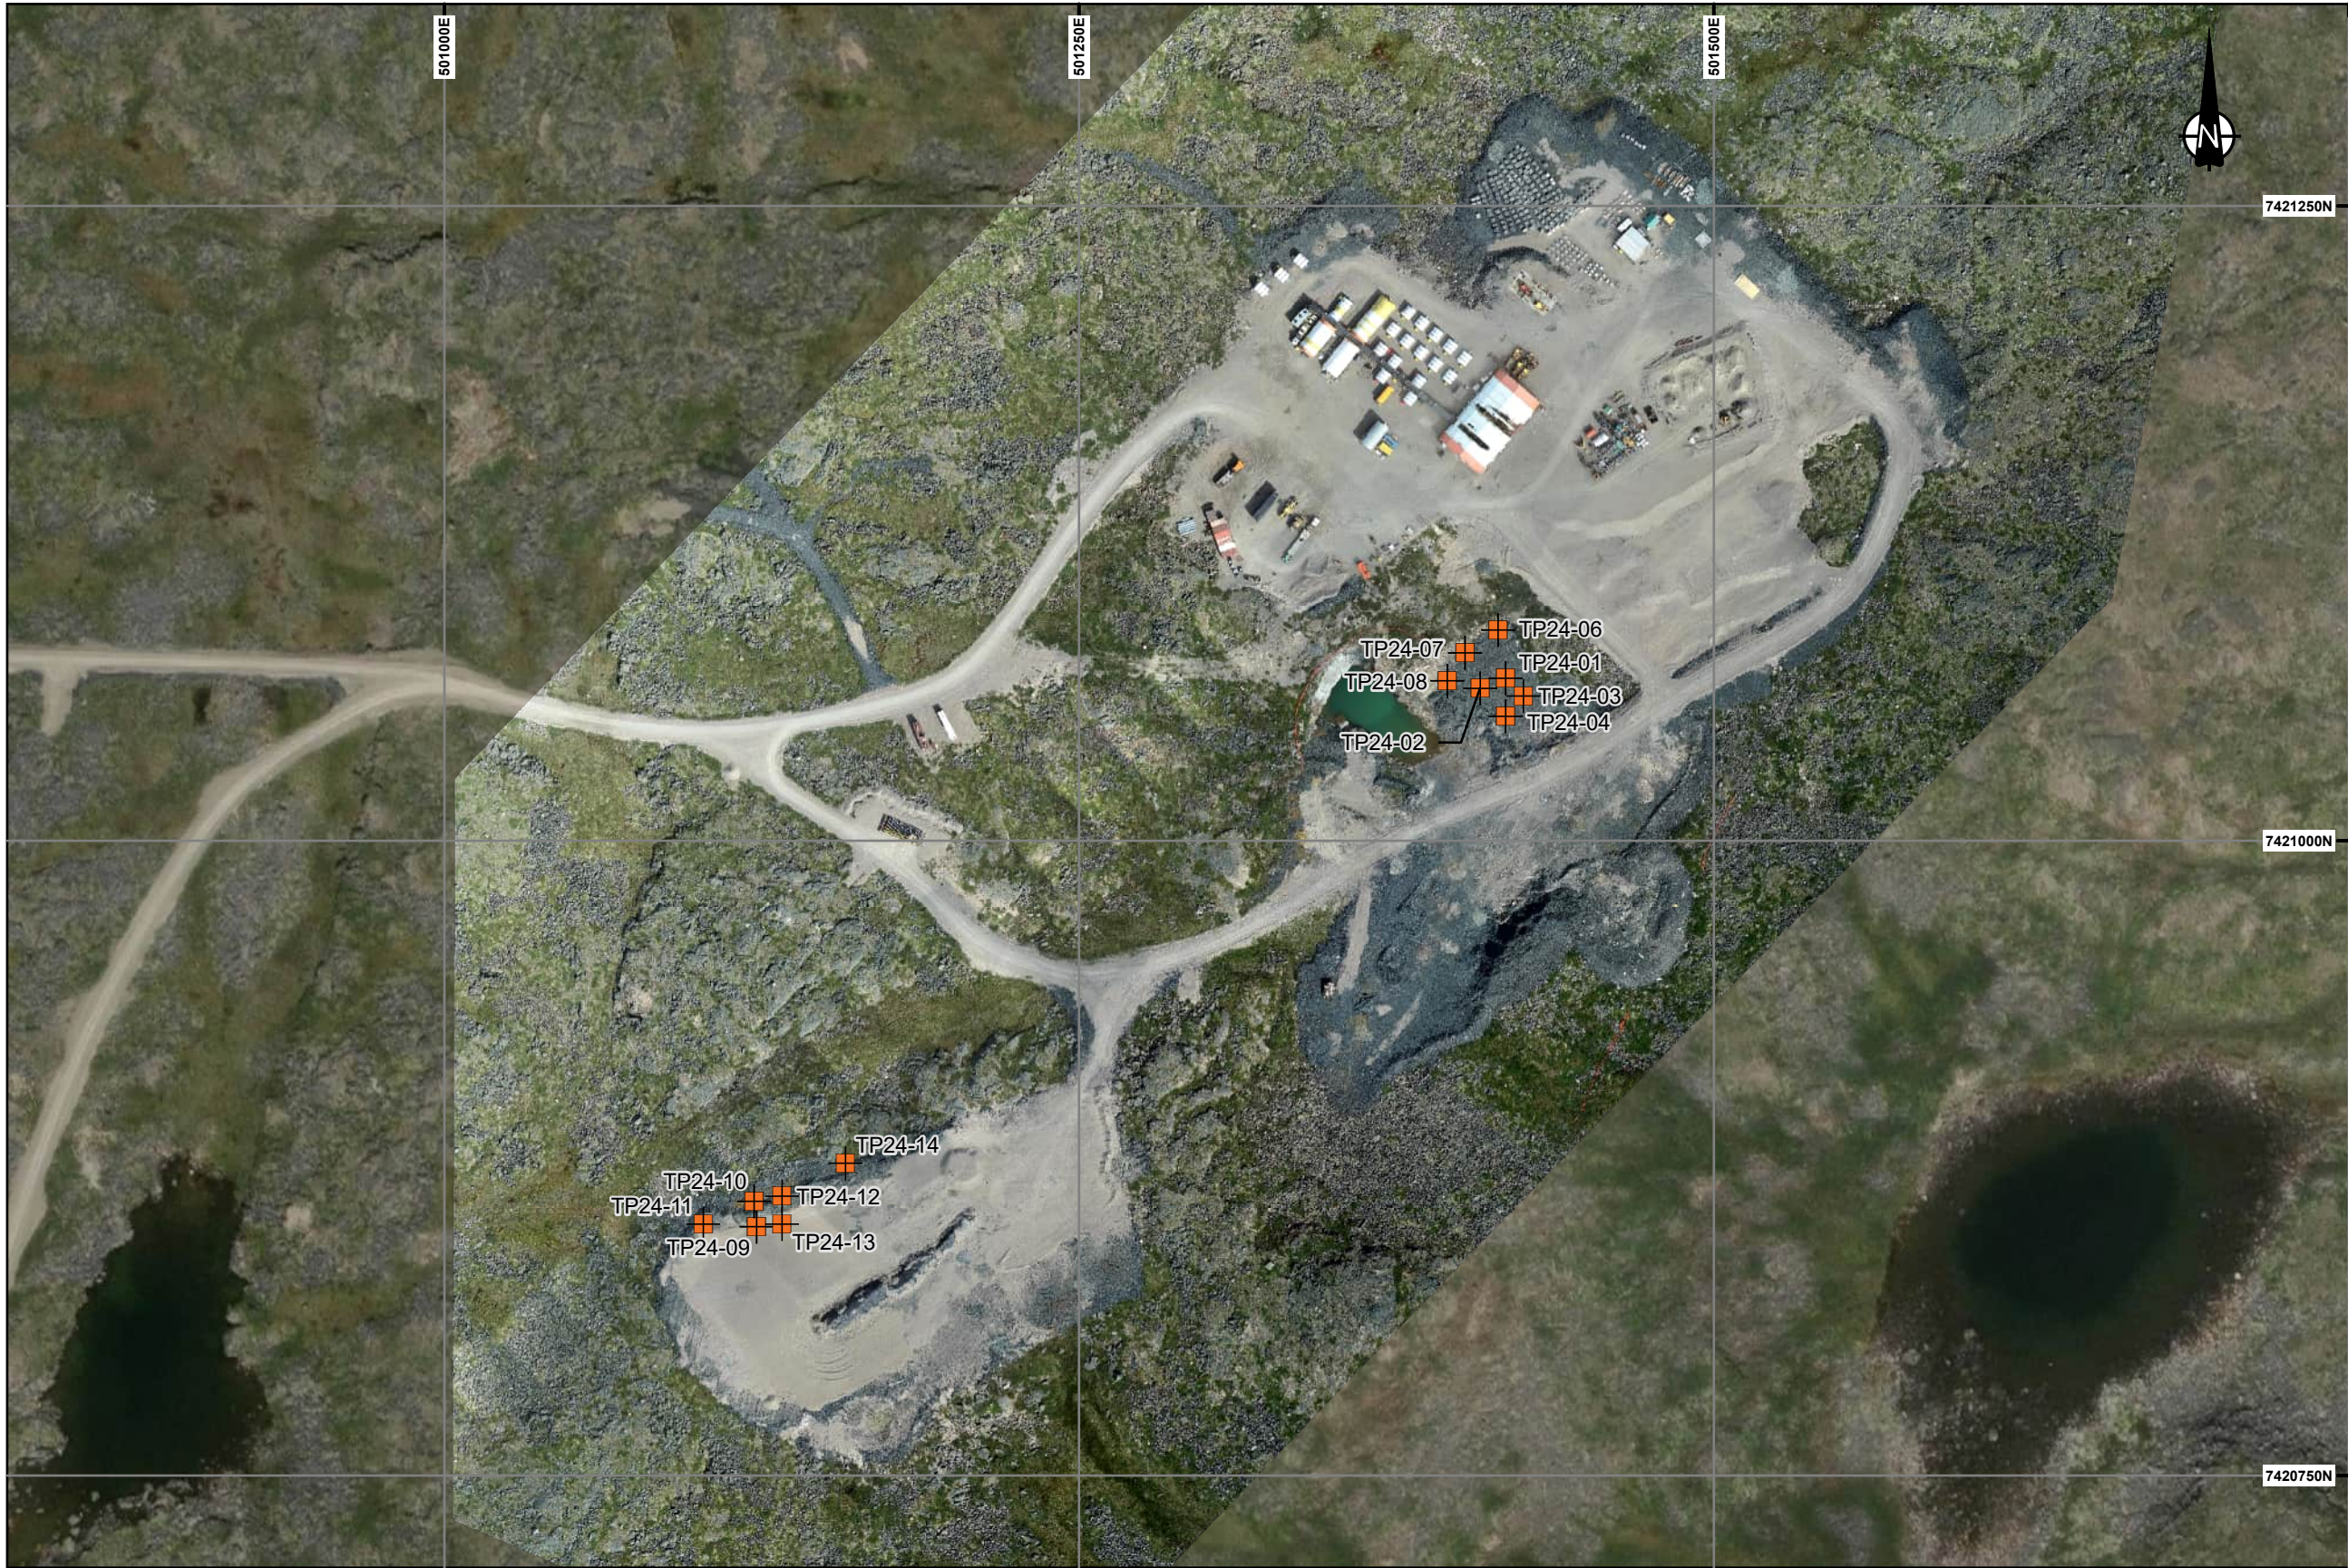
**Figure 3-2. Location (Zoomed in) of Rinse pH Samples from Mineralized Rock (2023 and 2024).**

Pits were dug by shovel or hand-shovel. Sample locations are shown in Figure 3-1 and Figure 3-2, and sample coordinates and logs are provided in Appendix A and Appendix B, respectively. Sample depths ranged from 0 to 45 cm and are provided with the results in Sections 5.2.5 and 5.3.2. Rinse testing included measurement of rinse pH and rinse conductivity.

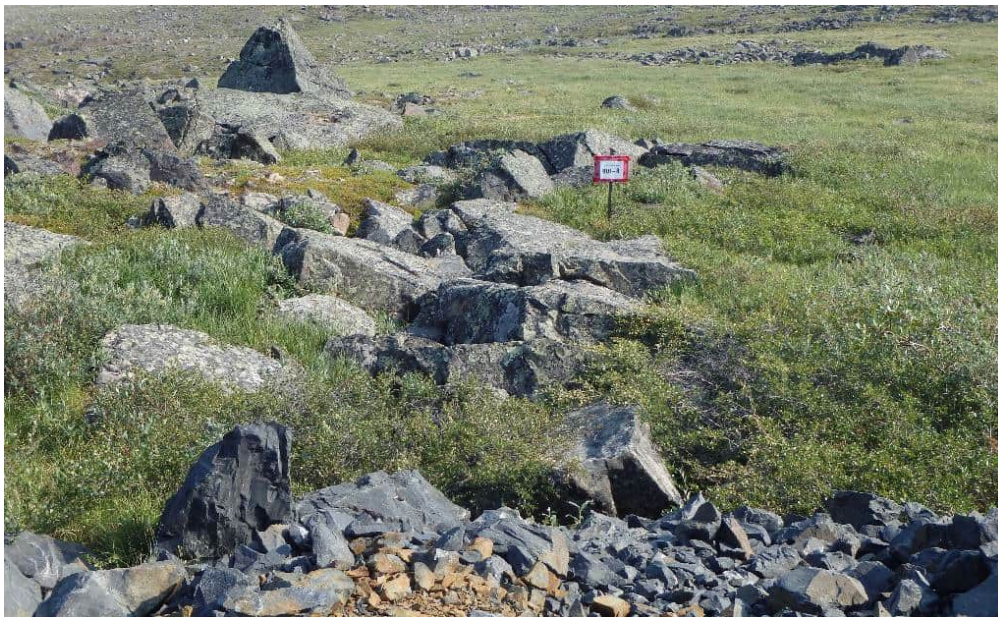
**Figure 5-2. Looking SE From the South Edge of the Ore Pad (Above ULU-8A) to ULU-8.**

It appears that sub-surface drainage at ULU-8, pools amongst large glacial boulders, that provide a depression for shallow groundwater to daylight (Figure 5-2). ULU-8 typically has standing water, but flowing water is observed when the up-gradient ULU-8A is flowing. Flow returns to the sub-surface away from the boulders. Seep-06 is the inflow to East Lake at the bottom of the drainage from the south side of the ore pad (Figure 3-3). It has been sampled in previous years (SRK 2024a) but was not monitored in 2024.

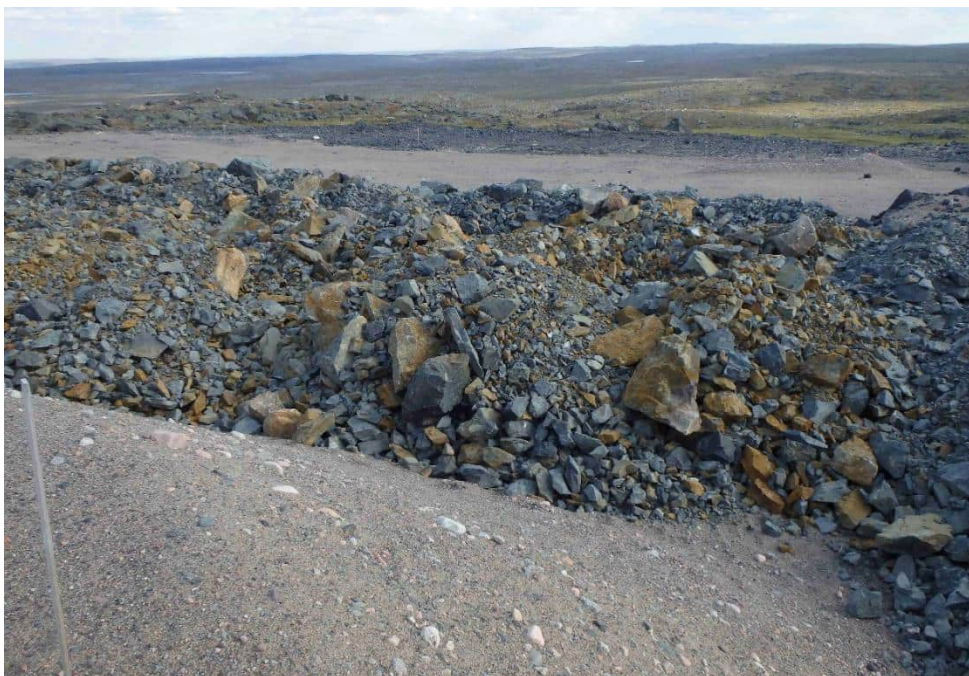
**Figure 5-4. Newly Relocated Rock on the Ore Pad (August 2024), Looking SE from the Covered Thermistor Site (Shown in Figure 5-1).**

Much of the rock in the ore pad (south of the drainage divide) therefore still appears to be weathering at circum-neutral pH; however, areas of acid generating rock have been identified, particularly along the south edge of the pad. Rock directly up-gradient of Seep-01 is more problematic as acid generating rock extends to 2 m, and rock directly upgradient of ULU-8/8A is more problematic due to leaching of weathering products likely resulting from the previously stockpiled mineralized rock. The newly placed acid generating rock is also particularly problematic; however, there are plans to cover this for mitigation.

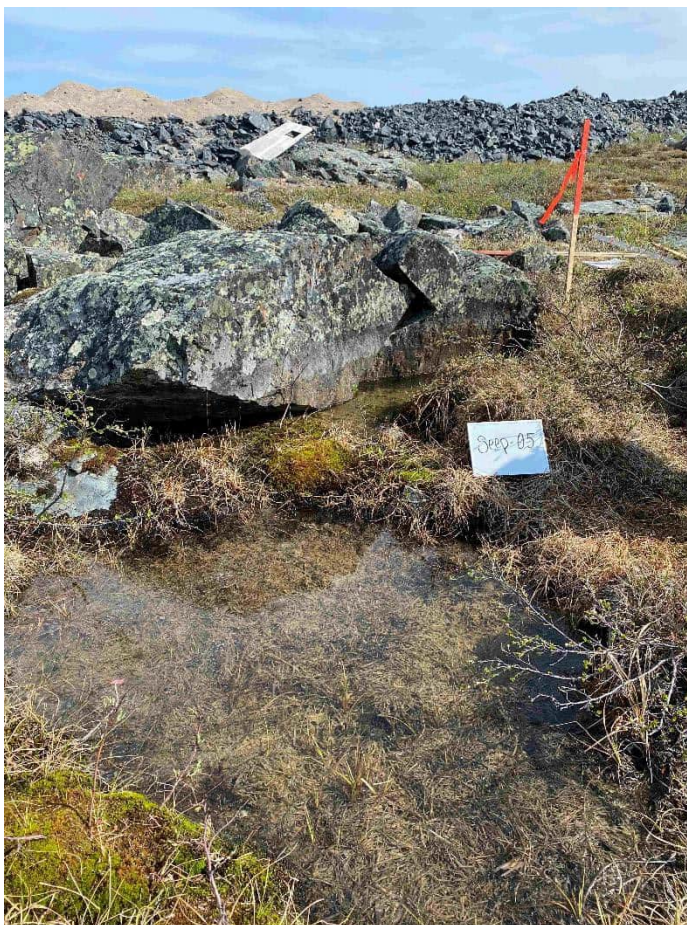
**Figure 5-15. Seep-05 Looking SE to the Ore Pad.**

North of the ore pad drainage divide, sub-surface flow is thought to drain to the northwest (Figure 5-1), where it daylights at Seep-05 (approximately 10 m from the NW corner of the ore pad) amongst large glacial boulders (Figure 5-15). Seep-05 typically has standing water and is at the start of a swamp that extends down-gradient to the west. Seep-12 is the inflow to Lake G43 at the bottom of the drainage from the north side of the ore pad (Figure 3-3). Seep-12 was sampled in previous years (SRK 2024a) but was not monitored in 2024.

Based on a pH-conductivity survey that tested in-situ pooled water amongst boulders along the drainage in July 2023, acidic pH's (pH 4.2 to 4.9) and conductivity an order of magnitude above background levels, were present within 25 m of the edge of the ore pad. Mildly acidic pH (6.0-6.3) and elevated conductivity extended from 25 m to 75 m from the NW corner of the ore pad, whereas conductivity was at background levels at 130 m from the corner of the ore pad (and pH remained mildly acidic, and similar to background). Sub-surface drainage was, therefore, interpreted to be impacted by acid generating rock at the edge of the ore pad (SRK 2024a).

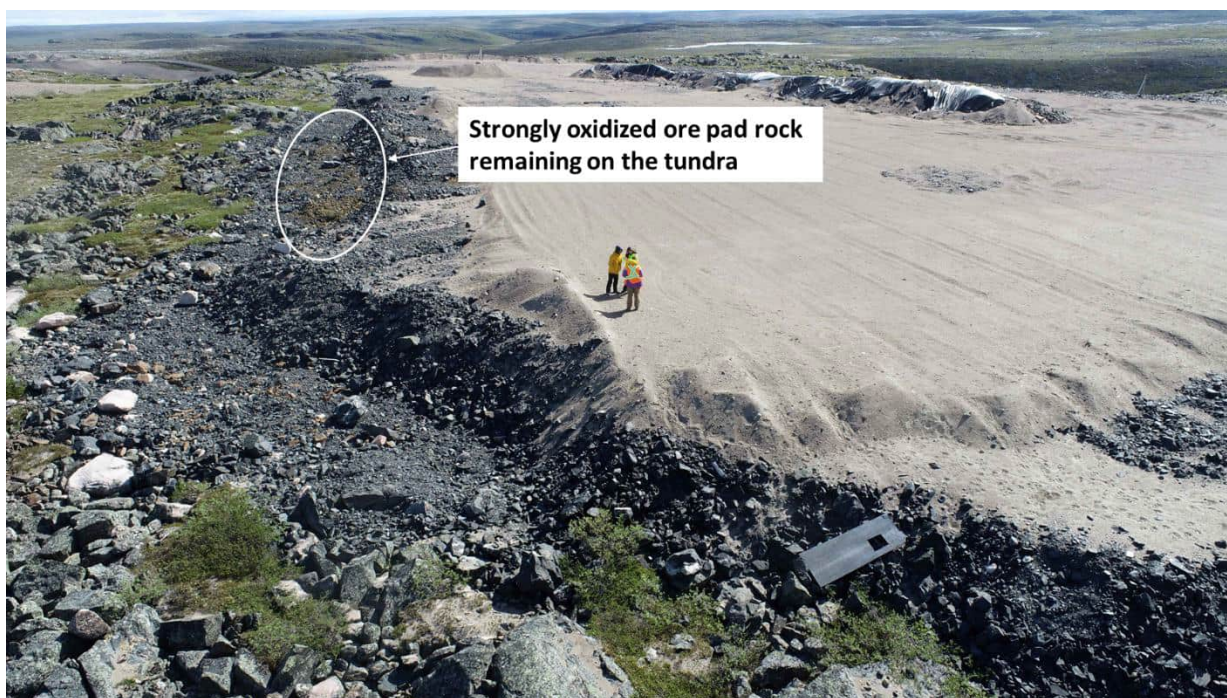
**Figure 5-16. Arial View of the North Edge of the Ore Pad Prior to Remediation in August 2024 (Looking East).**

Rock to the north of the ore pad drainage divide includes rock within the pad, and also residual rock left lying on the tundra from removal of part of the north edge of the pad in 2020 (Figure 1-1, Section 1.3.1, Figure 5-16). Part of the ore pad was not historically covered in esker sand (see pre-2018 ore pad inset in Figure 1-1), and this area contains more strongly oxidized rock than other parts of the pad. Where residual rock from this uncovered part of the pad was left exposed on the tundra, it had rinse pH of 2.9 in 2023 (SRK 2024a). Adjacent rock within the edge of the pad had rinse pHs of 3.6 to 7.9 in 2023, with acidic pH's associated with orange strongly oxidized rock, and circum-neutral pH's associated with grey rock with minor oxidation of sulphides (SRK 2024a).

During remediation works in August and September of 2024, the acid generating residual rock on the tundra was excavated, along with an adjacent area of the pad that had not been historically covered in esker sand and contained a mixture of orange and grey rock. Grab samples of the rock and underlying tundra soil, were collected by Blue Star during excavation and stockpiling of the rock onto the ore pad. Rinse test results for the 2024 grab samples are provided below.
