5.3 Waste Rock-Portal Pad Area and Landfill

5.3.3 Waste Rock-Portal Pad Area and Landfill Seepage Results

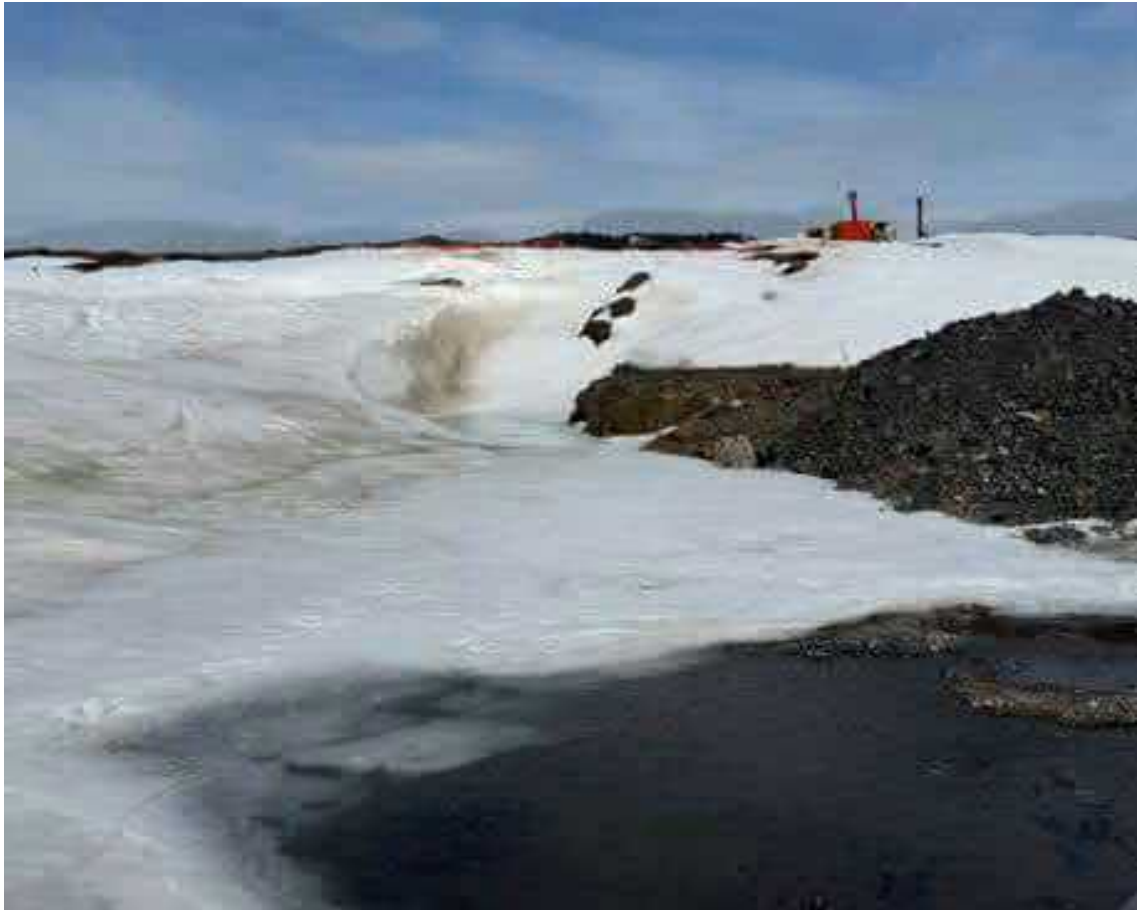
Figure 5-24. Frozen Portal Pond (ULU-4a, May 19, 2024) Looking NW, and Pooled Water Extending South to the Adjacent Road in the Foreground.

- The portal pond was predominantly frozen at freshet, but some water was present, and the water level was high extending out of the pond southeast towards the adjacent road and mine sump berm. No flow from the portal pond was observed.

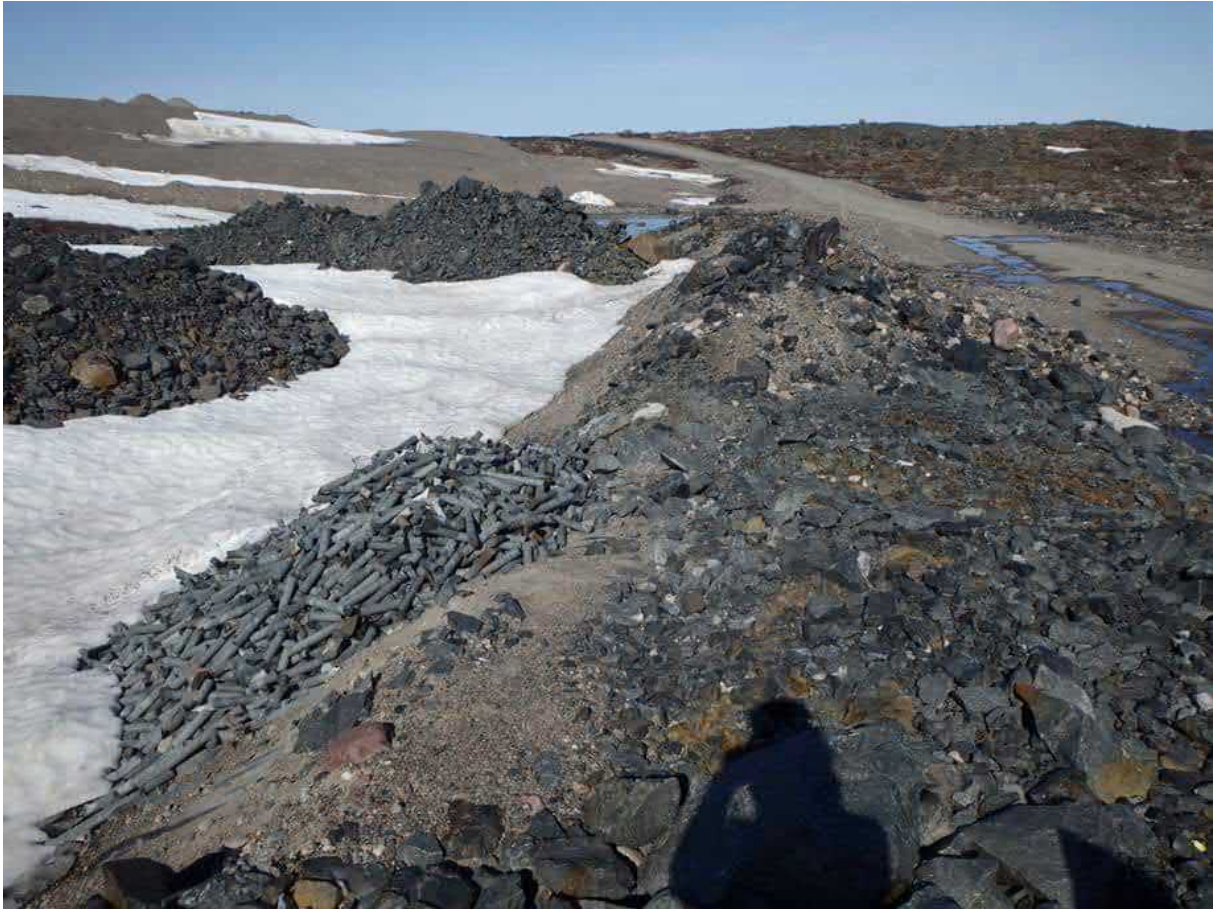
Figure 5-25. Snow Filled Mine Sump Looking NE (May 22, 2024).

- The mine sump pond was partially filled with snow at freshet. Seepage from the base of the mine sump berm was observed to flow along the north side of the adjacent road and then south across the road and into the roadbed (up-gradient of Seep-02). It is unclear if the seepage from the mine sump berm had flowed through the berm from the mine sump, or along the berm from water extending out of the portal pond.

Notes: Mine sump berm in the foreground. Stockpiled mineralized rock to the left and far centre. Sand covered landfill in the background.

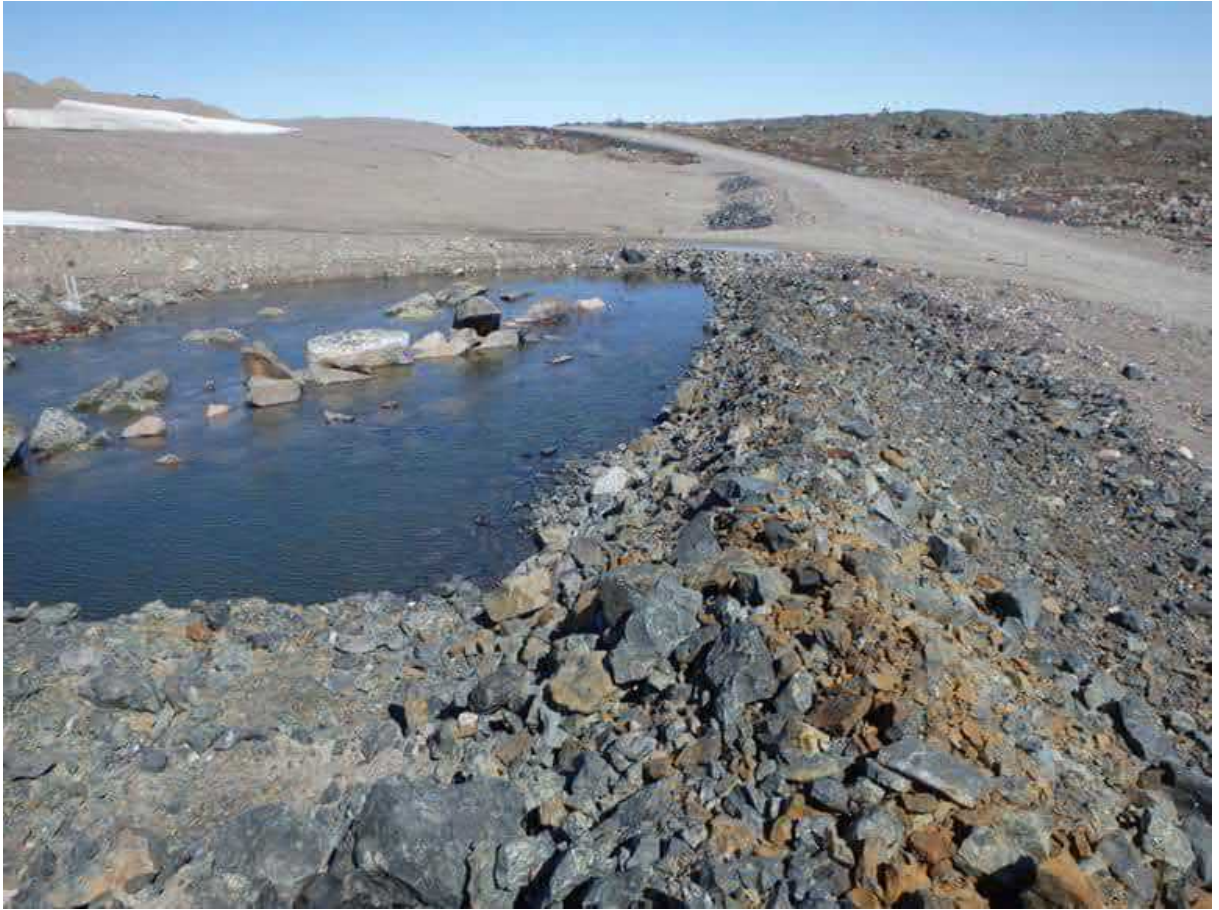
Figure 5-26. Temporary Pool-4c (May 26, 2024), Looking ENE from the Mine Sump Berm Towards the Landfill.

- Temporary Pool-4c had not previously been recognized but had high water level on May 22, and the water level had dropped to almost empty by May 28, with audible flow to the south/southeast beneath the adjacent road (up-gradient of Seep-02). Pool-4c was in contact with adjacent stockpiled mineralized rock when the water level was highest, and with strongly oxidized fill in the berm along the edge of the road.

Notes: Pool is approximately 15 m long. Water level was almost at the top of the highest boulder four days prior to this.

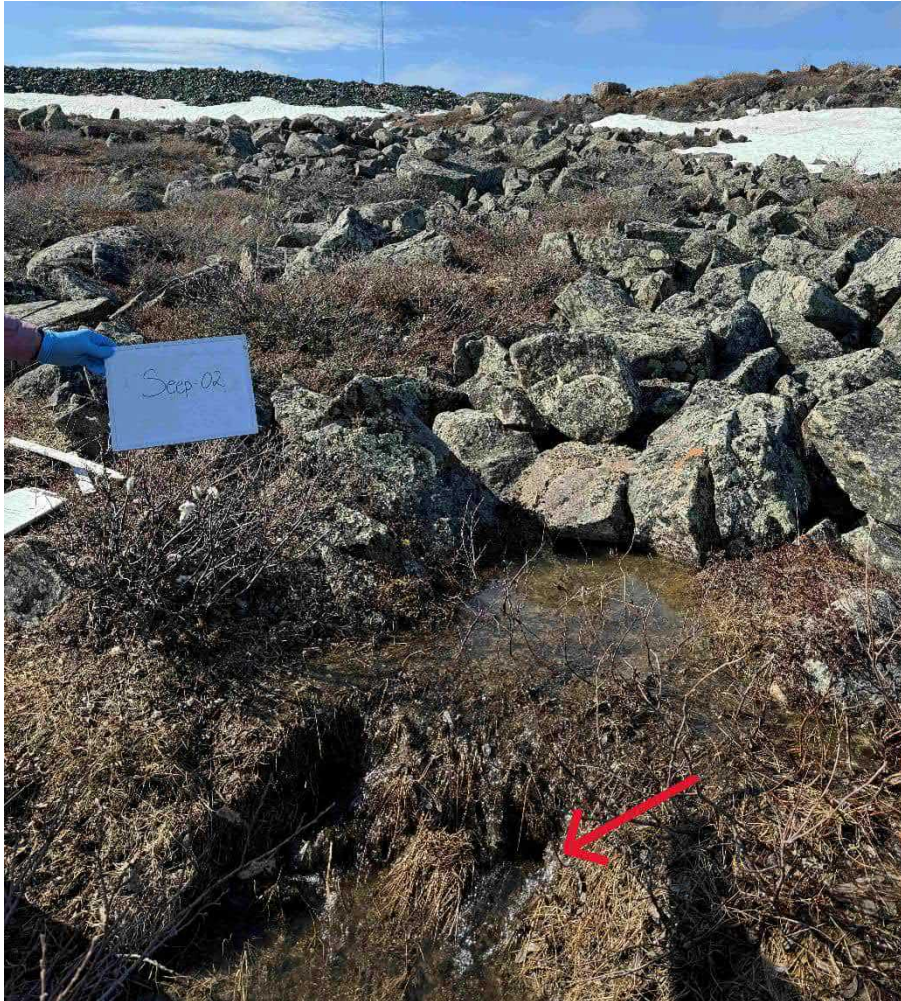
Figure 5-28. Seep-02 at Freshet, Looking NW/Up-Gradient Towards the Waste Rock-Portal Pad Area.

Notes: Arrow tip shows location of flow out from the tundra

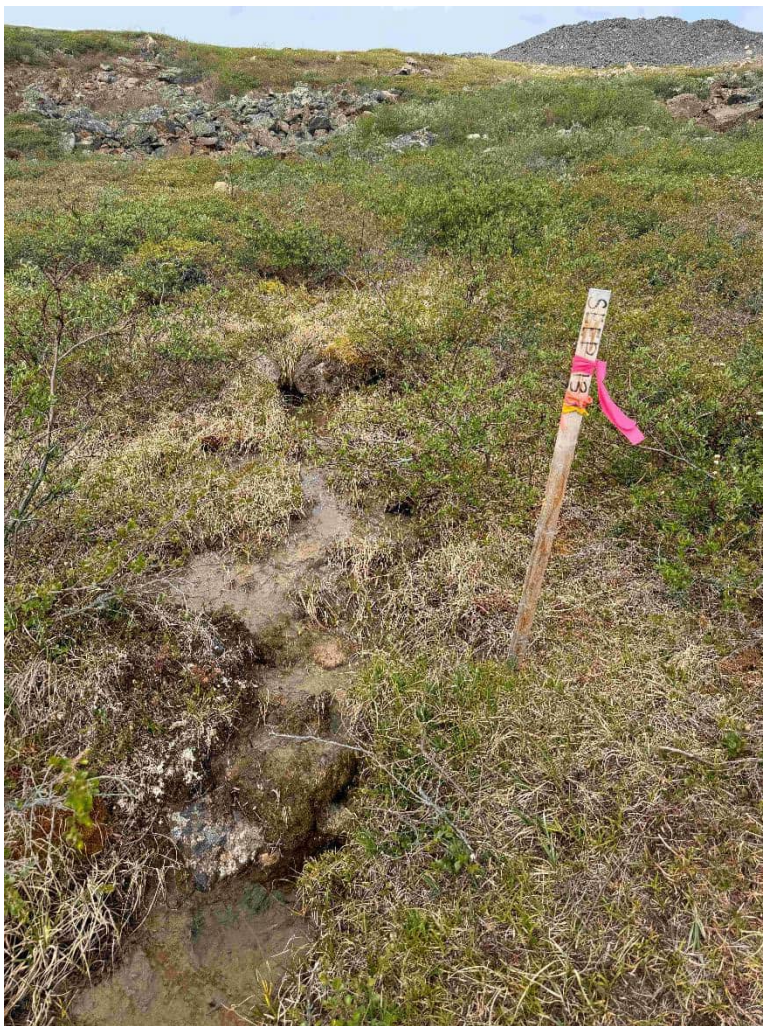
Figure 5-29. Seep-13 Looking Up-Gradient Towards the Waste Rock Stockpile.

In addition to Seep-02, the other on-going monitoring site down-gradient from the waste rock-portal pad is Seep-13 (Figure 5-29). Both Seep-02 and Seep-13 have had observed flow much more frequently than ULU-7 during the 2021 to 2024 monitoring seasons (Figure 5-30).

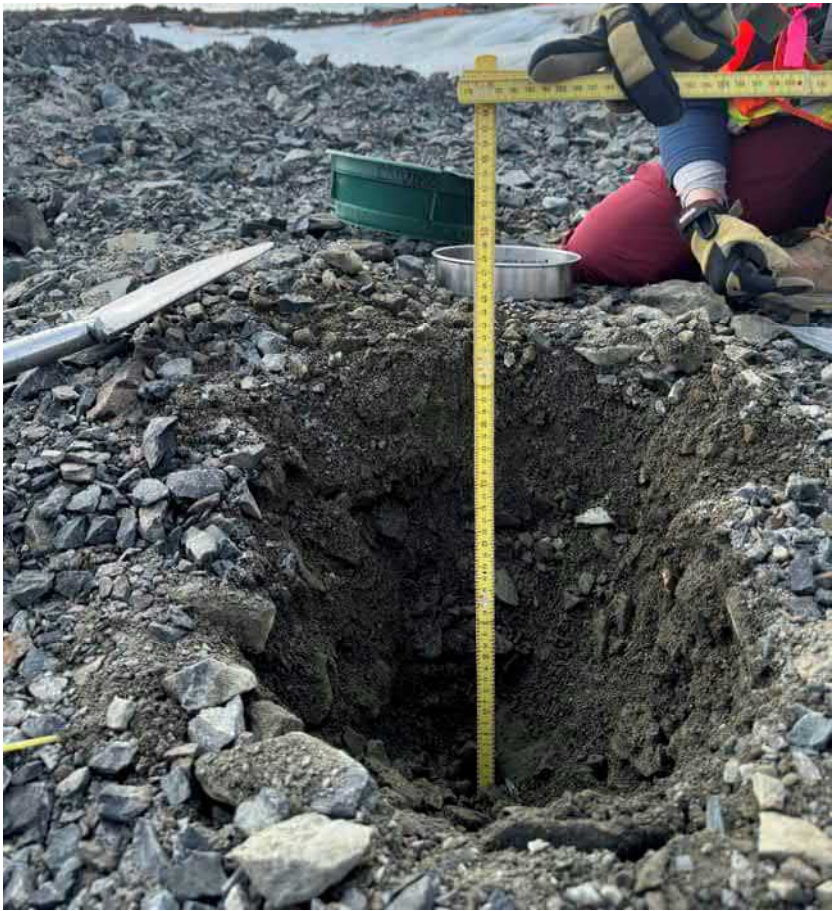
Photo 1: TP24-01

| Interval/sample | From (m) | To (m) | Description |
|---|---|---|---|
| 1A | 0.20 | 0.25 | Brown rock |
| 1B | 0.35 | 0.40 | Brown rock |

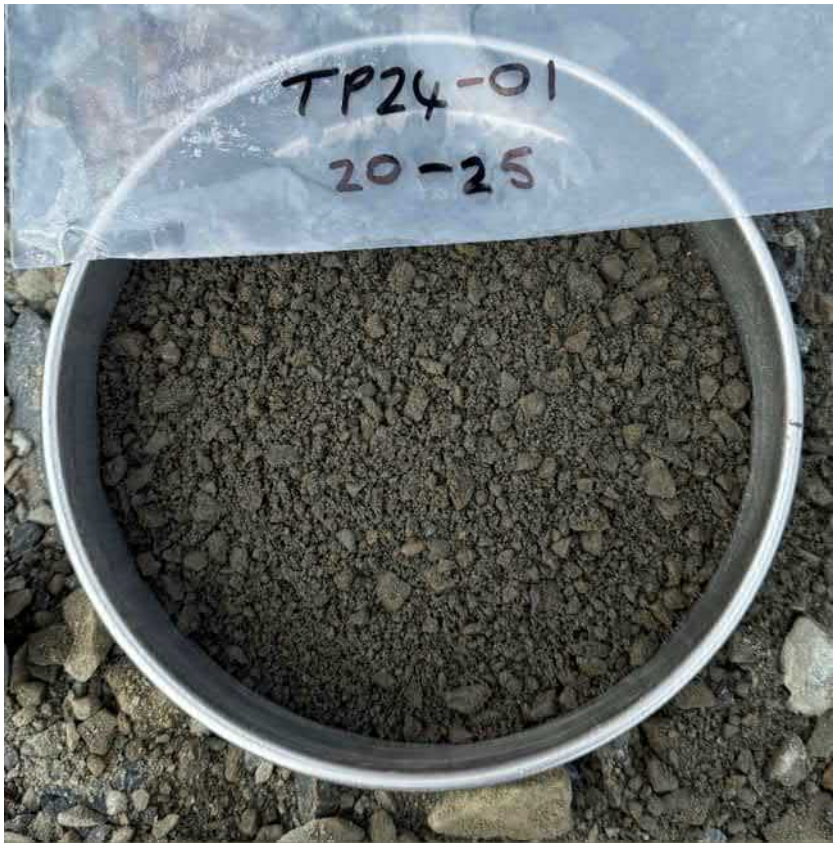
Photo 2: Sample before 2mm sieving

| | | Test Pit TP24-01 | |

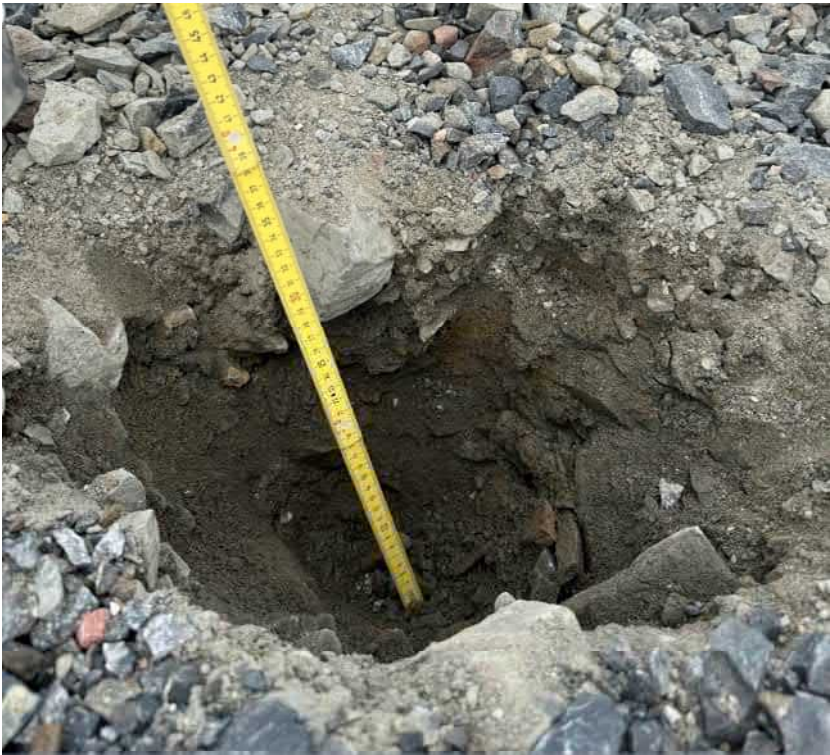
Photo 1: TP24-02

| Interval/sample | From (m) | To (m) | Description |
|---|---|---|---|
| 2A | 0.20 | 0.25 | Brown rock |
| 2B | 0.30 | 0.35 | Brown rock |

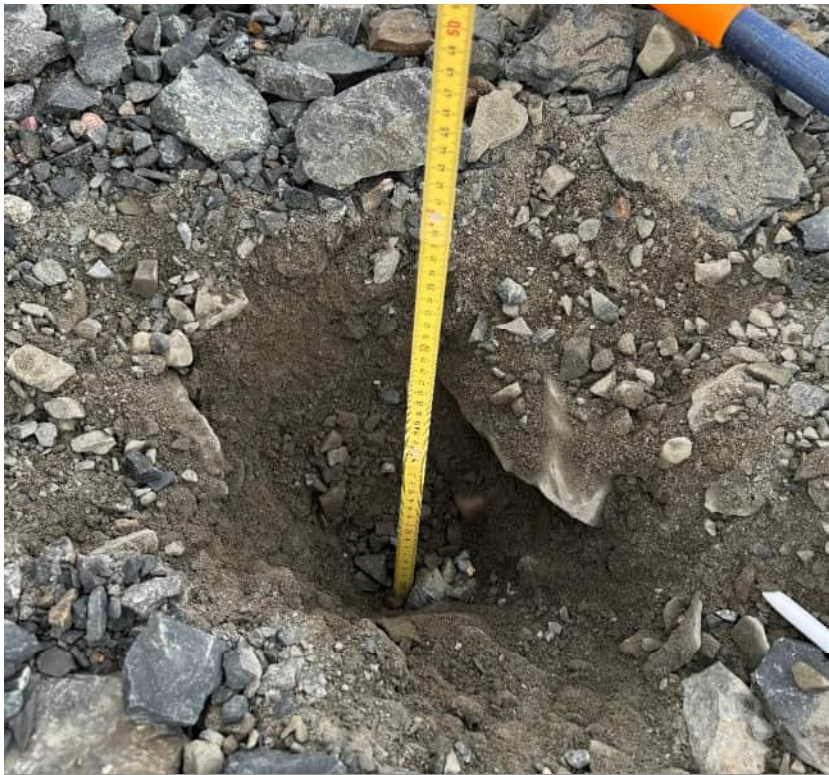
Photo 1: TP24-03

| Interval/sample | From (m) | To (m) | Description |
|---|---|---|---|
| | 0 | 0.25 | Grey rock |
| 3A | 0.25 | 0.30 | Grey rock |

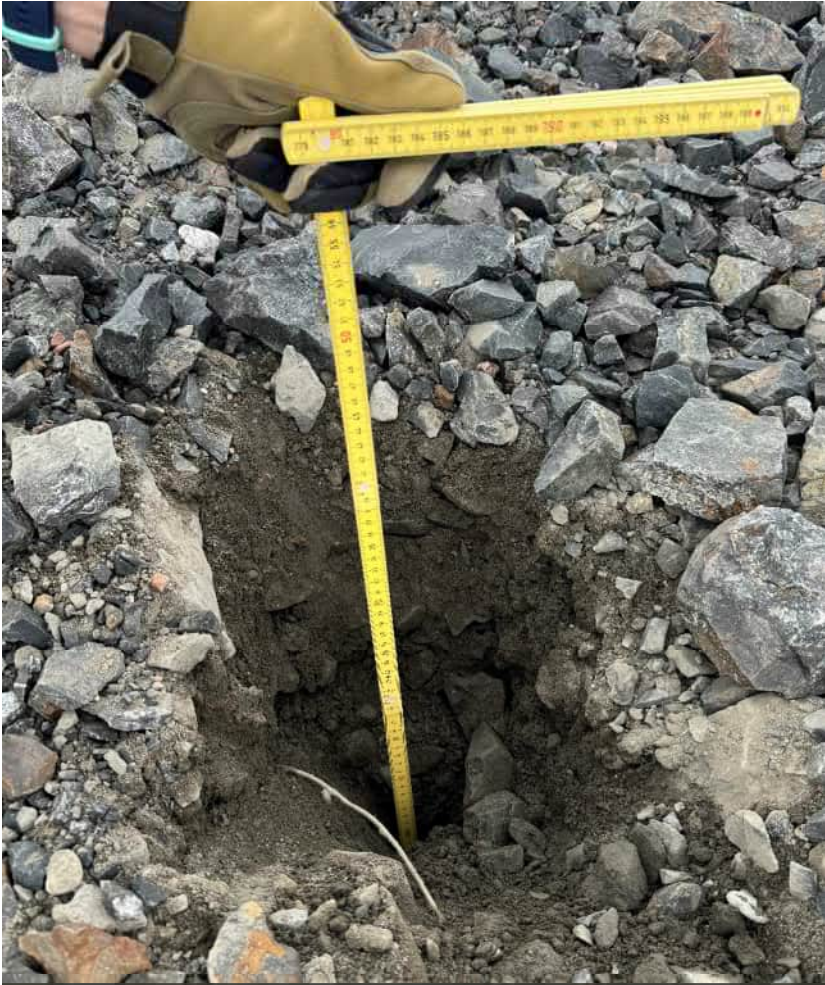
Photo 1: TP24-04

| Interval/sample | From (m) | To (m) | Description |
|---|---|---|---|
| 4A | 0.20 | 0.26 | Brown/Grey rock |
| 4B | 0.30 | 0.35 | Brown/Grey rock |

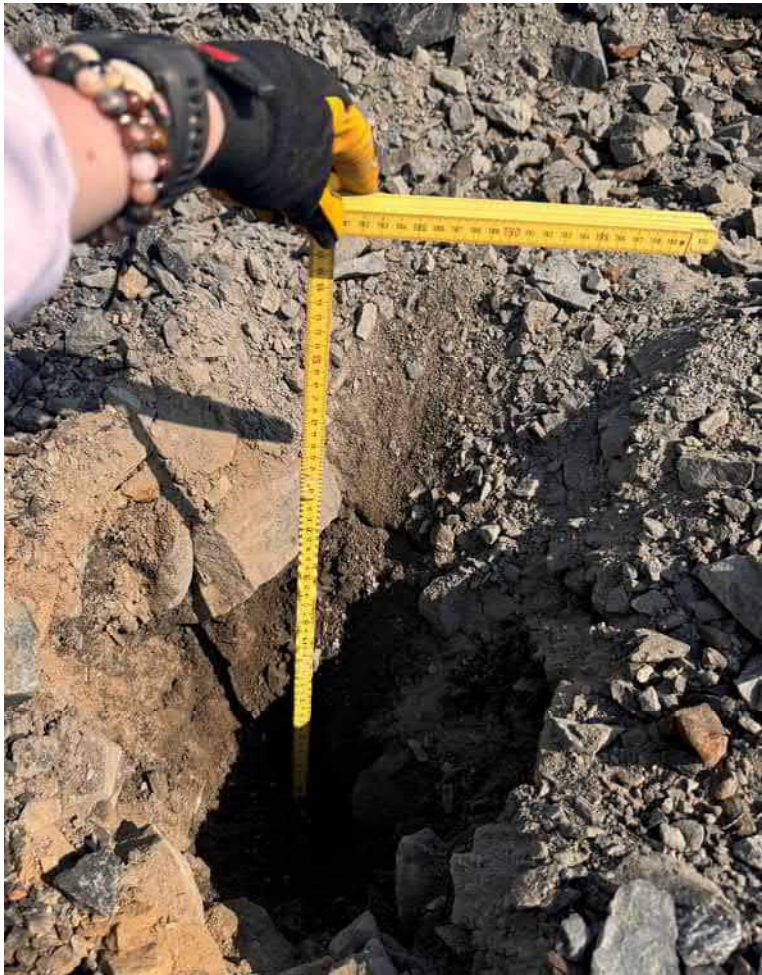
Photo 1: TP24-06

| Interval/sample | From (m) | To (m) | Description |
|---|---|---|---|
| 6A | 0.30 | 0.35 | Grey rock |
| 6B | 0.40 | 0.45 | Grey rock |

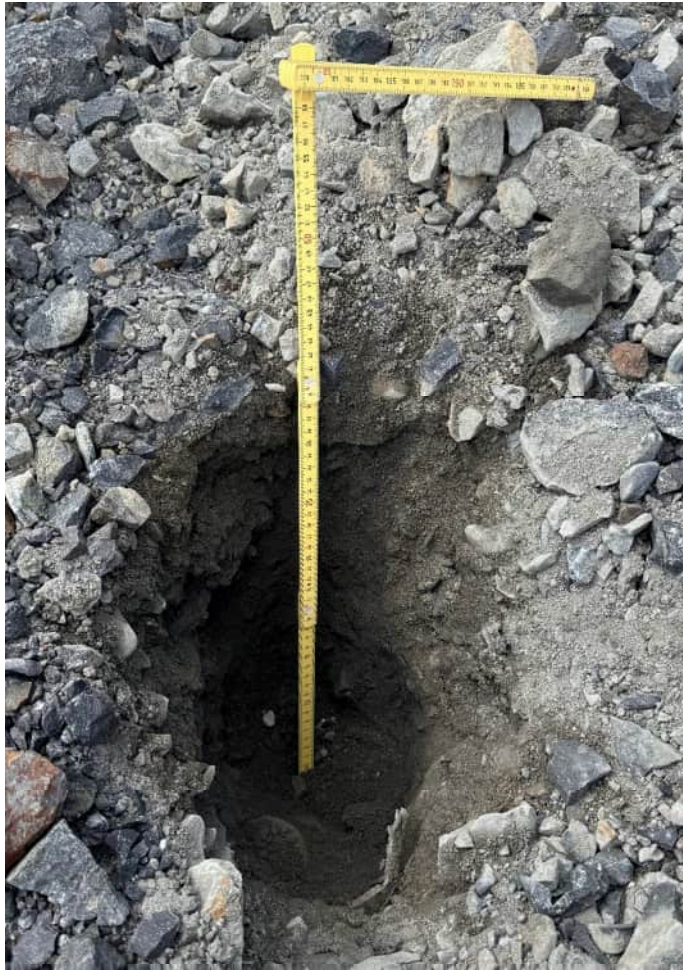
Photo 1: TP24-07

| Interval/sample | From (m) | To (m) | Description |
|---|---|---|---|
| 7A | 0.30 | 0.35 | Brown/Grey rock |
| 7B | 0.40 | 0.45 | Brown rock |

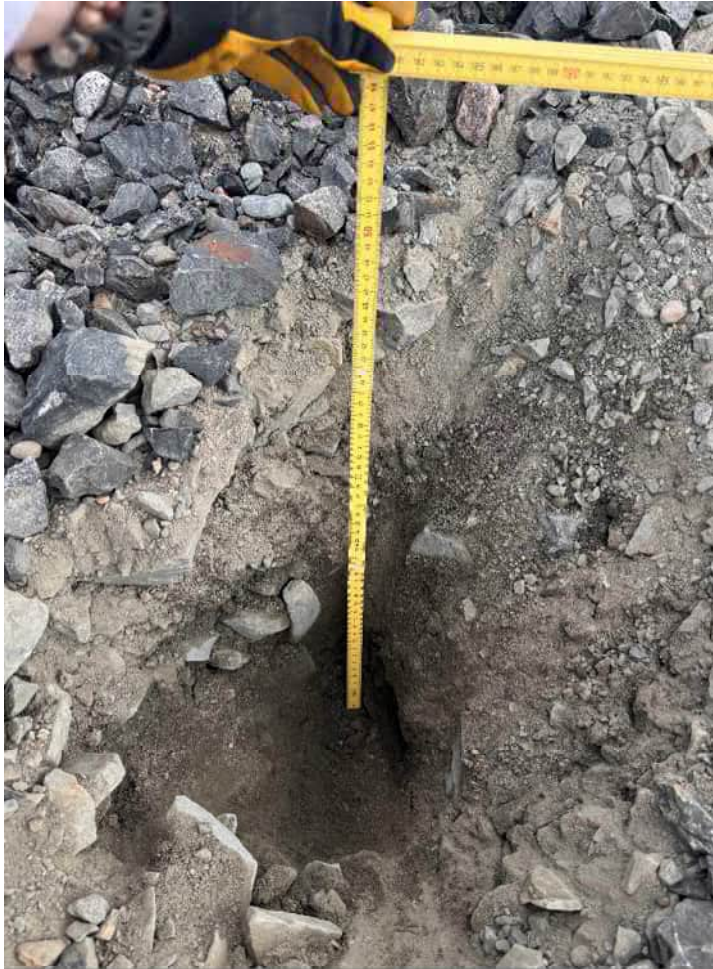
Photo 1: TP24-08

| Interval/sample | From (m) | To (m) | Description |
|---|---|---|---|
| 8A | 0.30 | 0.35 | Grey rock |
| 8B | 0.40 | 0.45 | Grey rock |

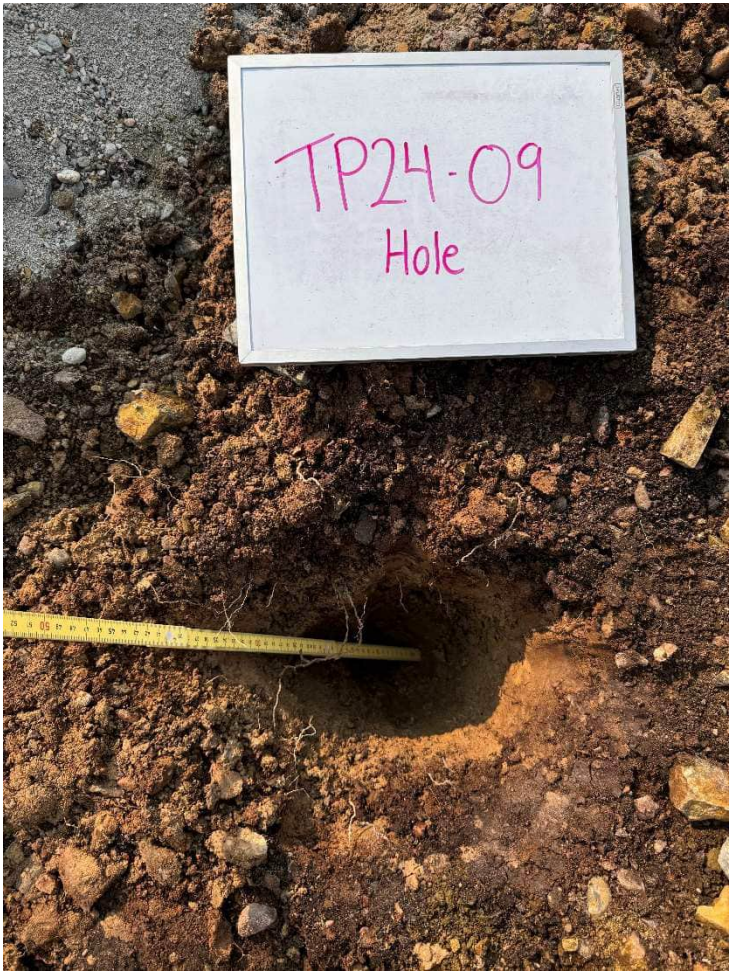
Photo 1: TP24-09

| Interval/sample | From (m) | To (m) | Description |
|---|---|---|---|
| 9A | 0 | 0.10 | Brown tundra soil |
| 9B | 0.40 | 0.45 | Orange tundra soil |

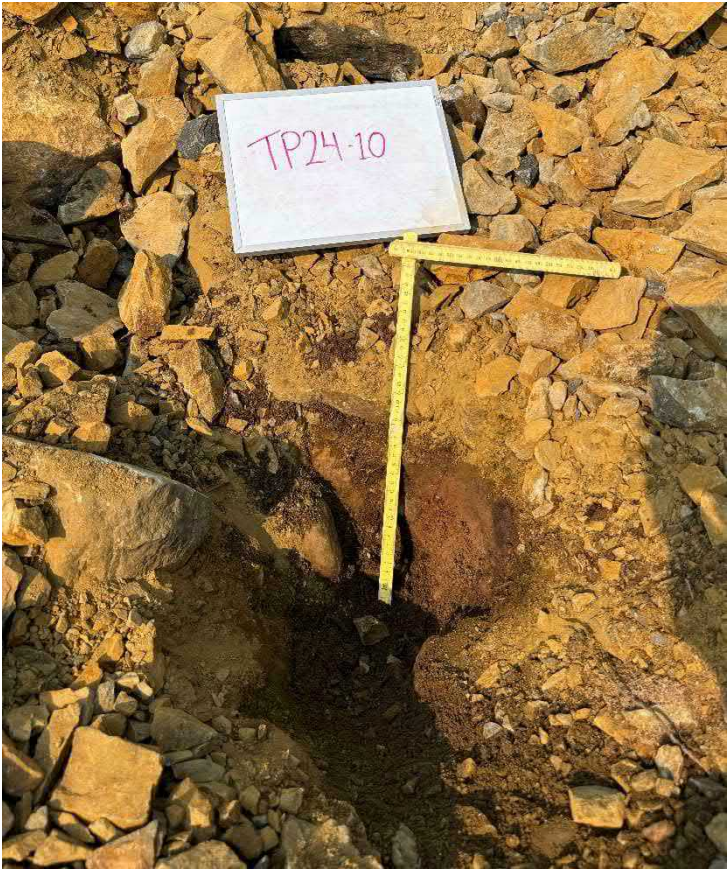
Photo 1: TP24-10

| Interval/sample | From (m) | To (m) | Description |
|---|---|---|---|
| 10A | 0 | 0.10 | Orange rock |
| 10B | 0.25 | 0.30 | Brown tundra soil |

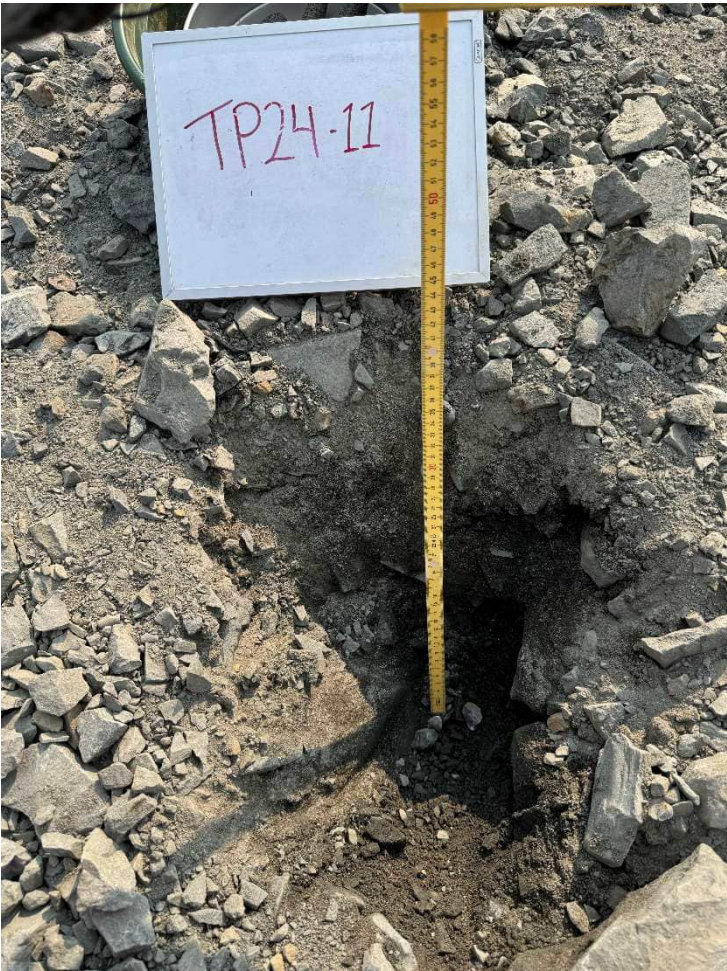
Photo 1: TP24-11

| Interval/sample | From (m) | To (m) | Description |
|---|---|---|---|
| 11A | 0.20 | 0.25 | Grey rock |

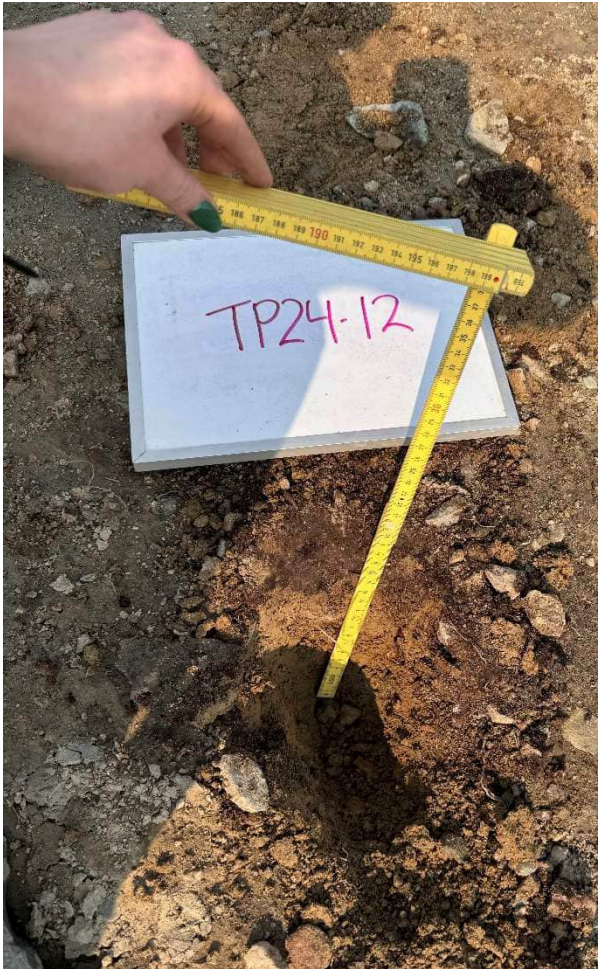
Photo 1: TP24-12

| Interval/sample | From (m) | To (m) | Description |
|---|---|---|---|
| 12A | 0.15 | 0.20 | Orang/Brown tundra soil |

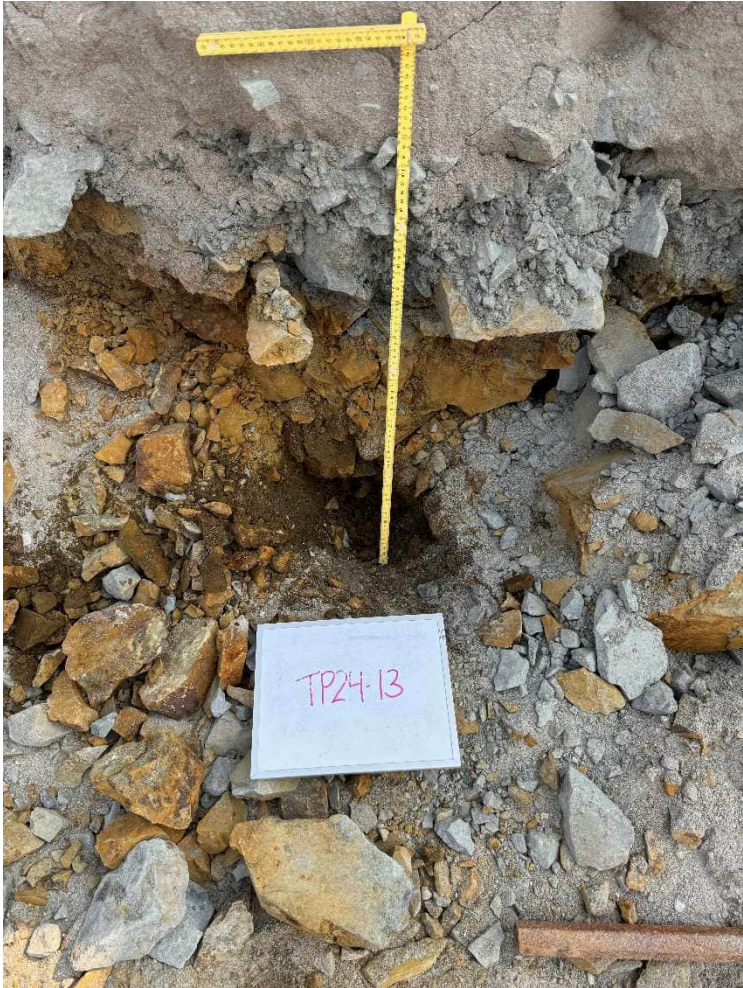
Photo 1: TP24-13

| Interval/sample | From (m) | To (m) | Description |
|---|---|---|---|
| 13A | 0 | 0.10 | Orange rock |

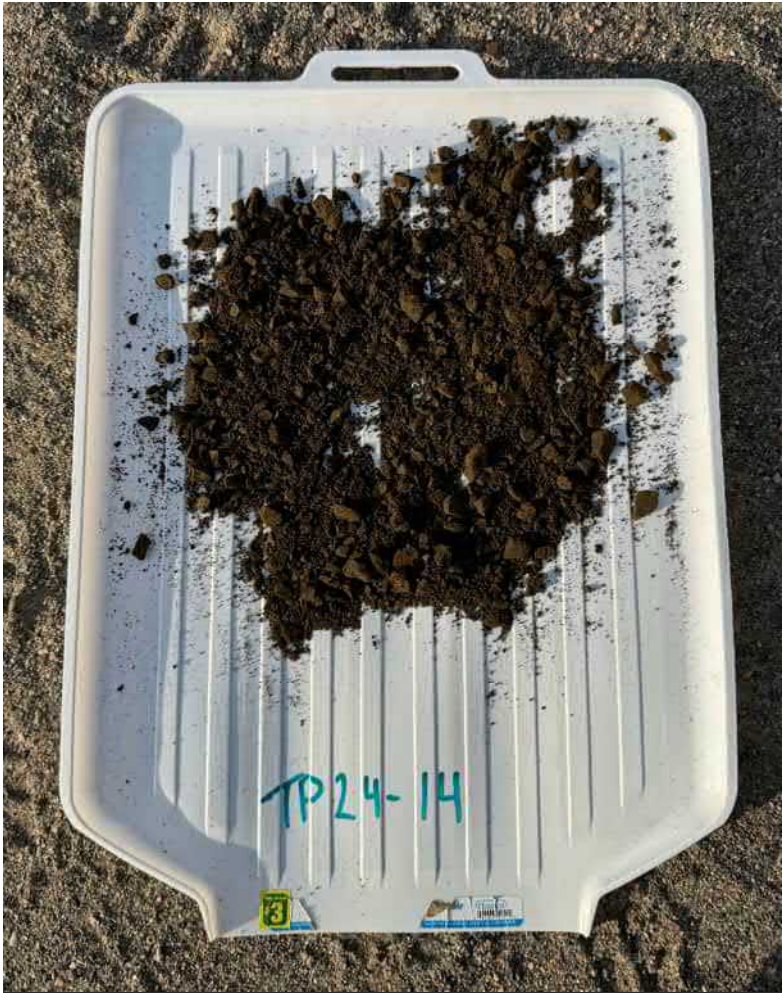
| Interval/sample | From (m) | To (m) | Description |
|---|---|---|---|
| 14A | 0 | 0.05 | Orange/brown rock/tundra soil |
