APPENDIX E

POND CP4, CHANNELS, AND BERMS

TITLE / TITRE
AS-BUILT REPORT FOR CHANNEL 4, POND CP4, AND BERM CP4
CP4 TYPICAL SECTION AND CP4 THERMAL PROTECTION BERM PROFILE

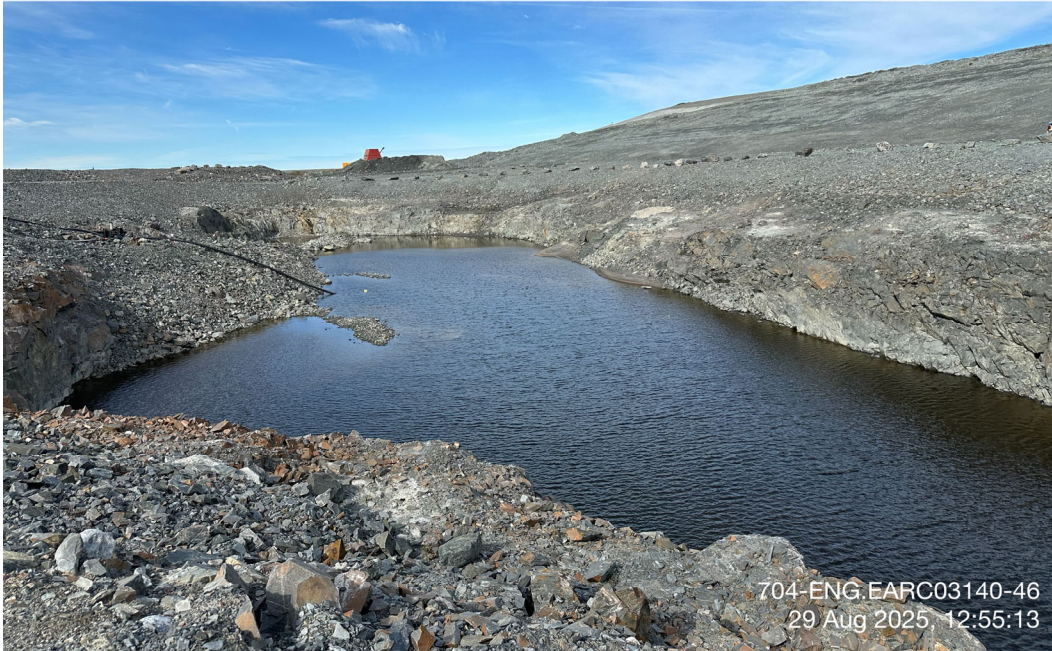
CP3 - Photo 1: CP3: Small amount of water stored in CP3, bedrock slopes with fractured rock, no stability concern. Facing north.

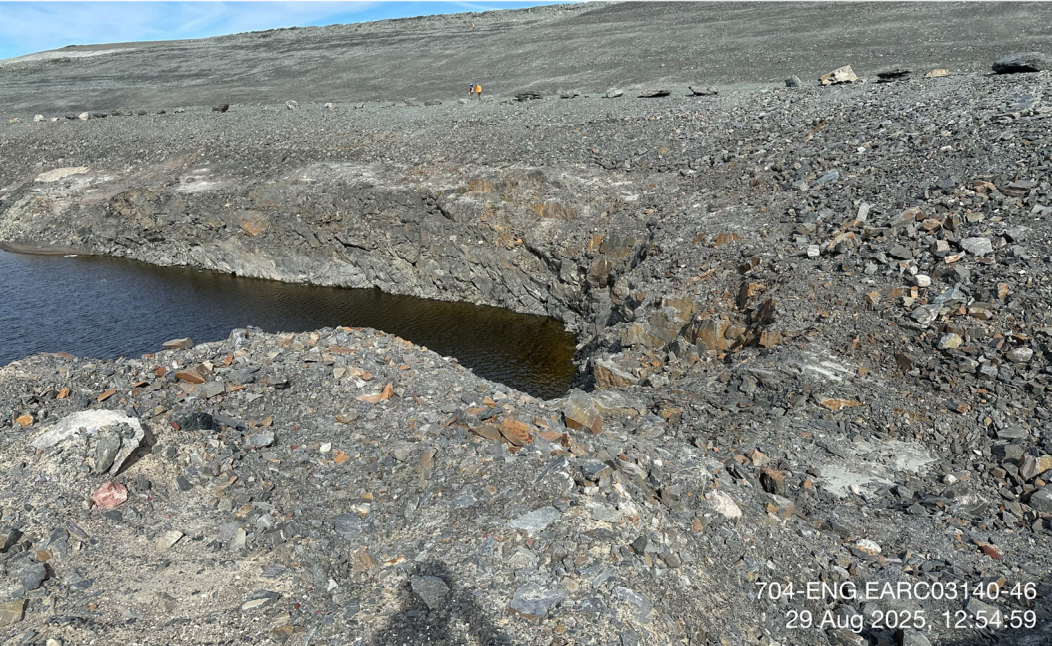
CP3 - Photo 2: CP3: Overview of Channel 3 outlet and rockfill cover placed between TSF toe and CP3 as thermal protection. Facing north.

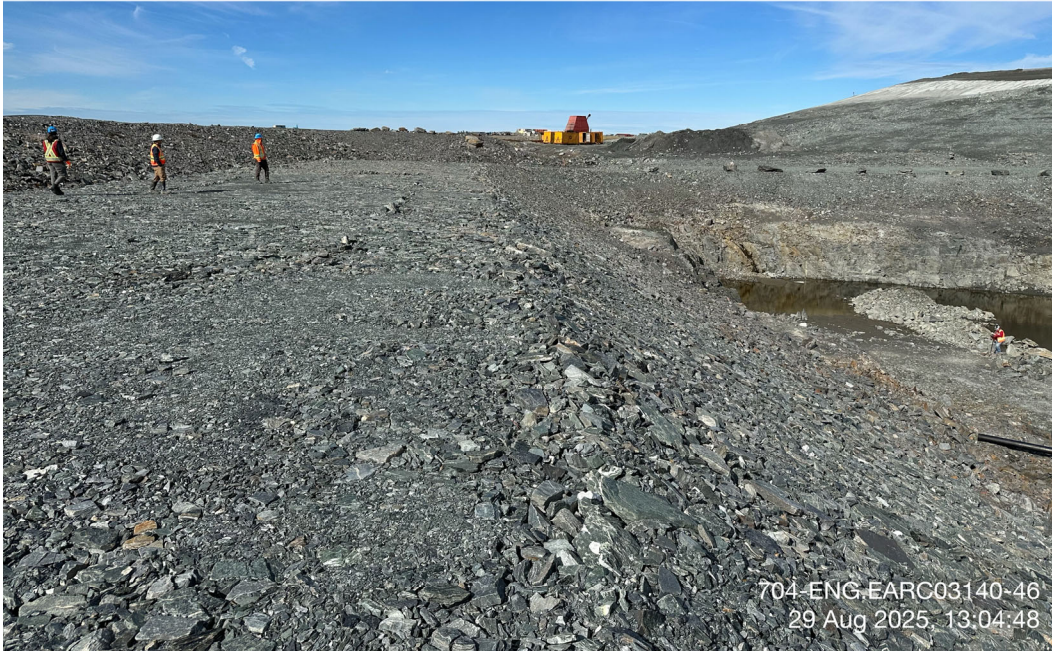
CP3 - Photo 3: CP3: Overview of CP3 Thermal Berm, CP3, and TSF including the snow stockpile between TSF and CP3 Thermal Berm. Facing northwest.

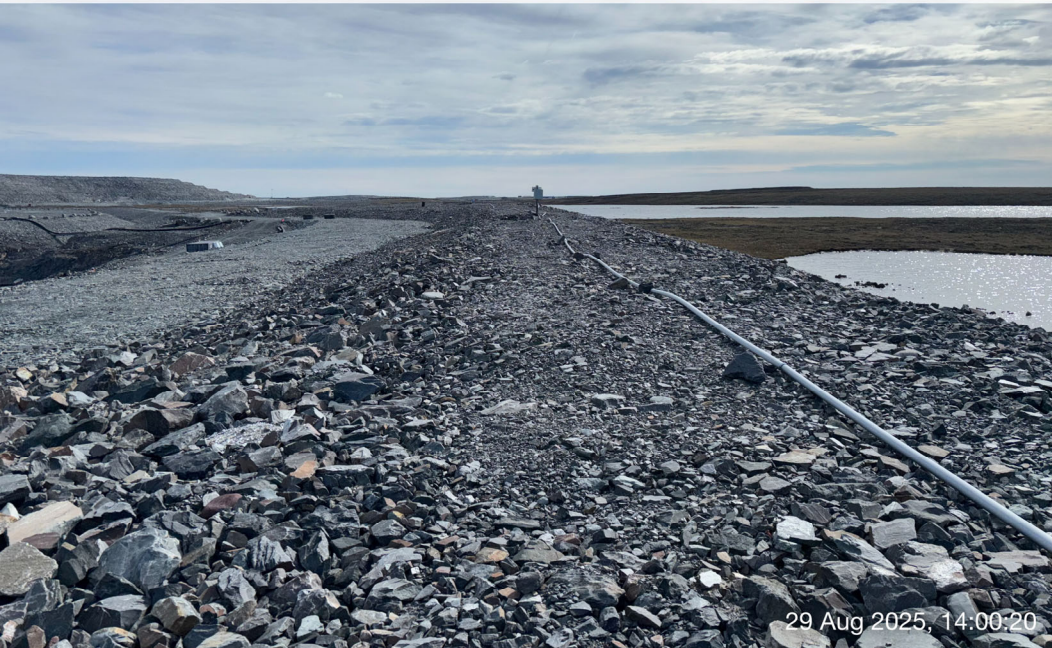
CP3 Thermal Berm - Photo 4: CP3 Thermal Berm: Crest of CP3 Thermal Berm, minor thaw settlement observed, similar conditions to the previous year. Facing southeast.

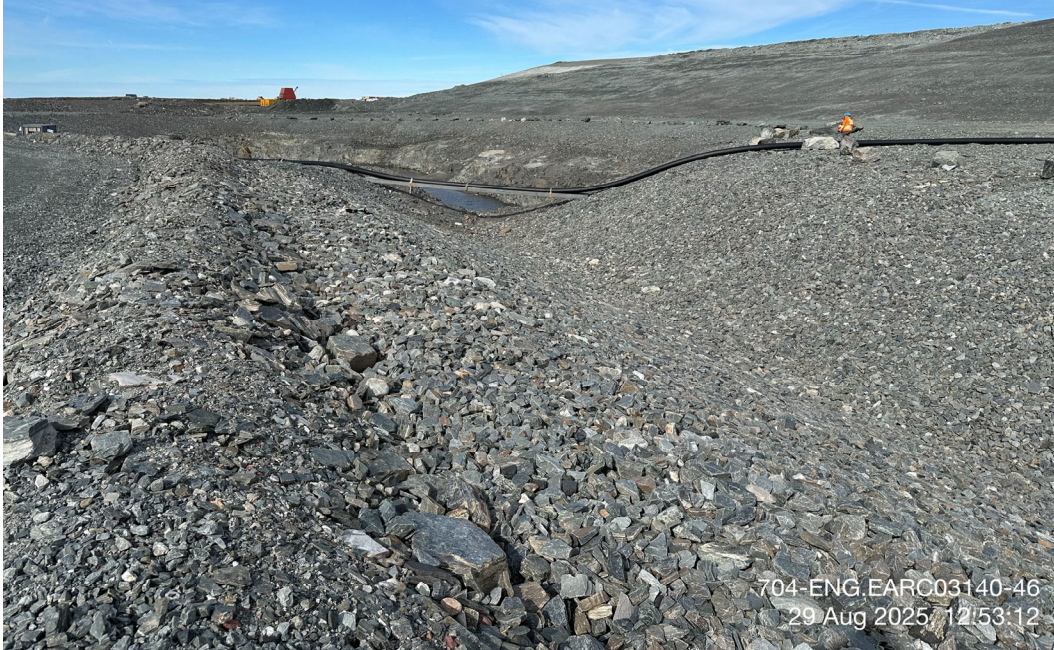
**Channel3 -
Photo 5:**

Channel3: Overview of Channel3 outlet, entering CP3. Facing north.

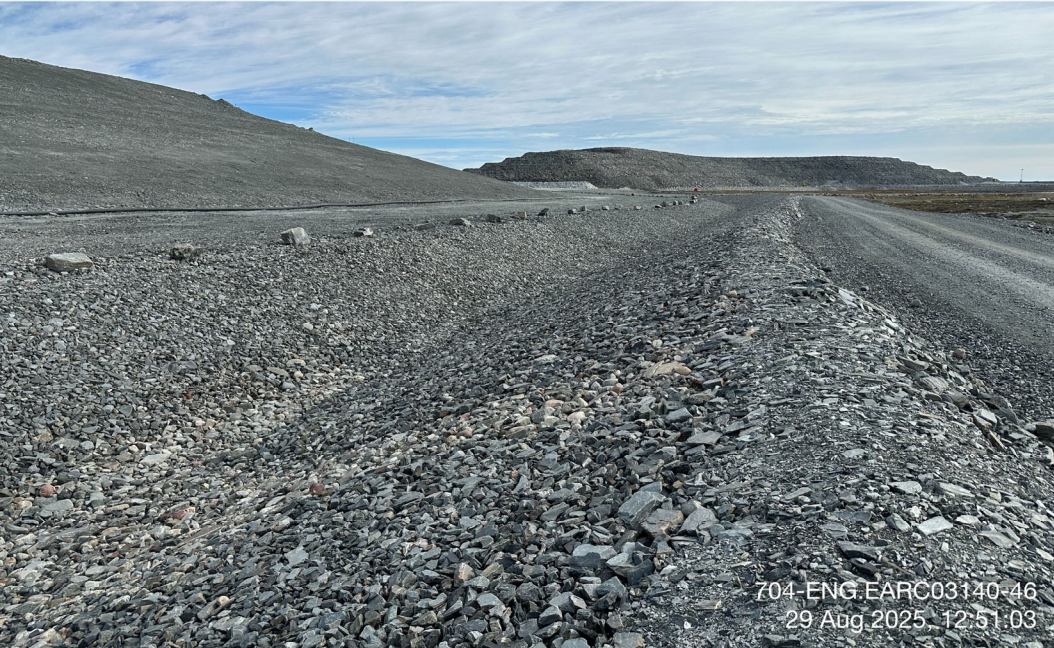
**Channel3 -
Photo 6:**

Channel3: Overview of Channel3. Facing east.

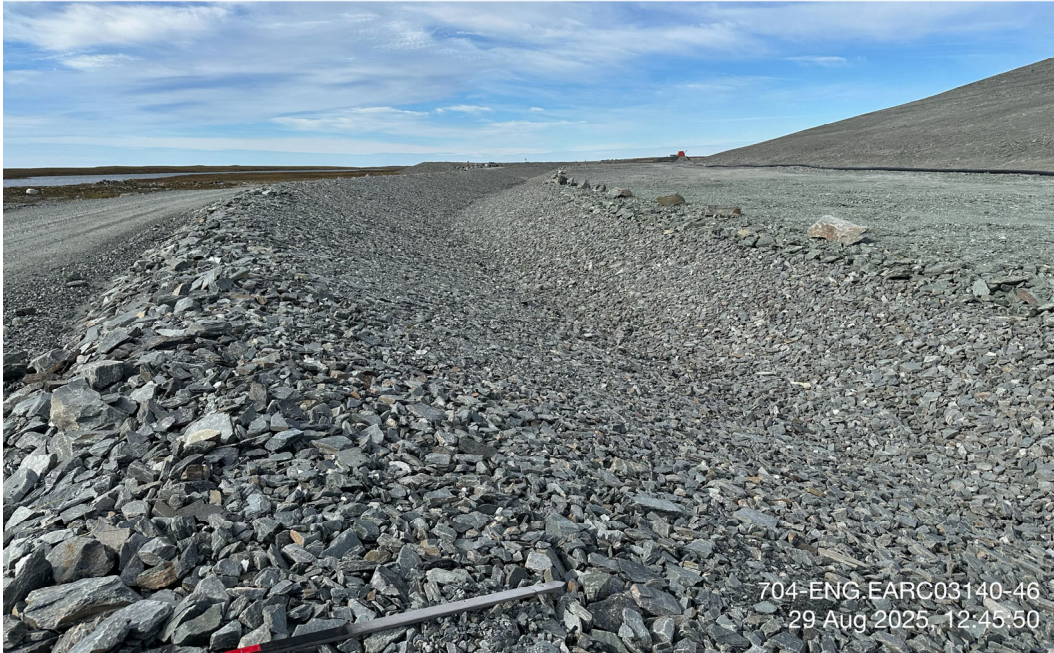
**Channel3 -
Photo 7:**

Channel3: Overview of the middle section of Channel3. Facing northwest.

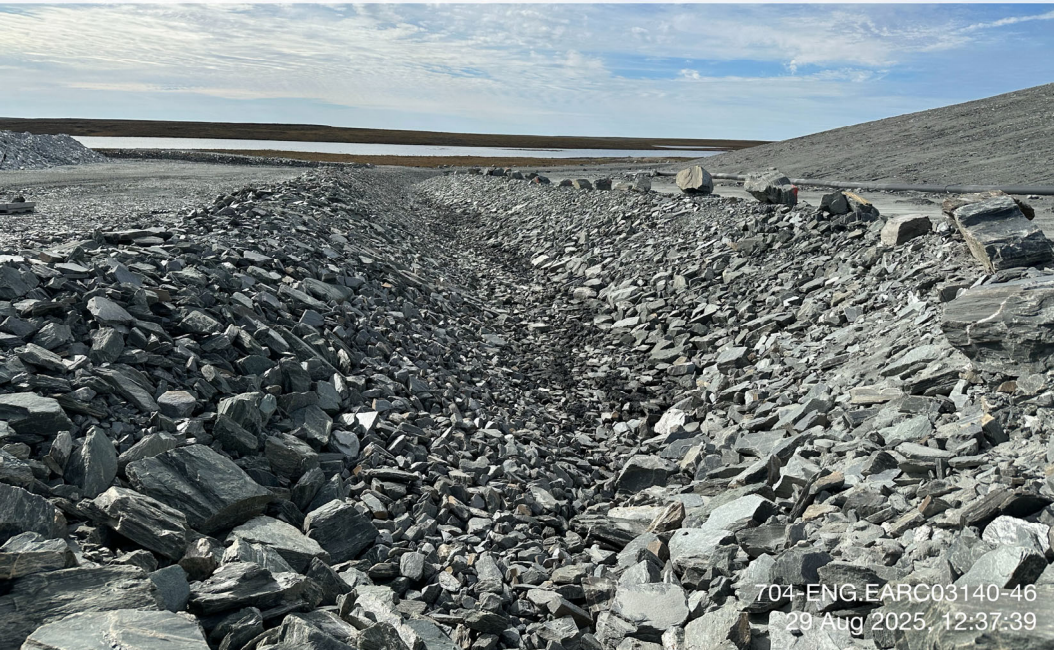
**Channel3 -
Photo 8:**

Channel3: Overview of the east end section of Channel3. Facing west.

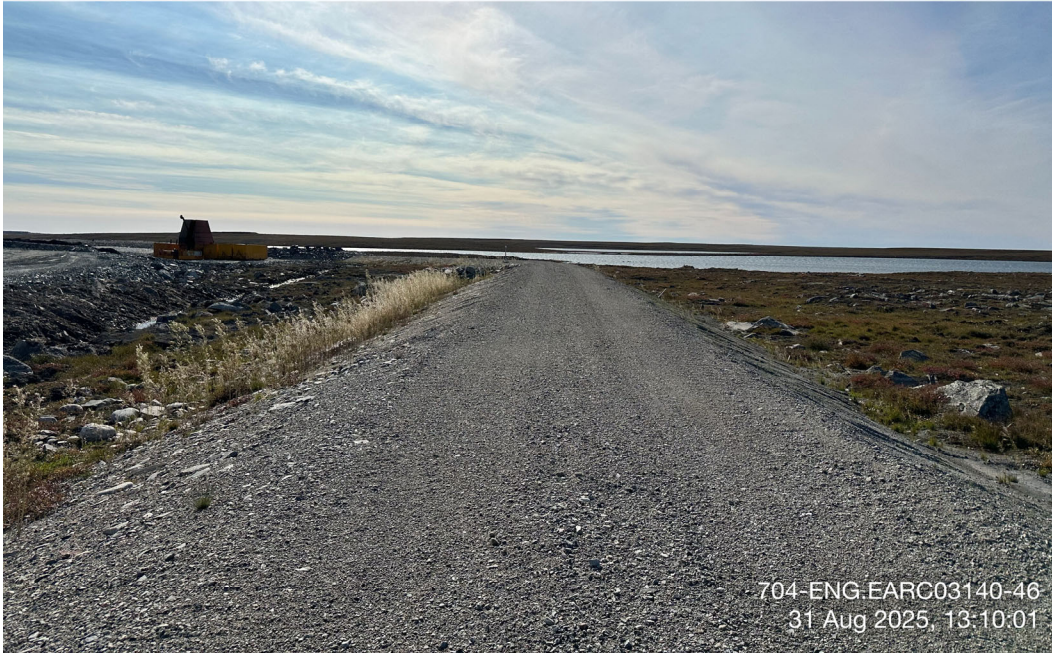
Berm2 - Photo 9: Berm2: Overview of Berm2 north portion, slope and crest, performing well, no stability concern. Facing southwest.

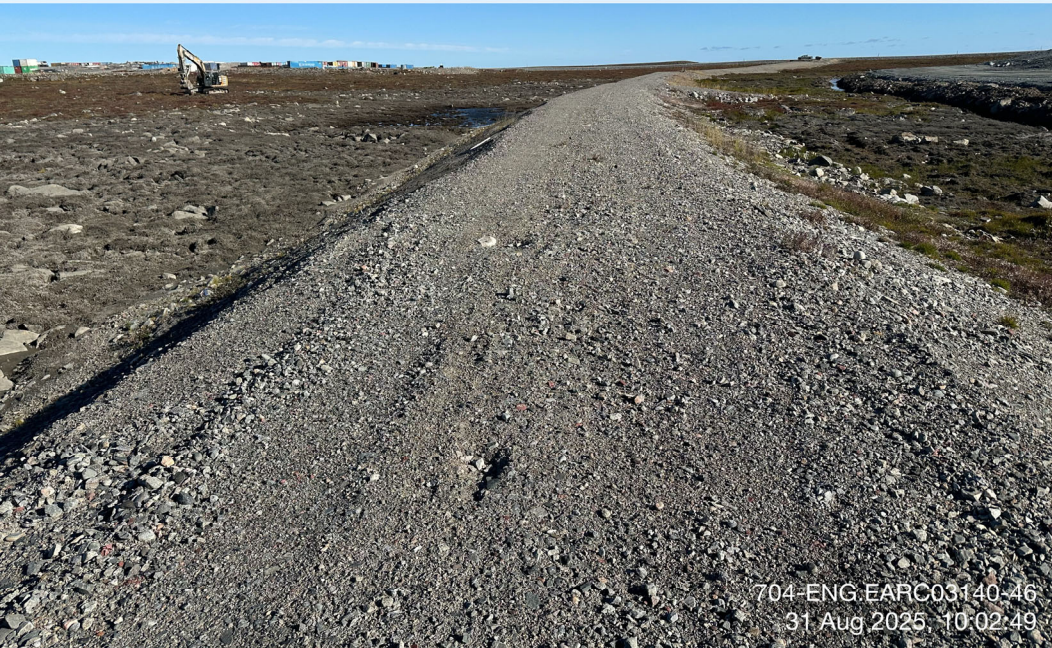
Berm2 - Photo 10: Berm2: Overview of Berm2 middle portion, slope and crest, performing well, minor cracking observed on crest and slopes, no stability concern, ponded water on both sides. Facing north.

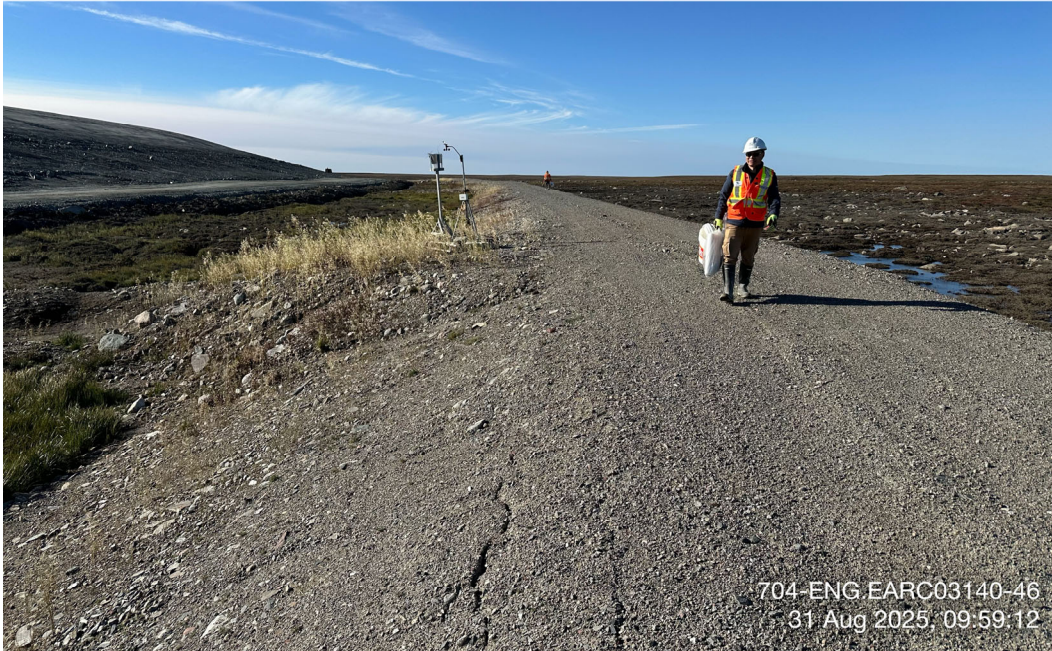
**Berm2 -
Photo 11:**

Berm2: Overview of Berm2 south portion, slope and crest, performing well, minor cracking observed on crest and slopes, no stability concern. Facing south.

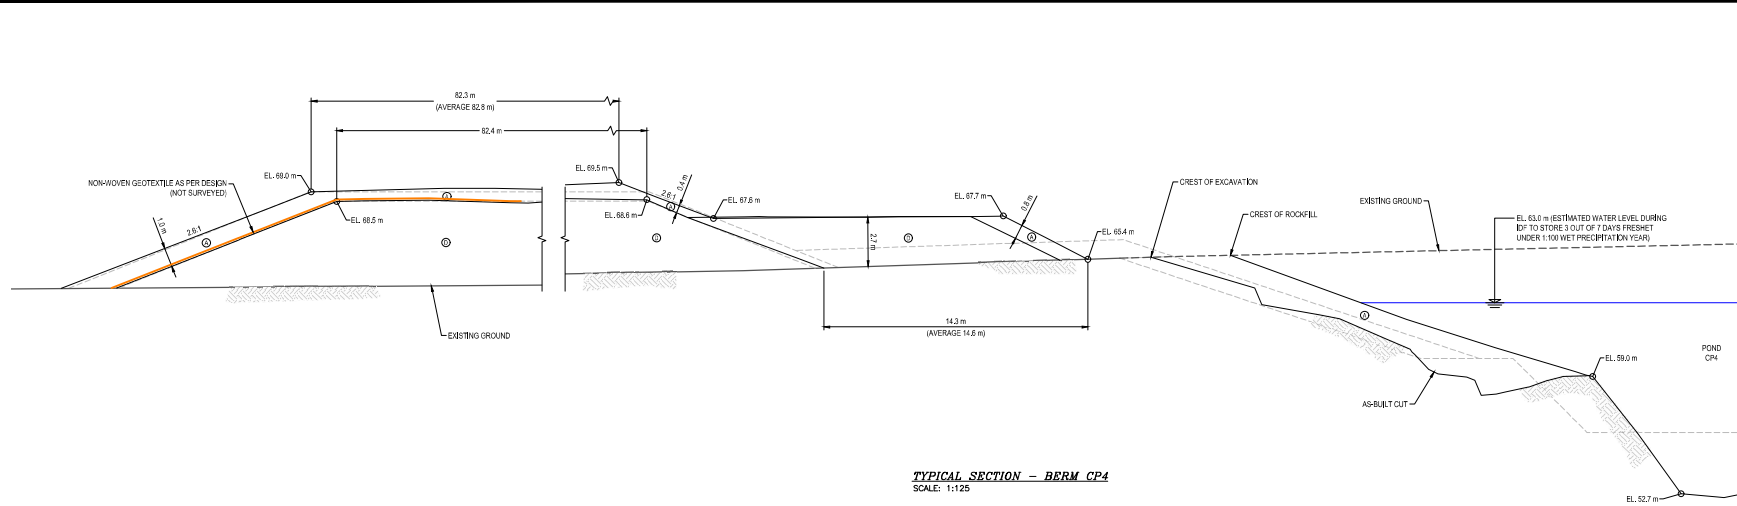
TYPICAL SECTION - BERM CP4
SCALE: 1:125

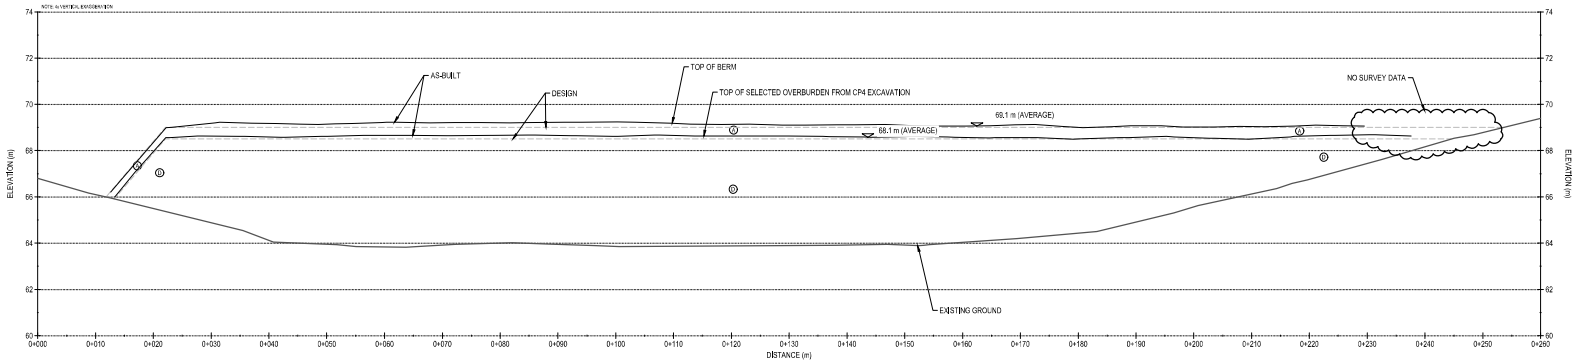
BERM CP4 - PROFILE
SCALE: H=1:400 V=1:100

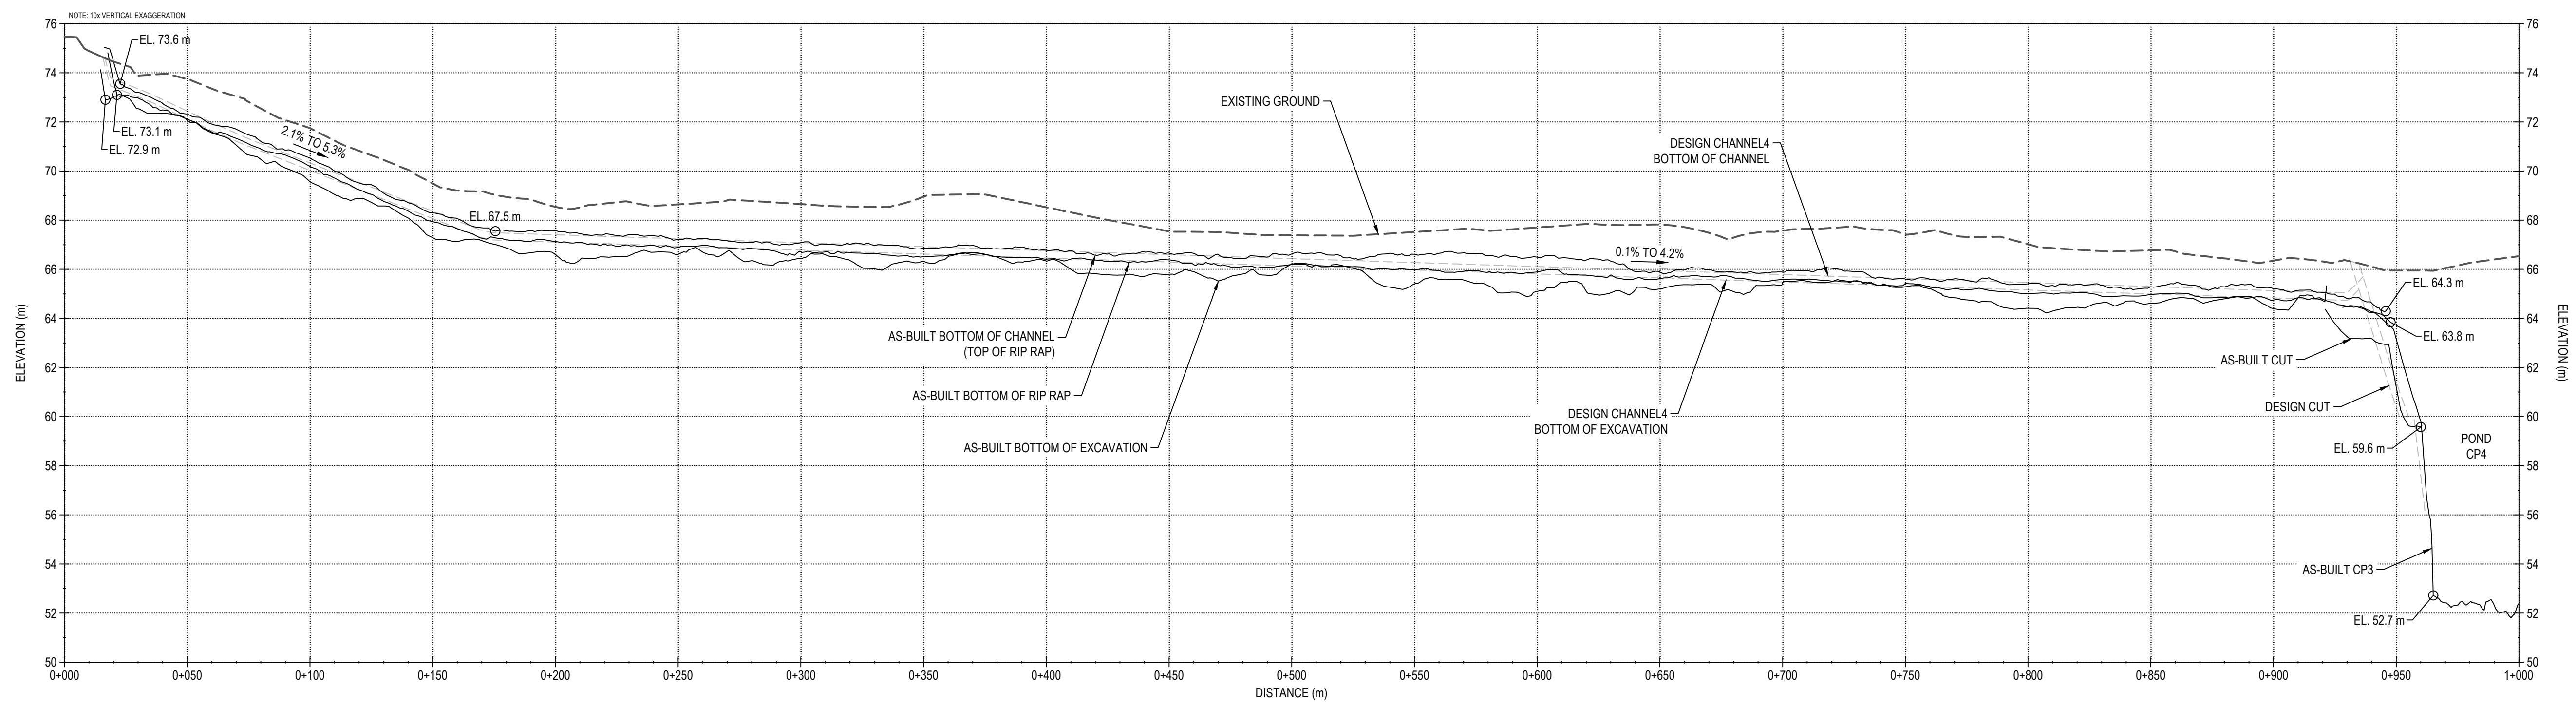
CHANNEL4 PROFILE
SCALE: H=1:1500 V=1:150

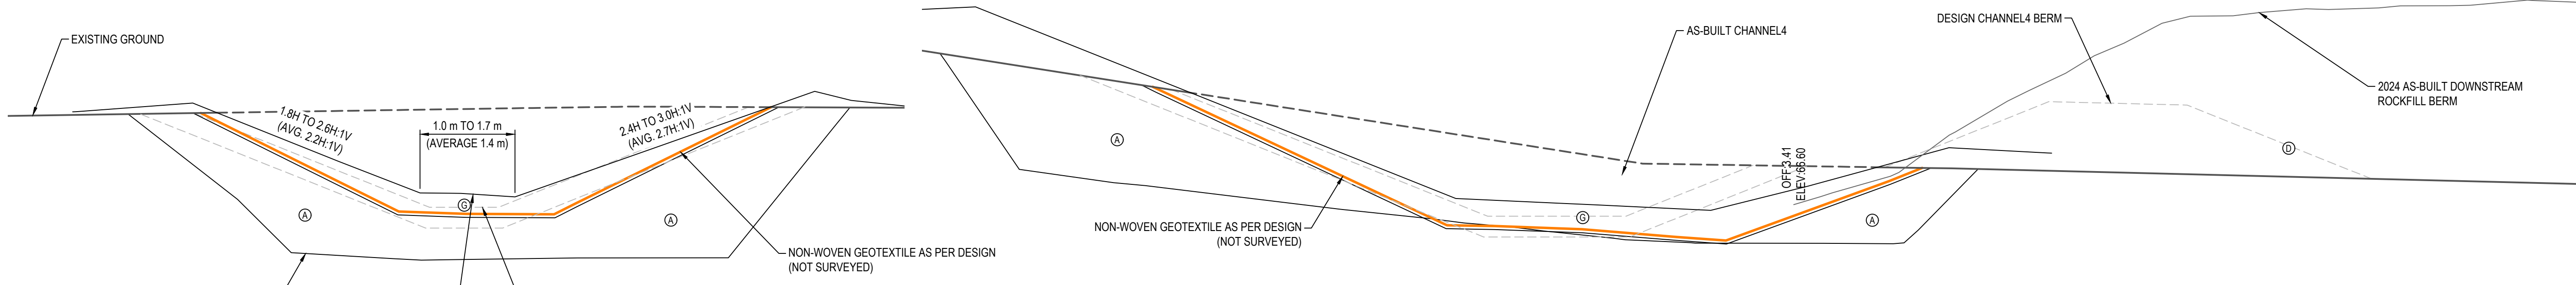
CHANNEL4 BERM AS-BUILT FROM STATION 0+180 TO 0+620
SCALE: 1:50

CHANNEL4 AS-BUILT FROM STATION 0+000 TO 0+135 (1 m WIDE CHANNEL BOTTOM)
SCALE: 1:50

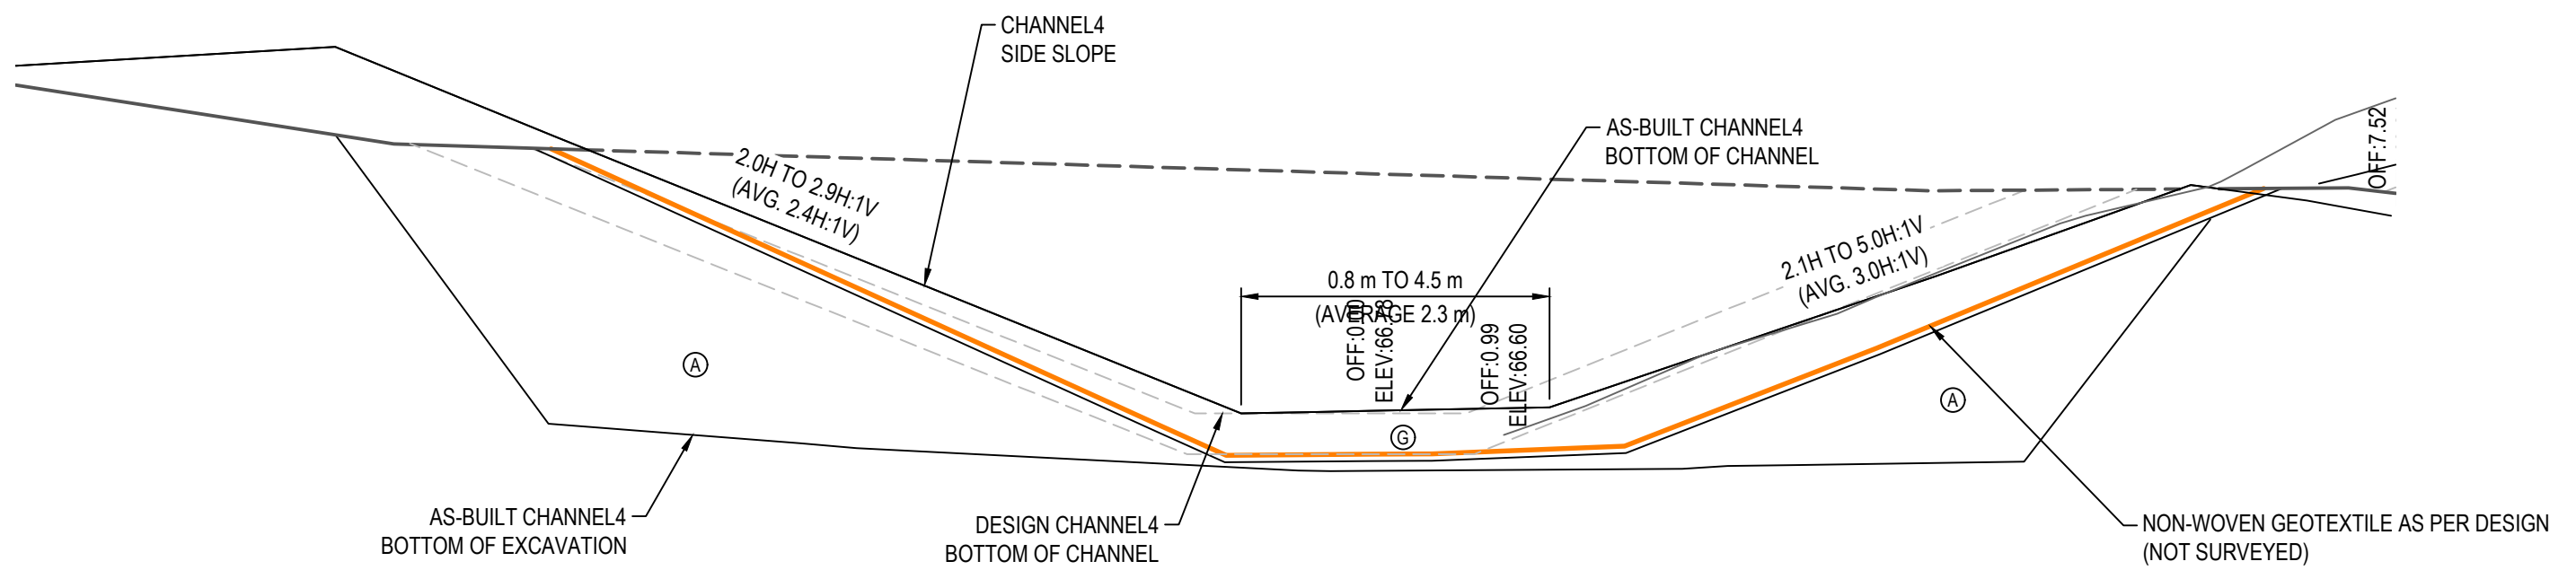
CHANNEL4 AS-BUILT FROM STATION 0+160 TO 0+923 (2 m WIDE CHANNEL BOTTOM)
SCALE: 1:50

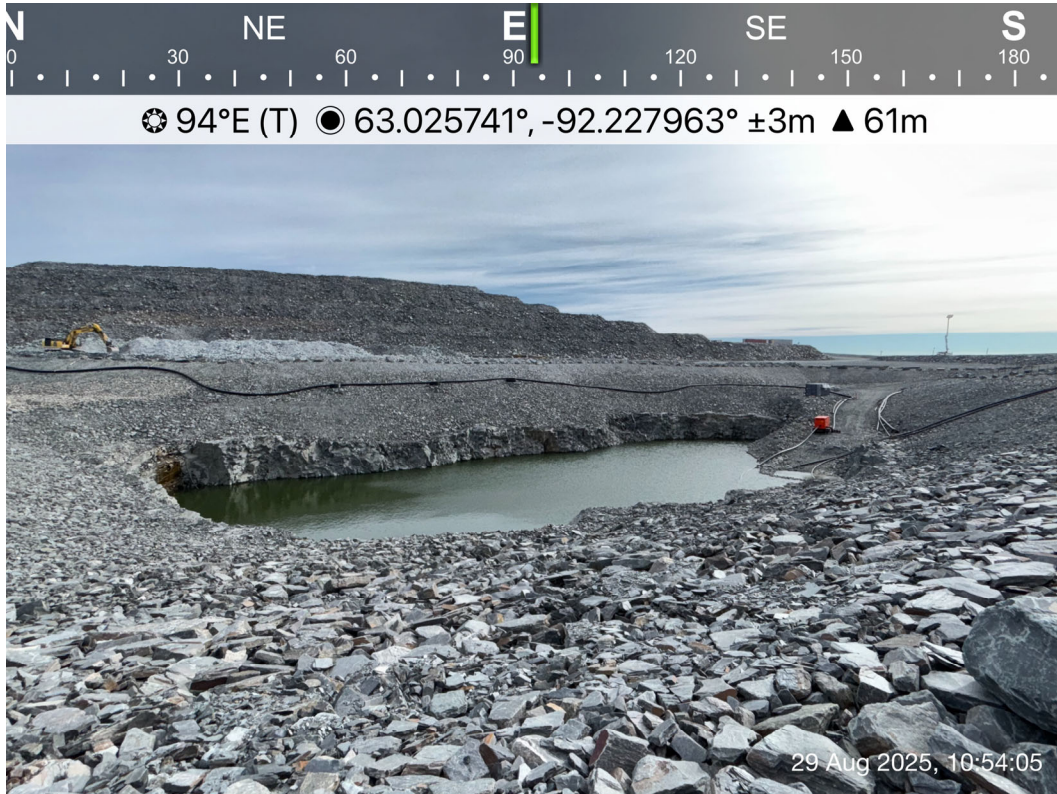
CP4 - Photo 1: CP4: Overview of CP4. Facing east.

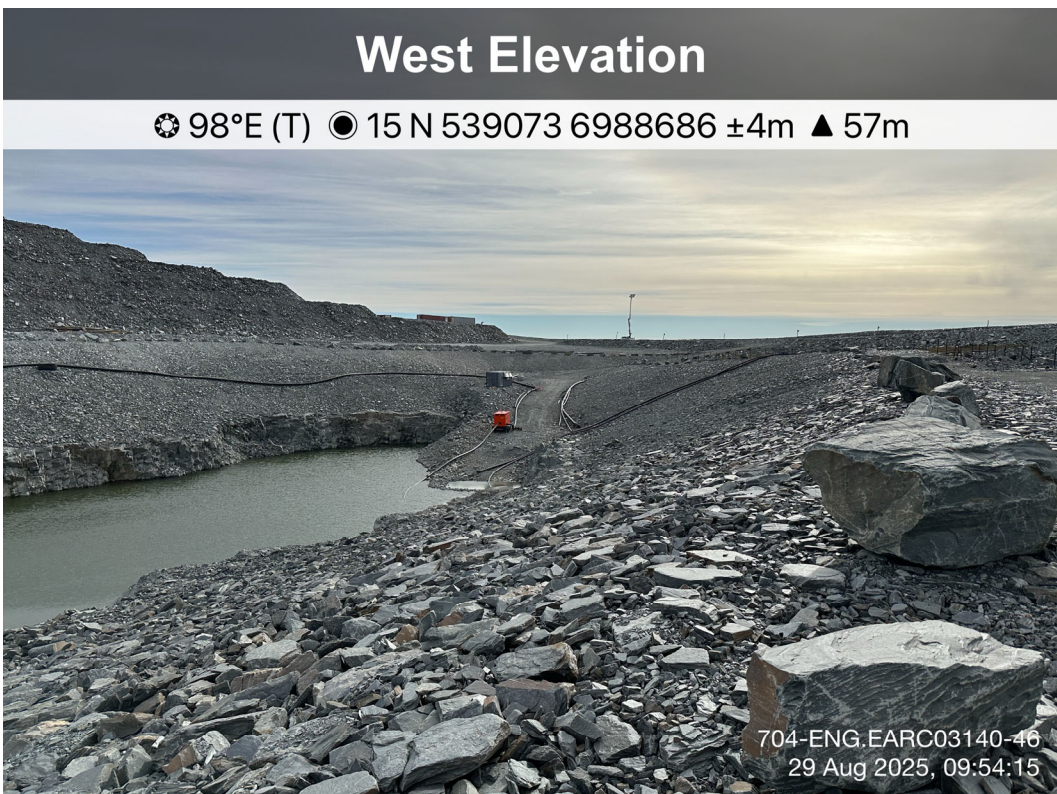
CP4 - Photo 2: CP4: Overview of southwest slope. Facing east.

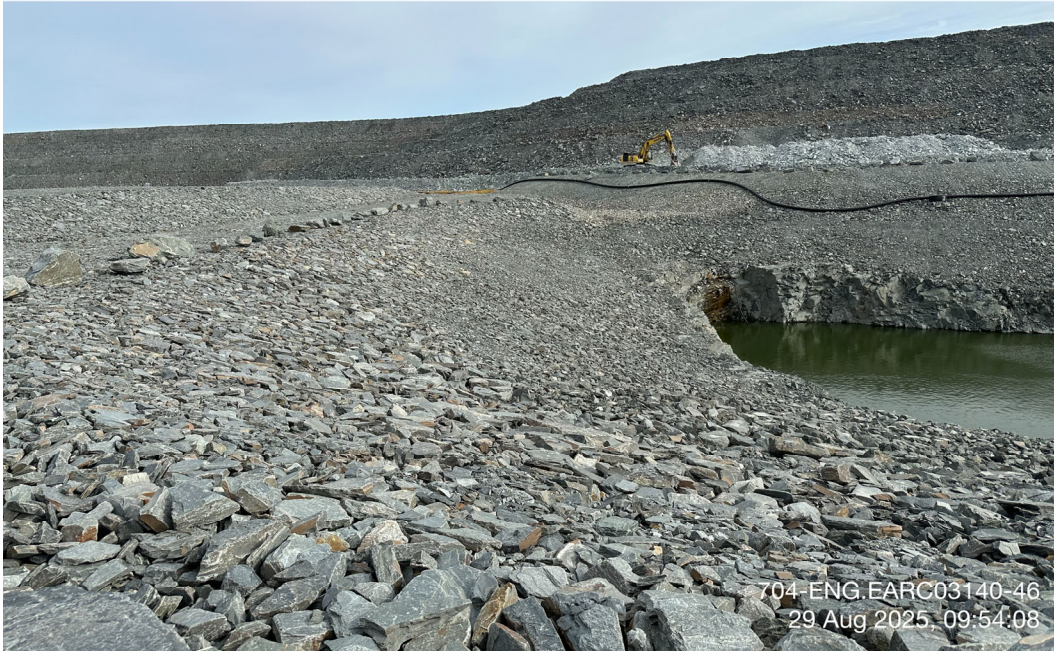
CP4 - Photo 3: CP4: Overview of northwest slope. Facing northeast.

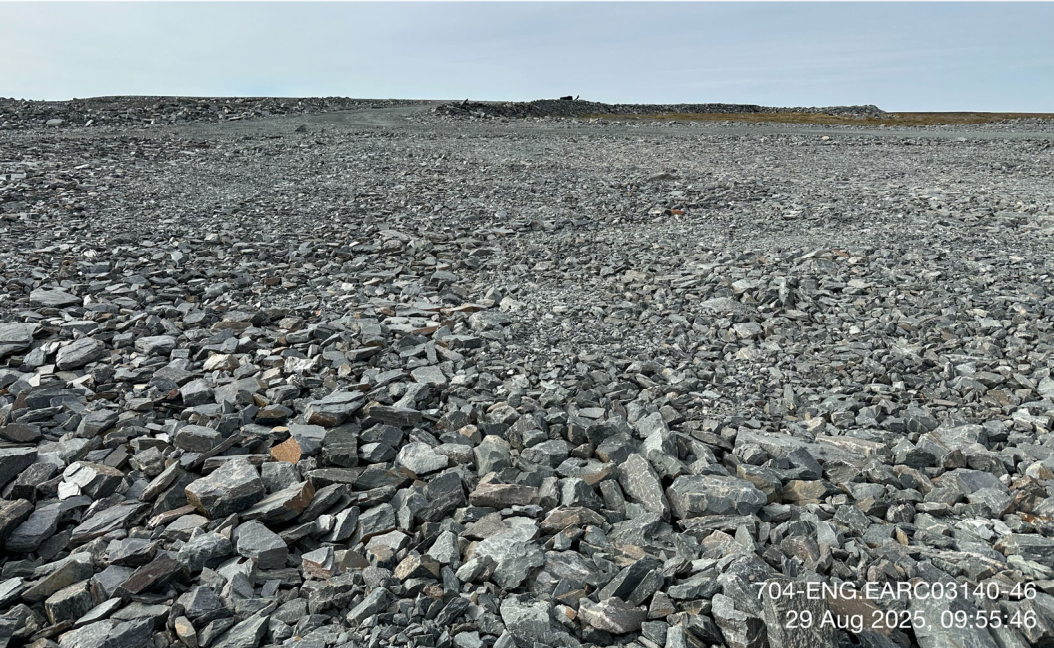
CP4 Thermal Berm - Photo 4: CP4 Thermal Berm: Overview of crest, performing well, no stability concern. Facing southwest.

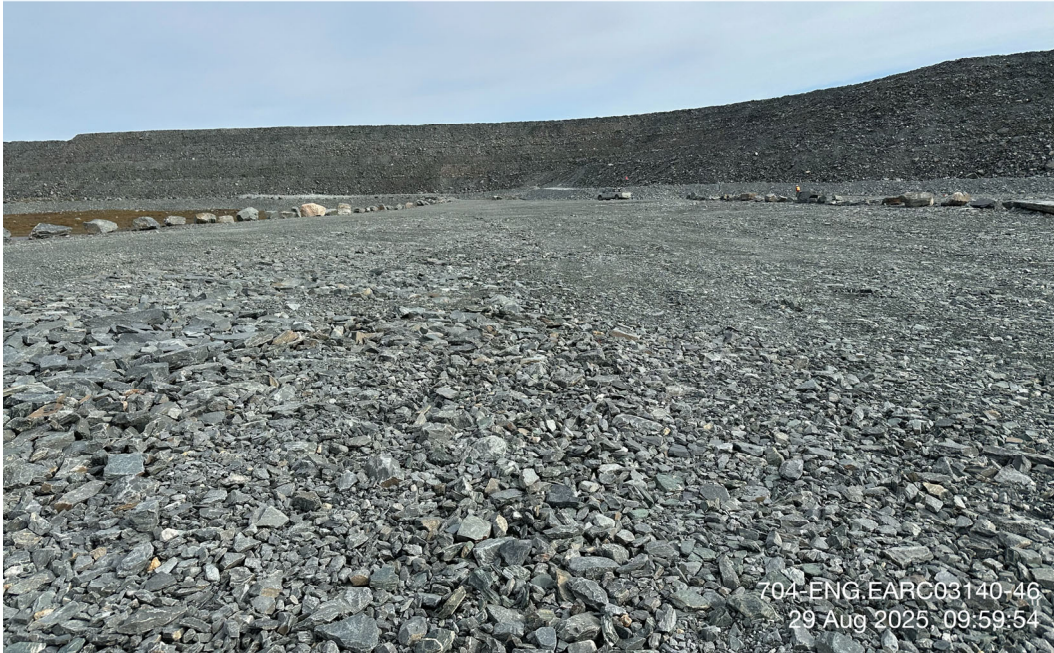
CP4 Thermal Berm - Photo 5:

CP4 Thermal Berm: Overview of crest, performing well, no stability concern. Facing northeast.

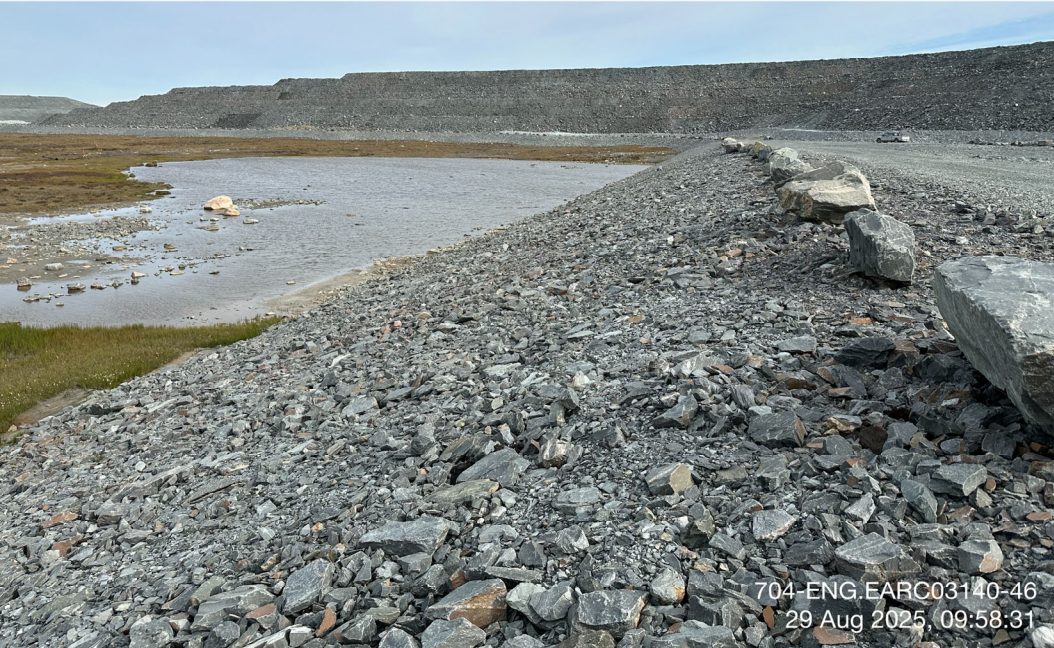
CP4 Thermal Berm - Photo 6:

CP4 Thermal Berm: Overview of downstream side slope. Facing northeast.

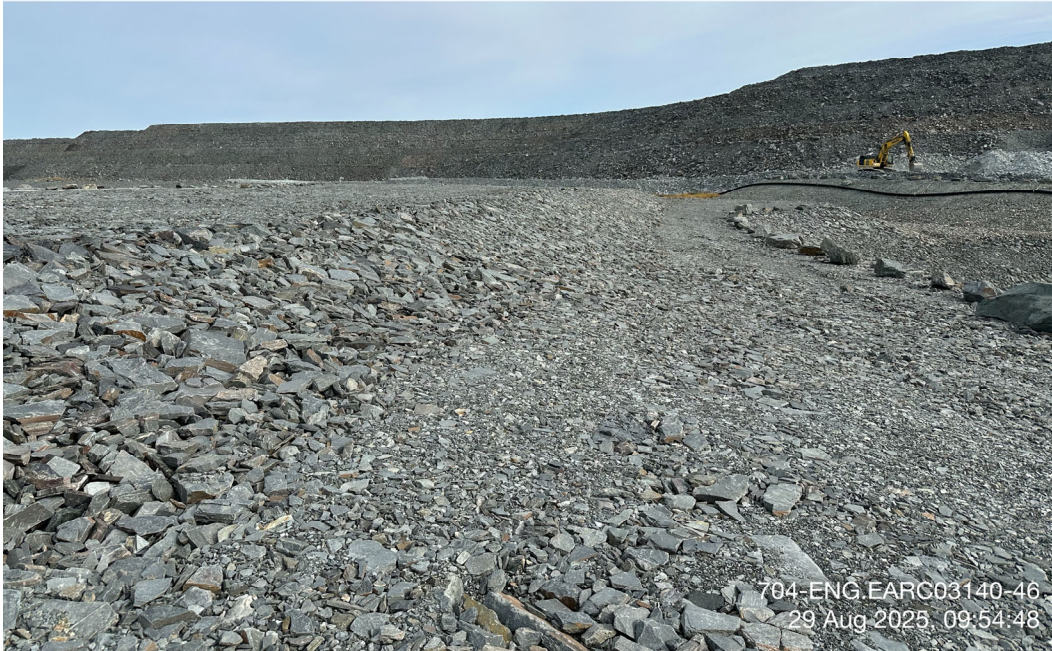
CP4 Thermal Berm - Photo 7:

CP4 Thermal Berm: Overview of upstream side slope. Facing northeast.

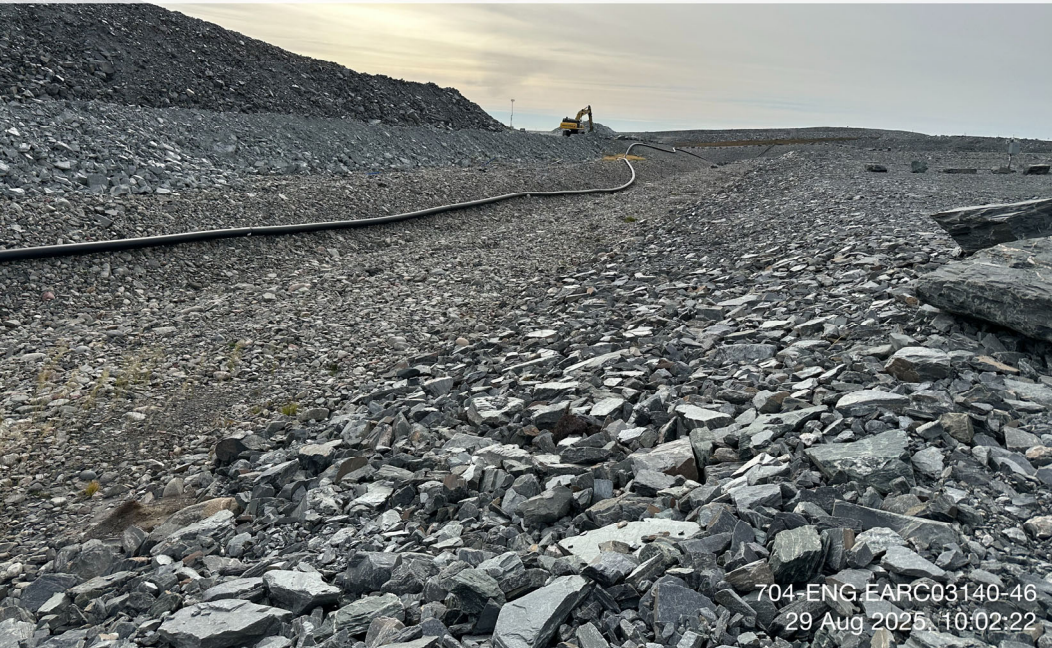
CP4 Thermal Berm - Photo 8:

CP4 Thermal Berm: Upstream side slope of CP4 Thermal Berm and south end of Channel4. Facing southeast.

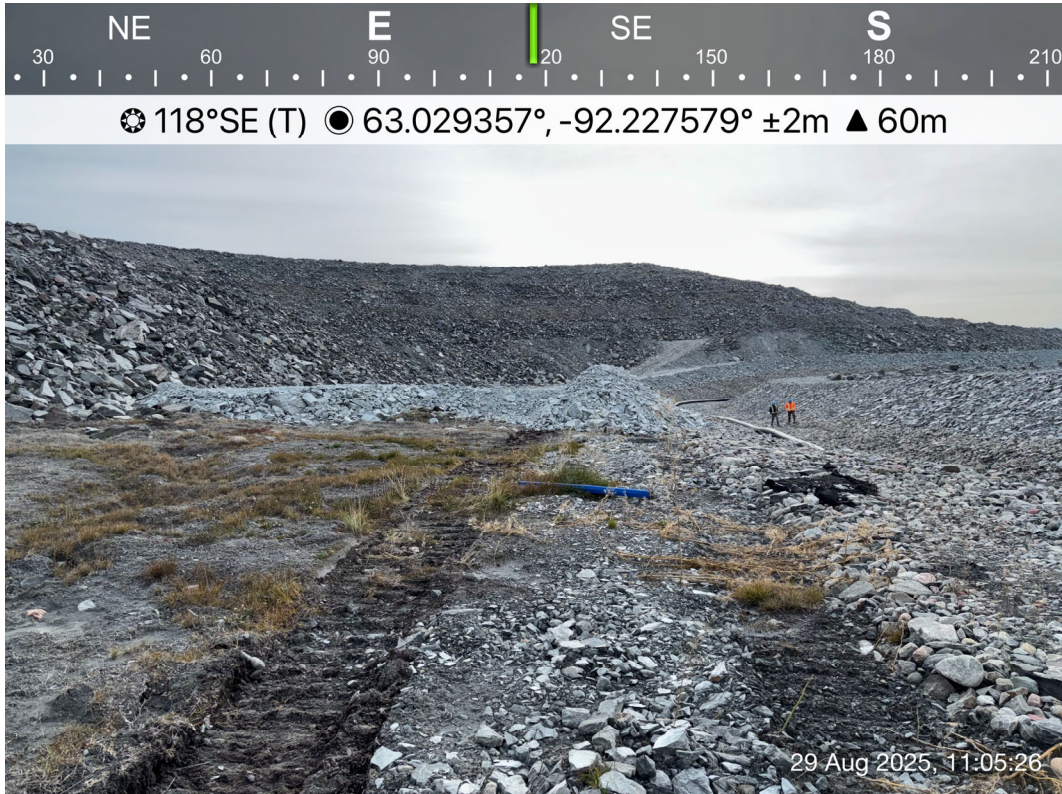
**Channel4 -
Photo 9:**

Channel4: Overview of Channel4, ongoing cover placement, some thaw subsidence observed between Channel4 and WRSF1. Facing southeast.

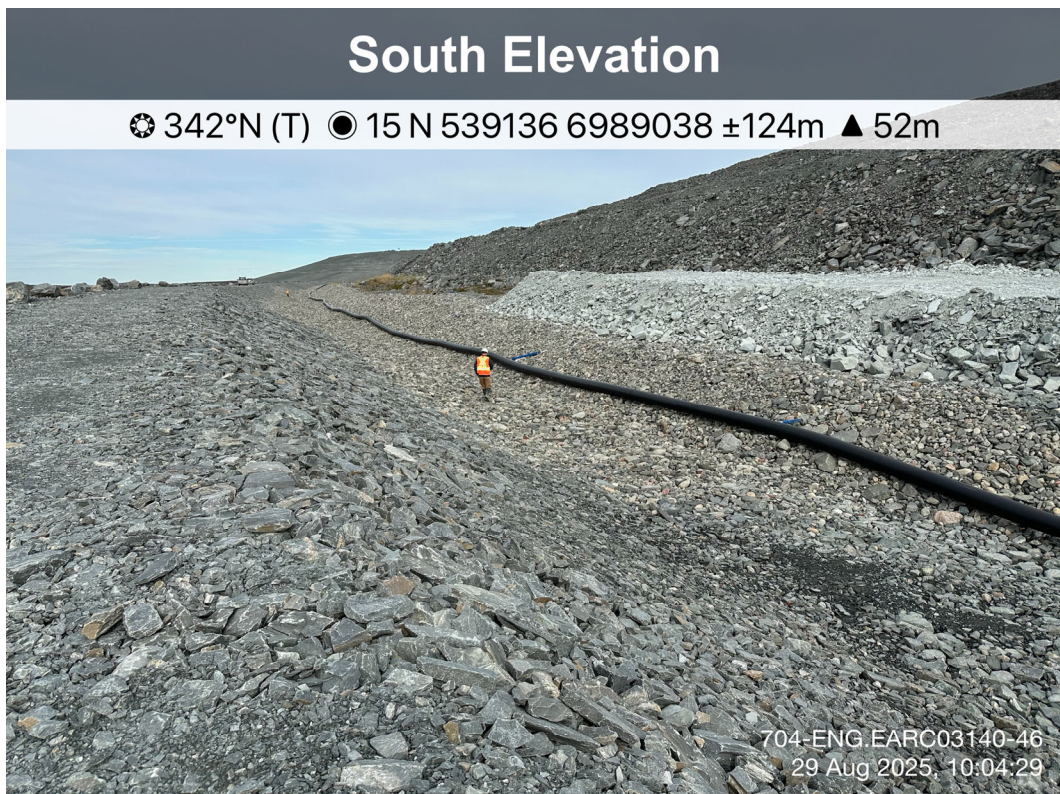
**Channel4 -
Photo 10:**

Channel4: Overview of Channel4, ongoing cover observed between Channel4 and WRSF1. Facing north.

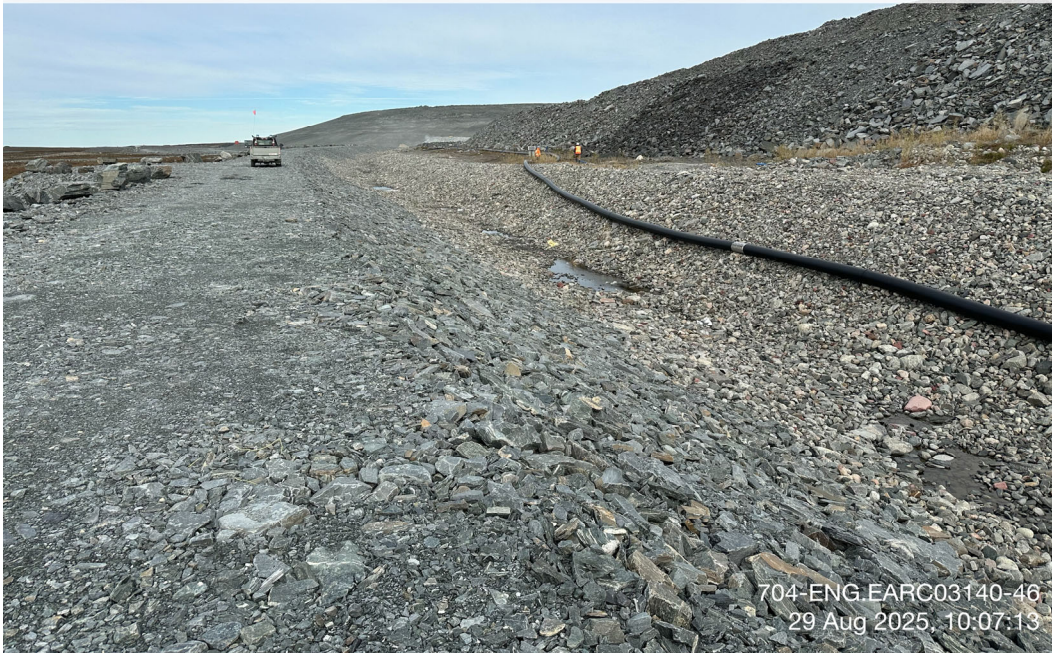
**Channel4 -
Photo 11:**

Channel4: Overview of Channel4 and ROM cover to mitigate surface erosion downstream of the channel, ponding water observed at the base of the channel. Facing north.

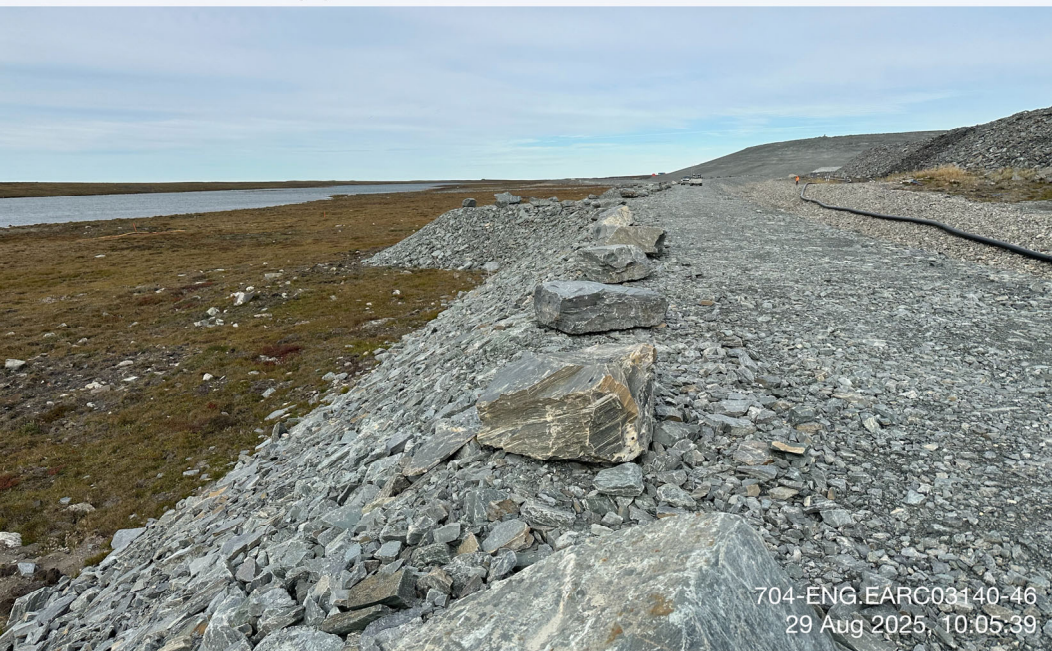
**Channel4 -
Photo 12:**

Channel4: View downstream of Channel4, performing well, no stability or seepage concerns. Facing northwest.
