APPENDIX E

POND CP4, CHANNELS, AND BERMS

TITLE / TITRE
AS-BUILT REPORT FOR CHANNEL 4, POND CP4, AND BERM CP4
CP4 TYPICAL SECTION AND CP4 THERMAL PROTECTION BERM PROFILE

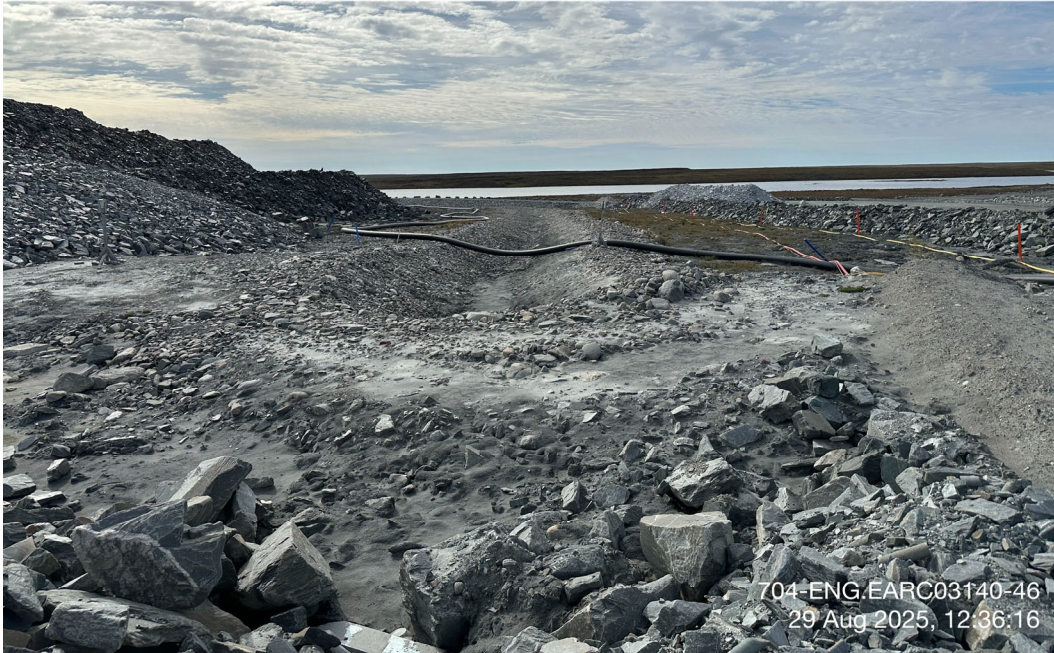
**Channel4 -
Photo 13:**

Channel4: Overview of upper portion, performing well, no stability concerns.
Facing southwest.

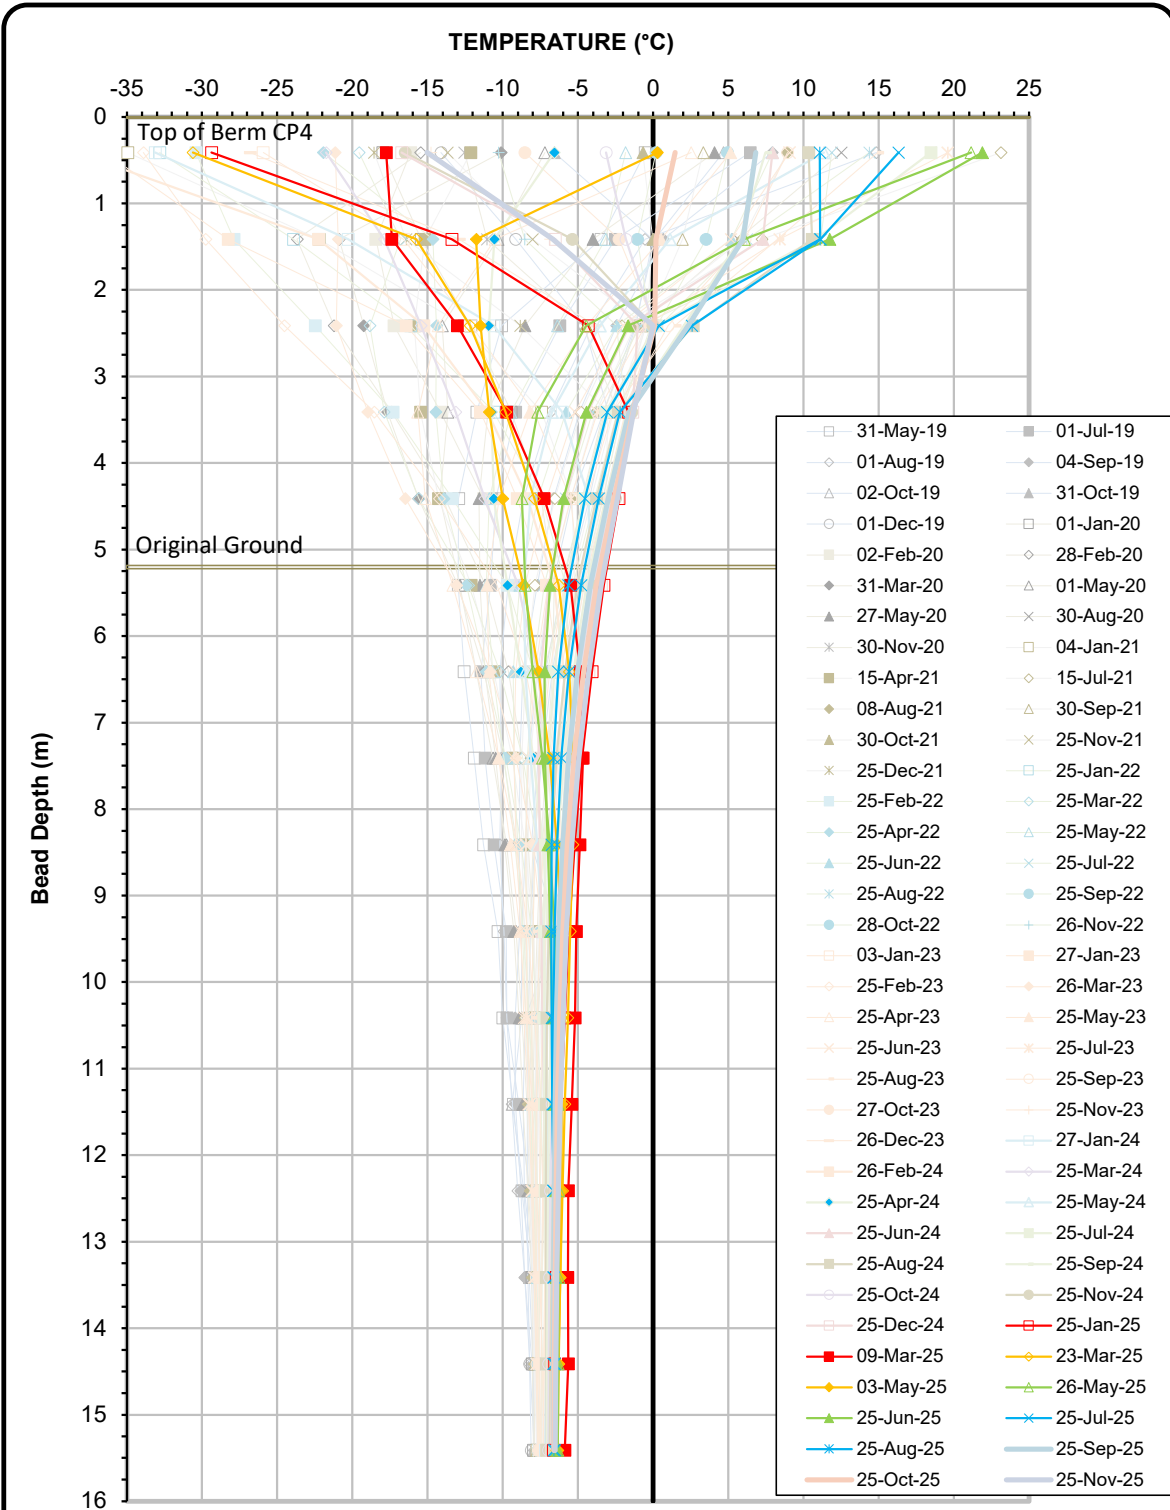
Ground Temperature Profile for Cable GTC-01

Serial No.: 2685
 Date Installed: May 18, 2019
