ENTERPRISES

ᐱᓕᑕᑲ ᐃᖃᐁᐃᓴᖃᐱᓴᓴᐃᑦ ᓕᑦᑎᑦ

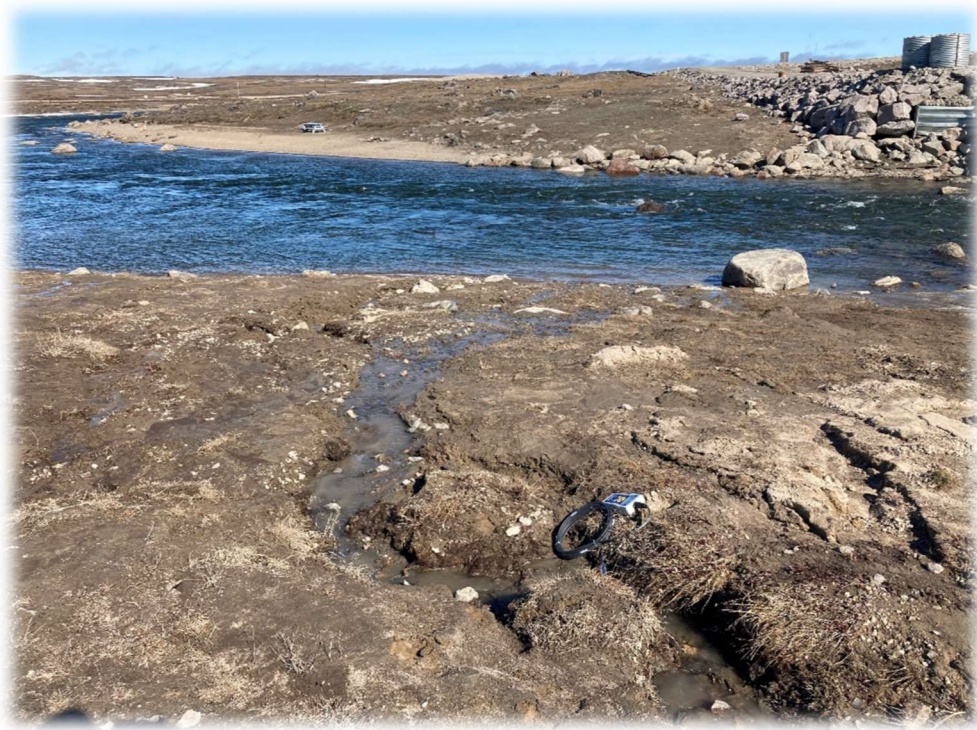
Monitoring Station 01

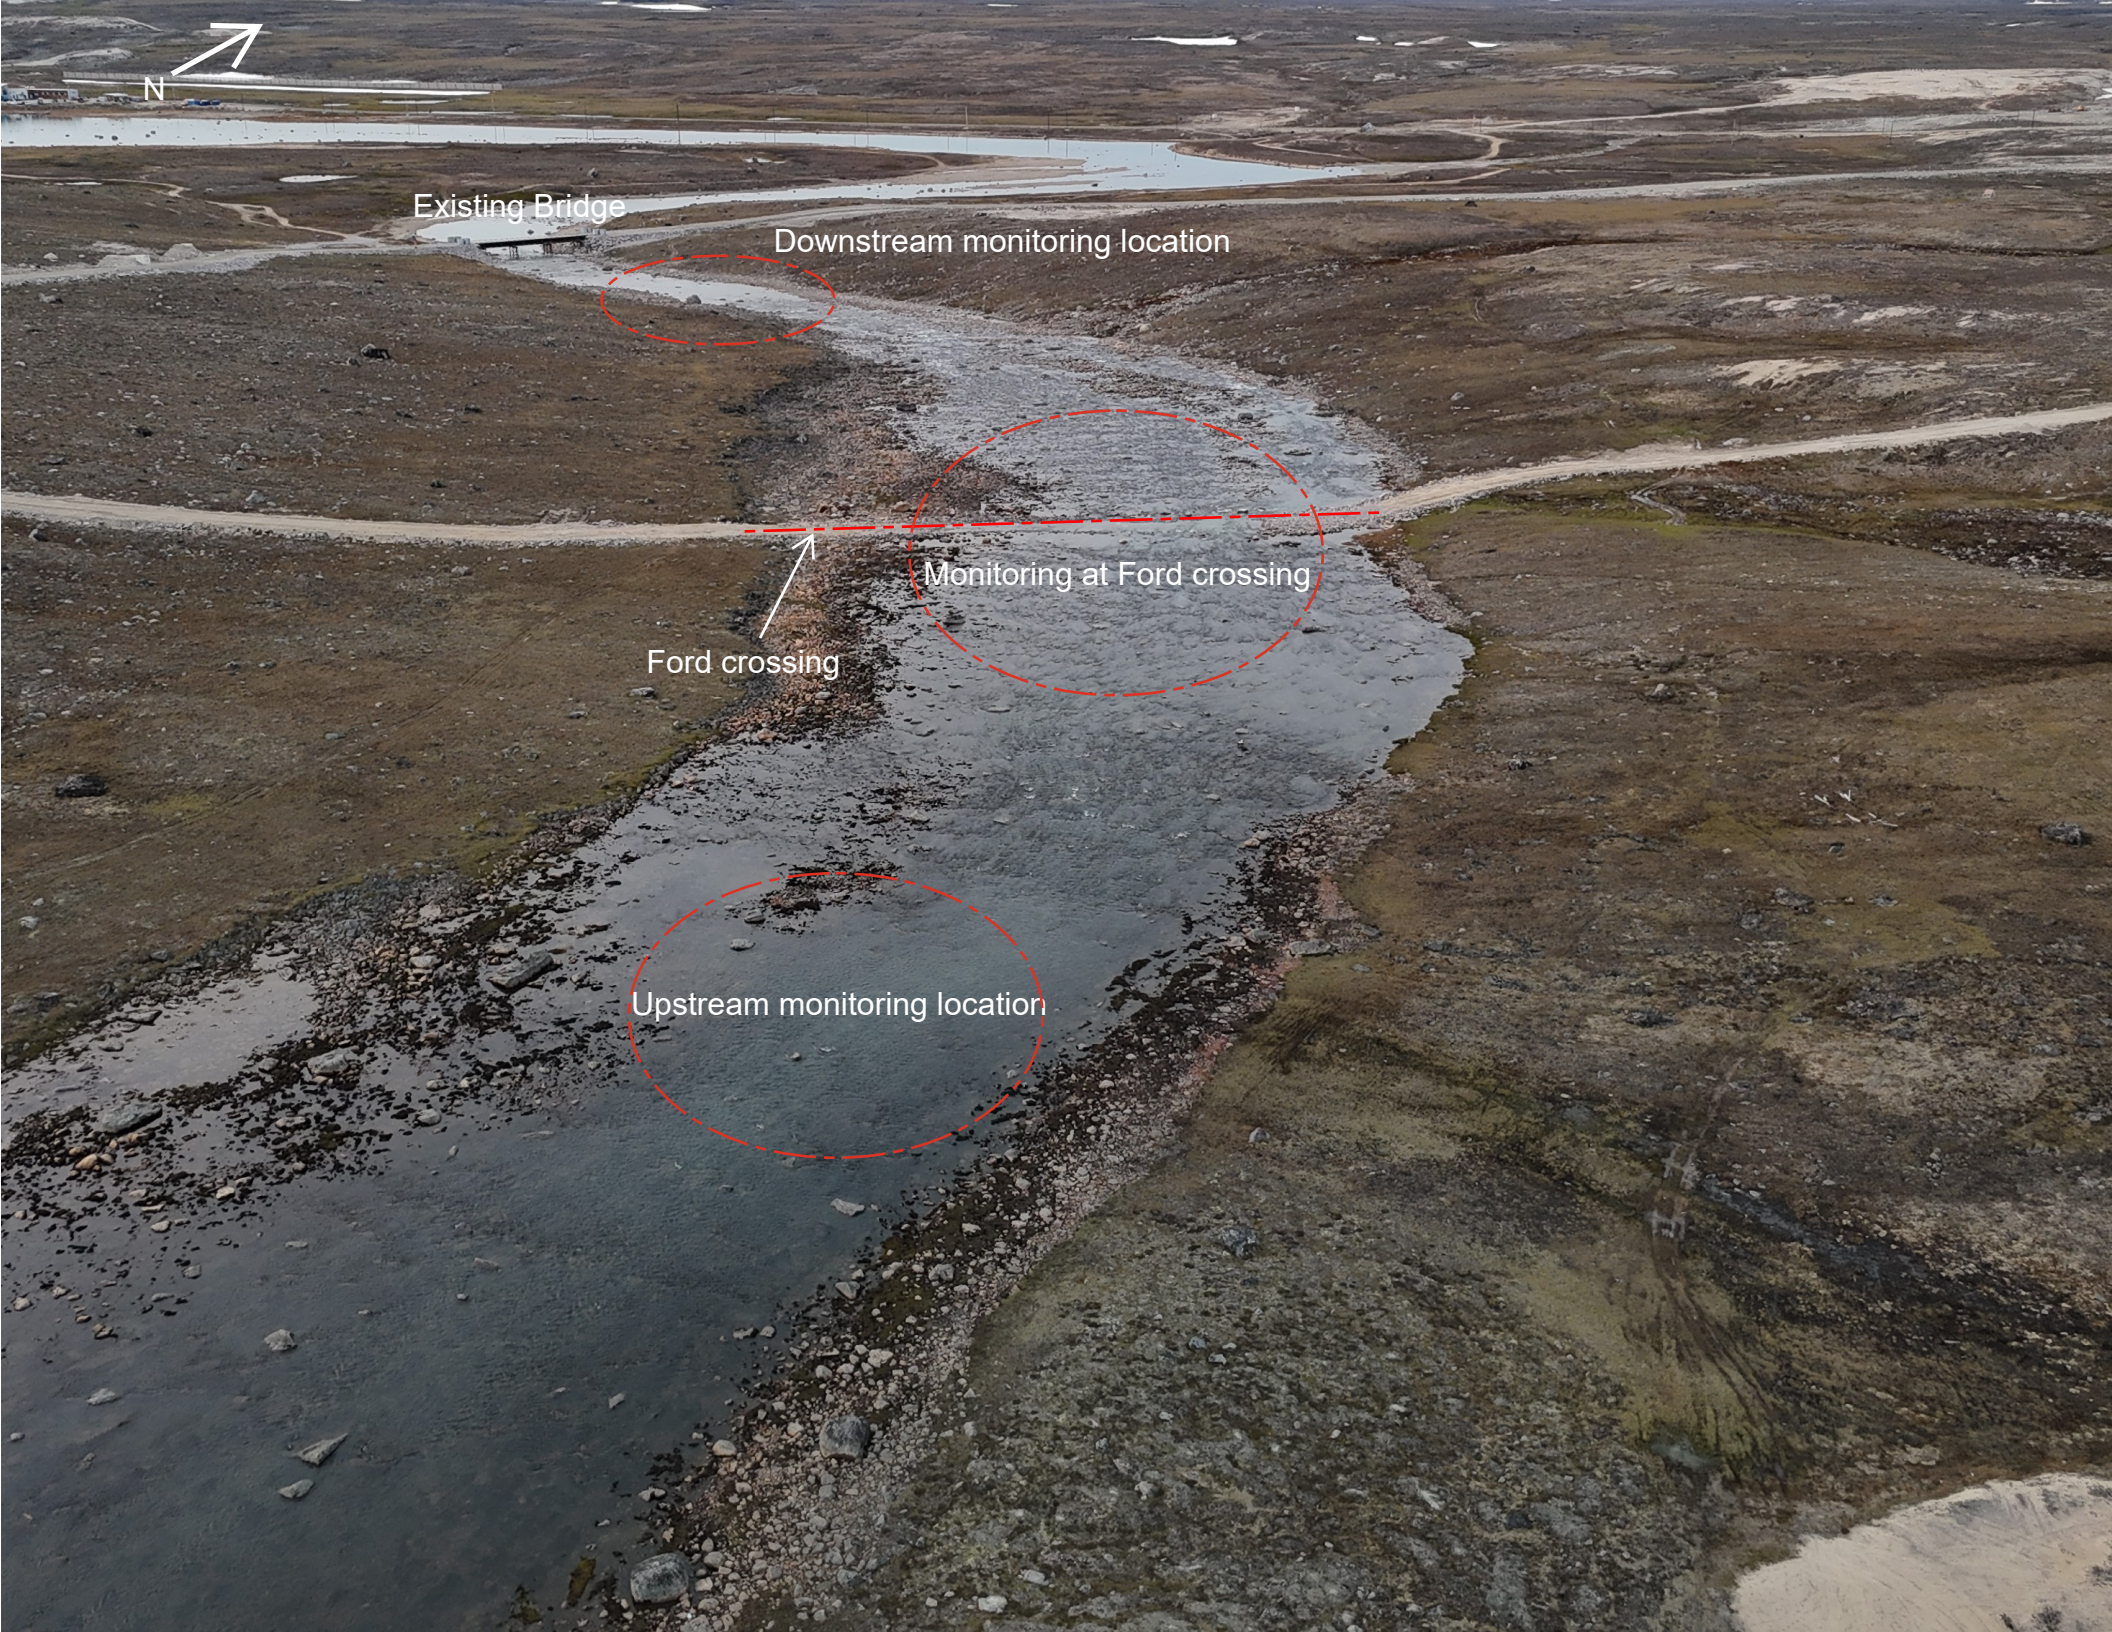
- Aug 9: Fish monitoring at the Ford crossing location, at 145 m upstream and at 250 m downstream by the wildlife monitor from 11 AM to 6 PM. No fish was observed. The monitoring was witnessed by the environmental monitor, the site superintendent and the consultant, refer to attached signed sheet.
- Aug 10: Fish monitoring at the Ford crossing, upstream and downstream, by the wildlife monitor before crossing the river. No fish was observed. The monitoring was witnessed by the environmental monitor, the site superintendent and the consultant, refer to attached signed sheet.
- Aug 10: The excavator, escorted by the wildlife monitor on an ATV, crossed the river at 11:02. The crossing took one minute, refer to the attached pictures.
- Aug 10: Fish monitoring at the Ford crossing after the excavator crossing. No fish was observed for the rest of the day.

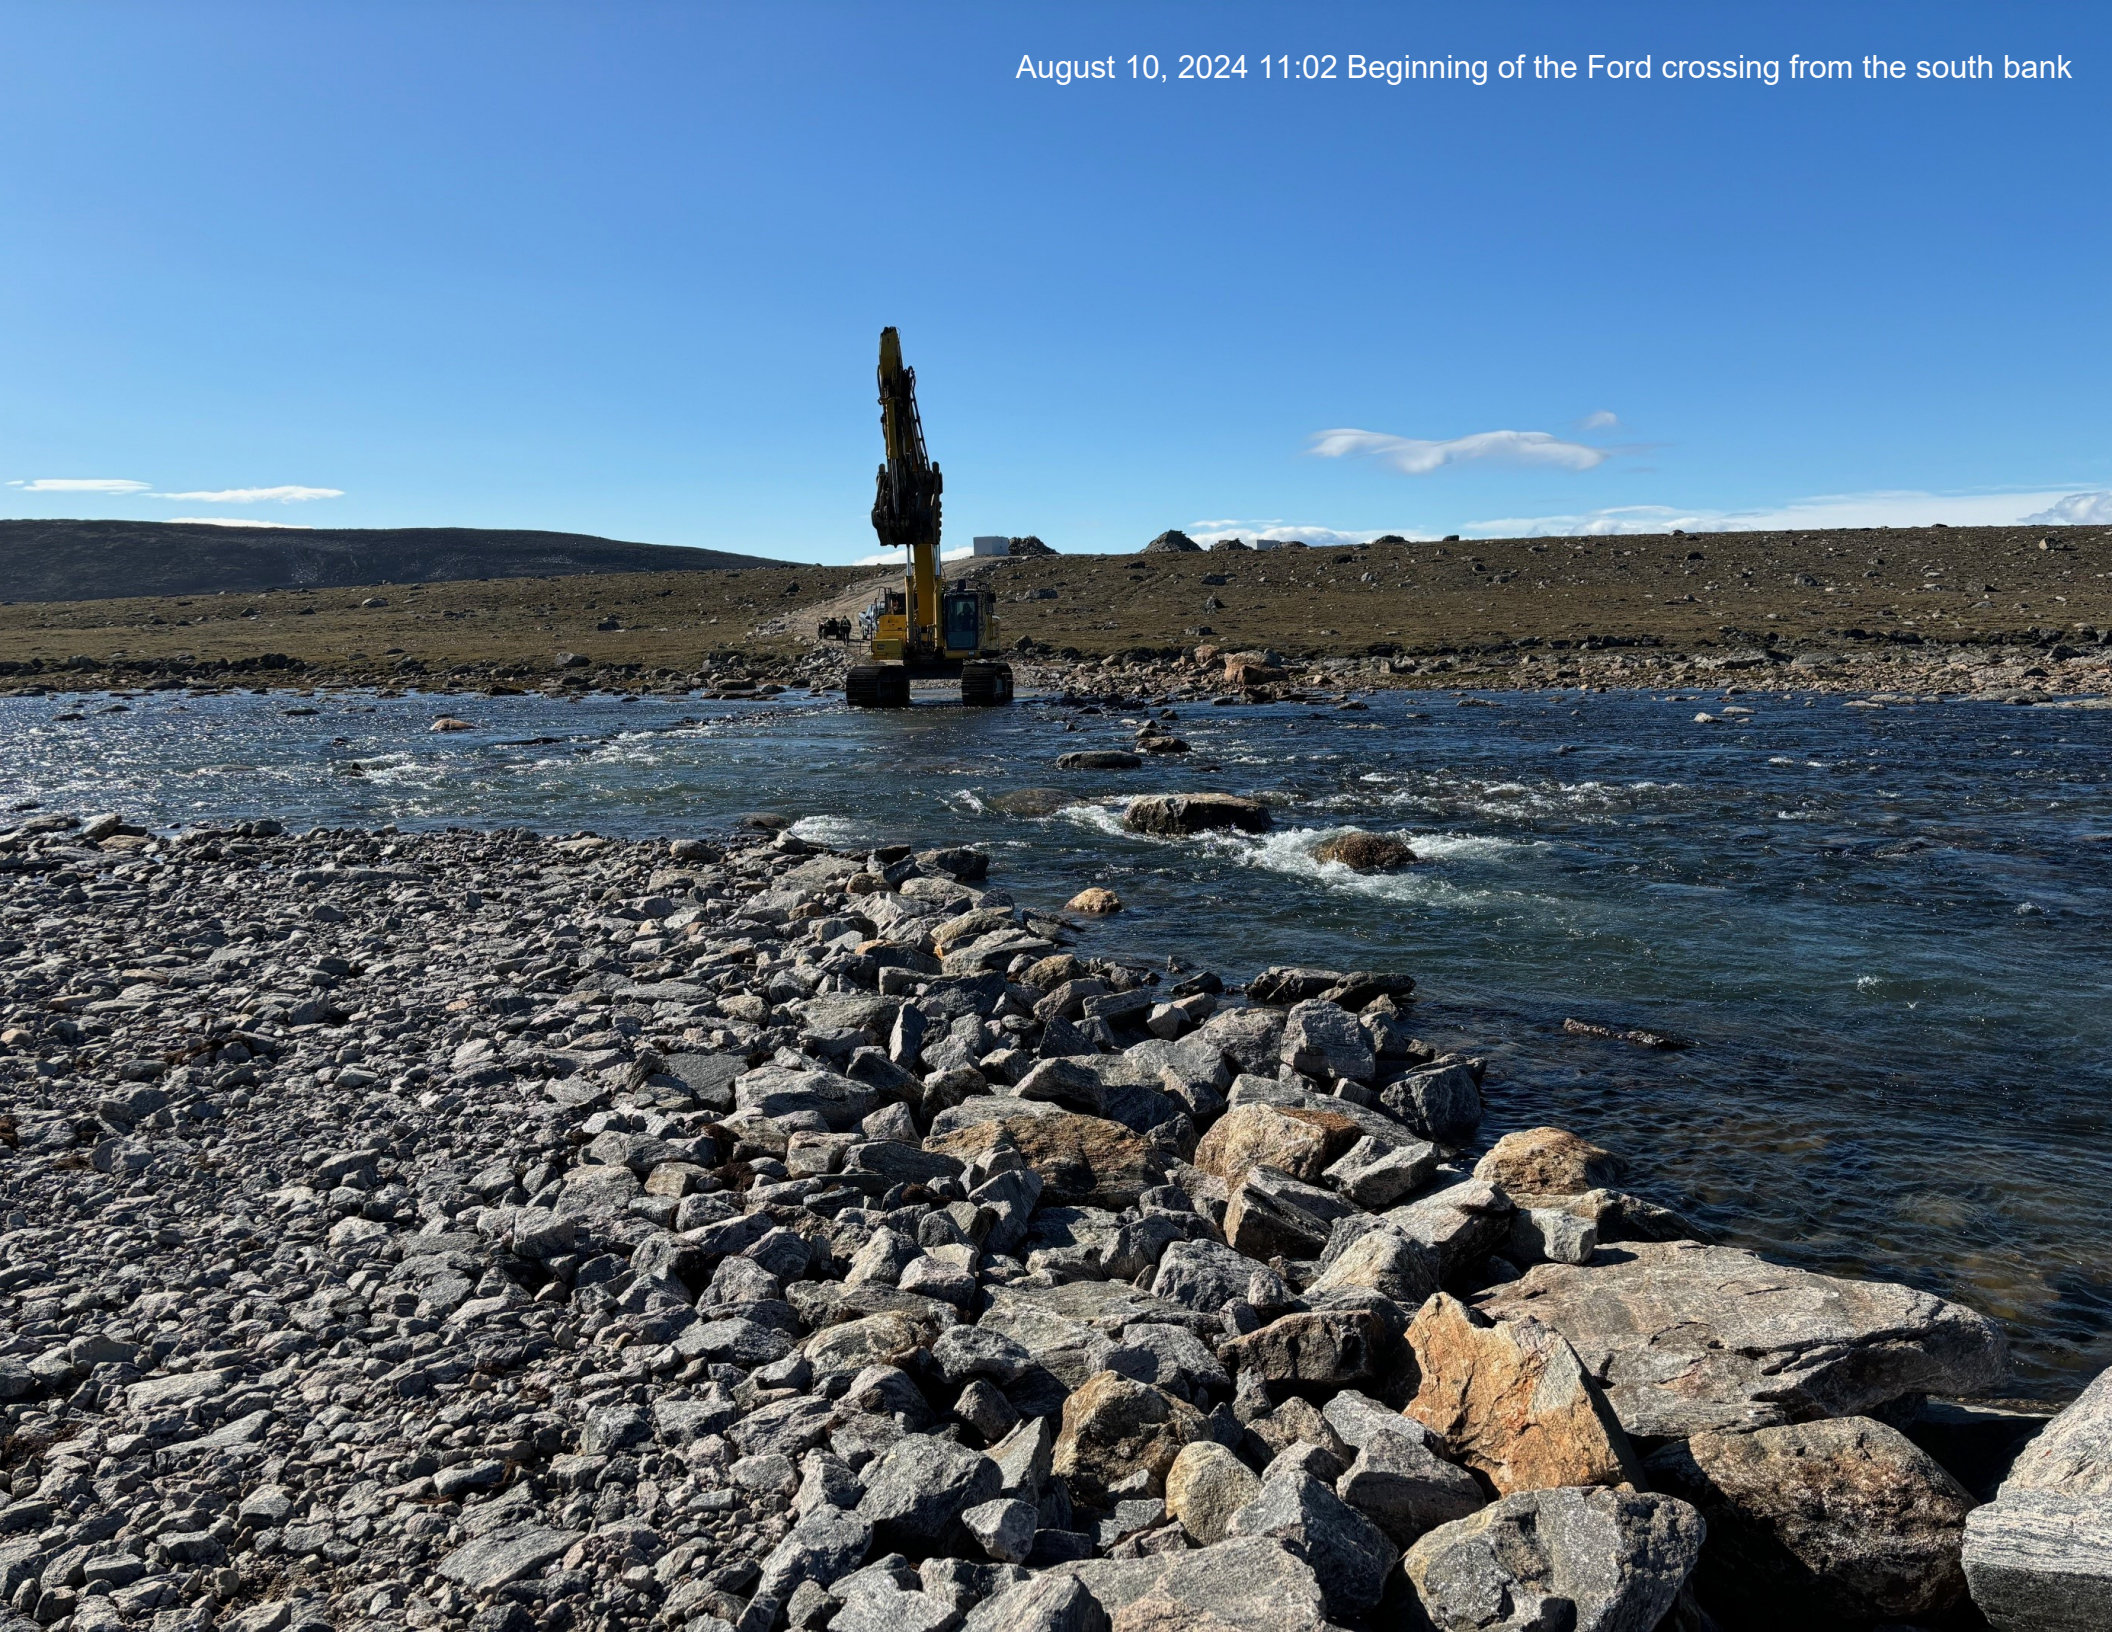
August 10, 2024 11:02 crossing

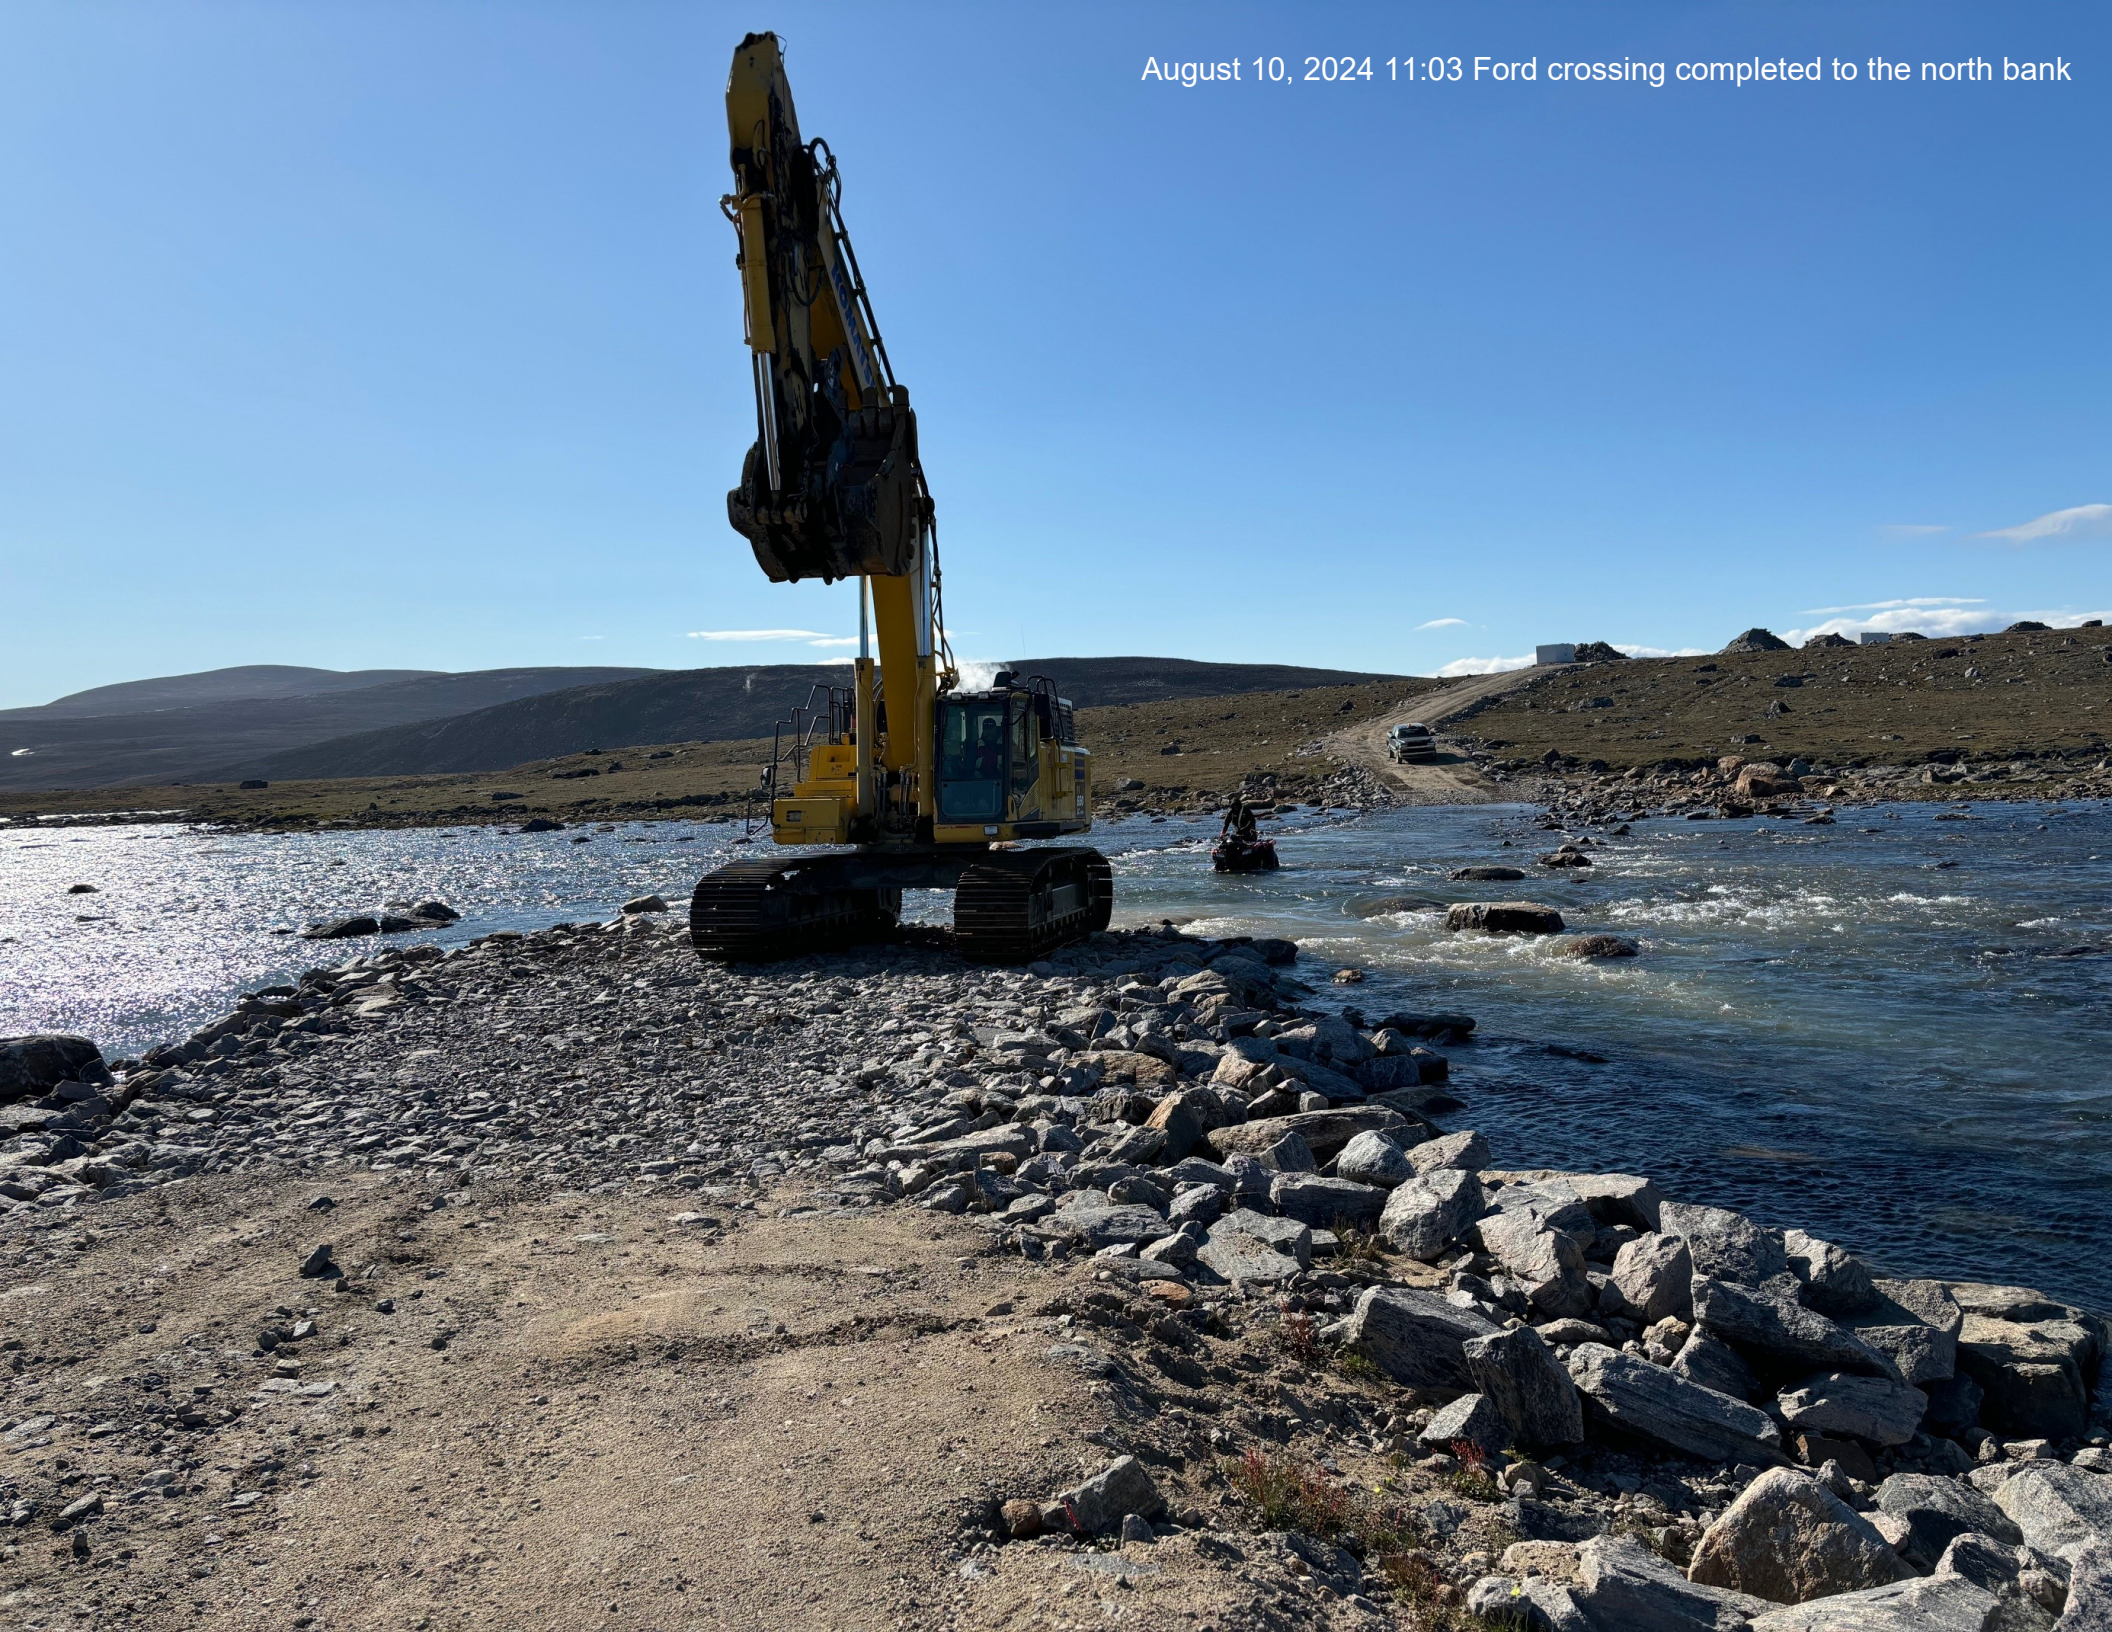
August 12, 2024 Ford crossing conditions

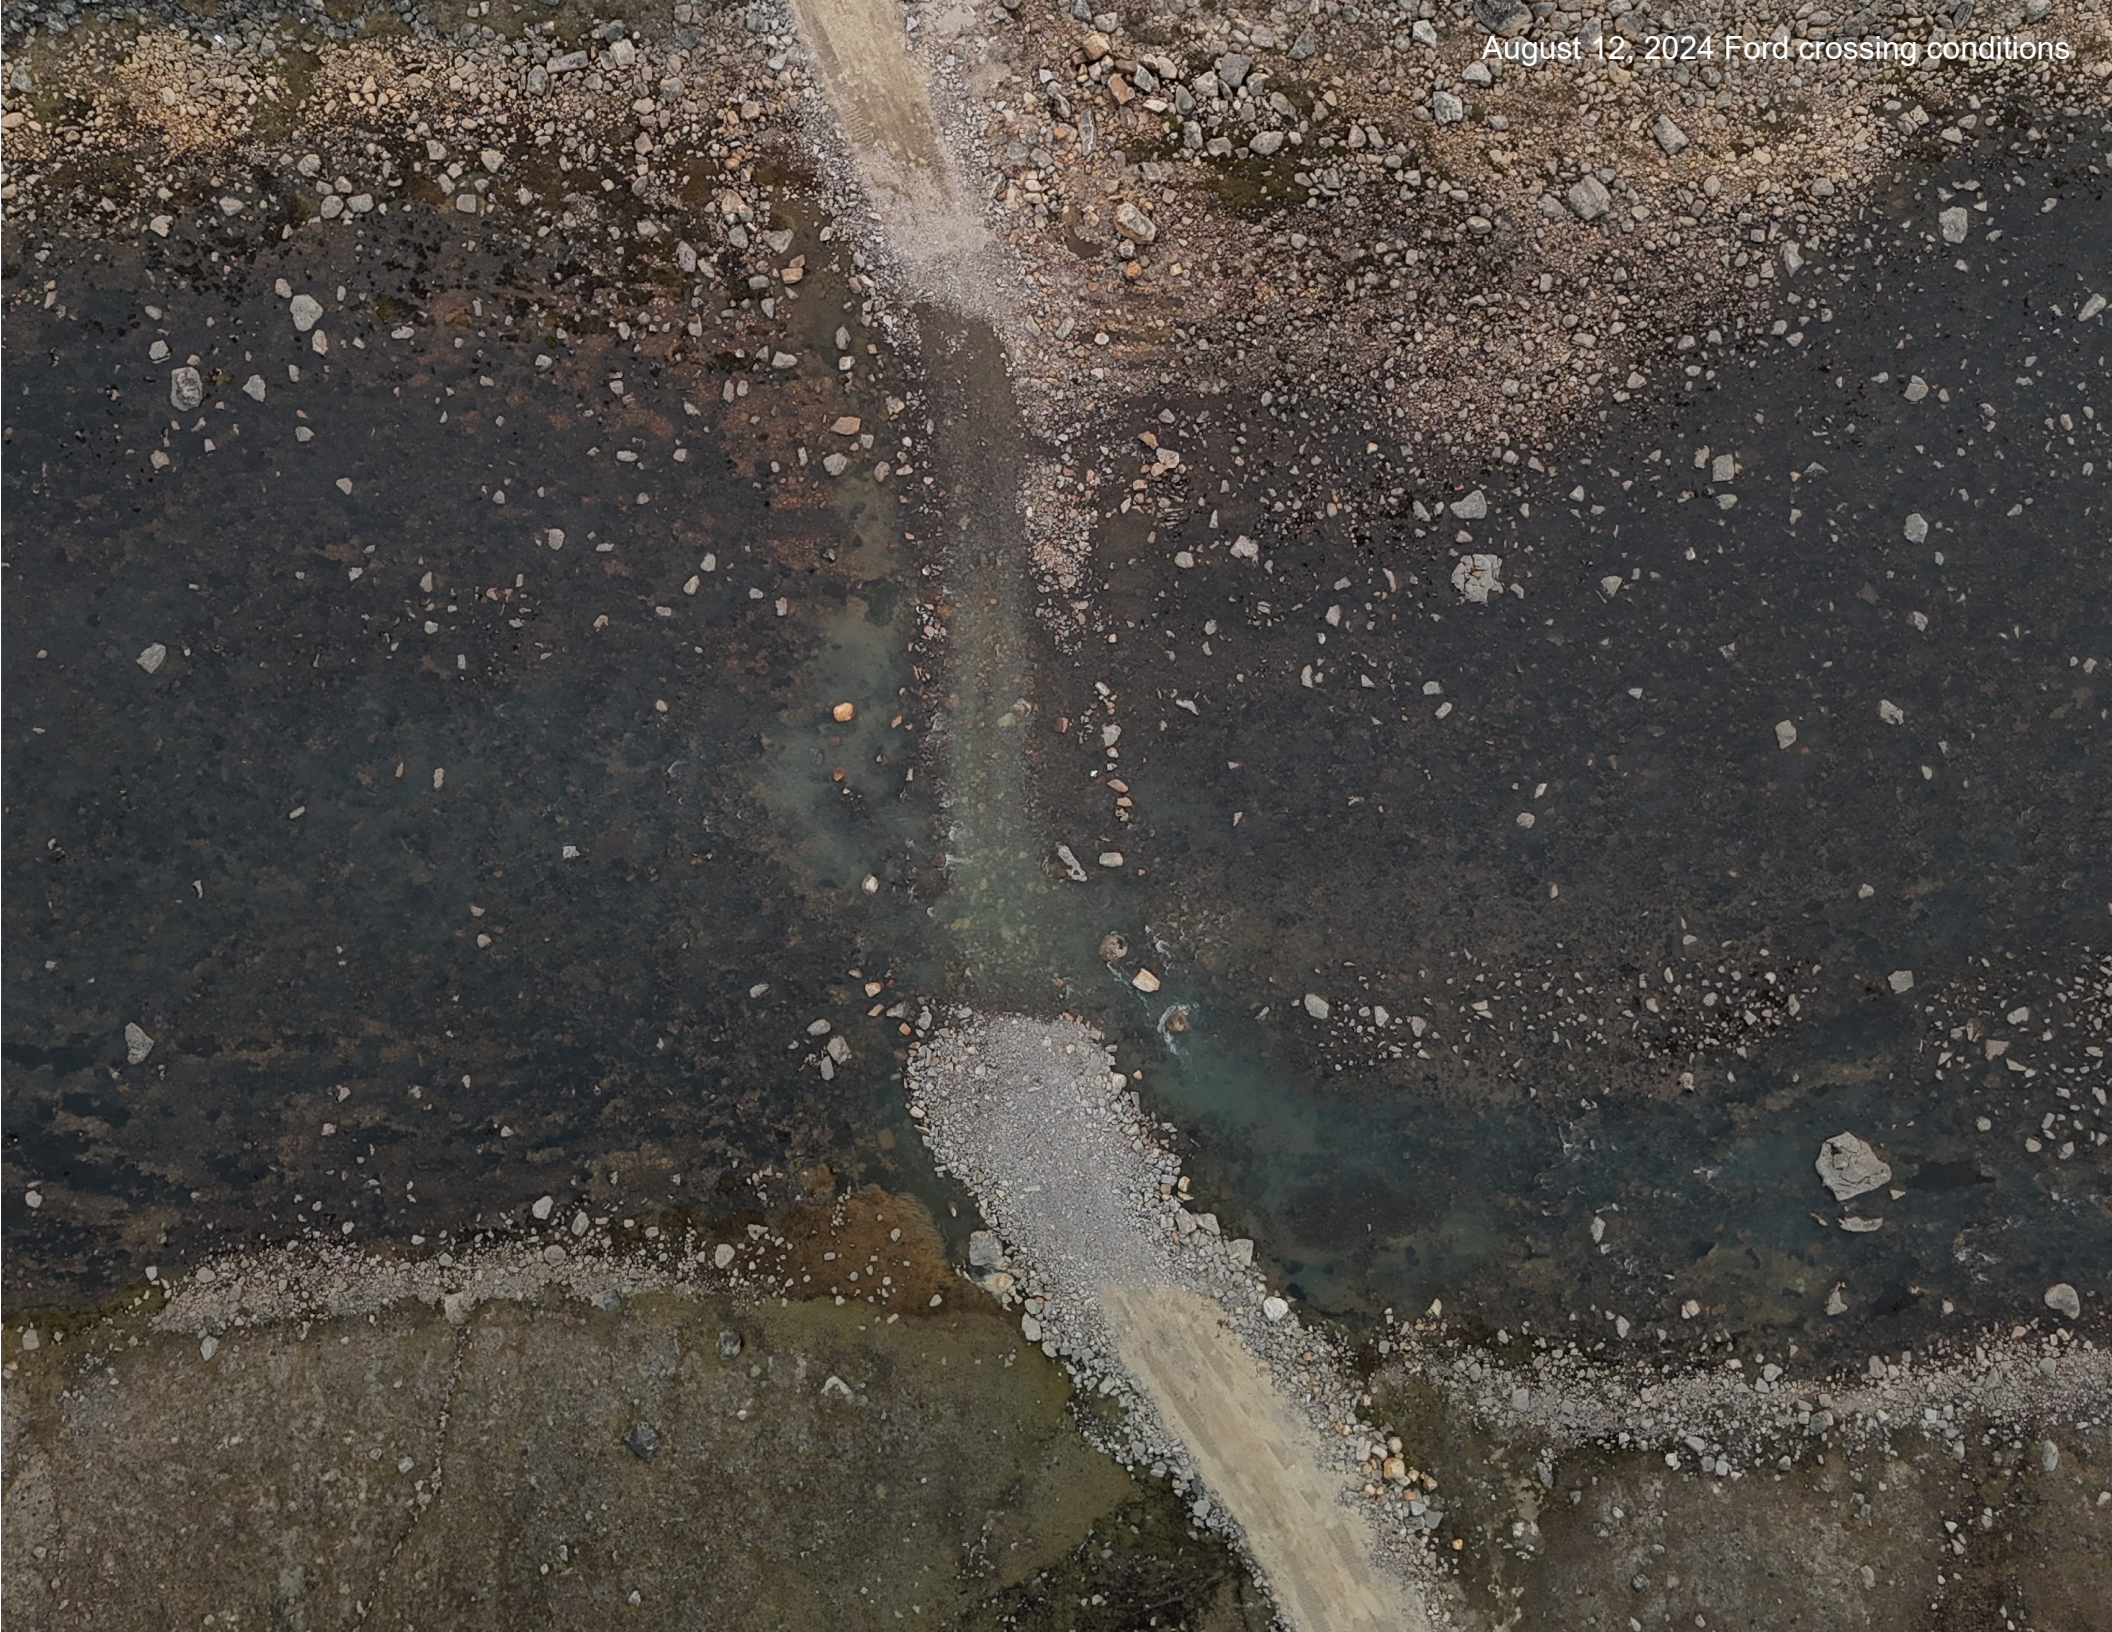
**Clyde River Harbour Development
(NIRB) Annual Report, File no.21YN032**
