# TOTE ROAD BG-24

Site ID:	BG-24	Dates Surveyed:	5-Jul-23	Waterbody Type:	Stream
Project Interaction:	Tote Road Culvert	UTM Coordinates:	17W 548766 E 7918878 N

BAFFINLAND IRON MINES  
MARY RIVER PROJECT

**North/South Consultants Inc.**  
Aquatic Environment Specialists

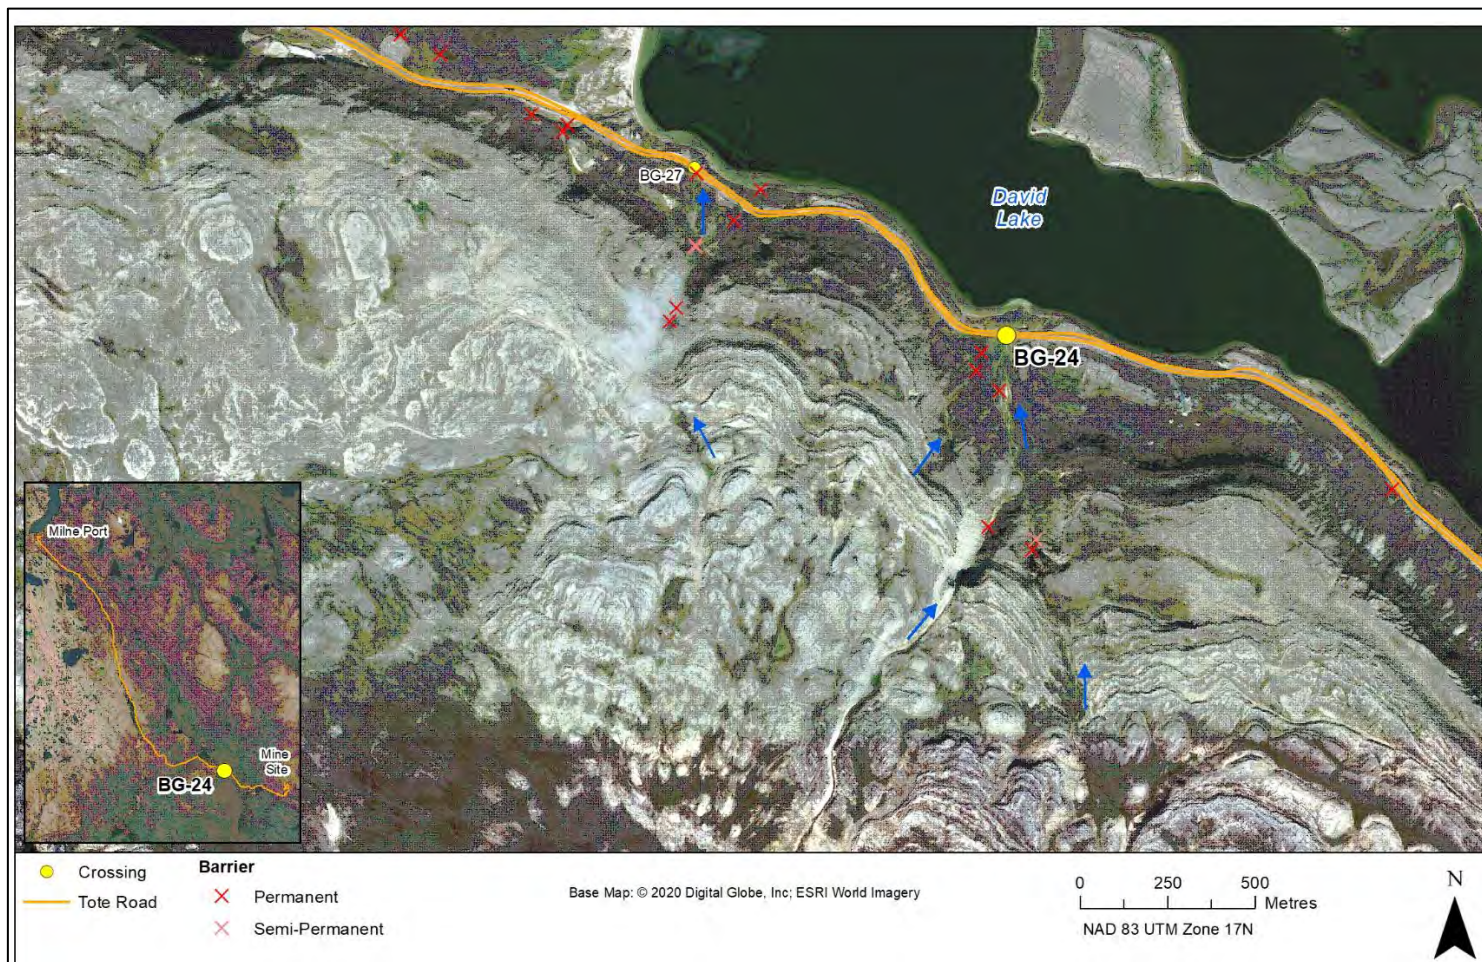
The Tote Road crosses a small, unnamed stream at site BG-24 that flows 110 m north into David Lake. Although a bathymetric survey has not been conducted, David Lake is believed to be of sufficient depth to support overwintering of both species.

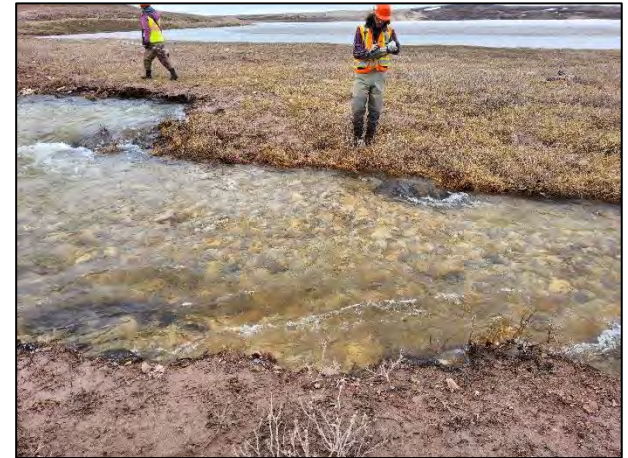
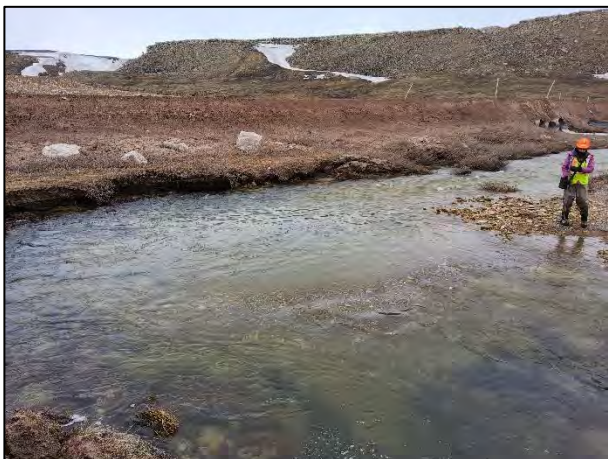
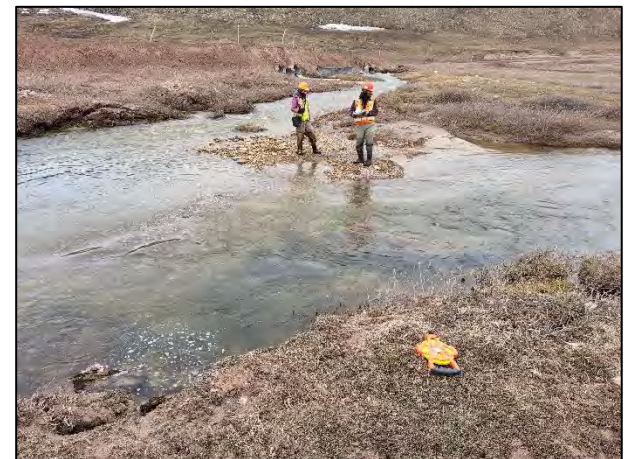
Photos 1-1. Photos taken 20 m downstream (top) and 60 m downstream (bottom) in spring 2023: (A,D) facing upstream; (B,E) facing downstream; and (C,F) across (left bank looking at right bank).

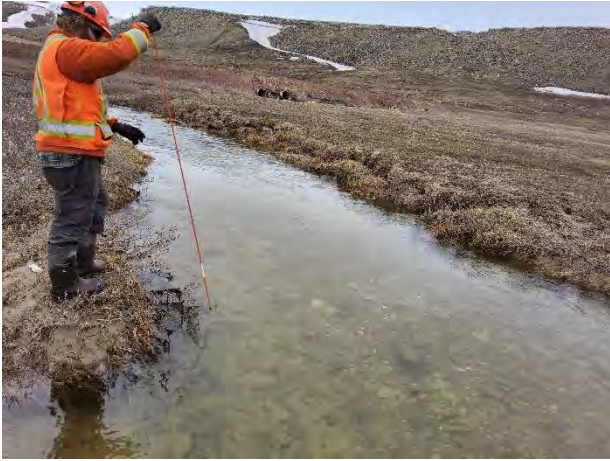
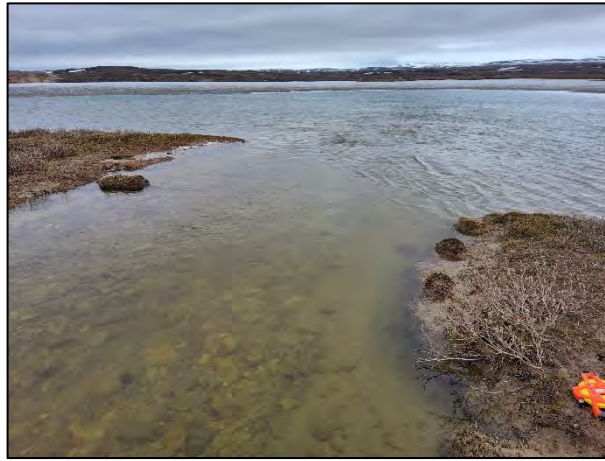
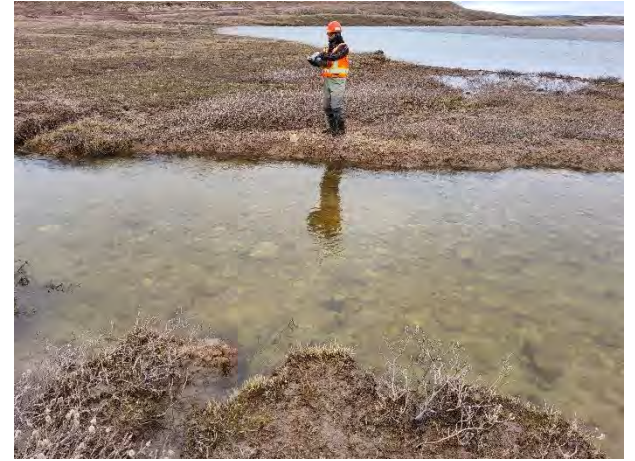
Photos 1-2. Photos taken 100 m downstream in spring 2023: (A) facing upstream; (B) facing downstream; and (C) across (right bank looking at left bank).

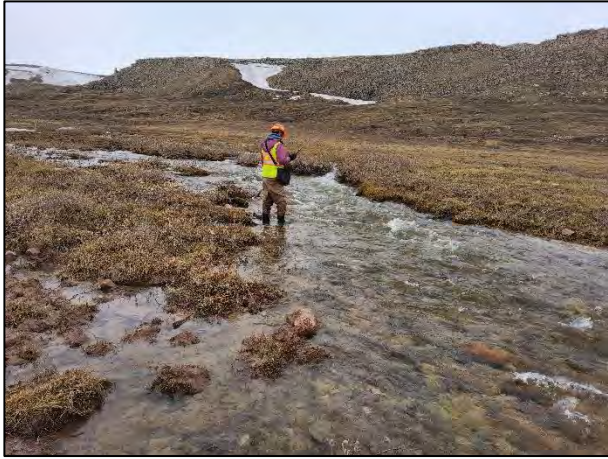
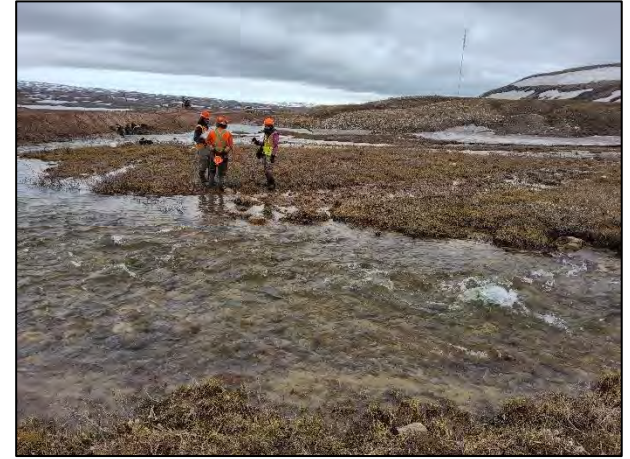
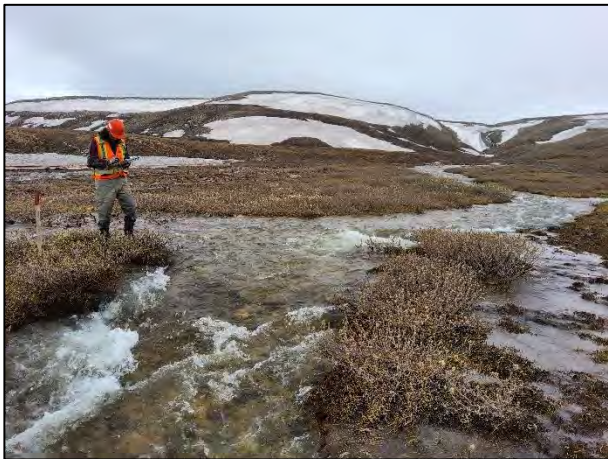
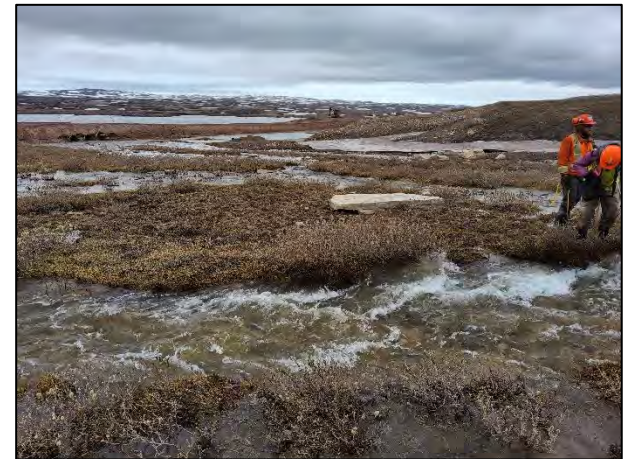
Photos 1-3. Photos taken 20 m upstream (top) and 60 m upstream (bottom) in spring 2023: (A,D) facing upstream; (B,E) facing downstream; and (C,F) across (right bank looking at left bank).

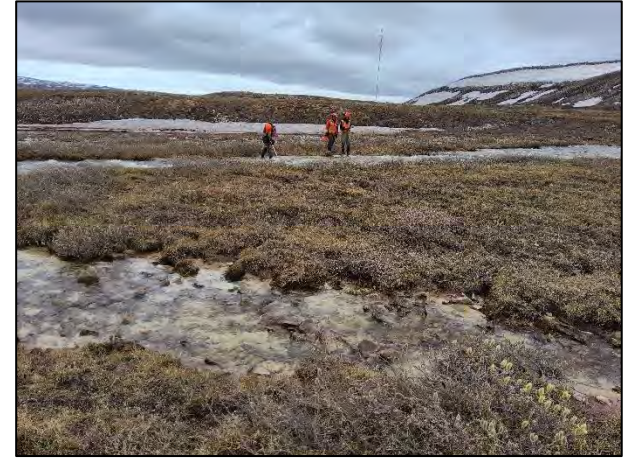
Photos 1-4. Photos taken 100 m upstream in spring 2023: (A) facing upstream; (B) facing downstream; and (C) across (left bank looking at right bank).

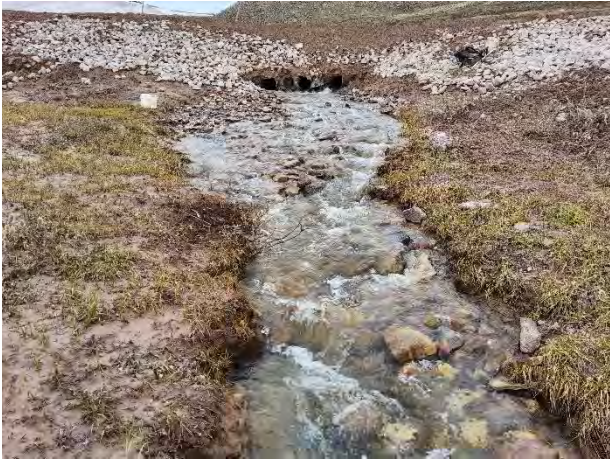
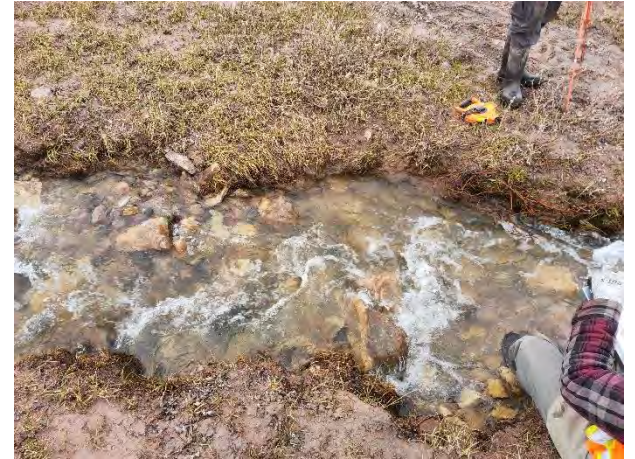
Photos 1-1. Photos taken 20 m downstream in spring 2023: (A) facing upstream; (B) facing downstream; and (C) across (left bank looking at right bank).

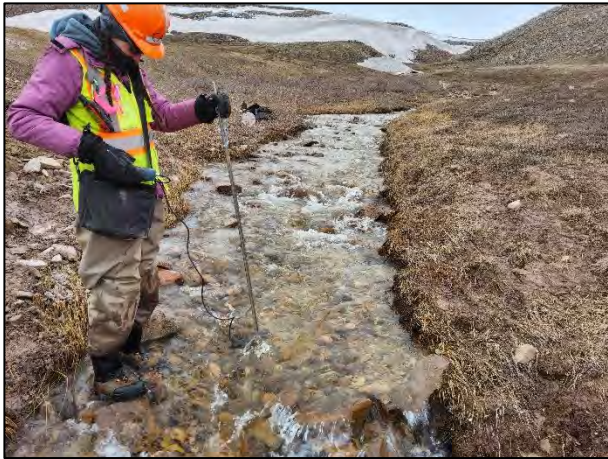
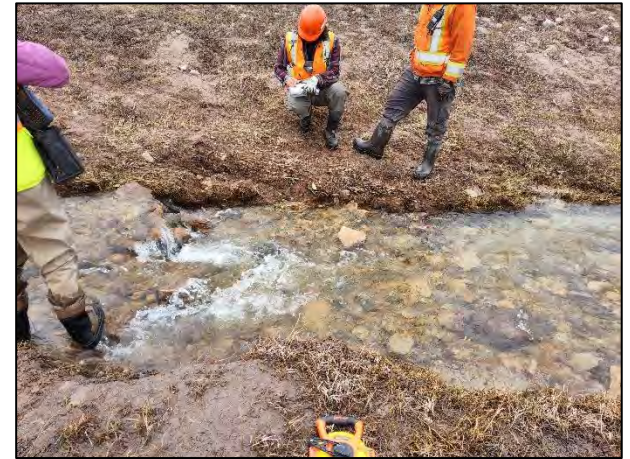
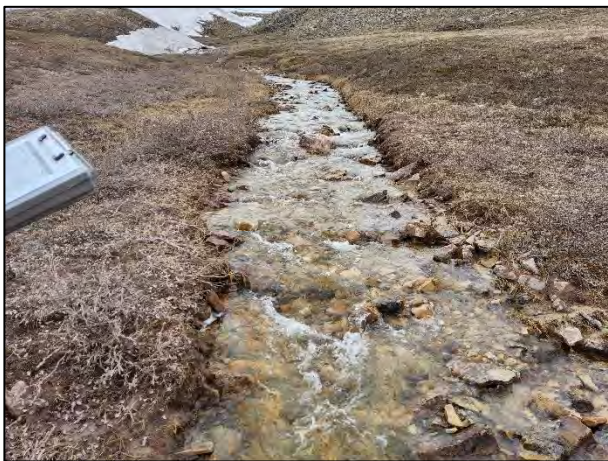
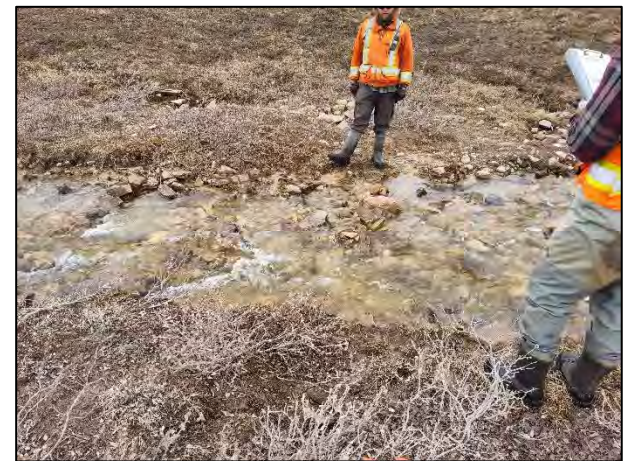
Photos 1-2. Photos taken 20 m upstream (top) and 60 m downstream (bottom) in spring 2023: (A,D) facing upstream; (B,E) facing downstream; and (C,F) across (left bank looking at right bank).

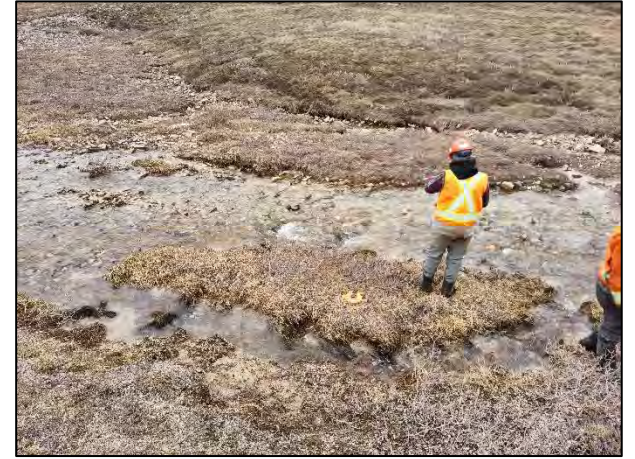
Photos 1-3. Photos taken 100 m upstream in spring 2023: (A) facing upstream; (B) facing downstream; and (C) across (left bank looking at right bank).

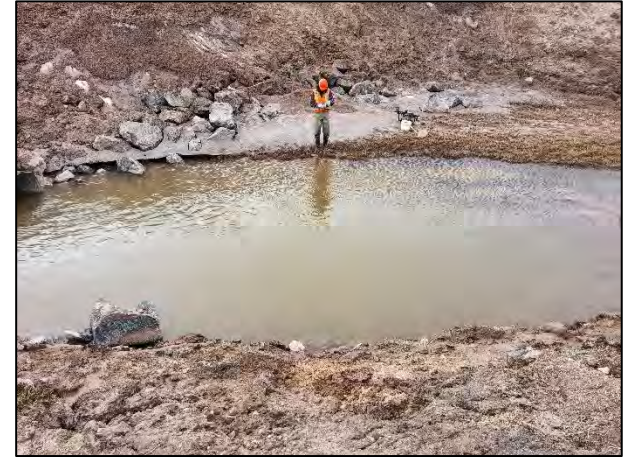
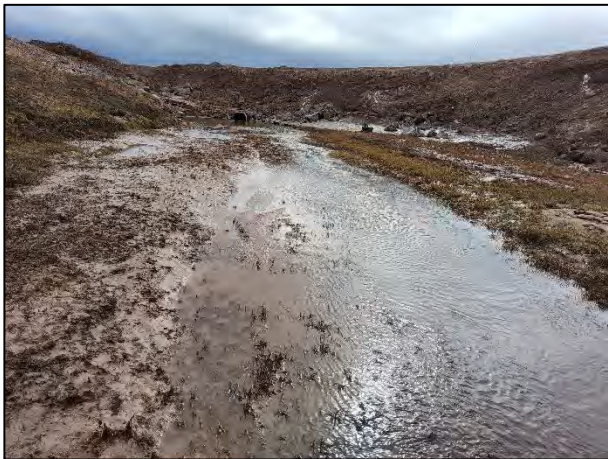
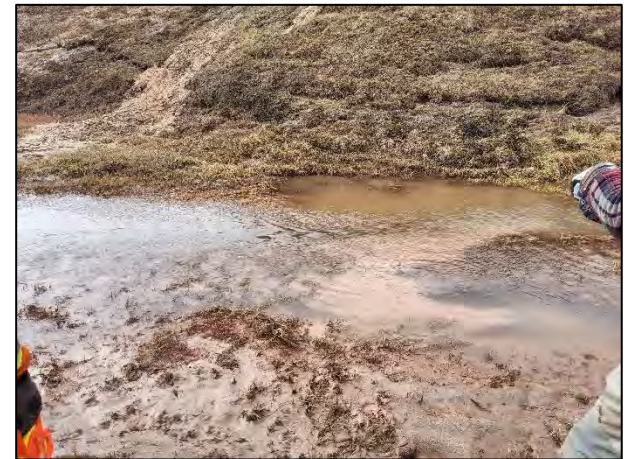
Photos 1-1. Photos taken 20 m downstream (top) and 60 m downstream (bottom) in spring 2023: (A,D) facing upstream; (B,E) facing downstream; and (C,F) across (left bank looking at right bank).

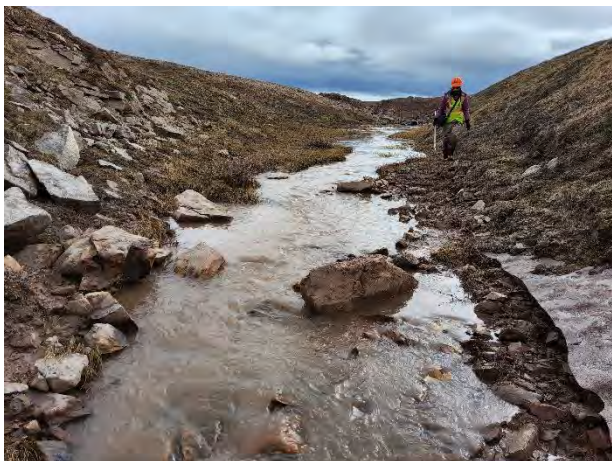
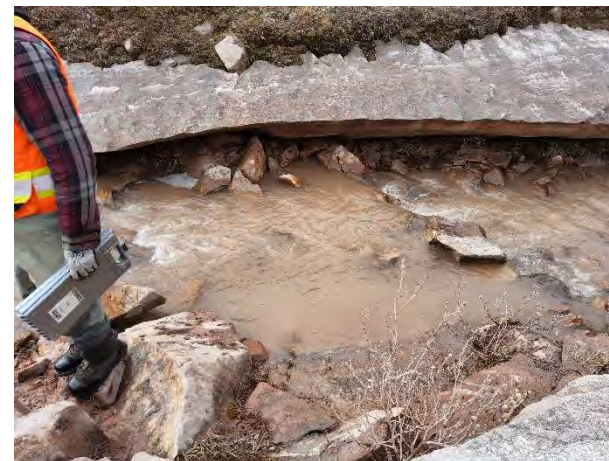
Photos 1-2. Photos taken 100 m downstream in spring 2023: (A) facing upstream; (B) facing downstream; and (C) across (left bank looking at right bank).

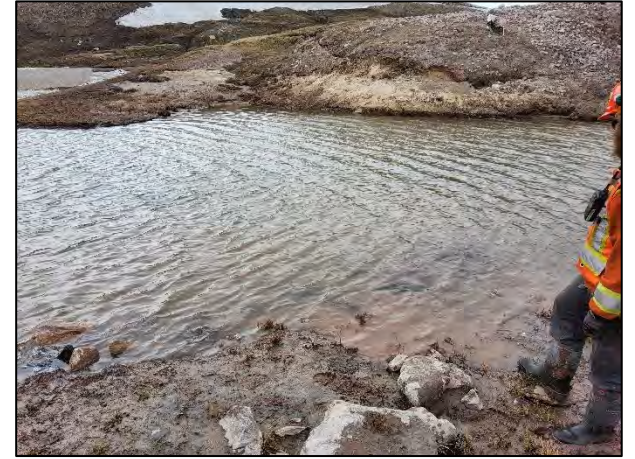
Photos 1-3. Photos taken 20 m upstream in spring 2023: (A) facing upstream; (B) facing downstream; and (C) across (left bank looking at right bank).

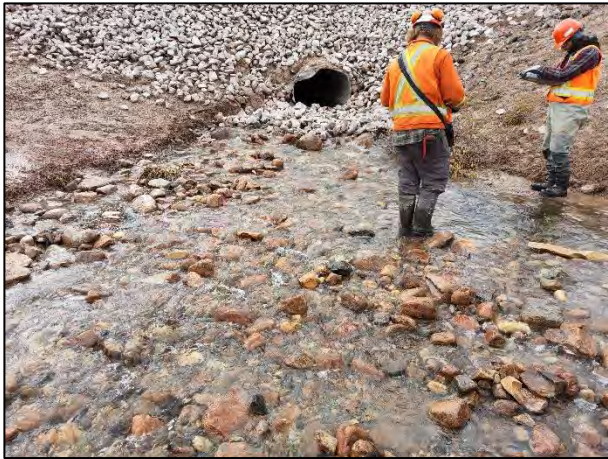
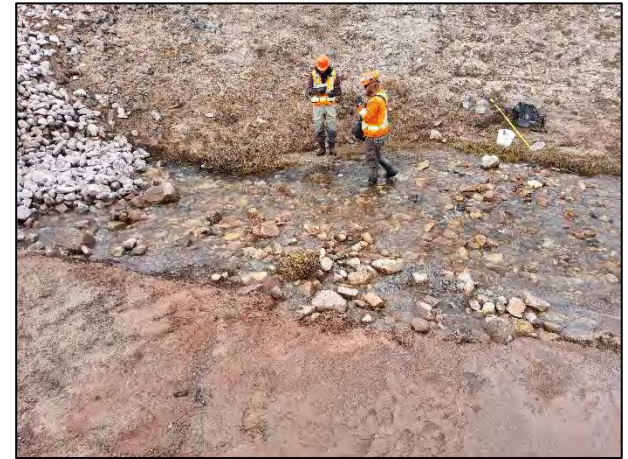
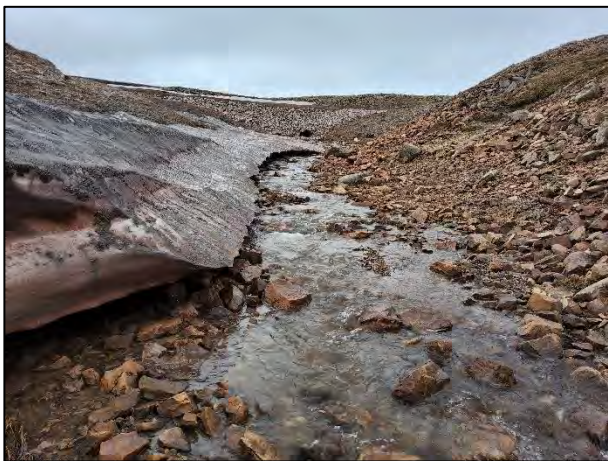
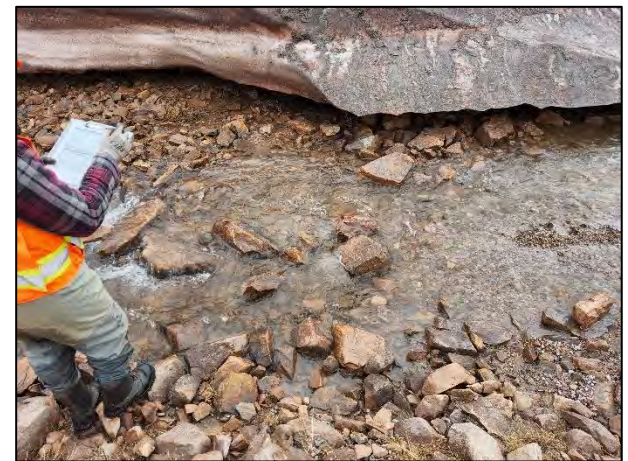
Photos 1-1. Photos taken 20 m downstream (top) and 60 m downstream (bottom) in spring 2023: (A,D) facing upstream; (B,E) facing downstream; and (C,F) across (left bank looking at right on top, right bank looking at left bank on bottom).

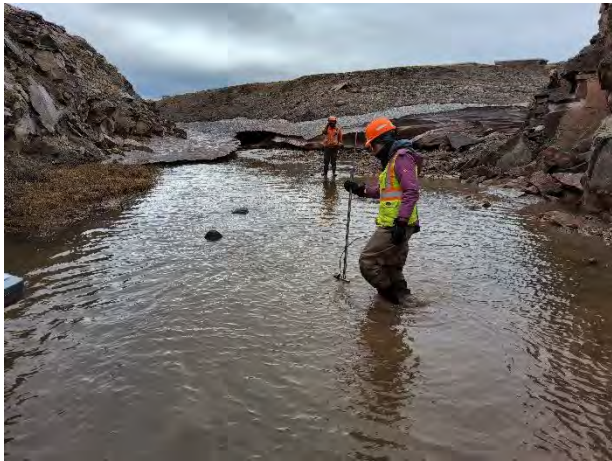
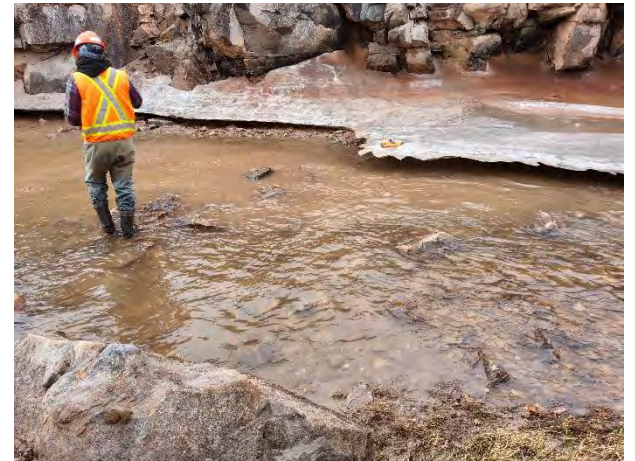
Photos 1-2. Photos taken 100 m downstream in spring 2023: (A) facing upstream; (B) facing downstream; and (C) across (left bank looking at right bank).

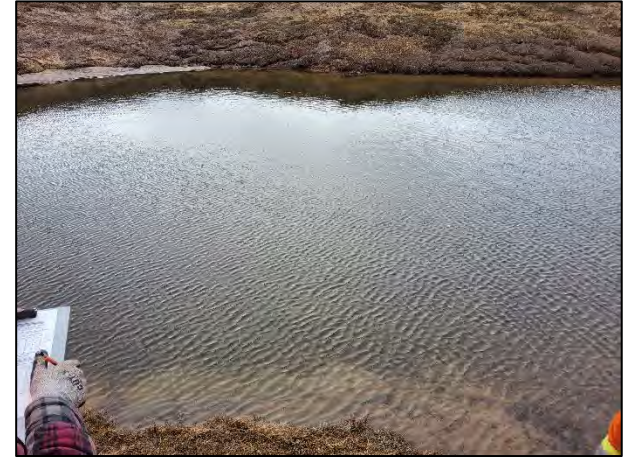
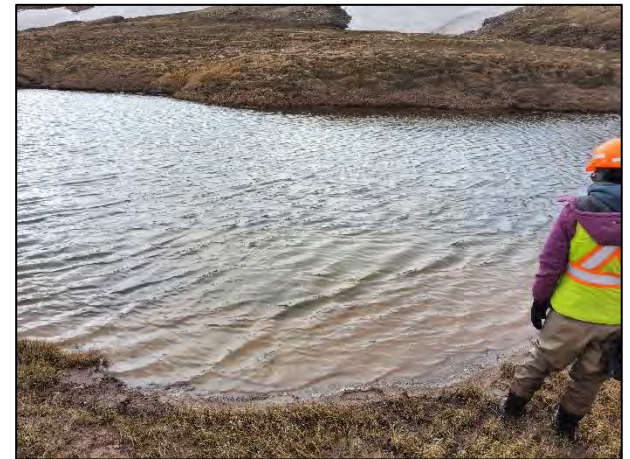
Photos 1-3. Photos taken 20 m upstream (top) and 60 m upstream (bottom) in spring 2023: (A,D) facing upstream; (B,E) facing downstream; and (C,F) across (right bank looking at left bank).

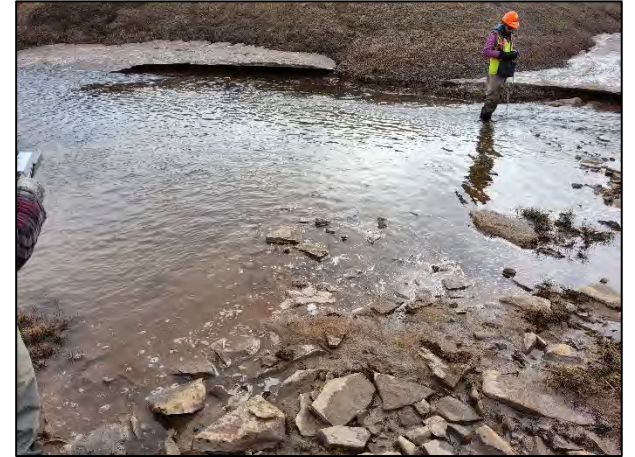
Photos 1-4. Photos taken 100 m upstream in spring 2023: (A) facing upstream; (B) facing downstream; and (C) across (right bank looking at left bank).

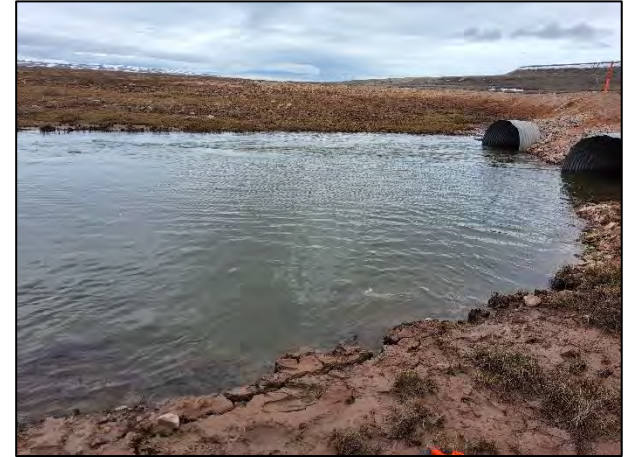
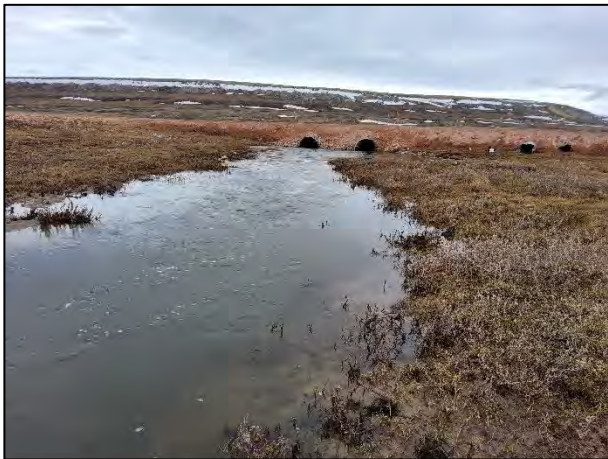
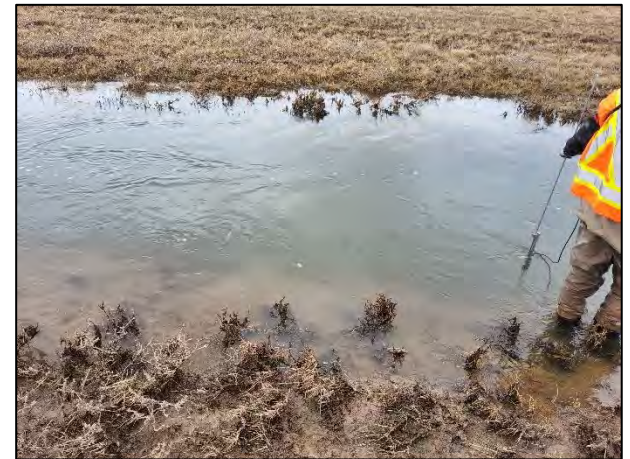
Photos 1-1. Photos taken 20 m downstream (top) and 60 m downstream (bottom) in spring 2023: (A,D) facing upstream; (B,E) facing downstream; and (C,F) across (right bank looking at left bank).

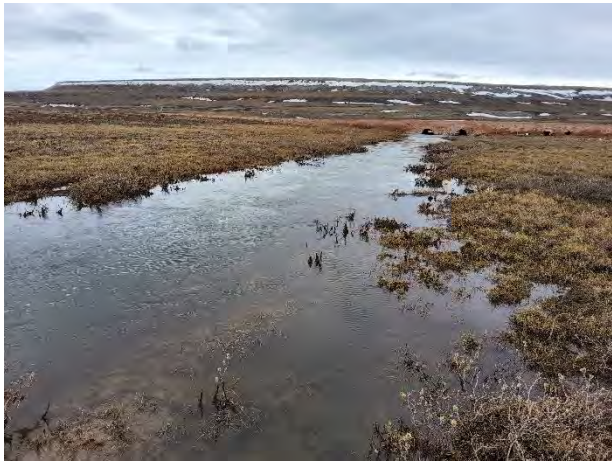
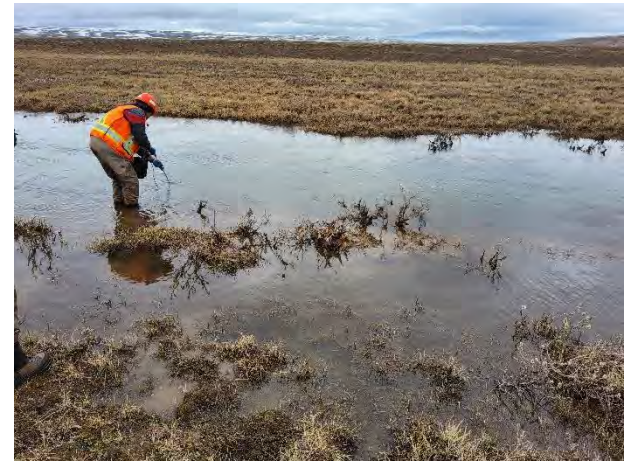
Photos 1-2. Photos taken 100 m downstream in spring 2023: (A) facing upstream; (B) facing downstream; and (C) across (right bank looking at left bank).

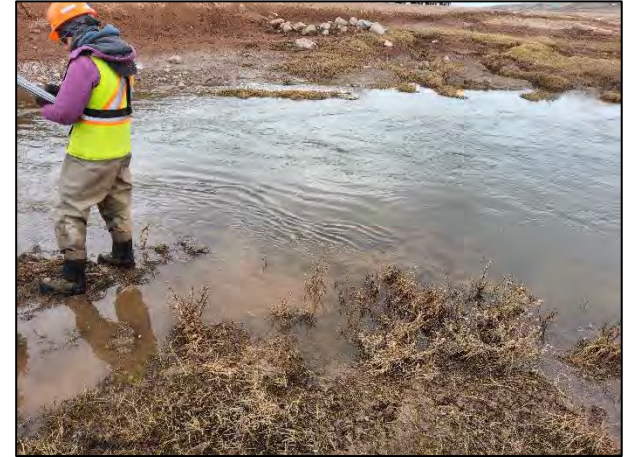
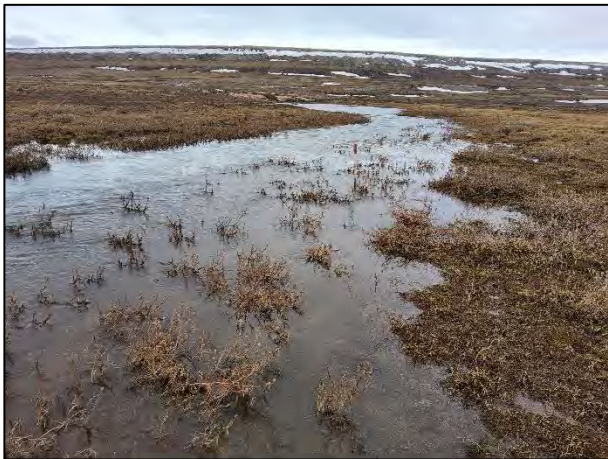
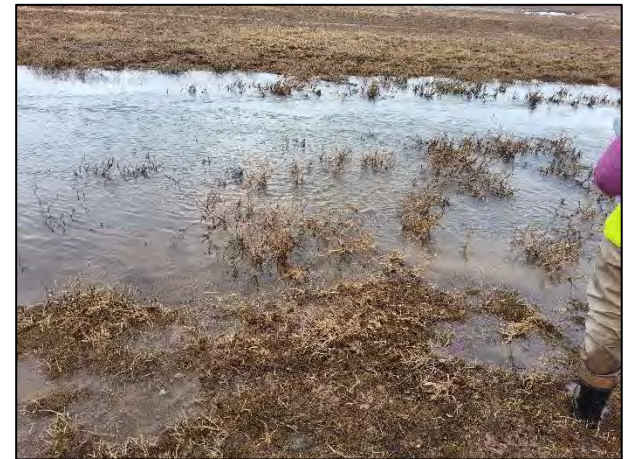
Photos 1-3. Photos taken 20 m upstream (top) and 60 m upstream (bottom) in spring 2023: (A,D) facing upstream; (B,E) facing downstream; and (C,F) across (right bank looking at left bank).

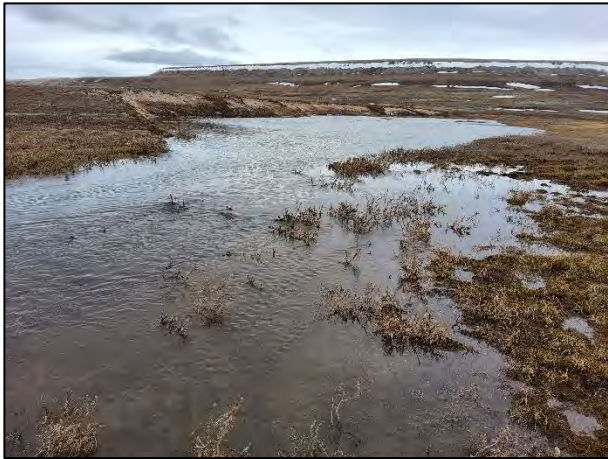
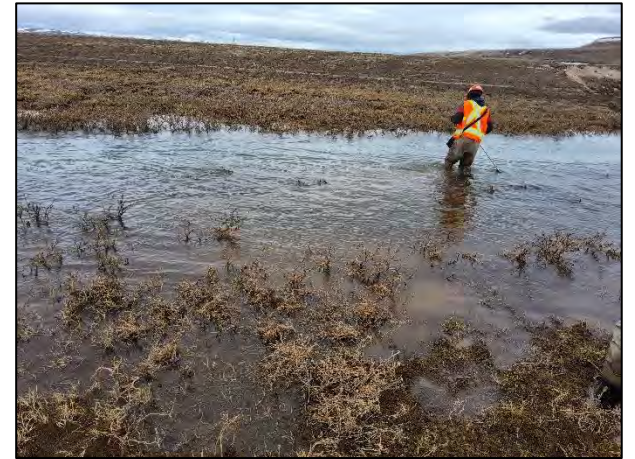
Photos 1-4. Photos taken 100 m upstream in spring 2023: (A) facing upstream; (B) facing downstream; and (C) across (right bank looking at left bank).

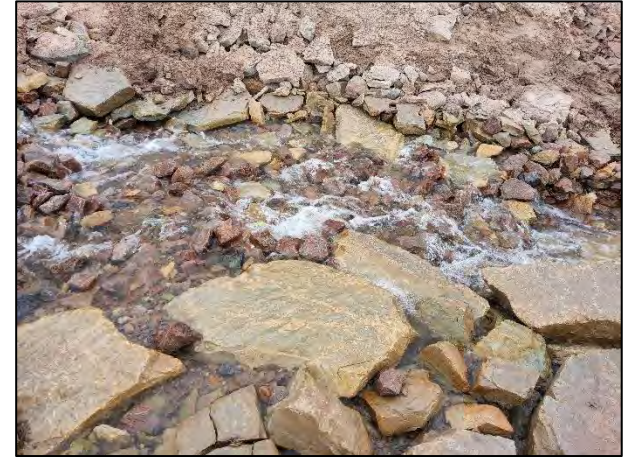
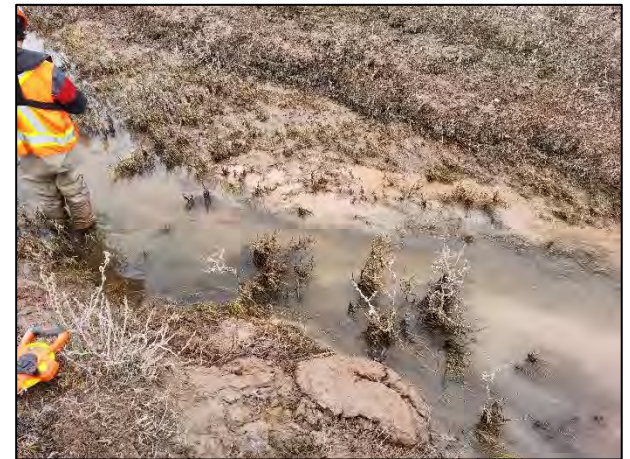
Photos 1-1. Photos taken 20 m downstream (top) and 60 m downstream (bottom) in spring 2023: (A,D) facing upstream; (B,E) facing downstream; and (C,F) across (right bank looking at left bank).

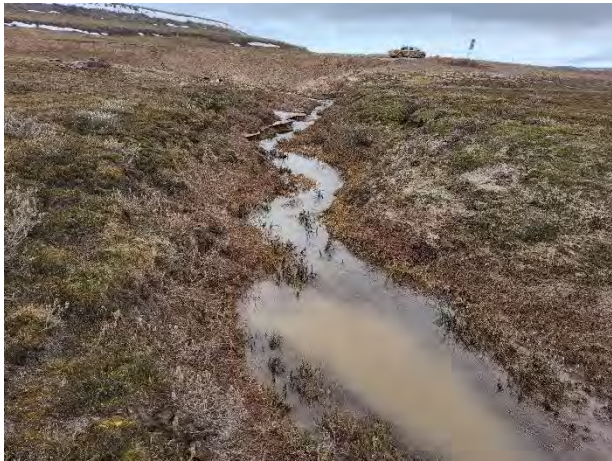
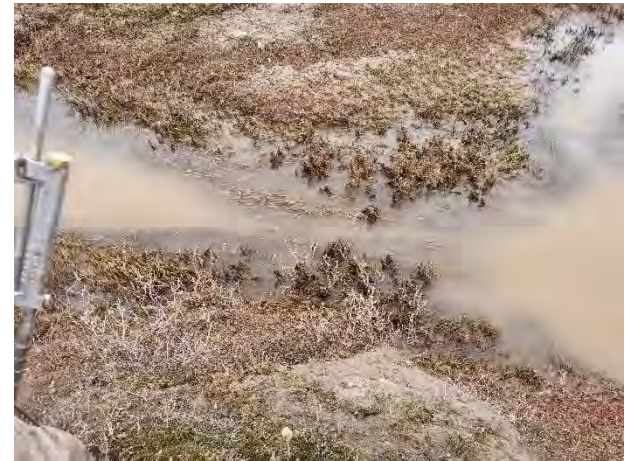
Photos 1-2. Photos taken 100 m downstream in spring 2023: (A) facing upstream; (B) facing downstream; and (C) across (right bank looking at left bank).

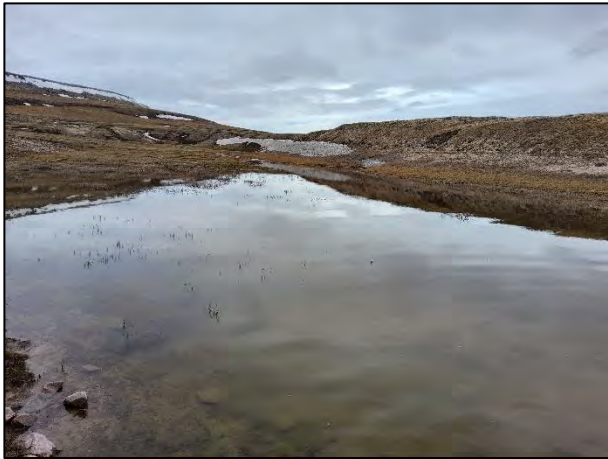
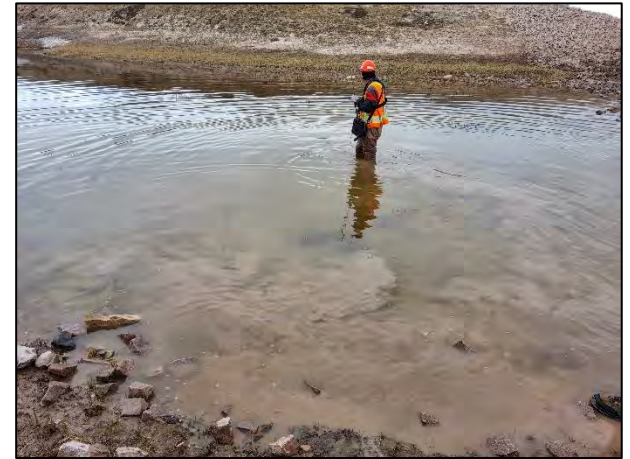
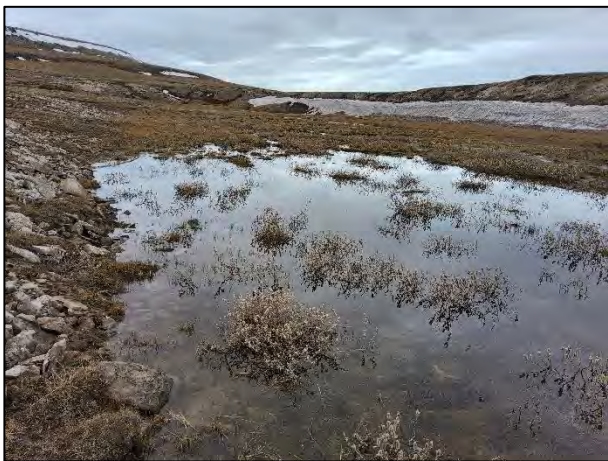
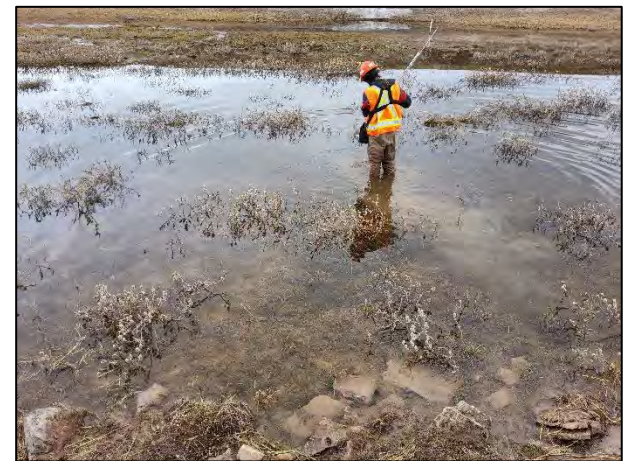
Photos 1-3. Photos taken 20 m upstream (top) and 60 m upstream (bottom) in spring 2023: (A,D) facing upstream; (B,E) facing downstream; and (C,F) across (left bank looking at right bank).

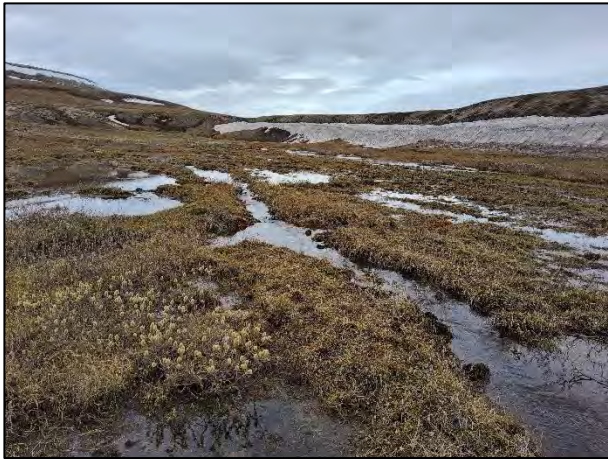
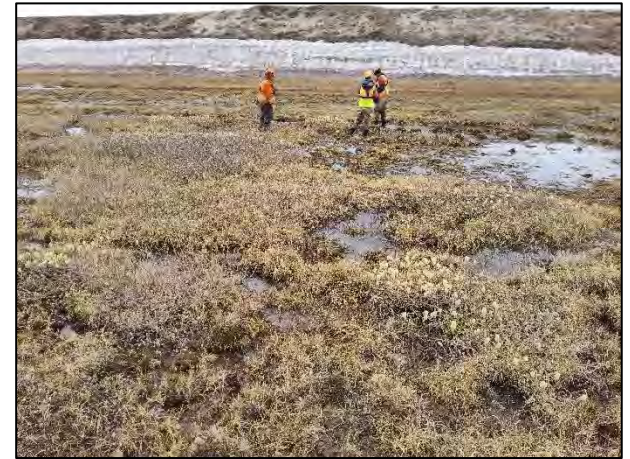
Photos 1-4. Photos taken 100 m upstream in spring 2023: (A) facing upstream; (B) facing downstream; and (C) across (left bank looking at right bank).

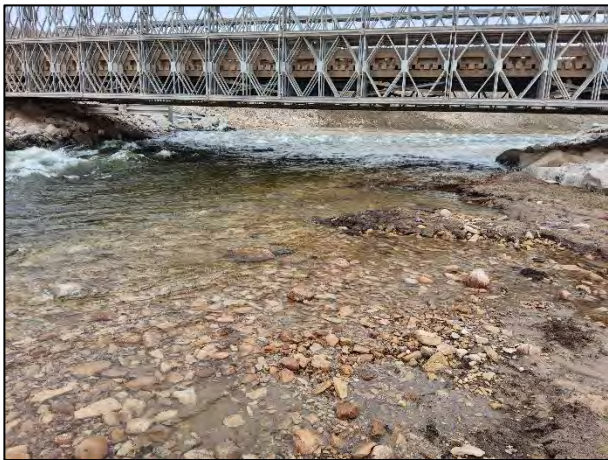
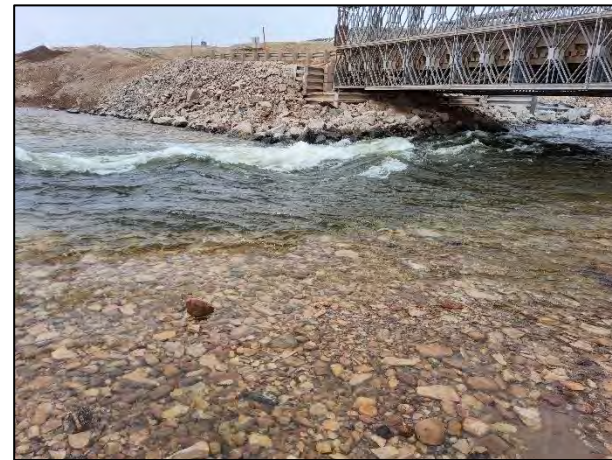
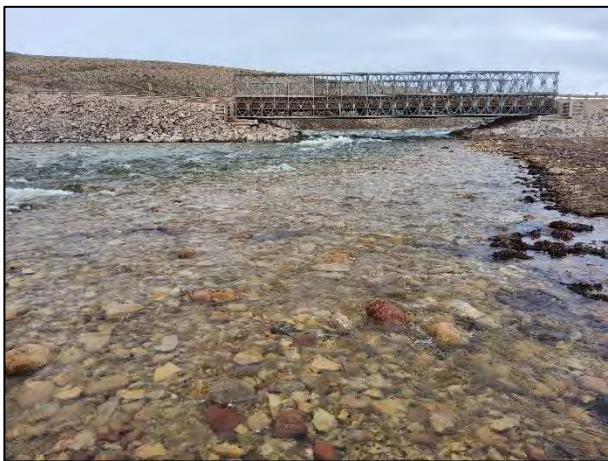
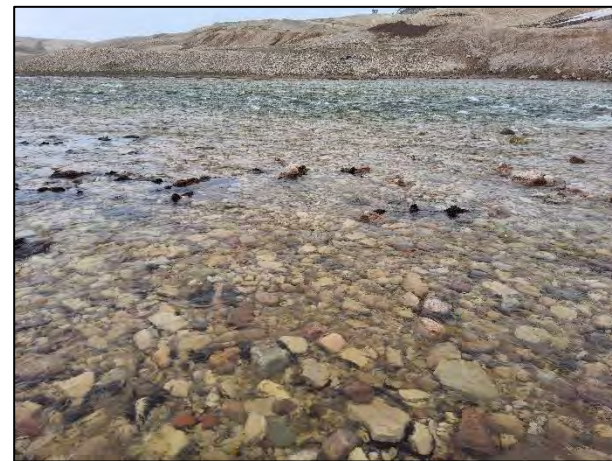
Photos 1-1. Photos taken 20 m downstream (top) and 60 m downstream (bottom) in spring 2023: (A,D) facing upstream; (B,E) facing downstream; and (C,F) across (right bank looking at left bank).

Stream morphology was primarily rapids and riffle. Substrates could not be directly observed due to the fast, deep water, appears to consist almost exclusively of cobble/boulder throughout based on site photographs.

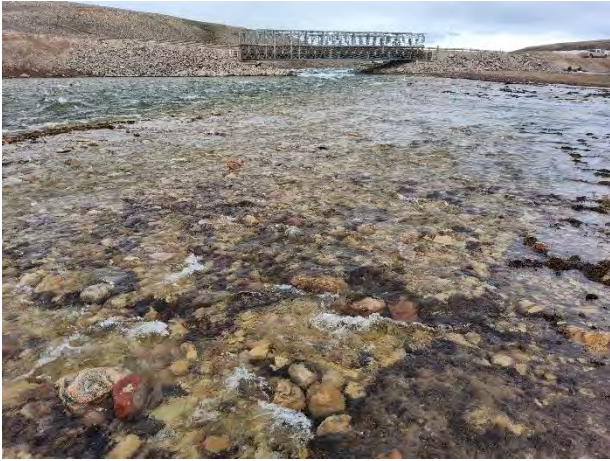
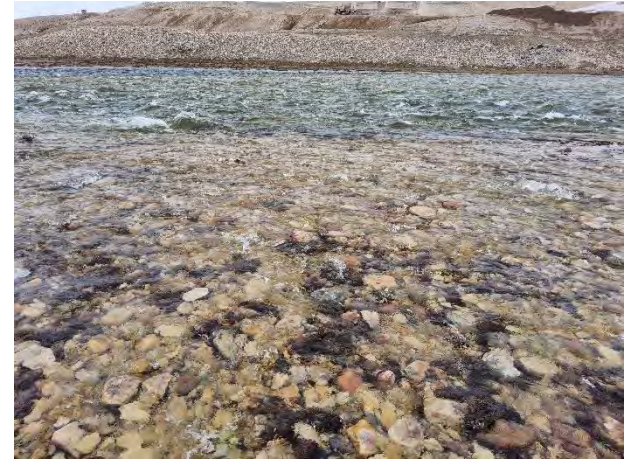
Photos 1-2. Photos taken 100 m downstream in spring 2023: (A) facing upstream; (B) facing downstream; and (C) across (right bank looking at left bank).
