TOTE ROAD CV-001

TOTE ROAD CV-021

BAFFINLAND IRON MINES
MARY RIVER PROJECT

**North/South Consultants Inc.**
Aquatic Environment Specialists

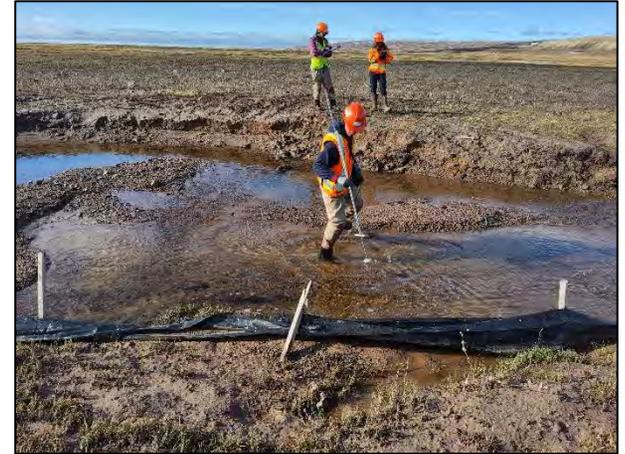
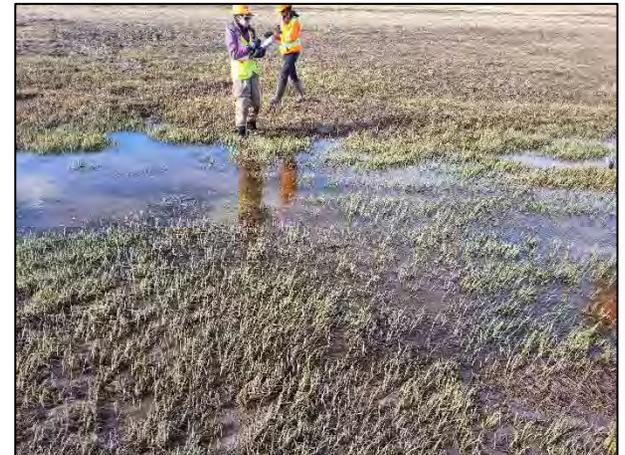
Photos 1-1. Photos taken 20 m downstream (top) and 60 m downstream (bottom) in spring 2023: (A,D) facing upstream; (B,E) facing downstream; and (C,F) across (left bank looking at right bank).

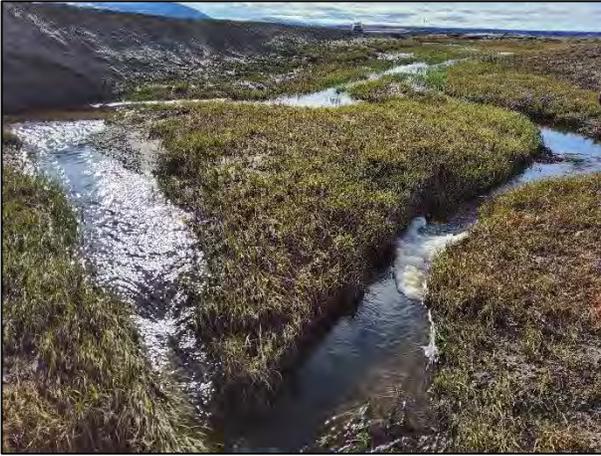
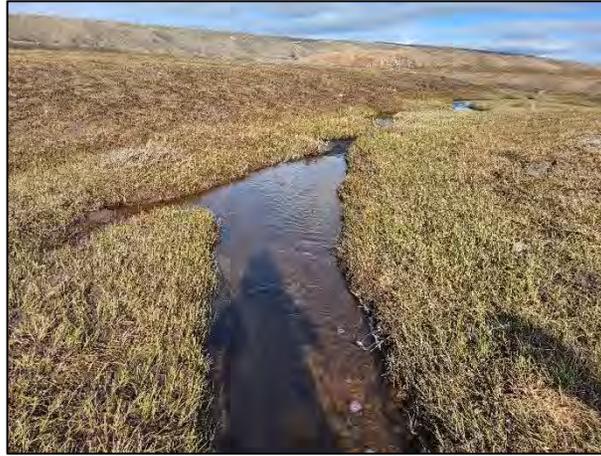
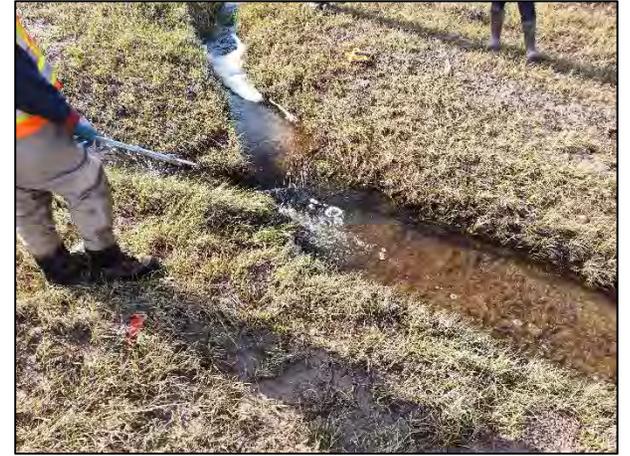
Photos 1-2. Photos taken 100 m downstream in spring 2023: (A) facing upstream; (B) facing downstream; and (C) across (left bank looking at right bank).

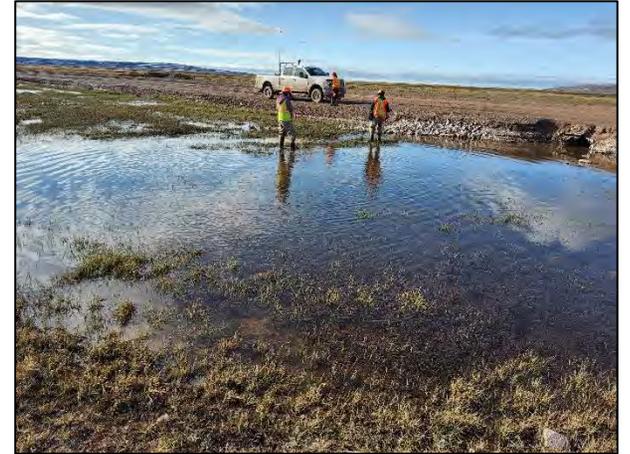
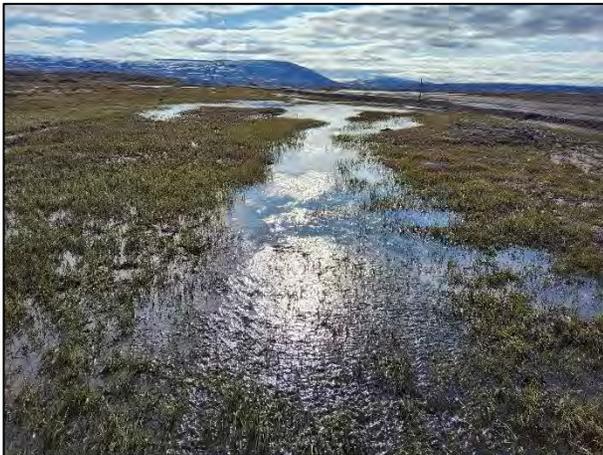
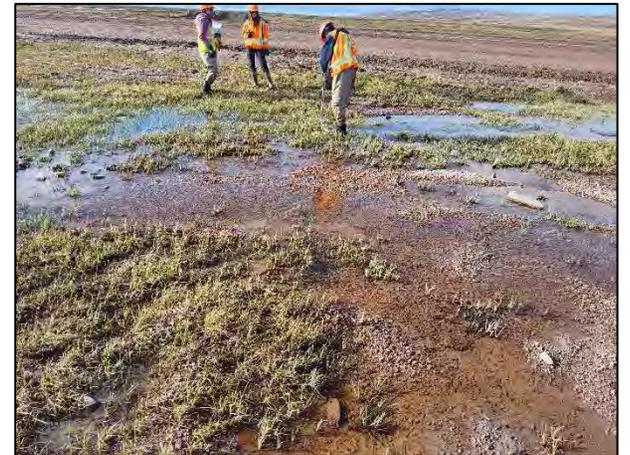
Photos 1-3. Photos taken 20 m upstream (top) and 60 m upstream (bottom) in spring 2023: (A,D) facing upstream; (B,E) facing downstream; and (C,F) across (left bank looking at right bank).

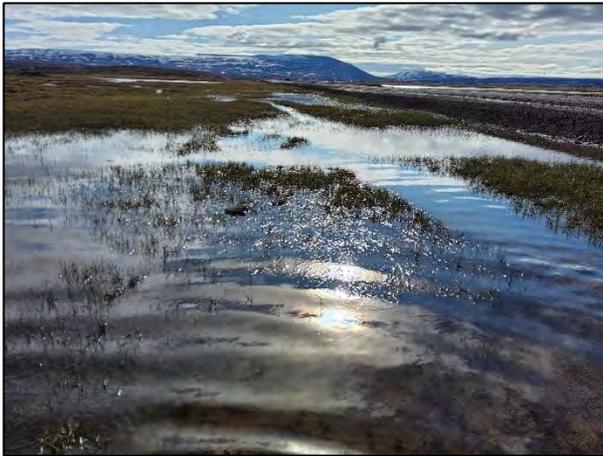
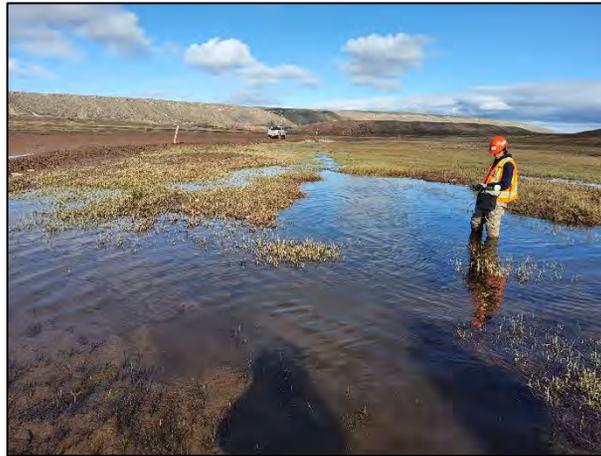
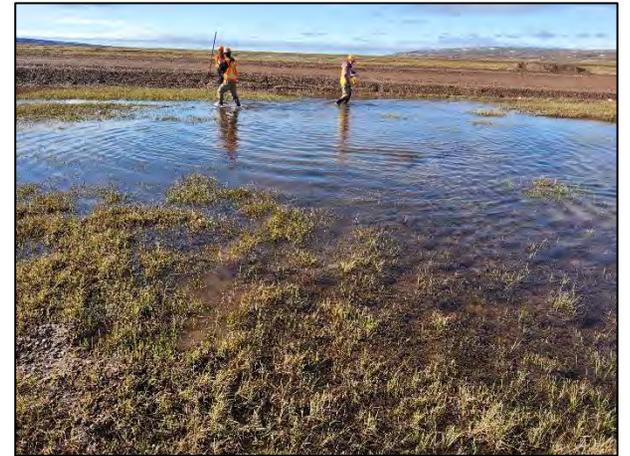
Photos 1-4. Photos taken 100 m upstream in spring 2023: (A) facing upstream; (B) facing downstream; and (C) across (left bank looking at right bank).

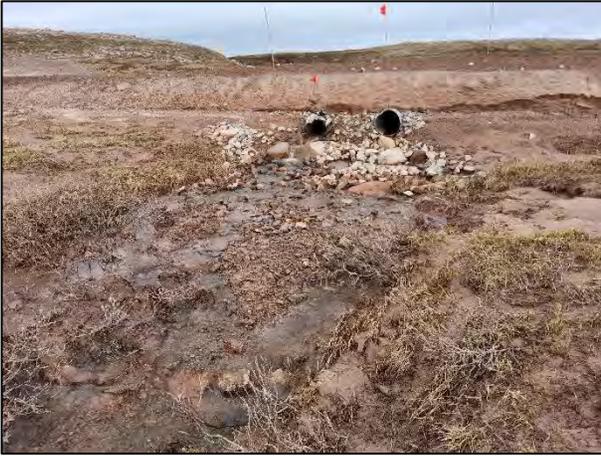
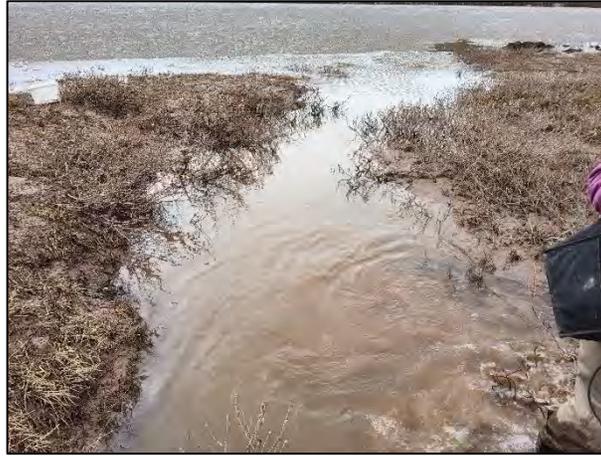
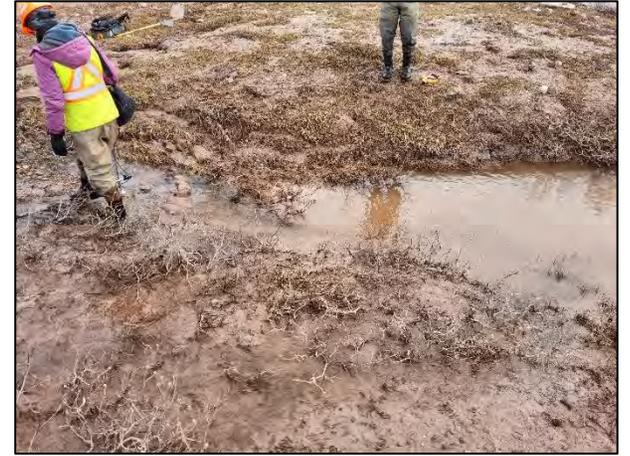
Photos 1-1. Photos taken 20 m downstream in spring 2023: (A) facing upstream; (B) facing downstream; and (C) across (left bank looking at right bank).

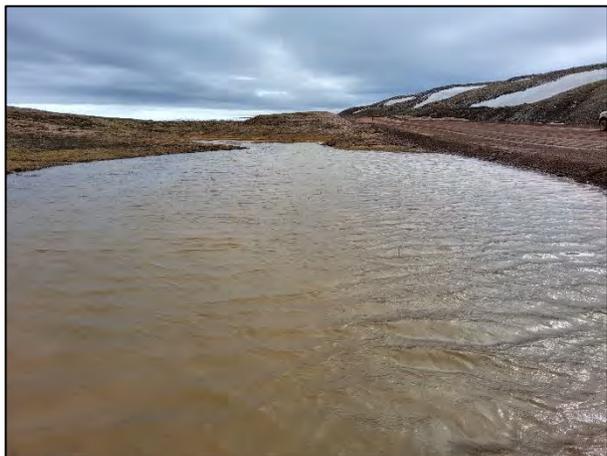
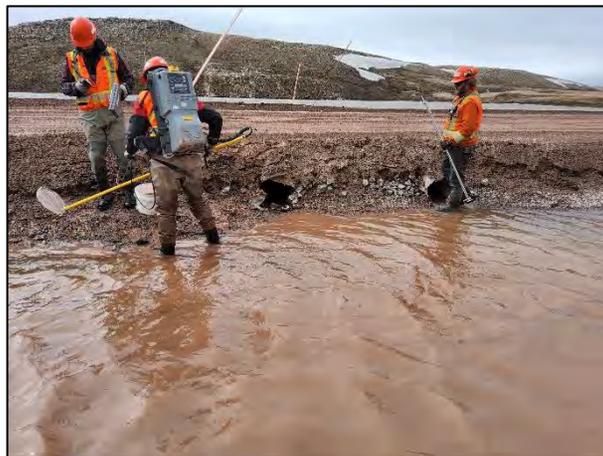
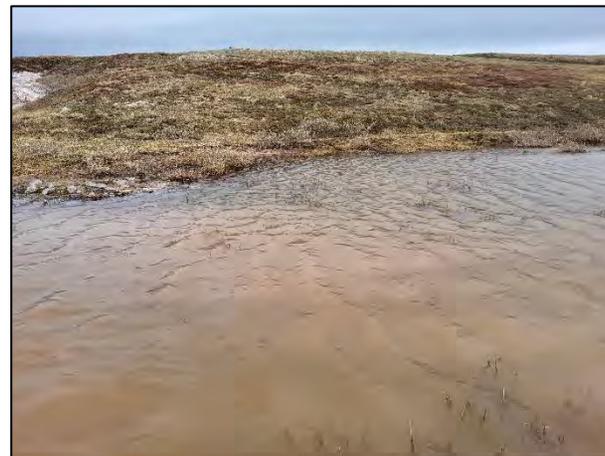
Photos 1-2. Photos taken 20 m upstream in spring 2023: (A) facing upstream; (B) facing downstream; and (C) across (right bank looking at left bank).

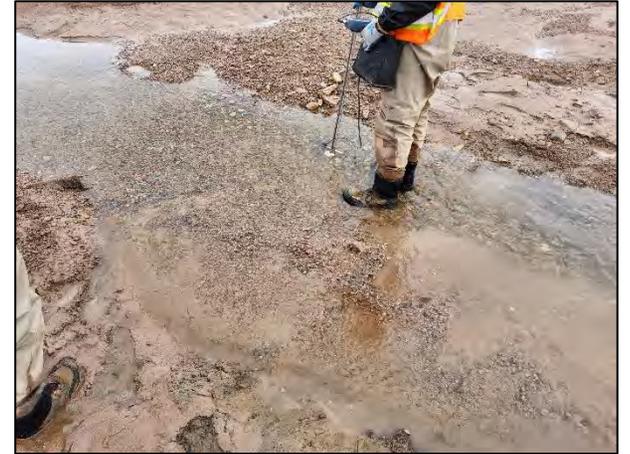
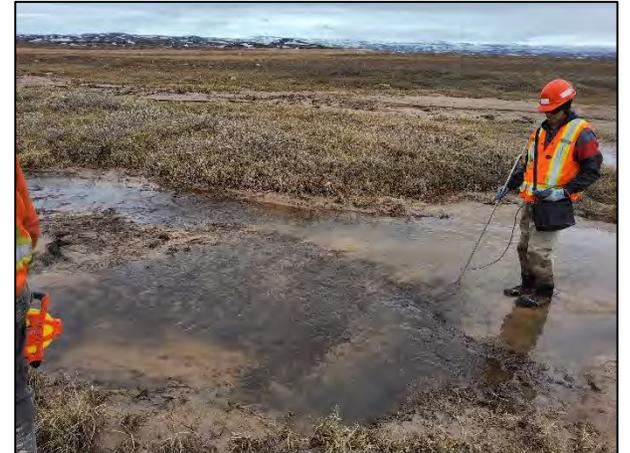
Photos 1-1. Photos taken 20 m downstream (top) and 60 m downstream (bottom) in spring 2023: (A,D) facing upstream; (B,E) facing downstream; and (C,F) across (right bank looking at left bank).

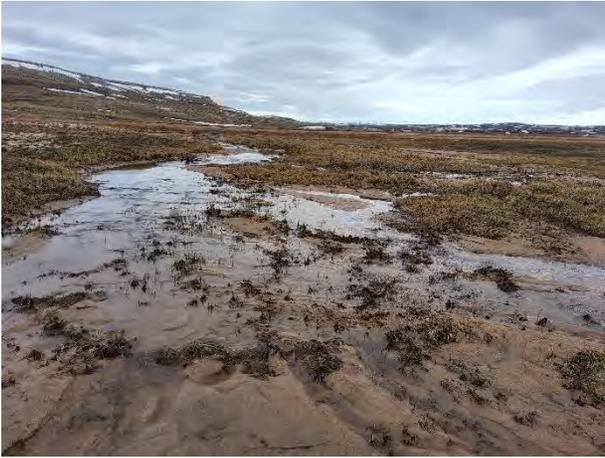
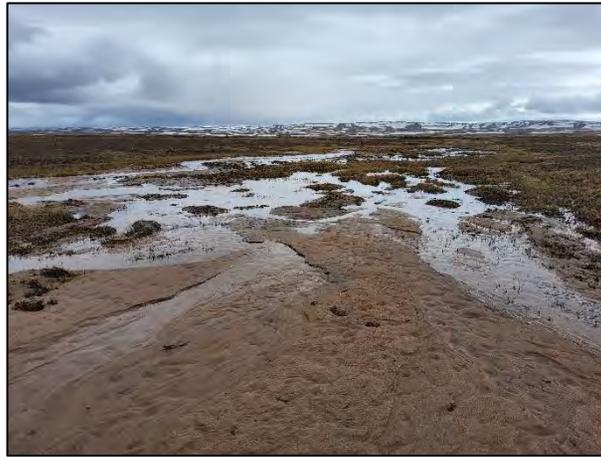
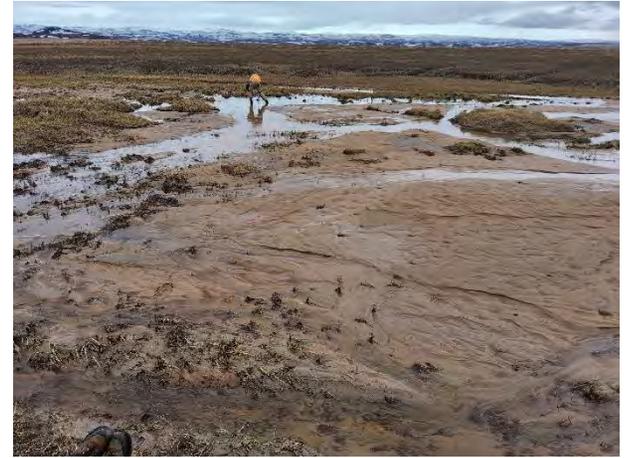
Photos 1-2. Photos taken 100 m downstream in spring 2023: (A) facing upstream; (B) facing downstream; and (C) across (right bank looking at left bank).

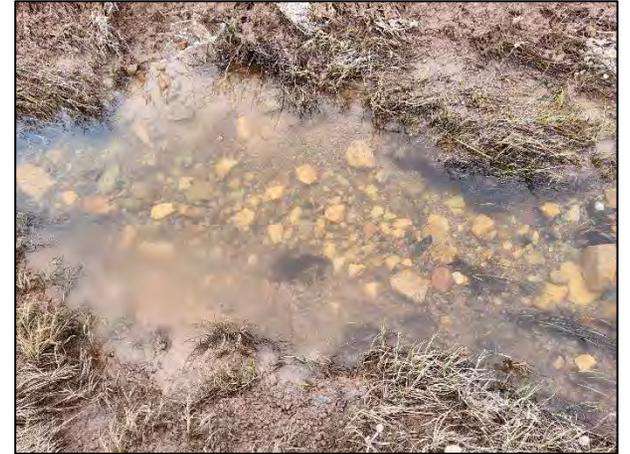
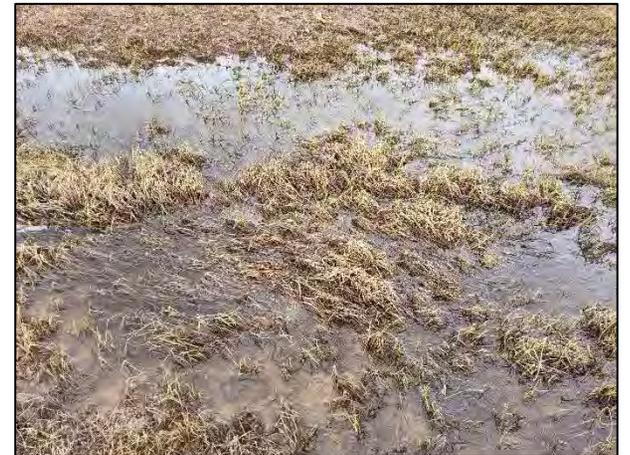
Photos 1-3. Photos taken 20 m upstream (top) and 60 m upstream (bottom) in spring 2023: (A,D) facing upstream; (B,E) facing downstream; and (C,F) across (left bank looking at right bank).

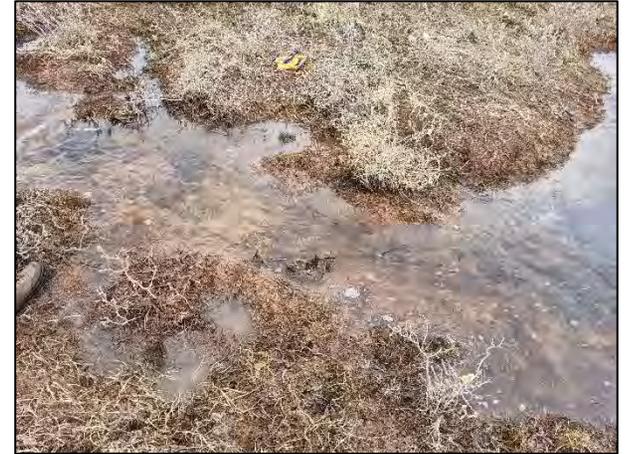
Photos 1-4. Photos taken 100 m upstream in spring 2023: (A) facing upstream; (B) facing downstream; and (C) across (left bank looking at right bank).

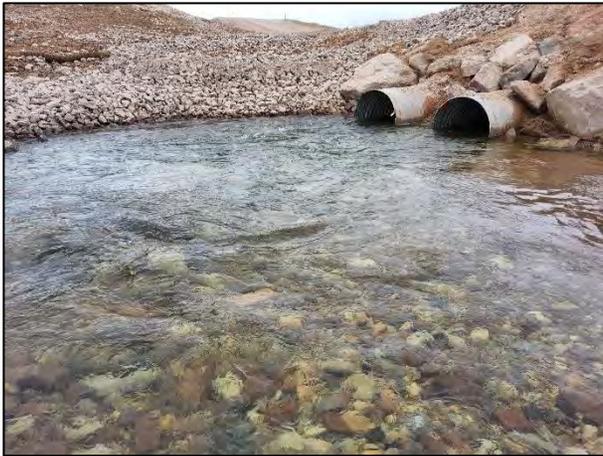
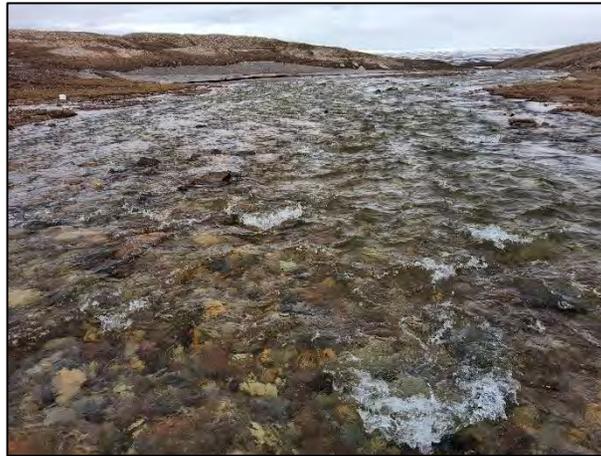
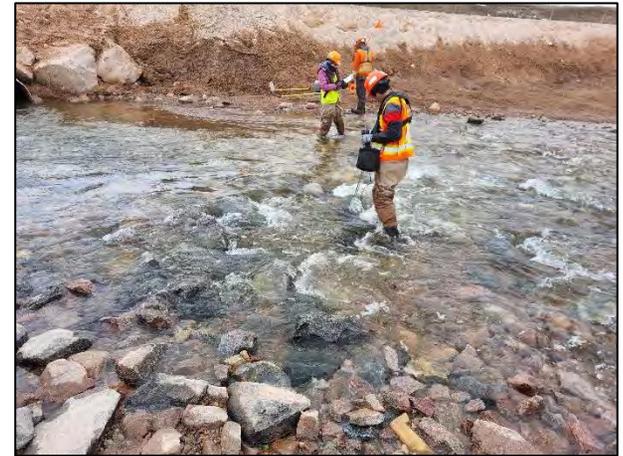
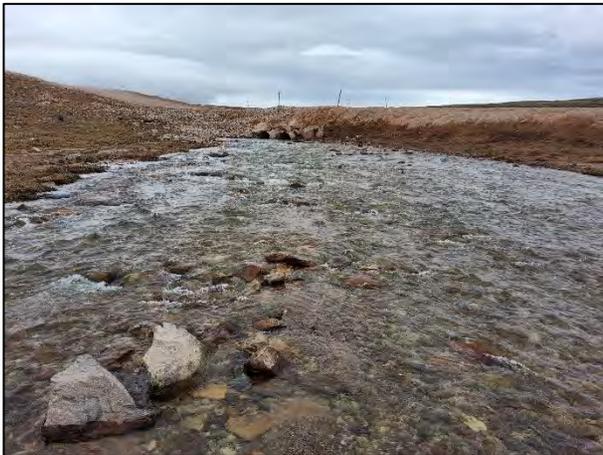
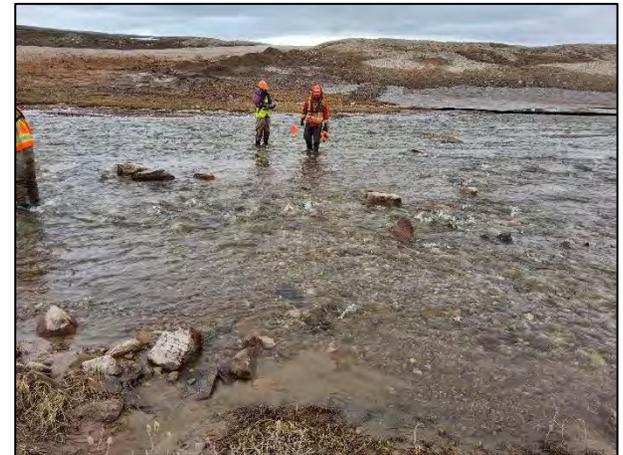
Photos 1-1. Photos taken 20 m downstream (top) and 60 m downstream (bottom) in spring 2023: (A,D) facing upstream; (B,E) facing downstream; and (C,F) across (right bank looking at left bank).

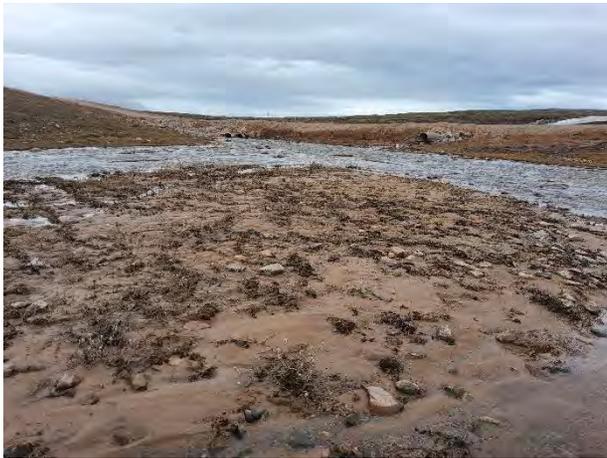
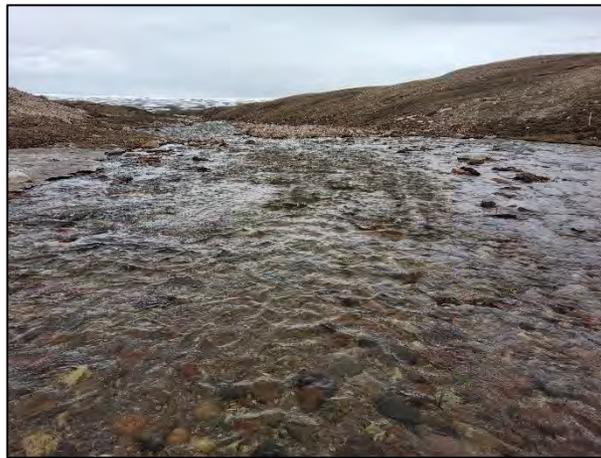
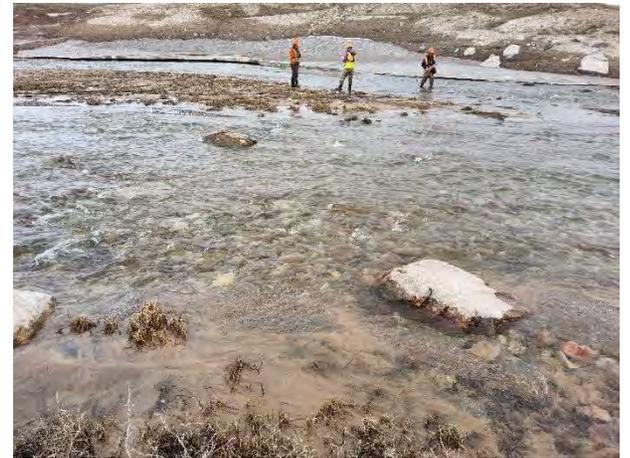
Photos 1-2. Photos taken 100 m downstream in spring 2023: (A) facing upstream; (B) facing downstream; and (C) across (right bank looking at left bank).

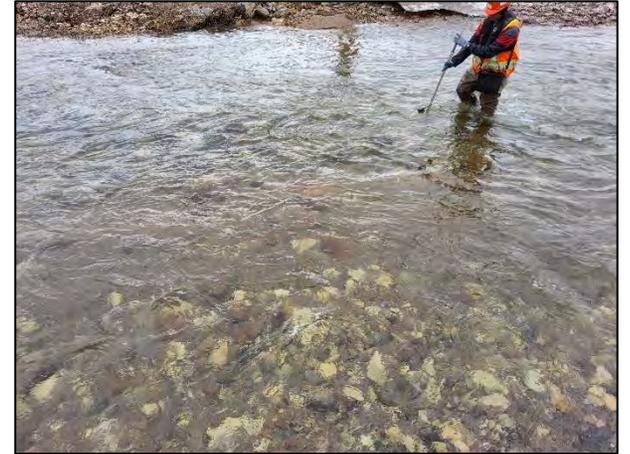
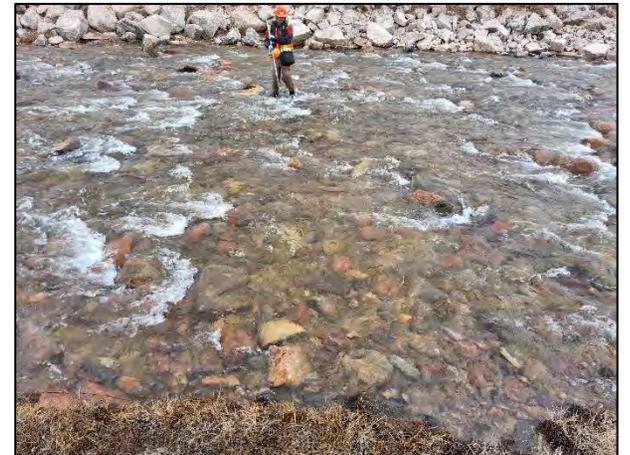
Photos 1-3. Photos taken 20 m upstream (top) and 60 m upstream (bottom) in spring 2023: (A,D) facing upstream; (B,E) facing downstream; and (C,F) across (left bank looking at right bank).

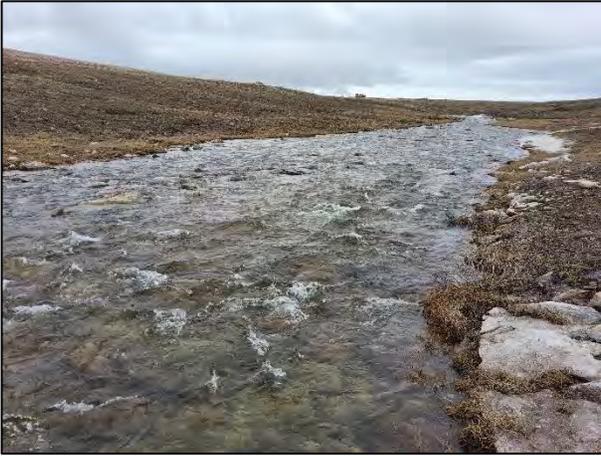
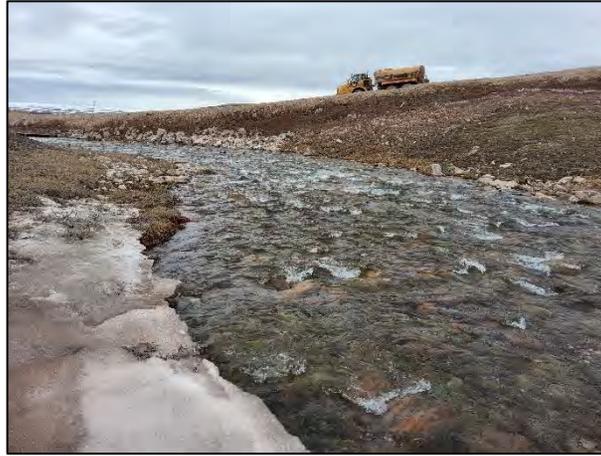
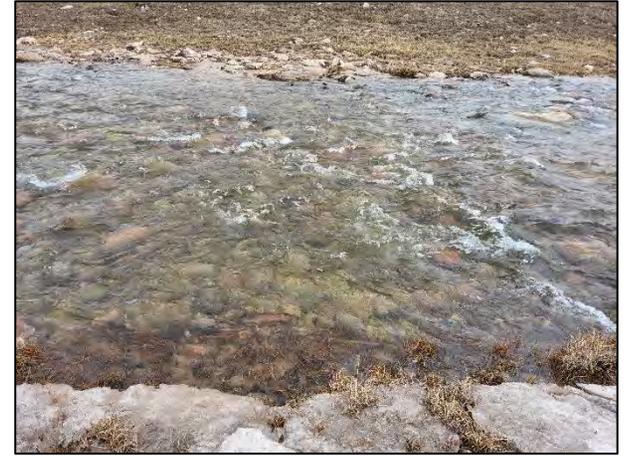
Photos 1-4. Photos taken 100 m upstream in spring 2023: (A) facing upstream; (B) facing downstream; and (C) across (left bank looking at right bank).

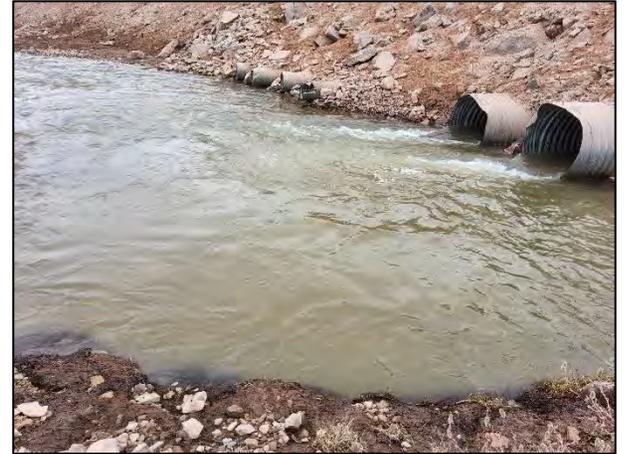
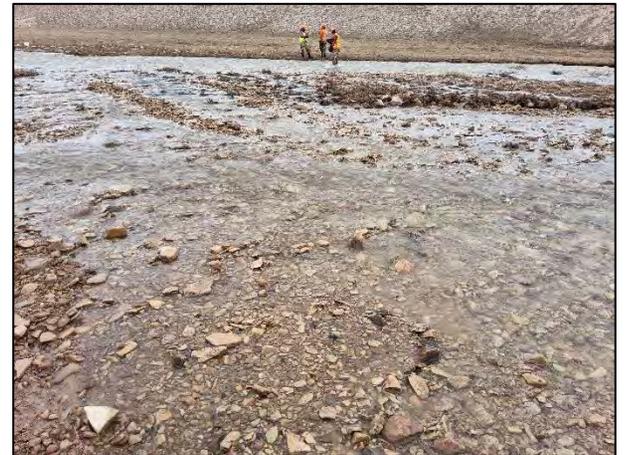
Photos 1-1. Photos taken 20 m downstream (top) and 60 m downstream (bottom) in spring 2023: (A,D) facing upstream; (B,E) facing downstream; and (C,F) across (right bank looking at left bank).

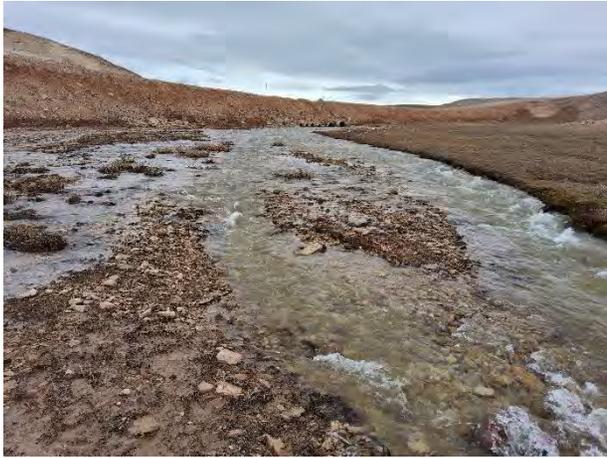
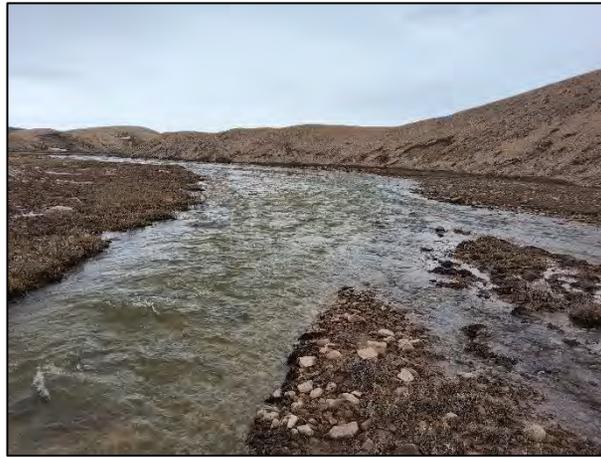
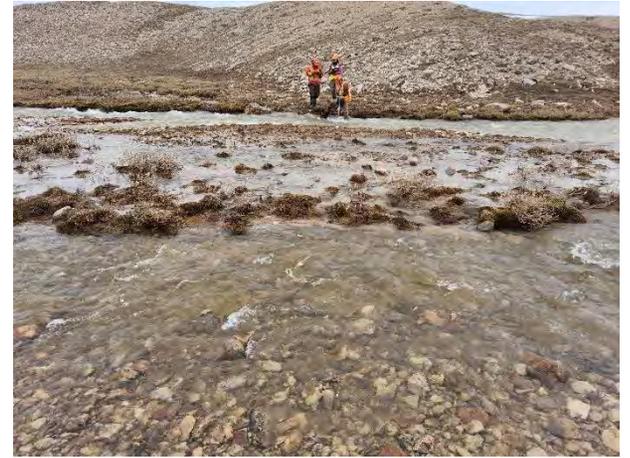
Photos 1-2. Photos taken 100 m downstream in spring 2023: (A) facing upstream; (B) facing downstream; and (C) across (right bank looking at left bank).

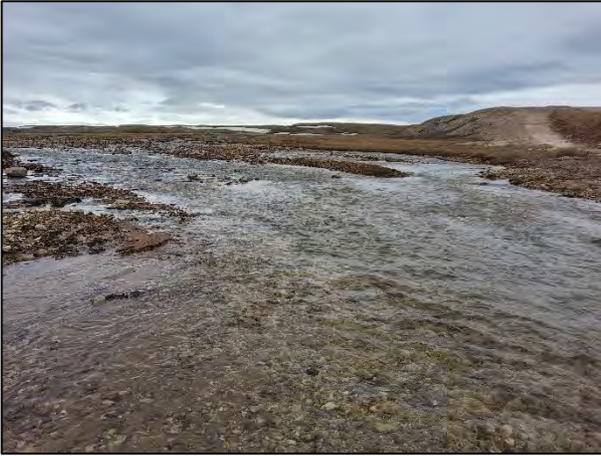
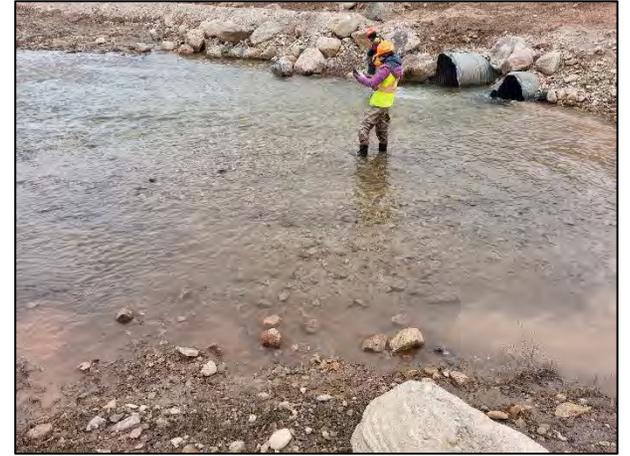
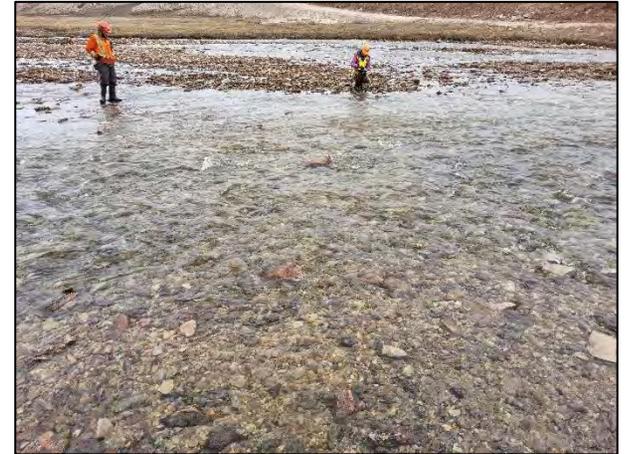
Photos 1-3. Photos taken 20 m upstream (top) and 60 m upstream (bottom) in spring 2023: (A,D) facing upstream; (B,E) facing downstream; and (C,F) across (left bank looking at right bank).

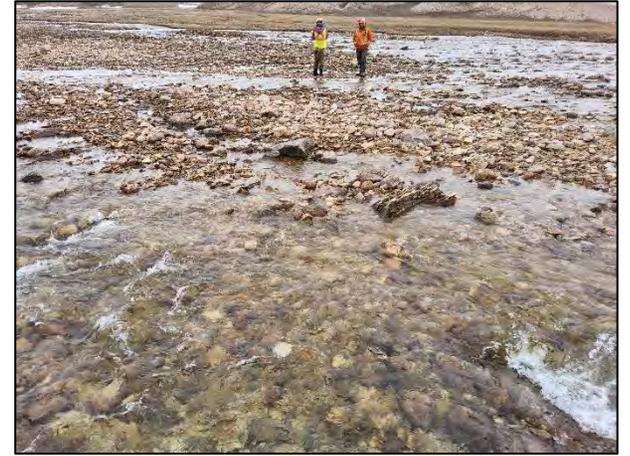
Photos 1-4. Photos taken 100 m upstream in spring 2023: (A) facing upstream; (B) facing downstream; and (C) across (left bank looking at right bank).

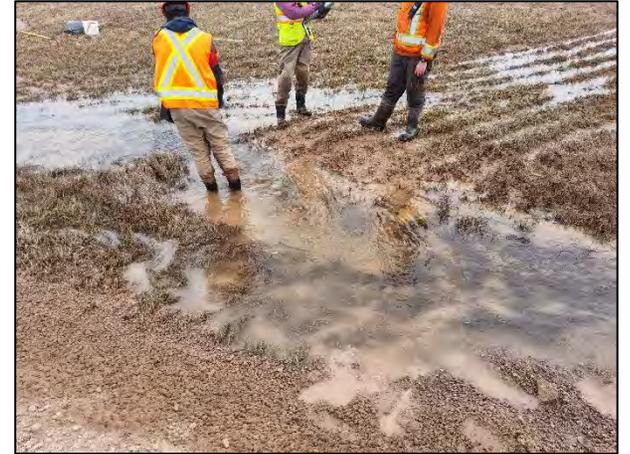
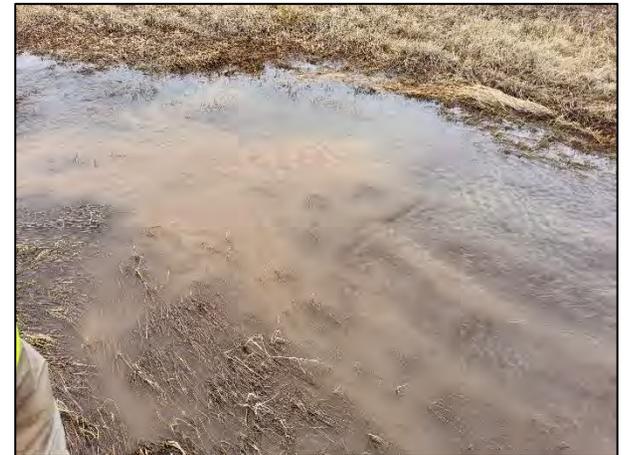
Photos 1-1. Photos taken 20 m downstream (top) and 60 m downstream (bottom) in spring 2023: (A,D) facing upstream; (B,E) facing downstream; and (C,F) across (left bank looking at right bank).

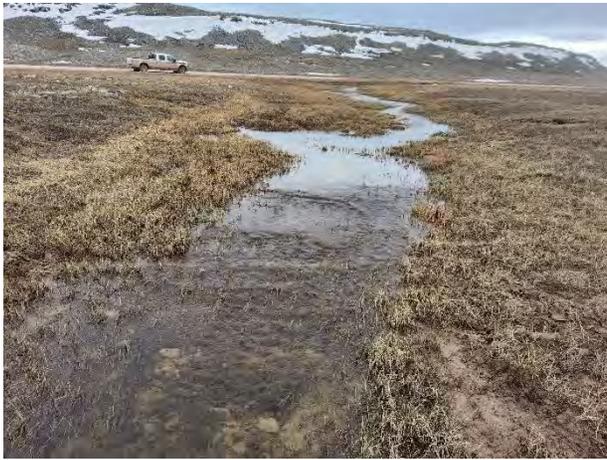
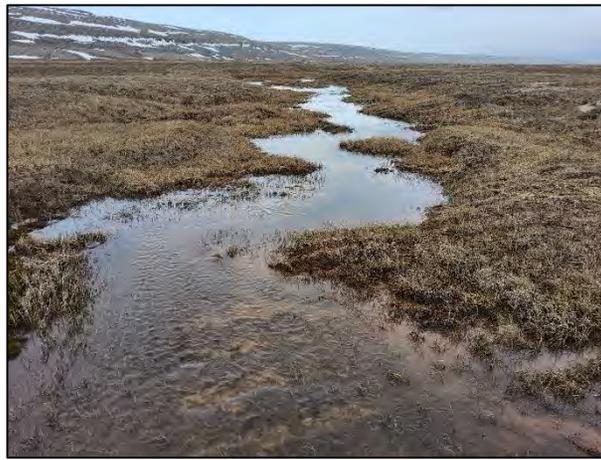
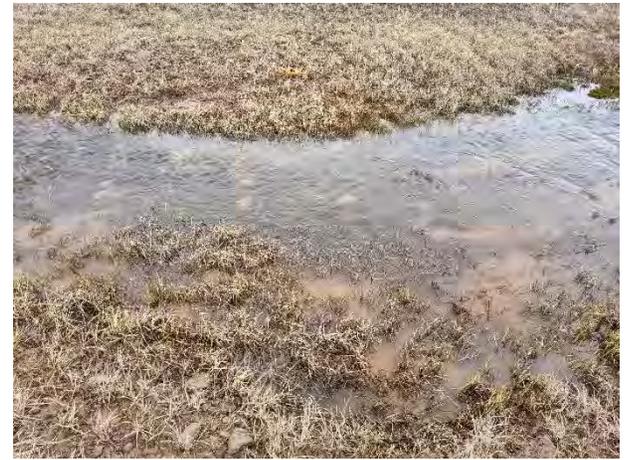
Photos 1-2. Photos taken 100 m downstream in spring 2023: (A) facing upstream; (B) facing downstream; and (C) across (left bank looking at right bank).

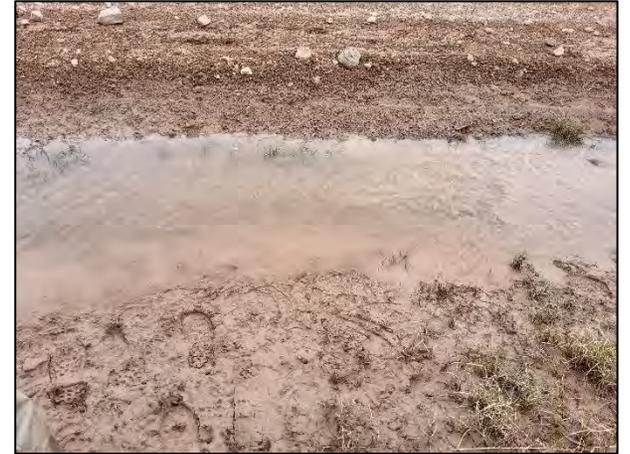
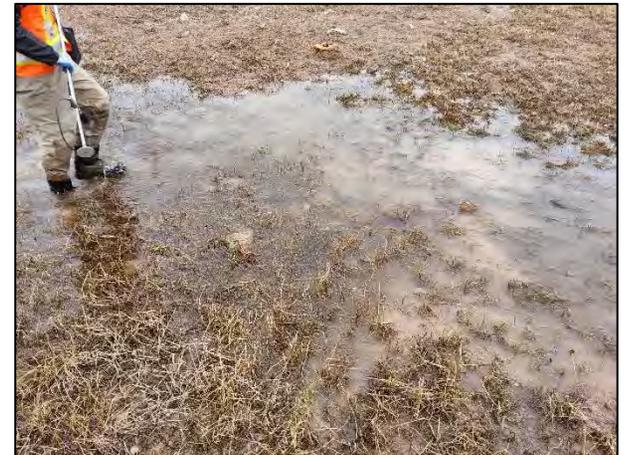
Photos 1-3. Photos taken 20 m upstream (top) and 60 m upstream (bottom) in spring 2023: (A,D) facing upstream; (B,E) facing downstream; and (C,F) across (left bank looking at right bank).

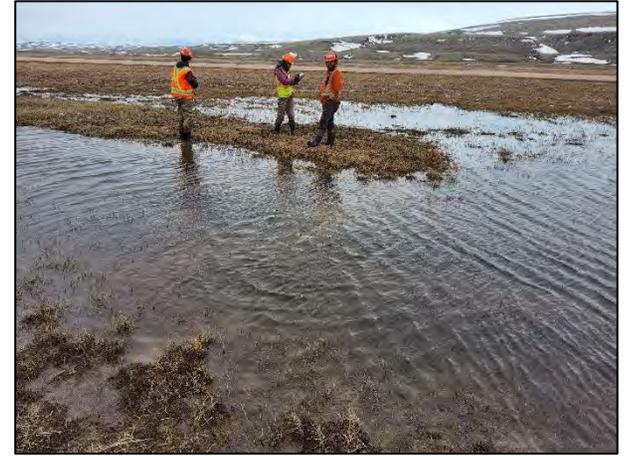
Photos 1-4. Photos taken 100 m upstream in spring 2023: (A) facing upstream; (B) facing downstream; and (C) across (left bank looking at right bank).

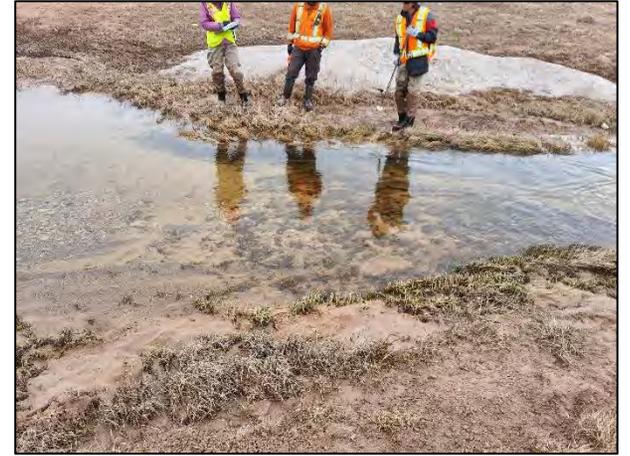
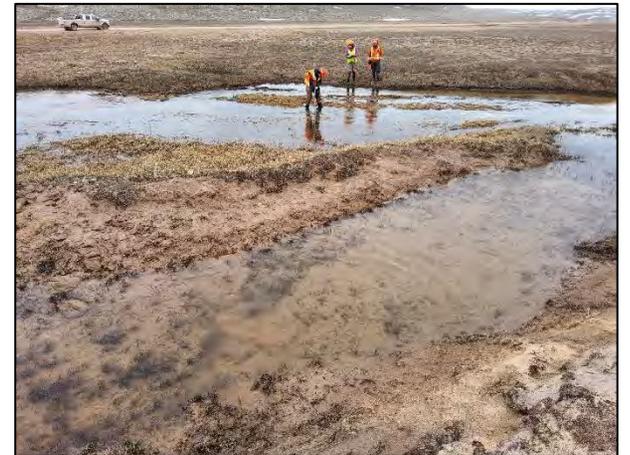
Photos 1-1. Photos taken 20 m downstream (top) and 60 m downstream (bottom) in spring 2023: (A,D) facing upstream; (B,E) facing downstream; and (C,F) across (right bank looking at left bank).

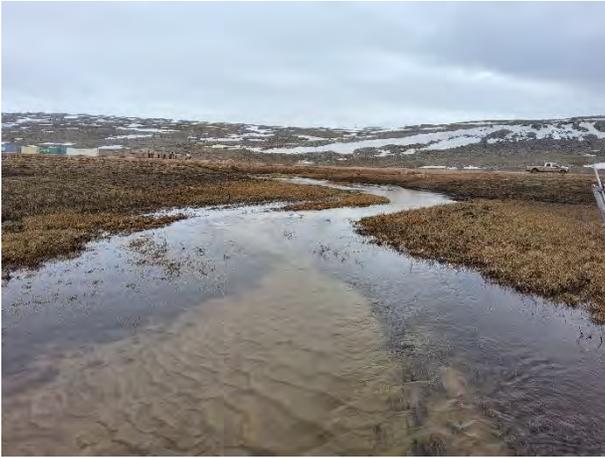
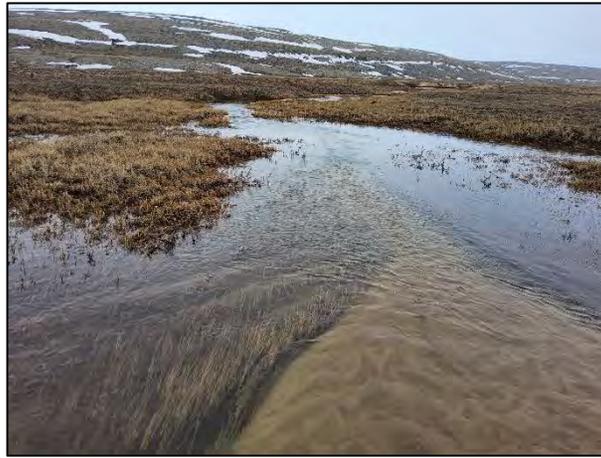
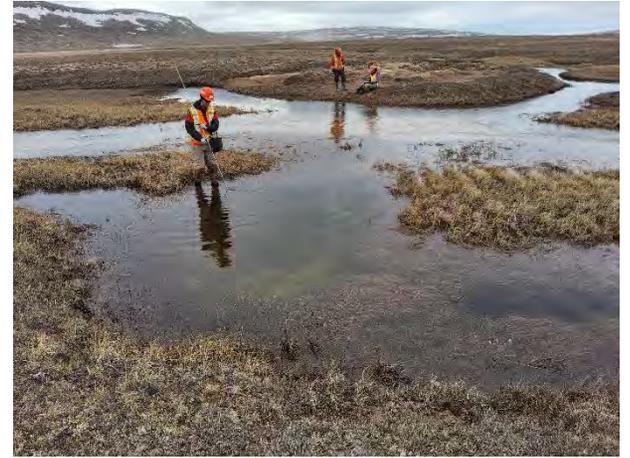
Photos 1-2. Photos taken 100 m downstream in spring 2023: (A) facing upstream; (B) facing downstream; and (C) across (right bank looking at left bank).

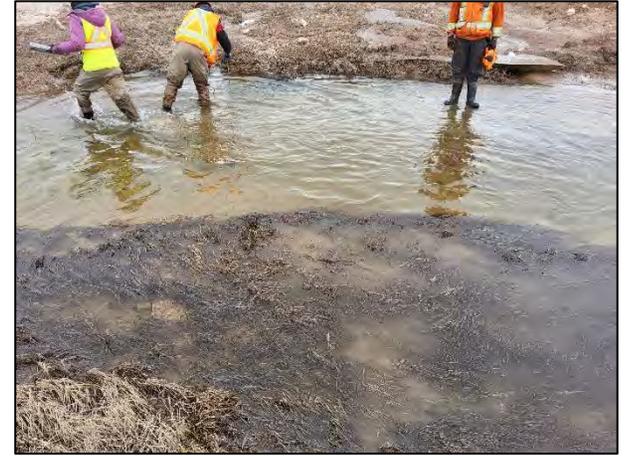
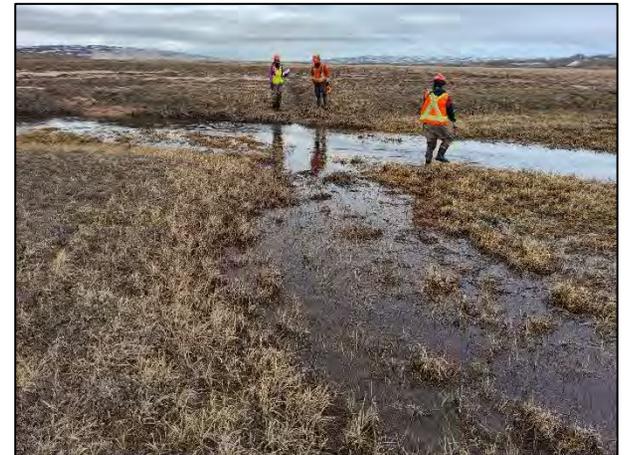
Photos 1-3. Photos taken 20 m upstream (top) and 60 m upstream (bottom) in spring 2023: (A,D) facing upstream; (B,E) facing downstream; and (C,F) across (left bank looking at right bank).

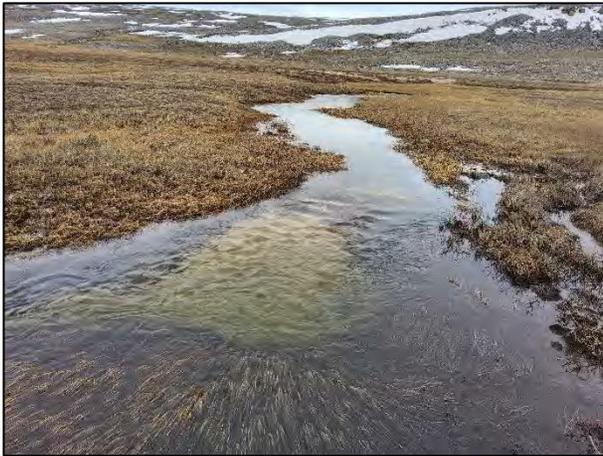
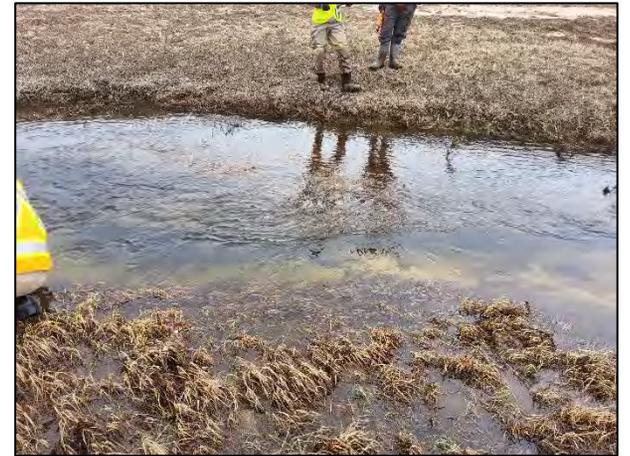
Photos 1-4. Photos taken 100 m upstream in spring 2023: (A) facing upstream; (B) facing downstream; and (C) across (left bank looking at right bank).
