TOTE ROAD CV-059

BAFFINLAND IRON MINES
MARY RIVER PROJECT

**North/South Consultants Inc.**
Aquatic Environment Specialists

SITE SUMMARY

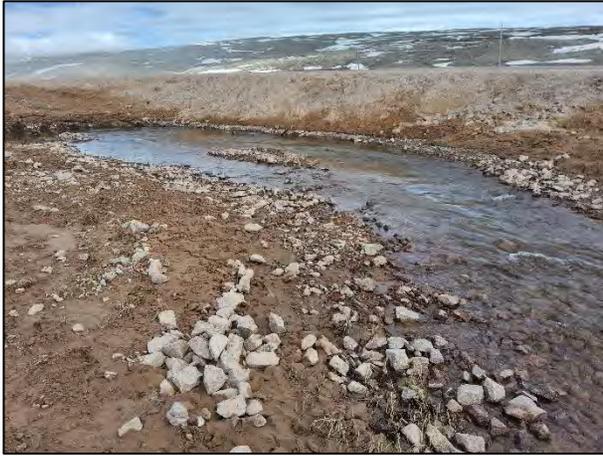
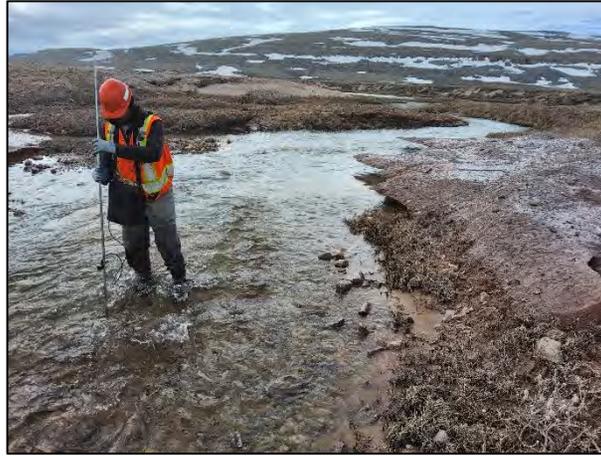
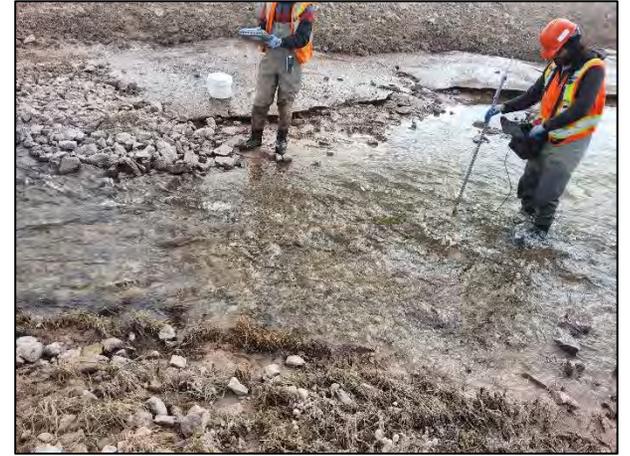
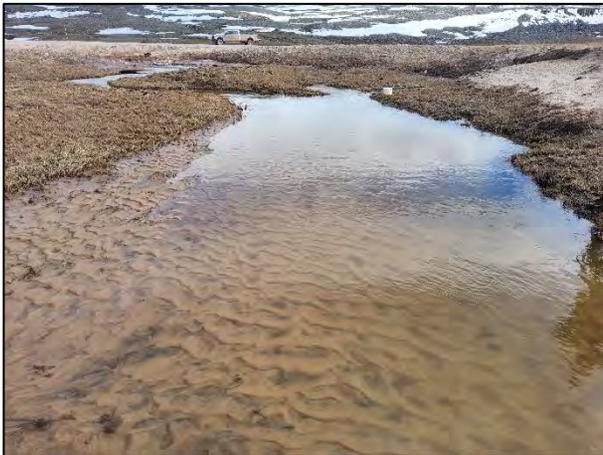
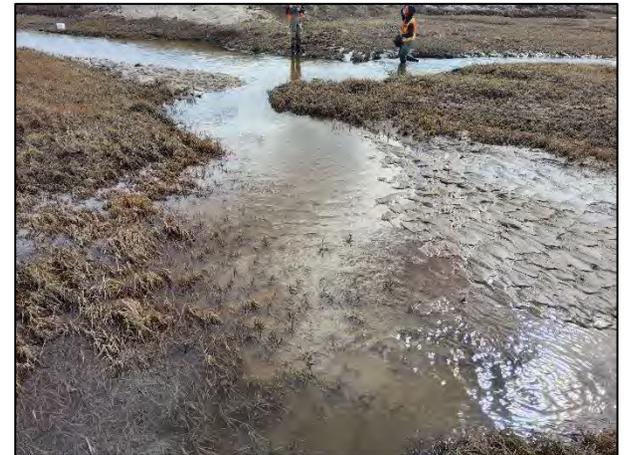
Photos 1-1. Photos taken 20 m downstream (top) and 60 m downstream (bottom) in spring 2023: (A,D) facing upstream; (B,E) facing downstream; and (C,F) across (left bank looking at right bank).

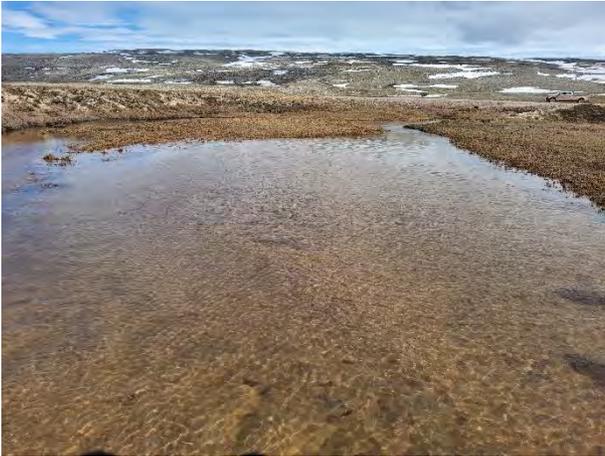
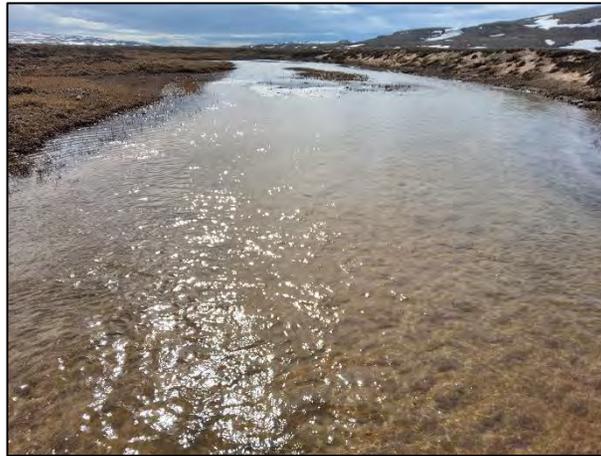
Photos 1-2. Photos taken 100 m downstream in spring 2023: (A) facing upstream; (B) facing downstream; and (C) across (left bank looking at right bank).

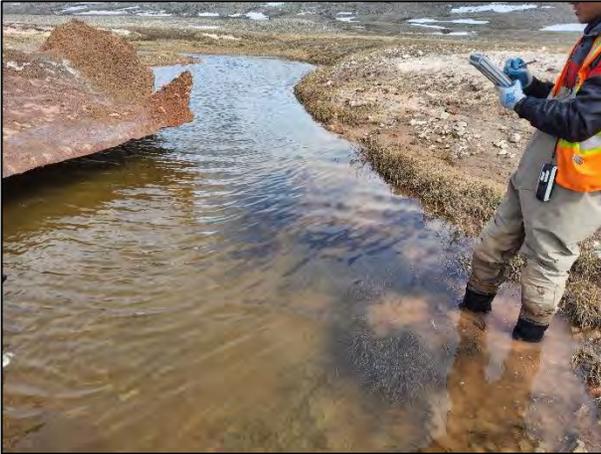
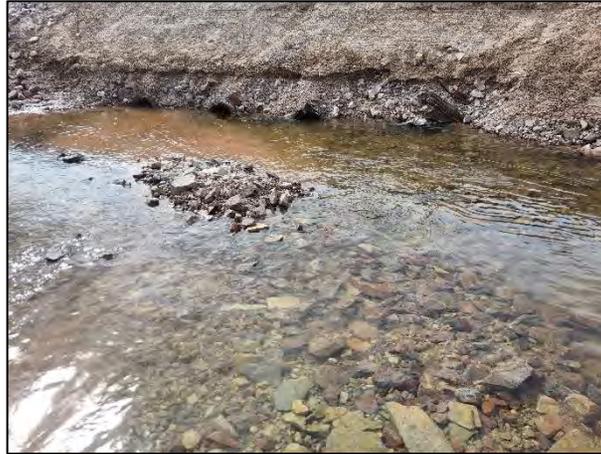
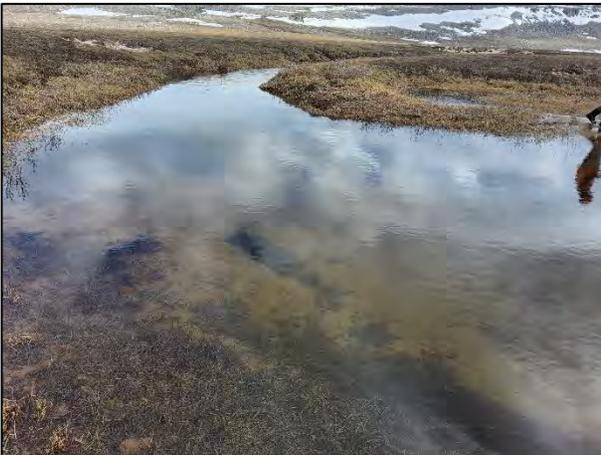
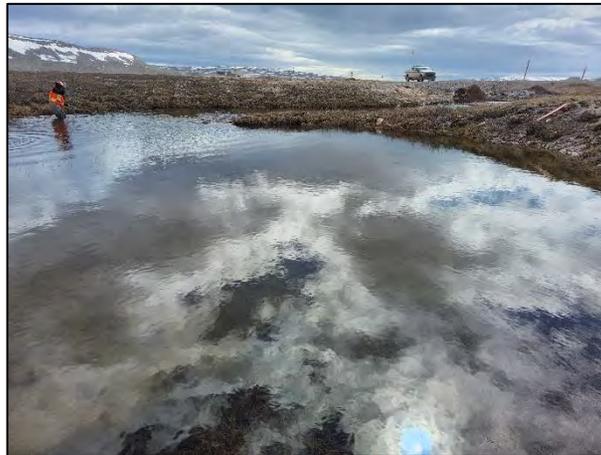
TOTE ROAD CV-059

Photos 1-3. Photos taken 20 m upstream (top) and 60 m upstream (bottom) in spring 2023: (A,D) facing upstream; (B,E) facing downstream; and (C,F) across (left bank looking at right bank).

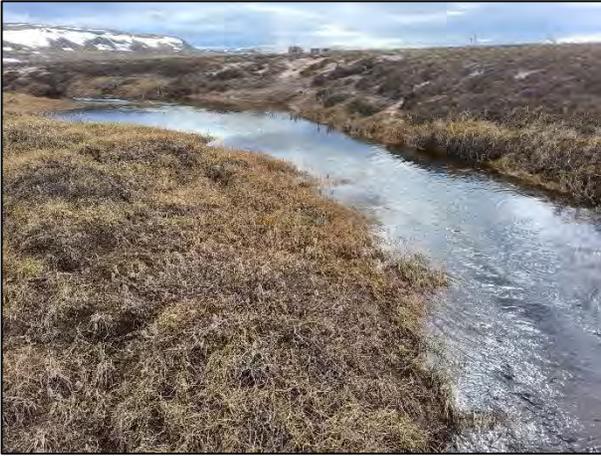
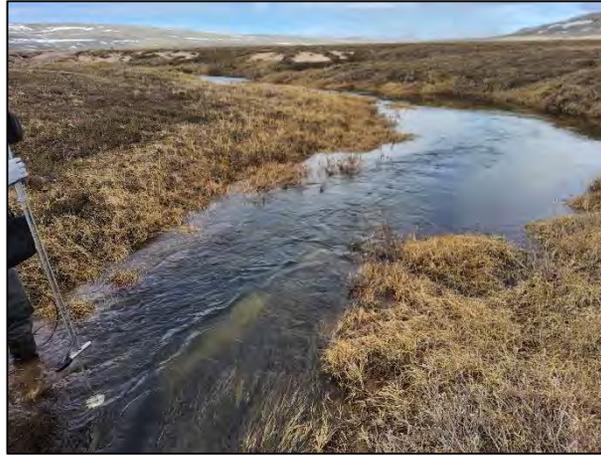
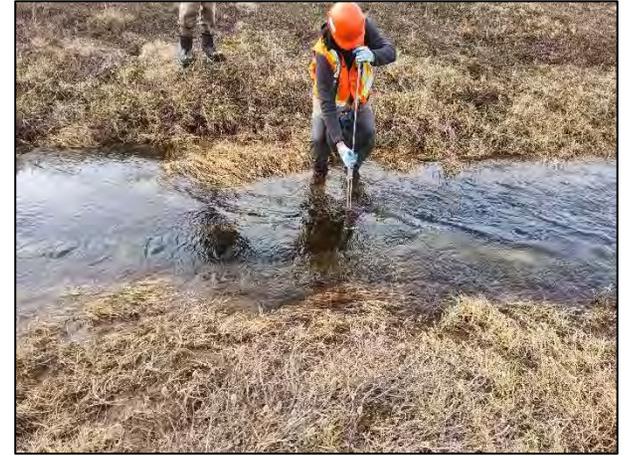
Photos 1-4. Photos taken 100 m upstream in spring 2023: (A) facing upstream; (B) facing downstream; and (C) across (left bank looking at right bank).

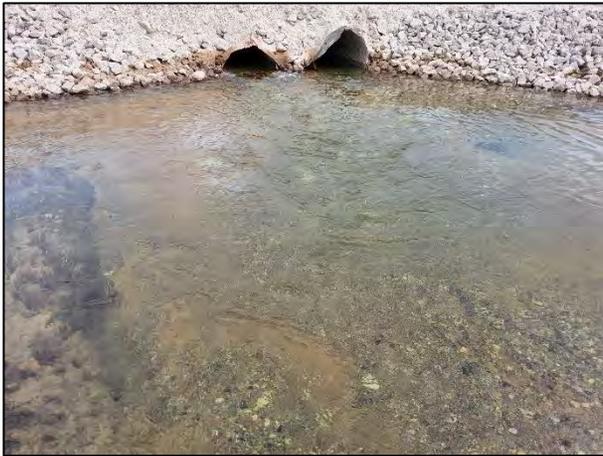
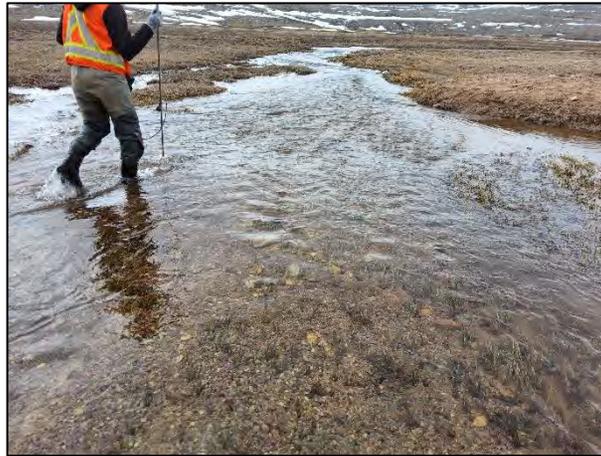
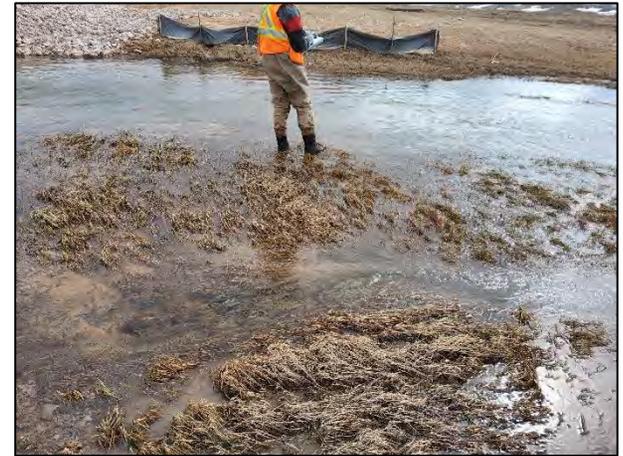
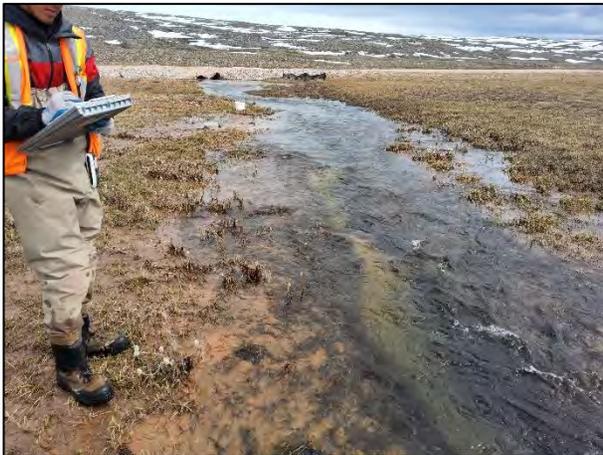
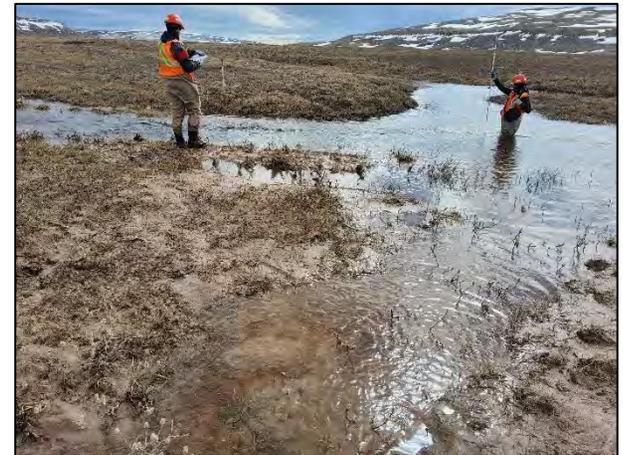
Photos 1-1. Photos taken 20 m downstream (top) and 60 m downstream (bottom) in spring 2023: (A,D) facing upstream; (B,E) facing downstream; and (C,F) across (right bank looking at left bank).

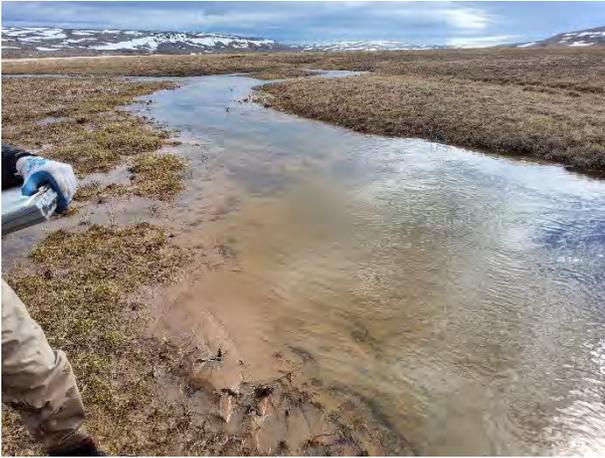
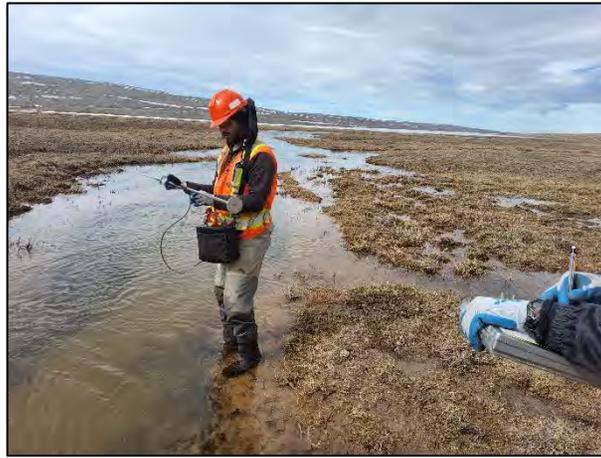
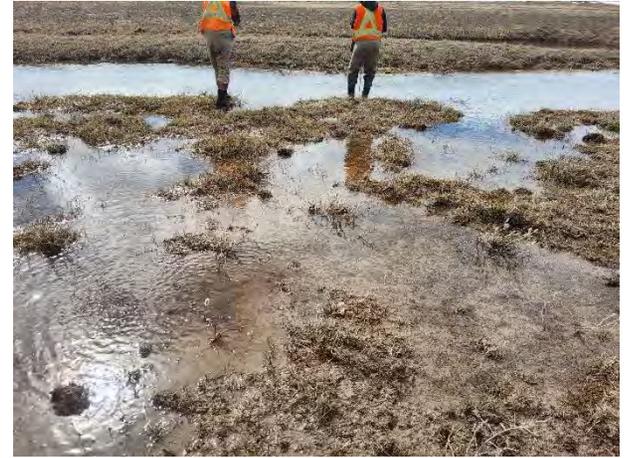
Photos 1-2. Photos taken 100 m downstream in spring 2023: (A) facing upstream; (B) facing downstream; and (C) across (right bank looking at left bank).

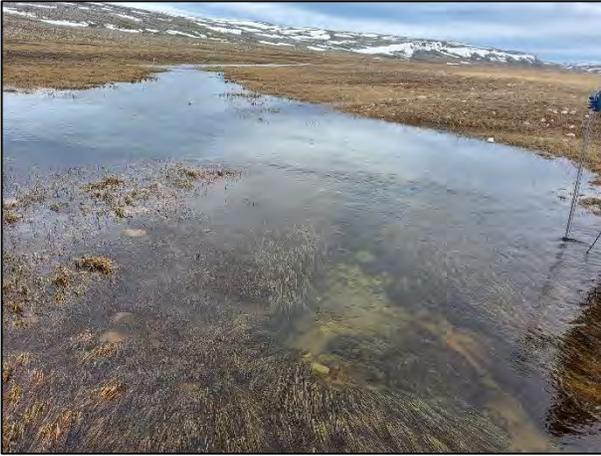
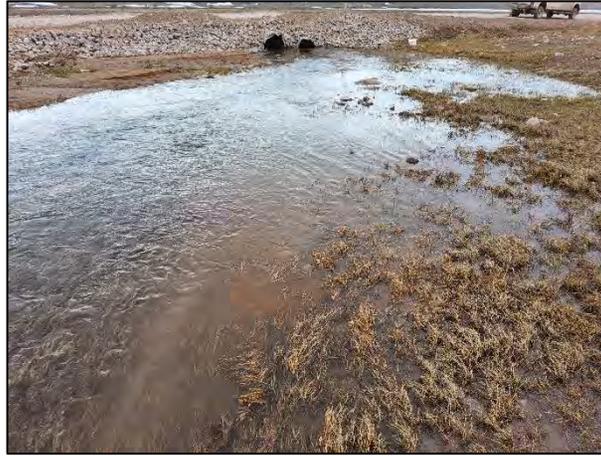
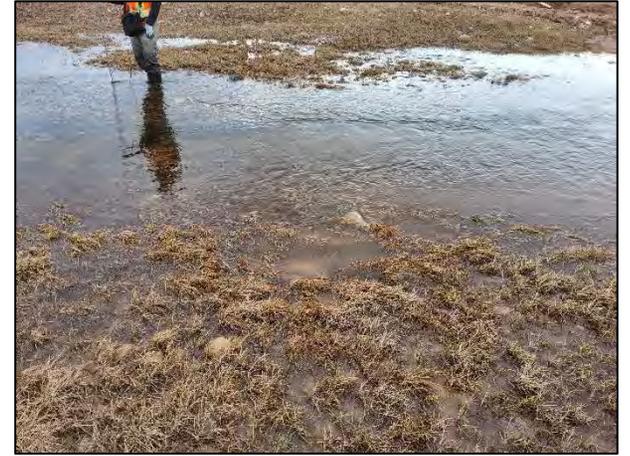
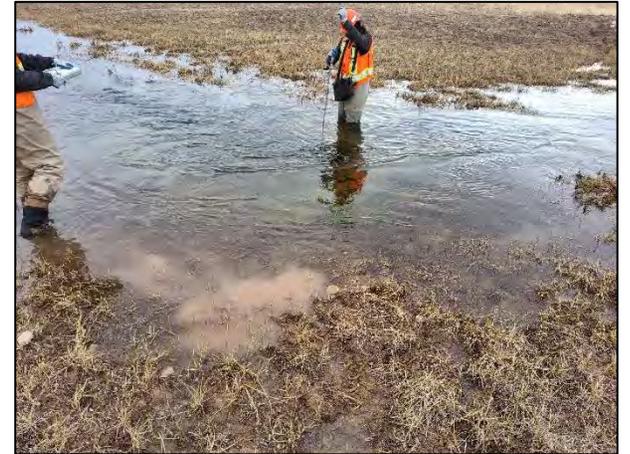
Photos 1-3. Photos taken 20 m upstream (top) and 60 m upstream (bottom) in spring 2023: (A,D) facing upstream; (B,E) facing downstream; and (C,F) across (left bank looking at right bank).

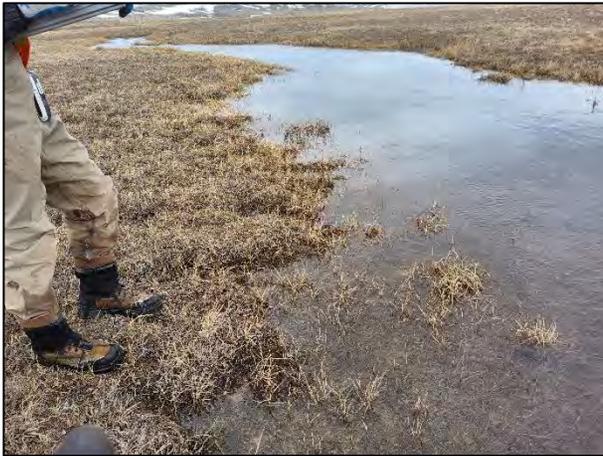
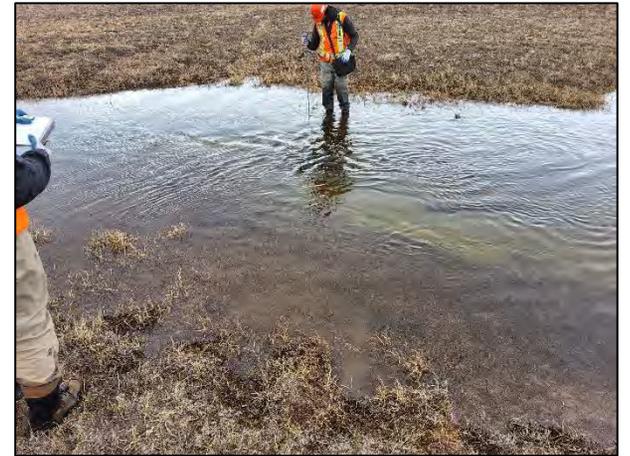
Photos 1-4. Photos taken 100 m upstream in spring 2023: (A) facing upstream; (B) facing downstream; and (C) across (left bank looking at right bank).

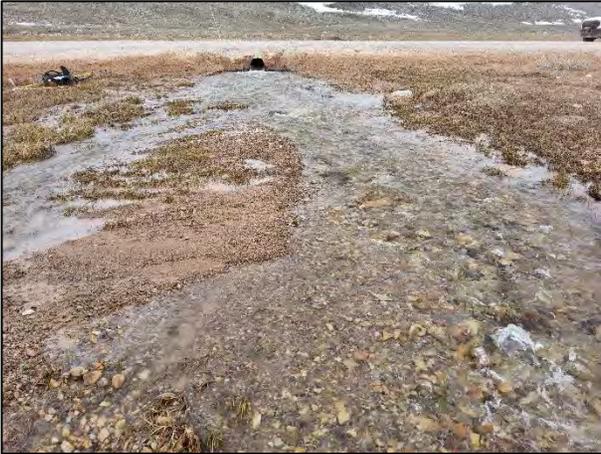
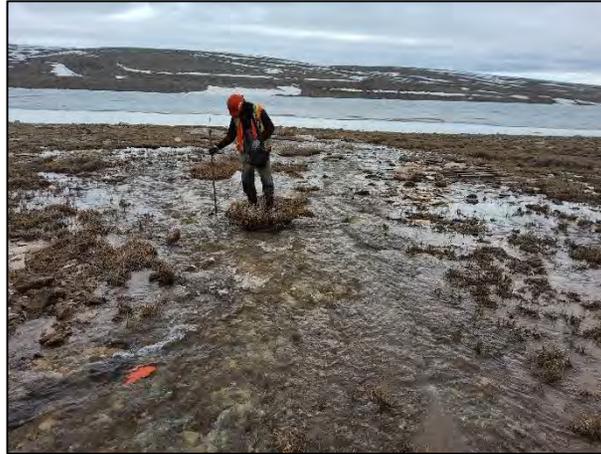
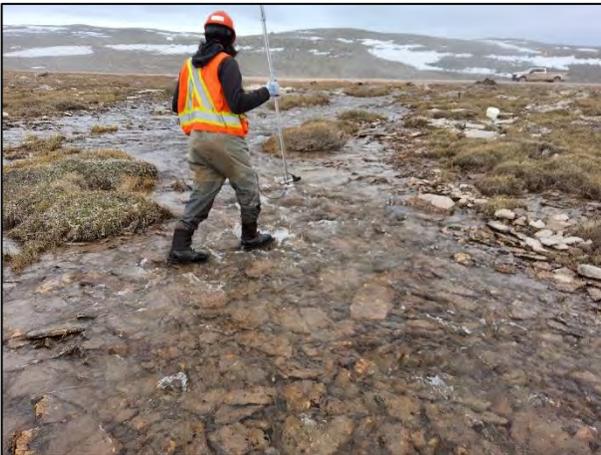
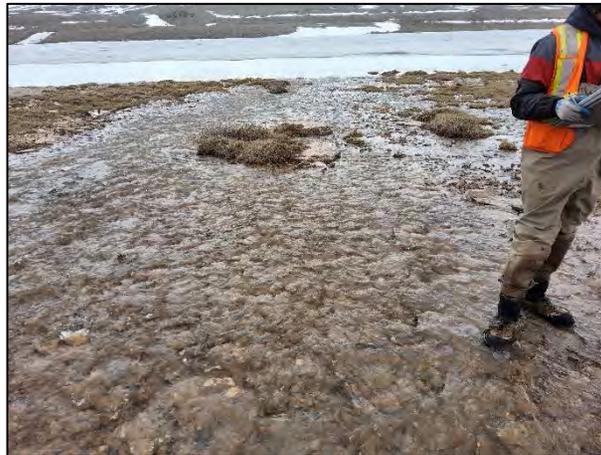
TOTE ROAD CV-061

Photos 1-1. Photos taken 20 m downstream (top) and 60 m downstream (bottom) in spring 2023: (A,D) facing upstream; (B,E) facing downstream; and (C,F) across (right bank looking at left bank).

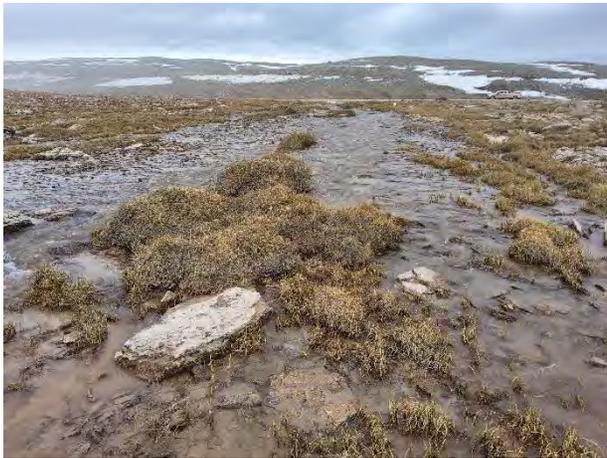
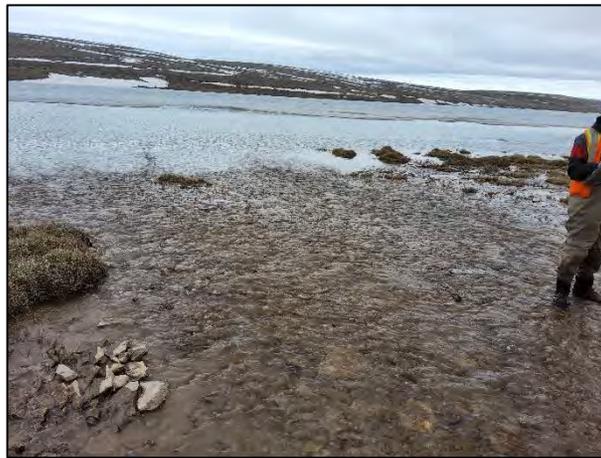
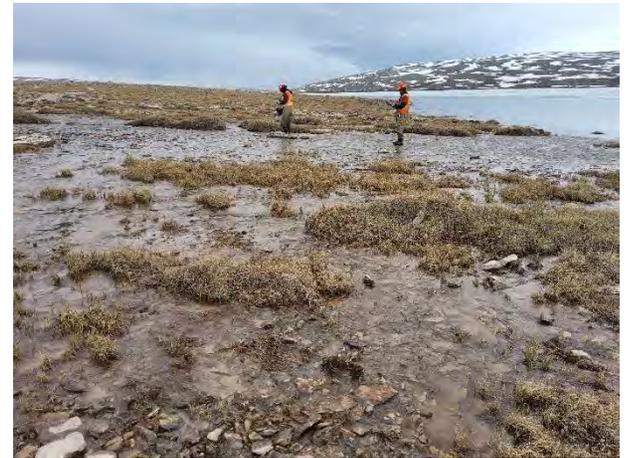
Photos 1-2. Photos taken 100 m downstream in spring 2023: (A) facing upstream; (B) facing downstream; and (C) across (right bank looking at left bank).

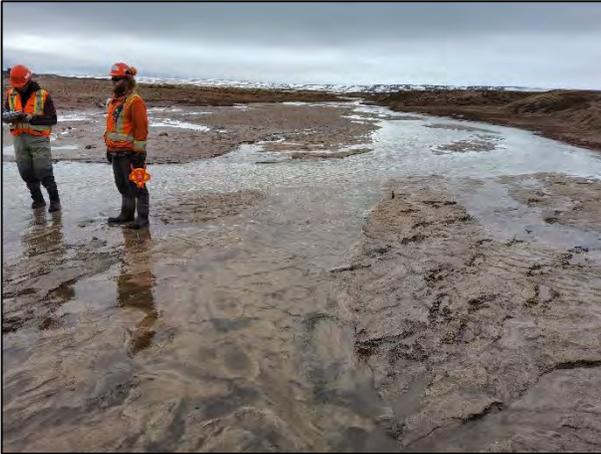
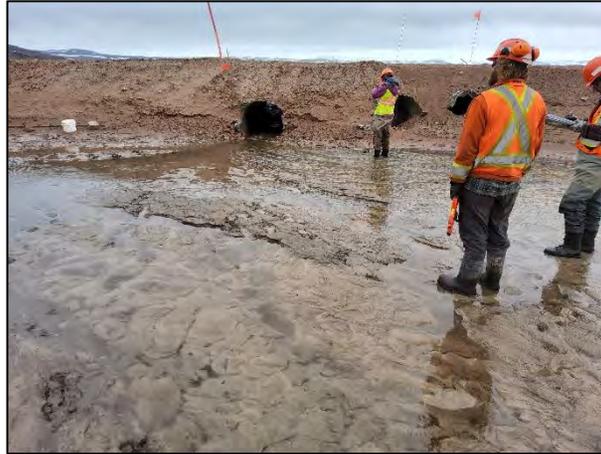
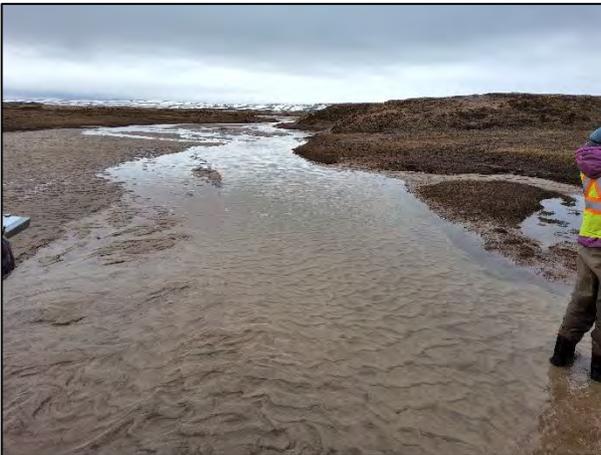
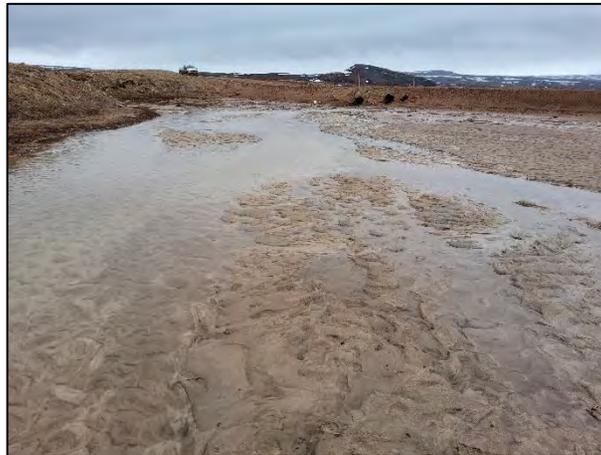
TOTE ROAD CV-061

Photos 1-3. Photos taken 20 m upstream (top) and 60 m upstream (bottom) in spring 2023: (A,D) facing upstream; (B,E) facing downstream; and (C,F) across (left bank looking at right bank).

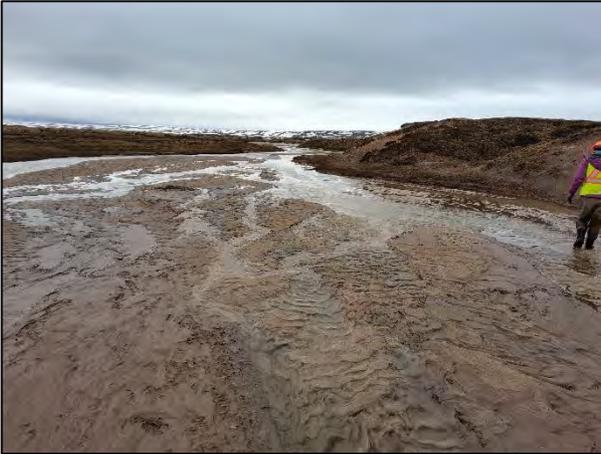
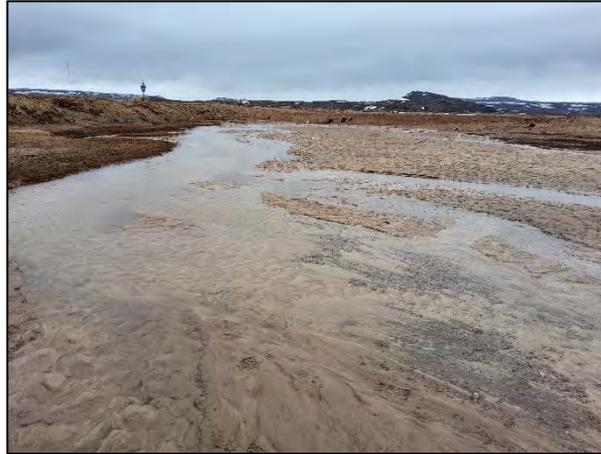
TOTE ROAD CV-061

Photos 1-4. Photos taken 100 m upstream in spring 2023: (A) facing upstream; (B) facing downstream; and (C) across (left bank looking at right bank).

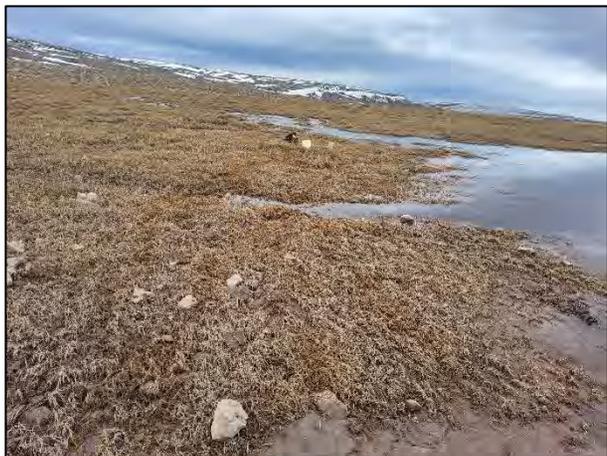
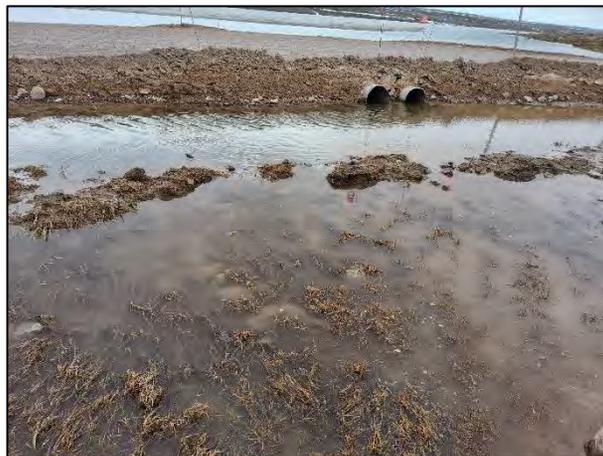
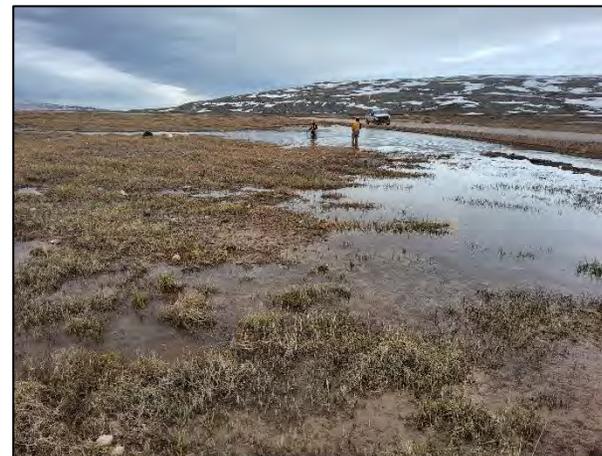
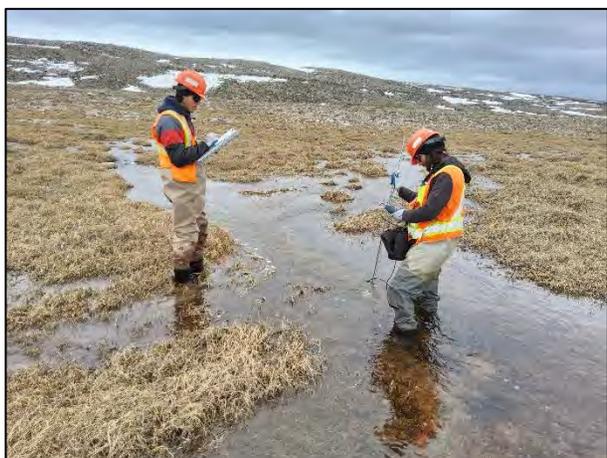
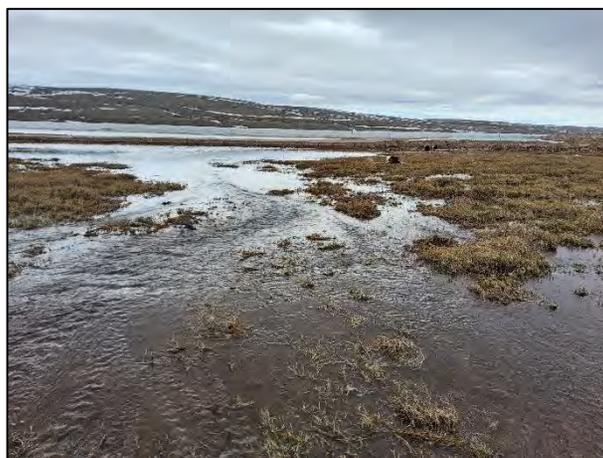
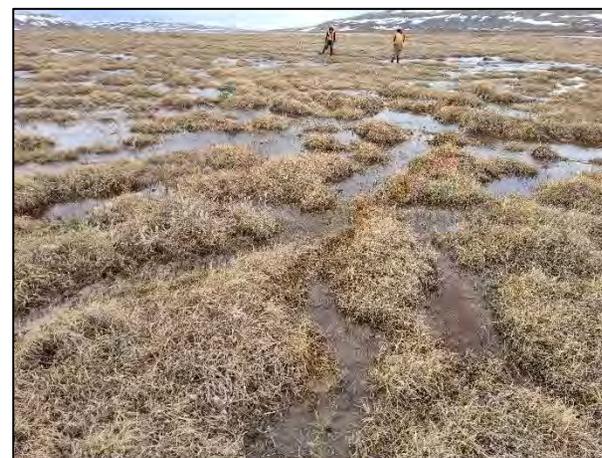
Photos 1-1. Photos taken 20 m upstream (top) and 60 m upstream (bottom) in spring 2023: (A,D) facing upstream; (B,E) facing downstream; and (C,F) across (left bank looking at right bank).

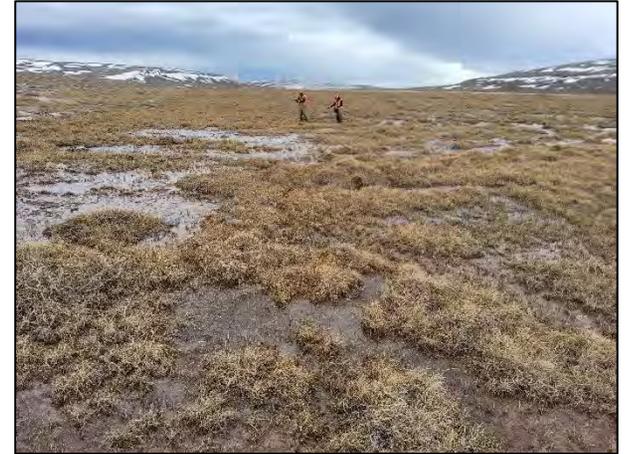
Photos 1-2. Photos taken 100 m upstream in spring 2023: (A) facing upstream; (B) facing downstream; and (C) across (left bank looking at right bank).

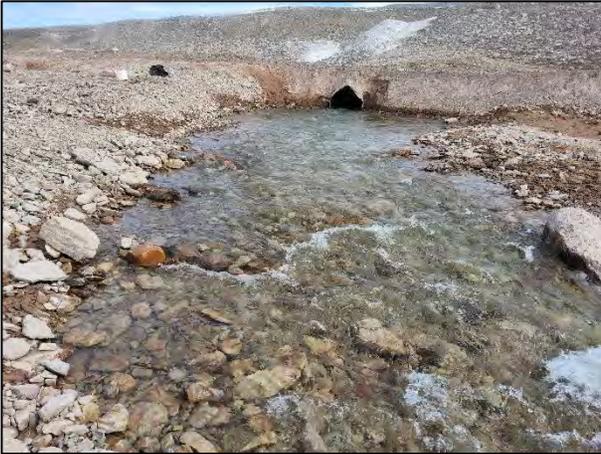
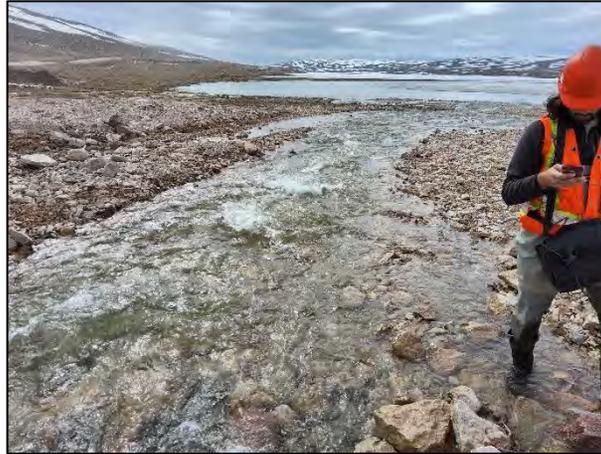
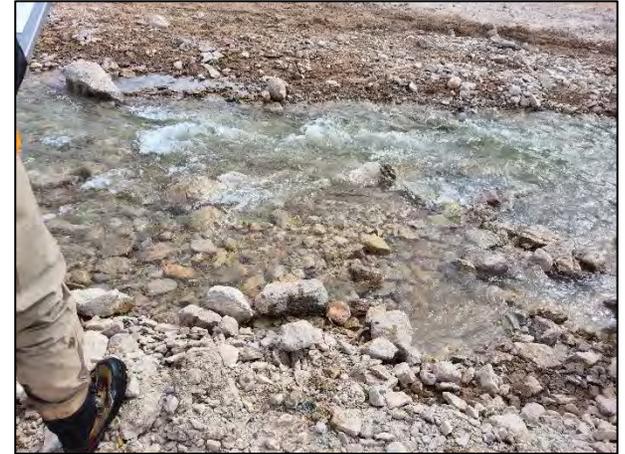
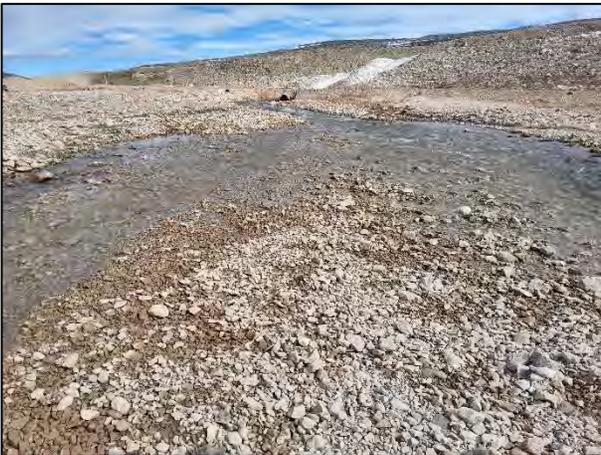
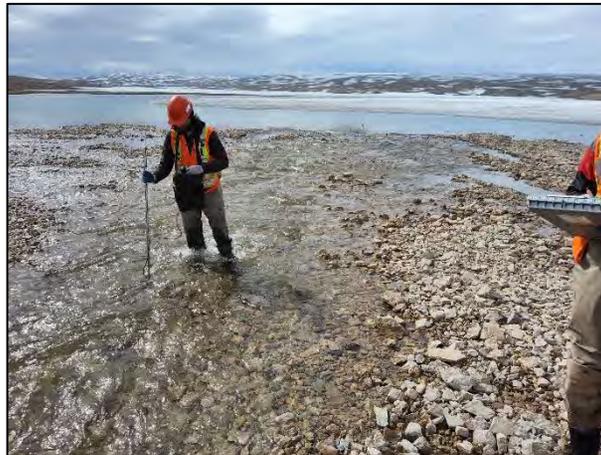
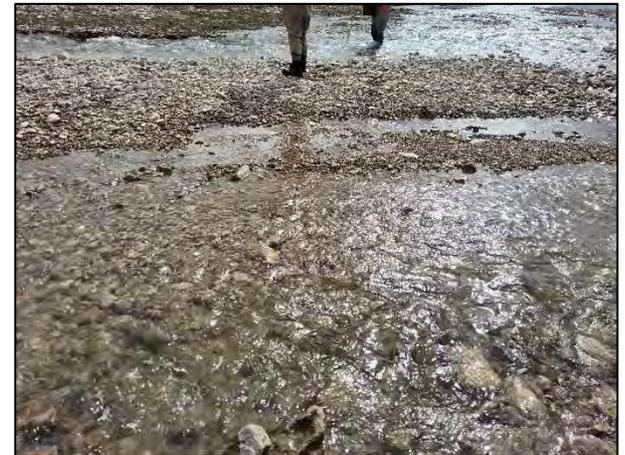
TOTE ROAD CV-072

Photos 1-1. Photos taken 20 m downstream (top) and 60 m downstream (bottom) in spring 2023: (A,D) facing upstream; (B,E) facing downstream; and (C,F) across (right bank looking at left bank).

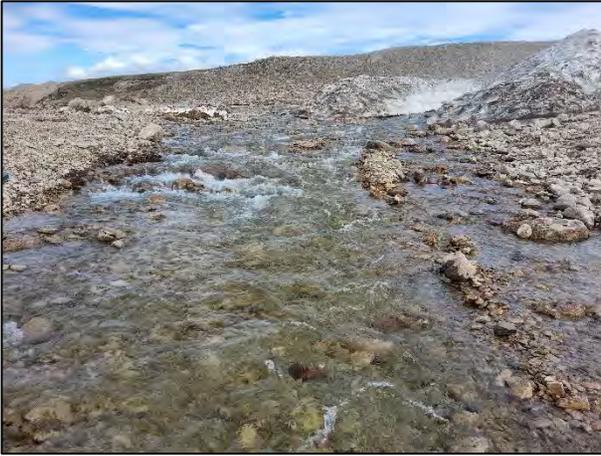
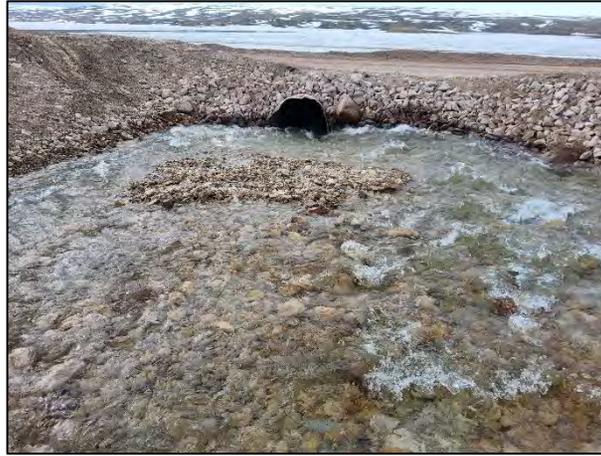
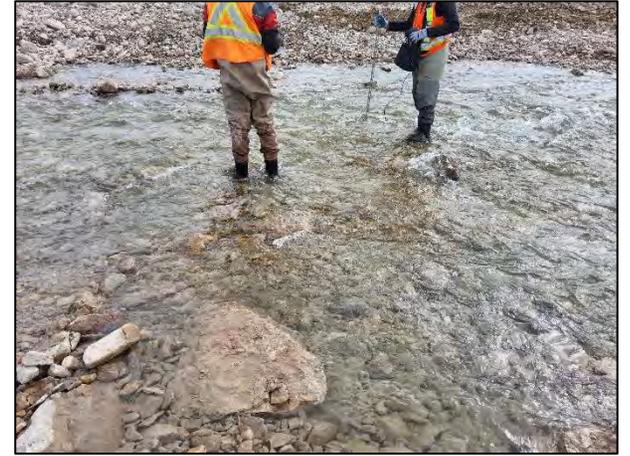
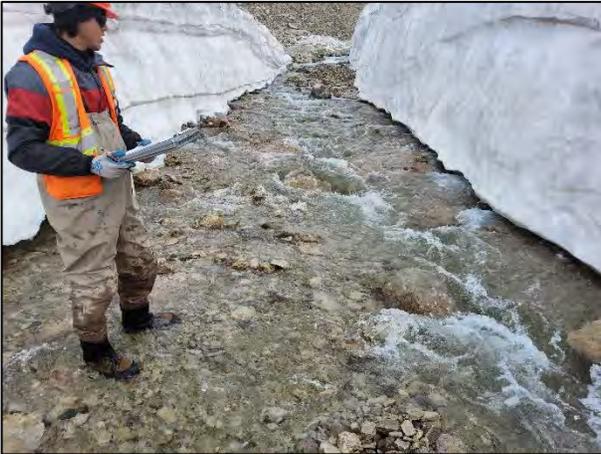
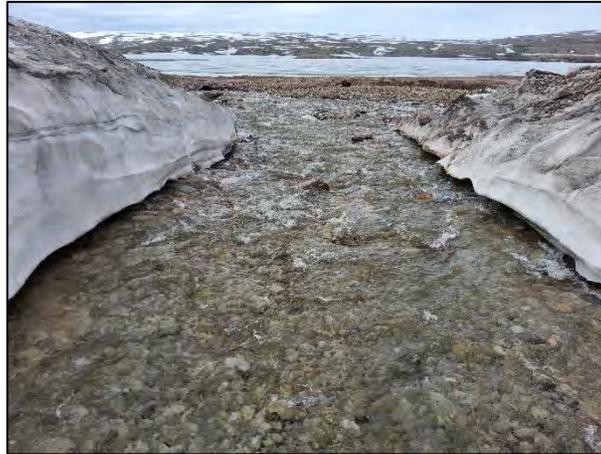
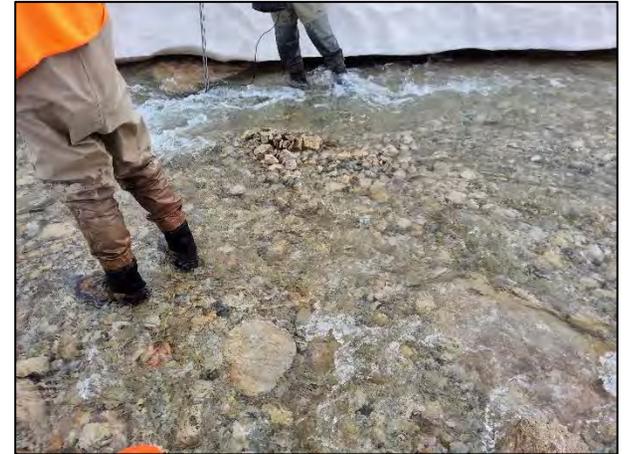
TOTE ROAD CV-072

Photos 1-3. Photos taken 20 m upstream (top) and 60 m upstream (bottom) in spring 2023: (A,D) facing upstream; (B,E) facing downstream; and (C,F) across (left bank looking at right bank).

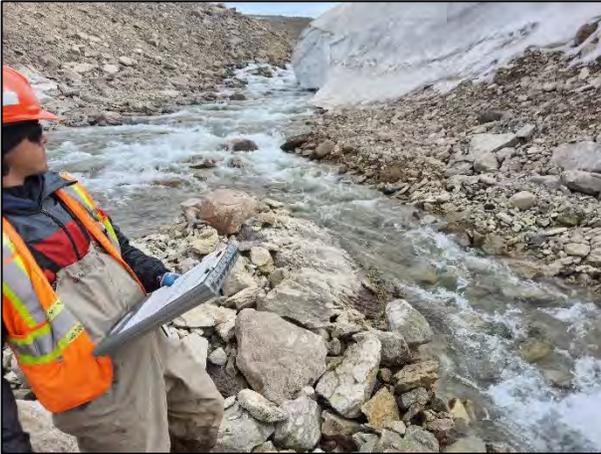
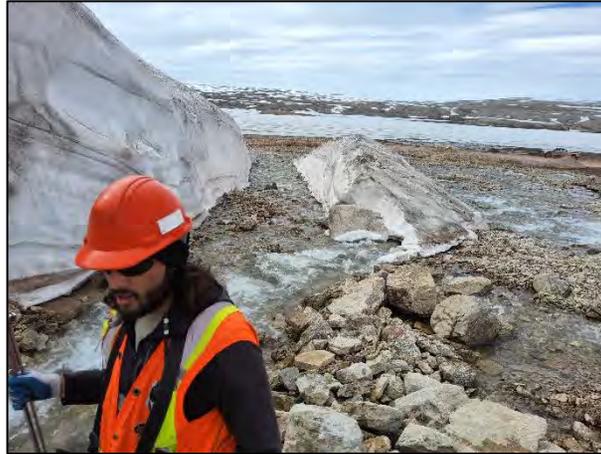
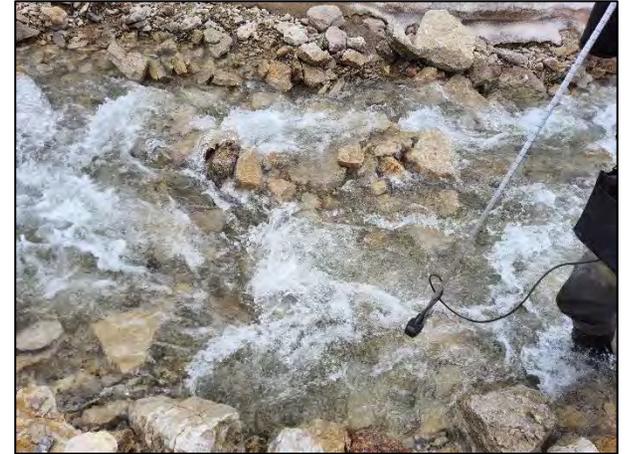
TOTE ROAD CV-072

Photos 1-4. Photos taken 100 m upstream in spring 2023: (A) facing upstream; (B) facing downstream; and (C) across (left bank looking at right bank).

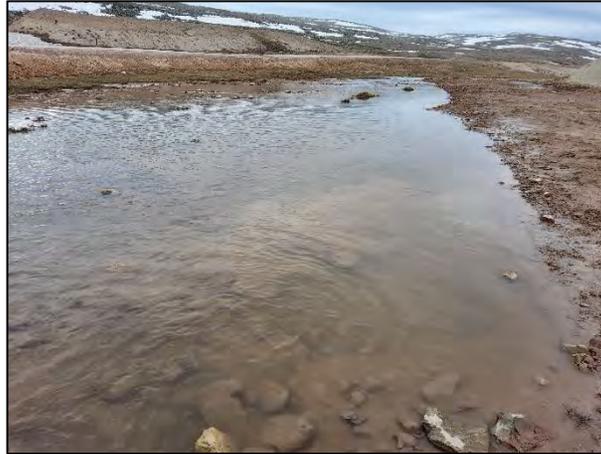
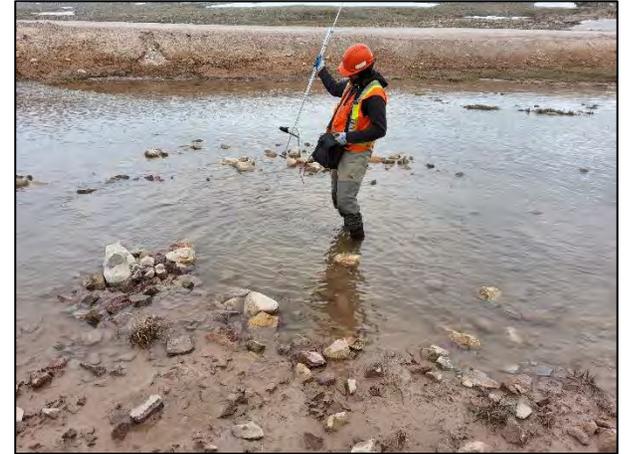
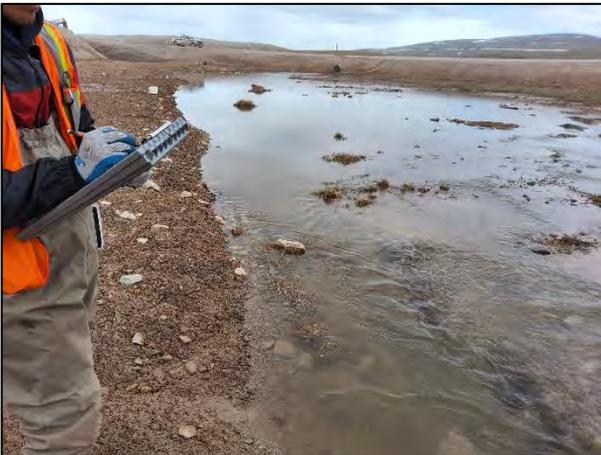
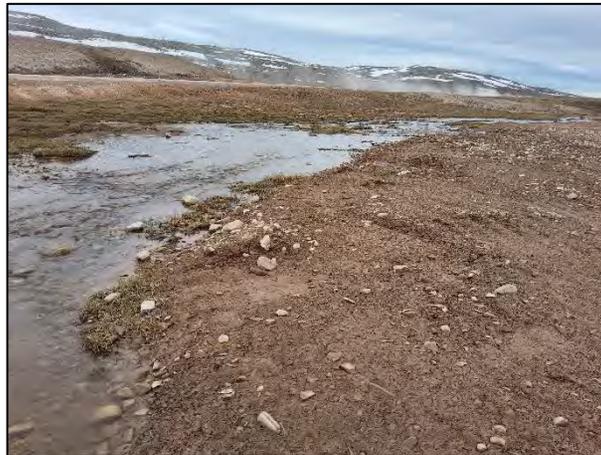
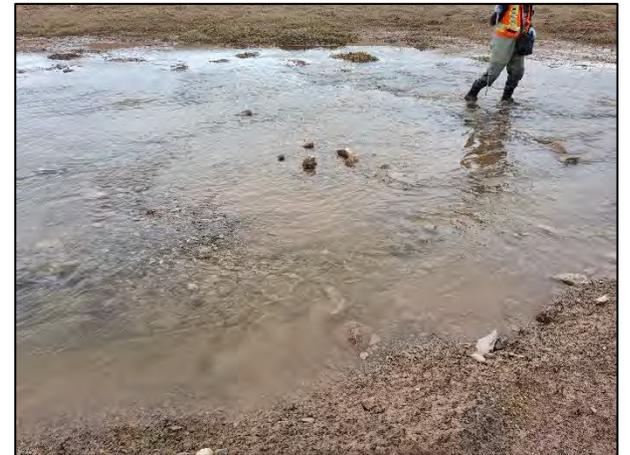
Photos 1-1. Photos taken 20 m downstream (top) and 60 m downstream (bottom) in spring 2023: (A,D) facing upstream; (B,E) facing downstream; and (C,F) across (right bank looking at left bank).

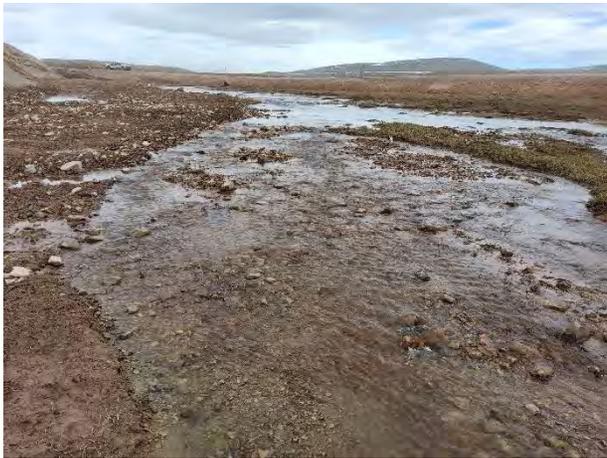
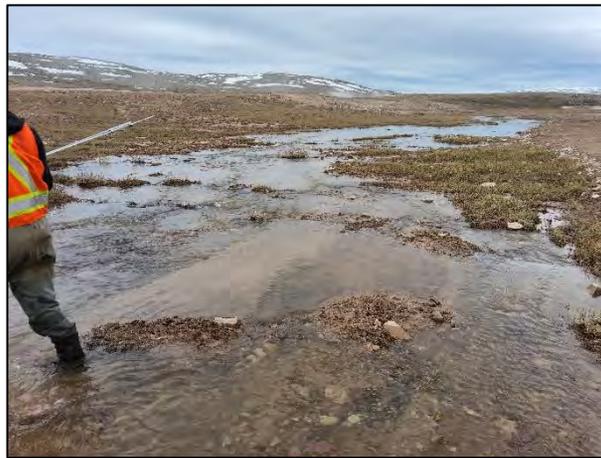
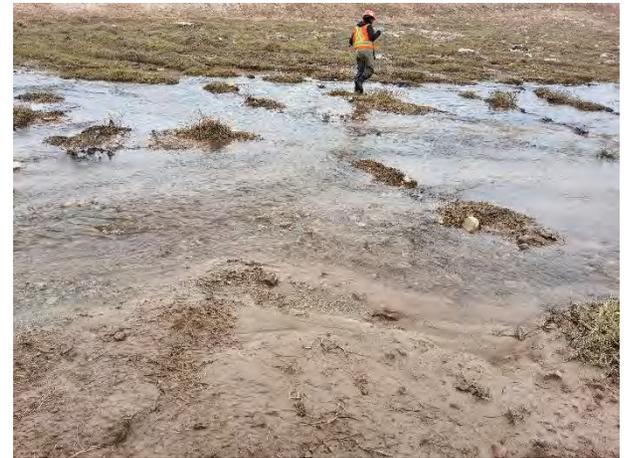
Photos 1-2. Photos taken 100 m downstream in spring 2023: (A) facing upstream; (B) facing downstream; and (C) across (right bank looking at left bank).

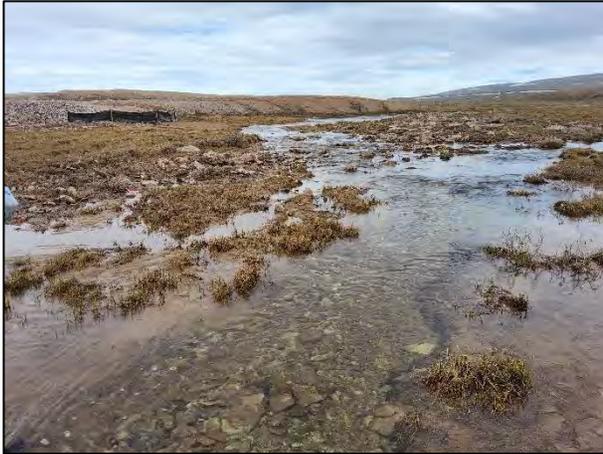
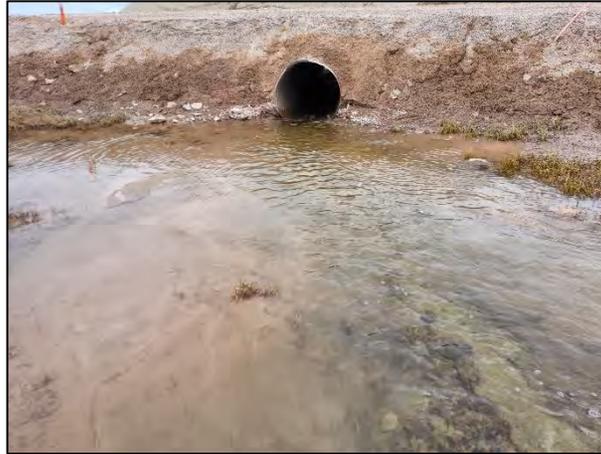
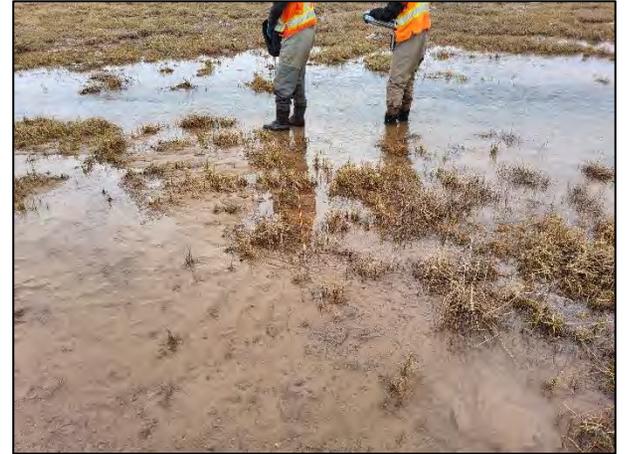
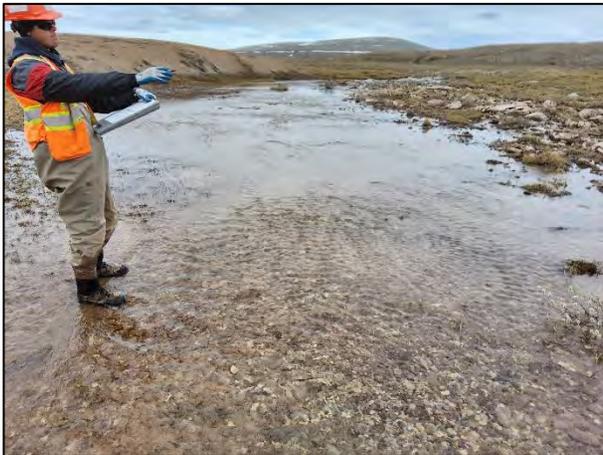
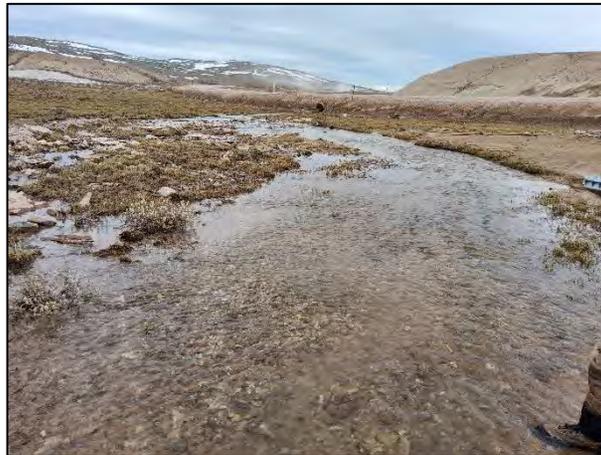
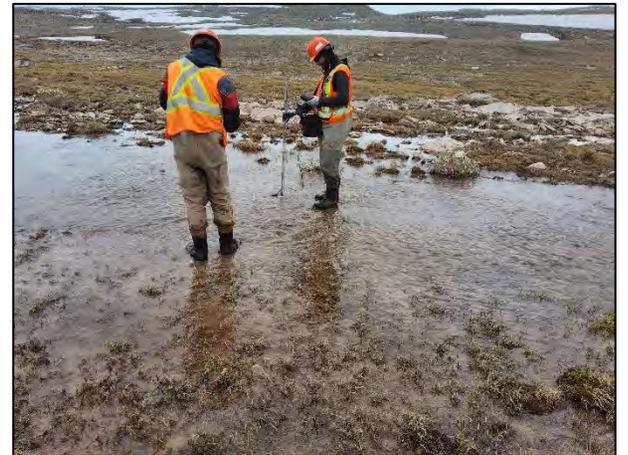
Photos 1-3. Photos taken 20 m upstream (top) and 60 m upstream (bottom) in spring 2023: (A,D) facing upstream; (B,E) facing downstream; and (C,F) across (left bank looking at right bank).

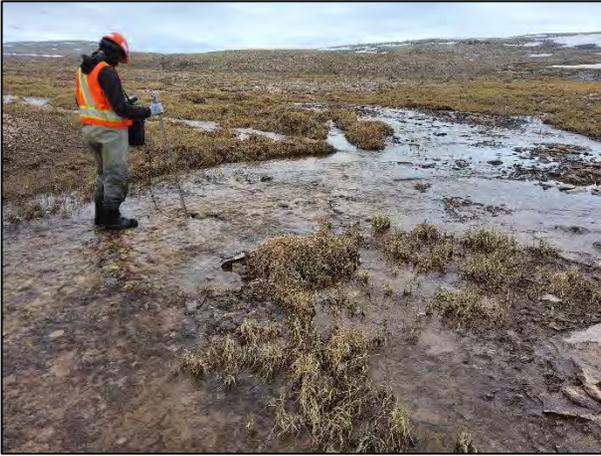
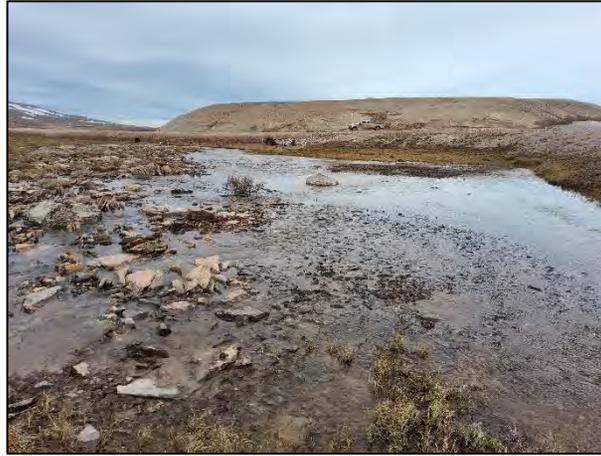
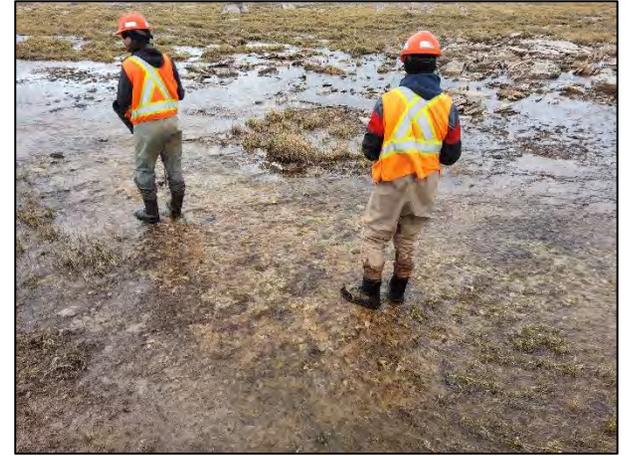
Photos 1-4. Photos taken 100 m upstream in spring 2023: (A) facing upstream; (B) facing downstream; and (C) across (left bank looking at right bank).
