TOTE ROAD CV-059

BAFFINLAND IRON MINES
MARY RIVER PROJECT

**North/South Consultants Inc.**
Aquatic Environment Specialists

SITE SUMMARY

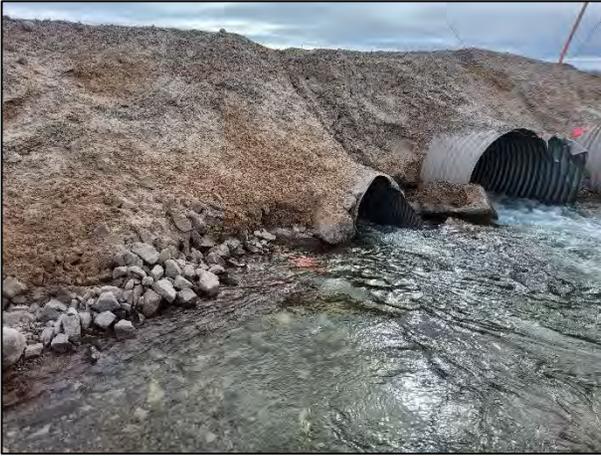
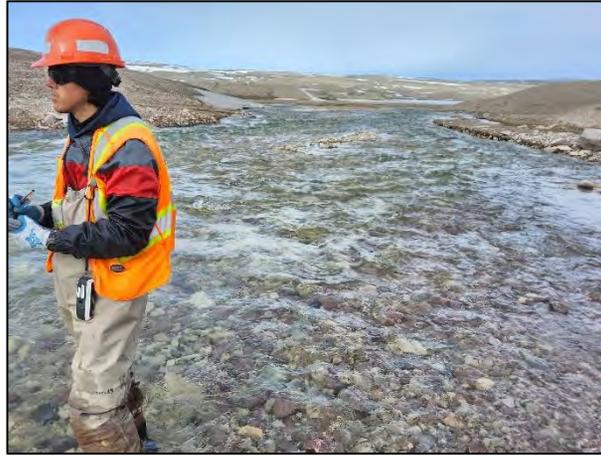
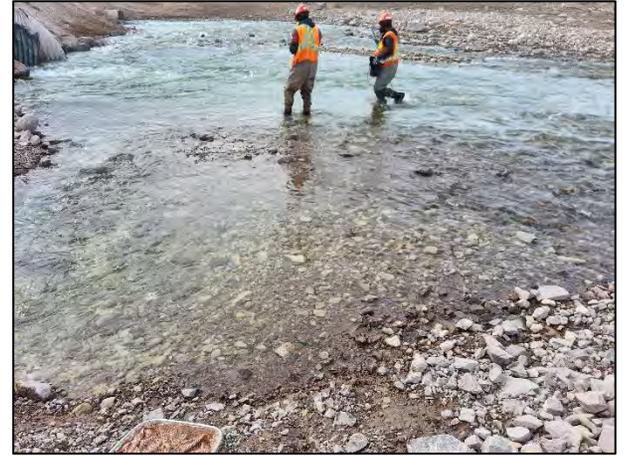
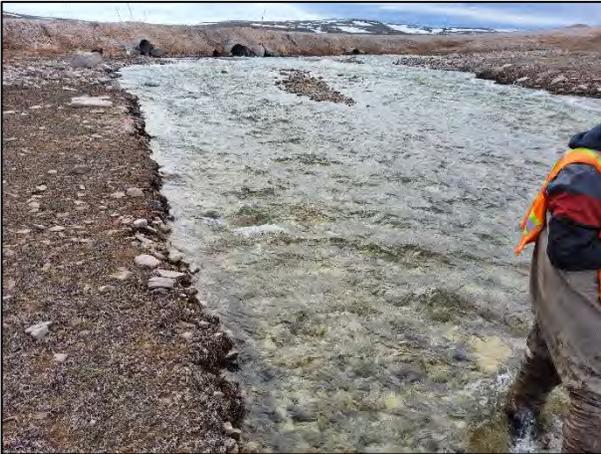
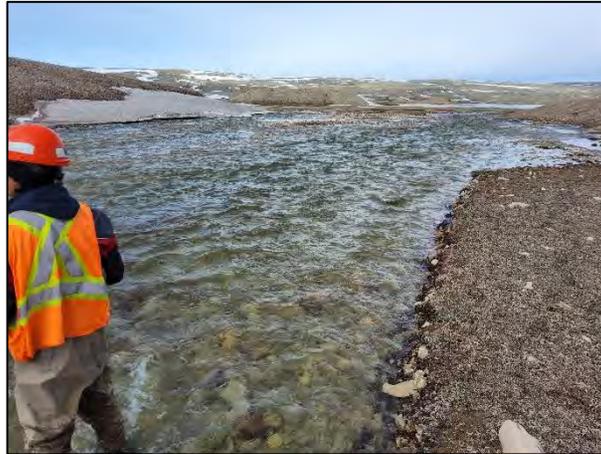
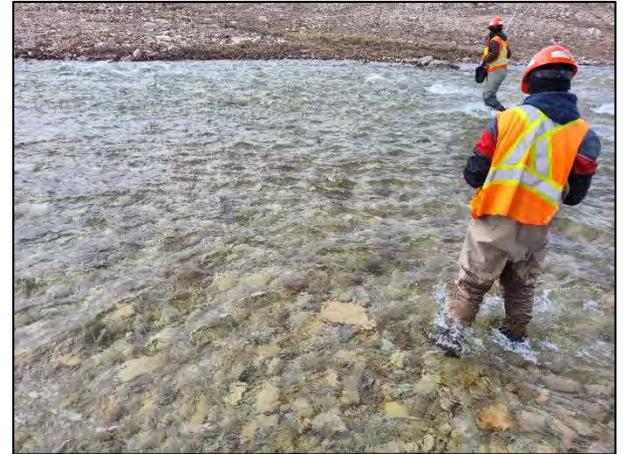
Photos 1-1. Photos taken 20 m downstream (top) and 60 m downstream (bottom) in spring 2023: (A,D) facing upstream; (B,E) facing downstream; and (C,F) across (right bank looking at left bank).

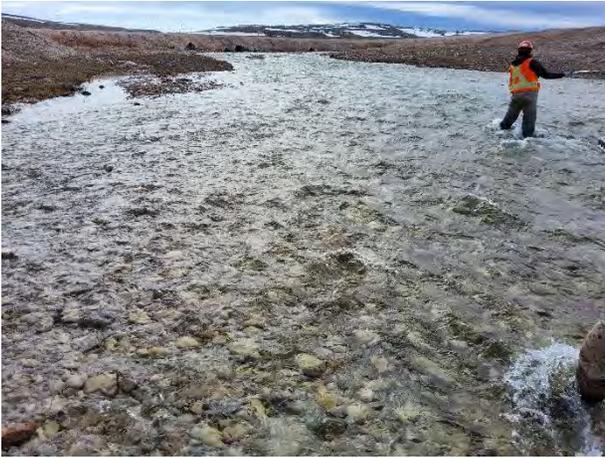
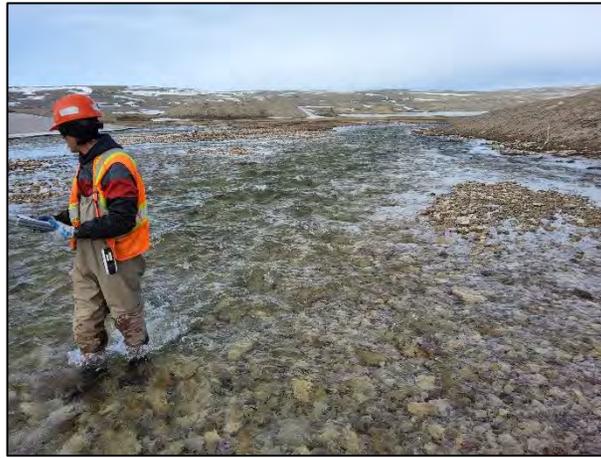
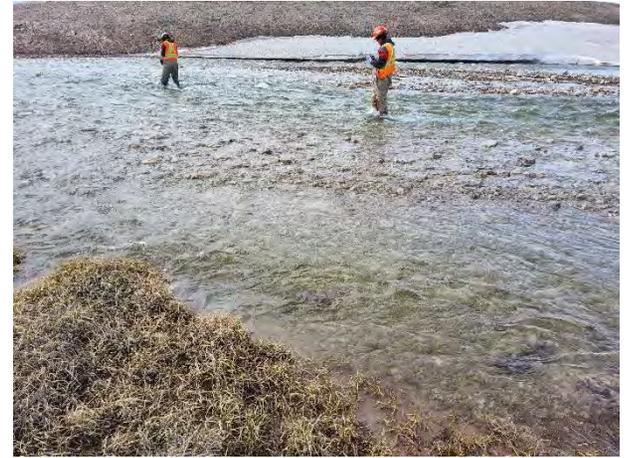
Photos 1-2. Photos taken 100 m downstream in spring 2023: (A) facing upstream; (B) facing downstream; and (C) across (right bank looking at left bank).

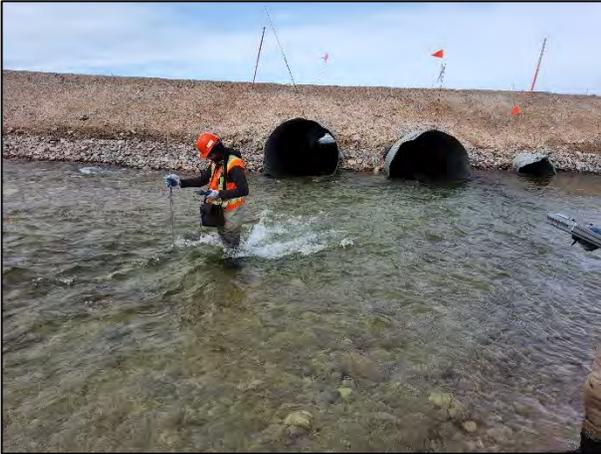
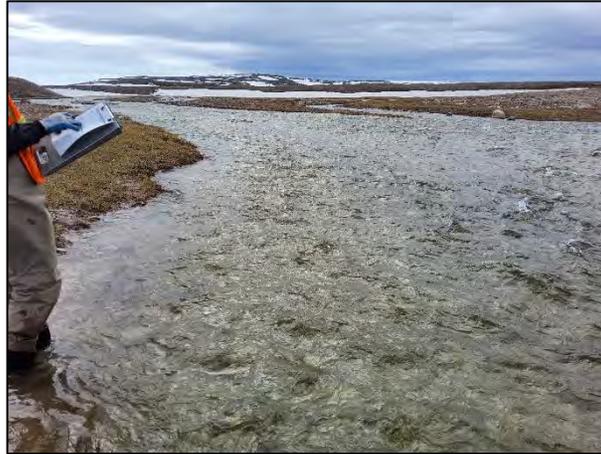
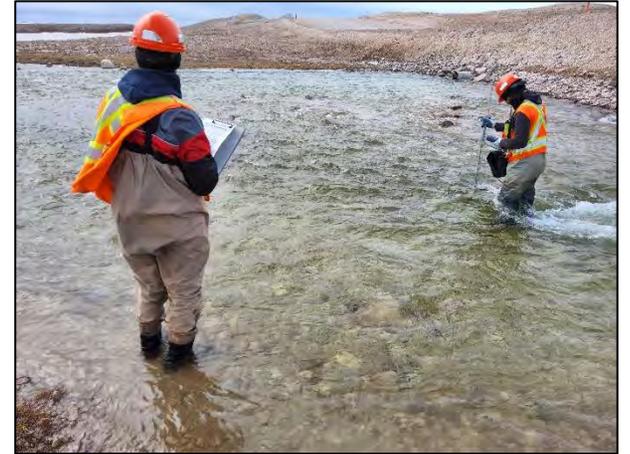
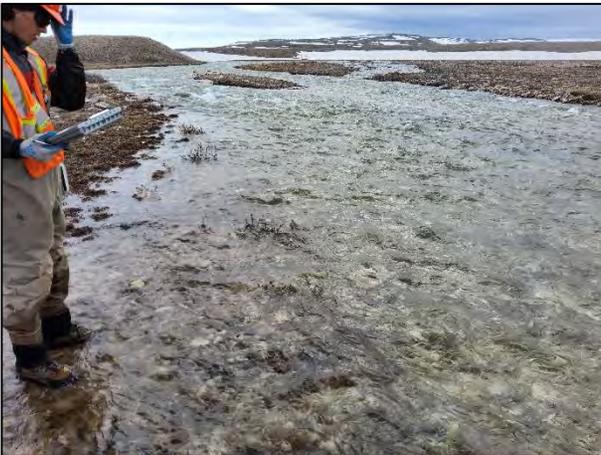
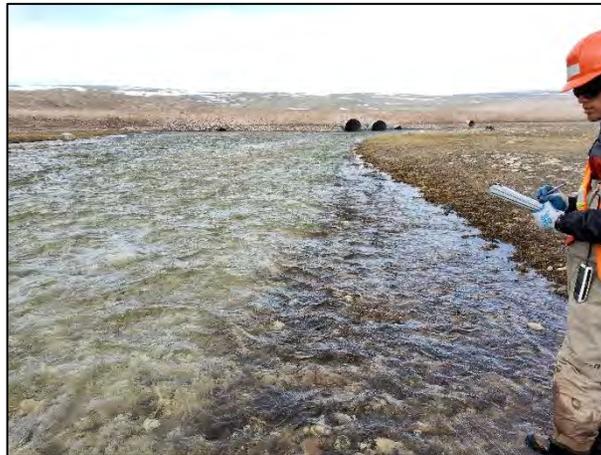
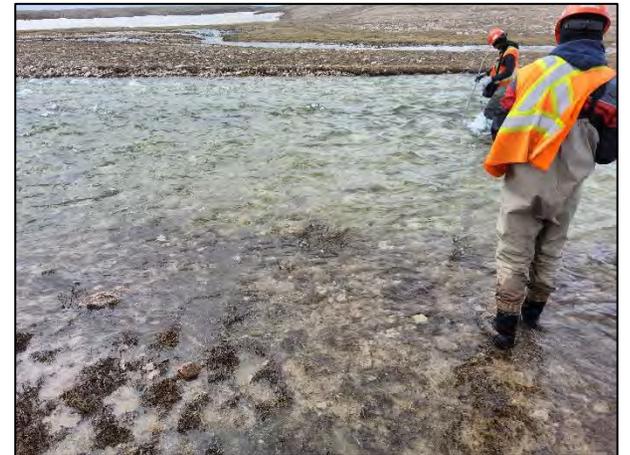
Photos 1-3. Photos taken 20 m upstream (top) and 60 m upstream (bottom) in spring 2023: (A,D) facing upstream; (B,E) facing downstream; and (C,F) across (left bank looking at right bank).

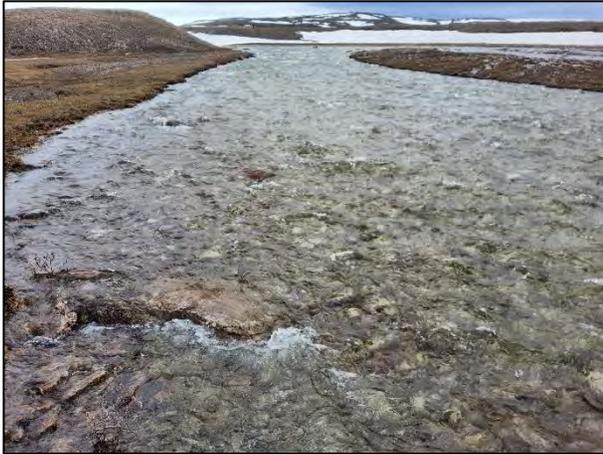
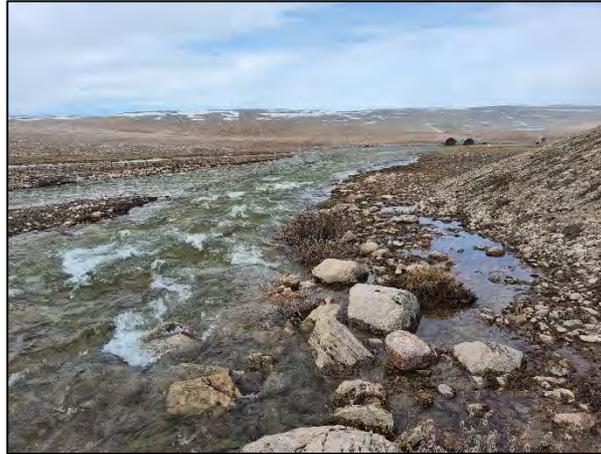
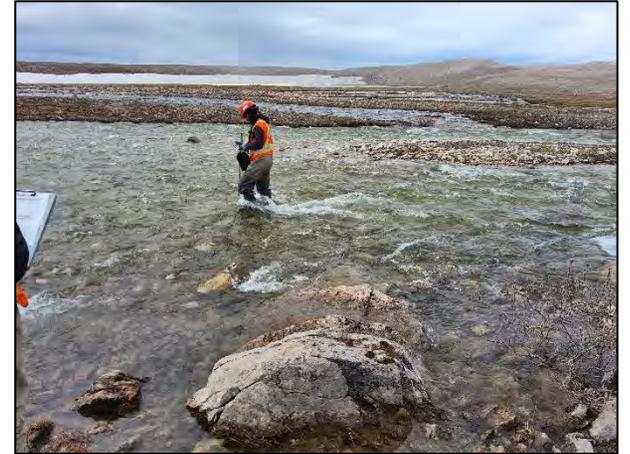
Photos 1-4. Photos taken 100 m upstream in spring 2023: (A) facing upstream; (B) facing downstream; and (C) across (left bank looking at right bank).
