TOTE ROAD CV-079

LOCATION AND CROSSING DESCRIPTION

BAFFINLAND IRON MINES
MARY RIVER PROJECT

**North/South Consultants Inc.**
Aquatic Environment Specialists

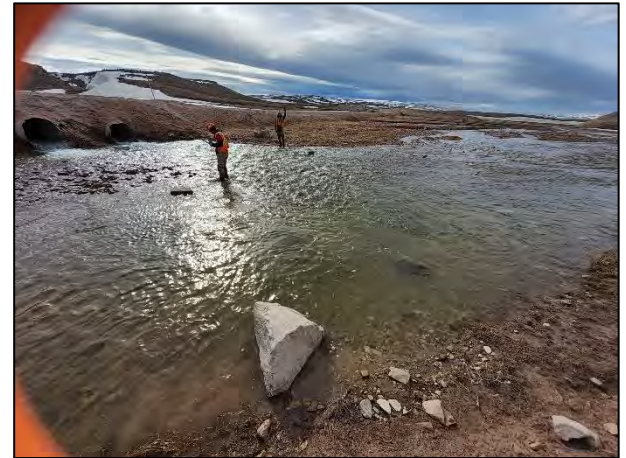
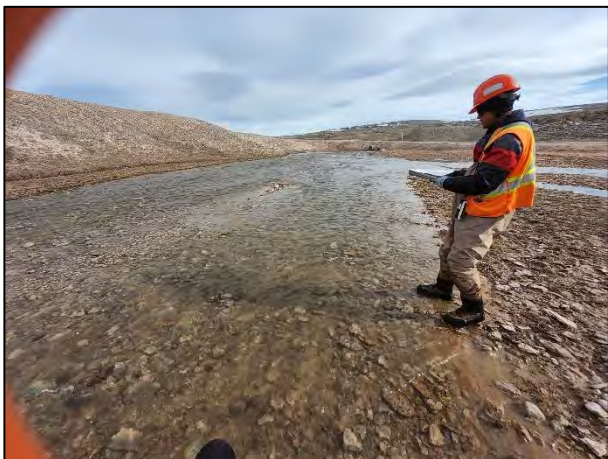
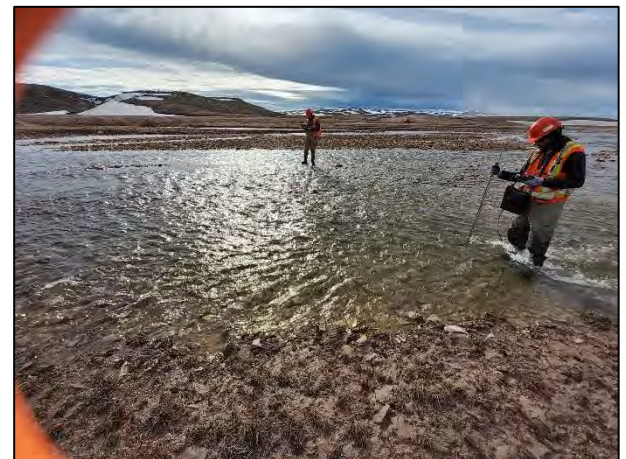
Photos 1-1. Photos taken 20 m downstream (top) and 60 m downstream (bottom) in spring 2023: (A,D) facing upstream; (B,E) facing downstream; and (C,F) across (right bank looking at left bank).

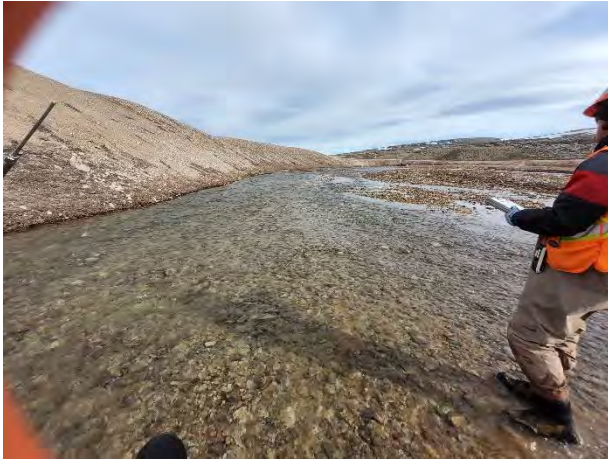
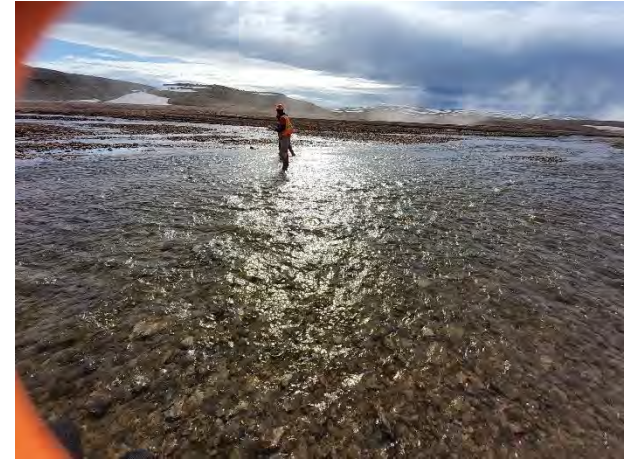
Photos 1-2. Photos taken 100 m downstream in spring 2023: (A) facing upstream; (B) facing downstream; and (C) across (right bank looking at left bank).

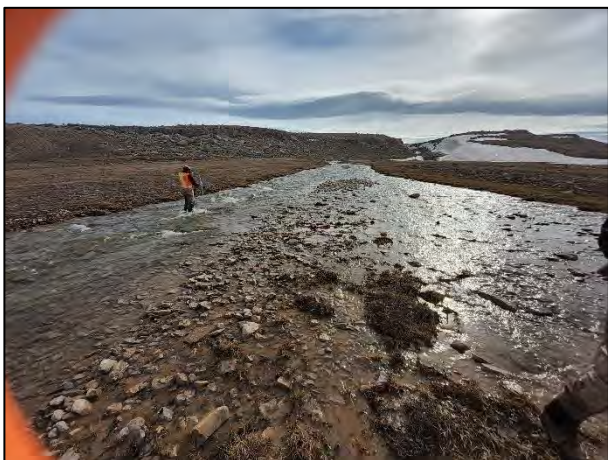
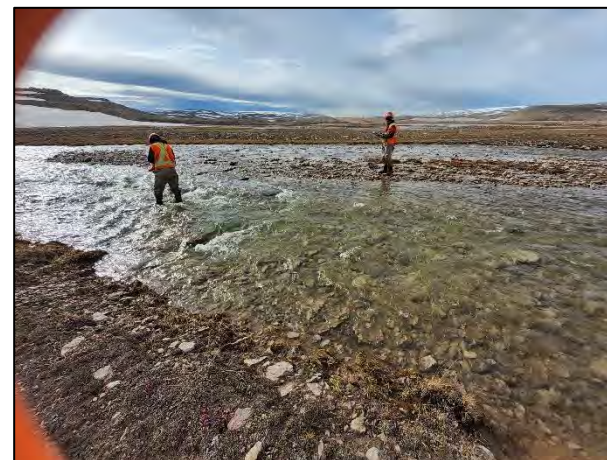
Photos 1-3. Photos taken 20 m upstream (top) and 60 m upstream (bottom) in spring 2023: (A,D) facing upstream; (B,E) facing downstream; and (C,F) across (left bank looking at right bank).

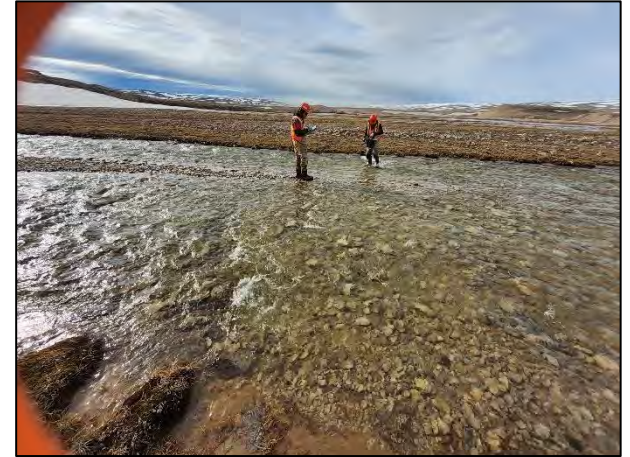
Photos 1-4. Photos taken 100 m upstream in spring 2023: (A) facing upstream; (B) facing downstream; and (C) across (left bank looking at right bank).

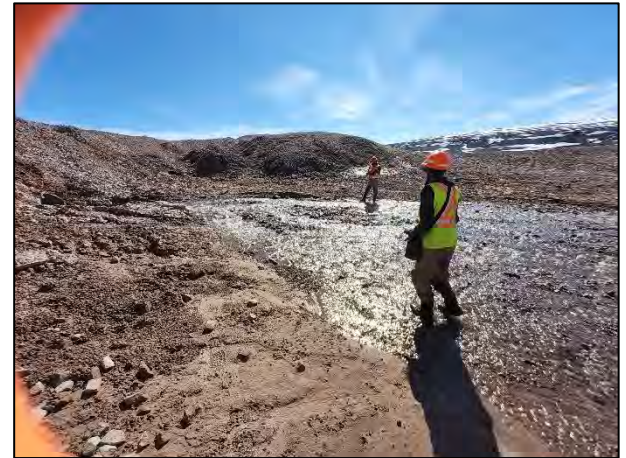
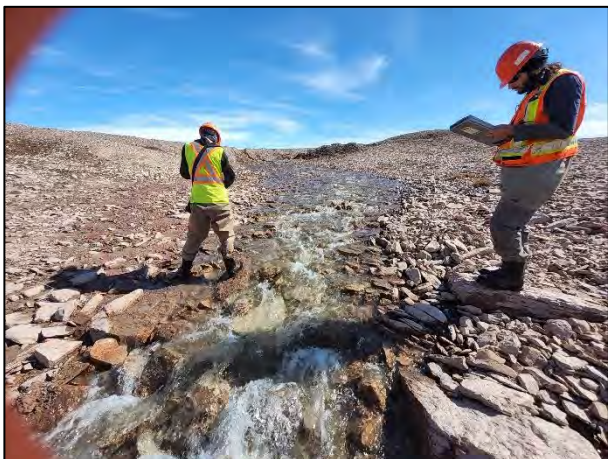
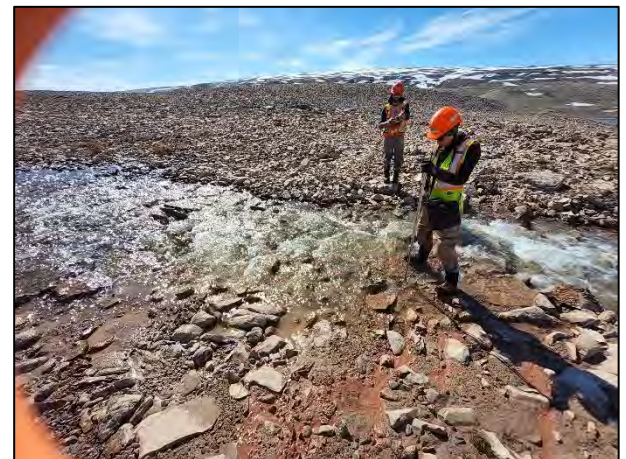
Photos 1-1. Photos taken 20 m downstream (top) and 60 m downstream (bottom) in spring 2023: (A,D) facing upstream; (B,E) facing downstream; and (C,F) across (right bank looking at left bank).

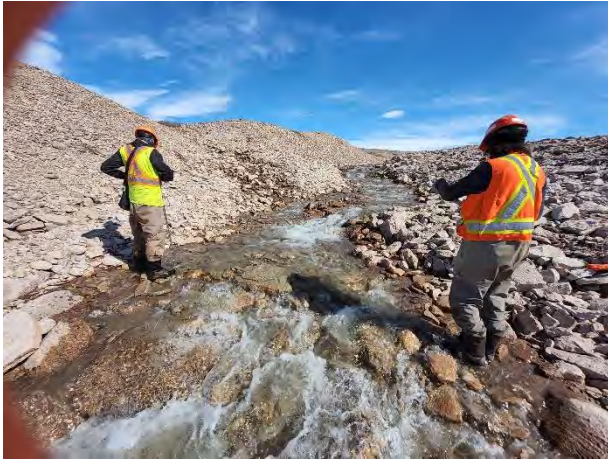
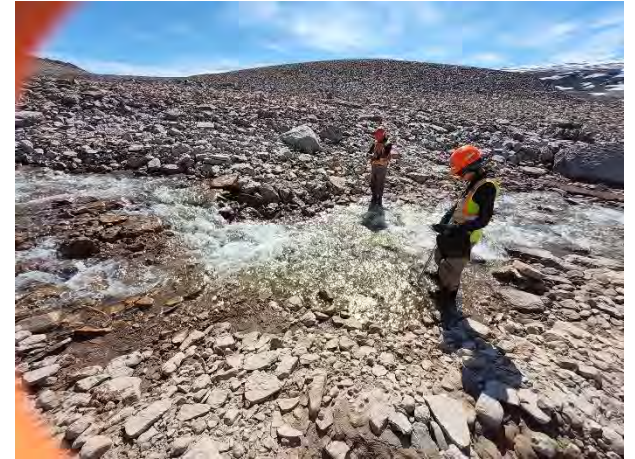
Photos 1-2. Photos taken 100 m downstream in spring 2023: (A) facing upstream; (B) facing downstream; and (C) across (right bank looking at left bank).

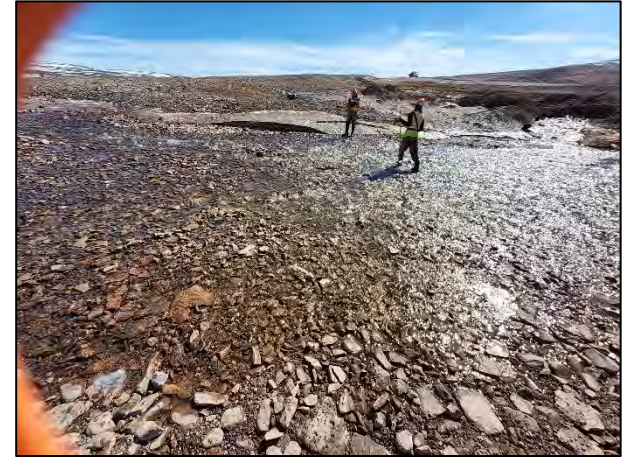
Photos 1-3. Photos taken 20 m upstream in spring 2023: (A) facing upstream; (B) facing downstream; and (C) across (left bank looking at right bank).

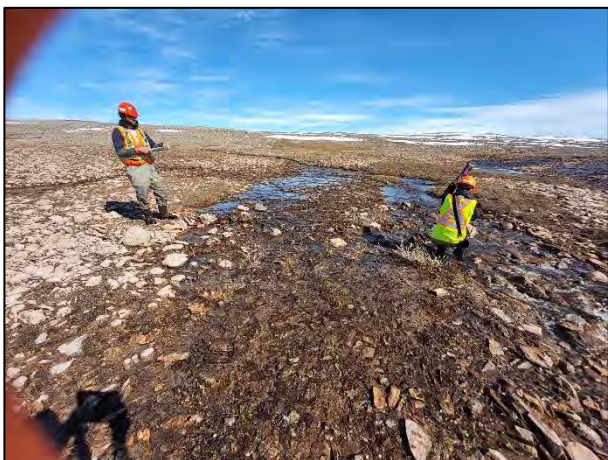
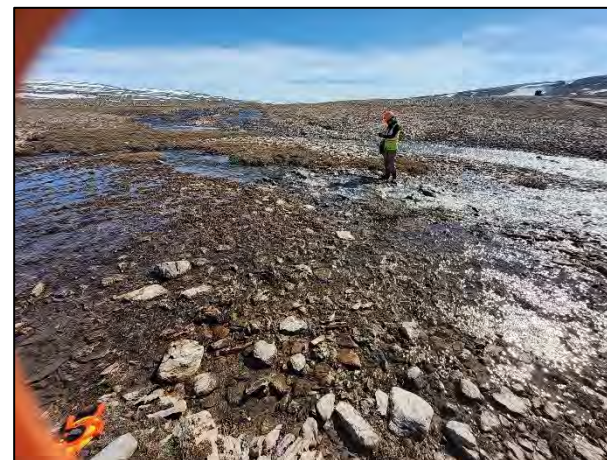
Photos 1-4. Photos taken 60 m upstream right branch (top) and 60 m upstream left branch (bottom) in spring 2023: (A,D) facing upstream; (B,E) facing downstream; and (C,F) across (left bank looking at right bank).

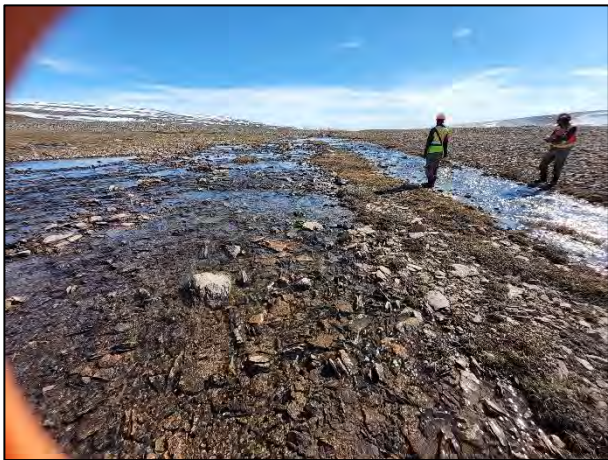
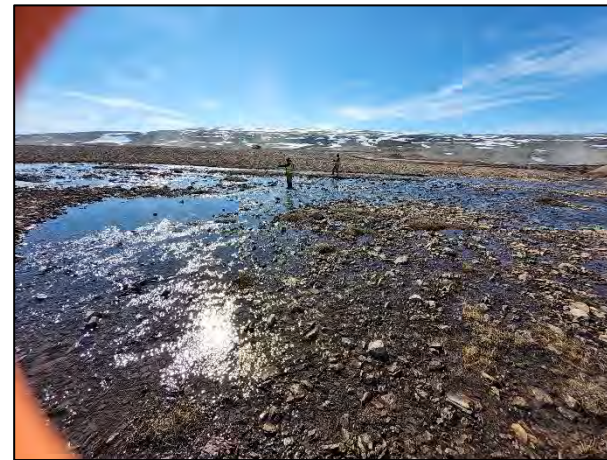
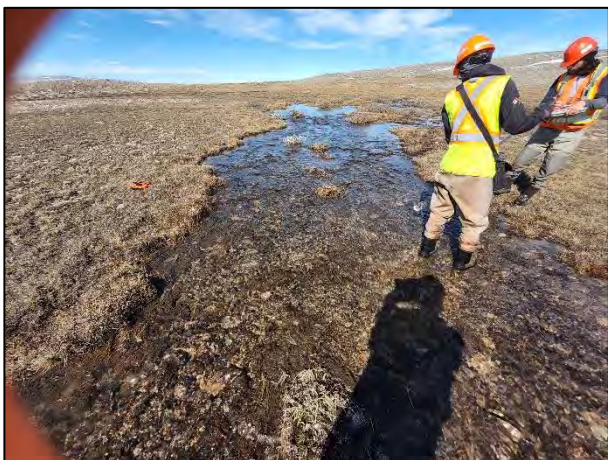
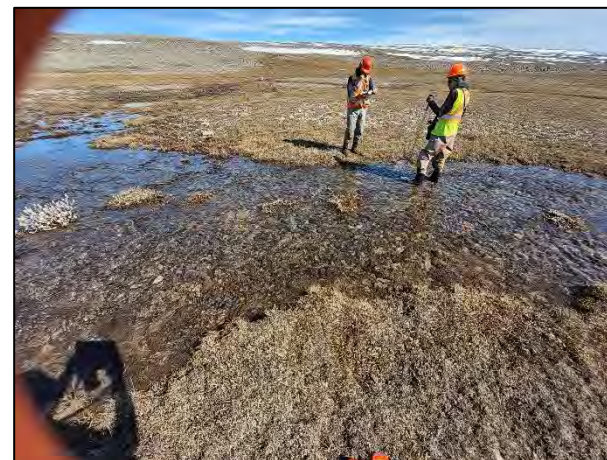
Photos 1-5. Photos taken 100 m upstream right branch (top) and 100 m upstream left branch (bottom) in spring 2023: (A,D) facing upstream; (B,E) facing downstream; and (C,F) across (right bank looking at left bank).

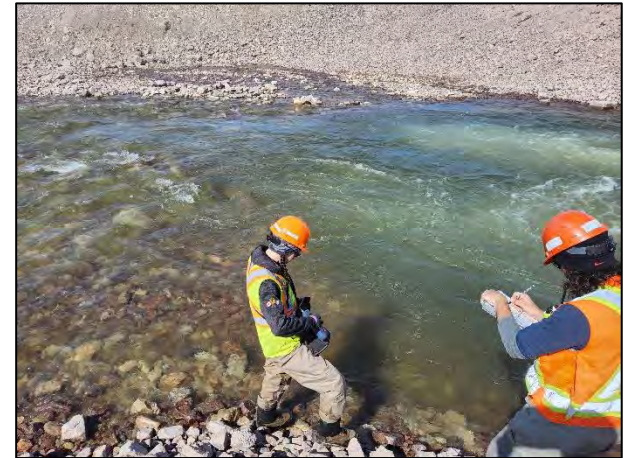
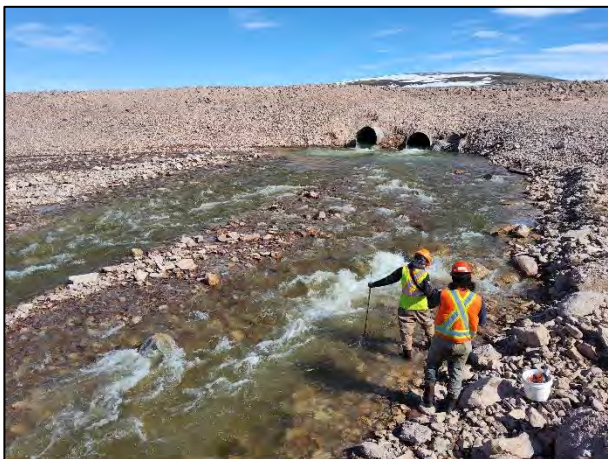
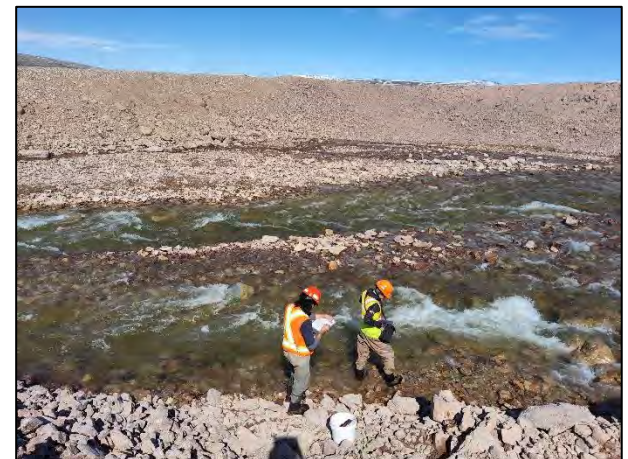
Stream morphology was mainly riffle/rapids with a few scattered deep pools, including a large pool at the downstream end of the culverts. Substrates were mainly cobble/boulder.

Photos 1-1. Photos taken 20 m downstream (top) and 60 m downstream (bottom) in spring 2023: (A,D) facing upstream; (B,E) facing downstream; and (C,F) across (right bank looking at left bank).

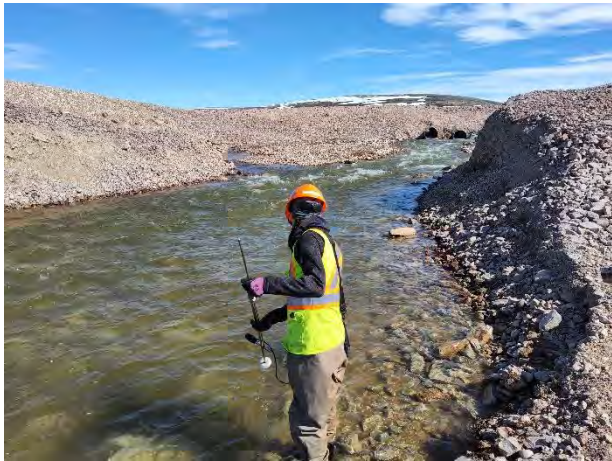
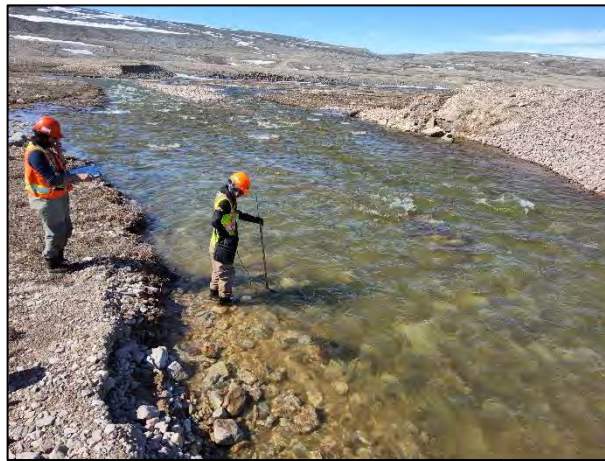
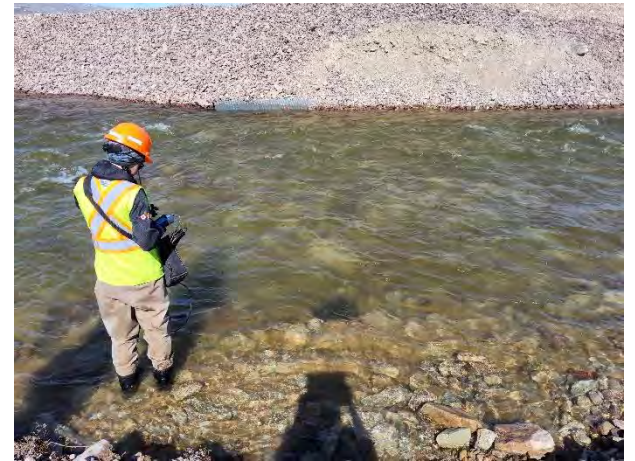
Photos 1-2. Photos taken 100 m downstream in spring 2023: (A) facing upstream; (B) facing downstream; and (C) across (right bank looking at left bank).

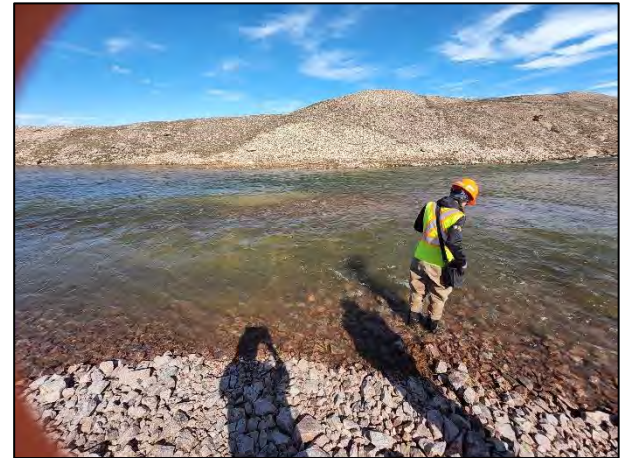
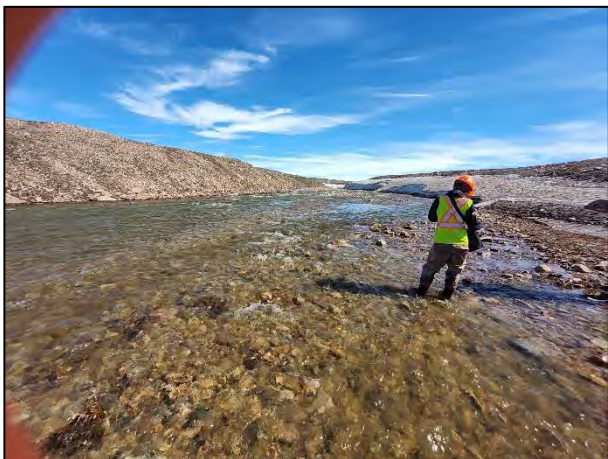
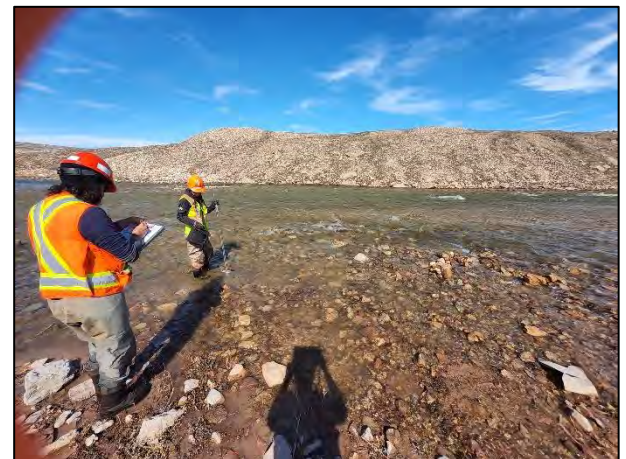
Photos 1-3. Photos taken 60 m upstream (top) and 100 m upstream (bottom) in spring 2023: (A,D) facing upstream; (B,E) facing downstream; and (C,F) across (right bank looking at left bank).

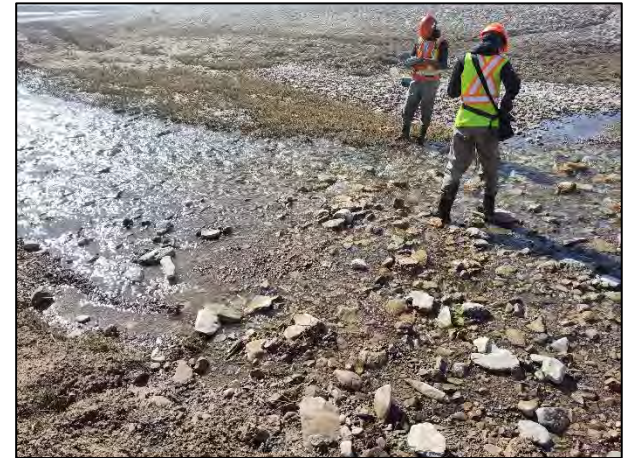
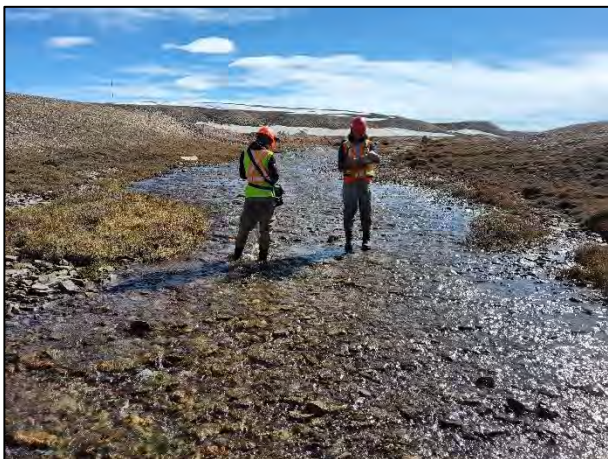
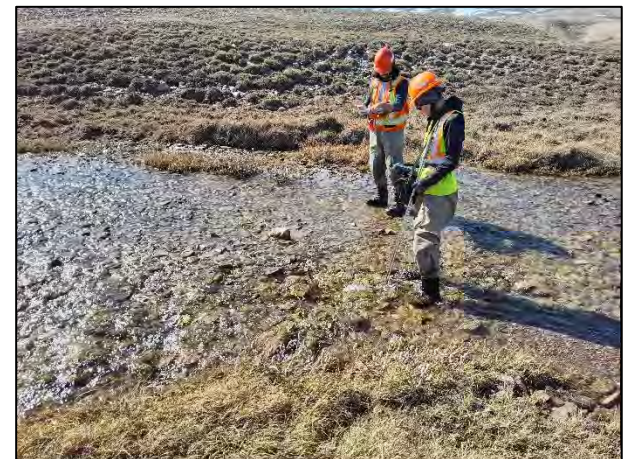
Photos 1-1. Photos taken 20 m downstream (top) and 60 m downstream (bottom) in spring 2023: (A,D) facing upstream; (B,E) facing downstream; and (C,F) across (left bank looking at right bank).

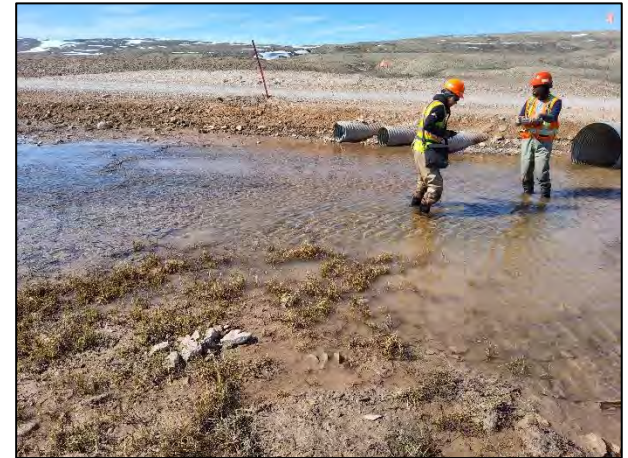
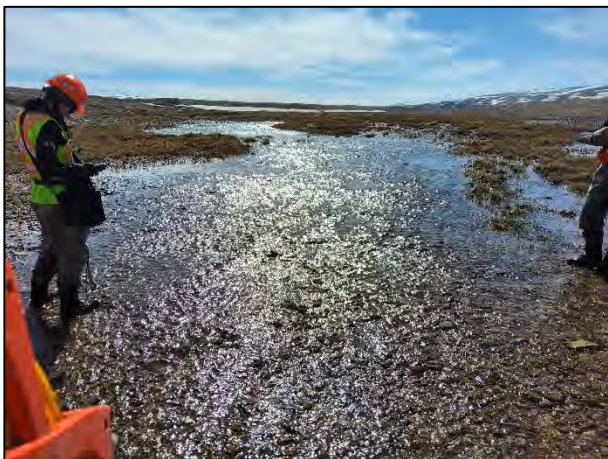
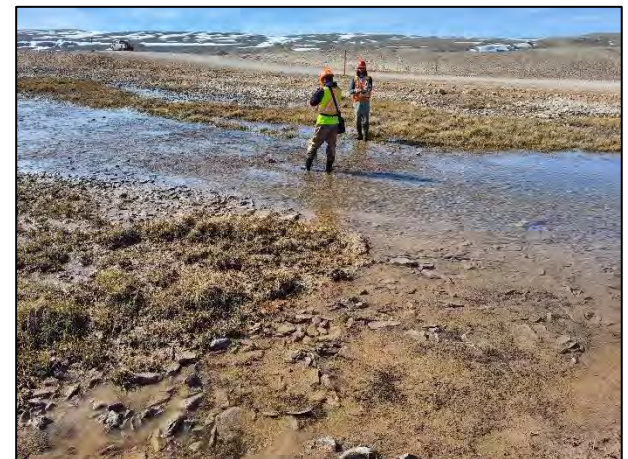
Photos 1-2. Photos taken 20 m upstream (top) and 60 m upstream (bottom) in spring 2023: (A,D) facing upstream; (B,E) facing downstream; and (C,F) across (left bank looking at right bank).

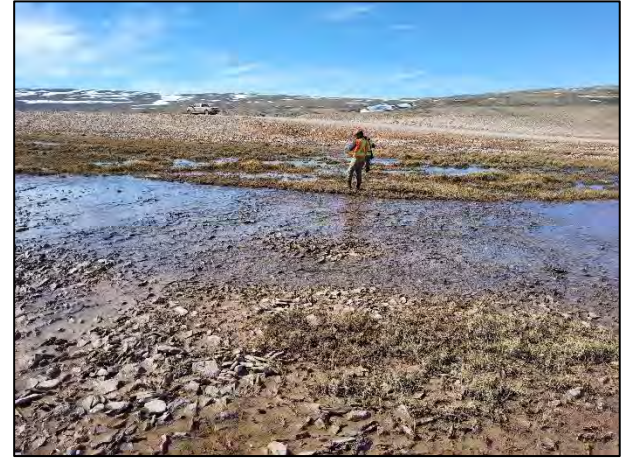
Photos 1-3. Photos taken 100 m upstream in spring 2023: (A) facing upstream; (B) facing downstream; and (C) across (left bank looking at right bank).

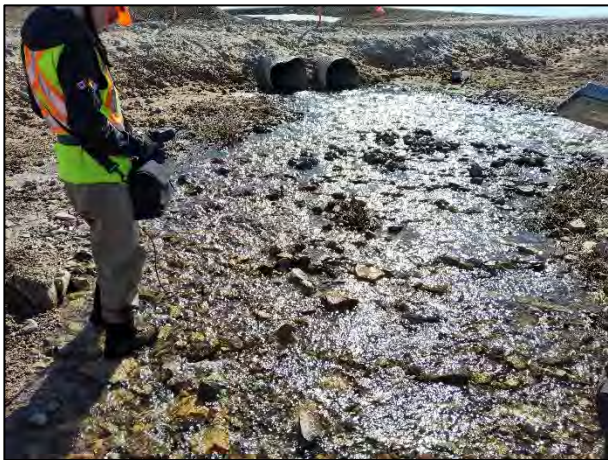
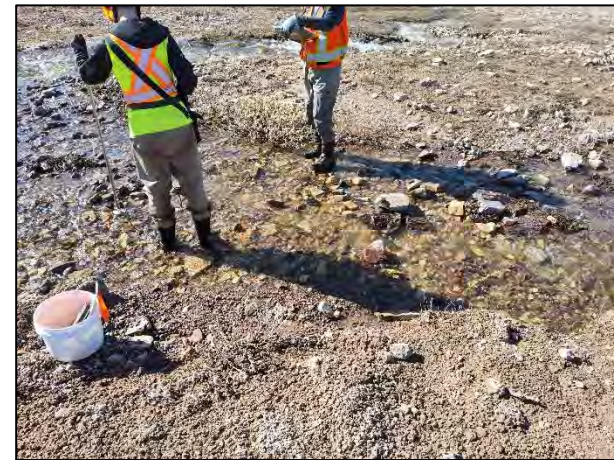
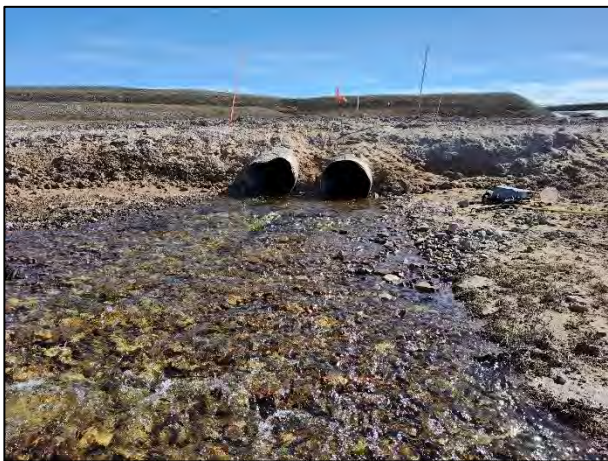
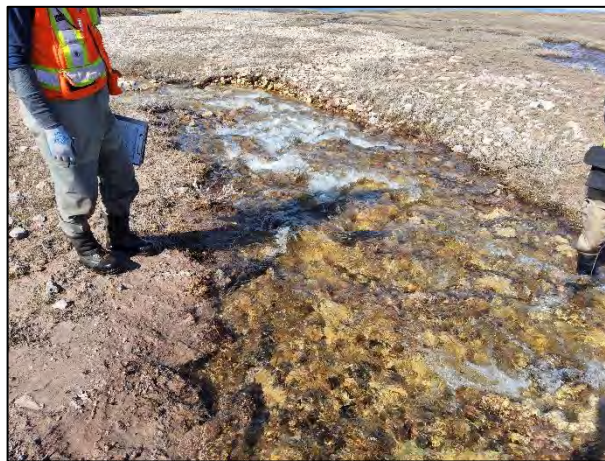
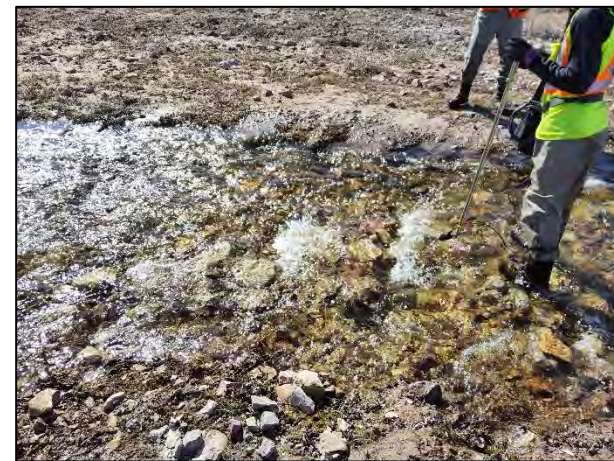
Photos 1-1. Photos taken 20 m downstream left branch (top) and 20 m downstream right branch (bottom) in spring 2023: (A,D) facing upstream; (B,E) facing downstream; and (C,F) across (right bank looking at left bank).

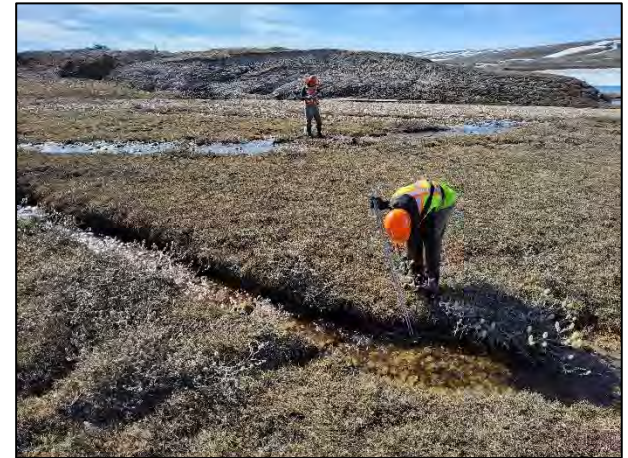
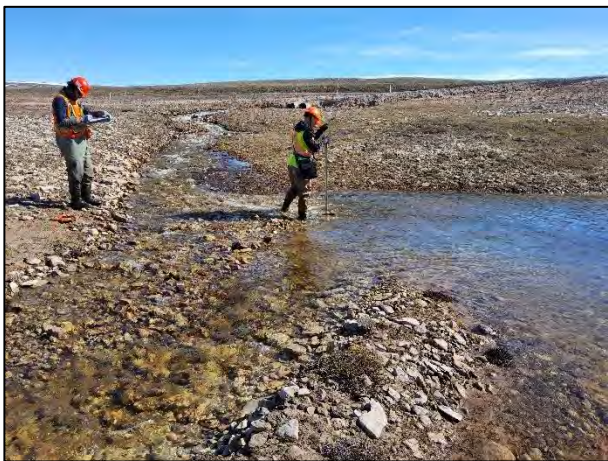
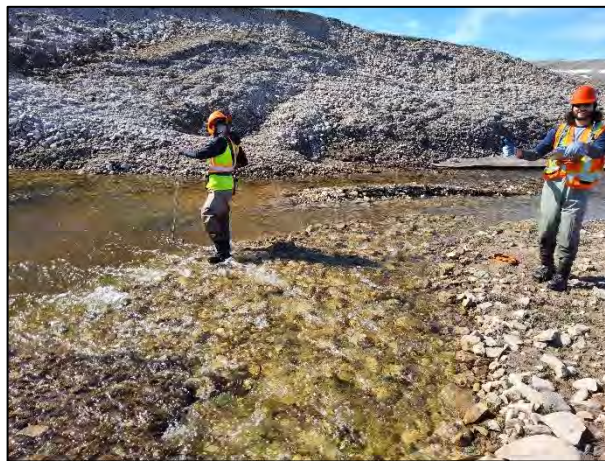
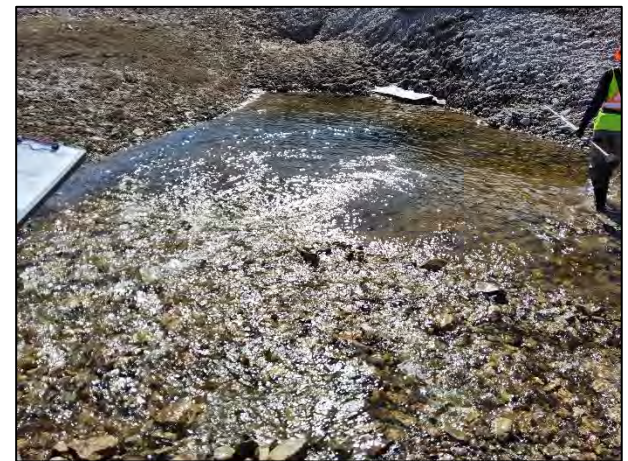
Photos 1-2. Photos taken 60 m downstream left branch (top) and 60 m downstream right branch (bottom) in spring 2023: (A,D) facing upstream; (B,E) facing downstream; and (C,F) across (right bank looking at left bank).

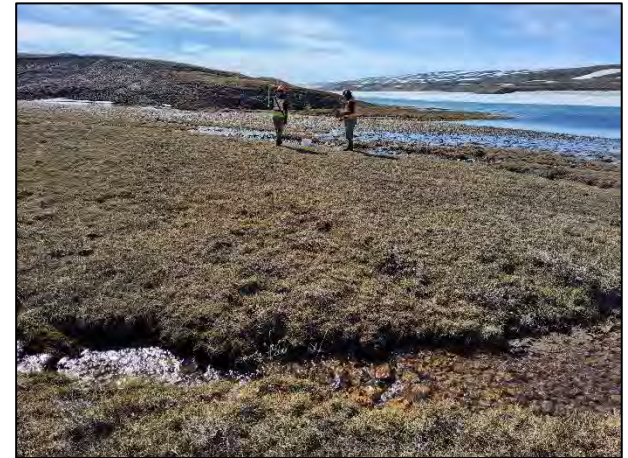
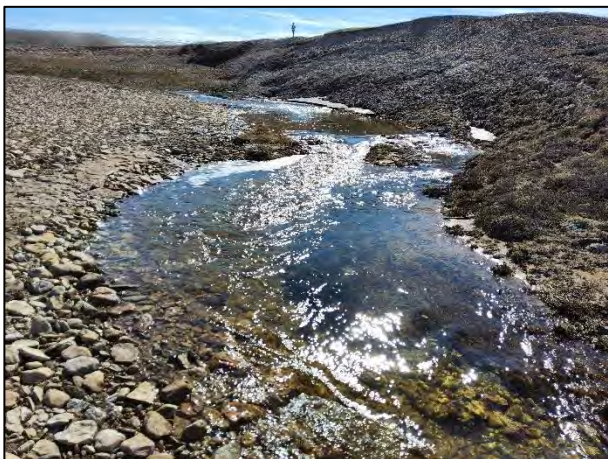
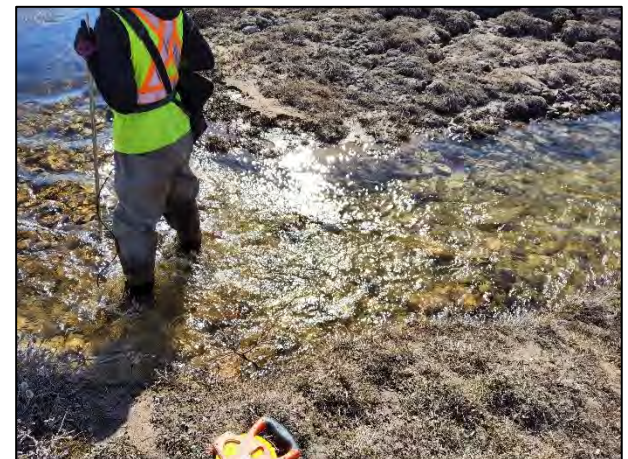
Photos 1-3. Photos taken 100 m downstream left branch (top) and 100 m downstream right branch (bottom) in spring 2023: (A,D) facing upstream; (B,E) facing downstream; and (C,F) across (left bank looking at right bank).

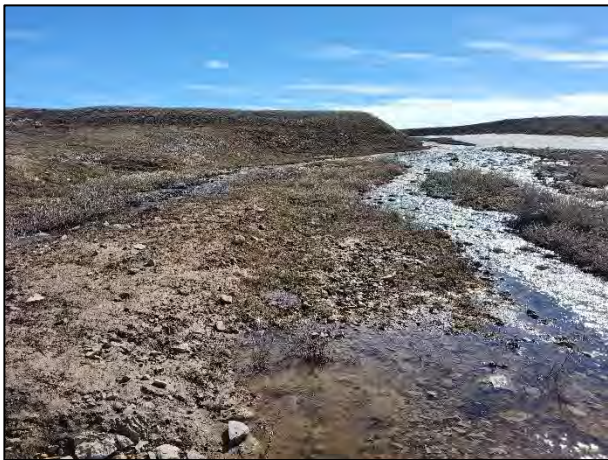
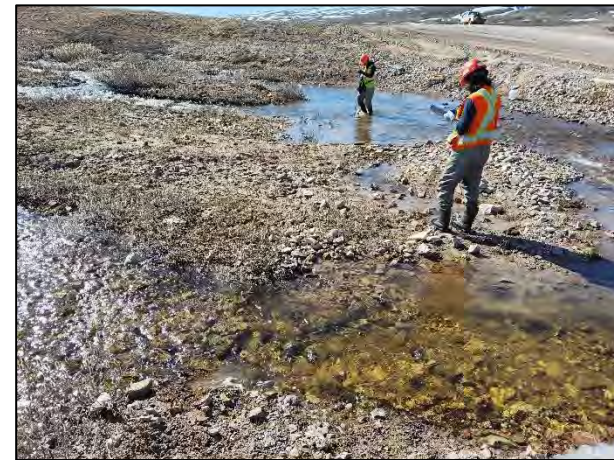
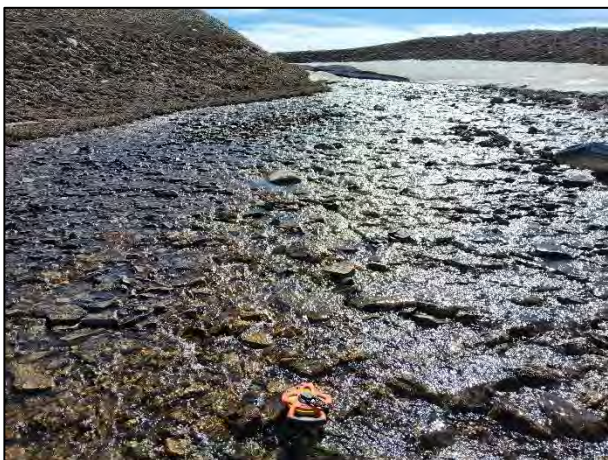
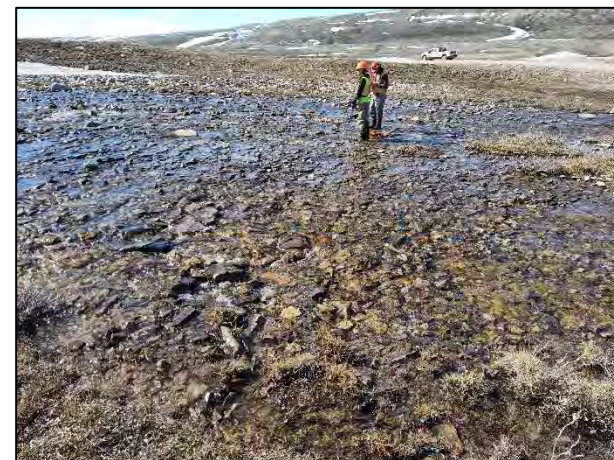
Photos 1-4. Photos taken 20 m upstream (top) and 60 m upstream (bottom) in spring 2023: (A,D) facing upstream; (B,E) facing downstream; and (C,F) across (left bank looking at right bank).

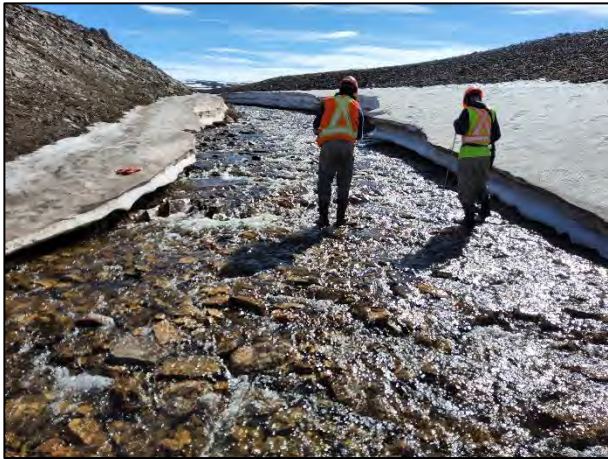
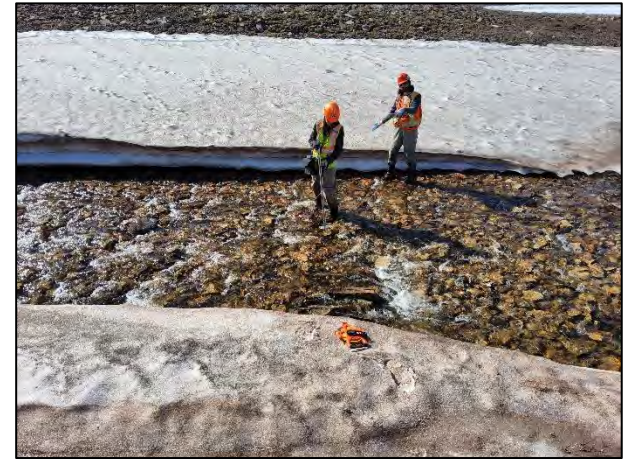
Photos 1-5. Photos taken 100 m upstream in spring 2023: (A) facing upstream; (B) facing downstream; and (C) across (left bank looking at right bank).

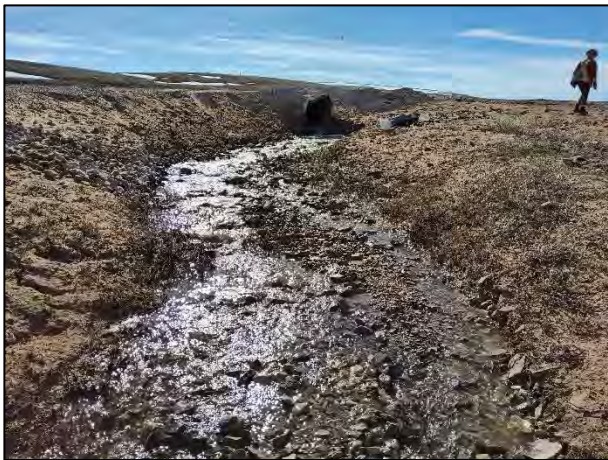
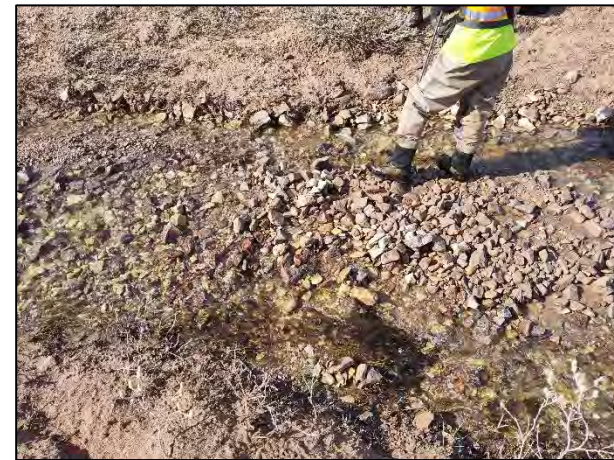
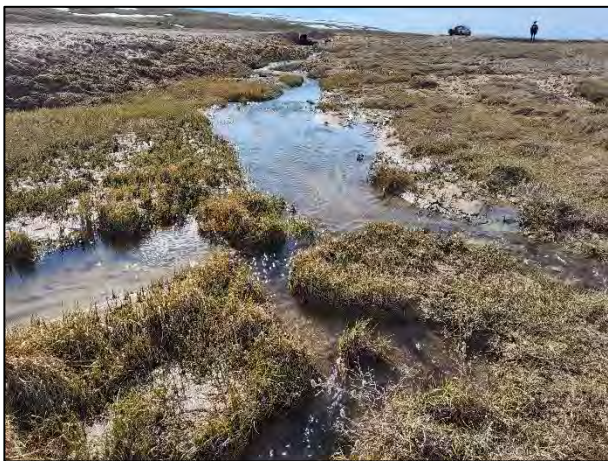
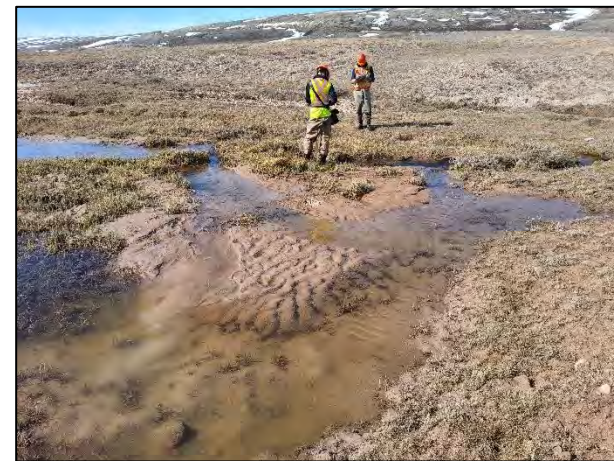
Photos 1-1. Photos taken 20 m downstream (top) and 60 m downstream (bottom) in spring 2023: (A,D) facing upstream; (B,E) facing downstream; and (C,F) across (left bank looking at right bank).

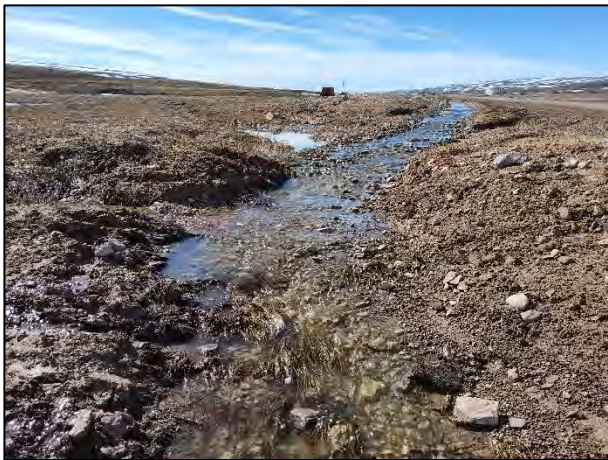
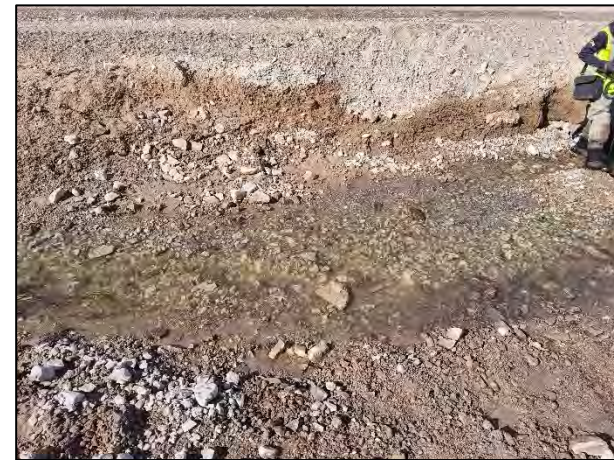
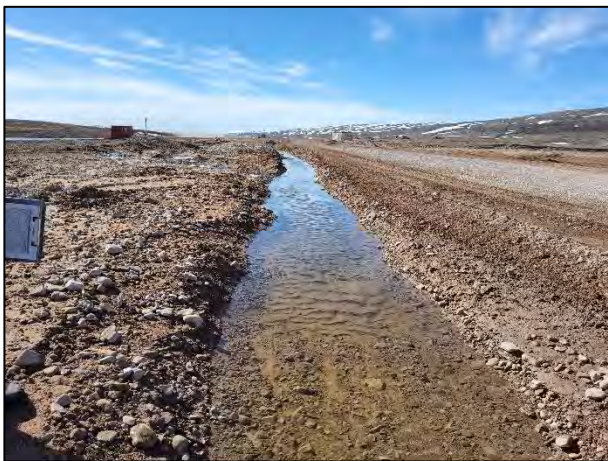
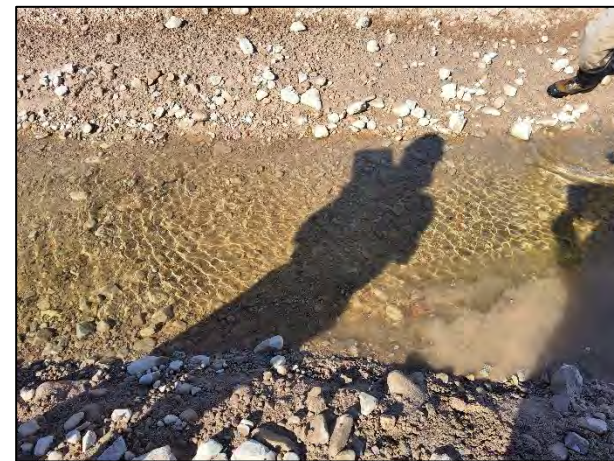
Photos 1-3. Photos taken 20 m upstream (top) and 60 m upstream (bottom) in spring 2023: (A,D) facing upstream; (B,E) facing downstream; and (C,F) across (left bank looking at right bank).

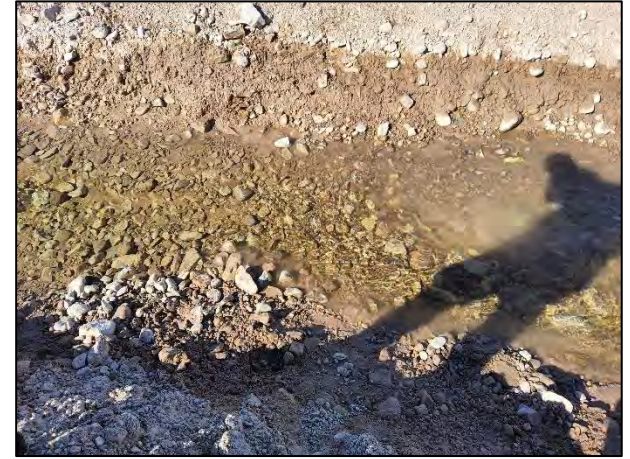
Photos 1-4. Photos taken 100 m upstream in spring 2023: (A) facing upstream; (B) facing downstream; and (C) across (left bank looking at right bank).
