# TOTE ROAD CV-111

Site ID:	CV-111	Dates Surveyed:	2-Jul-23	Waterbody Type:	Stream
Project Interaction:	Tote Road Culvert	UTM Coordinates:	17W 521355 E 7954524 N

BAFFINLAND IRON MINES  
MARY RIVER PROJECT

**North/South Consultants Inc.**  
Aquatic Environment Specialists

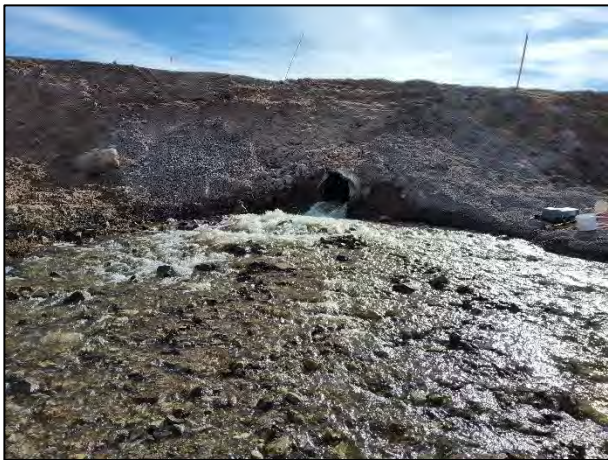
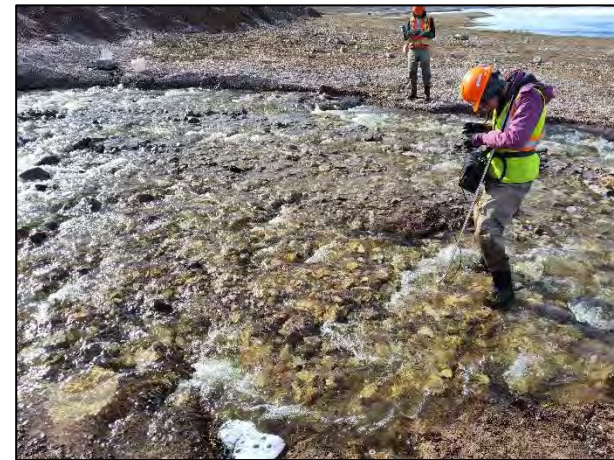
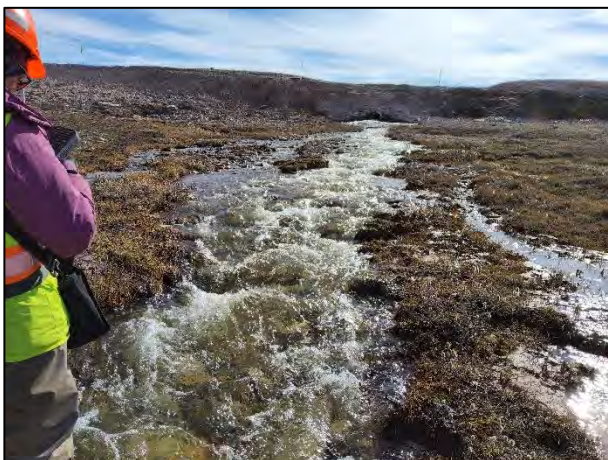
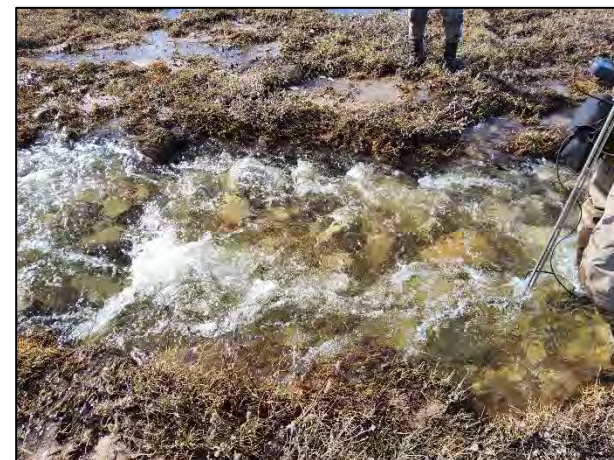
Photos 1-1. Photos taken 20 m downstream (top) and 60 m downstream (bottom) in spring 2023: (A,D) facing upstream; (B,E) facing downstream; and (C,F) across (right bank looking at left bank).

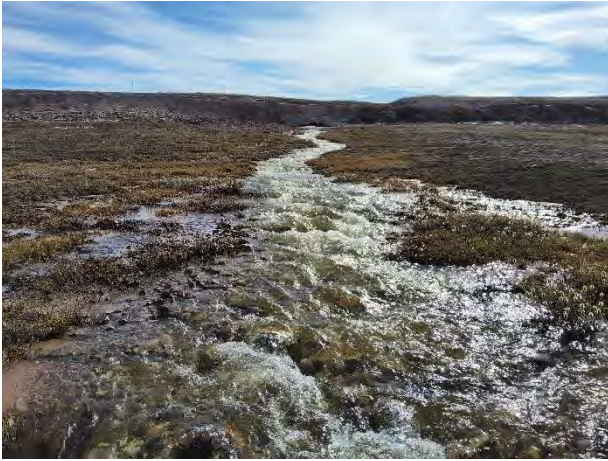
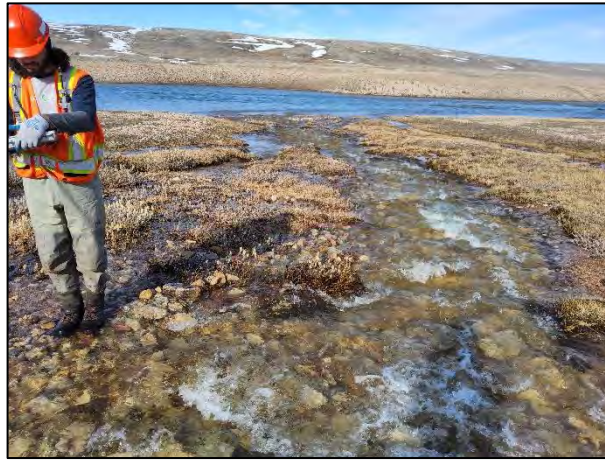
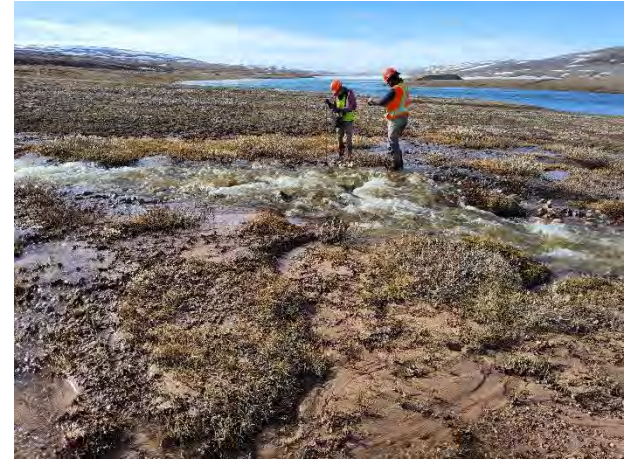
Photos 1-2. Photos taken 100 m downstream in spring 2023: (A) facing upstream; (B) facing downstream; and (C) across (right bank looking at left bank).

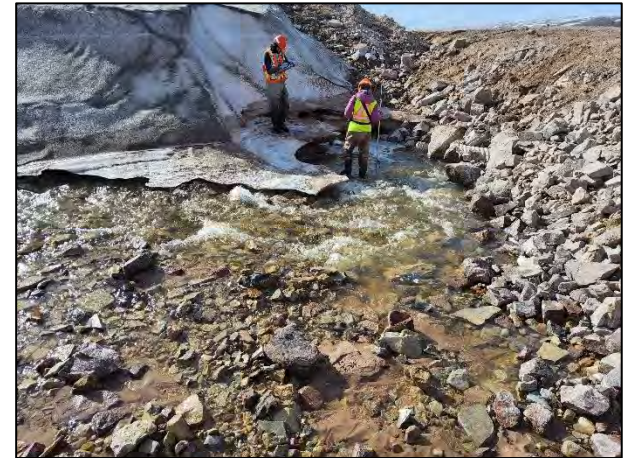
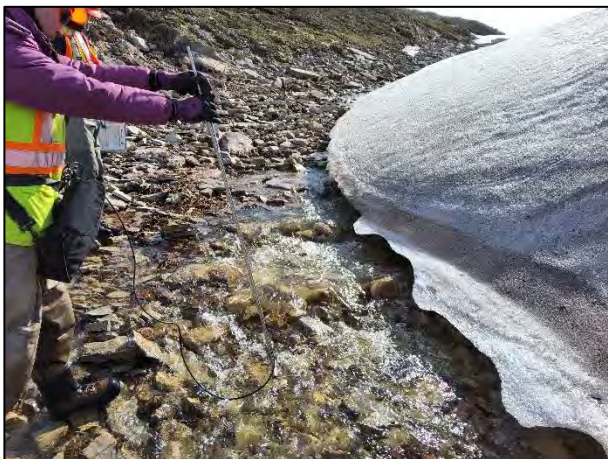
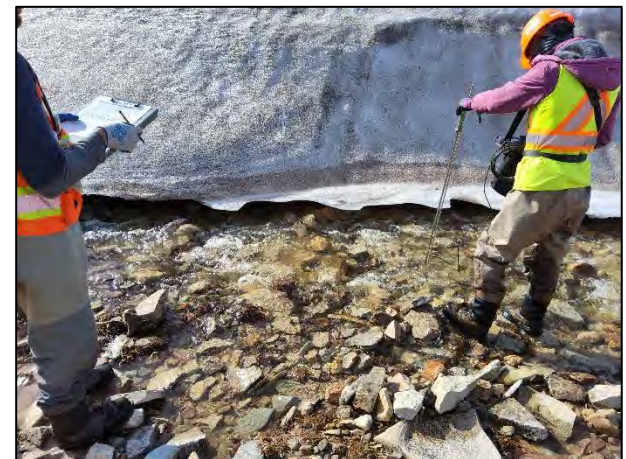
Photos 1-3. Photos taken 20 m upstream (top) and 60 m upstream (bottom) in spring 2023: (A,D) facing upstream; (B,E) facing downstream; and (C,F) across (left bank looking at right bank).

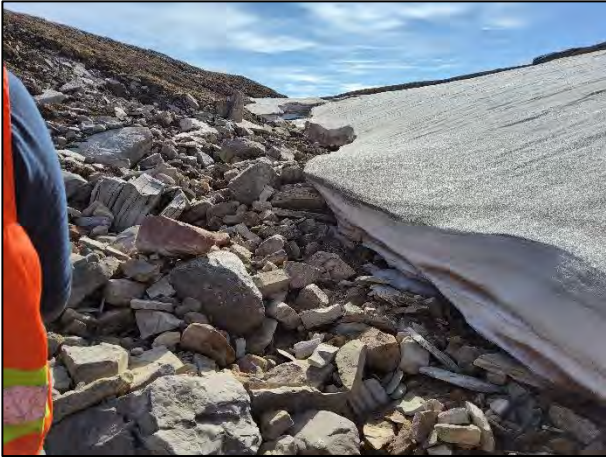
**A**

Photos 1-4. Photos taken 100 m upstream in spring 2023: (A) facing upstream; (B) facing downstream; and (C) across (left bank looking at right bank).

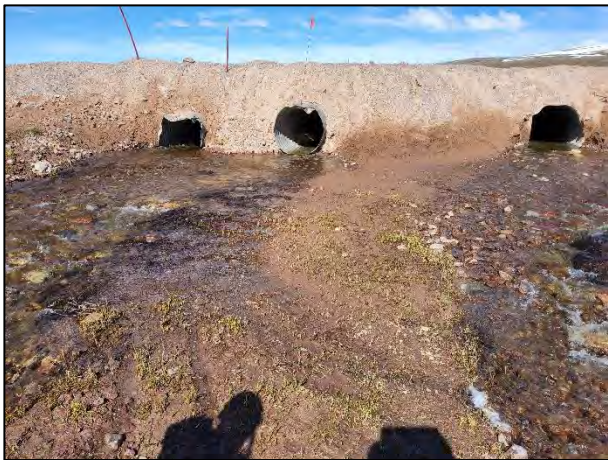
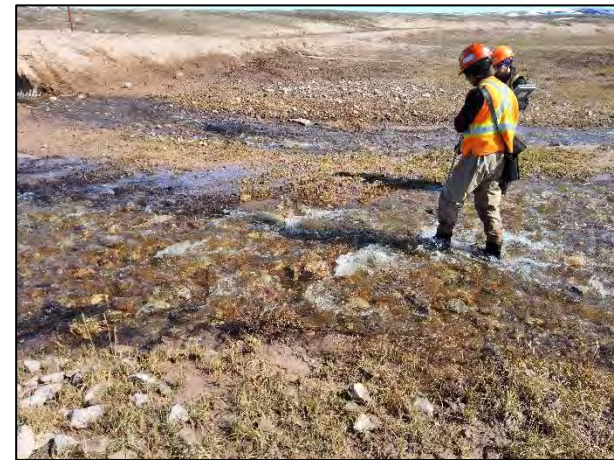
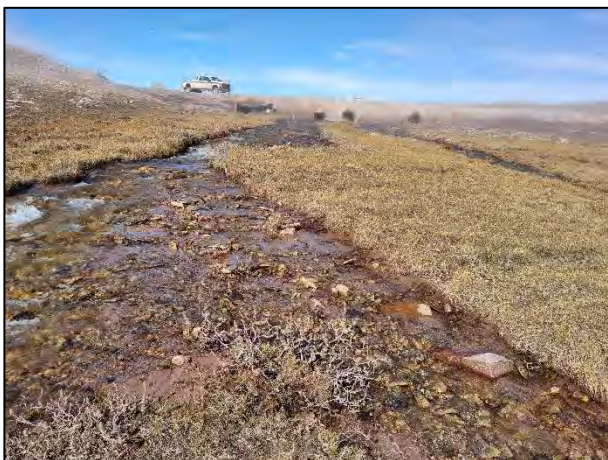
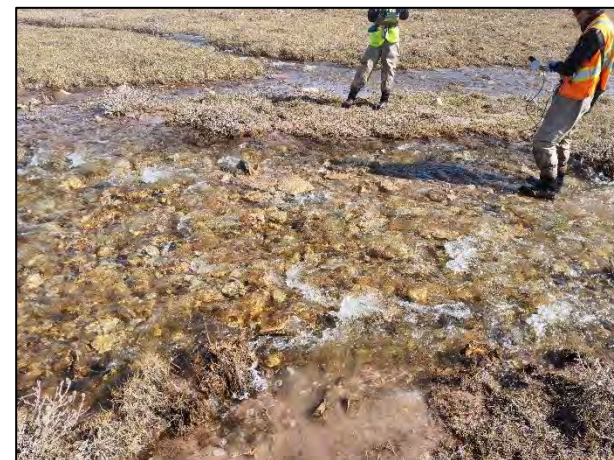
Photos 1-1. Photos taken 20 m downstream (top) and 60 m downstream (bottom) in spring 2023: (A,D) facing upstream; (B,E) facing downstream; and (C,F) across (left bank looking at right bank).

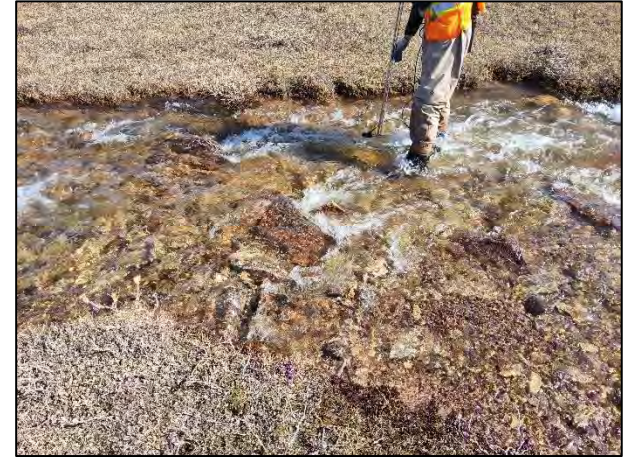
Photos 1-2. Photos taken 100 m downstream in spring 2023: (A) facing upstream; (B) facing downstream; and (C) across (left bank looking at right bank).

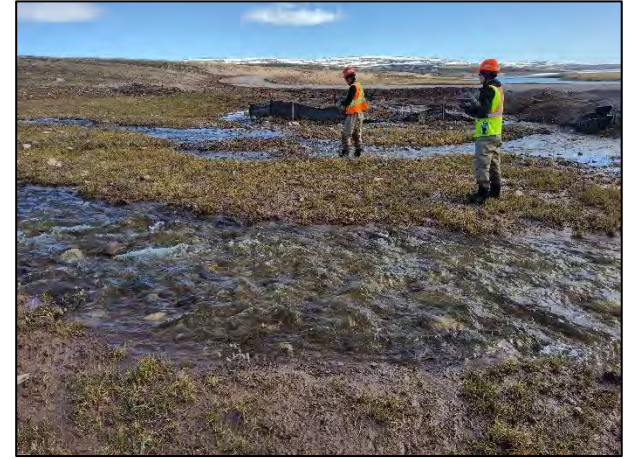
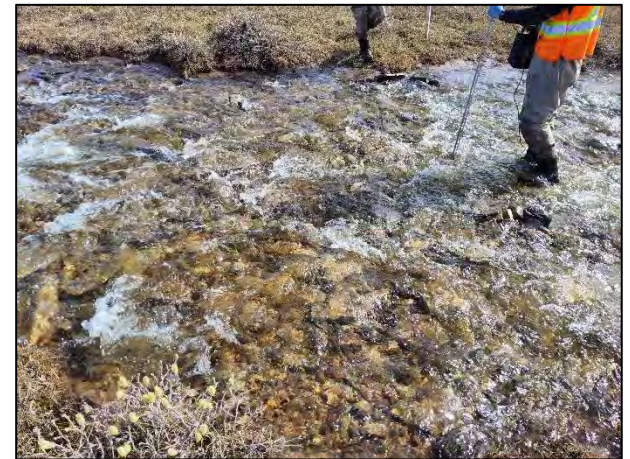
Photos 1-3. Photos taken 20 m upstream (top) and 60 m upstream (bottom) in spring 2023: (A,D) facing upstream; (B,E) facing downstream; and (C,F) across (left bank looking at right bank).

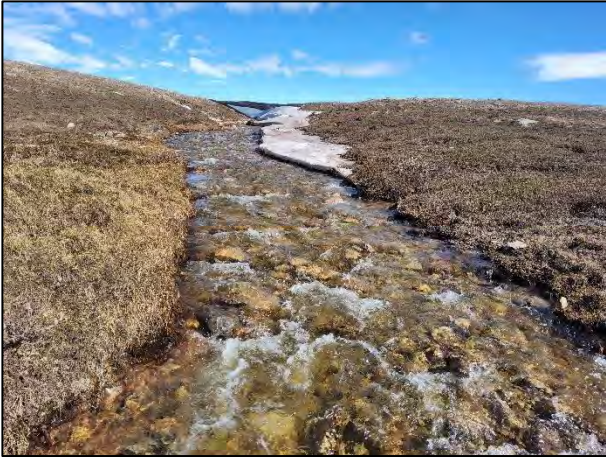
**A**

Photos 1-4. Photos taken 100 m upstream in spring 2023: (A) facing upstream; (B) facing downstream; and (C) across (left bank looking at right bank).

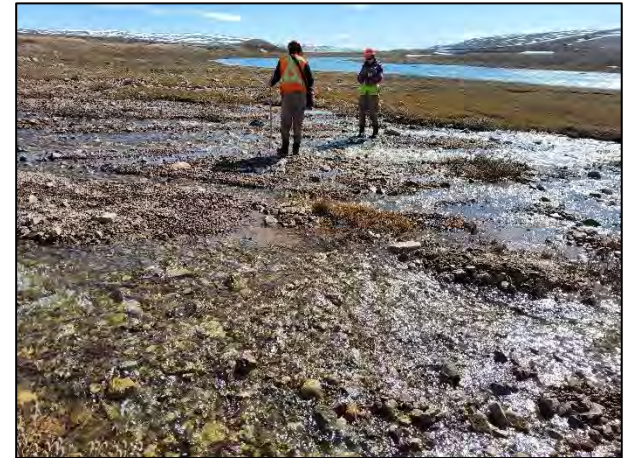
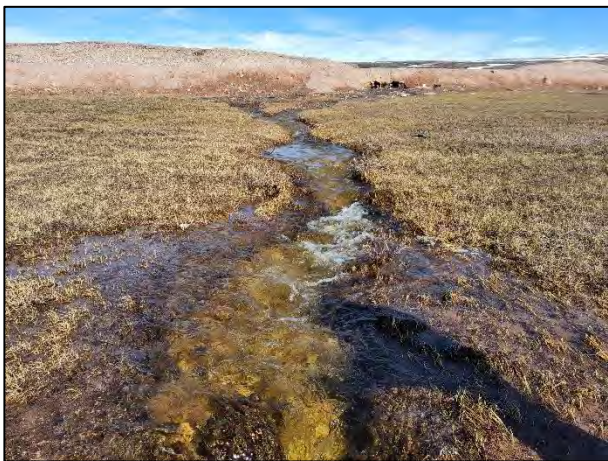
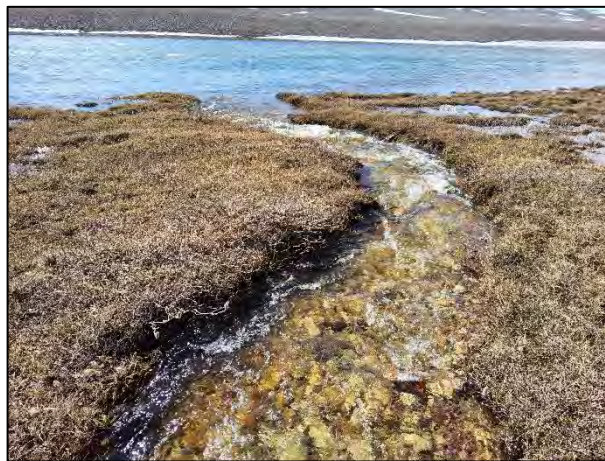
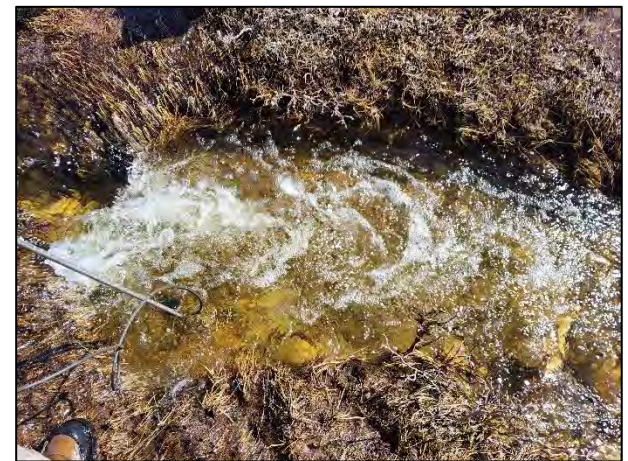
Photos 1-1. Photos taken 20 m downstream (top) and 60 m downstream (bottom) in spring 2023: (A,D) facing upstream; (B,E) facing downstream; and (C,F) across (left bank looking at right bank).

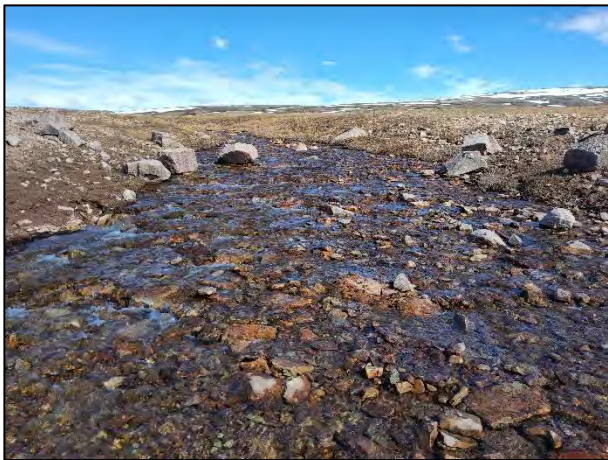
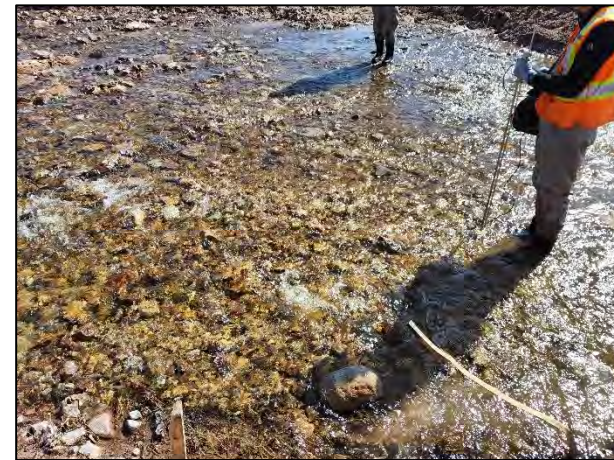
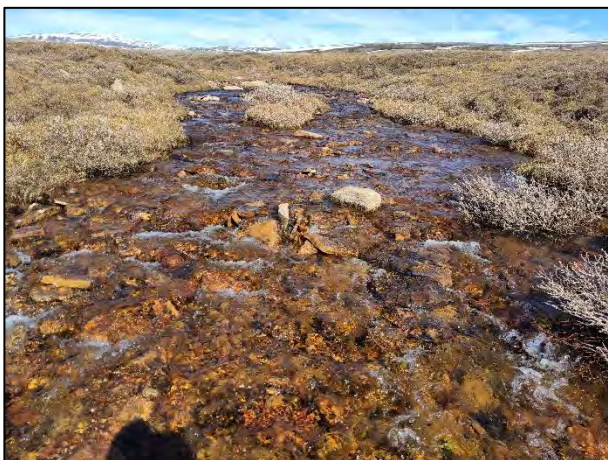
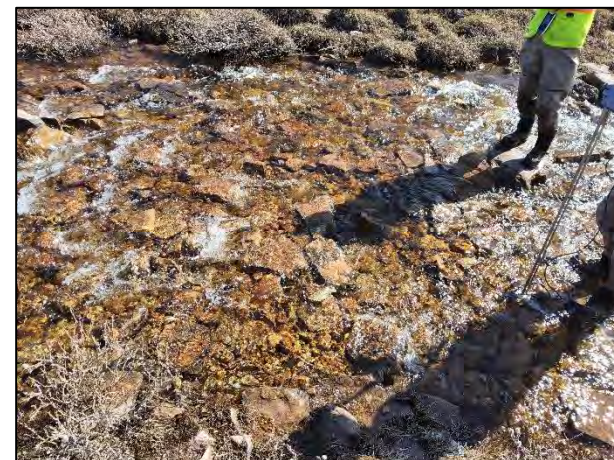
Photos 1-2. Photos taken 20 m upstream (top) and 60 m upstream (bottom) in spring 2023: (A,D) facing upstream; (B,E) facing downstream; and (C,F) across (left bank looking at right bank).

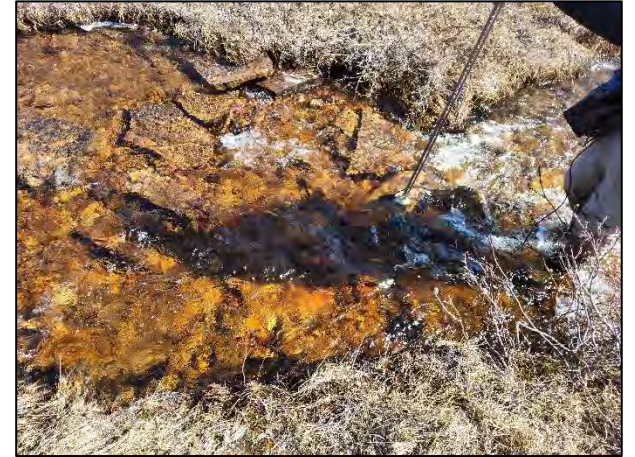
Photos 1-3. Photos taken 100 m upstream in spring 2023: (A) facing upstream; (B) facing downstream; and (C) across (left bank looking at right bank).

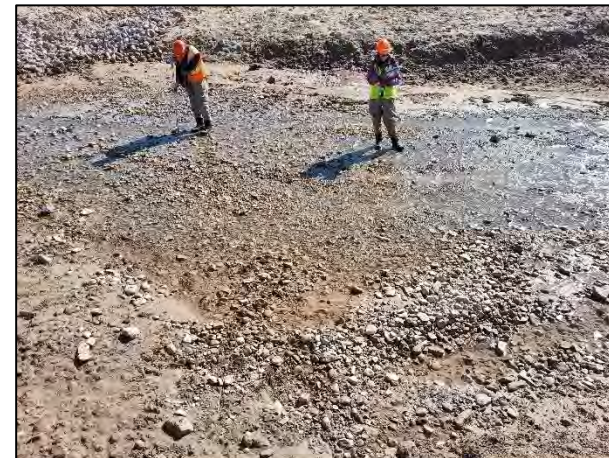
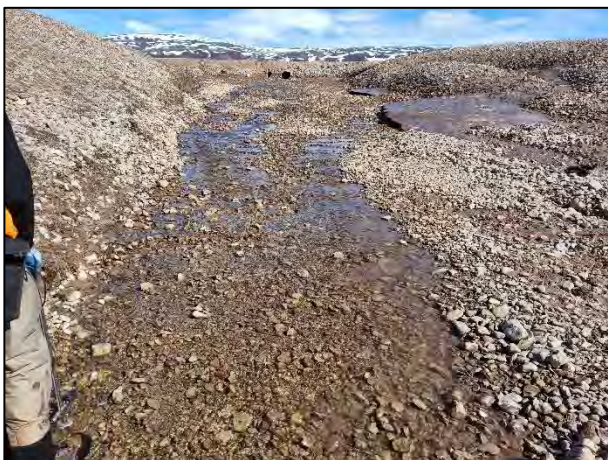
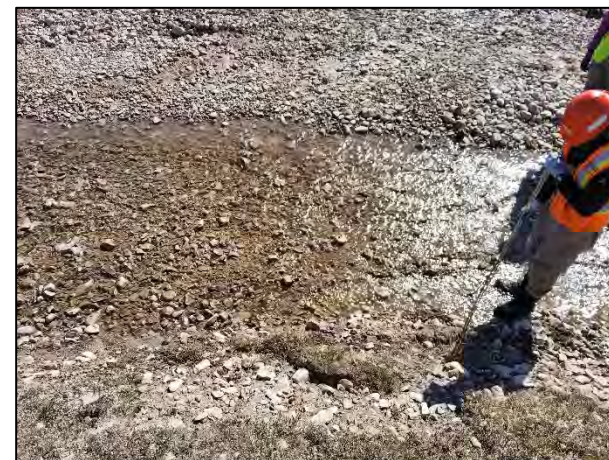
Photos 1-1. Photos taken 20 m downstream (top) and 60 m downstream (bottom) in spring 2023: (A,D) facing upstream; (B,E) facing downstream; and (C,F) across (right bank looking at left bank).

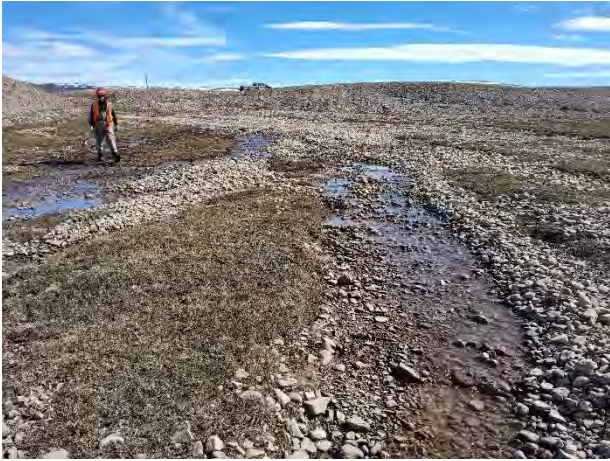
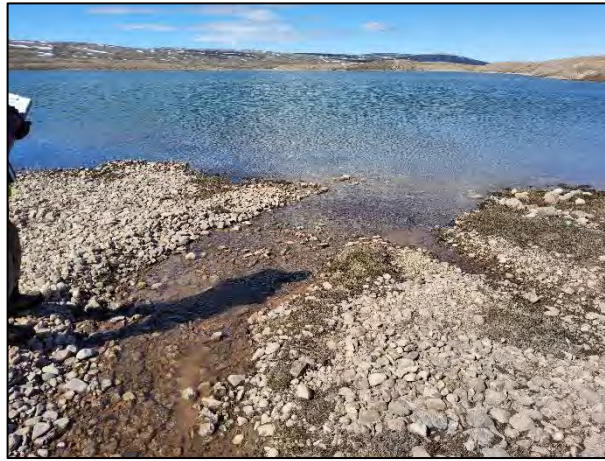
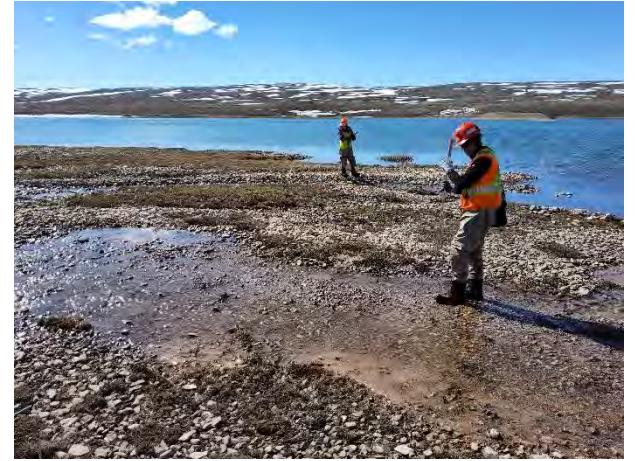
Photos 1-2. Photos taken 100 m downstream in spring 2023: (A) facing upstream; (B) facing downstream; and (C) across (right bank looking at left bank).

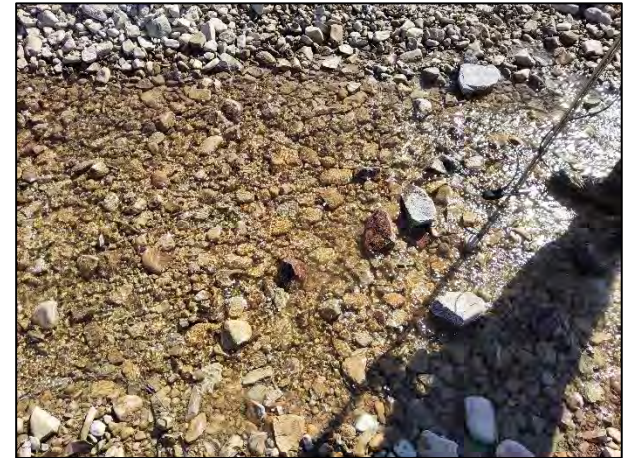
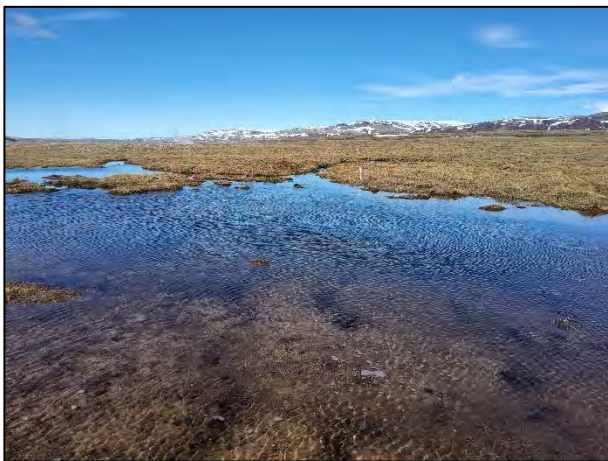
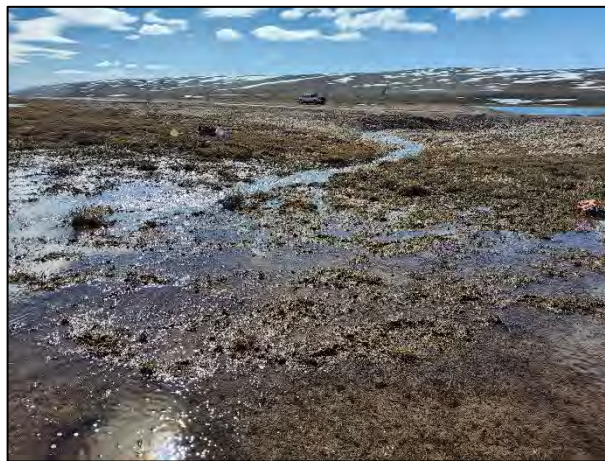
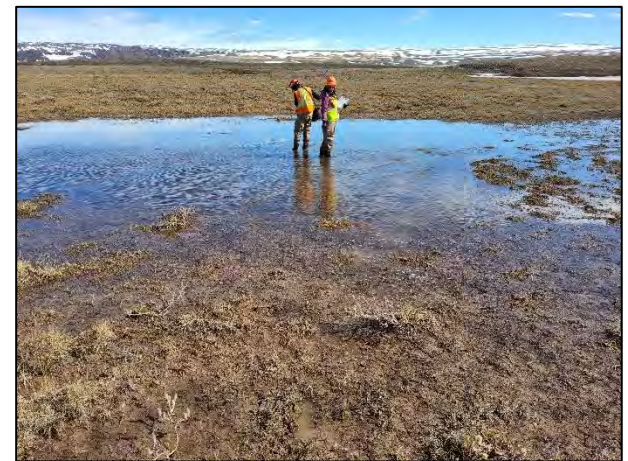
Photos 1-3. Photos taken 20 m upstream (top) and 60 m upstream (bottom) in spring 2023: (A,D) facing upstream; (B,E) facing downstream; and (C,F) across (left bank looking at right bank).

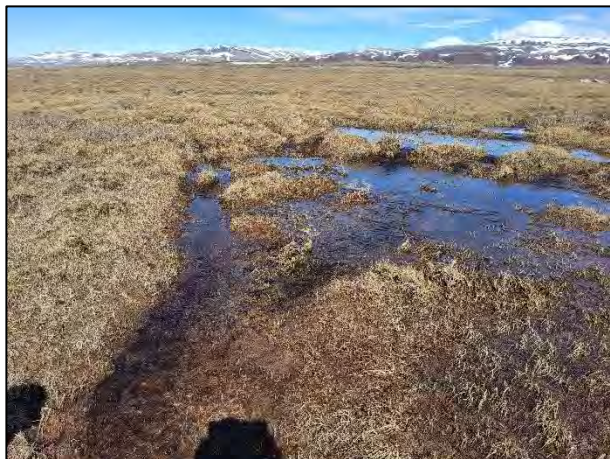
**A**

Photos 1-4. Photos taken 100 m upstream in spring 2023: (A) facing upstream; (B) facing downstream; and (C) across (left bank looking at right bank).

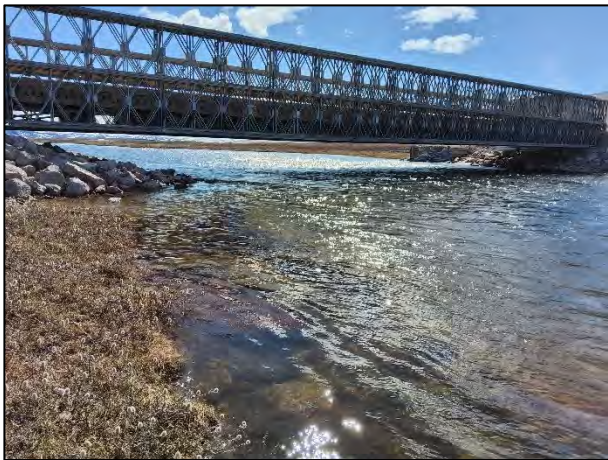
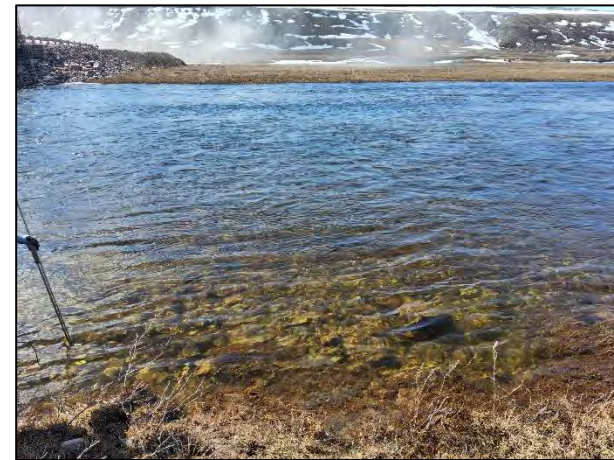
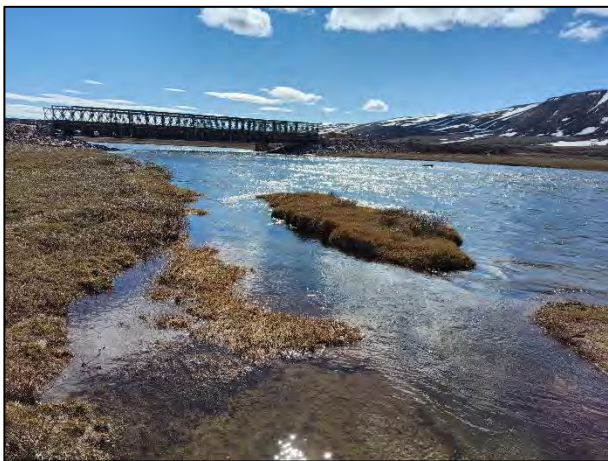
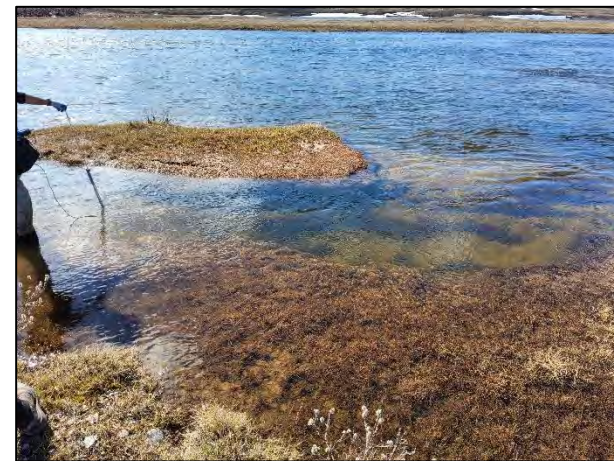
Photos 1-1. Photos taken 40 m downstream (top) and 100 m downstream (bottom) in spring 2023: (A,D) facing upstream; (B,E) facing downstream; and (C,F) across (left bank looking at right bank).

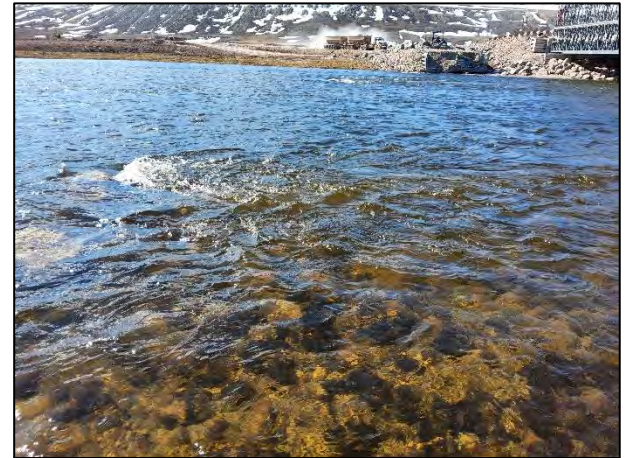
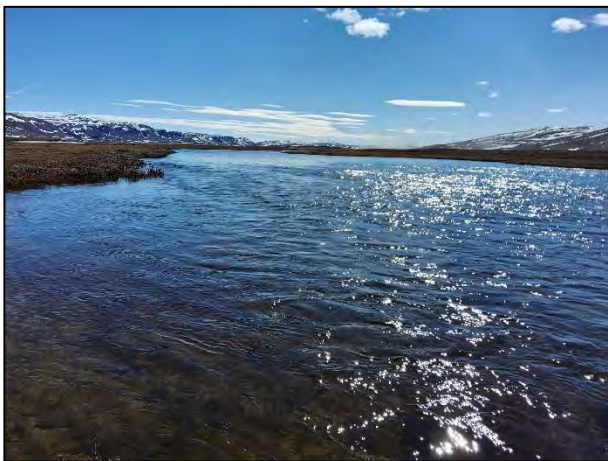
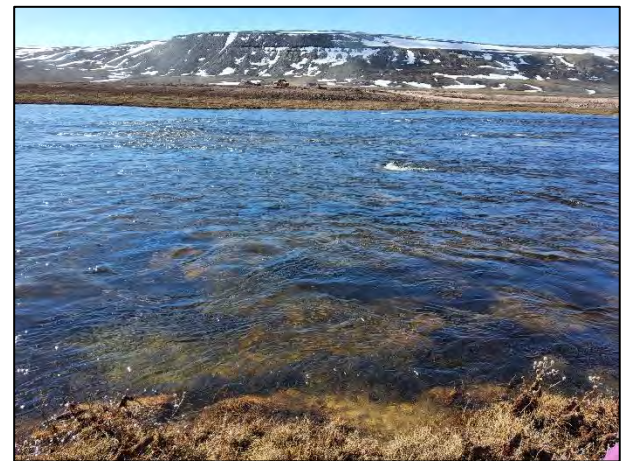
Photos 1-2. Photos taken 40 m upstream (top) and 100 m upstream (bottom) in spring 2023: (A,D) facing upstream; (B,E) facing downstream; and (C,F) across (left bank looking at right bank).

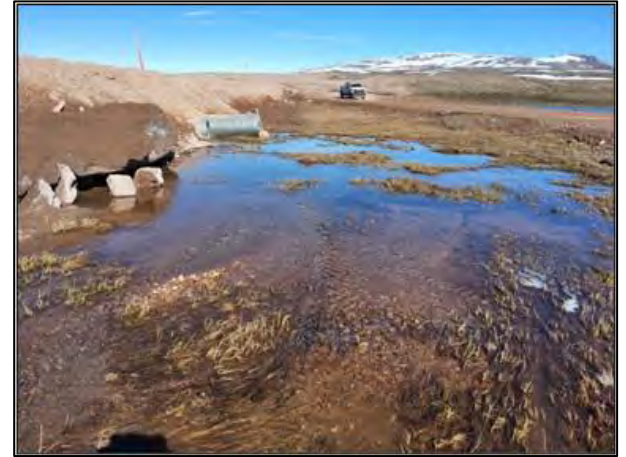
Photos 1-1. Photos taken 20 m upstream in spring 2023: (A) facing upstream; (B) facing downstream; and (C) across (right bank looking at left bank).

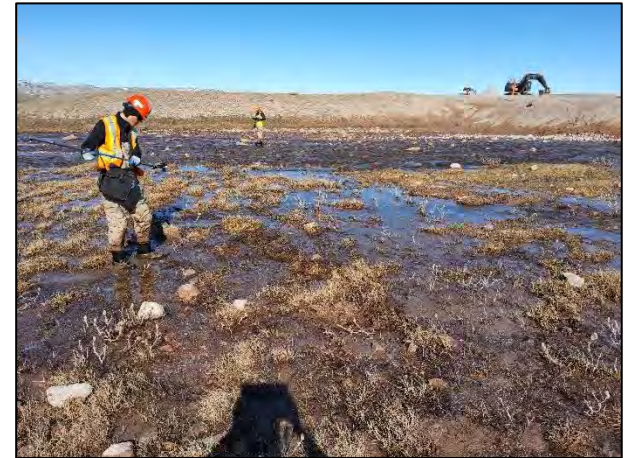
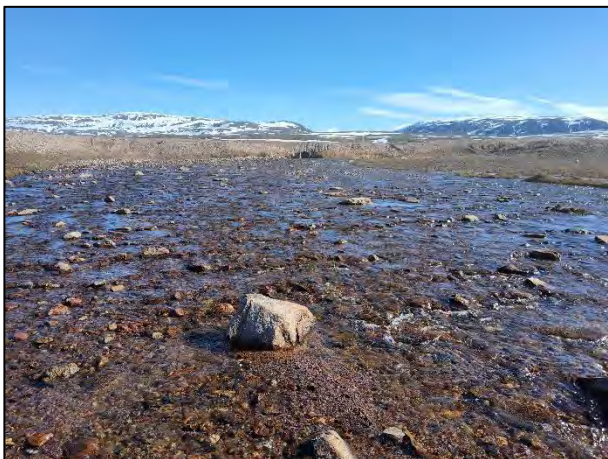
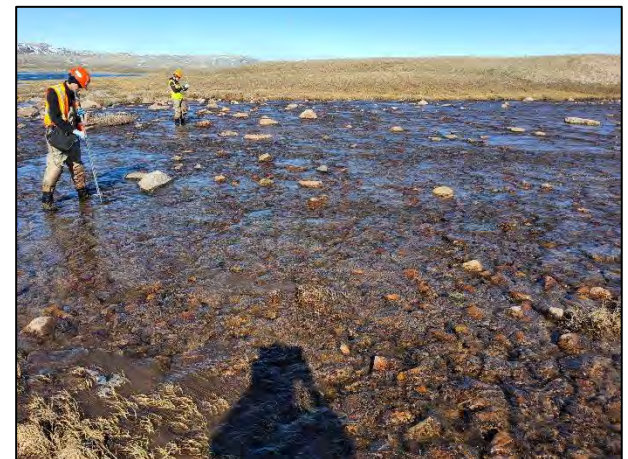
Photos 1-1. Photos taken 20 m downstream (top) and 60 m downstream (bottom) in spring 2023: (A,D) facing upstream; (B,E) facing downstream; and (C,F) across (right bank looking at left bank).

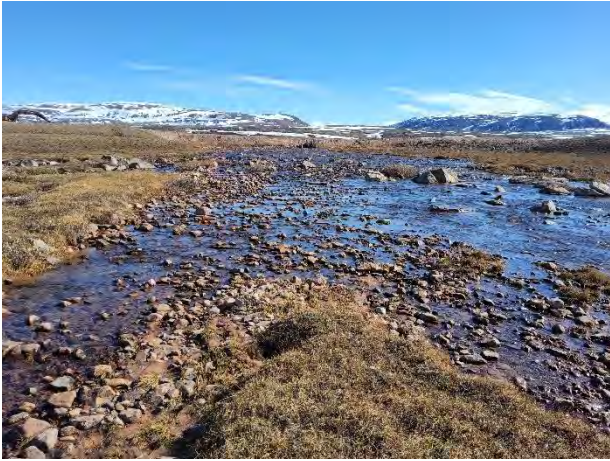
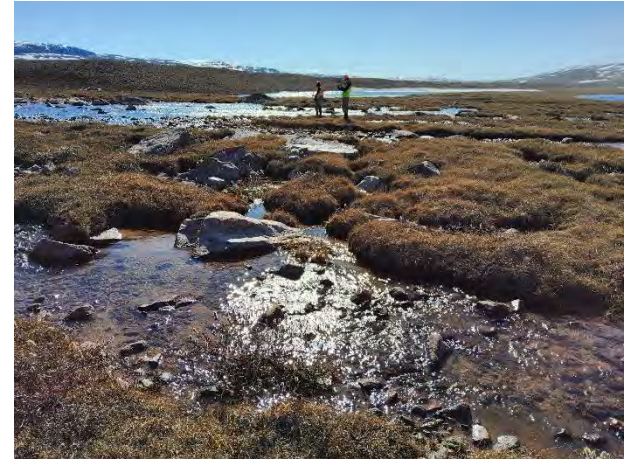
Photos 1-2. Photos taken 100 m downstream in spring 2023: (A) facing upstream; (B) facing downstream; and (C) across (right bank looking at left bank).

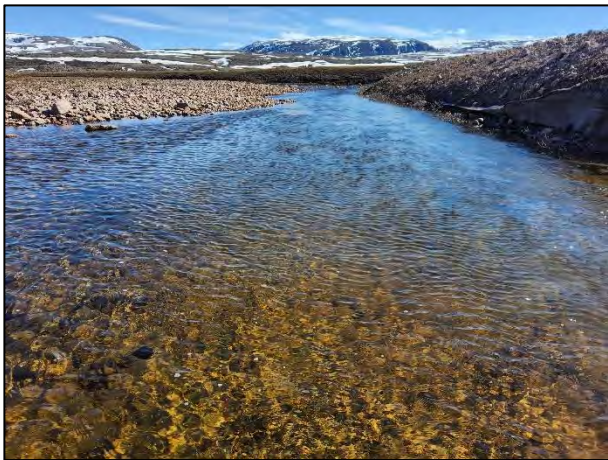
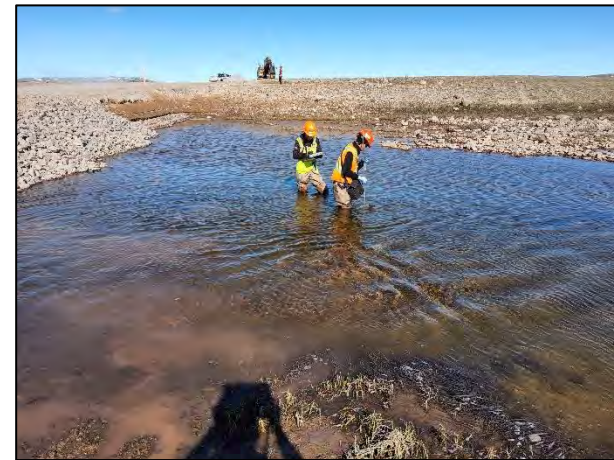
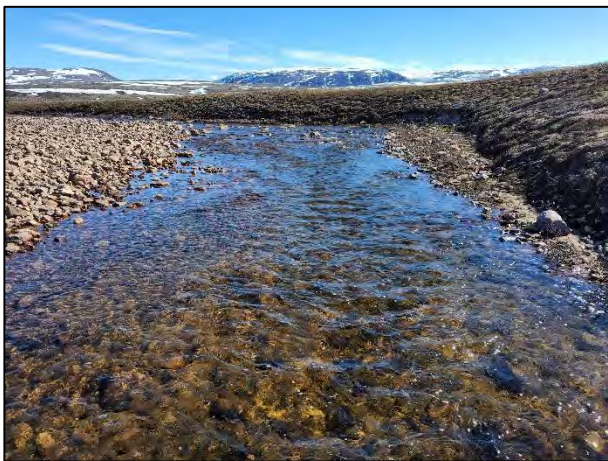
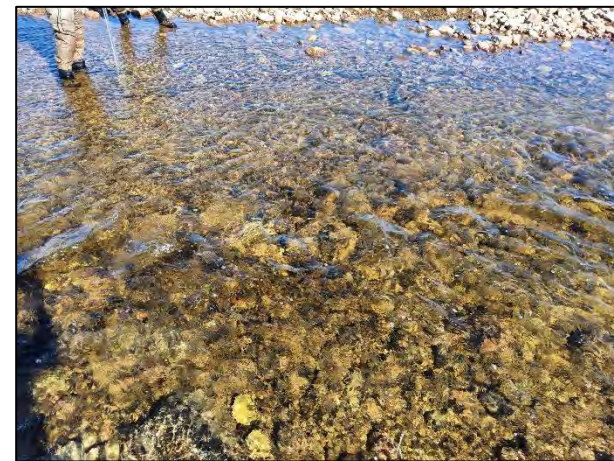
Photos 1-3. Photos taken 20 m upstream (top) and 60 m upstream (bottom) in spring 2023: (A,D) facing upstream; (B,E) facing downstream; and (C,F) across (left bank looking at right bank).

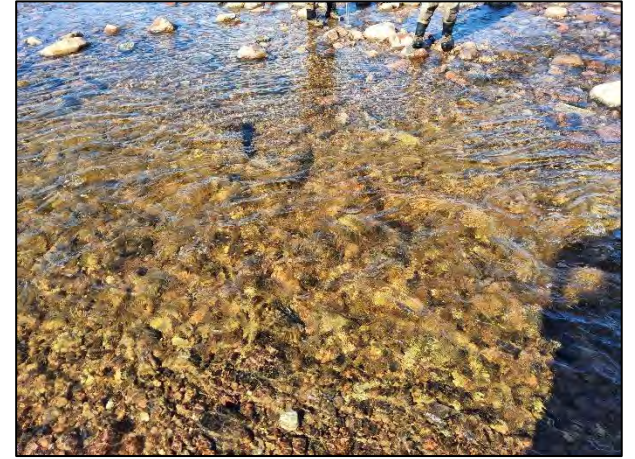
Photos 1-4. Photos taken 100 m upstream in spring 2023: (A) facing upstream; (B) facing downstream; and (C) across (left bank looking at right bank).

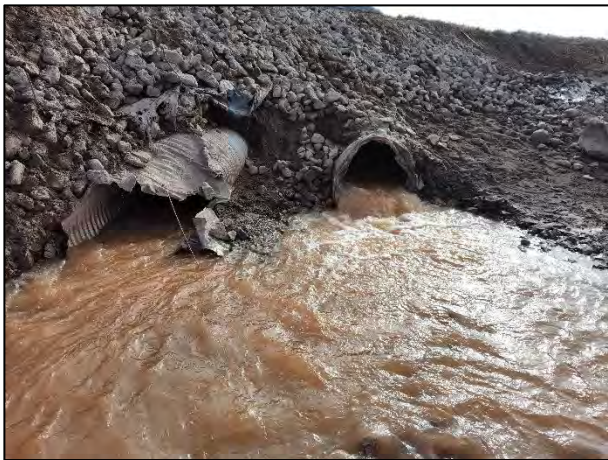
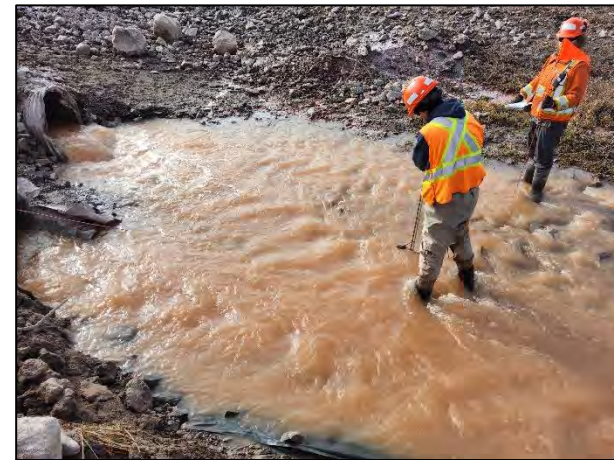
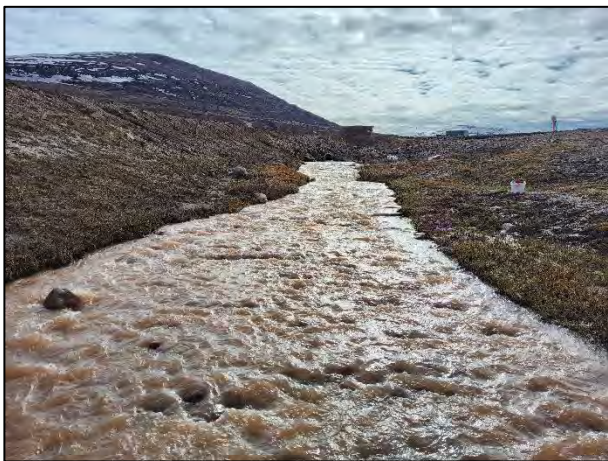
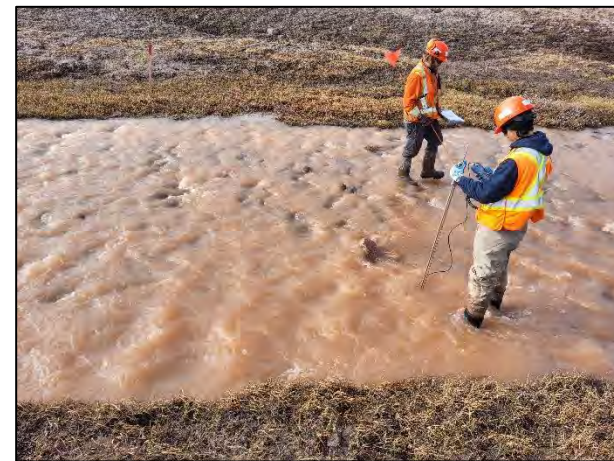
Photos 1-1. Photos taken 20 m downstream (top) and 60 m downstream (bottom) in spring 2023: (A,D) facing upstream; (B,E) facing downstream; and (C,F) across (left bank looking at right bank).

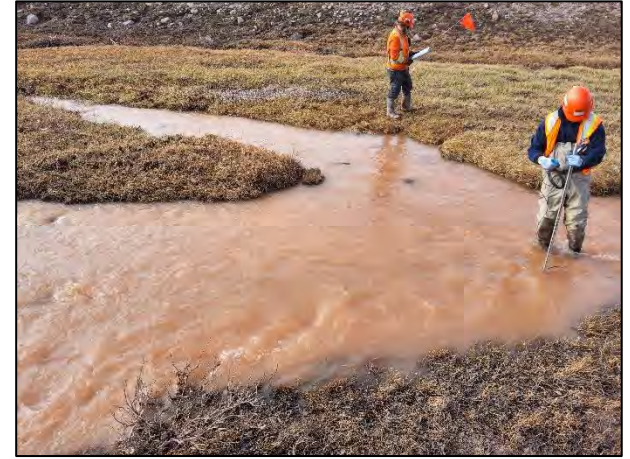
Photos 1-2. Photos taken 100 m downstream in spring 2023: (A) facing upstream; (B) facing downstream; and (C) across (left bank looking at right bank).
