TOTE ROAD CV-187

LOCATION AND CROSSING DESCRIPTION

BAFFINLAND IRON MINES
MARY RIVER PROJECT

**North/South Consultants Inc.**
Aquatic Environment Specialists

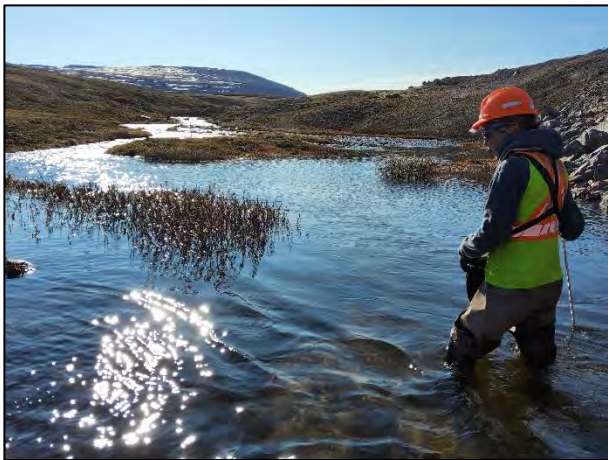
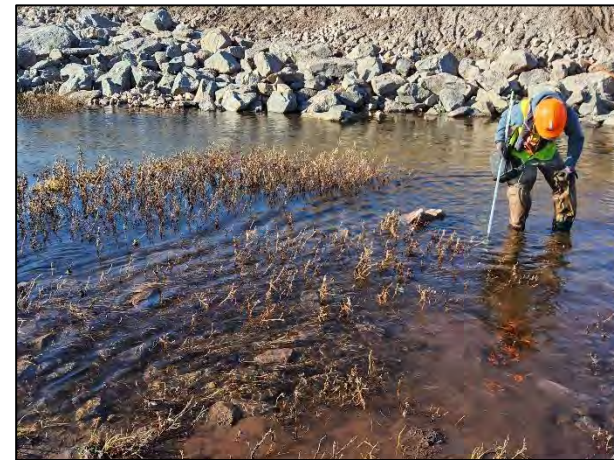
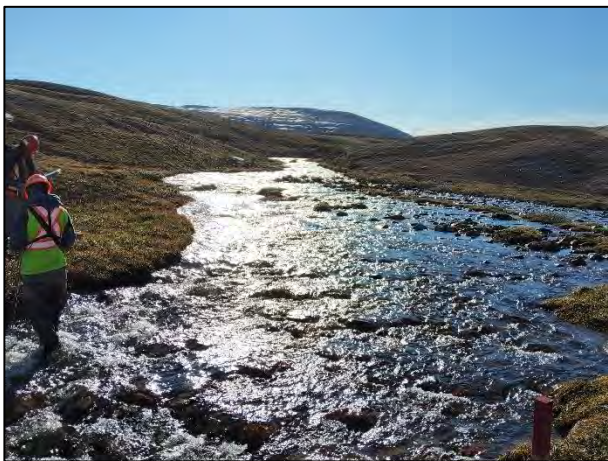
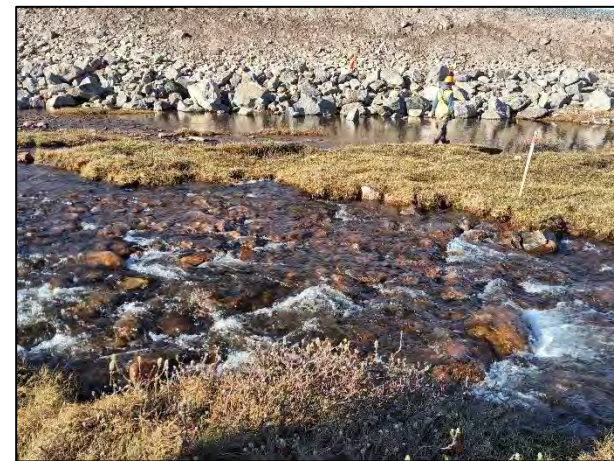
Photos 1-3. Photos taken 20 m upstream (top) and 60 m upstream (bottom) in spring 2023: (A,D) facing upstream; (B,E) facing downstream; and (C,F) across (left bank looking at right bank).

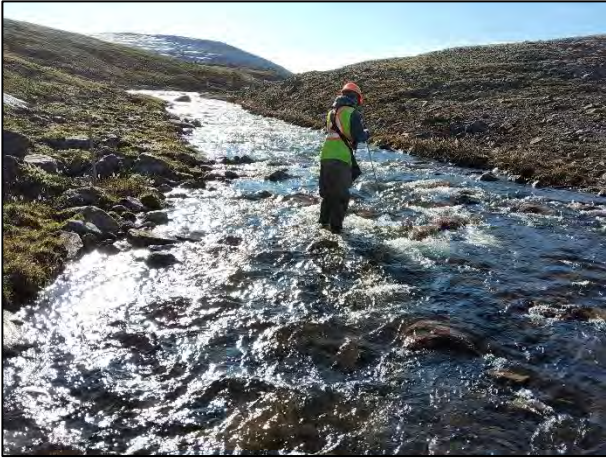
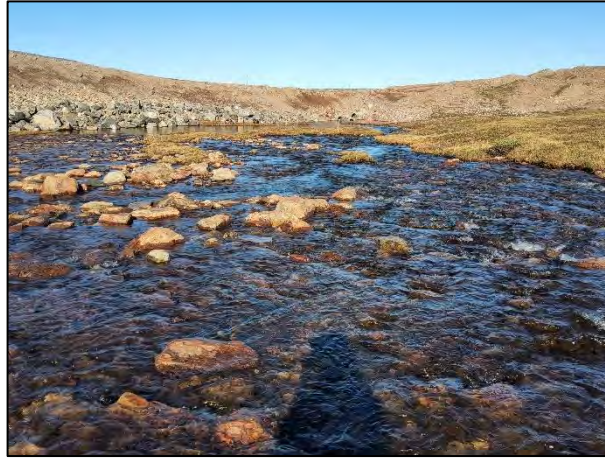
Photos 1-4. Photos taken 100 m upstream in spring 2023: (A) facing upstream; (B) facing downstream; and (C) across (left bank looking at right bank).

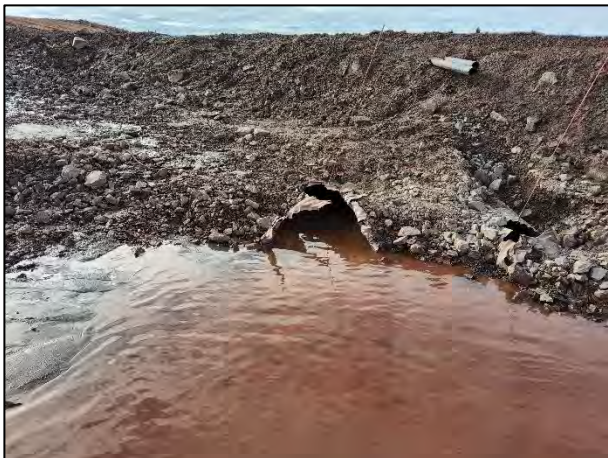
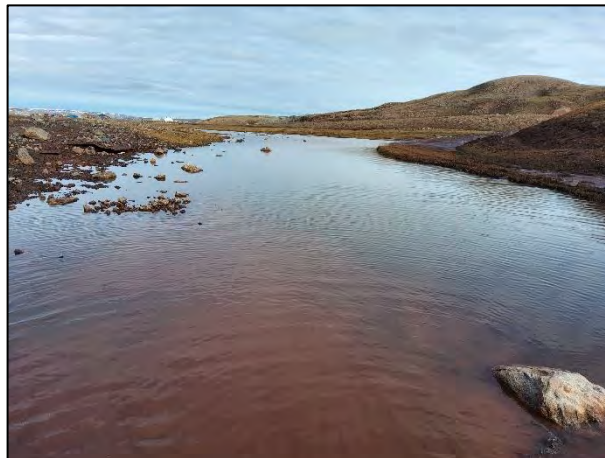
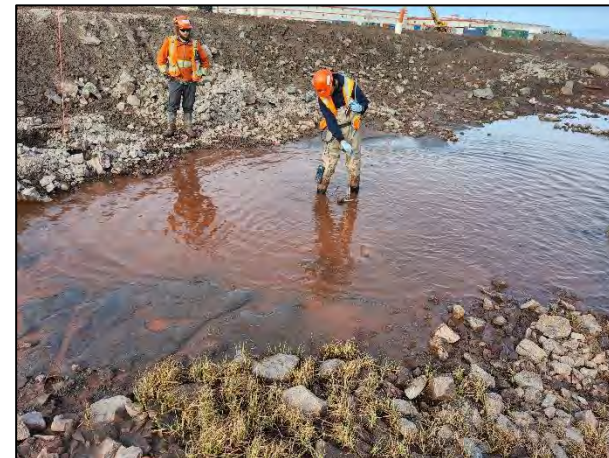
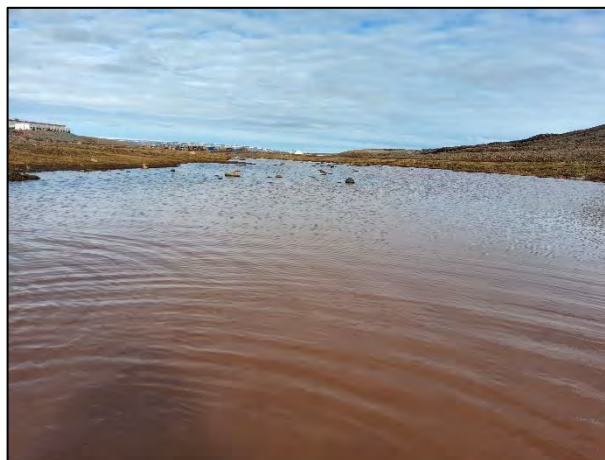
Photos 1-1. Photos taken 20 m downstream (top) and 60 m downstream (bottom) in spring 2023: (A,D) facing upstream; (B,E) facing downstream; and (C,F) across (left bank looking at right bank).

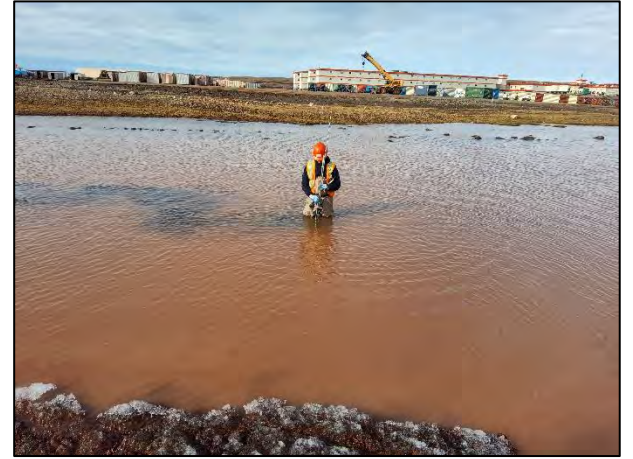
Photos 1-2. Photos taken 100 m downstream in spring 2023: (A) facing upstream; (B) facing downstream; and (C) across (left bank looking at right bank).

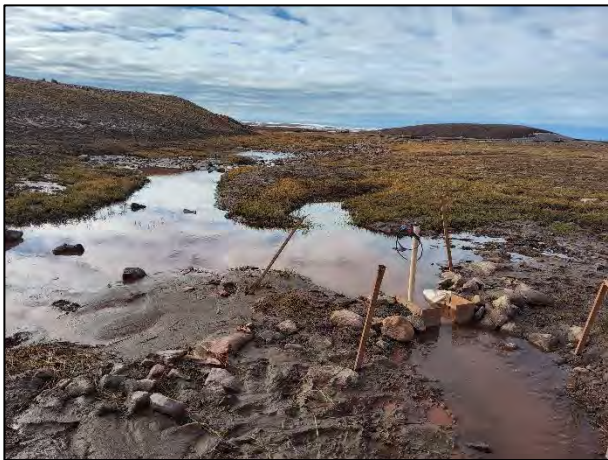
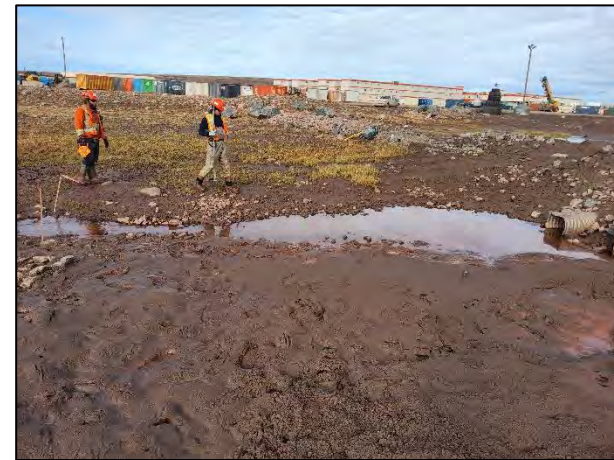
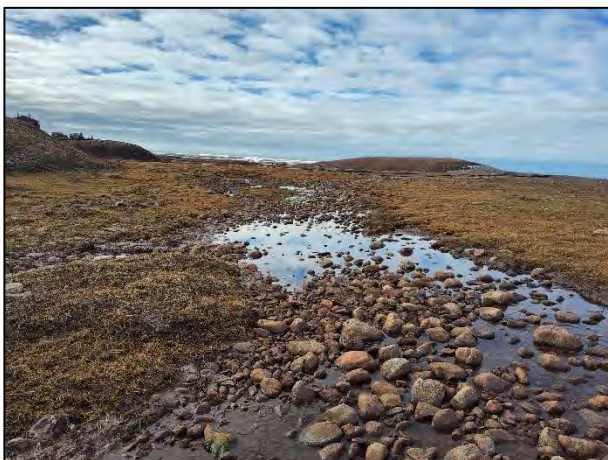
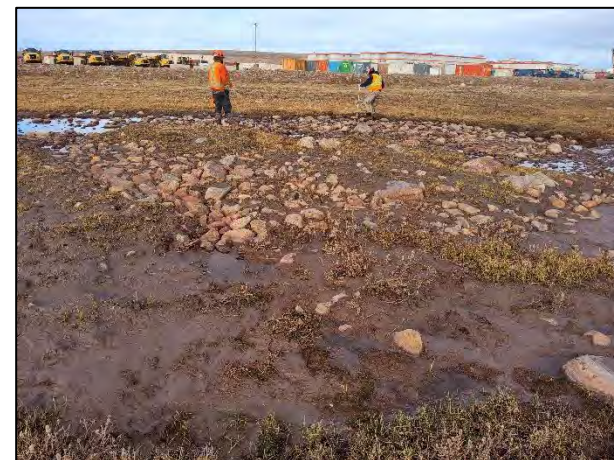
Photos 1-3. Photos taken 20 m upstream (top) and 60 m upstream (bottom) in spring 2023: (A,D) facing upstream; (B,E) facing downstream; and (C,F) across (left bank looking at right bank).

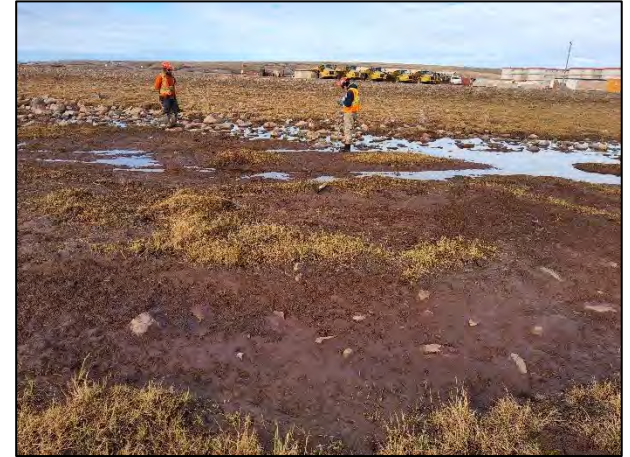
Photos 1-4. Photos taken 100 m upstream in spring 2023: (A) facing upstream; (B) facing downstream; and (C) across (left bank looking at right bank).

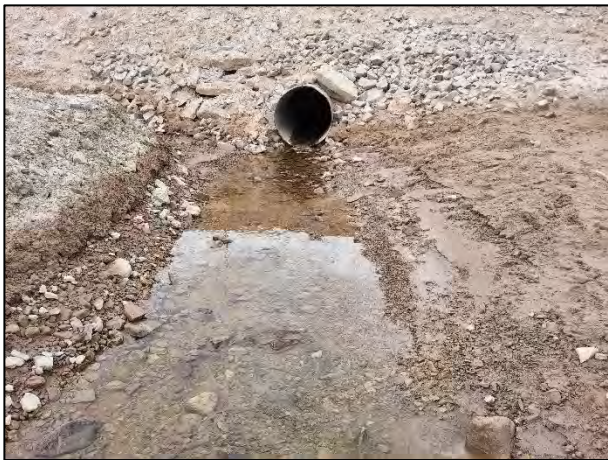
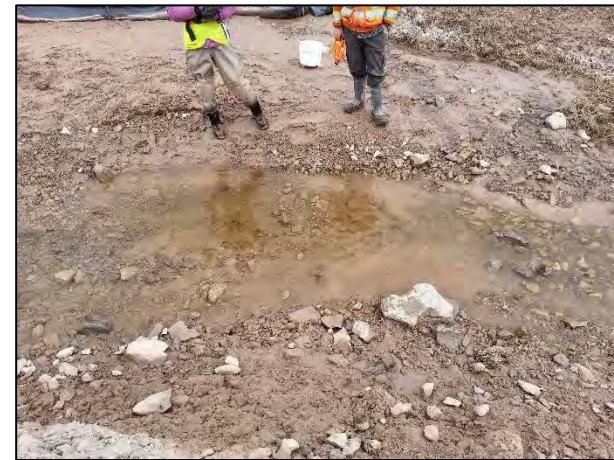
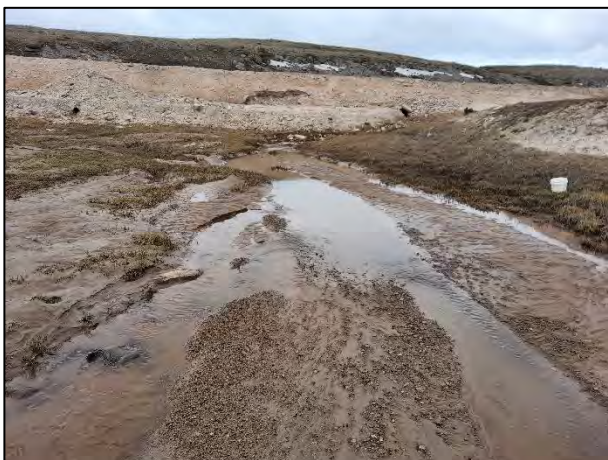
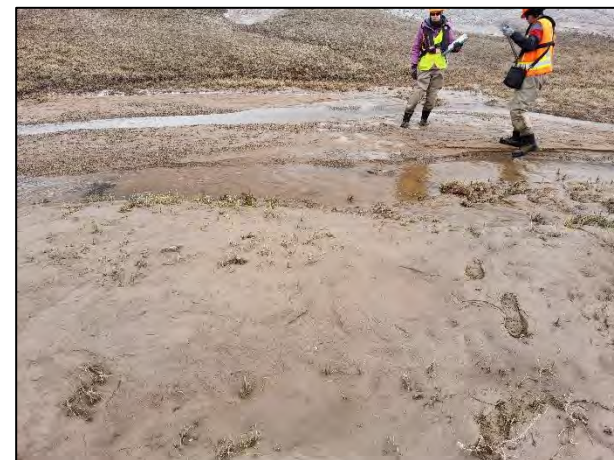
Photos 1-1. Photos taken 20 m downstream (top) and 60 m downstream (bottom) in spring 2023: (A,D) facing upstream; (B,E) facing downstream; and (C,F) across (right bank looking at left bank).

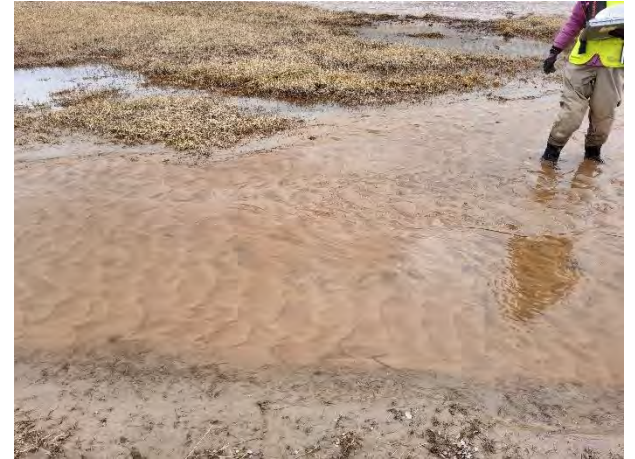
Photos 1-2. Photos taken 100 m downstream in spring 2023: (A) facing upstream; (B) facing downstream; and (C) across (right bank looking at left bank).

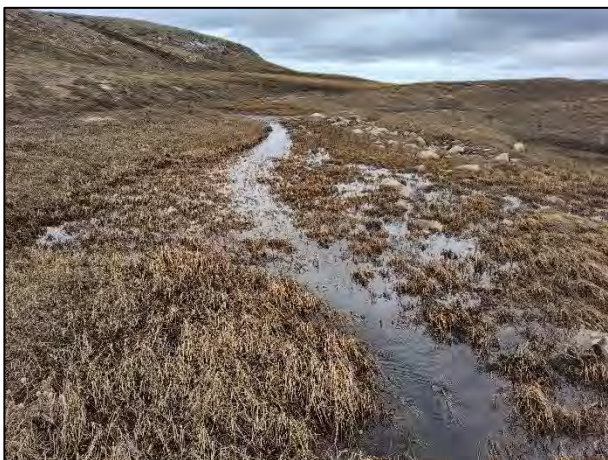
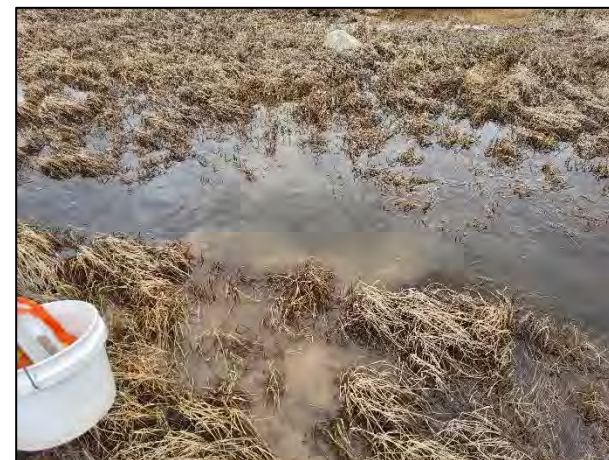
Photos 1-3. Photos taken 20 m upstream (top) and 60 m upstream (bottom) in spring 2023: (A,D) facing upstream; (B,E) facing downstream; and (C,F) across (left bank looking at right bank).

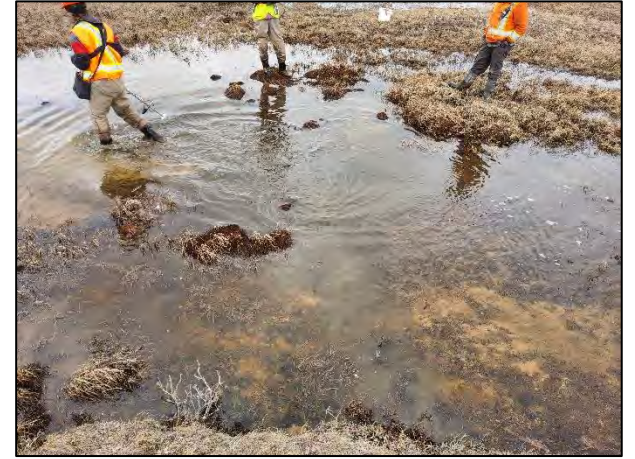
Photos 1-4. Photos taken 100 m upstream in spring 2023: (A) facing upstream; (B) facing downstream; and (C) across (left bank looking at right bank).

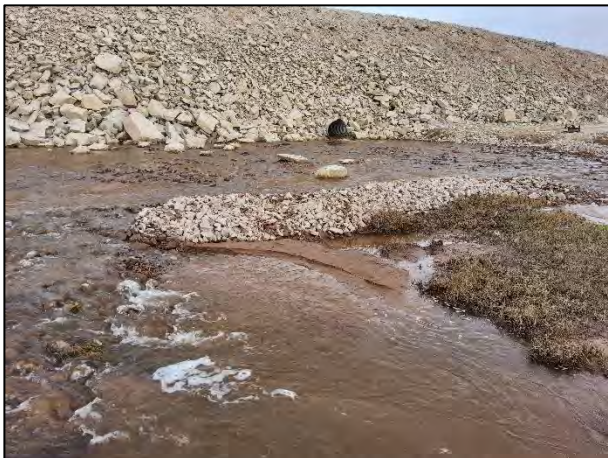
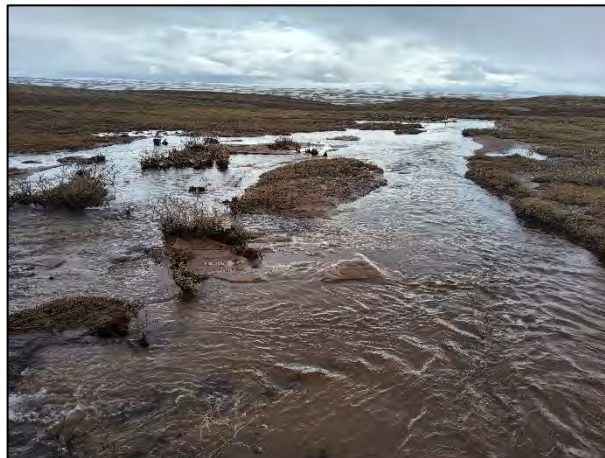
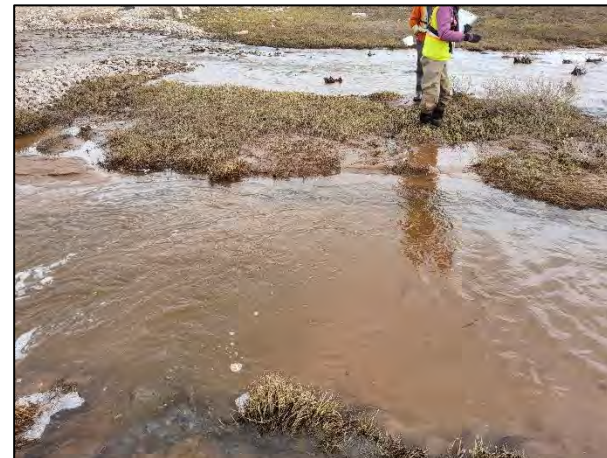
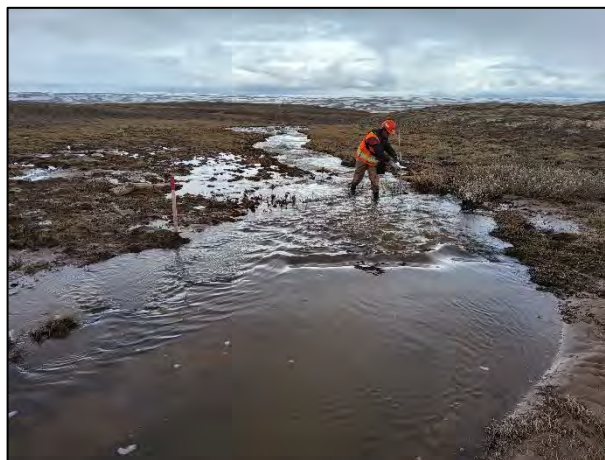
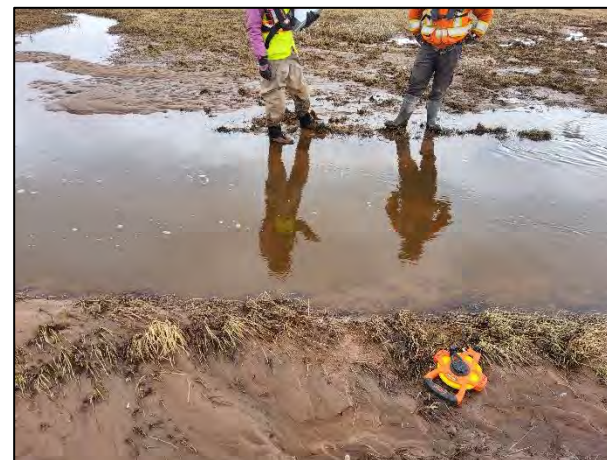
Photos 1-1. Photos taken 20 m downstream (top) and 60 m downstream (bottom) in spring 2023: (A,D) facing upstream; (B,E) facing downstream; and (C,F) across (right bank looking at left bank).

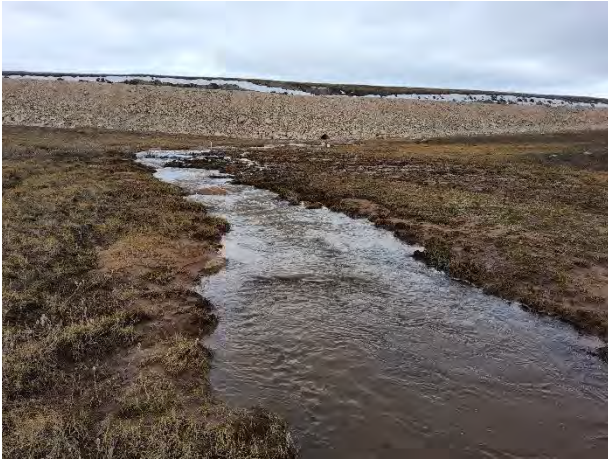
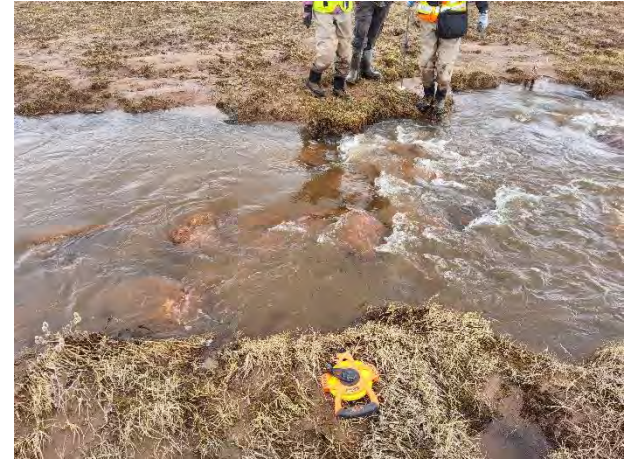
Photos 1-2. Photos taken 100 m downstream in spring 2023: (A) facing upstream; (B) facing downstream; and (C) across (right bank looking at left bank).

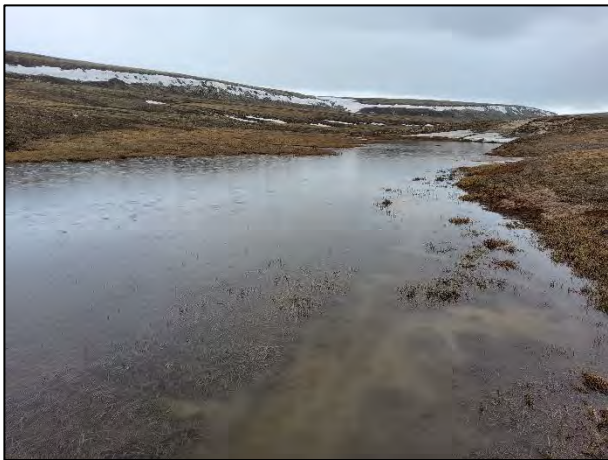
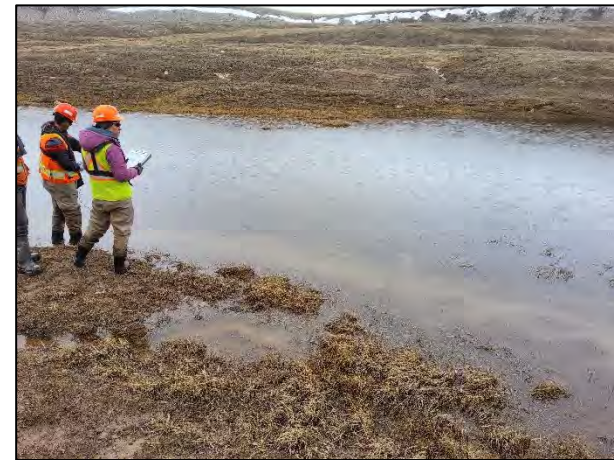
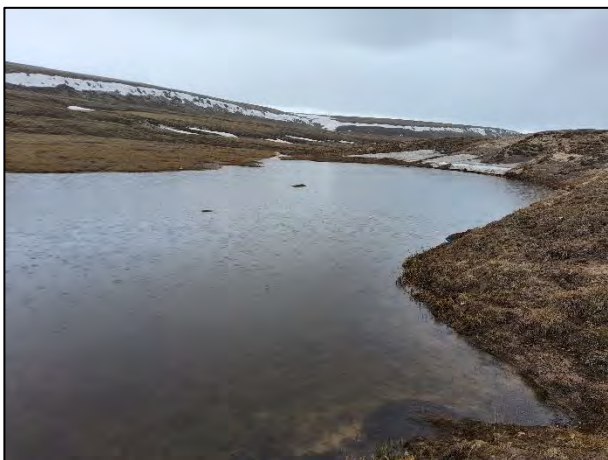
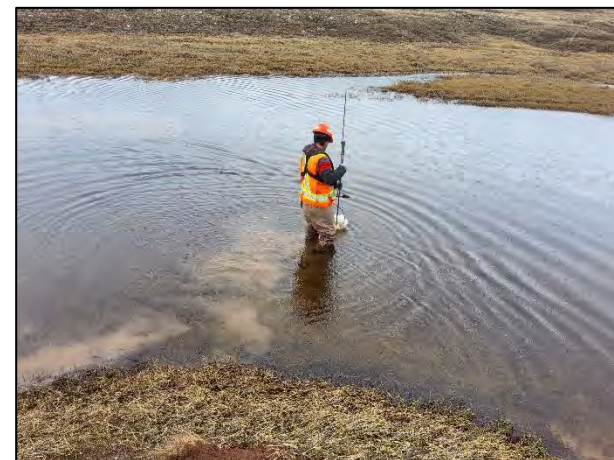
Photos 1-3. Photos taken 60 m upstream (top) and 100 m upstream (bottom) in spring 2023: (A,D) facing upstream; (B,E) facing downstream; and (C,F) across (left bank looking at right bank).

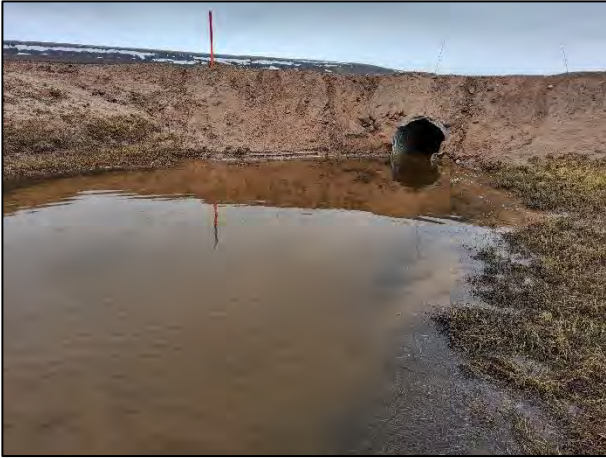
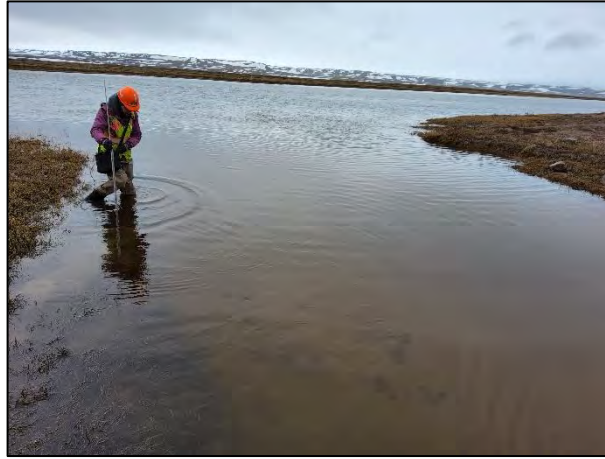
Photos 1-1. Photos taken 20 m downstream in spring 2023: (A) facing upstream; (B) facing downstream; and (C) across (right bank looking at left bank).

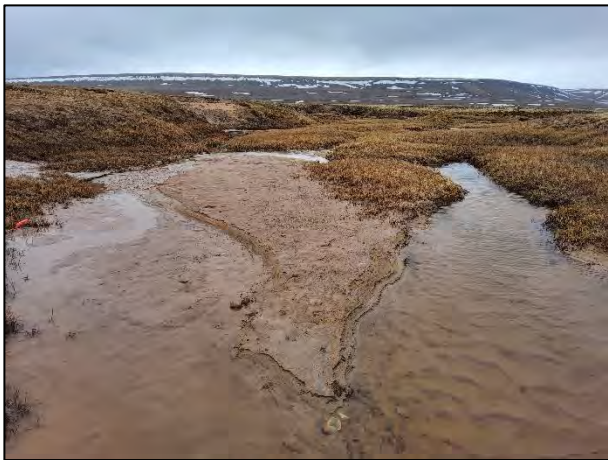
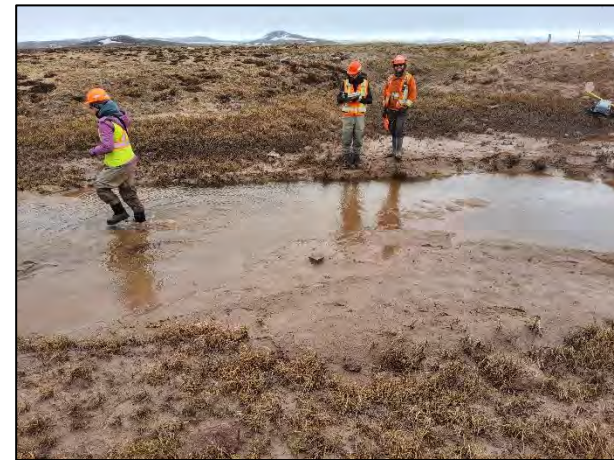
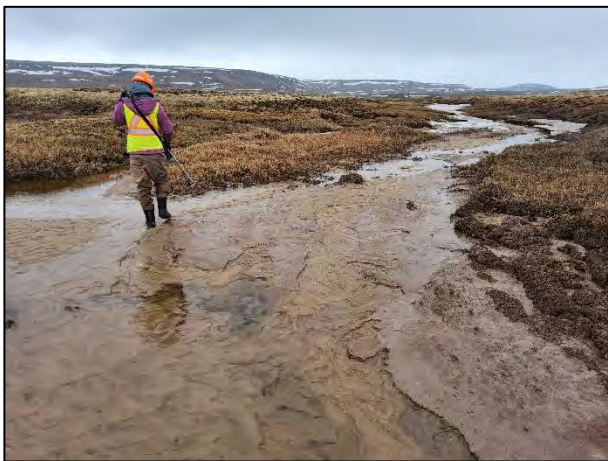
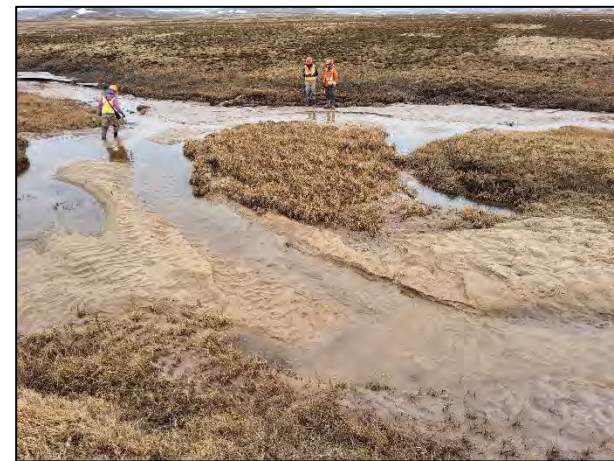
Photos 1-2. Photos taken 20 m upstream (top) and 60 m upstream (bottom) in spring 2023: (A,D) facing upstream; (B,E) facing downstream; and (C,F) across (right bank looking at left bank).

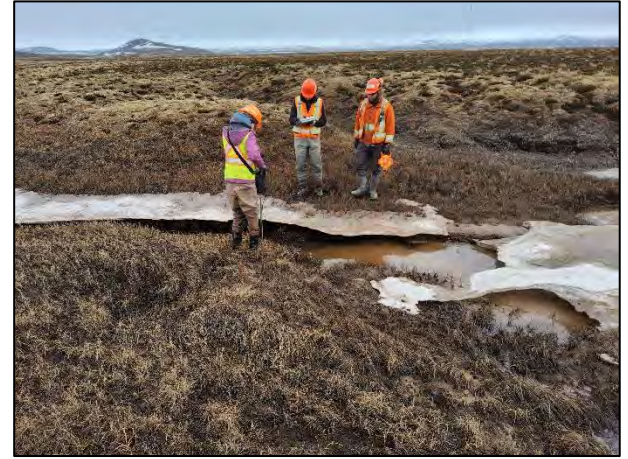
Photos 1-3. Photos taken 100 m upstream in spring 2023: (A) facing upstream; (B) facing downstream; and (C) across (right bank looking at left bank).

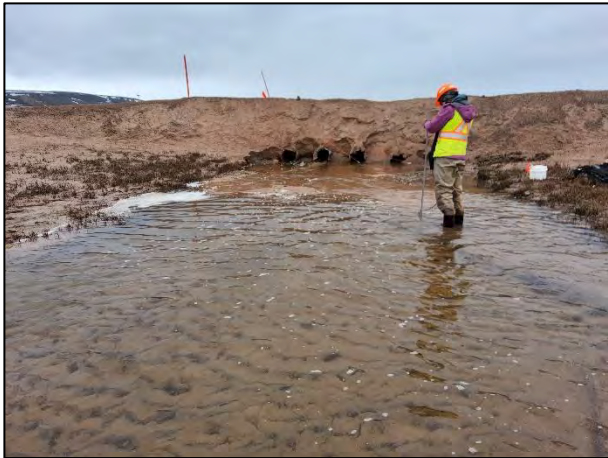
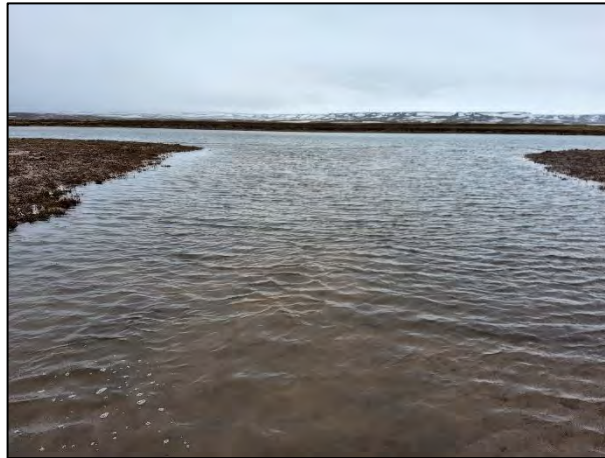
Photos 1-1. Photos taken 20 m downstream in spring 2023: (A,D) facing upstream; (B,E) facing downstream; and (C,F) across (left bank looking at right bank).

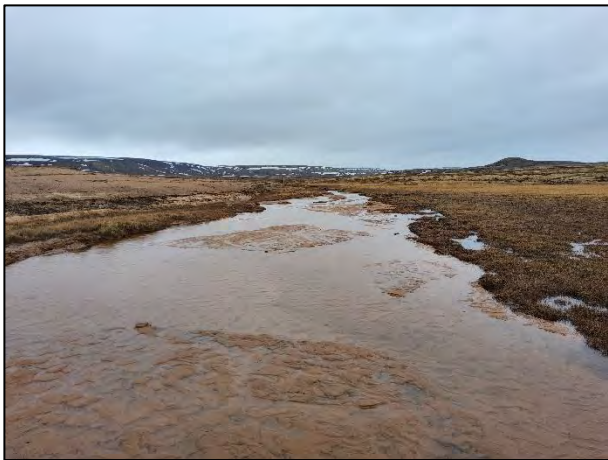
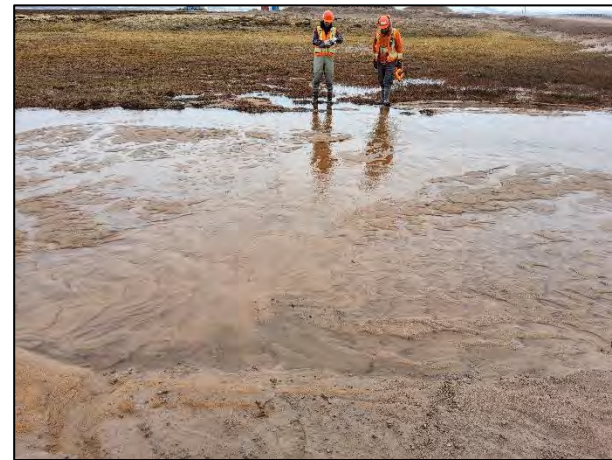
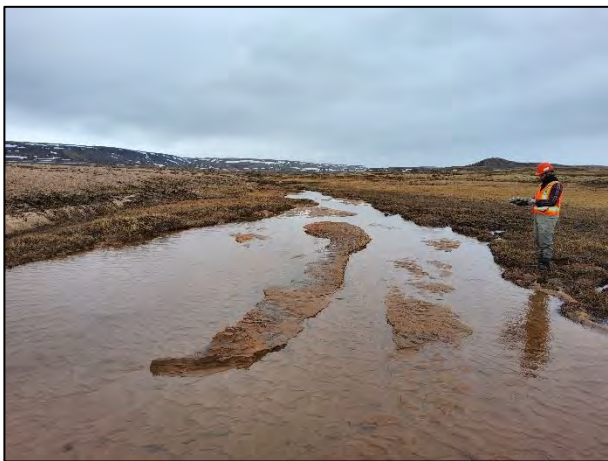
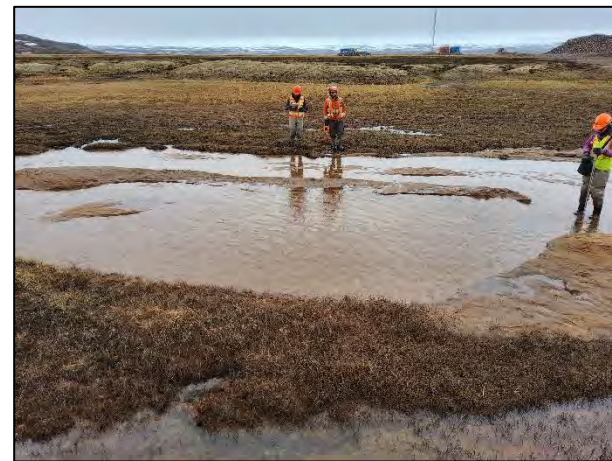
Photos 1-2. Photos taken 20 m upstream (top) and 60 m upstream (bottom) in spring 2023: (A,D) facing upstream; (B,E) facing downstream; and (C,F) across (left bank looking at right bank).

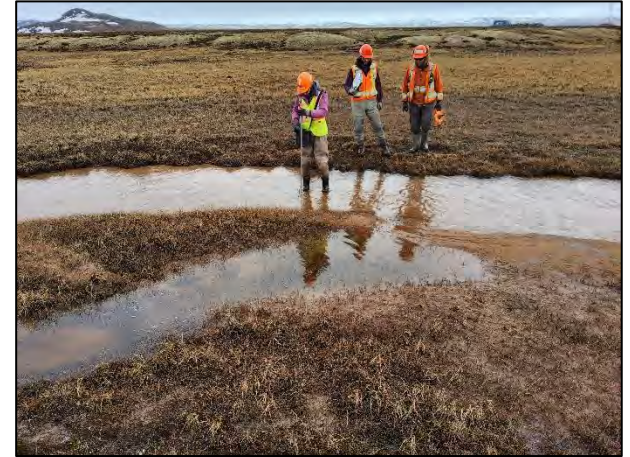
Photos 1-3. Photos taken 100 m upstream in spring 2023: (A) facing upstream; (B) facing downstream; and (C) across (left bank looking at right bank).

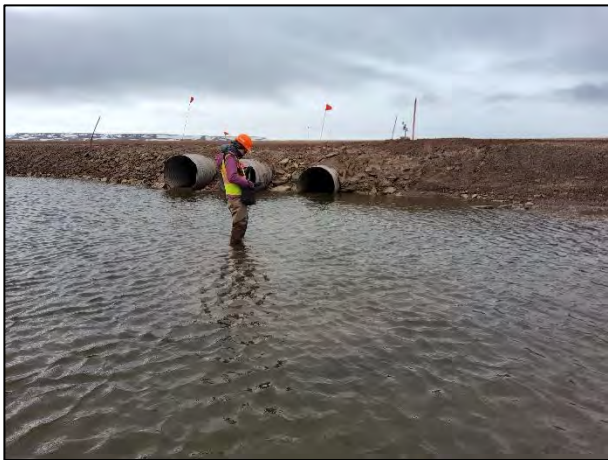
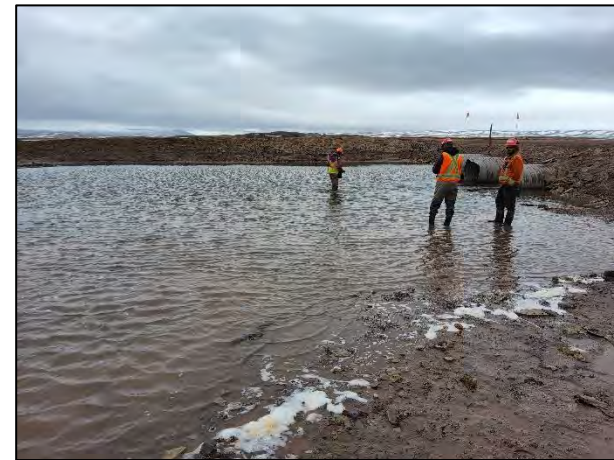
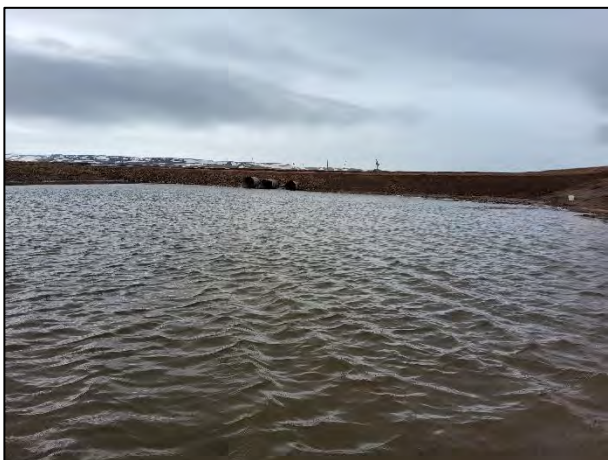
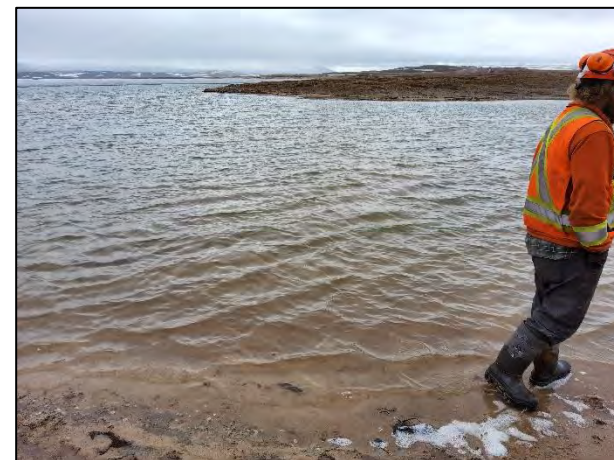
Photos 1-1. Photos taken 20 m downstream (top) and 60 m downstream (bottom) in spring 2023: (A,D) facing upstream; (B,E) facing downstream; and (C,F) across (right bank looking at left bank).

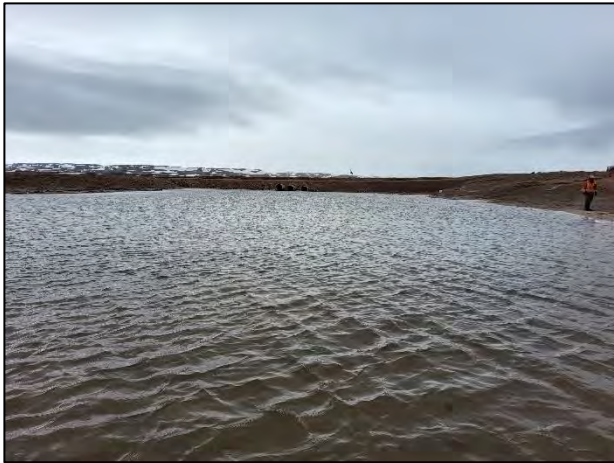
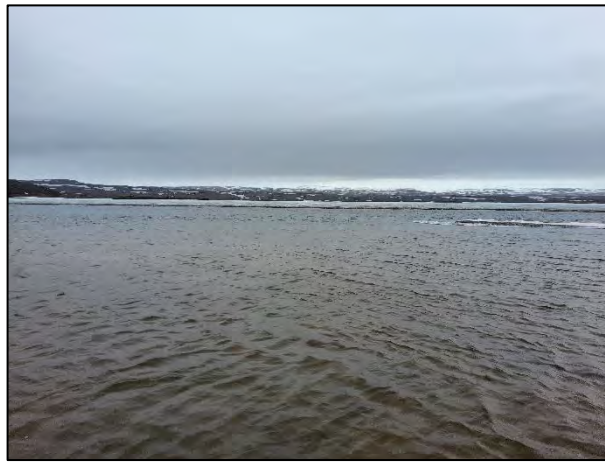
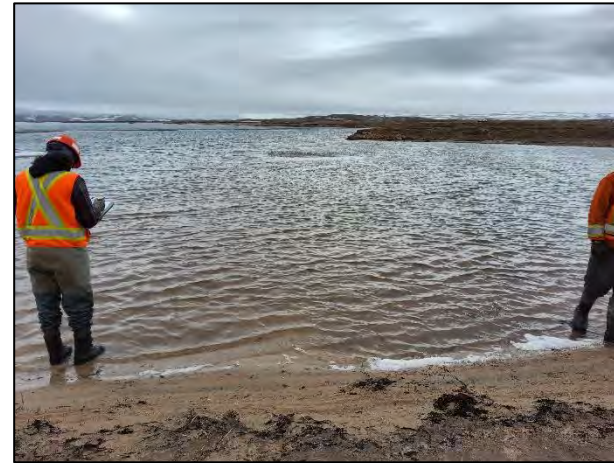
Photos 1-2. Photos taken 100 m downstream in spring 2023: (A) facing upstream; (B) facing downstream; and (C) across (right bank looking at left bank).

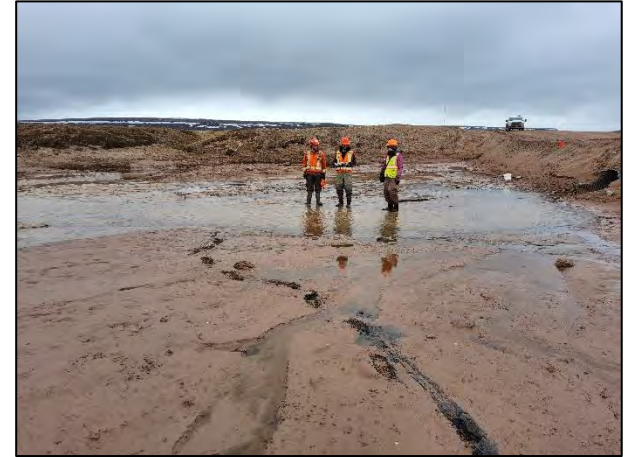
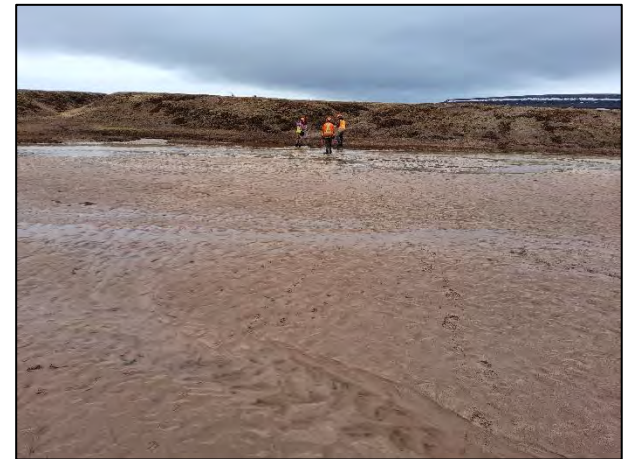
Photos 1-3. Photos taken 20 m upstream (top) and 60 m upstream (bottom) in spring 2023: (A,D) facing upstream; (B,E) facing downstream; and (C,F) across (left bank looking at right bank).

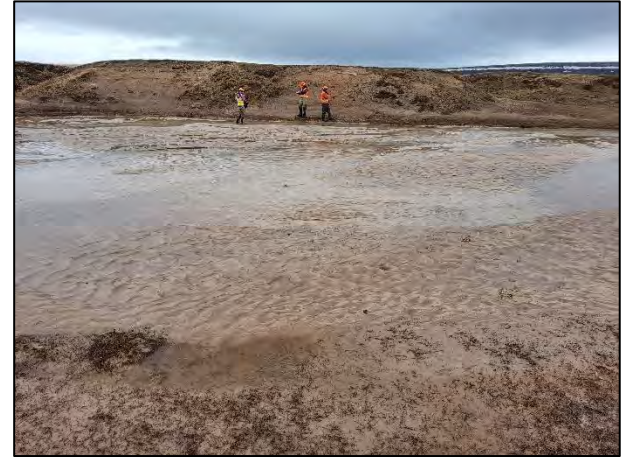
Photos 1-4. Photos taken 100 m upstream in spring 2023: (A) facing upstream; (B) facing downstream; and (C) across (left bank looking at right bank).

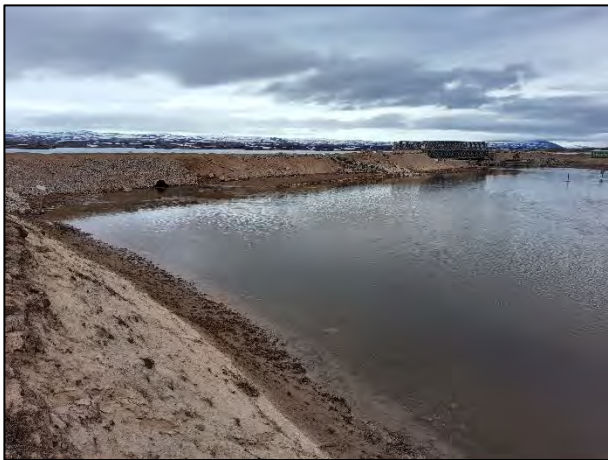
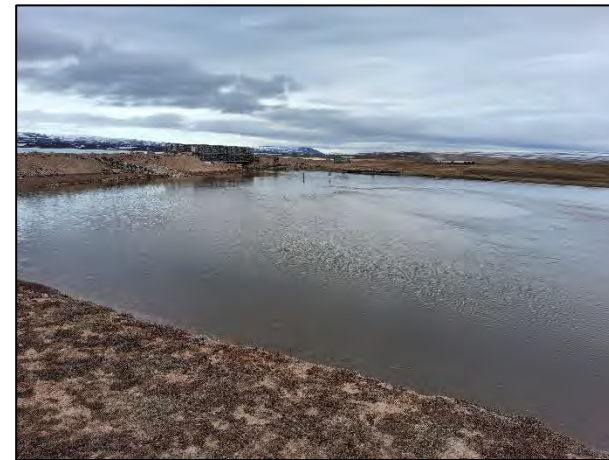
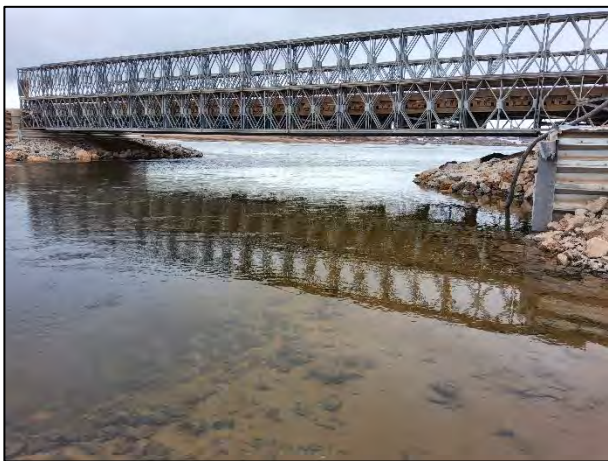
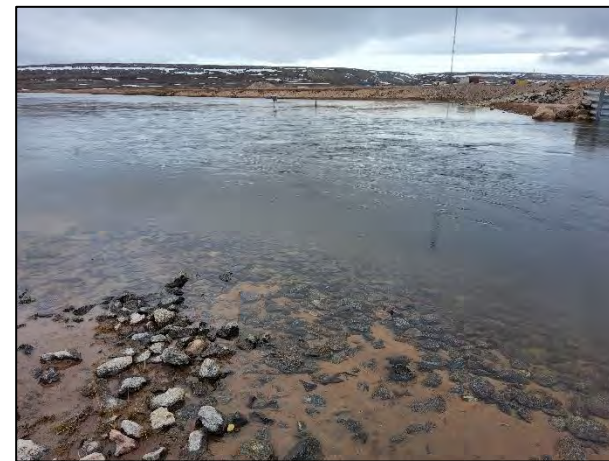
Photos 1-1. Photos taken from left-hand bank (top) and right-hand bank (bottom) in spring 2023: (A,D) facing upstream; (E) facing downstream; and (C,F) across (left bank looking at right bank).

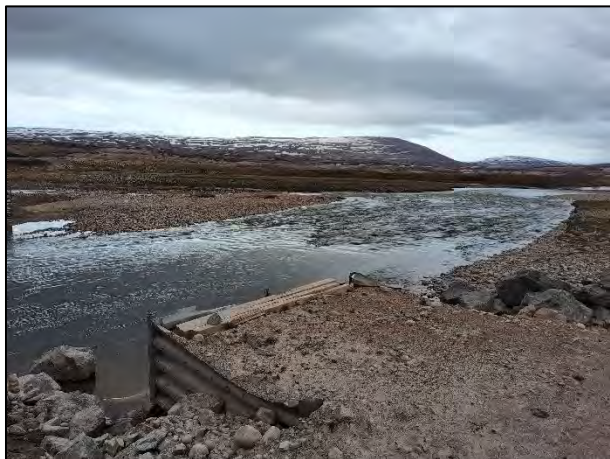
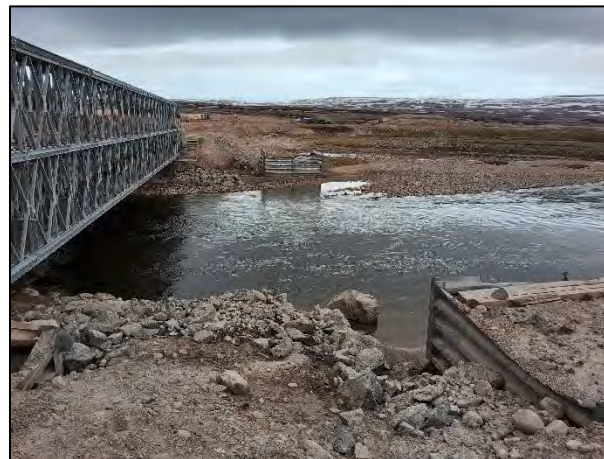
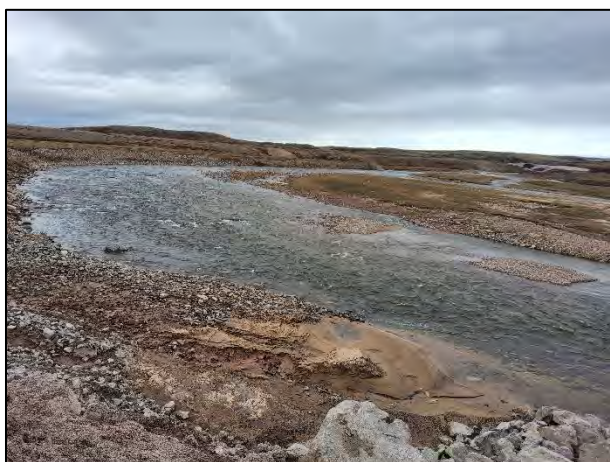
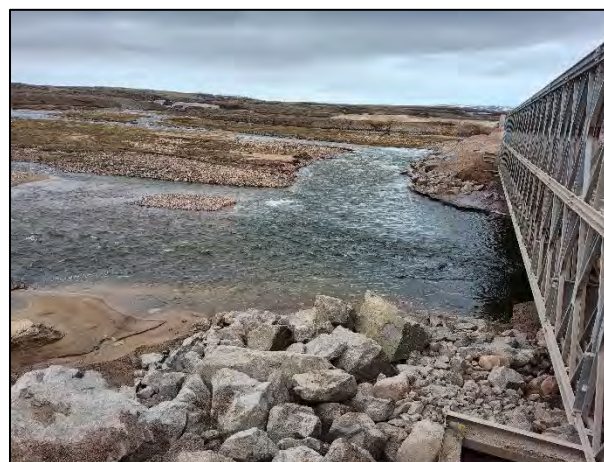
Photos 1-1. Photos taken 20 m downstream (top) and 20 m upstream (bottom) in spring 2023: (A) facing downstream; (C) facing upstream; and (B,D) across (left bank looking at right bank).

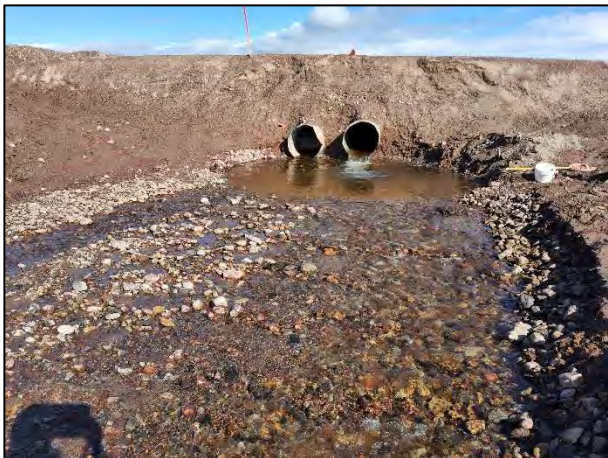
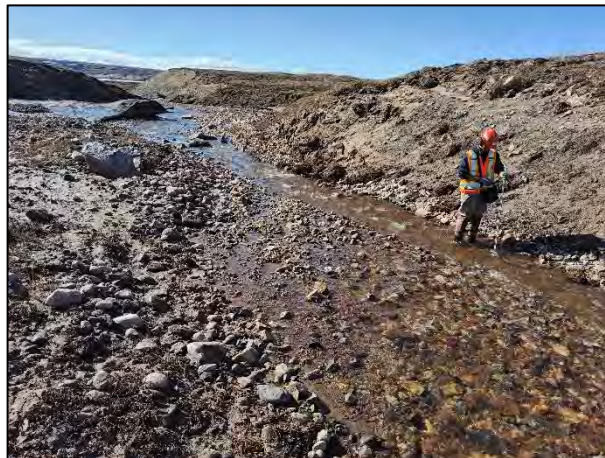
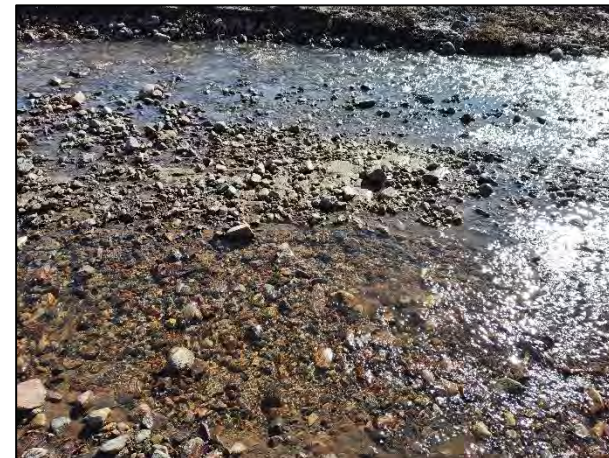
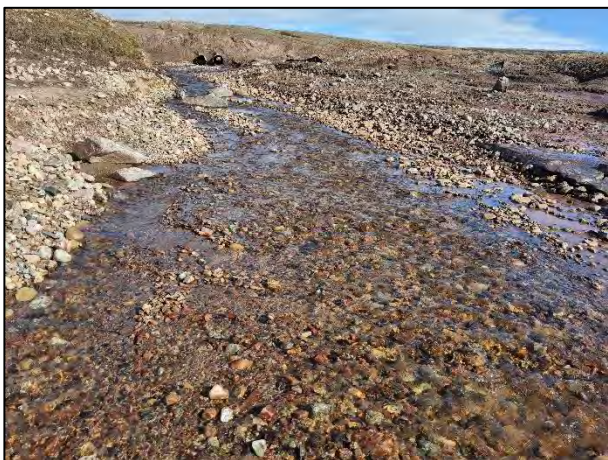
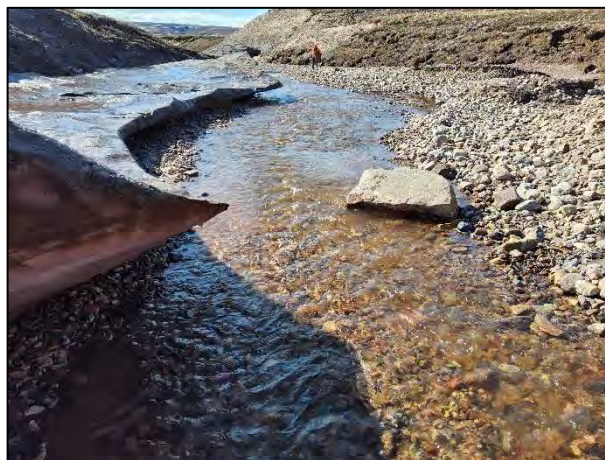
Photos 1-1. Photos taken 20 m downstream (top) and 60 m downstream (bottom) in spring 2023: (A,D) facing upstream; (B,E) facing downstream; and (C,F) across (left bank looking at right bank).

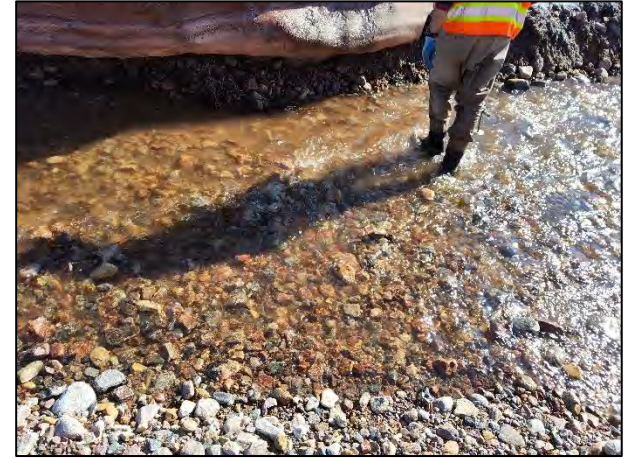
Photos 1-2. Photos taken 100 m downstream in spring 2023: (A) facing upstream; (B) facing downstream; and (C) across (left bank looking at right bank).

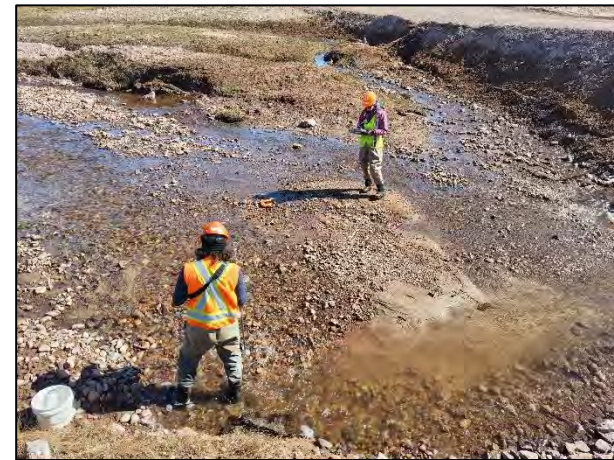
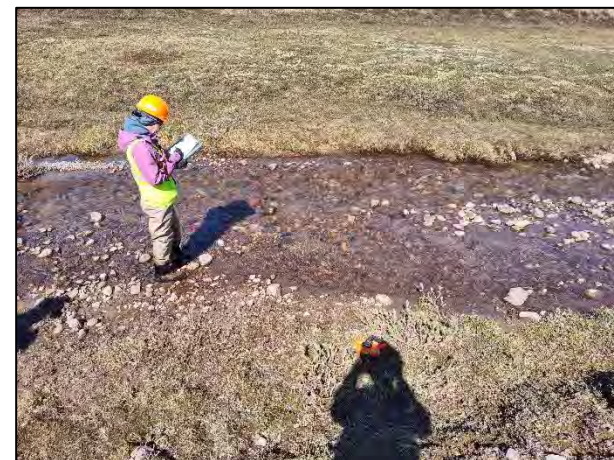
Photos 1-3. Photos taken 20 m upstream (top) and 60 m upstream (bottom) in spring 2023: (A,D) facing upstream; (B,E) facing downstream; and (C,F) across (left bank looking at right bank).

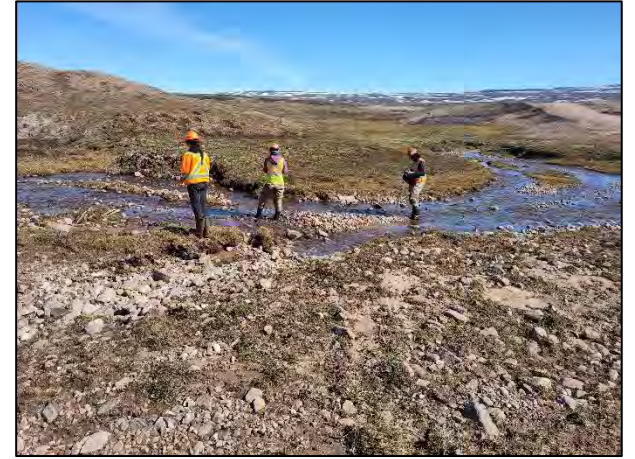
Photos 1-4. Photos taken 100 m upstream in spring 2023: (A) facing upstream; (B) facing downstream; and (C) across (left bank looking at right bank).
